NATIONAL TRANSPORTATION SAFETY BOARD
Office of Aviation Safety
Washington, D.C. 20594

AIRWORTHINESS GROUP CHAIRMAN'S FACTUAL REPORT

NTSB No: ERA17MA316

Operator: Duke University Health System
Aircraft: N146DU / Eurocopter Deutschland GMBH MBB-BK-117-C2
Location: Herford, NC
Date: September 8, 2017
Time: 1120 EDT

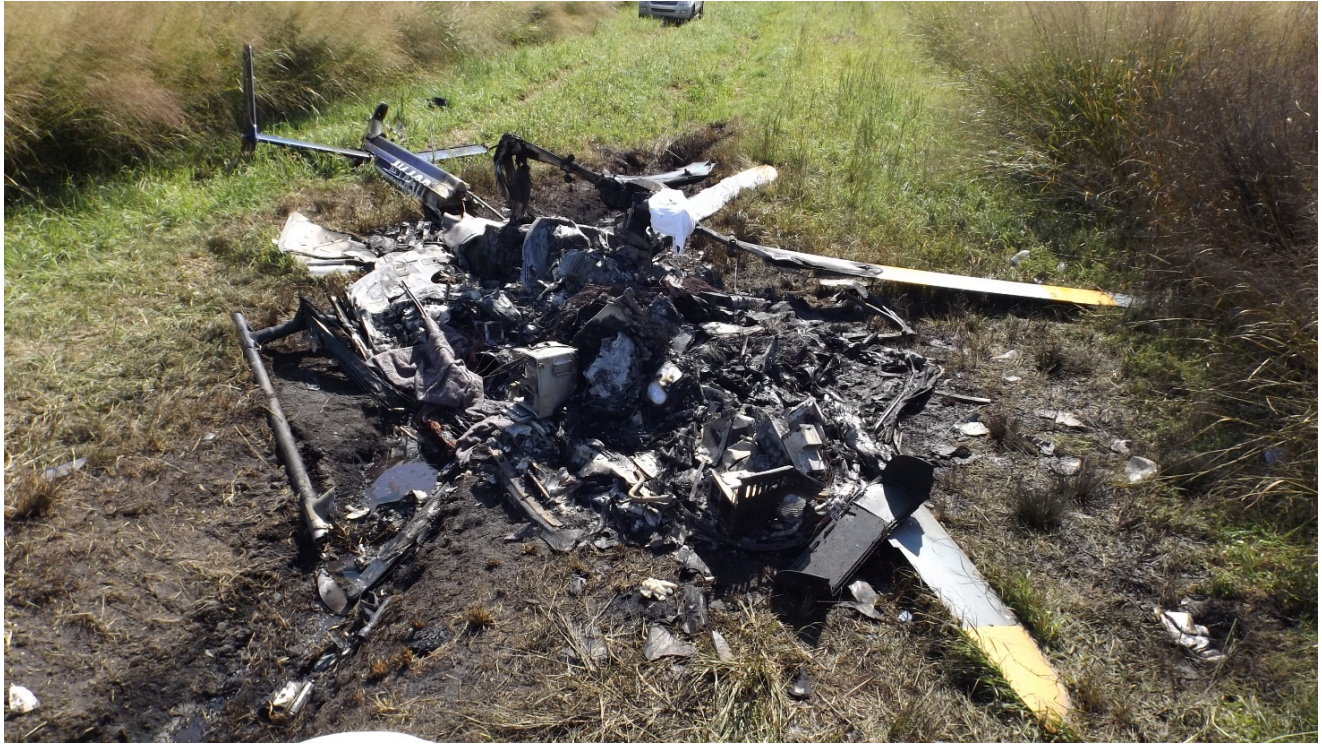
The cockpit and cabin were completely consumed by a postcrash fire. The upper fuselage had collapsed in to the cabin area. The tail boom was in line with the fuselage and exhibited thermal damage at the interface at the transition between the aft fuselage and tailboom, which appeared to effectively separate the tail boom from the postcrash fire. The surviving components of the landing skids were splayed outward and fragmented. Two fire bottles were heat damaged. Each bottle had two discharge ports. The squib on the right discharge port on each had been melted away, and remnants of each squib were near the bottles. The squibs on the left port of each bottle were still attached to their ports.

Photo 1 - Main wreckage viewed from the front of the helicopter.

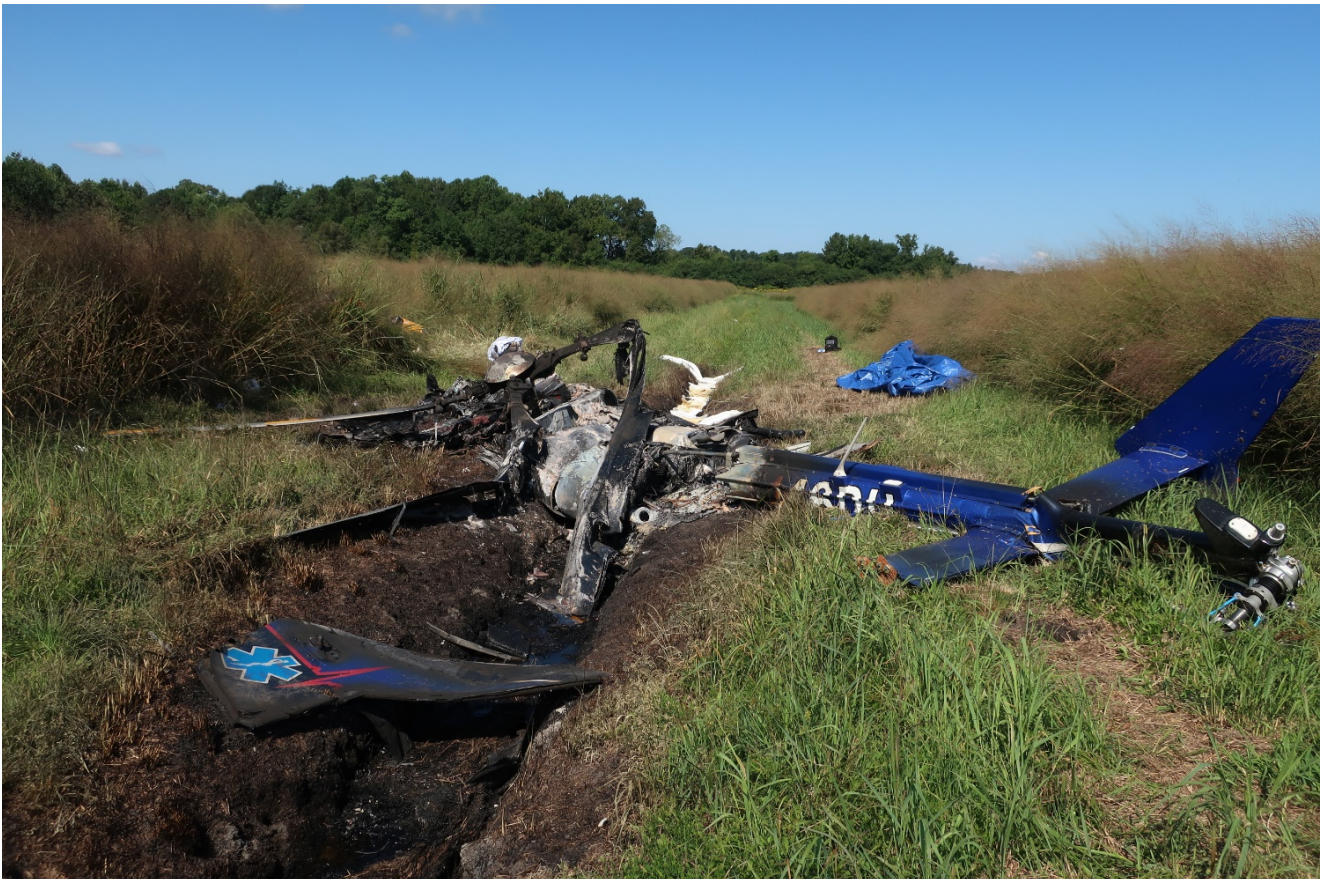
Photo 2 - Main wreckage viewed from the aft left quadrant.

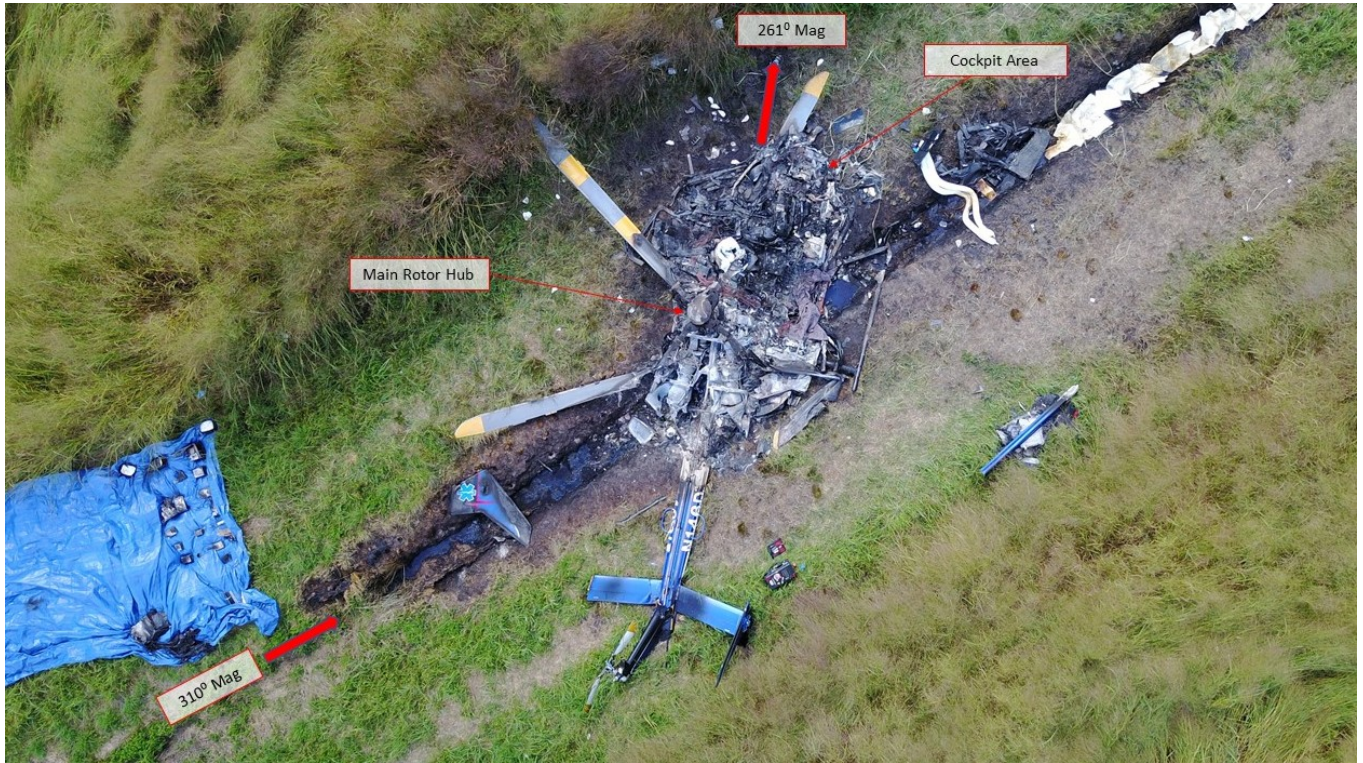
Photo 3 - Wreckage overhead view.

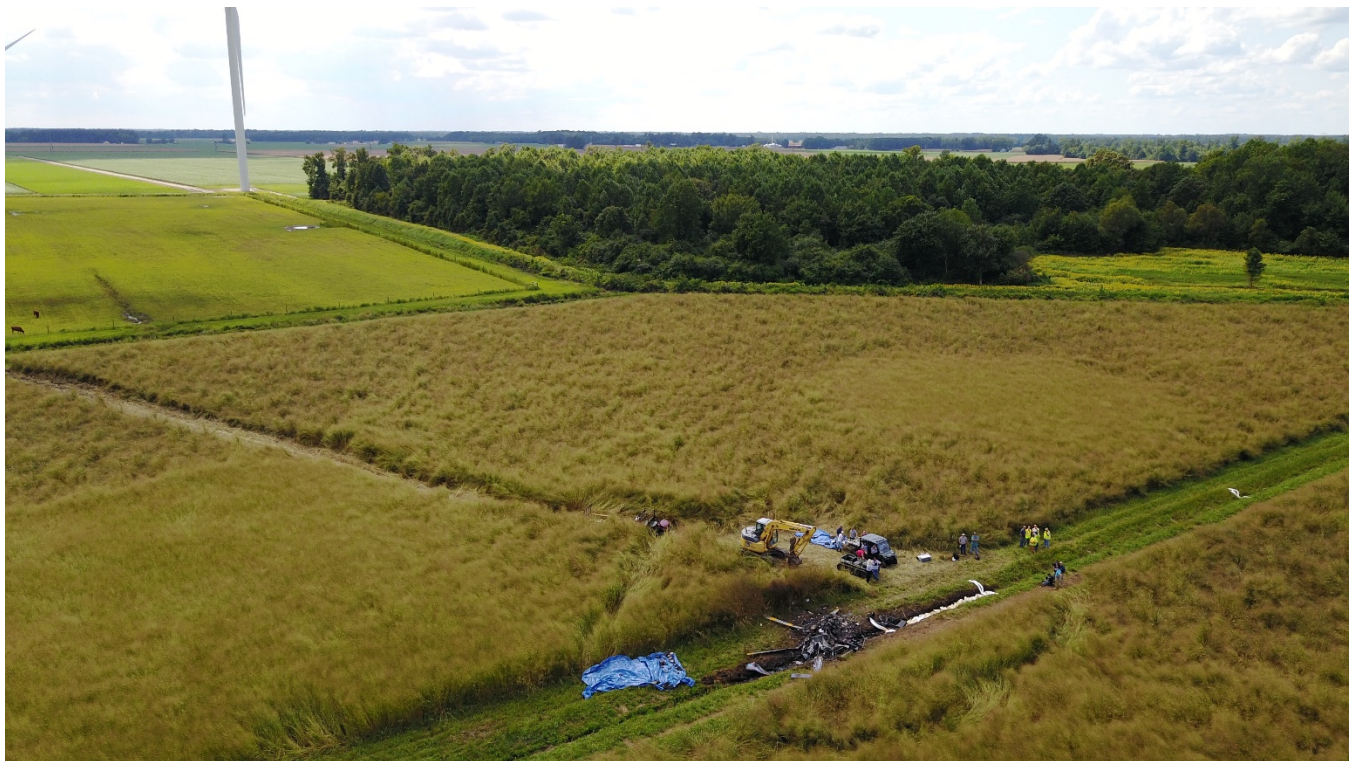
The wreckage was located 12 miles west of Elizabeth City, NC, in a field of 8-foot-tall switch grass, and populated with approximately 300 foot tall electric power wind farm towers. The area immediately around the wreckage had been maintained by mowed grass along a 7-foot-wide and 2.5 foot deep drainage ditch which was oriented along a 310° - 130° magnetic bearing. The helicopter was positioned directly over the drainage ditch oriented from tail to nose on a 261° magnetic bearing. The helicopter had been involved in a postcrash fire that consumed the majority of the cockpit, cabin, engine & transmission bays, and fuselage. The tail boom aft of the rear portion of the main fuselage remained oriented with the centerline of the helicopter and had experienced less thermal damage. The rotor blades radiated from the center of the wreckage and the green blade laid in 8 foot tall switch grass that was undisturbed on either side of it.

Photo 4 - Terrain surrounding accident site.

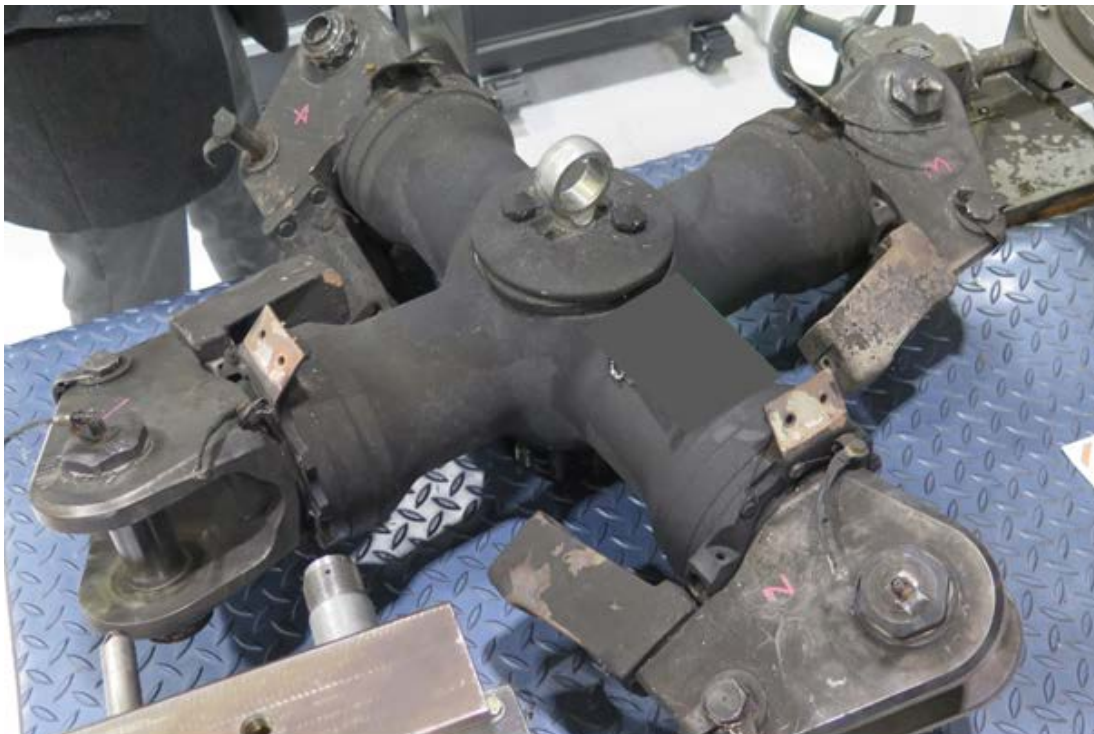
All 4 blade mounting forks were in their respective rotor arm. The number 4 blade (green) was rotated 150° counterclockwise (ccw), as viewed from the rotor blade tip towards the rotor head. The blade mounting fork was wedged into the circular end of the rotor arm. The rotor head cover, o-ring, lower cover, nut plate, and nut were removed. The main bolt was removed. No evidence of oil leakage was observed on the exterior of the rotor hub. Oil was observed to drain out of the rotor head. No signs of moisture were observed in the oil. The tension-torsion (T-T) strap retaining pins were removed from all 4 rotor arms. The inner sleeve and blade mounting forks for blades 1,2, and 3 were removed. The T-T strap for each was in place. All T-T strap exterior plastic coatings exhibited some localized melting. The No. 4 blade mounting fork was moved out of its jammed position by using a mallet. The inner sleeve was removed. The T-T strap retained an 80°-90° ccw set twist (as viewed from the blade end looking towards the rotor hub). All blade grip sleeve bearings and rotor arm needle bearings were undamaged and coated with oil.

Photo 6 - Rotor head removed from rotor mast for examination⁴.

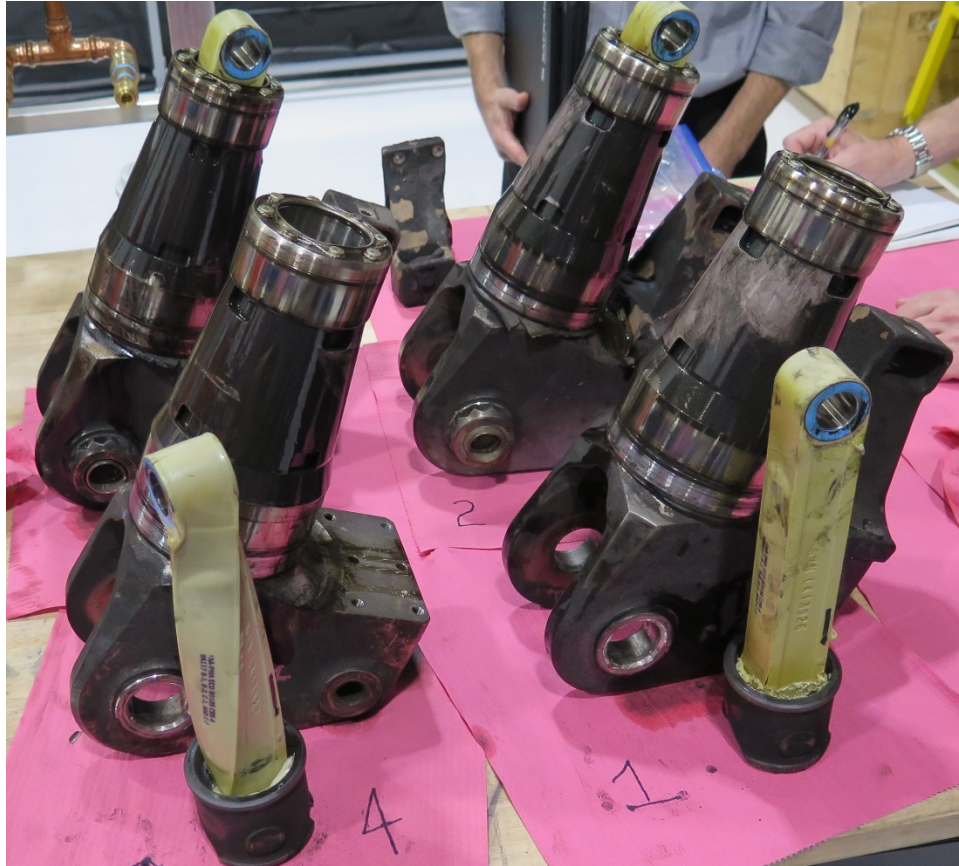
Photo 7 - Main rotor inner sleeve assemblies & T-T straps.

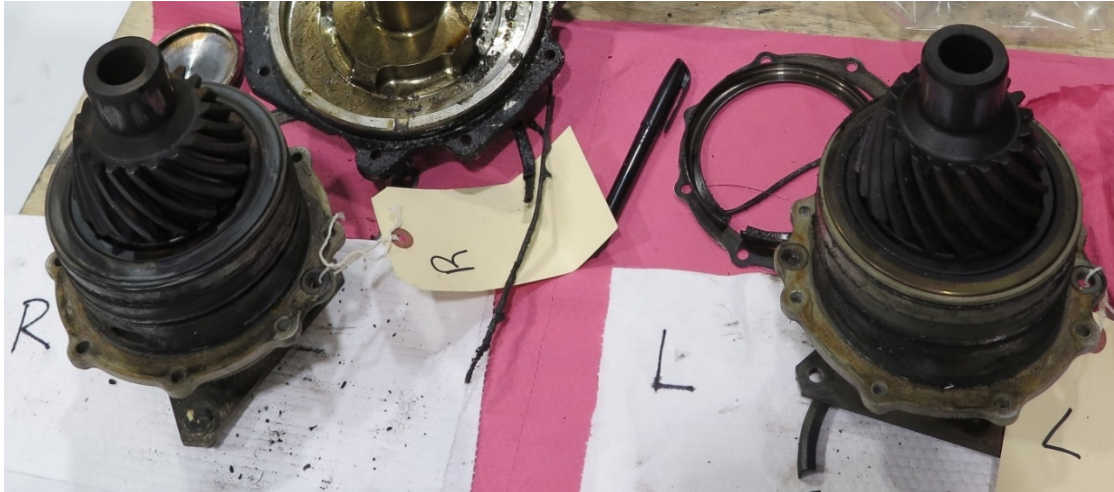
The bevel gear was discolored black with a flat dull surface appearance. The input bevel gear rotated in freewheel direction when rotated ccw by hand from the drive flange. The drive locked the bevel gear when rotated in the cw direction. The interior lip seal was melted. No oil was observed in the casing or on the bearings. The sprag bearing was removed. No scoring or damaged observed on the outer race with a smooth surface. The sprag elements were all present and held in place by the cage. No indications of sprag cage deformation were observed. No scoring was observed on the sprag elements. The interior retaining spring was in place and appeared undamaged. All interior roller bearings and ball bearings were visually examined and were seized.

The bevel gear was discolored black with a flat dull surface appearance. The input bevel gear rotated in freewheel direction when rotated ccw by hand from the drive flange. The flange could not be rotated in the cw direction. The interior lip seal was melted and fragmented. No oil observed in the casing or on the bearings. The sprag bearing was removed and no scoring or damaged observed on the outer race, outer race surface was smooth. Sprag elements were all present and held in place by the cage. No indications of sprag cage deformation were observed. No scoring was observed on the sprag elements. The interior retaining spring was in place and appeared undamaged. All interior roller bearings and ball bearings were visually examined, all (?) bearings were seized.

Photo 8 - Right & left freewheel units.

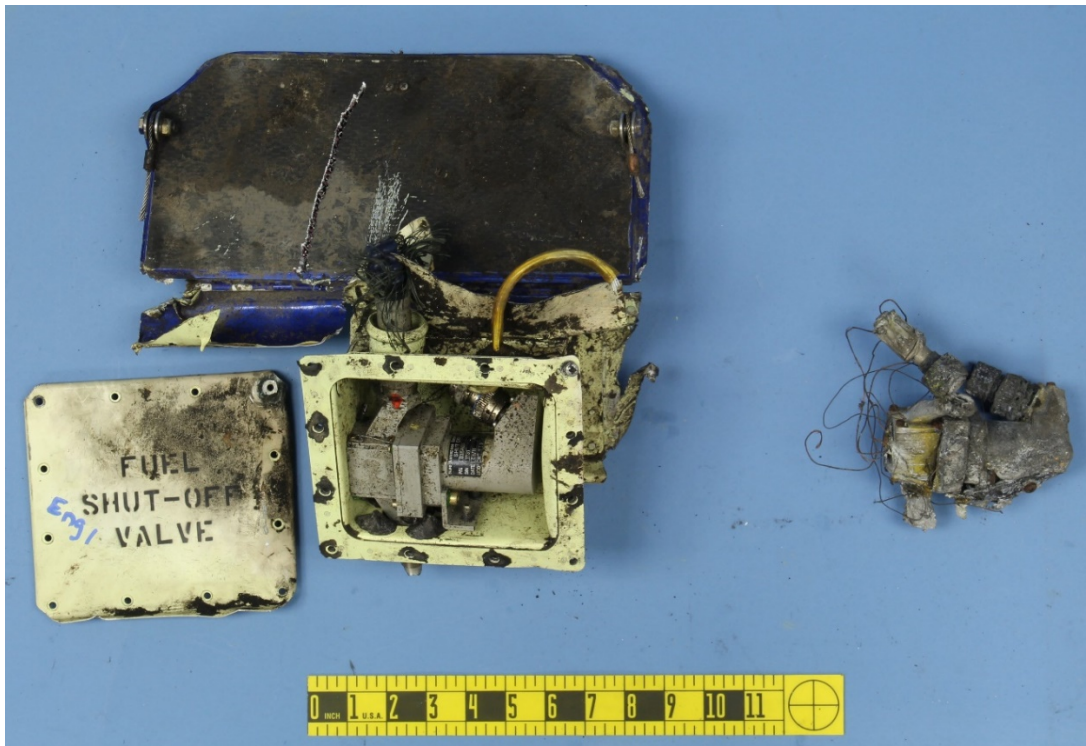
Photo 9 - Fuel Shutoff Valves

The fuel shutoff valves were submitted to the Materials Laboratory for examination as shown in Photo 9.

The intact fuel shutoff valve, labeled Fuel Shut-Off Valve #1, was removed from the surrounding structure. Fuel Shutoff Valve #2 exhibited melting and other fire related damage. Both valves were x-rayed to determine the valve position. Both valves were found to be in the same position as shown in the radiograph in Photo 10. Both valves appear to be in the OPEN position.

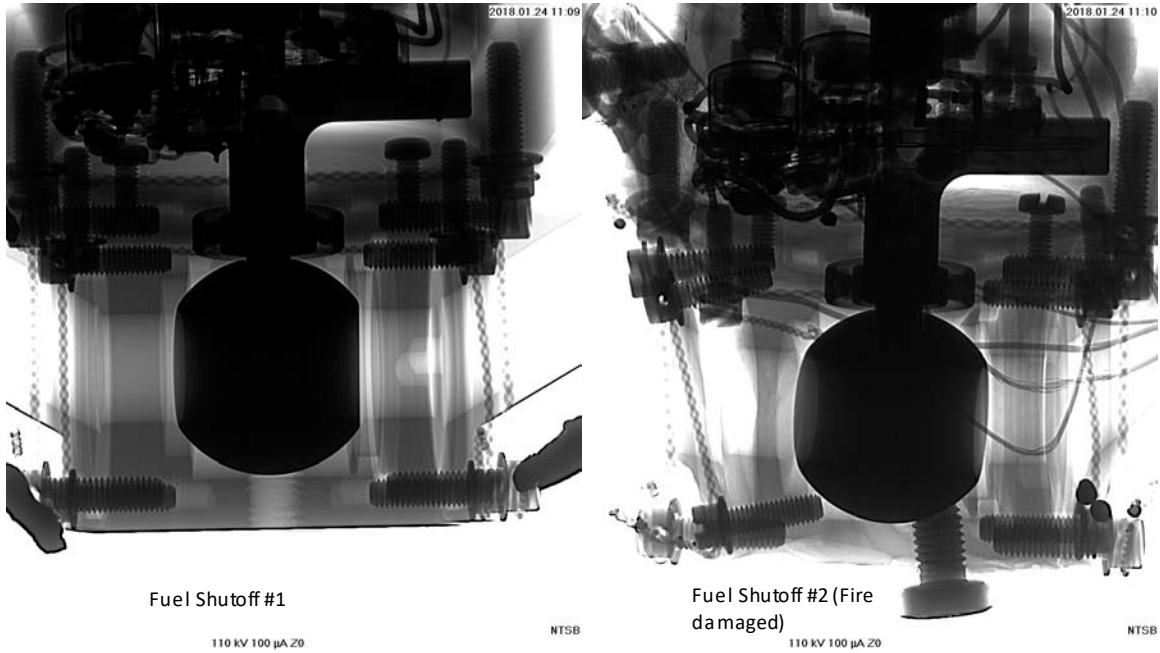
Photo 10 - Radiograph of Fuel Shutoff Valves.

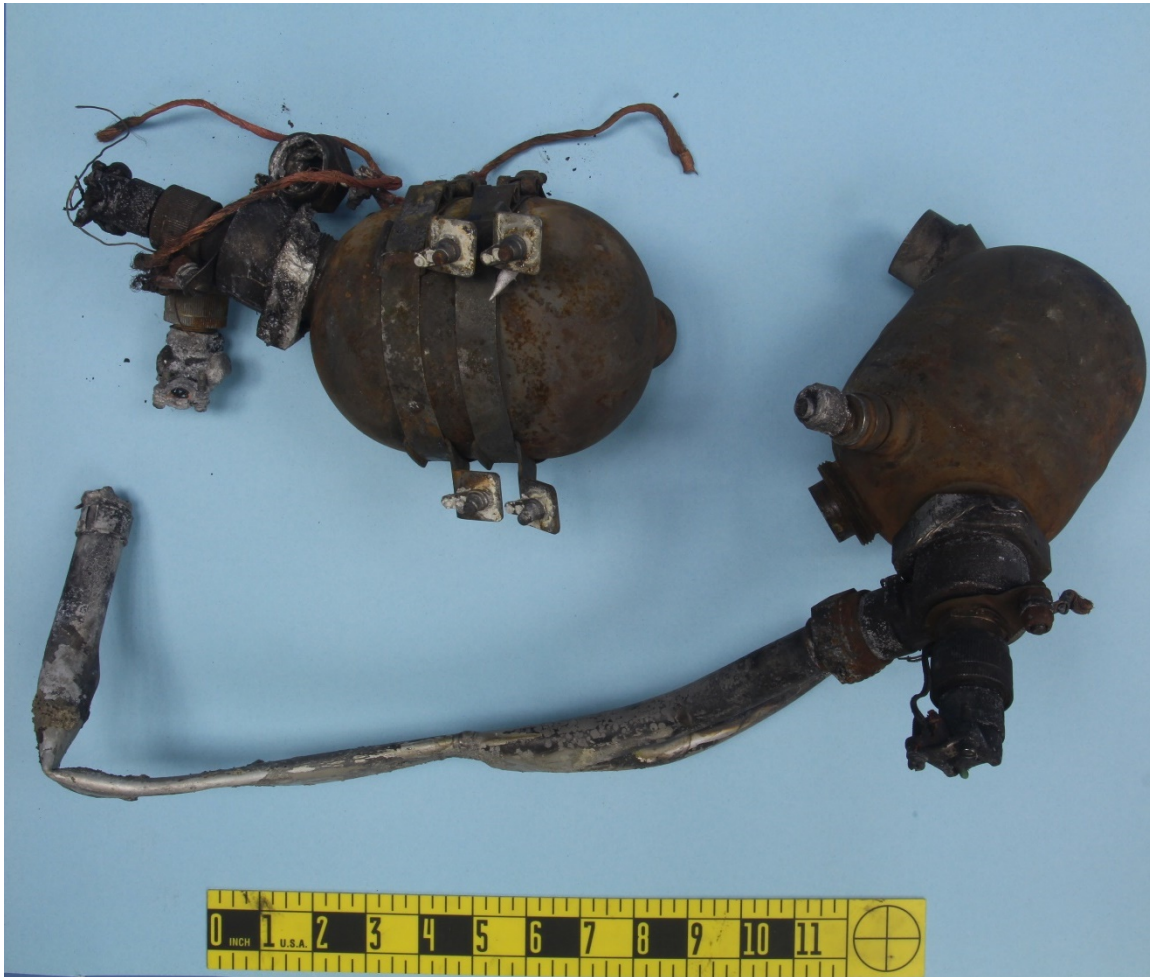
Photo 11 - Fire Suppressant Bottles.

The inlet/overpressure valves (the same valve performed both functions) were examined using x-ray. The valves could not be fully visualized in the radiographs. A boroscope was sent through the valve openings on both bottles. On one bottle, the inlet valve was hollow all the way into the bottle indicating the internal components missing and likely destroyed by fire. The second bottle had an obstruction. It could not be determined if the obstruction was part of the valve or melted debris. Therefore, the overpressure valve condition for both bottles could not be determined.

The bottle outlet valves were removed from each bottle. There was considerable fire damage in the interior of the valves indicating that fire/heat got inside of the bottles and destroyed the burst disc or disc remnants (if the bottles discharged). Therefore, the condition of the outlet valves could not be determined.

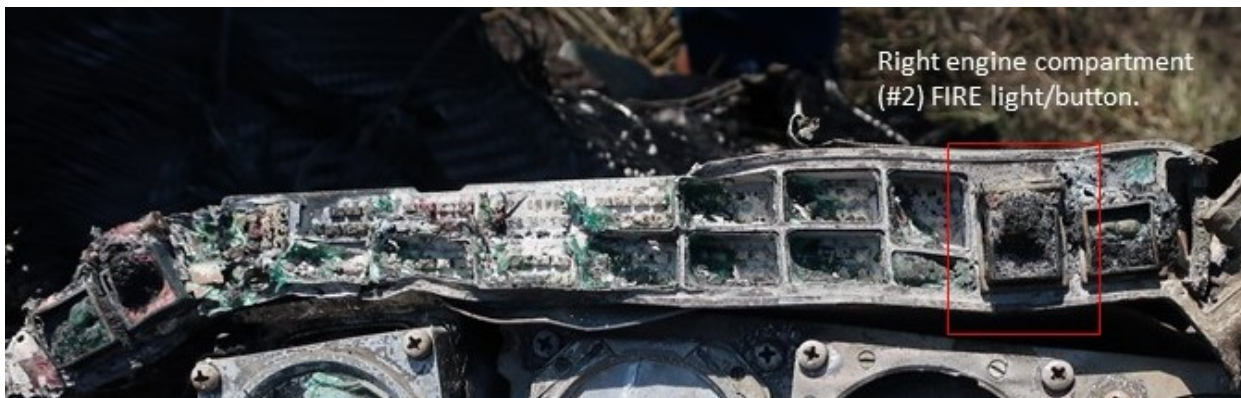
A recovered portion of the warning unit was submitted to the Materials Laboratory for examination. The four light bulbs for the engine #2 fire indicator were x-rayed to examine the filament in each bulb. The radiographs for the FIRE annunciator bulbs showed that the filaments for all the light bulbs were stretched. The radiographs also showed that all but one of the bulb filaments were intact. The bulb 1 filament was broken and stretched while bulbs 2-4 filaments were intact and stretched. The bulb numbering is arbitrary because the bulb positioning could not be determined due to fire damage. Radiograph images of all four bulbs are contained in the official docket. No light bulbs were identified by radiograph in the BOT 1 & BOT 2 button located next to the FIRE light/button.

Photo 12- Cockpit warning panel, #2 fire light identified.

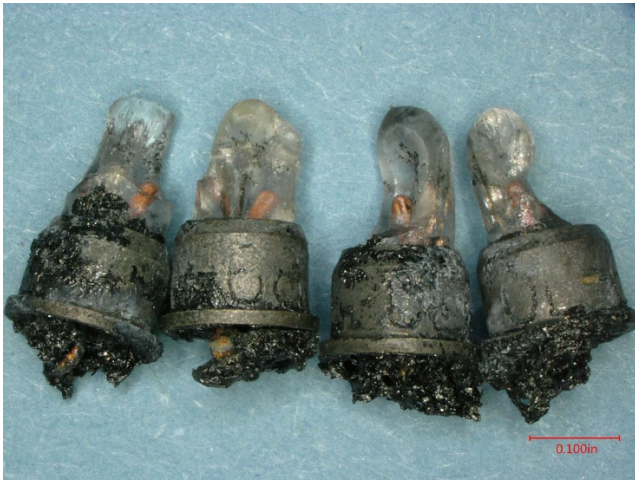
Photo 13 - Fire light bulbs, 20x magnification.

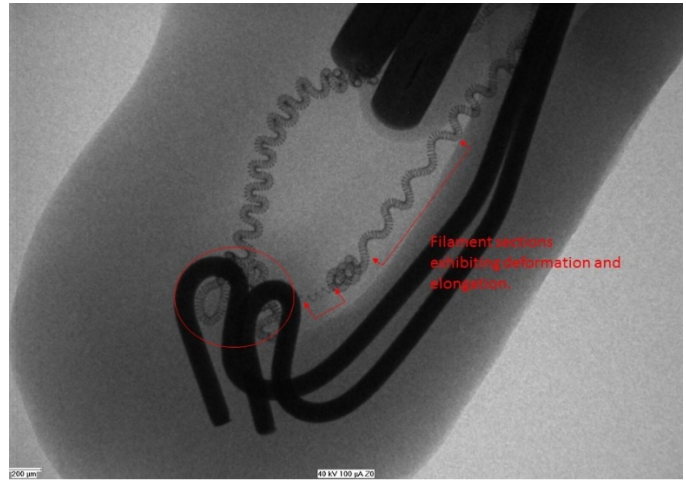
Photo 14 - Typical radiograph of stretched bulb filament.
