NATIONAL TRANSPORTATION SAFETY BOARD
Office of Aviation Safety
Ashburn, Virginia 20147

Airworthiness Group Chairman's Factual Report

WPR09MA159

Operator:	Eagle Cap Leasing Inc.
Location:	Butte, Montana
Date:	March 22, 2007
Time:	1430 Mountain Daylight Time (MDT)
Aircraft:	Pilatus PC12/45, N128CM

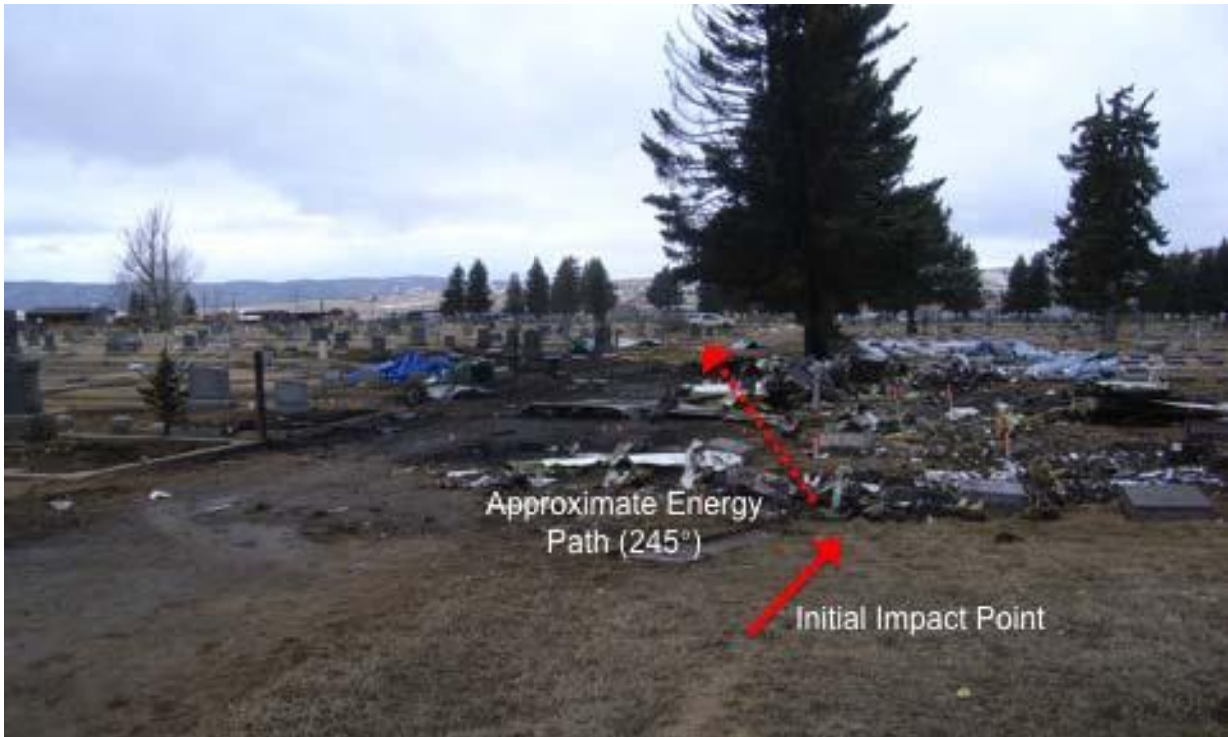
Figure 1 - Photo Showing Initial Impact Point and Approximate Energy Path

Components of the airplane found within the IIP included: the left main landing gear (which was oriented with the wing attachment point into the ground), portions of the left wing main spar, the hydraulic power pack (normally located near the left wing root-fuselage attachment point), the hydraulic selector valve, the inboard portion of the left wing flap, and the main aircraft battery (normally located in the tail, aft of the pressure bulkhead).

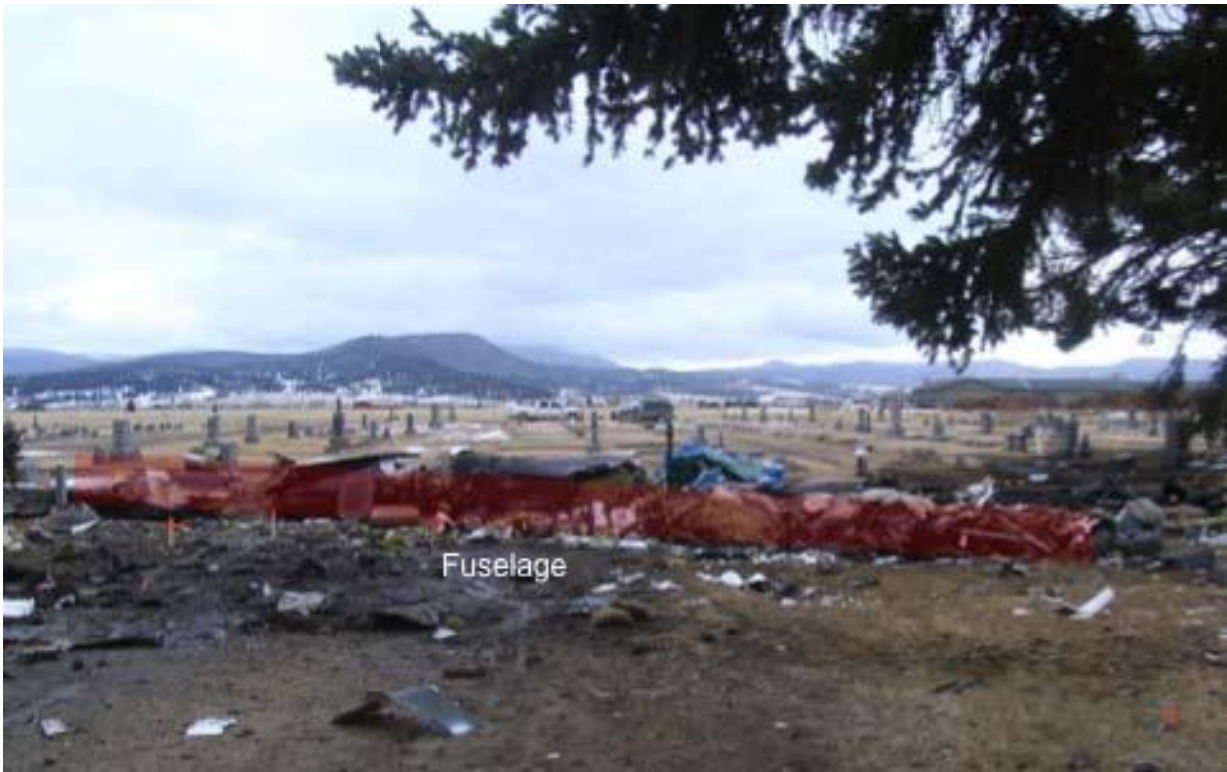
The fuselage was located along the energy path, with the tail being closest to the IIP at a distance of 20 feet. The remainder of the fuselage was located forward of the tail, oriented roughly 290 degrees magnetic. The fuselage was lying on its right side, and exhibited three main fracture separations. The engine remained partially attached to the firewall by the engine mounts.

Figure 2 - Photo of Fuselage (red bar highlights area from tail to engine)

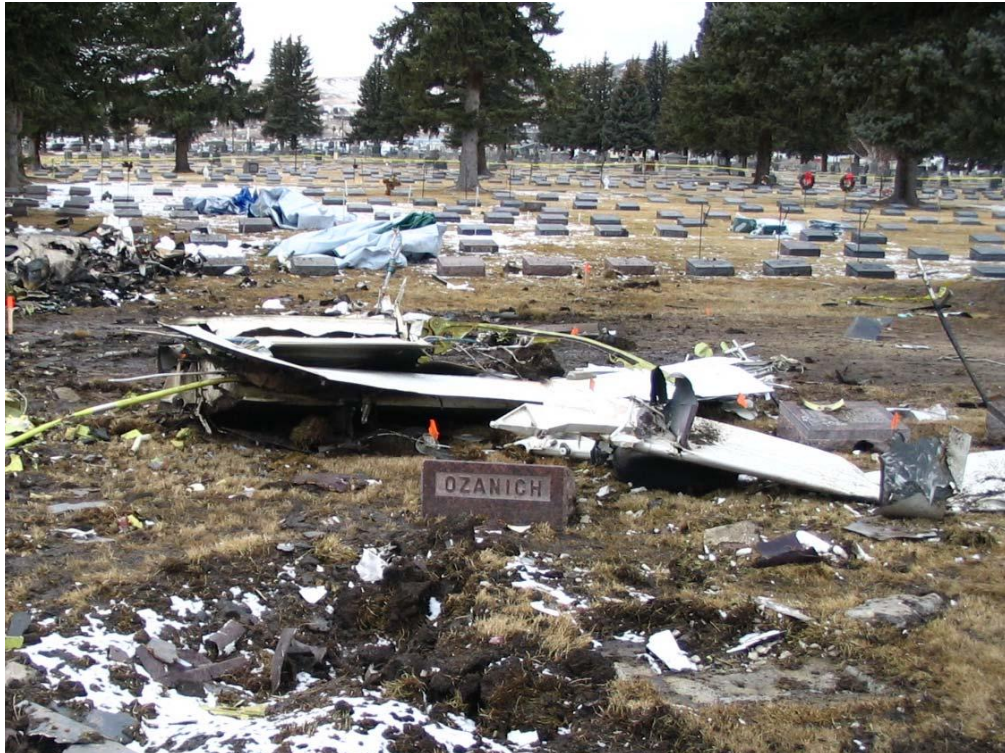
The right wing was sheared at its wing root. The inboard aileron control rod was separated immediately outboard of its threaded end. The outboard section came to rest ahead and to the right of the inboard wing section. The flap was separated from the main wing portion.

Figure 4 - Photo of Right Wing (from rear)

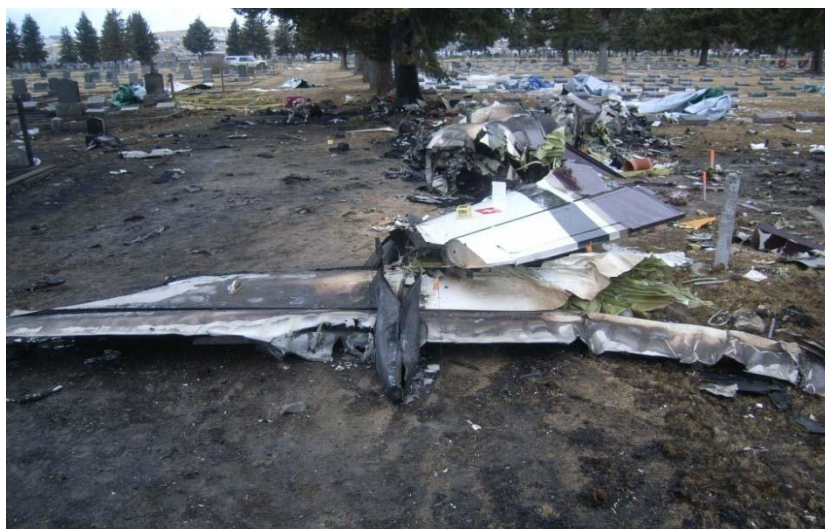
The elevator servo was found intact on its mount, and cable clamps and hardware were still in place on their respective elevator cables. The left horizontal stabilizer hinge was still attached, while the right stabilizer hinge was found torn from stabilizer. The left tip of the horizontal stabilizer was compacted at a 45-degree angle, beginning at the forward tip.

Figure 6 - Photo of Horizontal and Vertical Stabilizers (from rear)

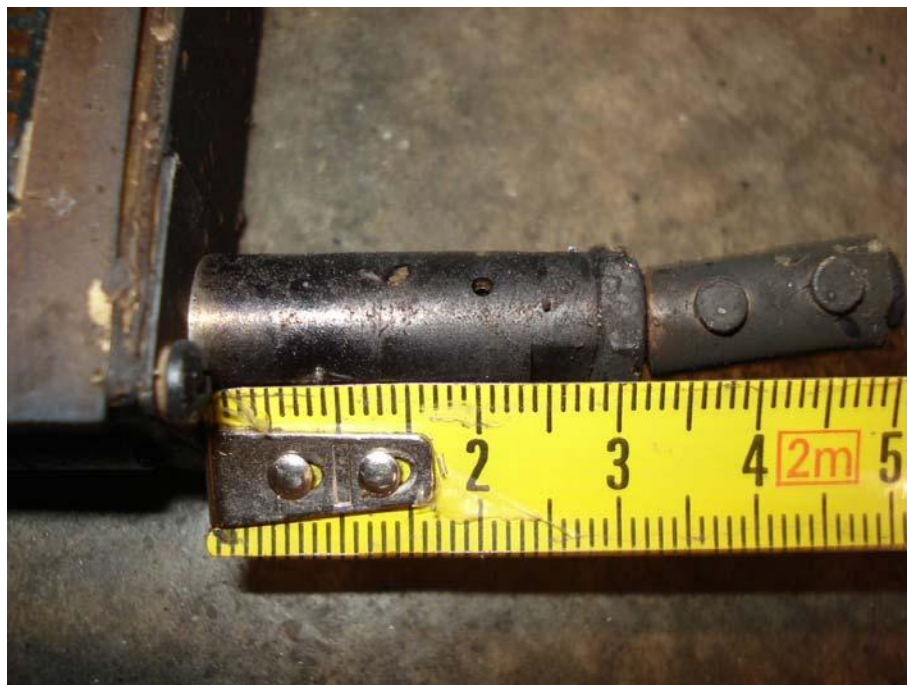
Figure 7 - Photo Visible Extension of the Aileron Trim Actuator

The aileron trim actuator was damaged during the crash sequence. The frame was bent along the actuator's axis, toward the center of the unit. The unit was externally fire-damaged. The external case screws remained attached, and the actuator rod was resistant to lateral or longitudinal movement. Measurement from the fixed end side of the gear housing to the movable end of the actuator ram tube was 5.089 inches (minus an airframe hardware thickness of .129 inches, plus .37 inches to reach the nominal distance to the bearing measurement point), which totaled 5.33 inches. A factory unit extended to its electrical limit stroke would be expected to extend to 5.32 inches.

The movement of the actuator was mechanically limited by an acme nut (or lead screw nut) and the stop tube. The as-found distance between the two components was roughly .010 inches, where a factory component would generally be expected to stop with .030 inches clearance (it should be noted that the deformation of the external case may account for this difference). The extend limit switch actuating spring was resting on the limit switch plunger.

Wires were internally connected to the extend limit switch. Electrical continuity testing of the extend limit switch revealed that based on the as-found condition, the switch was not contacting (and thus would not stop extension of the actuator). Given the physical condition/deformation of the unit and the observations made during the internal examination, the continuity test may not have been valid indication of the pre-impact condition. The internal potentiometer, which when connected to the airplane's instrumentation for aileron trim position, sensed the difference in resistance between two leads. The resistance measured between these two points was 1 k-ohm, which was also the total resistance provided by the potentiometer, and equated to full extension of the actuator.

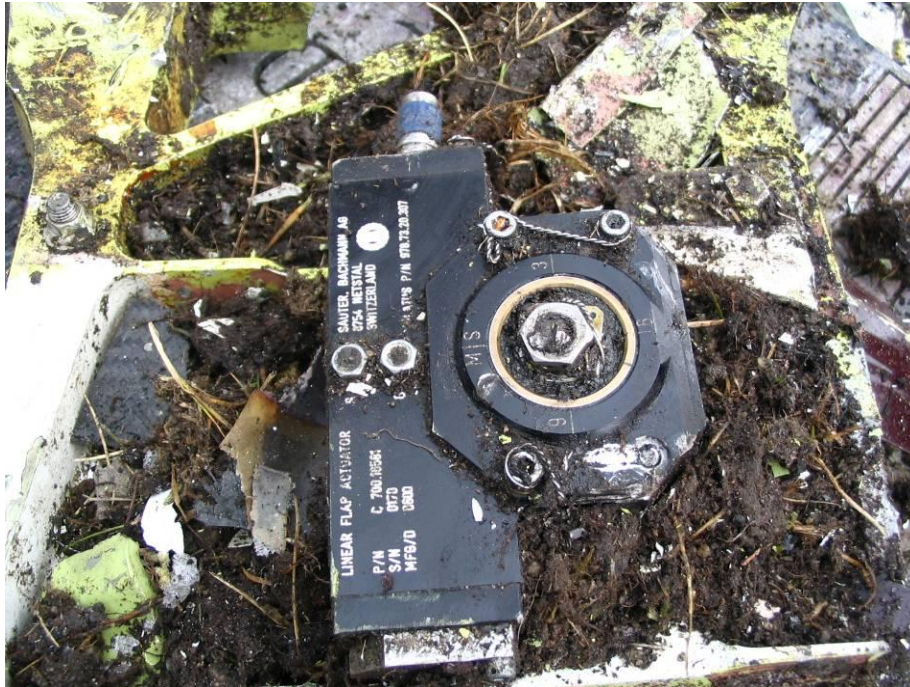
The flaps were single piece fowler-type flaps supported by three stations per wing. The flap actuators were of a jack-screw-type design. On each of the four actuators, the eye bolt connecting the actuator to the flap linkage was broken off immediately after the lock-nut of the ball-screw. All four flap actuators were set to a position consistent with the flaps retracted at impact.

Figure 8 - Photo Showing One of Four Fully Retracted Flap Actuators (left inboard shown)

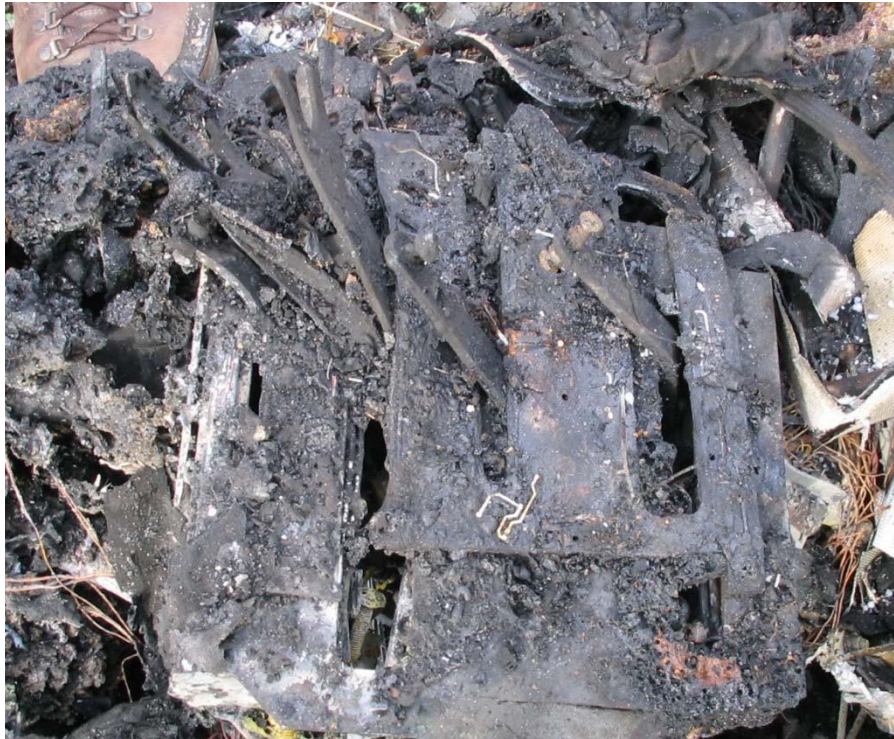
The power quadrant was recovered, but all linkages and cables had been severed. The emergency fuel shutoff lever was in the stowed position. The emergency landing gear hand pump was broken from its mount position, but in the stowed position. The landing gear selector had substantial damage, and the landing gear handle was missing.

Figure 9 - Photo Showing Power Quadrant

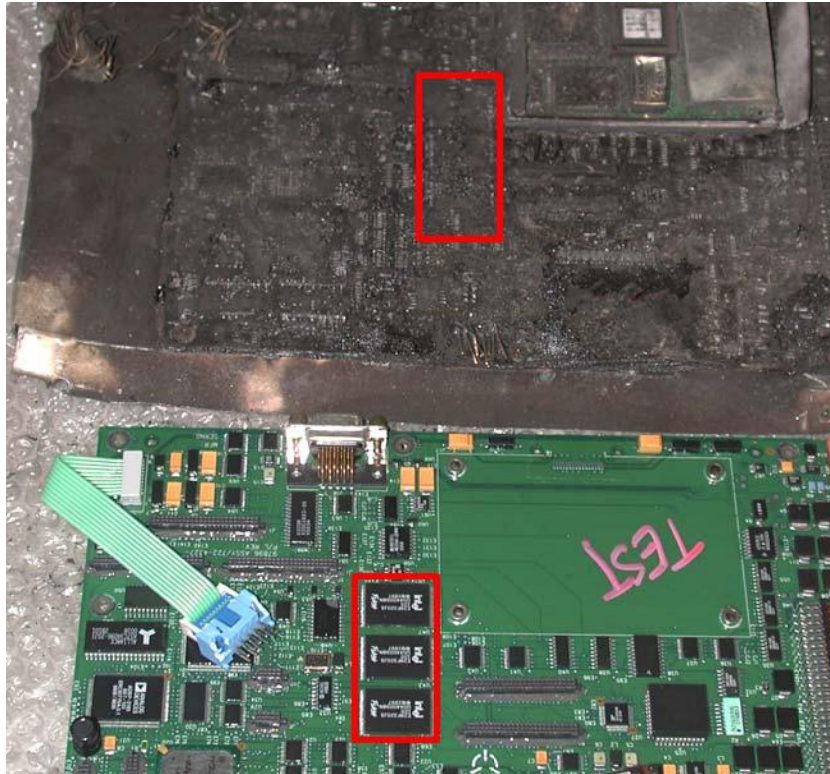
The IHAS unit was shipped to the manufacturer, Honeywell, for examination under the oversight of an NTSB investigator on April 30, 2009. The unit was severely fire-damaged, and most of the electronic components were separated from the printed circuit boards (PCBs). The flash memory chips containing all stored memory for the device had also separated from their PCB. The missing flash memory chips were not located, and presumed destroyed.

Figure 10 - Exemplar PCB and memory chips (below) and accident PCB with missing memory chips (above)

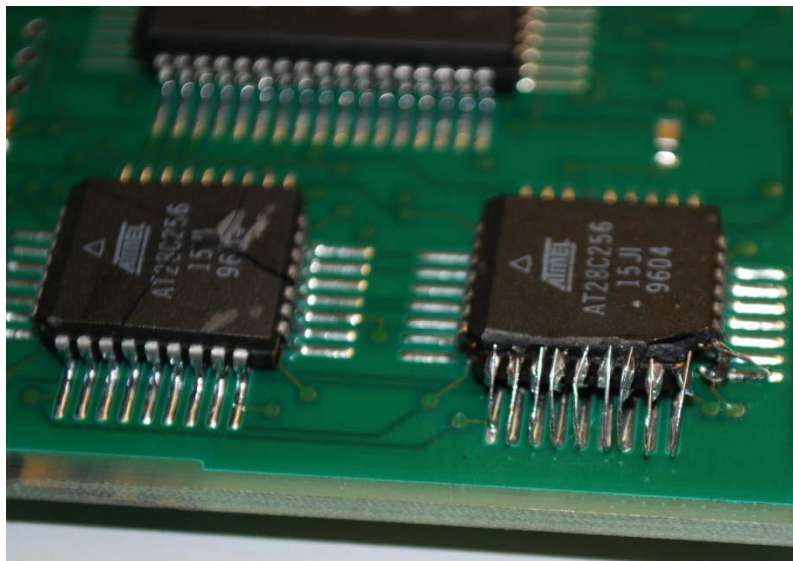
The unit 'A' chips were removed and placed onto a surrogate processor module board without difficulty. The unit 'B' chips exhibited external damage and cracking, and the legs of the unit 'B' U12 chip were broken, but were re-created using a “haywire” process.

Figure 12 - Photo of unit 'B' memory chips and 'haywire' of memory chip (right)

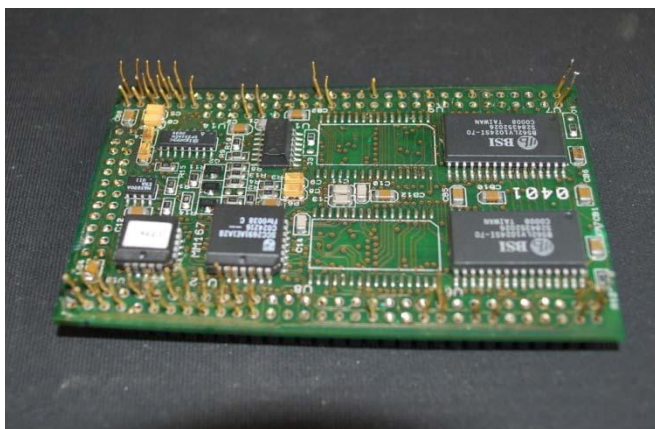
Members of the Airworthiness Group and a representative of the German Bundessstelle für Flugunfalluntersuchung (BFU) met at the facilities of Aircraft Electronic Engineering (AEE) GmbH in Seefeld/Droessling, Germany on May 18, 2009, to examine the CACU and attempt to extract data from the NVM. During the examination, the manufacturer explained that the components that retained NVM (contained on flash memory) were located on a sub-board, which also contained a processor and random access memory modules. The sub-board was intact, but impact damaged, and many of its input/output pins were bent. A plan was formulated to remove all of the pins that were not necessary for accessing and downloading the data stored in the flash memory. The remaining pins were straightened, and the positive (+) and negative (-) power pins were connected to a current-limited power supply. Subsequent continuity testing revealed that the pins had shorted, and that a download of the memory from the accident sub-board was not possible.

Figure 13 - Sub-board Pins Cut and Straightened

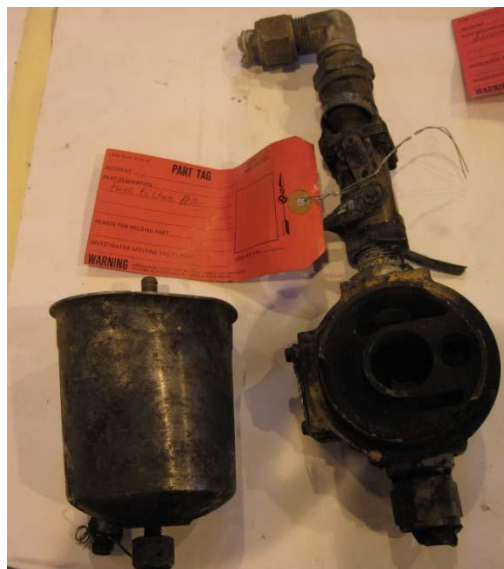
The airframe fuel filter was recovered in three pieces consisting of the fuel filter housing, the fuel filter bowl, and the fuel filter element. Each exhibited fire and varying degrees of impact damage.

Figure 16 - Airframe Fuel Filter Assembly

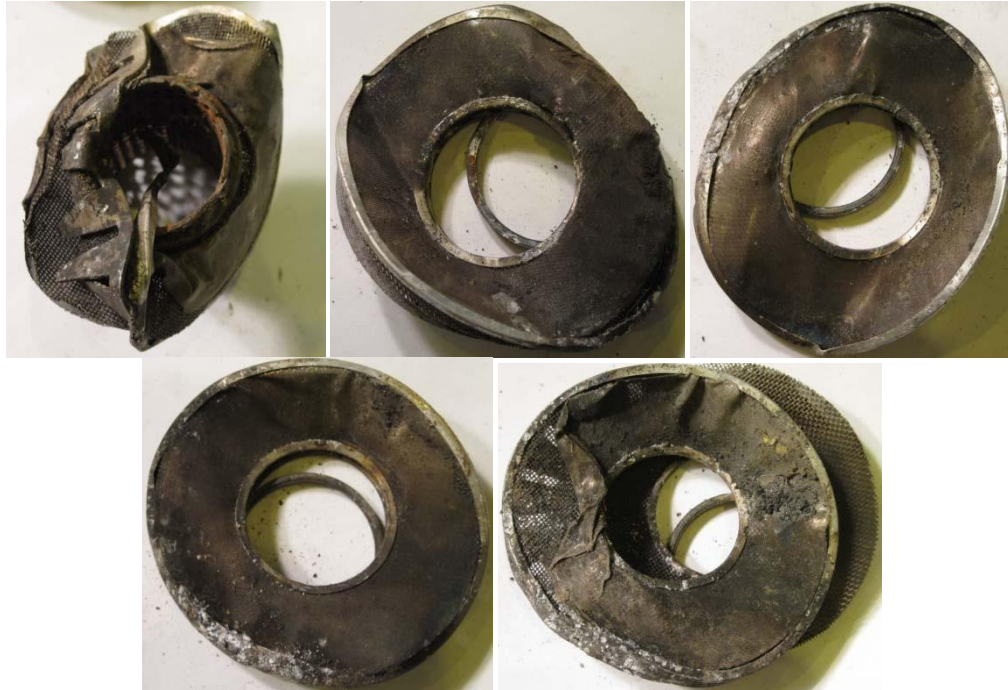
The fuel filter element was severely impact and fire damaged. No obvious evidence of blockage or deposits was observed.

Figure 17 - Airframe Fuel Filter Elements

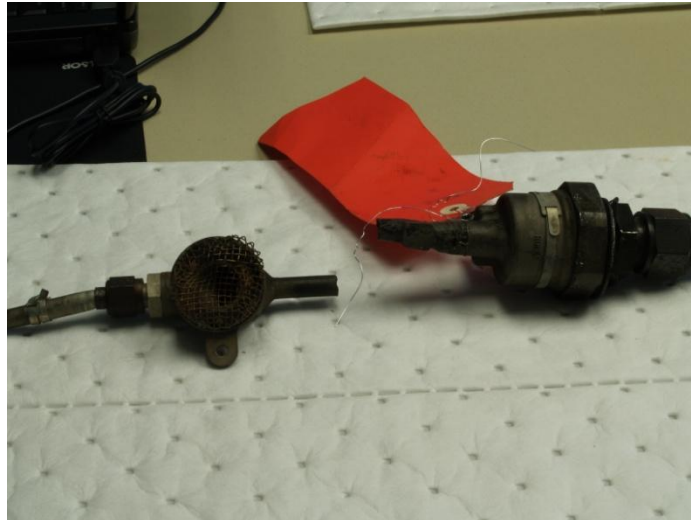
The pump exhibited fire damage, and was fractured at the conical center section. Disassembly revealed that the flapper valve was intact and free to move. No sealing ring was present on the flapper valve, but the interior displayed heat distress. The jet nozzle was absent of debris.

Figure 18 - External View of Right Fuel Delivery Jet Pump

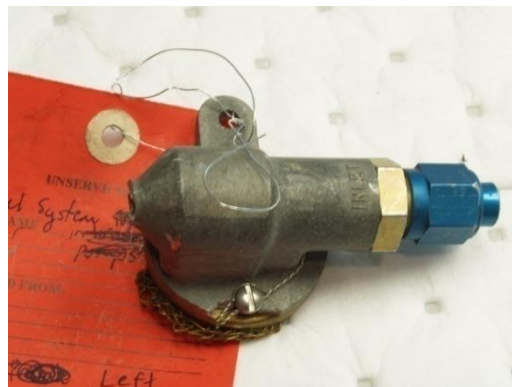
Only the screened portion intake was present (the flapper valve portion was not located). The jet nozzle had a small piece of debris bridging its diameter.

Figure 19 - Recovered Portion of Left Fuel Delivery Jet Pump

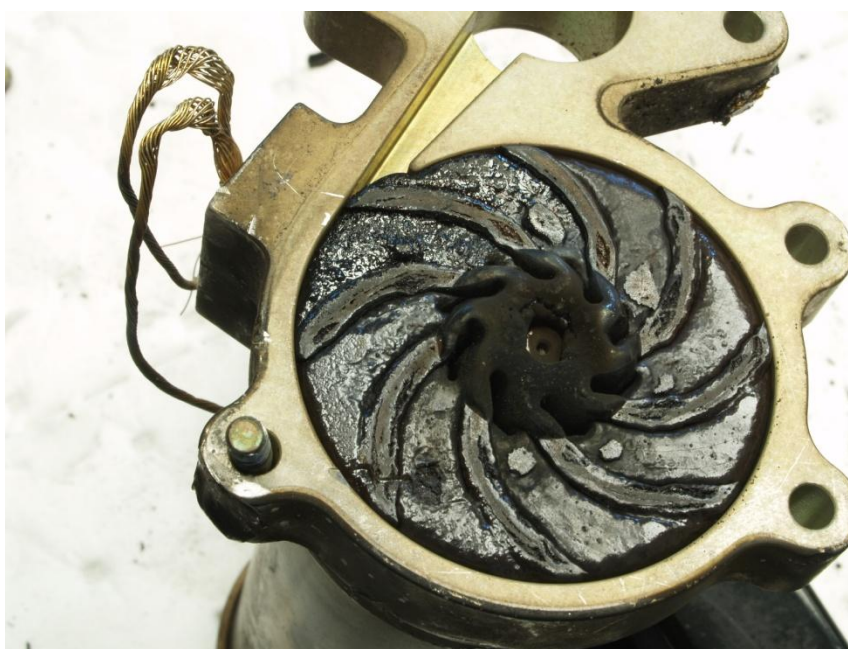
The electrical motor commutator exhibited normal wear, and the brushes were in good condition and free to move. Electrical testing of the thermal fuse showed that no continuity was present (thermal fuse melts above 378 degrees Fahrenheit).

Figure 20 - Melted Right Fuel Boost Pump Impeller

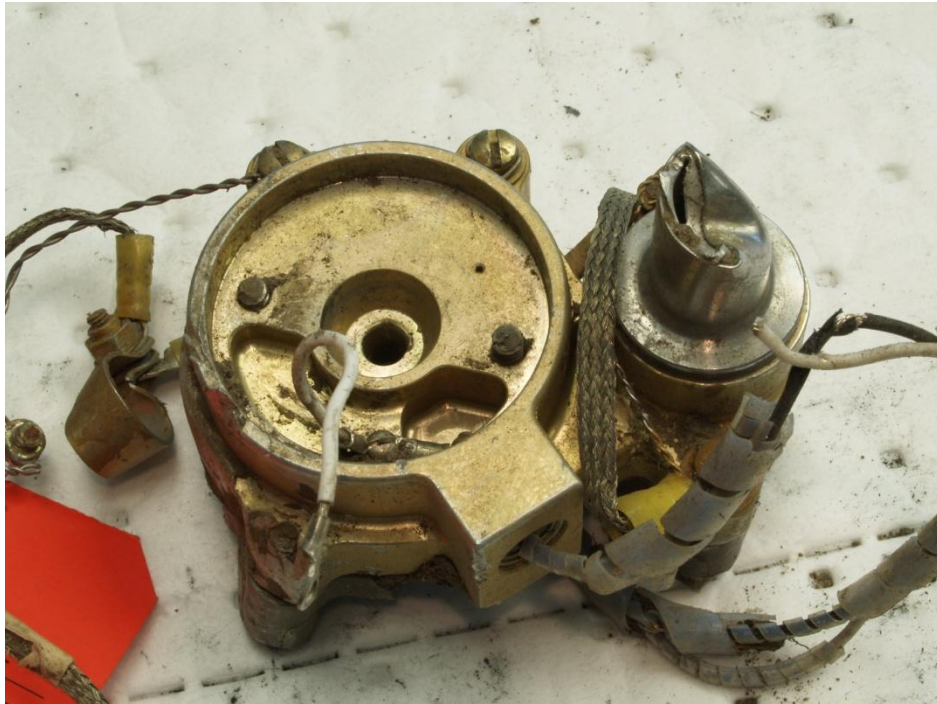
Only the impeller housing was recovered. Disassembly revealed the impeller remained intact, with the exception of two blades that were broken or cracked. The impeller and housing were held for further examination in the NTSB Materials Laboratory. Examination results can be found in NTSB Materials Laboratory Factual Report number 10-005, which resides in the public docket for this accident.

Figure 21 - Left Fuel Boost Pump Impeller Housing

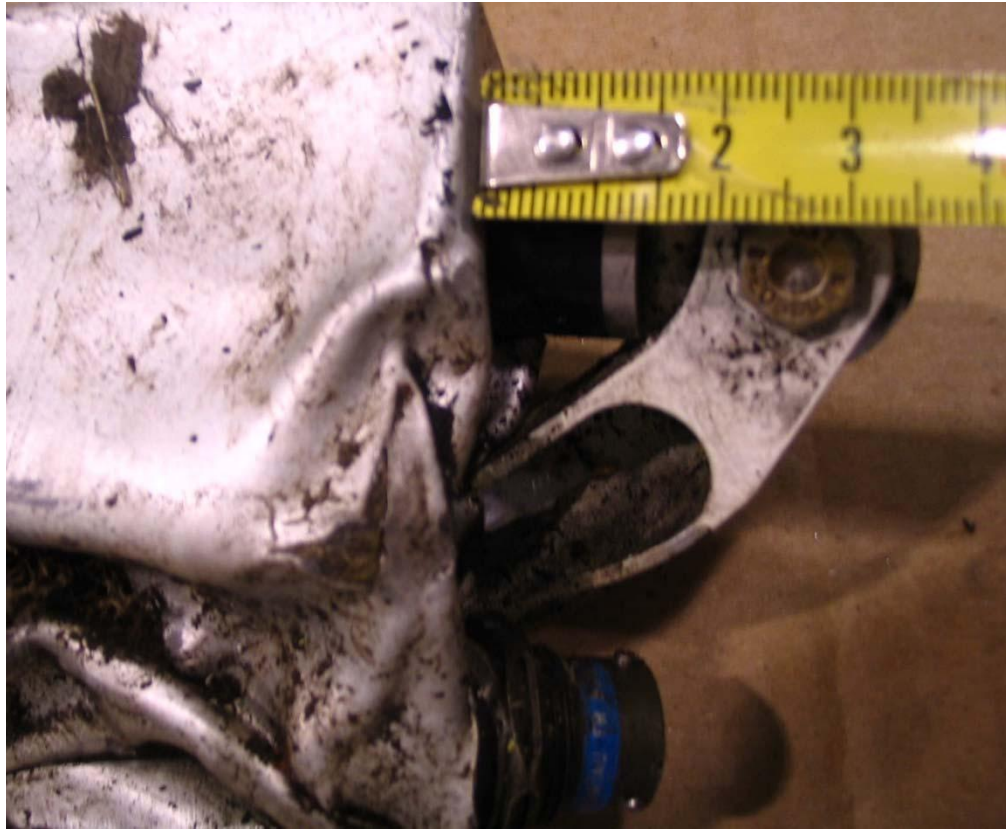
No icing system cockpit switches were located. The inertial separator actuator extension was measured at 0.55 inches, which equated to the OPEN position of the inertial separator door. The deice boots timer was located intact, to be sent to manufacturer for testing.

Figure 23 - Photo Showing Extension of Inertial Separator Actuator

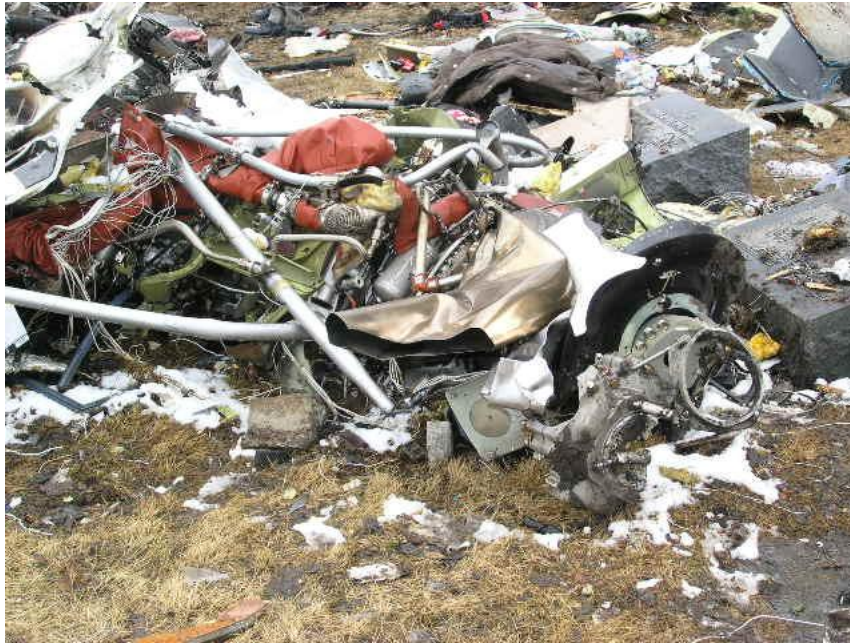
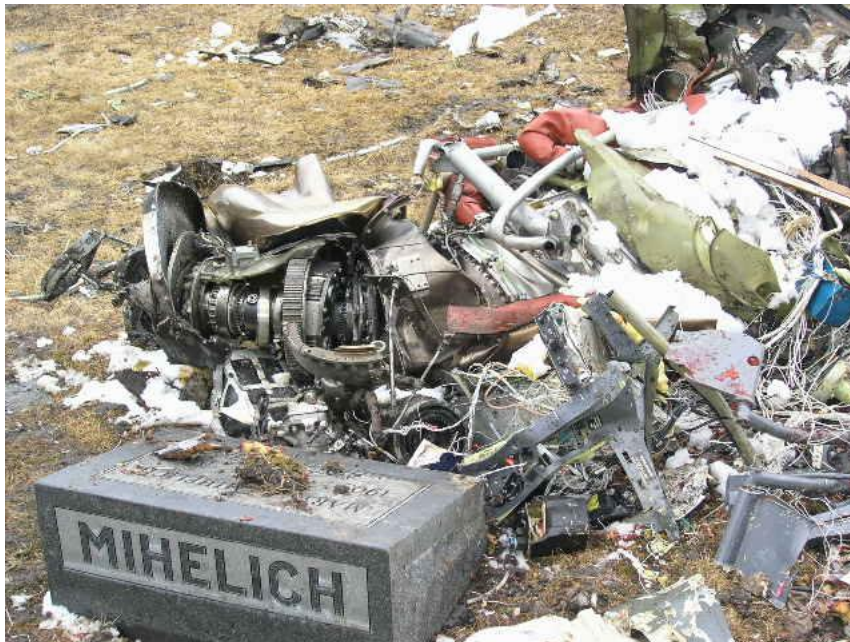
The engine was lying upright in the airframe nacelle and displayed severe impact damage. The firewall area displayed severe fire damage. The cowling was largely separated or consumed by fire. The airframe engine mounts, inlet shrouding, exhaust stubs, and pneumatic ducting displayed severe impact deformation. The propeller hub mounting flange and propeller spinner back plate remained attached to the propeller shaft, but the hub was disintegrated and the blades separated. The starter generator was fractured from its mounting boss and was located separately. The engine mount structure, oil cooler hoses, and wiring harness were cut as required to remove the engine for detailed inspection. Severe impact and fire damage precluded assessment of pre-impact continuity of the engine to firewall connections.

Figure 25 - Photo of Engine and Nacelle, Right Hand Forward View

Figure 26 - Photo of Engine and Nacelle, Left Hand View

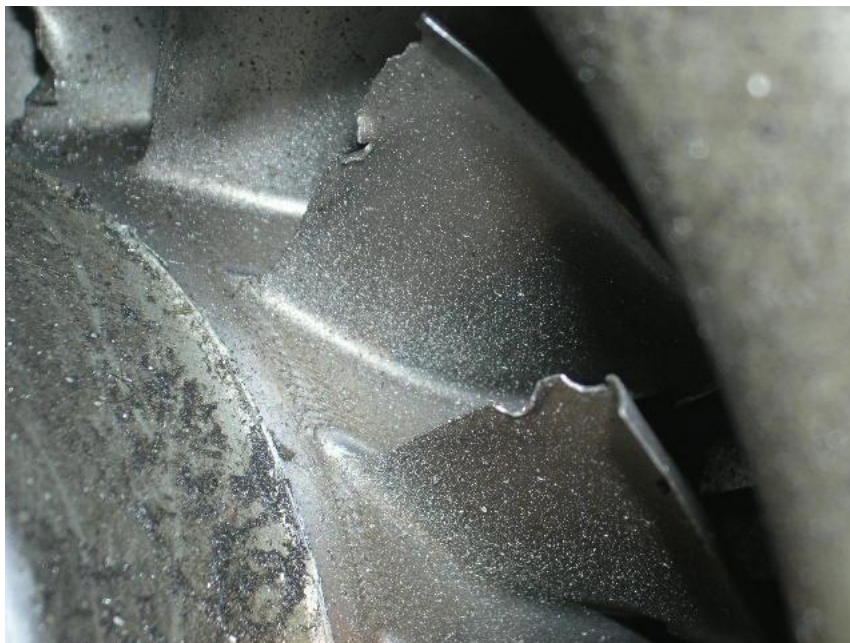
The compressor 1st stage was observed in-situ through the compressor inlet. The 1st stage blades displayed circumferential rubbing and deformation, opposite the direction of rotation, from radial contact with the 1st stage shroud. The blade leading edges displayed circumferential nicks, gouges, and tears consistent with the passage of ingested debris. The 1st stage shroud exhibited circumferential scoring abeam the 1st stage blade tips.

Figure 27 - Photo of Compressor First Stage Blades, Detail

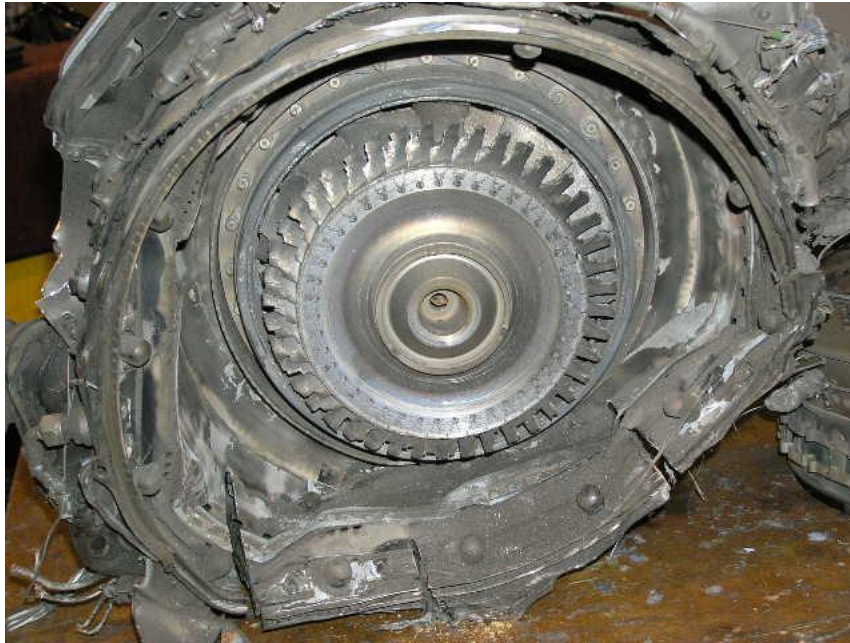
Deformation of the outer liner precluded removal. The outer liner to inner liner mating flange was sectioned radially to facilitate removal of the power section. The inner liner was sectioned axially to facilitate separation from the power turbine housing. The inner and outer liner displayed no indications of operational distress. The flame pattern indications appeared normal.

Figure 28 - Photo of Combustion Chamber Outer Liner and Compressor Turbine

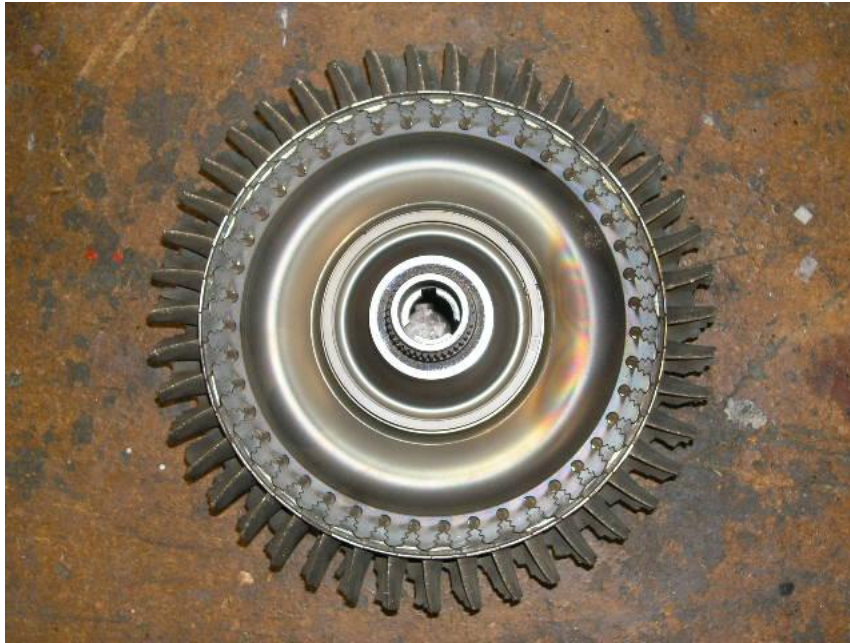
The vane airfoil trailing edges and tips were circumferentially machined and fractured. Under macroscopic examination, the fracture surfaces exhibited mechanical damage and coarse dendritic features characteristic of overload fracture, and no indications of fatigue or other progressive fracture mechanism. The disc upstream side exhibited circumferential rubbing. The disc downstream side displayed severe circumferential rubbing and scoring with the 1st stage power turbine vane ring and interstage baffle. The disc hub displayed heavy circumferential rubbing, with frictional heat discoloration and material smearing,.

Figure 29 - Photo of Compressor Turbine upstream Side

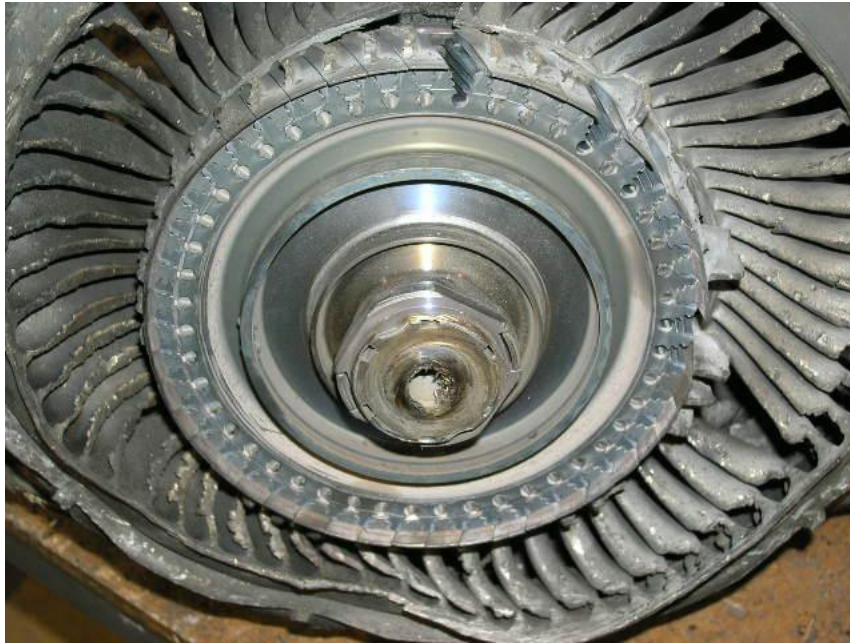
The disc hub displayed heavy circumferential rubbing, with frictional heat discoloration and material smearing,.

Figure 30 - Photo of First Stage Power Turbine

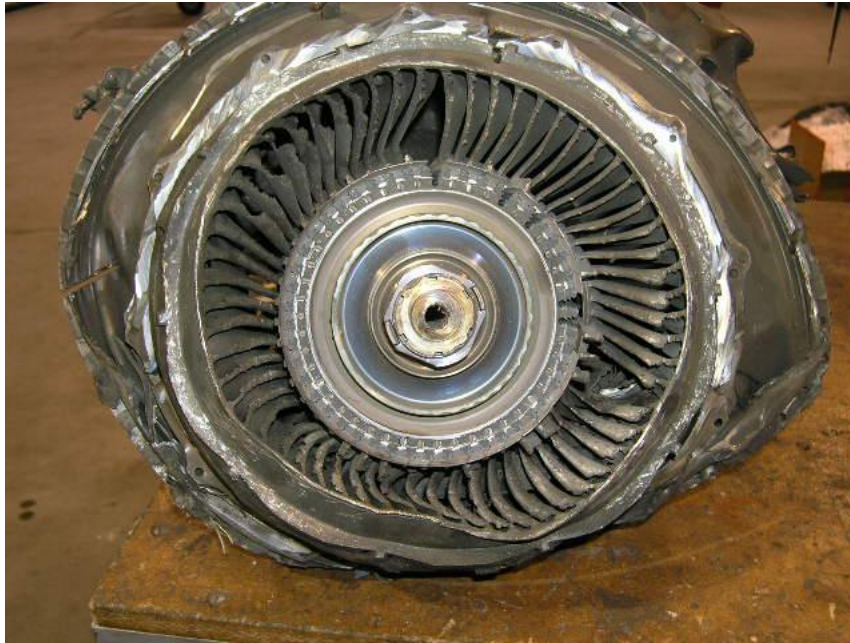
Observed in-situ through the exhaust duct and the 2nd stage power turbine vane ring. The blade airfoils were fractured. All of the blade roots were deformed opposite the direction of rotation and displayed heavy mechanical damage. Fractured blade debris was located within the exhaust duct.

Figure 31 - Photo of Second Stage Power Turbine Vane Ring

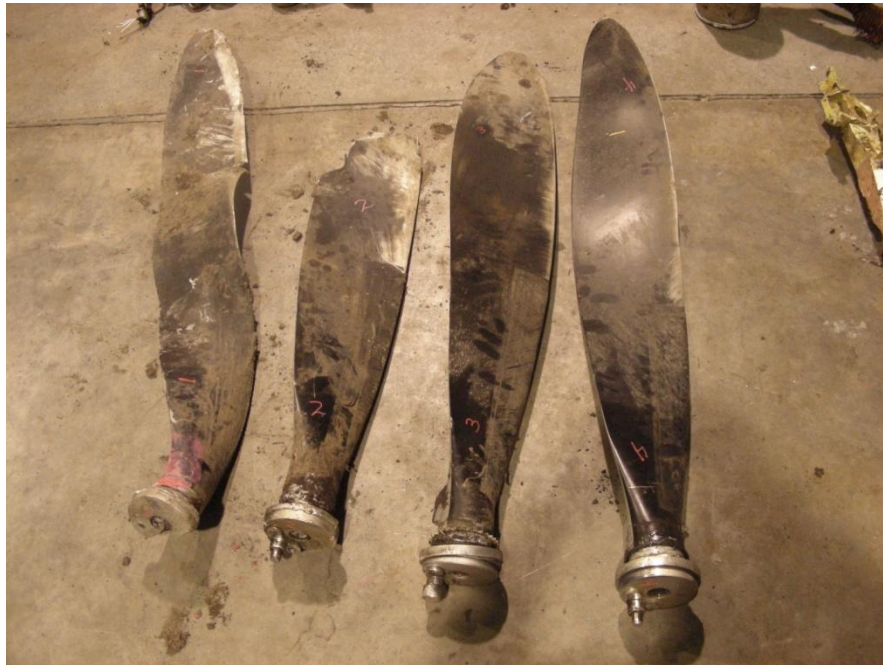
The blades were identified as 1-2-3-4 at the accident scene, with number 1 as the furthest from the main wreckage and number 4 as the closest. The sequence of the rotational order was unknown.

Figure 32 - Photo of the Propeller Blades
