NATIONAL TRANSPORTATION SAFETY BOARD

Airworthiness Group Chairman's Factual Report

NTSB ID No.: DCA17FA021

NTSB Accident Number: DCA17FA021
Location: Chicago, Illinois
Date: October 28, 2016
Time of Accident: About 1432 Central Daylight Time
Aircraft: Boeing 767-323(ER)
Registration Number: N345AN

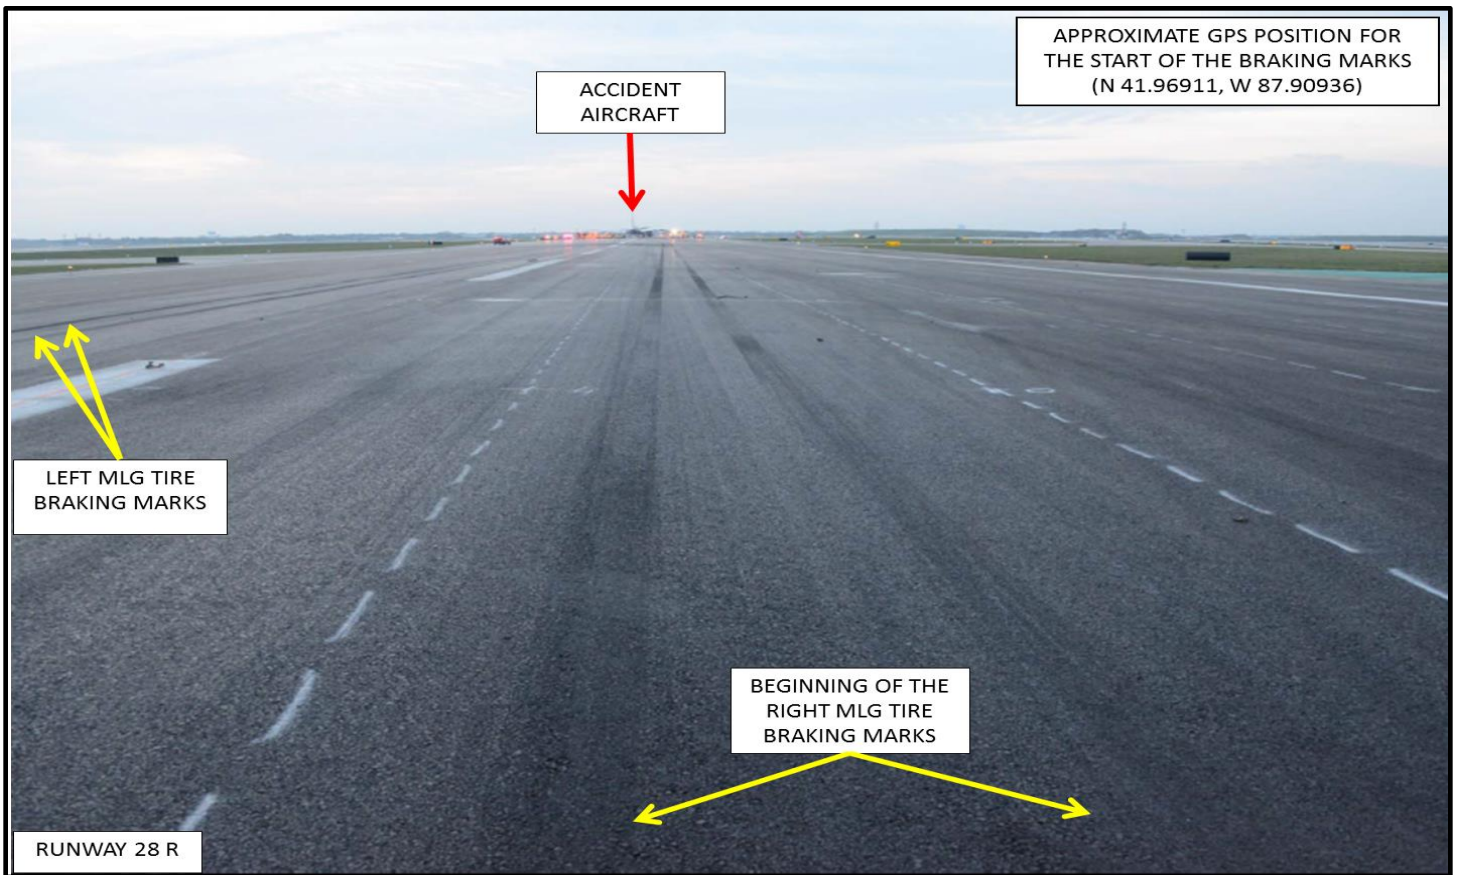
Figure 2 View showing the beginning of the braking marks on runway 28R

On Saturday, October 29, 2016, the Airworthiness group noted that the accident airplane was positioned approximately 9,225 feet from the threshold of 28R with approximately 3,775 feet of runway remaining. The length of runway 28R is 13,000 feet. The Airworthiness group walked runway 28R and noted that tire braking marks from the accident aircraft's left and right main landing gear tires were noticeable on the runway surface starting at approximately 6,941 feet from the threshold of 28R (or about 4,020 feet from taxiway N5¹). The braking marks continued approximately 2,284 feet to the airplane's final position.

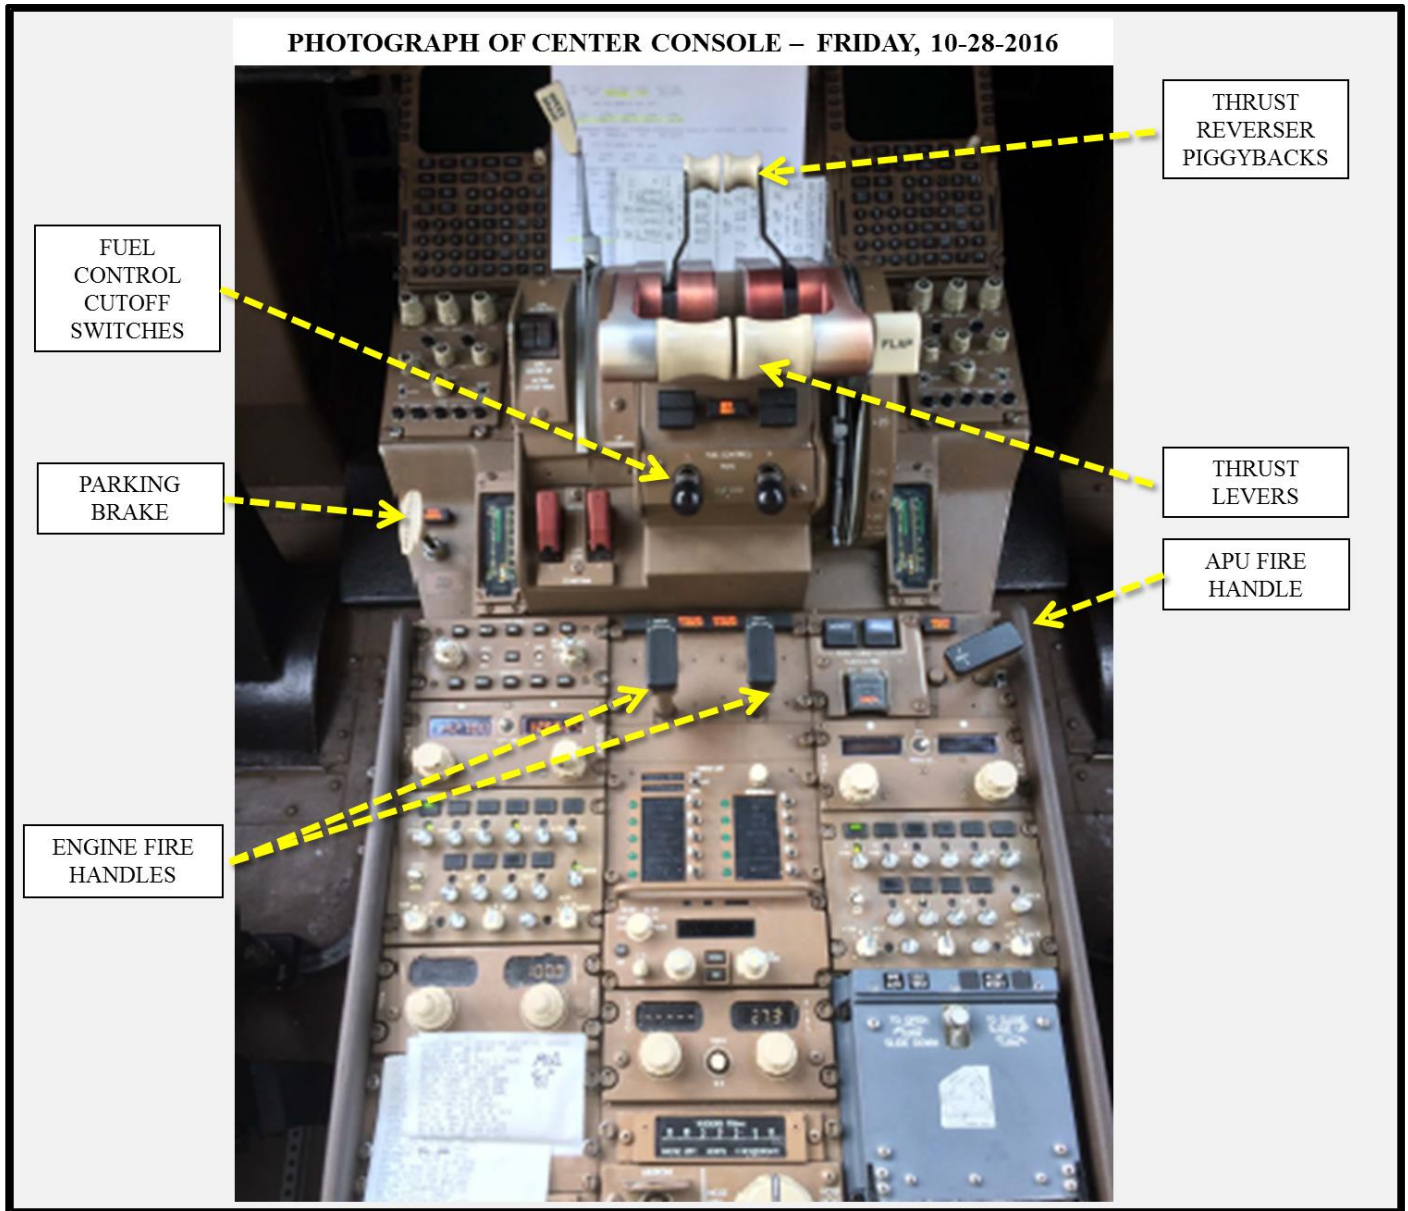
Figure 10 Center Console

Control	Position
Thrust levers	Both thrust levers (throttles) were against their aft stops.
Thrust reverse levers “Piggybacks”	Stowed.
L ENG FIRE handle	Fully extended and centered.
R ENG FIRE handle	Fully extended and centered.
APU FIRE handle	Fully extended and rotated counter clockwise.
EVAC Command Switch	The guard on the evacuation command switch was found raised and the toggle switch was found in the on position.
Fuel pumps (left main and right main)	ON
Cross feed and the center pump	OFF
Cargo fire (forward and aft)	Armed
Auto Brakes	OFF
Fuel Control Cutoff Switches	Both switches were found in the down and CUTOFF position.
Flap Handle and position indicator	Positioned to 15
Parking brake	Set
Oxygen Masks	All of the oxygen masks were found stowed.
Handheld Fire Extinguisher & Protective Breathing Equipment (PBE)	Stowed

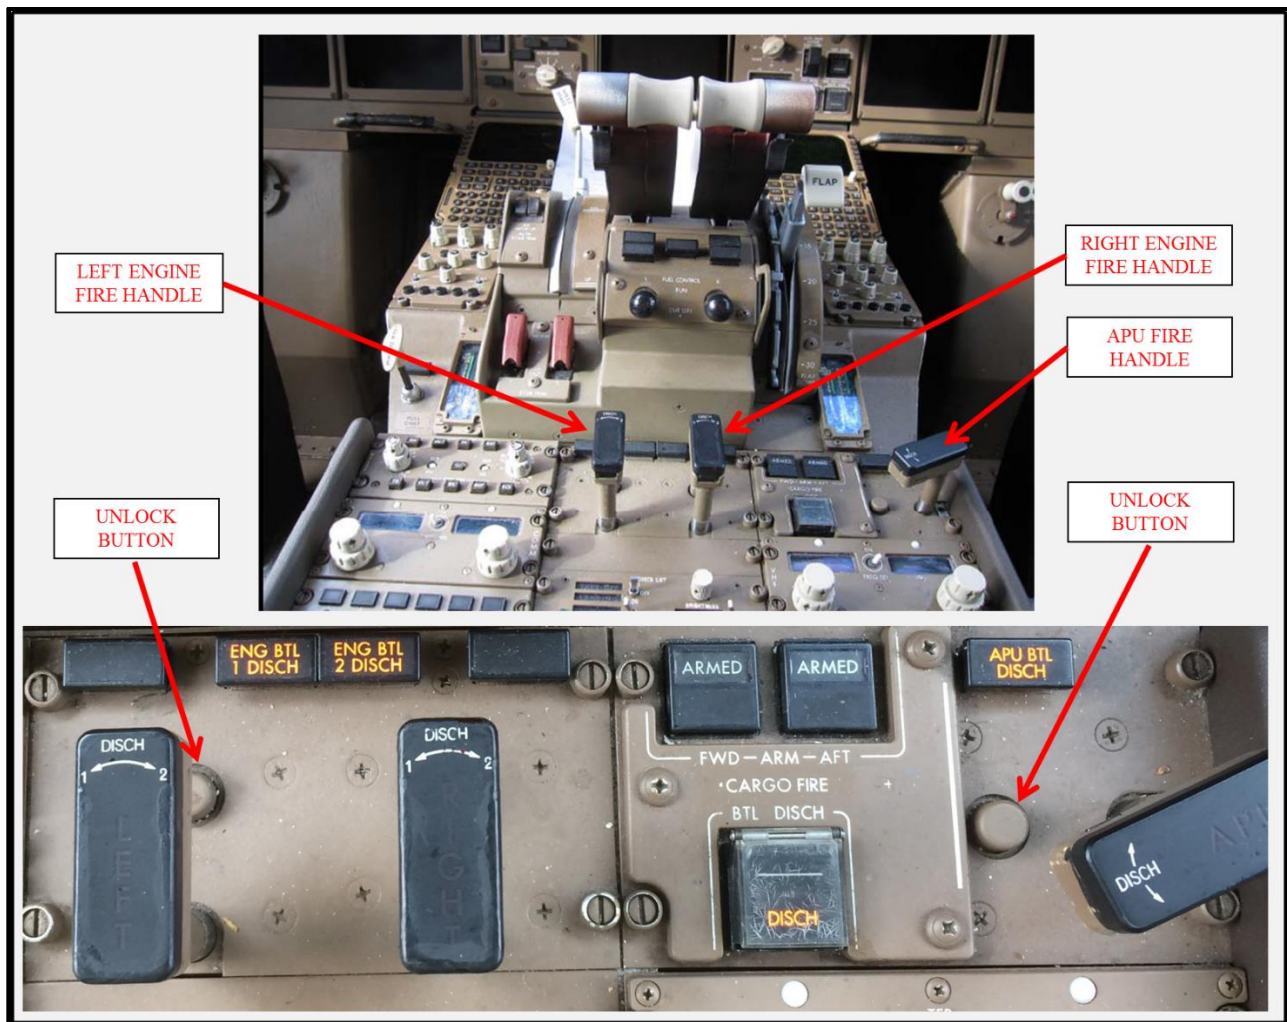
Figure 11 Photograph showing the engine fire control panel.

Visual inspection showed that the left and right engine handles were found extended and centered; neither was found rotated towards their number 1 or the number 2 fire bottle position.

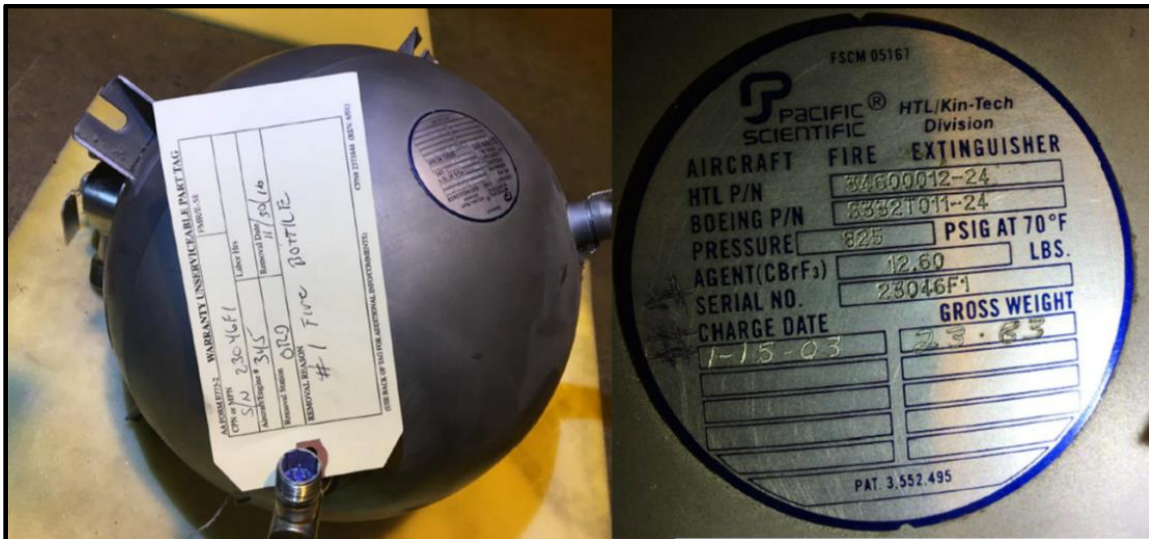
Figure 13 Number 1 fire extinguisher bottles after removal from the forward cargo compartment

As shown in Figure 13, the data label on the number 1 fire extinguisher bottle, recorded a pressure of 825 PSIG (at 70 Degrees) and a weight of 23.83 pounds. As shown in Figure 14, the data label on the number 2 bottle recorded a pressure of 825 PSIG (at 70 Degrees) and a weight of 23.92 pounds. After removal from the airplane, the weight of both bottles was measured and both were found to weigh about 10.5 pounds.

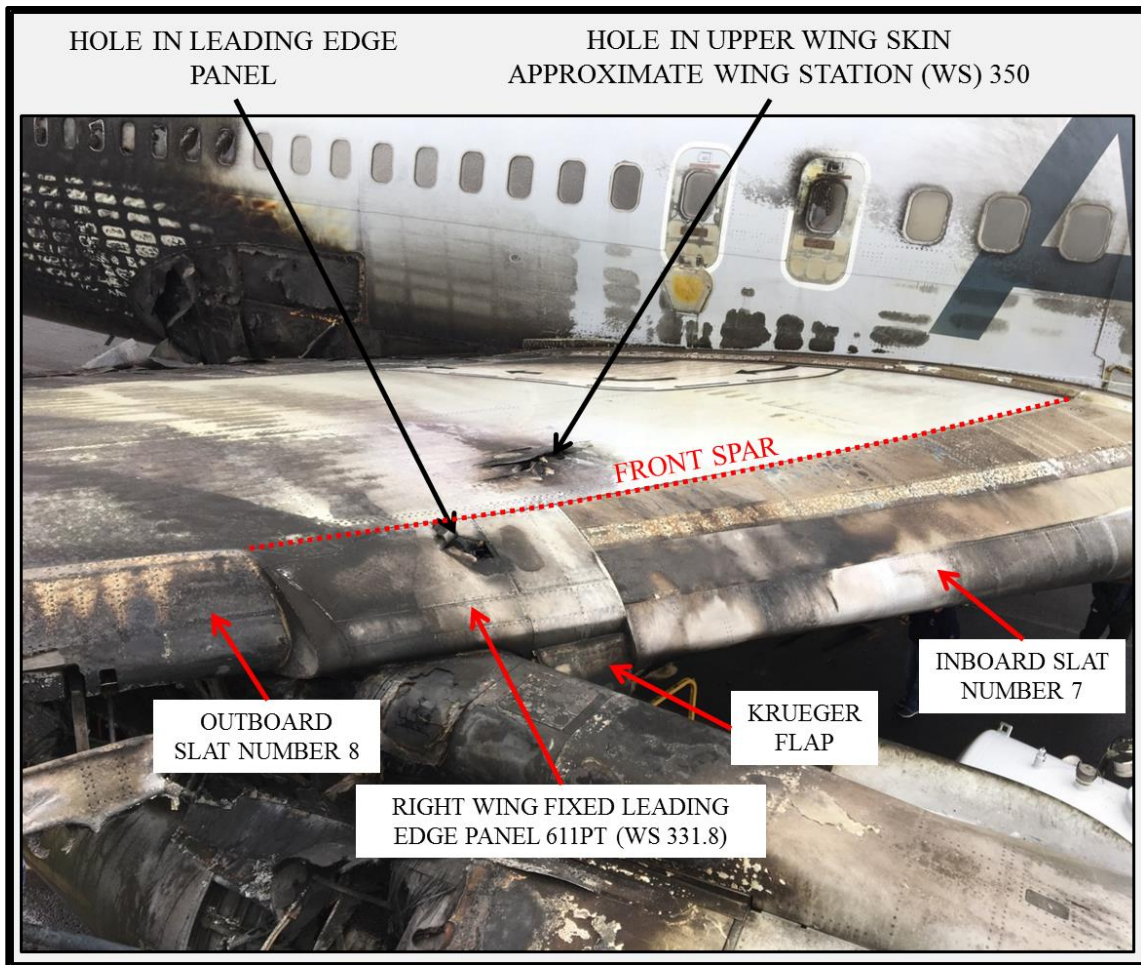
Figure 15 Damage to the right wing upper skin and leading edge

Visual inspection of the accident airplane's right wing revealed that all of the impact damage to the wing was located inboard of the pylon; no impact damage was observed outboard of the right engine pylon from exiting HPT stage 2 disk or engine debris. Inspection of the upper surfaces of the right wing revealed two through-hole penetrations; one hole was located forward of the front spar in the fixed-wing leading edge panel and the other was located aft of the wing front spar between wing rib 6 and 7 in the area of the dry bay. (Reference Figure 15) Inspection of the lower surfaces of the right wing revealed one hole aft of the wing front spar between wing rib 6 and 9 in the area of the dry bay, several small holes in the dry bay access door, and a few small holes inboard of rib 6. (Reference Figure 16)

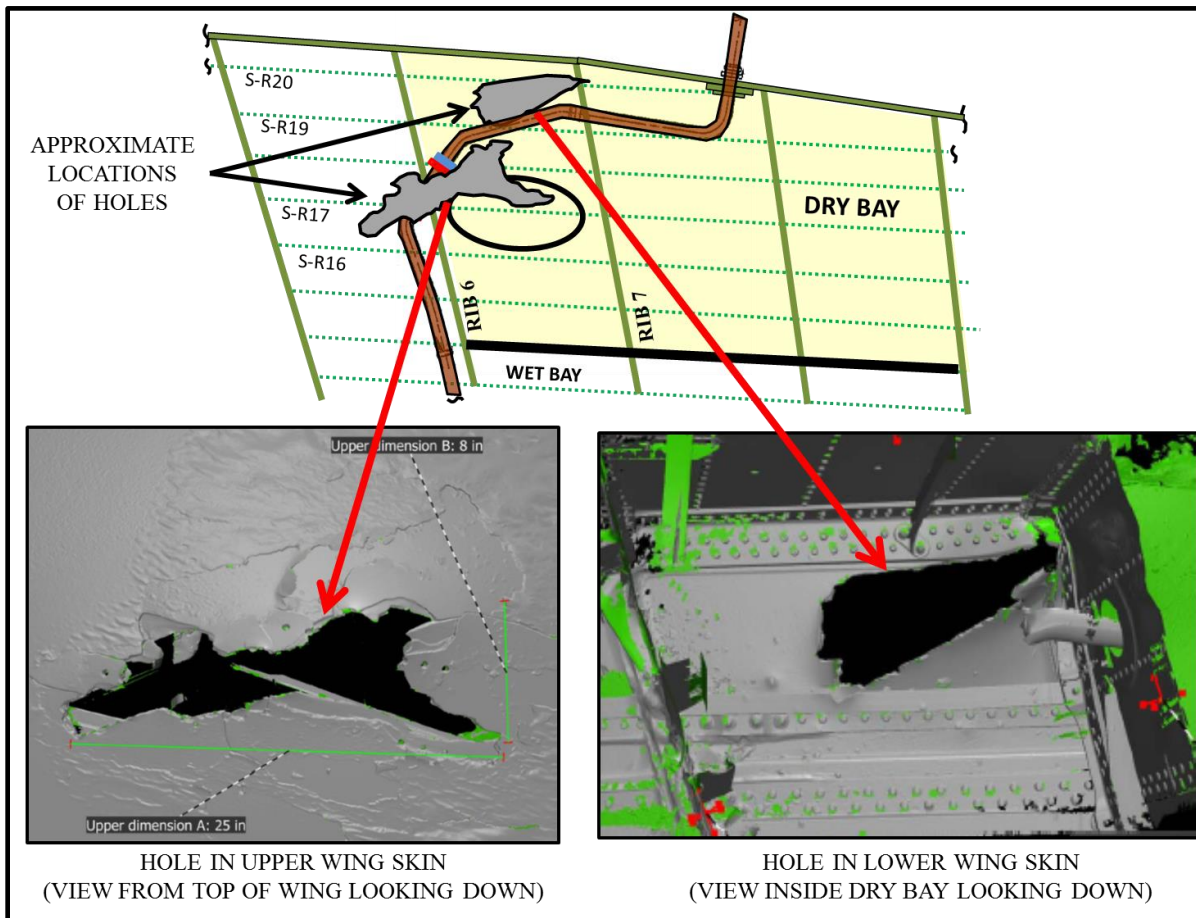
Figure 18 Location of the holes in the upper and lower wing skin in the area of the dry bay

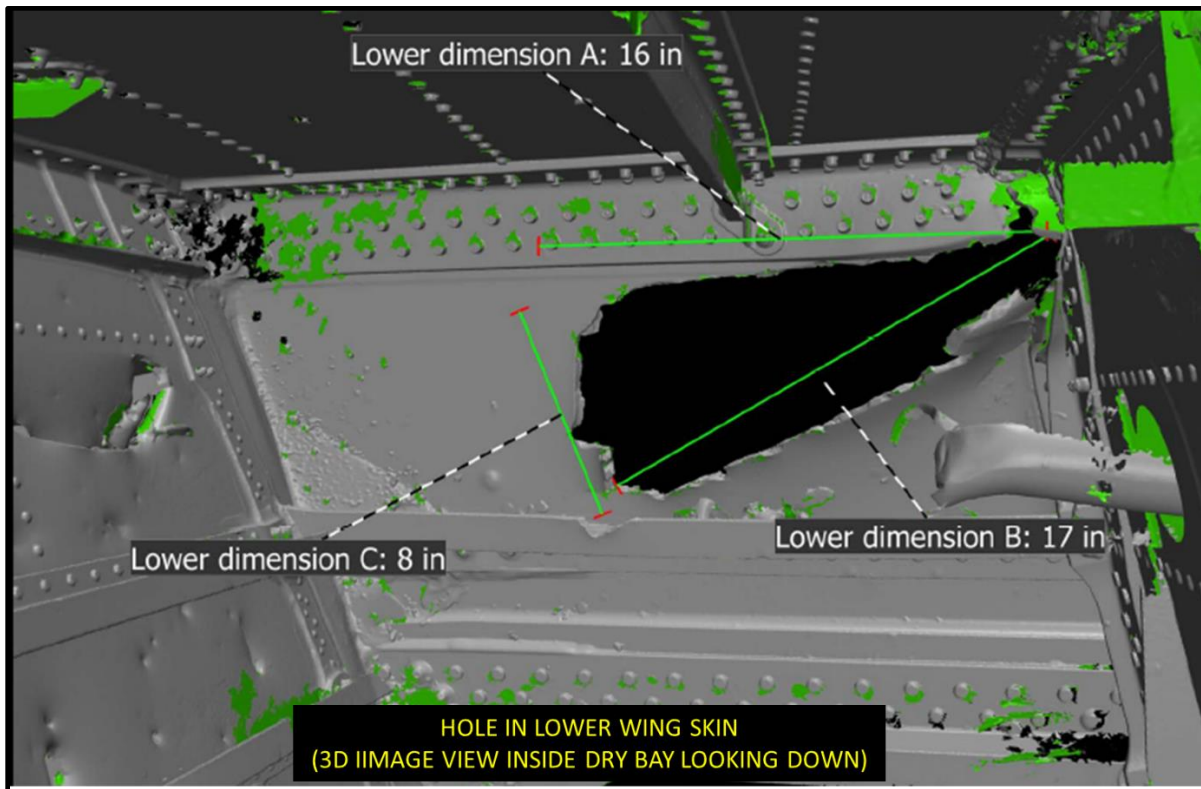
Figure 19 Close-up view of lower hole showing dimensions

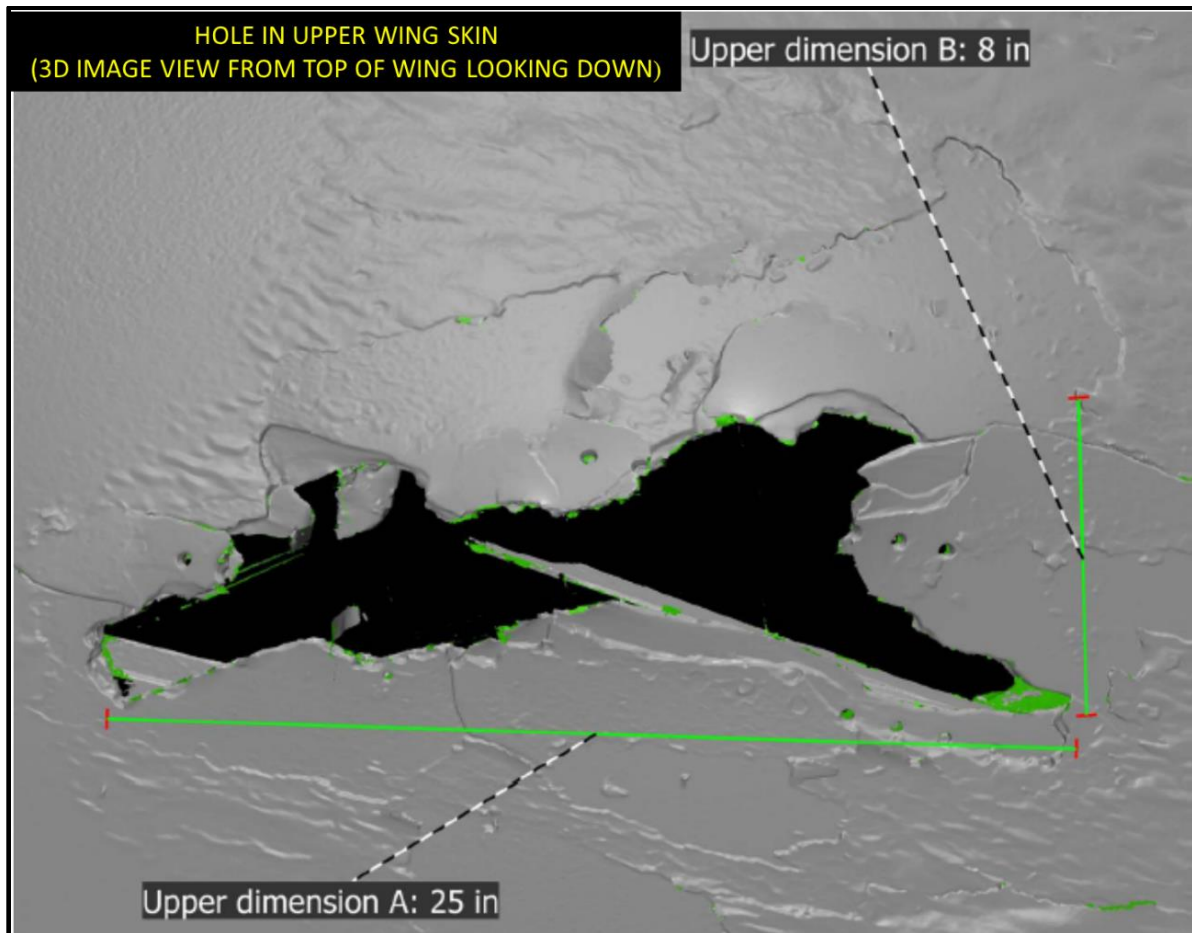
Figure 20 Close-up view of upper hole showing dimensions

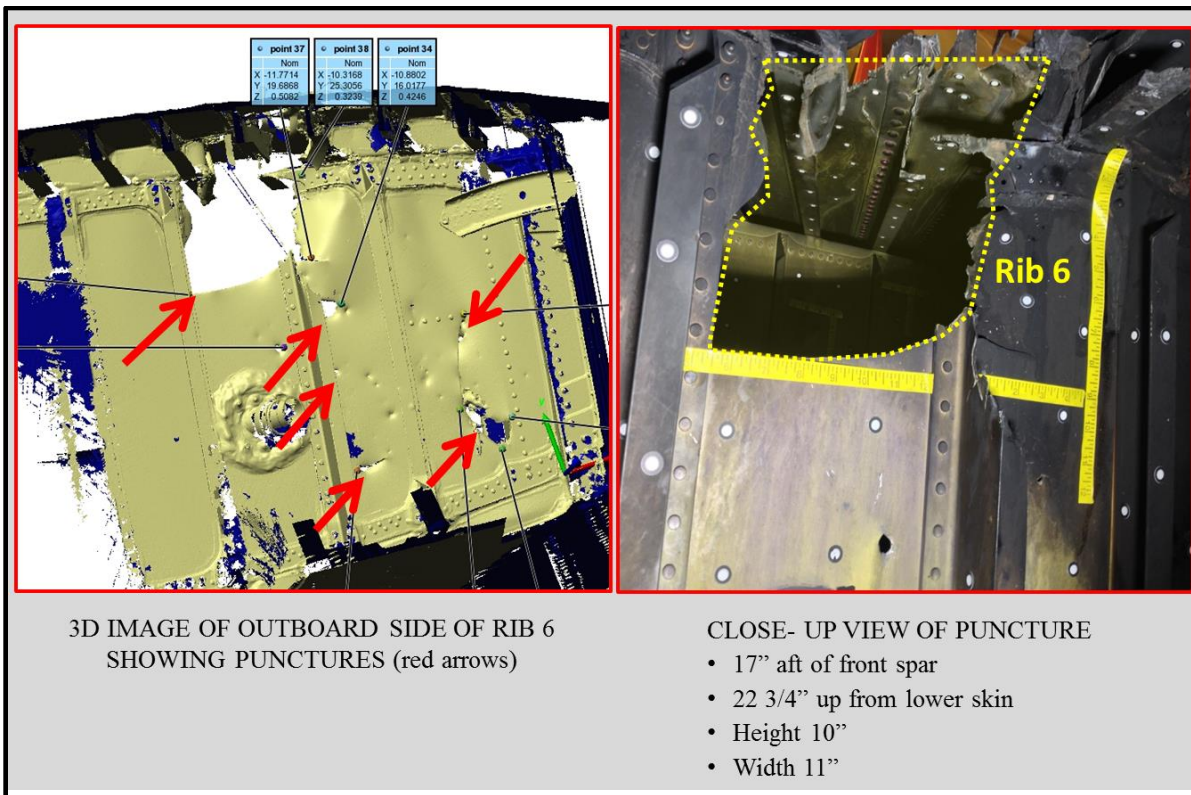
Figure 21 View showing the damage to rib number 6.

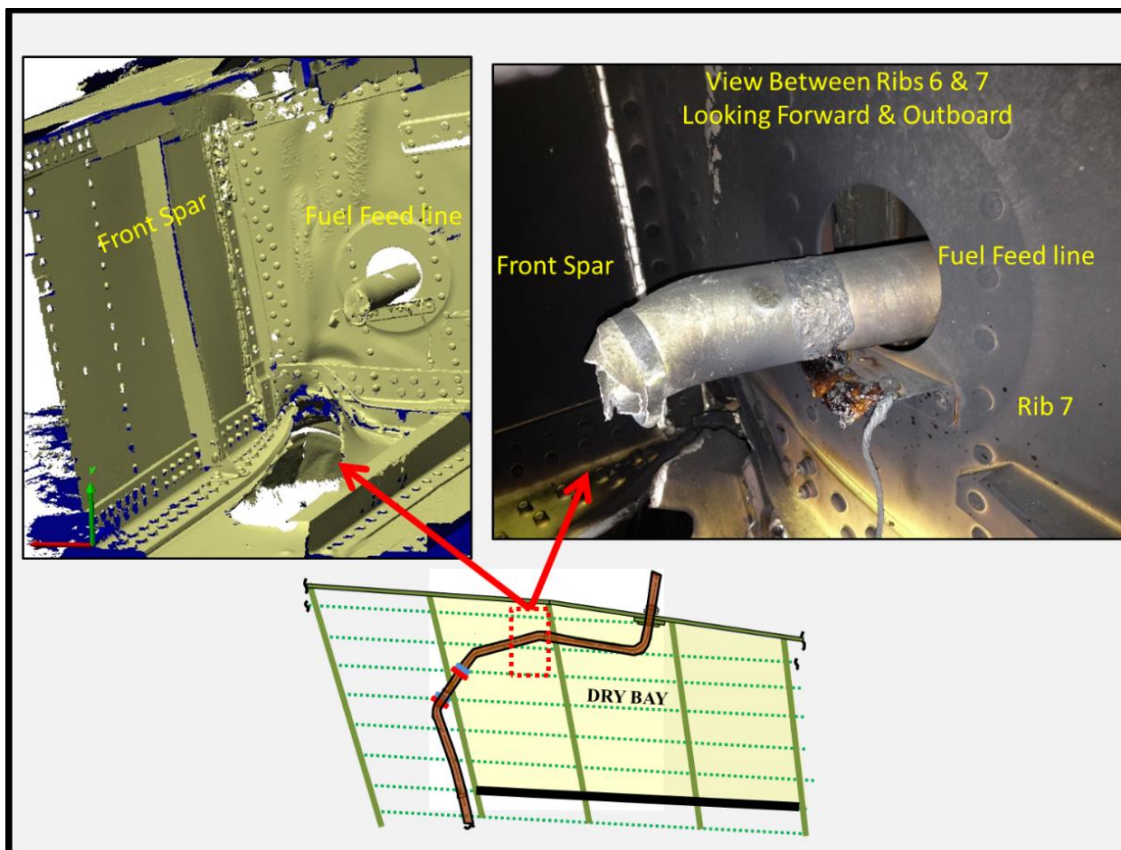
The main engine fuel feed line located between ribs 6 and 7 was found completely severed and open to the dry bay. Reference Figures 22 – 23. The fuel line has an approximate diameter of two inches and is made of 0.028” wall thickness aluminum tubing.

Figure 22 View of hole in lower wing skin and damaged main fuel feed line

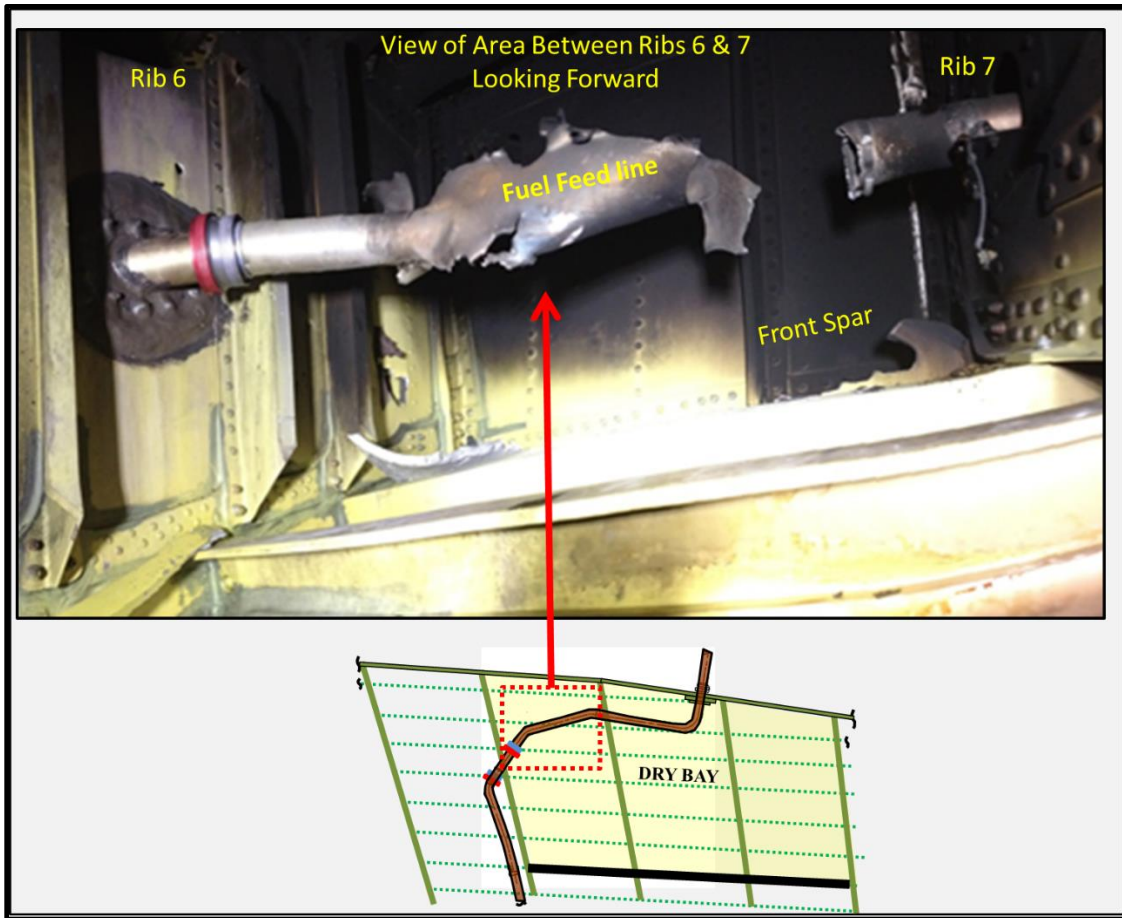
Figure 23 View of the damaged main fuel feed line

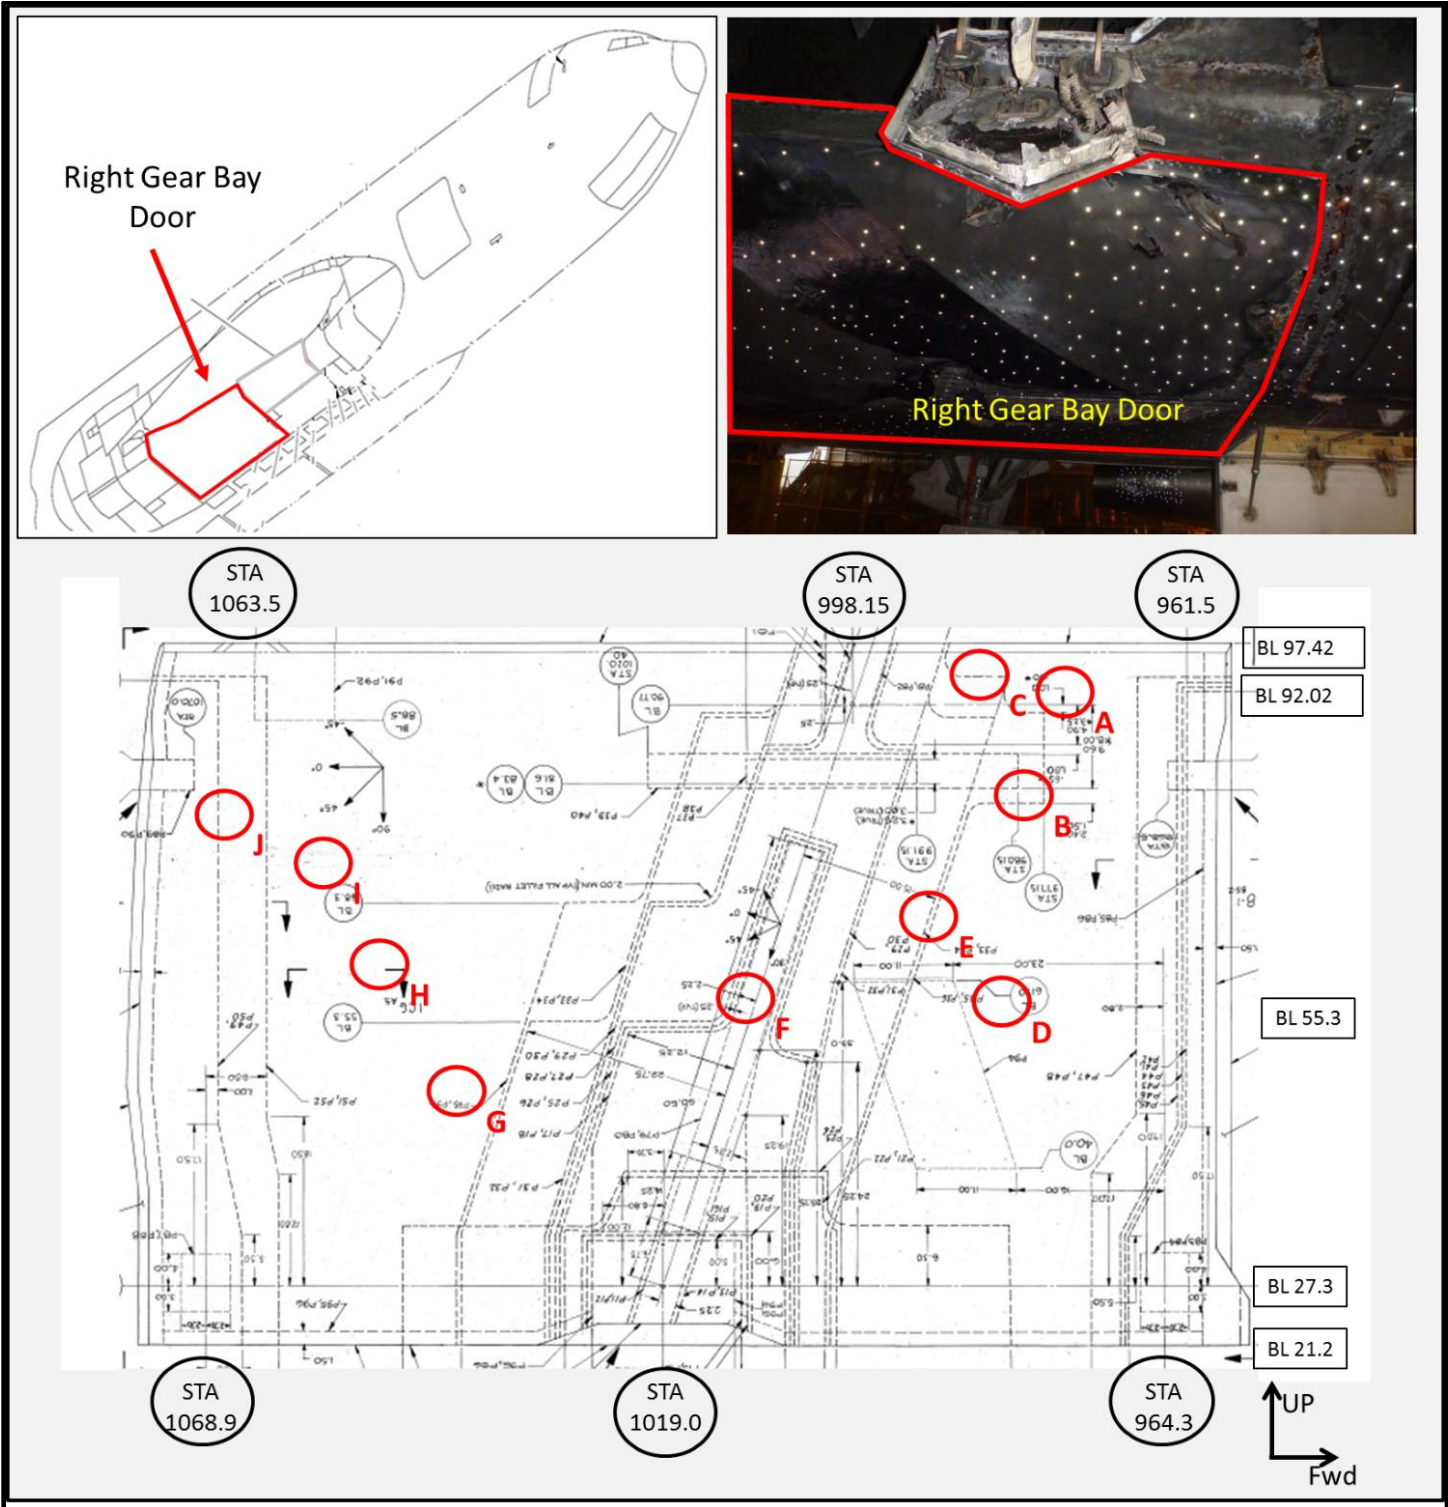
Figure 24 Drawing of right main landing gear door showing impact mark locations

Examination of the right MLG door revealed multiple areas where the door had been impacted by debris. Figure 24 provides a schematic of the landing gear door with the main impact areas highlighted by red circles and identified by letters ranging from A to J. Table 2 provides the details (location, length, width, and condition) of each of the identified impact areas. For the impact area identified as “A”, the examination revealed that a fragment from the right engine (a piece of the aft flange of the HPT inner shaft) remained embedded within the top edge of the forward portion of the gear door. (Figure 25).

- Condition 1: External skin punctured & core crushed.
- Condition 2: Complete puncture.
- Condition 3: External skin fiber damaged, other than heat, no core damage.

A	B	C	D	E	F	G	H
Length	1.2"	1.5"	4"	0.9"	0.6"	1.2"	1.0"	0.8"
Width	0.85"	0.7"	2.2"	0.6"	0.5"	0.1"	0.25"	0.6"
Condition	Outer Skin Hole & Core Crushed	Outer Skin Hole & Core Crushed	Complete Hole	Outer Skin Hole & Core Crushed	Outer Skin Hole & Core Crushed	Outer Skin Hole & Core Crushed	Outer Skin Hole & Core Crushed	Outer Skin Hole & Core Crushed

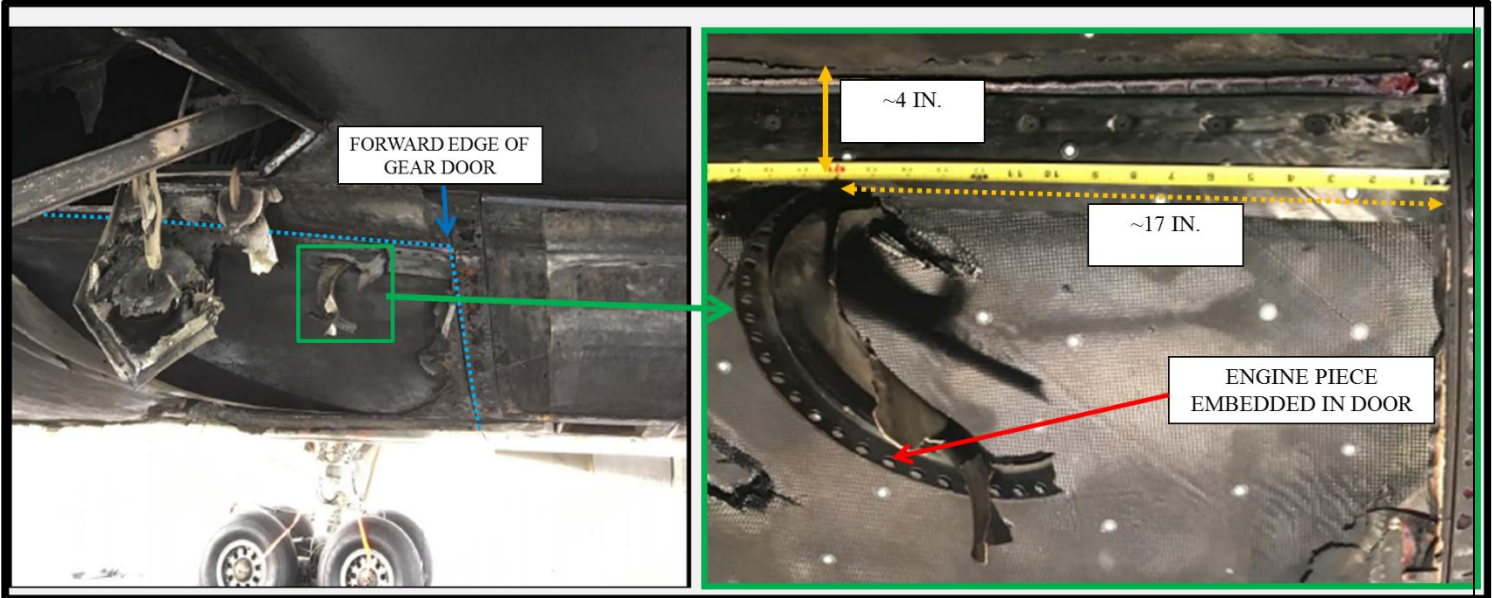
Figure 25 Photograph showing the piece of engine FOD embedded in right gear bay door

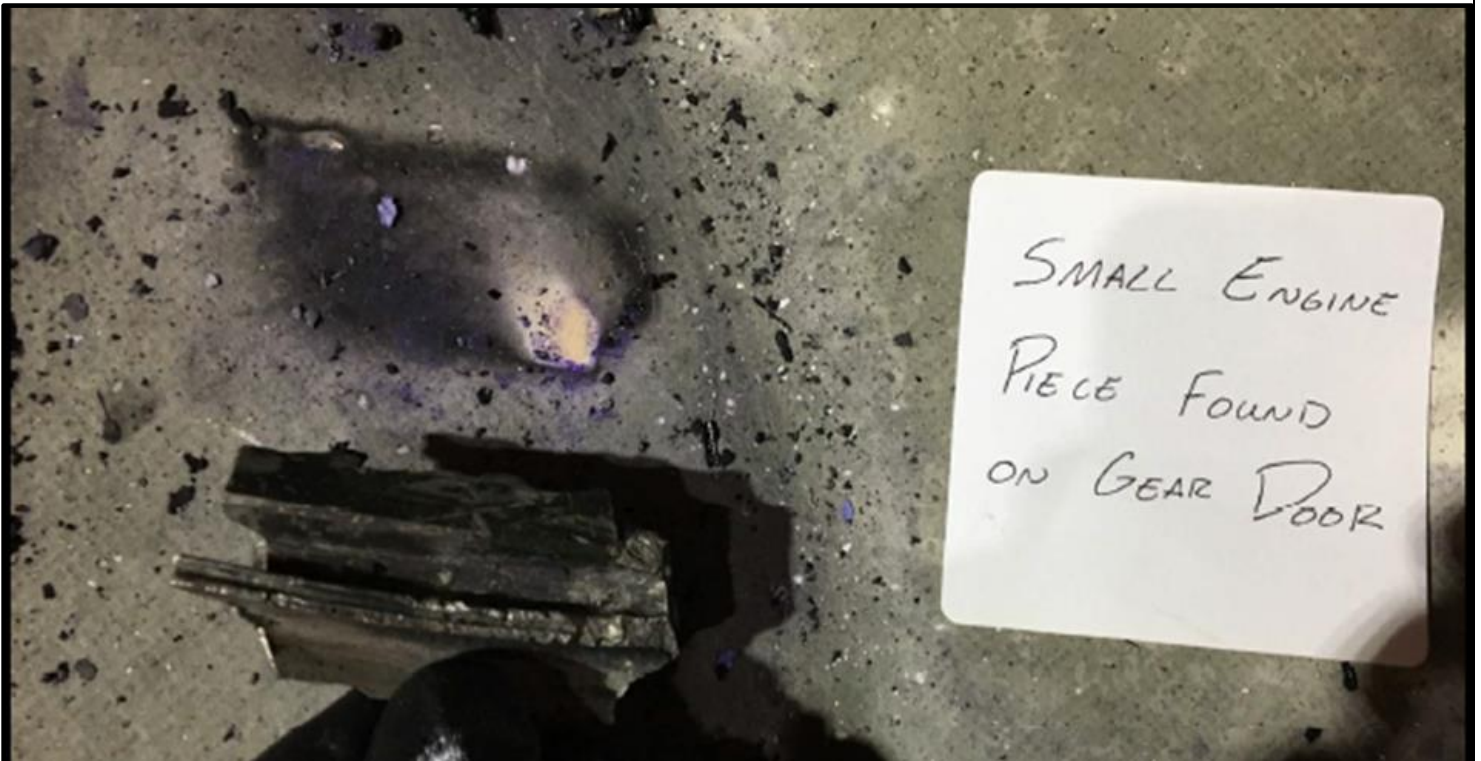
Figure 26 Small Engine piece found in right main gear bay when door opened

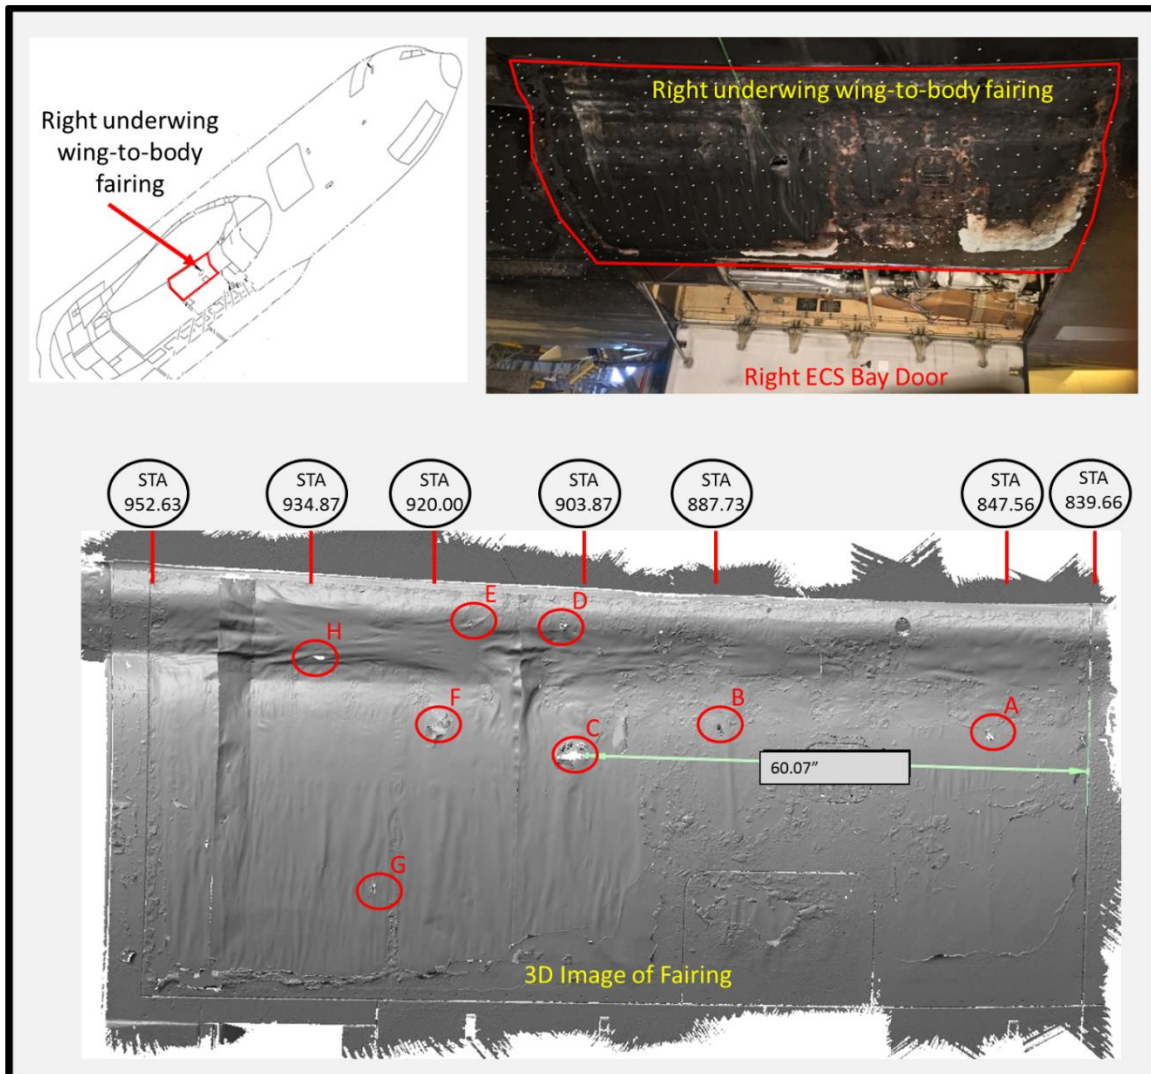
Examination of the underwing wing-to-body fairing revealed multiple areas where the door had been impacted by FOD. Figure 27 provides a photograph and a 3D image of the fairing with the main impact areas highlighted by red circles and identified by letters ranging from A to H. Table 3 provides the details (length, width, and condition) of each of the identified impact areas. Because the impact area identified as "C", penetrated completely through the fairing, the Airworthiness Group visually inspected and documented the area within the right ECS bay compartment for FOD and impact related damage. When the ECS bay door was opened, a small section of the stage 2 (HPT blade) from the No. 2 engine was observed resting on the lower section of the door. Additionally, a small piece of the No. 2 engine's aft heat shield was found near the third (from the aft) door hinge. (Figures 28 - 29) From the ECS bay, looking outboard toward the hole in the wing-to-body fairing, a hole was observed in the body crossover air supply duct. An impact mark (no puncture) was also observed on the primary heat exchanger duct. (Figure 30 - 31).

Figure 27 Picture of damaged underwing wing to body fairing panel (looking toward airplane centerline from right side)

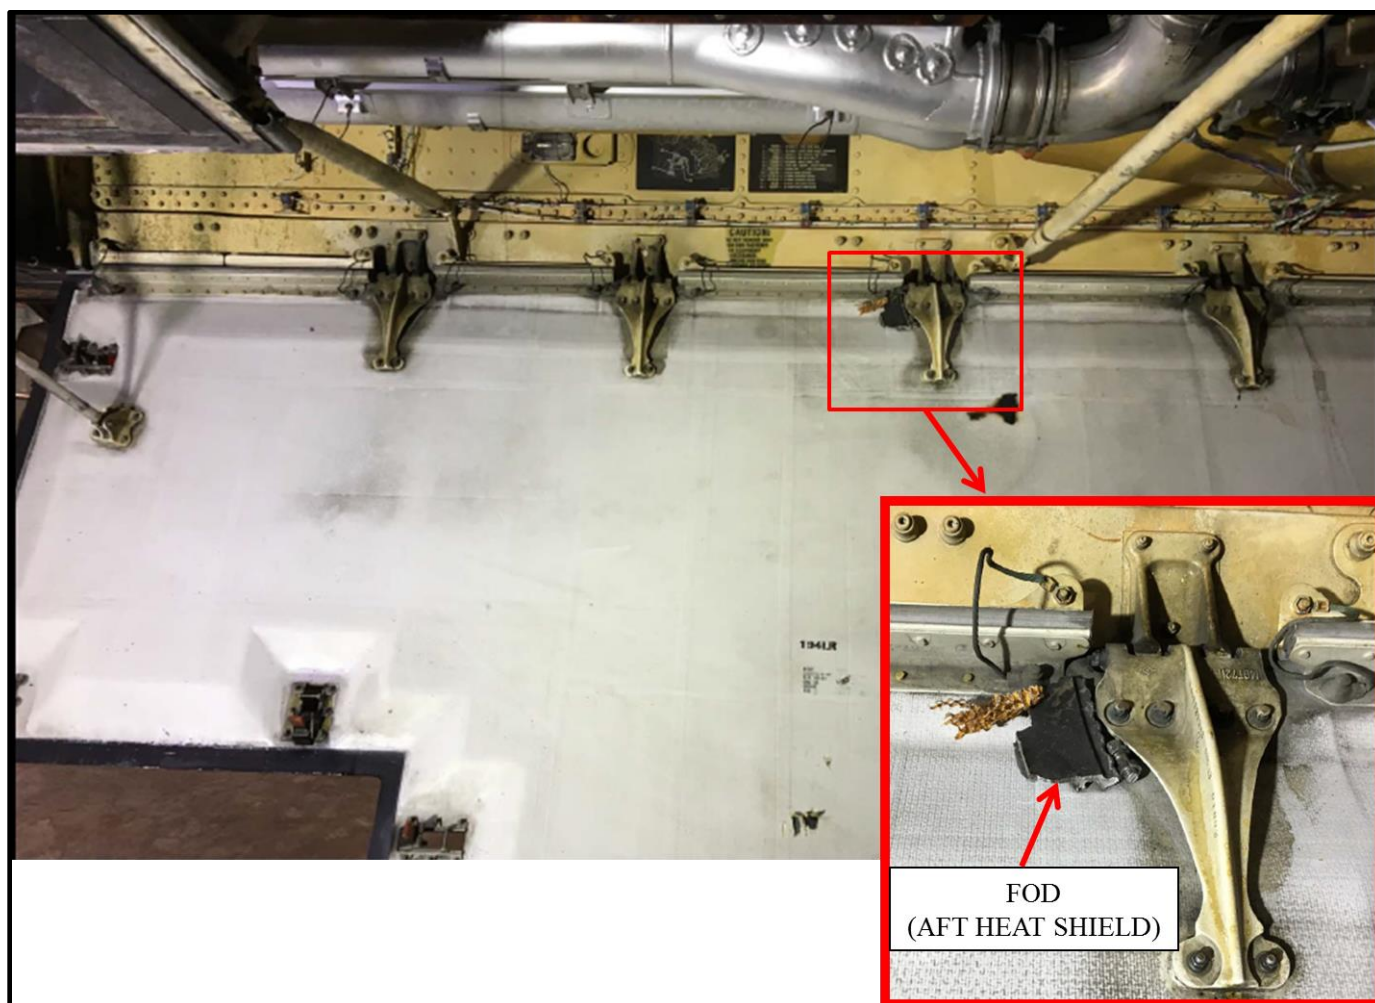
Figure 28 View showing 2nd piece of FOD in ECS bay

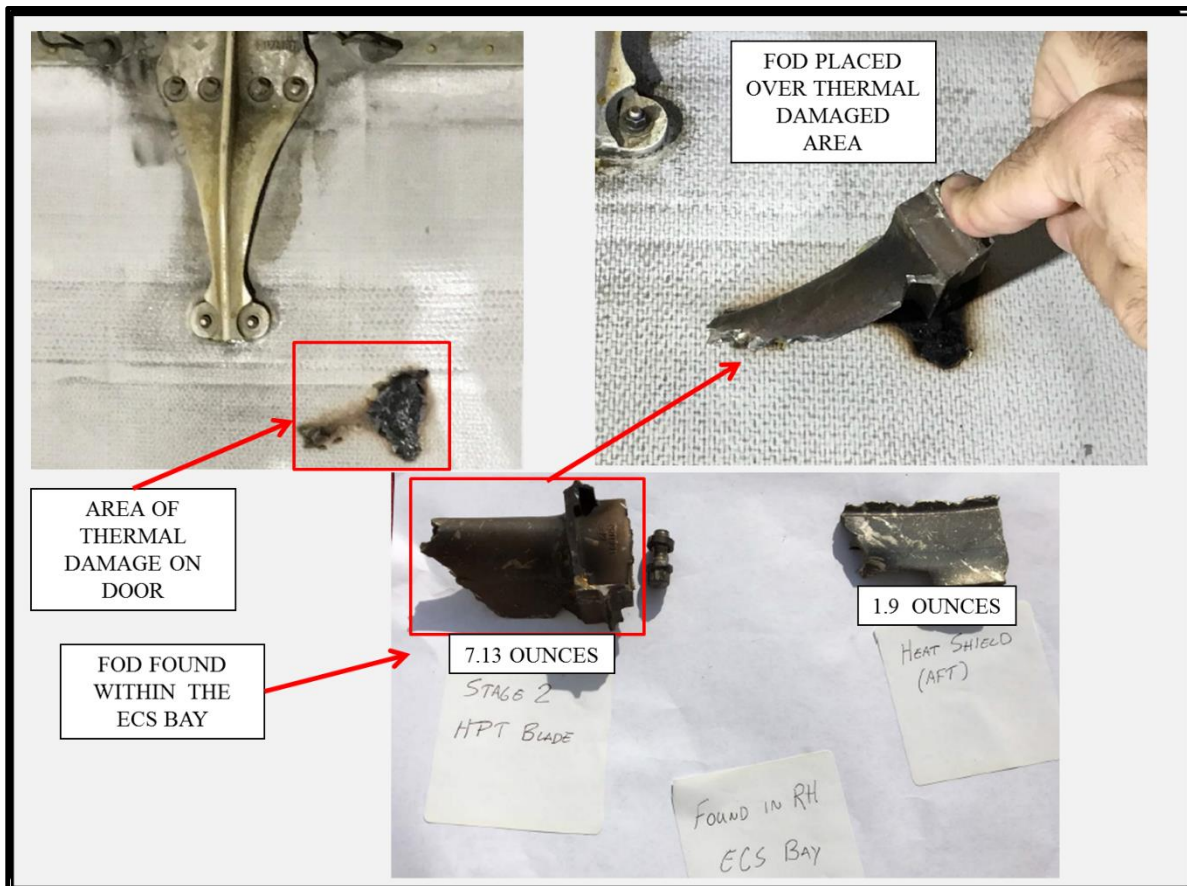
Figure 29 View of damage to right ECS bay door

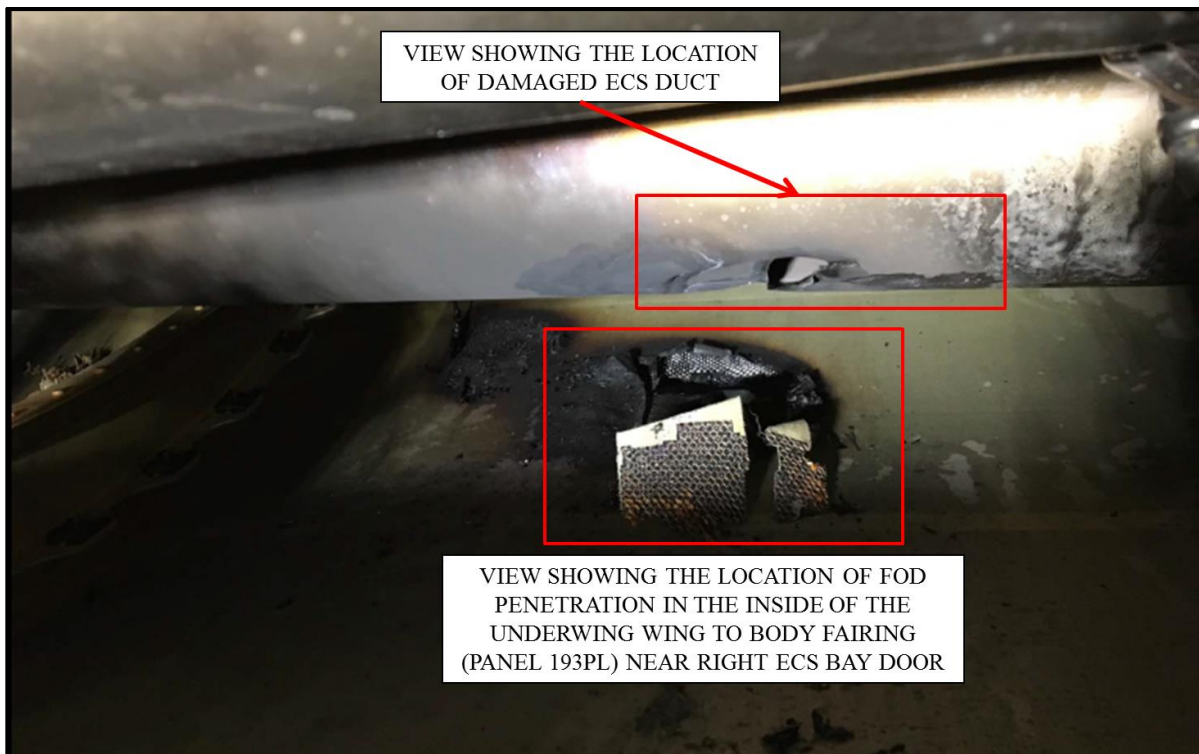
Figure 30 View of inside of ECS bay looking outboard
