NATIONAL TRANSPORTATION SAFETY BOARD

Airworthiness Group Chairman's Factual Report

NTSB ID No.: DCA17FA021

NTSB Accident Number: DCA17FA021
Location: Chicago, Illinois
Date: October 28, 2016
Time of Accident: About 1432 Central Daylight Time
Aircraft: Boeing 767-323(ER)
Registration Number: N345AN

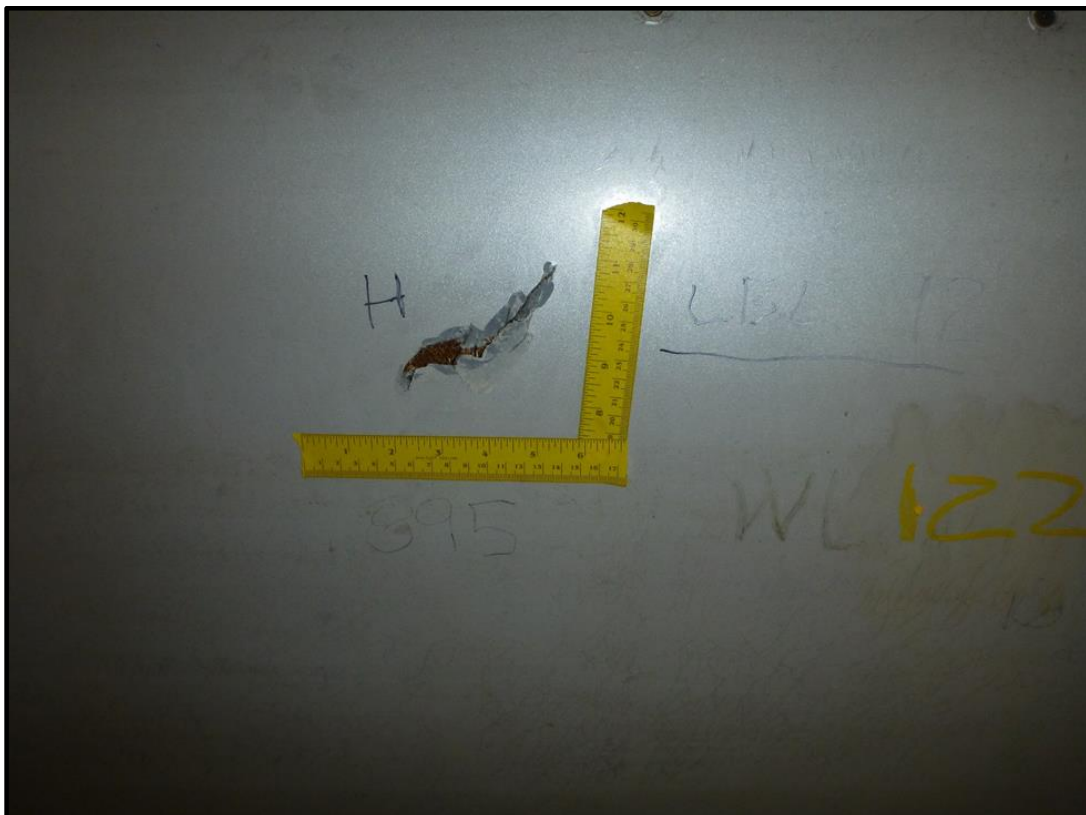
Figure 33 Impact H, ECS pack bay left side

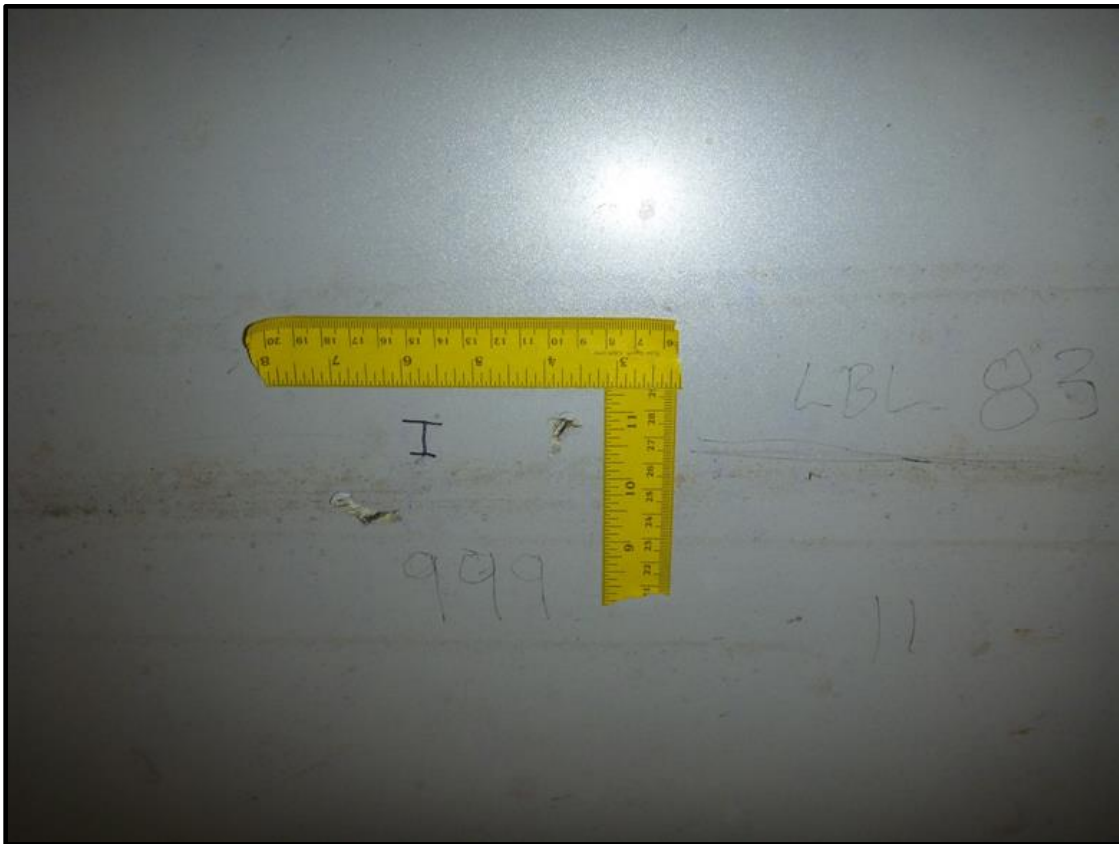
Figure 34 Impact I, Main gear door left side

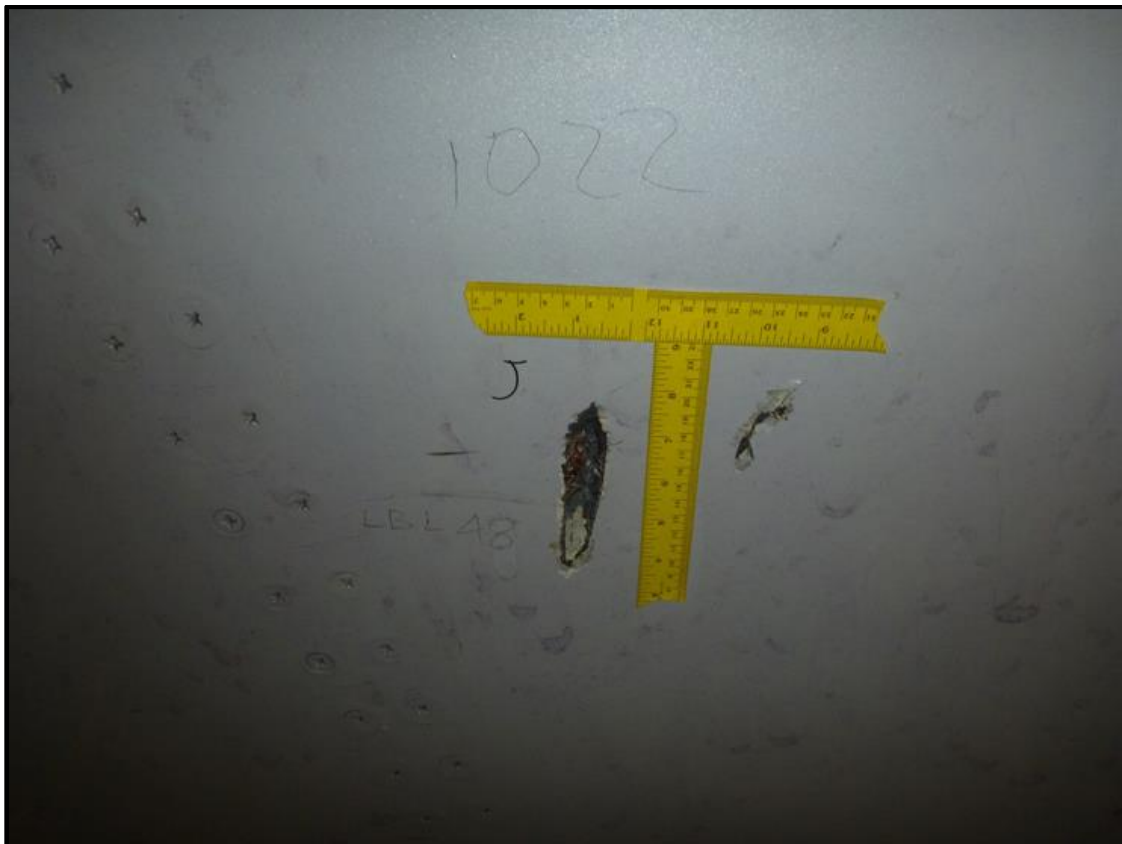
Figure 35 Impact J, Main gear door left side

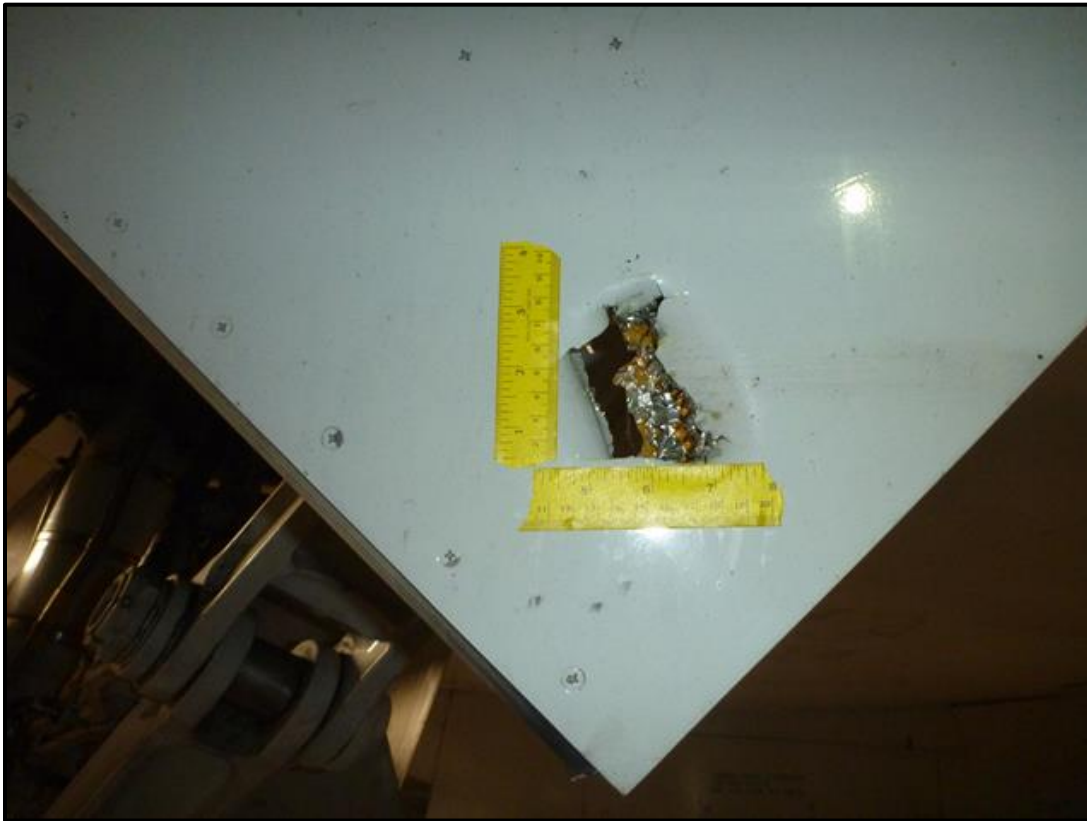
Figure 38 Impact L, left main gear drag strut door

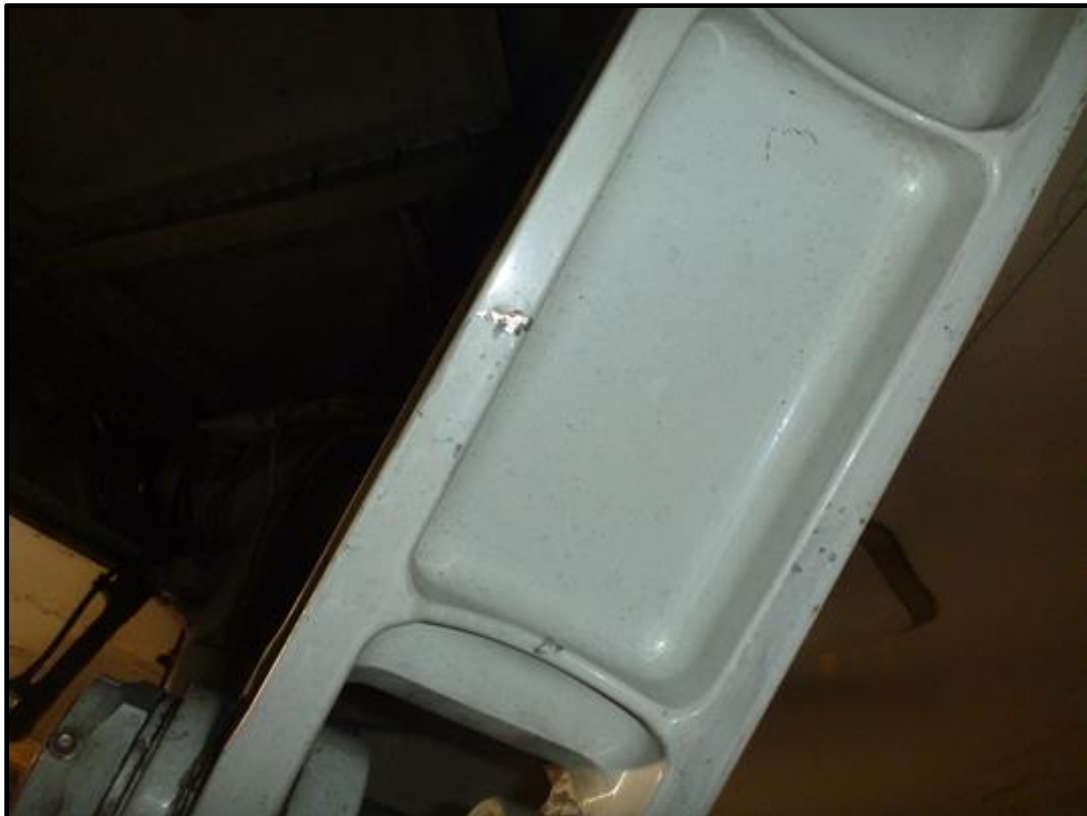
Figure 39 Impact M, left main gear drag strut link

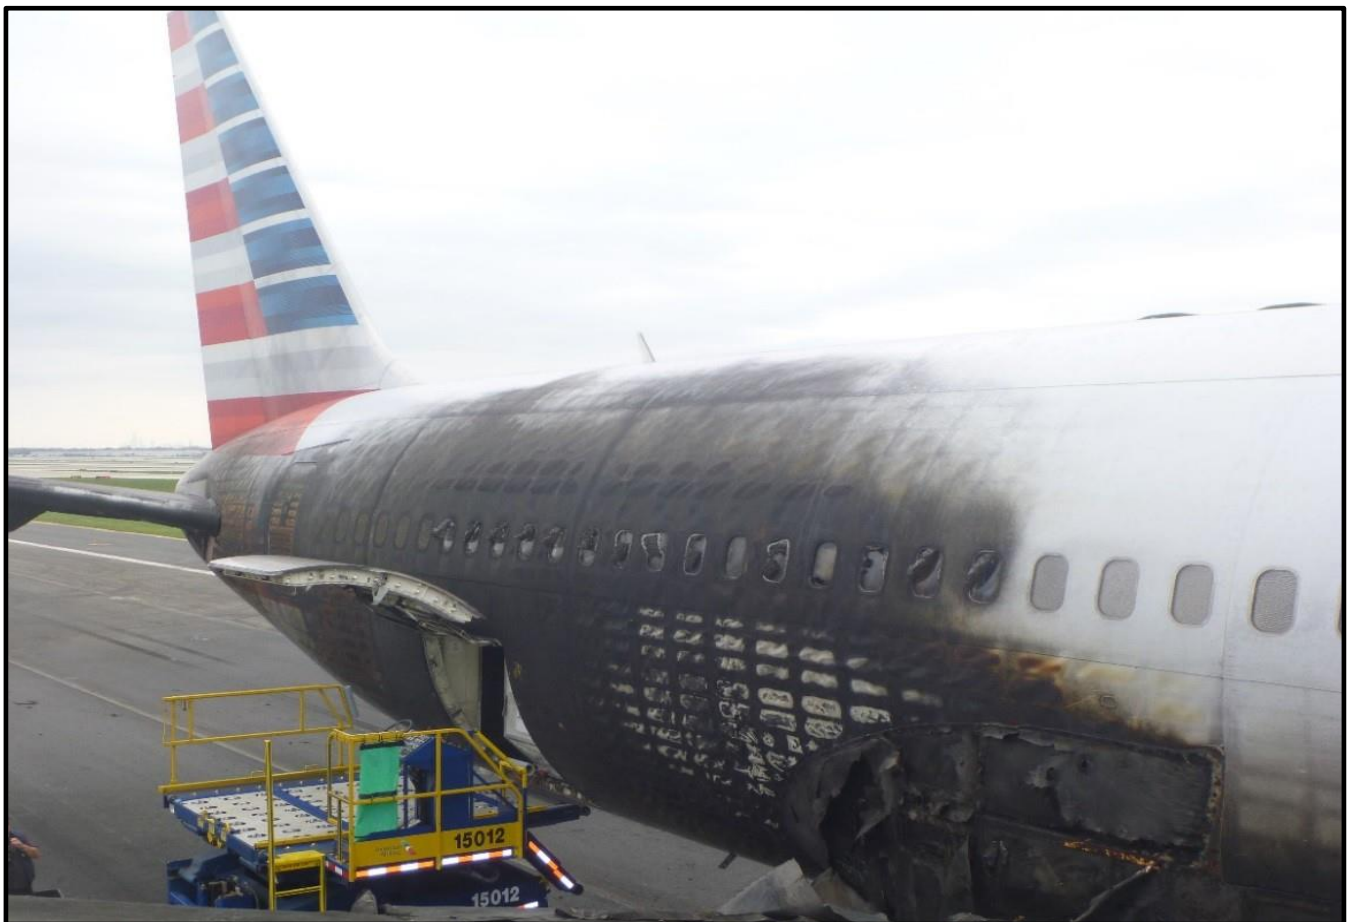
Figure 43 Thermal damage to the right side of the fuselage

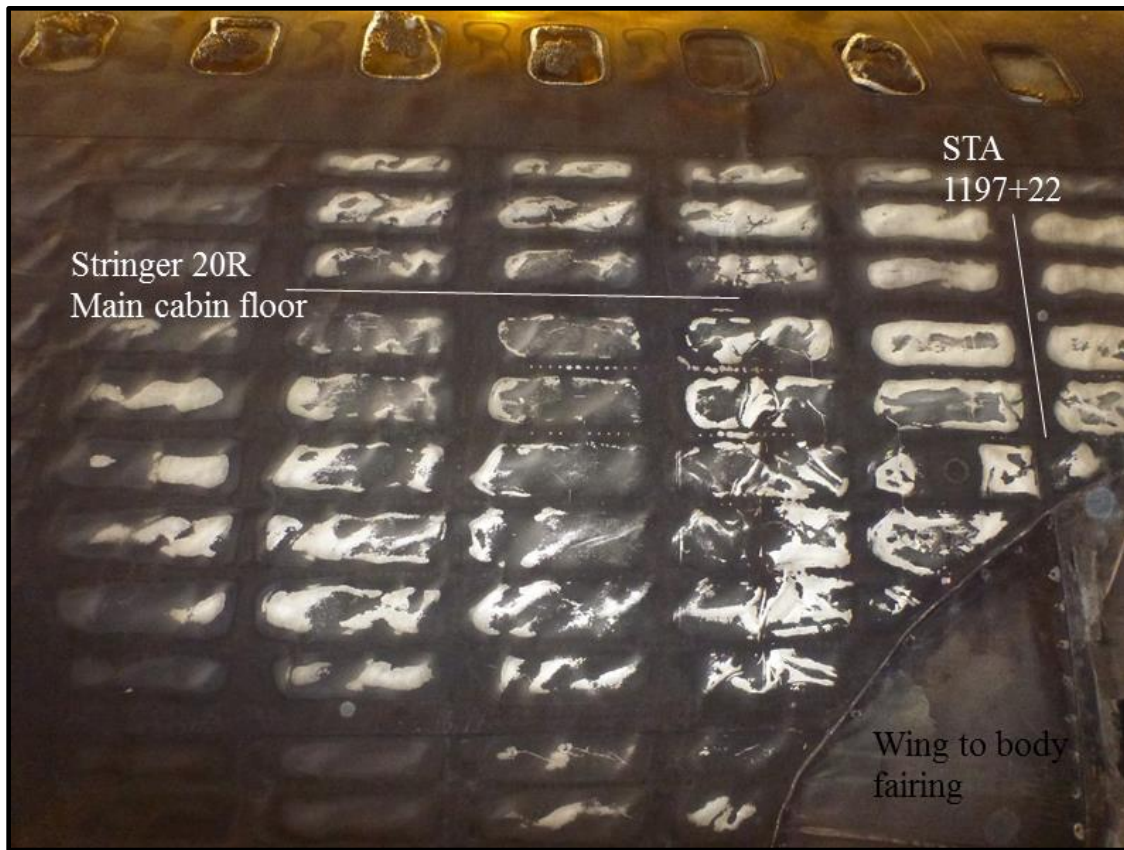
Figure 44 Thermal damage on the right side fuselage skin

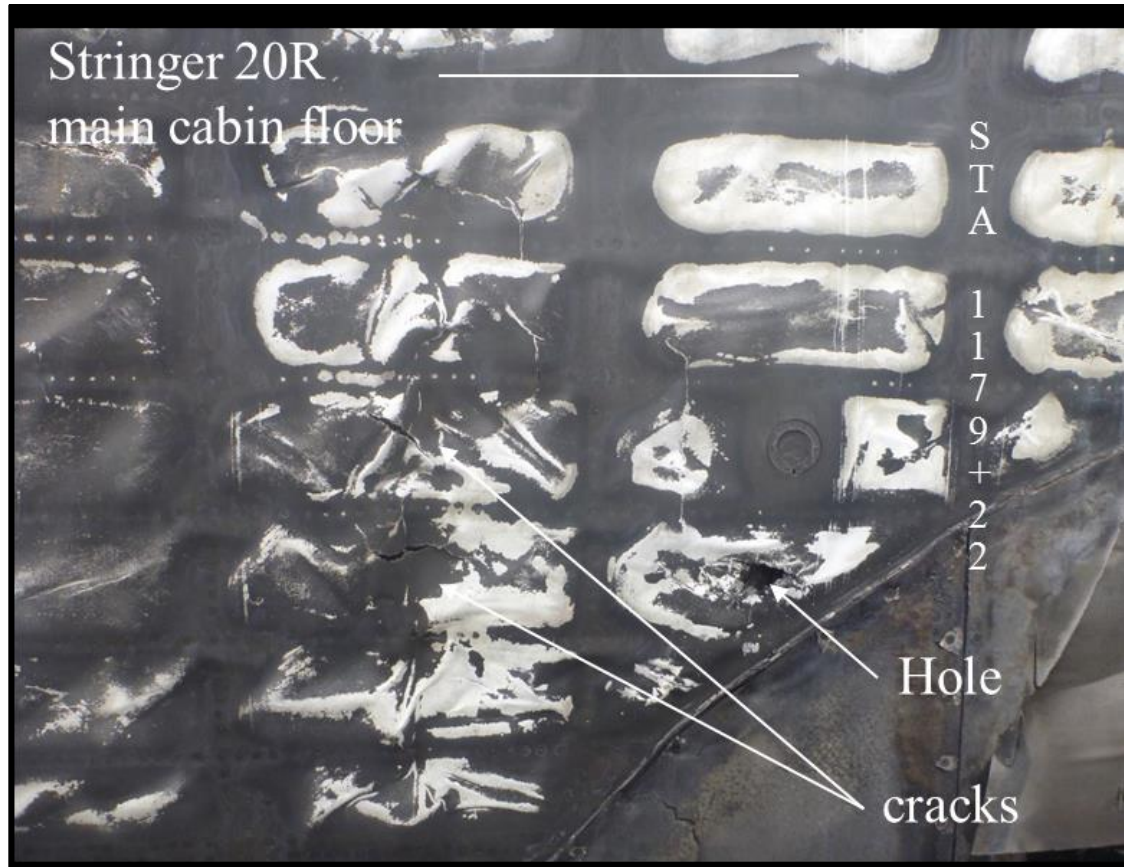
Figure 45 Multiple thermal cracks and hole in fuselage skin

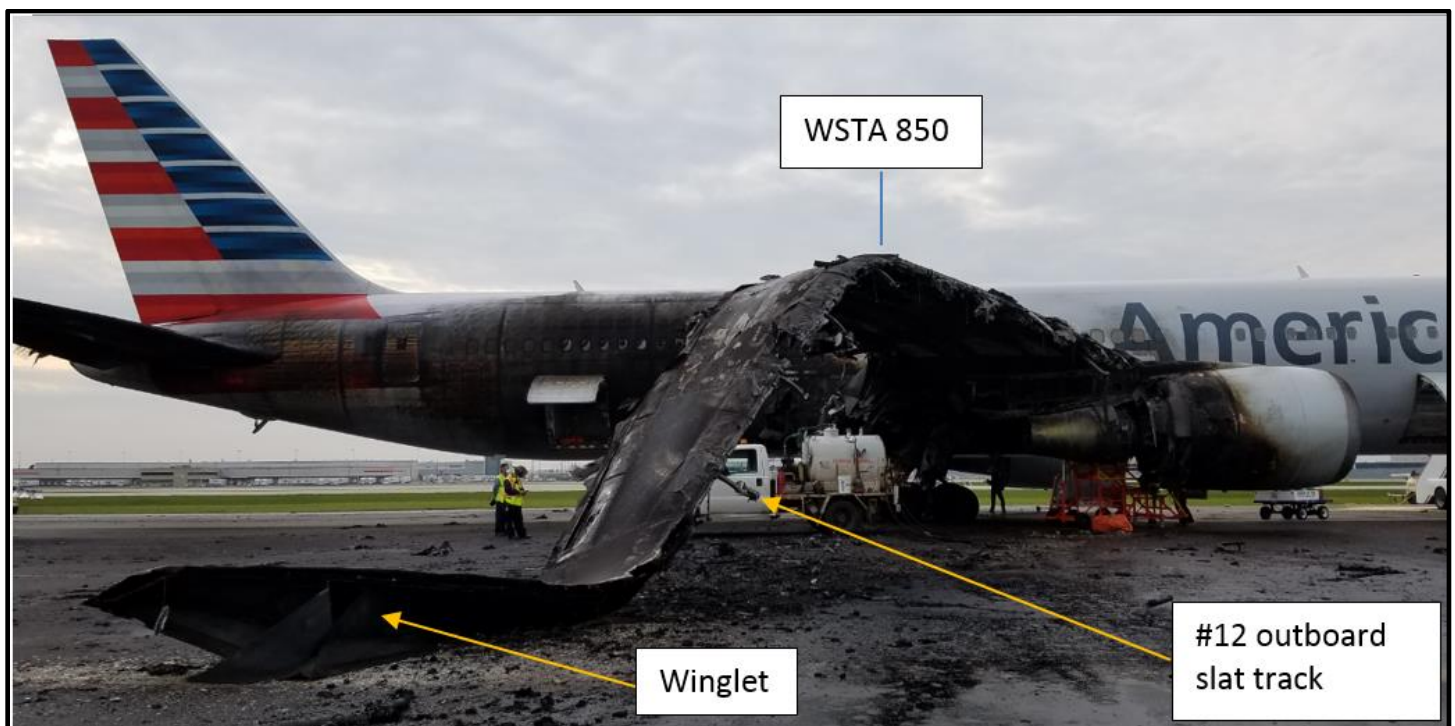
The majority of the lower wing in-spar skin and ribs outboard of wing station 800 were found consumed. The outboard end of the right wing was found sagging and touching the ground at the wing to winglet interface. Reference Figure 46 – 50.

Figure 46 View looking inboard at right wing bent down and contacting the tarmac

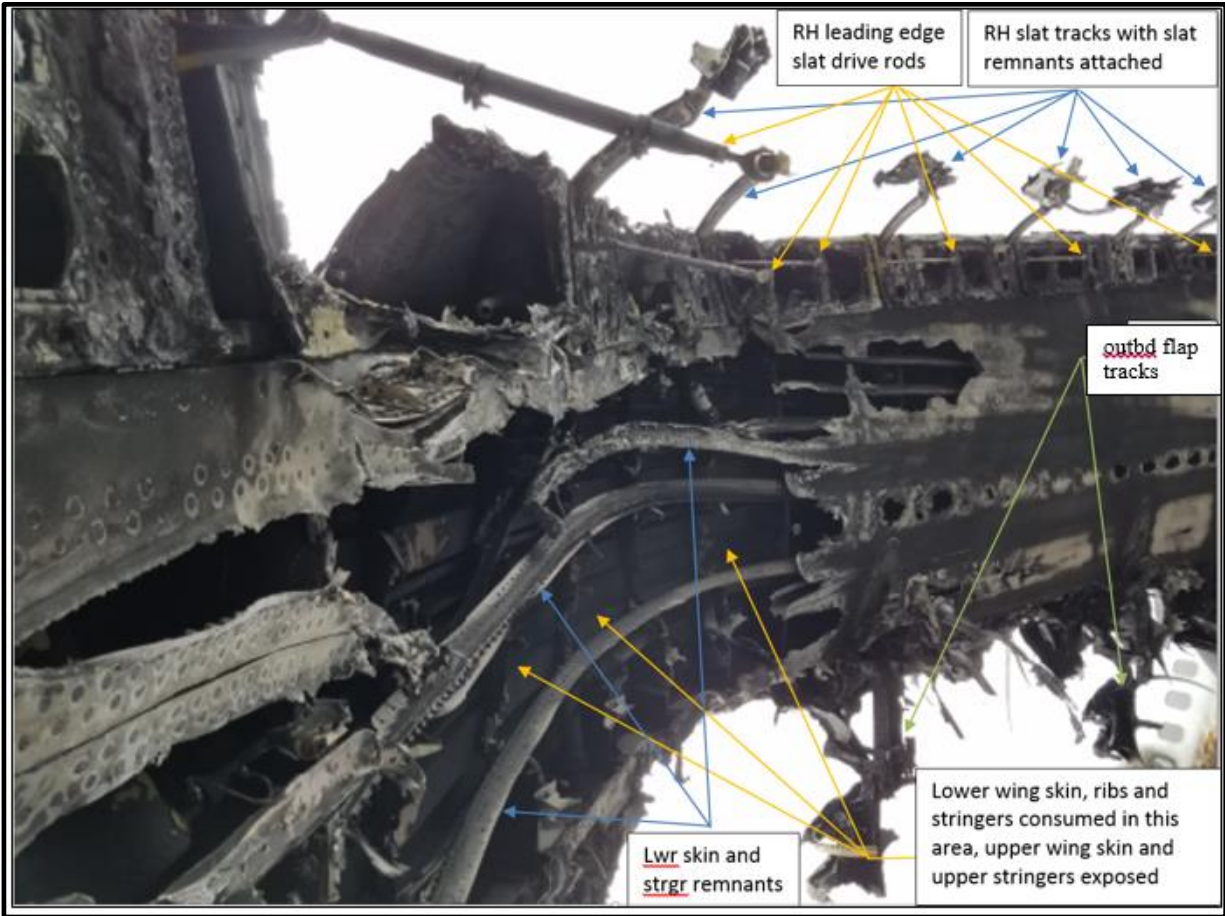
Figure 47 View looking up and inboard at right wing underside in area of bend in wing.

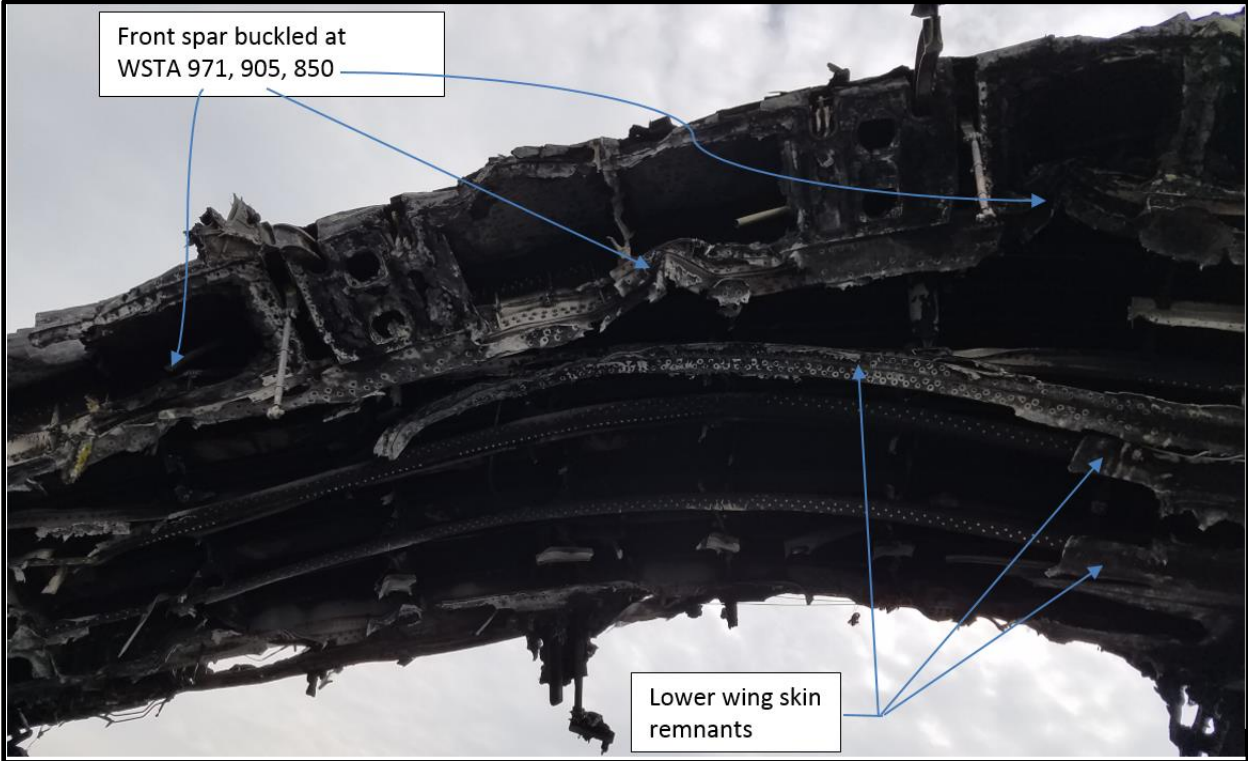
Figure 48 View looking aft and up at wing from WSTA 825-960 showing front spar buckles

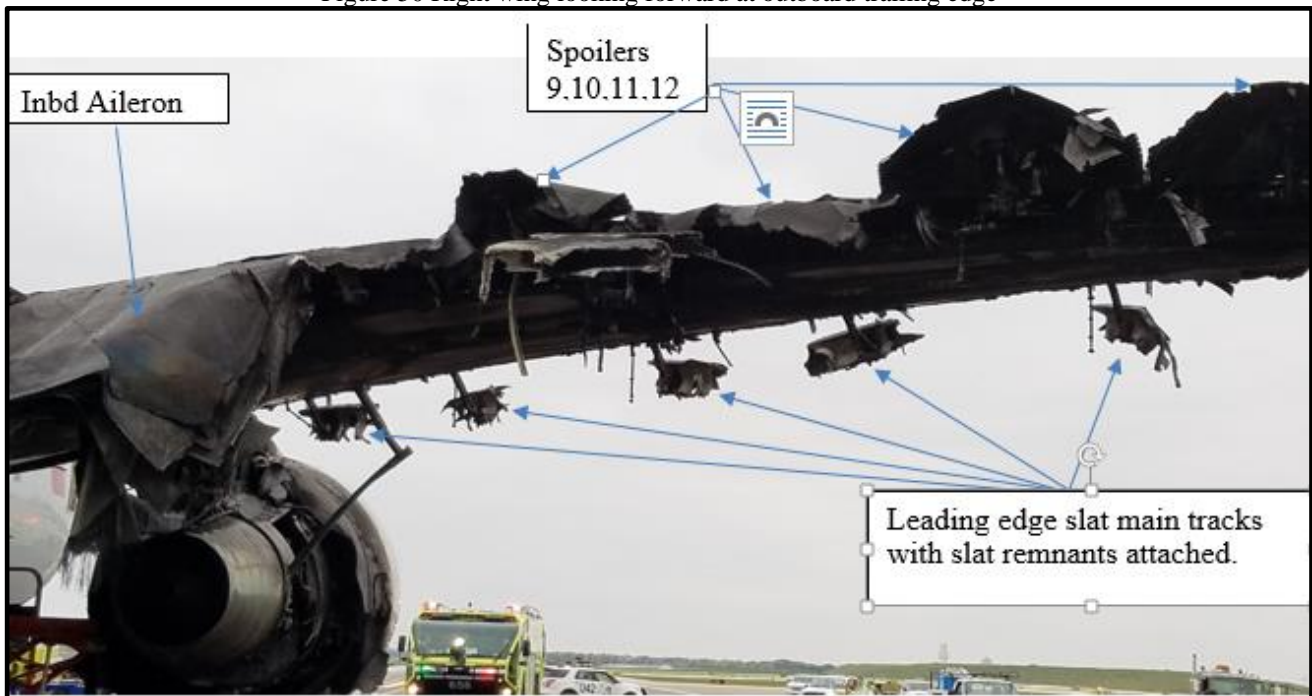
Figure 50 Right wing looking forward at outboard trailing edge

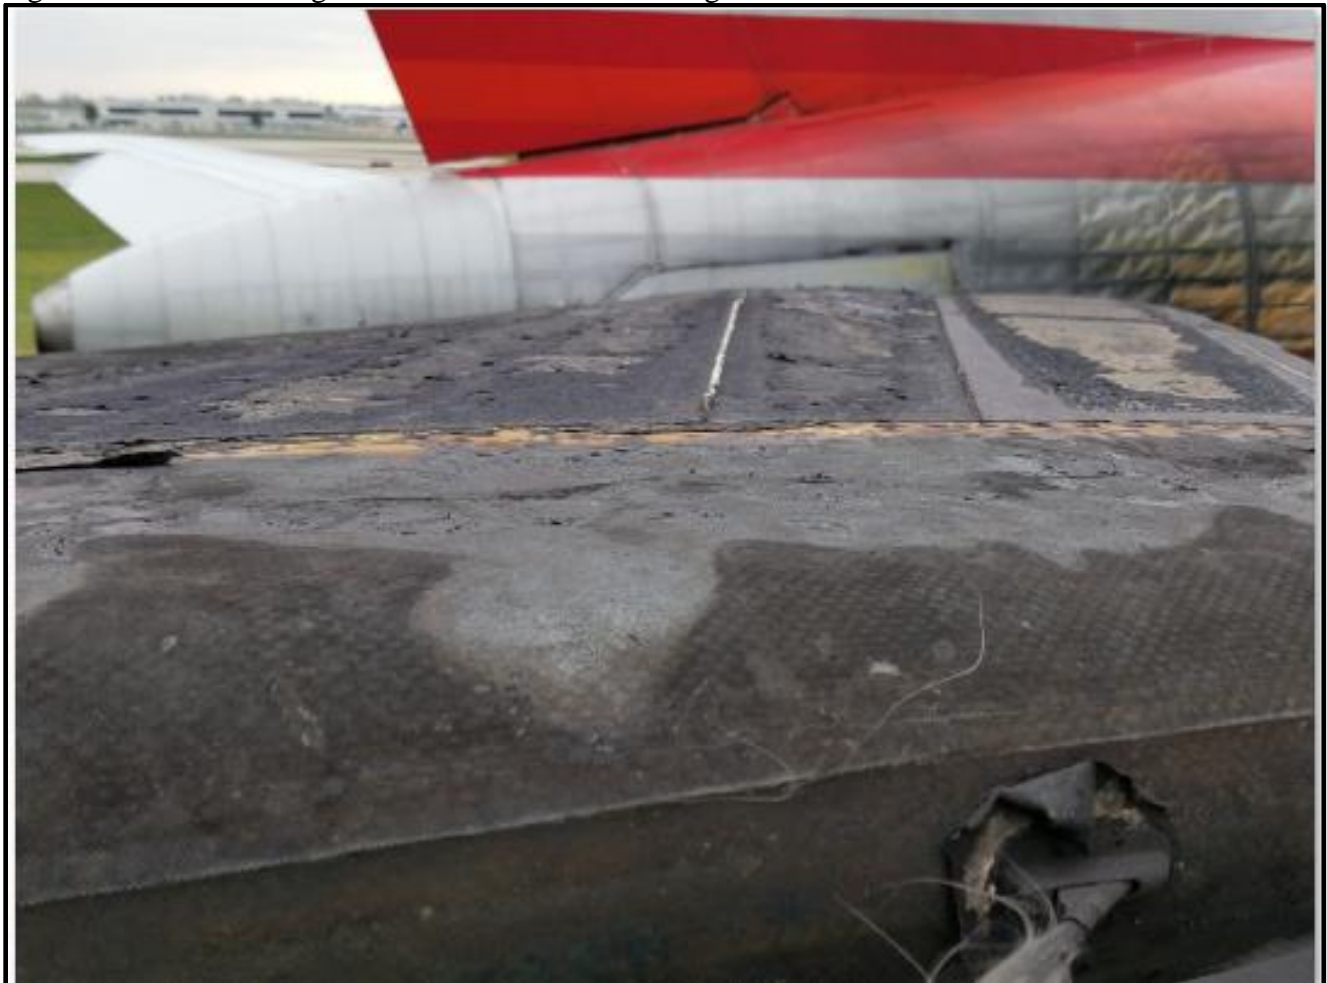
Visual examination revealed that the right horizontal stabilizer had impact damage on its leading edge surface; the stabilizer also appeared to be slightly sagging. Reference Figure 51. The stabilizer lower in-spar skin had been consumed outboard of stabilizer auxiliary spar station number 290 and the upper in-spar skin was found warped and upper stringers were found cracked and split in some areas, the ribs were found intact.

Figure 52 View of the right horizontal stabilizer looking inboard from the outboard end of the stabilizer

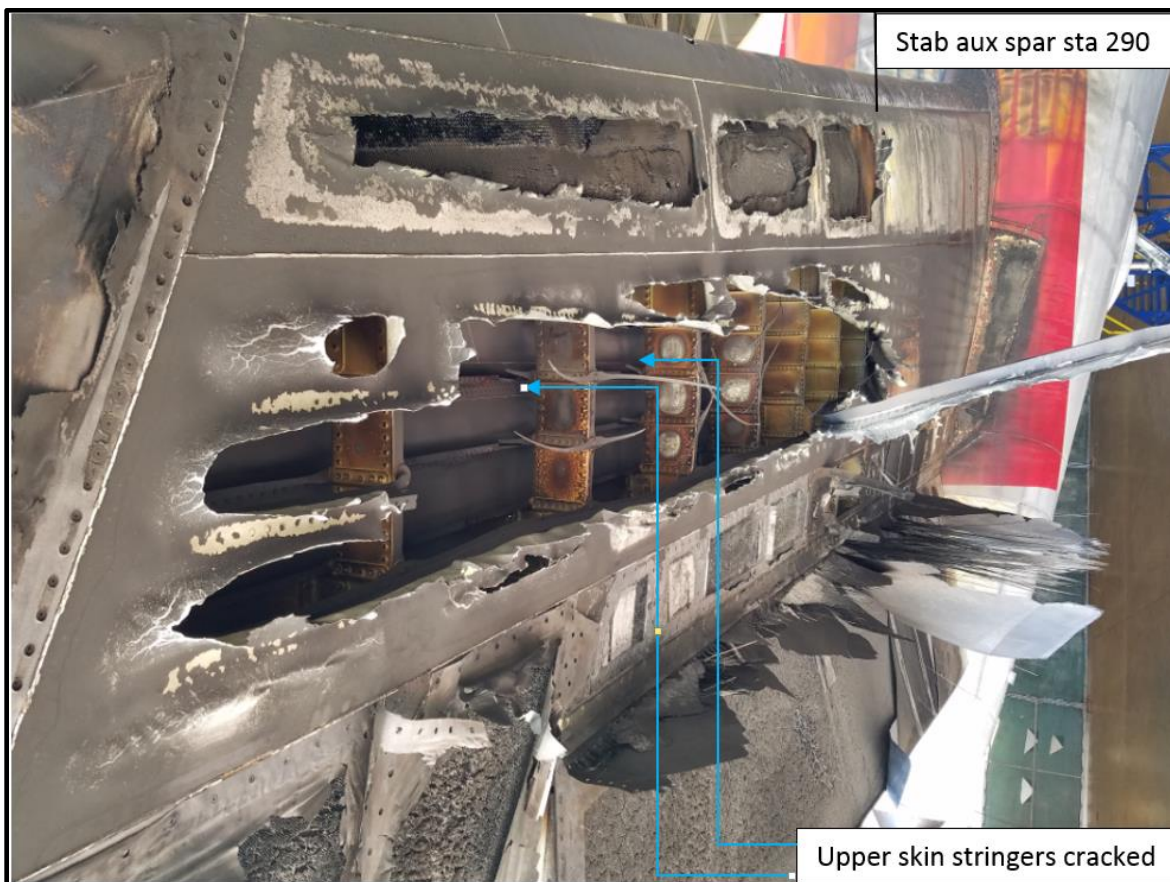
Figure 53 View of the underside of the horizontal stabilizer looking up and inboard from below its outboard tip

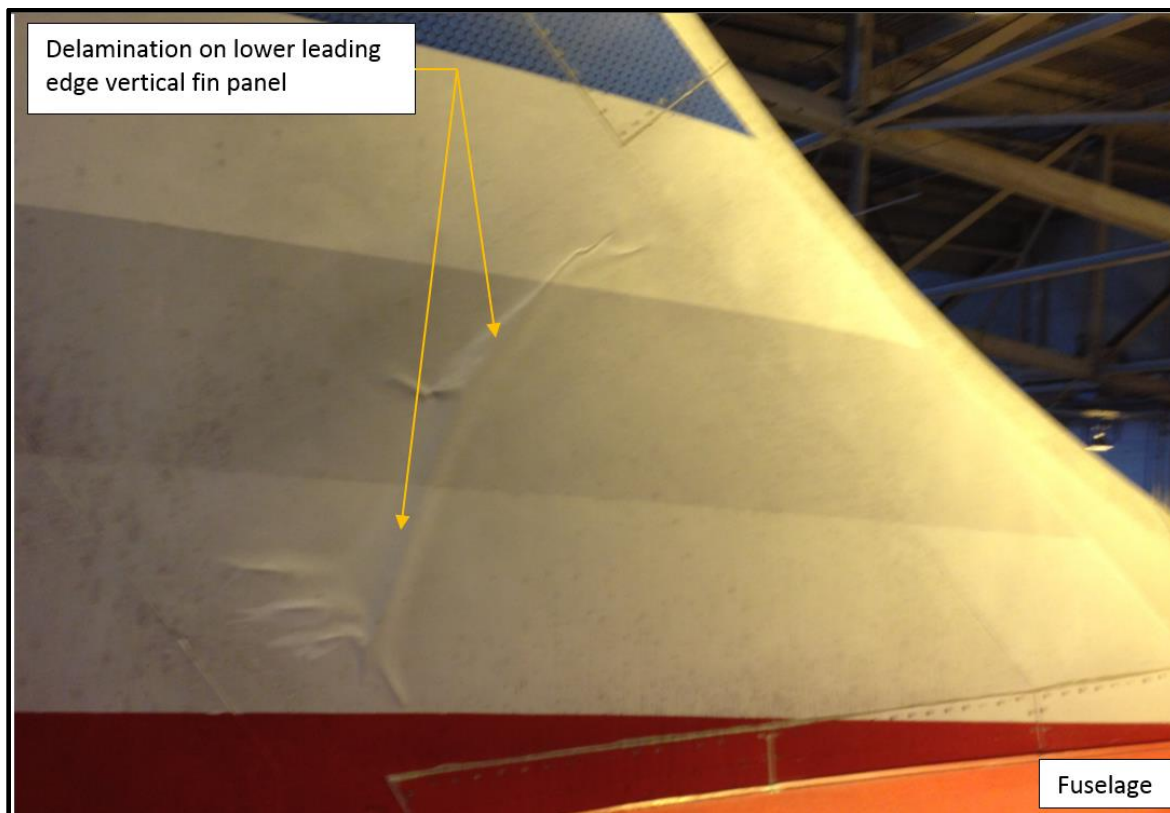
Figure 54 Vertical Stabilizer showing delamination

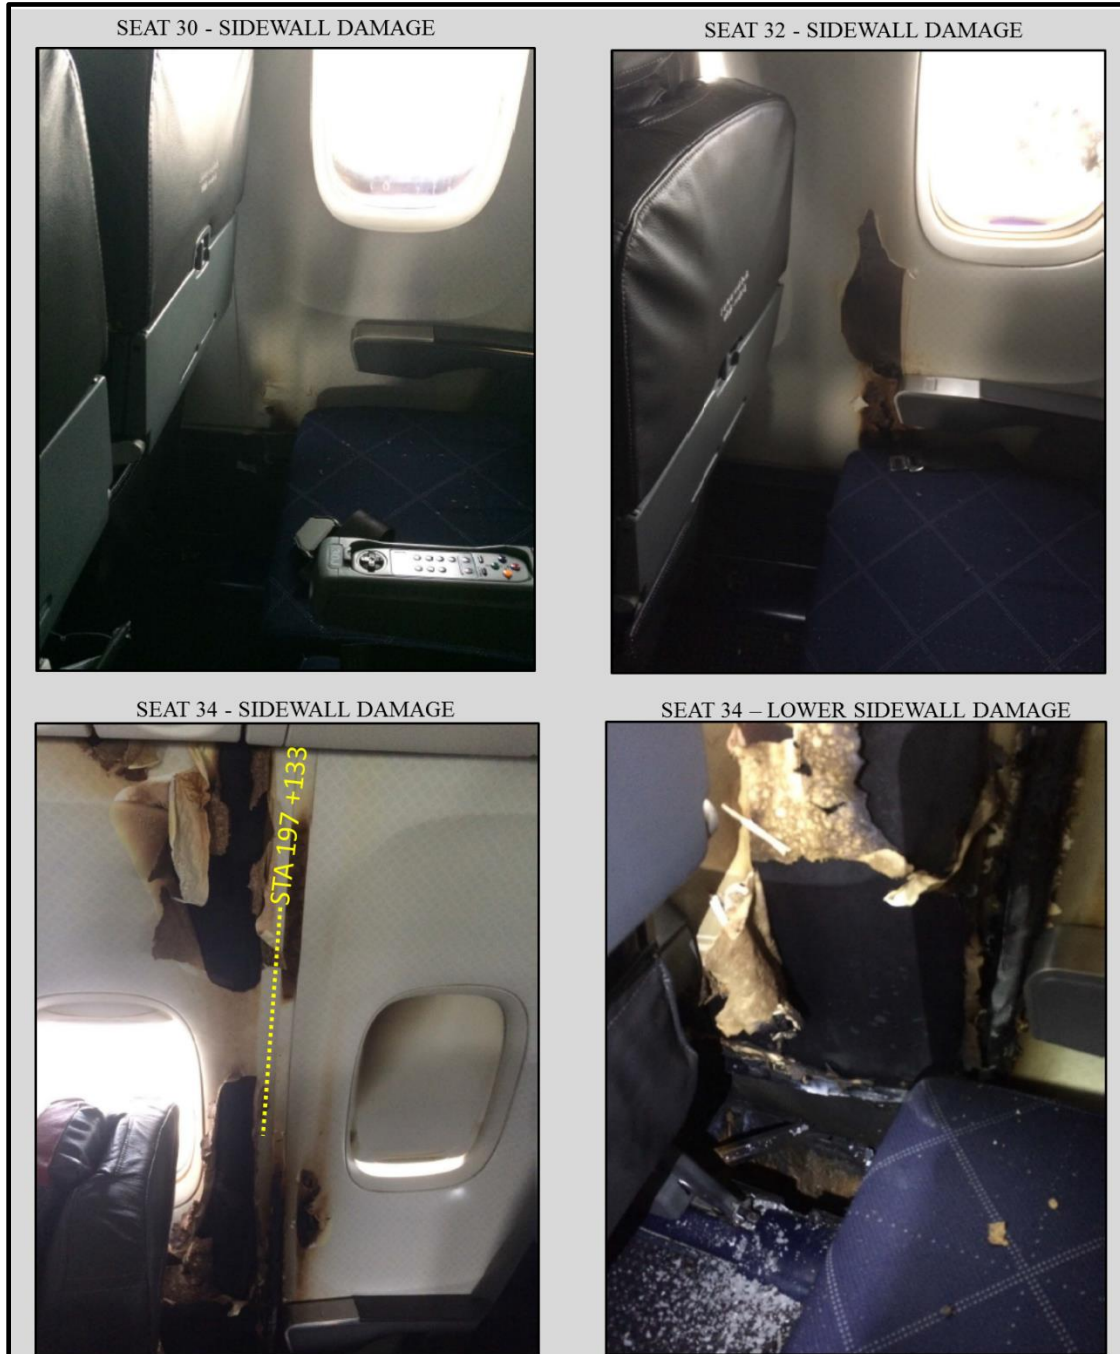
Figure 55 Sidewall Damage at seat locations 30 to 34

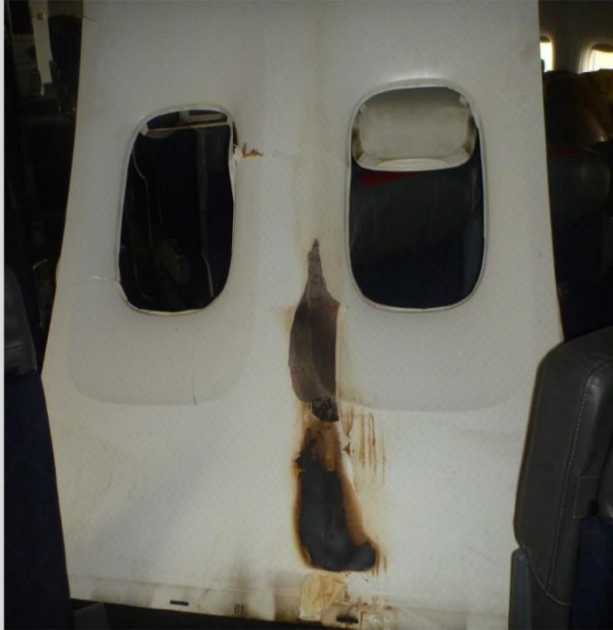
SEAT 32 - SIDEWALL PANEL

The visible damage (other than crazed windows) was limited to the interior sidewall panels at seats 30, 32, 34, and 35. The damage to the panels consisted of melting and charring of the decorative laminate, and charring to their inboard and outboard sides. (Reference Figure 56).

Figure 56 Damage to sidewall panels

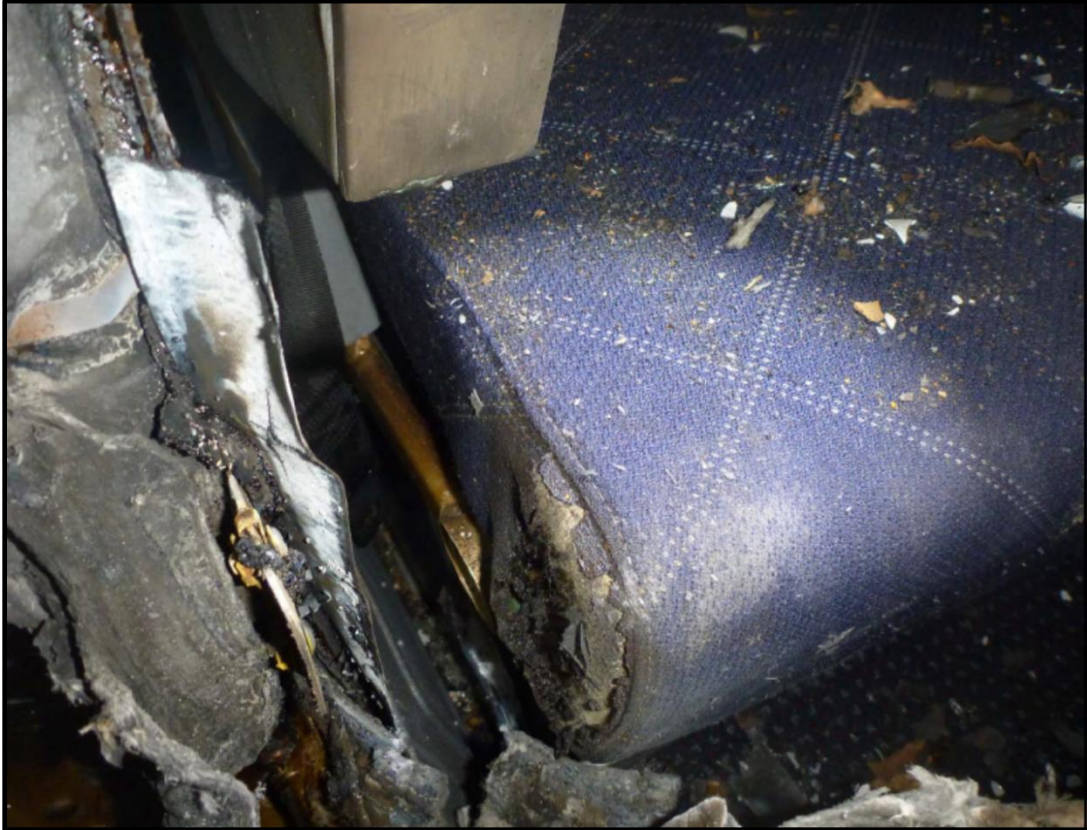
Figure 57 Seat 34 charred seat cushion

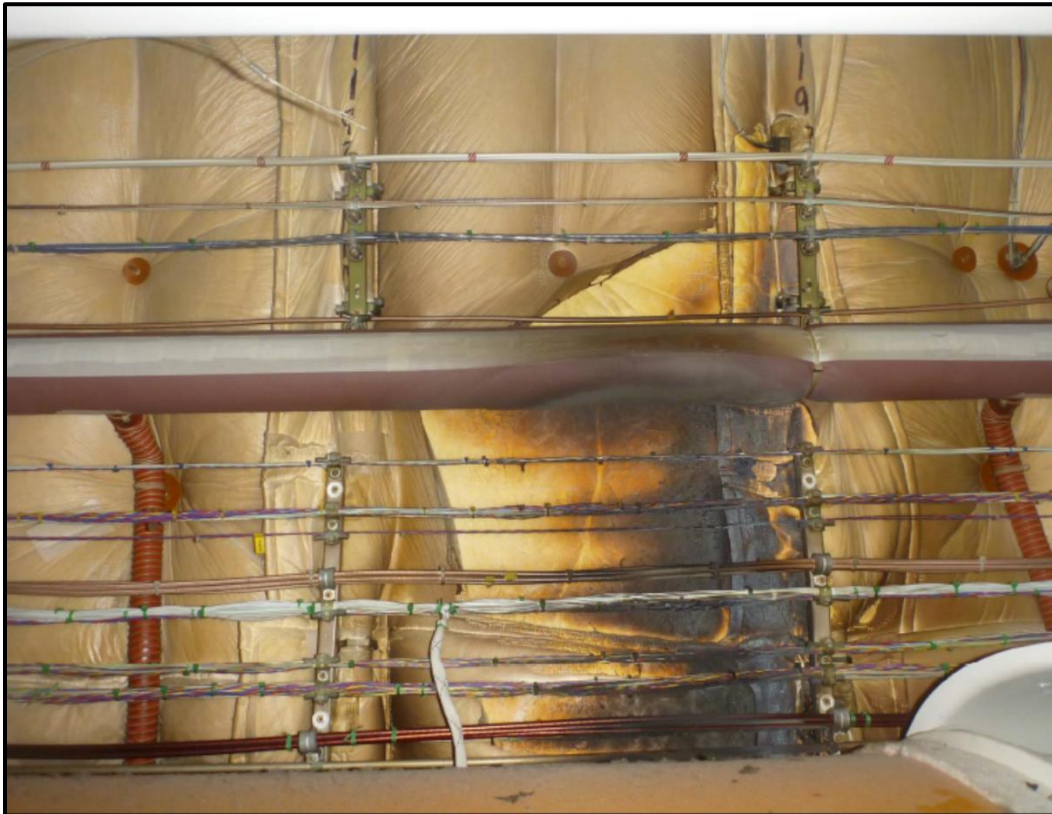
Figure 58 Charred insulation and wiring in crown above seat 34

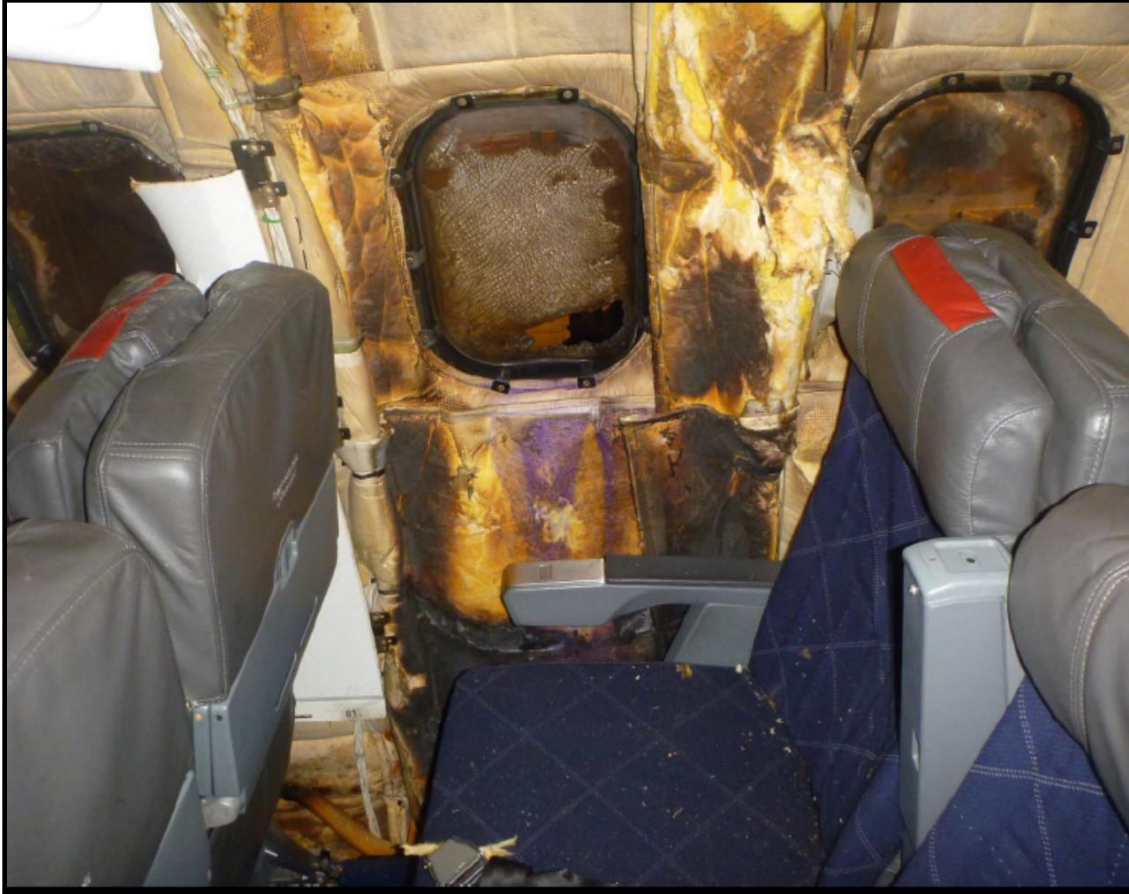
Figure 59 Charred insulation blankets and melted window at seat 30

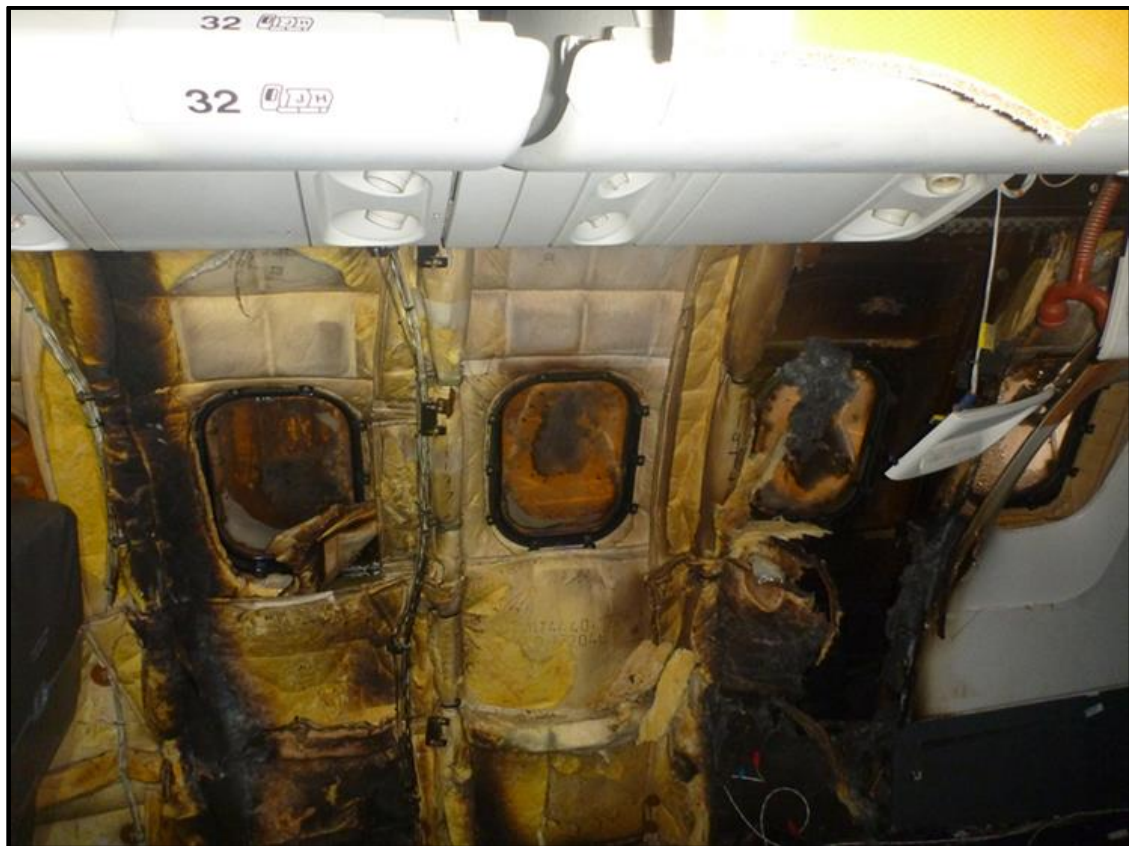
Figure 60 Charred insulation at seats 33 through 34

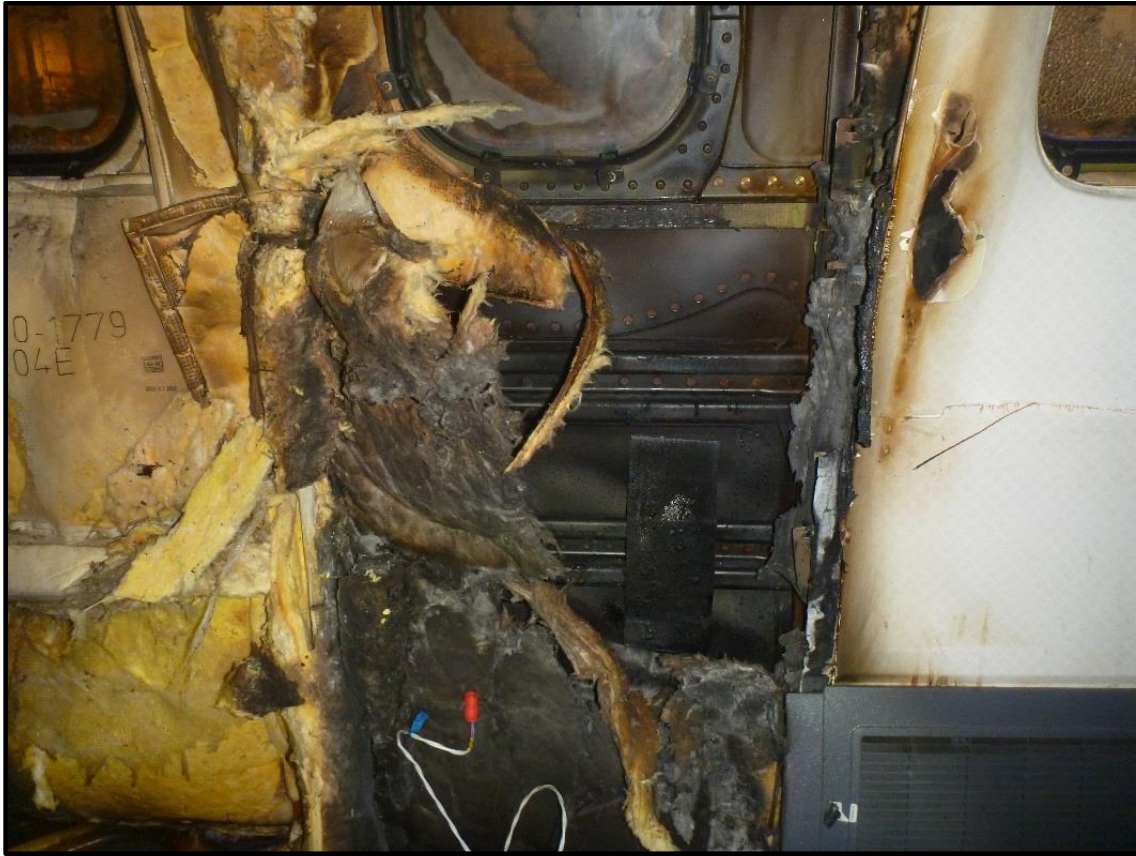
Figure 61 Charred insulation and CIC on skin at seat 34

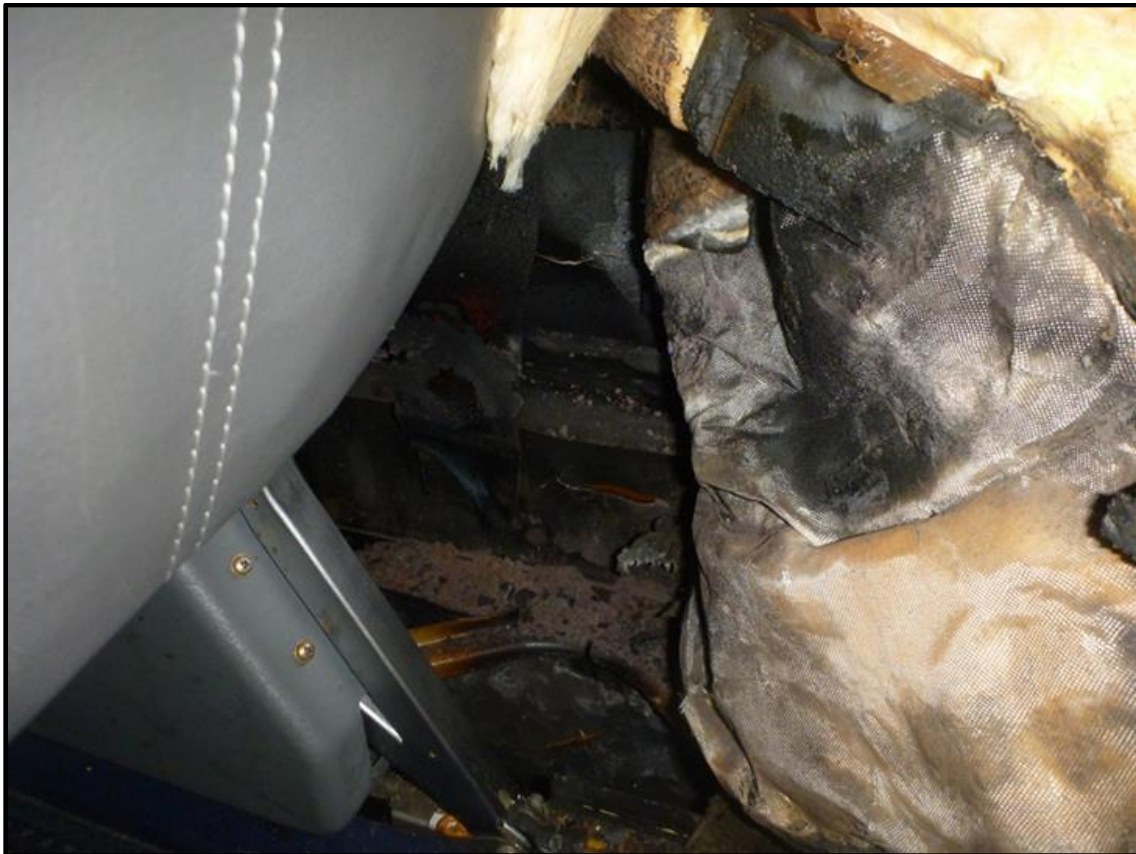
Figure 62 Charred insulation and crack in skin at seat 31
