NATIONAL TRANSPORTATION SAFETY BOARD

Airworthiness Group Chairman's Factual Report

NTSB ID No.: DCA17FA021

NTSB Accident Number: DCA17FA021
Location: Chicago, Illinois
Date: October 28, 2016
Time of Accident: About 1432 Central Daylight Time
Aircraft: Boeing 767-323(ER)
Registration Number: N345AN

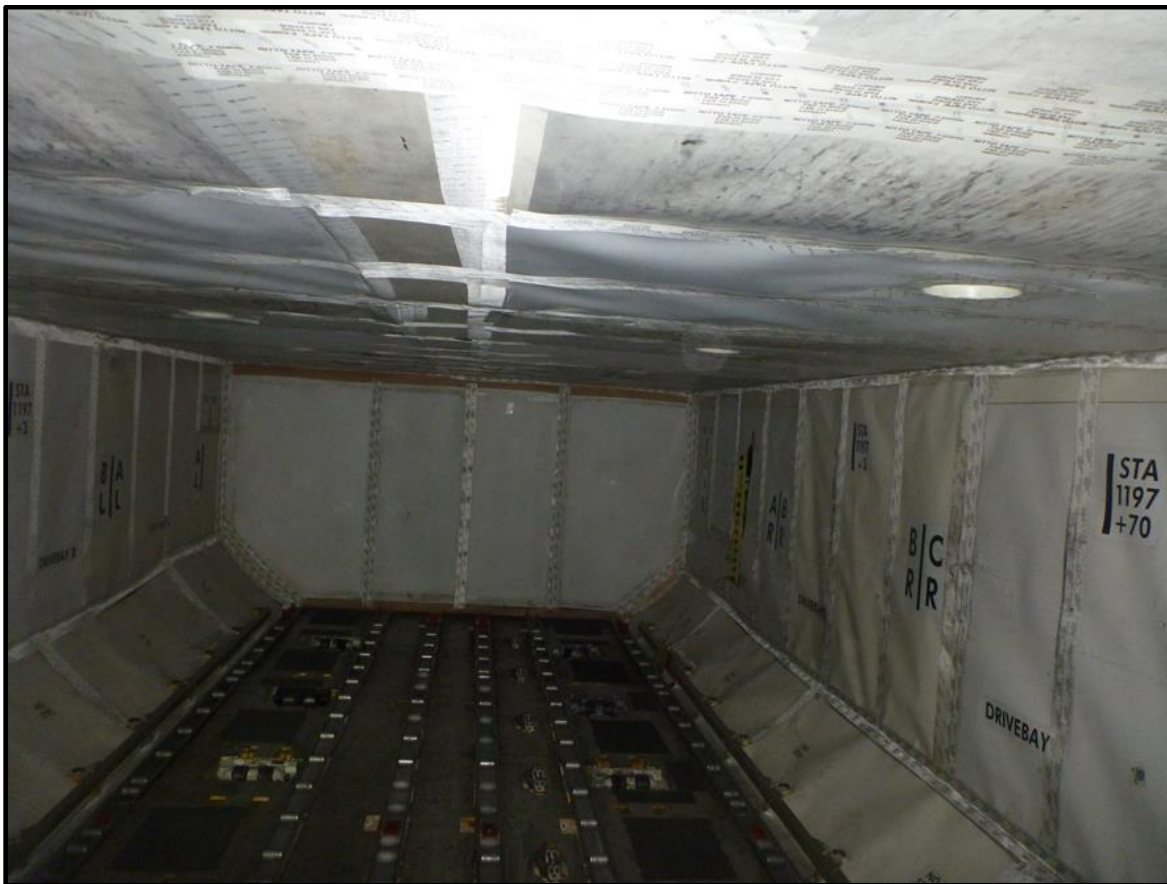
As shown in Figure 63, the aft cargo compartment looked normal, all the liners were in good condition and the joints taped. There were no signs of any heat damage or soot.

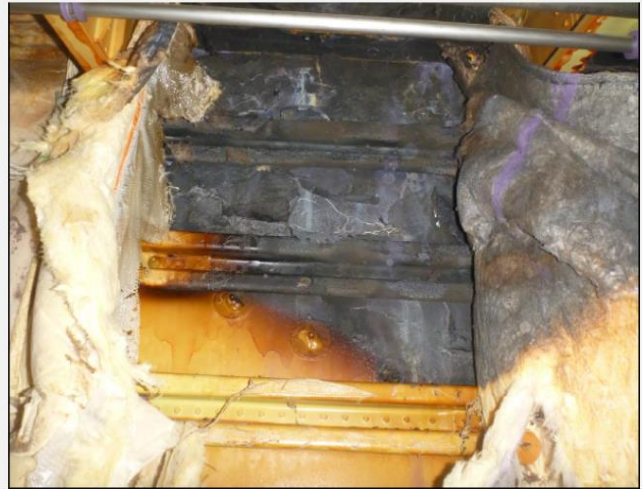
STA 1197 to 1197+22 (note the cracks)

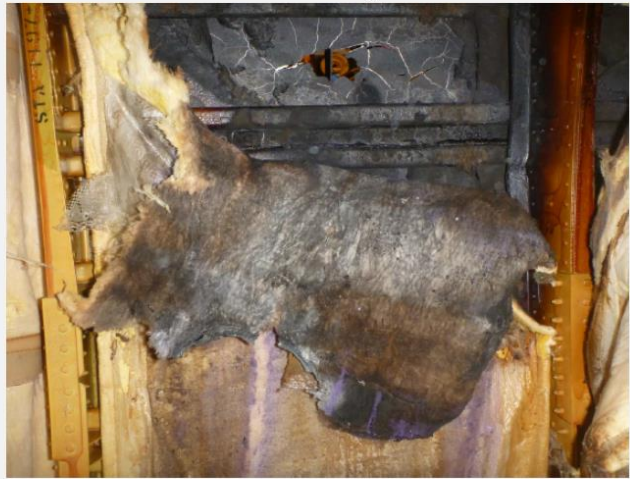
STA 1197+22 to 1197+44 (note hole/cracks)

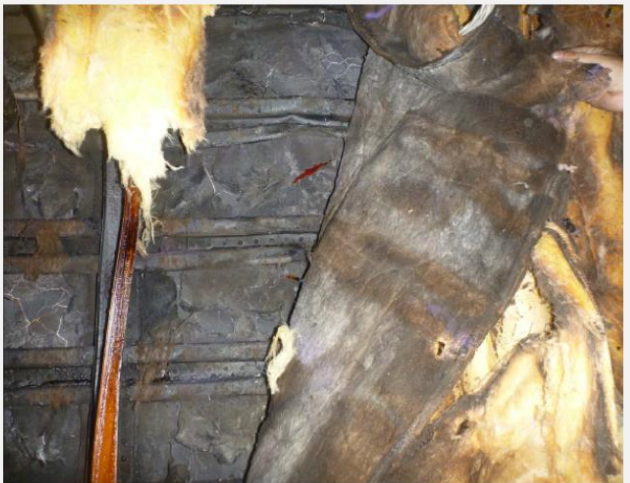
STA 1197+44 to 1197+66 (note the cracks)

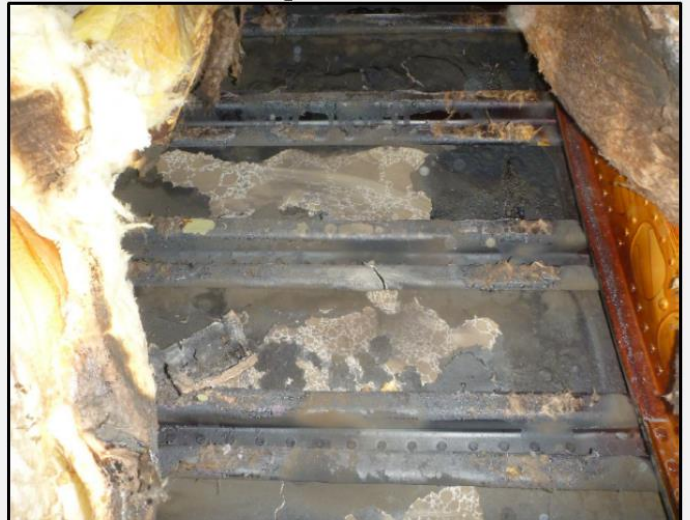
Cracked stringer 25R at STA 1197+120

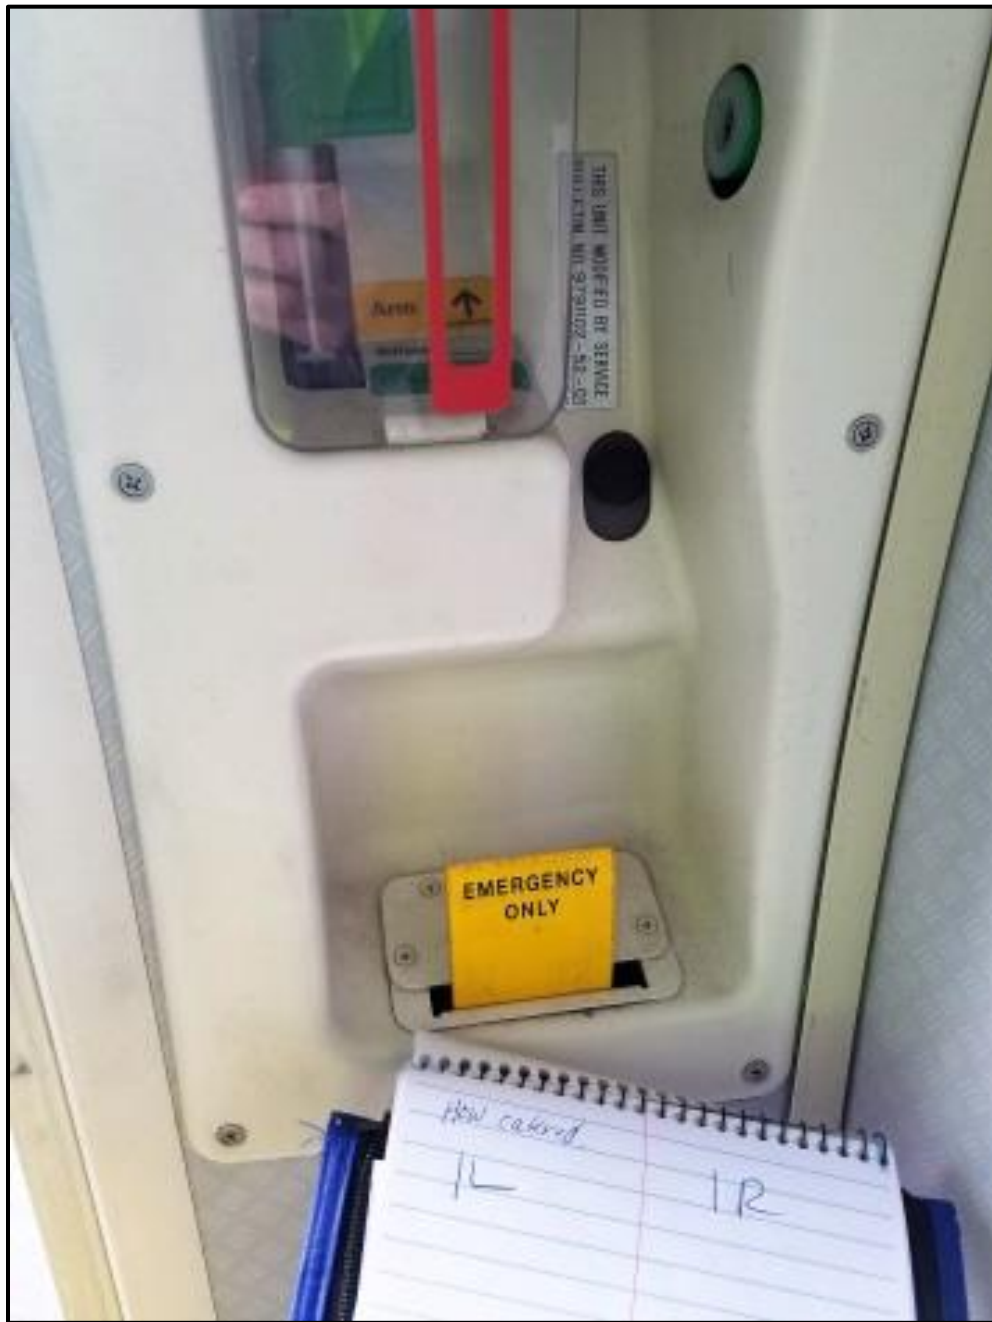
Figure 67 Door 1L was armed and open with ramp stand in place

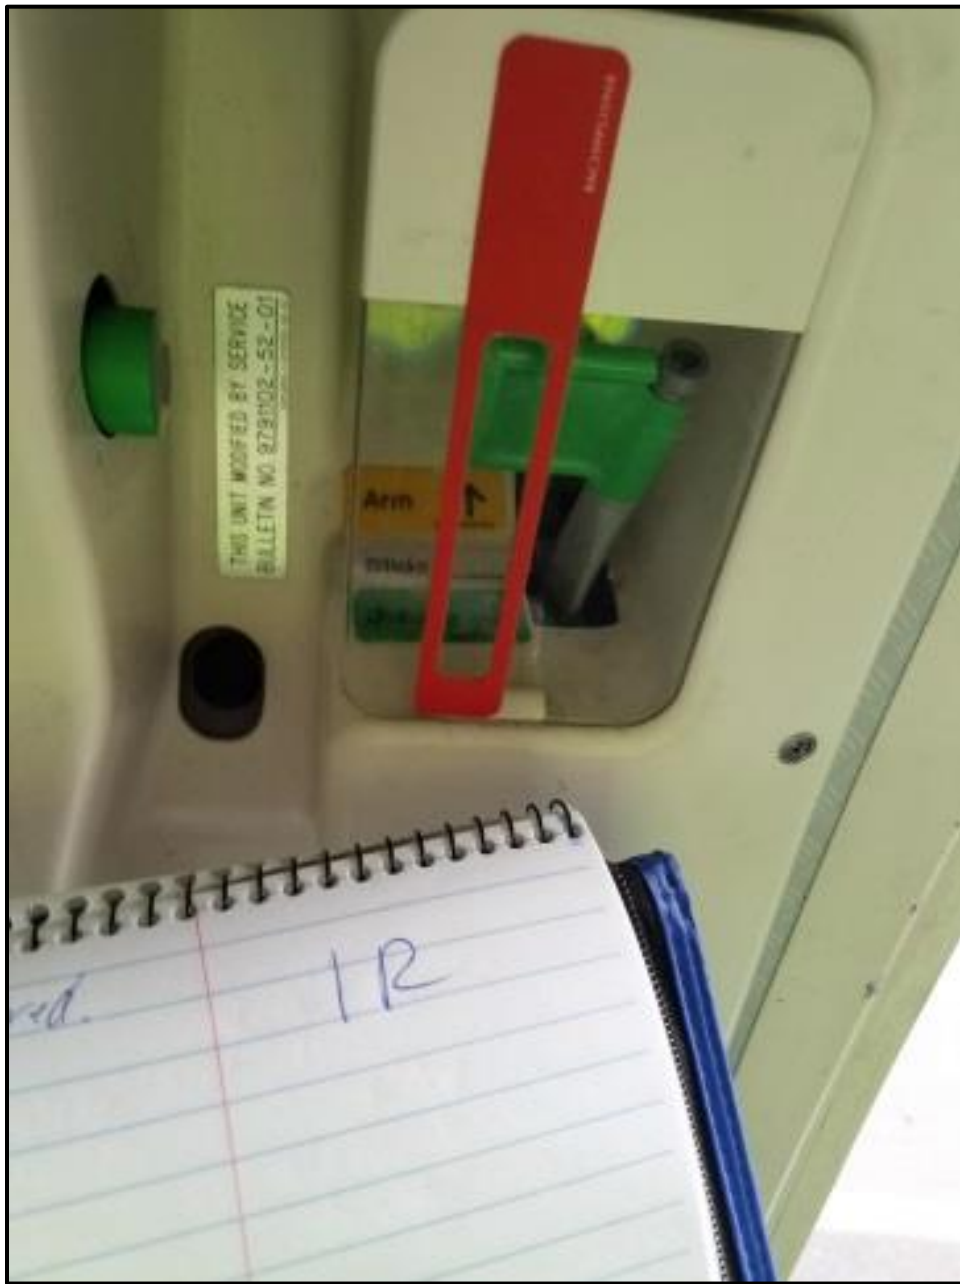
Figure 68 Door 1R was found open and in a disarmed position
