National Transportation Safety Board

ANC22FA041

AIRWORTHINESS

Group Chair's Factual Report

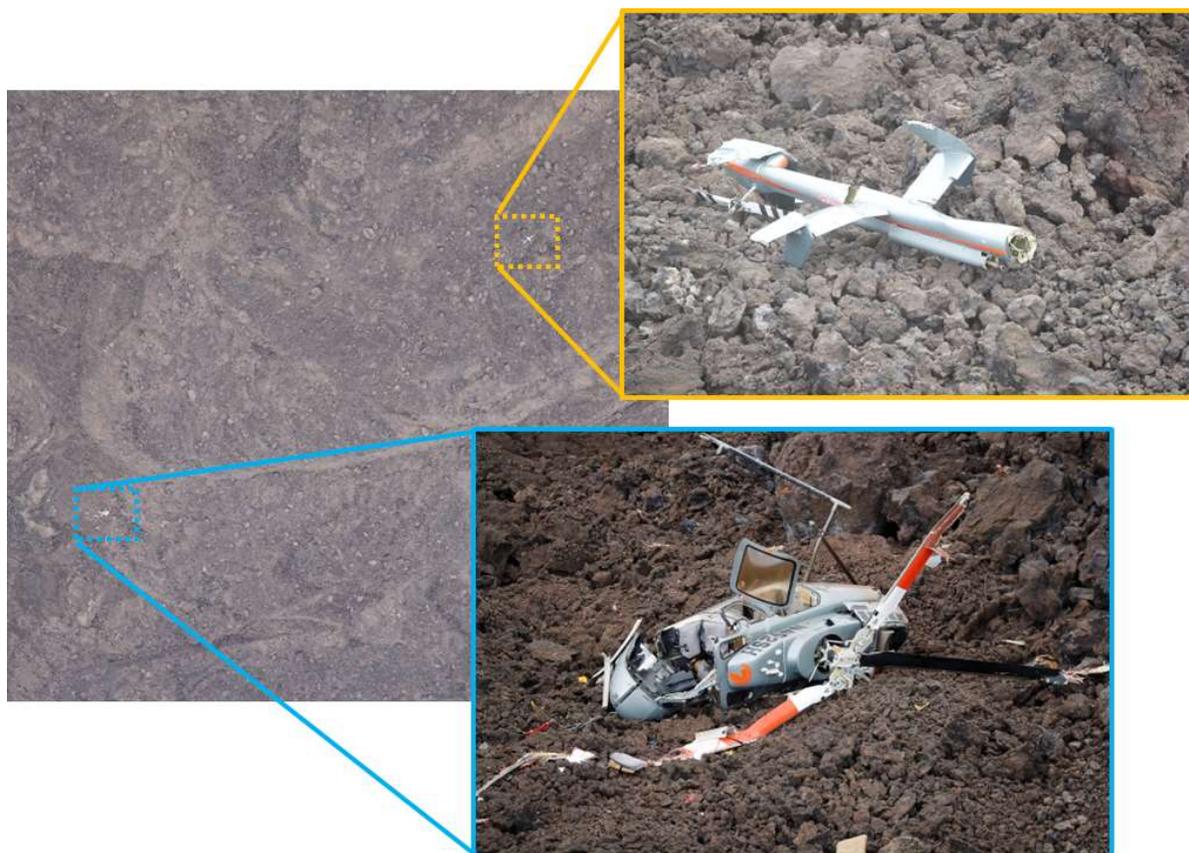
There were two distinct wreckage sites: the main wreckage site and the empennage wreckage site (**Figure 4**). The empennage wreckage site was about 762 feet to the northeast of the main wreckage site. The empennage wreckage site was composed of the tail boom; the aft fuselage bulkhead and portions of the upper-right, lower-left, and lower-right longeron attachment fittings still attached via their attachment hardware; the horizontal stabilizer; the vertical stabilizer; the tail rotor and its gearbox; and the tail rotor drive shafts from the tail boom attachment point aft to the tail rotor gearbox. The main wreckage site was composed of the forward fuselage, intermediate fuselage, landing gear, main rotor system, and the engine.

Figure 4. An aerial view (left image) showing the main fuselage wreckage (lower-right image) and the empennage wreckage (upper-right image). (Aerial image courtesy of Paradise Helicopters and edited by the NTSB.)

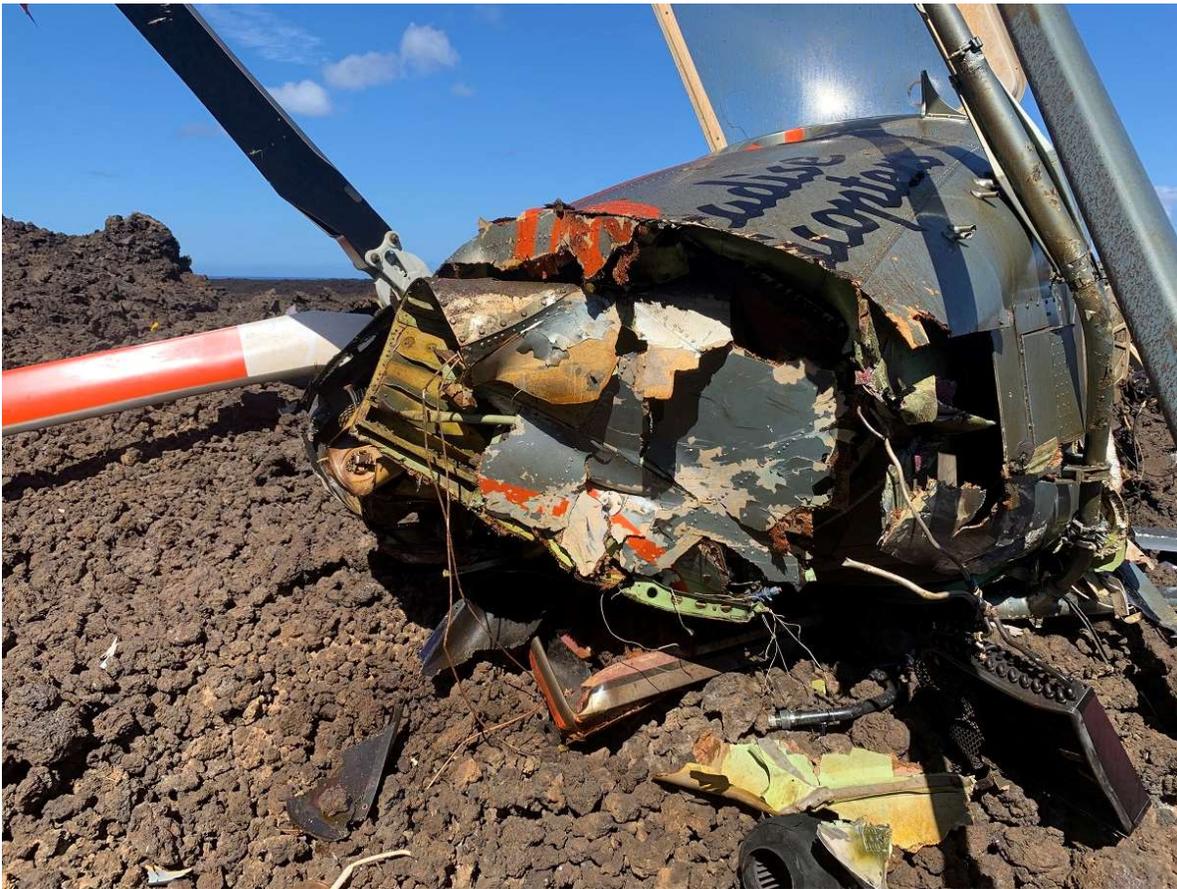
The aft fuselage exhibited impact deformation primarily in the inward, upward, and left directions in the area of the tail boom attachment points and the baggage compartment (**Figures 5 and 6**). The aft fuselage upper-left longeron was whole and remained installed to the aft fuselage but its tail boom attachment hardware was not present (**Figure 7**). The aft fuselage bulkhead was not present. The upper-right, lower-right, and lower-left longerons attachment fittings were fractured near the radius where the longitudinal wall transitions to the bolt hole. A portion of the upper-right longeron had separated from the aft fuselage and was found at the empennage wreckage site. The longerons for the lower-left and lower-right attachment fittings remained installed on the aft fuselage. The horizontal deck between the lower-left and lower-right longerons (which attaches to the aft fuselage bulkhead via 11 rivets) was present within the aft fuselage but had deformed and rotated about 90 degrees clockwise. Additional observations of these attachment fitting fractures can be found in Section 2.1.4 of this report. Portions of the aft fuselage, containing the aft fuselage longerons, were cut from the wreckage and retained by the NTSB for further evaluation. The details of the NTSB Materials Lab examination of the aft fuselage structural pieces can be found in Materials Laboratory Factual Report No. 22-071 in the docket for this investigation.

Figure 5. An overview of the aft fuselage wreckage. (Photo courtesy of the FAA.)

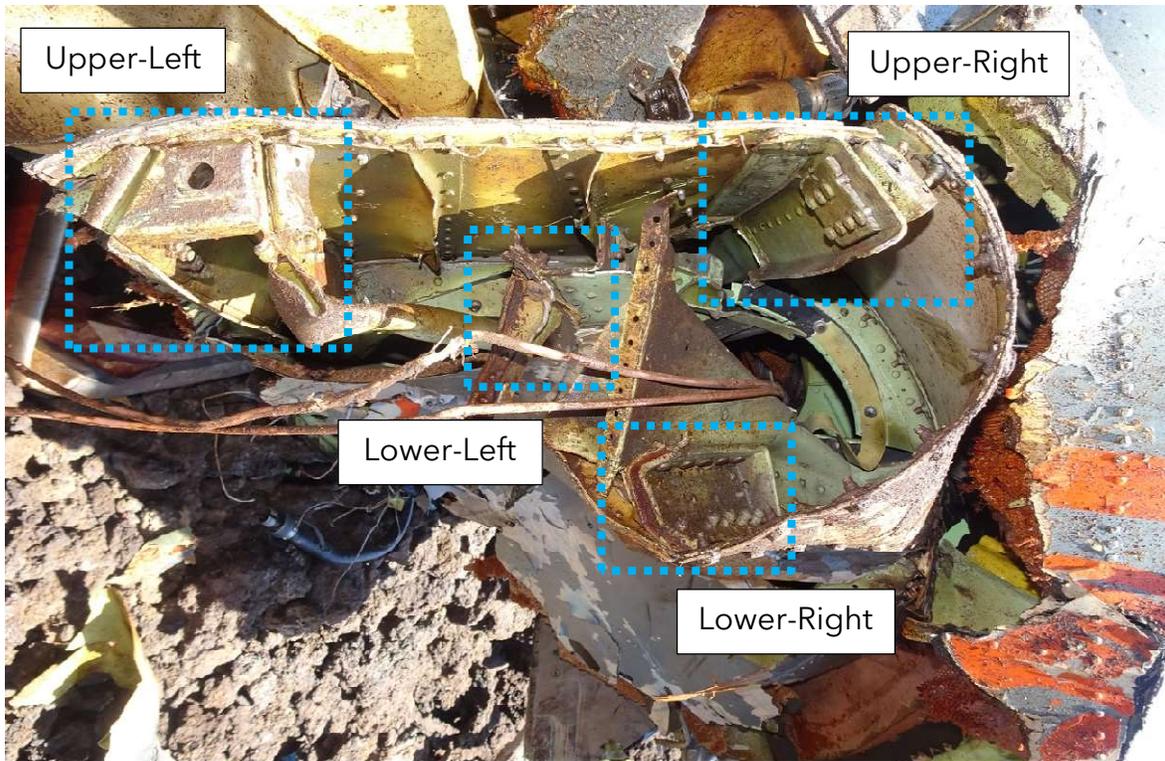
Figure 6. The aft fuselage with the four longeron locations annotated. Note the photo has been rotated and ground level at the accident site is to the left.

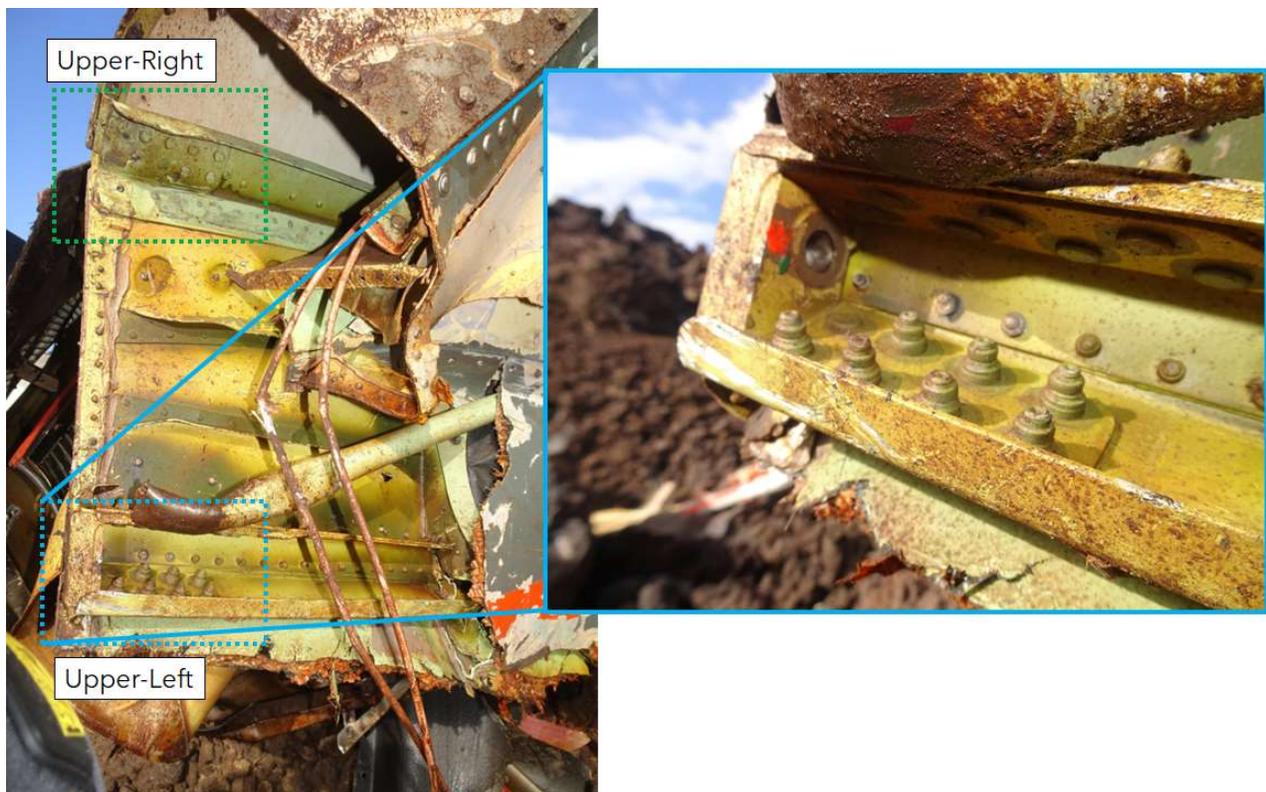
Figure 7. A view of the aft fuselage upper-left longeron and its bolt hole.

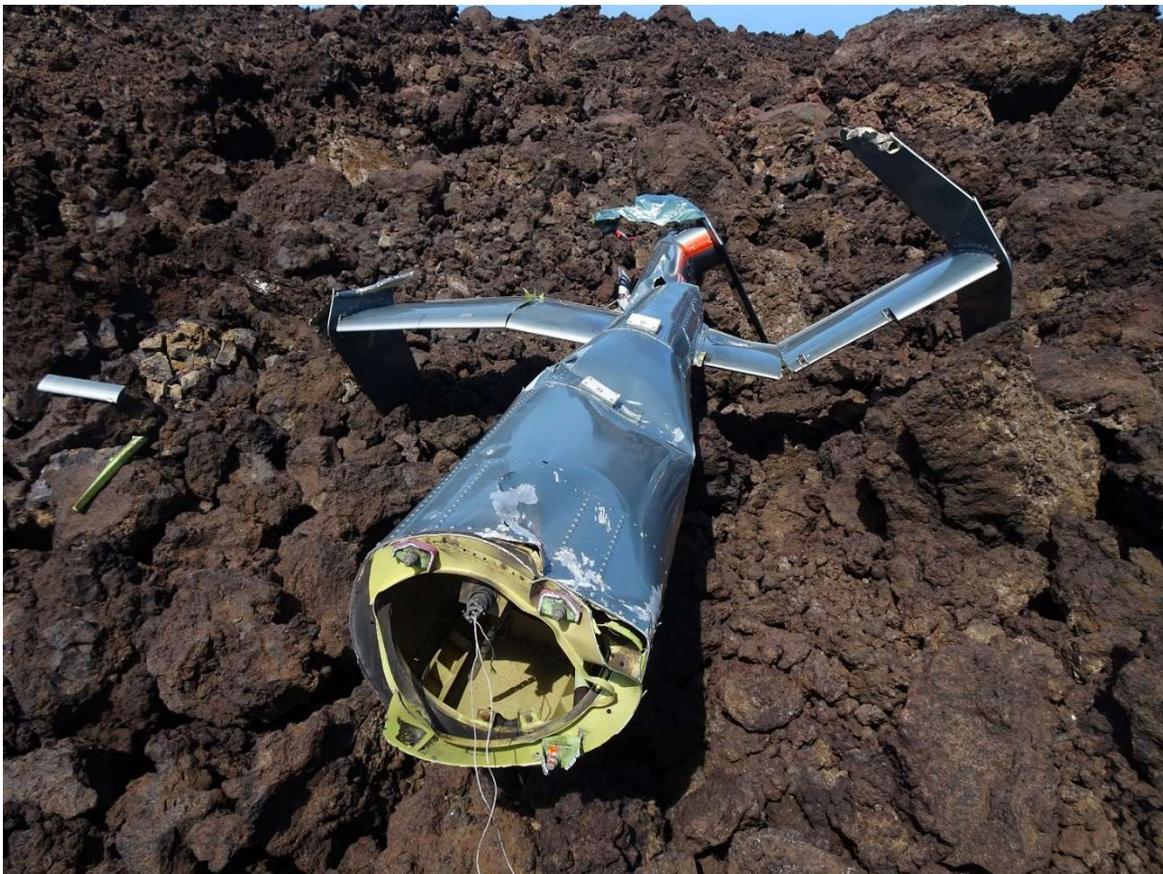
The empennage came to rest inverted at a heading of about 57 degrees magnetic (**Figure 8**). The underside of the tail boom exhibited impact deformation primarily on its forward half. The tail boom was partially separated immediately aft of the horizontal stabilizer, but remained as one assembly with the tail rotor drive train continuity intact between these two segments.

Figure 8. The empennage wreckage at the accident site.

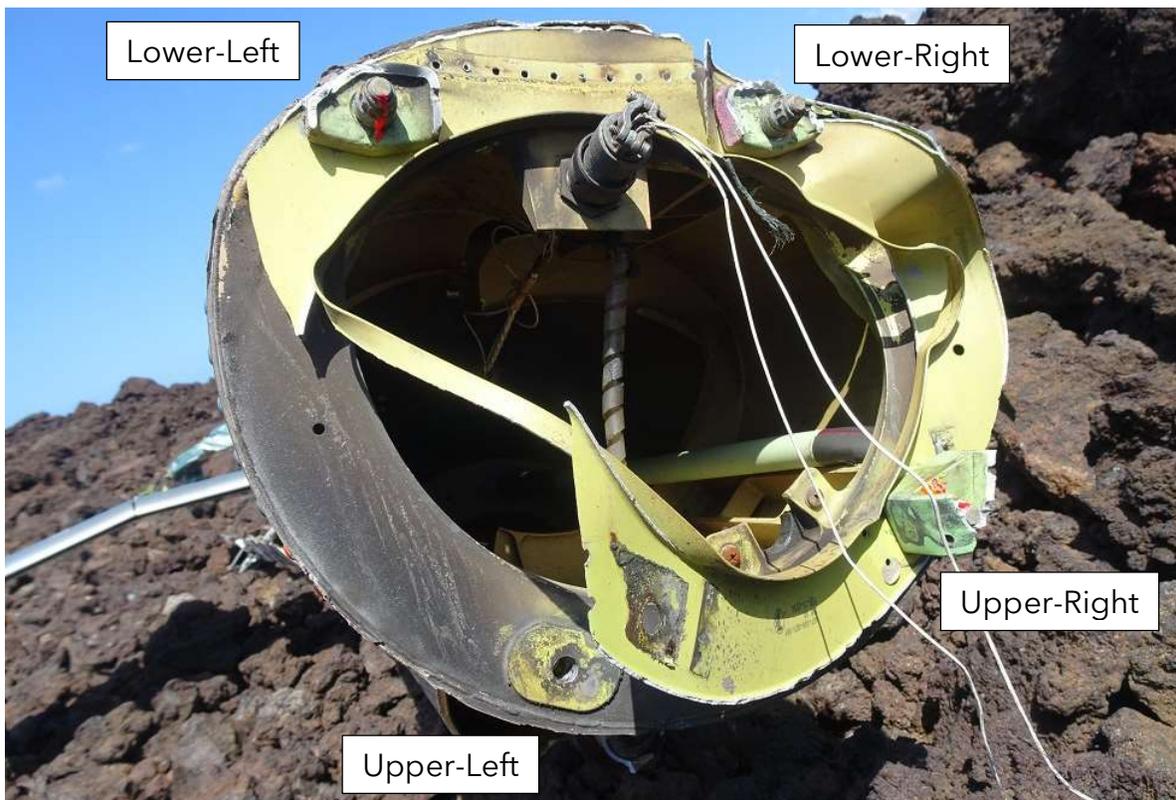
The tail boom forward bulkhead, located at the forward end of the tail boom, was present and exhibited impact deformation primarily between the 3 o'clock to 6 o'clock region and was partially separated from the tail boom in this area (**Figure 9**). The aft fuselage bulkhead, except for its outer circumference that is riveted to the aft fuselage skin, remained attached to the forward end of the tail boom and exhibited a circumferential fracture along its outer circumference. The aft fuselage bulkhead also exhibited a fracture to the outboard of the upper-left and lower-left attachment fittings, from about the 8 o'clock to 10 o'clock range; this portion of the aft fuselage bulkhead was deformed in the forward direction.

Figure 9. The aft fuselage bulkhead (light yellow-green in color) and the remnant upper-right, lower-left, and lower-right tail boom attachment fittings and hardware found in the empennage wreckage.

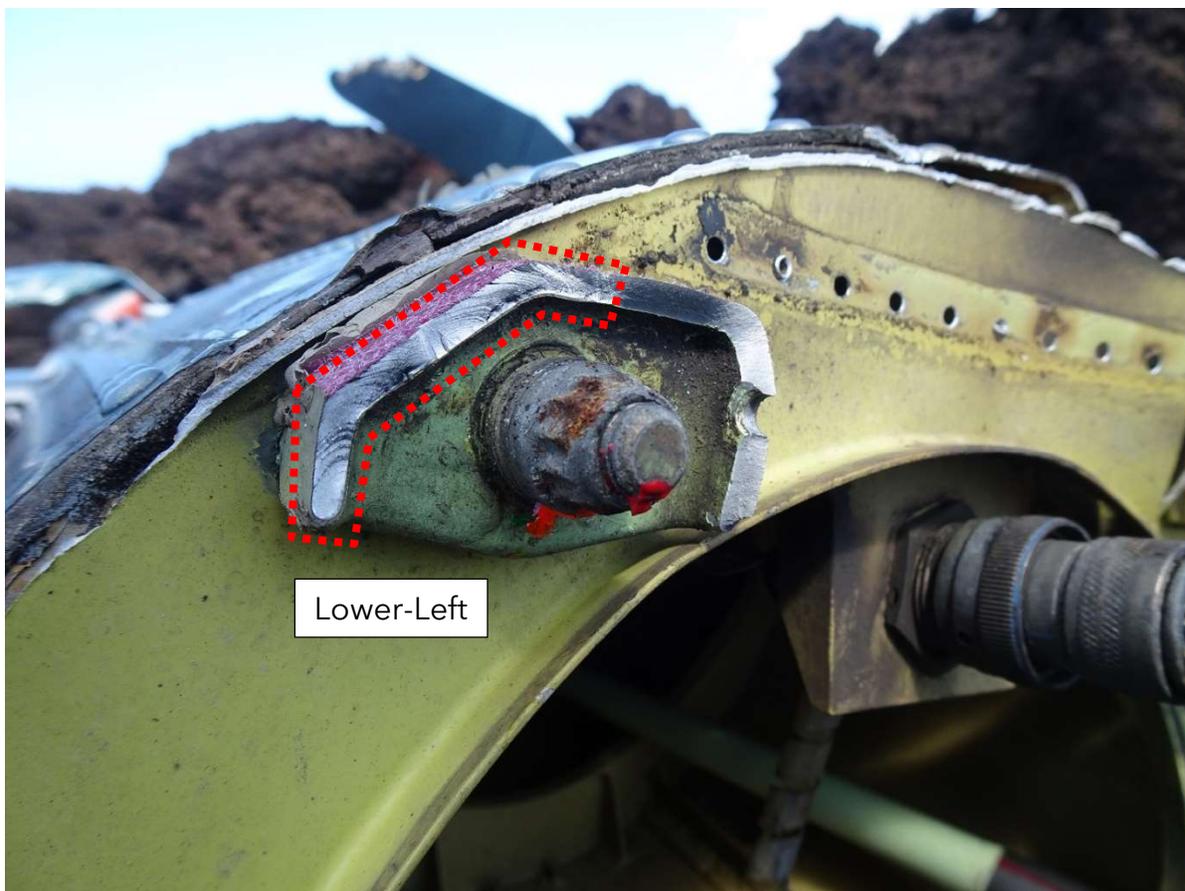
All four tail boom-side attachment fittings were present. The aft-most portions of the upper-right, lower-right, and lower-left aft fuselage-side attachment fittings remained connected to the aft fuselage bulkhead via their attachment hardware; these three attachment fittings exhibited fractures and the remainder of those longerons were found installed in the aft fuselage. The lower-left aft fuselage-side attachment fitting exhibited signatures of fatigue on the outboard side of the fracture surfaces and the remainder of the fracture exhibited signatures of overload (**Figure 10**). The lower-right aft fuselage-side attachment fitting exhibited signatures of overload as well as impact marks overload on a small portion of the fracture surfaces. The upper-right aft fuselage-side attachment fitting exhibited signatures of overload and its remnant structure was bent in the outboard/right direction. The location where the aft fuselage upper-left longeron assembly was normally installed onto the aft fuselage bulkhead exhibited a dark brown and grey discoloration. The attachment fitting hardware had remnant orange-colored torque stripe present on their nuts, nut-side threads, and on the attachment hardware clamping surface.

Figure 10. On the aft fuselage lower-left attachment fitting, the area within the dotted red lines exhibited signatures of fatigue.

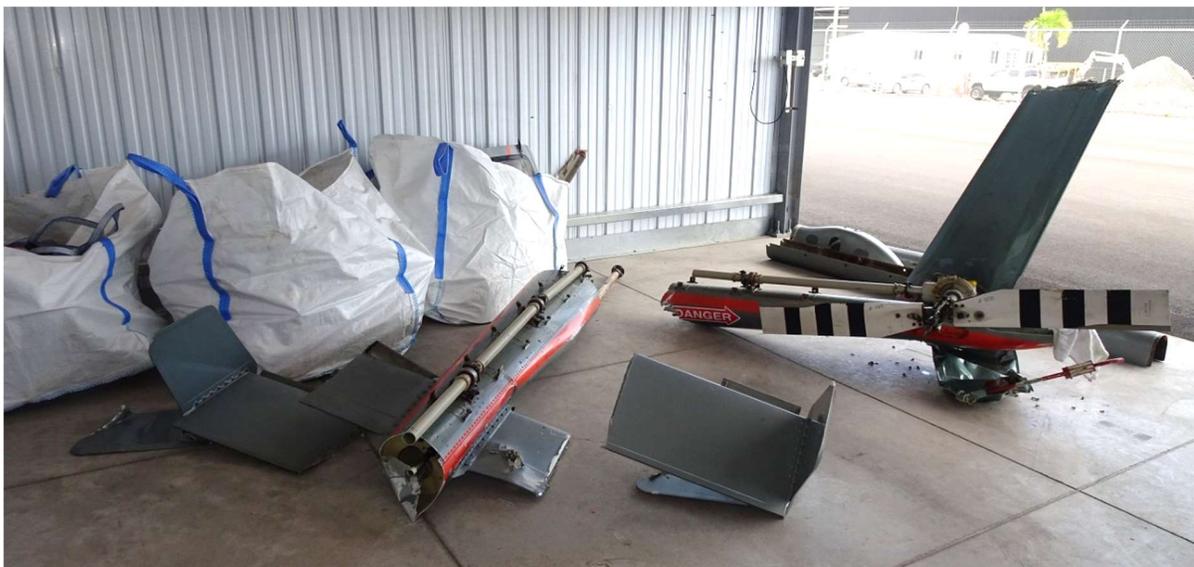
The aft short shaft (aluminum) remained installed within the empennage and its forward flange exhibited fractures at its flange lobes; the fractures exhibited signatures of overload. The aft short shaft was continuous to the tail rotor gearbox (**Figure 11**). The tail rotor gearbox remained installed onto the empennage via its hanger bearings and the tail rotor remained installed. Rotation of the aft short shaft segments resulted in a corresponding rotation of the tail rotor; the rotation was smooth and exhibited no evidence of binding or restrictions. Oil was present in the tail rotor gearbox. The tail rotor gearbox chip detector was inspected and contained no magnetic chips.

Figure 11. The tail rotor drive system and tail rotor. Note the horizontal stabilizers and portions of the tail rotor drive train were cut to facilitate recovery of the empennage wreckage.

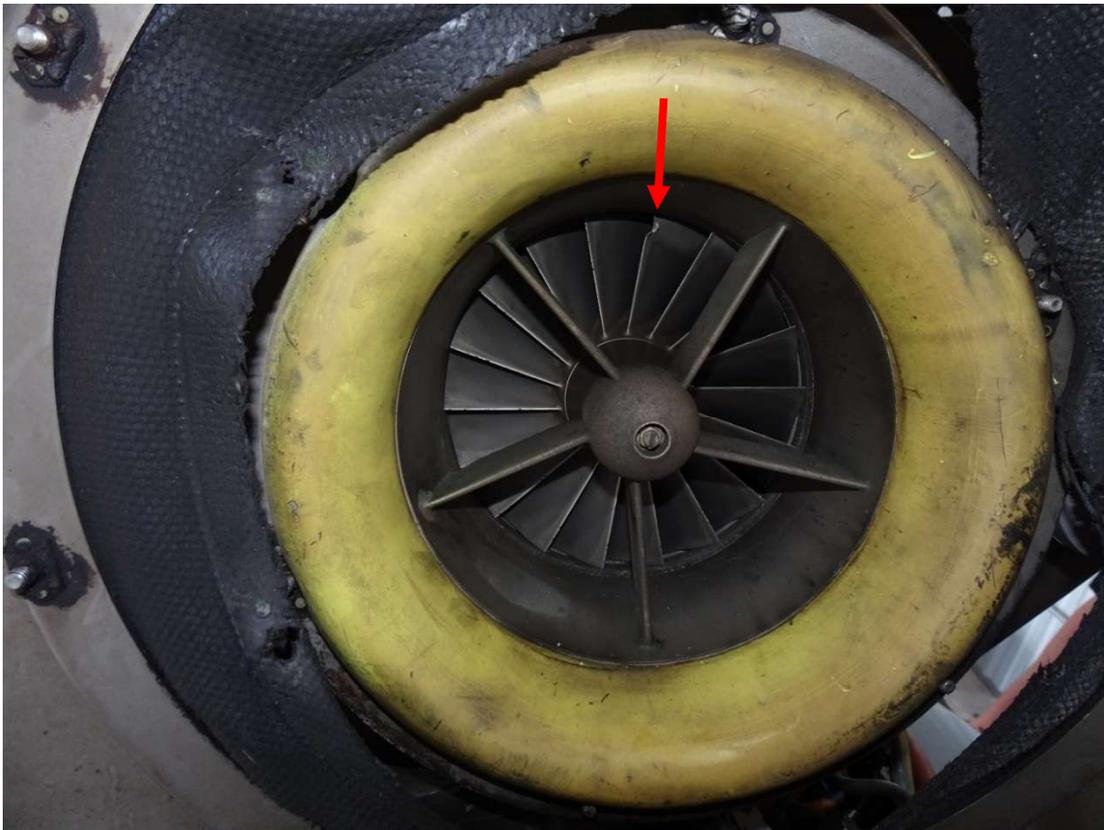
The engine was whole and remained installed onto the airframe but its mounts were deformed due to impact. The reduction gearbox case was fractured at the exciter box attachment. The [single-stage] compressor was able to be manually rotated by hand and exhibited smooth rotation with no evidence of restrictions. The gas generator turbine-to-compressor (N1) drivetrain continuity was confirmed between the compressor and the starter-generator. One compressor blade exhibited a gouge on its leading edge while several other compressor blades had small indentations on its leading edges (**Figure 12**). The power turbine was able to be rotated manually by hand through the engine exhaust; rotation was smooth with no evidence of restrictions. A small amount of metal splatter was observed on the fourth stage power turbine blades, but there was no other damage to those blades. All fittings and B-nuts were checked by hand and did not exhibit looseness. The engine was not removed from the airframe during these examinations.

Figure 12. A view of the engine inlet and compressor. The red arrow points to the gouge observed on one of the compressor blades.

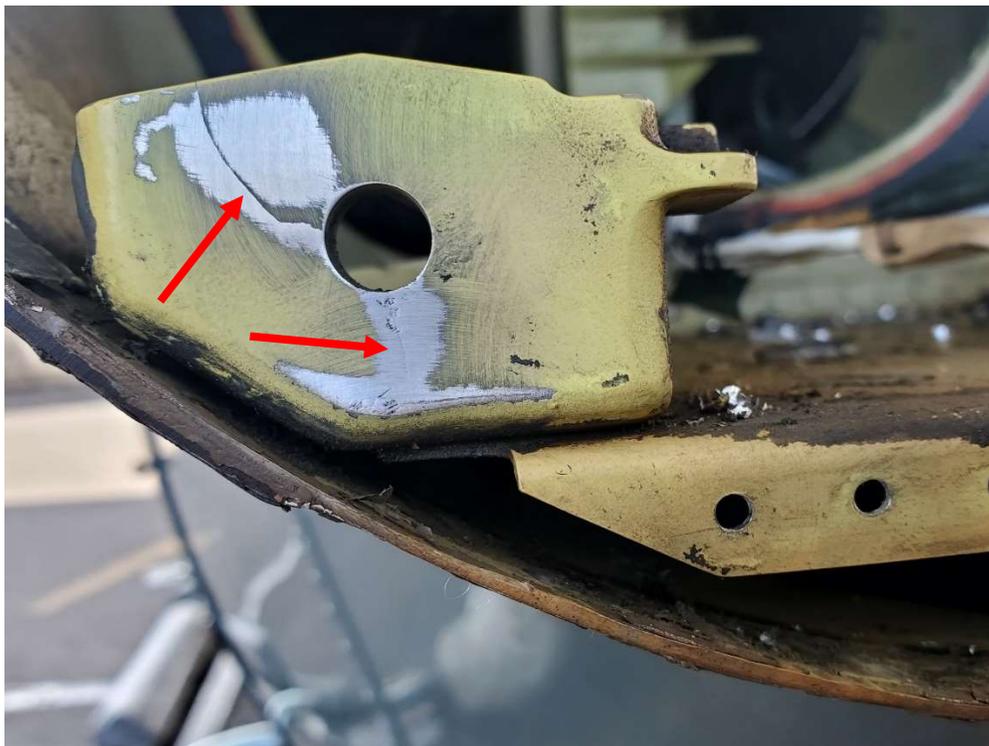
In addition to the attachment hardware replacements, the operator performed an eddy-current nondestructive inspection (NDI) on the aft fuselage longerons (to which the tail boom attaches) of their remaining Bell 407 helicopters as another precautionary measure. These NDIs found cracking indications on two helicopters, N807PH and N437MY. On N807PH, two crack indications were identified: 1) on the aft faying surface of the lower-left longeron at the bolt hole (**Figure 13**) and 2) within the bolt hole of the upper-left longeron. On N437MY, three crack indications were identified: 1) on the outboard surface of the outboard longitudinal channel of the upper-right longeron, 2) on the inboard surface of the outboard longitudinal channel of the upper-left longeron, and 3) on the lower surface of the outboard longitudinal channel of the upper-left longeron.

Figure 13. The crack indications (red arrows) found via NDI on the aft fuselage lower-left longeron attachment fitting on N807PH. Note the surface coating was removed after the NDI indication to visually see the crack indication. (Photo courtesy of Paradise Helicopters.)

As a result of this accident, the operator elected to replace the tail boom attachment hardware on their remaining five Bell 407 helicopters as a precautionary measure. At the request of the NTSB, the operator performed a torque check of all installed attachment hardware prior to their removal. The operator reported no evidence of loose tail boom attachment hardware on their remaining Bell 407 helicopters.
