## **AIRWORTHINESS GROUP FACTUAL REPORT**

**NTSB No. DCA20LA100**

**Sikorsky Memorandum on the Materials Laboratory Examination of the  
Pedal Damper Check Valve Housing and Bolt Fractures  
(14 pages)**

SUBJECT: NTSB N908CH Pedal Damper Materials Report (P/N S6165-61517-2 AN3H5A Bolts Qty 2)

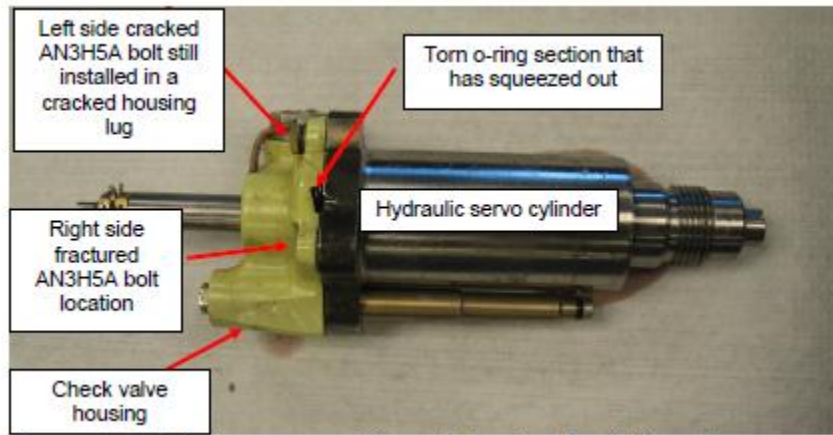
Figure 1 Pedal damper assembly at Sikorsky Trumbull prior to disassembly. The cylinder, bolts, housing, and o-ring were sent to the Materials Lab.

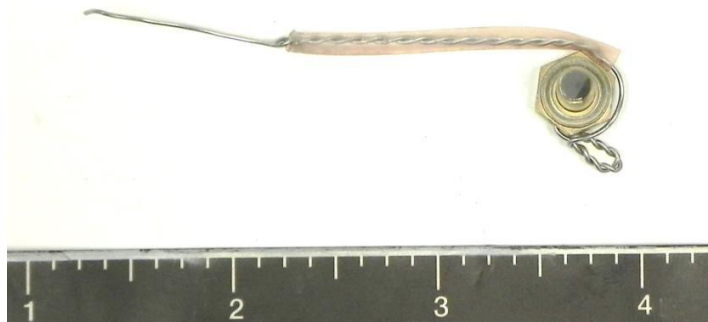
SEM examination of the fractured bolt confirmed a fatigue mode originating from the root of the first engaged thread (Figure 2 ,3,5,6,7). The fracture surface was about 75% fatigue and about 25% overload. Safety wire was present on this bolt with some pink tubing and white sealant present (Figure 4). The fracture surface and impartial threads were cut off and mounted for metallographic inspection (Figure 8,9). The microstructure appeared typical for 8740 in the hardened condition. Cold worked elongated grains were not visible in the thread roots. Root radius was not measured on this bolt as the intact threads were left inside the hydraulic servo cylinder (Figure 10,11). Spectrochemical analysis shows the bolt material is 8740 conforming to one of the required specs, MIL-S-6049. Hardness ranged from 27.2 to 29.8 HRC meeting the 26 to 32 HRC requirement per MIL-B-6812. Hardness was measured with direct HRC (no conversions) in the center of the shank three times cutting off a portion of the shank with a diamond saw to get a new measurement each time.

1. One of the AN3H5A bolts fractured by fatigue originating in the root of the first engaged thread followed by overload. No abnormalities were present at the origin.

Figure 2 Fractured bolt.

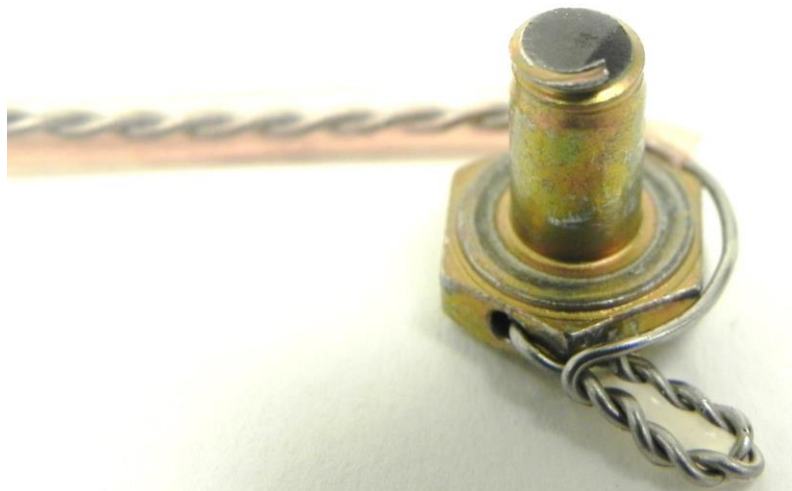
Figure 3 Fractured bolt isotropic view.

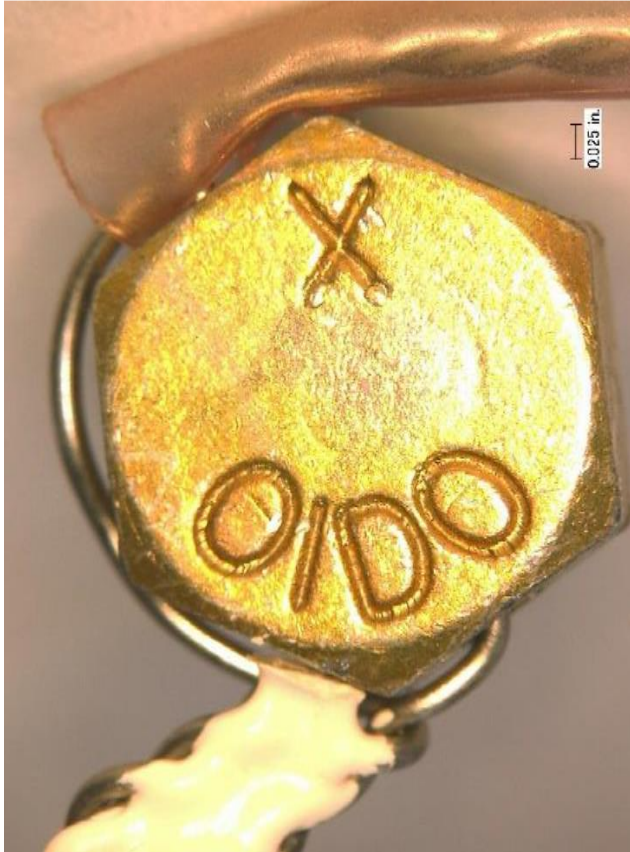
Figure 4 Fractured bolt part markings indicate that the manufacturer was Mac Fasteners. (Cracked bolt had identical markings)

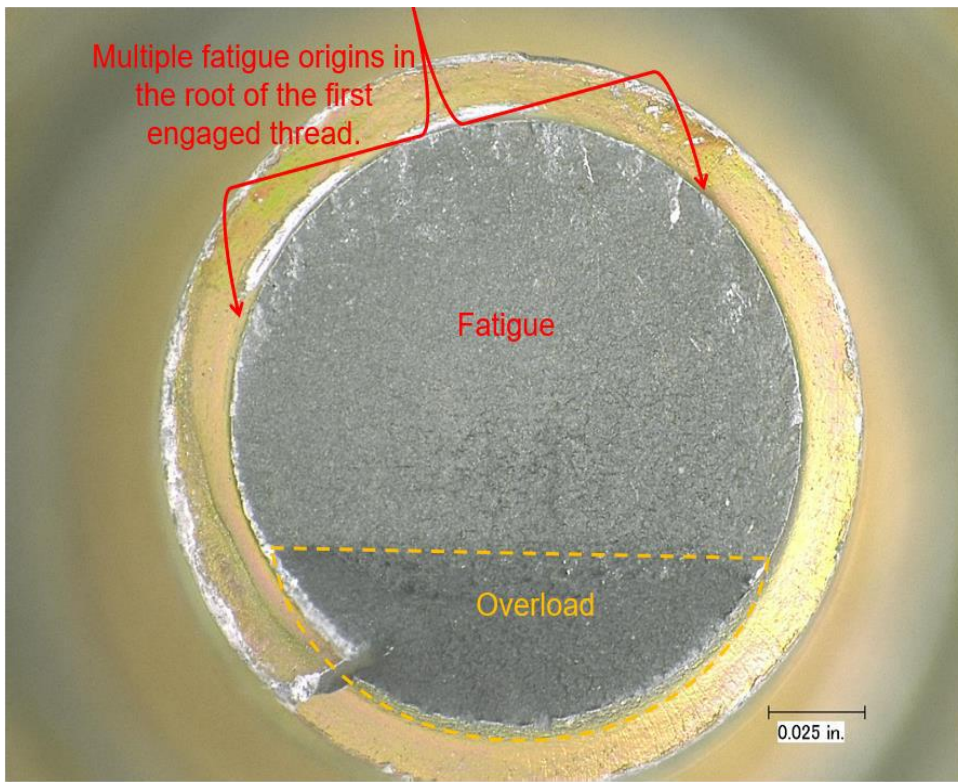
Figure 5 Fatigue origins of fractured bolt.

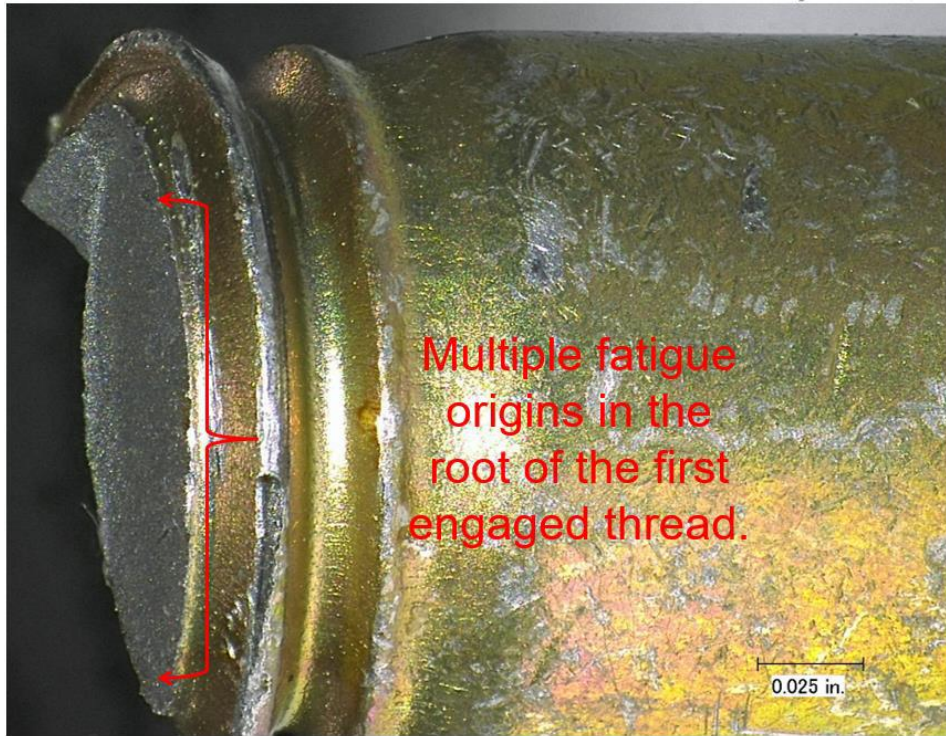
Figure 6 Side view of fatigue origins of fractured bolt.

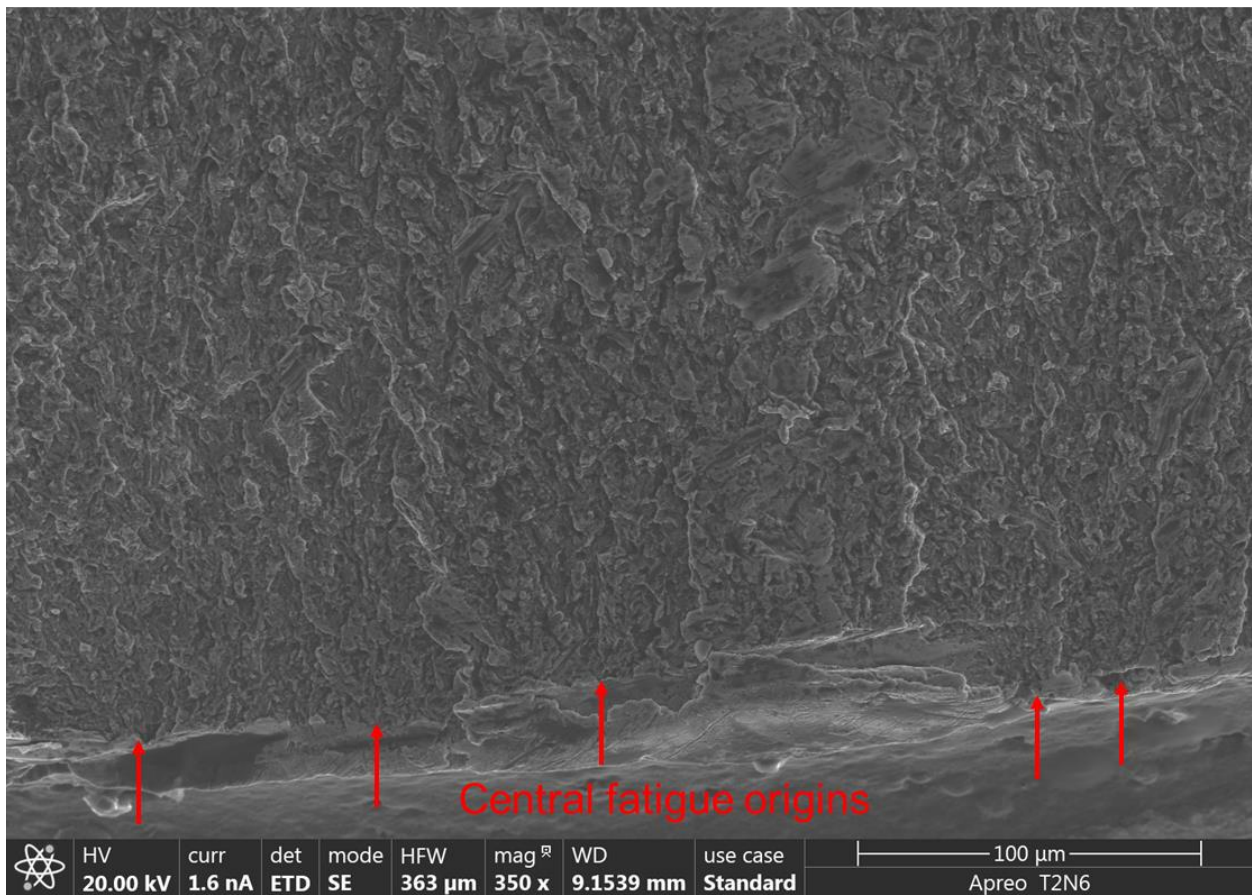
Figure 7 SEM image of fatigue origins at the center of the fatigue zone on the fractured bolt.

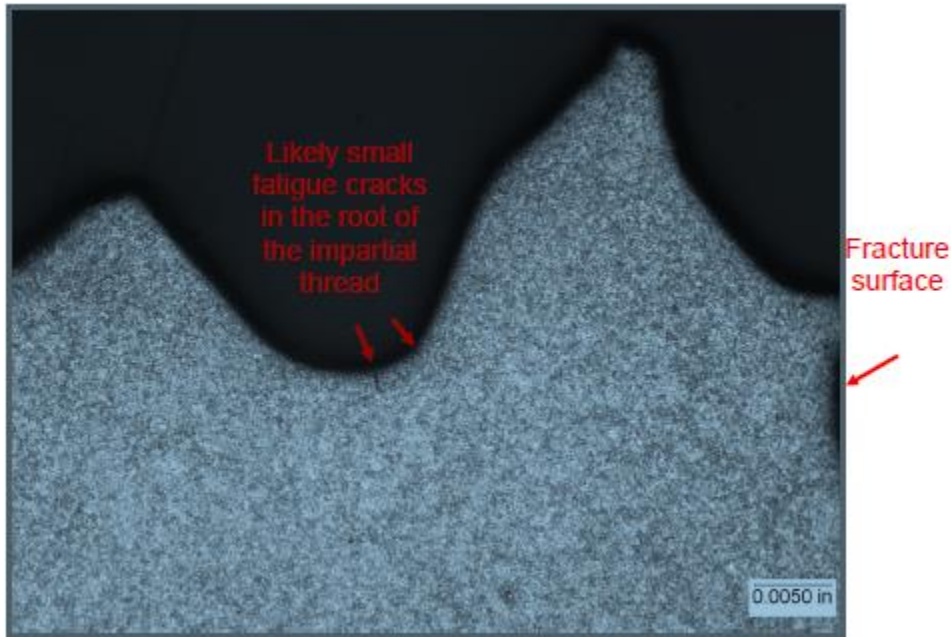
Figure 8 Metallographic cross section of the fractured bolt etched in nital. Likely small fatigue cracks in the root of the impartal thread. Microstructure is typical of martensitic steel. The thread roots do not exhibit elongated grains.

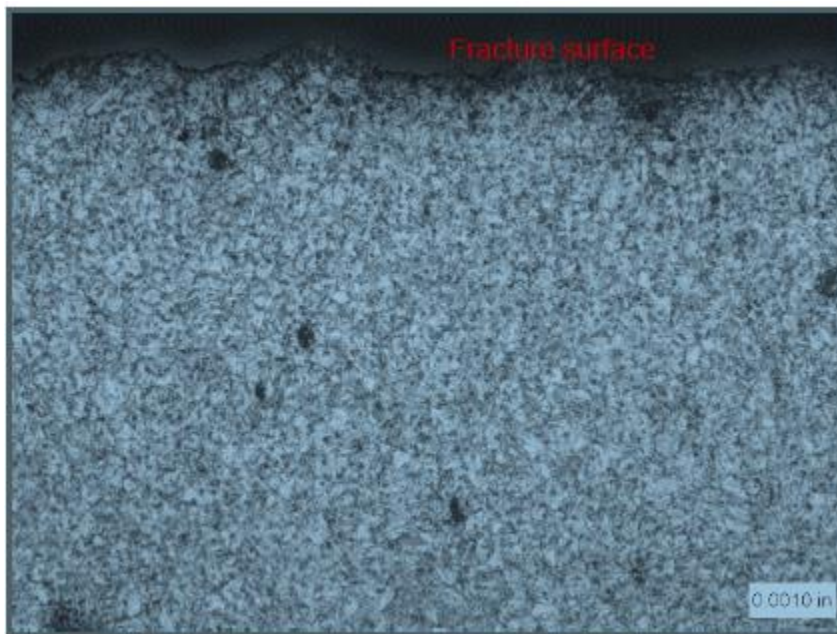
Figure 9 Metallographic cross section of the fractured bolt etched in nital at higher magnification.

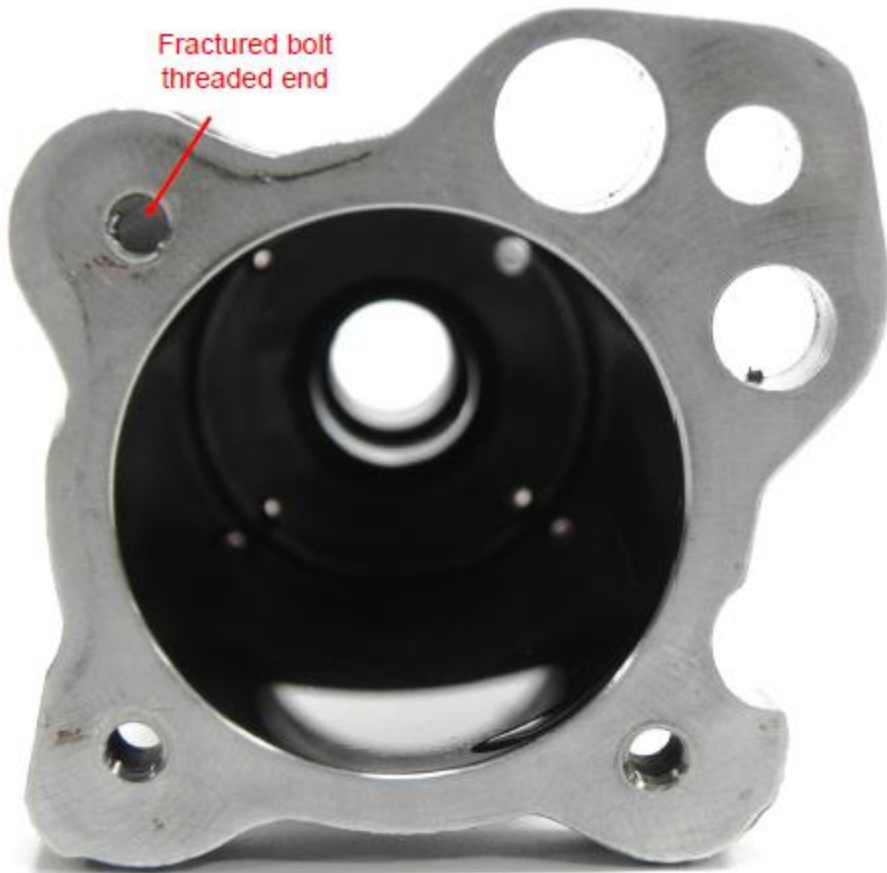
Figure 10 Hydraulic servo cylinder with remaining portion of fractured bolt threads still inside.

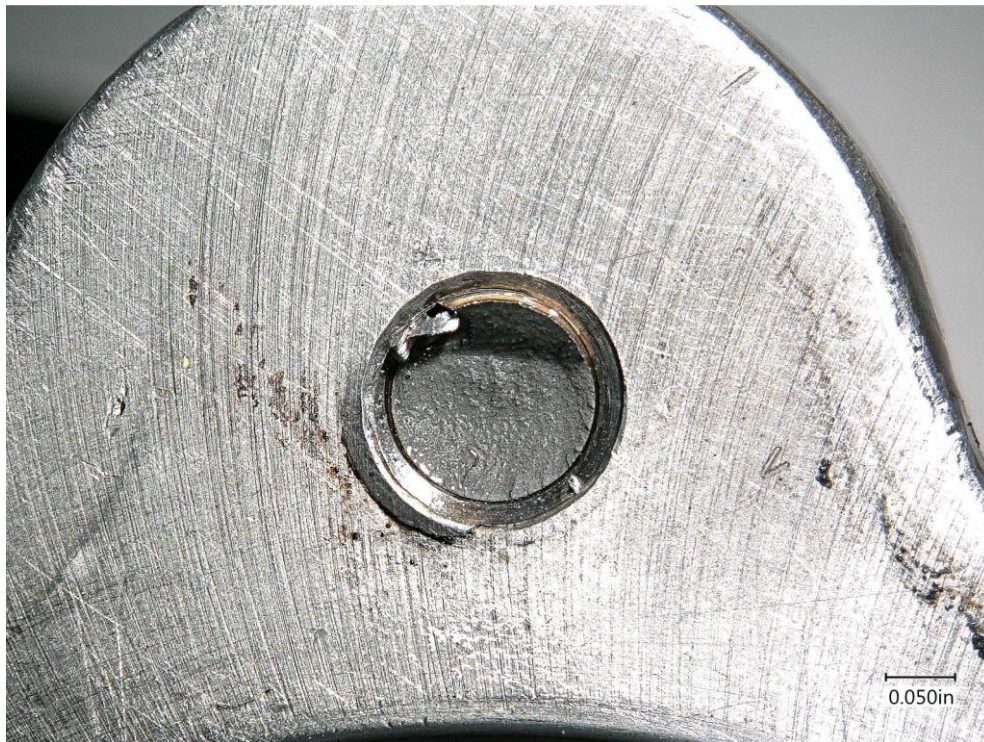
Figure 11 Hydraulic servo cylinder lug with remaining portion of fractured bolt threads still inside.

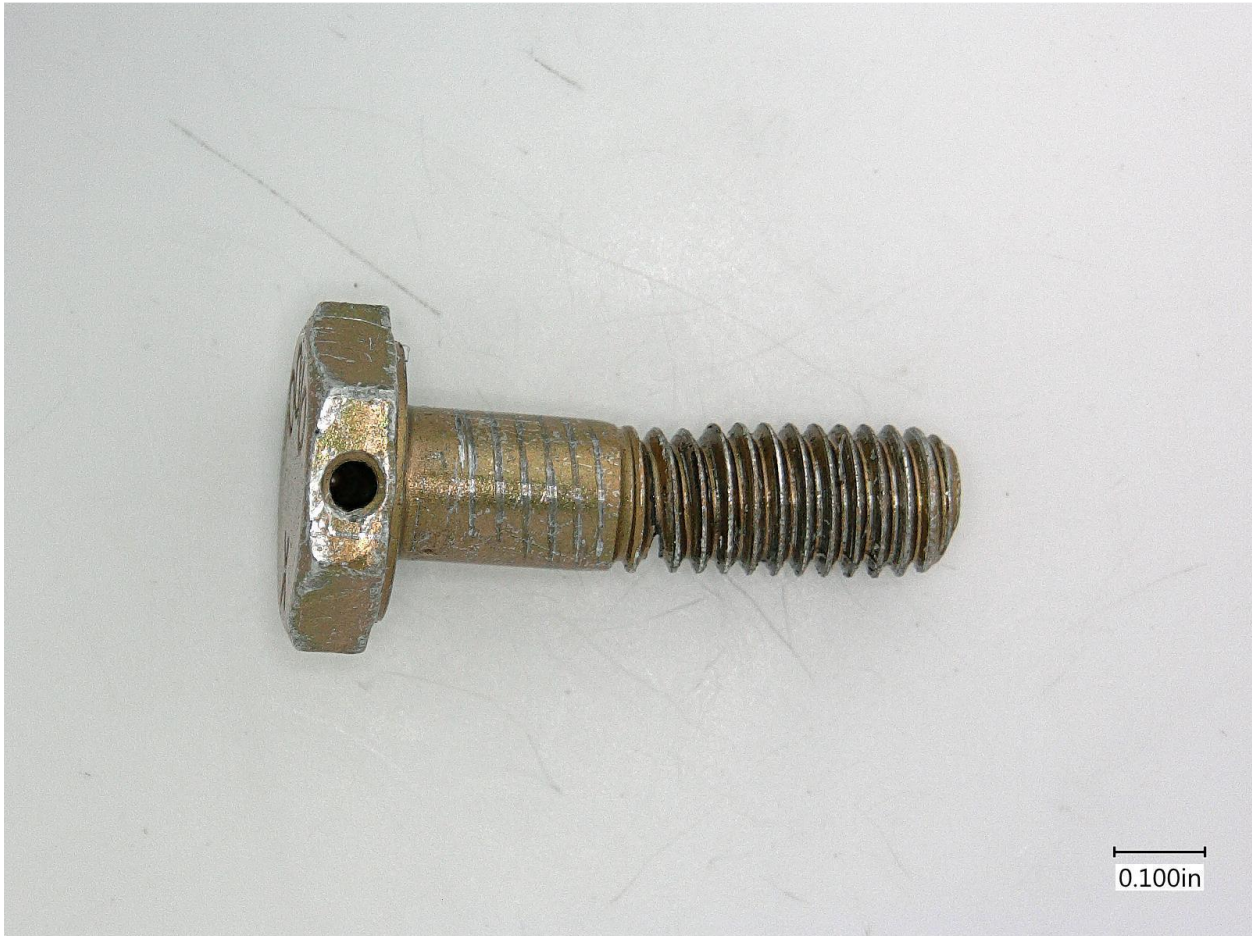
The additional bolt from the left side lug exhibited three cracks in the first three engaged threads (Figures 12-15). Root radii were measured on a Keyence microscope to be about .005". There is no requirement for root radius on these AN series bolts. A metallographic cross section of the threads exhibited seams in the thread crests confirming that the threads were rolled (Figure 16). The absence of grain flow in the roots and presence of seams in the crests indicates that the bolts were brought to a normalizing temperature after the threads were rolled.

2. The other AN3H5A bolt exhibited multiple cracks in the first three engaged thread roots.
3. The housing crack in the lug (associated with the cracked bolt) was due to fatigue originating from a lug face edge. No abnormalities were present at the origin.

Figure 12 Cracked bolt.

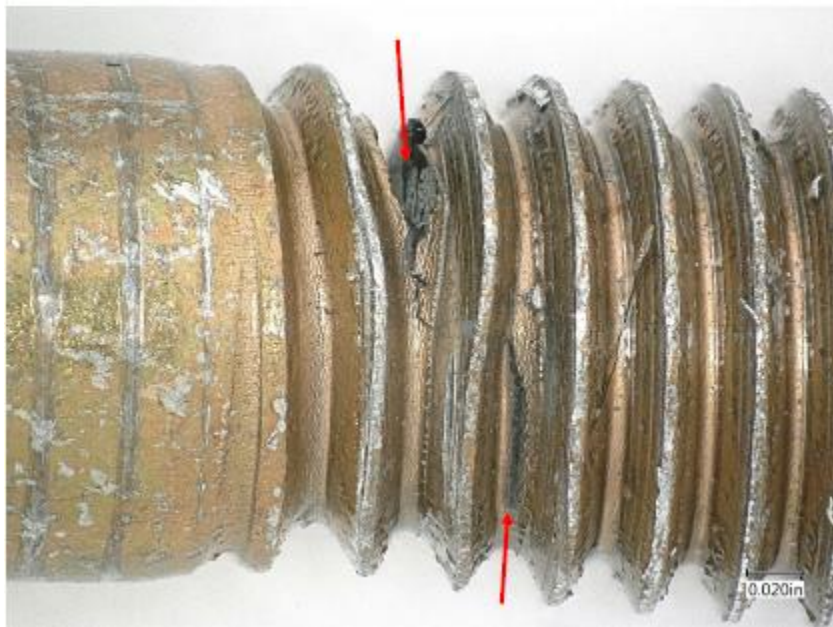
Figure 13 Cracks visible in the first and second engaged threads.

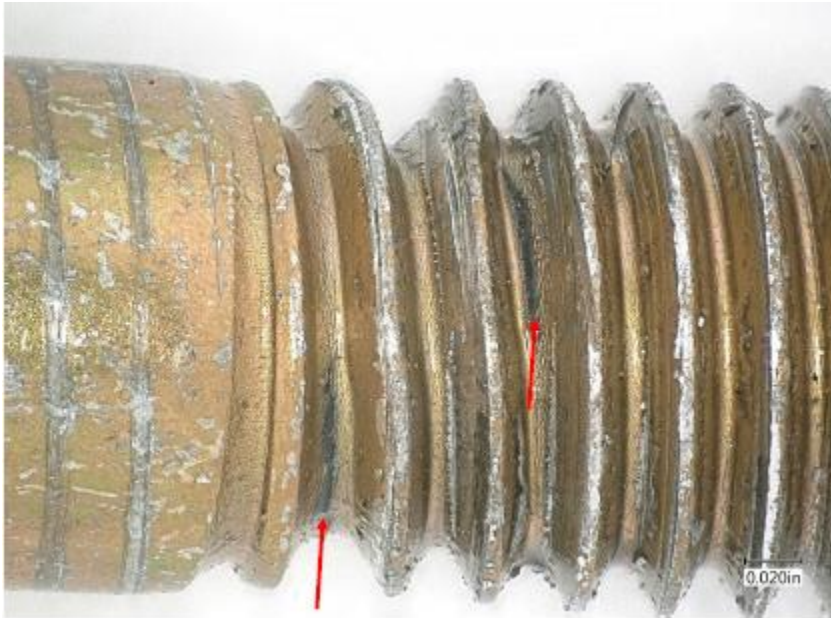
Figure 14 Opposite side of the cracked bolt again showing the cracks in the first engaged thread and an additional crack in the third engaged thread.

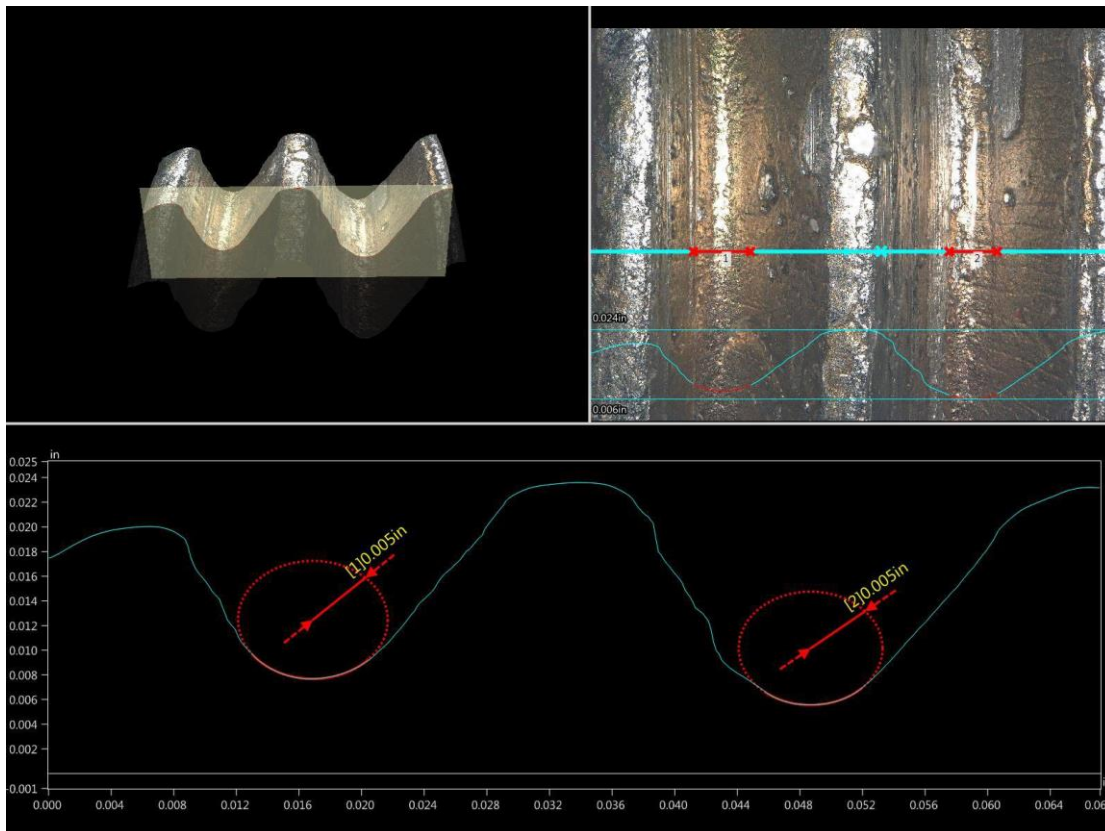
- b. The fractured bolt had a conforming composition and hardness. Microstructure was typical for the material.
  - c. The thread root radius measured 0.005 inch.

Figure 15 Root radii measured about .005". There is no requirement for root radius.

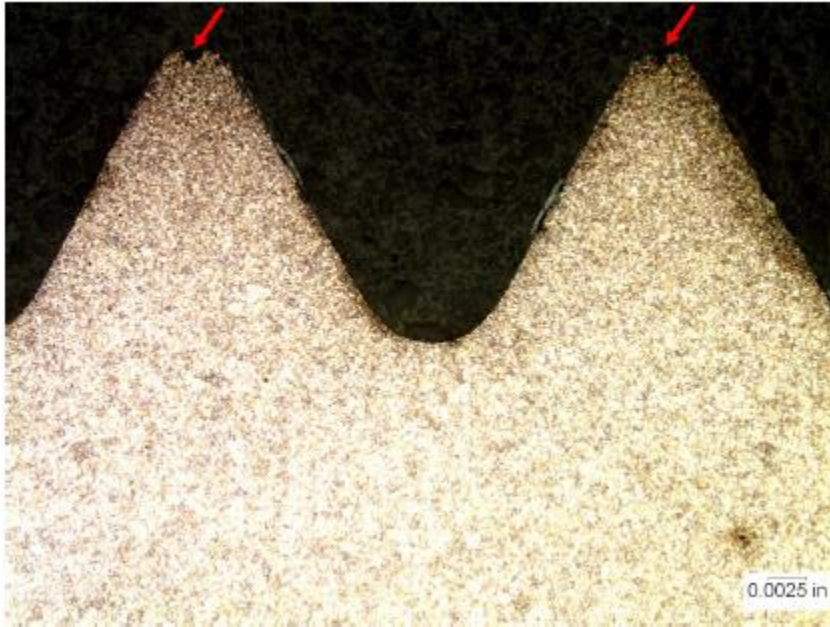
Figure 16 Cross section of the cracked bolt threads etched in nital exhibited seams at the thread crests (red arrows) indicating that threads were rolled.

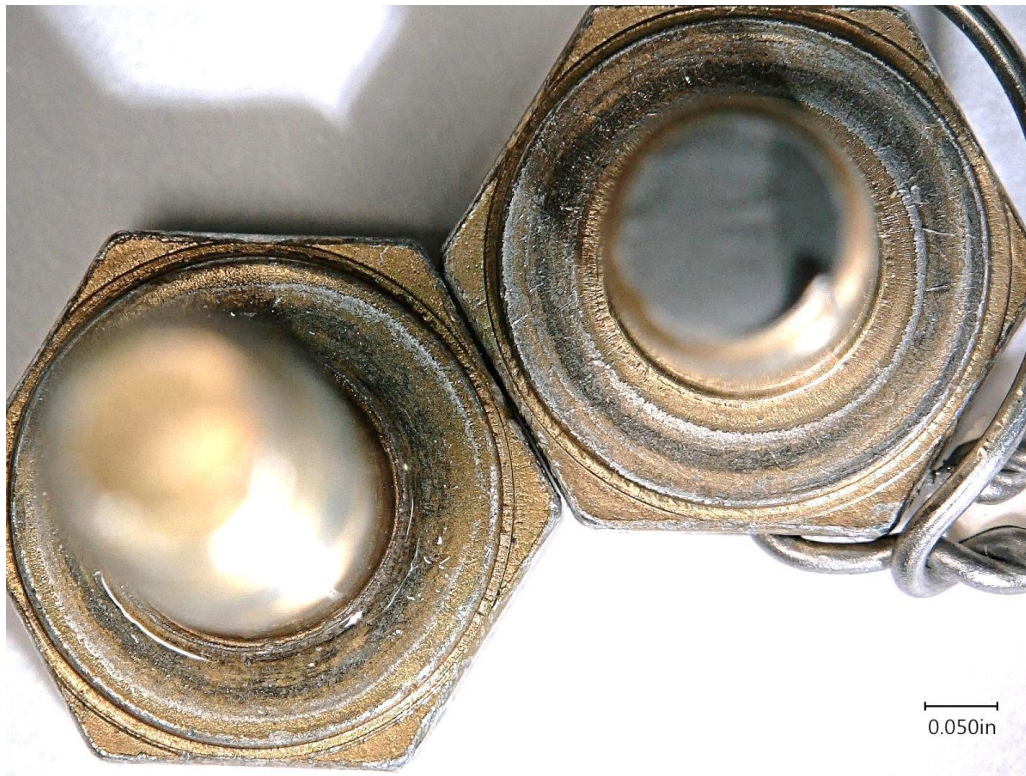
The underside of the fractured and cracked bolt heads are shown in Figure 17. The bolts appeared to be the required configuration based on grip length, thread length, and major and minor diameters.

Figure 17 Underside of heads on the cracked bolt(left) and fractured bolt(right).

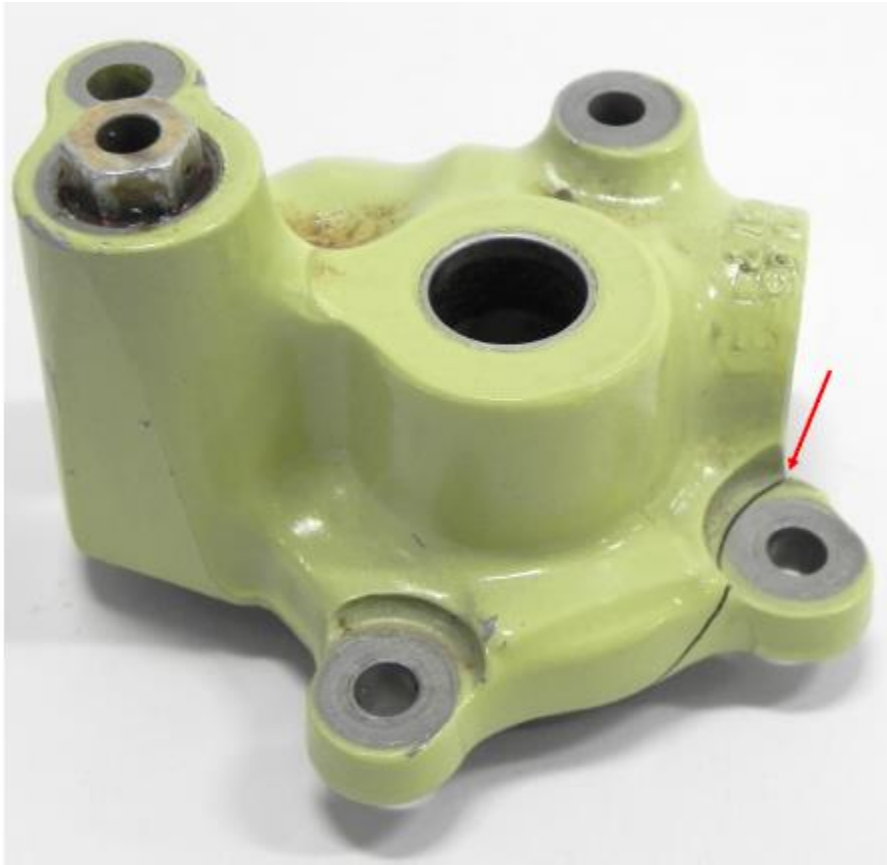
The check valve housing (also referred to as endcap gland) is shown in Figure 18 and Figure 19. Exposure of the crack surface and examination determined the mode was fatigue originating at the radius of the left side lug. A reddish oil was still present inside the crack when it was opened. There was no apparent damage or wear at the origin and paint appeared to be intact. SEM examination indicated almost the entire crack was fatigue except for a small portion of overload that was created when the lab opened the crack (Figure 20-23). The radius of the lug at the origin measured about .003". Spectrochemical analysis shows the housing material is 7079 conforming to the AMS 4138 specification. Hardness ranged from 158 to 166 HB 10/500 meeting the requirement of 135 or greater per AMS 4138 in the T6 condition. Conductivity averaged 30.6 IACS which appears typical for 7079 in the T6 condition. Microstructure appeared typical for the material (Figure 24).

Figure 18 Check valve housing with red arrow indicating fatigue origin.

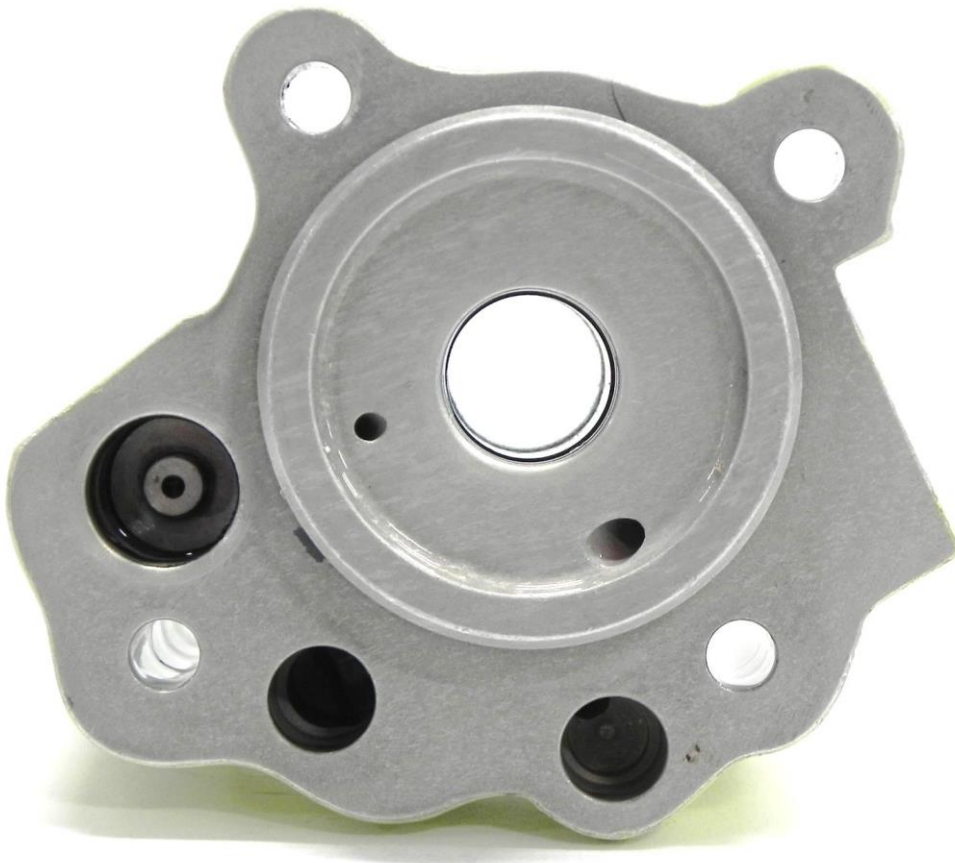
Figure 19 Underside of check valve housing.

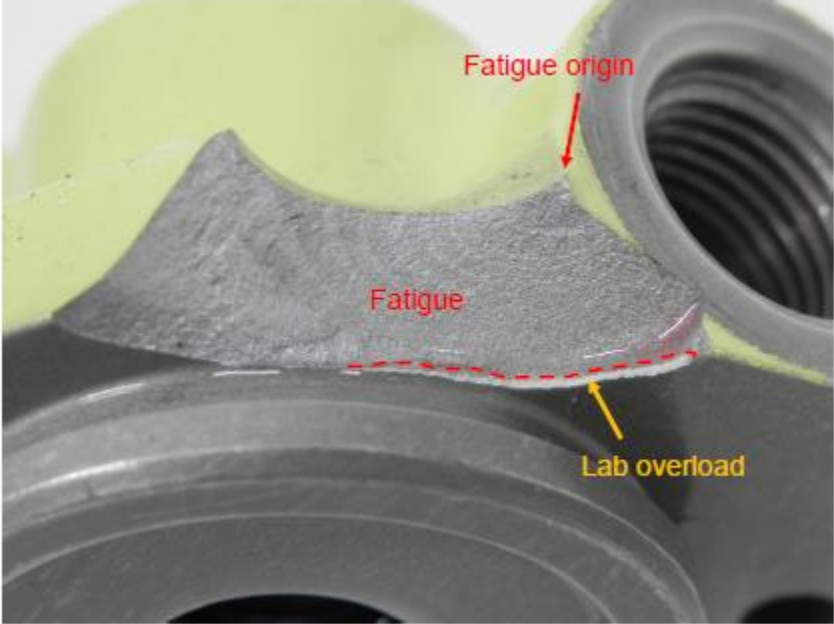
Figure 20 Check valve fracture surface was entirely fatigue except for a small portion of lab created overload created while opening the crack.

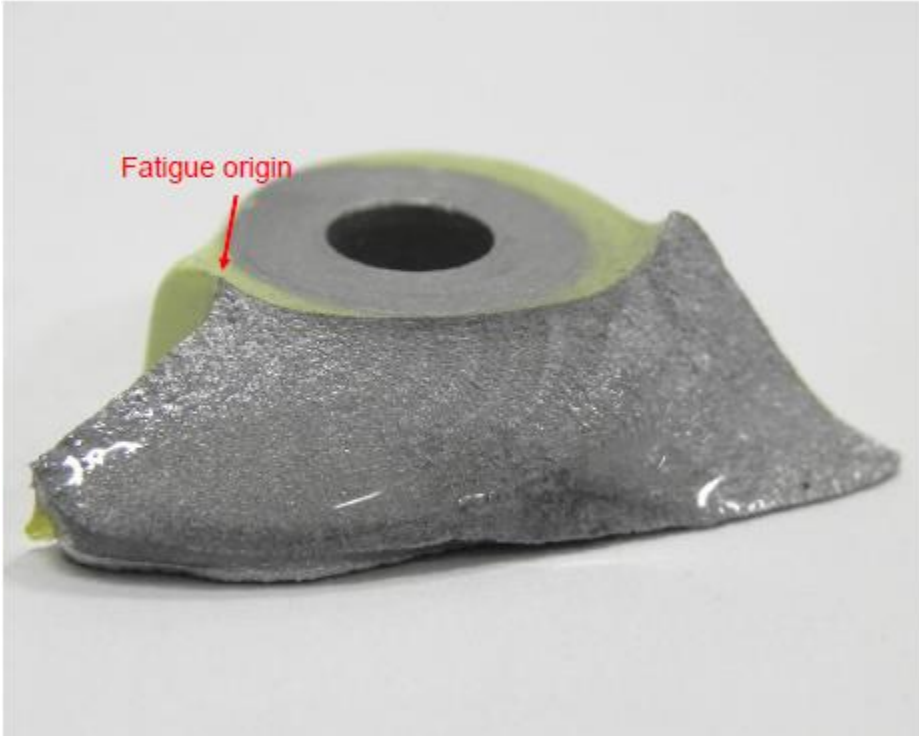
Figure 21 Lug half of housing fracture.

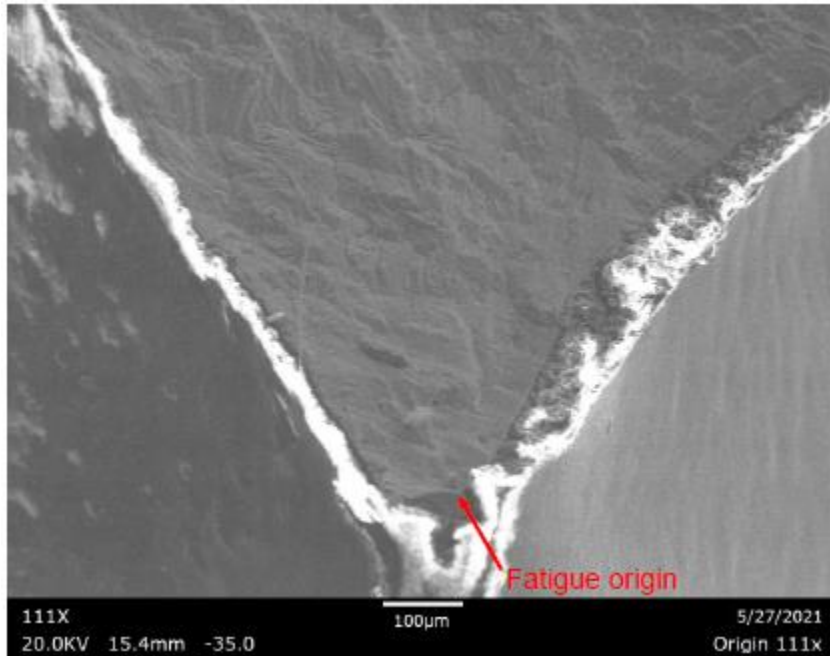
Figure 22 SEM examination of lug half of housing fracture.

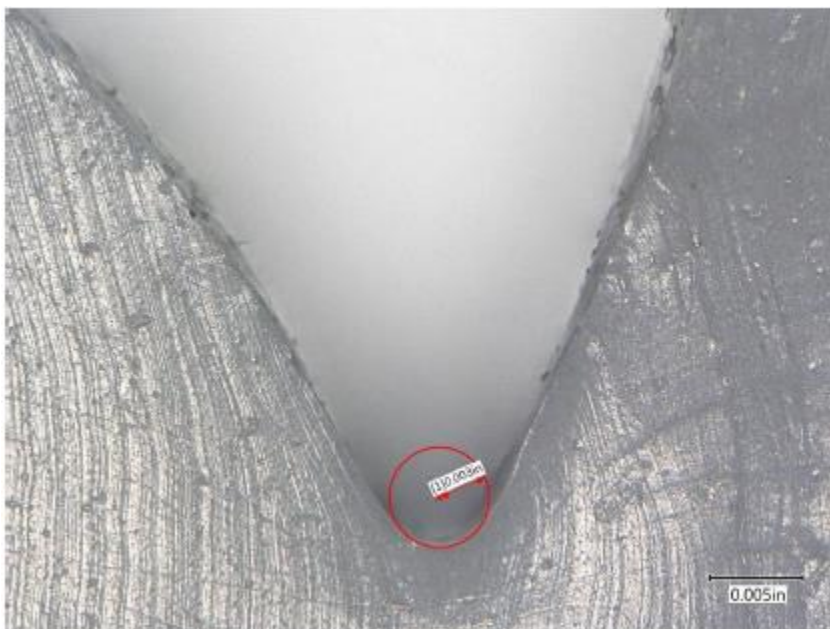
- d. The housing had a conforming composition and hardness. Microstructure and conductivity were typical for the material.
  - e. The geometry of the edge where the housing crack initiated was a 0.003 inch radius. The requirement is to break all sharp edges .005 to .015R.

Figure 23 Replica cross section near housing origin. Radius measures about .003".

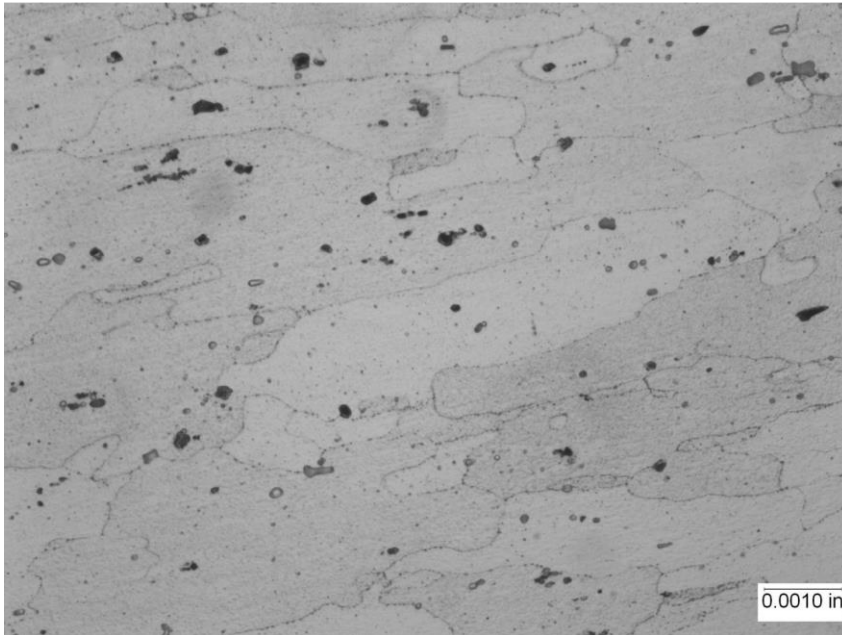
Figure 24 Housing microstructure at 500X etched with Keller's

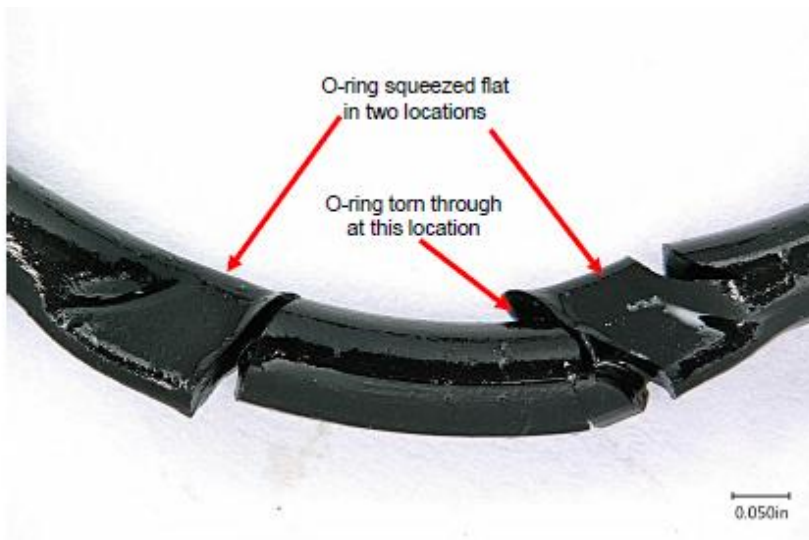
The o-ring was torn in one location and compressed at two adjacent locations likely from hydraulic pressure blowing out the side and then getting compressed between the housing and cylinder (Figure 25).

Figure 25 20X microscope image of o-ring damage.
