NATIONAL TRANSPORTATION SAFETY BOARD
Office of Aviation Safety
Washington, D.C. 20594

AIRWORTHINESS GROUP CHAIRMAN'S FACTUAL REPORT

NTSB No: DCA20LA100

Operator: Construction Helicopters, Inc.
Aircraft: Sikorsky S-61N, registration N908CH
Location: Camp Dwyer, Afghanistan
Date: April 20, 2020
Time: 0800 local time

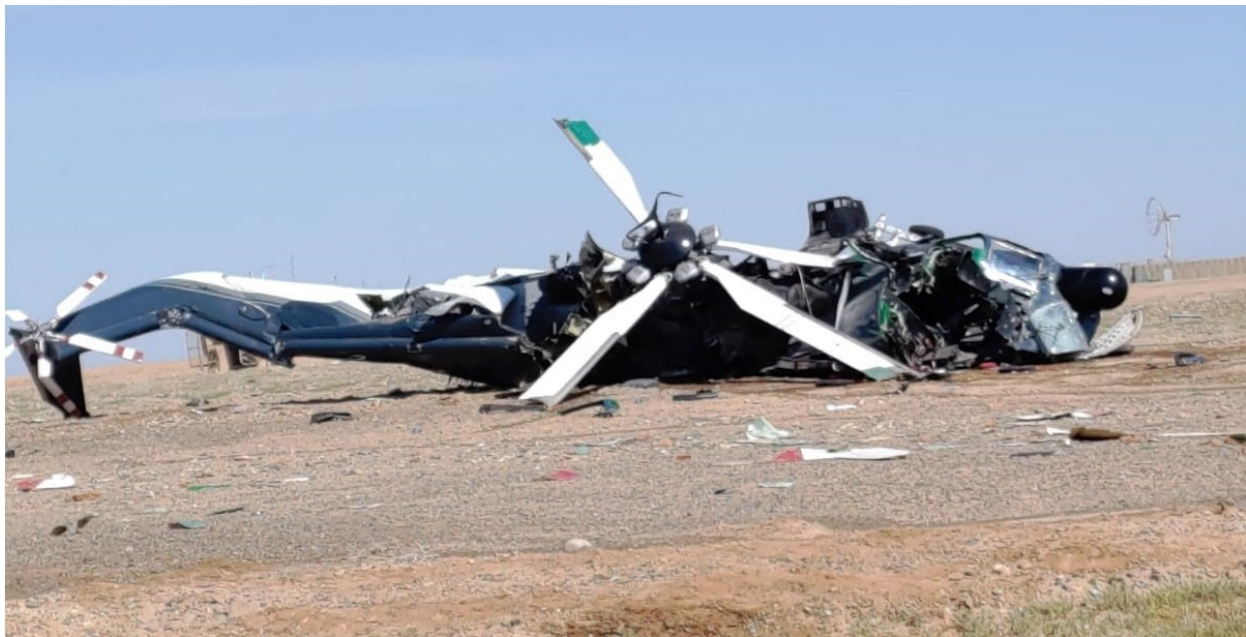
The helicopter came to rest on its right side at a heading of about 74 degrees magnetic (**Figure 2**). There was no evidence of an inflight breakup of its airframe. The tail boom was twisted further to the right compared to the main fuselage. The main rotor gearbox remained attached to the airframe and the main rotor head remained installed. All five main rotor blade cuffs remained attached to the main rotor head. The inboard sections of four main rotor blades remained attached to their respective cuffs and the outboard sections of these blades were found in the vicinity of the main wreckage, with the furthest section found about 979 feet away from the main wreckage. The ‘white’ main rotor blade had separated from its cuff but was found near the main wreckage. Main rotor blade weights and along with blade fragments were found generally to the right of the main wreckage in various distances. All main rotor rotating controls, from the rotating swashplate to the pitch change links, were present.

Figure 2. The accident helicopter. (Image courtesy of CHI Aviation)

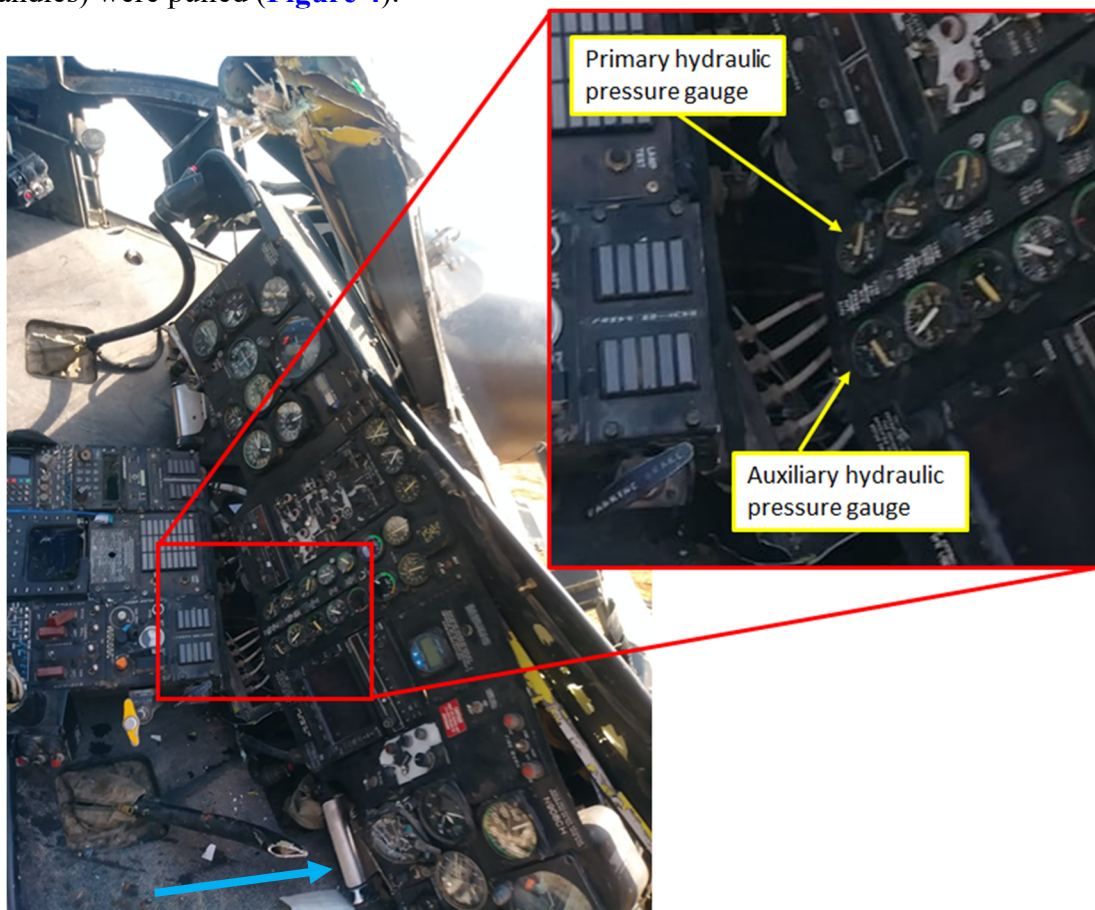
The primary hydraulic pressure gauge remained installed on the instrument panel and indicated slightly above the 9 o'clock position (Figure 3).³ The auxiliary hydraulic pressure gauge remained installed on the instrument panel and indicated slightly above the 3 o'clock position, which was about the 0 pounds per square inch (psi) on the gauge. Both engine speed selector levers were in the shut-off position and both fire emergency shut-off selectors (T-handles) were pulled (Figure 4).

Figure 3. A view of the cockpit instruments. The blue arrow points to the right pilot's right pedal. The inset photo shows the primary and auxiliary hydraulic pressure gauge needle positions. (Image courtesy of CHI Aviation)

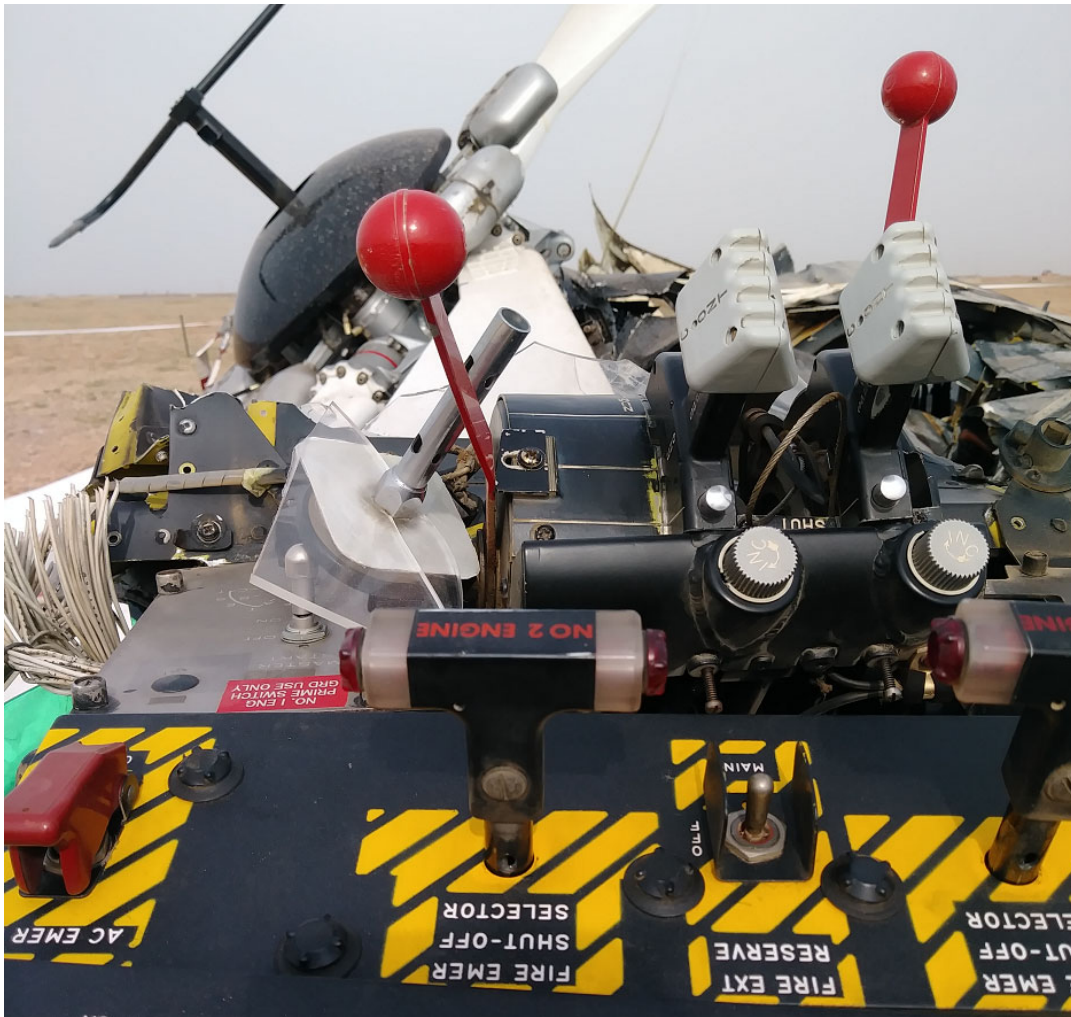
Figure 4. The engine speed selector levers and emergency shut-off T-handles. Note the cockpit roof appears upside-down due to its partial separation during the postcrash rescue of the crewmembers. (Image courtesy of CHI Aviation)

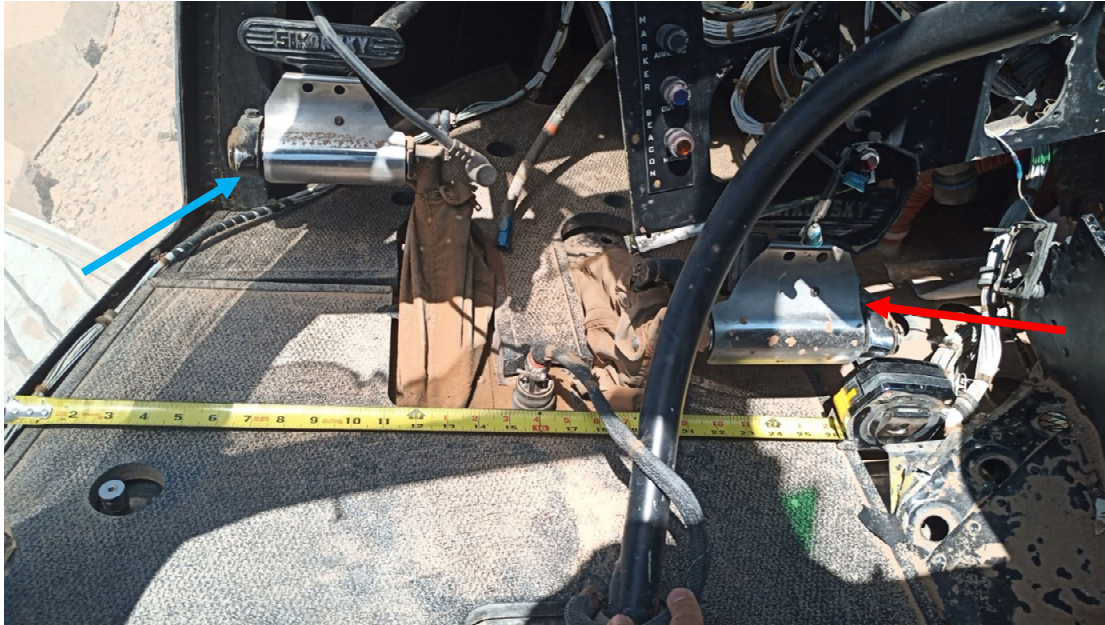
The left pilot seat cyclic, collective, and pedals remained installed. The collective head was fractured but remained connected to the collective control via wiring. The left pedal was displaced fully forward and the right pedal was displaced fully aft (**Figure 5**). The collective-mounted hydraulic switch was found in the “AUX OFF” position (**Figure 6**).⁴

Figure 5. The left pilot's pedals. The left pedal (blue arrow) was displaced forward of neutral while the right pedal (red arrow) was displaced aft of neutral. (Image courtesy of CHI Aviation)

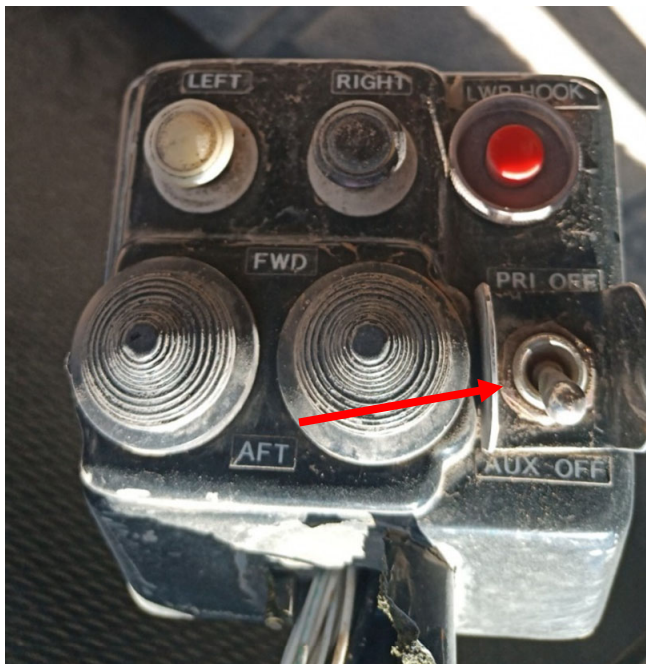
Figure 6. The left pilot's collective-mounted hydraulics switch. (Image courtesy of CHI Aviation)

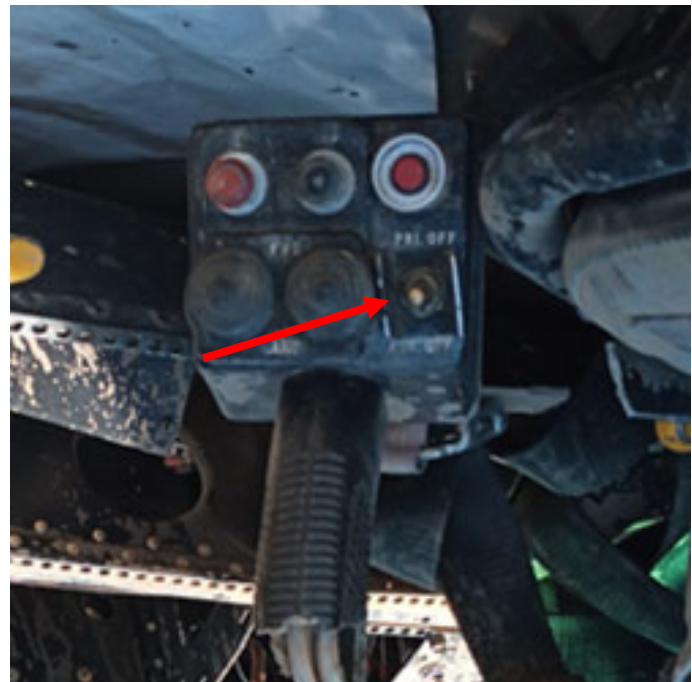
collective head was fractured but remained connected to the collective control via wiring. The collective-mounted hydraulic switch was found in the center position (**Figure 7**). The left pedal could not be accessed due to crushing damage, therefore its position could not be determined. The right pedal was visible and appeared to be aft of its neutral position (**Figure 3**).

Figure 7. The right pilot's collective-mounted hydraulics switch. (Image courtesy of CHI Aviation)

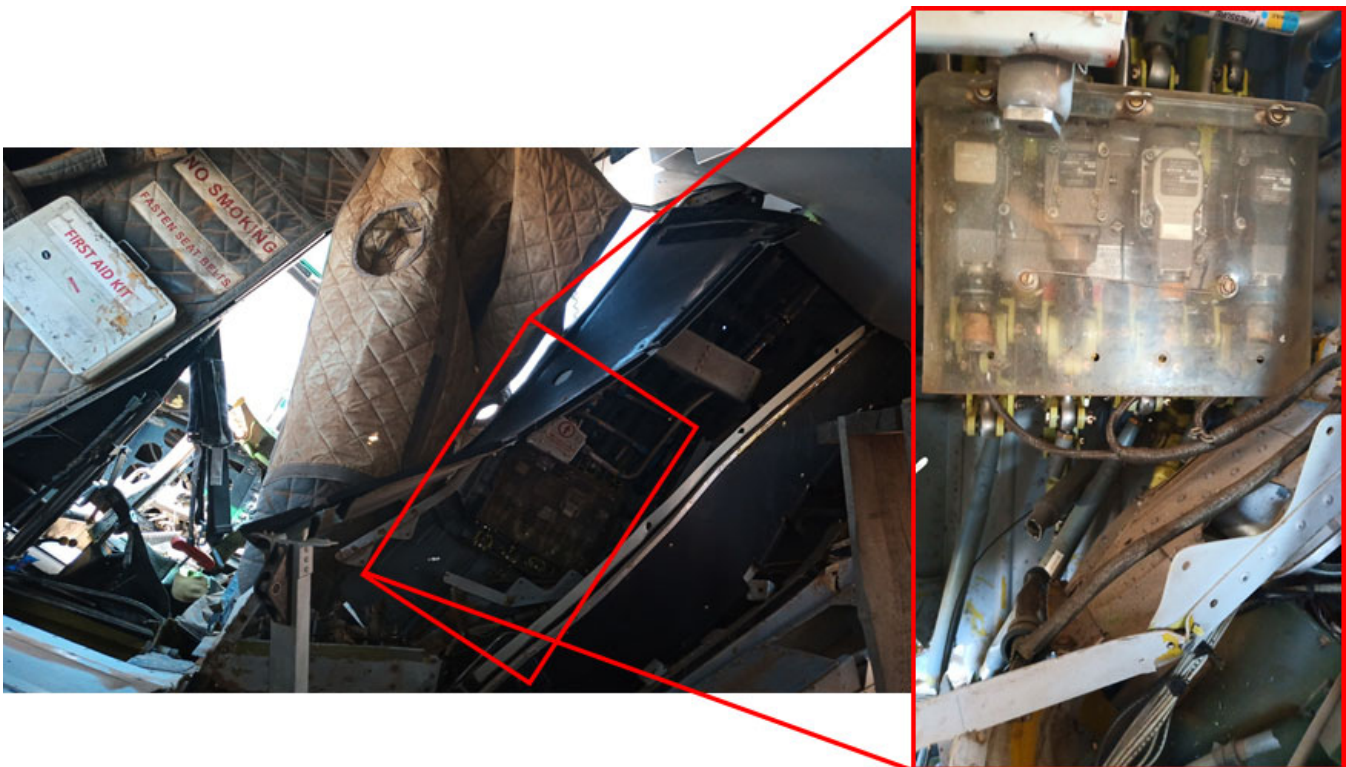
The auxiliary servocylinder remained installed but its surrounding structure had partially collapsed to the right (**Figure 8**). The input control tubes to the auxiliary servocylinder remained connected at their rod ends but the tubes were fractured at various locations. The output control tubes from the auxiliary servocylinder remained connected at their rod ends, but there was no evidence of disconnection of the control tubes leading up to the mixing unit. The hydraulic lines to the auxiliary servocylinder remained attached and the plastic shield was intact. A small pool of hydraulic fluid was observed to the right of the auxiliary servocylinder (**Figure 9**).

Figure 8. The auxiliary servocylinder installation. (Image courtesy of CHI Aviation)

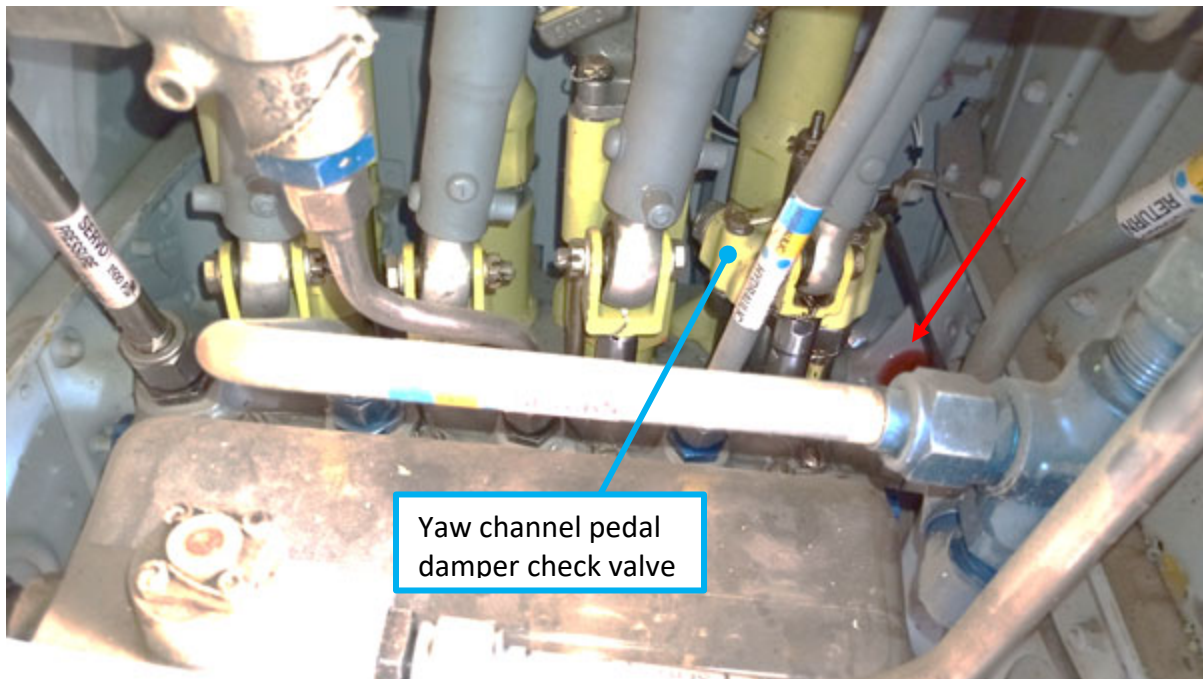
Figure 9. A red arrow points to a small pool of hydraulic fluid visible to the right of the auxiliary servocylinder. (Image courtesy of CHI Aviation)

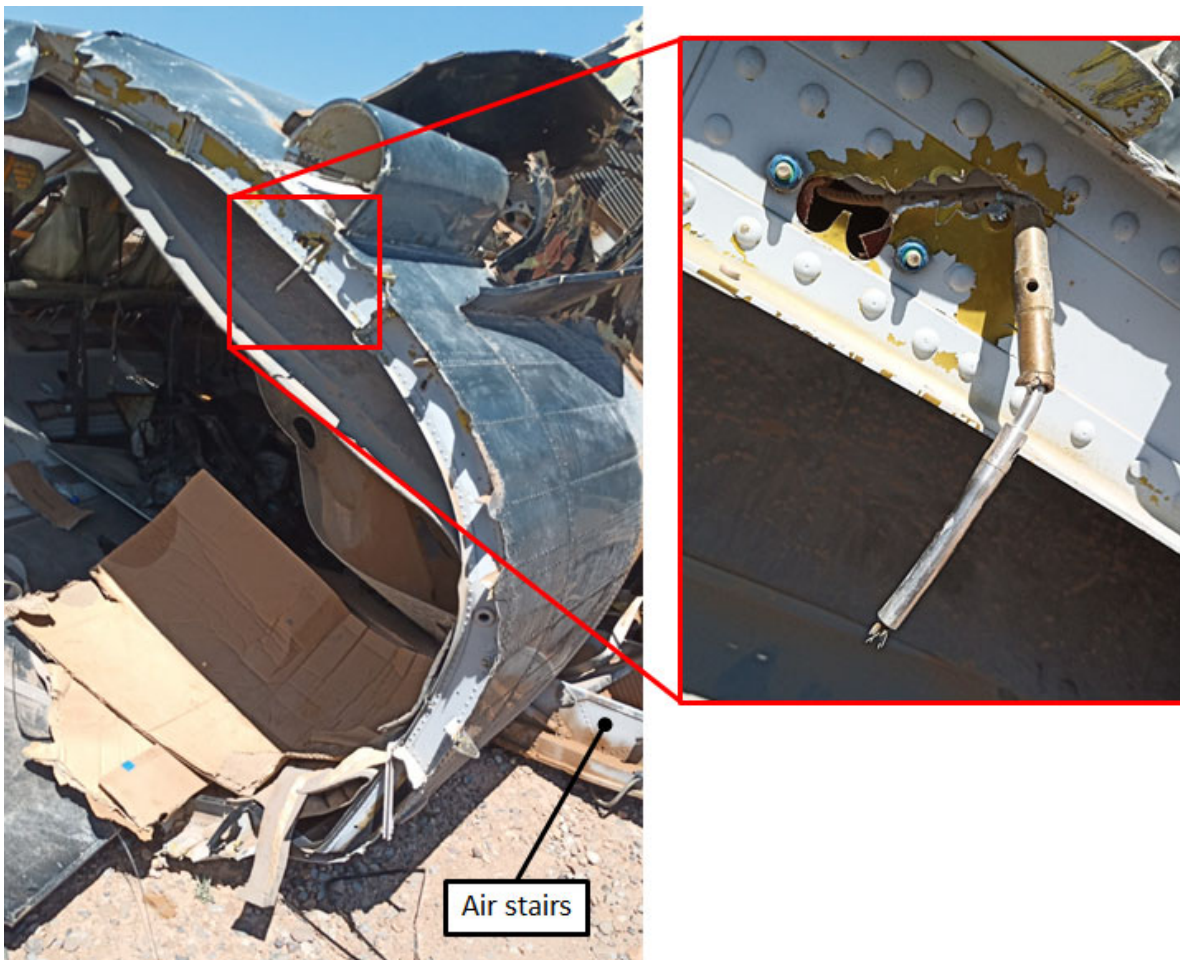
The tail rotor control cables were fractured in multiple locations between the forward and aft control quadrants. A single control cable, routed through the right-side holes in multiple structural frames, was visible near the No. 1 TRDS, which was fractured and frayed at its forward end and continued aft below the blower fan, past the right-side air stairs. The aft end of this single control cable had torn through a structural frame toward the right side of the helicopter (**Figure 10**). Two control cables were observed within the tail boom and were continuous to the aft control quadrant, which remained installed within the tail boom structure. The control tubes between the aft control quadrant were continuous to the tail rotor gearbox. The negative force gradient spring remained attached to the airframe and the tail rotor bellcrank (**Figure 11**).

Figure 10. A fractured tail rotor control cable observed within a structural frame. (Image courtesy of CHI Aviation)

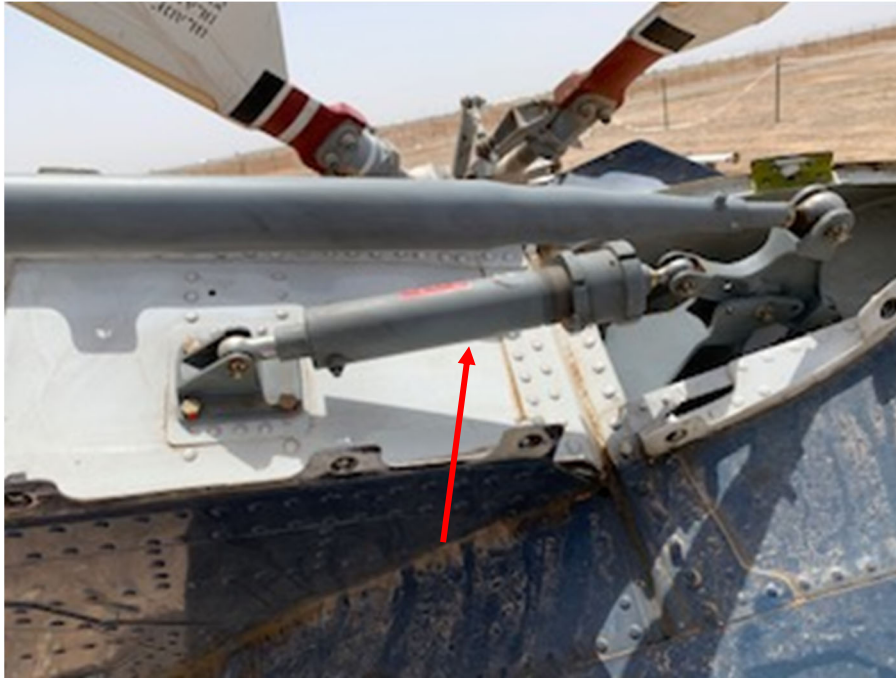
Figure 11. The negative force gradient spring (red arrow) installation on the vertical fin. (Image courtesy of CHI Aviation)

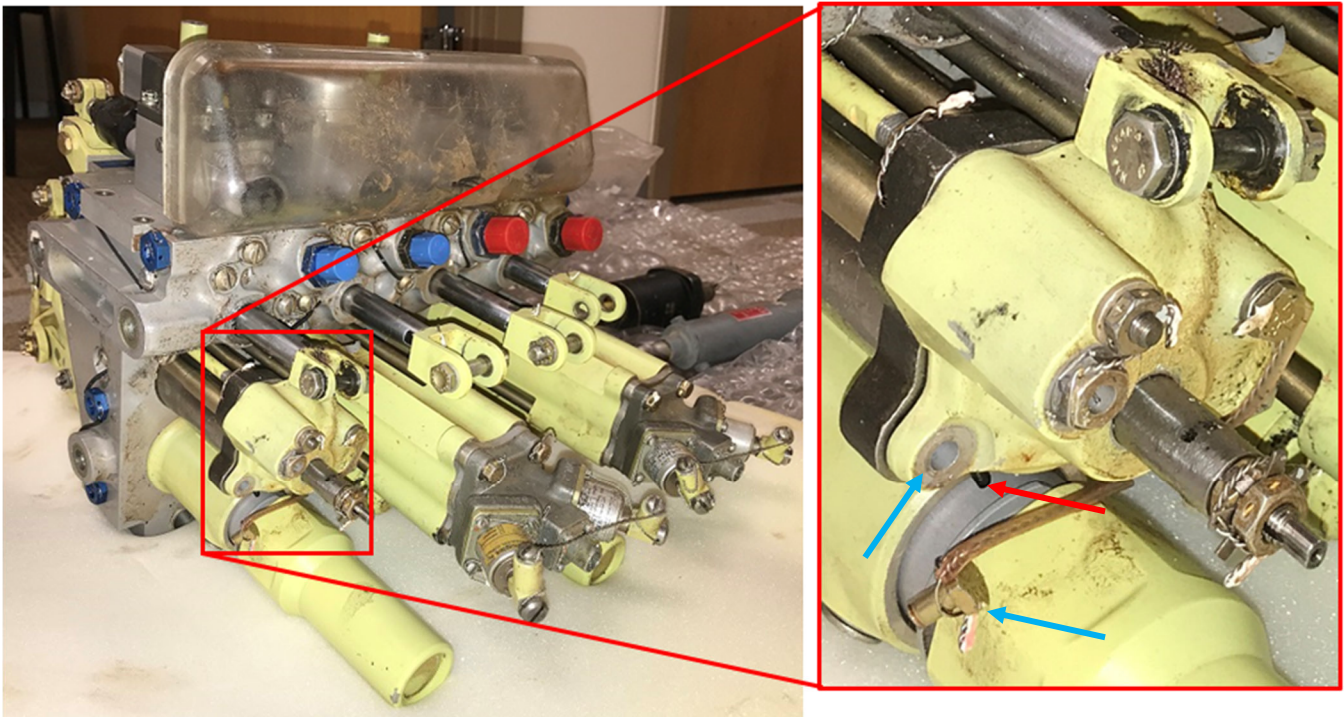
At the request of the NTSB, the operator recovered the auxiliary servocylinder assembly from the accident helicopter and shipped it to the NTSB in Washington, District of Columbia (DC) for further examination. On the yaw channel pedal damper check valve housing (P/N S6165-61517-2), the forward-right bolt⁵ (P/N AN3H5A) was fractured but its bolt head remained attached to its safety wiring (**Figure 12**). The safety wiring remained attached to the forward-left bolt (also P/N AN3H5A) on the pedal damper check valve housing. Additionally, an extruded piece of an O-ring near the fractured bolt was present at the interface between the pedal damper check valve and the pedal damper body.

Figure 12. The auxiliary servocylinder as received. The blue arrows point to the fractured forward-right AN3H5A bolt and its bolt hole. The red arrow points to the extruded O-ring.

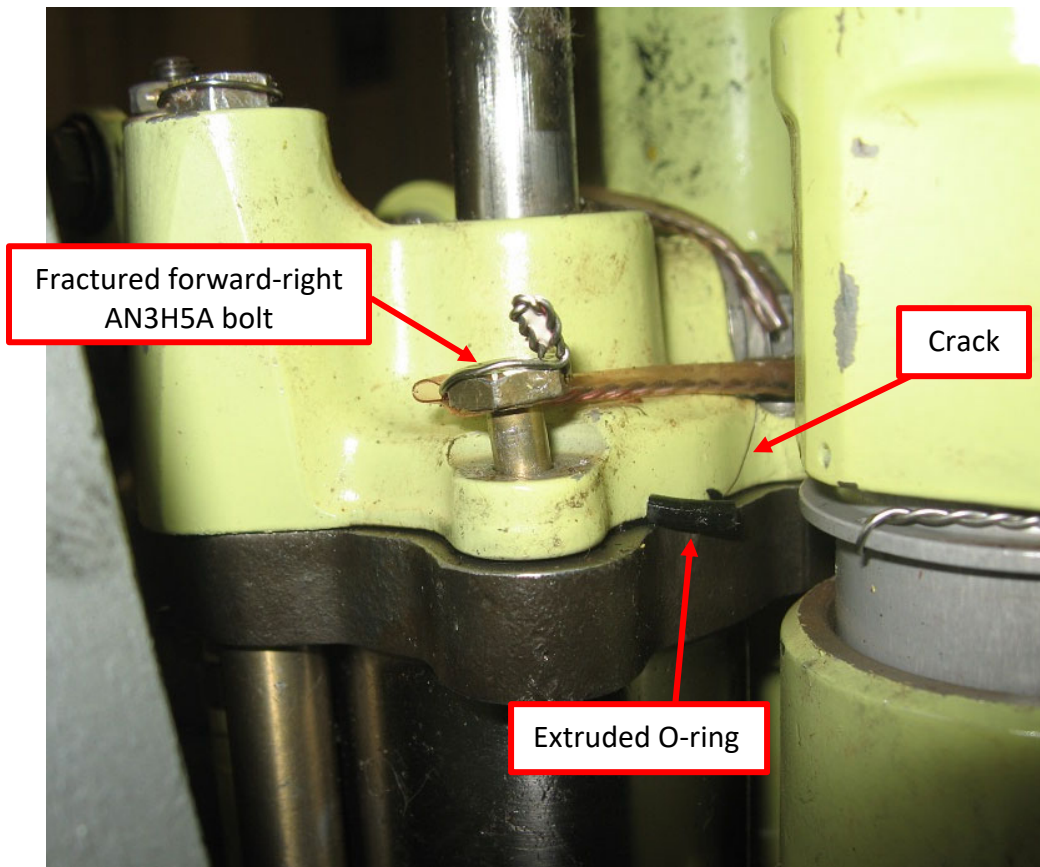
Figure 14. The auxiliary servocylinder pedal damper check valve housing. (Image courtesy of Sikorsky)

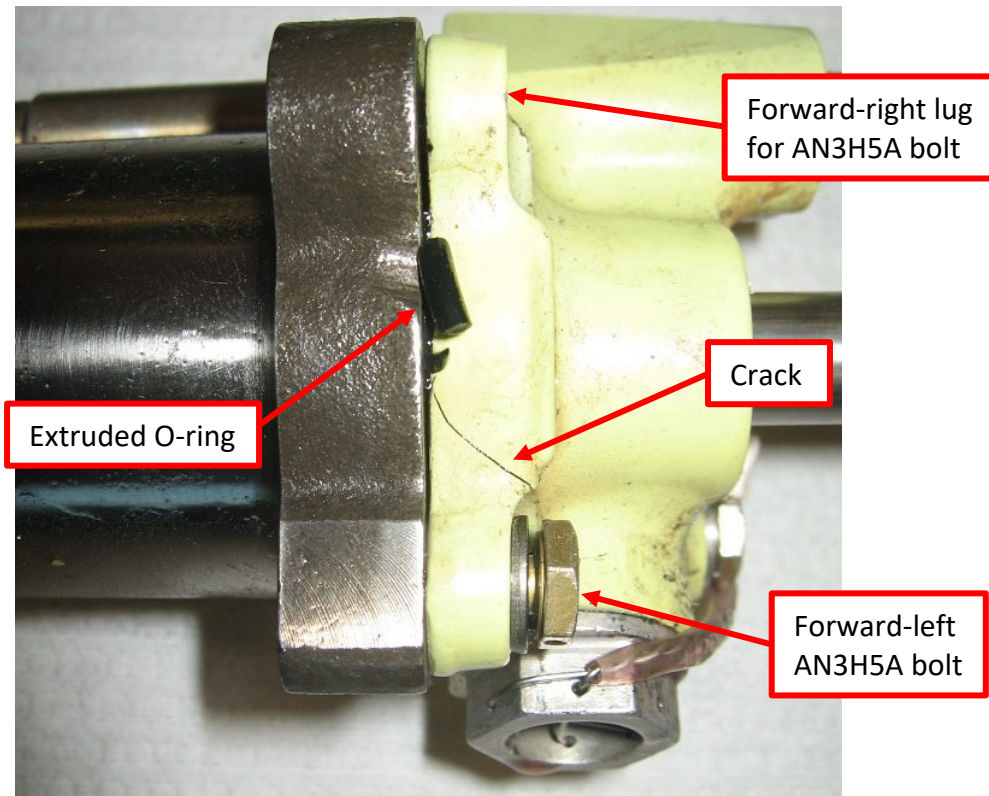
Figure 15. The pedal damper check valve housing still installed on the pedal damper. (Image courtesy of Sikorsky)

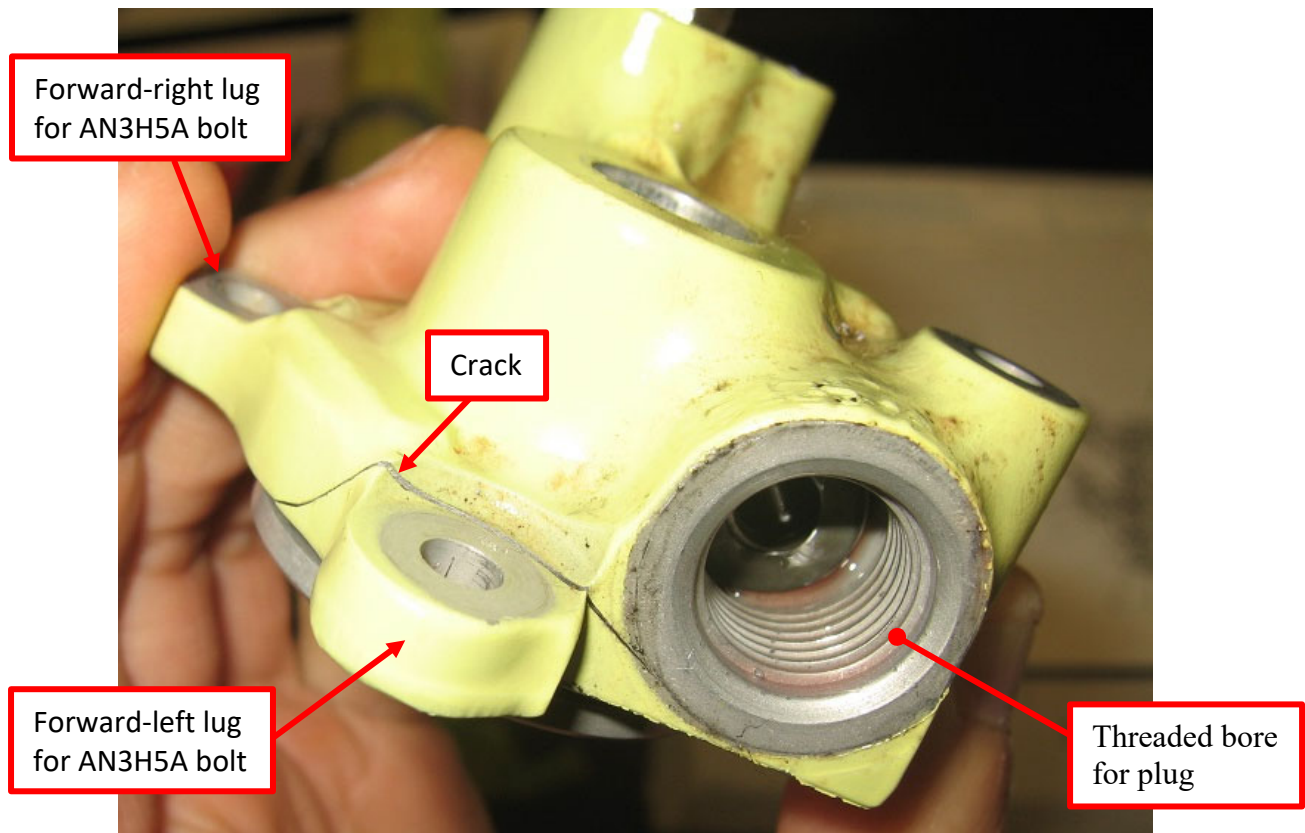
Figure 16. A view of the pedal damper check valve housing showing the extent of crack growth on the AN3H5A bolt hole lug. (Image courtesy of Sikorsky)

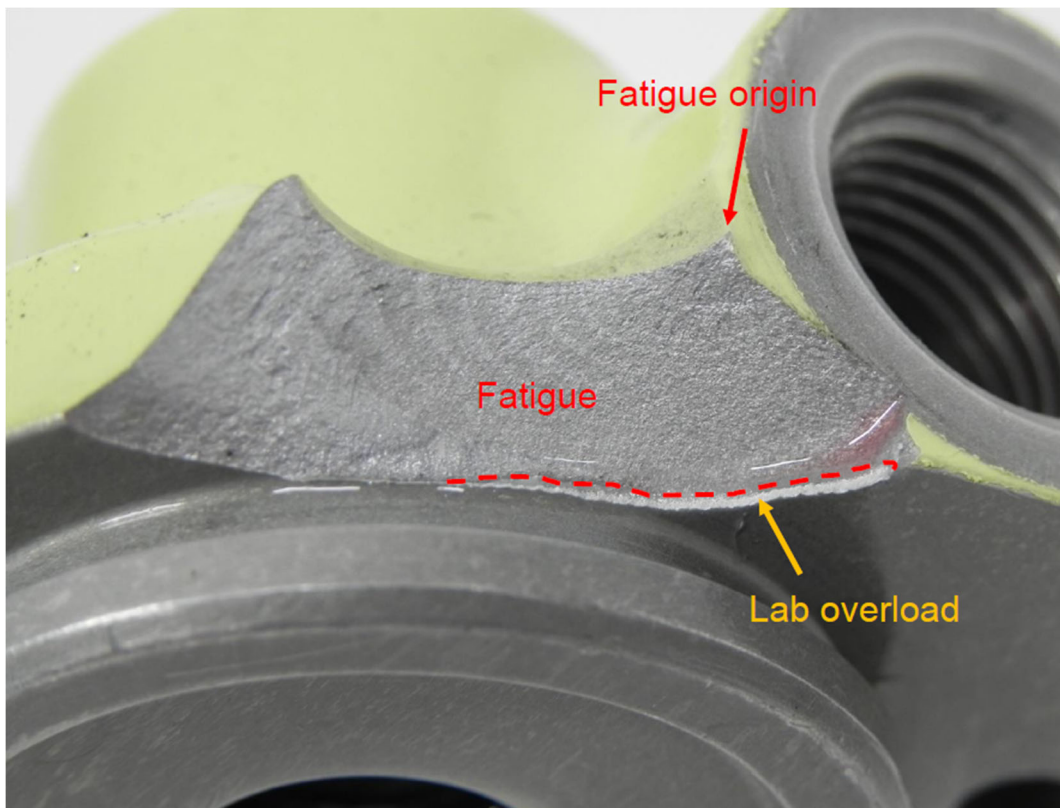
The check valve housing crack was mechanically fractured in the lab to expose the fracture surface. The fracture surface exhibited fatigue for the vast majority of the surface, aside from a small portion of overload that was created when the lab opened the crack (**Figures 17 and 18**). The fatigue fracture surface showed no evidence of damage or contact wear. A red-colored oil, likely hydraulic fluid, was present within the crack when it was opened. The fatigue origin was located near the radius of the lug. The radius was measured to be about 0.003 inches, which did not conform with drawing requirements to break all sharp edges to 0.005 to 0.015 inches. The material composition and hardness conformed to drawing requirements, and the microstructure appeared typical for the material.

Figure 17. Areas of fatigue cracking identified on the forward-left lug of the pedal damper check valve housing. (Image courtesy of Sikorsky)

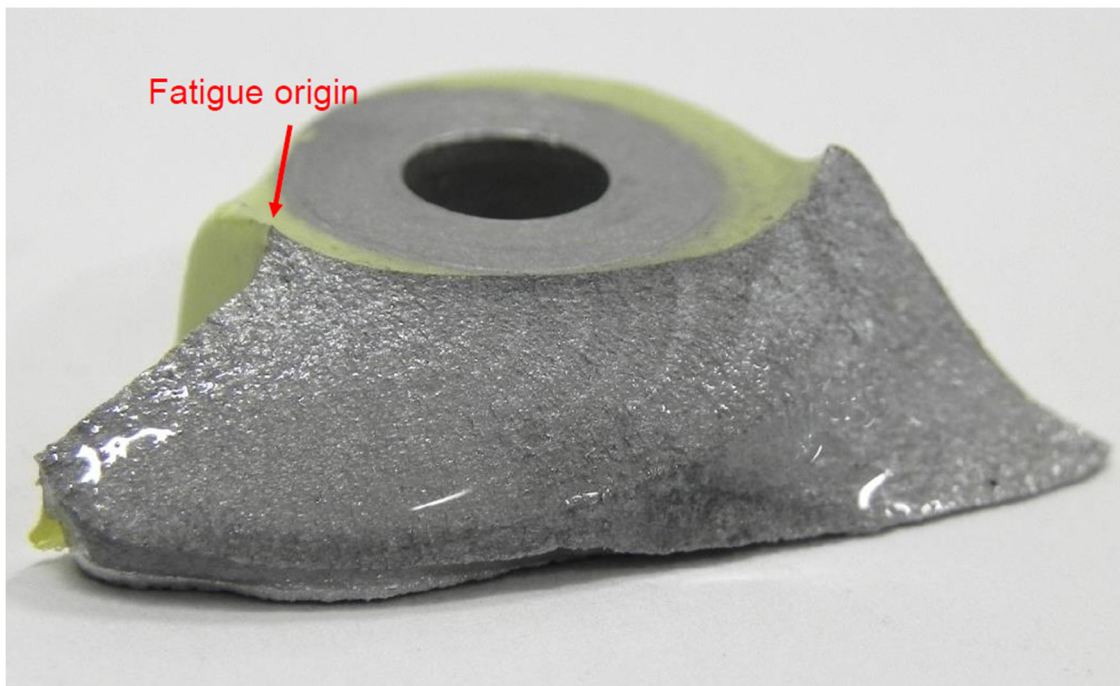
Figure 18. Fatigue cracking on the forward-left lug of the pedal damper check valve housing. (Image courtesy of Sikorsky)

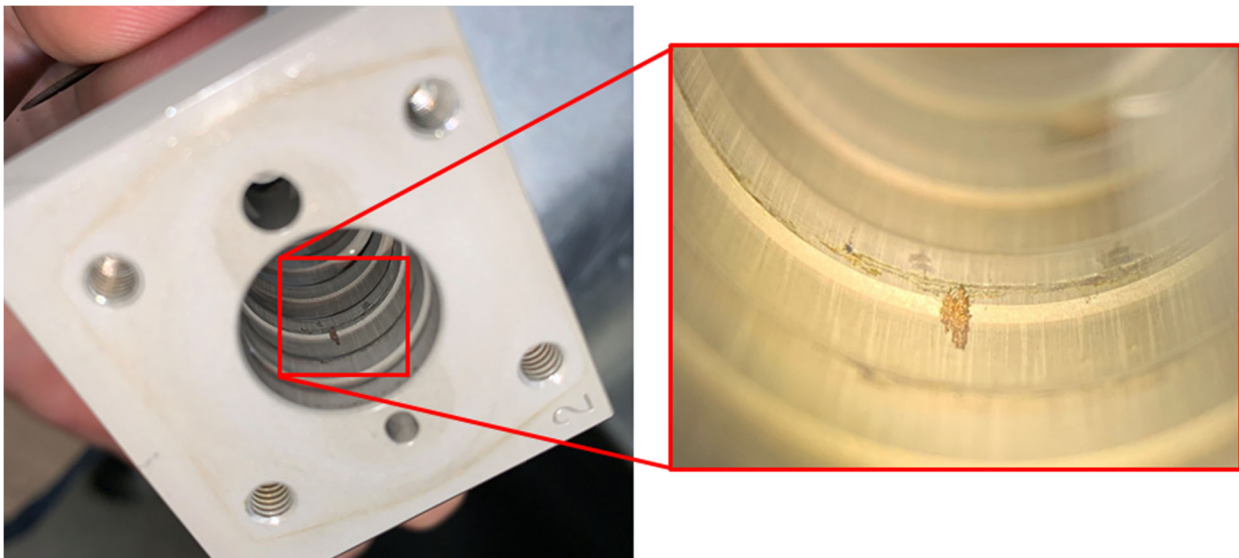
The electrical connector was removed and exhibited no anomalous damage. The wiring between the electrical connector and the motor was cut by the technician as part of the normal disassembly process. The motor cap was removed and the large O-ring between the motor cap and servo body exhibited small, grit-like debris. The motor was removed and the surface of the servo, to which the motor attaches, also had a small amount of the grit-like debris.⁶ The connector-side of the surface of the servo had anomalous wear where the O-ring contact the servo surface. The input link exhibited typical service wear and no anomalous damage. The two [internal] filters were removed and grit-like debris was present on both filters. The two end caps were removed and their O-rings appeared to be in good condition. The spool and sleeve were removed and neither exhibited anomalous damage. On the servo body, a small linear gouge as well as circumferential damage was observed on the surface that contacts the sleeve (**Figure 19**).

Figure 19. Damage observed within the sleeve bore of the yaw servovalve.

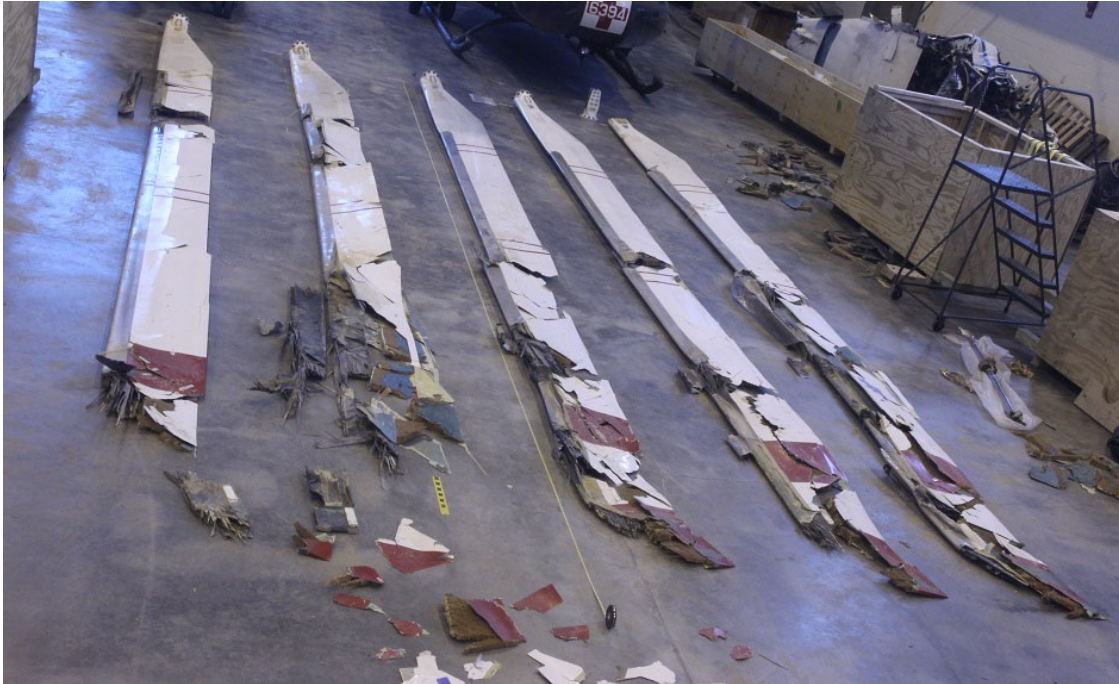
Figure 21. The reconstructed main rotor blades.

Numerous blade skin and core pieces that could not be matched to a blade were set aside. All five main rotor blades exhibited significant fragmentation on their outboard ends. The inboard ends of the blades were generally whole with distinctive fractures in a generally chordwise direction. Additional details of the findings from the main rotor blade reconstruction and examination can be found in NTSB Materials Laboratory Report No. 20-062 in the docket for this investigation.
