NATIONAL TRANSPORTATION SAFETY BOARD
Office of Aviation Safety
Washington, D.C. 20594

AIRWORTHINESS GROUP CHAIRMAN'S FACTUAL REPORT

NTSB No: CEN18FA391

Operator: Chinilna Equipment, LLC
Aircraft: Airbus Helicopters AS350 B3e, N907PL
Location: Gustavus, Alaska
Date: September 28, 2018
Time: 1057 Alaska daylight time

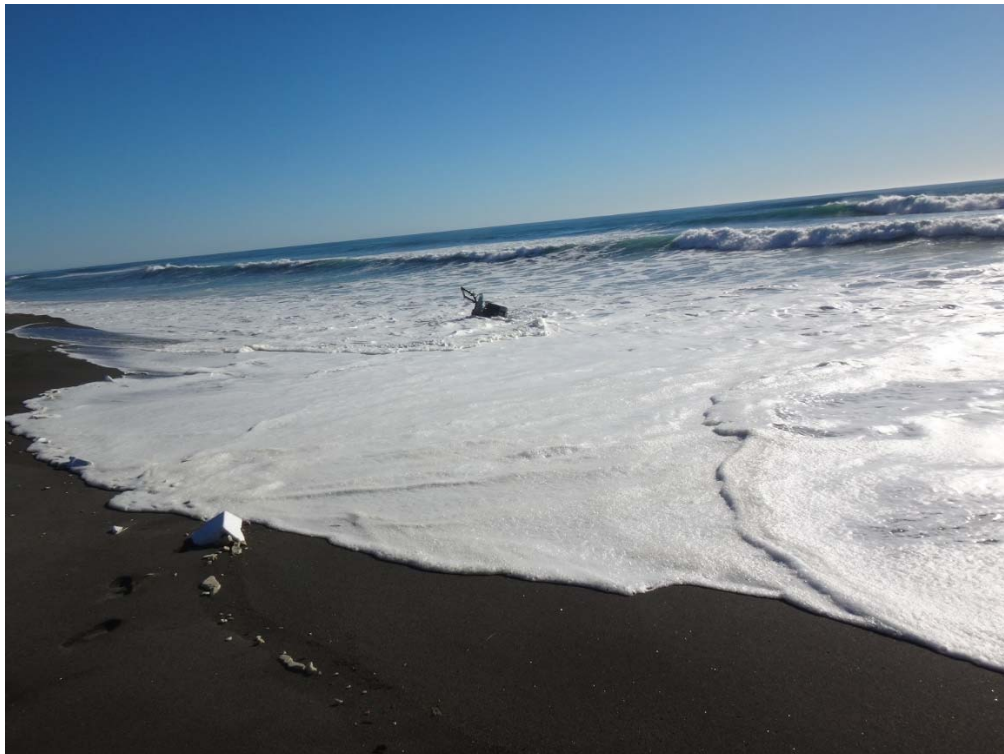
Photo 1. The helicopter wreckage during high tide. The right skid is visible. (photo courtesy of the USCG)

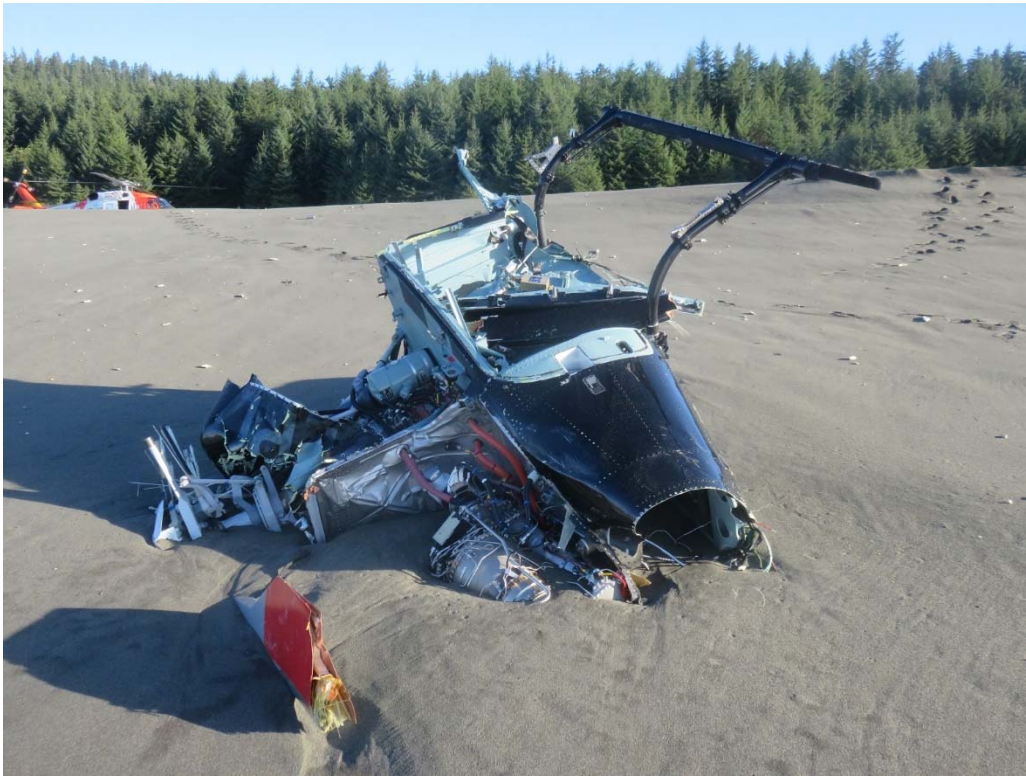
Photo 2. The helicopter wreckage at low tide. (photo courtesy of the USCG)

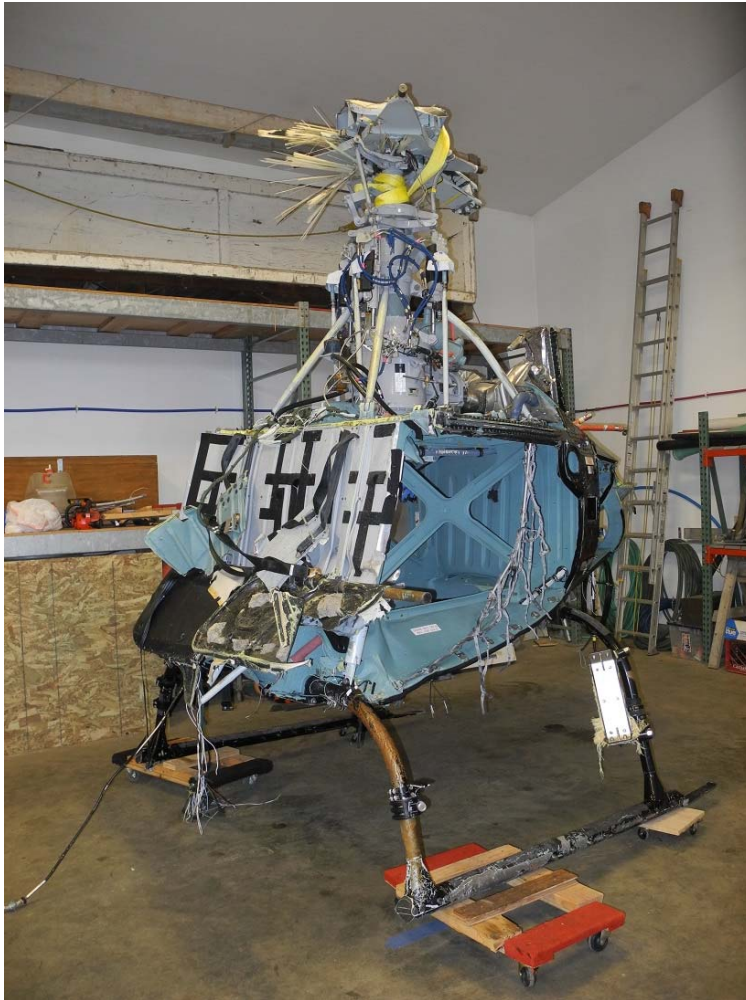
The main fuselage was found on a beach on its left side. The main fuselage was partially buried in the sand. The structure forward of the aft cabin bulkhead had separated from the main fuselage. The left and right aft bench seat remained attached to the aft cabin bulkhead. The two longitudinal floor beams, for the cabin floor structure, were fractured about 6.5 inches (left beam) and 5 inches (right beam) forward of the aft cabin bulkhead. The rear structure of the main fuselage was crushed inward throughout its circumference. The ring frame, located about 7.5 inches forward of the tail boom attachment to the rear structure, was partially fractured and deformed forward at about the 9 o'clock position. All upper cowlings had separated from the main fuselage (**Photo 3**). The left side transmission cowling was recovered as a single piece. The right side transmission cowling was recovered in two pieces. Multiple pieces of honeycomb sandwich composites were recovered. The engine firewall remained attached to the main fuselage and its base was

deformed in the aft direction and its upper portion was partially fractured. The engine deck was deformed downward. The engine air inlet barrier filter remained installed within its frame but the cowling surrounding the frame had separated. Sand was found within the barrier filter.

Photo 3. The recovered main fuselage with the main transmission and main rotor head attached. The fuel tank was previously separated for the recovery effort and remained uninstalled.

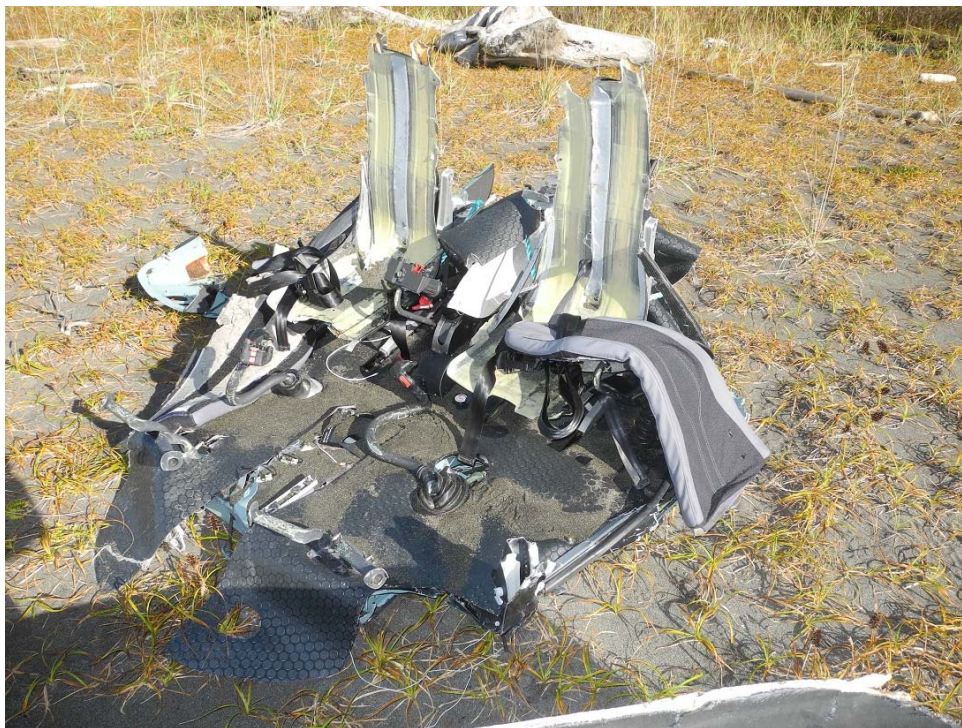
The cockpit floor, with the front seats attached, was recovered (**Photo 4**). The cockpit and cabin roof structure, about 5.5 feet in length measured from the upper windshield attachment, was also recovered. The Appareo Vision 1000 image recorder remained attached to the roof structure and was retained for further analysis.³ For both front seats, the seat bottom and seat back cushions had separated but were recovered.

Photo 4. The separated cockpit with front seats still attached.

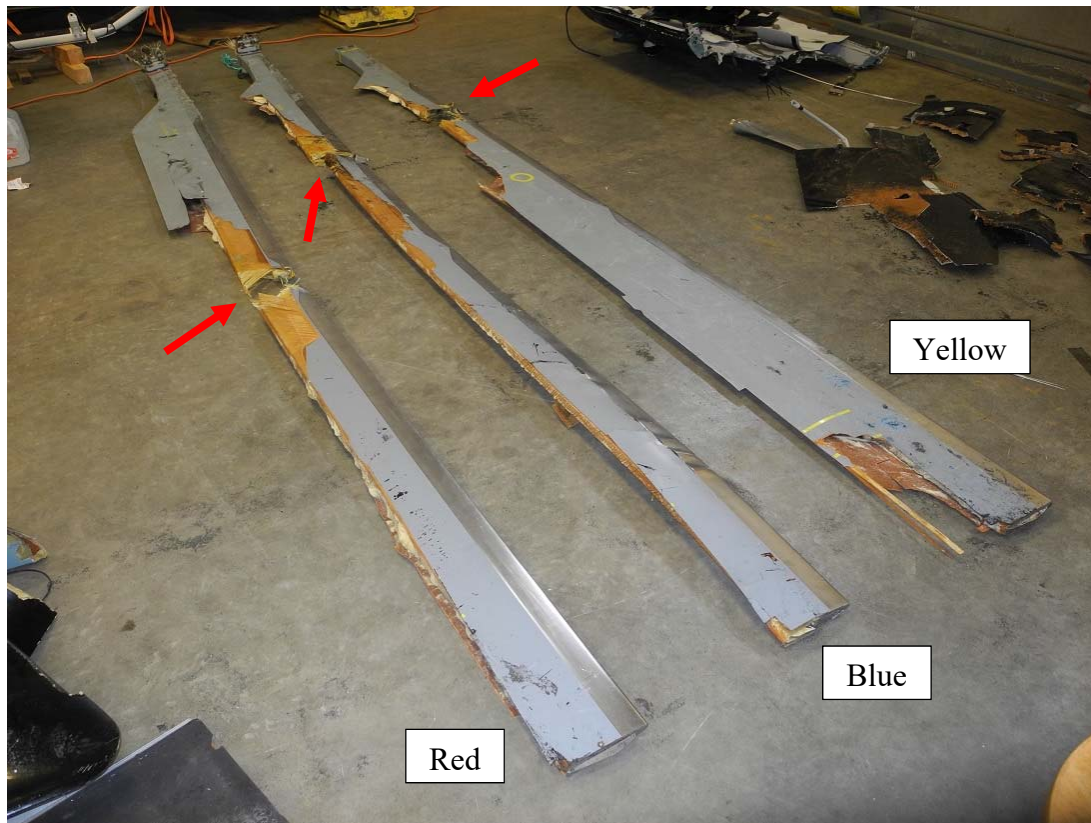
The ‘yellow’ main rotor blade was fractured into two large sections: the inboard section and outboard section (**Photo 5**). The inboard section of the blade spanned from its root end to about 55 inches outboard where the blade was fractured, measured from the root end. The outboard section of the blade spanned from the fracture to the blade tip end. The inboard section remained attached to its sleeve assembly. The afterbody for the inboard section of the blade was present until about 31 inches outboard of the root end, beyond which the afterbody had separated and was missing. The spar exhibited a broomstrawed appearance at the blade fracture location. For the outboard section of the blade, the afterbody had separated and was missing at the inboard and outboard ends but was present at the midsection. The blade tracking tab remained installed but was deformed.

The ‘red’ main rotor blade was fractured into two large sections: the inboard section and outboard section. The inboard section of the blade spanned from its root end to about 106 inches outboard where the blade was fractured, measured from the blade retention pin bushings. The outboard section of the blade spanned from the fracture to the blade tip end; this section exhibited a slight upward bend. The spar exhibited a broomstrawed appearance at the blade fracture location. The afterbody had separated and was missing on the outboard half of the inboard section and along the entire span of the outboard section. The outboard portions of the sleeve assembly remained attached to the root end of the blade and exhibited a broomstrawed appearance. Part of the frequency adapter remained installed between the upper and lower sleeves. The blade tracking tab remained installed and did not exhibit significant deformation.

Photo 5. The recovered main rotor blades. Red arrows indicate the fractures separating the blade into two sections.

The 'blue' main rotor blade was fractured into two large sections: the inboard section and outboard section. The inboard section of the blade spanned from its root end to about 69 inches outboard where the blade was fractured, measured from the blade retention pin bushings. The outboard section of the blade spanned from the fracture to the blade tip end; this section of blade exhibited bowing with its tip end exhibiting an upward bend. The afterbody had separated and was missing for the majority of the entire span of the blade. The leading edge strip exhibited wrinkling deformation from the blade tip end to about 50 inches inboard. Red-colored contact marks were observed on the underside of the leading edge strip, about 19 inches from the blade tip end. The outboard portions of the sleeve assembly remained attached to the root end of the blade and exhibited a broomstrawed appearance. Part of the frequency adapter remained installed between the upper and lower sleeves. The blade tracking tab end plate had separated and was missing.

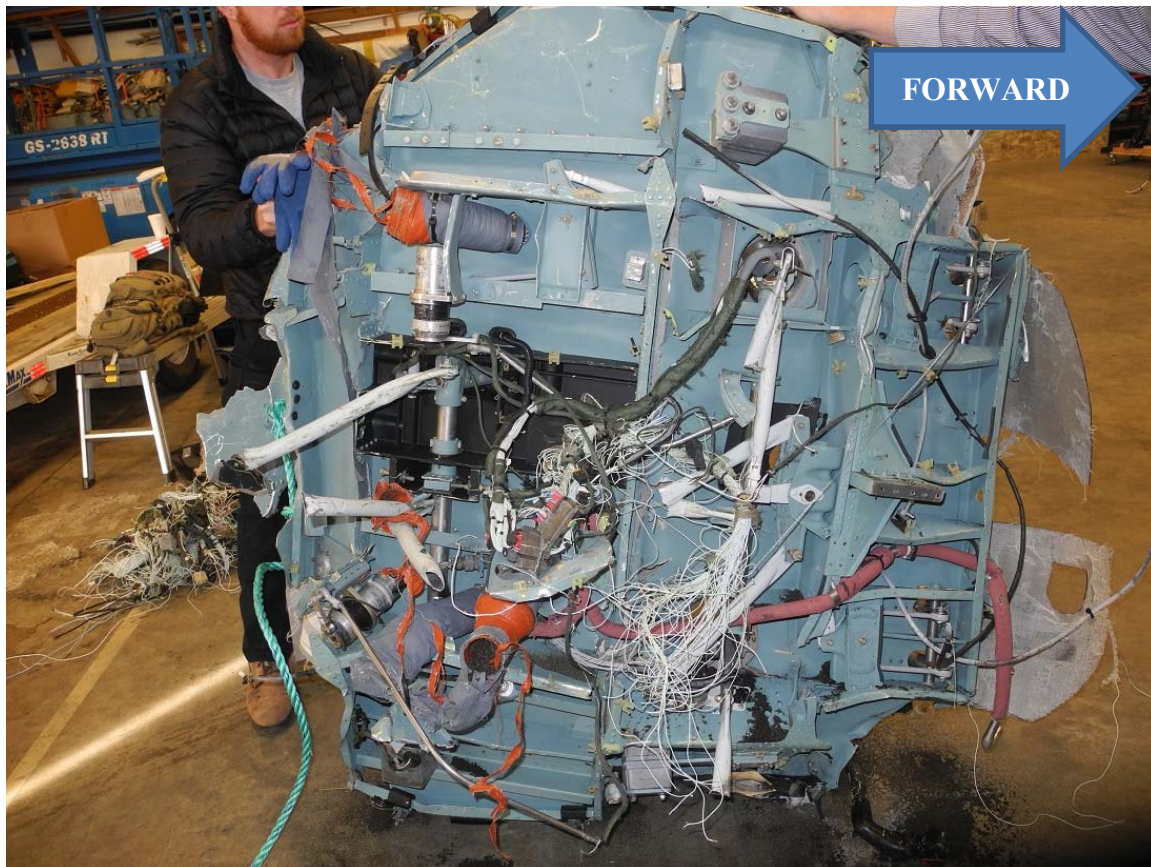
The pilot and co-pilot collective controls remained installed. The pilot collective head was present on the control stick but was partially separated and rotated to the right. The co-pilot collective head had separated and was missing from the control stick. The engine throttle twist grip was present on the pilot and co-pilot collective controls and both twist grips were in the “flight” position. An attempt to manually rotate the twist grip was unsuccessful. Fractures were observed on multiple control tubes between the pilot and co-

pilot collective controls to the mixing unit. All fractures exhibited signatures consistent with overload.

Photo 6. The underside of the cockpit floor containing the control tubes from the cyclic controls to the mixing unit.

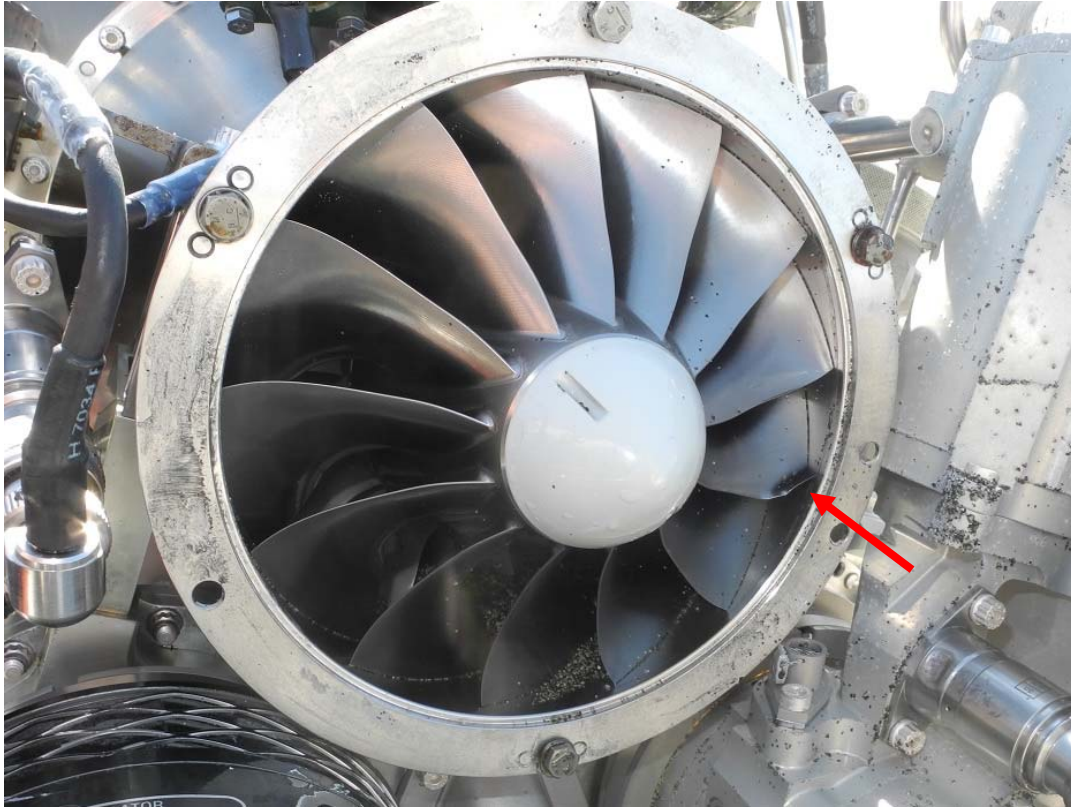
One of the first stage compressor blades exhibited curling deformation in the direction opposite of normal rotation at its tip end (**Photo 7**). The curling deformation extended about 0.5 inches toward the root. The air intake duct had separated from the engine and was not found. The bolts for the air intake duct remained installed on its

Photo 7. Curling deformation observed on one of the first stage compressor blades.

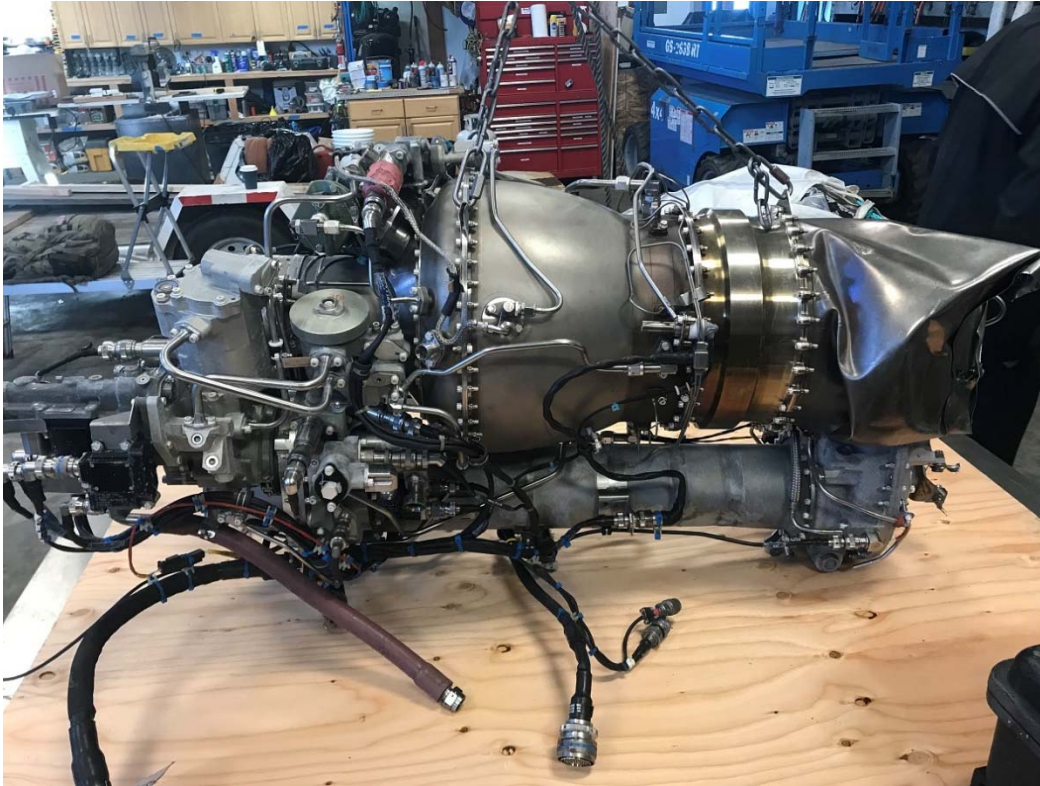
The engine was partially disassembled after recovery (**Photo 8**). The linking tube, that housed the power transmission shaft, was dented on its underside where it normally contacts the engine rear mount saddle. The reduction gearbox was removed from the engine. The index mark on the splined nut was observed to be slightly offset in the tightening direction.⁷ The offset was measured to be greater than 0 millimeter (mm) but less than 1 mm. The splined nut and its mating splines did not exhibit anomalous damage. The reduction gearbox geartrain exhibited continuity but rotation was limited with evidence of binding. Sand was observed within the visible interior surfaces of the reduction gearbox.

Photo 8. The recovered engine prior to disassembly.
