NATIONAL TRANSPORTATION SAFETY BOARD
Office of Aviation Safety
Washington, D.C. 20594

AIRWORTHINESS GROUP CHAIRMAN'S FACTUAL REPORT

NTSB No: ERA19FA210

Operator: Challenger Management LLC
Aircraft: Leonardo AW139, Registration N32CC
Location: Big Grand Cay, Bahamas
Date: July 4, 2019
Time: 0153 eastern daylight time

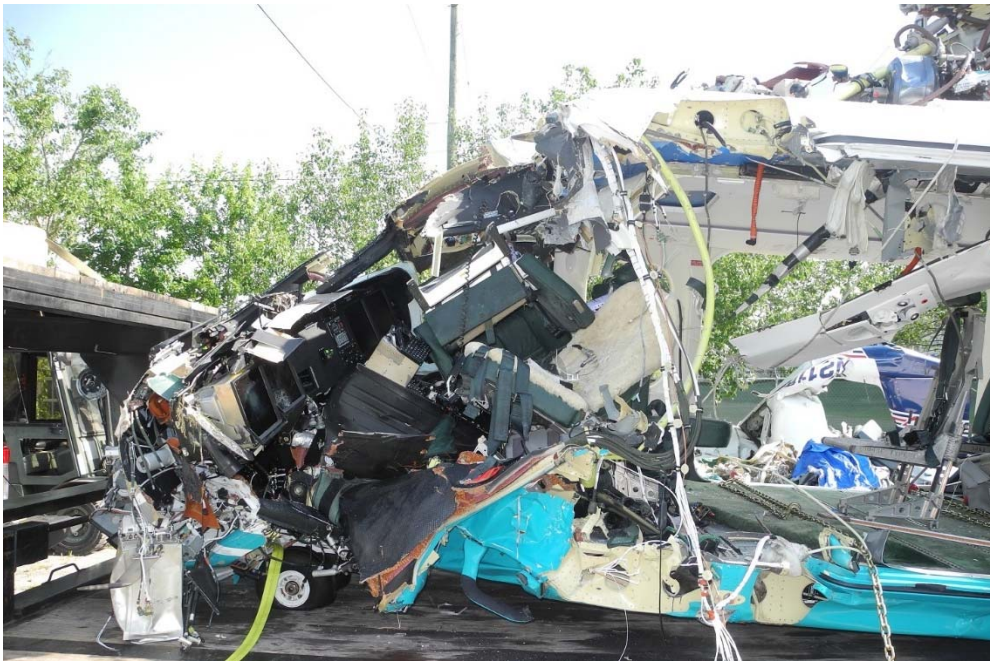
The cockpit remained attached to the center fuselage. The left windshield was not present and the right windshield was partially separated and fractured from impact. The left side cockpit skin panel and roof structure was missing (**Figure 1**). The floor was crushed and buckled along an approximate 45-degree line between the outboard lower longeron at frame station (STA) 3120⁵ and the left nose landing gear support longeron. Some of the buckled skin panels appeared to be hydroformed. Some remaining structure in the area of the forward cabin floor was bent up, aft, and inboard. A part of the door track in this area was also bent up and aft. The co-pilot floor was pushed up by this buckling and the left side of the center console was crushed or buckled inboard. The cockpit skin main beam at butt line (BL) 0⁶ was severed 25 inches from the STA 1500 rivet line. The bulkhead frame at STA 1500 was severed approximately 6 inches to the left of BL 0. Buckling and a fracture of the bulkhead frame was observed on the upper right side about 10 inches forward of the right pitot-static tube. The nose cowling was missing but some internal structure and components remained. The left side of the nose landing gear wheel bay had a bend 18 inches aft of the forward edge that turned the forward edge to the left. The right side cockpit upper window frame is separated at the outboard side and the lower door frame

was separated at the forward side. The resulting large section of structure was twisted in a counter-clockwise direction.

Figure 1. The left side of the cockpit.

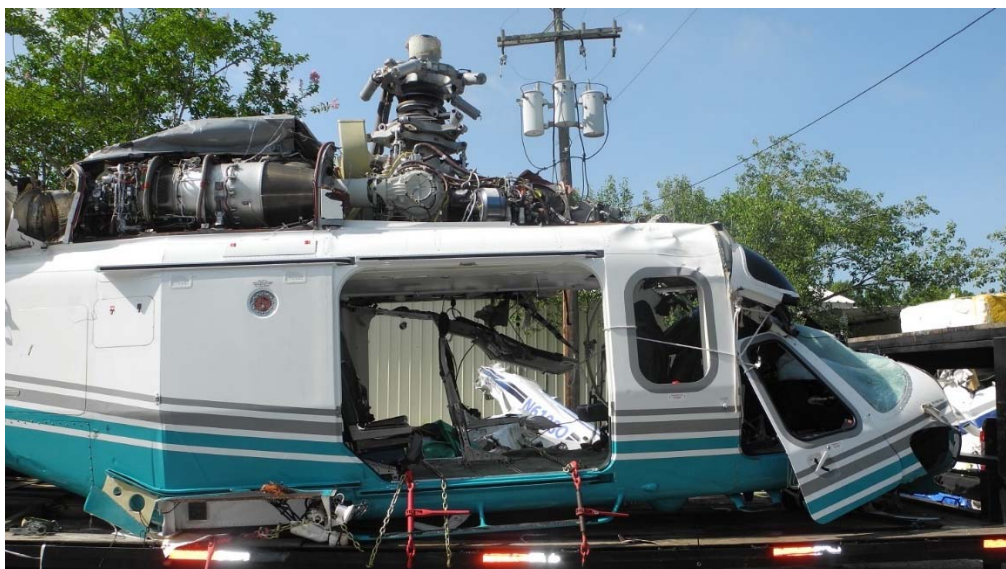
The upper right side of the cockpit roof was separated along the STA 3120 rivet line and bent downward (**Figure 2**). The right cockpit and cabin steps remained attached to the fuselage. The right main landing gear segments were relatively perpendicular to the fuselage. The majority of the right side skin paneling did not exhibit significant damage. The right side skin panel between the ceiling and the upper deck was bent inwards between STAs 3120 to 3900 and a shaded impact mark was present. A crack was observed on the lower door frame at STA 3900. The distance from the upper door frame to the lower door frame at STA 5700 and at STA 3900 measured 52.5 inches. Some skin panel buckling was observed at STA 6700 below the floor line.

Figure 2. The right side of the cockpit and center fuselage.

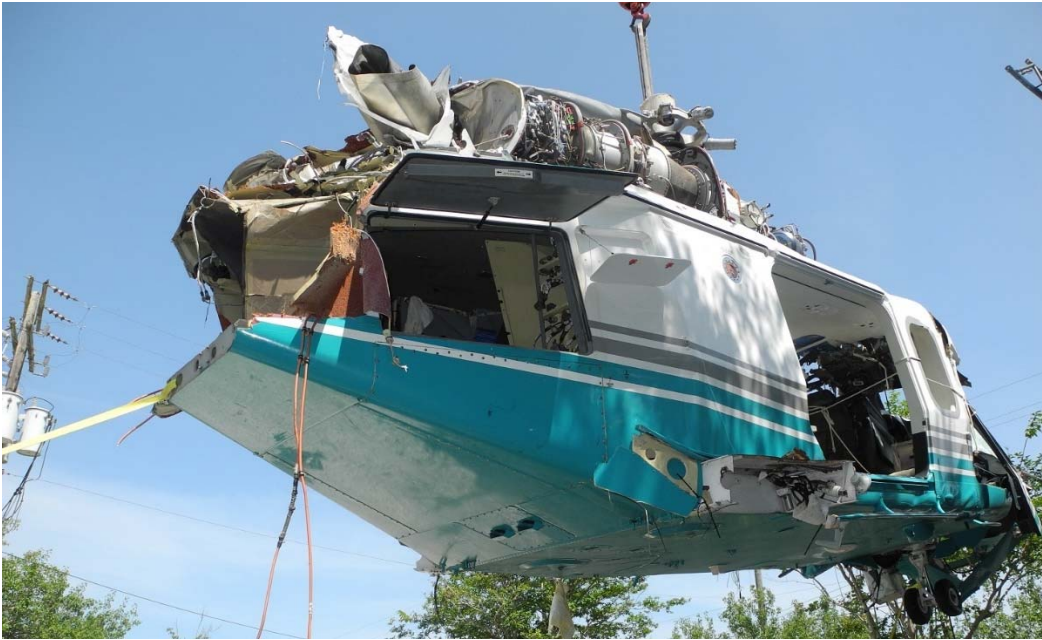
The aft fuselage remained attached to the main fuselage but the tail boom was separated ([Figure 3](#)). The aft fuselage's aft section exhibited deformation to the right on the upper deck and left upper longeron, but the floor structure appeared to be relatively straight. A section of the right side skin panel was missing from STA 8700 to STA 8150. A portion of the roof panel was missing from the aft tail boom fracture, following an approximate 45-degree angle, to right side skin fracture at STA 8150. The remaining roof panel was deformed and had a long dent or buckle that started approximately 15 inches forward of STA 8700 and was perpendicular to the missing roof panel fracture. The upper left and lower right tail boom attachment points were present on the aft fuselage; within these attachment points were remnant pieces of the attachment bolt. The lower left, middle left, upper right, and middle right tail boom attachment points were fractured and separated from the aft fuselage. Portions of the aft fuselage containing the upper-right, middle-right, lower-left, and middle-left attachment points remained connected to the tail boom. The lower right attachment bolt was bent to the right and had a large lip on the left side.

Figure 3. A view of the aft fuselage of the helicopter.

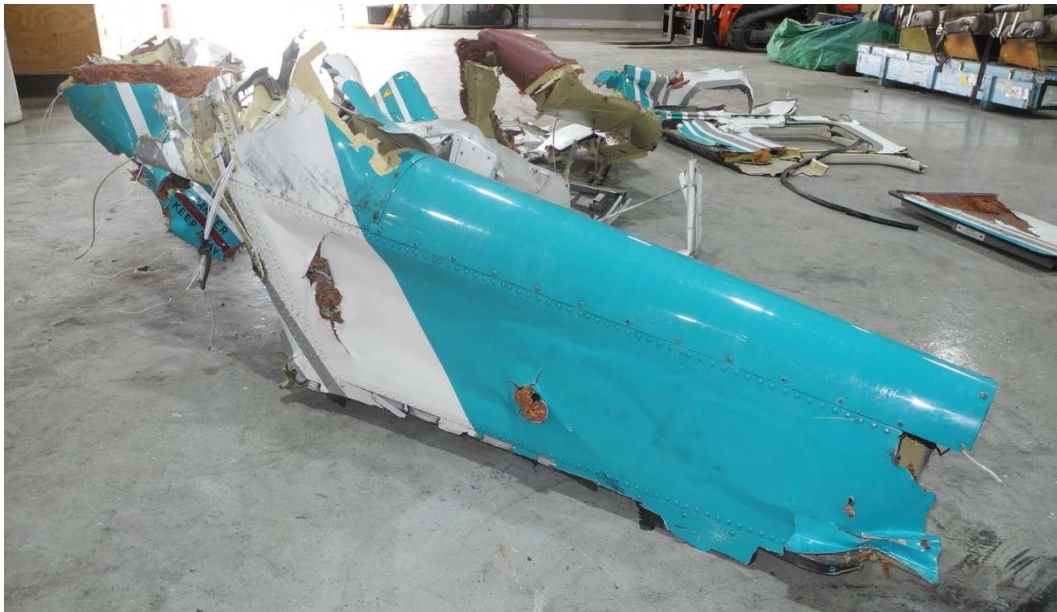
The aft end of the tail boom, where it attaches to the vertical fin, was fractured and separated from the tail boom. The aft end of the tail boom was deformed to the right and exhibited an impact mark with yellow-colored paint transfer about 24 inches forward of the front vertical fin attachment point. The vertical fin remained attached to the aft end of the tail boom (**Figure 4**). The aft fairing of the vertical fin was separated. The forward fairing remained installed but was fractured near its base. A 30-inch section of the tail gearbox fairing with the strobe light and aft white position light attached was recovered. Most of the left and right sides of the horizontal stabilizers were recovered. The horizontal stabilizer was in multiple pieces.

Figure 4. The vertical fin attached to the aft end of the tail boom.

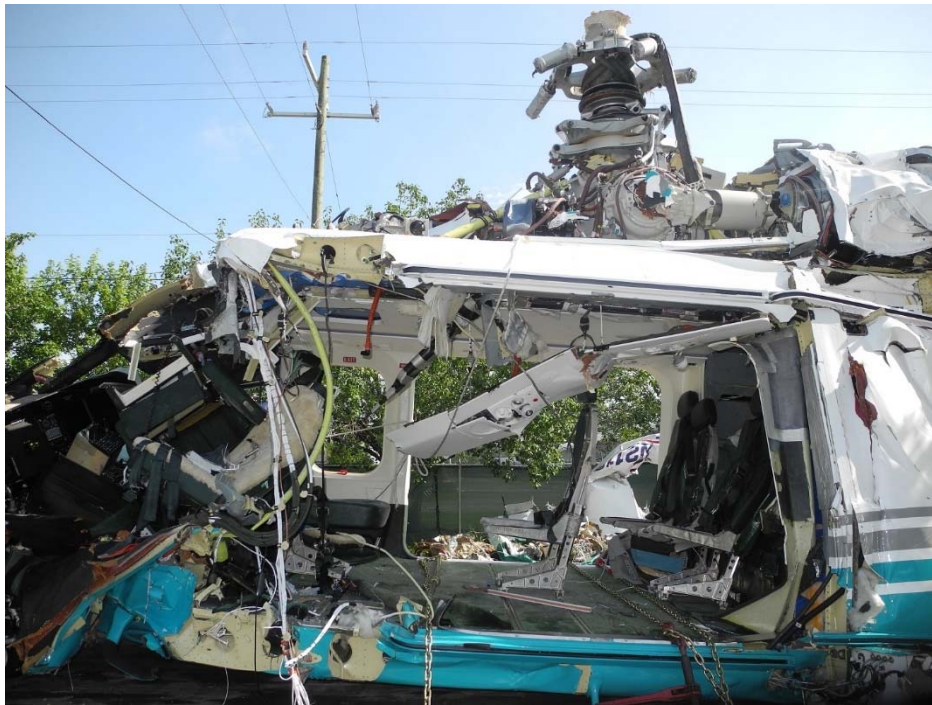
The cabin contained three rows of seats (**Figure 5**). In the first row, a single rear-facing seat remained attached to the floor and was located behind the cockpit center console. The copilot seat was resting on the left side of the seat back of the rear-facing seat. The seat bottom and back cushions and the headrest were present on rear-facing seat frame. In the second row, a single forward-facing seat remained attached to the floor in the center of the cabin and was located [laterally] in line with the rear-facing seat. The bottom and back cushions were not present on the second row seat, but a headrest was present. In the third row, three forward-facing seats remained attached to the floor. Of the four available installation positions, the three seats present were: outboard-right, inboard-right, and inboard-left. A seat was not present on the outboard-left seat installation position. All three seats remained attached to the floor. The outboard-right seat was missing a bottom cushion, but the back cushion and headrest were present. The inboard-right seat was missing both its bottom and back cushions, but its headrest was present. The inboard-left seat was missing its bottom cushion, but the back cushion and headrest were present. The inboard-right seat frame was partially collapsed downward on its right side.

Figure 5. A view of the cabin showing the passenger seats that remained installed.

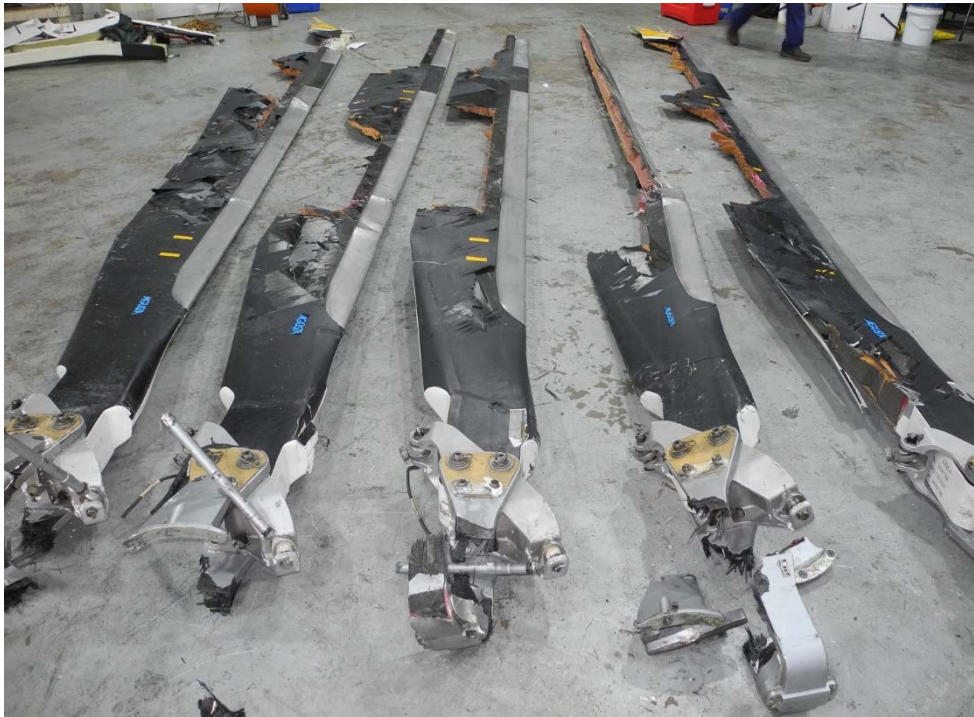
The ‘red’ blade exhibited separation of portions of its afterbody about 68 inches to 134 inches, and then from 169 inches to its outboard end. The leading edge abrasion strip exhibited deformation at 67 inches, 88 inches, and 211 inches, and a crack at 79 inches, all measured from the blade retention bolts. The tip cap was separated and not recovered. The four holes at the tip cap attachment remained filled.

The ‘black’ blade exhibited separation of portions of its afterbody from 129 inches to its outboard end. The leading edge abrasion strip exhibited cracks about 74 and 140 inches from the blade retention bolts. The leading edge abrasion strip was separated from 200 inches to its outboard end. The tip cap was separated but was recovered. A standoff bolt, consistent with those found on the tail boom interior for the hydraulic lines, was found lodged inside the afterbody on the underside of the ‘black’ bolt, about 181-182 inches from the blade retention bolts and about 14.5 inches aft of the leading edge.

The ‘white’ blade exhibited separation of its afterbody from about 68 inches to 135 inches, and then from 172 inches to its outboard end (measured from the blade retention

bolts). The leading edge strip was deformed about 76-77 inches from the blade retention bolts. The tip cap was separated and not recovered. The four holes at the tip cap attachment remained filled. The underside of the 'white' blade exhibited three distinct areas of chord-wise scoring about 167 to 183 inches from the blade retention bolts. The inboard area of scoring had spacing about 2.5 inches apart. The middle-area of scoring had spacing about 2 inches apart. The outboard-area of scoring had spacing about 2.25 inches apart.

Figure 6. An overview of the five main rotor blades. From left-to-right, the blades are the following colors: 'black', 'red', 'white', 'blue', 'yellow'.

The 'yellow' blade exhibited separation of portions of its afterbody from 75 to 224 inches from the blade retention bolts. The leading edge abrasion strip was cracked about 123 inches from the blade retention bolts.

The 'blue' blade exhibited separation of portions of its afterbody from 58 inches to its outboard end (measured from the blade retention bolts). The leading edge and spar exhibited a fracture about 76 inches from the blade retention bolts. The tip cap was separated and not recovered. The four holes at the tip cap attachment were empty.

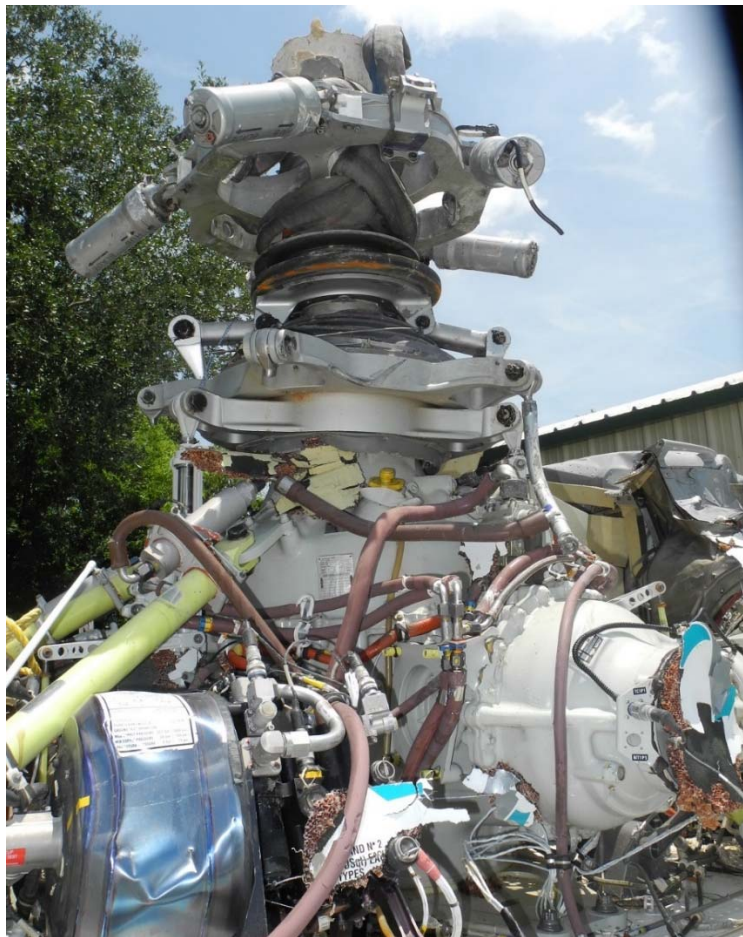
The swashplate assembly remained installed on the main rotor shaft centering plate (**Figure 7**). The upper boot for the rotating swashplate was attached at its lower end but separated at its upper end. The lower boot for the stationary swashplate was attached but partially torn. The ‘blue’ pitch change link remained attached to the rotating swashplate and was continuous up to the nut securing the upper rod end to the link body. The ‘blue’ pitch change link upper rod end was fractured from the link; the upper rod end remained attached to the ‘blue’ pitch change lever. The ‘blue’ pitch change link exhibited deformation inboard and in the direction opposite of advancing rotation. The remaining four pitch change links were fractured at their lower rod ends; the lower rod ends remained attached to the rotating swashplate. The remaining four pitch change links remained attached to their respective pitch change levers. The ‘yellow’ pitch change link did not exhibit deformation between the link body and the upper rod end. The ‘white’ pitch change link body did not exhibit deformation but the upper rod end thread was bent outboard. The ‘red’ pitch change link body exhibited slight deformation but its upper rod end connection did not appear bent. The ‘black’ pitch change link body did not exhibit deformation but its upper rod end threaded connection was bent inboard. All observed fractures exhibited signatures consistent with overload.

Figure 7. The main gearbox, swashplate assembly, and main rotor hub.

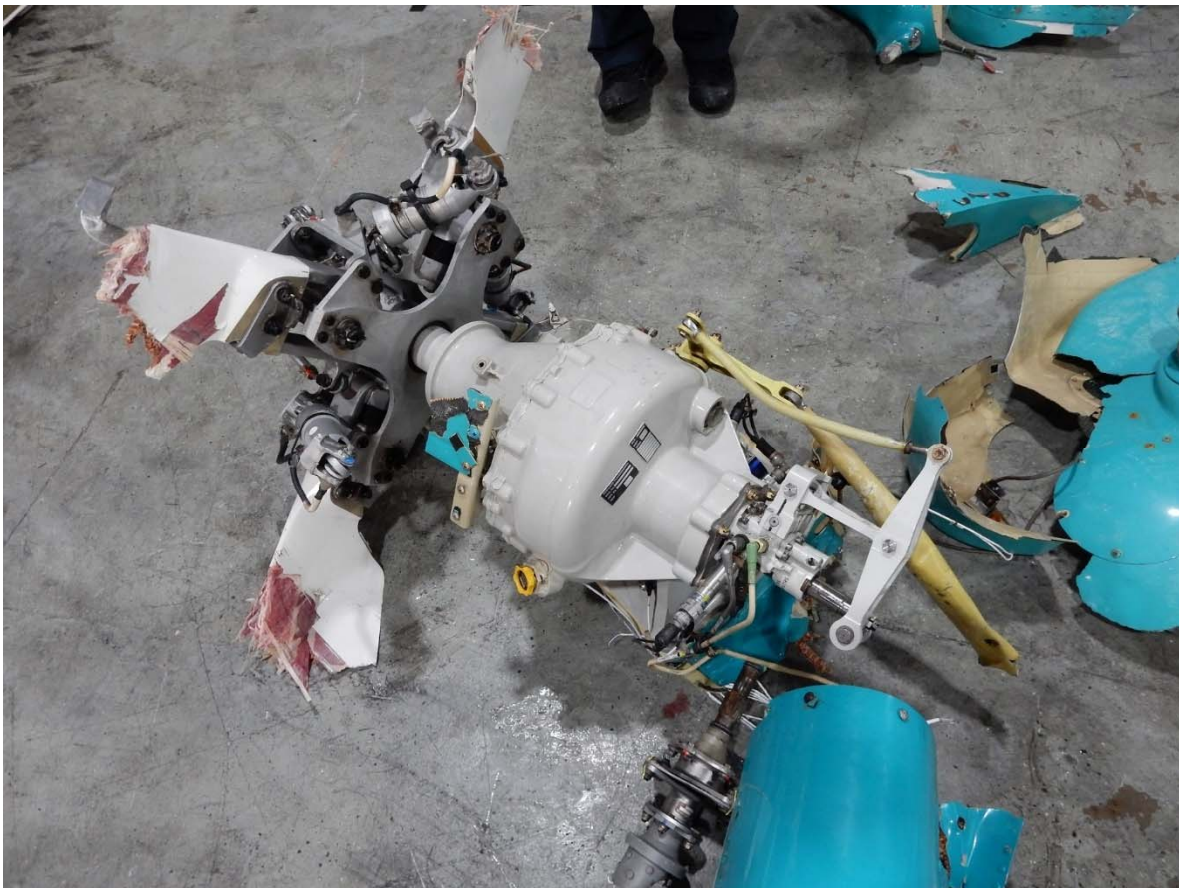
The tail rotor hydraulic actuator remained installed on the tail rotor gearbox (**Figure 8**). The input control rod and the piston remained attached to the control lever. The input lever remained connected between the control lever and the hydraulic actuator. The piston extension, measured in line with the piston from the control lever attachment bolt to the actuator housing, was approximately 2.5 inches. The pressure transducers and hydraulic fittings remained installed.

Figure 8. The tail rotor gearbox and its hydraulic actuator.

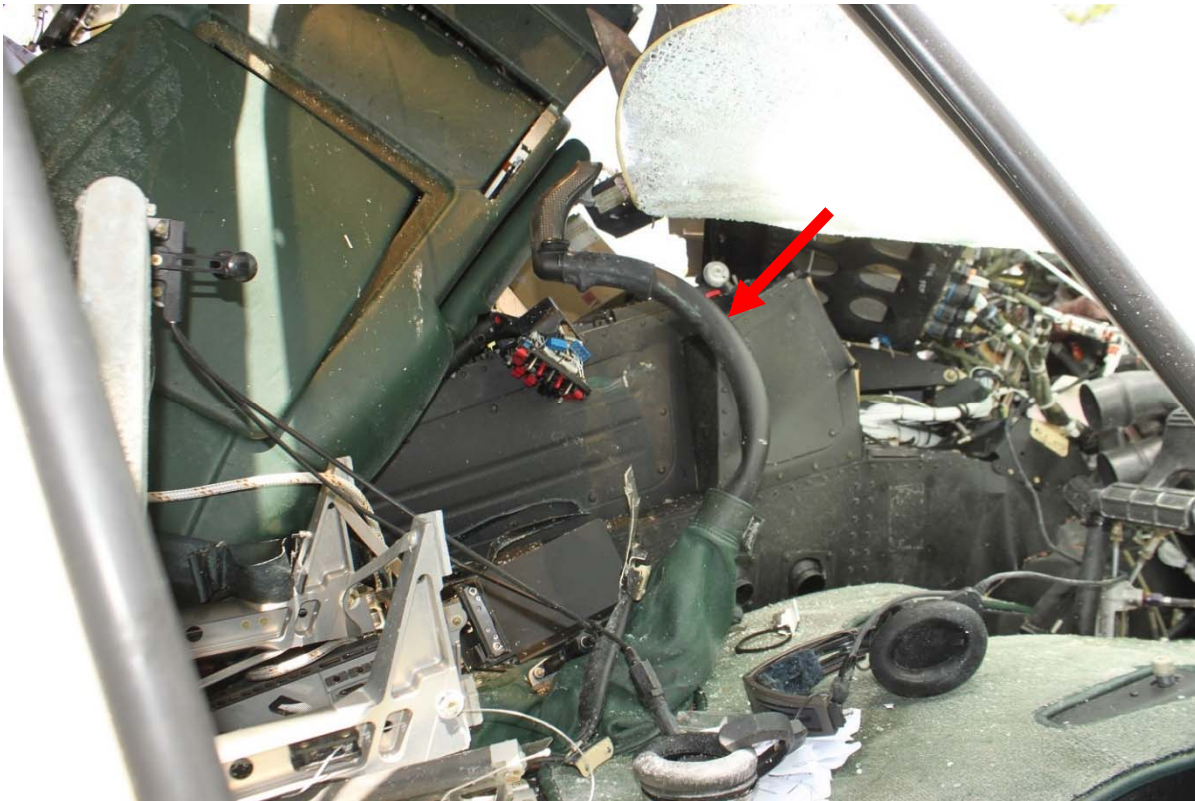
The right-seat cyclic control remained installed (**Figure 9**). The cyclic grip was present but the cyclic head was fractured but attached via wiring. The pilot-side door post interior covers were removed to facilitate examination of the control tubes. Movement of the cyclic in the fore-aft axis resulted in movement of the vertical control tube (in the pilot-side door post) but the freedom of movement was extremely limited. Movement of the cyclic in the fore-aft axis resulted in movement of the transmission deck-mounted bell cranks (connected to the main rotor servo input rods). The cyclic control could not be moved in the lateral axis.

Figure 9. The red arrow points to the right-seat cyclic control. The head of the collective control and a portion of the pedals are also visible.

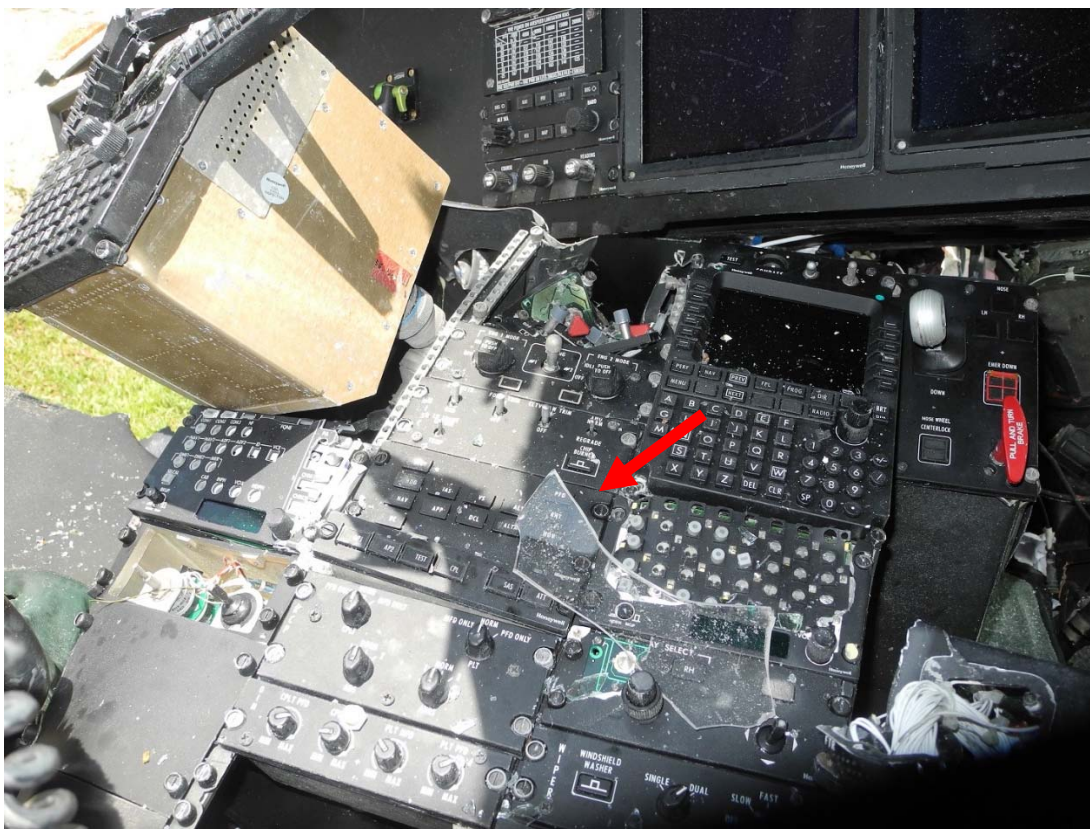
The guidance controller and AP control panel remained retained in the center console but the control cover exhibited slight deformation due to impact (**Figure 10**). On the guidance controller, the lateral/vertical approach (APP), altitude (ALT), altitude acquire (ALTA), and hover/velocity hold (HOV) buttons were found depressed (down position); the remaining buttons on the guidance controls were found not depressed (up position). The AP switch positions could not be determined. On the miscellaneous control panel, both the force trim and the collective/yaw trim switches were in the “on” (forward) position.

Figure 10. The center console of the cockpit. The red arrow points to the guidance controller and AP control panel.

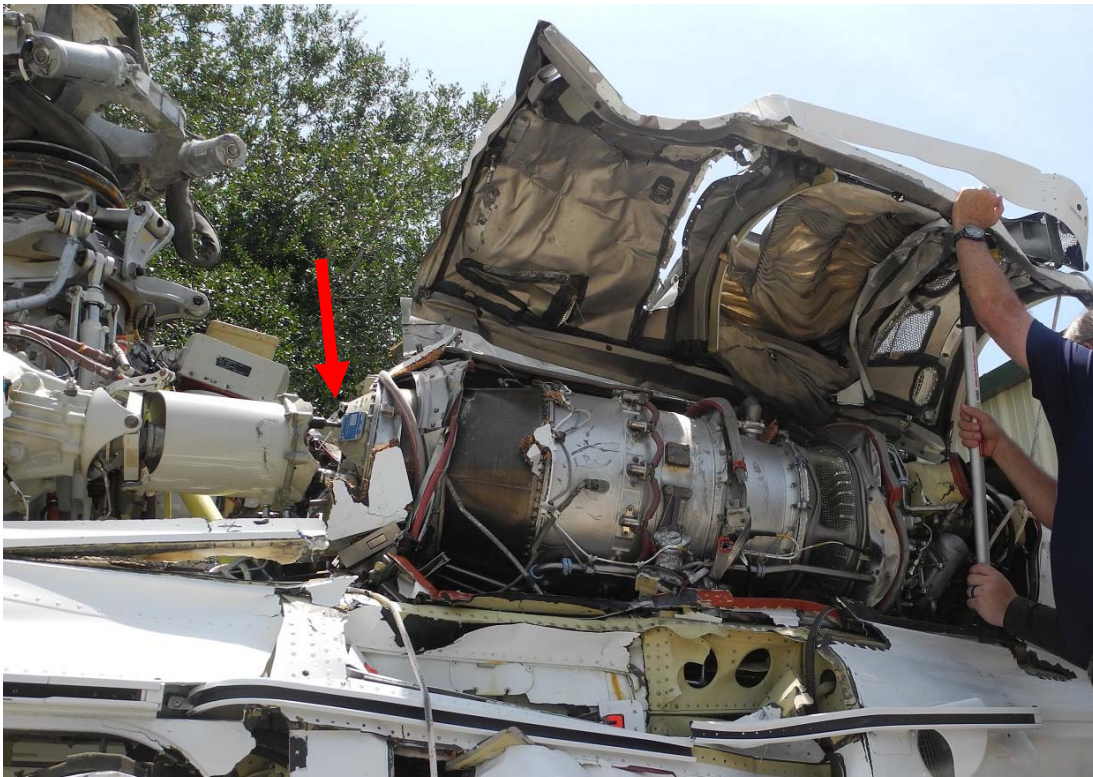
Figure 11. The No. 1 engine installed on the accident helicopter. The red arrow points to the fractured No. 5 bearing support case.

The No. 5 bearing housing support case was fractured into two pieces. The power turbine speed/torque sensor, which had remained installed in the aft portion of the No. 5 bearing housing support case, was bent. The sensor tip showed evidence of contact with the torque sensing teeth. Four of the torque sensing teeth had sheared off and a fifth tooth was bent in the direction opposite of normal rotation. The bolts holding the two shafts together had also sheared off. The other power turbine speed and torque sensor remained with the broken front portion of the No. 5 bearing housing support case and was undamaged.

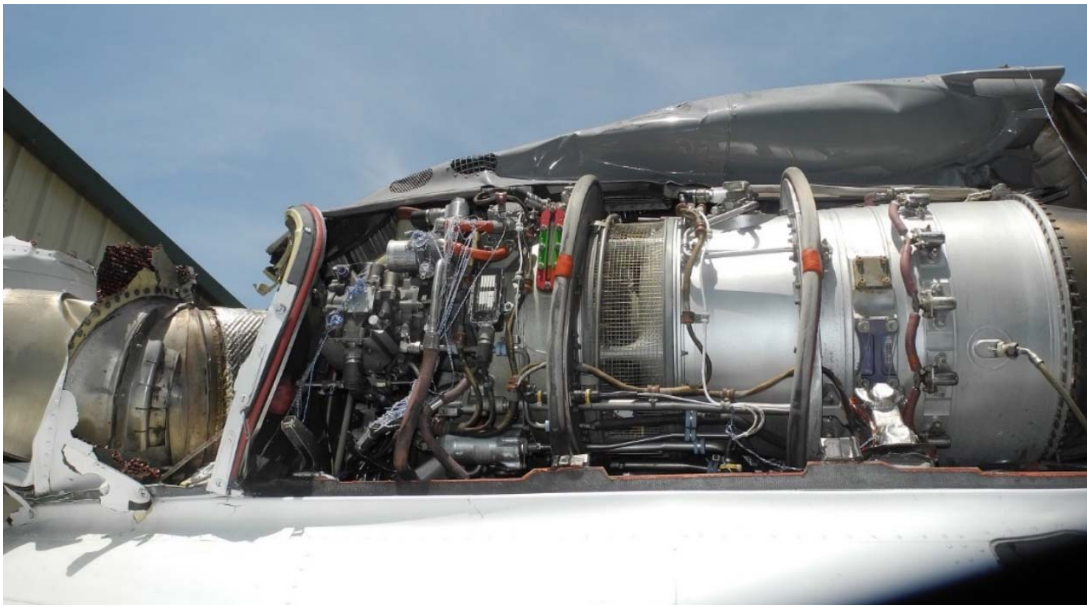
Examination of the No. 2 engine, PT6C-67C, S/N KB0239, revealed no visible damage was noted to the engine exterior (**Figure 12**). The outboard mount was slightly deformed upward. The DCU, S/N 18061916, remained attached, was removed by the group for further examination, and subsequently rinsed and submerged in fresh water.

Figure 12. The No. 2 engine installed on the accident helicopter.
