**NATIONAL TRANSPORTATION SAFETY BOARD**  
**Office of Aviation Safety**  
**Washington, D.C. 20594**

**AIRWORTHINESS GROUP CHAIRMAN'S FACTUAL REPORT**

**NTSB No: WPR18MA087**

Operator: Papillon Airways, Inc.  
Aircraft: Airbus Helicopters EC130 B4, Registration N155GC  
Location: Peach Springs, Arizona  
Date: February 10, 2018  
Time: 1719 mountain standard time

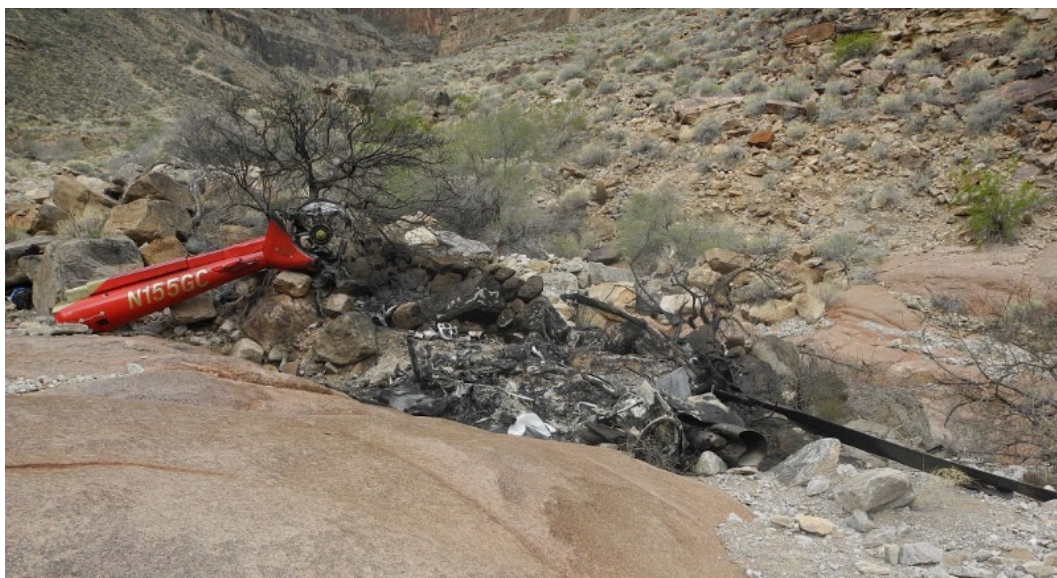
The main fuselage came to rest upright on rocky terrain at a heading of 222 degrees magnetic ([Figure 1](#)). The majority of the main fuselage was consumed by the postcrash fire. A boulder was found protruding between the front and aft skid crosstubes. The skids were fractured and separated from the main fuselage, but were found in the general vicinity of where they are normally installed with respect to fuselage orientation. The left-front crosstube, normally connected to the front portion of the left skid, was fractured and found rotated forward about 90 degrees. The rear-left crosstube and fairing were upright. All skid segments were thermally damaged, and surviving fracture surfaces undamaged by postcrash fire exhibited signatures consistent with overload. The left and right skids exhibited fractures about 1/3 of its length behind the front of the skid. A segment of the right skid, from its midpoint back to the skid heel, was missing. One of

**Figure 1. The helicopter wreckage as seen when the Airworthiness Group arrived on scene.**

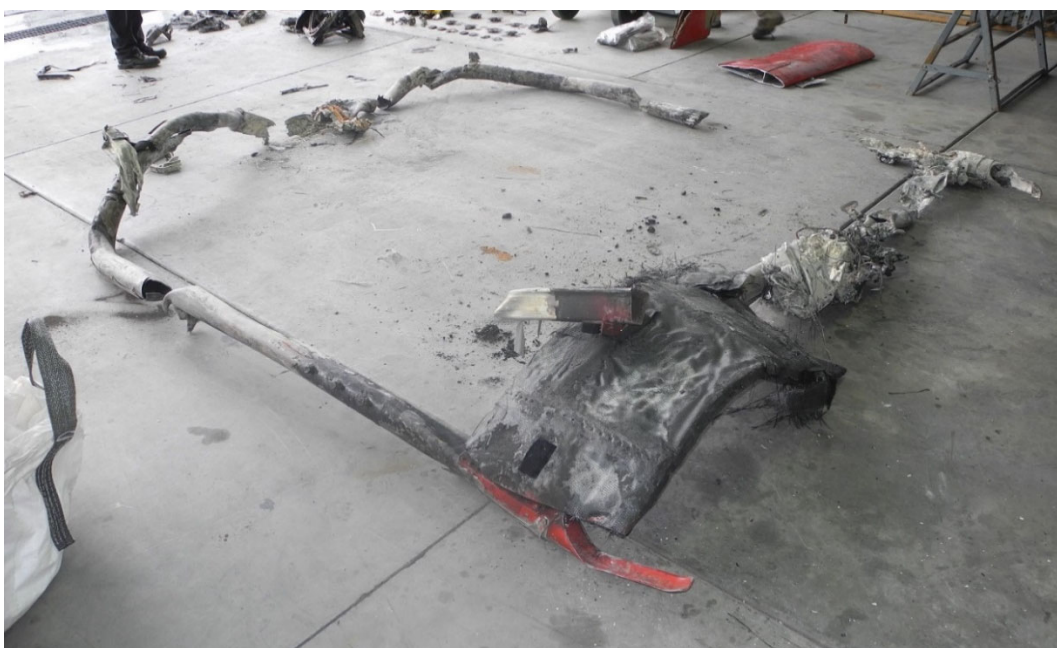
the forward attachments for the forward crosstube was found as a completed assembly, but loose within the wreckage. **Figure 2** shows a reconstruction of the recovered pieces of the landing gear. The fuel tank and the airframe surrounding the fuel tank were consumed by the postcrash fire.

**Figure 2. A reconstruction of the landing gear.**

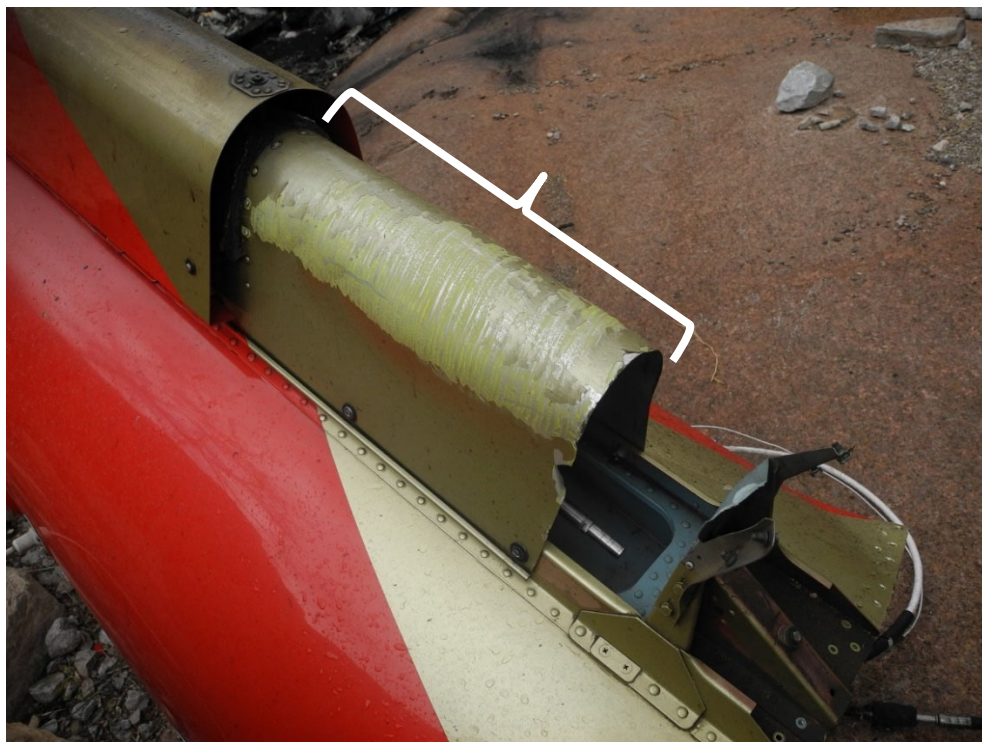
The tail boom, with fenestron still attached, was separated from the main fuselage at its forward circular attachment frame (adjacent to the aft end of the engine deck). The tail boom came to rest upright to the front-left of the cockpit. The tail boom was angled upward, with the aft end resting on a mound of rocks. The tail rotor drive shaft cover exhibited circular impact marks protruding outboard in the location where the steel and aluminum tail rotor drive shafts connect (**Figure 3**). A rotating tail rotor drive shaft flange contacting the interior surface of its cowling can produce circular impact marks protruding outboard. On the tail boom-side of the circular attachment frame, the majority of the rivets were missing and none of the rivet holes exhibited missing material; the lower half of the frame was deformed consistent with impact damage. On the main fuselage-side of the circular attachment frame, the majority of the rivet heads were present but the frame was deformed, fractured on its right side, and exhibited thermal damage. A puncture about 3 inches in length (in the helicopter longitudinal axis) was observed on the upper left skin of the tail boom, adjacent to the forward end of the fenestron drive shaft cover and about 35 inches from the circular attachment frame.

**Figure 3. Circular impact marks (white bracket) on the fenestron drive shaft cover.**

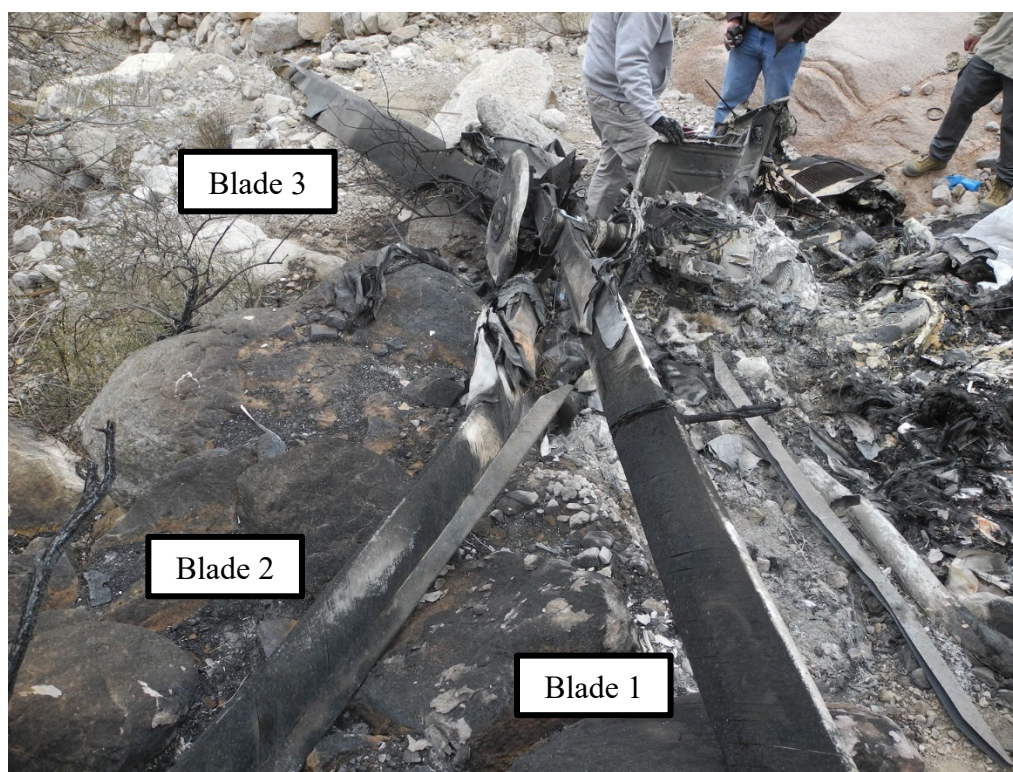
All three main rotor blades were found at the main wreckage site (**Figure 4**). The color of the blades could not be identified due to thermal damage. With the cockpit forward heading at the 12 o'clock position, one blade was at a 1 o'clock heading (identified as "blade 1" for this report); another blade was at the 2 o'clock heading ("blade 2"); and the third blade was at the 6 o'clock heading ("blade 3"). All three main rotor blades remained attached at their root ends to their respective main rotor blade sleeves. All three main rotor blade sleeves remained attached to the Starflex. The elastomeric thrust bearing, located between the sleeve and the Starflex, for all three blades were thermally damaged. All three pitch horns remained attached to their respective sleeves. All three Starflex arms were fractured at an angle across their width. Blades 1 and 2 were heavily sooted with most of the blade afterbody missing.<sup>2</sup> Loose pieces of the leading edge abrasion strip were found in the main wreckage. Blade 3 was partially sooted and contained most of its afterbody. Small pieces of main rotor skin and foam core were found in the area surrounding the main wreckage site. Additionally, the tip ends of blades 1, 2, and 3 were fractured and broomstrawed. The main rotor vibration absorber remained installed at the top of the main rotor head.

**Figure 4. The main rotor blades, main rotor head, and main transmission.**

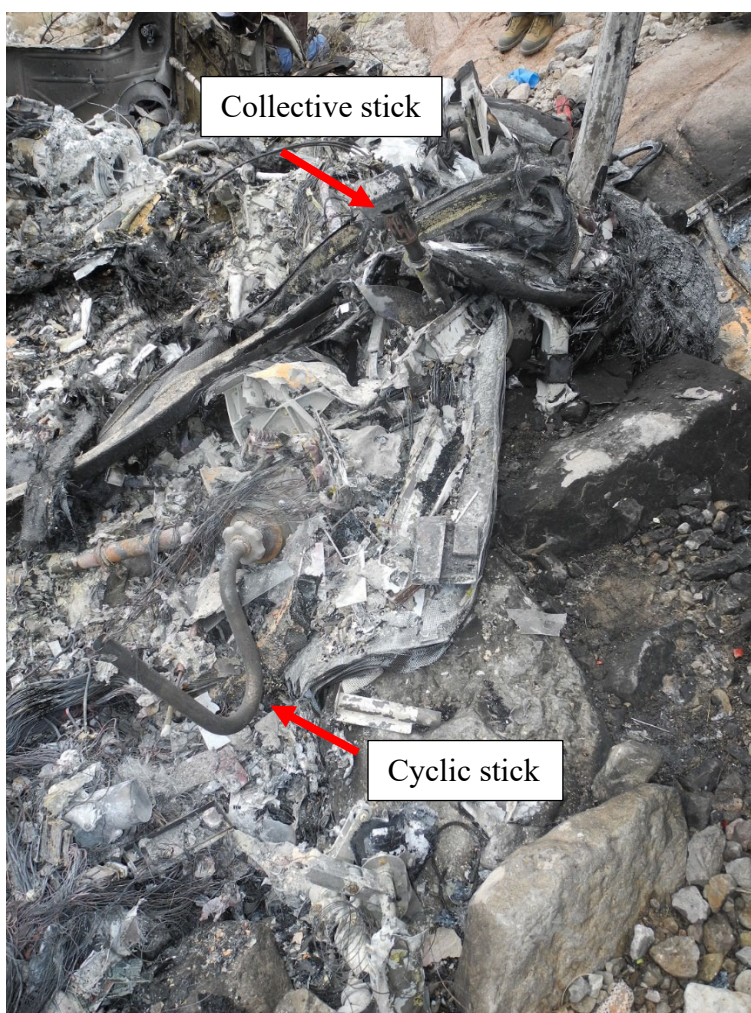
The helicopter was equipped with a single-pilot, left-side flight controls. The cyclic stick was found in the wreckage at its normally installed location ([Figure 5](#)). The cyclic stick head was not attached to the cyclic stick and was not observed in the main wreckage. The lateral torque tube was found in its normally installed location and was bent about midspan. The collective stick was found in the wreckage in its normally installed location. The collective stick was found in a nearly full-up position. The engine twist-grip throttle was found to be in the “flight” gate. The left and right pedals were separated from their respective posts and found loose in the main wreckage near their normally installed locations. The pedal control bellcrank was found in its normally installed location. The control mixing unit was found in its normally installed location. The mixing unit push-pull tubes and the push-pull tube attachment points were fractured

and thermally damaged. All cyclic, collective, and pedal control components observed in the main wreckage were thermally damaged.

**Figure 5. The pilot cyclic and collective sticks (viewed forward-looking-aft).**

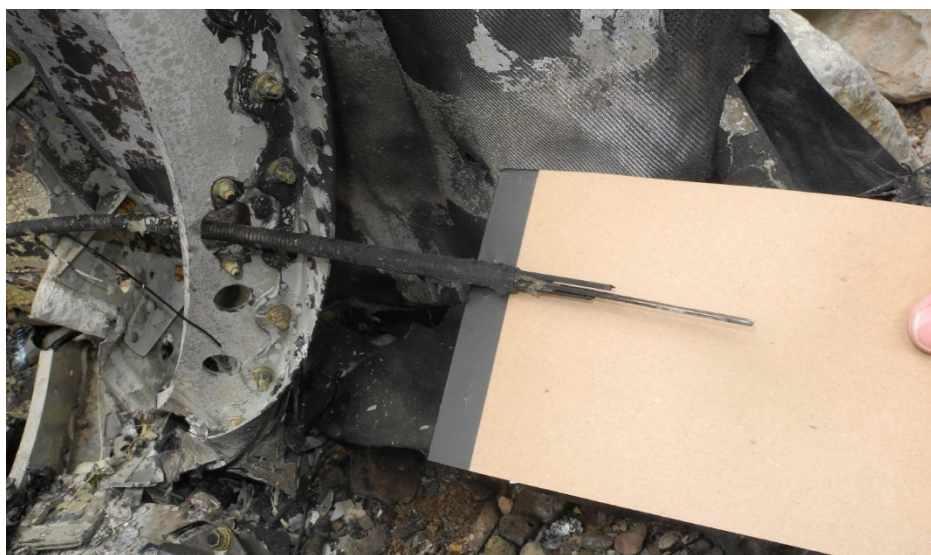
The fenestron control cable was fractured near the tail boom attachment frame separation (**Figure 6**). The aft portion of the fenestron control cable was found within the tail boom; continuity of control was confirmed from its fracture (at its forward end) to the fenestron blades. The control cable junction box (triangular flanges which are bolted together) was disassembled revealing the junction, a circular dovetail connection, which remained connected. The flex-ball control cable was fractured but a portion of it remained within the forward junction box. The dovetail, the aft portion of the forward flexball cable, and the forward junction housing were retained for further examination.<sup>3</sup> Evidence of the forward portion of the fenestron control cable was observed in the main wreckage, including the mating fracture to the aft portion of the fenestron control cable. Control continuity of the forward portion of the fenestron control cable could not be determined due to melted and crushed airframe.

**Figure 6. The fenestron control cable near the aft end of the main fuselage.**

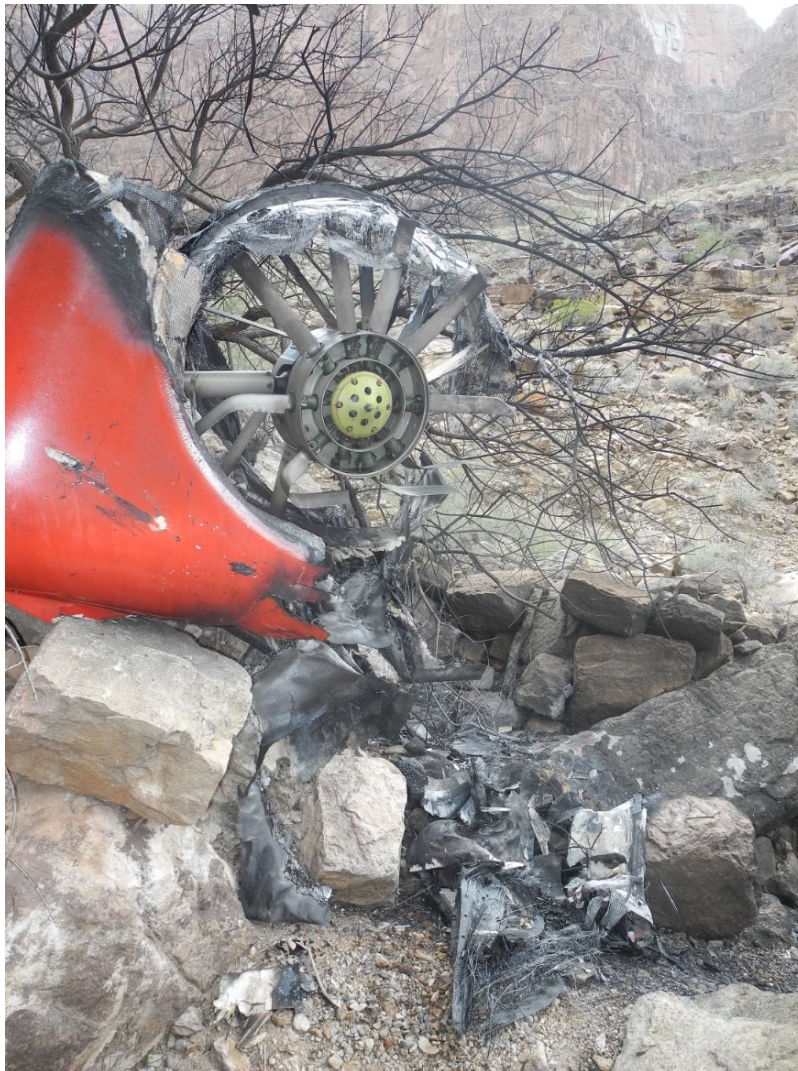
The fenestron remained attached to the tail boom but was thermally damaged from the postcrash fire (**Figure 7**). Three stators from the lower portion of the fenestron were found on the ground immediately below the fenestron. All but one of the fenestron blades remained attached to the fenestron hub. One fenestron blade was fractured at its root and the blade was found on the ground immediately below the fenestron. Four consecutive fenestron blades from the lower half of the fenestron were bent in the direction opposite of normal rotation. The fenestron hub cover was found on a slope to the south-southeast of the main wreckage.

**Figure 7. The fenestron as observed on scene.**

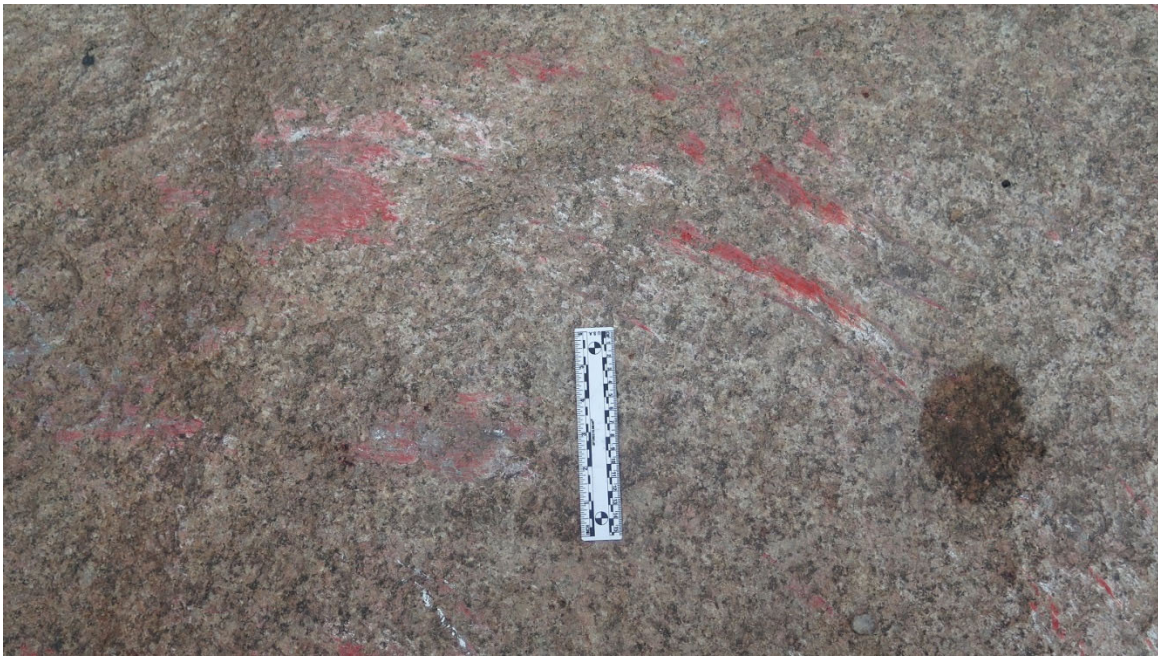
Reddish-orange colored markings, consistent with paint transfer marks, were observed on the ground (essentially large boulders) immediately to the south of the main fuselage. One set of these markings were primarily linear in directionality; a second set of markings exhibited an arc pattern ([Figure 8](#)). The accident helicopter fuselage paint scheme was a reddish-orange color.

**Figure 8. Reddish-orange colored markings with an arc pattern.**
