NATIONAL TRANSPORTATION SAFETY BOARD
Office of Aviation Safety
Washington, D.C. 20594

AIRWORTHINESS GROUP CHAIRMAN'S FACTUAL REPORT

NTSB No: WPR21FA143

Operator: Soloy Helicopters
Aircraft: Airbus Helicopters AS350 B3, registration N351SH
Location: Palmer, Alaska
Date: March 27, 2021
Time: 1834 Alaska daylight time

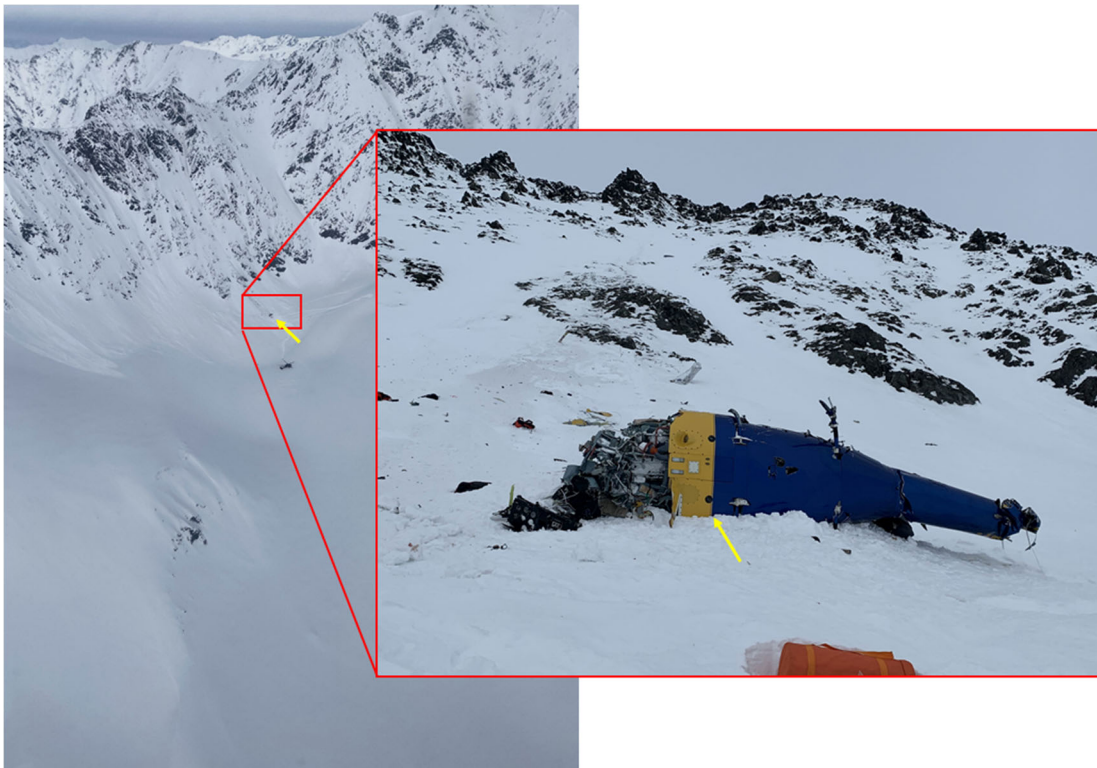
Figure 2. The bulk of the main wreckage (yellow arrow) located near the base of a mountain. (Images courtesy of the Alaska State Troopers)

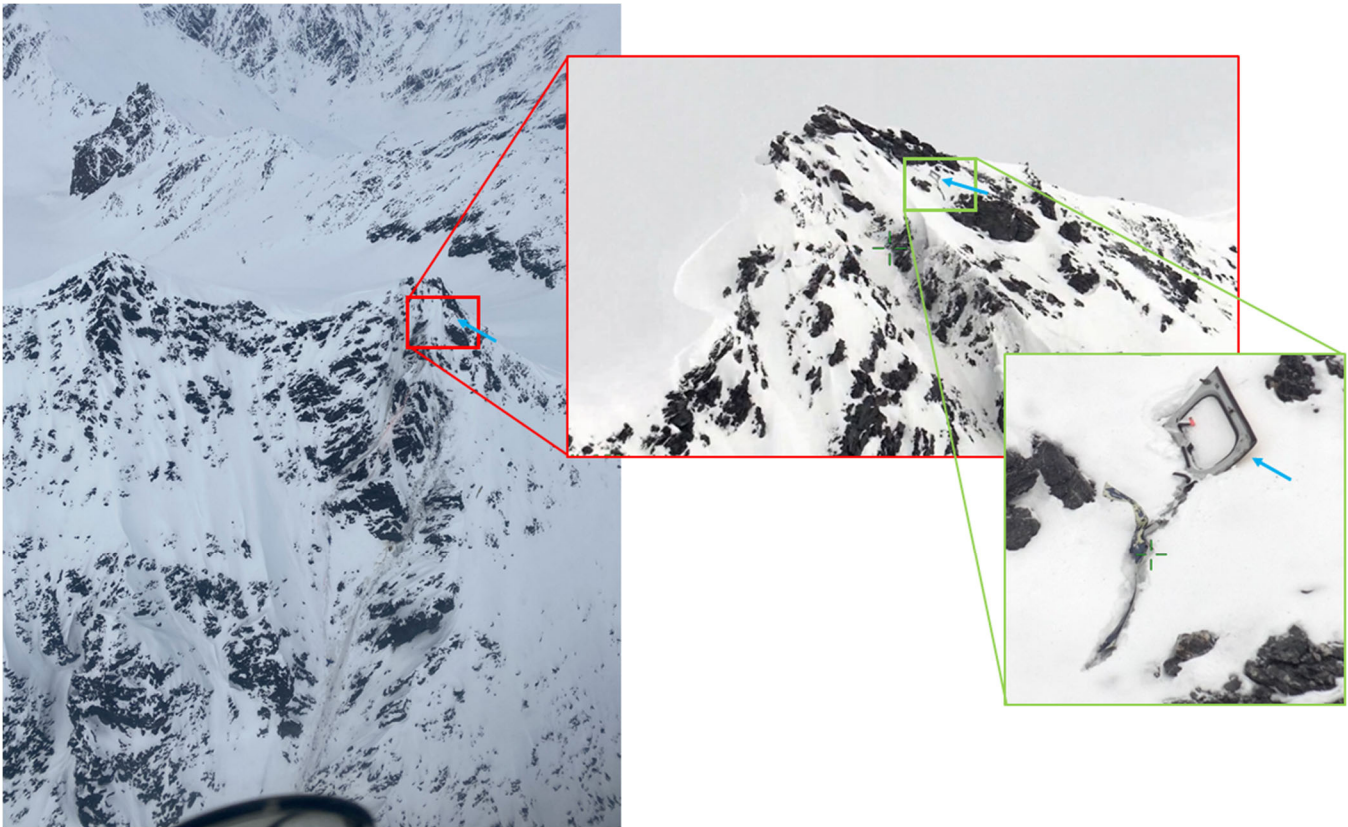
Figure 3. A cockpit door (blue arrow) near the peak of a mountain, the highest altitude piece of wreckage identifiable by investigators. (Images courtesy of the Alaska State Troopers)

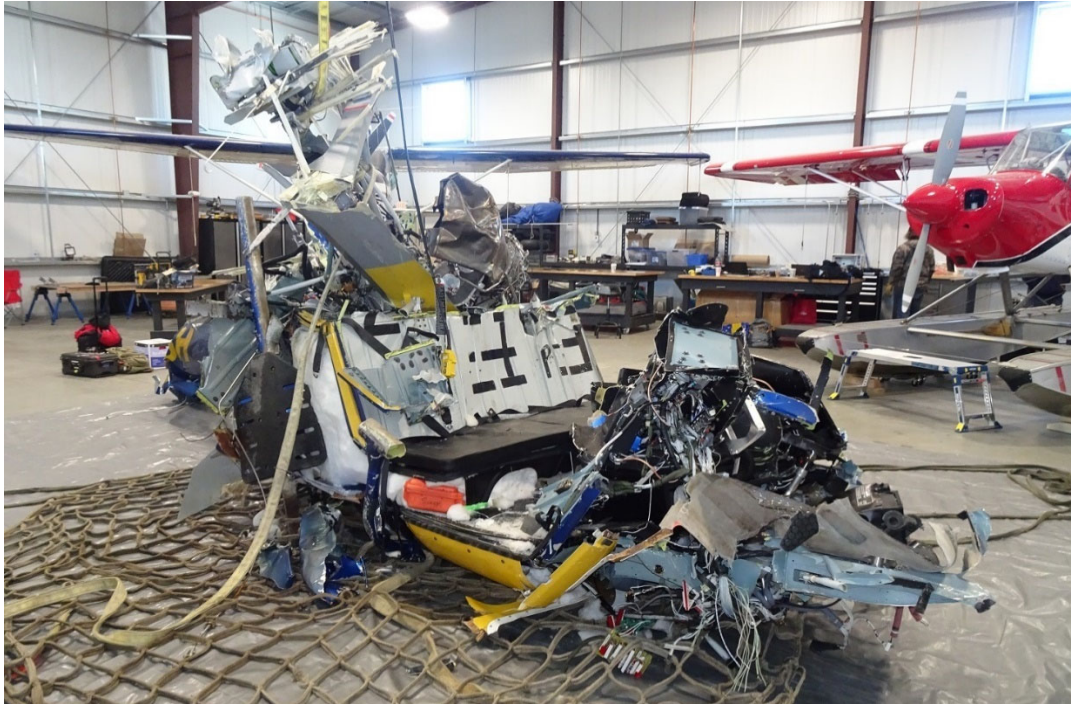
The main fuselage, with the forward portion of the tail boom still attached, was found near the bottom of the mountain. The canopy, including the windscreen, cockpit doors, and cabin doors, had separated from the main fuselage (Figure 4). The windscreen center post and the upper-forward portion of the canopy structure, containing the rotor

brake and emergency fuel shutoff levers, was recovered separated from the main fuselage as a single assembly. The structure to the left and right of the two main [floor] longitudinal beams was fractured and separated. Additionally, the structure forward of the main beams, forward of the pedal controls, was fractured and separated. The instrument panel was separated from the structure but remained connected the main fuselage via wiring.

Figure 4. The recovered main fuselage wreckage.

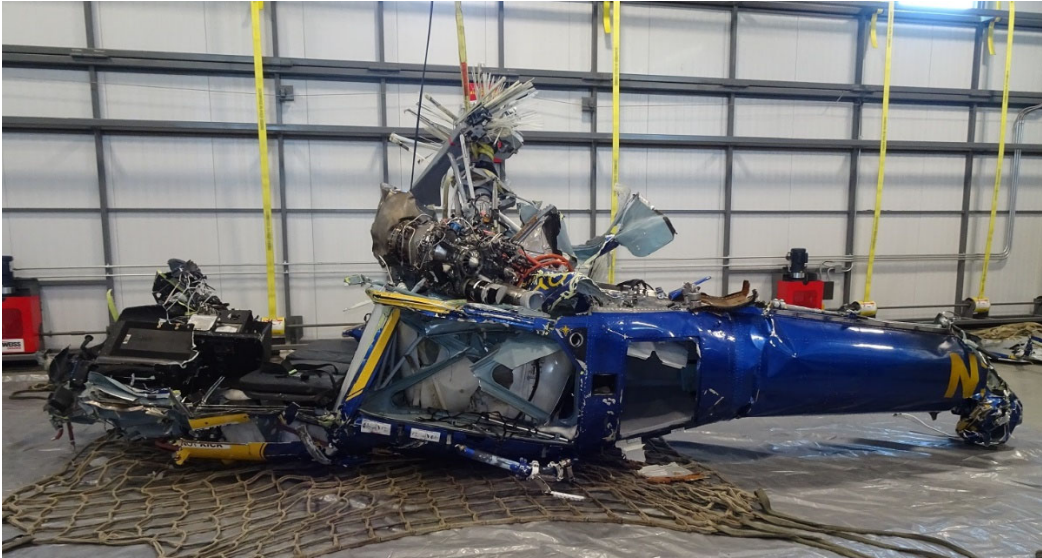
The fuel tank was fractured in multiple locations, but the bulk of the tank remained within the center structure (**Figure 5**). The X-brace on the left side of the airframe exhibited

deformation and was fractured near the center of the “X”. The X-brace on the right side of the airframe exhibited deformation but no major fractures. The transmission deck was deformed downward into the area of the fuel tank and exhibited fractures in multiple locations. Additional information of the main transmission attachment to the structure can be found in Section 2.2.3 of this report.

Figure 5. The left side of the main fuselage wreckage.

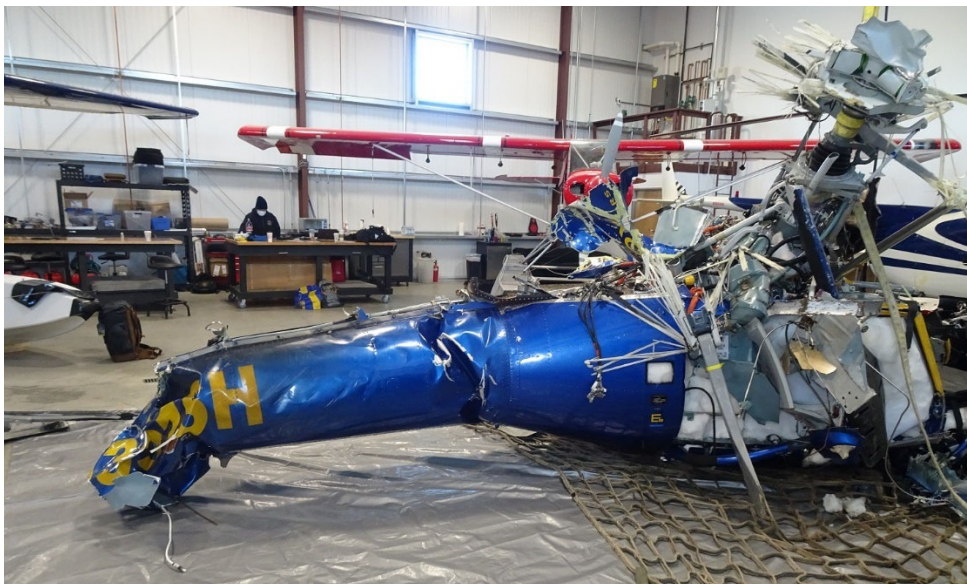
The forward section of the tail boom was attached to the aft fuselage but exhibited deformation on its right side, adjacent to the aft fuselage’s ring frame, also called the tail boom-to-fuselage bulkhead (**Figure 6**). The remnant section of tail boom was bent to the right. The tail boom was fractured and crumpled about mid-length, about 12 inches forward of where the leading edge of the horizontal stabilizer is normally located. The horizontal stabilizer, vertical fins, and the aft section of the tail boom were not recovered, but images from the Alaska State Troopers showed their condition at the accident site (**Figures 7 and 8**).

Figure 6. The right rear area of the main fuselage wreckage.

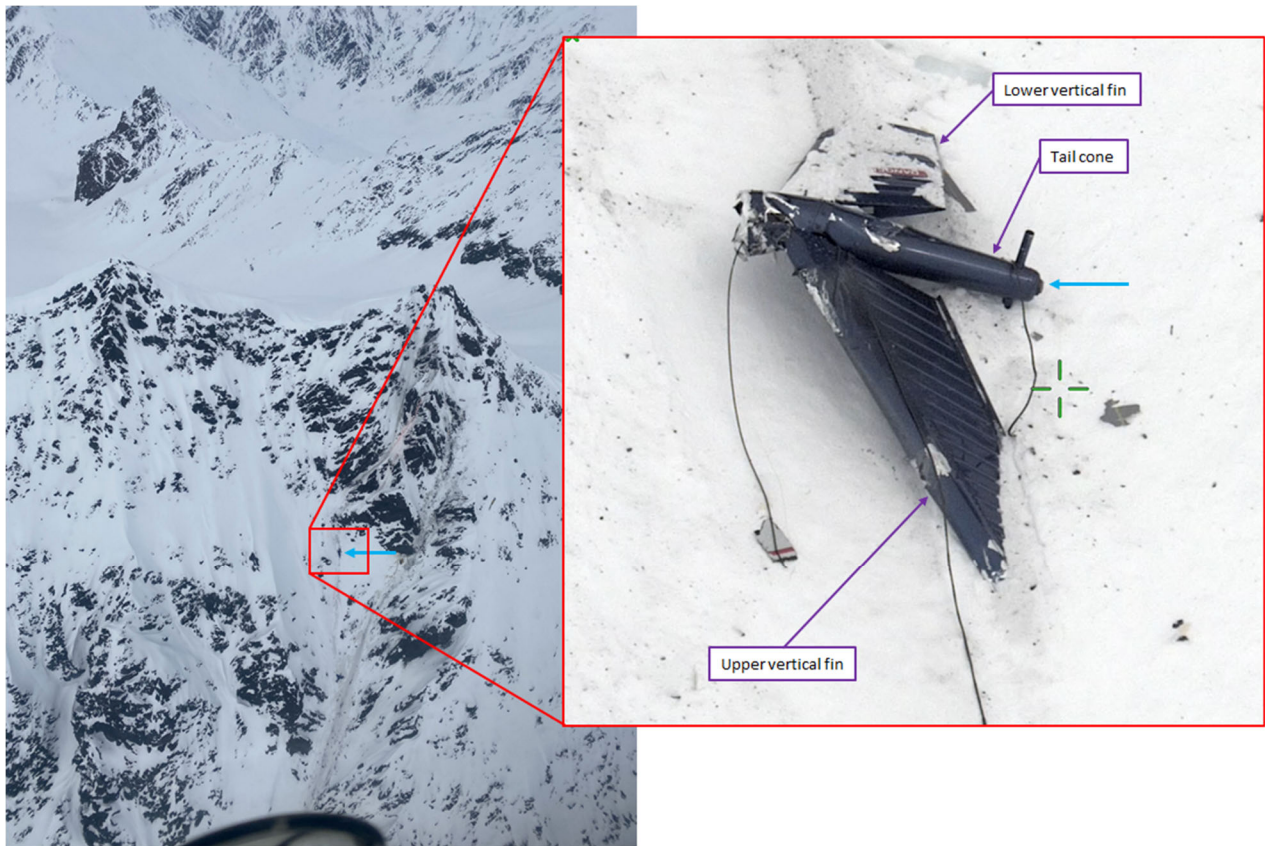
Figure 7. The vertical fin as seen at the accident site. (Images courtesy of the Alaska State Troopers)

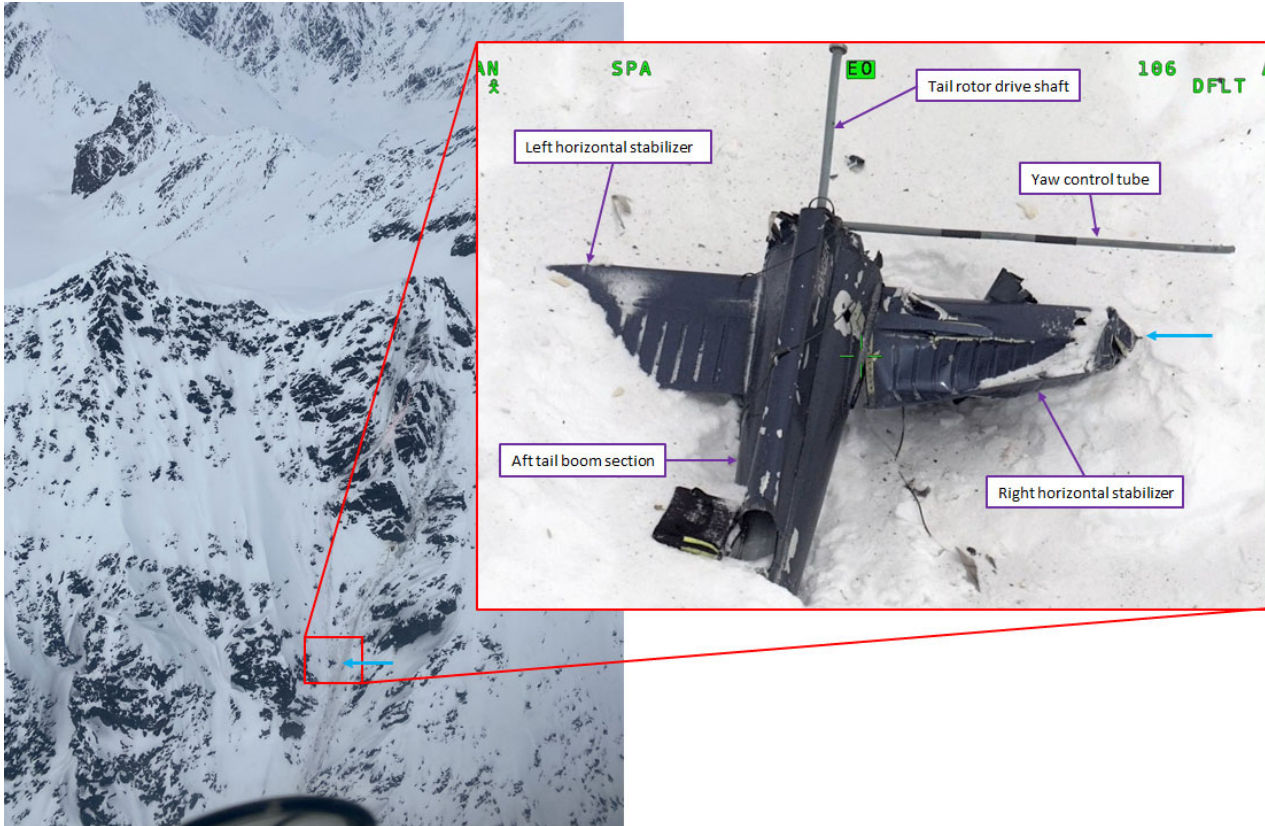
Figure 8. The horizontal stabilizer and aft tail boom section as seen at the accident site. (Images courtesy of the Alaska State Troopers)

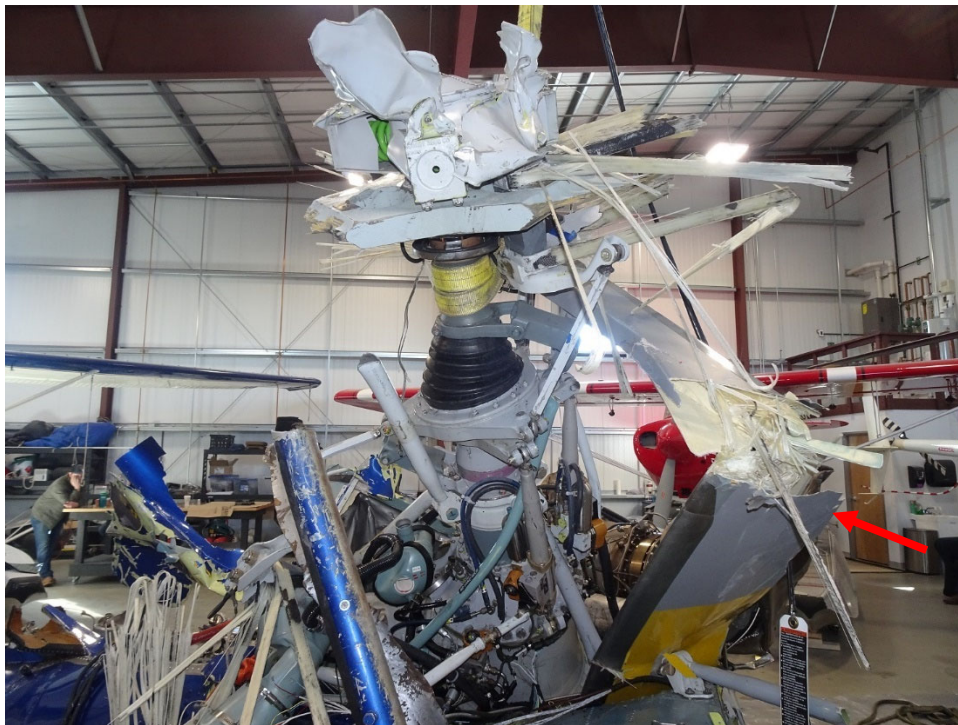
The Starflex remained attached to the main rotor shaft and all three Starflex arms were fractured (**Figure 9**). The ‘red’ and ‘blue’ Starflex arms exhibiting 45 degree lateral fracture angles while the ‘yellow’ Starflex arm exhibited a laterally flat fracture. All three main rotor blade sleeves exhibited impact damage and a broomstraw appearance.² The inboard portion of the ‘blue’ and ‘red’ sleeves remained attached to the Starflex and their thrust bearing. The ‘blue’ thrust bearing was rotated laterally in the direction opposite of normal rotor rotation and the ‘red’ thrust bearing did not exhibit a similar lateral rotation. The inboard portion of the ‘yellow’ sleeve, along with its thrust bearing, were not present and not recovered. The vibration absorber remained installed on the main rotor head and all three springs were present. The vibration absorber housing was deformed due to impact. The droop stop ring remained installed underneath the Starflex.

Figure 9. The main rotor head, shaft, and main transmission. The red arrow points to the inboard portion of the ‘red’ main rotor blade.

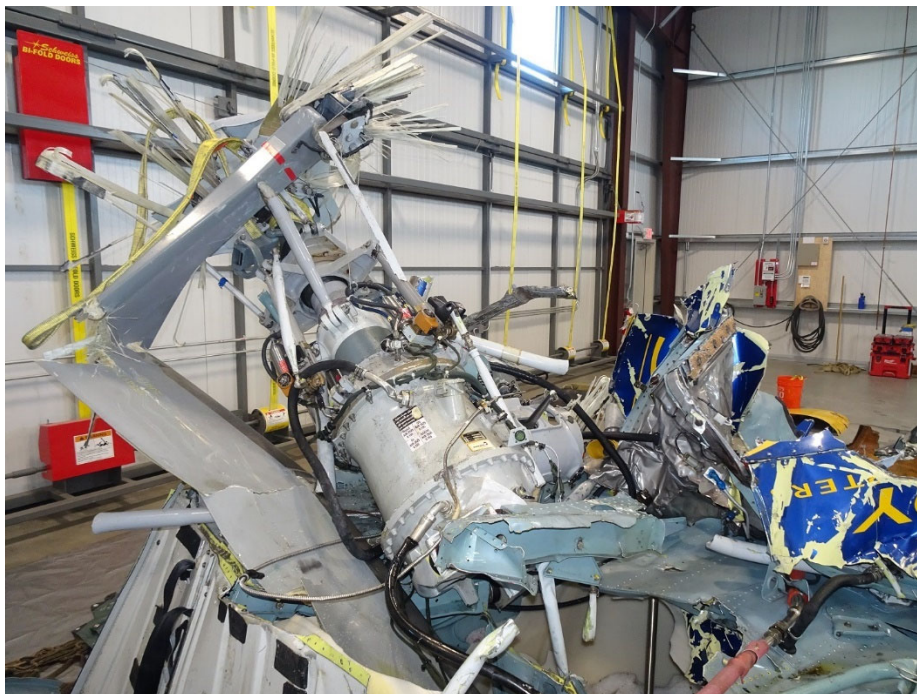
The main transmission remained attached to the airframe via the bi-directional beam but the left side of the transmission structure had separated from the transmission deck (**Figure 10**). The four suspension bars remained attached to the main transmission upper housing but all four bars were fractured about mid-length of the bar. The lower portion of all four suspension bars remained attached to their transmission deck attachment mounts. All fractures exhibited signatures consistent with overload.

Figure 10. The main transmission and the transmission deck.

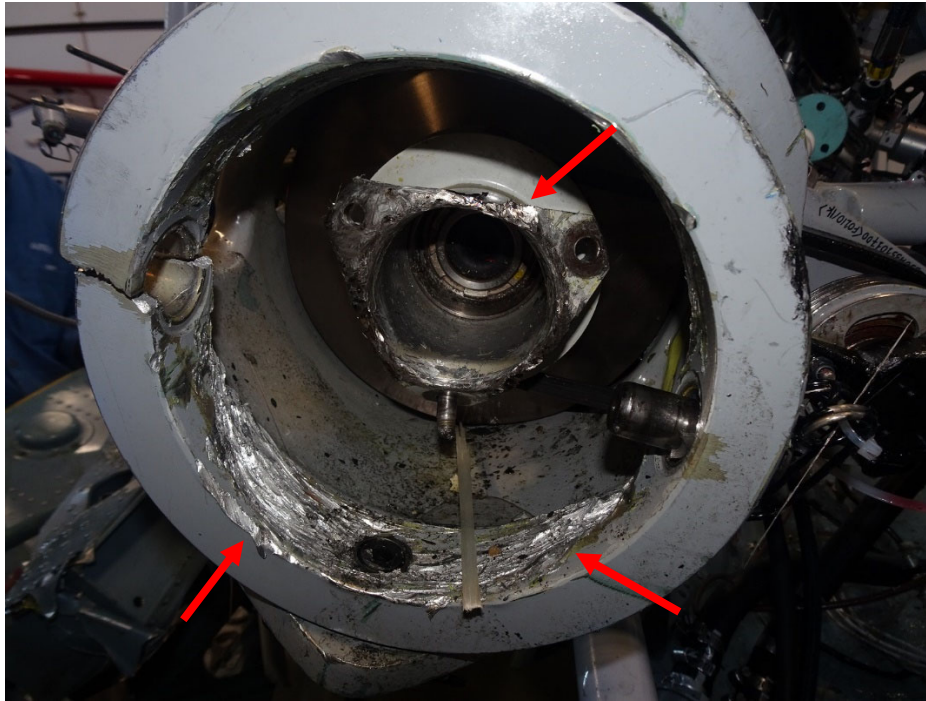
The input driveshaft was recovered within the engine power transmission shaft housing. The input driveshaft was straight with no evidence of anomalous deformation. The aft flexible coupling assembly remained attached to the aft flange of the input driveshaft. The forward flexible coupling assembly was not present and the forward input driveshaft flange, as well as the main transmission input flange and the forward section of the universal coupling, exhibited rotational scoring on their surfaces (**Figure 11**). One remnant bolt shank was present within the main transmission input flange bolt hole. Rotation of the main transmission input flange resulted in a corresponding rotation of the main rotor head, confirming continuity of drive within the main transmission.

Figure 11. Rotational scoring (red arrows) observed within the forward section of the universal coupling and on the main transmission input flange. (Image courtesy of Airbus)

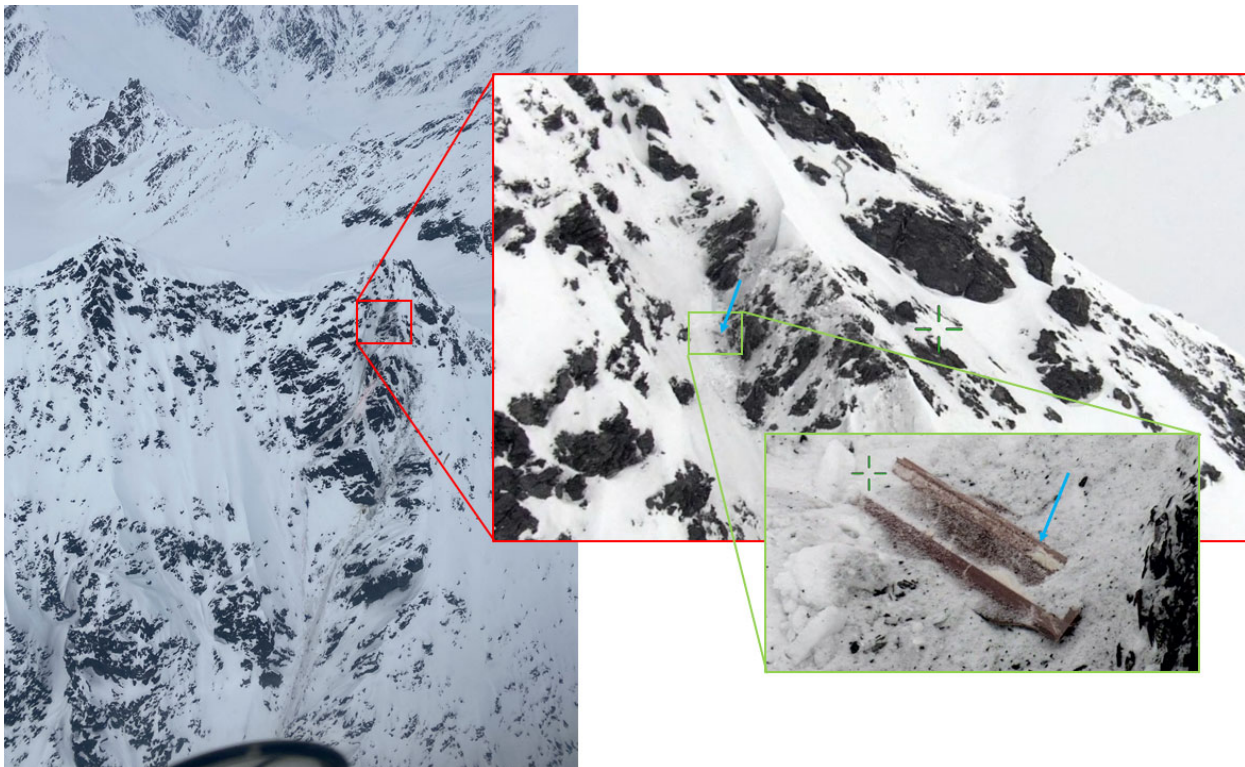
The tail rotor was not recovered. Images from the Alaska State Troopers showed a potential section of one tail rotor blade near the peak of the mountain (**Figure 12**).

Figure 12. A potential section of one tail rotor blade (blue arrow) at the accident site. (Images courtesy of the Alaska State Troopers)

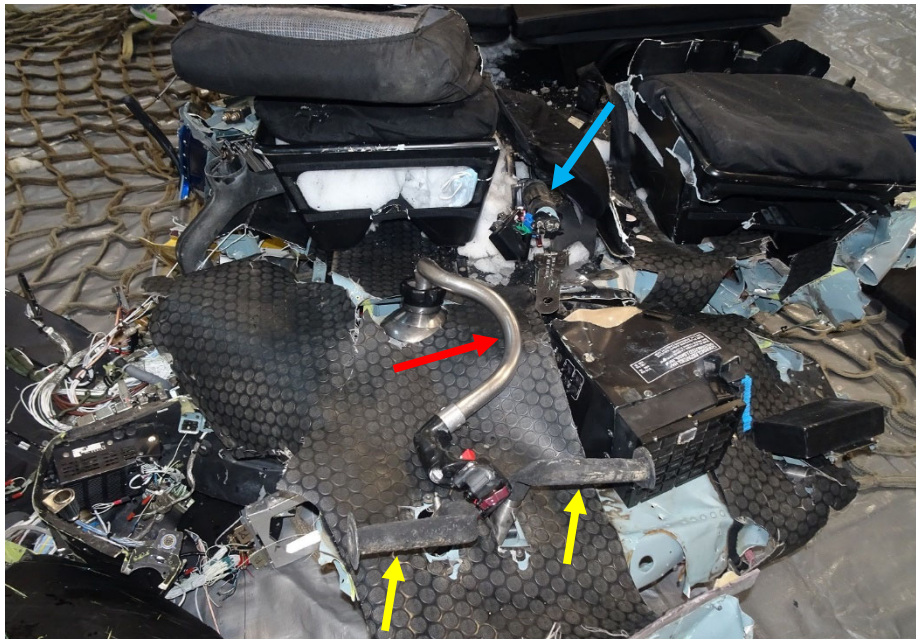
The pilot's cyclic, collective, and pedal controls remained installed in the cockpit (**Figure 13**). The cyclic control was bent, primarily in the forward-right direction, and fractured at its base. The cyclic grip remained attached to the control stick. The cyclic control friction knob was present and was able to be manipulated by hand. The friction knob was in a higher friction ("tight") setting, but there was deformation of the structure near its base.

The collective control was found in a low collective position with about 1 inch of downward travel remaining until it hit its lower stop. The collective-mounted twist grip throttle was found in the "flight" position. The collective head was fractured and separated from the collective control but remained attached via wiring. The hydraulic cut-off switch was separated from the collective head and was not found in the recovered wreckage. The collective lock remained attached to the airframe but its attachment base was deformed. The collective lock hole exhibited normal wear around its edges but no cracks or fractures.

For the pilot's pedal controls, both pedals were found in approximately the neutral position. The pedals could be manually moved. The pedals remained attached to the quadrant and interconnected to the left seat pedal mounts. The lateral interconnect tube was bent such that the pedal position between the left seat and right seat pedals were not aligned. The left seat pedal controls were not installed and a cover was present over the left seat pedal mounts.

Figure 13. The pilot's cyclic control (red arrow), collective control (blue arrow), and pedals (yellow arrows).

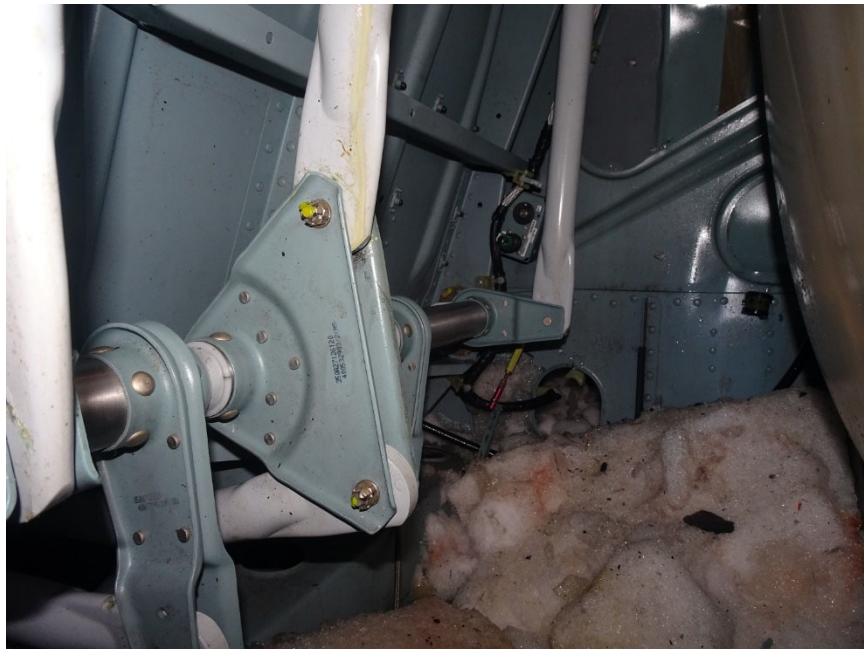
The mixing unit remained installed on the airframe (**Figure 14**). Multiple impact fractures and deformation was observed on the control tubes between the mixing unit and the cyclic, collective, and pedal controls. The three vertical push-pull tubes remained connected to the mixing unit but were fractured near their transmission deck side. There was no evidence of disconnection between the control linkages. The collective position (XPC) link remained connected to its mixing unit arm but was separated from the collective position sensor.

Figure 14. The flight control mixing unit installed on the airframe.

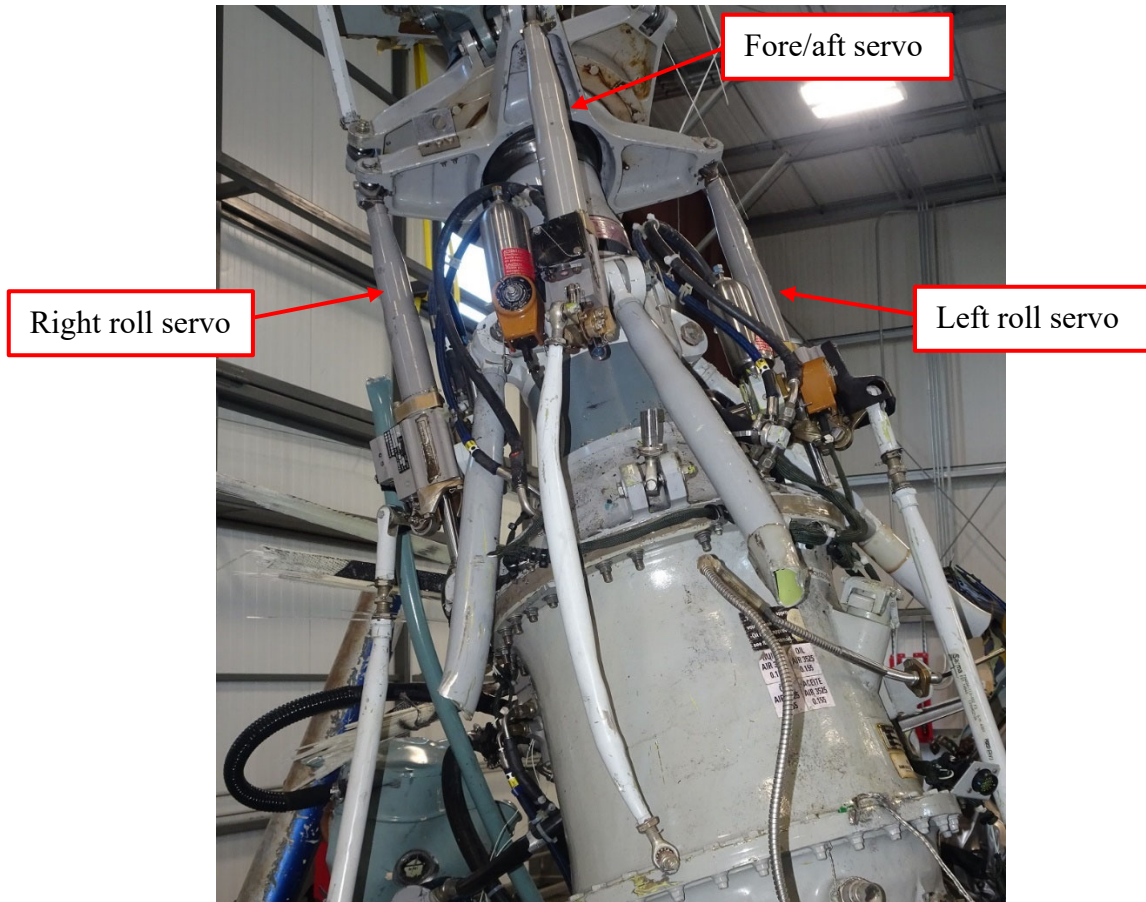
The fore/aft servo remained connected to the stationary swashplate but its piston was fractured (**Figure 15**). The lower portion of the piston remained connected to its main transmission attachment point. The piston fracture surfaces exhibited signatures of overload. The input linkage to the fore/aft servo remained connected to the vertical control tube, but the control tube's rod end was separated from its bellcrank, with the rod end attaching hardware remaining connected to the rod end. The hydraulic lines remained attached to the fore/aft servo.

Figure 15. The three main rotor servos.

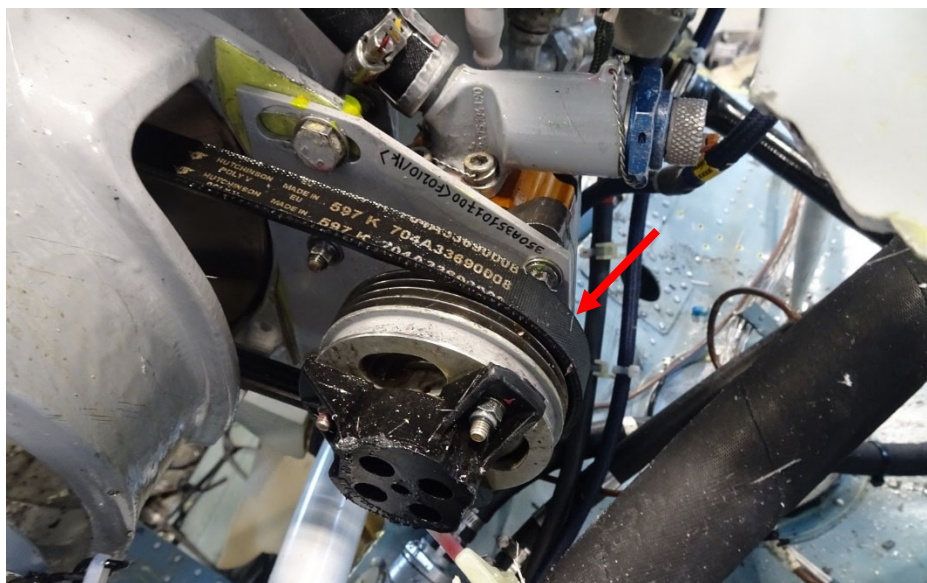
The hydraulic pump remained installed on the main transmission. The hydraulic pump drive belt remained installed with no evidence of breaks. On the pump's pulley, the drive belt was partially displaced in the forward direction (**Figure 16**). The hydraulic reservoir remained attached to the aft side of the main transmission housing and exhibited impact deformation. The hydraulic reservoir filler cap was not present.

Figure 16. The red arrow points to the hydraulic pump drive belt that was displaced forward.

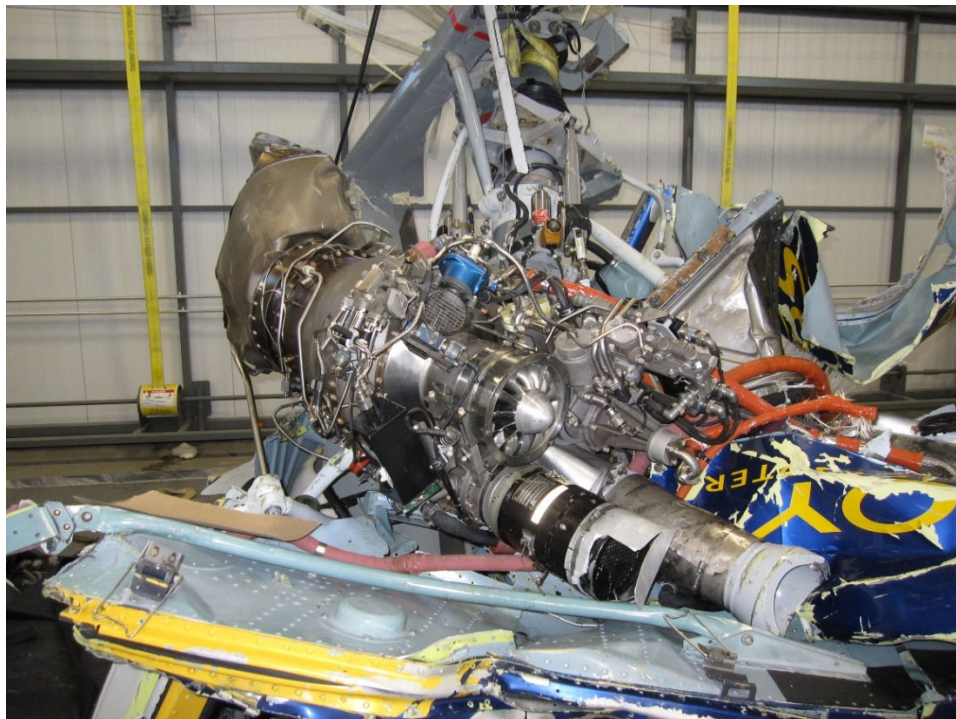
The engine was found loose within the area of the engine compartment and only remained attached to the helicopter structure via fuel lines and electrical cables (**Figure 20**). There was no evidence of thermal or fire damage on the engine. The exterior of the engine did not exhibit any signs of case breaches or uncontained engine failures. The power turbine containment ring was intact and undamaged.

Figure 20. The engine resting on the recovered wreckage.

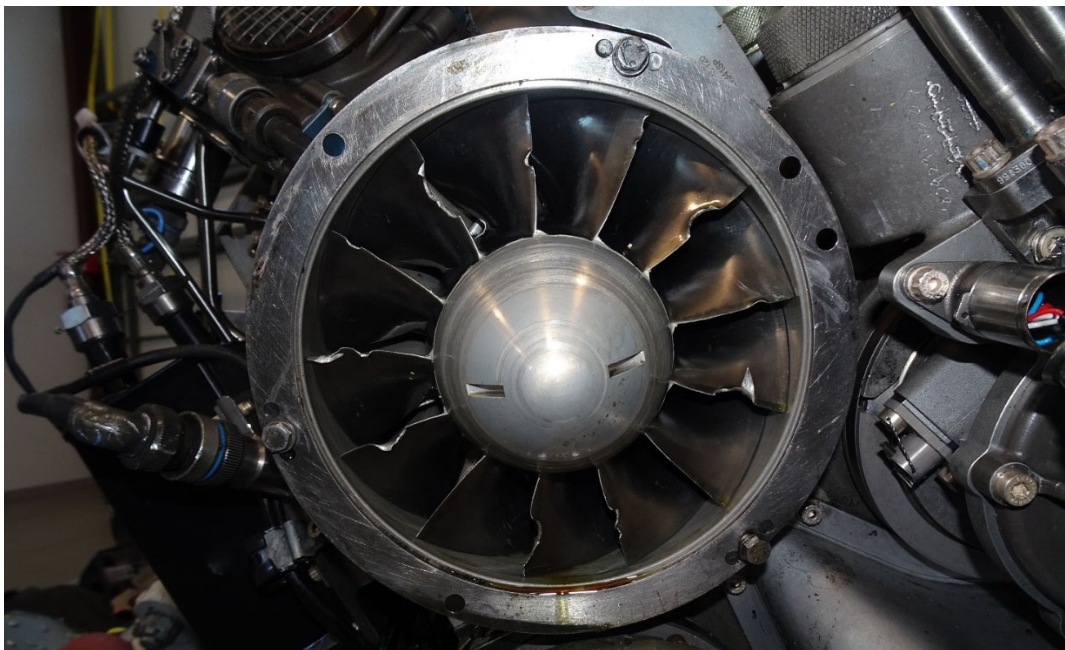
All axial compressor blades were present and of full length. Every axial compressor blade exhibited some combination of hard- and soft-body leading edge impact damage and airfoil material loss (**Figure 21**).⁴ The axial compressor turned freely and smoothly when rotated by hand. The air inlet cone was intact and exhibited light circumferential scoring. The flow path of the compressor case exhibited light circumferential scoring along the blade running position.

Figure 21. A view of the leading edge damage on the engine axial compressor blades.

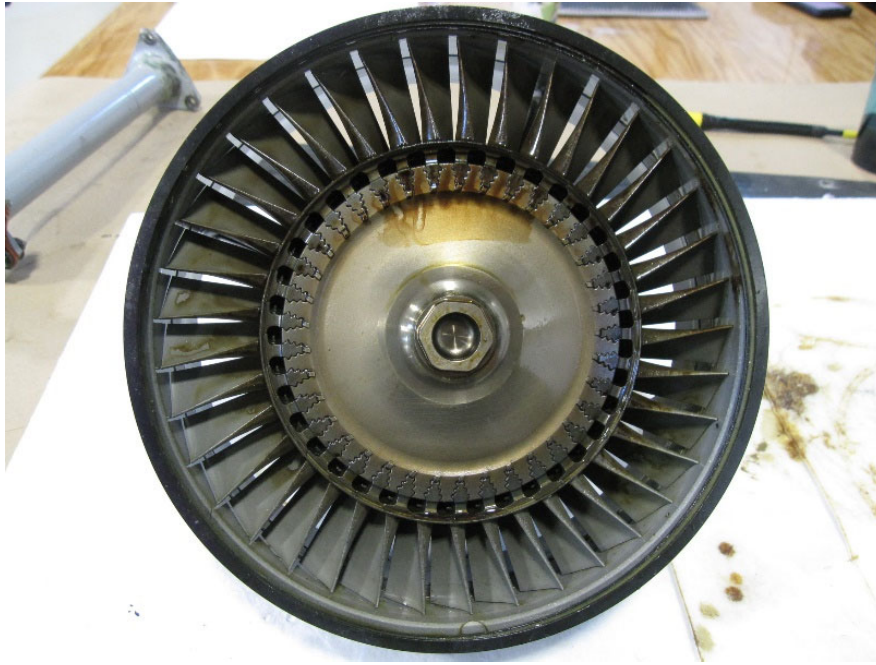
Examination through the engine exhaust pipe revealed all power turbine blades were present, full length, and intact (**Figure 22**). Continuity of drive between the power transmission shaft, reduction gearbox, and the power turbine was confirmed by rotating the power transmission shaft (at the front of the engine) and observing a corresponding rotation of the power turbine. Normal operation of the freewheeling unit was also confirmed.

Figure 22. A view of the leading edge of the power turbine blades (after removal from the engine).

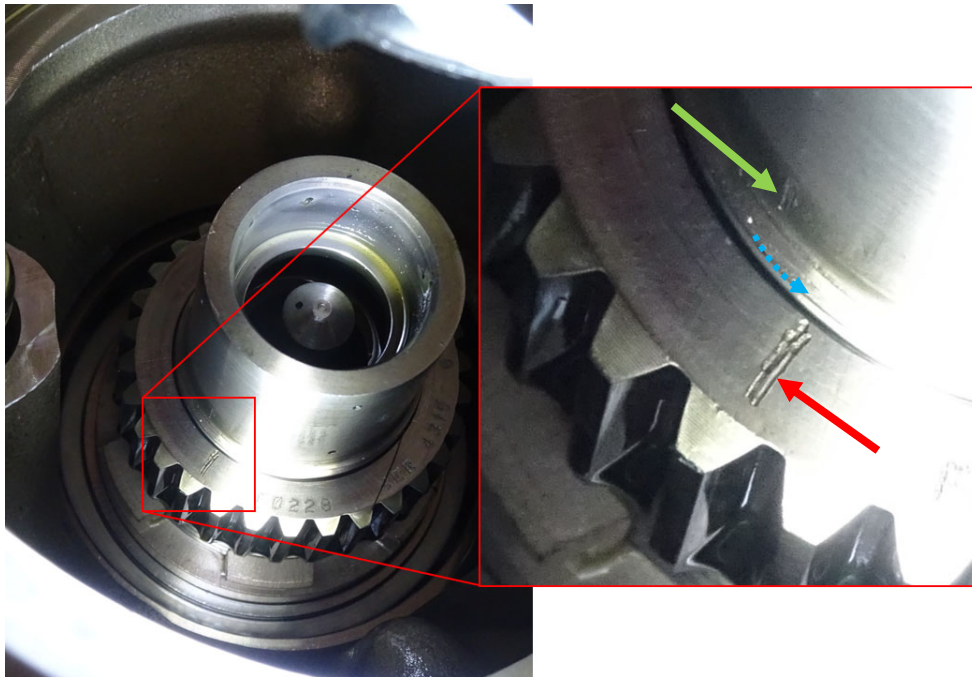
The reduction gearbox and power turbine modules were removed from the engine. The index mark between the input pinion gear and its splined nut was offset by about 3 millimeters in the counterclockwise (tightening) direction (**Figure 23**).⁵ The power turbine was rotated by hand and exhibited smooth movement. The power turbine shroud exhibited light circumferential scoring along the blade running position and the blades had no anomalous leading or trailing edge airfoil damage. The power turbine nozzle guide vane assembly was intact and exhibited no impact damage. All of the power turbine nozzle guide vanes were covered with metal splatter that had adhered to the suction (convex) side of the airfoils.

Figure 23. The index mark on the splined nut (red arrow) and the pinion gear (green arrow) was offset by about 3 millimeters. The blue arrow shows the direction of the index mark's movement.

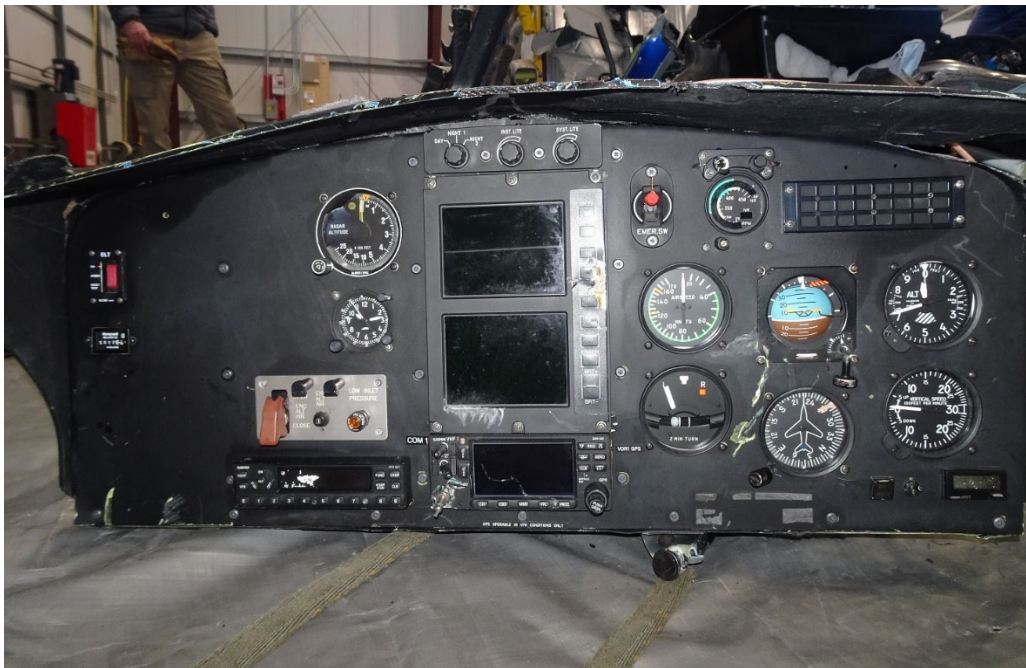
The instrument panel was generally intact with all instruments still installed on the panel (**Figure 24**). The pitot tube was found lodged within the instrument panel. The hour-meter displayed 5,673.7 hours. The vehicle engine monitoring display (VEMD) remained installed within the instrument panel. The VEMD was removed and its data sticker showed P/N B19030MD05 and S/N 6109. The VEMD was shipped to the Bureau d'Enquêtes et d'Analyses pour la Sécurité de l'Aviation Civile (BEA) in Le Bourget, France to download its onboard data. See Section 3.2 of this report for additional details of the data download.

Figure 24. The recovered instrument panel. The VEMD is composed of the two screens at the center of the instrument panel.

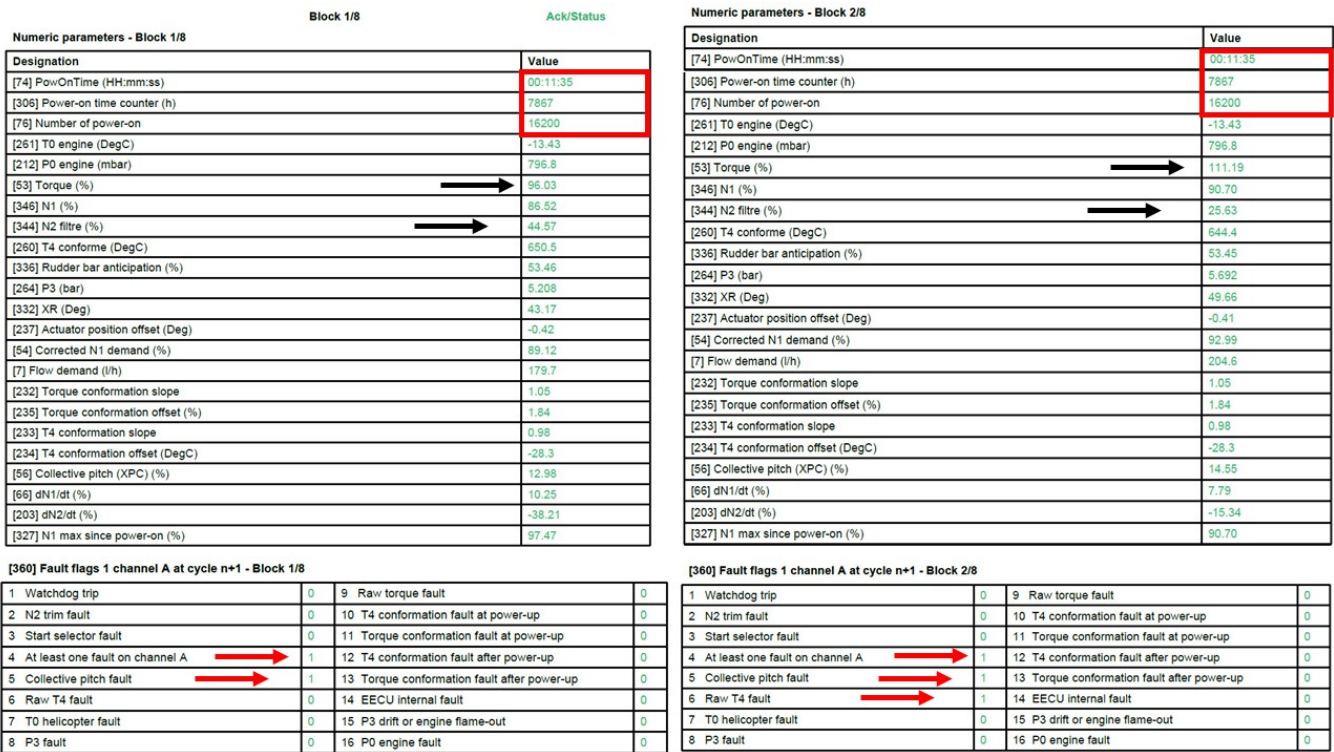
Figure 25. DECU Channel A Fault Context Data – engine parameters and logic words. (Courtesy of Safran Helicopter Engines)

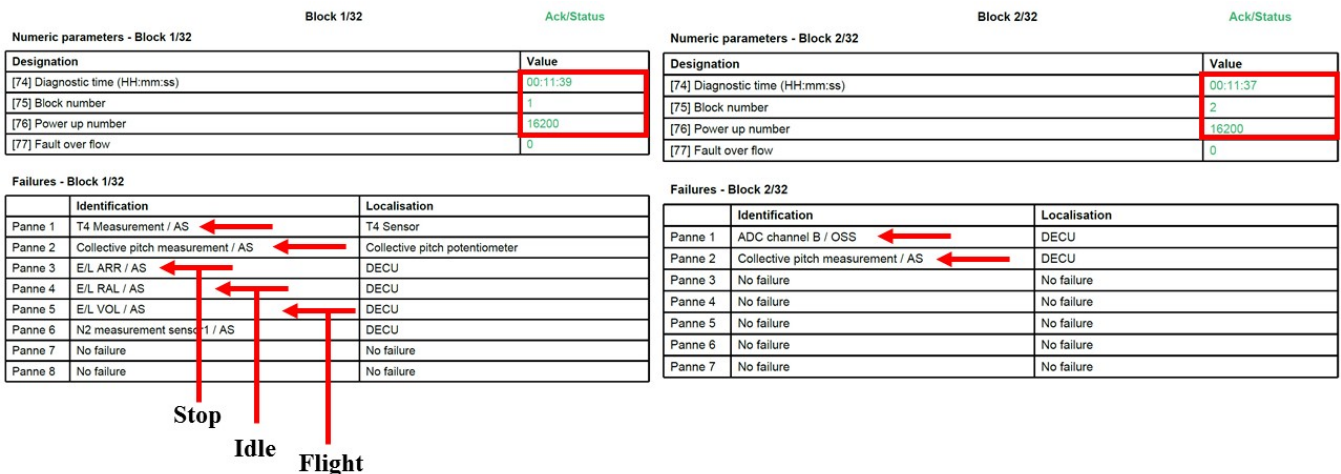
Review of the Channel A Technical Occurrences data file showed that the 4 seconds (11 minutes 39 seconds after PowOn Time and 16,200 total Number of Power-Ons) after the Collective Pitch Fault and the Raw T4 fault occurred, a Stop, Idle, and Flight selector fault occurred along with a NF measurement sensor fault (Fault Block 1/32). Two seconds (11 minutes 37 seconds after PowOn Time and 16,200 total Number of Power-Ons) after the Collective Pitch Fault and the Raw T4 fault occurred, an alternate direction current (ADC) Channel B operating system software (OSS) fault occurred (Fault Block 2/32) (Figure 26). Based on the same timestamps, these two sets of Fault Blocks were likely part of the accident flight. The remaining 30 Fault Blocks were correlated with PowOn Times and total Number of Power-Ons that preceded the first two sets of Fault Blocks by many operations/flights.

Figure 26. DECU Channel A Technical Occurrences. (Courtesy of Safran Helicopter Engines)
