National Transportation Safety Board

WPR21FA143

Group Chair's Factual Report - Supplemental

Location: Palmer, Alaska
Date: March 27, 2021
Time: 1834 Alaska daylight time
Helicopter: Airbus AS350 B3, registration N351SH

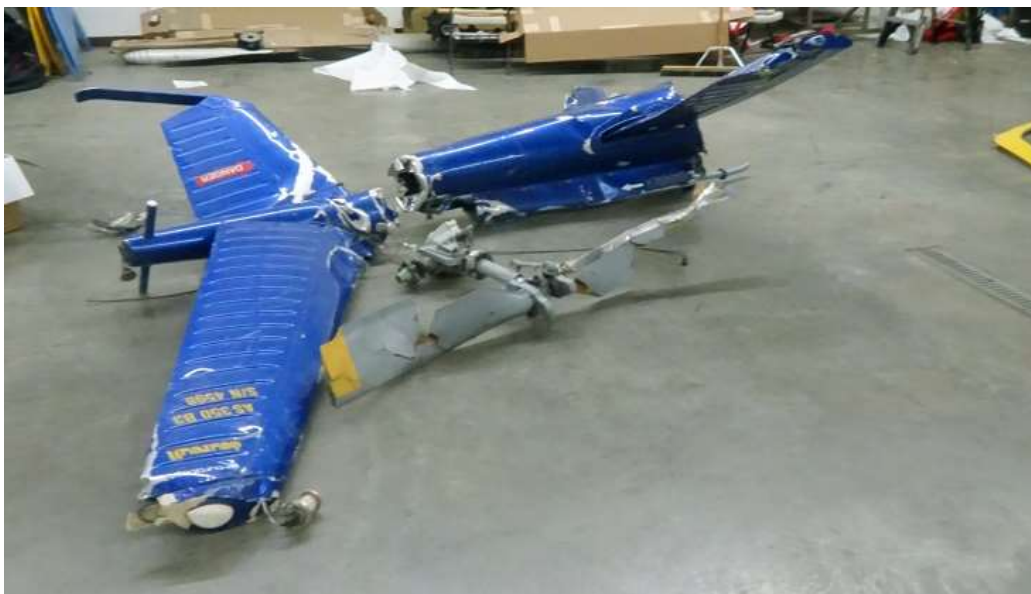
The aft portion of the empennage had separated into two sections (**Figure 1**). One section was composed of the tail boom with the horizontal stabilizer. The second section was composed of the tail boom with the upper and lower vertical fins and the tail cone.

Figure 1. The aft tail boom section and the vertical fins.

On the aft tail boom wreckage (with the vertical fins), the forward structure exhibited a counterclockwise twist. The vertical fins were whole and exhibited localized impact deformation on portions of their leading edges as well as the top portion of the upper vertical fin. The upper vertical fin trailing edge was displaced to the left of the tail cone while the lower vertical fin trailing edge was displaced to the right of the tail cone. The stinger did not exhibit impact deformation and remained attached to the lower vertical fin.

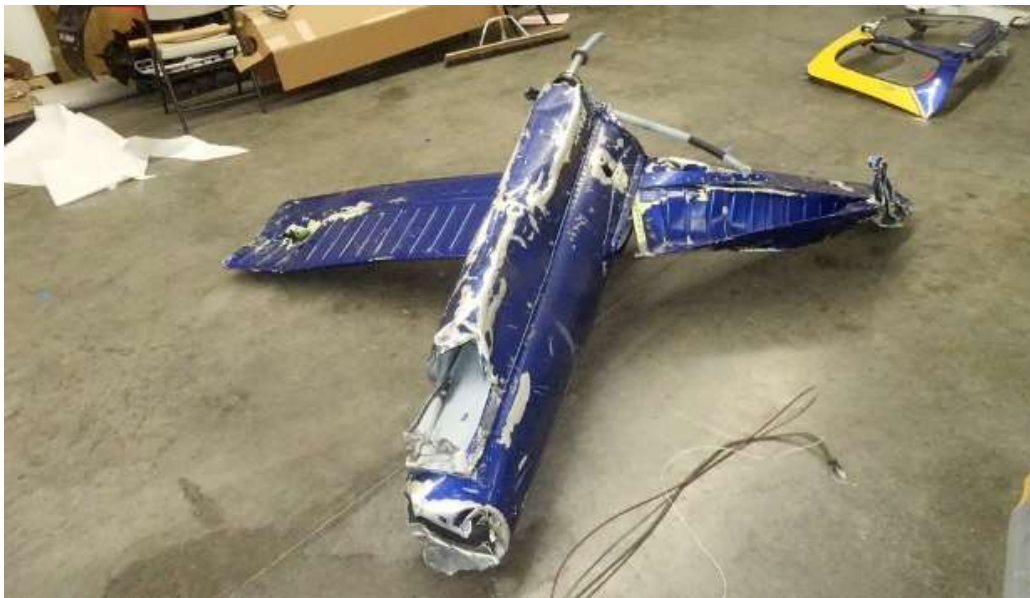
The horizontal stabilizer remained installed on the tail boom and was continuous through the tail boom structure (**Figure 2**). The right side of the horizontal stabilizer was deformed downward, and its outboard trailing edge exhibited impact deformation in the forward direction. The aft portion of the [right side] root end was separated consistent with the trailing edge deforming forward. The right side leading edge, about 2.5 inches outboard of its root, was deformed inward. The left side of the horizontal stabilizer exhibited less deformation than the right side. The outboard trailing edge exhibited minor impact deformation and puncturing of its upper surface. The Nos. 5 and 6 hanger bearing supports remained attached to the tail boom. The hanger bearings exhibited minor deformation.

Figure 2. The aft tail boom section with the horizontal stabilizer.

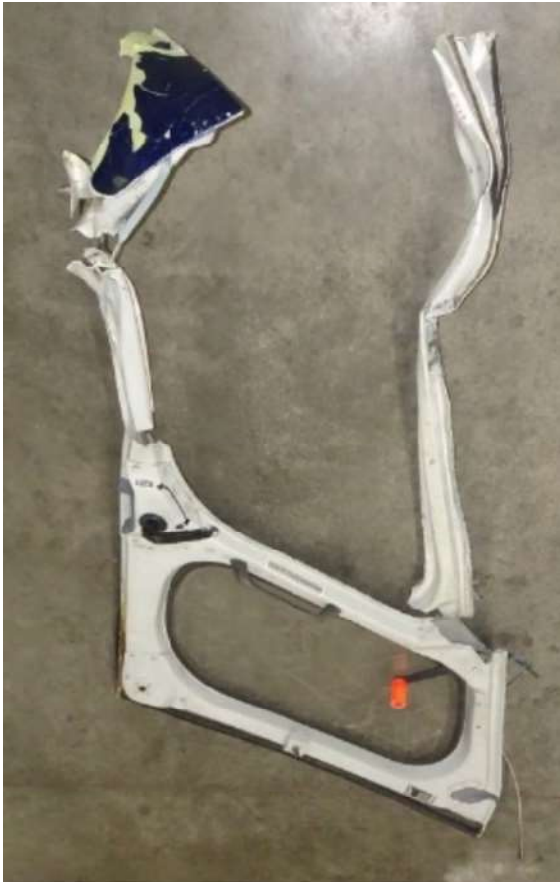
Figure 3. The left cockpit door.

The upper portion of the left cockpit door was fractured and deformed at its upper-aft and forward vertical posts. The left cockpit door was not attached to any remnant piece of the forward windscreen side post. The left cockpit door handle was in the "open" position and remained functional. Based on the accident site photos, the left cockpit door handle was consistent with being in the "open" position (**Figure 5**). The left cockpit door emergency release handle remained installed but its release rod (within the cockpit door post) was deformed.

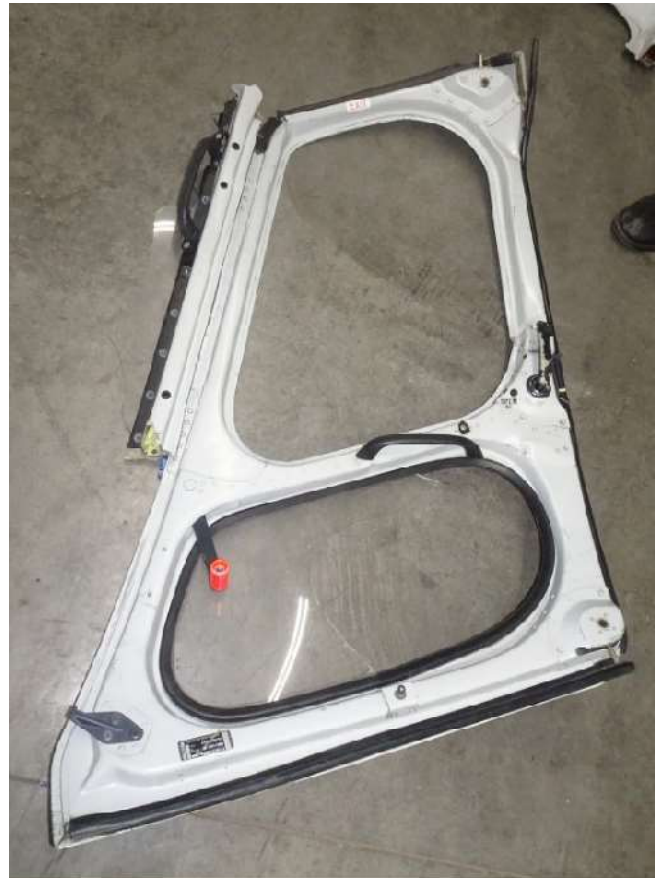
Both the left and right cockpit doors had separated from the airframe (**Figures 3 and 4**). The right cockpit door was whole and remained attached to a remnant piece of the windscreen side post. The right cockpit door handle (a black-colored handle) was in the "closed" position and remained functional. The right cockpit door emergency release handle (an orange-colored handle) remained stowed. The emergency release handle was actuated upward and the remnant windscreen side post separated from the right cockpit door.

Figure 4. The right cockpit door.

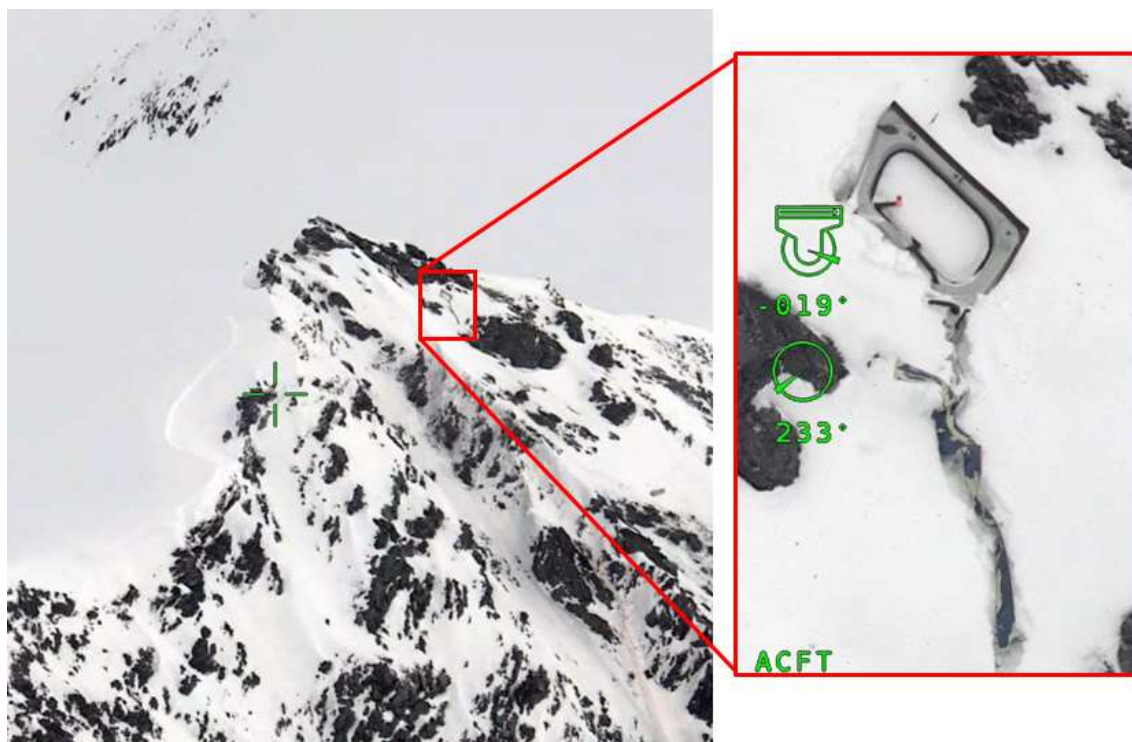
**Figure 5. The left cockpit door as seen at the accident site on March 28, 2021.
(Images courtesy of the Alaska State Troopers.)**

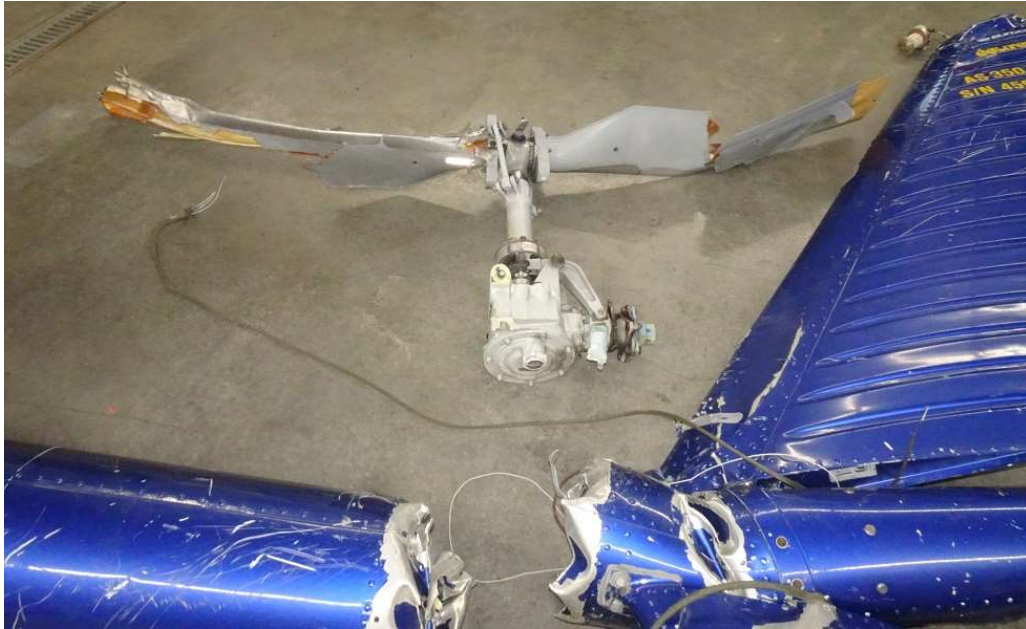
The tail rotor, tail rotor gearbox, and pitch change spider were found as a single assembly and was separated from the tail boom (**Figure 6**). The tail rotor gearbox housing's left mount lug was fractured and exhibited signatures of overload. The corresponding fracture on the tail rotor gearbox housing's left mount lug remained installed on the tail boom section containing the vertical fin, with the spacer, nut plate, and safety wiring installed (**Figure 7**). The tail rotor gearbox housing's right mount lug was whole and the mounting bolt, with spacer, nut plate, and safety wire, remained installed on the bolt. The forward mount remained attached to the gearbox housing, but its two mounting lugs had fractured in overload. The corresponding fractured mounting lugs remained installed on the tail boom section containing the horizontal stabilizer.

Figure 6. The tail rotor and tail rotor gearbox.

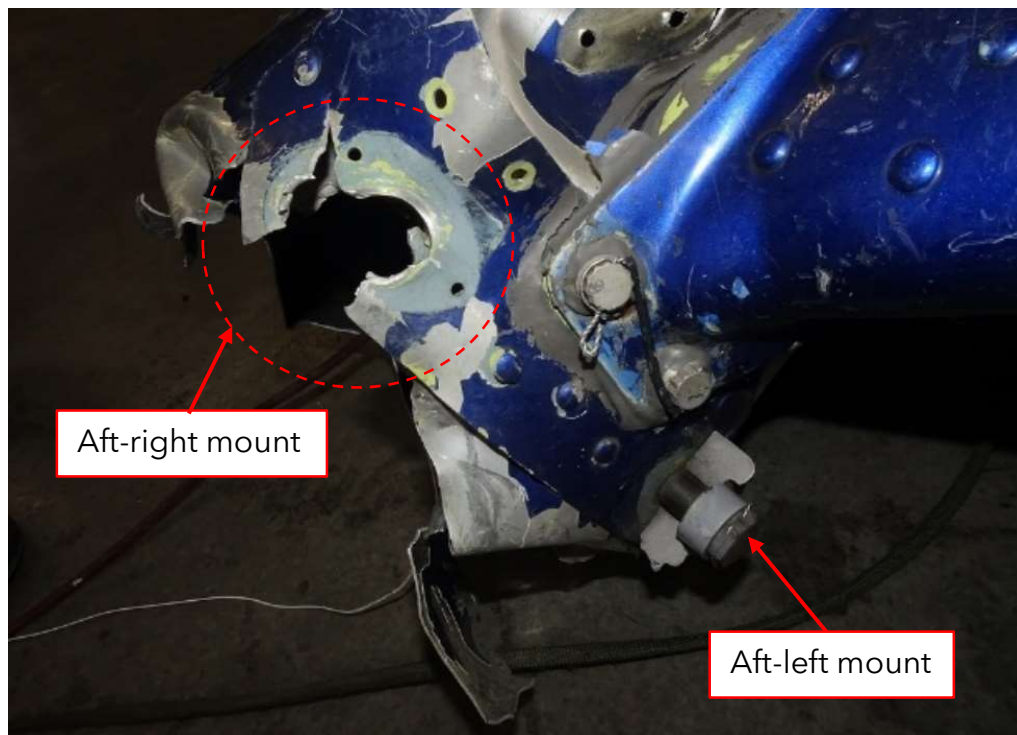
Figure 7. The tail gearbox aft mount locations near the base of the vertical fin.

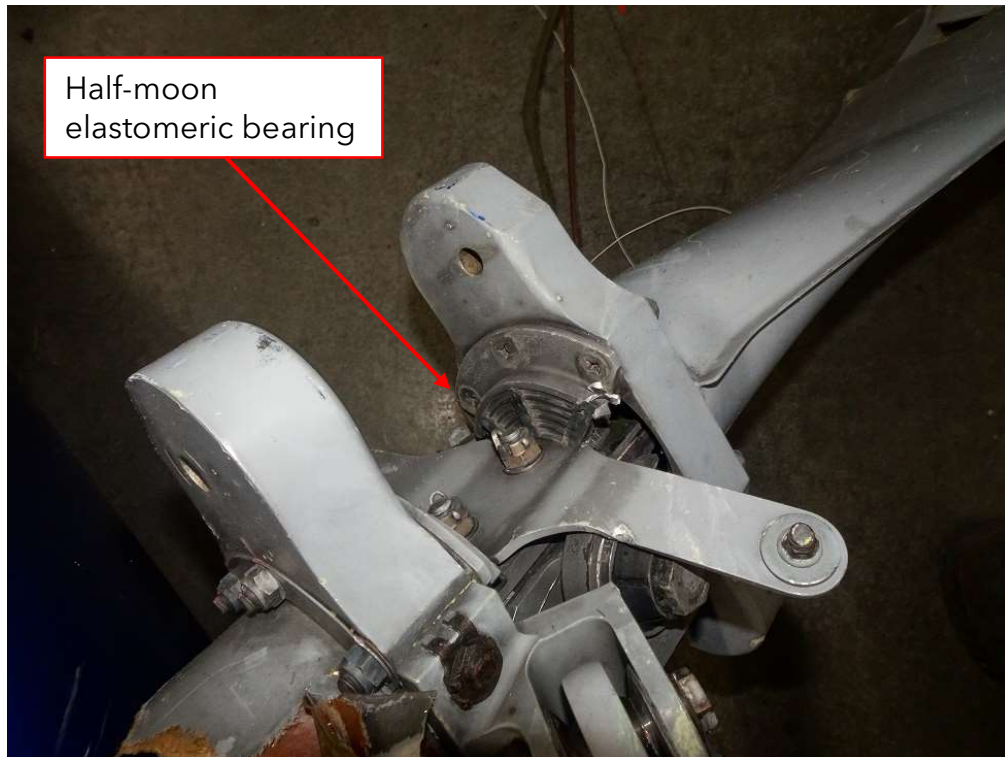
Due to the presence of moisture and corrosion in the tail rotor gearbox, the tail rotor could not be easily rotated by hand and the pitch change spider could not be manually moved along the gearbox output shaft. The tail rotor pitch change links remained installed and were whole. The four half-moon elastomeric bearings, found at the root end of each blade airfoil, remained installed (**Figure 8**). One blade, with a

red-colored dot on its pitch link and pitch change spider attachment lug, was whole from the root to the tip but its afterbody and skin had fractured about midspan. The second blade's afterbody was fractured and separated from about midspan to the outboard end of the blade. The root end of the second blade was fractured circumferentially but remained attached to the spar. The leading edge of the second blade exhibited impact deformation on the outboard end of the blade, with a flattened appearance at the tip end. The two blade leading edges had deformed in the outboard-right direction.

Figure 8. One of the four tail rotor half-moon elastomeric bearings.

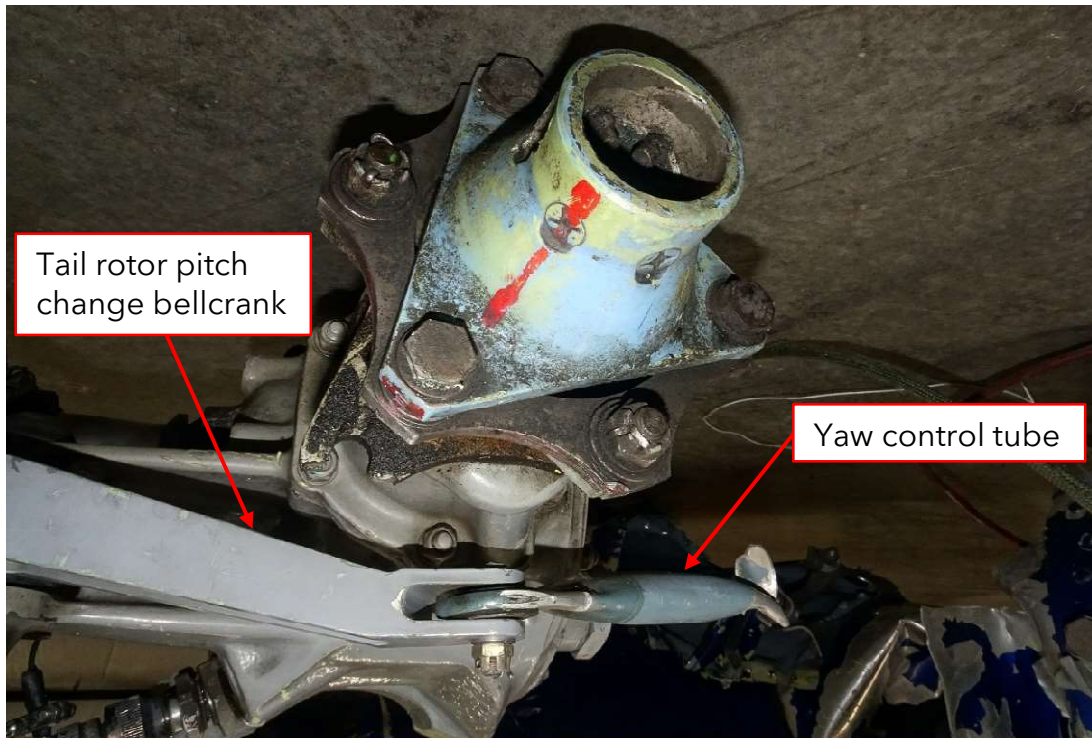
The tail rotor gearbox output shaft and pitch change spider did not exhibit significant bending deformation. The tail rotor gearbox chip detector was removed, and no magnetic chips were present on the chip detector. The oil filler cap was removed, and no residual oil was observed within the gearbox. Rust-colored deposits were observed on both the strainer and the underside of the oil filler cap. The tail rotor pitch change bellcrank remained installed and connected between the pitch change spider and the yaw control tube (also called the tail gearbox actuating rod). The yaw control tube was fractured about 4.25 inches from its connecting bolt at the tail rotor gearbox and its fracture surface exhibited signatures of overload (**Figure 9**).

Figure 9. The yaw control tube installed on the tail rotor pitch change bellcrank.

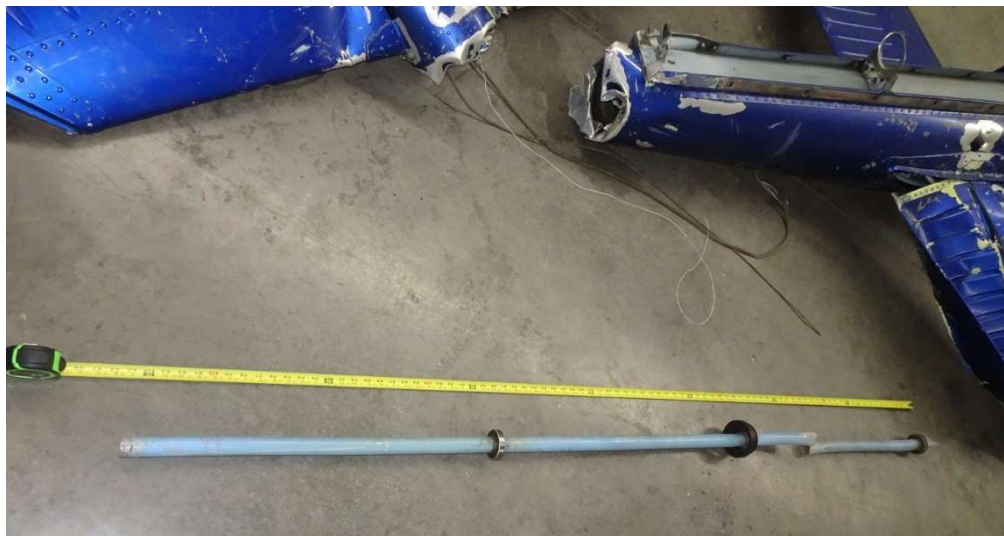
A 62-inch segment of the tail rotor drive shaft, containing two hanger bearings, was present within the aft tail boom wreckage (**Figure 10**). A 22-inch segment of the tail rotor drive shaft, containing one hanger bearing, was found separated from the wreckage. The fracture surfaces observed on the tail rotor drive shaft exhibited signatures consistent with overload.

Figure 10. The 62-inch (left) and 22-inch (right) segments of the tail rotor drive shaft.
