NATIONAL TRANSPORTATION SAFETY BOARD
Office of Aviation Safety
Ashburn, Virginia 20147

Airworthiness Group Chairman's Factual Report

Addendum 1

WPR09MA159

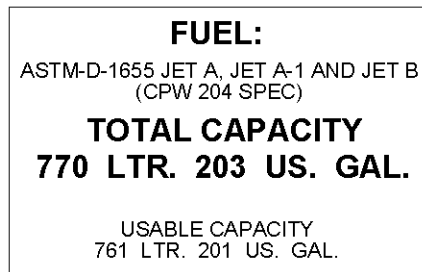
Figure 1 – PC-12 Fuel filler placard

According to the PC-12 Approved Airplane Flight Manual (AFM), Section 2, Limitations, a placard (see **Figure 1**) specifying the type of fuel to be used, as well as the total and usable fuel capacity of each fuel tank, was placed near each fuel filler port.

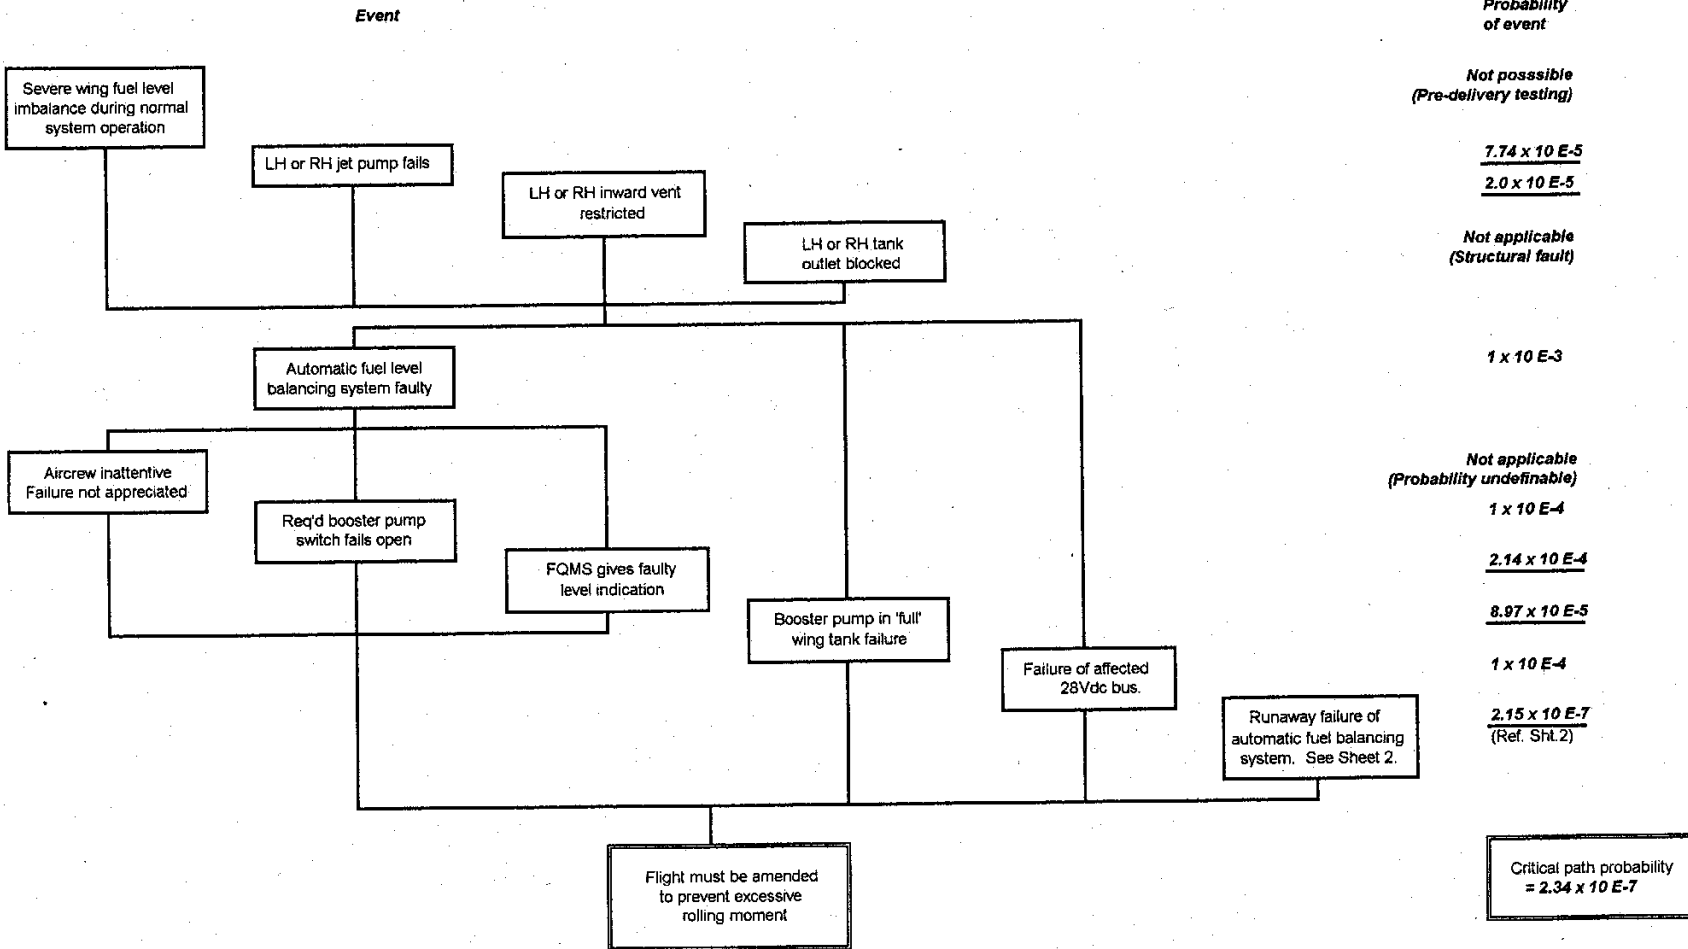
Figure 2 – Dependence Path Analysis, Excessive difference in wing fuel tank levels

An excessive difference in the wing fuel tank levels was considered by the assessment to be the result of a combination of faults that must occur in sequence. Those faults were a significant differential in fuel flow from the left and right wing tank, and the inability to select the electric fuel boost pump in the heavier wing to restore balance. The sequence of events depicted in **Figure 2** below determined the failure state to be improbable.

Pilatus' analysis further describes that the failure condition would arise in the event of a loss of fuel flow from one of the wing tanks followed by a failure of the automatic fuel balancing system to recognize or correct the resulting difference in wing tank fuel levels. Following this, the failure may be prevented if the fuel imbalance is detected and corrected by the flight crew manually activating the required fuel boost pump. This would not occur if the flight crew were inattentive, deceived by an incorrect fuel quantity indication, or if there was a malfunction of the required fuel boost pump. The failure condition could also be created by a malfunction of the automatic fuel balancing system resulting in the continuous operation of one fuel boost pump. Once the situation was observed the flight crew, the failure condition may simply be prevented by manually deselecting the automatic fuel balancing system or deactivating the circuit breaker of the 'runaway' fuel boost pump. The analysis discussed above is depicted in **Figure 2** below.

Failure Condition :- **Excessive difference in wing fuel tank levels**
(Ref. Section 2.7.6)

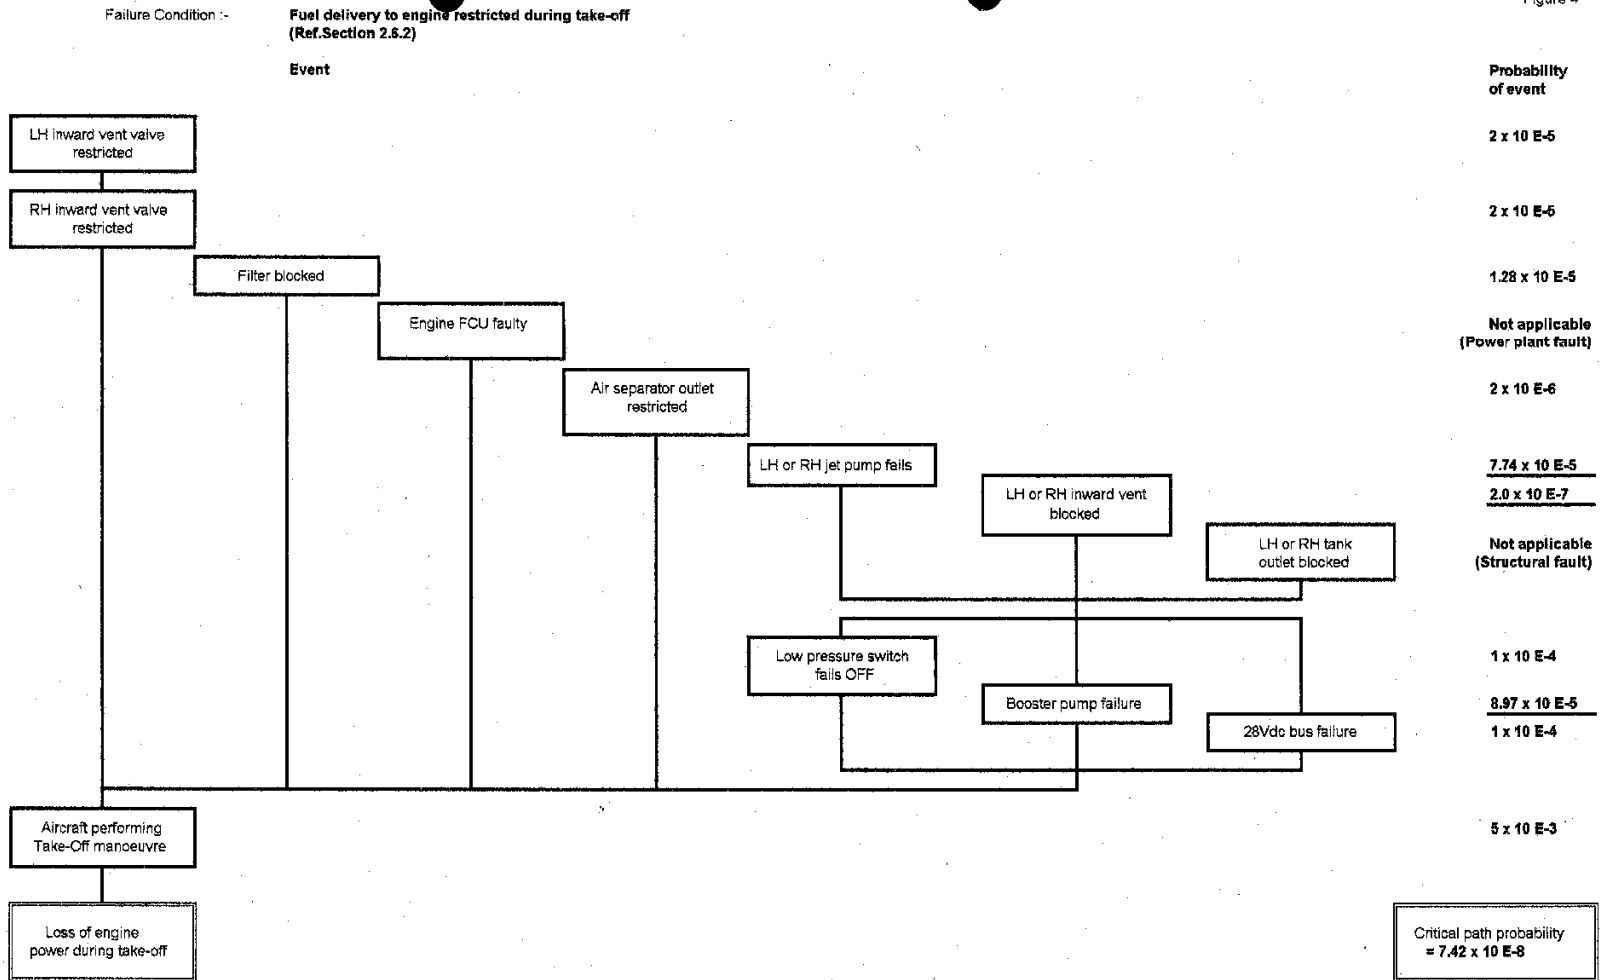
Figure 3 – Dependence Path Analysis, Fuel delivery to engine restricted during take-off

A failure of either fuel boost pump selector switch in the off position would result in the affected boost pump not being able to operate if required (either manually or automatically). While normal operation of the fuel supply system would not be affected by this failure, a failure that coincided with another system malfunction would be considered major. The probability of failure of the electrical connector switch was considered to be 1×10^{-4} , a standard value used throughout the hazard assessment for the reliability of standard electrical components. The probability of a separate system malfunction, which would under normal circumstances require the operation of the booster pump was considered to be 1.48×10^{-5} . This value was derived from the malfunctions considered in **Figure 3**.

The above probabilities resulted in an overall probability of the failure occurring of 1.48×10^{-9} , and the failure condition was considered improbable.

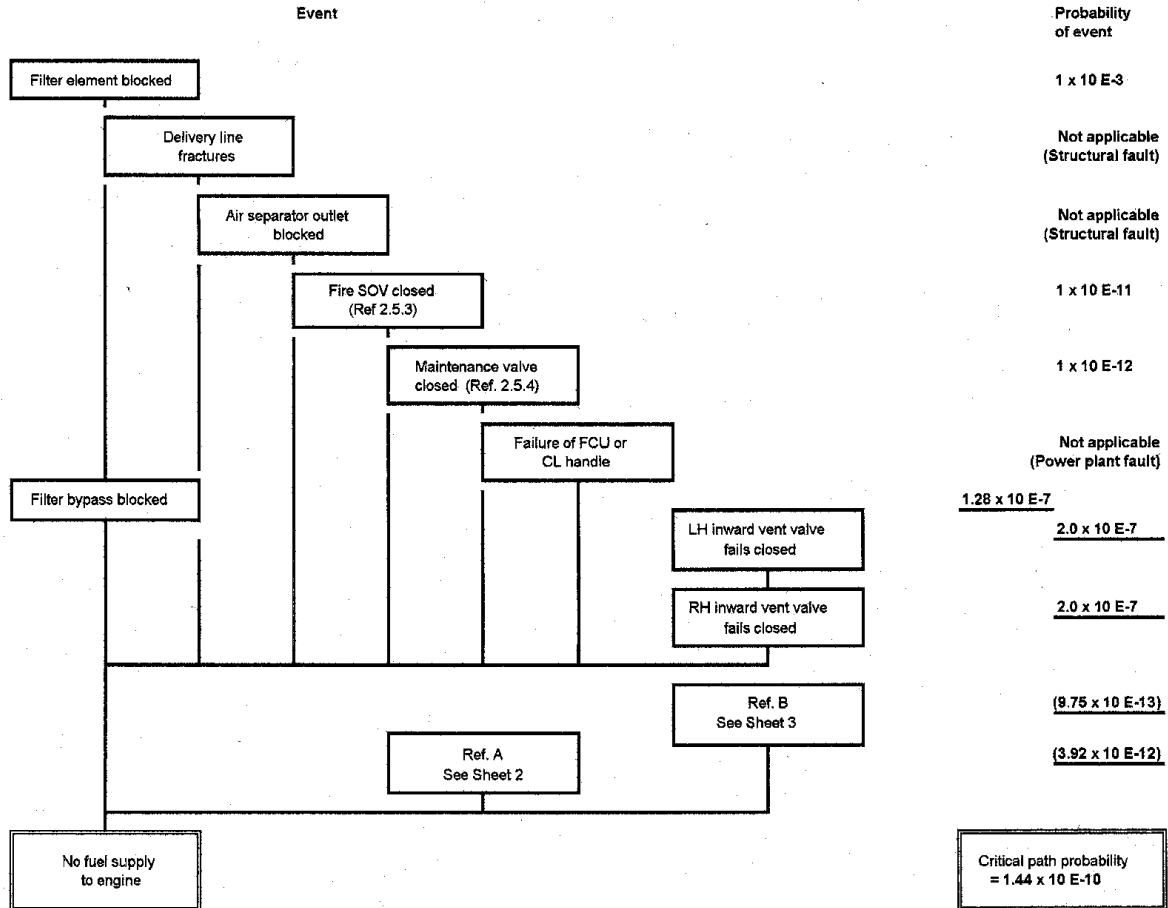
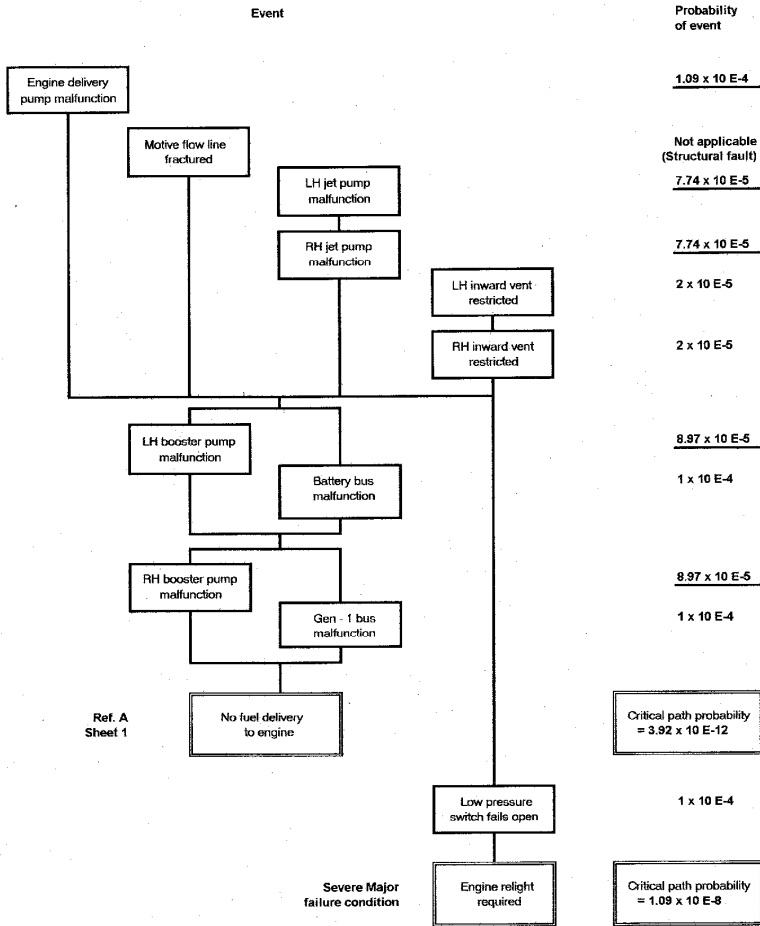
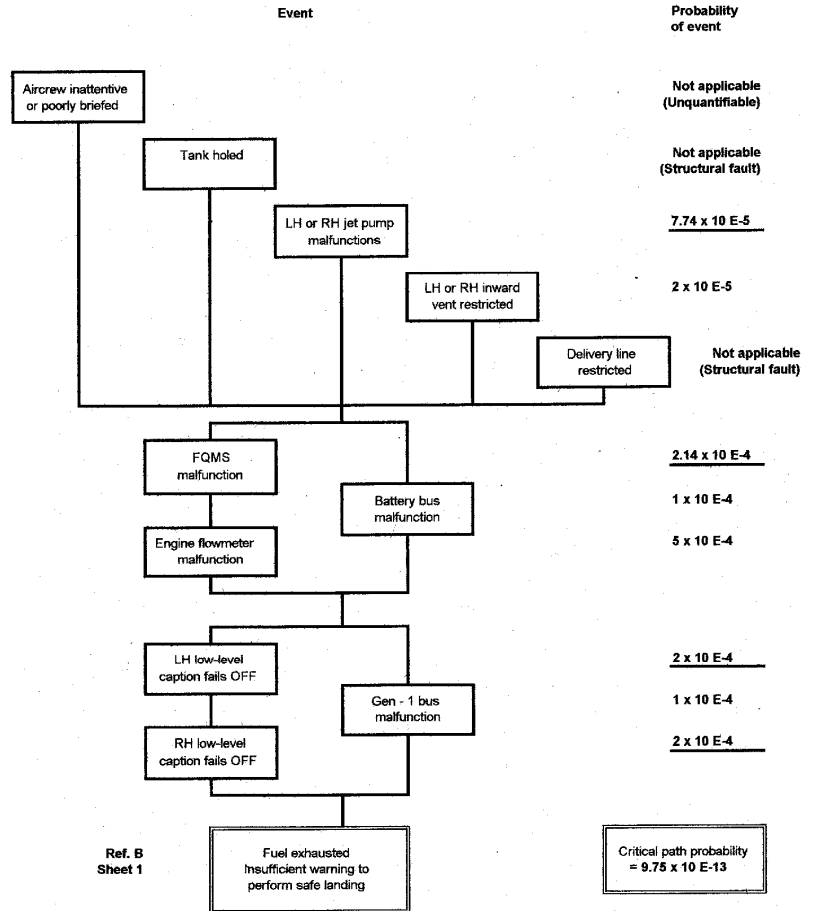
Figure 4 – Dependence Path Analysis, No fuel delivery to engine (1 of 3)

Maintenance/servicing errors were also addressed by the assessment. One such error was, "Failure to drain wing tanks at regular intervals. This may result in the accumulation of large quantities of water within the fuel tanks, which may cause icing problems in low ambient temperatures." Another error listed was, "Failure to ensure that fuel includes anti-icing additives. This may cause icing problems in low ambient temperatures." Each of these maintenance errors could result in a restricted or blocked fuel filter element, a failure which is considered in **Figure 4**.

The hazard assessment listed the reliability of certain fuel system components based on service experience from other aircraft that share the same fuel system with the PC-12. The fuel filter had a mean time between failure of 78,000 hours. A failure of the fuel filter could consist of either the fuel flow being restricted or completely blocked. It was assumed that 1-percent of all failures would result in the bypass valve, as well as the fuel filter being blocked. The probability of a restricted fuel filter was calculated to be 1×10^{-3} , while the probability of a blocked filter was calculated to be 1.28×10^{-5} . The probability of a blocked fuel filter bypass was 1.28×10^{-7} (note that this figure is only representative of the bypass being blocked, and not the filter and bypass).

The fuel boost pumps were listed as having a mean time between failure of 11,143 hours, and all failures were assumed to result in an inability of the pump to pass fuel flow. The probability of failure of the fuel boost pump was subsequently calculated to be 8.97×10^{-5} .

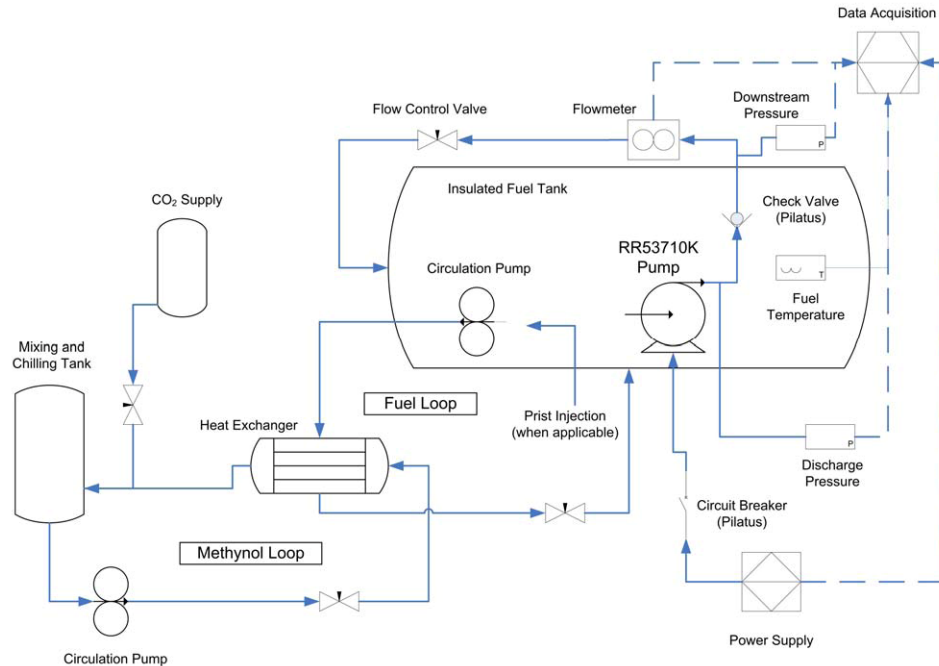
Figure 5 – Test stand

The test stand (**Figure 5**) consisted of a 50-gallon tank filled with Jet-A fuel, with provisions for the installation of a RR53710K fuel boost pump. The discharge port of the

fuel boost pump was piped through a check valve supplied by Pilatus (identical to the check valve used in the aircraft fuel system), to a fuel flow control valve, which was installed to facilitate performing the initial calibration tests required. Pressure sensors were installed in-line with the discharge path of the fuel boost pump, both before and after the check valve, and a flow meter was installed prior to the fuel flow control valve. Fuel temperature was controlled through the use of a circulation pump that routed fuel through a heat exchanger that was chilled with methanol.
