National Transportation Safety Board

ERA21FA195

AIRWORTHINESS

Group Chair's Factual Report

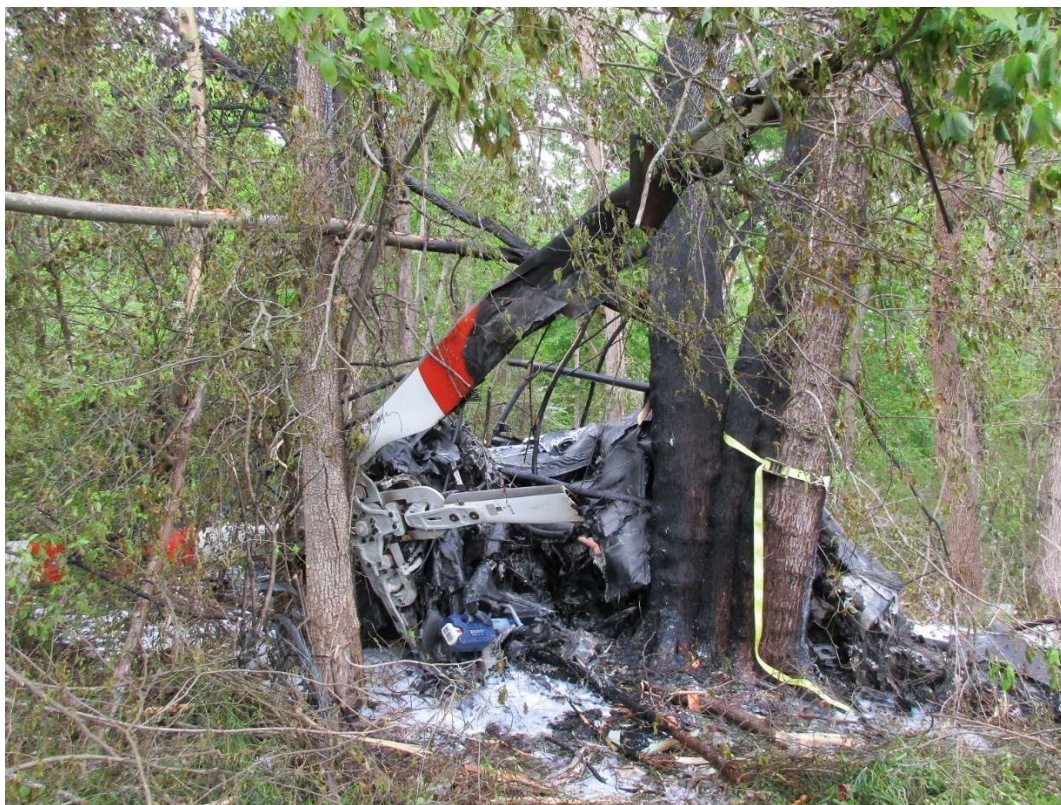
The helicopter impacted wooded terrain and came to rest at a heading of about 251° magnetic. The main wreckage site, composed of the majority of the helicopter including the fuselage and tail boom, was located at 36° 29' 49" north by 79° 43' 07" west at an elevation of about 570 feet. The fuselage came to rest on its right side at the base of a tree (**Figures 1 and 2**). A postcrash fire occurred and damaged the majority of the fuselage.

Figure 1. The main wreckage site. (Image courtesy of the FAA)

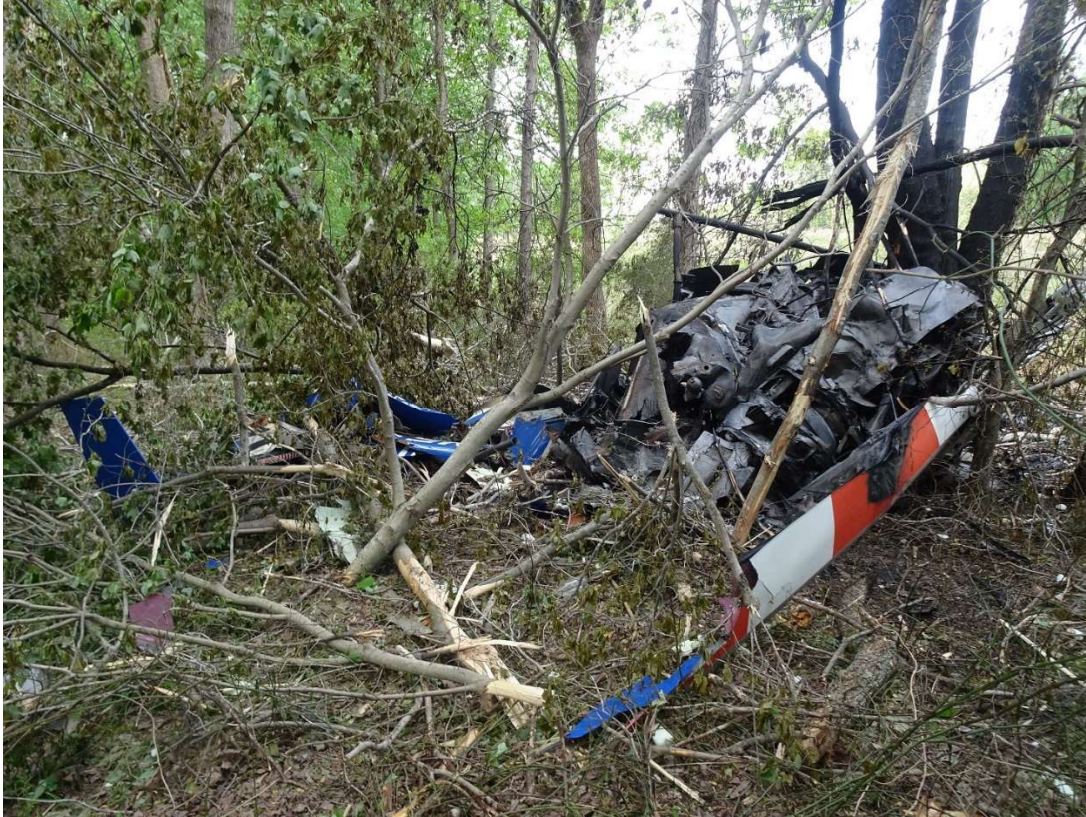
Figure 2. The main wreckage site.

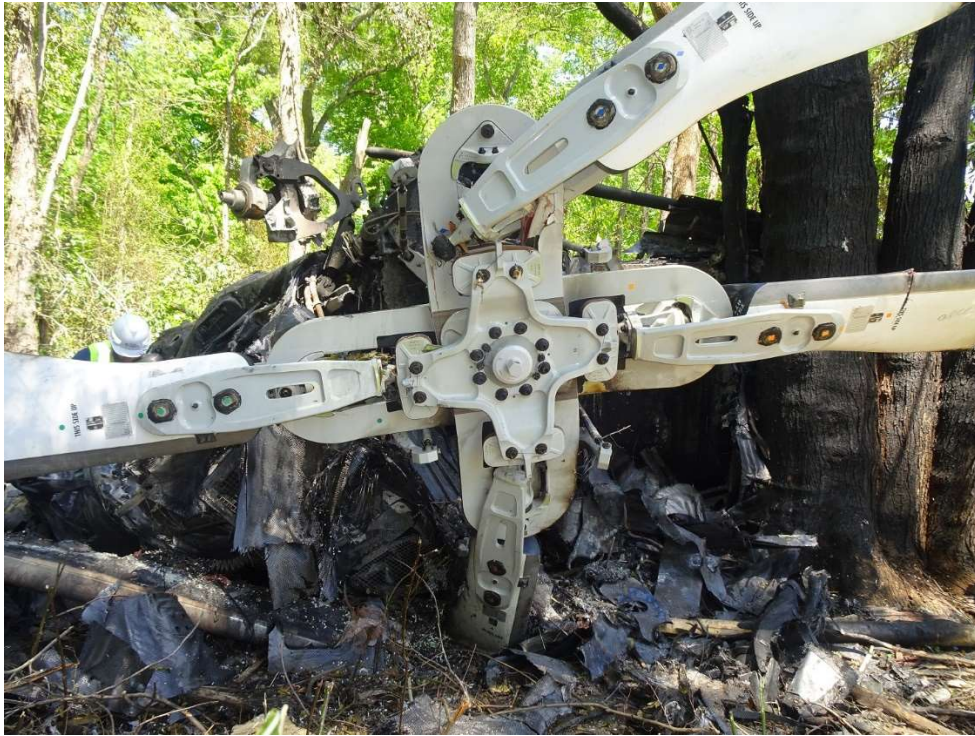
The main rotor hub remained attached to the mast assembly and the mast nut remained installed (**Figure 3**). The 'blue' blade flexbeam was partially fractured and deformed in the direction opposite of normal rotation. The remaining blade attachments on the flexbeams did not exhibit significant fragmentation but had several layers of laminate separated on their lower sides. The upper and lower mount plate assemblies and lead-lag dampers remained installed. The 'blue' lead-lag damper was partially sheared on its lower end. All blade grips remained installed and the CF bearings were attached to their respective grips except for the 'blue' CF bearing, which was torn and separated at its elastomers due to partial separation of the 'blue' blade and grip. The 'red' CF bearing elastomer was separated near its outboard end. The 'green' and 'orange' CF bearing elastomers were separated about mid-way outboard. The up-flap stops for the 'orange' and 'green' blades were fractured, with the corresponding up-flap stops on the 'orange' and 'green' blade grips exhibiting impact marks biased toward the blade-advancing side. The 'red' up-flap stop was impact-damaged. The up-flap stop on the 'red' blade grip had a large impact mark at its center and a smaller impact mark biased toward the blade-advancing side. The 'blue' up-flap stop was relatively undamaged with the up-flap stop on the 'blue' blade grip exhibiting multiple small impact marks and a large impact mark near its blade-retreating side.

Figure 3. The main rotor head with all four main rotor blades present.

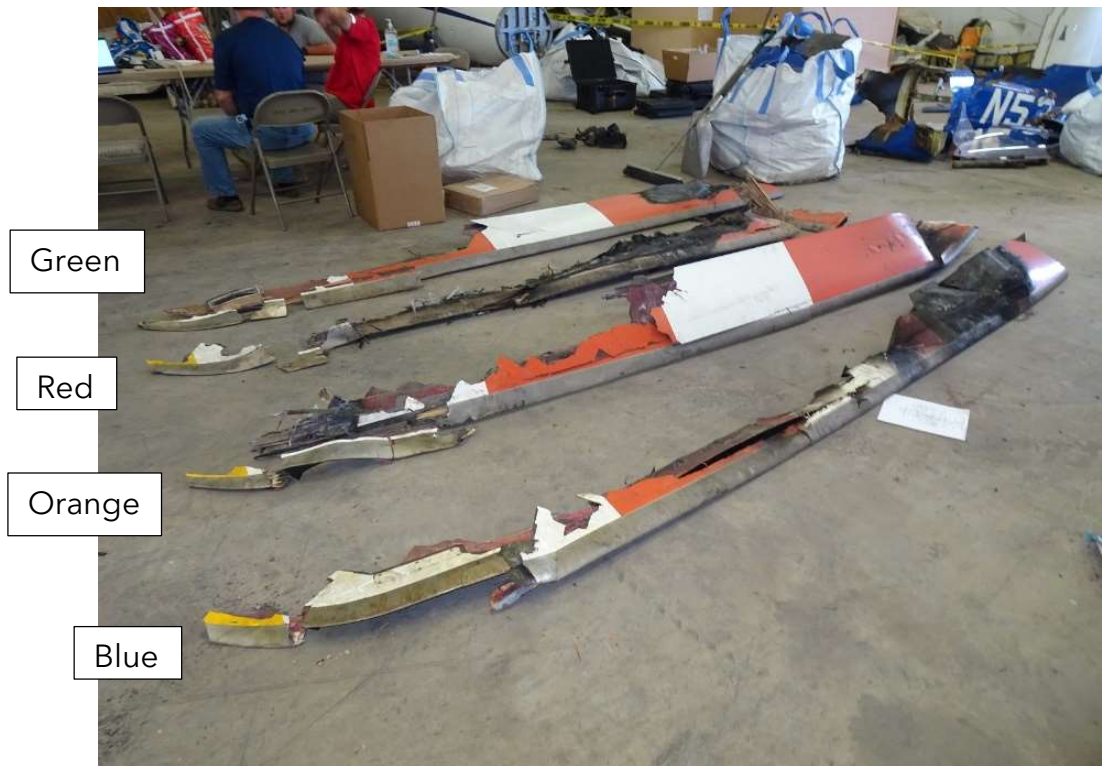
All four main rotor blades remained installed to their respective grips via blade pins. All four pitch horn and grip assemblies remained intact. Two separated tip weight boxes and two tip weight box covers were recovered in the debris field surrounding the main wreckage site. The 'blue' main rotor blade tip weight box and its cover remained installed in the blade. The fourth tip weight box and its cover were not found. **Figure 4** show a reconstruction of the recovered main rotor blades.

The 'blue' main rotor blade was continuous from its inboard end to the tip weight box, but exhibited spar fractures in multiple locations along its span. The inboard side of the 'blue' blade was thermally damaged due to the postcrash fire and the blade afterbody was not present from the blade midspan area (painted white) to its tip end.

The 'orange' main rotor blade was cut near its inboard end by first responders. The separated 'orange' blade was found on the ground and exhibited thermal damage due to the postcrash fire. The 'orange' blade afterbody was not present from the blade midspan area to its tip end.

The 'red' main rotor blade was missing the majority of its afterbody throughout its span. The 'red' blade spar exhibited multiple fractures on its inboard end and was

bent and embedded into the ground. The outboard section of the remnant 'red' blade was thermally damaged.

The inboard portion of the 'green' main rotor blade (painted orange) was thermally damaged near its trailing edge. The 'green' blade afterbody was present until the end of the midspan area of the blade. The remaining outboard section of the 'green' blade exhibited fragmentation.

Figure 4. A reconstruction of the four main rotor blades.

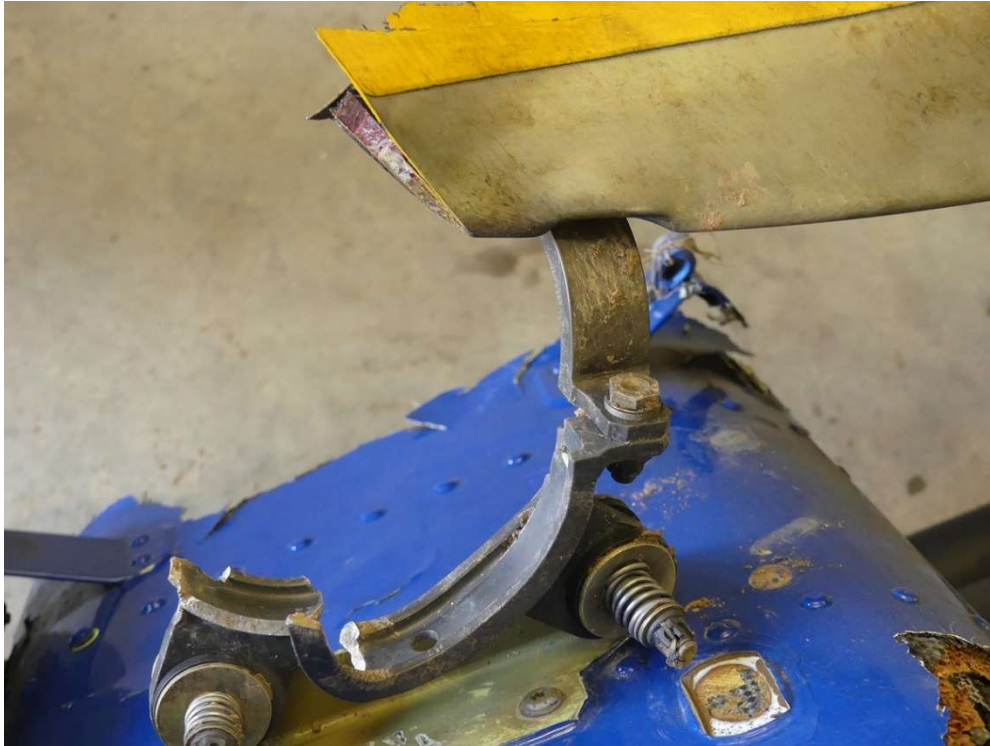
Three separated leading edge pieces near the tip end, including the tip cap lap joint, also known as the "taco patch", were found in the debris field surrounding the main wreckage. Two swept tip ends, which were fractured and separated, were reconstructed by the investigation team to the 'blue' and 'orange' main rotor blades. Two additional swept tip ends, also fractured and separated, exhibited impact damage with a width consistent with contact with the tail rotor drive system aft snubber and belonged to the 'red' and 'green' main rotor blades (**Figure 5**). All four swept tip ends were found in the debris field leading up to and around the main wreckage.

Figure 5. A leading edge impact mark on the tip end of the 'red' main rotor blade matched to the aft snubber. (Image courtesy of Bell.)

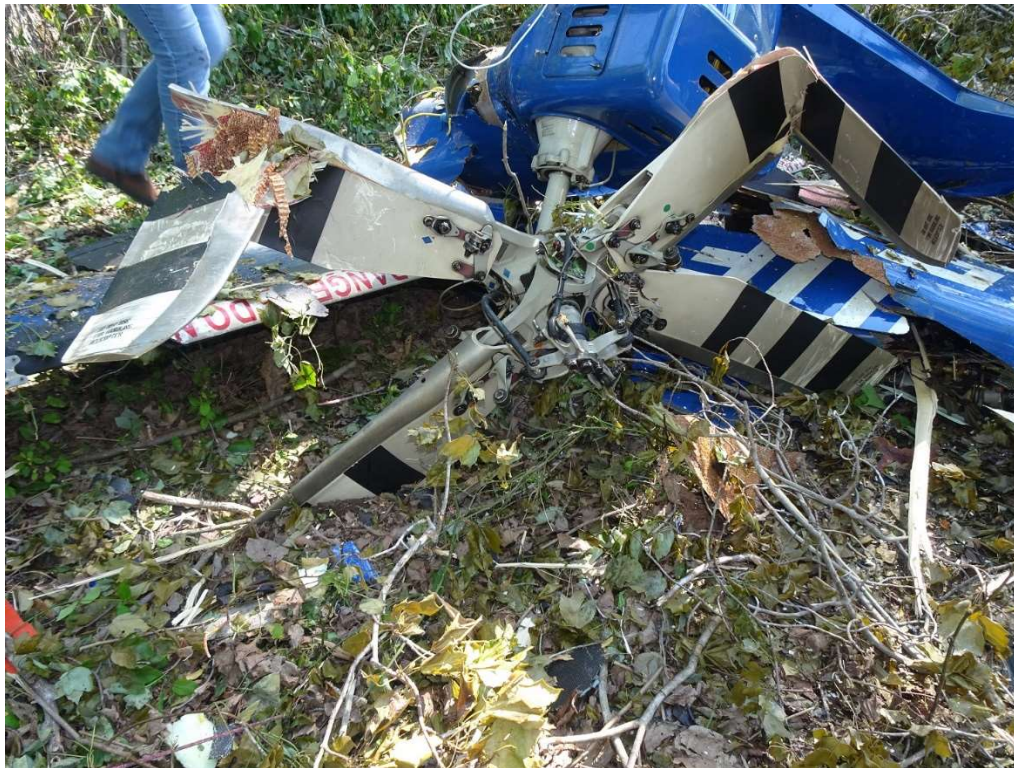
The tail rotor gearbox output shaft had fractured and separated, but the tail rotor remained attached to the tail rotor gearbox via the tail rotor pitch control rod, the latter of which was bent about 90°. The tail rotor hub remained attached to the outboard portion of the tail rotor gearbox output shaft (**Figure 6**). The inboard yoke ('blue' and 'red' tail rotor blades) was able to be manually teetered but the outboard yoke ('green' and 'orange' tail rotor blades) exhibited resistance to manual teetering. The curvic coupling between the upper and lower yokes were disengaged allowing for independent rotation of the upper yoke from the lower yoke.

All four tail rotor blades remained installed to their respective yokes. The 'blue' tail rotor blade had partially fractured chordwise, about midspan, and bent outboard, but the entire span of the 'blue' blade was present. The 'blue' blade tip was generally intact. Chordwise scuff marks were visible on the outboard portion of the 'blue' blade on both inboard and outboard surfaces of the blade. The 'orange' tail rotor blade was whole with no evidence of leading edge or spar fractures. The tip end of the 'orange' blade was embedded into the ground. The 'red' tail rotor blade exhibited no

evidence of fractures on its leading edge or spar and was generally intact except for the loss of a portion of the blade afterbody at its tip end. The 'green' tail rotor blade was partially fractured chordwise, about midspan, and bent outward. Chordwise scuff marks were present at the tip end of the 'green' blade, on both inboard and outboard surfaces. The paint on the inboard side of the 'green' blade exhibited bubbling consistent with exposure to the postcrash fire.

Figure 6. The tail rotor and tail rotor gearbox.

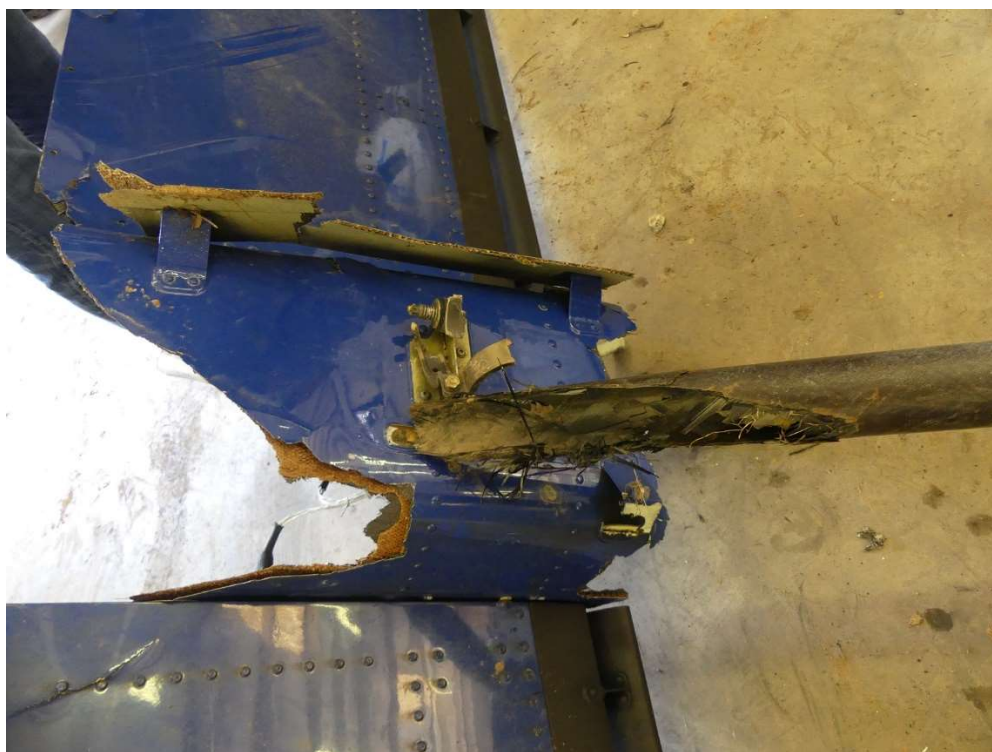
The steel tail rotor drive shaft was continuous to the fan blower shaft. The fan blower shaft and oil cooler blower remained installed on the airframe but were crushed from impact forces. The forward segmented drive shaft was attached at its forward end to the fan blower shaft but one of the trilobe flanges had fractured. The forward segmented drive shaft was fractured about 25 inches aft of its forward attachment flange. Two additional pieces from the forward segmented drive shaft were recovered: 1) the midsection of the forward segmented drive shaft, containing the stainless steel snubber sleeve, was found in the wreckage adjacent to the tail boom and 2) the aft section of the forward segmented drive shaft, about 40 inches in length, remained attached to a separated section of the tail boom and remained connected to a forward portion of the aft segmented drive shaft, about 23 inches in length, and the hanger bearing between them. The aft portion of the 34-inch section of the aft segmented drive shaft exhibited an angled cut (**Figure 7**). The segmented drive shaft hanger bearing and its mount remained attached to the tail boom. A 34-inch long section of the aft segmented drive shaft was found embedded near-vertically into the ground, about 18 inches of which was embedded into the ground.

Figure 7. The 34-inch long section of the aft segmented drive shaft, the aft end of which exhibited the angular cut.

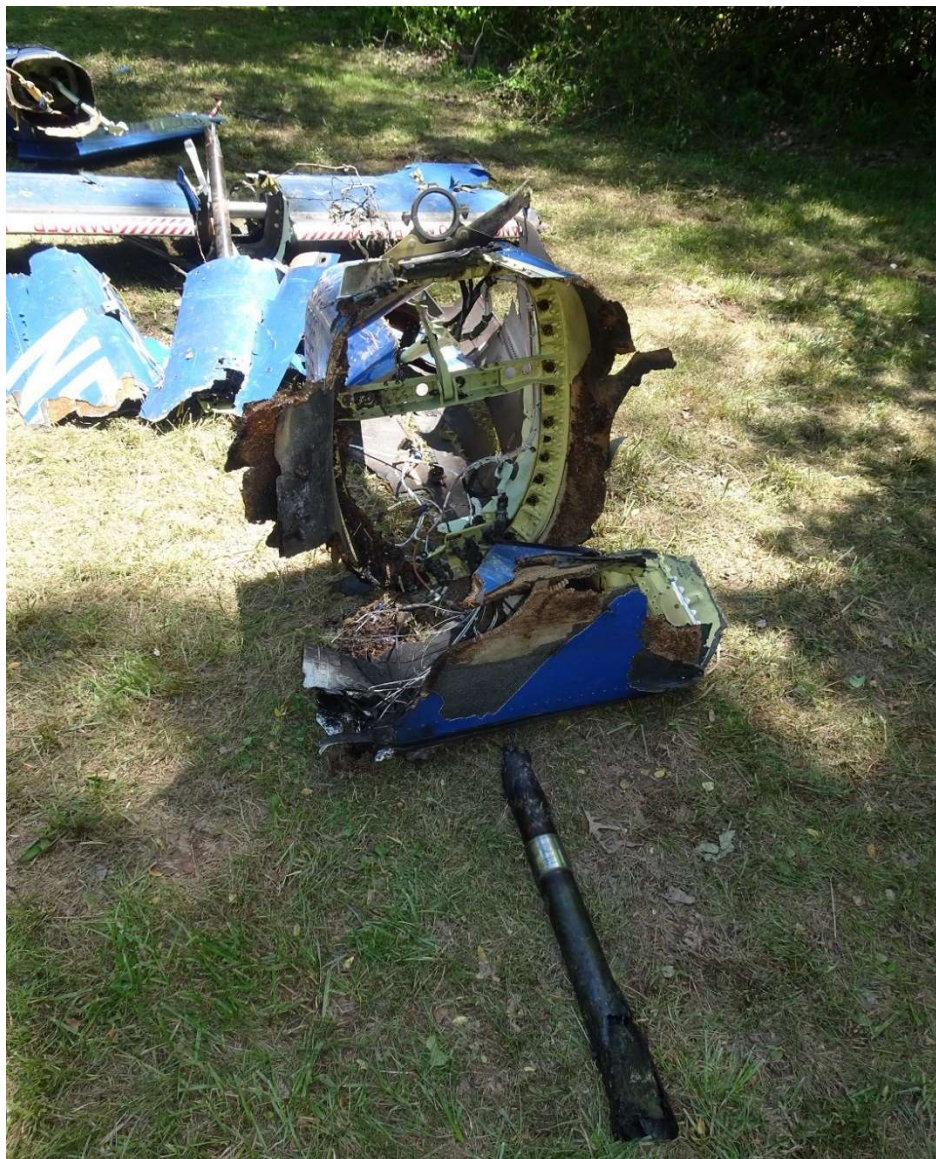
The forward snubber remained attached to a portion of the tail boom and did not exhibit impact deformation (**Figure 8**). A 5-inch long section of the aft segmented drive shaft remained connected to the tail rotor gearbox. A stainless steel sleeve for the aft snubber was found in the debris field and exhibited significant deformation. For the aft snubber mount on the tail boom, the left snubber mount remained attached but the snubber was fractured immediately adjacent to the mount. Additionally, the right snubber mount remained attached with a portion of the upper and lower halves of the snubber present and leaning to the right. A piece of a tail rotor drive shaft, semi-circular in its cross-section, was found about 172 feet from the main wreckage. Additional smaller fragments of composite tail rotor drive shaft were found in the debris field leading up to the main wreckage.

Figure 8. The midsection of the forward segmented drive shaft and the forward snubber installed on a piece of the tail boom.

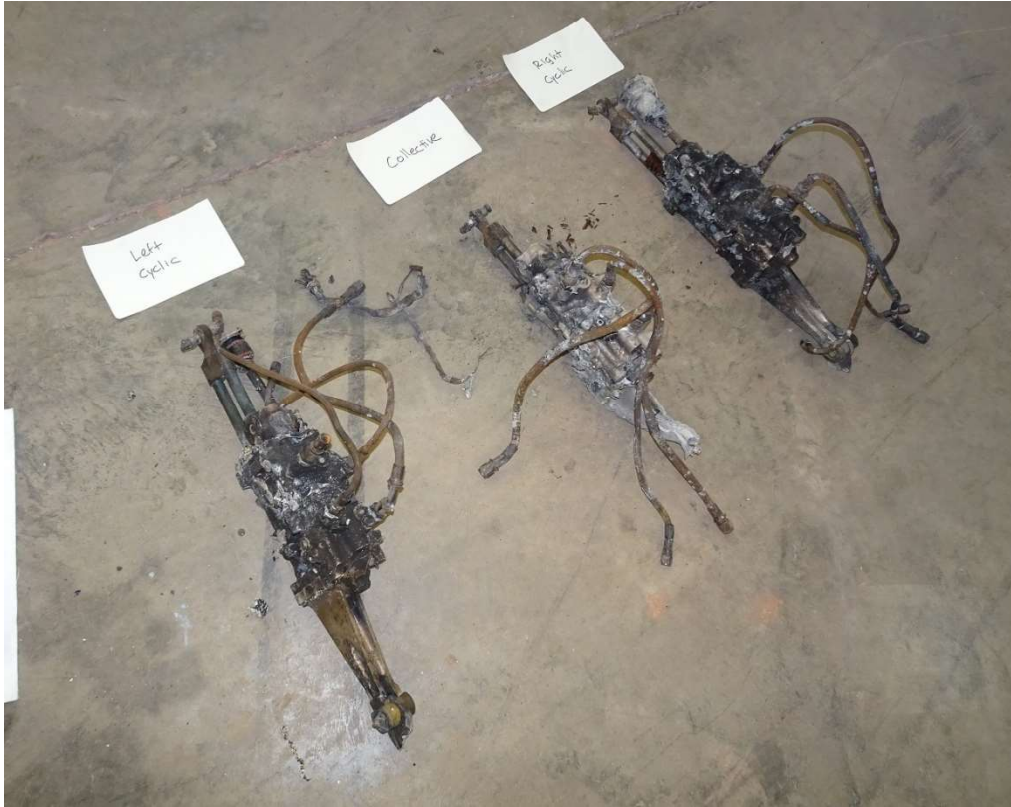
The majority of the flight control linkages from the cockpit flight controls to the stationary swashplate were thermally damaged or consumed by the postcrash fire. In the remnant pieces of the flight controls, none of the connection points between linkages and bellcranks exhibited evidence of fastener disconnection or separation. The main rotor servo actuator mounts, on the forward side of the main transmission housing, were mostly consumed by the postcrash fire and found separated and on the ground. The three main rotor servo actuators were found separated on the ground near the forward end of the main transmission. All three main rotor servo actuators exhibited thermal damage, and the data tags for the three servo actuators were separated and not found (**Figure 9**). The hydraulic lines remained connected to the three servo actuators, allowing for identification of their positions. The tail rotor servo actuator was found in the tail boom wreckage and its hydraulic lines remained connected. The control linkages connecting to the tail rotor servo actuator were present but fractured in overload. Additional details of the servo actuators can be found in Section 4.0 of this report.

Figure 9. The three main rotor servo actuators after recovery.

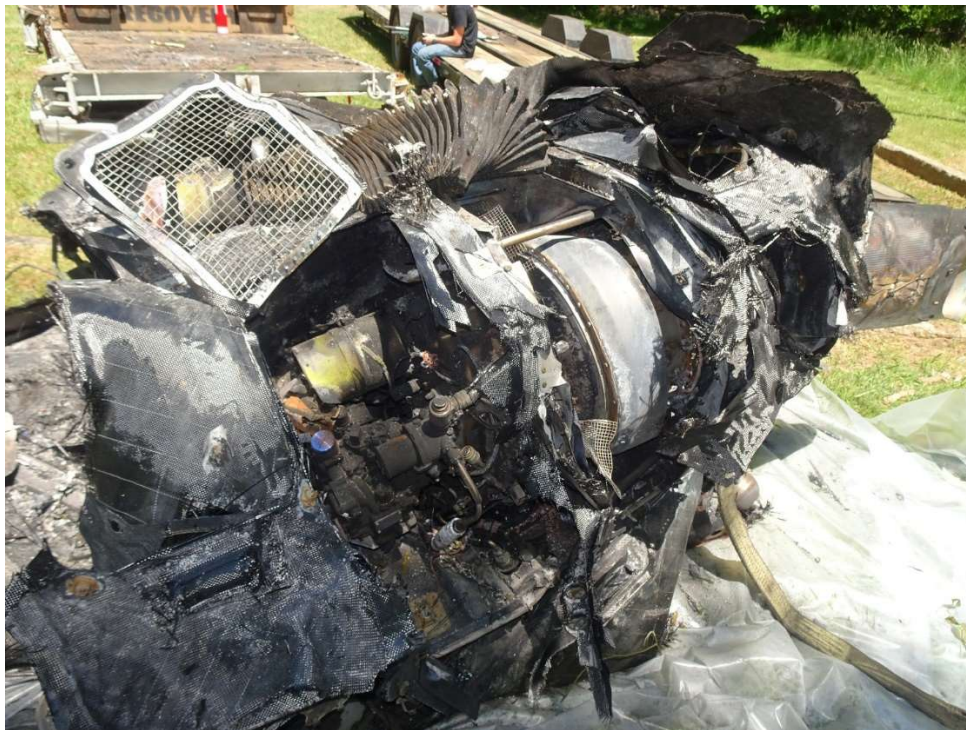
The No. 1 engine remained installed on the engine deck and was thermally damaged (**Figure 10**). Its front-left mount was present but the mount bolt had fractured in overload. The aft mount remained installed but had bent forward. The inlet barrier filter was partially separated from its frame, but the inlet screen was intact. The inlet barrier filter was removed and the first stage compressor blades were examined and exhibited no damage to their leading edges. The No. 1 engine data collection unit (DCU) remained attached to the engine but its housing was thermally compromised, exposing its internal circuit card. The starter-generator could not be manually rotated, but the engine output coupling was able to be manually rotated. The No. 1 EEC remained attached to the airframe and its housing was covered in soot.

Figure 10. The No. 1 engine on the engine deck after removal from the main wreckage site. The inlet screen and barrier filter were removed by investigators.

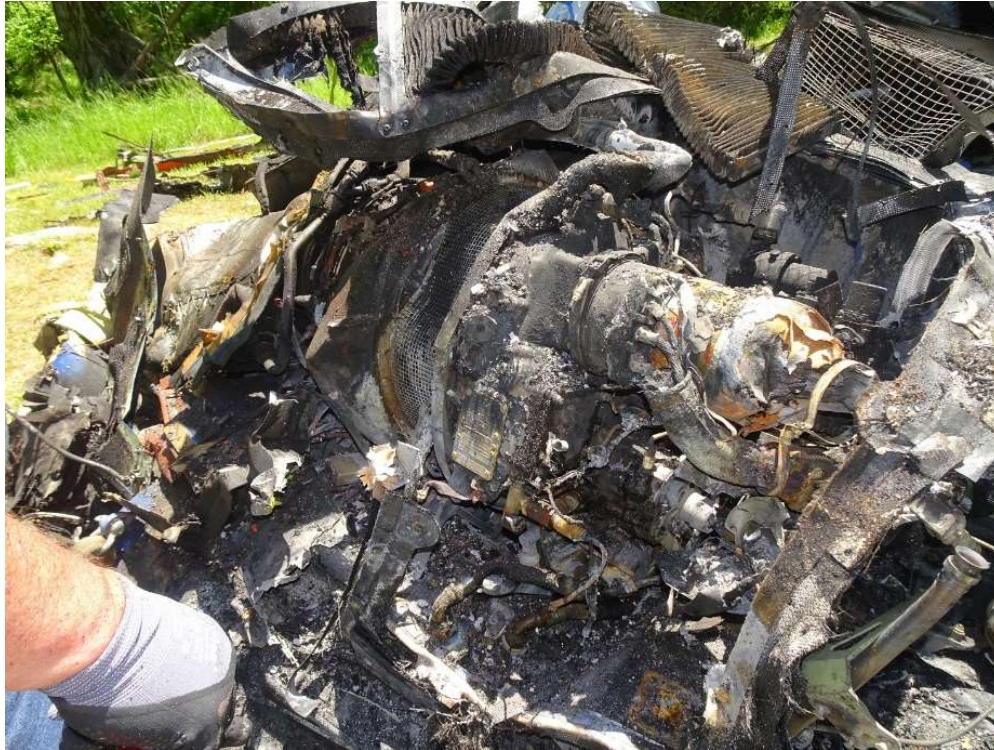
The No. 2 engine remained installed on the engine deck and was thermally damaged (**Figure 11**). The inlet barrier filter remained installed on its frame and the inlet screen was intact. The inlet barrier filter was removed and the first stage compressor blades were examined and exhibited no damage to their leading edges. The No. 2 engine data collection unit (DCU) remained attached to the engine but its housing was thermally compromised, exposing its internal circuit card. The starter-generator was manually rotated and a corresponding rotation of the first stage compressor was observed. The engine output coupling was not able to be manually rotated. The No. 2 EEC remained attached to the airframe and its housing was covered in soot.

Figure 11. The No. 2 engine on the engine deck after removal from the main wreckage site. The inlet screen and barrier filter were removed by investigators.
