# National Transportation Safety Board

ERA22FA279

Group Chair's Factual Report

Location: Amherstdale, West Virginia  
Date: June 22, 2022  
Time: 1645 eastern daylight time  
Helicopter: Bell UH-1B, registration N98F

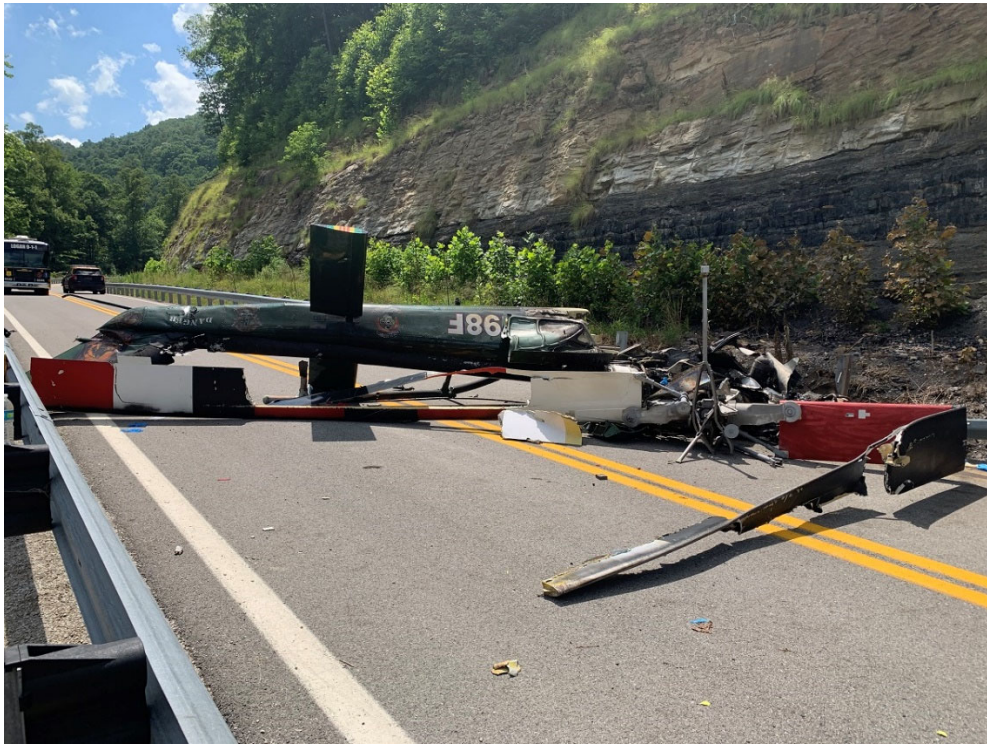
The helicopter came to rest on its right side, partially inverted, at a heading of 335° magnetic (**Figure 1**). The accident location was about 37°52'6" N by 81°50'35" W on an asphalt road that was adjacent to a steep rock face to the north. Near the top of the steep rock face, about 40 feet high, pieces of Plexiglas, a blue colored T-fitting, a segment of spring, the aft cap of the left skid, and a rock with green paint transfer

**Figure 1.** The main wreckage site with the steep rock face to the right in the image.

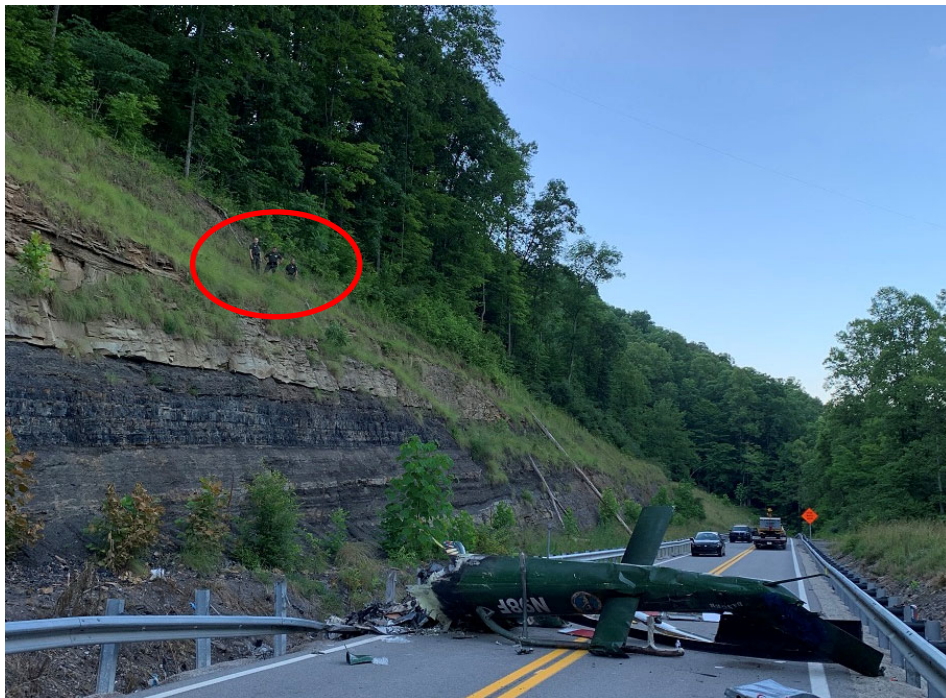
was found north of the main wreckage (Figure 2). A section of tail rotor blade was also found on this steep rock face.

**Figure 2.** The red circle denotes the area where pieces of Plexiglas, the aft cap of the left skid, a tail rotor blade segment, and a green paint transfer onto a rock.

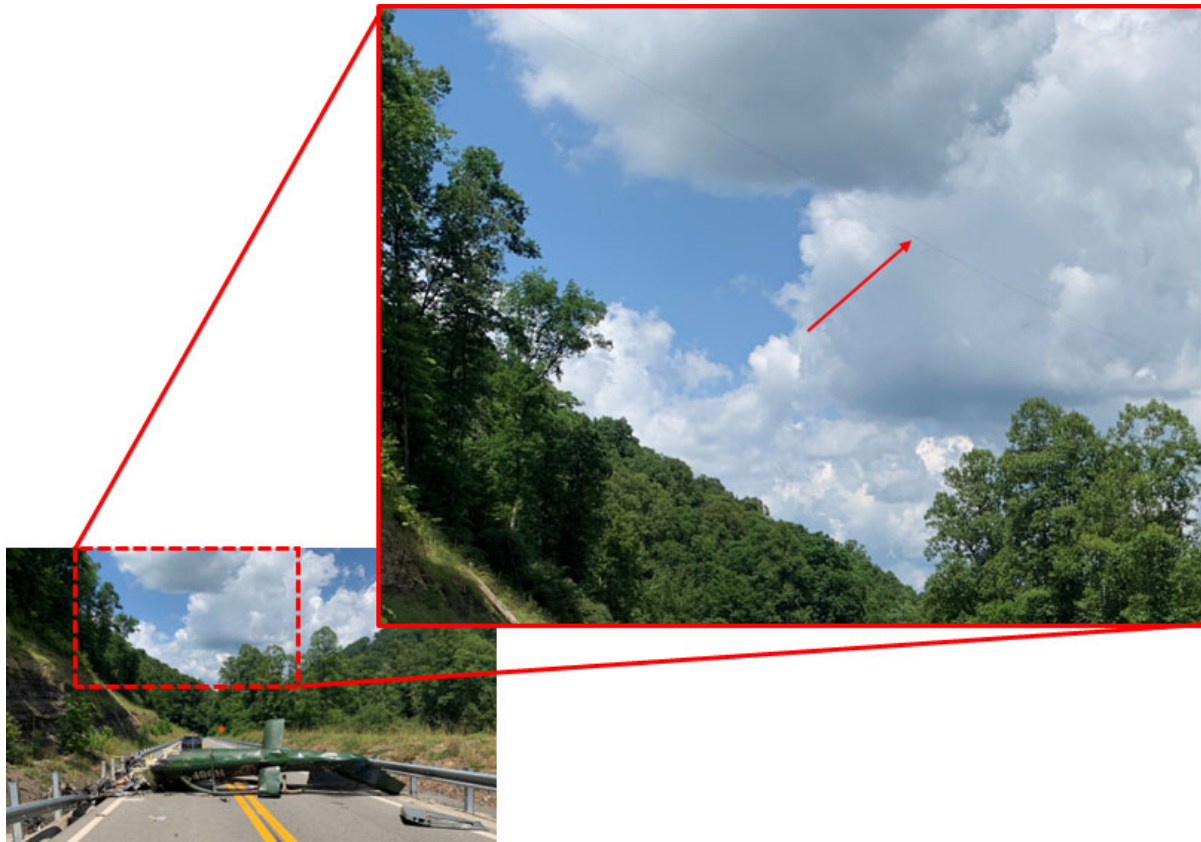
About 542 feet to the northeast of the wreckage, a single [inactive] powerline, about 180 feet high, remained suspended in the air and crossed the road (**Figure 3 and Appendix A**). Two severed [inactive] powerlines were found on the ground and displaced toward the wreckage, about 220 feet and 397 feet, from the single suspended powerline (**Figures 4 and 5**). Google Street View (images circa June 2021) of the location of the single powerline still suspended in the air showed there were previously three power lines spanning the road (**Figure 6 and Appendix A**). A piece of the main gearbox fairing (**Figure 7**) was found in the vegetation to the south of the road about 225 feet northeast of the wreckage.

**Figure 3.** A single suspended powerline about 542 feet northeast of the main wreckage.

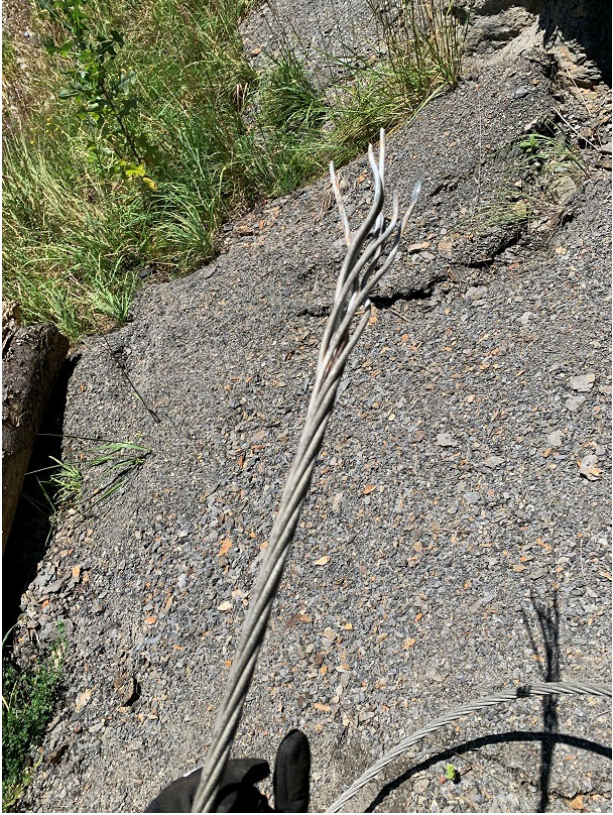
**Figure 4.** The severed end of powerline about 220 feet away from the single suspended powerline.

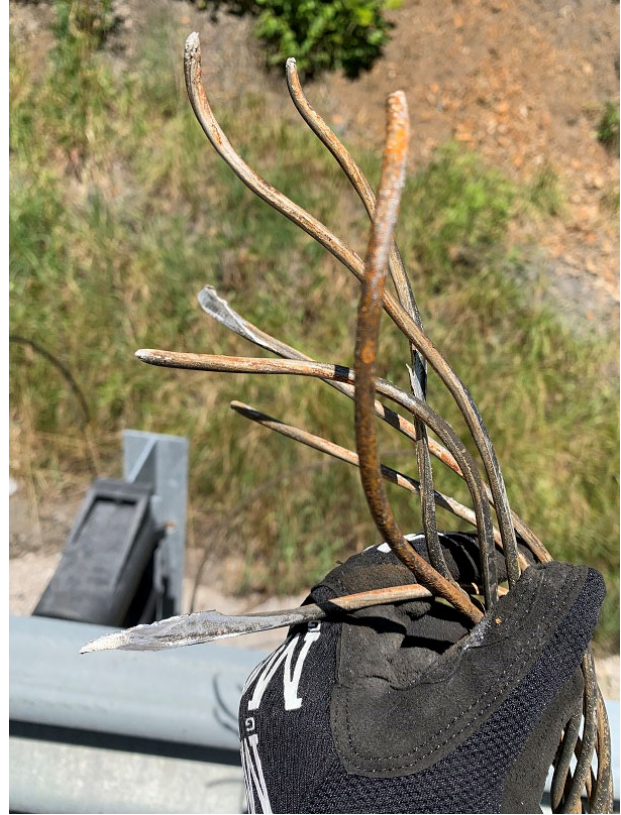
**Figure 5.** The severed end of the powerline about 397 feet away from the single suspended powerline.

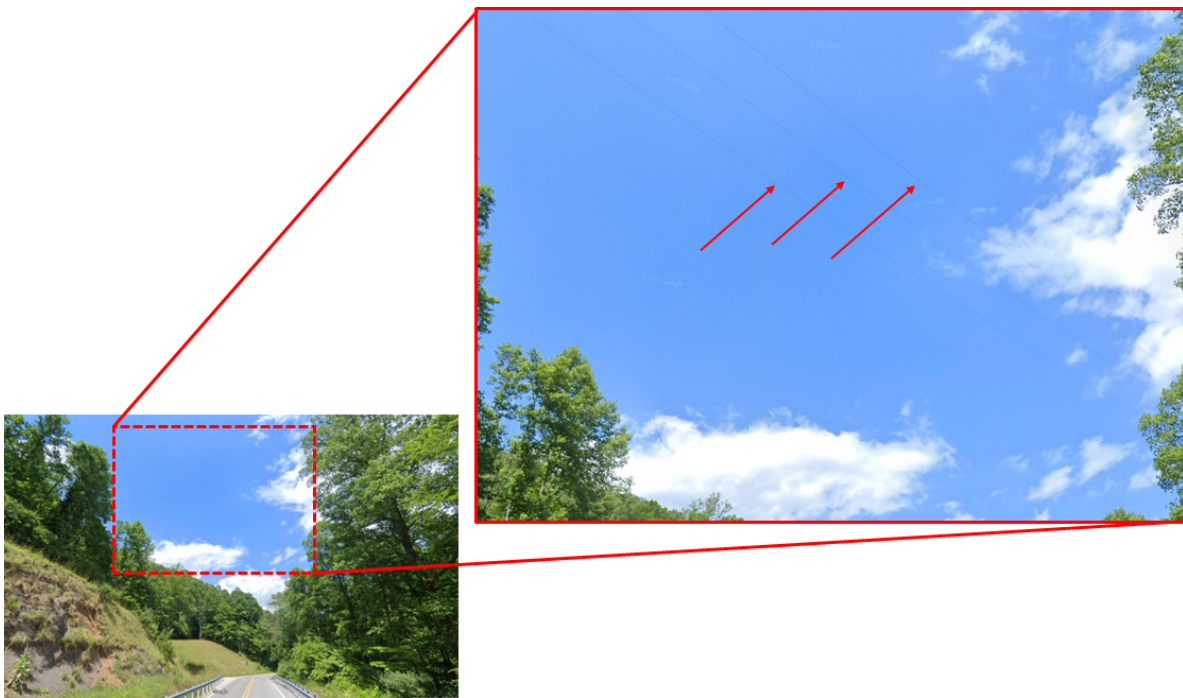
**Figure 6.** Three powerlines visible in Google Street View near the accident site.

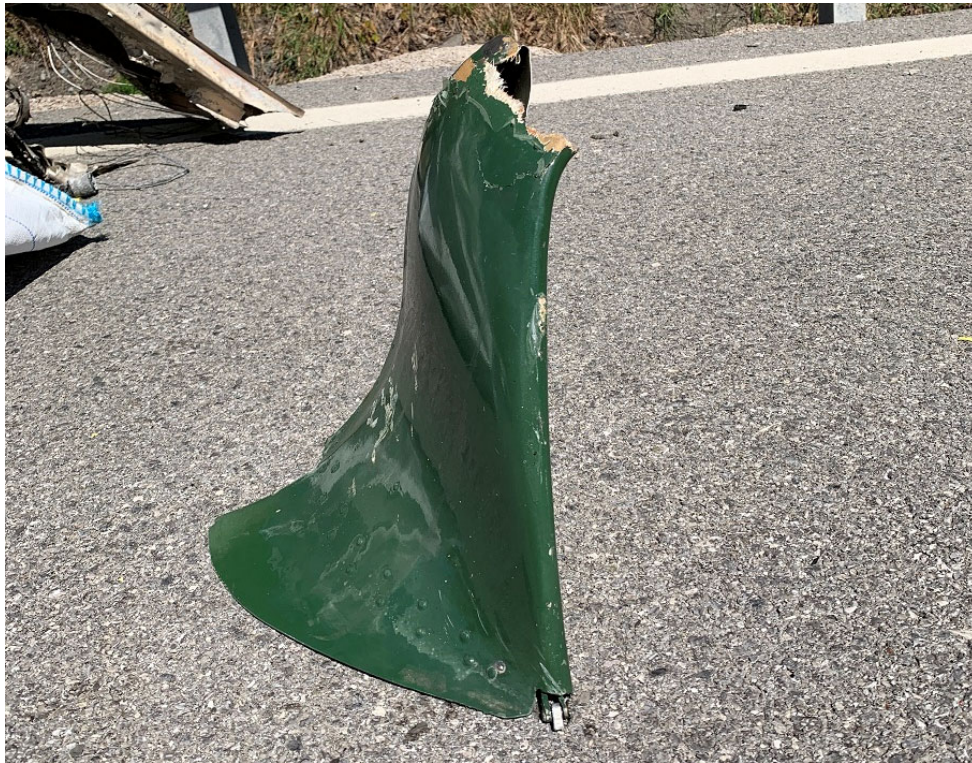
**Figure 7.** A fractured piece of the main gearbox forward fairing found about 225 feet northeast of the main wreckage.

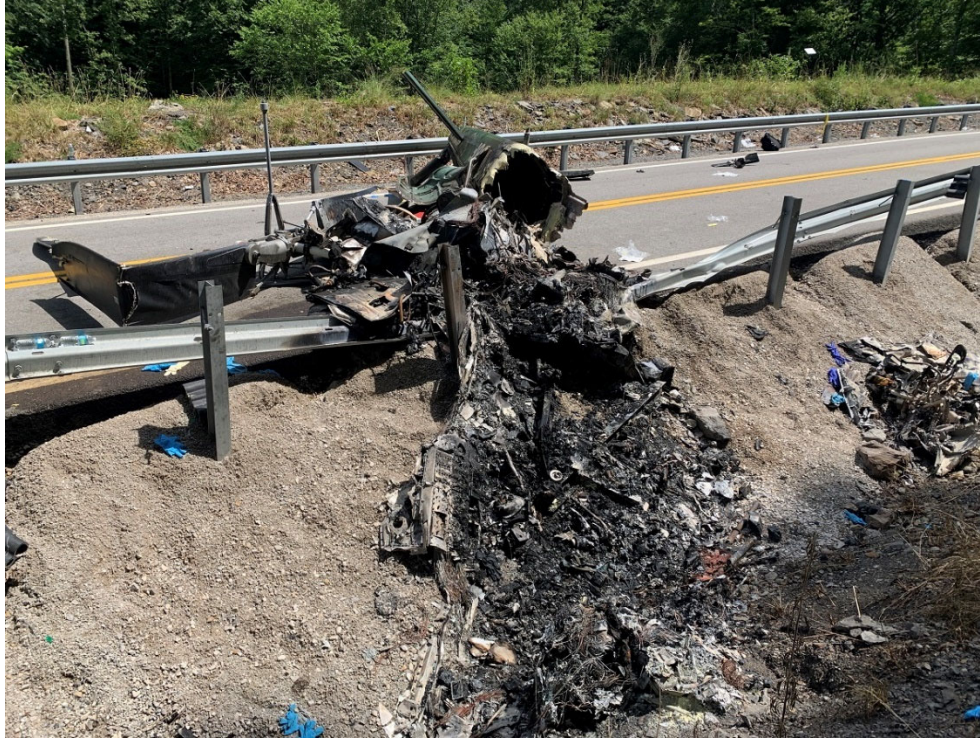
The cockpit and cabin had impacted the road and a guardrail, and both were consumed by the postcrash fire (**Figure 8**). The empennage, composed of the tail boom, vertical fin, and horizontal stabilizer, remained attached to the aft fuselage. The right horizontal stabilizer was impact deformed at its tip end and the left horizontal stabilizer was intact. The vertical stabilizer and tail boom exhibited wrinkling on its skin from impact. Additionally, at the lower portion of the vertical fin, where it attaches to the tail boom, the cowling was impact deformed, possibly due to main rotor blade contact.

**Figure 8.** The cockpit and cabin wreckage.

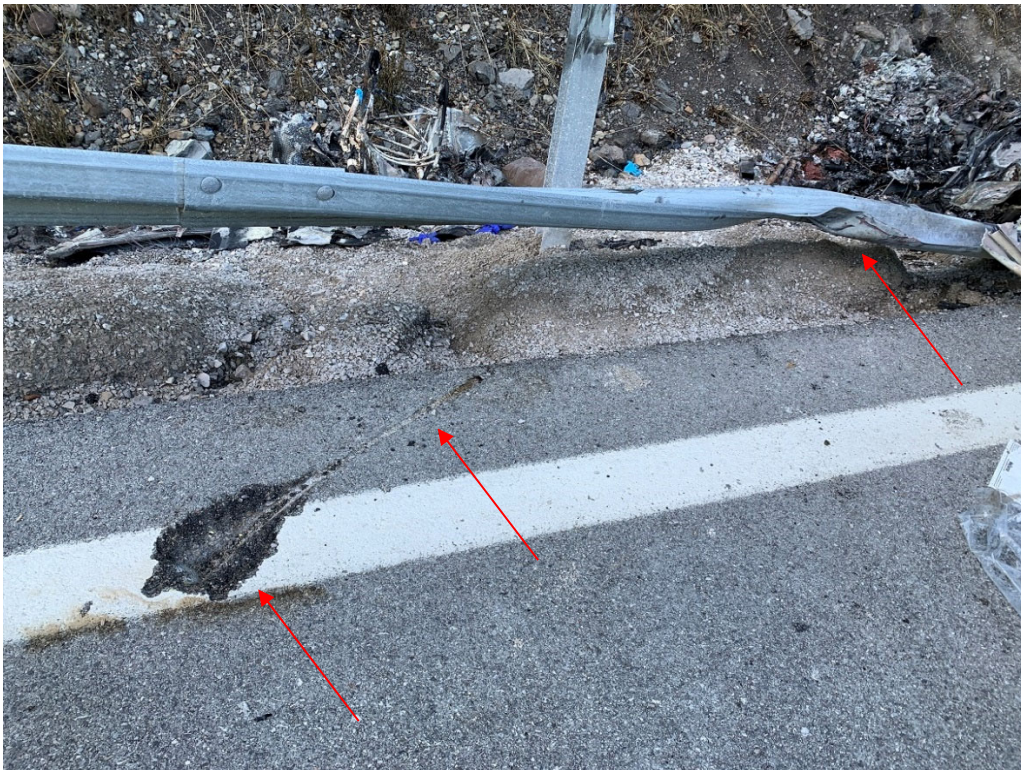
The 'red' main rotor blade was P/N 204-011-001-15 and S/N A00000015. The outboard half of the blade exhibited deformation in the direction opposite of normal rotation and the afterbody in this section was fragmented into multiple pieces. These afterbody pieces were found to the east of the main wreckage. The tip end had impact damaged that matched an impact gouge on the road (**Figure 9**). The impact gouge on the road was about 3 inches deep and generally oriented to the northeast. The leading edge spar was continuous to the tip. There was a chordwise upward bend near the inboard side of the main rotor blade.

**Figure 9.** Suspected ground and guardrail strike from the 'red' main rotor blade.

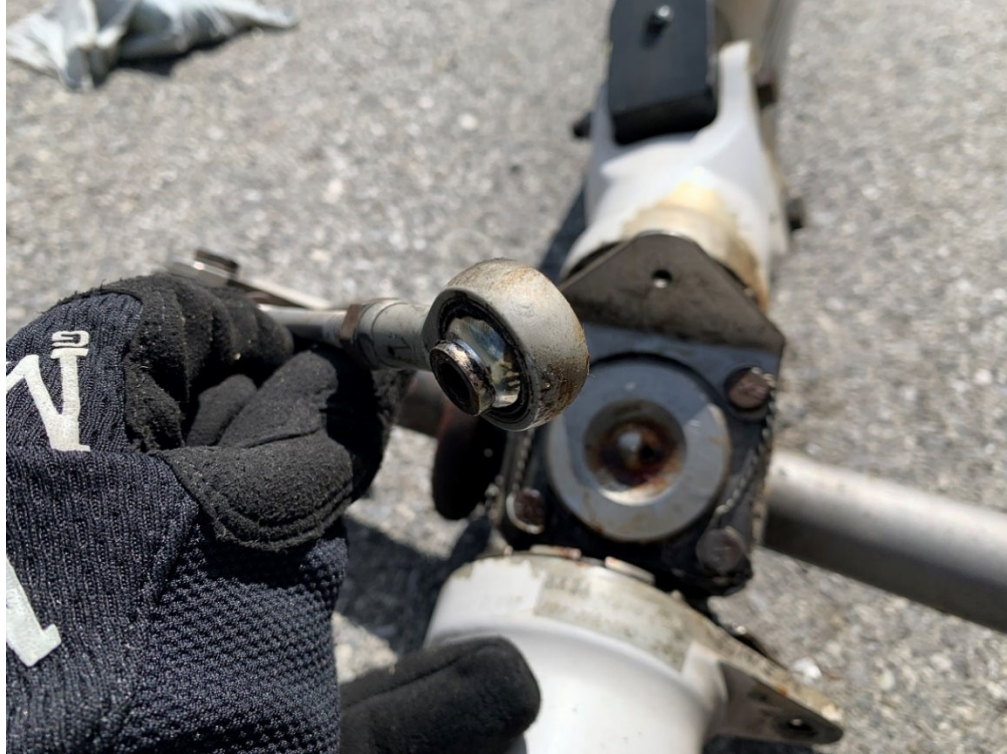
The outboard section of one tail rotor blade, S/N ATR72106, was found on the side of the road about 10-20 feet away from the main wreckage. The pitch change link of tail rotor blade S/N ATR72106 remained attached to the pitch change crosshead but was separated from its pitch horn; the hardware was not present at the pitch change horn (**Figure 10**). However, the inboard metal boss, which mates to the pitch change link, exhibited an indent deformation localized to about 1/5 of its circumference (**Figure 11**).

**Figure 10.** The separated pitch change link for tail rotor blade ATR72106.

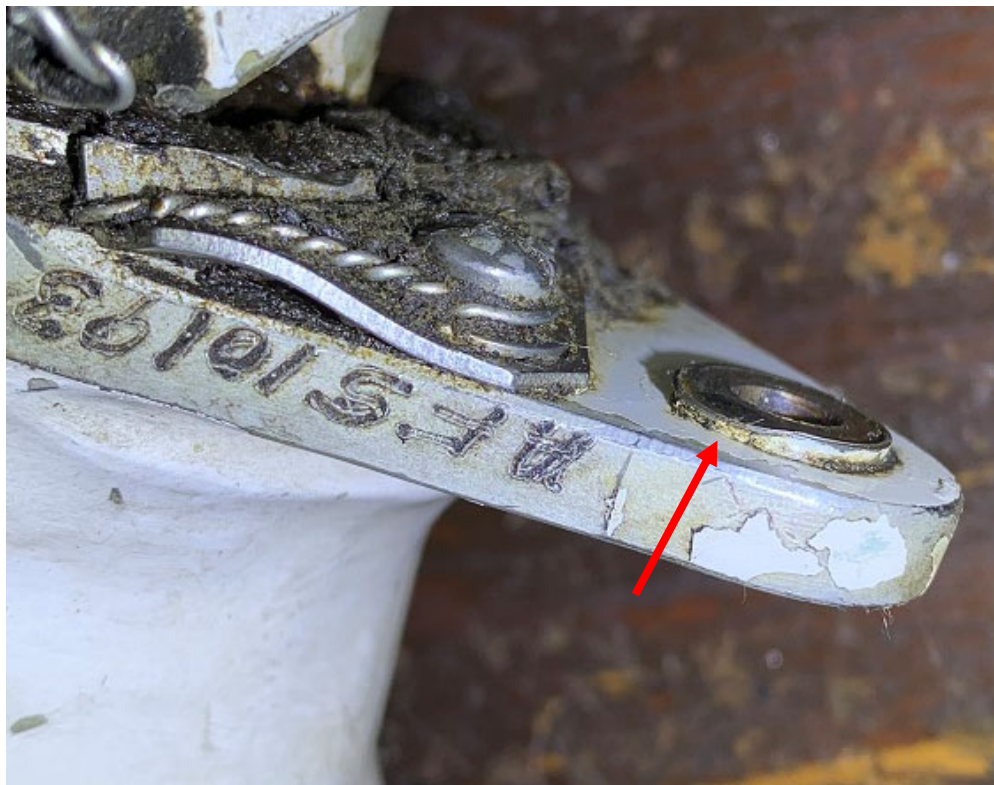
**Figure 11.** The red arrow points to the visible indentation on the metal boss of the pitch link connection to tail rotor blade S/N ATR72106.

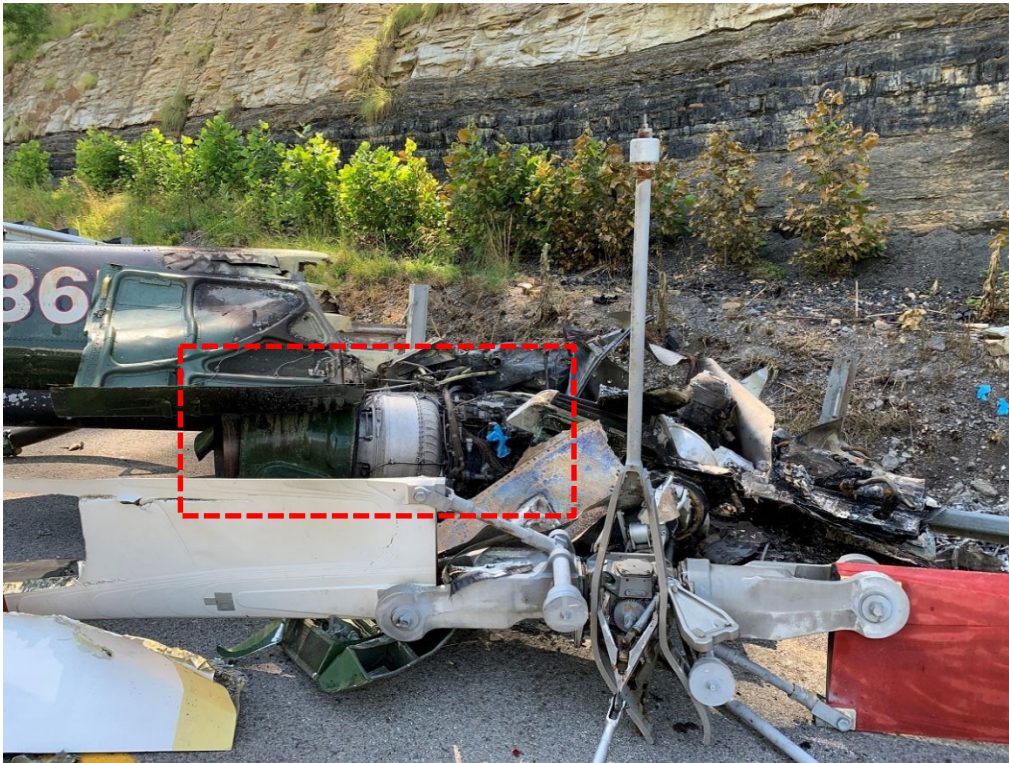
The engine, S/N LE-12411, remained partially attached to the airframe but remained within its normally installed area (**Figure 12**). Pieces of the inlet screen were present but was separated from the engine's inlet duct. The engine inlet duct was present but was separated from the engine inlet housing. When viewing the power turbine blades through the engine exhaust diffuser, two blades had fractured and separated near the blade root (**Figure 13**). There was one intact turbine blade between the two separated blades. The remaining power turbine blades appeared intact, full length, and did not exhibit thermal damage. The investigation of the accident engine can be found in the Powerplants Group Chair's Factual Report, found in the docket for this investigation.

**Figure 12.** The red box identifies the engine within the wreckage.

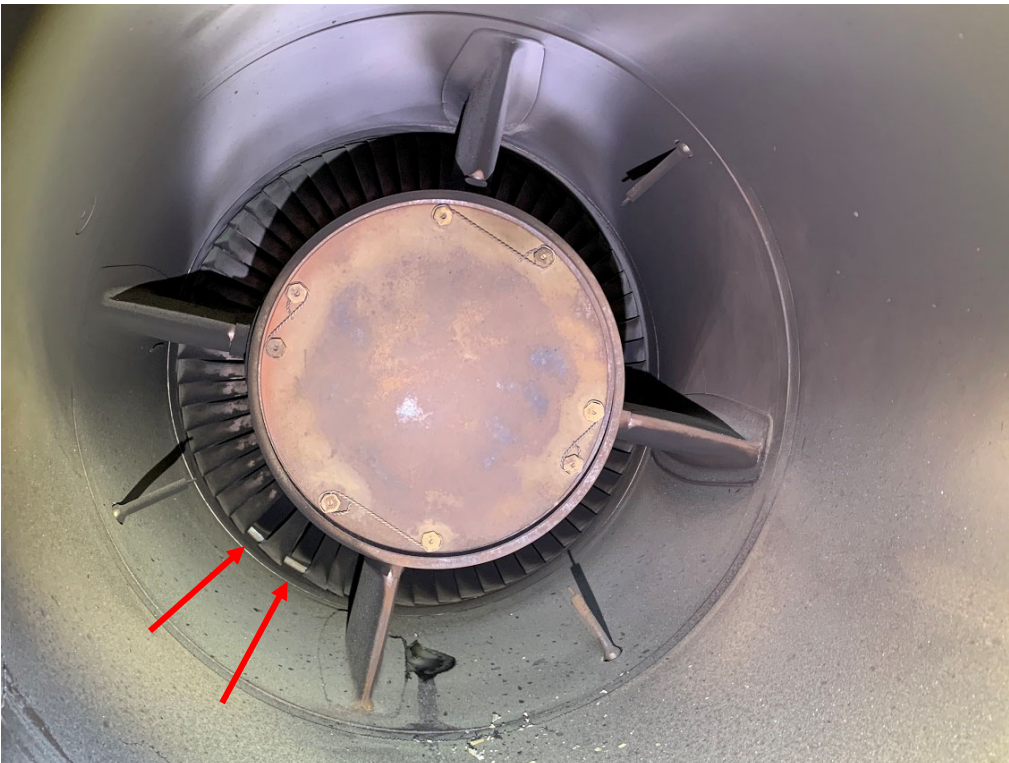
**Figure 13.** The power turbine blades viewed through the exhaust. The red arrows point to the two missing power turbine blades.

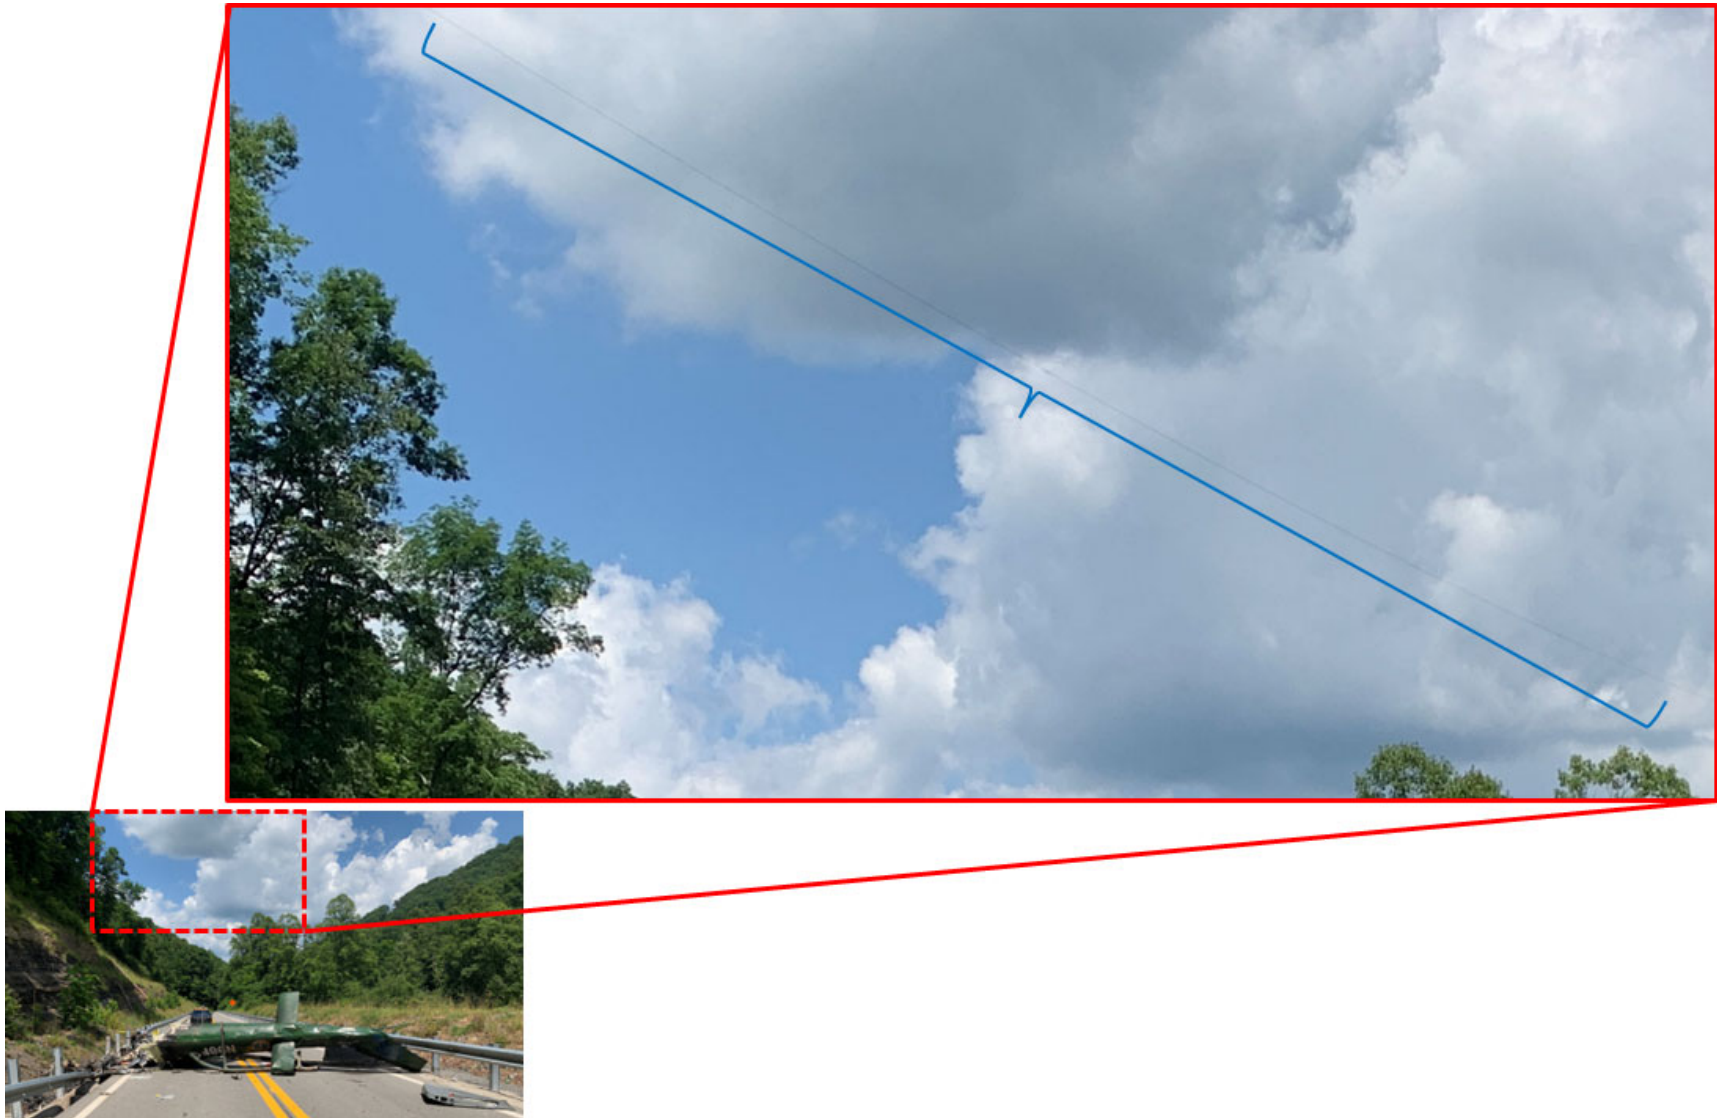
**Figure A-1.** A larger image of the single suspended powerline about 542 feet northeast of the main wreckage.

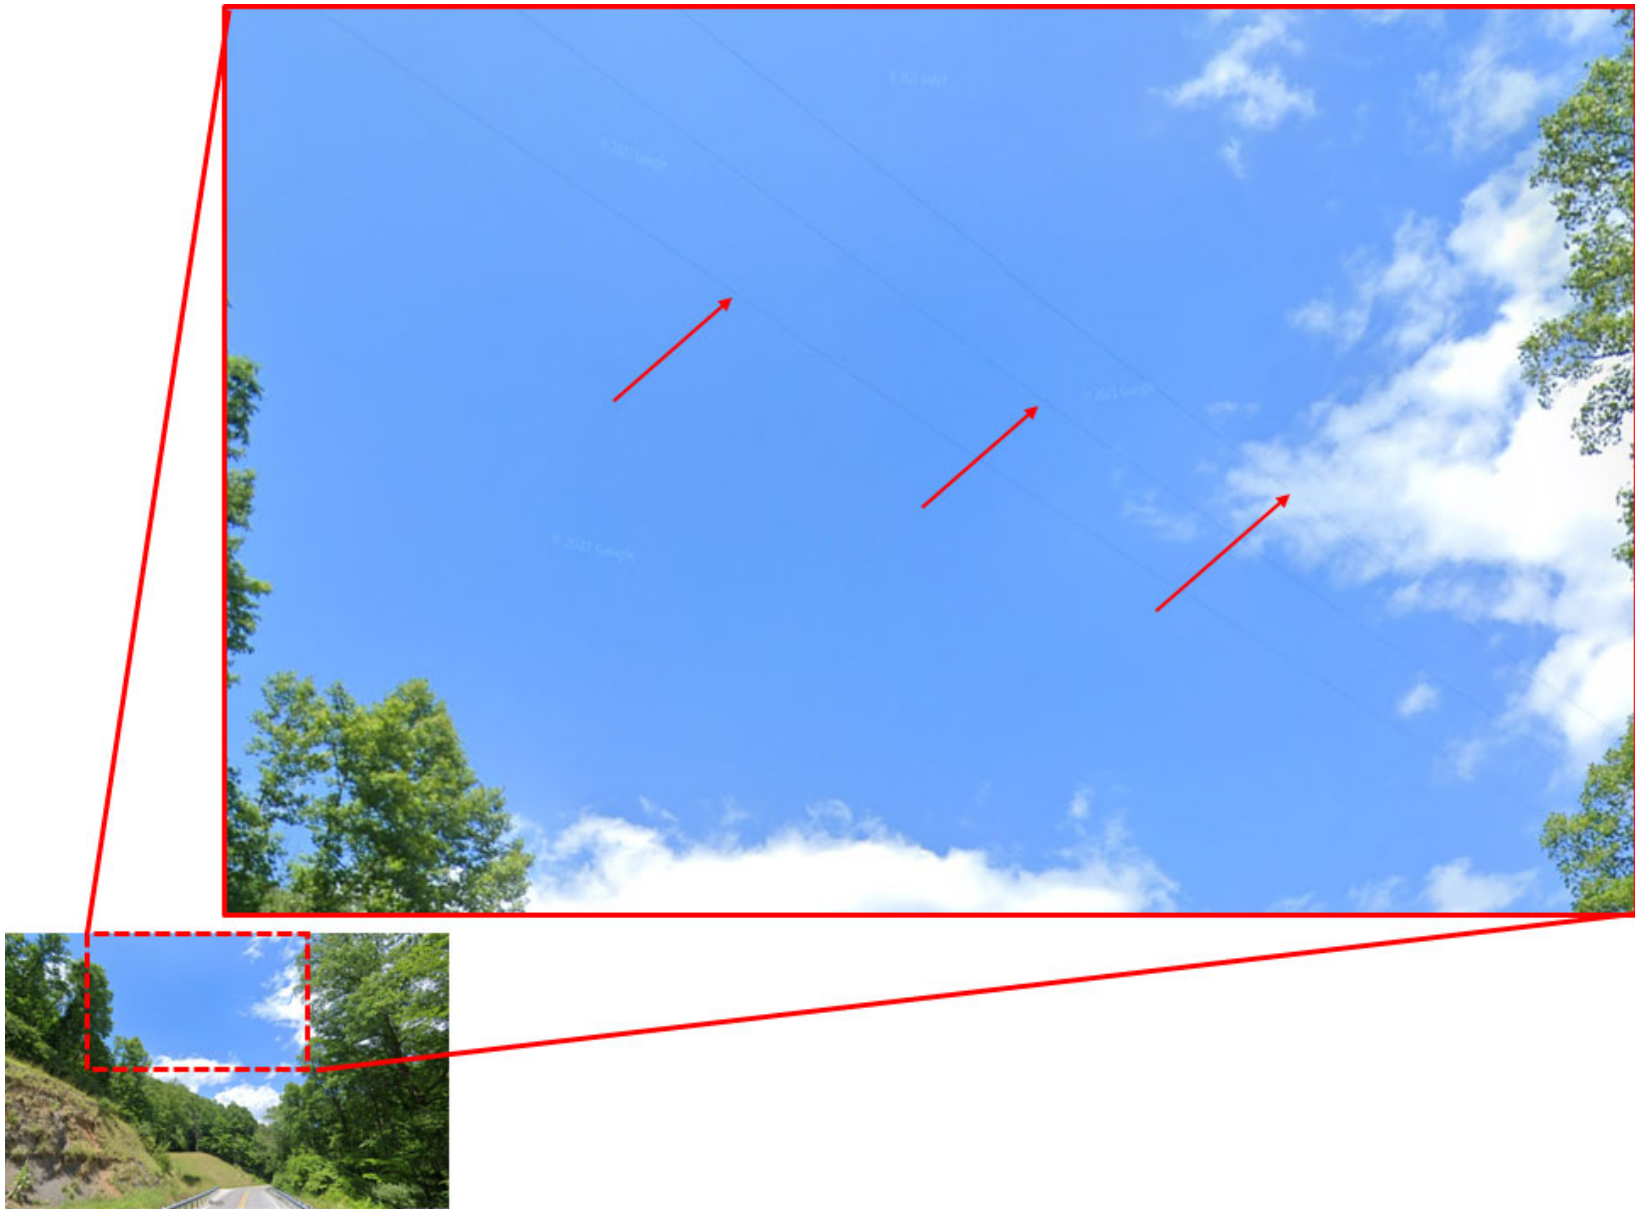
**Figure A-2.** A larger image of the three powerlines visible in Google Street View near the accident site.
