National Transportation Safety Board

ERA22LA145

AIRWORTHINESS

Group Chair's Factual Report

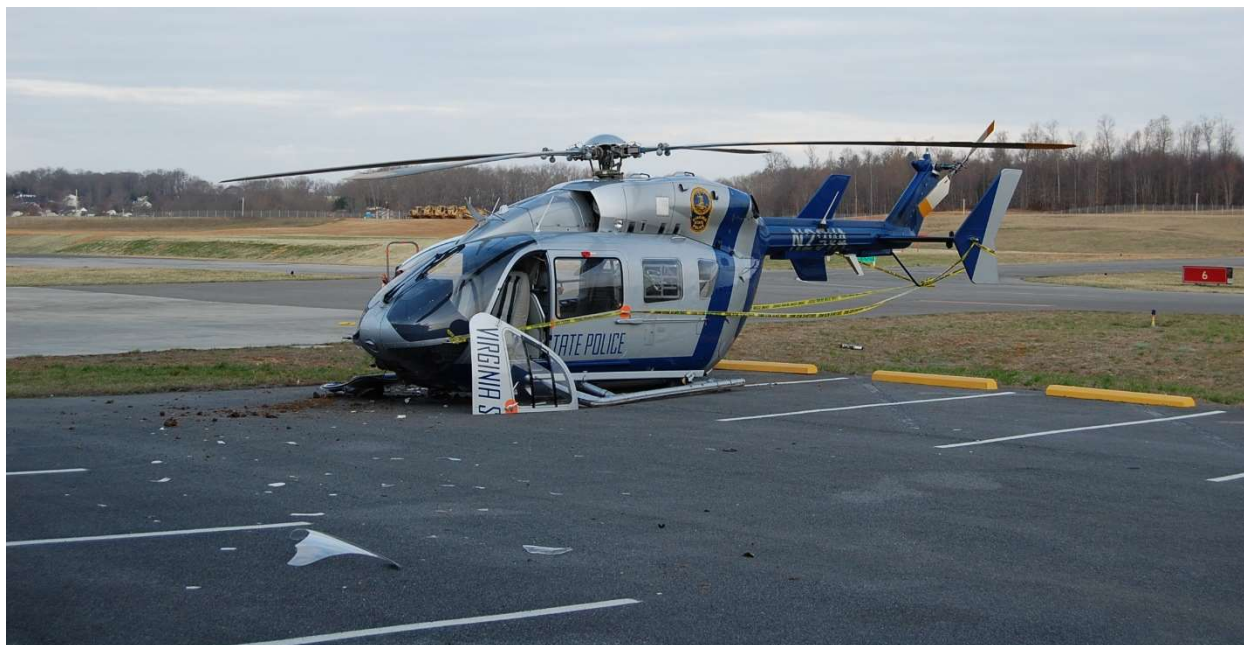
Figure 1. The accident helicopter at the accident site. (Photo courtesy of Virginia State Police.)

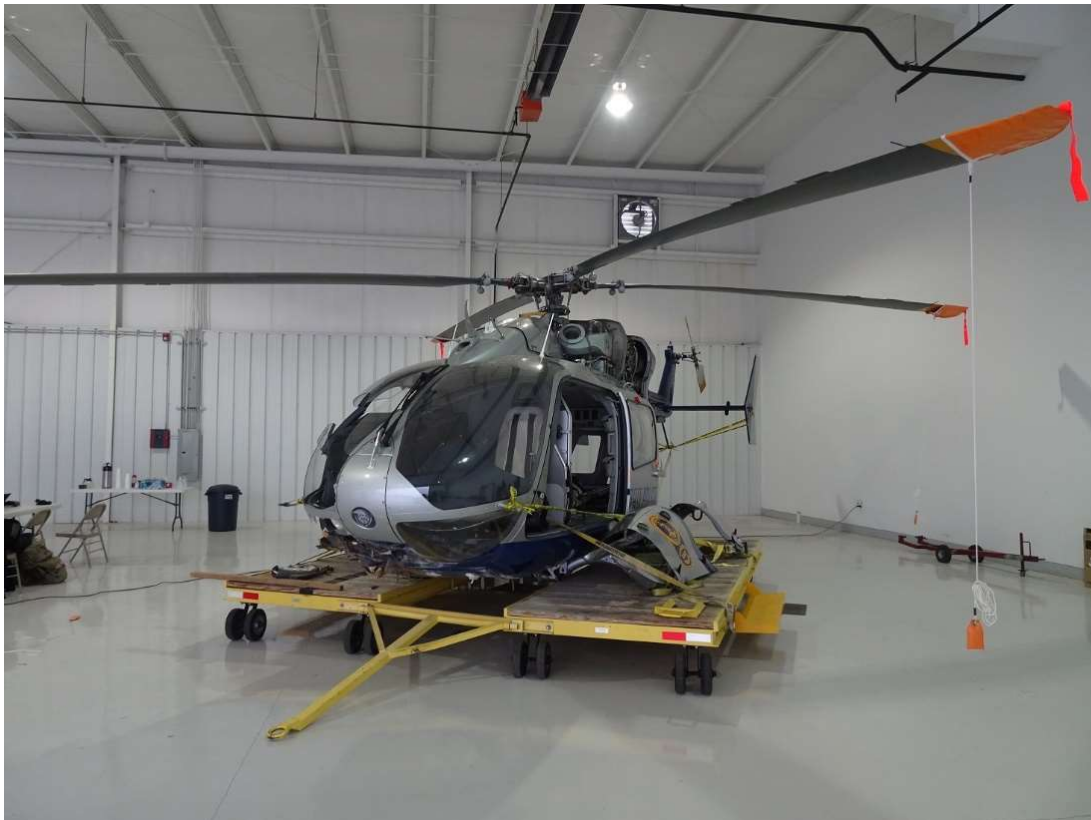
The main fuselage was whole and the tail boom and empennage remained attached to the main fuselage (**Figure 2**). The forward nose, nose shell, and bottom access panels of the main fuselage exhibited ground impact deformation. The right chin bubble window and right windscreen were fractured. The left chin bubble window and left windscreen were intact. The right sliding cabin door and both left and right cockpit doors were separated from the main fuselage. The left sliding cabin door remained installed on the airframe. The clamshell doors remained installed at the aft end of the main fuselage.

The right landing gear skid tube and step had fractured and separated from the landing gear. The left skid tube and step remained attached to the landing gear crosstubes but were deformed outward. The landing gear's forward and aft crosstubes remained attached to the airframe. The forward crosstube was fractured on its right side, near its fuselage attachment point. The aft crosstube was fractured near its right skid attachment point. Both crosstubes had moved laterally to the right in relation to the landing gear fittings.

Figure 2. The accident helicopter after recovery to a hangar.

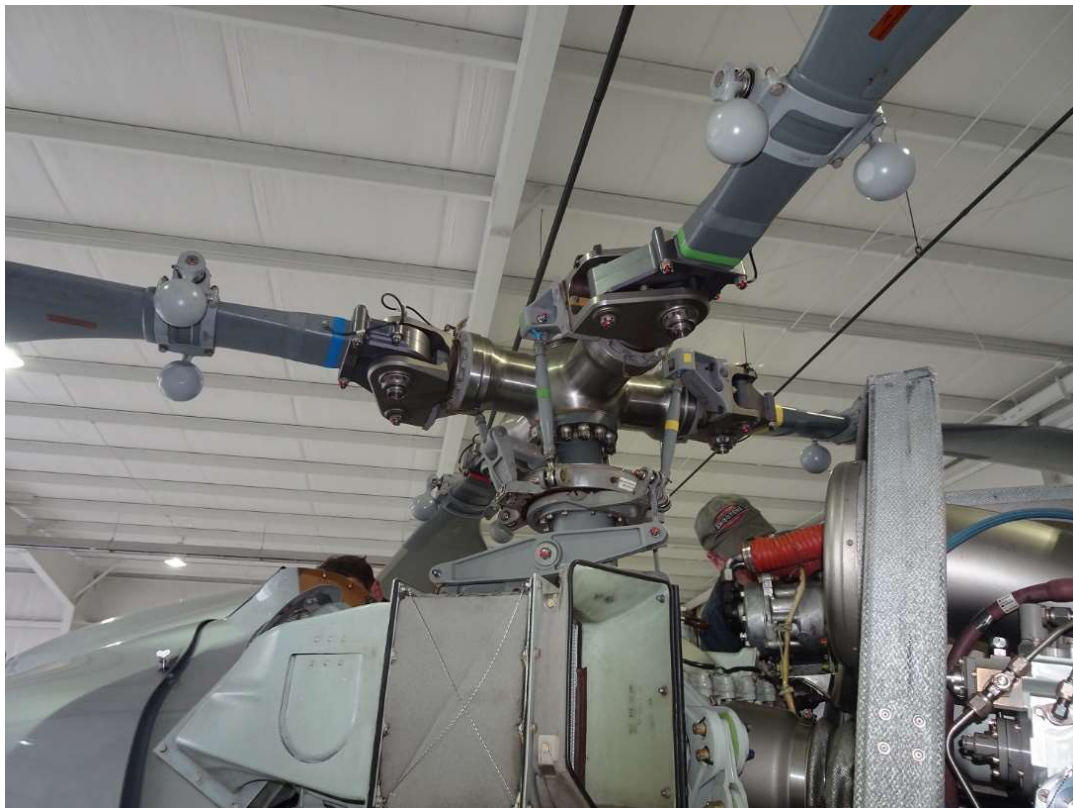
All four main rotor blades remained attached to the hub and were whole (**Figure 3**). The 'red' and 'yellow' blades exhibited impact damage on its leading edge consistent with contact with the upper wire strike cutter. The 'blue' and 'green' main rotor blades exhibited impact marks on their lower surfaces consistent with contact with the upper wire strike cutter. The main rotor head remained attached to the main rotor shaft. There were no missing or separated components from the main rotor head. The oil reservoir at the top of the main rotor head showed no observable oil level. When the access panel in the cabin, underneath the main transmission, was removed, residual oil, likely from the main rotor head, was observed dripping down.

The swashplate assembly remained installed and intact. All four pitch change links remained connected between the rotating swashplate and the main rotor blades. The rotating scissors remained connected between the drive plate, connected to the bottom side of the main rotor hub, and the rotating swashplate. The pitch, roll, and collective control levers remained installed and exhibited no anomalous damage.

Figure 3. The main rotor head.

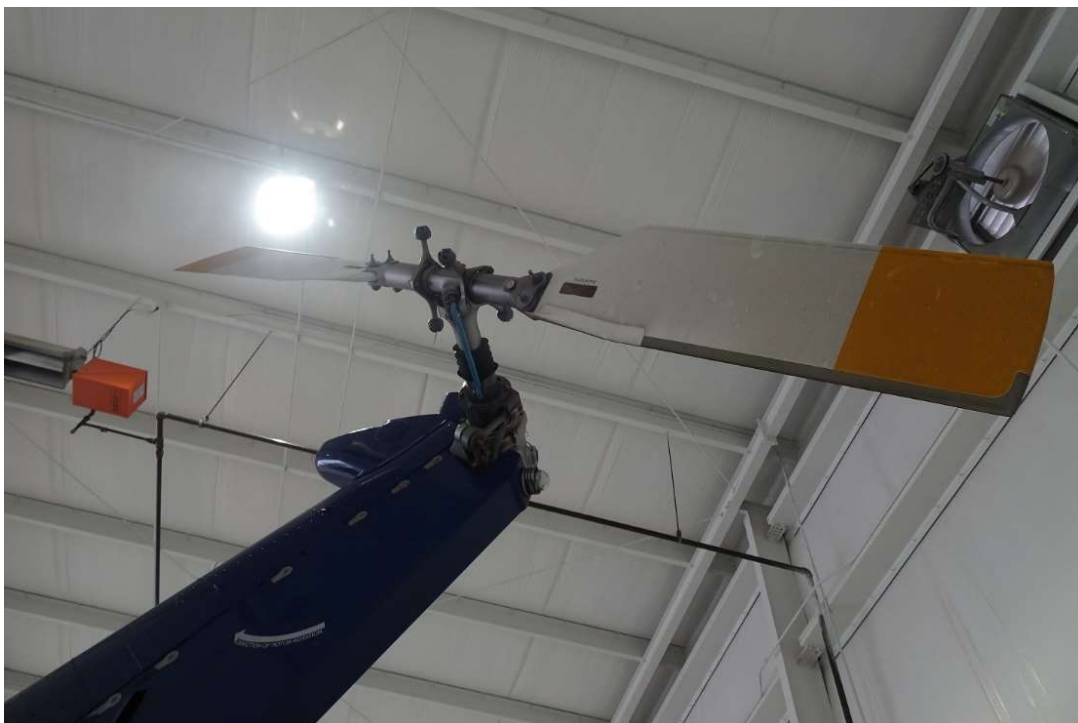
The two tail rotor blades remained connected to the tail rotor hub (**Figure 4**). The tail rotor pitch change links, sliding sleeve, and pitch change bellcrank (mounted on the tail rotor gearbox) remained installed with no anomalous damage. Movement of the gearbox-mounted bellcrank resulted in corresponding pitch changes to the tail rotor blades.

Figure 4. The tail rotor and vertical fin.

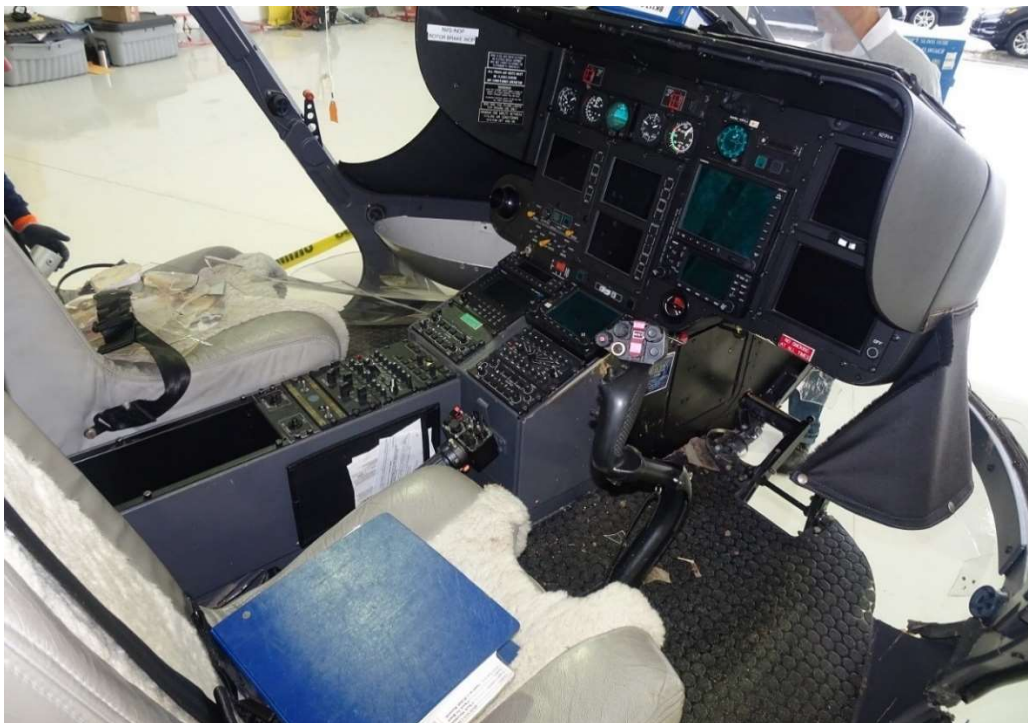
Only the right seat cockpit flight controls were installed (**Figure 5**). Covers were present over the left seat cockpit flight control connections. The cyclic and collective controls remained installed with no deformation or damage. Manual movement of the cyclic and collective controls resulted in a corresponding movement of the swashplate. Additionally, movement of the collective control resulted in a corresponding movement of the anticipator on both engines. The collective control had shifted laterally and longitudinally in relation to the collective lock due to airframe deformation, such that the collective locking pin could not engage with the locking latch.

Figure 5. A view of the cockpit showing the right seat controls.

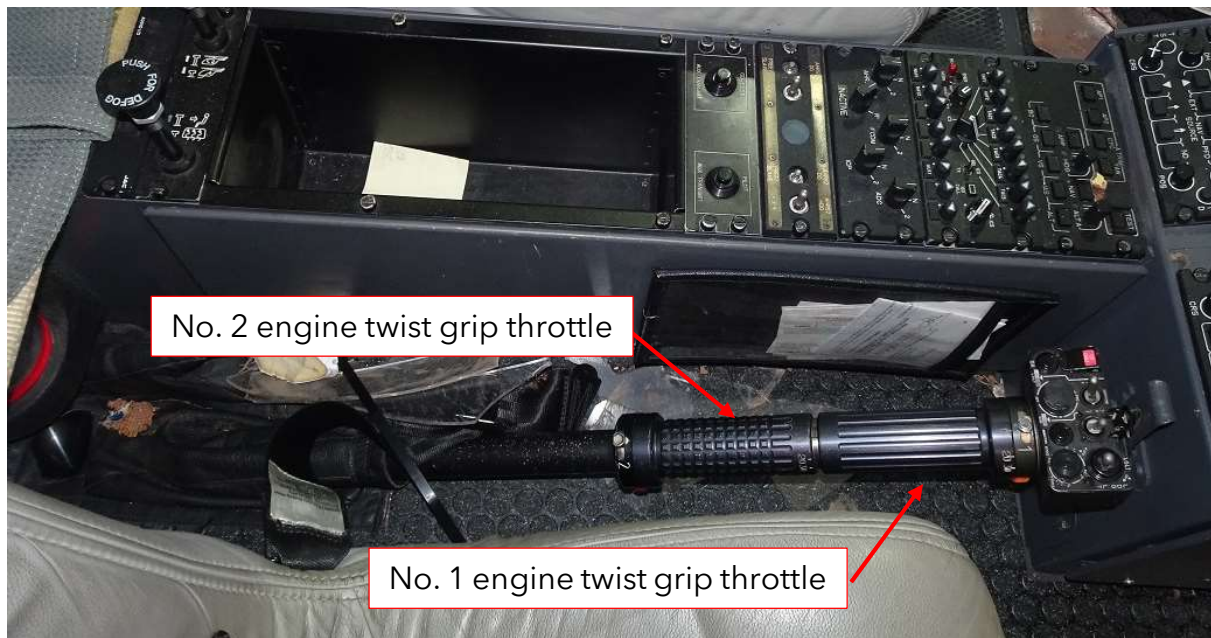
Both the Nos. 1 and 2 collective-mounted engine twist grips were in the off ("0") position (**Figure 6**). Both twist grips were rotated from the off position to flight ("F") position and the movement was smooth with no restriction. A tactile detent engagement was felt when the twist grips were placed in the flight position. Both emergency guards were stowed, preventing movement of the twist grip into the emergency ("EMER") range. For each twist grip, the investigation team opened the emergency guard and rotated the twist grip through the emergency range. The movement was smooth with no evidence of restriction. The idle stop, designed to prevent movement of the twist grip past idle toward the off position, was present. The twist grips would not rotate past the idle stop button unless the button was actuated. The rigging between the engine twist grips and the engine fuel control unit (FCU) throttles were documented by the Powerplants Group.

Figure 6. The collective control and twist grip throttles.

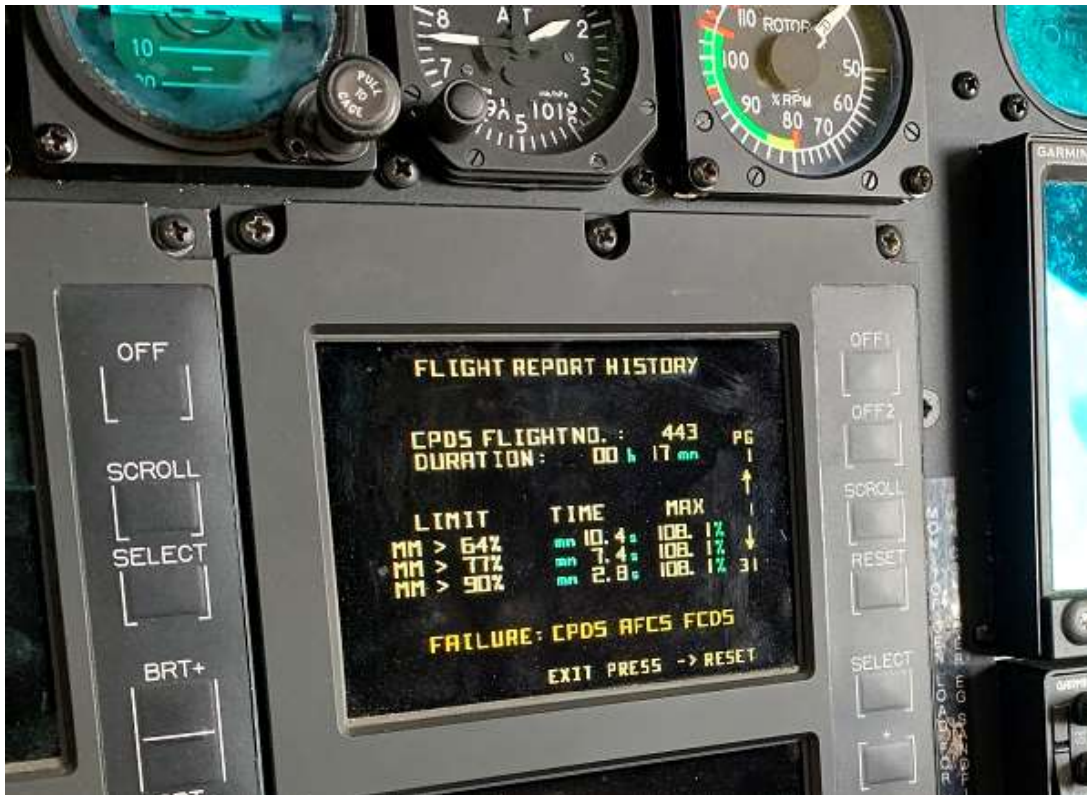
After application of battery power to the helicopter, the vehicle and engine management display (VEMD) and the caution advisory display (CAD) were powered up in order to access their maintenance mode. The accident flight displayed as flight No. 443 and was about 17 minutes in duration (the last recorded ground-flight-ground cycle). For flight No. 443, the flight report history showed a mast moment² exceedance of >90% for 2.8 seconds and a maximum recorded mast moment of 108.1%. **Figures 7 through 11** shows the maintenance mode screens for flight No. 443.

Figure 7. Flight No. 443 mast moment exceedance information on the VEMD.

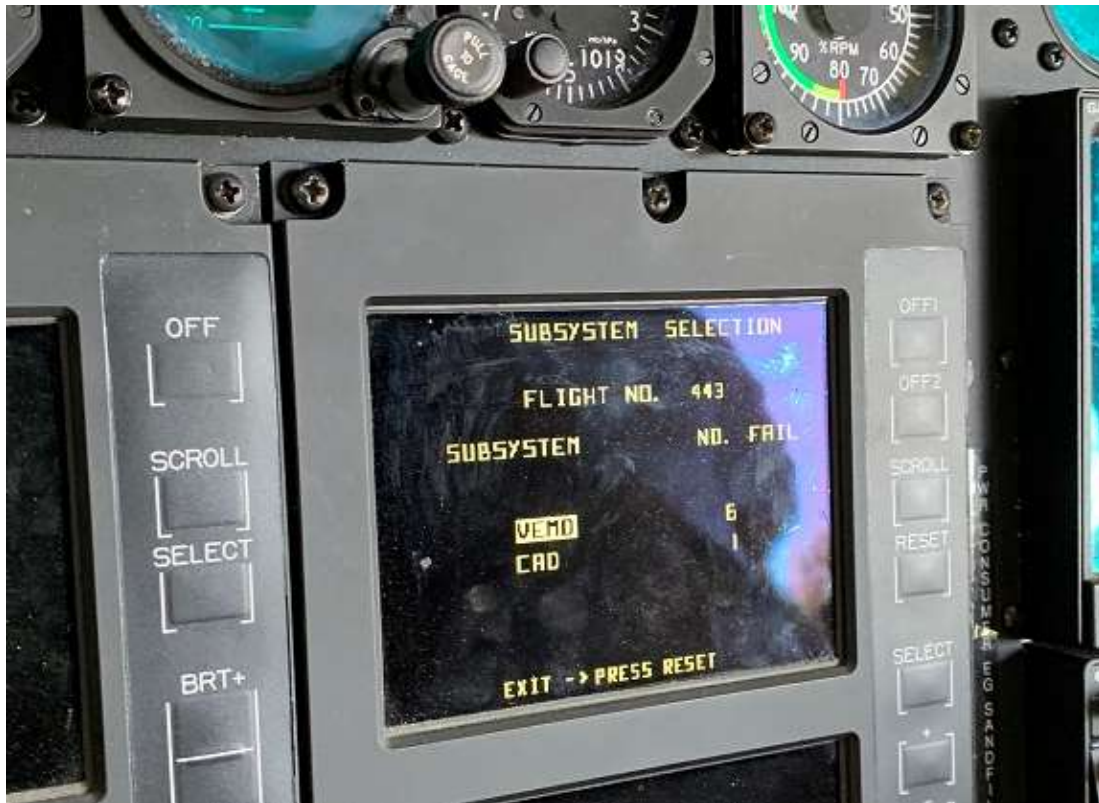
Figure 8. Flight No. 443 failures summary on the VEMD.

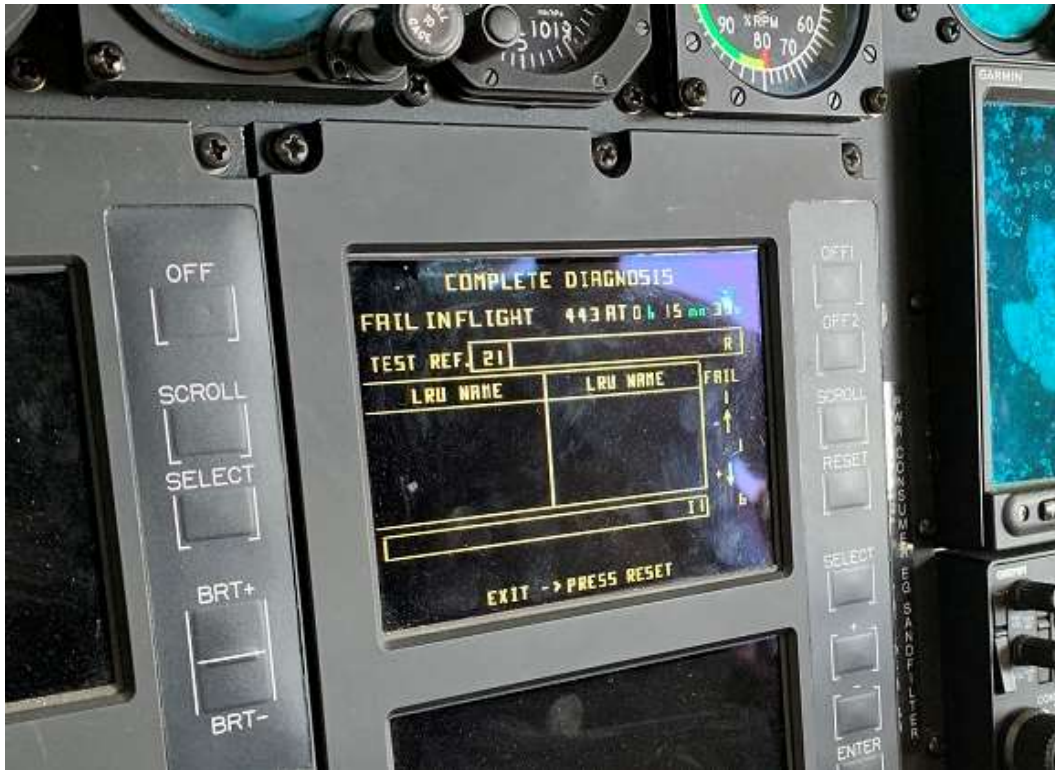
Figure 9. Flight No. 443 inflight failures screen on the VEMD.

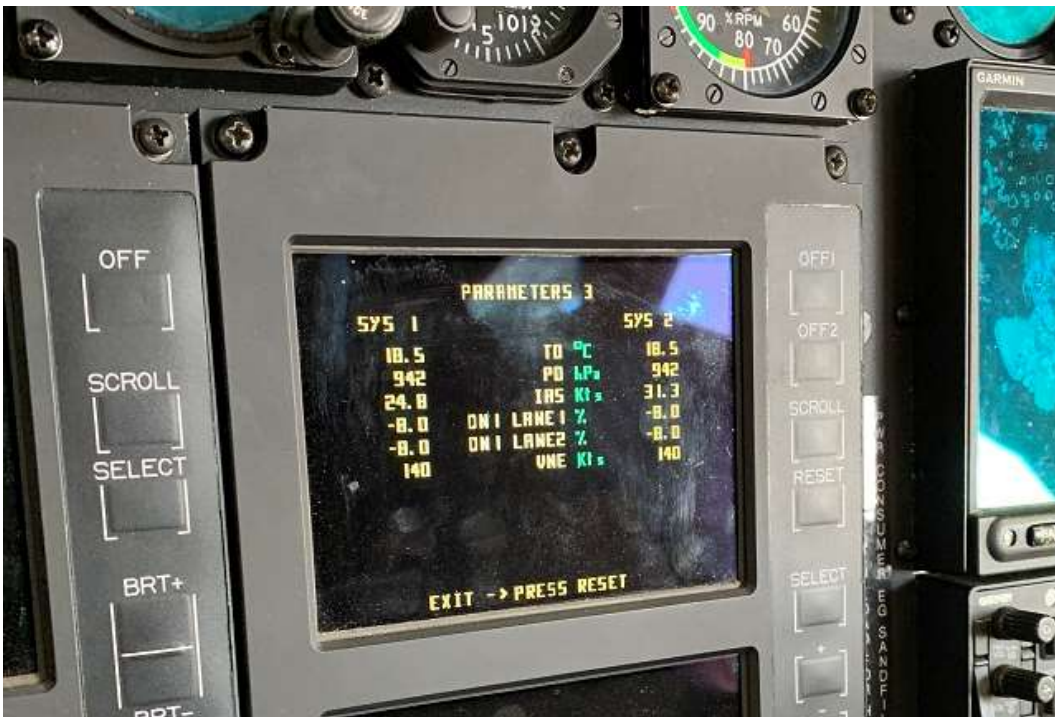
Figure 10. Flight No. 443 inflight failure parameters on the VEMD.

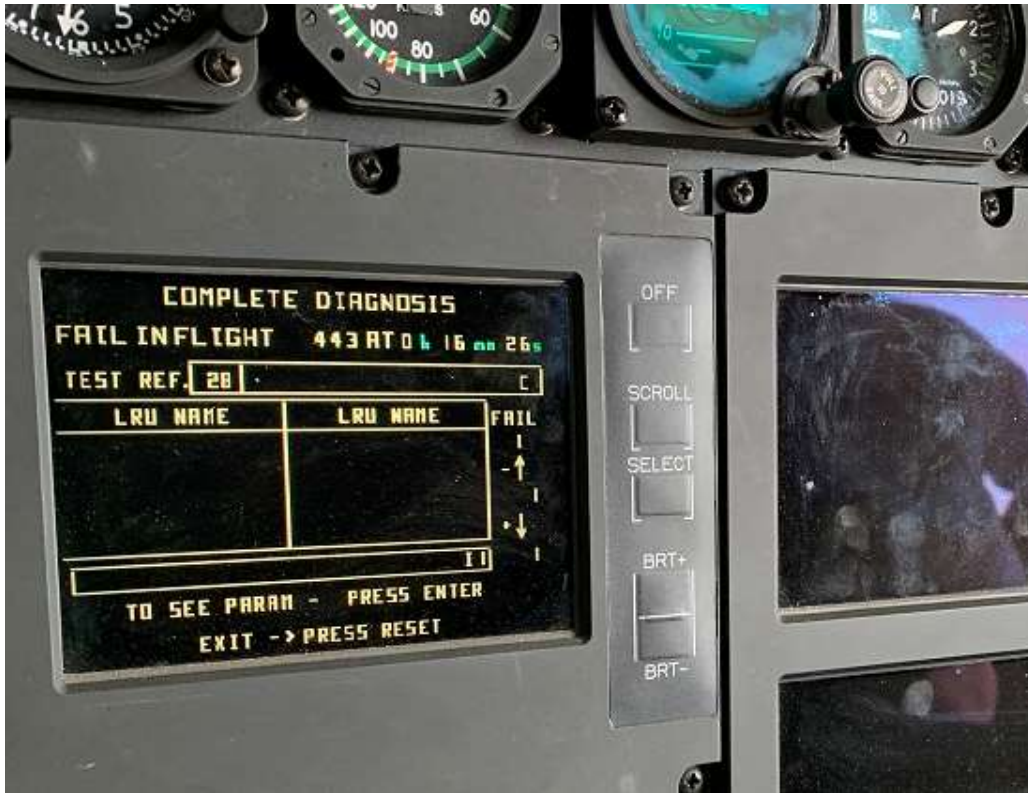
Figure 11. Flight No. 443 inflight failures screen on the CAD.
