# National Transportation Safety Board

ANC22FA041

Group Chair's Factual Report - Addendum

Location: Kalea, Hawaii  
Date: June 8, 2022  
Time: 1726 Hawaii-Aleutian standard time  
Helicopter: Bell 407, registration N402SH

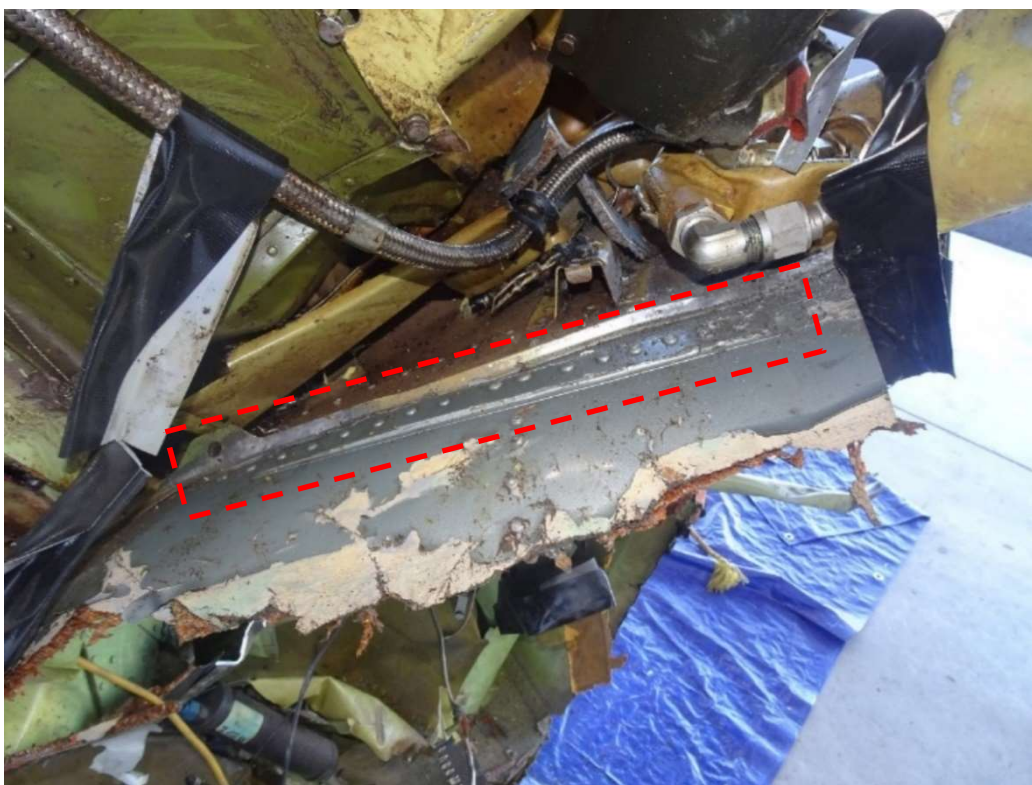
On the accident helicopter, the upper-left longeron was observed to have design features unique to part number (P/N) 206-031-314-237B.<sup>1</sup> The three external strap doublers remained installed with no evidence of looseness or separation from the airframe (**Figure 1**). The channel of the upper-left longeron had the following hand-written marking on its inboard surface: "WB72373-00". At frame station (STA) 217, for the upper-left longeron, both clips pointing inboard were fractured at the clip but its rivets remained installed. The fractured showed no obvious signatures of fatigue. The third clip pointing outboard remained installed but slightly deformed and lifted off from STA 217. The channel of the upper-left longeron remained continuous through STAs 217 and 204 and connected at its forward end to the engine pan longeron. Aft of the channel's [forward end] connection to the engine pan longeron, the channel was deformed and folded over (**Figure 2**).

**Figure 1.** The strap doubler installation visible on the exterior of the aft fuselage.

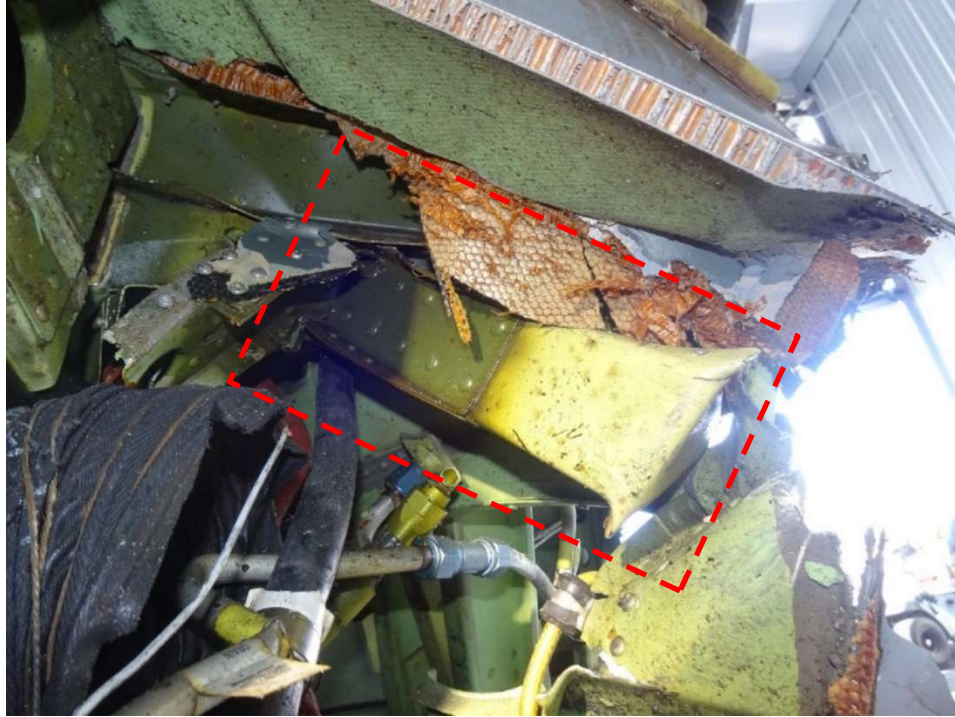
**Figure 2.** The upper-left longeron's connection to the engine pan longeron.

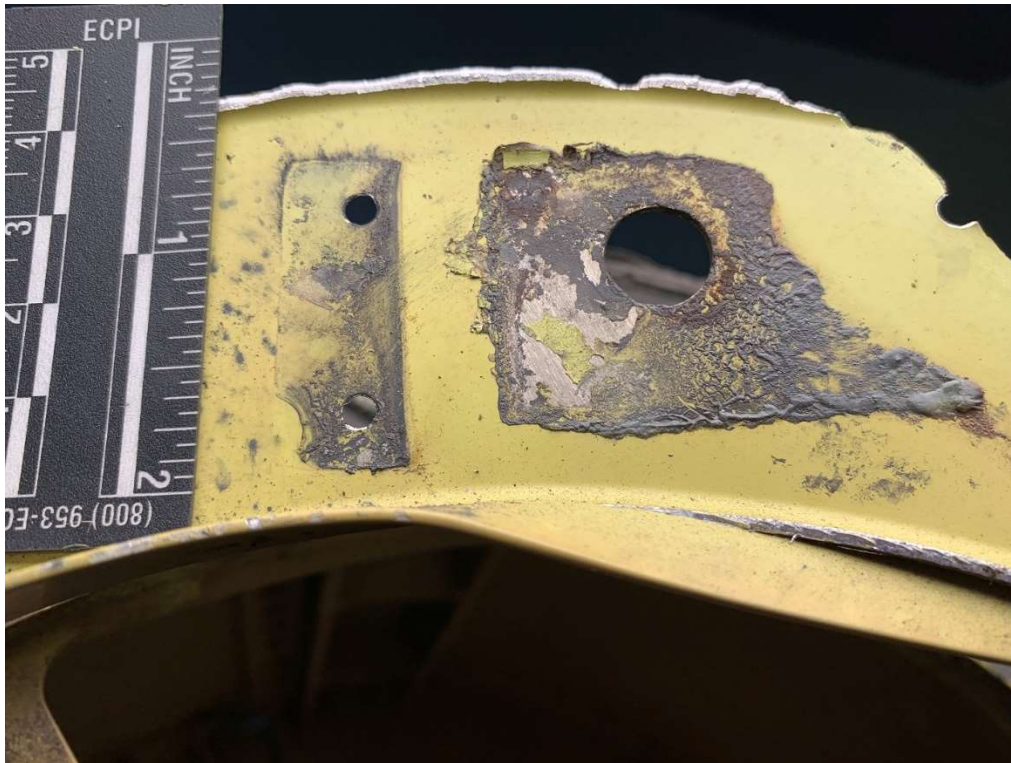
On the accident aft fuselage bulkhead, the faying surface to which the upper-left longeron was attached showed evidence of sealant (**Figures 3 and 4**). Additionally, the aft fuselage bulkhead contained the following part marking (**Figure 5**):

**Figure 3.** The aft fuselage bulkhead faying surface to which the upper-left longeron fitting's aft face contacted.

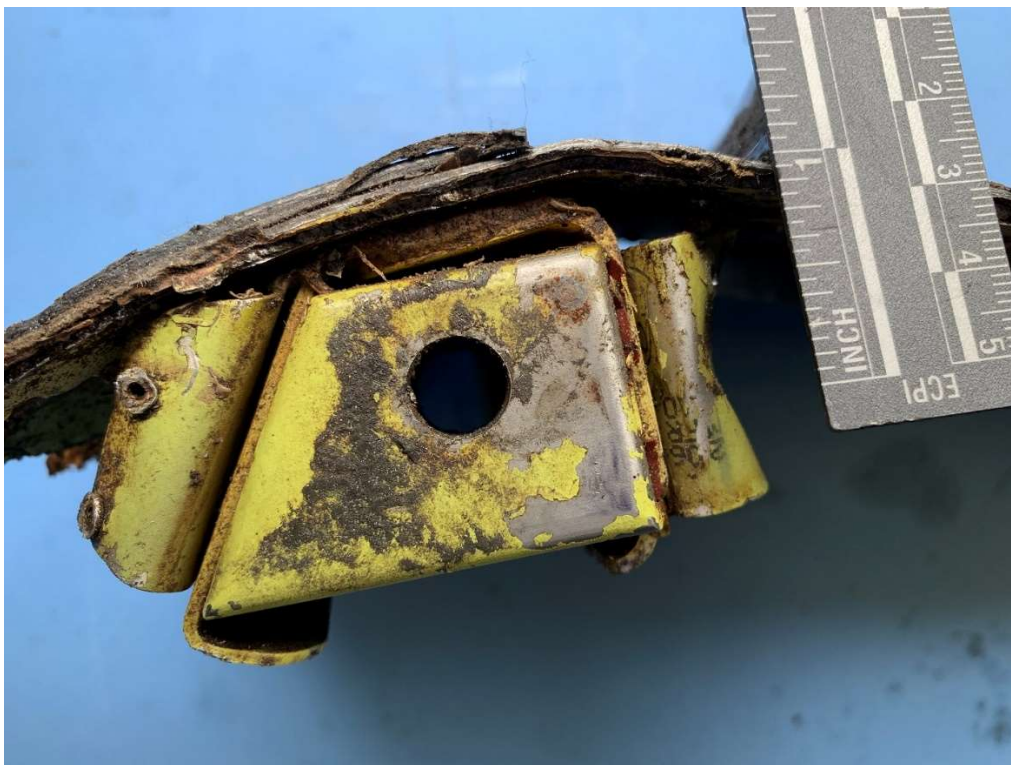
**Figure 4.** The upper-left longeron fitting's aft face.

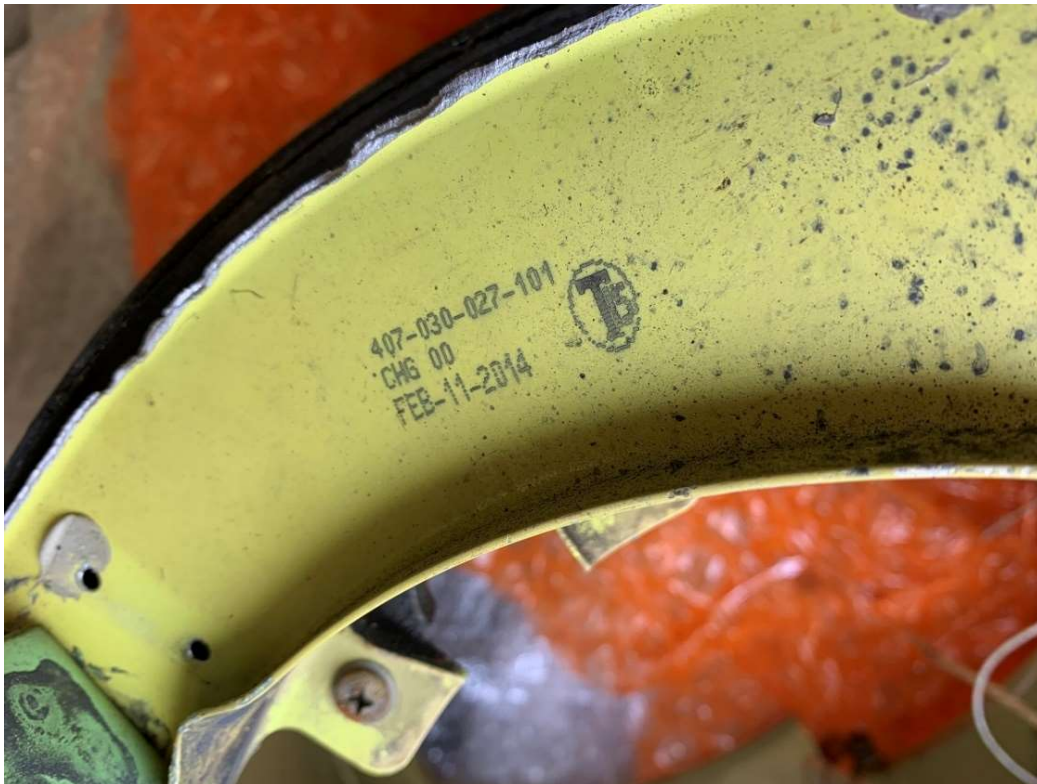
407-030-027-101  
CHG 00  
FEB-11-2014

**Figure 5.** Part markings seen on the aft fuselage bulkhead.

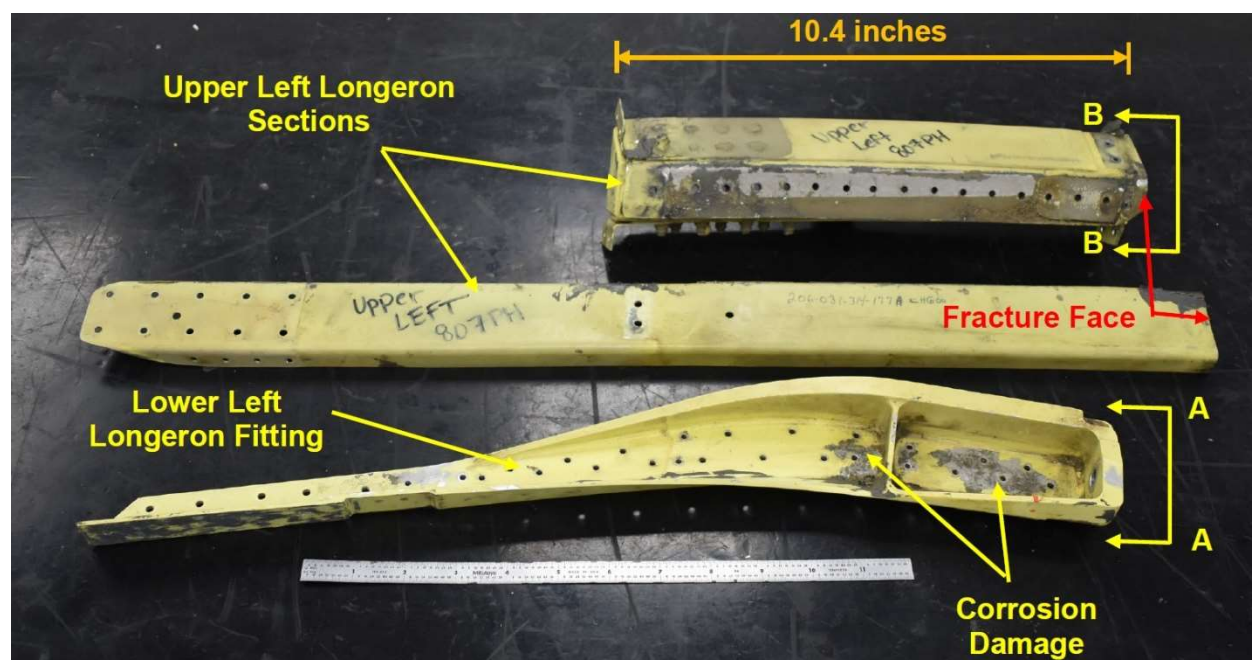
After the accident occurred, the operator conducted eddy-current nondestructive inspection (NDI) on the aft fuselage longerons of their remaining Bell 407 helicopters. On N807PH<sup>10</sup>, the eddy current inspection found cracking indications on the aft faying surface of the lower-left longeron bolt hole and within the bolt hole of the upper-left longeron. At the request of the NTSB, the Bell FI Lab conducted an examination of the two longerons (**Figure 8**).

**Figure 8.** The upper-left and lower-left longerons from N807PH received by the Bell FI Lab. (Image courtesy of Bell)

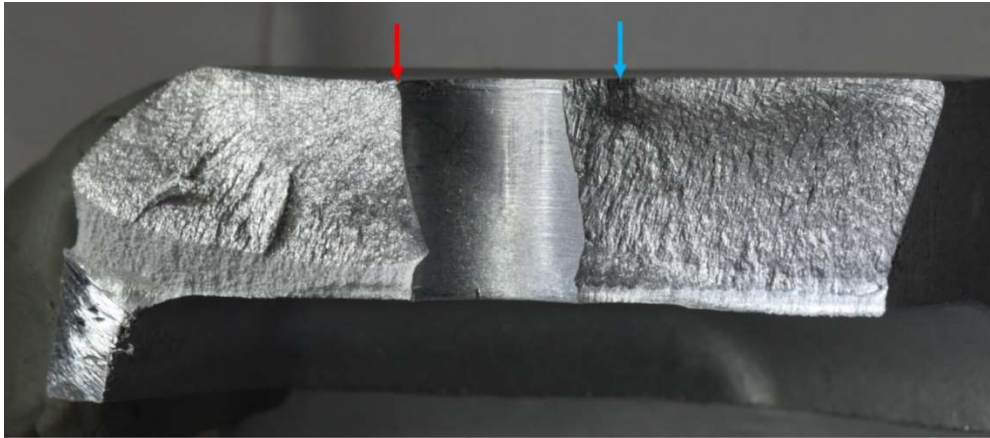
On the lower-left longeron, two cracks were present on the aft face of the longeron (Section A-A in **Figure 8**). The two cracks had not propagated to a complete fracture and had to be opened by the lab for examination. Examination of the crack surfaces found signatures of fatigue (**Figure 9**). The fatigue crack located near the 6 o'clock location of the bolt hole originated from a corrosion pit about 0.011 inches deep. The fatigue crack located near the 9 o'clock location of the bolt hole originated from a material anomaly at the surface, about 0.010-inch deep by 0.030-inch wide (**Figure 10**). The material anomaly at the surface did not exhibit crack features and thus could not be well defined. The lower-left longeron met drawing requirements for material composition and hardness.

**Figure 9.** The crack origins on the lower-left longeron bolt hole. The red arrow points to the fatigue crack originating at the 6 o'clock location and the blue arrow points to the fatigue crack at the 9 o'clock location. (Image courtesy of Bell)

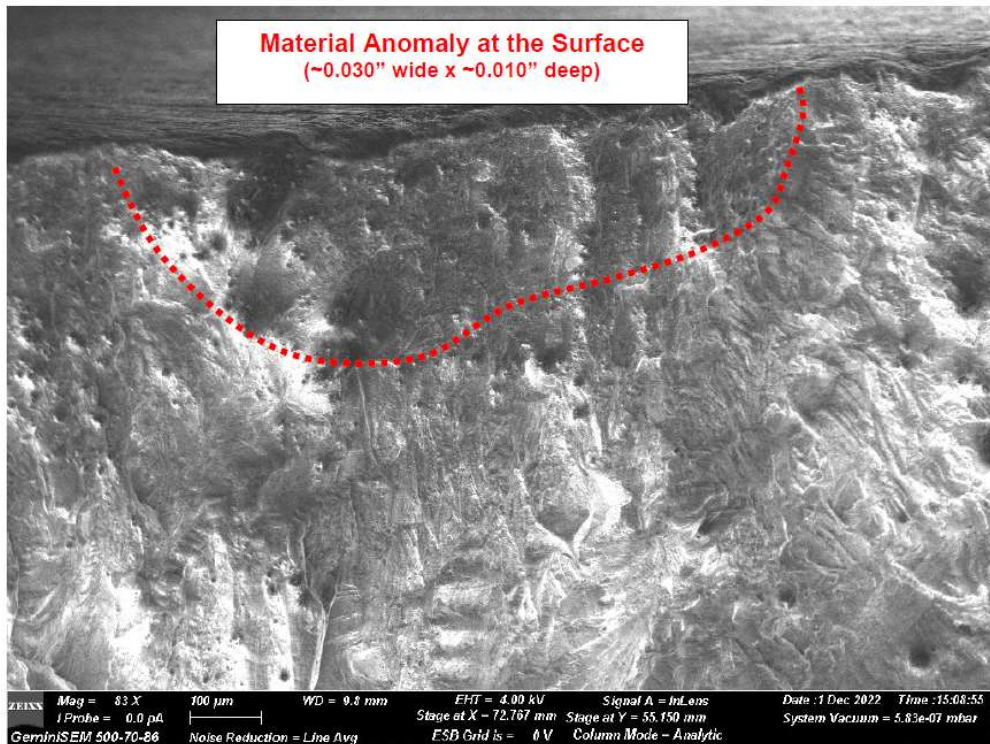
**Figure 10.** The anomaly at the surface of the fatigue crack located at the 9 o'clock location. Signatures of fatigue was observed emanating from this anomaly. (Image courtesy of Bell)

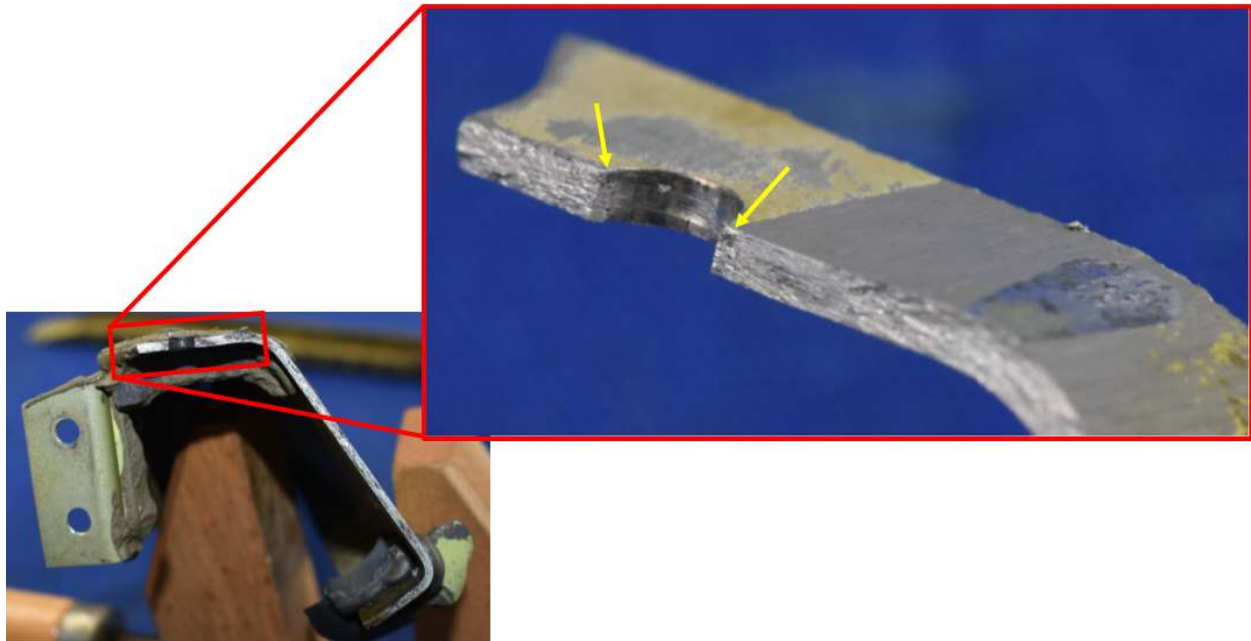
On the upper-left longeron, a fracture was observed through a rivet hole about 10.4 inches forward of the aft face of the longeron (Section B-B in **Figure 8**). Signatures of fatigue was observed at the rivet hole (**Figure 11**), but mechanical damage, likely from the rivet removal process, had obscured the origin areas. The spot face on the radius block of the upper-left fitting was observed to have been

**Figure 11.** The upper-left longeron section containing a fracture about 10.4 inches forward of the aft face. The yellow arrows shows the location of the rivet hole in which cracks with signatures of fatigue were present. (Images courtesy of Bell)

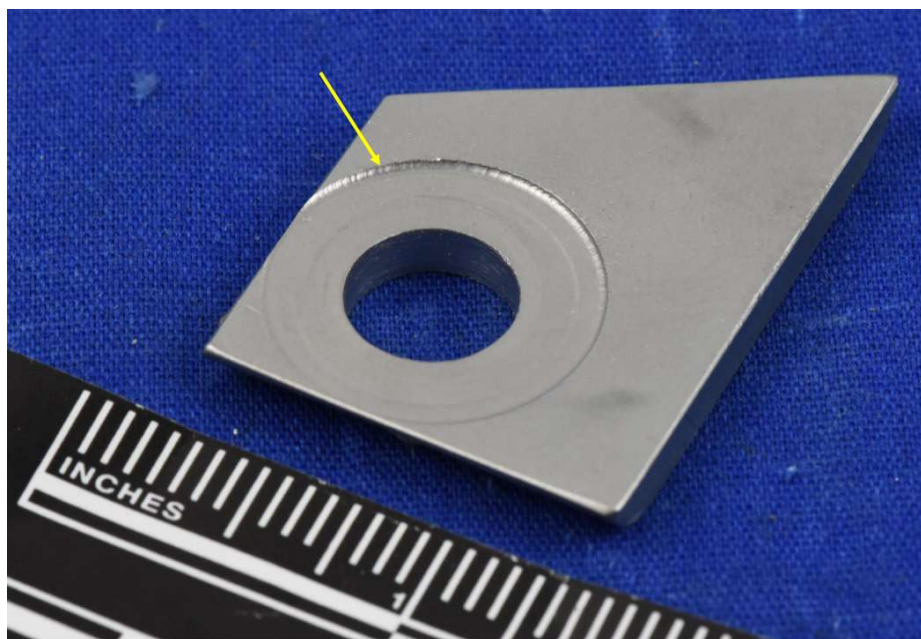
uneven in depth (**Figure 12**). The upper-left longeron met drawing requirements for material composition and hardness.

**Figure 12.** The radius block from the upper-left longeron fitting whose spot face (yellow arrow) exhibited an uneven depth. (Image courtesy of Bell)

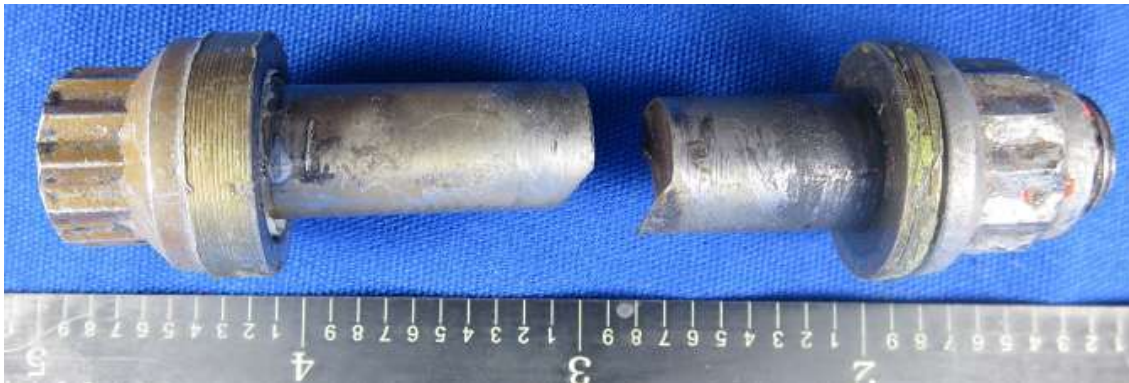
## 5.0 Bell 407 S/N 53563 Upper-Left Attachment Bolt Fracture

**Figure 13.** The fractured bolt found on Bell 407 S/N 53563. (Image courtesy of Bell)

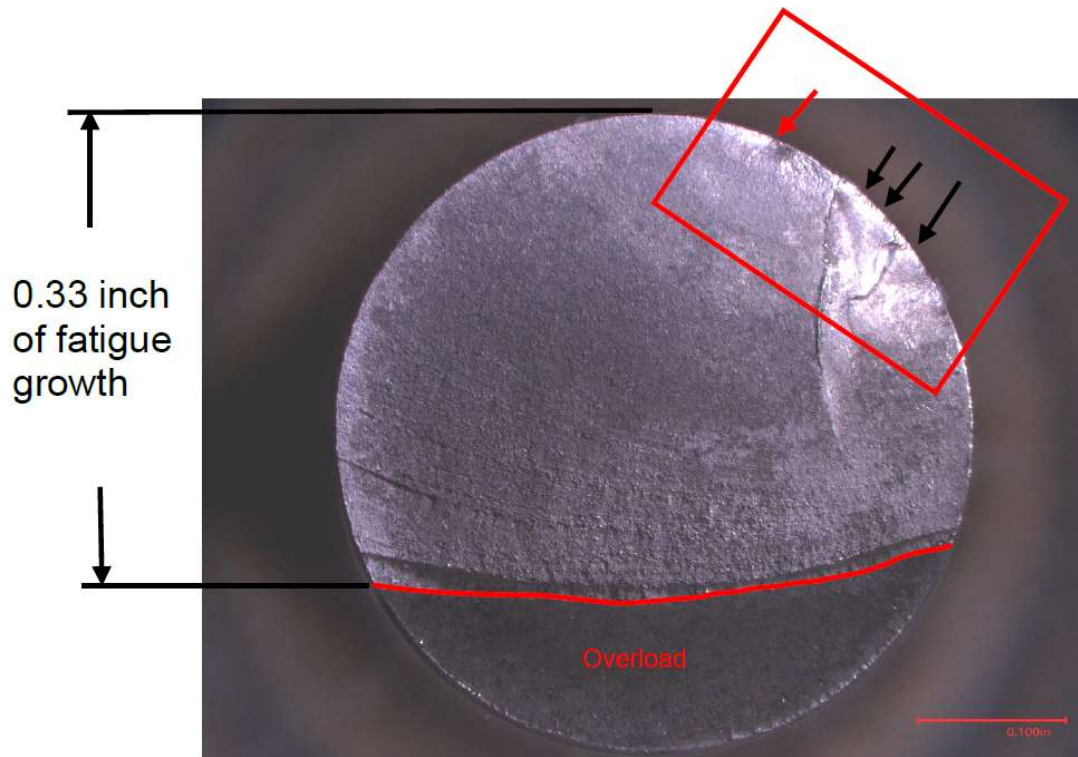
**Figure 14.** The black arrows point to fatigue origins with the red arrow pointing to the primary fatigue origin. (Image courtesy of Bell)

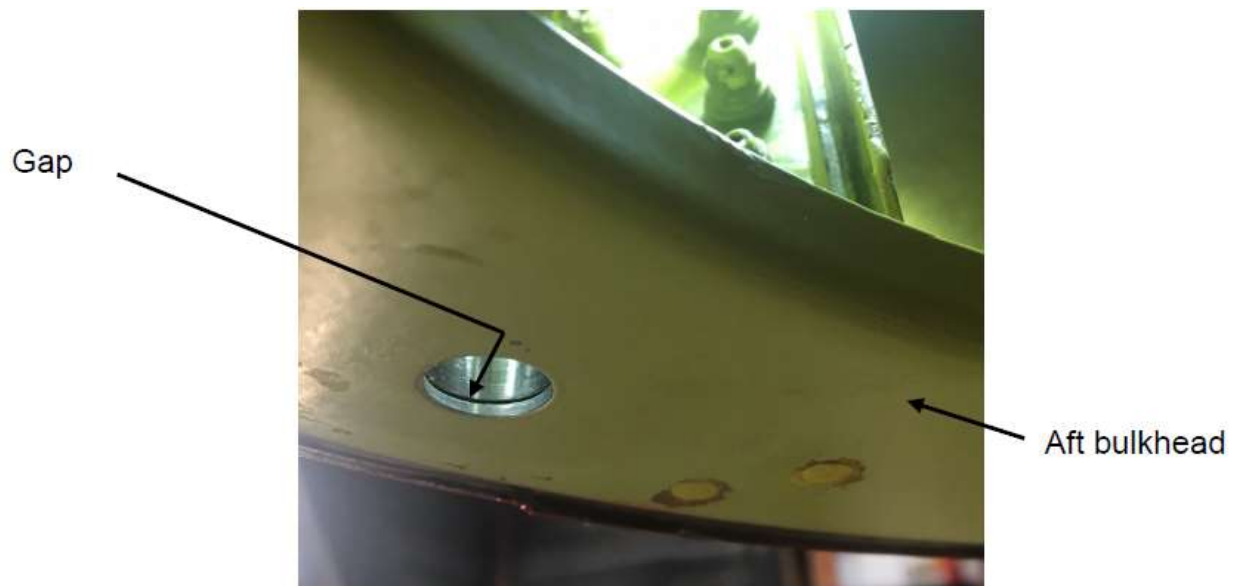
**Figure A-2.** A gap, measured to be about 0.008 inches, identified between the upper-left longeron and aft fuselage bulkhead. (Image courtesy of Arrow Aviation)

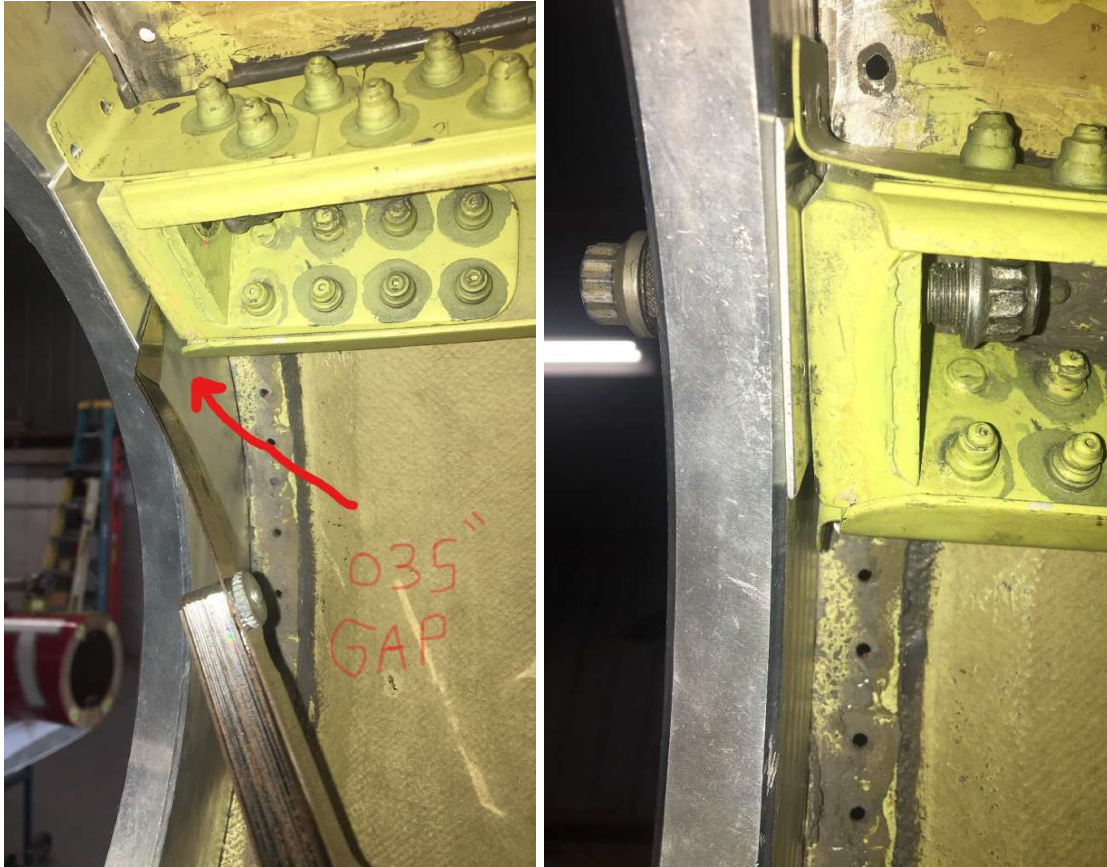
**Figure A-3.** A gap, measured to be about 0.035 inches, identified between the drill plate and the upper-left longeron attachment fitting. (Image courtesy of Arrow Aviation)

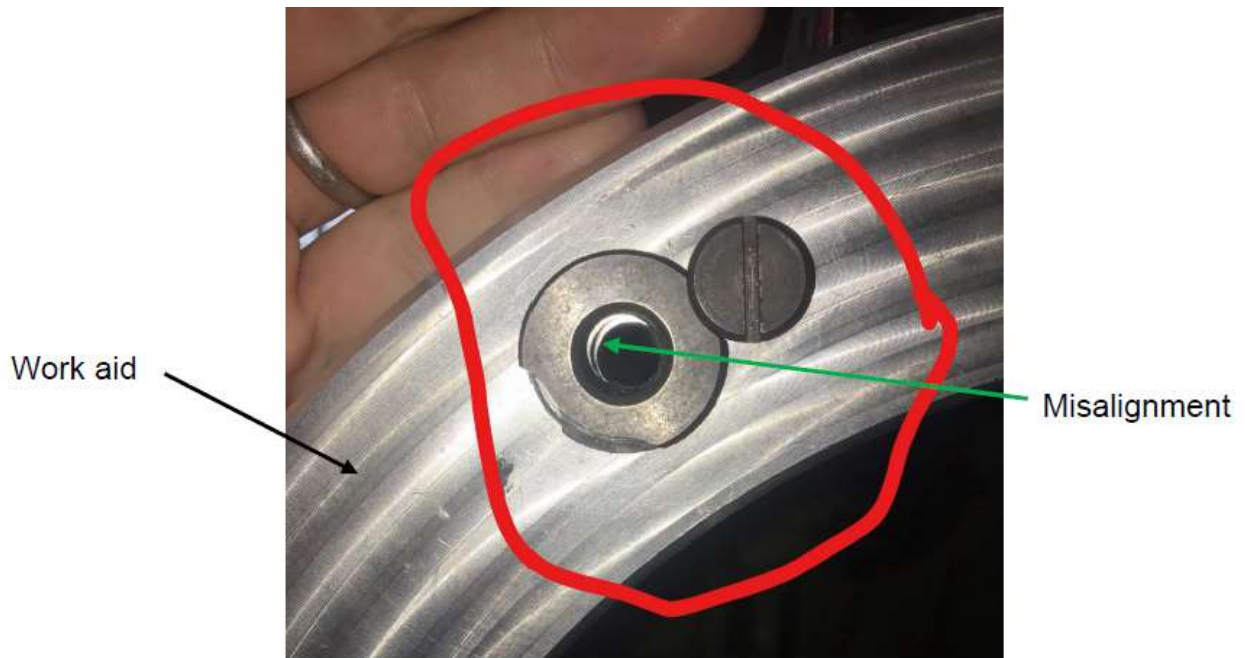
**Figure A-4.** Misalignment identified between the drill plate (work aid) and the upper-left longeron bolt hole. (Image courtesy of Bell)
