**NATIONAL TRANSPORTATION SAFETY BOARD**  
Office of Research and Engineering  
Washington, D.C. 20594

## **Video Study**

**NTSB Case Number:**  
**WPR21FA265**

Location: Albany, Oregon  
Date: July 9, 2021  
Time: 20:51 PDT  
Aircraft: North Wing Mustang 3-15

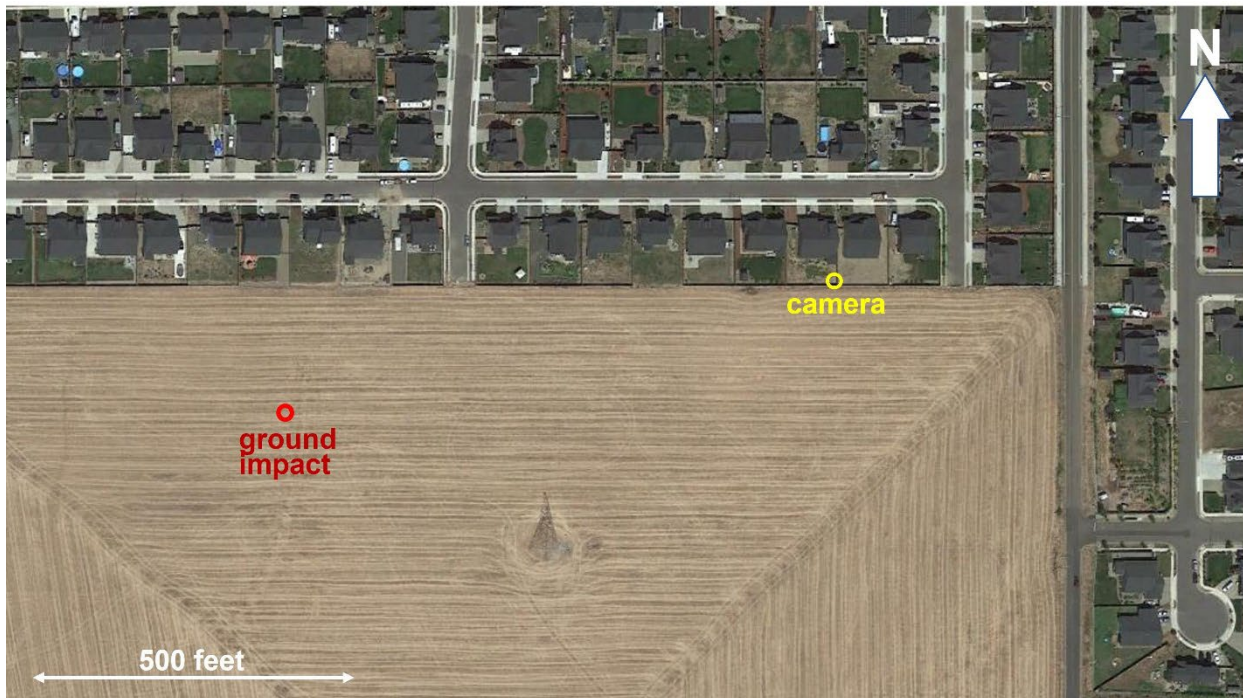
**Figure 1. Aerial View of the Accident Area**

Figure 1 shows an aerial view of the accident area. The camera location and the location where the aircraft impacted ground are marked in the figure. The camera location was in the back yard of a house and was constant during the video.

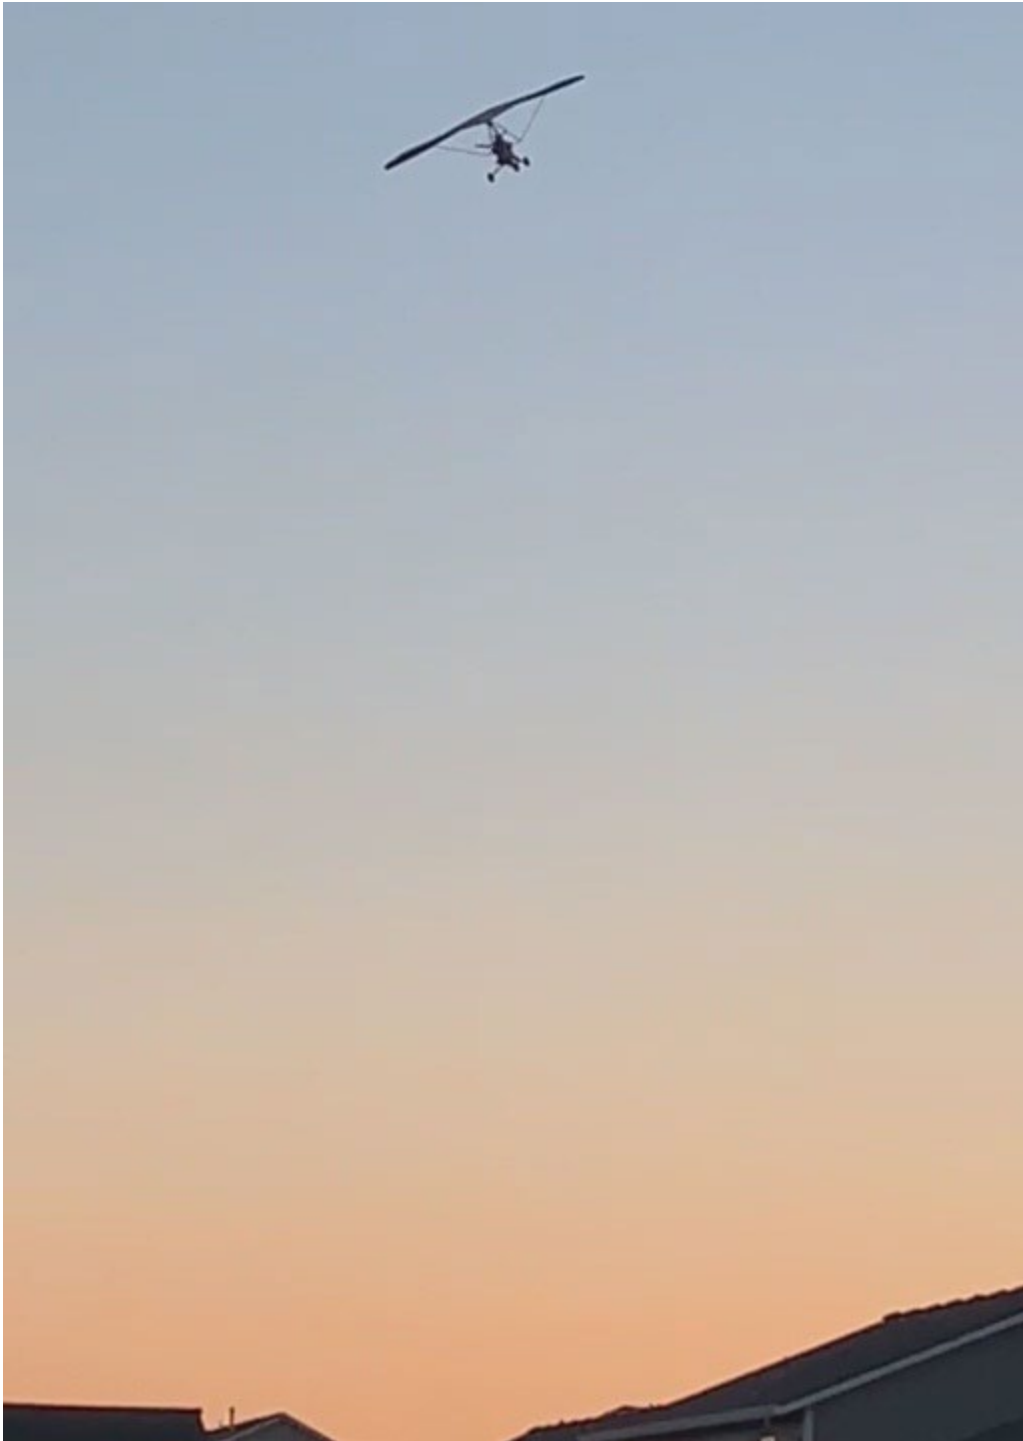
**Figure 2. Bottom 75% of Video Frame Recorded at Video Time 33.4 seconds**

Figure 2 shows the bottom 75% of the video frame recorded at video time 33.4 seconds. It shows the limited ground references available at that time for the calibration of the camera HFOV and orientation angles. The camera owner was pitching the camera up at that time and between video times 33.7 seconds and 37.3 seconds, only the aircraft and the sky were visible in the video. During this time, the aircraft left-wing-down roll angle increased from about  $30^\circ$  to about  $87^\circ$ . At video time 37.3, the aircraft was 3.4 seconds from ground impact.

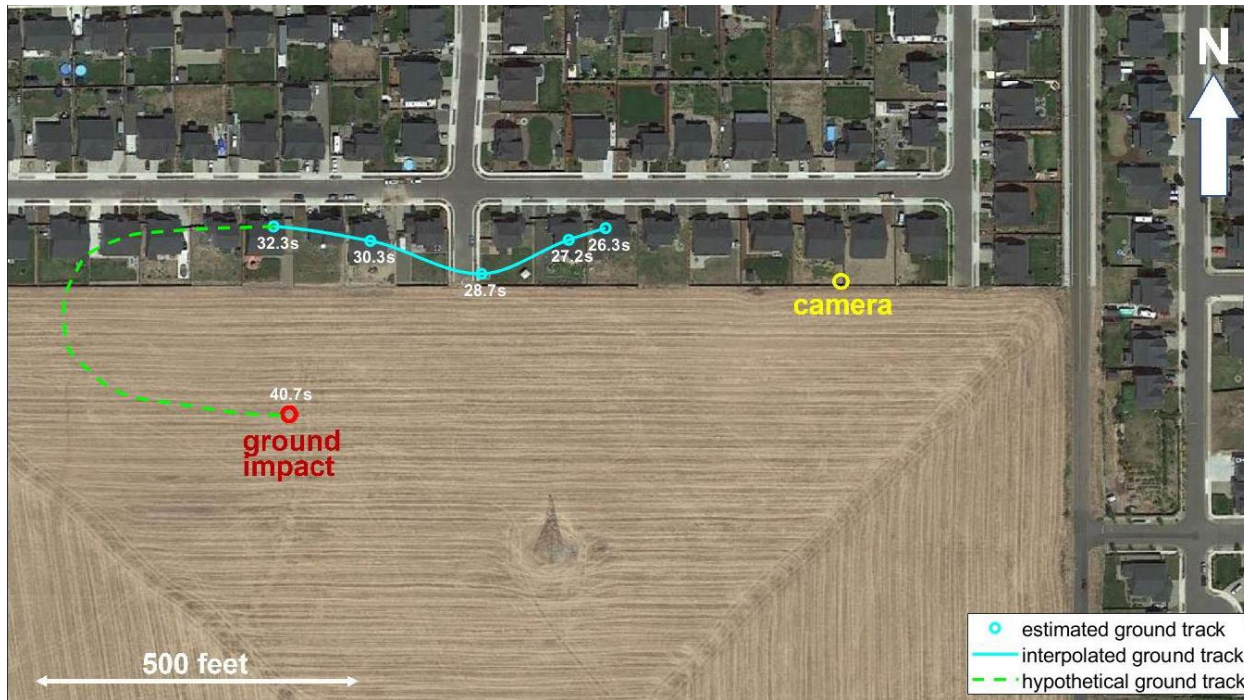
**Figure 3. Estimated Ground Track of the Aircraft**

Figure 3 shows the estimated ground track of the aircraft. The five circular markers show the five locations that were estimated based on the five analyzed video frames. The numbers under these markers are the corresponding video times. The solid line is the interpolated ground track. Past video time 32.3 seconds, the camera could not be

accurately calibrated. The broken line between time 32.3 seconds and ground impact time of 40.7 seconds is hypothetical and not based on analysis. However, the broken line is consistent with the video showing the aircraft flying approximately west at time 32.3 seconds and approximately east as it approached the ground impact location.

The estimated aircraft ground speed during the six seconds between time 26.3 seconds and time 32.3 seconds, was 59 mph (51 kts). The estimated ground speed during the 3.6 seconds between time 28.7 seconds and time 32.3 seconds, was 61 mph (53 kts). Accounting for the unavoidable analysis uncertainty, it is estimated that the aircraft speed leading into the left turn that resulted in ground impact was  $60 \pm 3$  mph ( $52 \pm 3$  kts).

The estimated AGL altitude of the aircraft was constant at  $233 \pm 10$  feet during the analyzed six seconds between time 26.3 seconds and time 32.3 seconds. During the 8.4 seconds from time 32.3 seconds to the ground impact time of 40.7 seconds, as the aircraft descended from AGL altitude of 233 feet to ground level, the average descent rate was 1664 feet/minute.

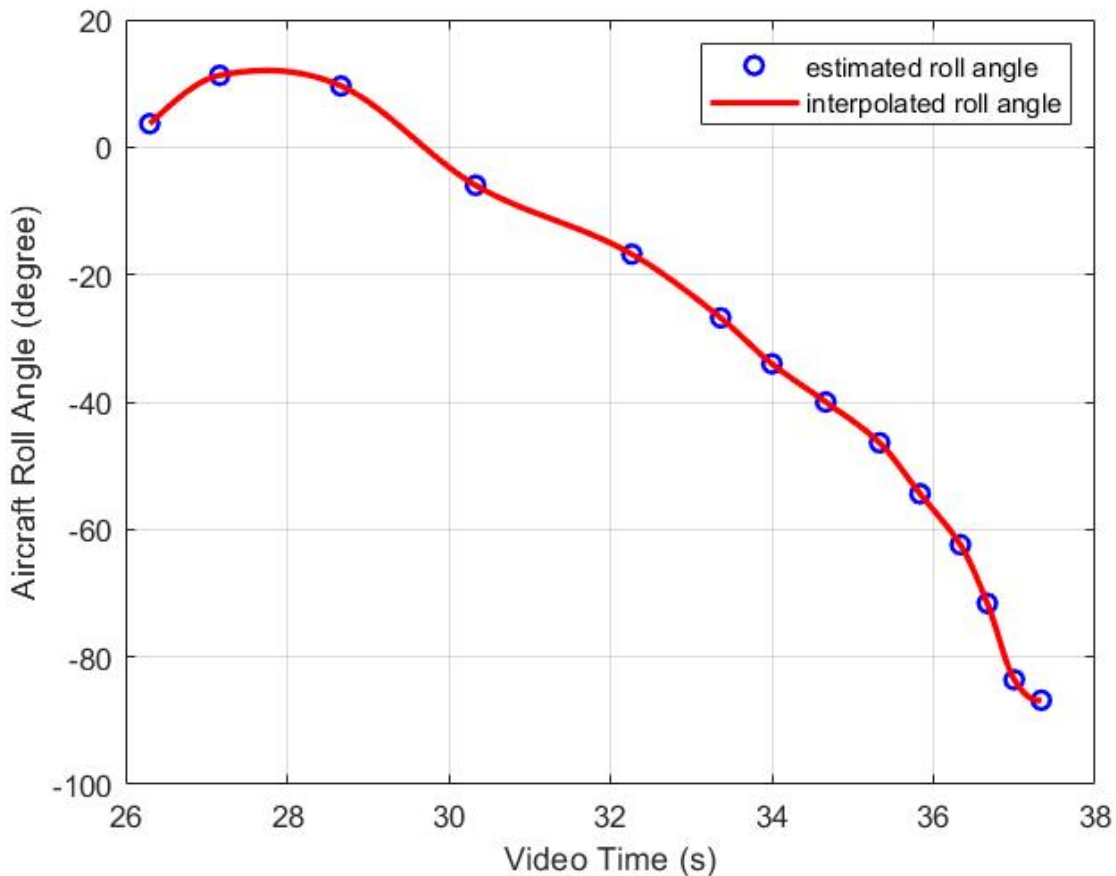
**Figure 4. Estimated Aircraft Roll Angle (negative angle is left wing down)**

Figure 4 shows the estimated aircraft roll angle between video time 26.3 seconds and video time 37.3 seconds. Negative roll angle in the figure corresponds to left wing down. The accuracy of the estimated roll angles is  $\pm 5^\circ$ . The figure shows that the aircraft roll angle increased from left wing down of  $17^\circ$  to left wing down of  $87^\circ$  during the five seconds past video time 32.3 seconds, the last time when camera calibration was possible. The aircraft impacted the ground at video time 40.7 seconds.

Figure 4 shows that at video time 36 seconds, the magnitude of the roll angle was high (60° left wing down) and increasing rapidly. At that time, the engine speed was still within the normal 5100 rpm to 5500 rpm range. Therefore, it is estimated that the steep bank angle was not a result of engine failure.
