**NATIONAL TRANSPORTATION SAFETY BOARD**

**TRACK AND ENGINEERING FACTUAL REPORT**

**RRD18MR007**

**CSX Railroad, Derailment and Partial Bridge Collapse**

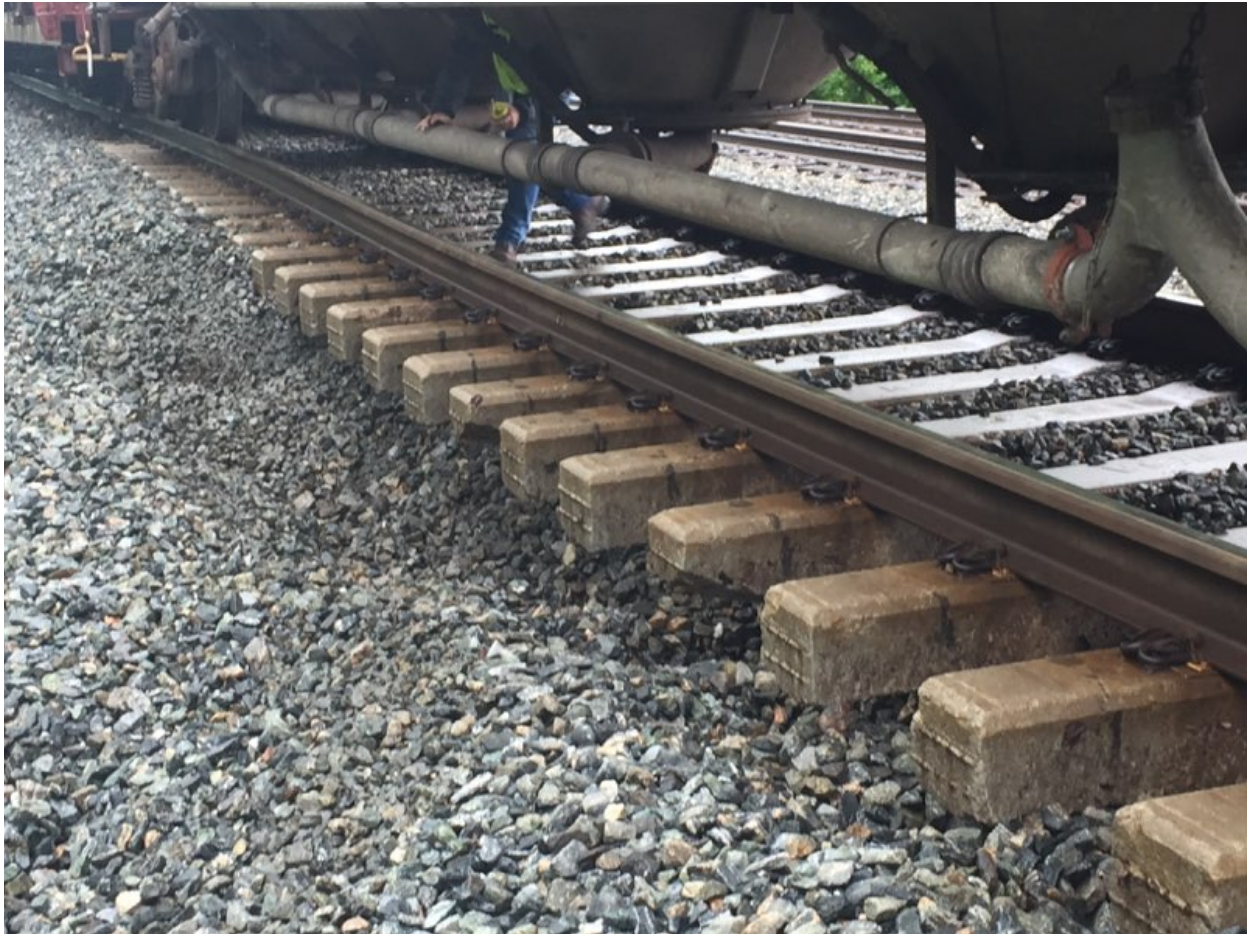
The investigation revealed an area in a curve where the subgrade fill was subsided from the track structure on No.1 main track. Railroad personnel found that this fill and ballast was subsided for about 26 feet, at a depth of about 18 inches upon their arrival on scene (See figure 1.) The fill continued to subside throughout the course of the on-scene investigation activities (See figure 2.) It was determined that the POD was near milepost CFP- 102.9; in this location NTSB investigators identified a flange mark traversing over the top of the rail head in the curve at the location of the subsided subgrade (See figure 3.) Investigators were unable to determine the amount of vertical deflection present on the low-rail in the curve at the time of the accident. However, the loss of fill under the track structure would have allowed vertical deflection of the low rail in the curve causing a geometry condition. Investigators photo documented flange and tread marks from the derailed rail car wheels that were found on various track components that were damaged by wheel impact. (See figure 4.) The POD was about 1/10<sup>th</sup> of a mile north of the

*Figure 1. This photo shows the subgrade, fill-failure as it was about 4 hours after the derailment.*

- The embankment fill in the failure area was composed of relatively weak and wet soil
- There was a concentration of water in a ballast pocket after the successive heavy rains in the area which saturated the slope in the failure area
- A crib wall that was approximately two feet high and one-hundred feet long built from railroad ties stacked up three ties high was discovered in the fill failure area. It was determined that this crib wall did not contribute significantly to slope stability.

CSX reported that planned remediations include excavating the poor fill material within the fill failure location, building a seventy-foot-long soldier pile retaining wall, and replacing the removed fill with a more compactable structural backfill material.

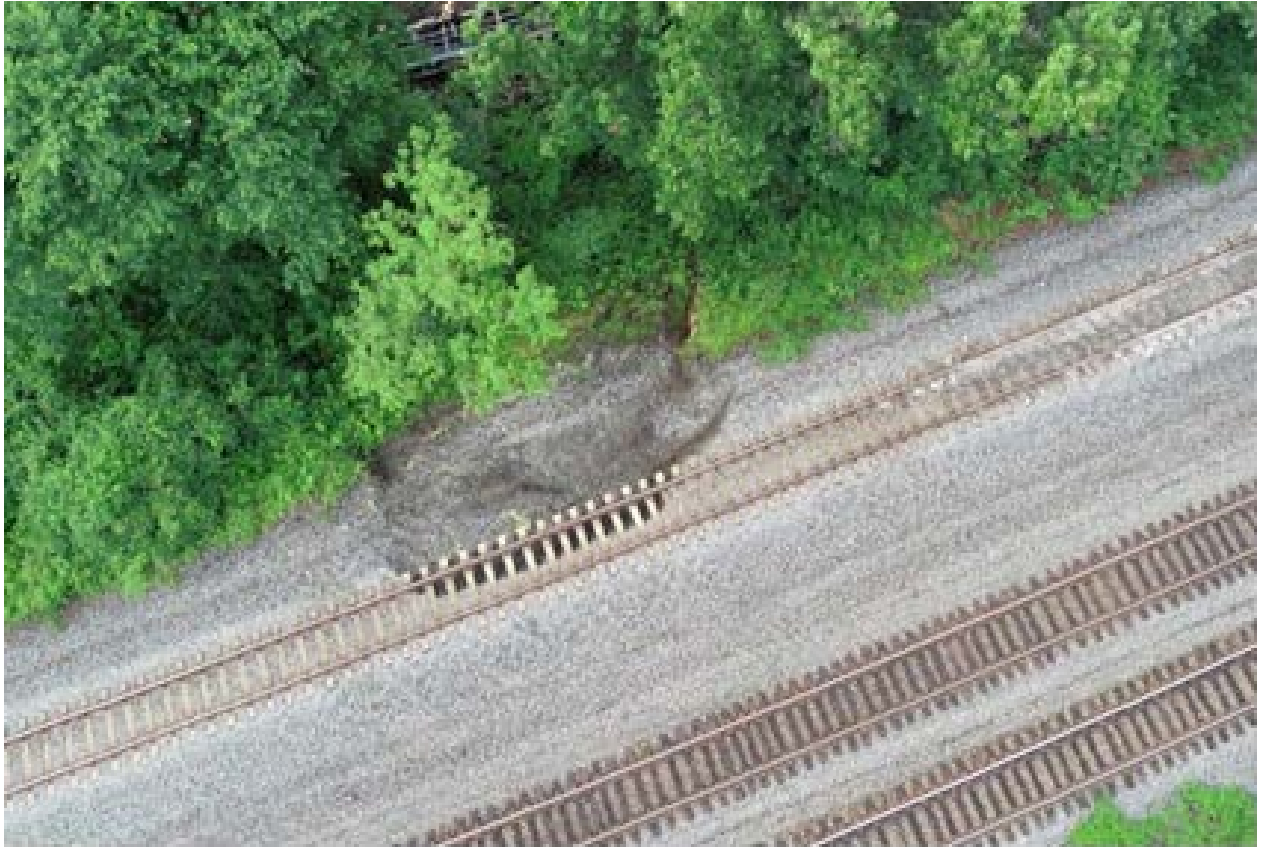
*Figure 2. Aerial view of subgrade fill failure location on May 20th. Note additional degradation.*

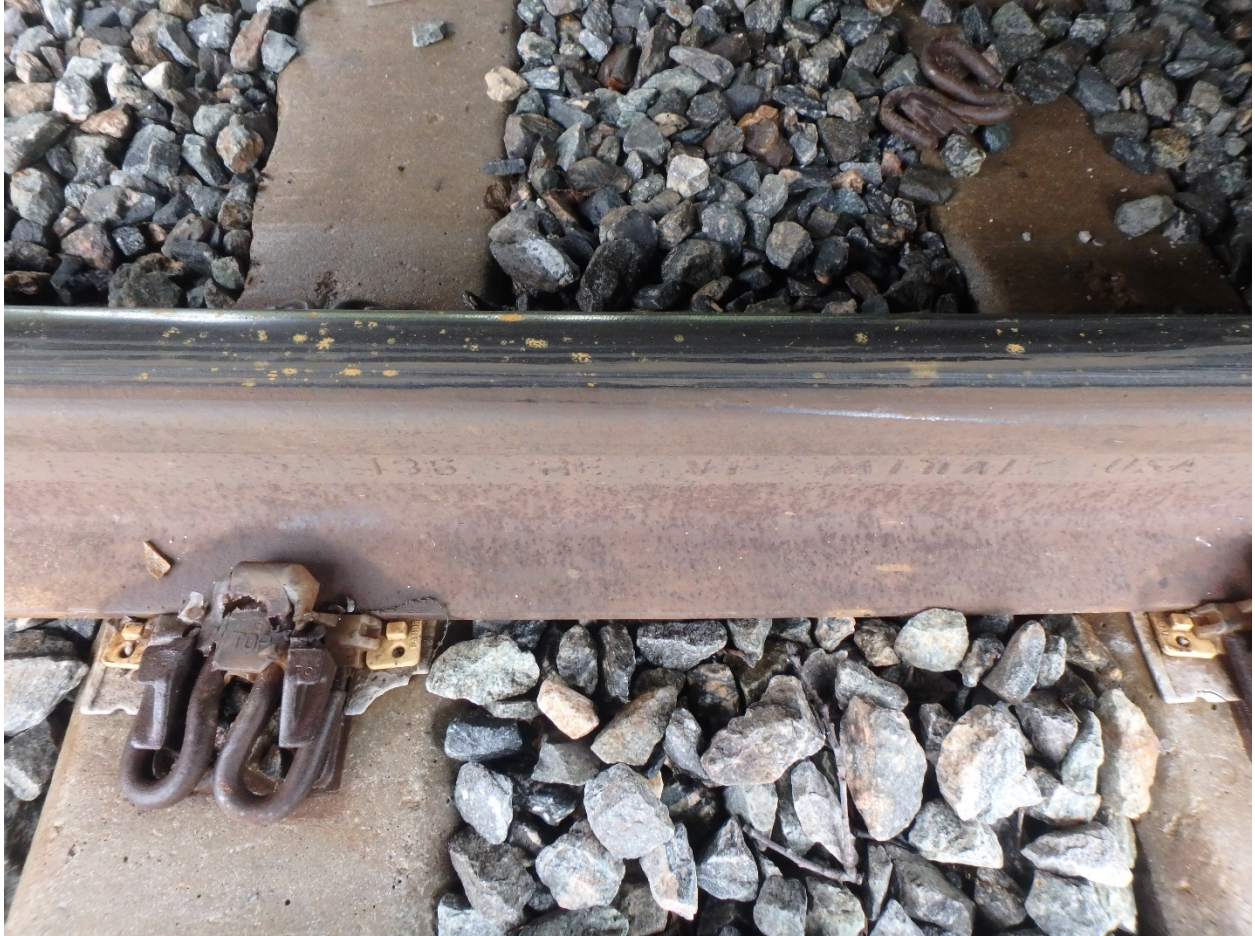
*Figure 3. Photo showing the flange mark from a railcar wheel traversing over the top of the rail head in the curve at the location of the subsided subgrade.*

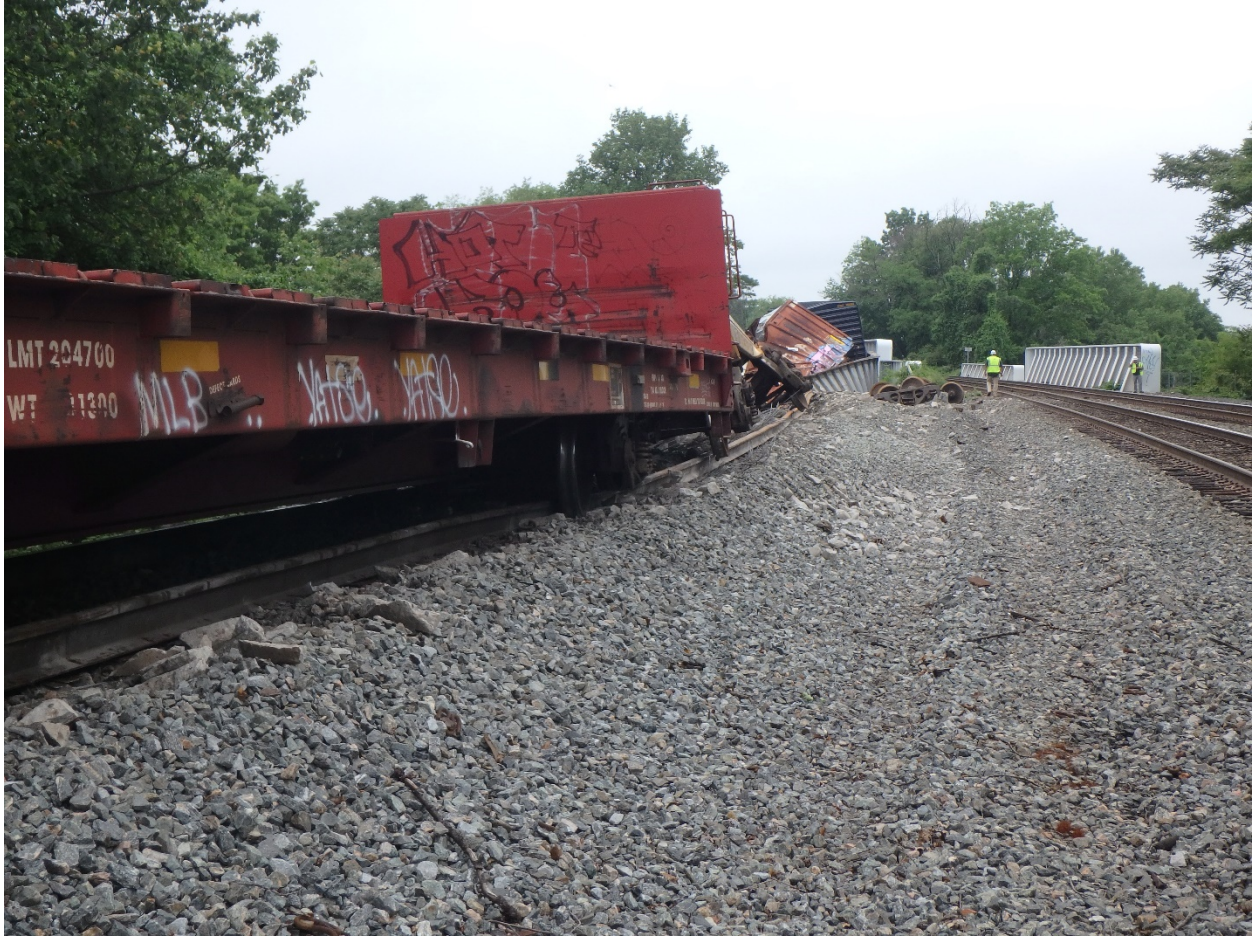
Figure 4. Photo showing track components damaged by wheel impact.

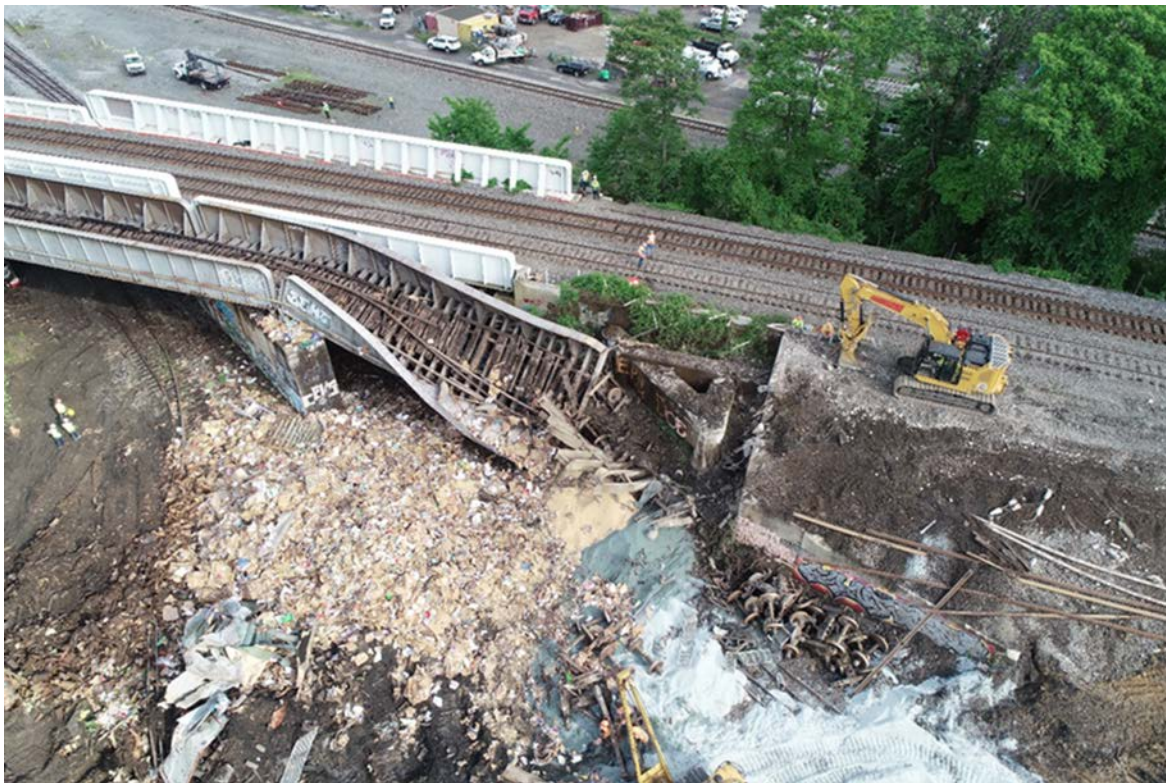
The bridge that was impacted was a two-span 205 feet long open deck through plate girder structure that was built in 1947. The bridge deck and first span were taken to the ground below the bridge superstructure. The damaged bridge's original design was an open deck, through plate girders, with two spans and a step span on the north end. On the bridge deck there were inner and outer guardrails.

*Figure 5. Aerial photo of displaced bridge structure. No. 1 track, MP CFP 102.8*
