HIR-23-11

# Pickup Truck Centerline Crossover Collision with Transit Van and Postcrash Fire

Andrews, Texas  
March 15, 2022

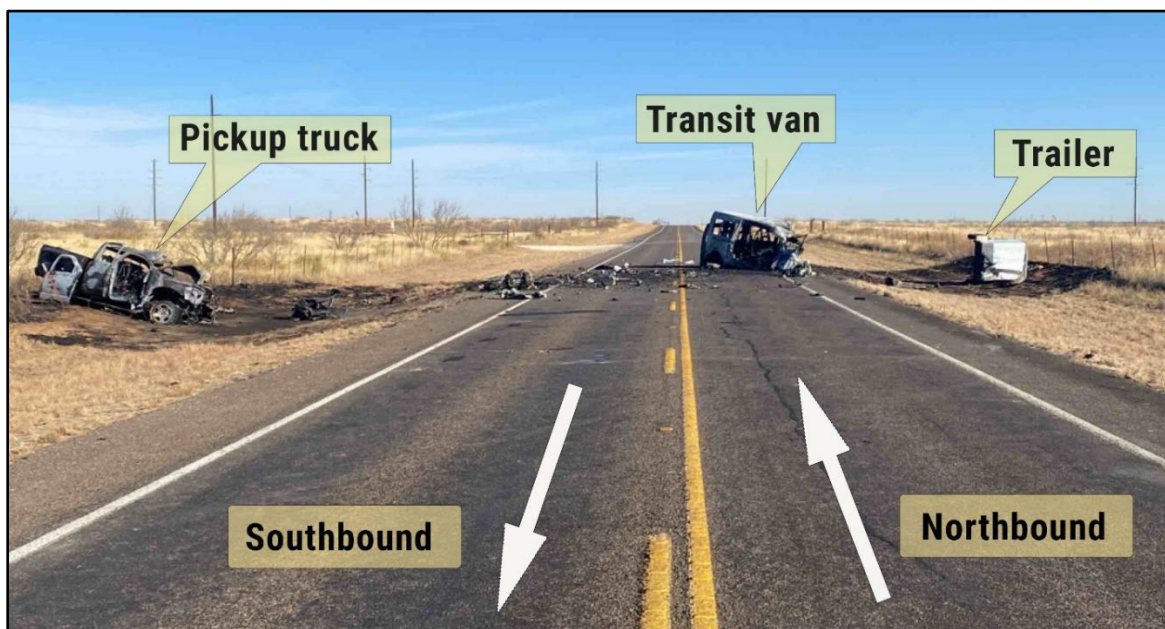
**Figure 1.** The north view of FM 1788, showing the final rest positions of the involved vehicles. (Source: Texas Department of Transportation, annotations added by NTSB)

The nearly head-on impact caused both vehicles to rotate counterclockwise. The van came to rest in the northbound lane—at the impact location but rotated—while the pickup truck came to rest off the roadway, southwest of the impact location. The trailer separated from the van at impact and came to rest off the roadway, east of the location of the van. Both the van and the pickup truck sustained catastrophic intrusion damage

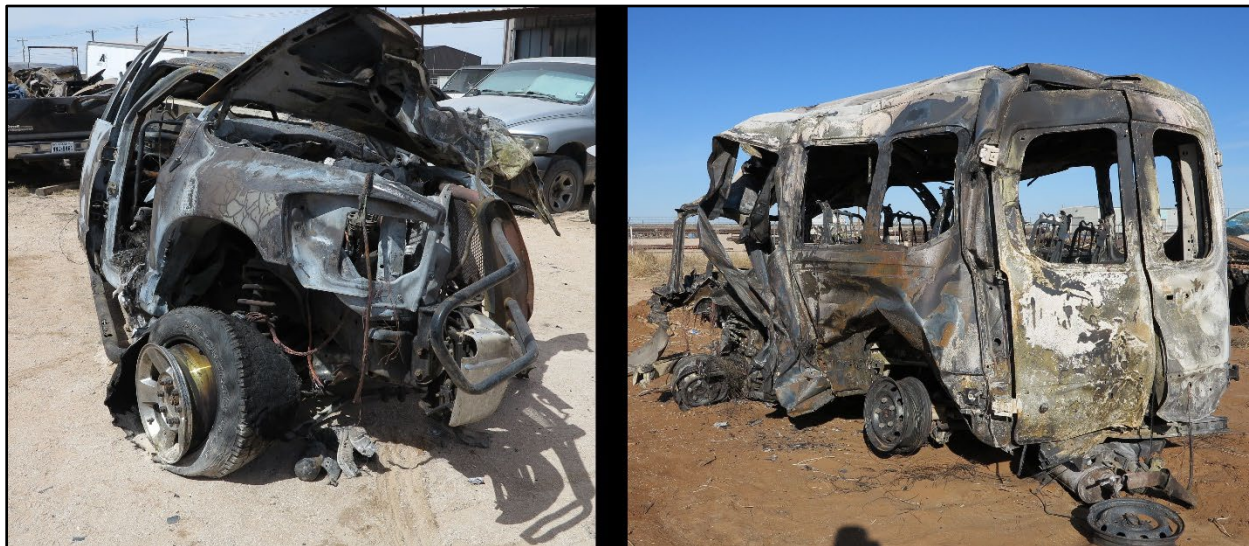
and were consumed by postcrash fire (see figure 3). The trailer sustained impact damage to the left-front corner and limited thermal damage on the left side.

**Figure 3.** Left, damage to the pickup truck (right front view); right, damage to the van (left rear view).

The Cummins engine control module and the airbag control module (ACM) from the pickup truck were destroyed in the postcrash fire. The ACM from the van was recovered, but the device was extensively fire-damaged. As a result, no usable data could be retrieved from the recording modules on either of the vehicles. The limited postcrash inspection identified no precrash mechanical deficiencies for either vehicle.<sup>2</sup>
