NATIONAL TRANSPORTATION SAFETY BOARD

Highway Group Chairman's Factual Report

HIGHWAY FACTORS

HWY22MH006

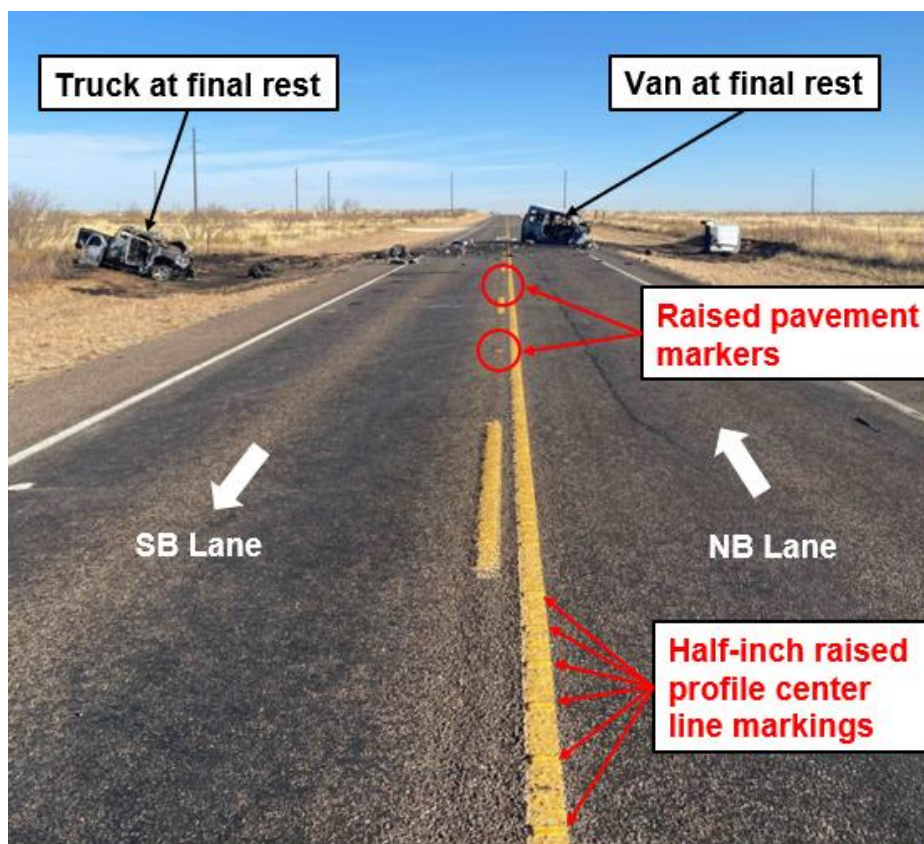
Profile center line markings existed along the center line of FM 1788 in the vicinity of the crash.¹⁰ The profile center line markings were raised from the pavement approximately a half-inch and were approximately 4-inches wide made of preformed thermoplastic strips that were spaced approximately 12-inches on center. In addition, profile edge line markings existed along the edge of the northbound and southbound lanes with the above stated dimensions.¹¹ **Figures 2 and 3** illustrate the location of the half-inch raised profile center line markings in the vicinity of the crash.

Figure 2 – Location of the half-inch raised profile center line markings and raised pavement markers in the vicinity of the crash looking to the north (Source: TxDOT revised).

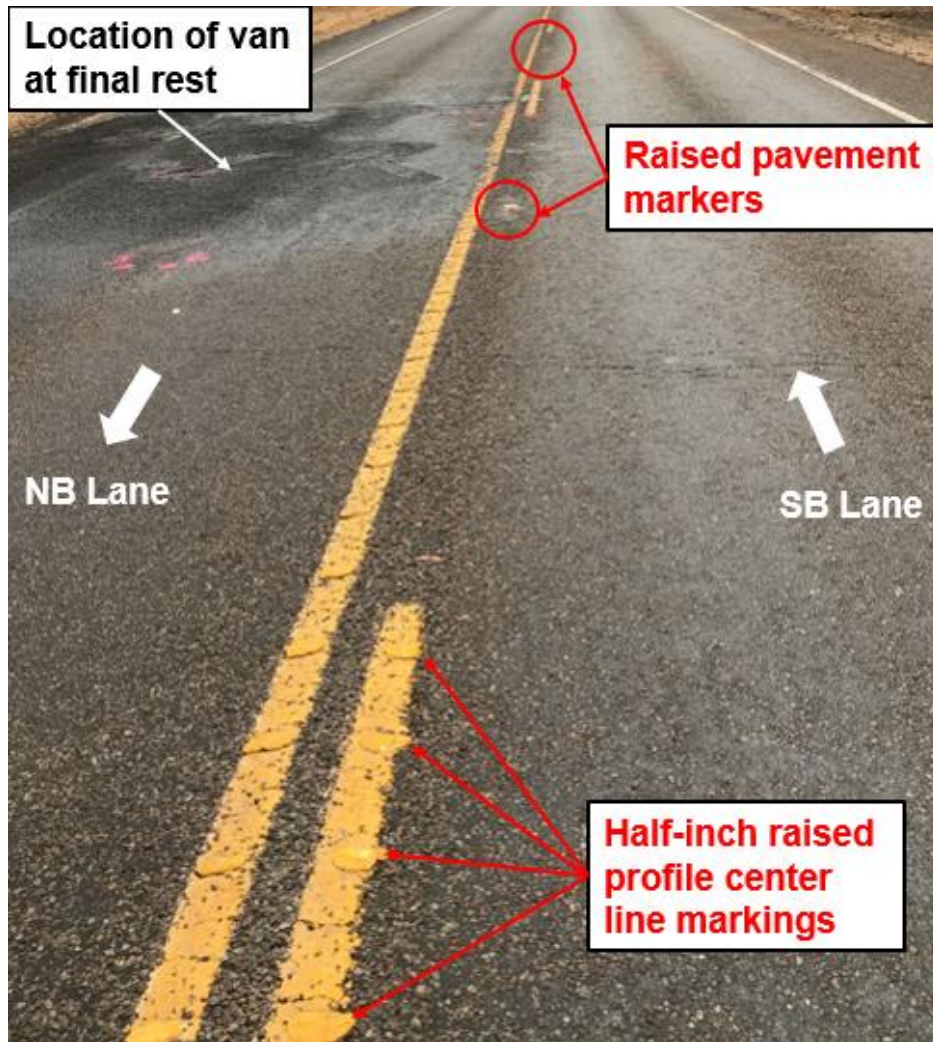
Figure 3 – Location of the half-inch raised profile center line markings and raised pavement markers in the vicinity of the crash looking to the south (Source: TxDOT revised).

“The section of FM 1788 from Gaines County line south to SH 115 has raised profile markings for both centerline and edgeline. The section of FM 1788 from SH 115 south to SH 176 has depressed milled rumble strips¹³ for both centerline and edgeline. Yes, the [TxDOT] Odessa District uses depressed milled rumble strips on state and interstate highways. Milled rumble strips are preferred when adequate pavement depth is available. Adequate pavement depth is recommended of 2” [inches] or more. The section of FM 1788 from Gaines County line south to SH 115

[the section in which the crash occurred] *does not have adequate pavement depth to support the milled rumble strips.*”

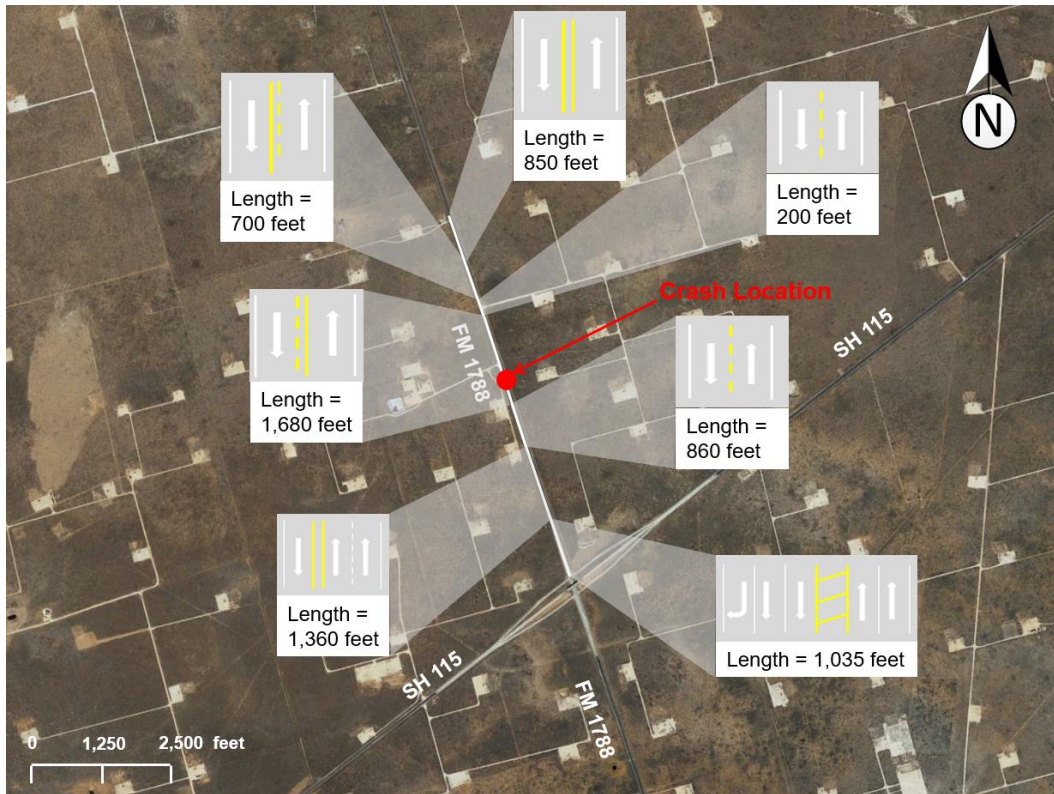
Figure 4 illustrates the passing and no-passing zones approximately one-half mile north and south of the crash location. TxDOT indicated to NTSB investigators the passing and no-passing zones were established based on the vertical grade changes that effect sight distance.¹⁹ In the vicinity of the crash location, a passing zone existed in the southbound direction of travel and a no-passing zone existed in the northbound direction of travel.

Figure 4 – Passing and no-passing zones approximately one-half mile north and south of the crash location. White arrows are for illustration purposes only (Source: Google Earth revised).
