**NATIONAL TRANSPORTATION SAFETY BOARD
OFFICE OF HIGHWAY SAFETY
WASHINGTON, D.C.**

**TECHNICAL RECONSTRUCTION GROUP CHAIRMAN'S
FACTUAL REPORT**

ANDREWS, TEXAS – HWYM22H006

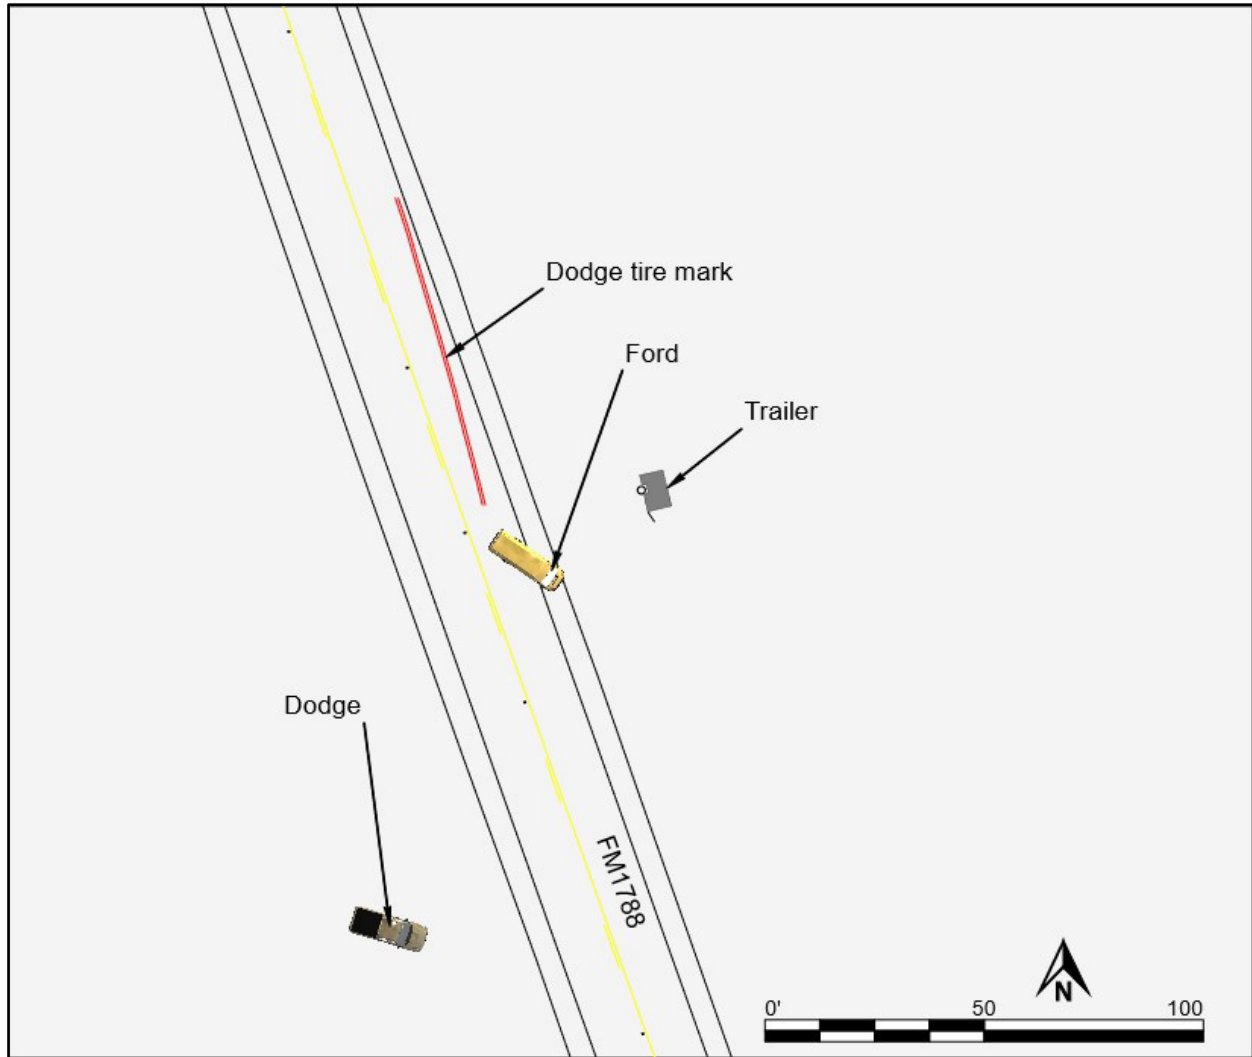
There was a single tire friction mark observed in the northbound lane. The outside and inside edges of the tire imprinted on the roadway surface which terminated at the area of impact. The friction mark extended southwestward in the northbound travel lane for approximately 73 feet. The distance between the two edges of the friction mark measured approximately 7.5 inches apart consistently throughout the length of the mark. The tire friction mark measured approximately 1.8 feet from the white edge line in the northbound lane at the onset and about 6.6 feet from the white edge line at its termination (area of impact). The tire friction mark displayed a shallow rightward arc throughout its length.

As shown in TXDPS scene photographs, the Ford remained partially in the northbound travel lane and on the northbound shoulder. The Dodge Ram traveled off the southbound side of the roadway and became entangled in a barbed wire fence. At final rest, the Ford and the Dodge Ram had a heading toward the southeast. The trailer came to rest east of the Ford on its left side with a southeasterly heading. At final rest the Ford was at an angle of about 226° relative to its initial direction of travel (northbound). The Dodge Ram, at final rest, was at an angle of about 127° relative to its initial direction of travel (southbound), and approximately 89 feet southwest of the Ford. The trailer separated from the Ford and overturned onto its left side. At rest, the trailer was located about 32 feet east of the Ford, off the roadway, at an angle of 180° relative to its initial direction of travel.

Figure 2. Collision site diagram showing post-crash final rest positions of the vehicles with tire mark evidence. Diagram based on sUAS mapping data provided by the TXDPS.

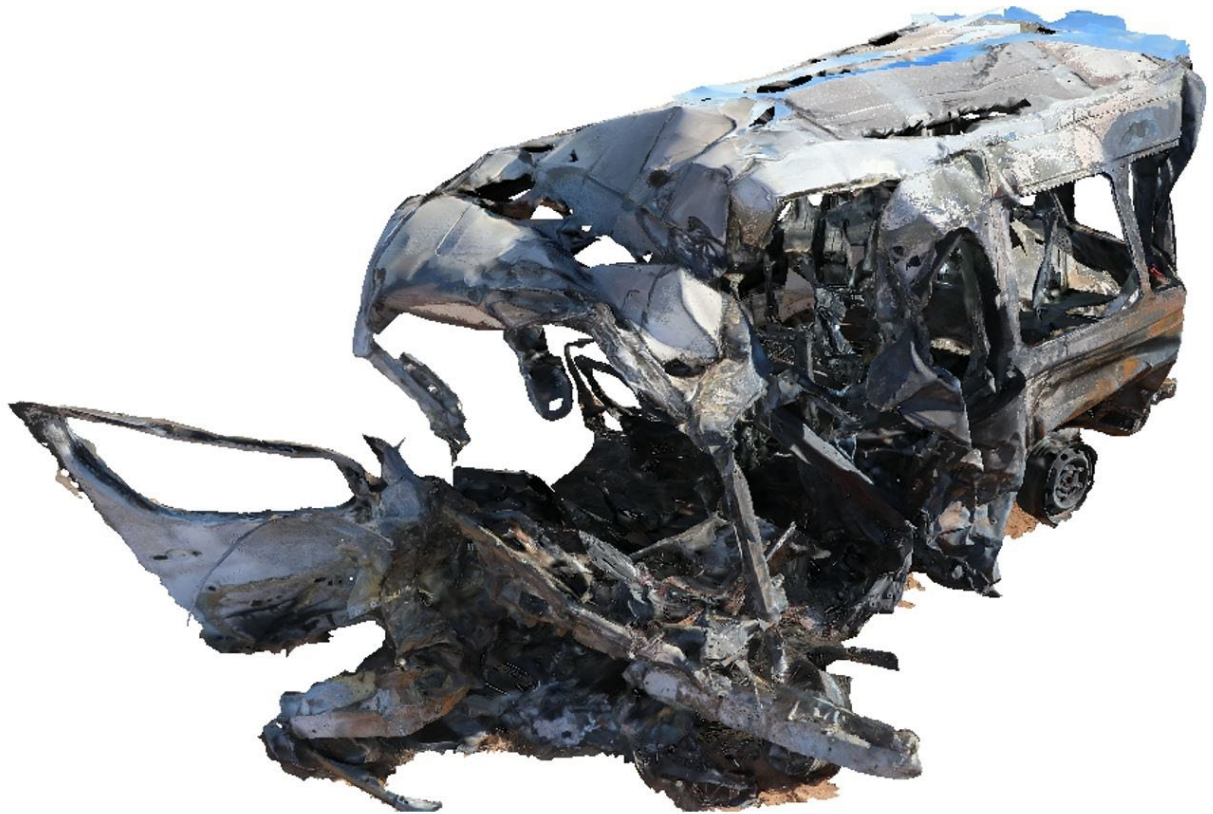
Figure 3 is a 3D image of the collision damage exhibited by the Ford. Overall, the Ford exhibited catastrophic damage. The vehicle had sustained an offset frontal collision on the driver’s side with contact damage overlapping about 47.3 inches of the lateral width of the vehicle, as

measured from the sidewall at the left front axle position. The motor had been torn from the mounts and was dislodged from the vehicle. The left fender was pushed rearward and down. The firewall was separated from both “A” pillars and displaced rearward and down. The leading edge of the roofline had also exhibited contact damage and was crumpled rearward. The driver’s door and first passenger side window area were pushed rearward to the “B” pillar and had been torn from the roofline. The front axle had been pushed rearward and down and the bumper was torn in half along the centerline. The left half of the bumper and left front wheel were displaced rearward and laterally to the left. The left side of the left bumper half was pushed rearward toward the centerline of the vehicle causing the right edge of the bumper outward, ultimately facing to the front of the Ford. Another area of contact damage was identified on the left rear of the Ford. The damage

Figure 3. The image shows a 3D view of the Ford looking at the left front of the vehicle where the damage was concentrated.

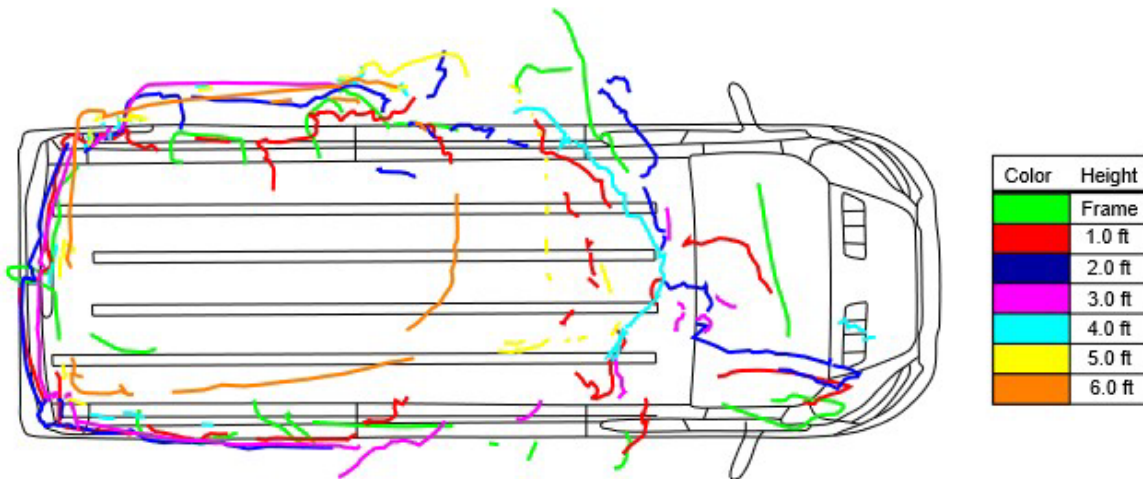
resulted from the collision induced rotation between the Ford and trailer. A post-crash fire caused extensive fire damage. **Figure 4** shows the damage profile of the Ford atop an undamaged outline of an exemplar Ford.

Figure 4. Image depicts a two-dimensional, top-down illustration of damage to the Ford atop an undamaged outline. Damage outlines were drawn from the 3D scan data at one-foot vertical intervals beginning at the axle height.

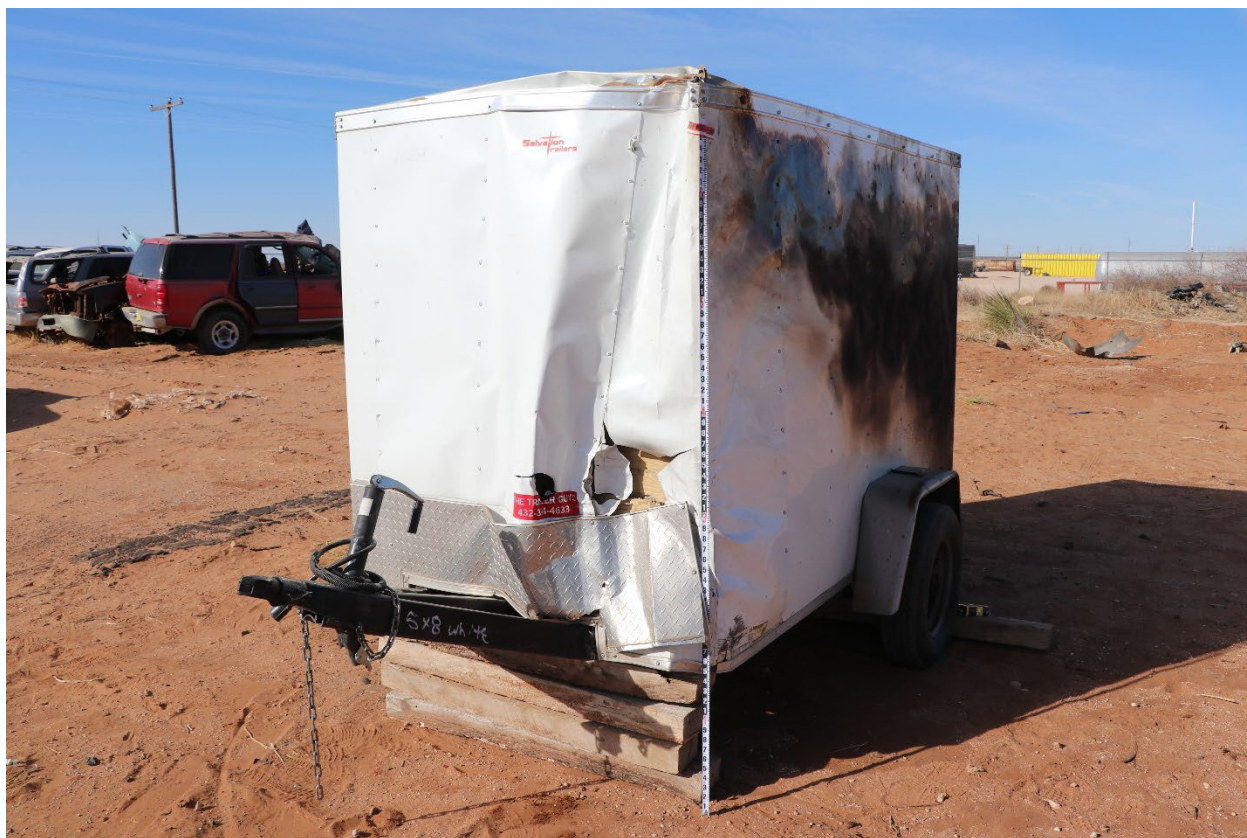
The tongue of the trailer had been bent upwards to approximately a 30° angle. There was direct contact damage identified on the front left that extended the full vertical height of the trailer. The sheet metal had been pushed rearward into the storage area of the trailer. About 2 feet upward from the bottom of the trailer the sheet metal had been torn exposing the interior wood frame. The left

side of the trailer received fire damage. The trailer was weighed during the examination. The weight, which included all equipment, was determined to be 1,350 pounds. **Figure 5** depicts the damage to the Salvation trailer.

Figure5. Photograph depicting the damage sustained by the Salvation trailer.

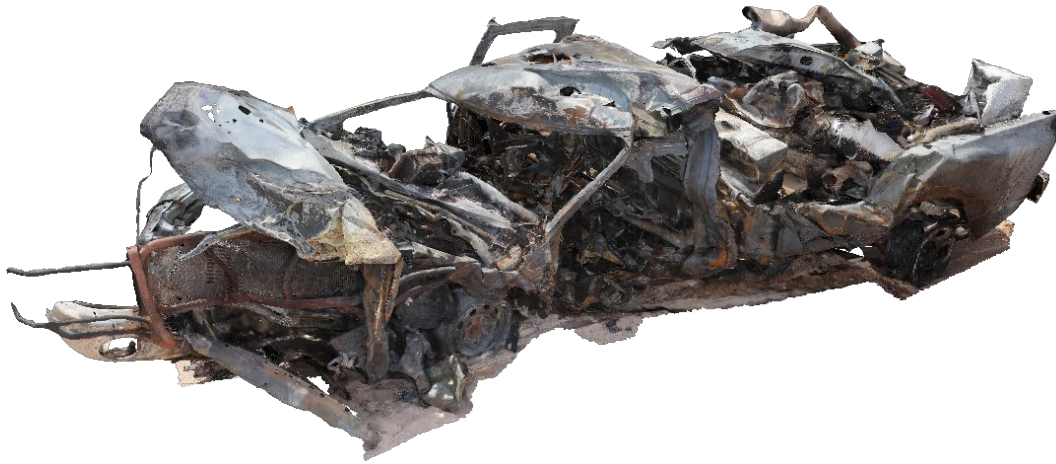
The Dodge Ram exhibited severe front-end damage from an offset frontal collision. The direct contact damage extended laterally across the full front of the vehicle. The front end of the vehicle had been pushed through the engine compartment into the firewall. The left side had been displaced further rearward than the right side. The right side had shifted leftward, toward the driver's side. As a result of the collision the Dodge Ram exhibited extensive fire damage that had consumed the entire vehicle. The Dodge was weighed during the examination, and it was determined that the post-crash weight was approximately 7,140 pounds. **Figures 6 and 7** depict 3D and damage patterns exhibited by the Dodge.

Figure 6. 3D rendering of the Dodge. View of the damage sustained by the Dodge looking at the front left side.

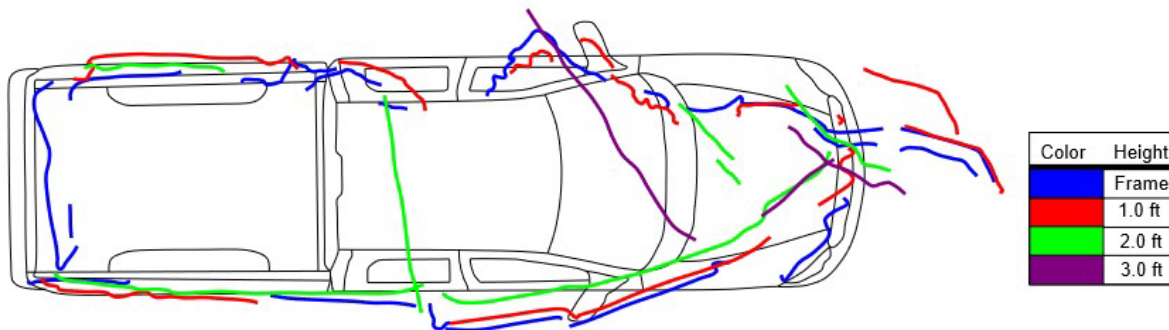
Figure 7. Image depicts a two-dimensional, top-down illustration of damage to the Dodge atop an undamaged outline. Damage outlines were drawn from the 3D scan data at one-foot vertical intervals beginning at the axle height.
