NATIONAL TRANSPORTATION SAFETY BOARD

Vehicle Factors Group Chairman's Factual Report

HWY22MH006

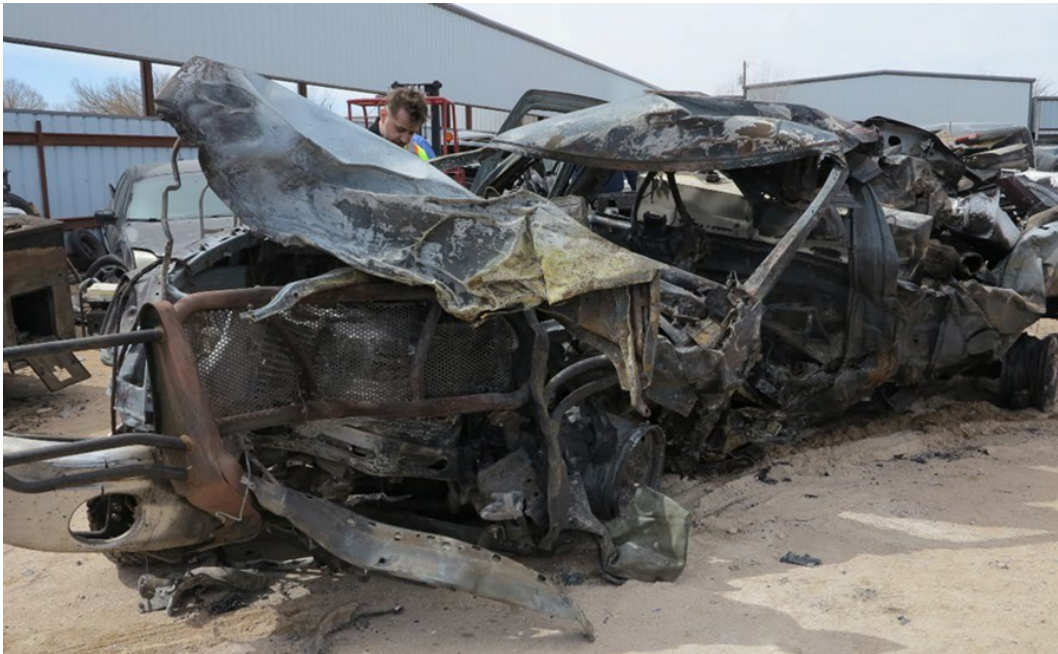
The complete truck sustained extensive crash and post-crash fire damage, see **Figure 1**. The front of the vehicle was displaced towards the left. The hood was crushed rearward. The front of the engine had been rotated to the left, and the fuel lines had separated from the engine. The left-front fender and driver’s door were missing. The left A-pillar had been displaced rearward, and along with the cab of the vehicle. All vehicle glass was missing. The sheet metal on the left side of the cargo bed had been crushed rearward, and the top of the cargo bed had been displaced downward. The left frame rail was bent downward at the rear of the cab. The 35-gallon plastic fuel tank, which had been mounted beneath the left-front of the cargo bed, was missing from the mounting straps.

Figure 1: A view looking at the damage sustained to the left front and left side of the truck.

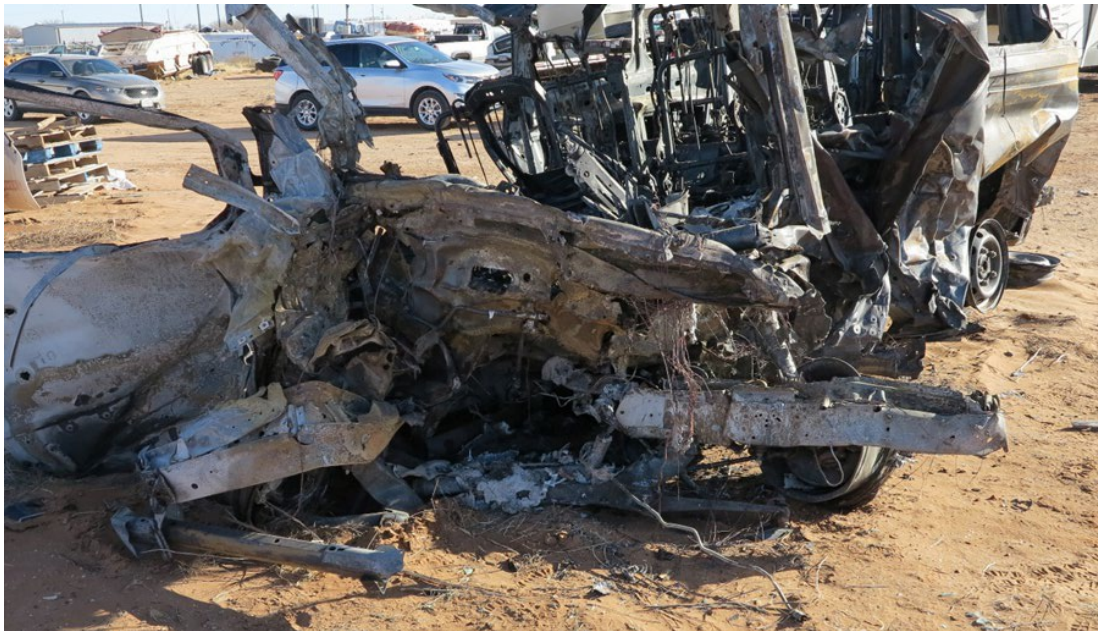
The only mechanical components left at the front of the van were the steering gear and front axle assembly, as shown in **Figure 2**. The engine and transmission were in the debris field. The 25-gallon polyethylene fuel tank was missing from the fuel tank mounting straps. The frame rails were bowed in an upward arch forward of axle 2 spring hangers.

Figure 2: A front view of the 2017 Ford Transit Van showing the extensive crash and post-crash fire damage.

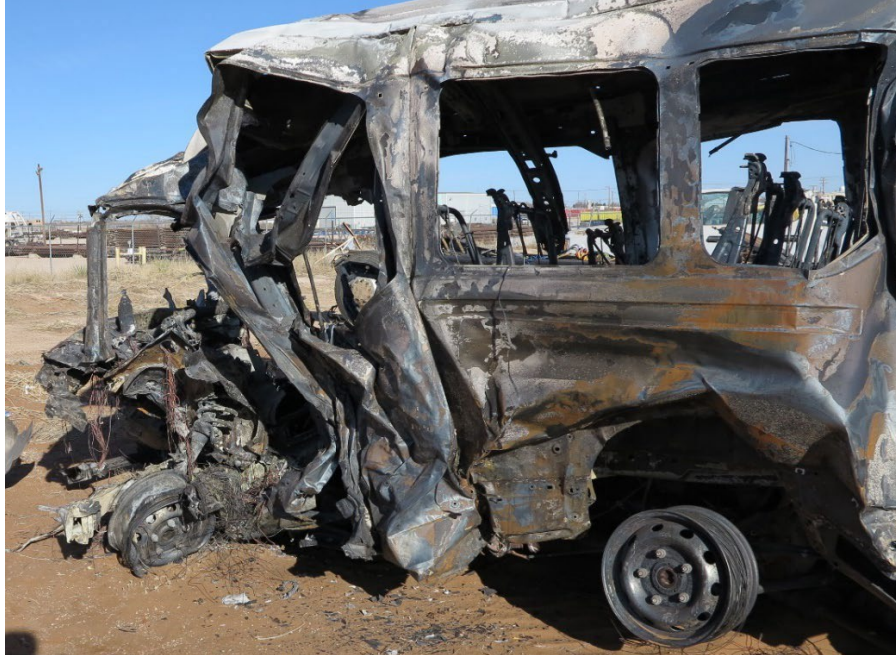
The left front to the van sustained rearward crush damage with the collected exterior sheet metal found at the approximate center of the vehicle, as shown in **Figure 3**. The right-side sliding door had been removed during recovery. See Vehicle Factors Photograph Attachment for more photographs depicting collision and post fire damage.

Figure 3: Left-side view of the transit van showing the extensive damage crash and post-crash fire damage.

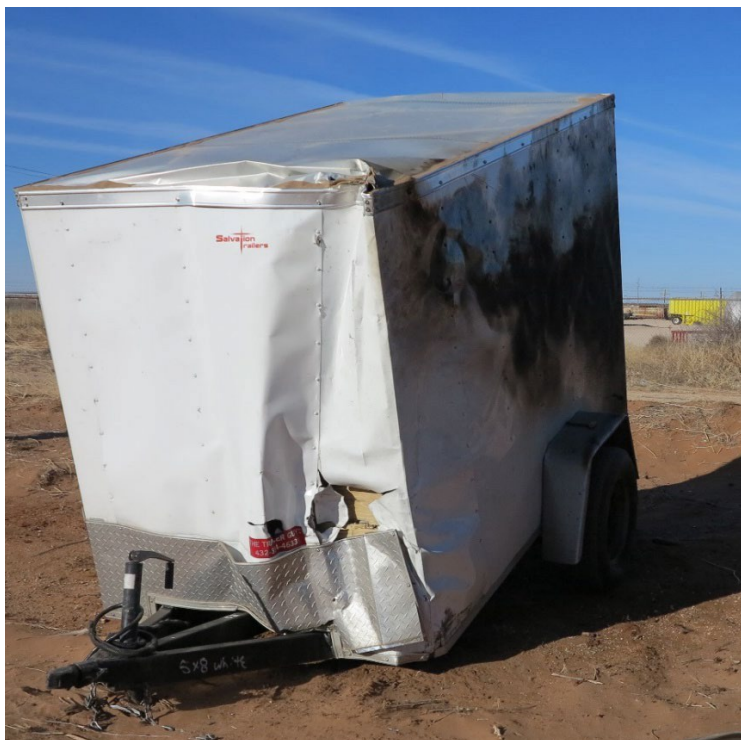
The enclosed utility trailer sustained impact damage to left-front corner, and the tongue was bent in an upward direction. The left side of the trailer had some thermal damage, as seen in **Figure 4**.

Figure 4: A view of the left-front and side of the 2019 Salvation trailer.
