Preliminary Report HWY22MH006

Centerline Crossover and Head-on Crash

Andrews, TX
March 15, 2022

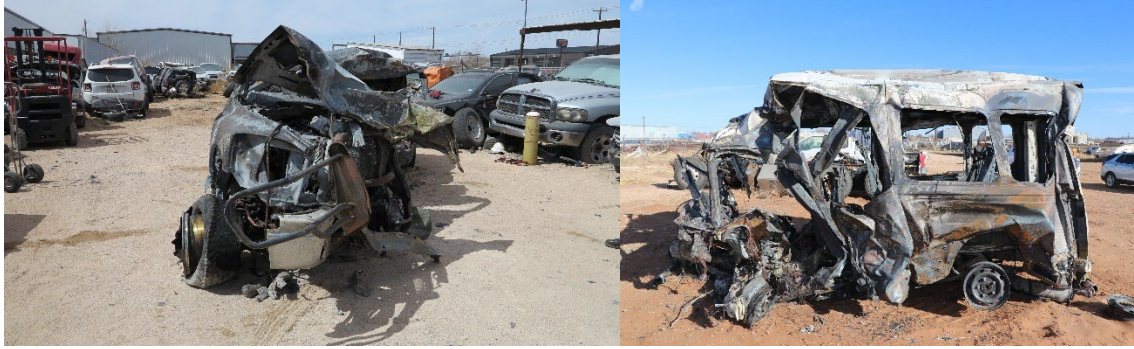
Figure 1. Damage to pickup truck (left) and transit van (right) from impact and postcrash fire.

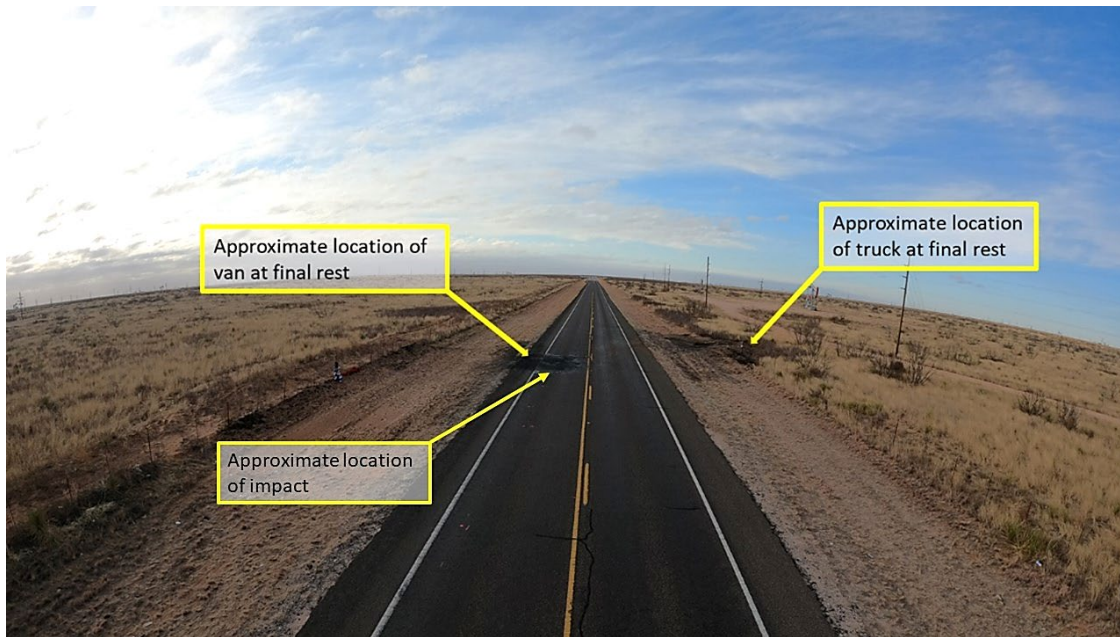
In the area of the collision, FM 1788 consisted of one northbound and one southbound travel lane, each approximately 12 feet wide. Raised pavement markers were spaced at 40-foot intervals along the painted centerline. The raised pavement markers, which had reflectorized surfaces on both sides, were intended to augment the lane markings delineating the travel lanes. Near the crash location, the roadway was straight, and no highway lighting was installed. (See figure 2.)

Figure 2. Southbound view of FM 1788 showing the north- and southbound lanes near the crash site, and the locations of the transit van and pickup truck at final rest.
