**National Transportation Safety Board
Internal Inspection Factual
Bellingham, Washington
Accident DCA99-MP008**

Appendix 10 Olympic dig sheet dated 7/97

OLYMPIC PIPE LINE COMPANY

LINALOG DIG INFORMATION

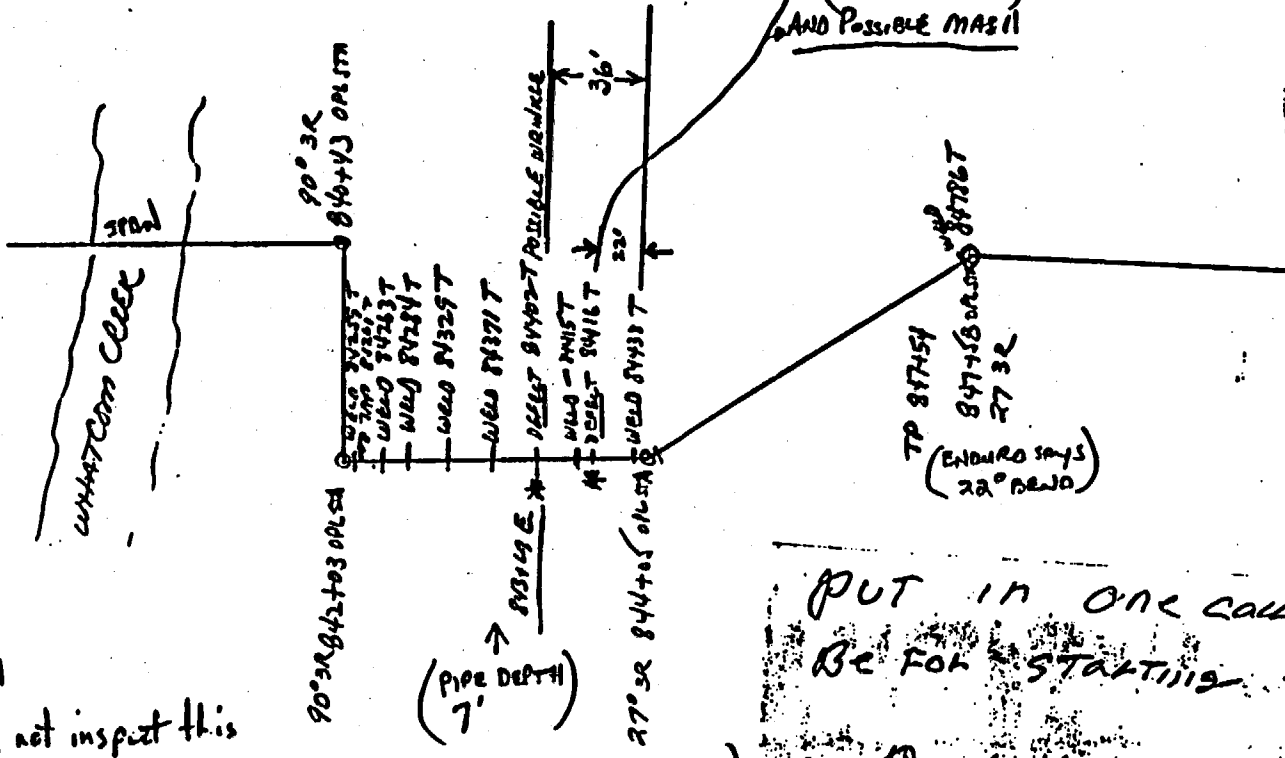
Drawing # FE-1

Defect % 23

Defect Length 0.4"

Position 1 O'clock

2 welds
4' apart

(1'-6" from weld)
AND POSSIBLE MASH

TP 87454
87455 OR 87456
27 3R
(ENOURO SAYS
22° BEND)

491
Did not inspect this location.
Tuboscope possible Mill/mach 23% (min)
Enclosure 4:5 sharp (less than repairable)

PUT IN ONE CALL
BE FOR STARTING
Back Hoe
EXTEND A HOE
