**National Transportation Safety Board
Internal Inspection Factual
Bellingham, Washington
Accident DCA99-MP008**

SMART PIG DATA ANALYSIS

Final Report

Olympic Pipeline Company Gasoline Pipelines
16" Cherry Point to Ferndale
16" Ferndale to Allen
16" Allen to Renton
20" Allen to Renton

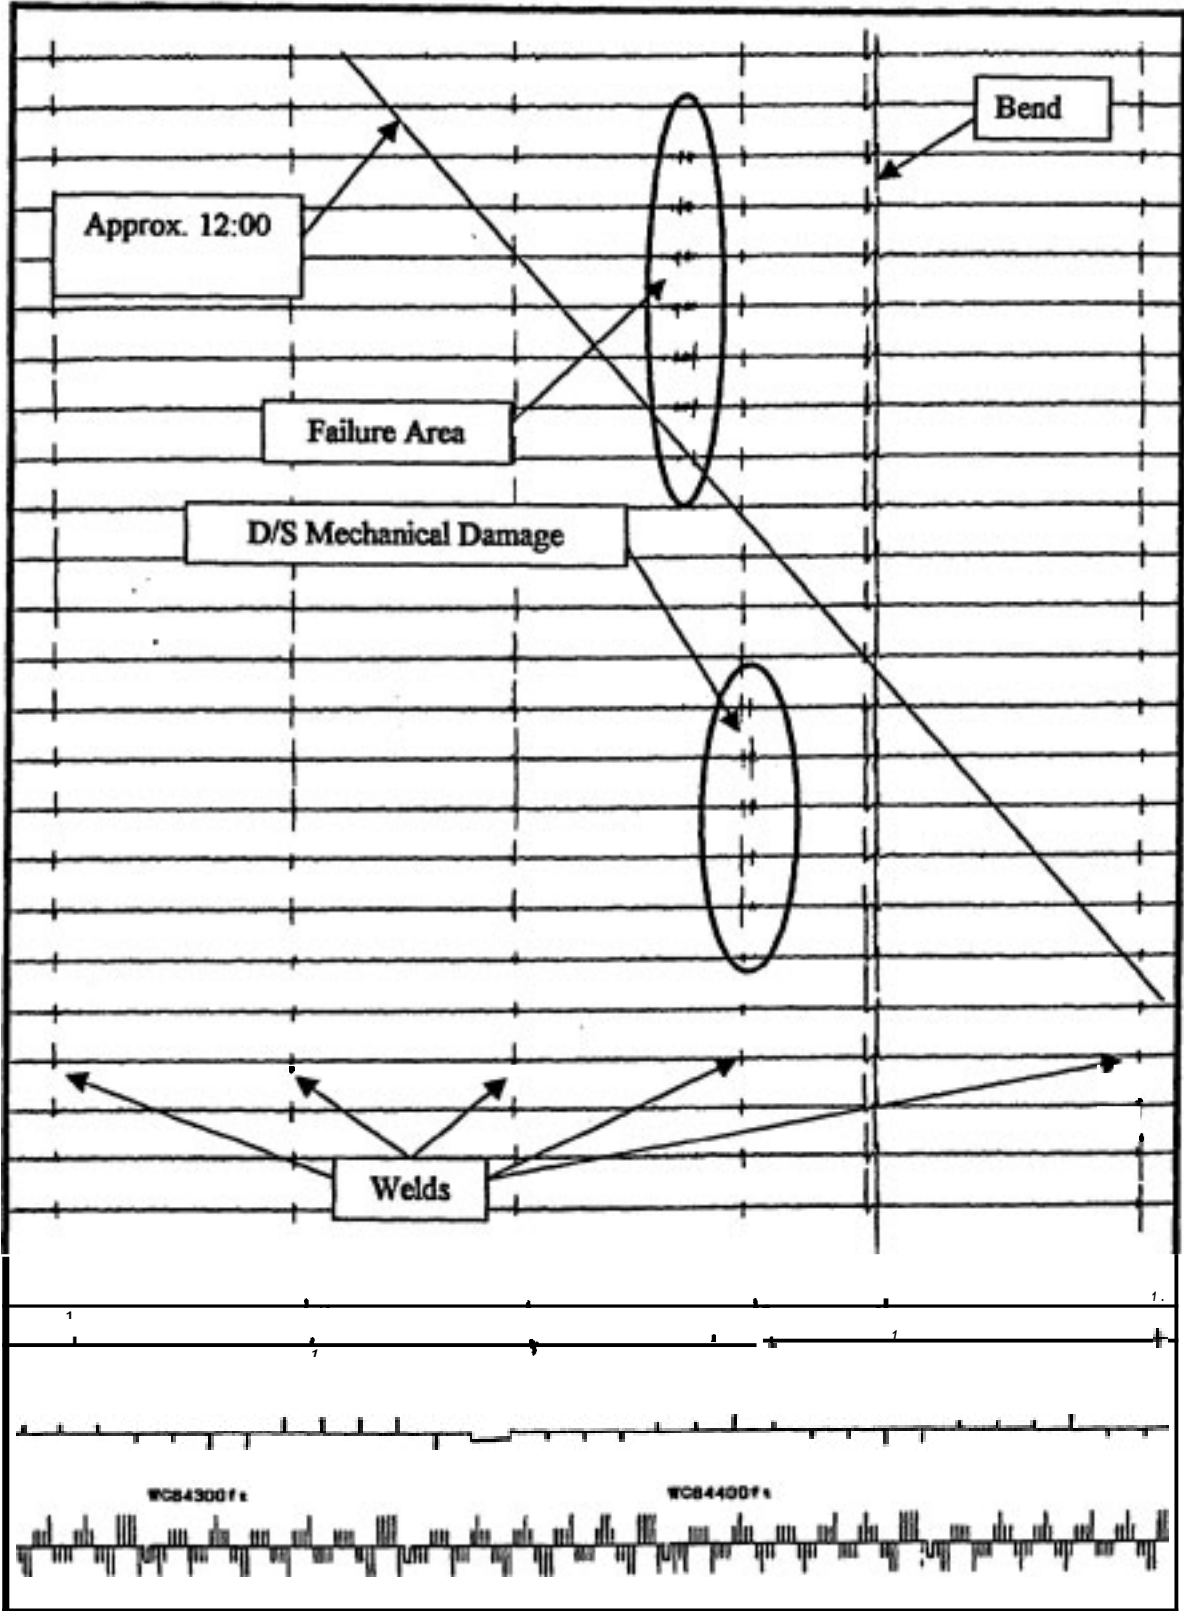
Figure 1. is a scanned graphic of the 1996 Linalog log at an area described by others as the origin of failure which is contained within an area on the log centered at approx. wheel count WC 84404. I added all annotations to the graphic for clarification purposes except the wheel count (WC) at the bottom that is a permanent part of the original log presentation.

It is impossible to establish a precise log correlation to each of the gouges in the area of the origin of failure due to the presence of corresponding denting at each point of damage. The physical resultant on the log is a series of predominantly low frequency, low amplitude signals indicative of denting over a large area with several higher amplitude, higher frequency signals present throughout the area. Physical movement of the transducer assembly in toward the central axis of the pipe as it passes over a dent causes a low frequency signal to be generated. Thus, it is an indicator that deformation is present. It is not always as prevalent as is shown here and that is a function of the abruptness of the dent. These impact origin dents are usually quite abrupt as compared to a dent caused from the pipe resting on a rock or a skid. Also this same movement causes poor correlation to three dimensional, metal-loss defects due to the additional variables introduced. The prominent variables are; loss in sensitivity to flux leakage due to sensor proximity (lift off), flux leakage patterns normal to the deformed pipe surface instead of normal to straight pipe, and spurious signals generated as a result of sensor assembly bounce.

As a general statement, the signals in the area containing the origin of failure are less than the signals in amplitude and are not a proper waveform to be considered as metal loss. The Tuboscope analysts did, however, recognize the area as one of some potential importance and chose to

bring it to the attention of OPL by annotating it as a "Possible Wrinkle Bend". I cannot take exception to this procedure because a series of dents does look like the pattern you would expect from a wrinkle bend. In the next joint downstream and just 1.5' downstream from the upstream weld, the analyst called a high frequency, relatively high amplitude signal as a "Possible Mill/Mechanical" with a "Possible Mash" immediately downstream of that. We have seen pictures of this specific location taken from the inside of the pipe after it was removed and the Possible Mash appears to be a quite abrupt dent. Since there are no pictures or any other input relating to the outside of the pipe at that location, we have to assume that the high frequency signal is derived from a gouge associated with the dent. For the record, the analyst has called the bend immediately downstream as a repair sleeve. He observed excess metal type signals only 2 feet in length and called it a sleeve and we now know it to be a bend (which also has excess metal since it is a forged fitting).

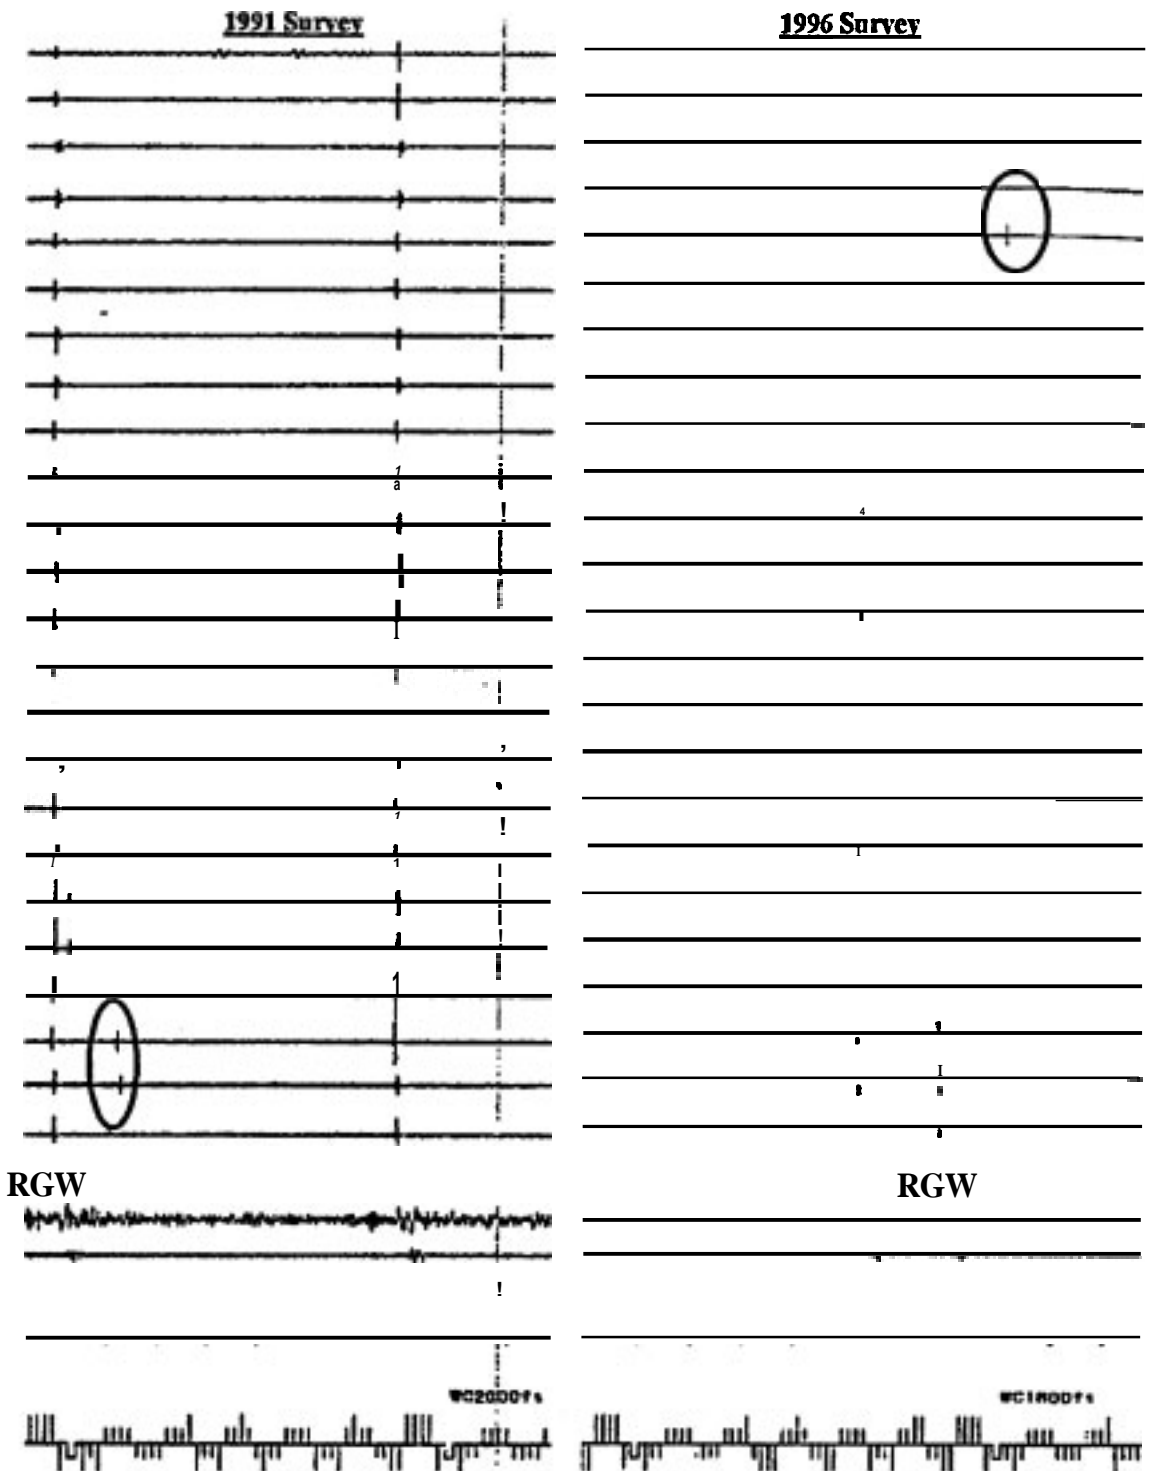
^a
D1, RGW = 1792' 3.2", Defect is 8' 7.4" D/S of RGW at 5:00. Hi Freq. Mill origin type signal.

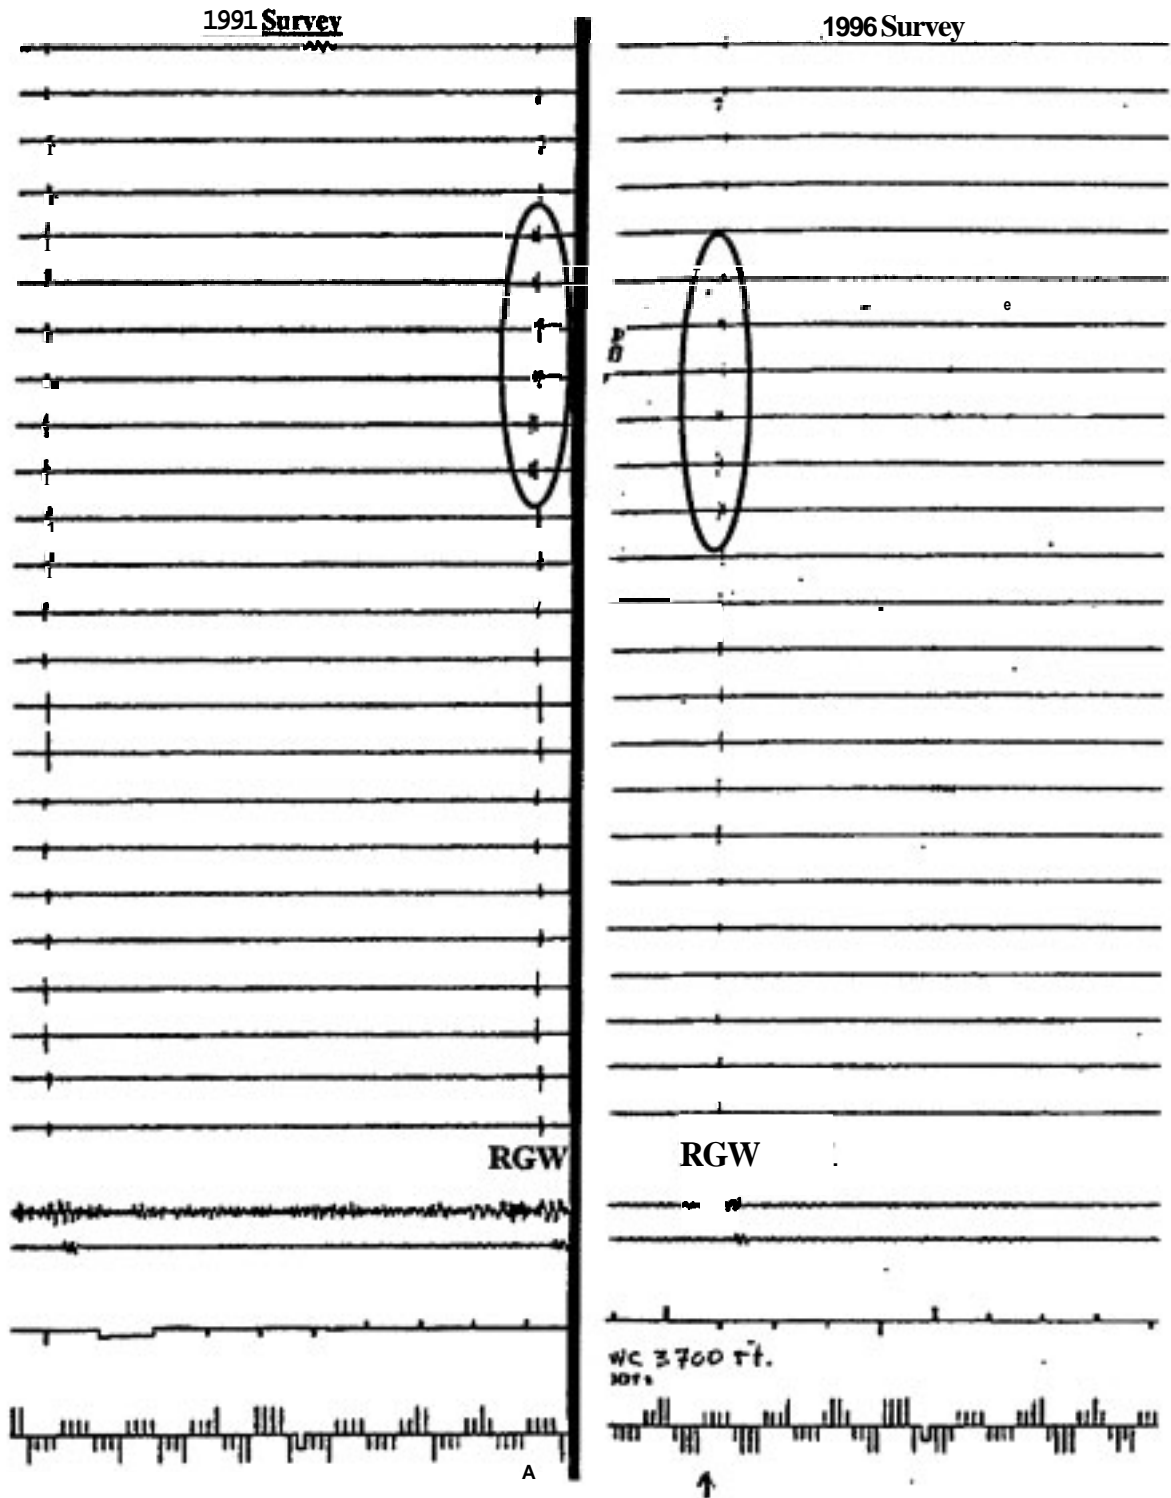
D2, RGW = 3722' 2.3", Defect is 6.7" U/S of RGW at 3:00. Weld area corrosion pattern.

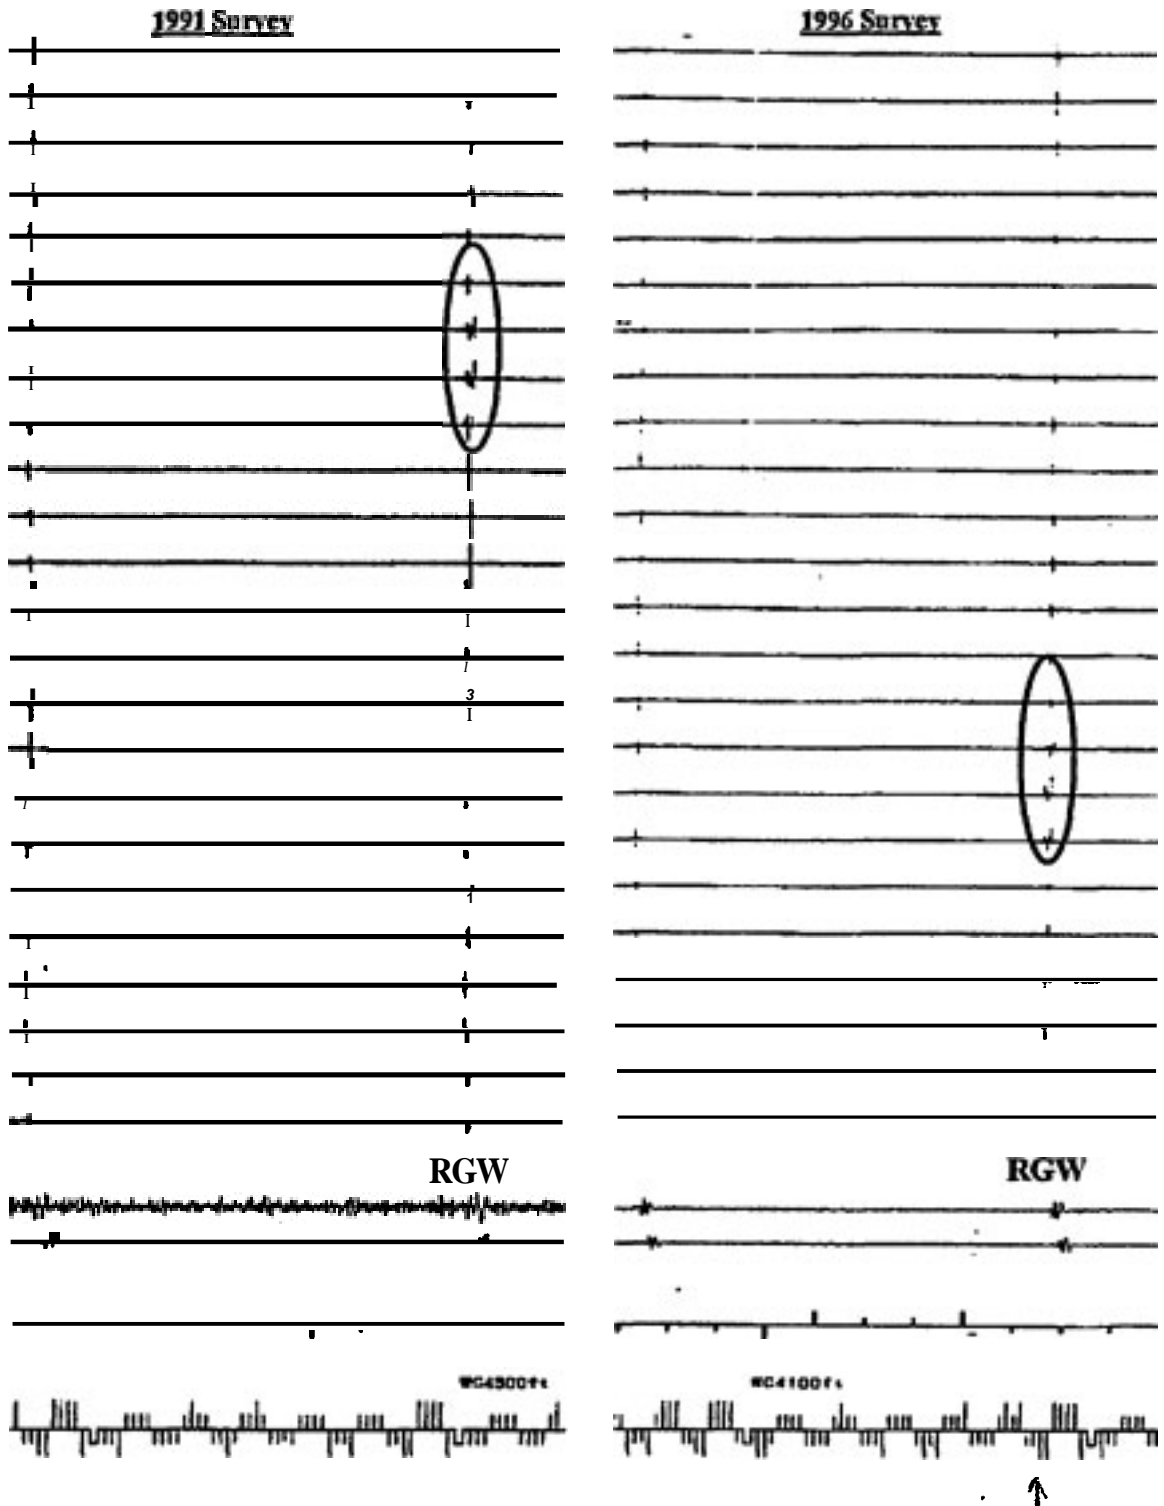
D3, RGW = 4143' 8.2", Defect is 6" U/S & D/S of RGW at 4:00. Weld area corrosion.

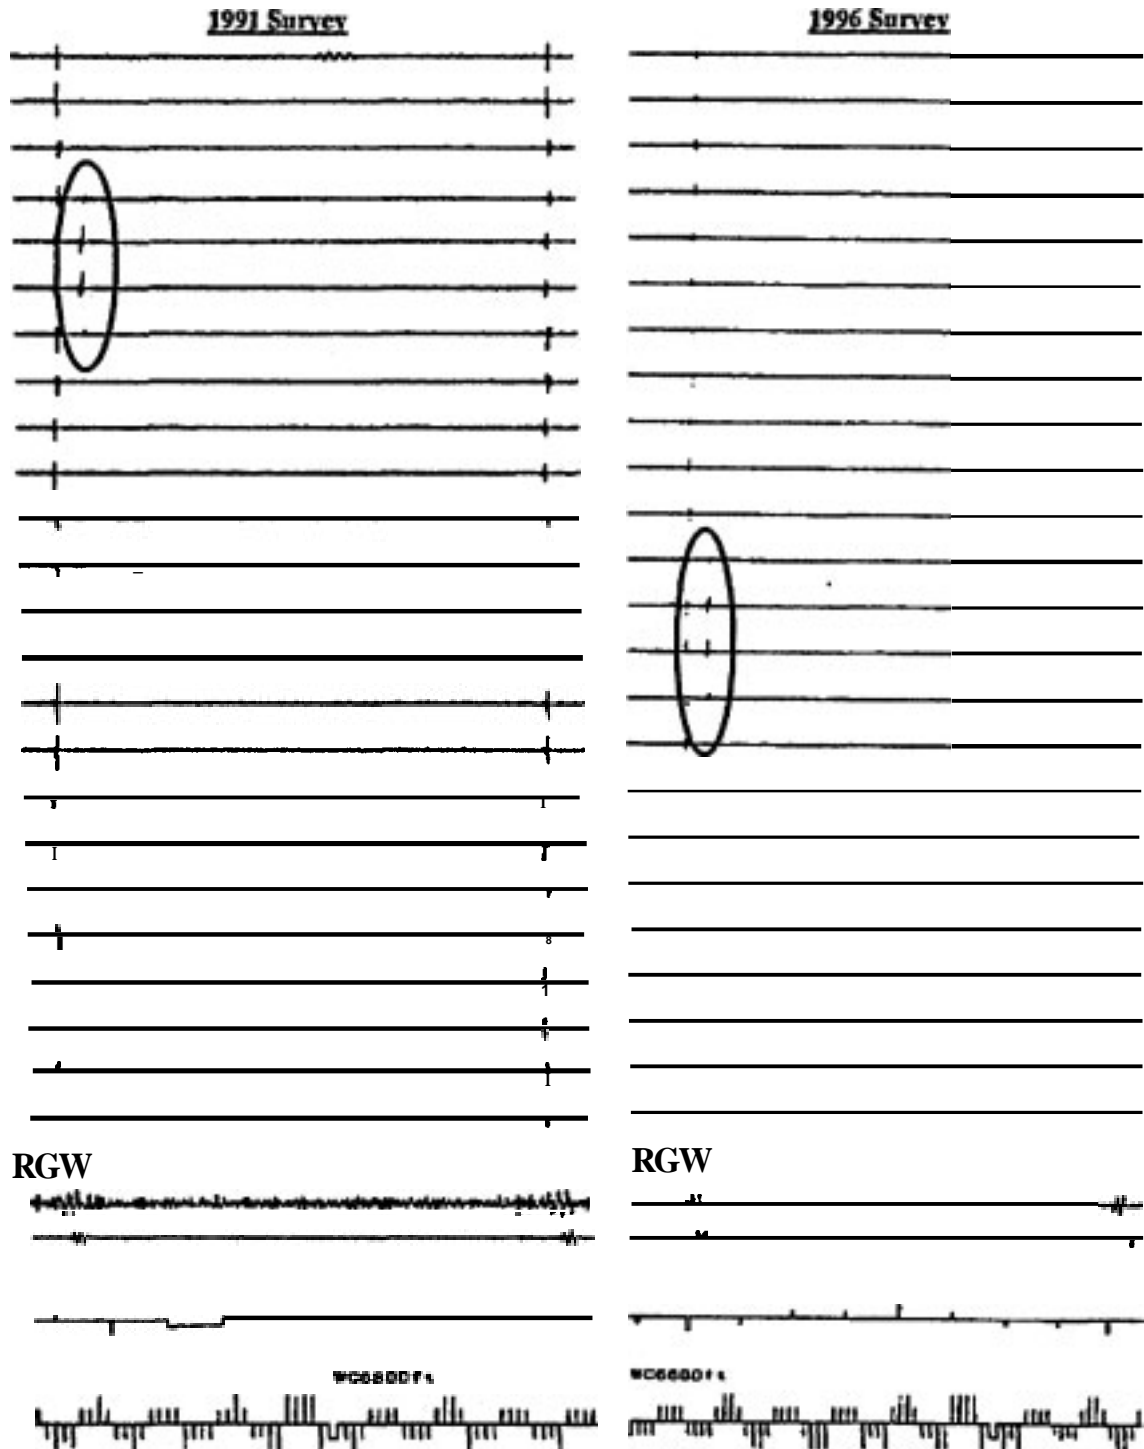
FEATURE, RGW = 6610' 9.2", Defect is 3' D/S of RGW at 6:00. Isolated corrosion or mill origin defect.

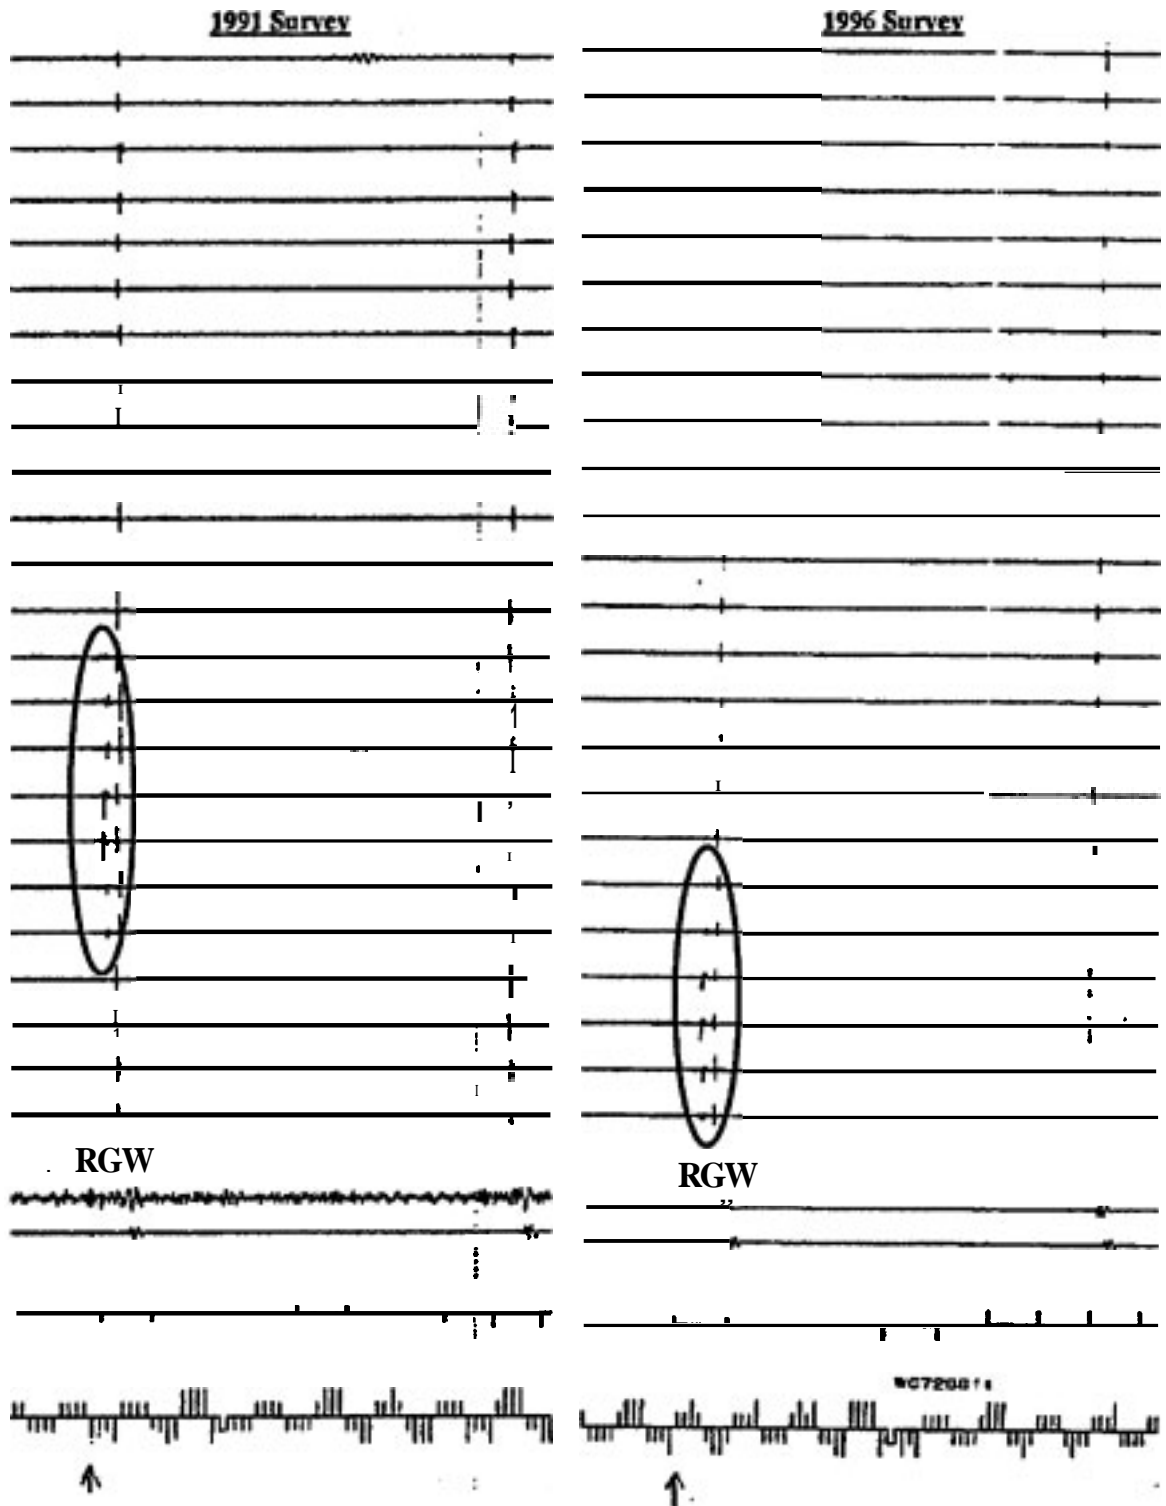
FEATURE, RGW = 7175' 3.9", Defect is 1' 5" U/S of RGW at 8:00. Mill origin type signal.

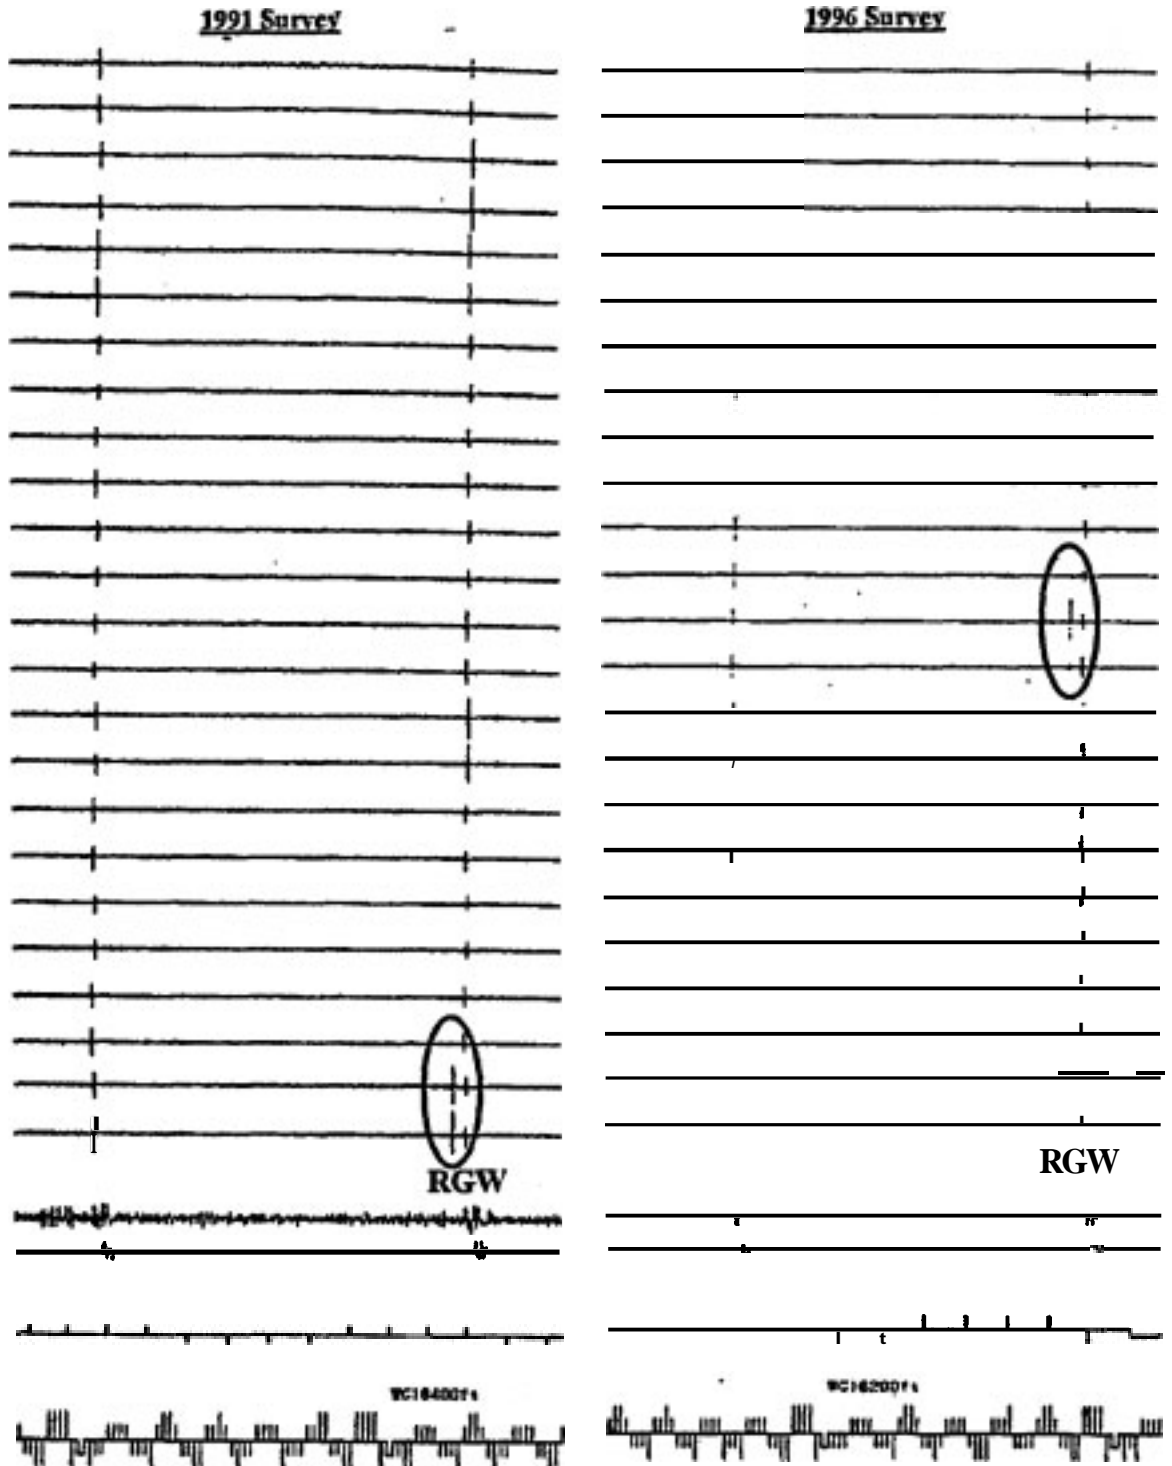
D5, RGW = 16244' 2.3", Defect is 2' 2.5" U/S of RGW at 4:00. Isolated Corrosion
α Mill origin defect.

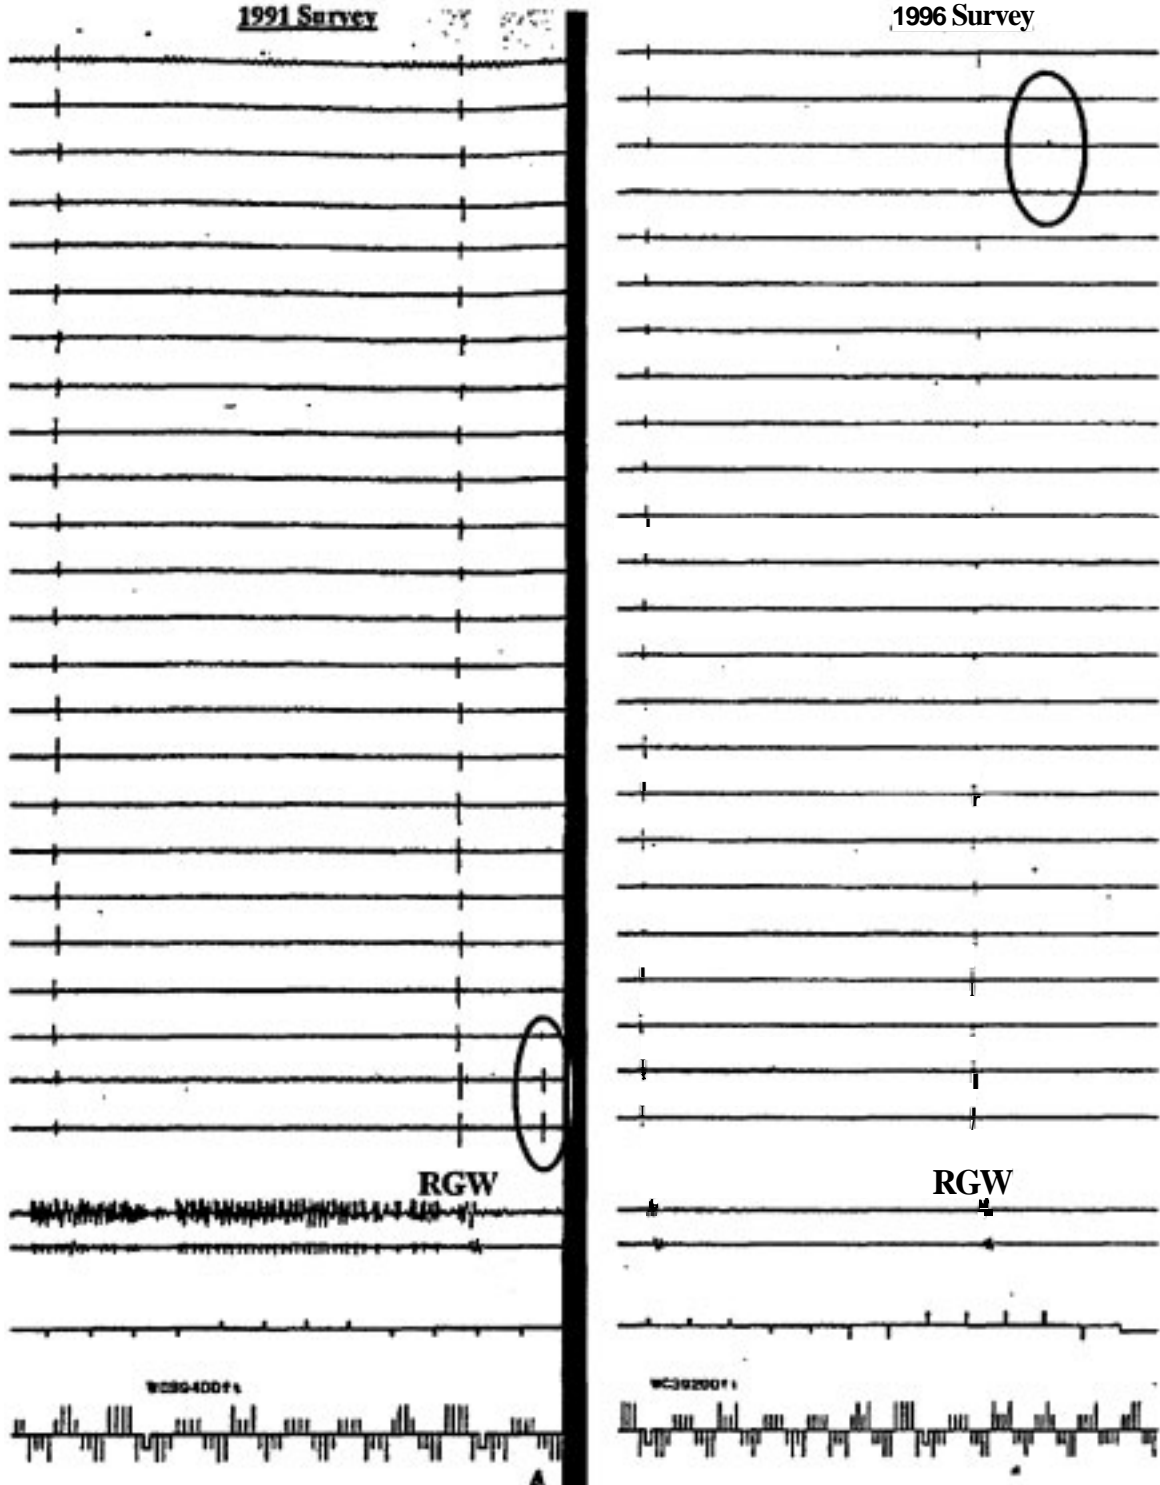
D6, RGW =39259' 0.3", Defect is 12' 8.3" D/S of RGW at 6:00. Hi Freq, Mill origin
Type defect.

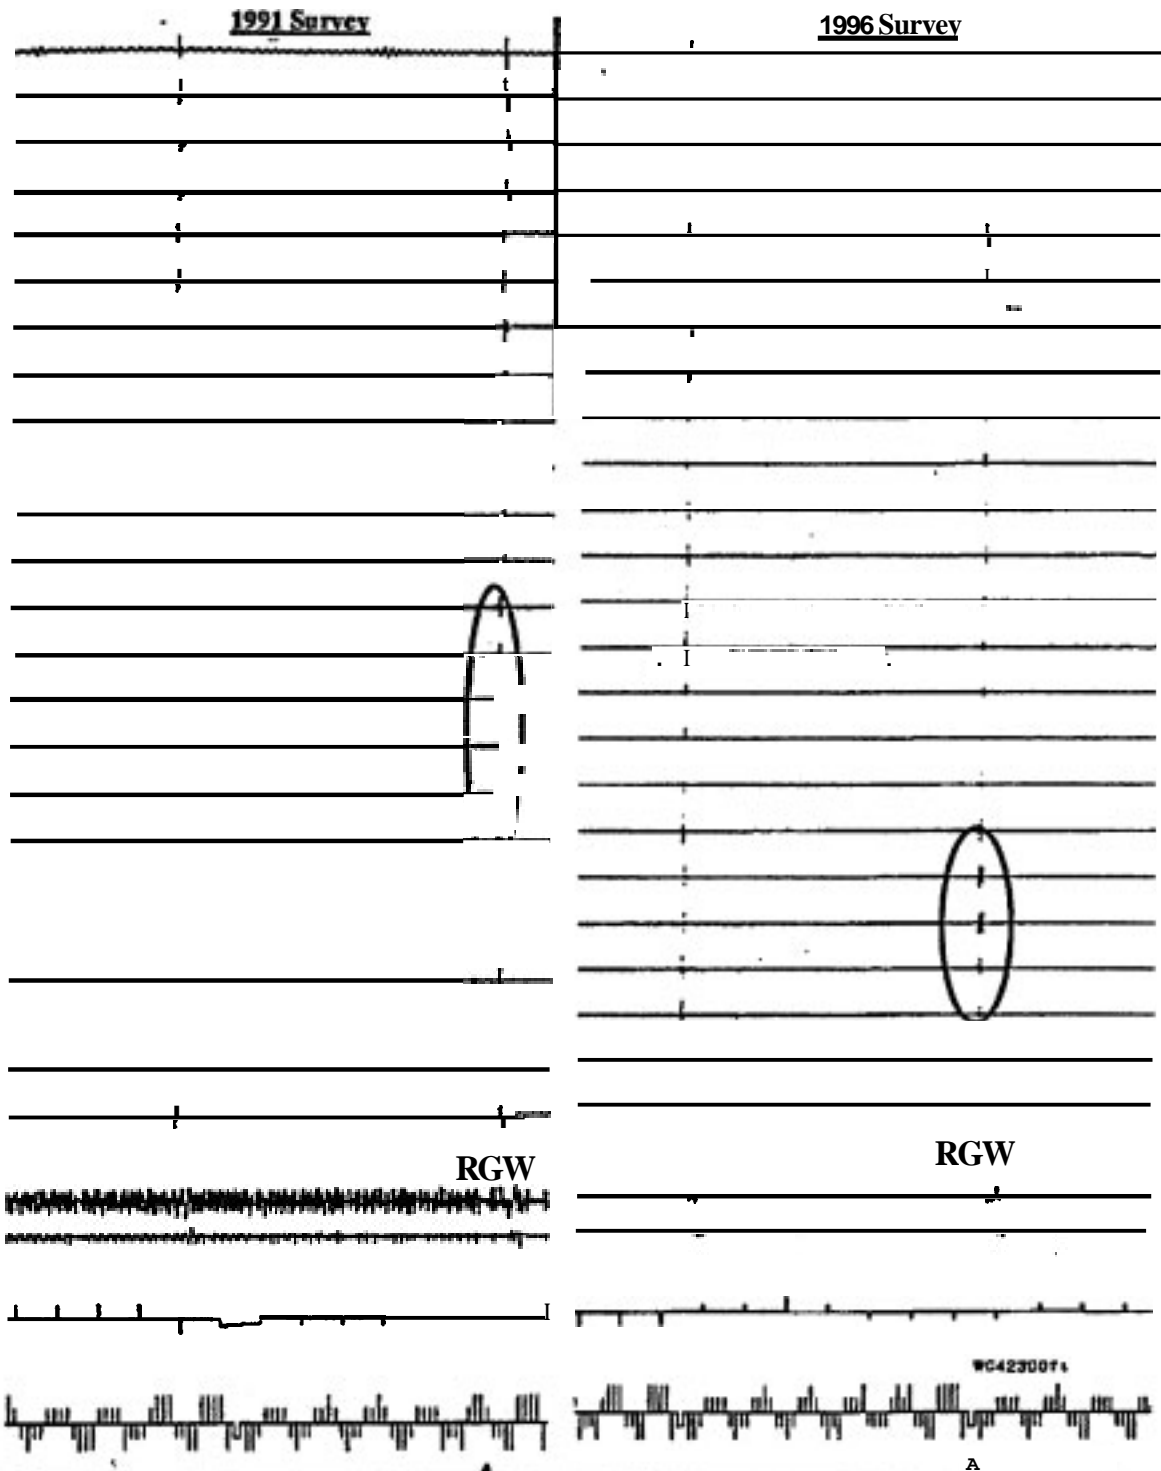
D7, RGW = 42309' 9.3", Defect is 6.0" U/S & D/S of RGW at 4:00. Weld area corrosion.

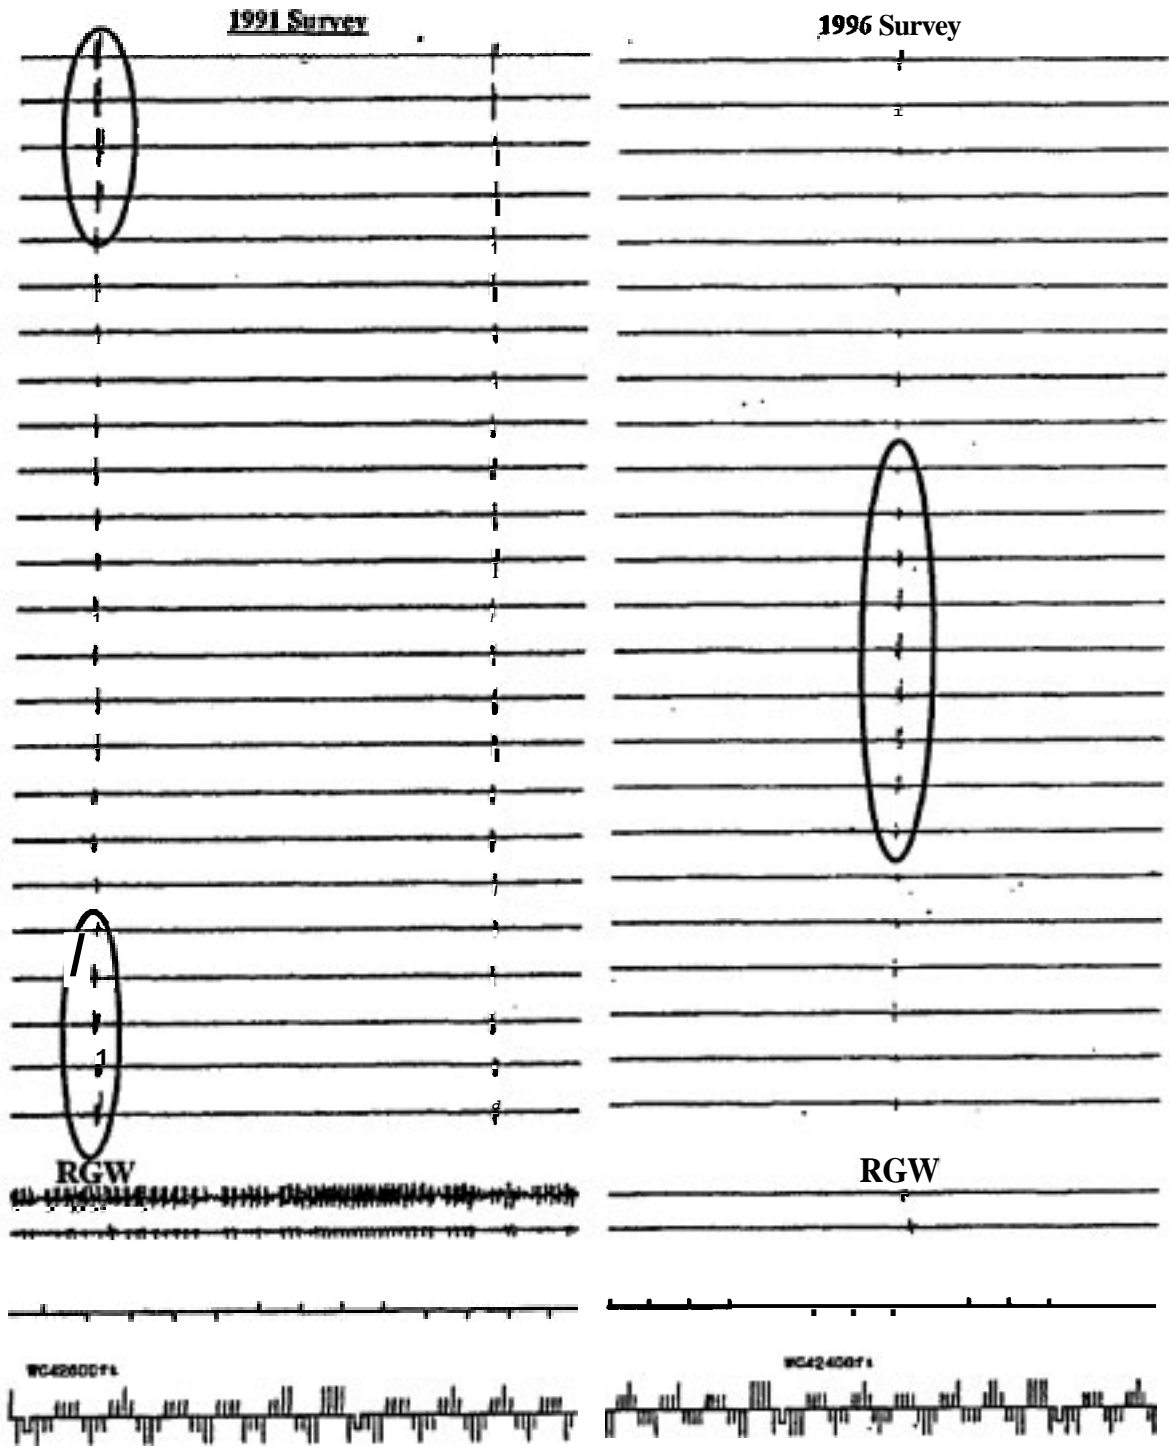
DS, RGW = 42420' 7.7", Defect is 6.0" U/S & D/S of RGW at 5:00. Weld area corrosion.

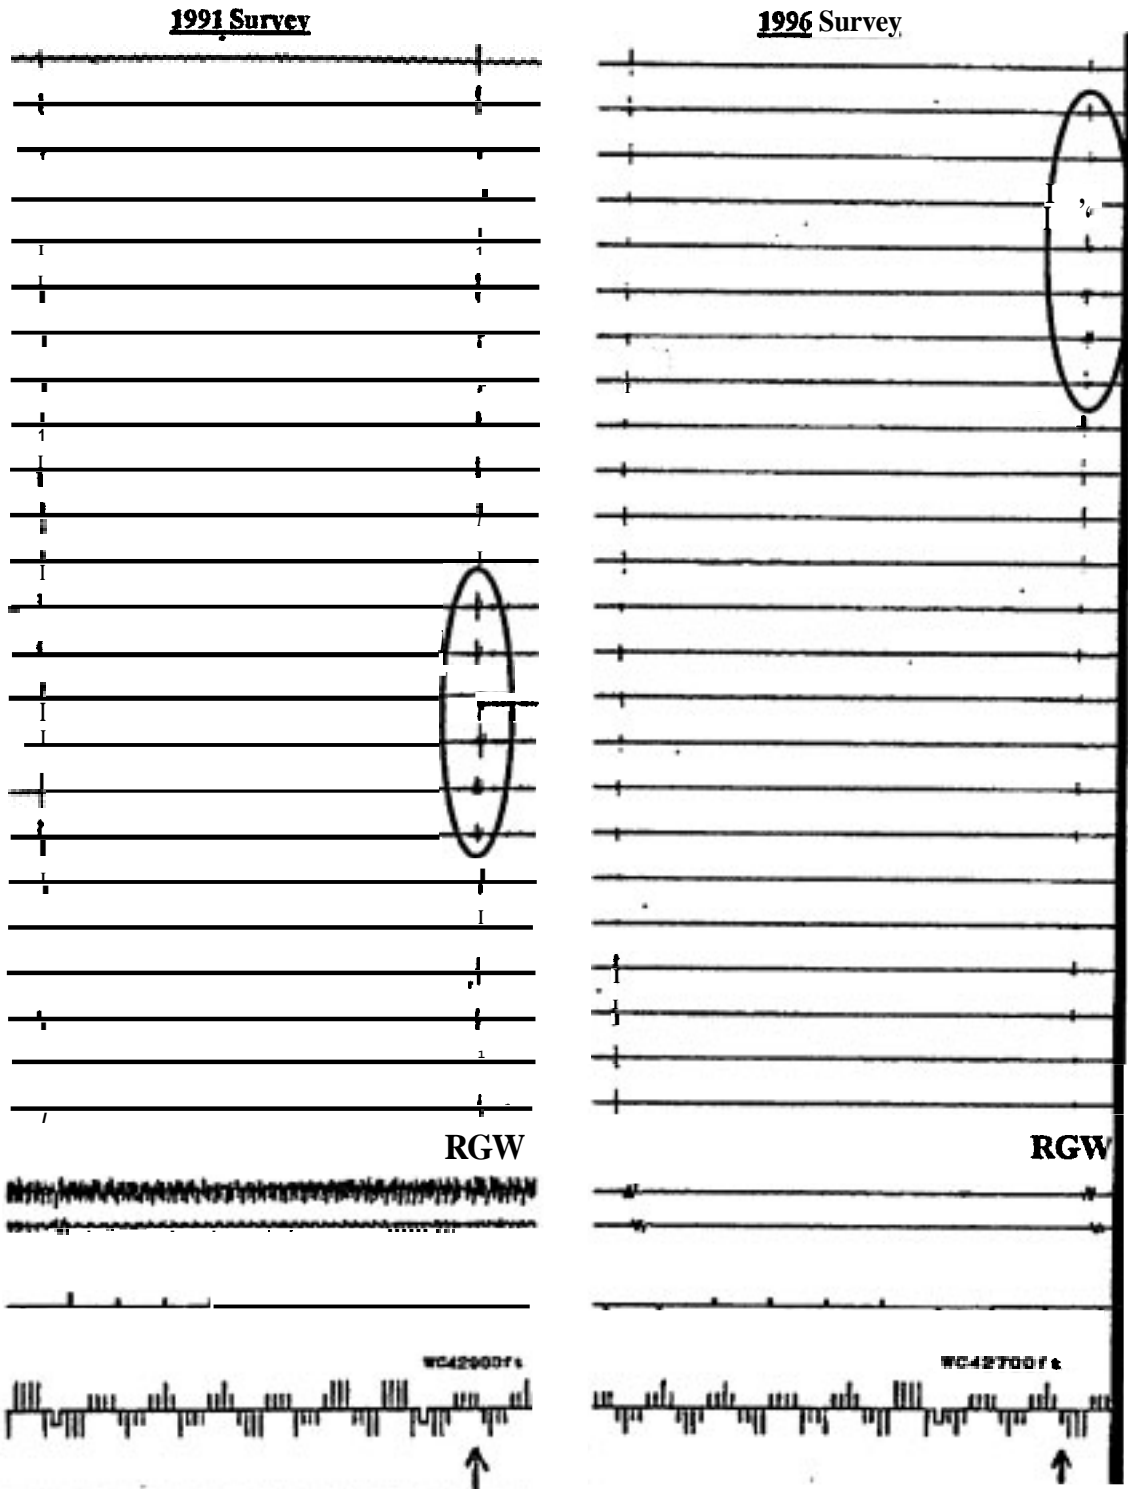
HIND I, RGW 42718' 2.5", Defect is 6" U/S & D/S of RGW at 4:00. Weld area corrosion.

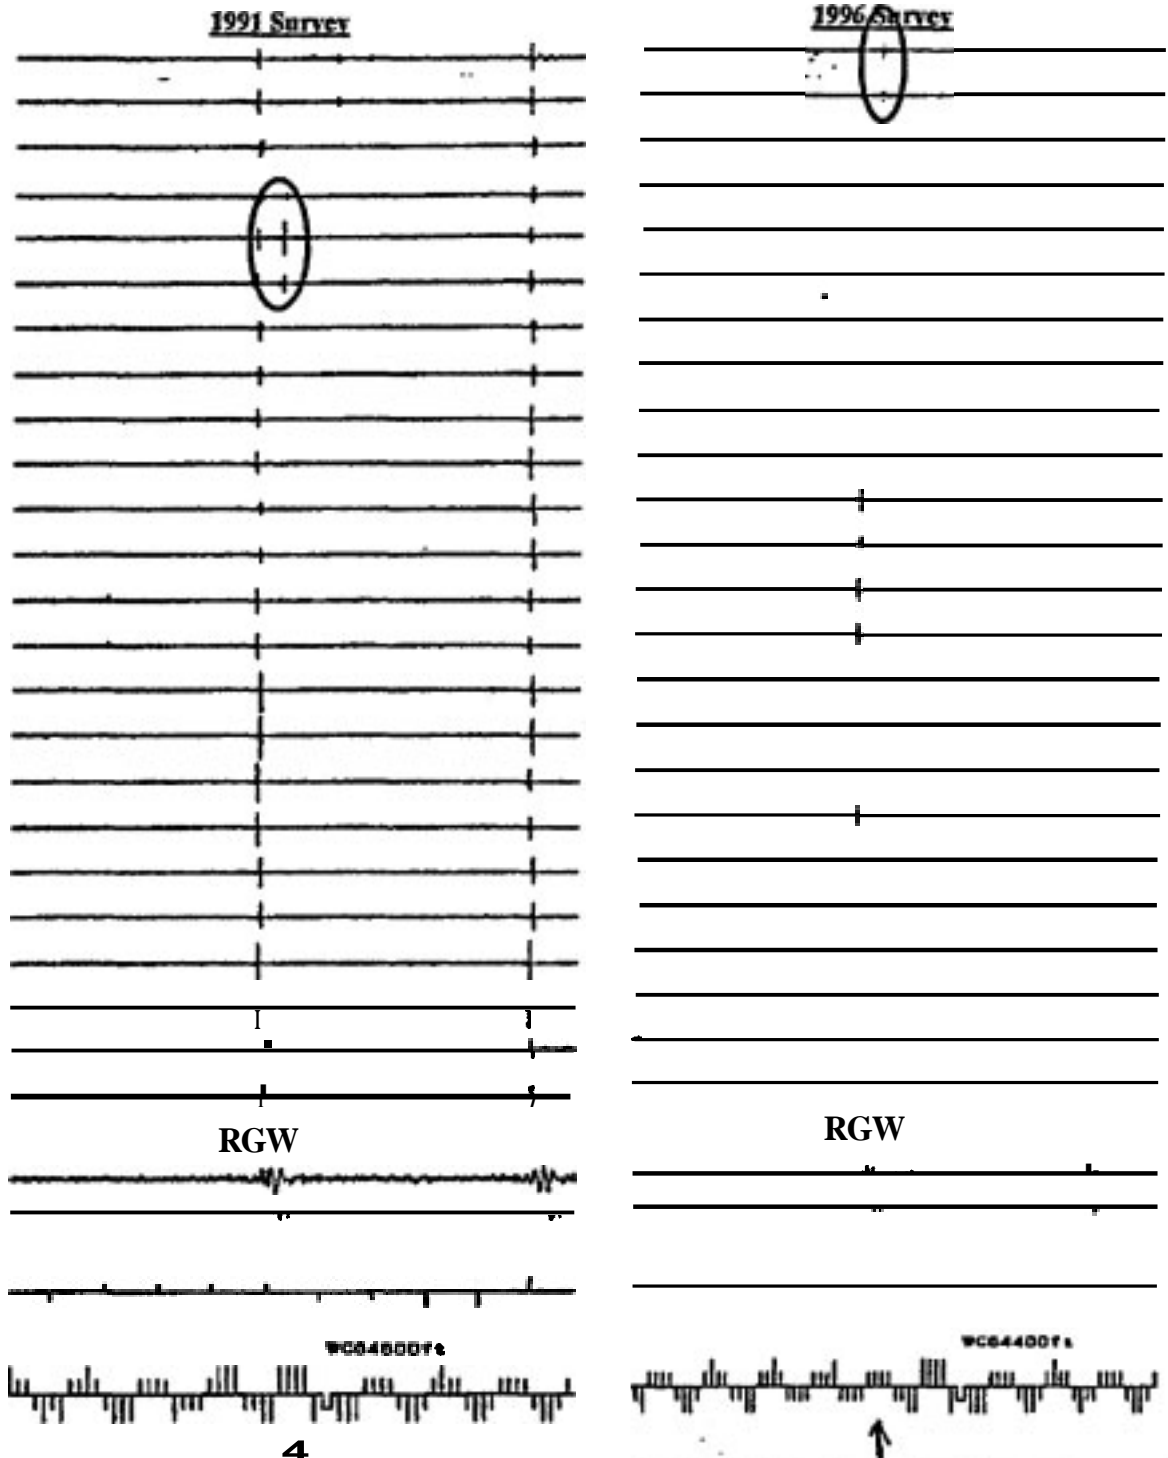
D10, RGW =64385' 0.5", Defect is 3'0.5" D/S of RGW at 1:00. Hi Freq Mill origin.
