**National Transportation Safety Board
Internal Inspection Factual
Bellingham, Washington
Accident DCA99-MP008**

SMART PIG DATA ANALYSIS

Final Report

Olympic Pipeline Company Gasoline Pipelines
16" Cherry Point to Ferndale
16" Ferndale to Allen
16" Allen to Renton
20" Allen to Renton

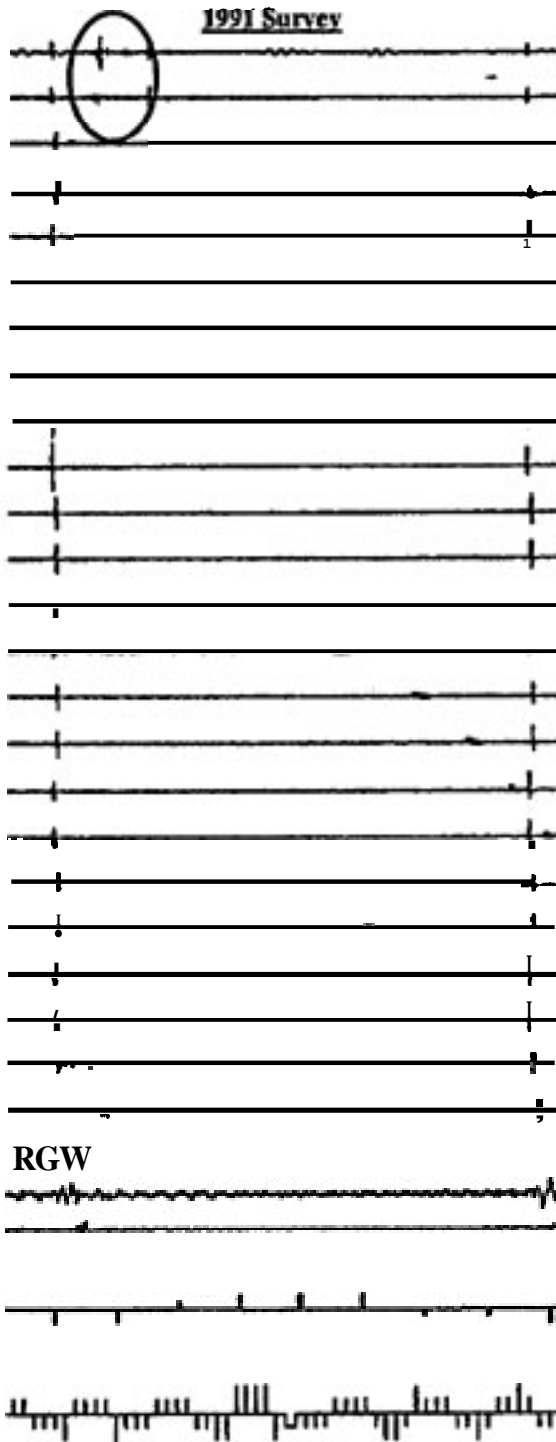
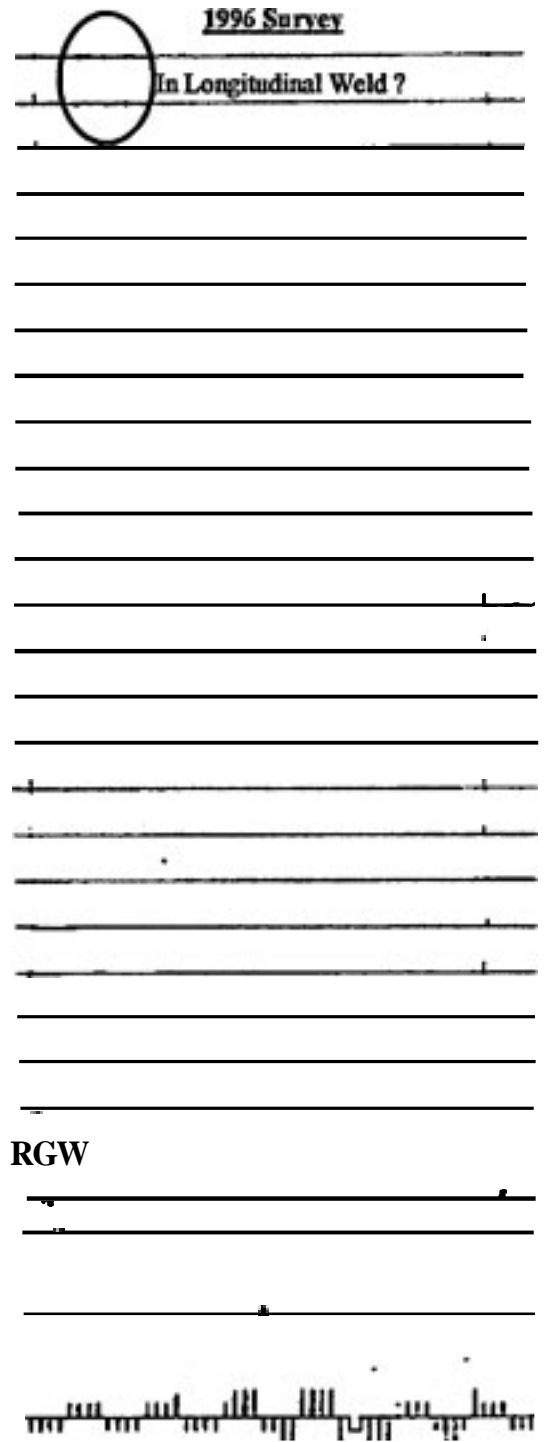
D11, RGW =68017' 0.1", Defect is 9'1.1" D/S of RGW at 1:00. Hi Freq Mill origin.

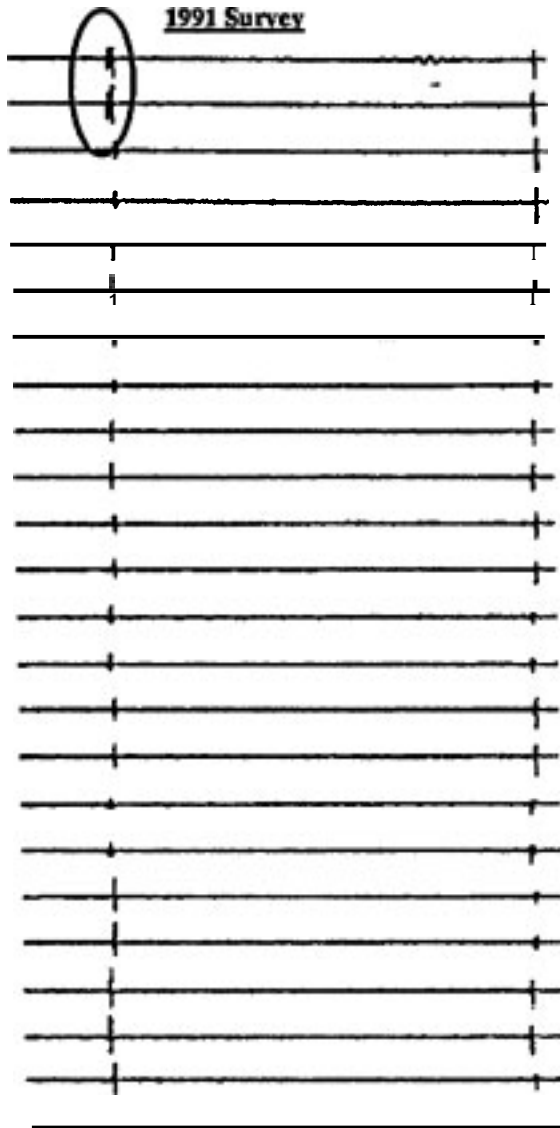
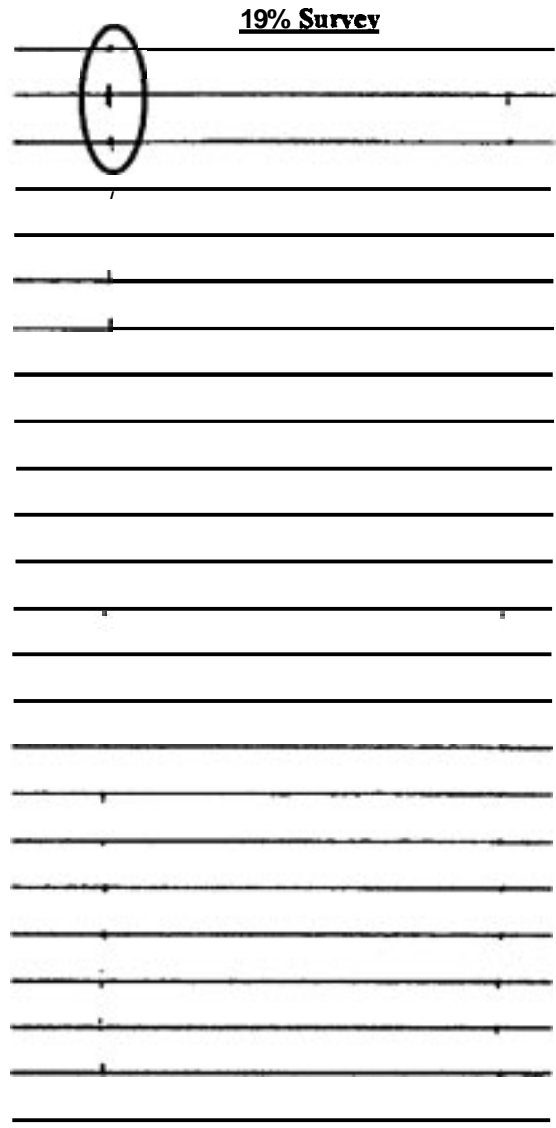
D12, RGW = 68695' 10.9", Defect is 5.5" U/S of RGW at 5:00. Weld Area Corrosion.

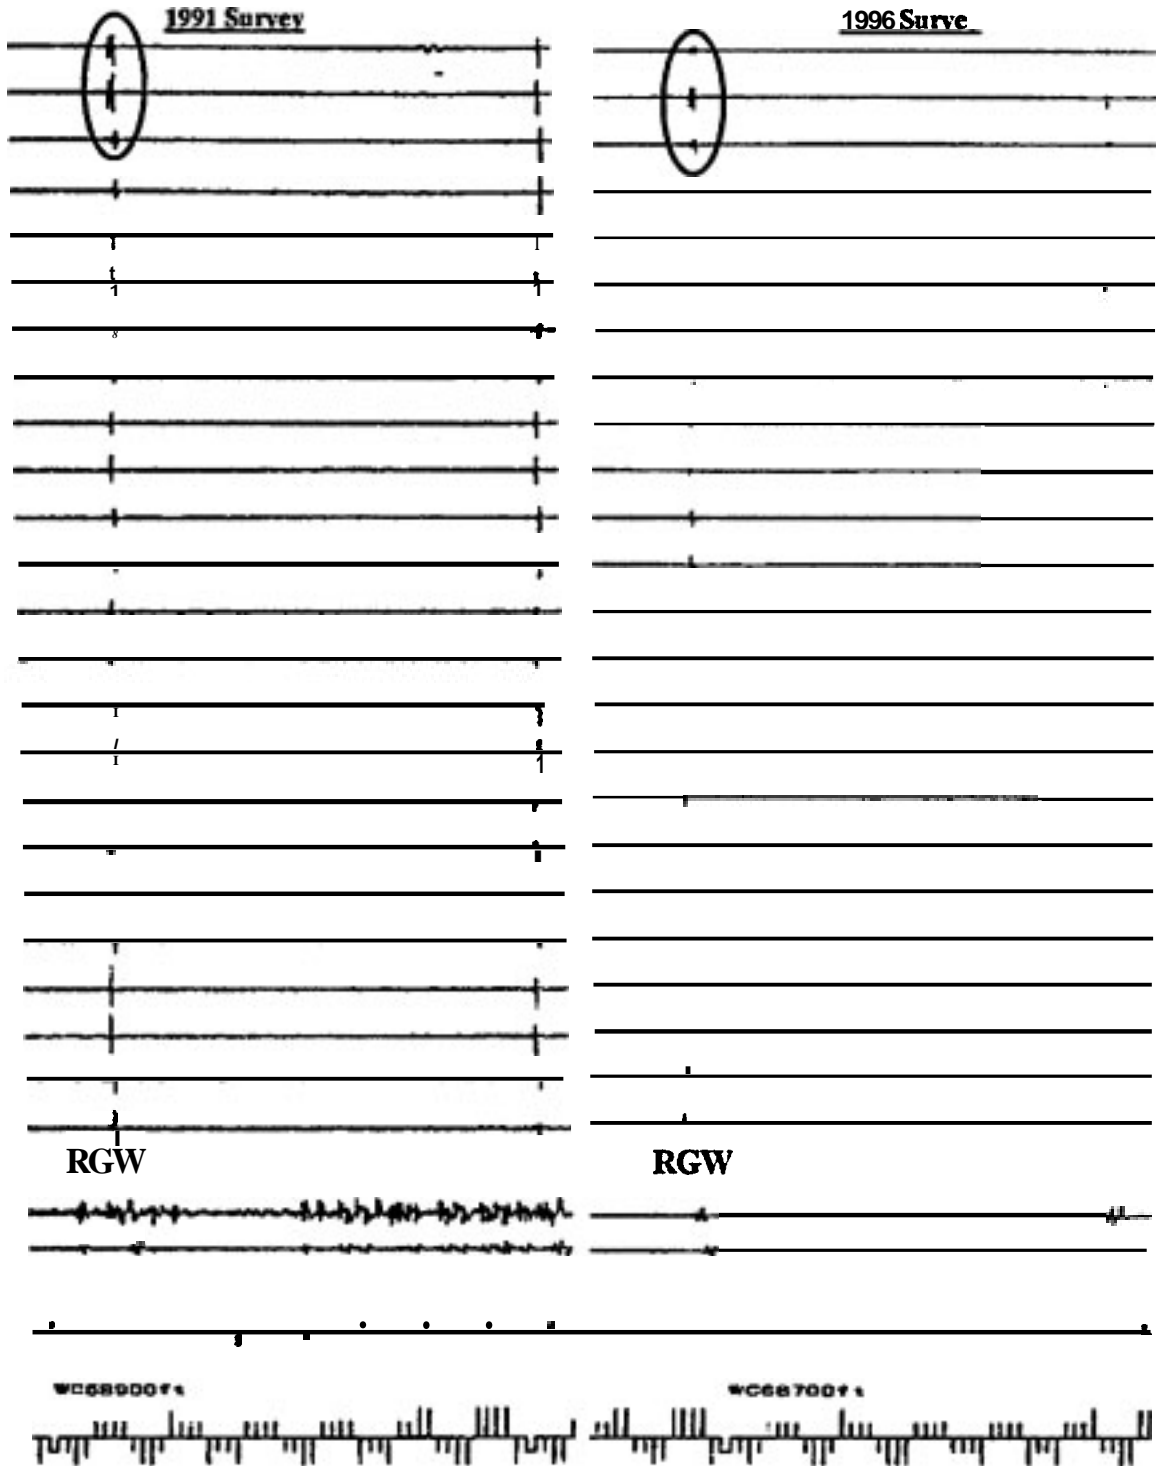
DL3, RGW = 68695' 10.9", Defect is 2.7' U/S of RGW at 5:00. Weld Area Corrosion.

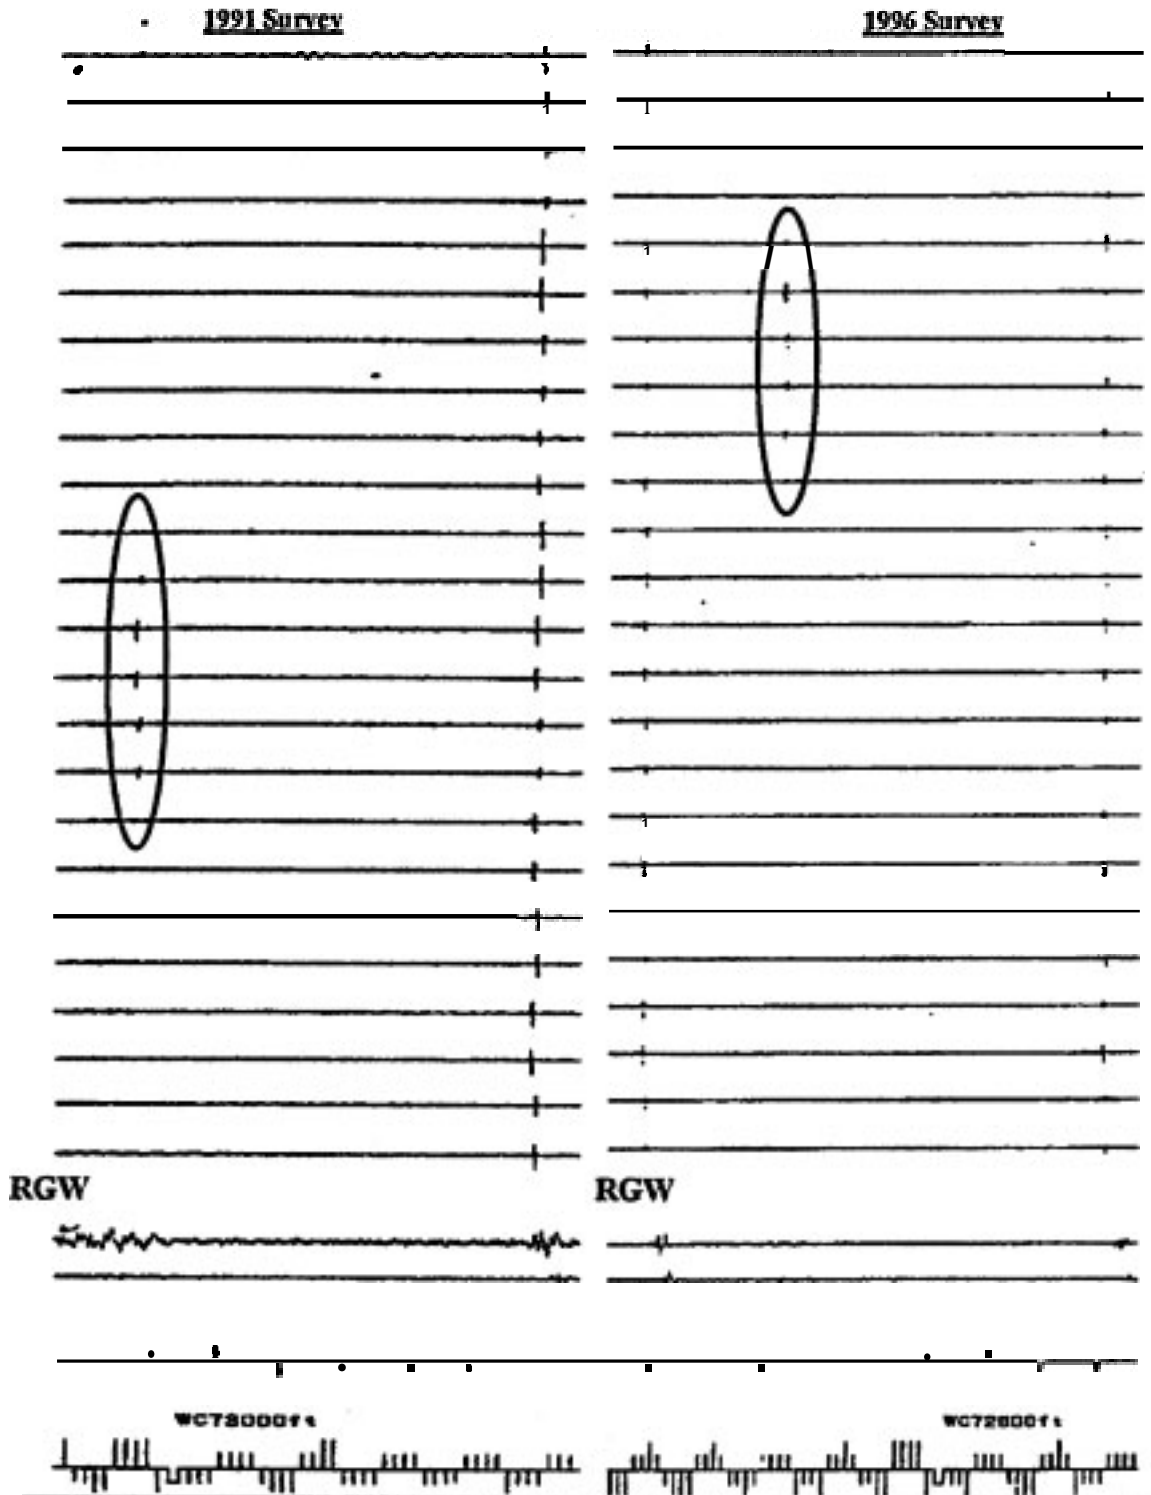
D14, RGW = 72764' 6.4", Defect is 17' 3" D/S of RGW at 7:00. Hi Freq, Mill origin.

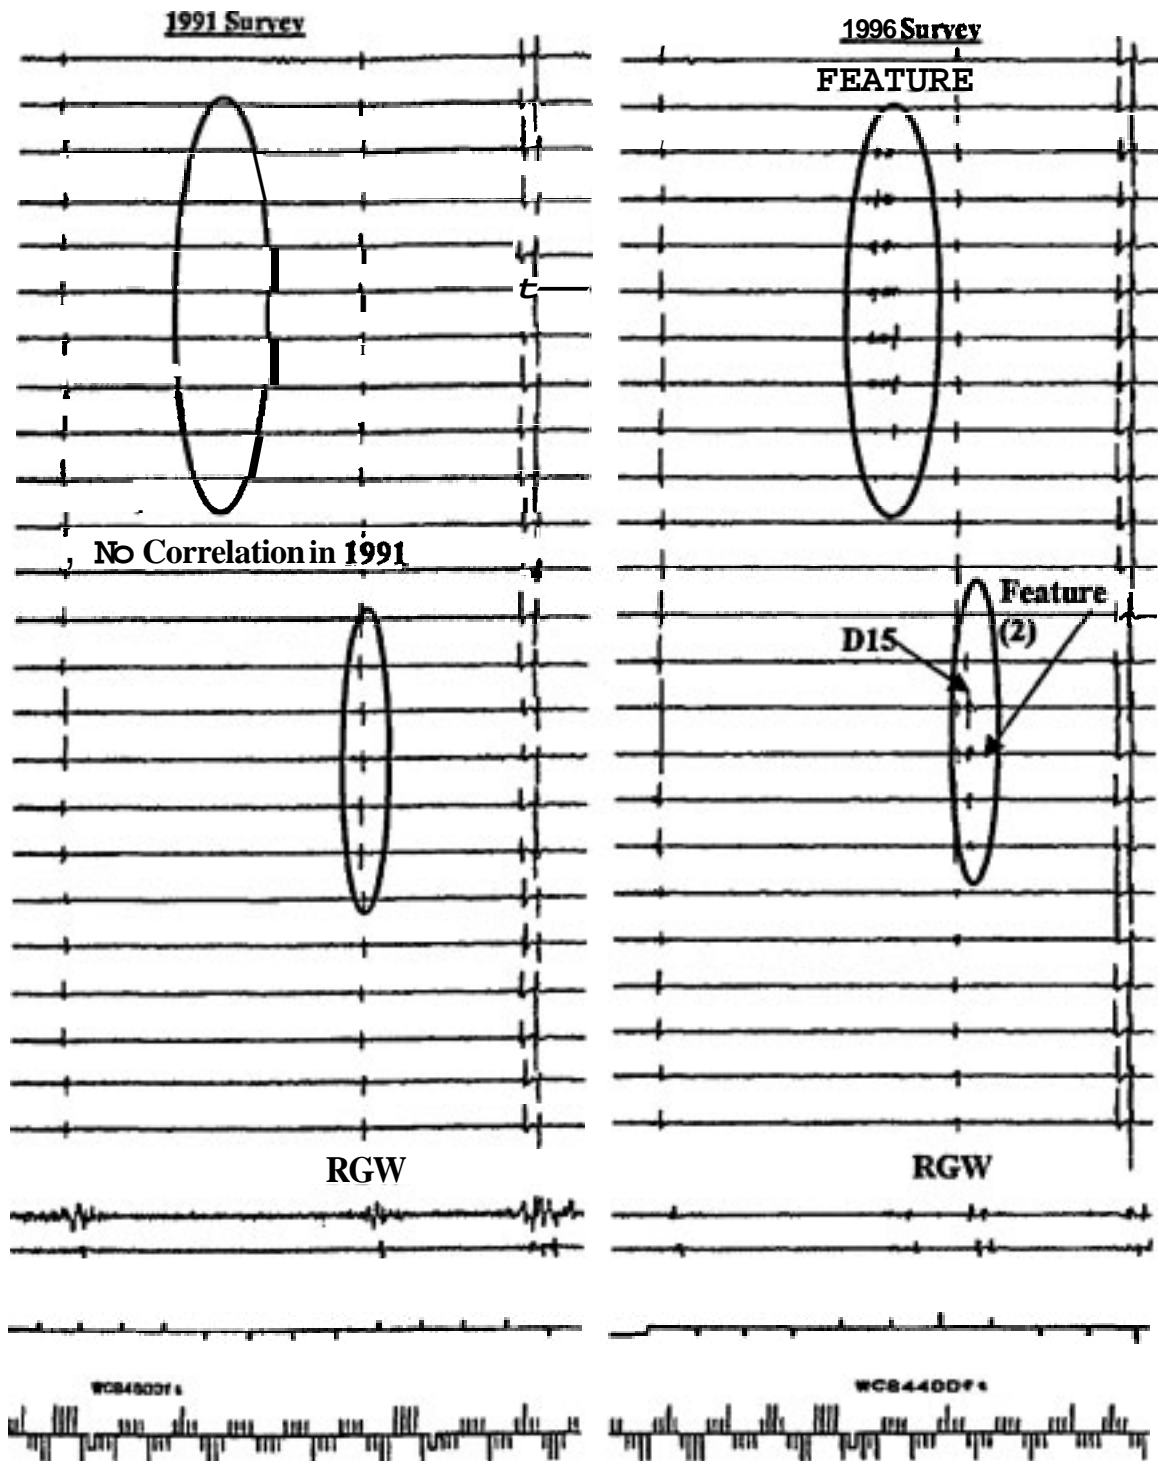
FEATURE, D15, Feature (2). RGW=84402', Defect Area contains Origin of Failure and other damage D/S of Origin. See Body of Report for Details.

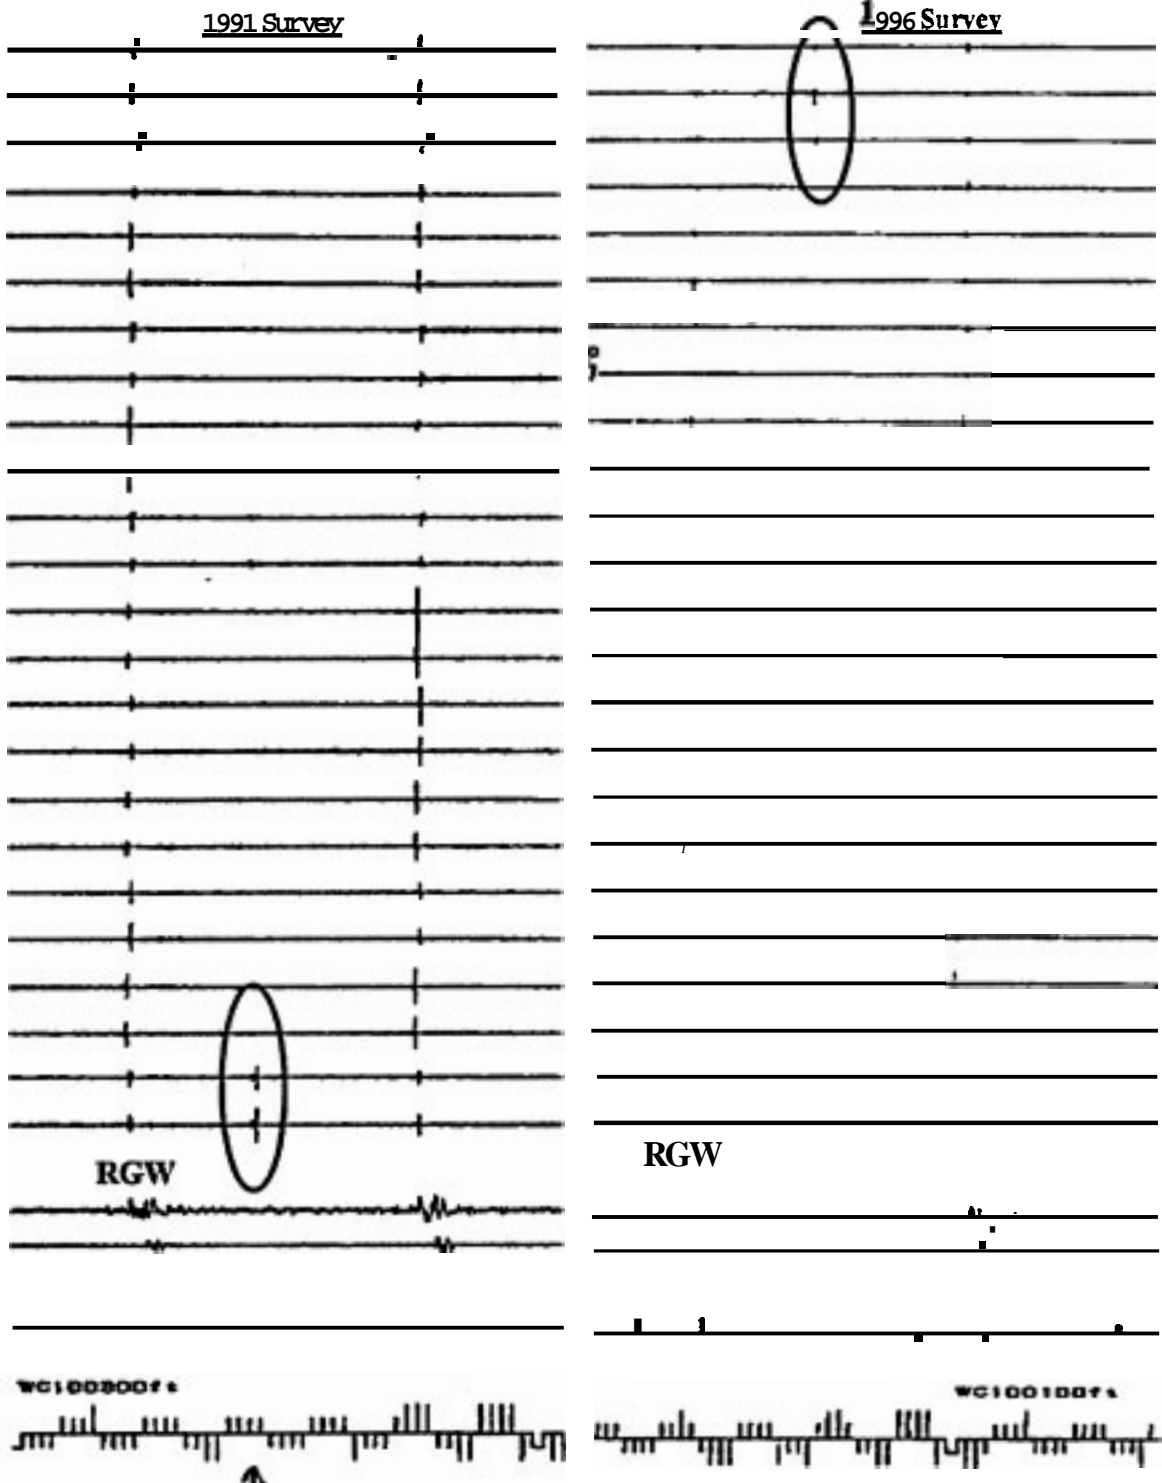
D16, RGW -100072' 11", Defect is 12'1.3" D/S of RGW at 10:00. Hi Freq, Mill origin.

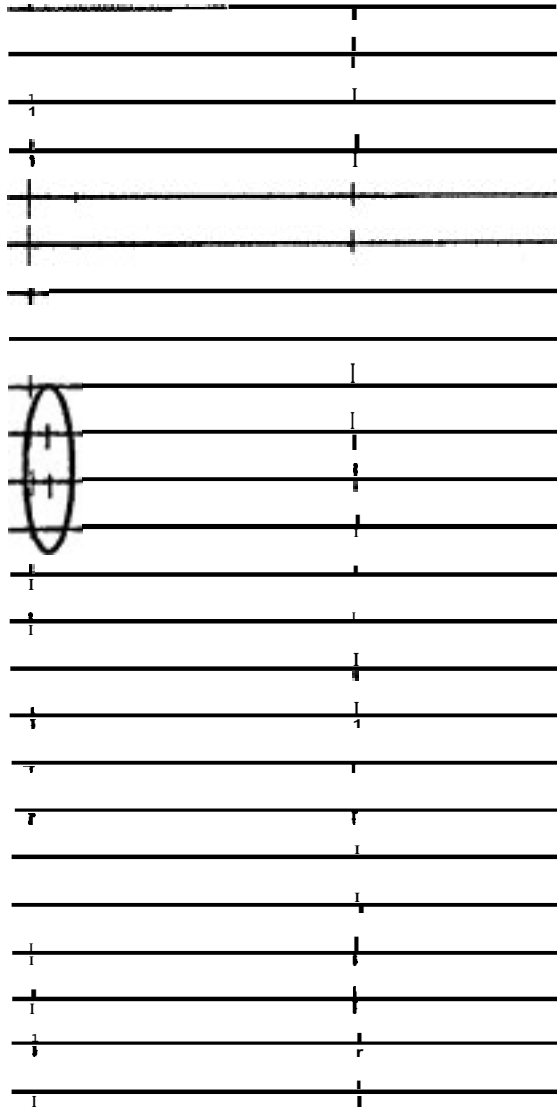
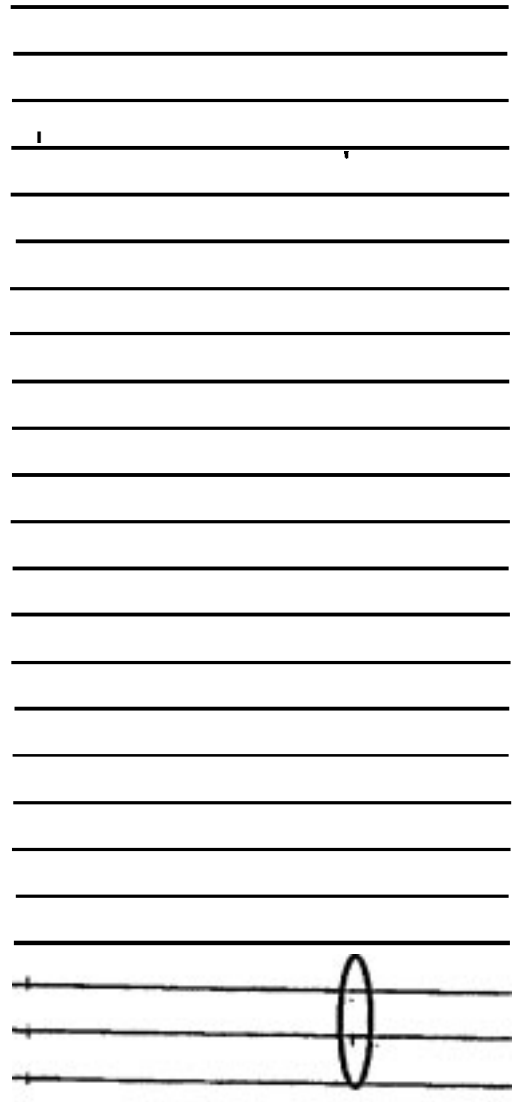
D17, RGW =107986' 3.1", Defect is 3'1.1" D/S of RGW at 8:00. Hi Freq, Mill origin.

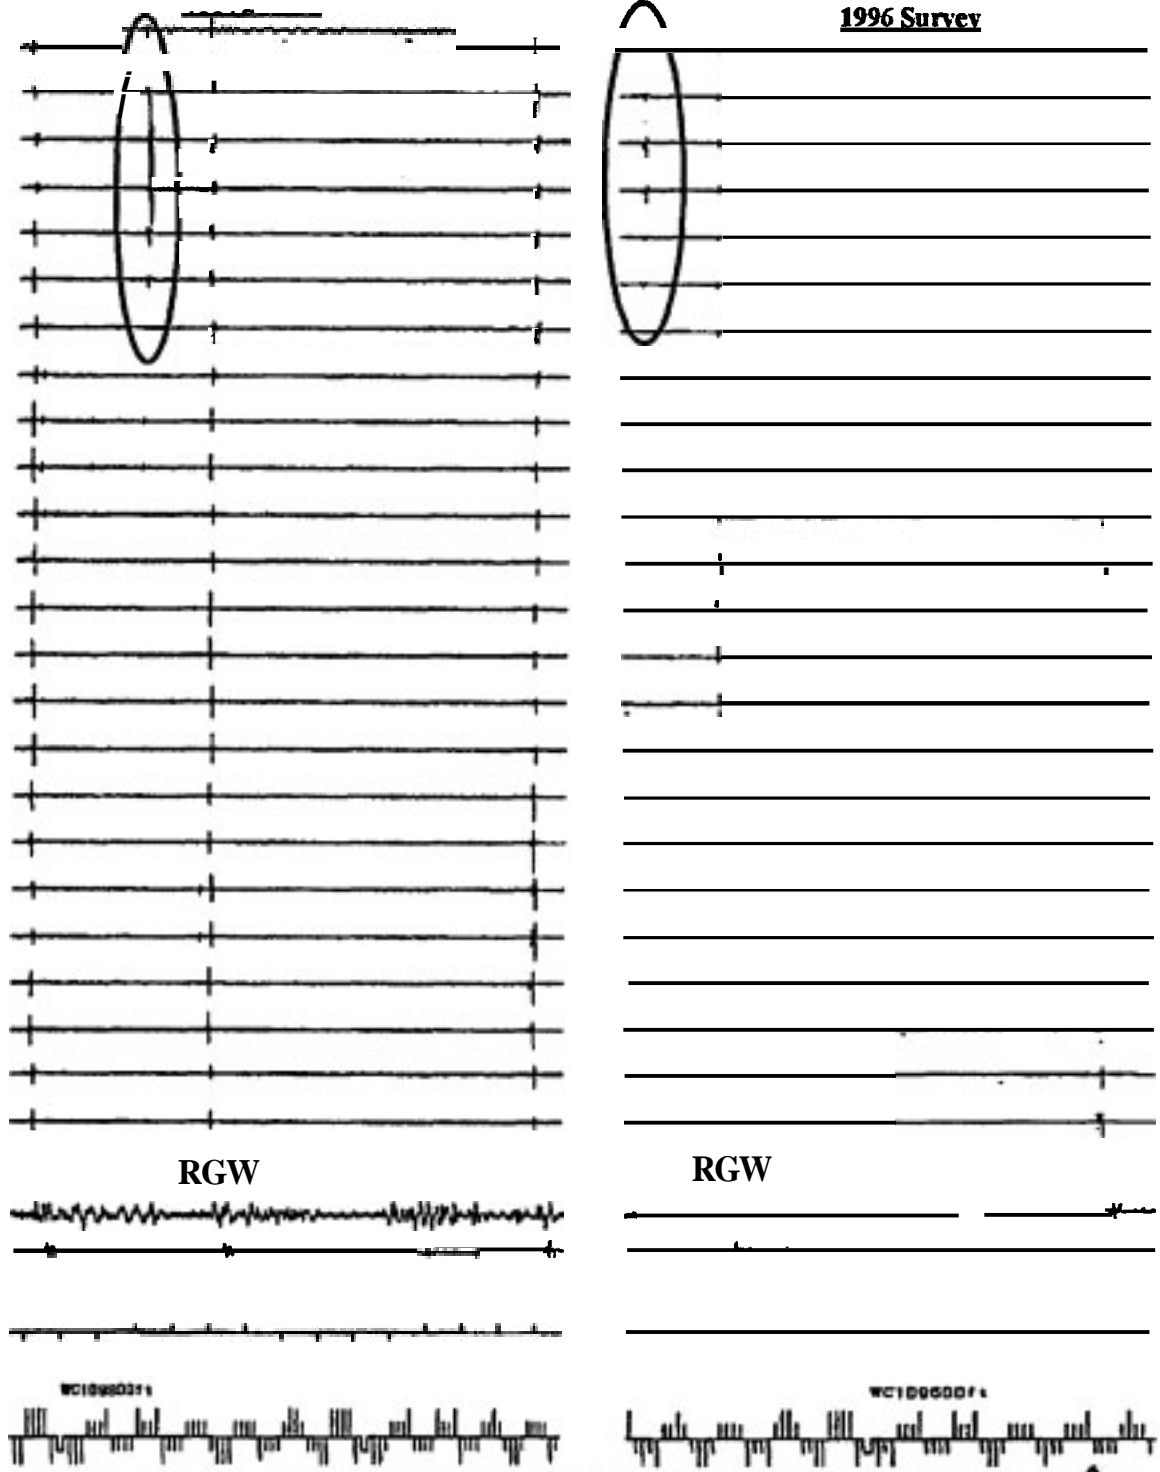
HNE 2, RGW =109634' 0.8", Defect is 8.0" U/S of RGW at 6:00. Weld Area Corrosion.

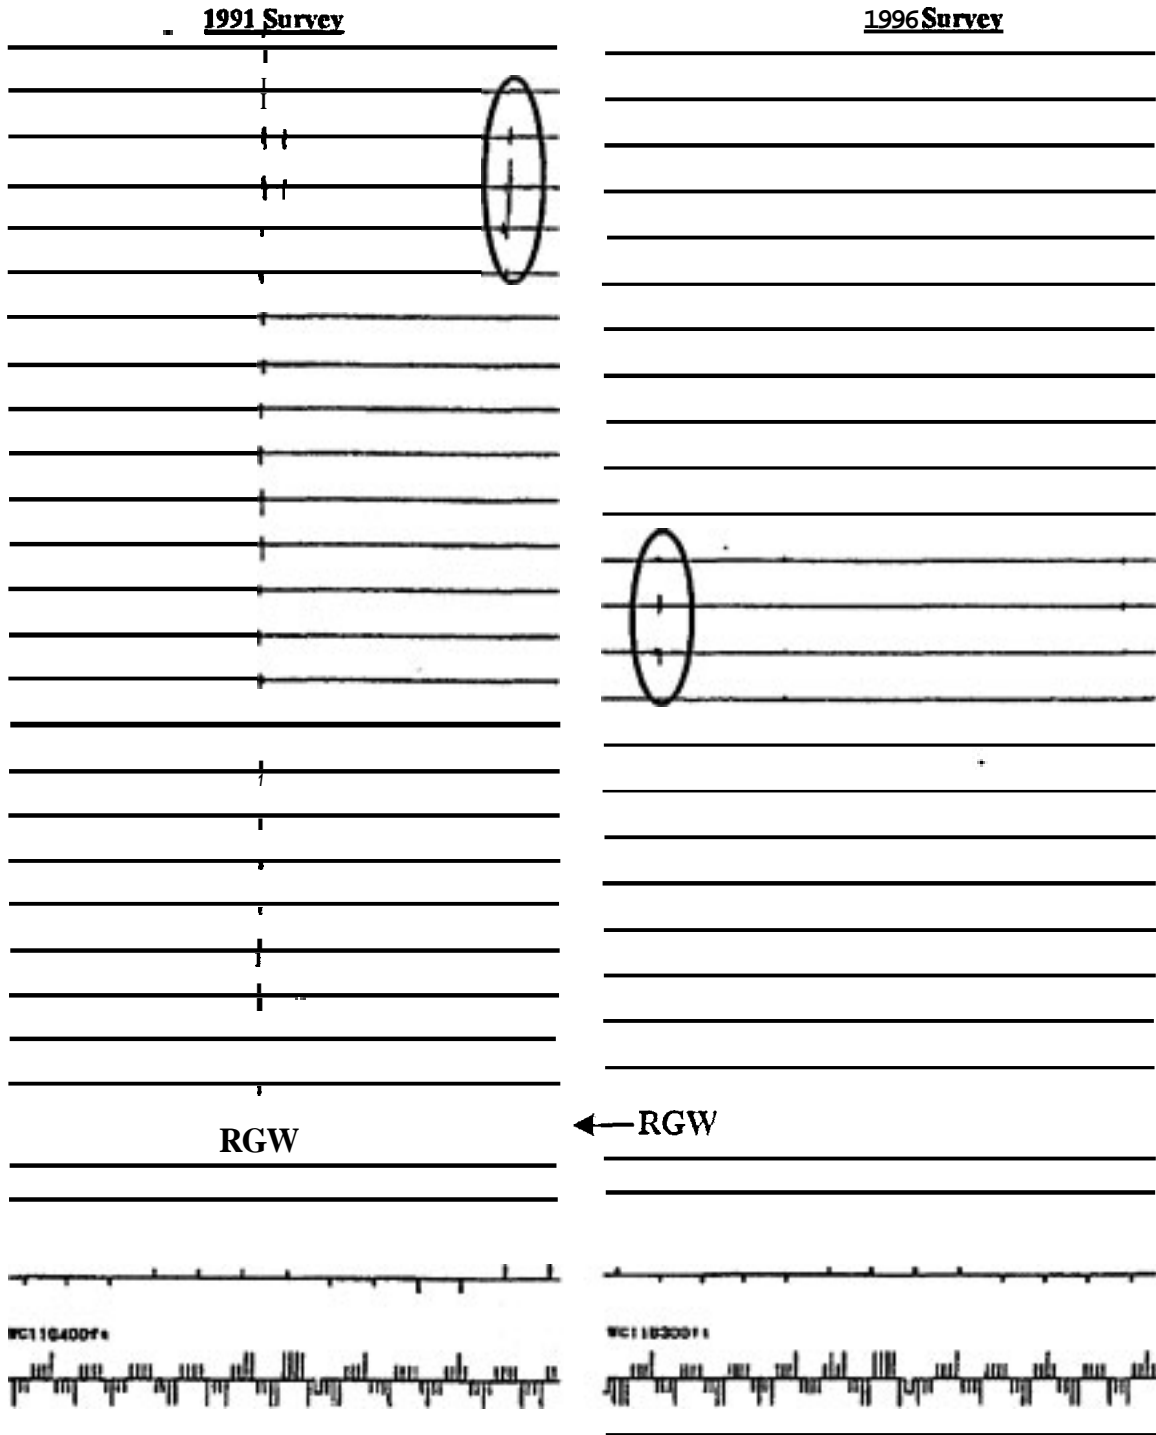
D18, RGW = 110330' 1.9", Defect is 20'10.2" U/S of RGW at 5:30. Isolated Corrosion or Mill origin Type.

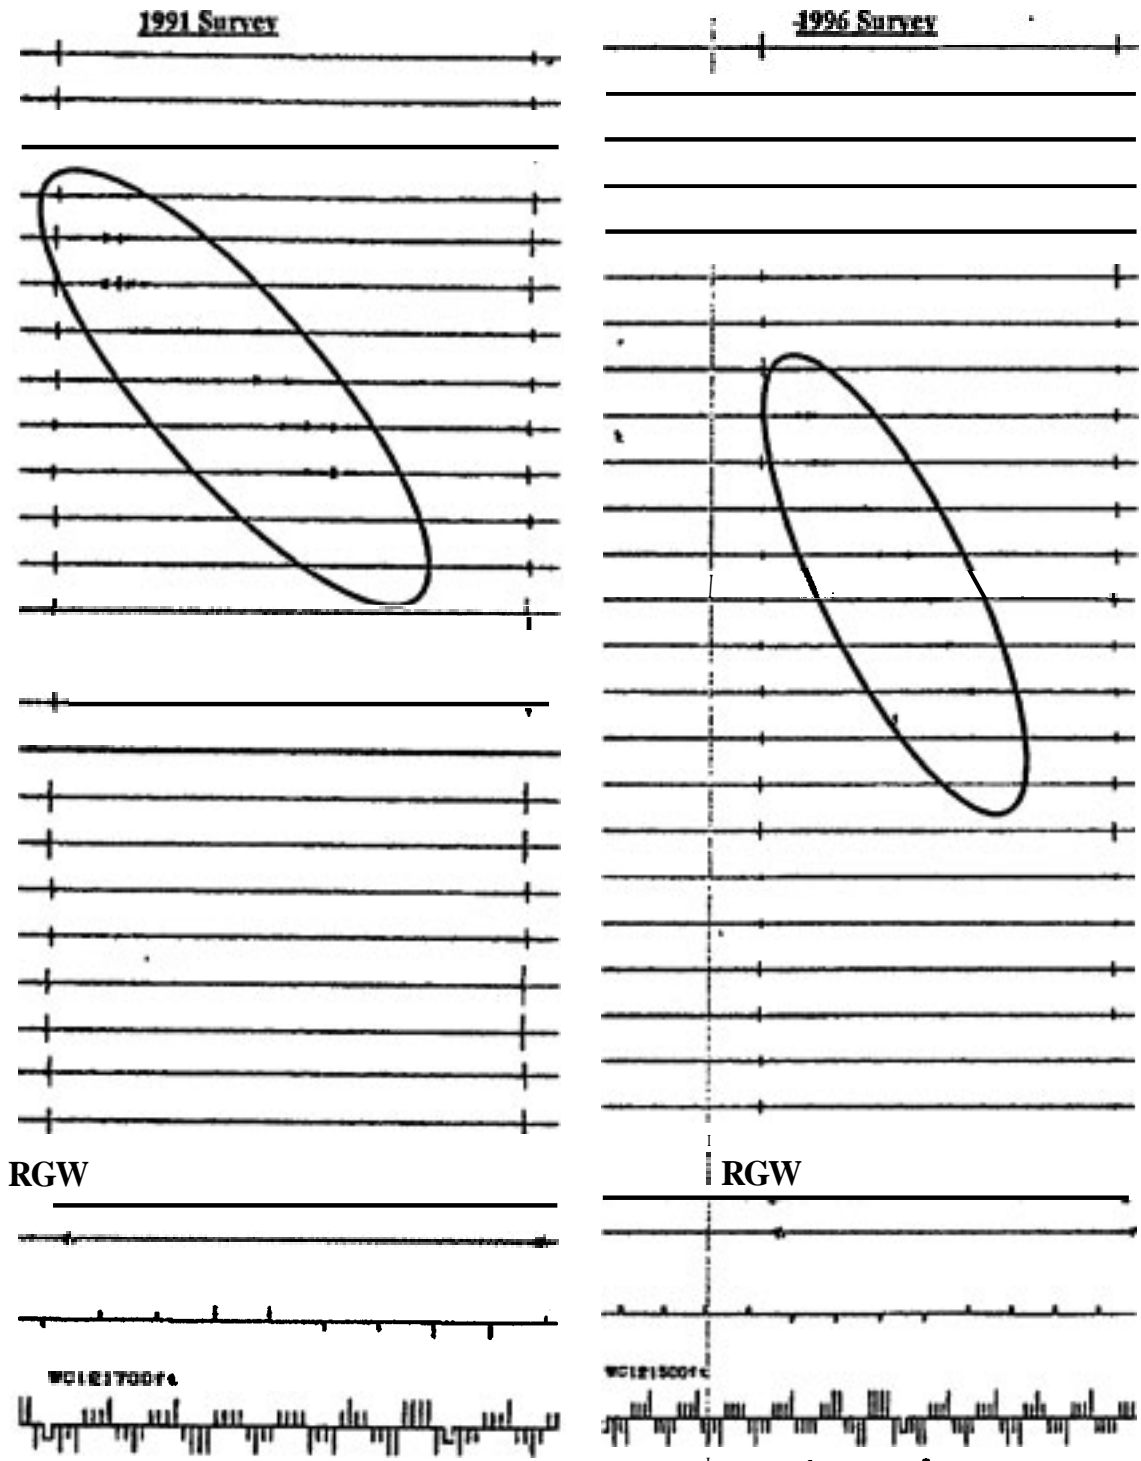
HND3, RGW = 121526' 9.5", Defect is 6' to 33' D/S of RGW at 11:00. H Freq, Very Light Corrosion & Mechanical Damage.

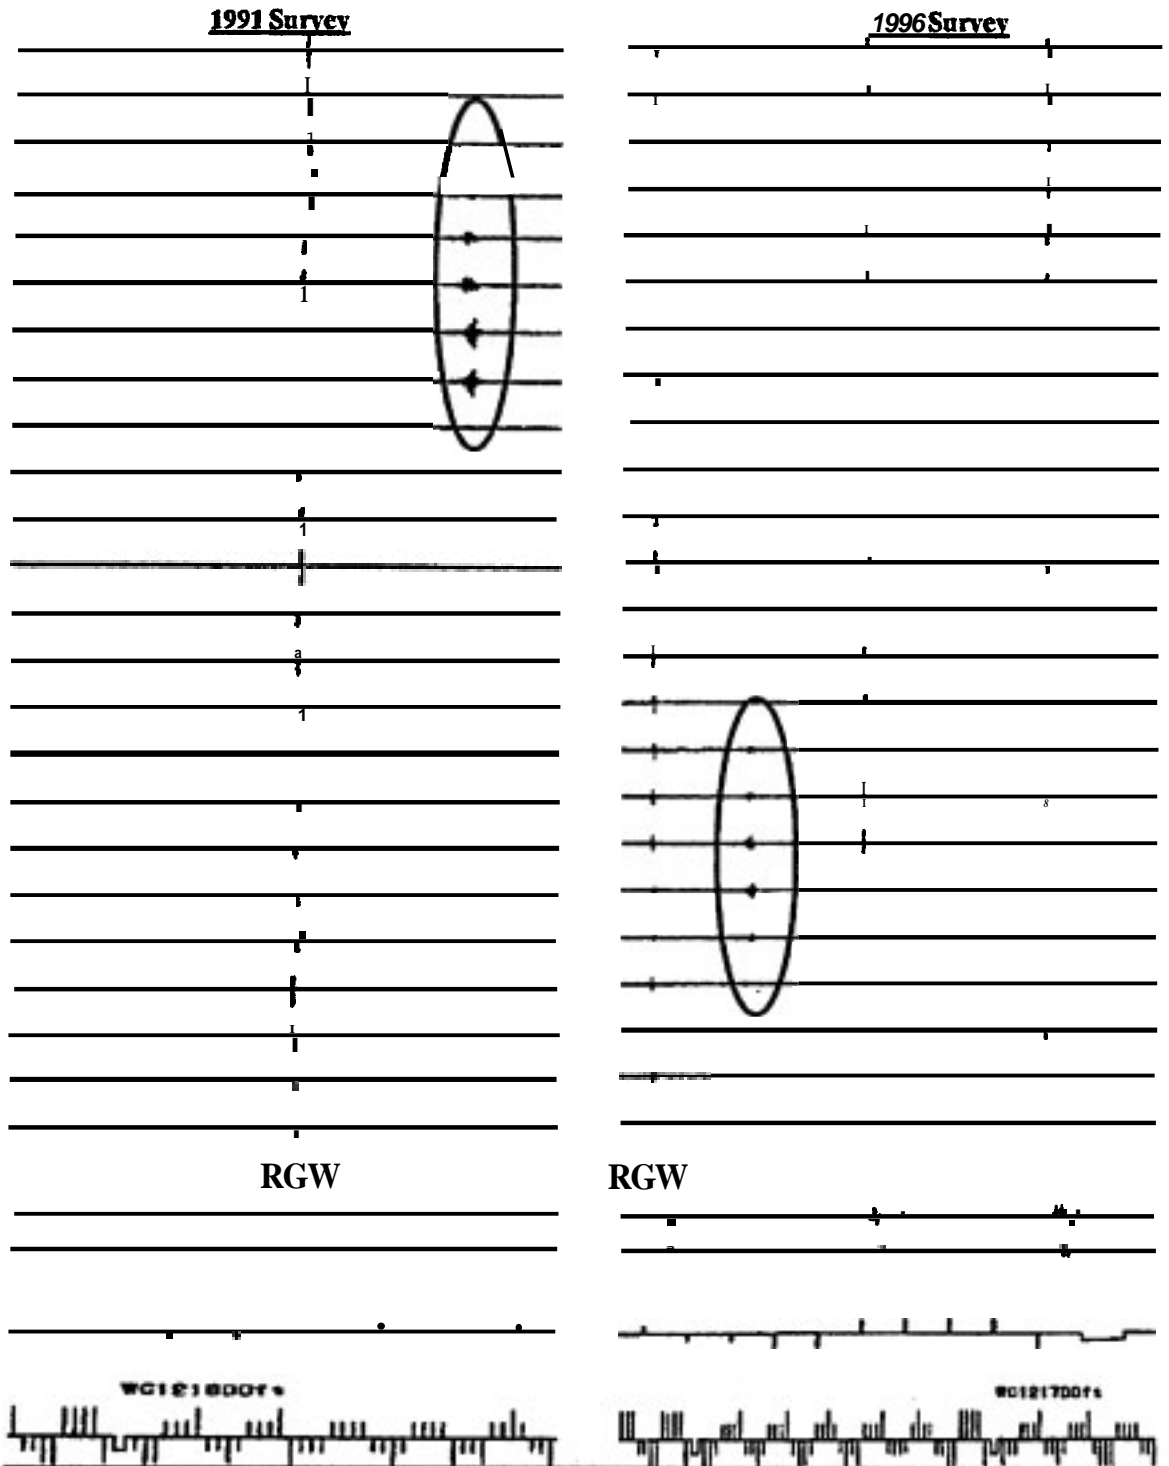
HND4, RGW =121643' 3.0", Defect is 16' D/S of RGW at 6:00. H Freq, Corrosion Area.

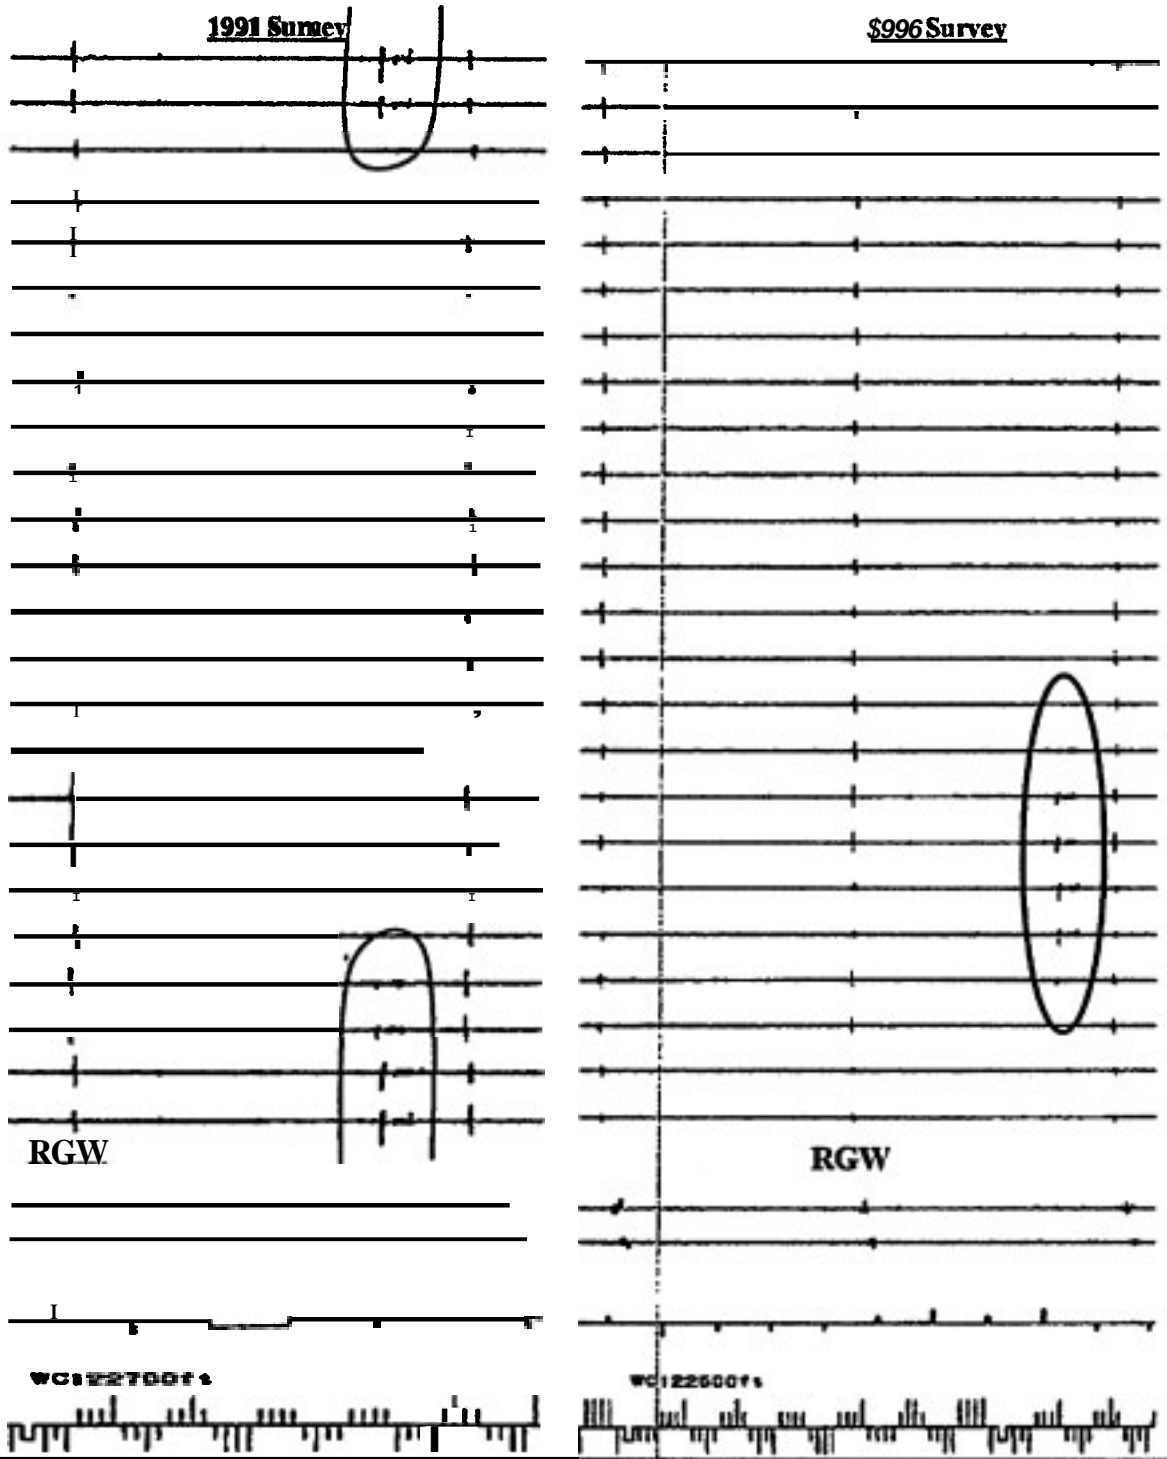
D19, RGW -122530' 7.2", Defect is 26'1.2" D/S of RGW at 5:00. Corrosion of Mill origin.

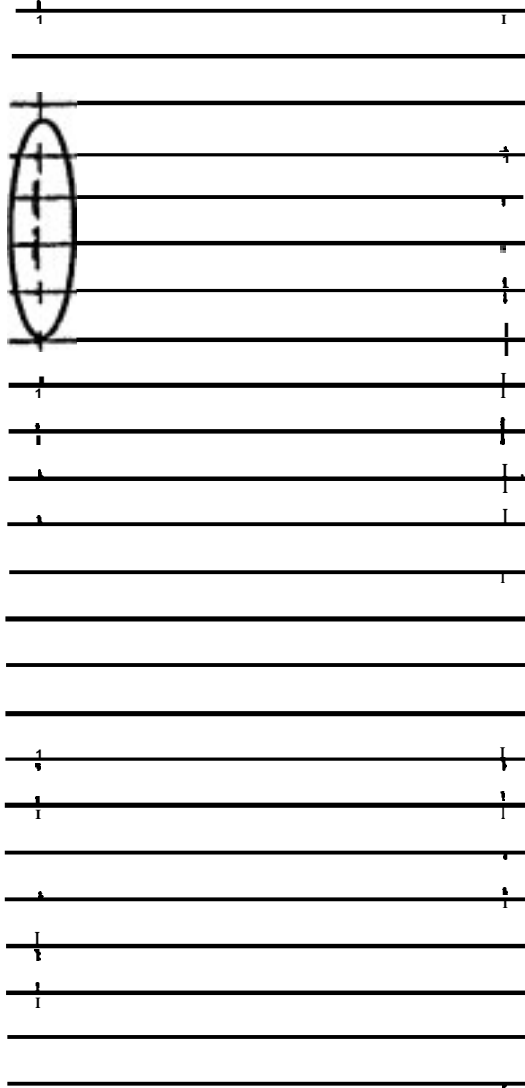
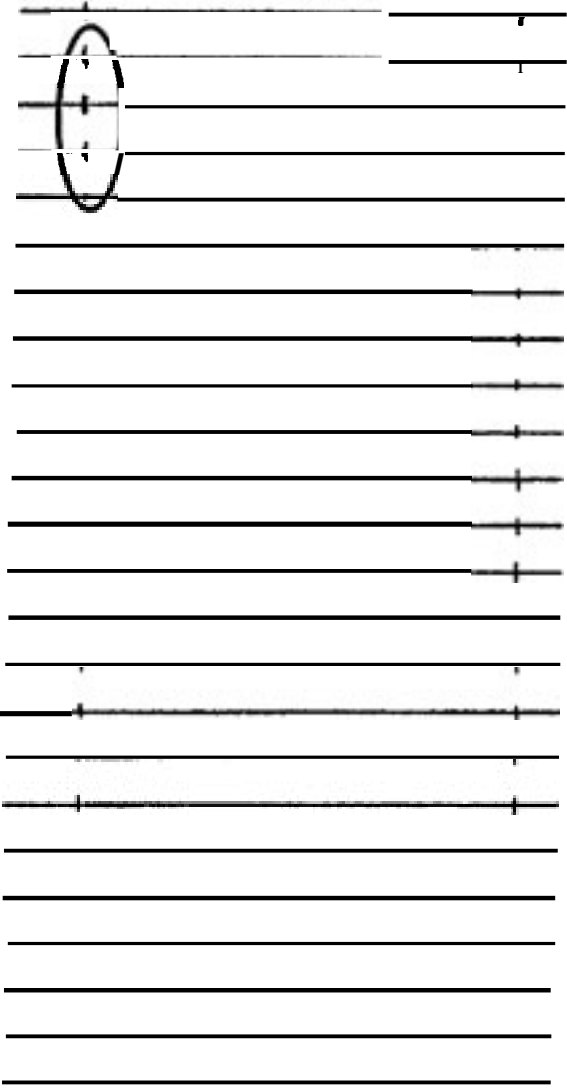
D20, RGW = 135577' 4.1", Defect is 6' U/S of RGW at 4:00. Weld Area Corrosion.

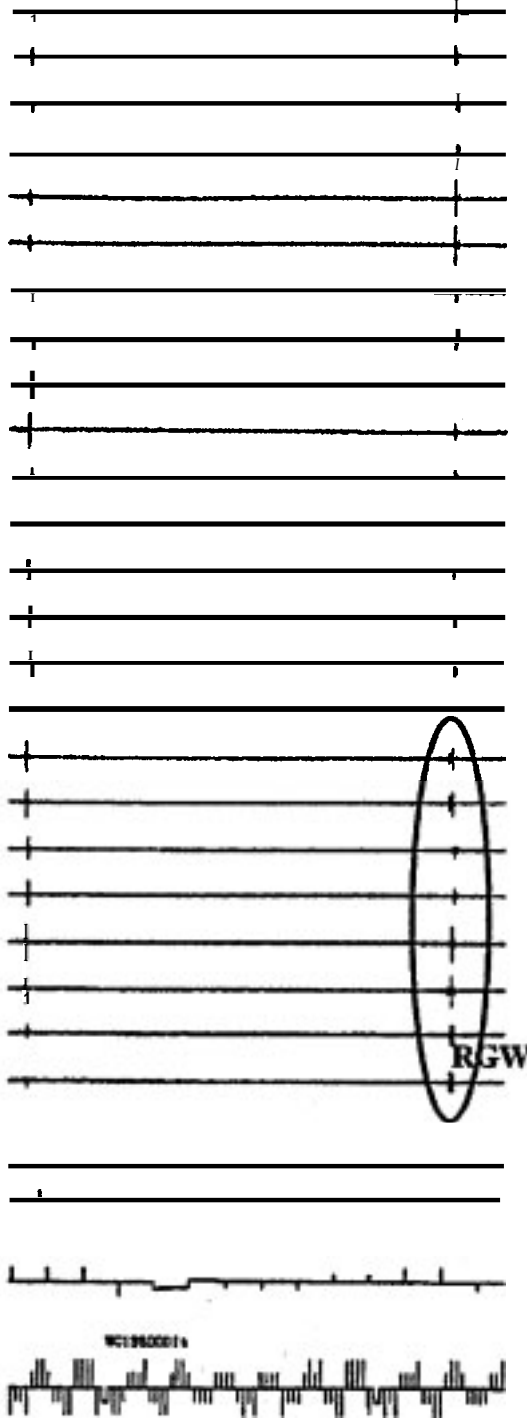
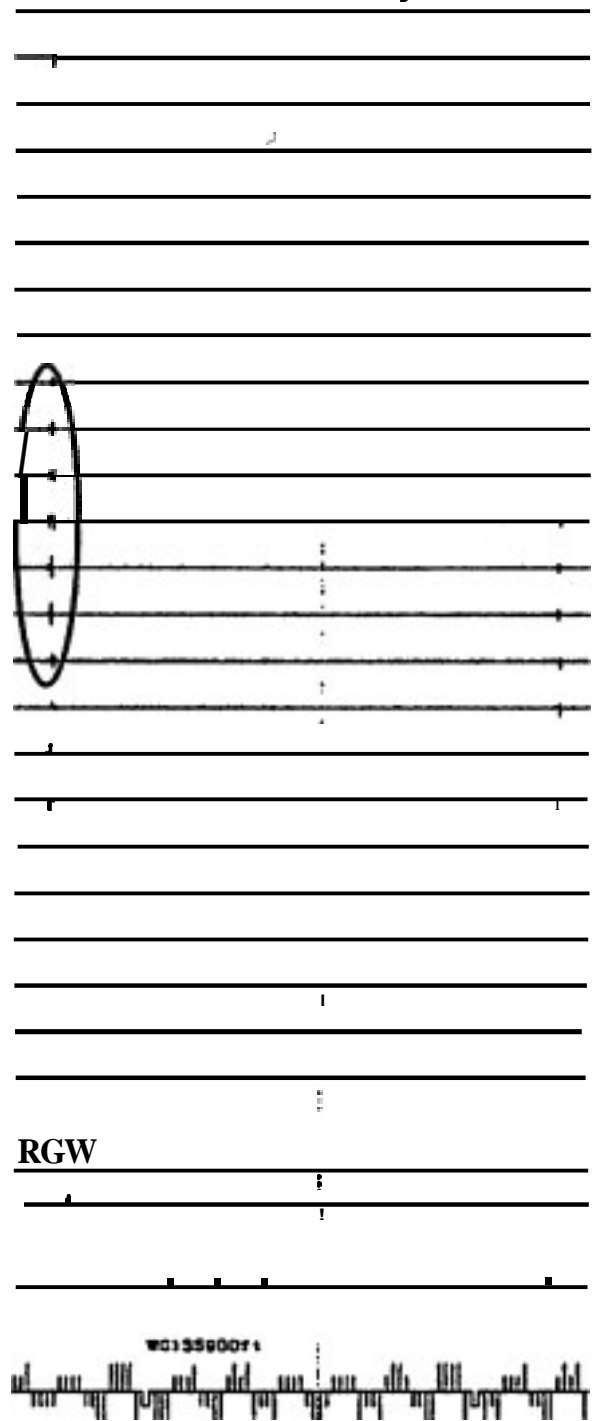
HND5, RGW =135885' 2.2", Defect is 6" U&D/S of RGW at 4:00. Weld Area Corrosion.
