**National Transportation Safety Board
Internal Inspection Factual
Bellingham, Washington
Accident DCA99-MP008**

SMART PIG DATA ANALYSIS

Final Report

Olympic Pipeline Company Gasoline Pipelines
16" Cherry Point to Ferndale
16" Ferndale to Allen
16" Allen to Renton
20" Allen to Renton

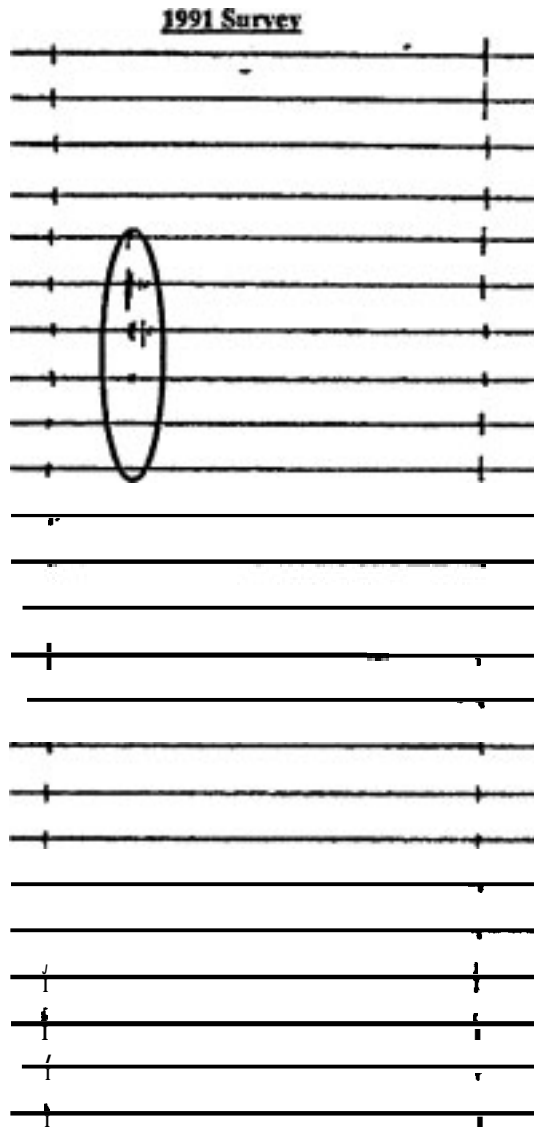
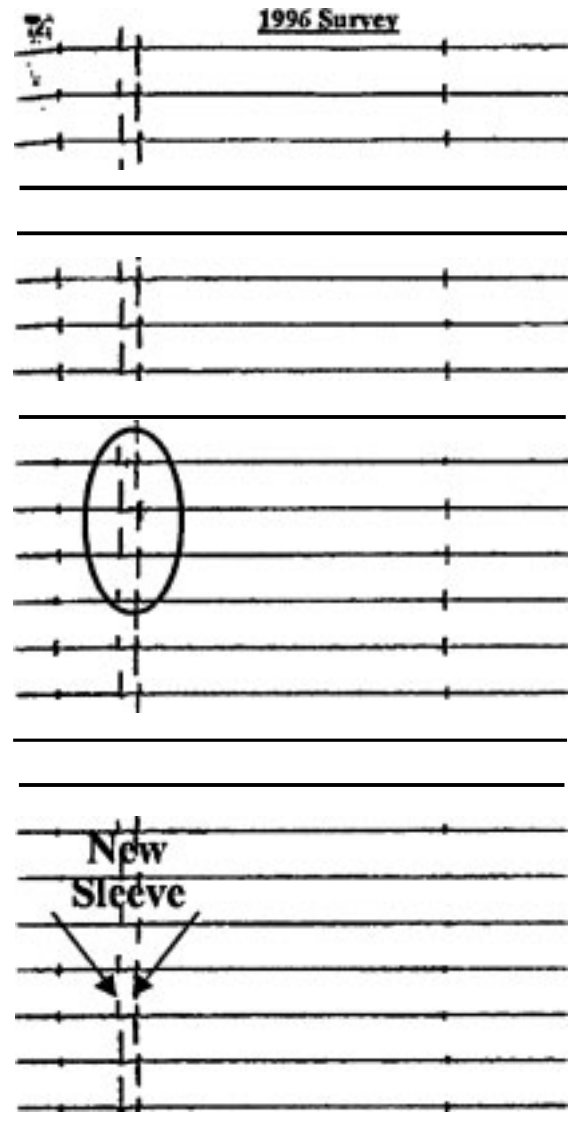
There are six locations found on the 1996 Linalog, MFL survey logs that were not called by Tuboscope and they are designated as HND1 through HND6. Three of these (HND1, HND2, and HND5) are light in nature and appear to be probable external corrosion located in the immediate vicinity of the girth weld as discussed above. HND3 is the only group of signals in the entire pipeline section that has a long-length external corrosion pattern and even though it falls below the minimum reportable level, it will be valuable to understand their source. HND4 is in the next joint downstream from HND3 and has a unique corrosion-type signal character also. The signals are contained in a much smaller area, are low in amplitude and high in frequency. HND6 is at a repair area where a sleeve was installed over an internal defect found during the 1991 survey and it appears that the sleeve does not cover the entire defect.

HNDG, RGW = 169502' 9.1", Defect is 2'1.1" D/S of RGW. Sleeve does not cover defect.

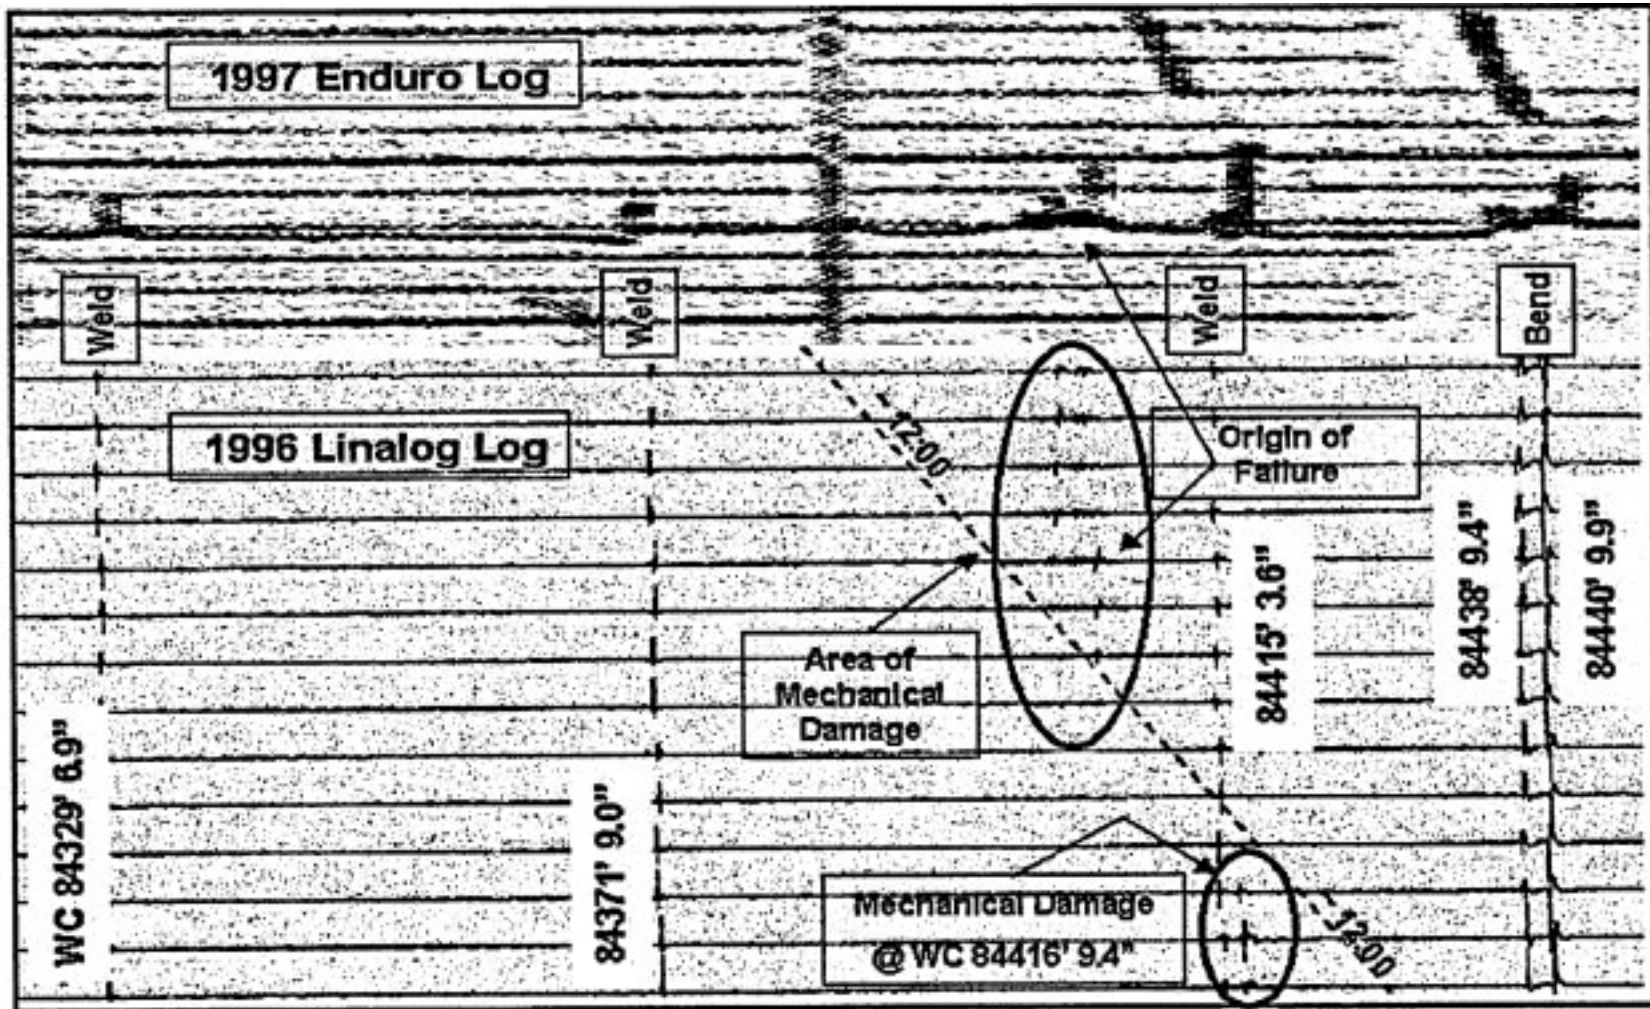
**OLYMPIC PIPELINE COMPANY 16", BELLINGHAM, WA.
LINALOG/ENDURO COMPARISON AT FAILURE LOCATION**

Page 2 of this Appendix contains an excerpt from the 1997 Enduro survey and an excerpt from the 1996 Linalog MFL survey. The Enduro survey excerpt was rotated 180 degrees along a vertical axis through the center. This was required because the two survey presentations are from opposite directions due to the method of recording. The two surveys were then adjusted in horizontal scale so that the girth welds were in reasonable alignment. The Enduro system has a mechanical drive device that advances the record paper as a function of the movement of the pig and thus all velocity variations are eliminated in the recording. The Linalog recording device is controlled as a function of time by a motor control circuit and thus pig velocity variations are reflected in the data. Thus, it is impossible to attain 100% correlation due to the small instantaneous velocity variations that are ever present. In this case, the velocity variations only cause a very minor alignment deviation at the welds. This graphic clearly proves that both systems did detect the damaged area around the origin of failure and in the joint downstream. It is my opinion that neither clearly detected the specific origin of failure (due to its longitudinal orientation) such that one could point to a single set of signals within the many signals present and state with a high degree of certainty exactly which one is the origin of failure. They both, however, have recorded data indicative of mechanical damage beginning at least two feet upstream of the origin and ending 16 to 18 inches downstream. The Linalog survey shows signals from the shoes bouncing and minor flux leakage throughout the area along the top of the pipe that is low in amplitude but typical in signal form. The Enduro survey shows very little but a single event since the scale is 1"=250'.

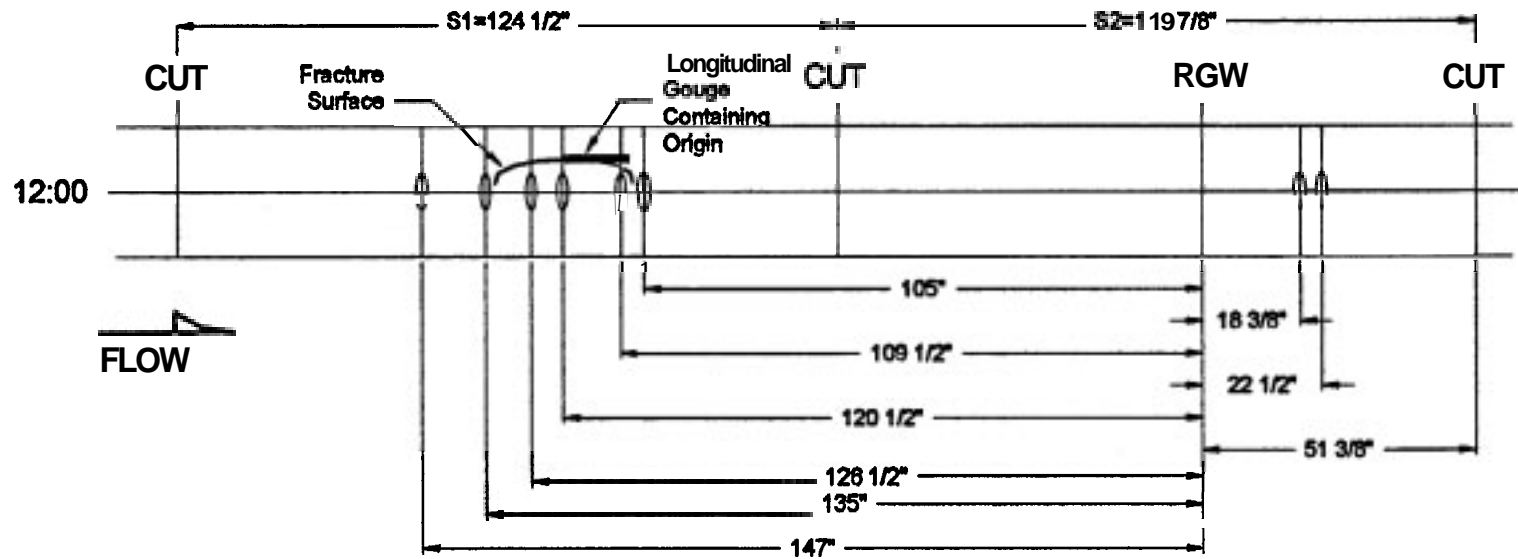
16" OLYMPIC PIPELINE FAILURE - BELLINGHAM, WA. MECHANICAL DEFORMATION LAYOUT

The Mechanical layout on page 3 shows there to be six points of deformation in the area around the origin of failure and two points of deformation in the downstream joint. I was able to correlate all of these but the one 109 1/2' upstream of the reference girth weld. It appears that this one is lost due to shoe bounce or some other similar element. There are signals where the defect should be but there is not a clear set that can be isolated and attributed to this particular point of damage.
