**National Transportation Safety Board
Internal Inspection Factual
Bellingham, Washington
Accident DCA99-MP008**

Appendix 7 Olympic responses to WDOE order

RE: Administrative Order No. DE 96CP-N289

Subject: Failure Analysis of 20 inch Diameter Pipe

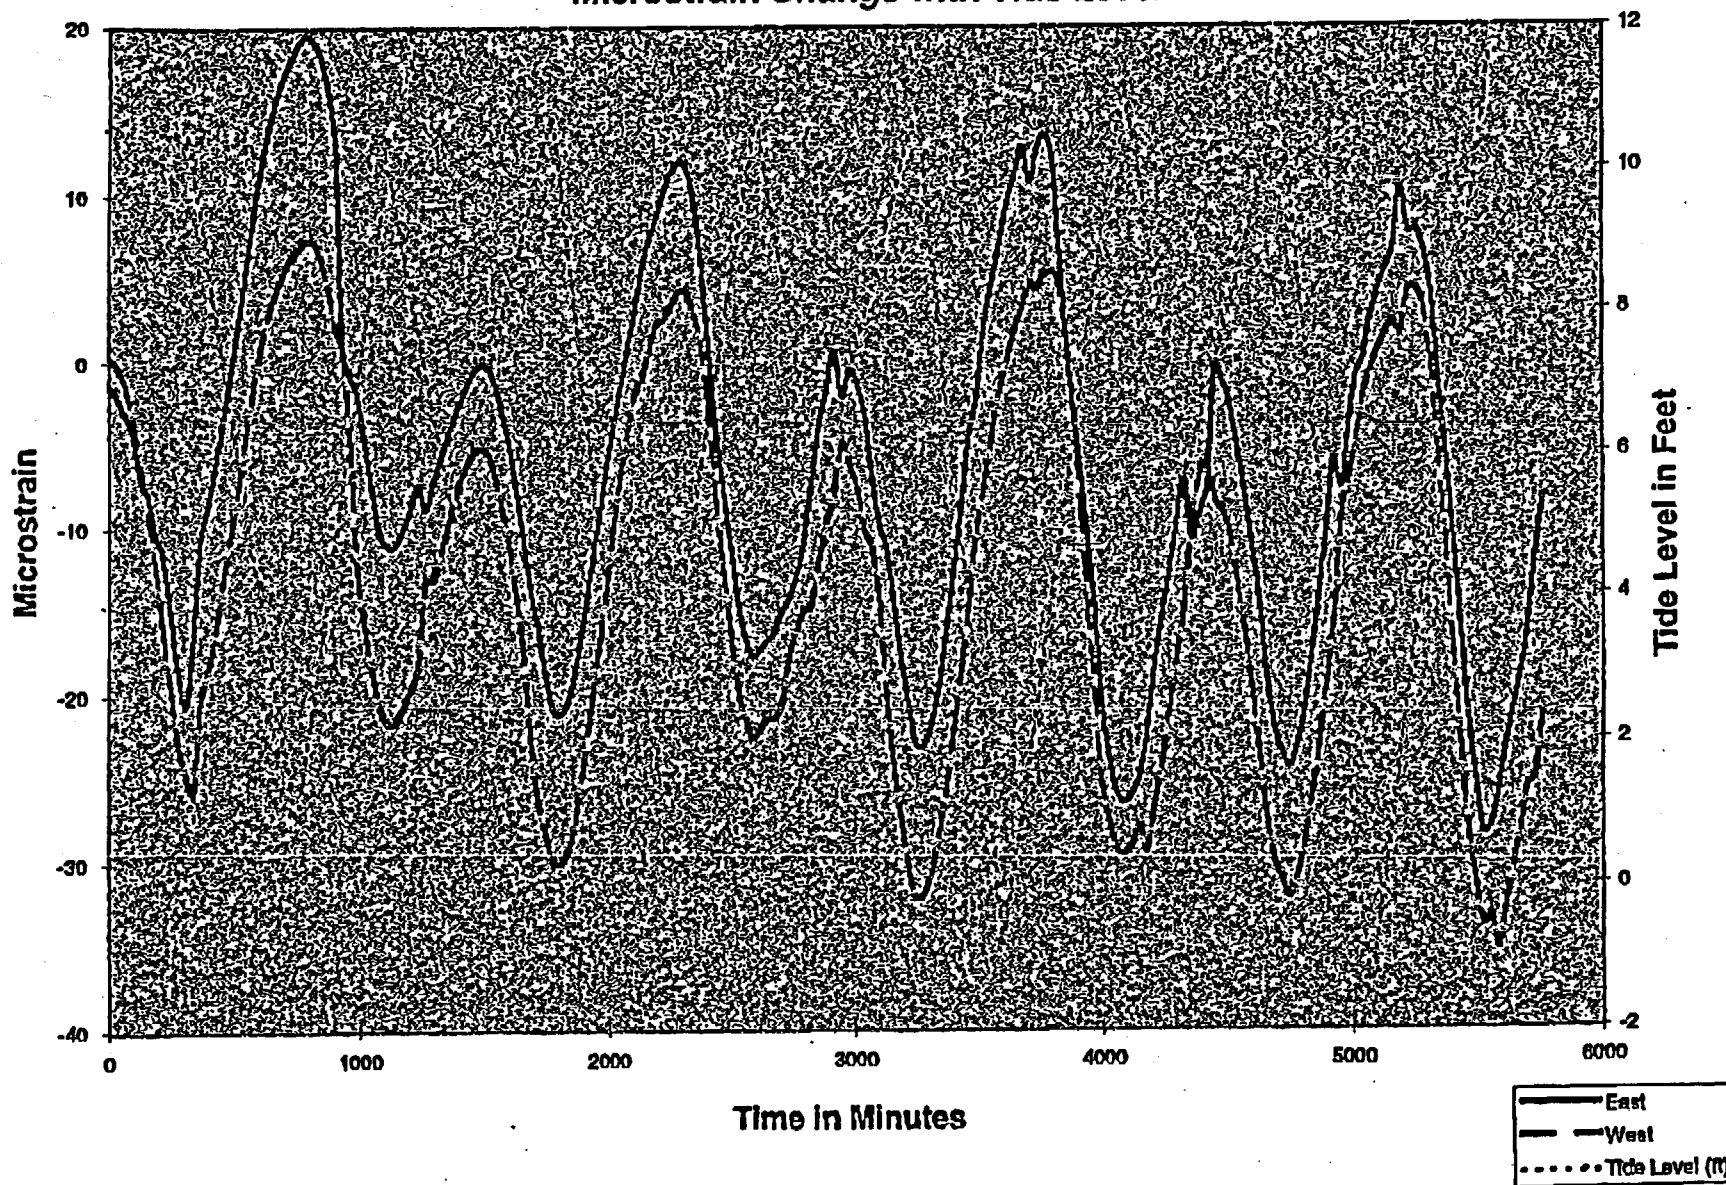
Ebey Slough - Station 1957 + 03
Microstrain Change with Tide Level

As we noted earlier, the measured strains induced on Olympic's 20" line at the Ebey Slough crossing are very low relative to both the elastic or yield strength and ultimate strength of the steel pipe. The strain is also cyclical with the tides and there is no evidence of permanent deformation of the levee that could cause a build up of strain in the entire levee system.

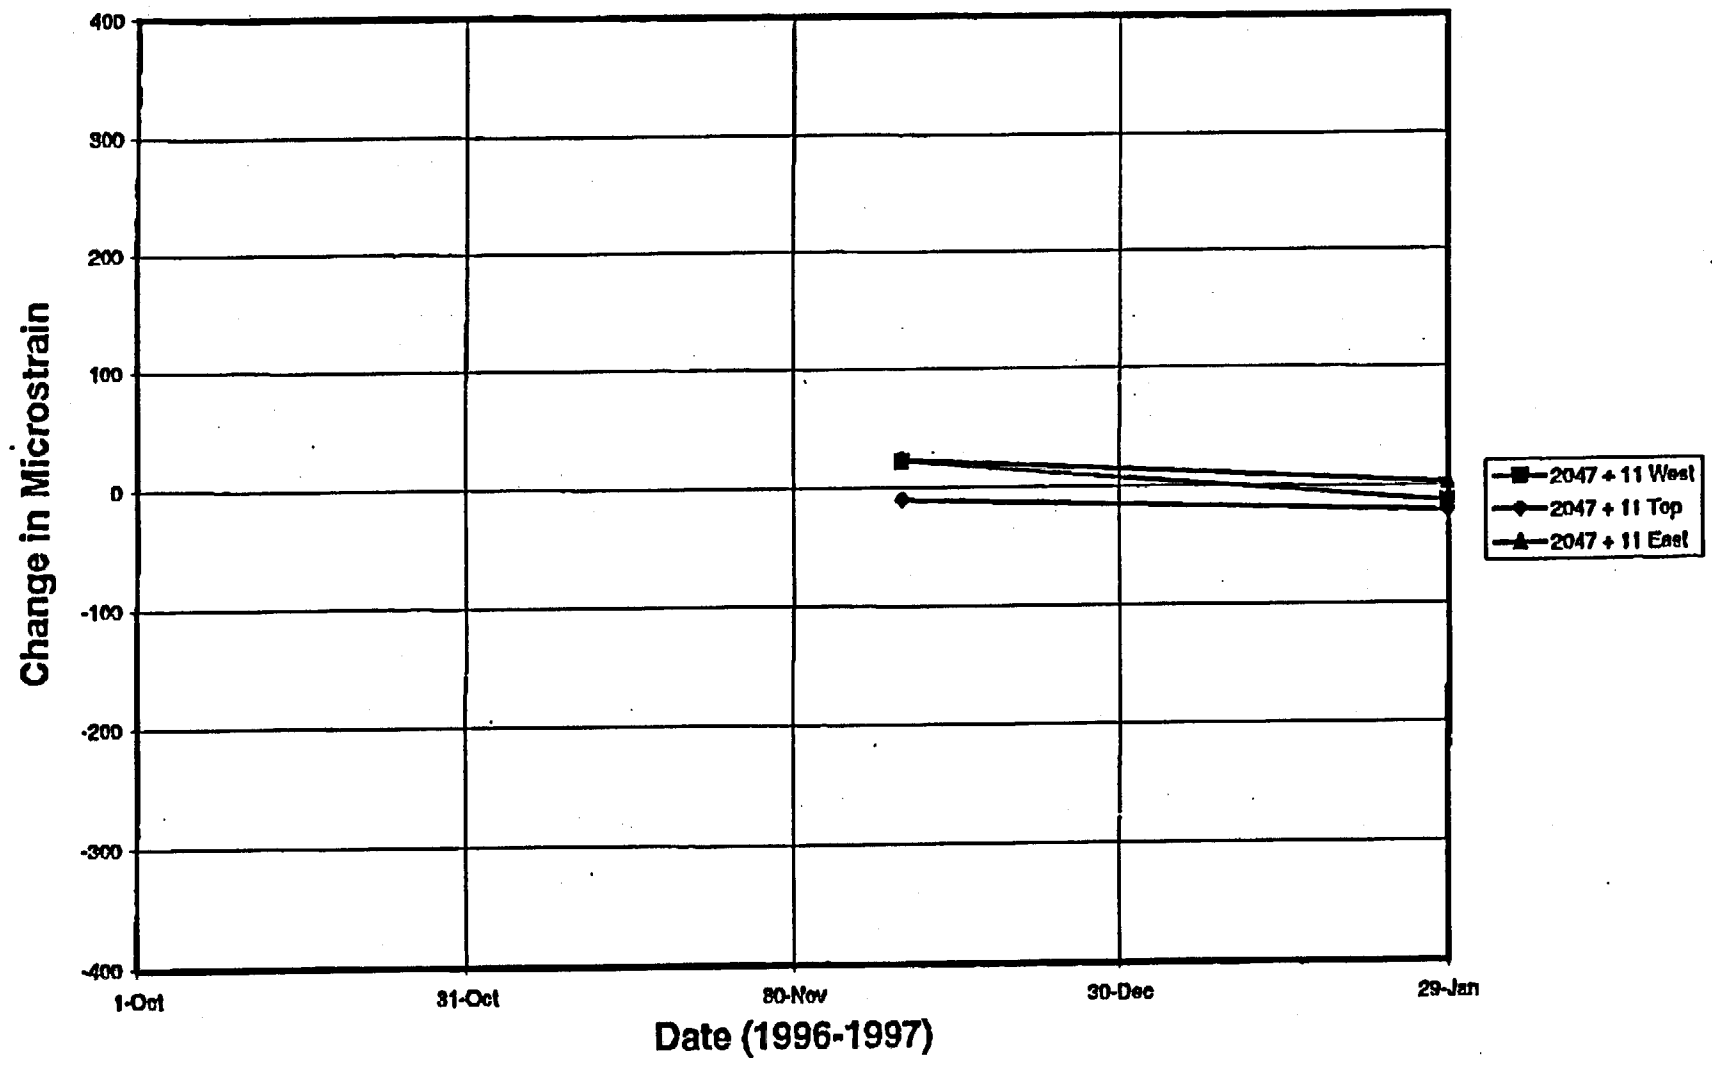
Mile Post 74 - South Ebey Slough Station 2047 + 11

We do think that the hydraulic forces created when the levee broke ten years ago at the north side of our south Ebey Slough crossing, did cause strains in the plastic range. These have the potential to cause a problem in the future, which is why we plan to re-install this crossing with a new bored installation at the cost of over \$650,000.
