Title of Investigation:
Fire - Spirit of Boston

ORIGIN AND CAUSE REPORT

Bureau of Alcohol, Tobacco, Firearms and Explosives (ATF) Certified Fire Investigator (CFI) origin and cause determination. ATF case title: Fire - Spirit of Boston, ATF case number [REDACTED]

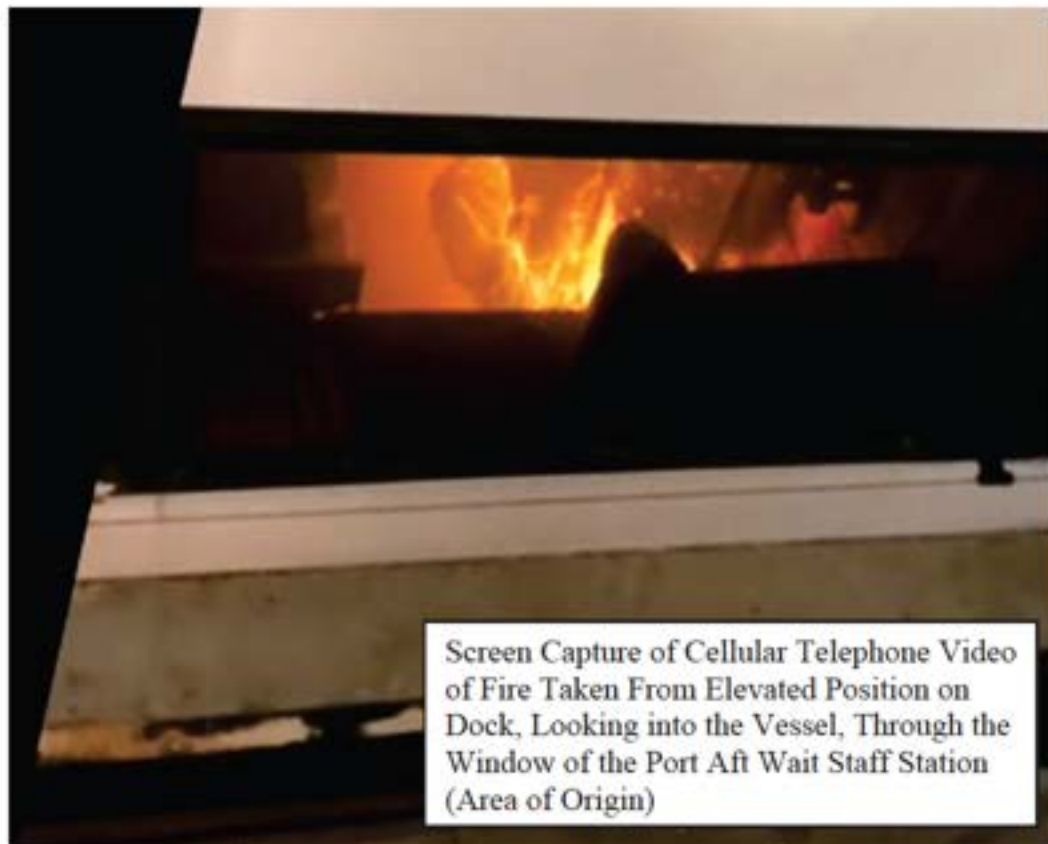
Screen Capture of Cellular Telephone Video of Fire Taken From Elevated Position on Dock, Looking into the Vessel, Through the Window of the Port Aft Wait Staff Station (Area of Origin)

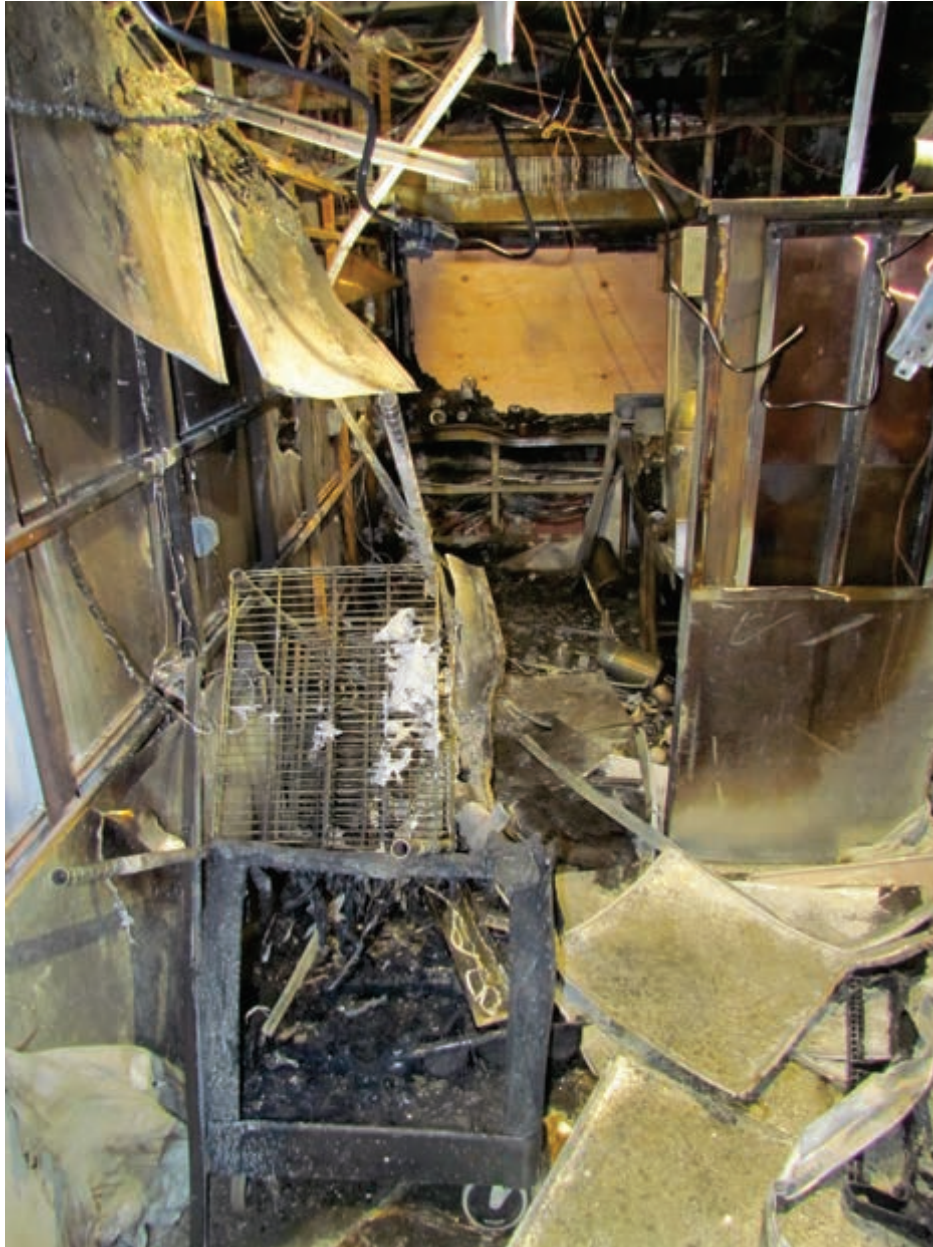
213. The directionally damaged wheeled plastic cart and corresponding oxidation pattern on the aft wall of the port side station metal wall paneling, in combination, comprised the starboard portion of fire “V” pattern on the aft wall of the port aft side wait staff station. The fire “V” pattern originated at the deck in the port aft side wait staff station and rose upward and outward. The wheeled plastic cart carried several silverware storage trays.

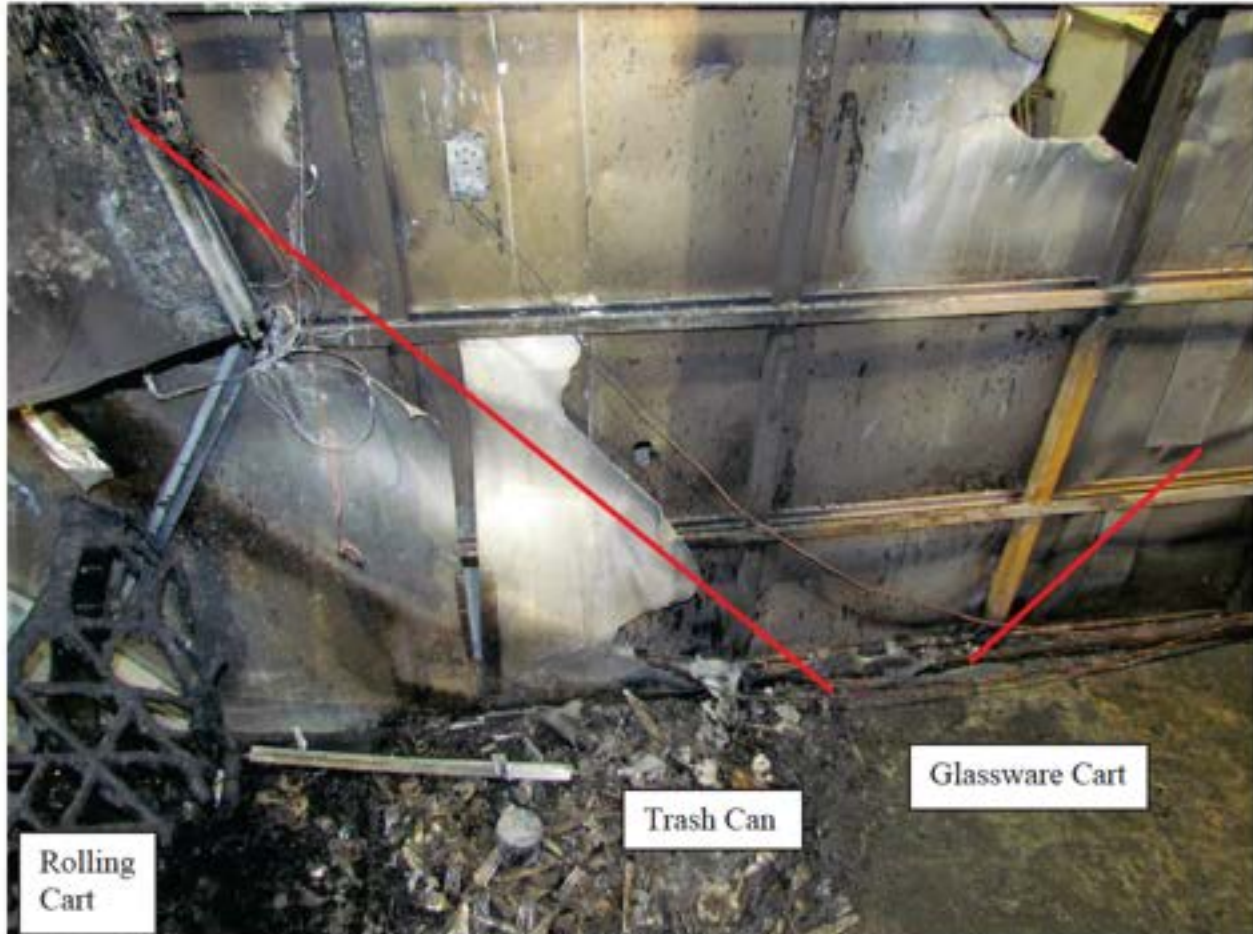
215. The port side aft wait staff station partition wall extended past the entryway starboard forward wall which separated the port side hallway from the port aft side wait staff station. The port side aft wait staff station partition wall was constructed of vertical metal posts and metal horizontal slats with metal paneling covered with a as the wall covering. The metal panel wall covering was consumed which resulted in a fire "V" pattern. The fire "V" pattern originated at the deck and extended upward and outward from the center of the partition wall. Oxidation on the vertical metal posts and slats demonstrated a fire "V" pattern which originated at the deck and extended upward and outward from the center of the partition wall.

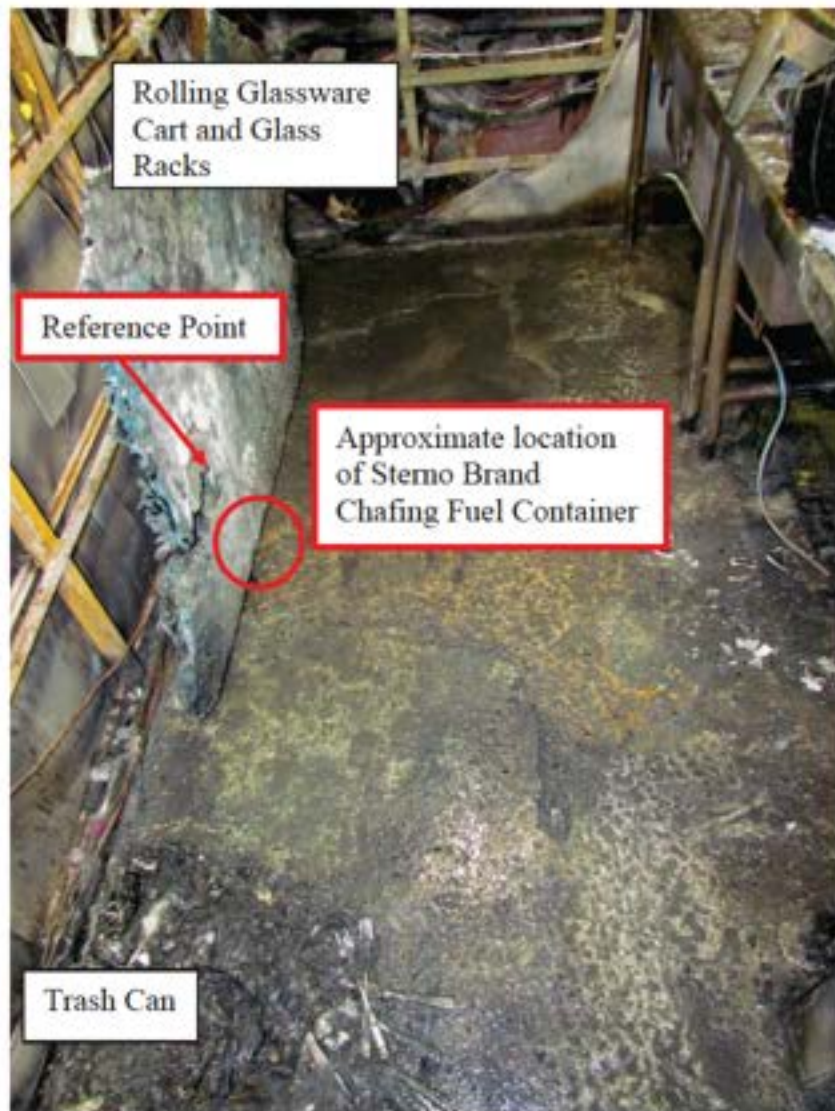
230. The melted trash can was removed from the floor and examined. The trash can was identified as a Rubbermaid, model Slim Jim, black, twenty-three (23) gallon waste container. The solidified plastic debris contained silverware from the melted wheeled plastic cart which was next to it. The top of the melted debris revealed a black plastic trash can liner. The contents were mechanically removed. Within the trash can liner were plastic drink cups, paper cleaning wipes, paper single use sugar packet wrappers, a metal button, partial paper drinking straw, paper disposable tea bag wrapper, and miscellaneous other paper product rubbish.
231. Comparison photographs of plastic trash can in port aft wait staff station can to exemplar located on vessel.

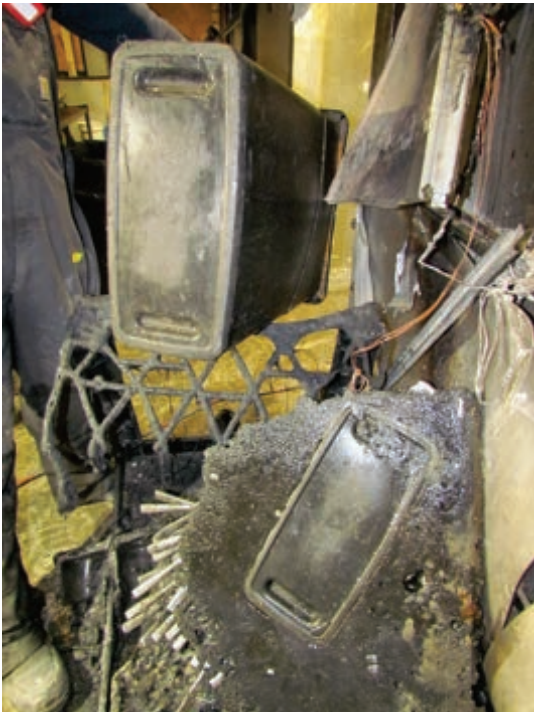
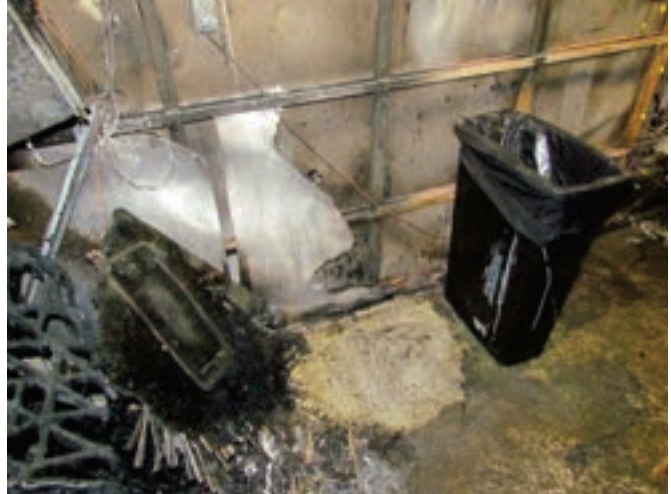
232. Remains of melted plastic trash can removed from port aft wait staff station for contents examination.

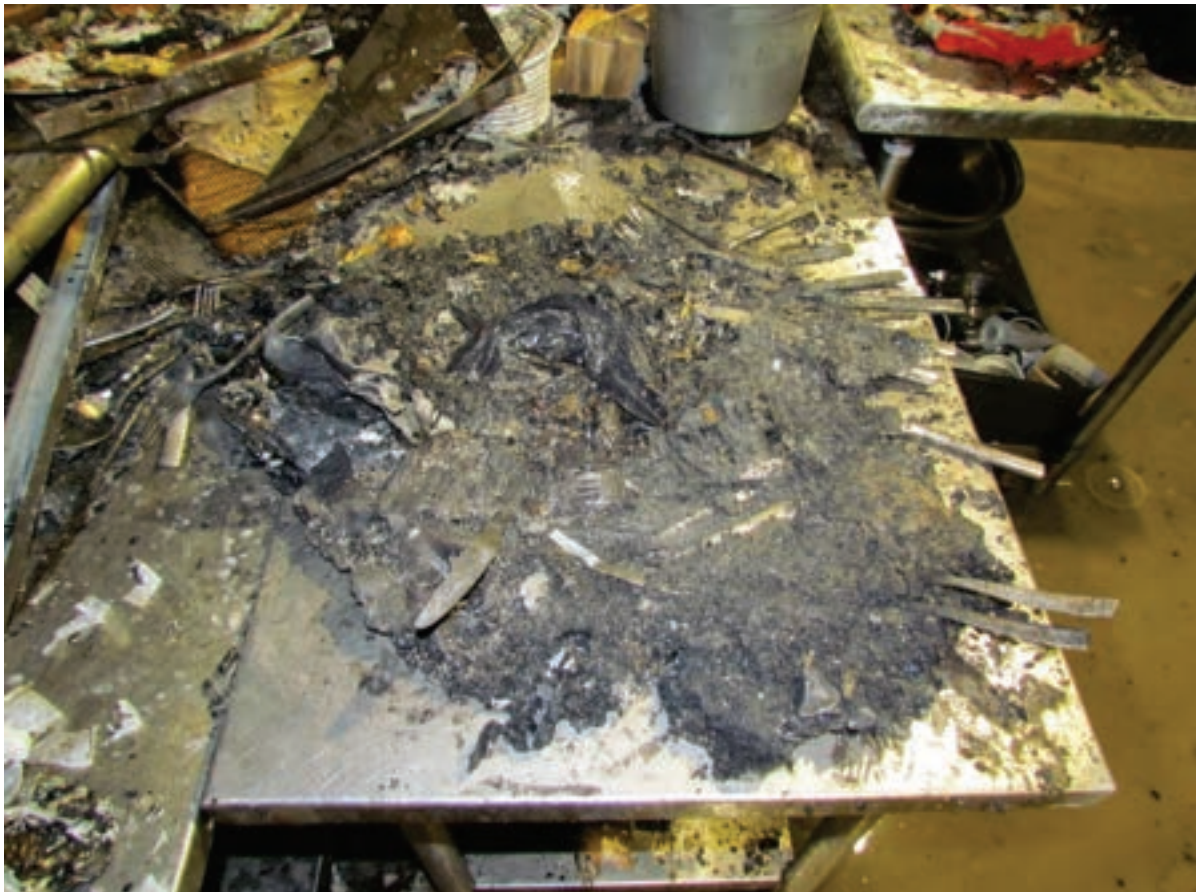
233. Mechanical removal of contents from remains of melted plastic trash can from port aft wait staff station.

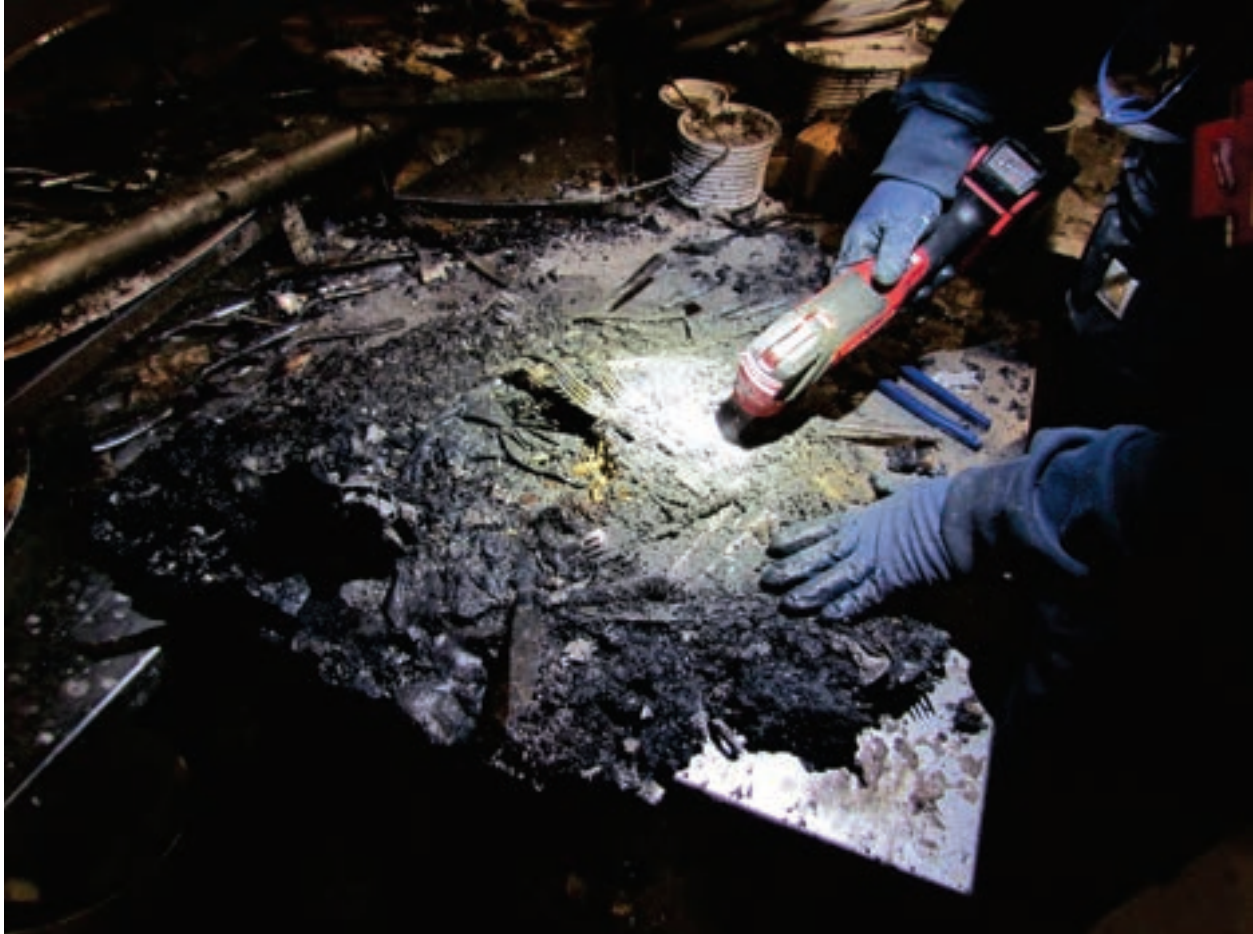
234. Sorted contents from remains of melted plastic trash can from port aft wait staff station.

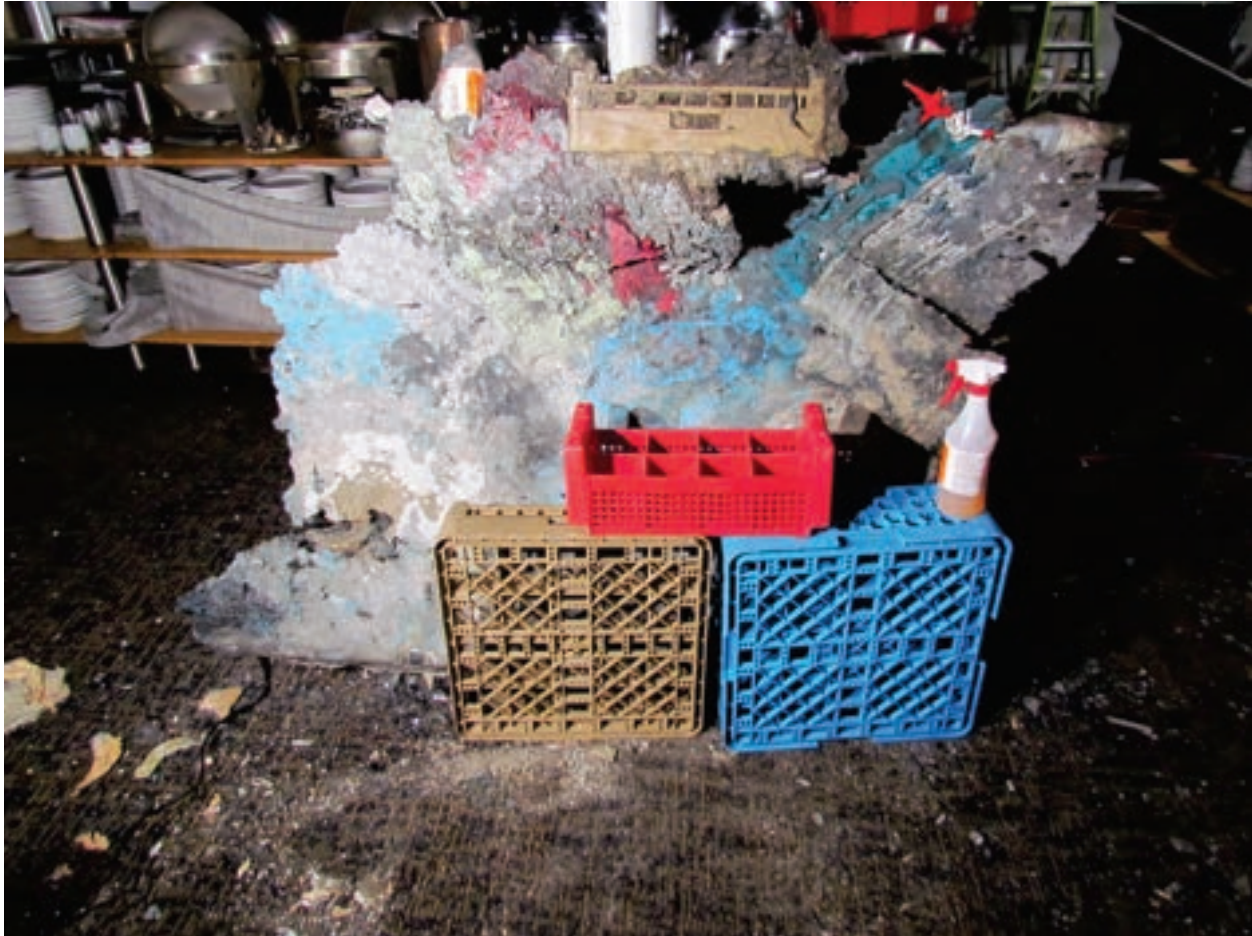
237. The solidified plastic debris was subjected to x-ray examination. The x-rays identified a chafing fuel container located in the area under the dish and glass rack dolly which was stored between the Rubbermaid Slim Jim waste container and the metal wire rack storage shelving unit. The container was located on its side. A physical examination determined it was a Sterno brand six (6) hour Stem Wick chafing fuel container. The portion of the container which was flush with the floor revealed the paper label was unburned.

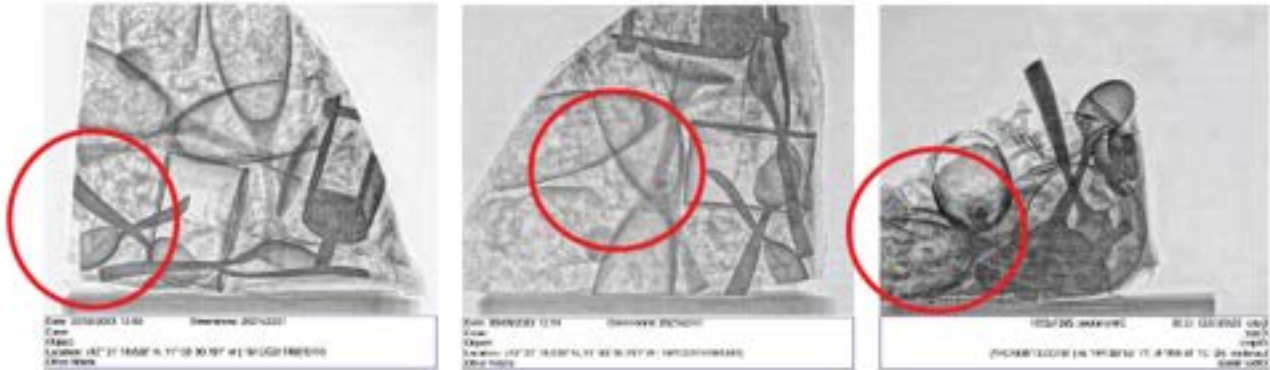
239. Exposed portion of Sterno Brand chafing fuel container after administrative X-Rays.

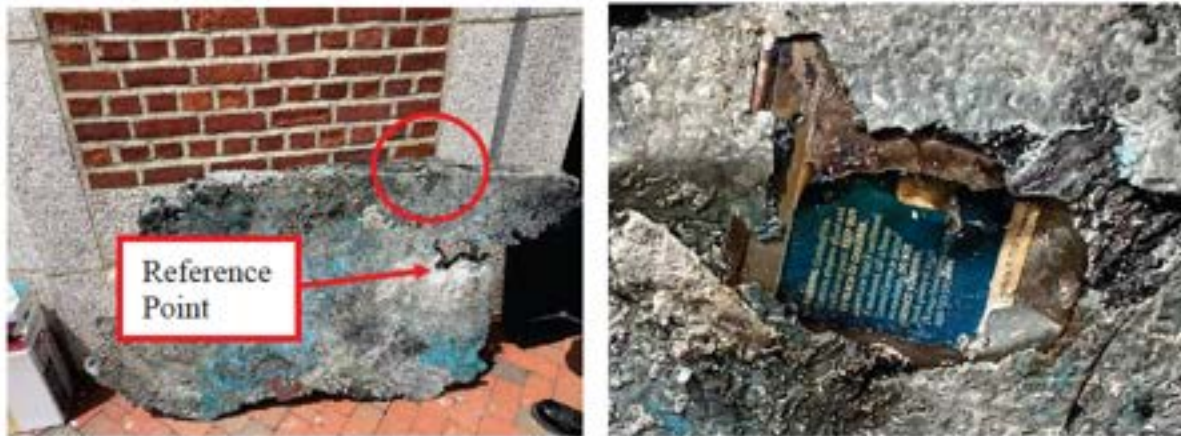
240. The Sterno brand chafing fuel container was mechanically removed from the solidified plastic debris for examination (left photograph). The Sterno brand chafing fuel container demonstrated a distinct pattern to one (1) half of the container. One (1) half of the container was significantly more discolored than the other half. Right hand photo is exemplar Sterno brand chafing fuel container, placed on its side, after FRL test fire.

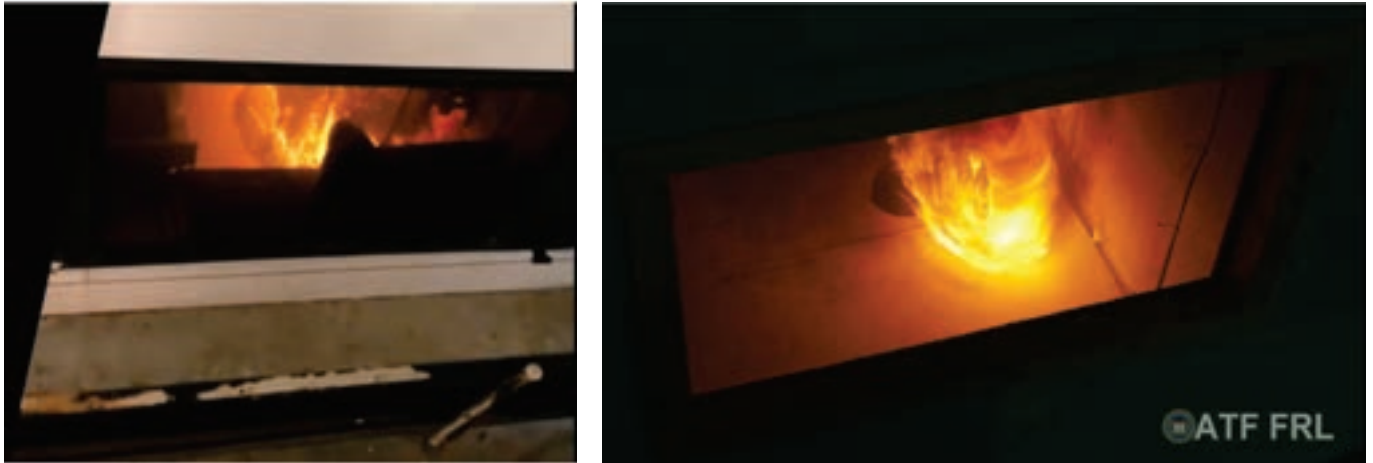
244. Screen capture of FRL of “Master” video of full scale testing.

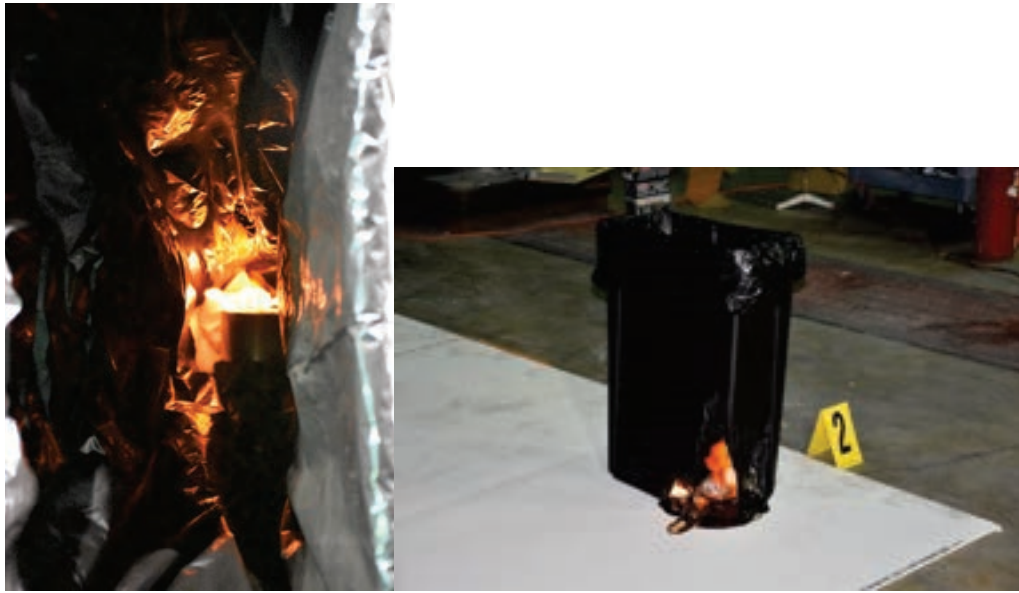
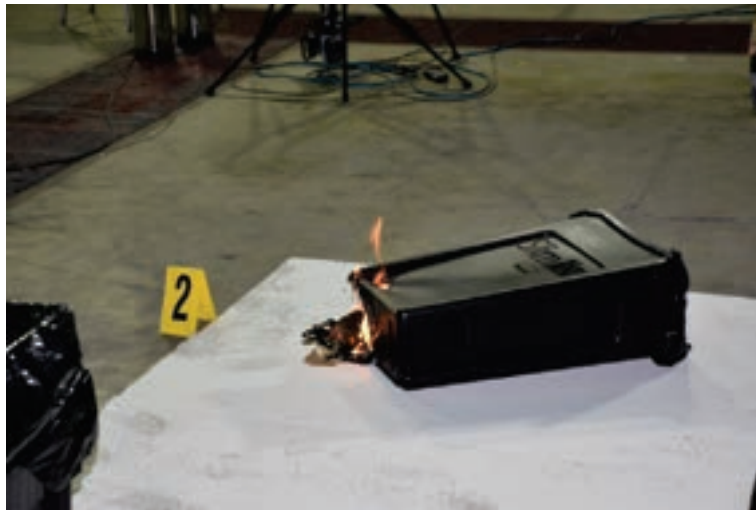
247. Screen capture of ambient environment and forward looking infrared (FLIR) camera video of exemplar plastic trash can fire research testing.

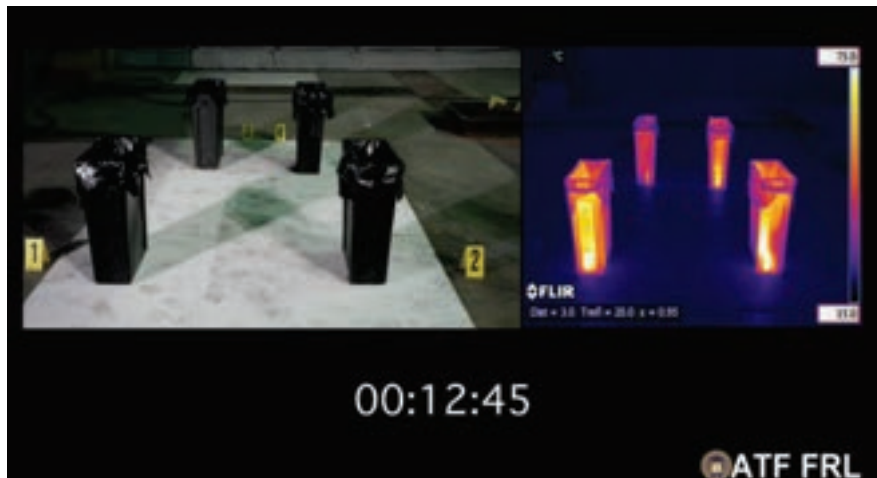
248. Screen capture of full scale FRL testing of exemplar plastic trash can as exposure to fire under exemplar rolling plastic glassware cart with stacked glassware racks.

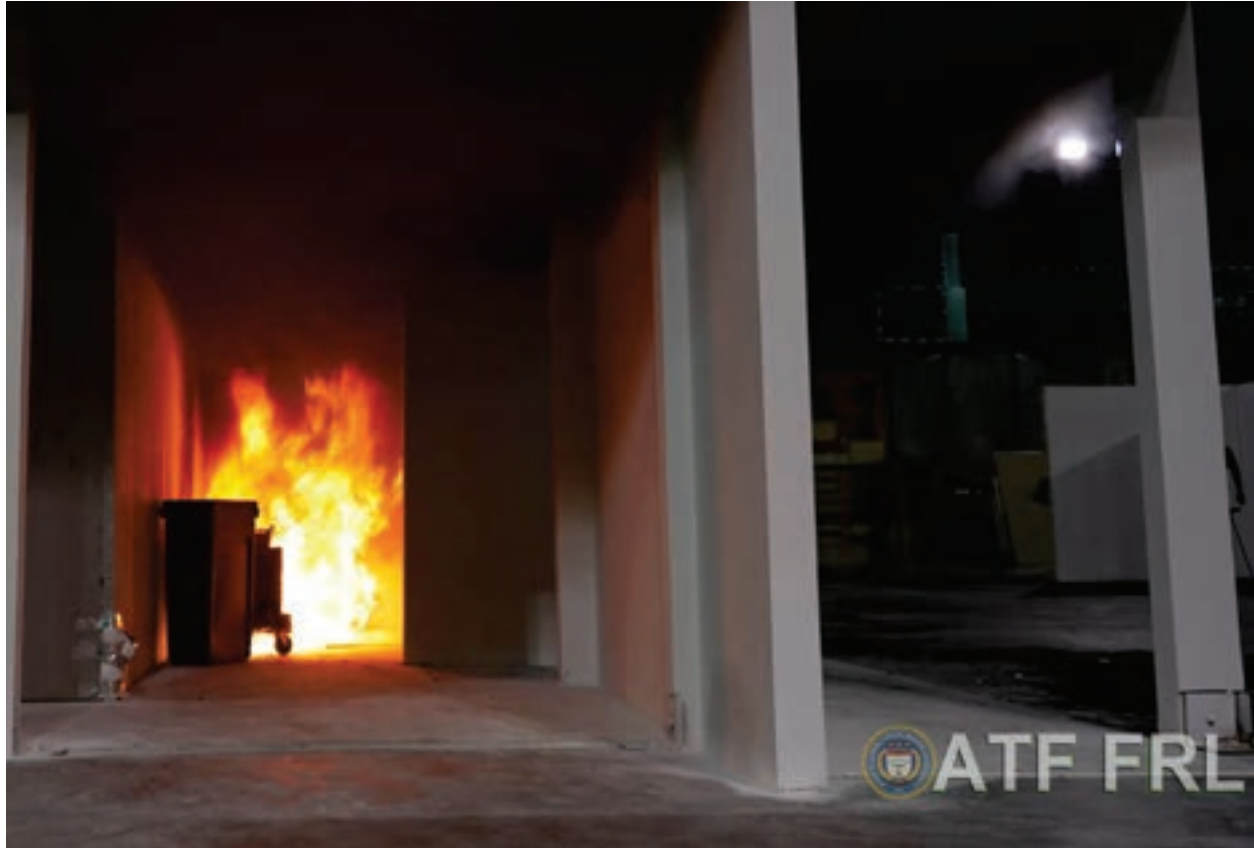
249. Screen captures of “Master” video of full scale FRL fire testing. It should be noted shortly after dripping plastic was observed, sounds could be heard that were described by observers as “crackling” and “hissing”. Subsequent to crackling and hissing, the fire continued to grow in size until light smoke was observed coming out of the test structure. Video of one series of testing was conducted with audio recording which captured the as described noise(s).
