NATIONAL TRANSPORTATION SAFETY BOARD  
OFFICE OF AVIATION SAFETY  
WASHINGTON, D.C. 20594

## **POWERPLANTS GROUP CHAIRMAN'S FACTUAL REPORT**

NTSB ID No.: DCA19MA086

Location: Anahuac, Texas  
Date: February 23, 2019  
Time: 1239 central standard time  
Aircraft: Boeing 767-375BCF, N1271A, Atlas Air flight 3591

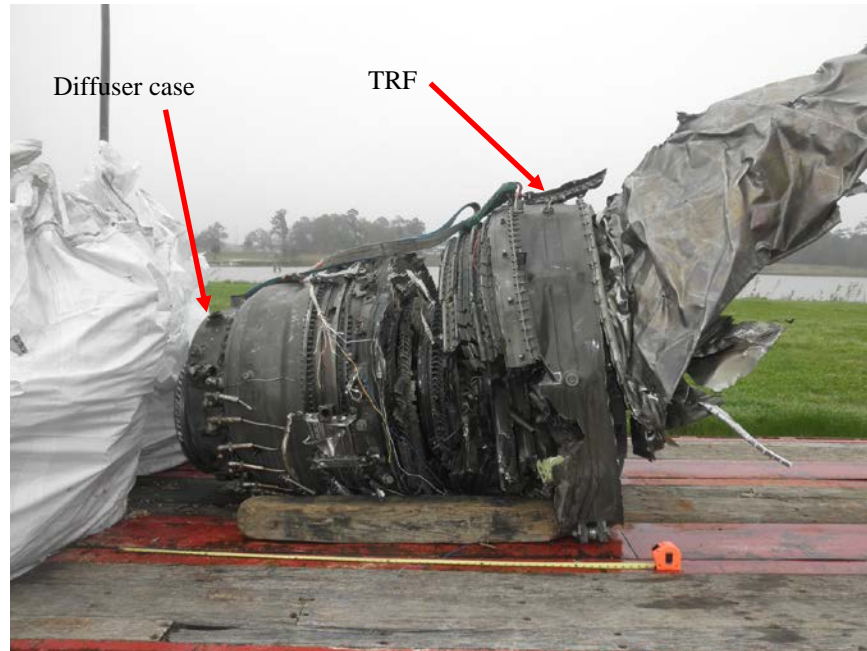
There were two large pieces of engine wreckage recovered. There was a large piece of engine wreckage that extended from the HPC stage 14 disk to the rear flange of the turbine rear frame (TRF). (Photo No. 1) The other large piece of engine wreckage extended from the stub shaft and the front of the HPC, which was complete, to the LPT stage 3 disk. (Photo No. 2) The two large pieces of engine wreckage were both recovered from the water. Also recovered was an individual HPC stage 2 disk, part number (PN) 9390M27P03, SN SNG05682, which was found on a marsh island, that was identified from engine maintenance records as having been installed in the No. 1 engine. (Photo No. 3) The engine wreckage shown in Photo No. 2 had a complete HPC that included the HPC stage 2 disk. Since the recovered HPC stage 2 disk that according to maintenance records had been installed in the No. 1 engine, that would make the engine wreckage shown in Photo No. 1, which was missing the front of the HPC including the HPC stage 2 disk, the No. 1 engine. Since the wreckage shown in Photo No. 1, is the No. 1 engine, that would make the engine wreckage shown in Photo No. 2 the No. 2 engine.

Photo No. 1: Largest piece of No. 1 (left) engine recovered that extended from front of diffuser on left to turbine rear frame on the right.  
To the right of the turbine rear frame is the crushed exhaust duct.

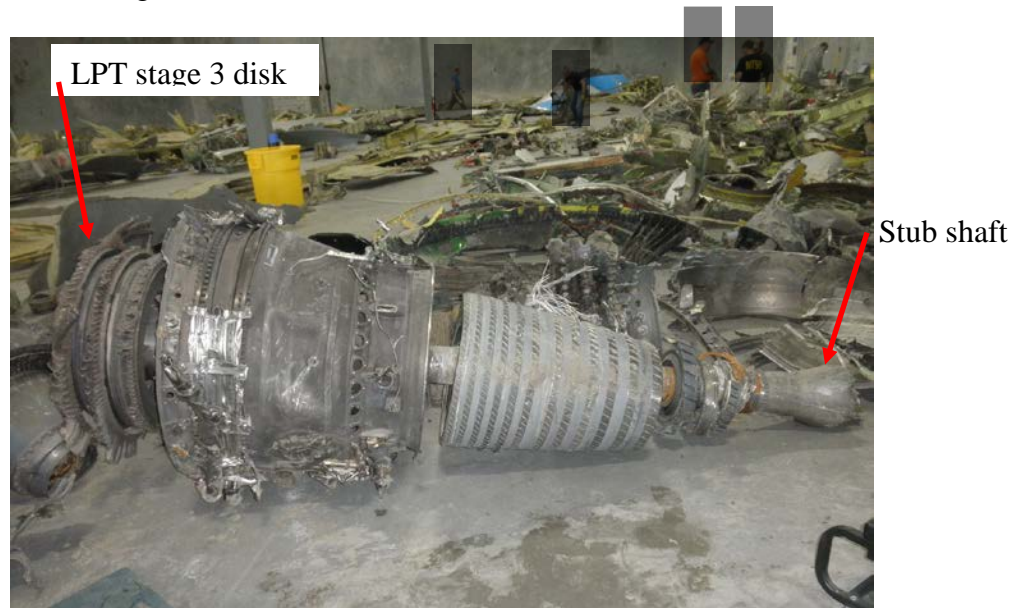
Photo No. 2: Largest piece of No. 2 (right) engine recovered that extended from stub shaft on the right to LPT stage 3 disk on the left.

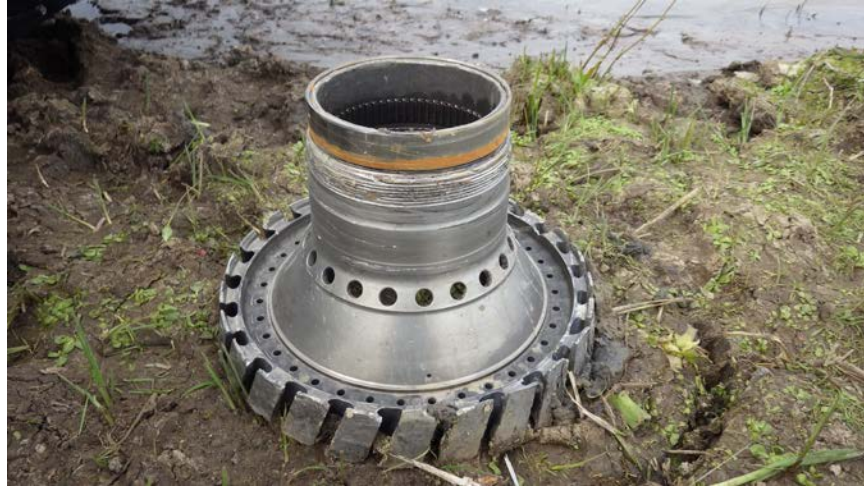
Photo No. 3: HPC stage 2 disk, PN 9380M27P03 SN SNG05682, laying on the ground, front side up, at the crash site identified from records as having been installed in the No. 1 (right) engine. (GE)

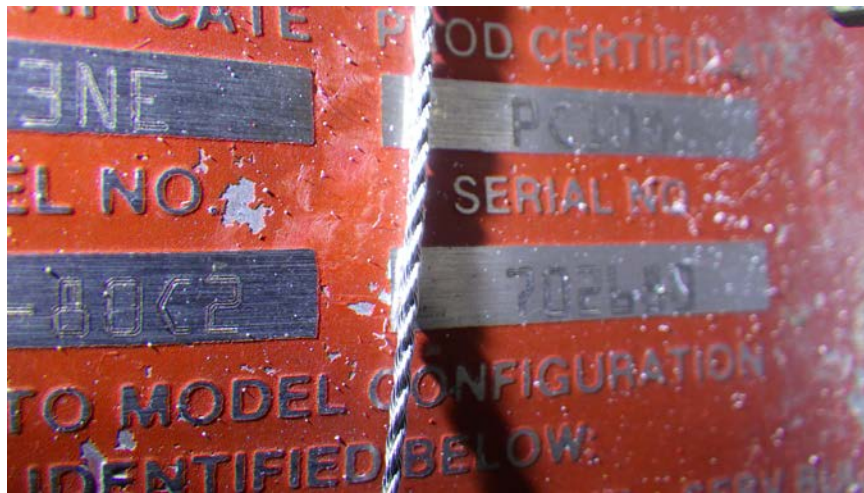
A bracket was recovered that had the engine's data plate indicating the engine was a CF6-80C2B6F SN 702680, that corresponded to the records for the No. 1 engine. (Photo No. 4)

Photo No. 4: A data plate from one of the engines confirming the engine SN as 702680. (GE)

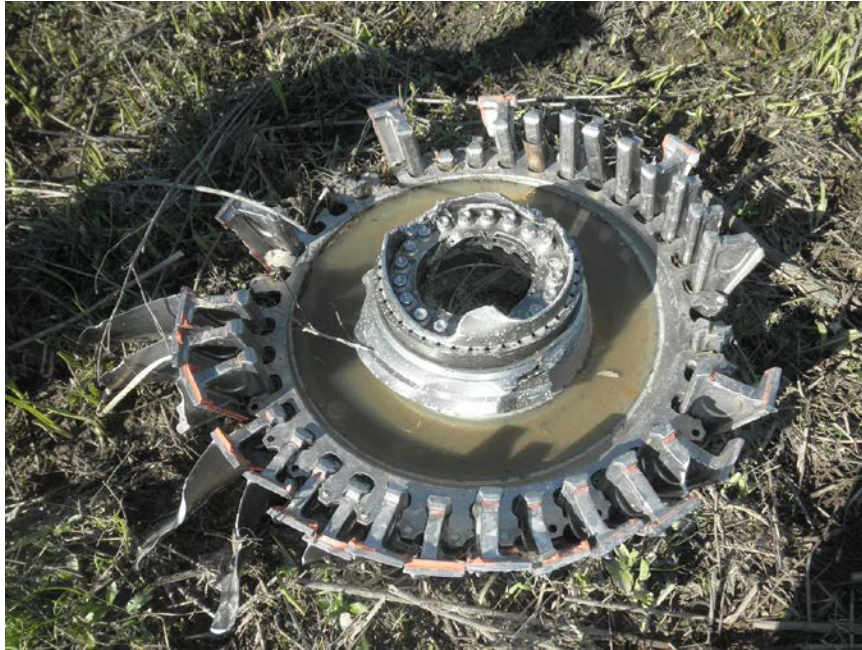
The fan disk was intact. (Photo No. 5) The No. 1 engine's fan disk was found on one of the marsh islands down range from the point of impact. The forward end of the stub shaft remained attached to the fan disk. The forward end of the stub shaft was fractured at various

Photo No. 5: Left engine's fan disk, front face down, with 28 of 38 fan blades in place in the blade slots, laying on marshy ground at the crash site. The forward end of the stub shaft is still bolted in place to the rear of the fan disk.

There were 28 of 38 fan blades that remained in the blade slots. Of the fan blades that remained in the slots, 10 fan blades were still fully in the slot and 18 were displaced rearward out of the slots for various lengths. All of the fan blades were fractured transversely across the airfoil adjacent to the blade root platform except for an arc of five blades that were fractured across the airfoil between about 5.5- and 8-inches above the blade root platform. The fracture surfaces on all of the fan blades had shear lips and chevrons<sup>2</sup> that pointed towards the leading edge.

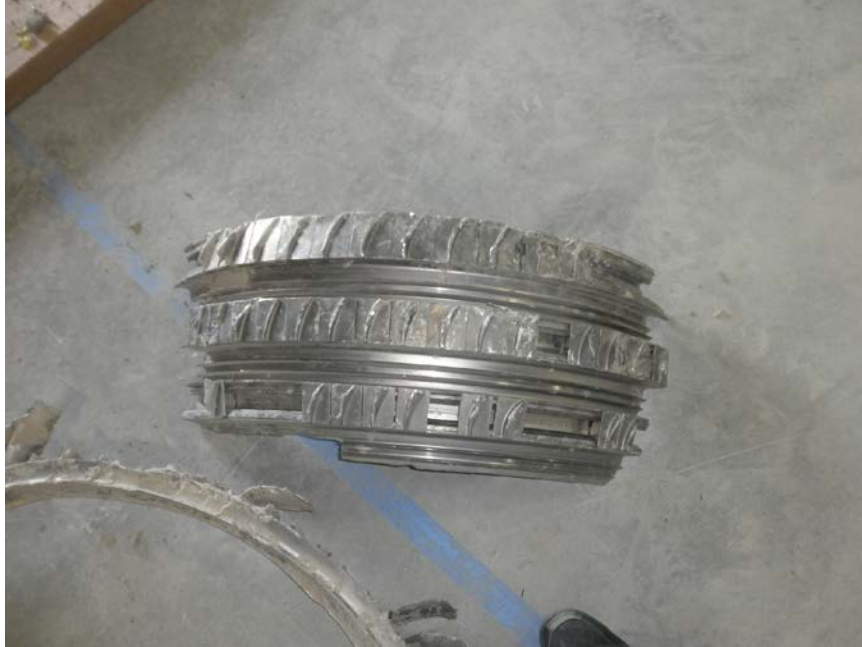
There was a piece of the booster spool that measured about 34-inches circumferential by about 13-inches axial and included stages 1, 2, and 3. There were booster blades in each stage: 11 stage 1 blades, 15 stage 2 blades, and 10 stage 3 blades; most of which were fractured transversely across the airfoil adjacent to the platform. (Photo No. 6) There were several blades that had a bit of airfoil up to about an inch that were bent opposite the direction of rotation. There was complete stage 4 booster rim that was twisted, but the bore was missing. (Photo No. 7) All of the booster stage 4 blades were in the disk slots with the blades being various lengths from fractured directly adjacent to the platform to being full length. All of the longer blades were bent opposite the direction of rotation.

Photo No. 6: Piece of No. 1 engine's booster spool, stages 1 through 3.

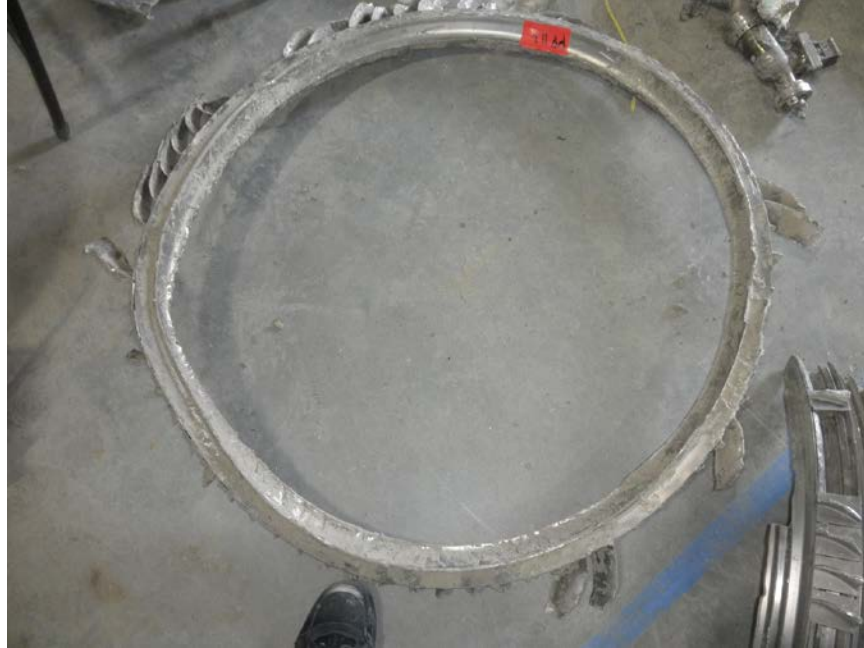
Photo No. 7: The No. 1 engine's booster stage 4 disk rim.

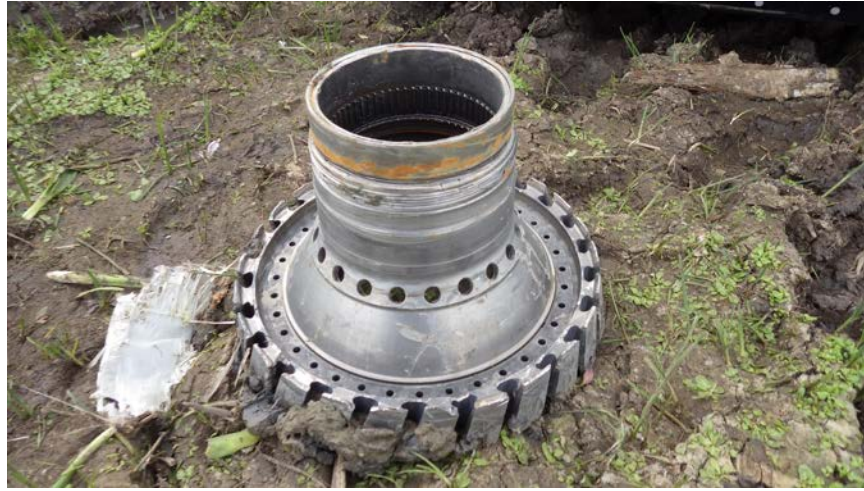
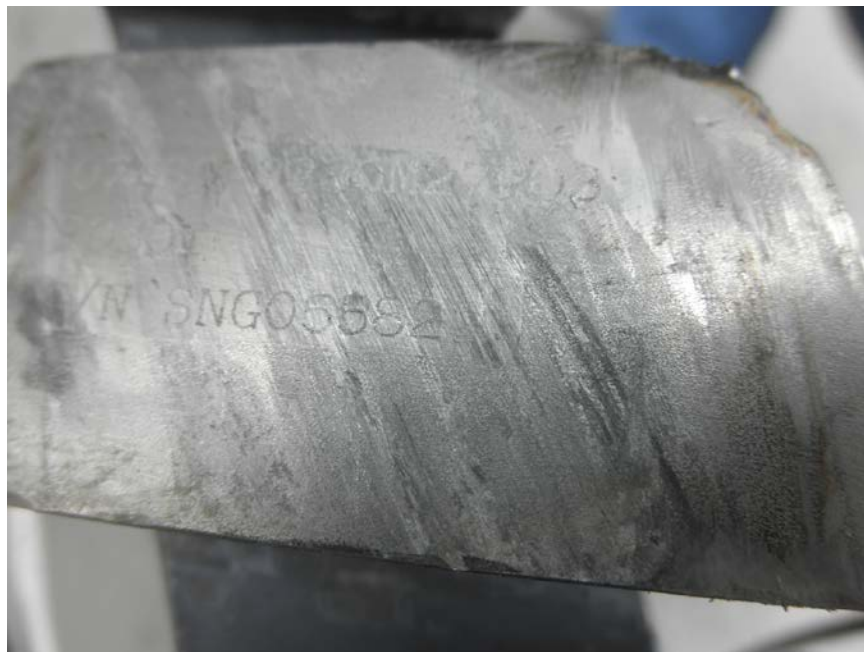
The HPC stage 2 disk, PN 9380M27P03, SN SNG05582, that corresponded to the No. 1 engine, was intact. (Photos Nos. 8 and 9) There was an arc of eight blade lugs that had the front tangs partially or completely broken off. And then separated by nine blade posts in the clockwise direction, there were arcs of three and five blade posts, which were separated by three blade posts, that had the rear tangs broken off. There were circumferential rub marks and gouges

Photo No. 8: The No. 1 engine's HPC stage 2 disk laying on the ground at the crash site. (GE)

Photo No. 9: Serial number of No. 1 engine's HPC stage 2 disk.

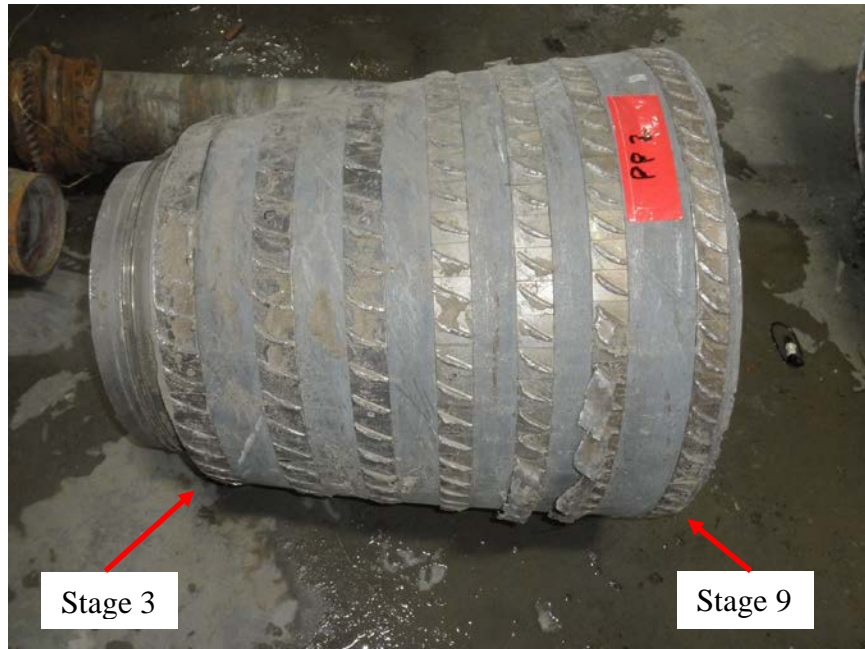
The HPC stage 3-to-9 spool was complete and intact. There was an axial line of holes punched into the spool between stages 6 and 9. All of the blades were in place except for two stage 7 blades and one stage 9 blade that were missing. The HPC stage 3 through stage 6 and stage 9 blades were all fractured transversely across the airfoil adjacent to the blade platform. Most of the HPC stage 7 and 8 blades were also fractured transversely across the airfoil adjacent to the platform. Those HPC stage 7 and 8 blades that still had the airfoils were bent opposite the direction of rotation and slightly forward flat against the outer diameter of the spool. (Photo No. 10)

Photo No. 10: The No. 1 engines HPC stage 3-to-9 spool with blades broken off adjacent to platform or bent over opposite the direction of rotation.

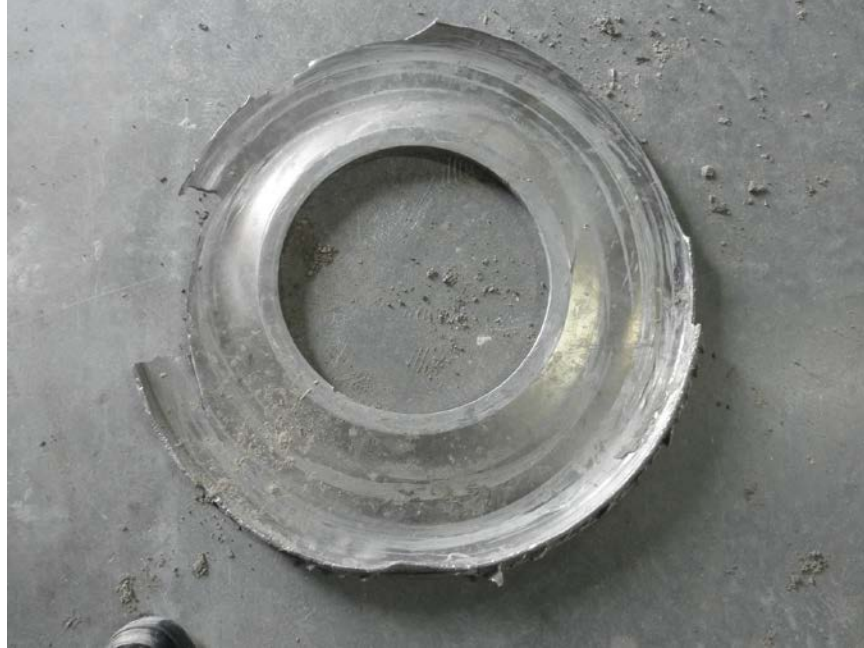
There was an unknown stage HPC disk that had the bore and inner part of the web intact. (Photo No. 11) This disk had an approximately 7-inch long circumferential by 2.25 inch wide radial piece of the outer web about 3.5-inches outboard of the bore missing. This disk had an approximately 150° arc of the blade rim still attached with arcs of 3 and 14 blade roots still in the blade slots. The front and rear faces of the disk had circumferential scoring marks and scratches. The rim of this disk was bent aft slightly. All of the blades except one were fractured across the airfoil directly adjacent to the platform. The one longer blade was fractured about 0.75-inches above the platform and the end of the airfoil was bent opposite direction of rotation.

Photo No. 11: An unknown stage HPC disk from the No. 1 engine.

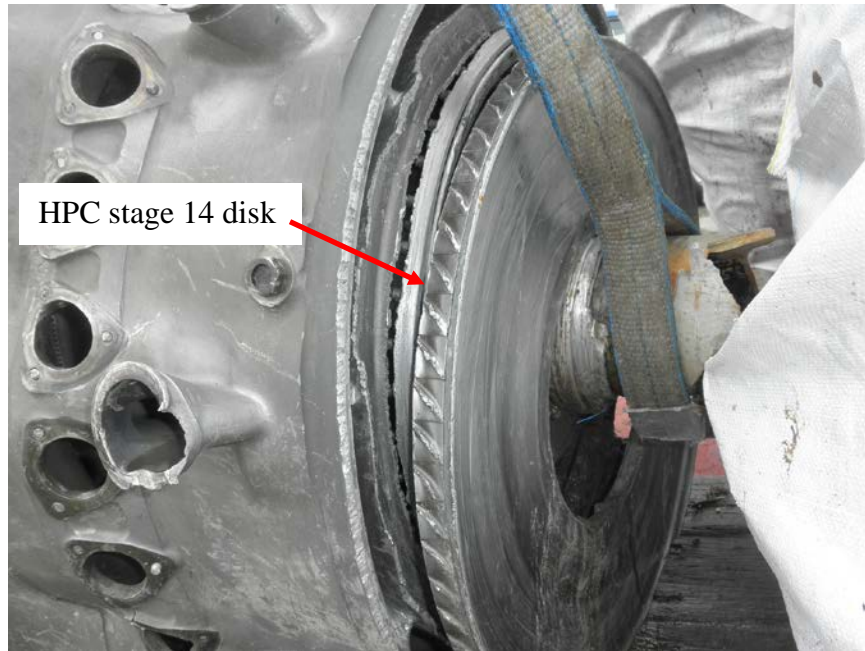
The HPC 14th stage disk, which is part of the stage 11-to-14 spool, was loose laying on the LPT shaft in front of the diffuser case. (Photo No. 12) The disk's web and bore were intact although there was circumferential scoring and scratches on the front and rear faces. The drive cone was broken away from the rear of the disk at the transition radius between the rear face of the disk and the drive cone. The aft inner end of the cone was visible in the bore of the diffuser case, but the cone portion was all broken up. There was about a 260° continuous sector of HPC 14th stage blades, 55 of 76 blade platforms, still in the disk. The rim of the disk was bent aft slightly. All of the blades' airfoils were fractured transversely across the airfoil directly adjacent to the platform. Within the approximately 90° arc of missing blades, there was an approximately 60° arc that was also missing the disk's rim section.

Photo No. 12: The No. 1 engine's HPC stage 14 disk laying on the LPT shaft.

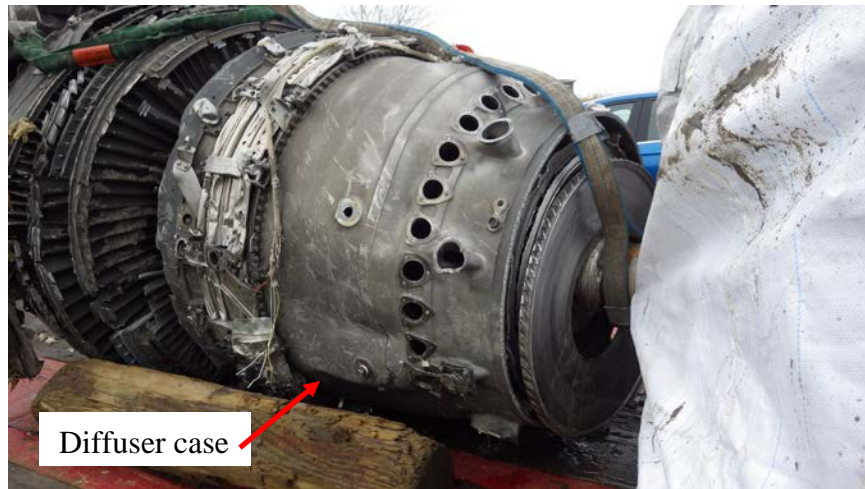
The diffuser case was in place on the front of the HPT case. The forward flange of the diffuser case was missing. (Photo No. 13) The diffuser case measured about 22 inches from the rear flange to the forward edge. The diffuser case did not have any indications of thermal distress. The diffuser case was buckled inward and had multiple dents between about 10 and 7 o'clock. There were seven fuel nozzles that were still in place in the diffuser case with five of the seven fuel nozzles partially out of the case and bent rearward. The diffuser case between about 5 and 7 o'clock had circumferential cracks between the fuel nozzle mount pads. The fuel manifolds attached to the fuel nozzles were bent rearward. The dome of the combustor liner was visible from the front of the diffuser. The combustor dome did not have any thermal distress or metal spray material. (Photo No. 14) The igniter plug at 3:30 o'clock was completely missing and the igniter plug at 5 o'clock was broken off flush with the exterior of the diffuser case.

Photo No. 13: The No. 1 engine's diffuser case. (GE)

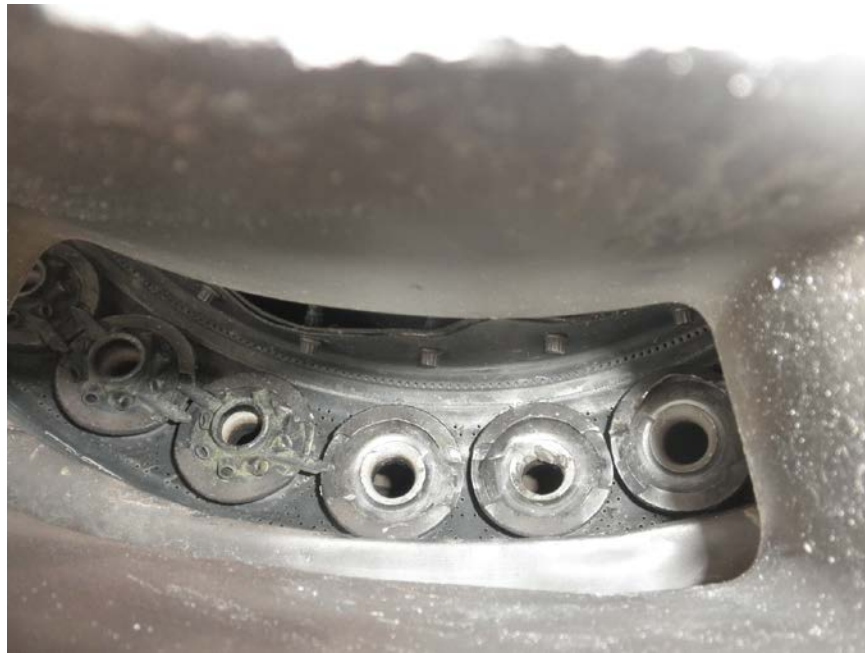
Photo No. 14: The No. 1 engine's combustor dome showing no metal spray.

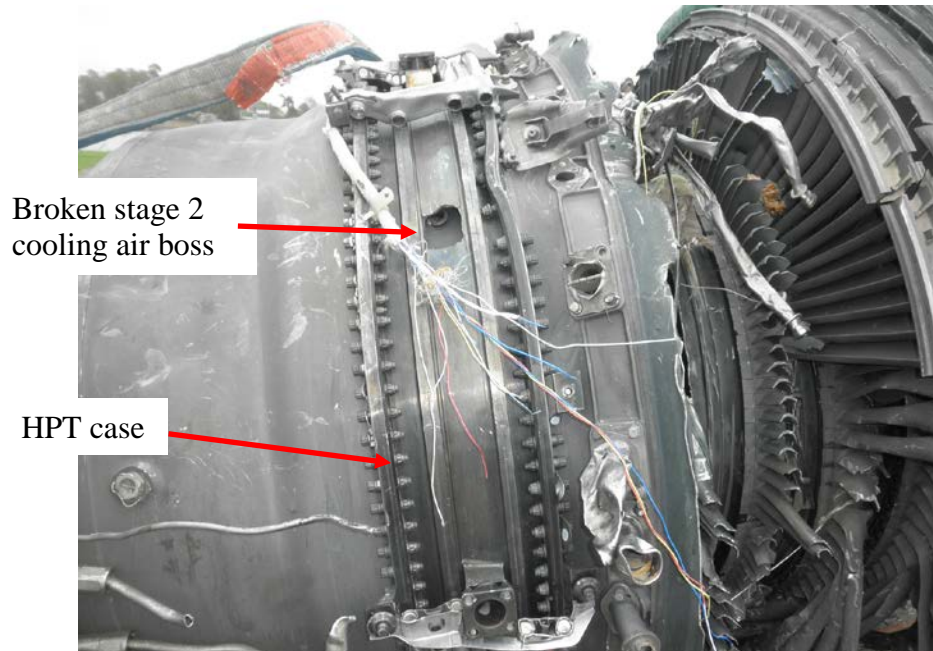
The HPT case was in place between the diffuser case and LPT case. The case appeared to be intact except for two HPT stage 2 nozzle cooling air bosses at about 8 and 11 o'clock that were broken away flush to the case. (Photo No. 15) The HPT case did not have any visible dents or holes. Only parts of the HPT active clearance control (ACC)<sup>4</sup> tubes and manifolds

Photo No. 15: The No. 1 engine's HPT case showing one of the stage 2 cooling air bosses broken away.

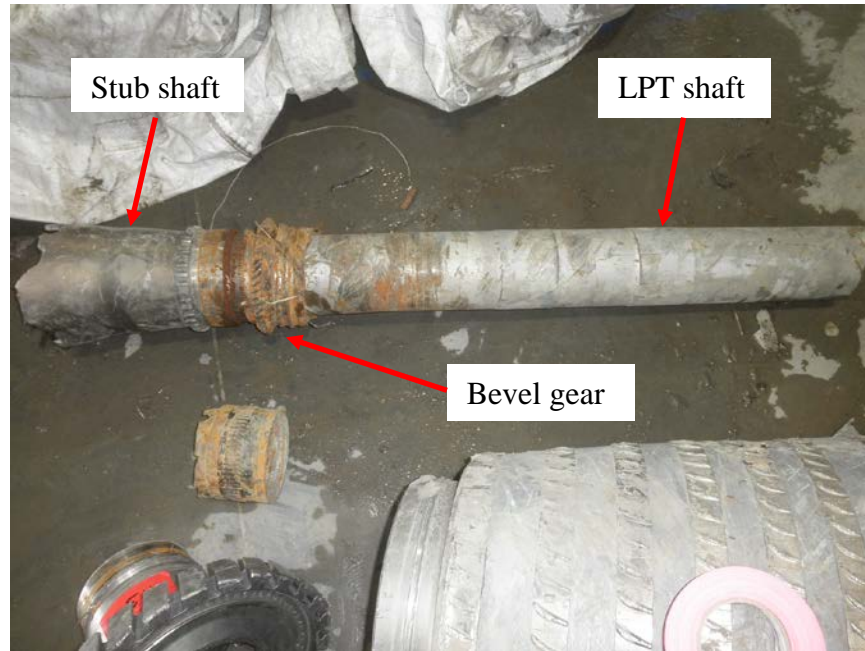
The aft end of the stub shaft was attached to the front of the LPT shaft, but was broken about 16.5-inches forward of the bevel drive gear. (Refer to Photo No. 16)

The LPT shaft was broken into several pieces not all of which were recovered. There was an approximately 61-inch long piece of the LPT and stub shaft. (Photo No. 16) The stub shaft and LPT shaft were still joined and the stub shaft extended about 16.5 inches forward of the bevel drive gear and the LPT shaft extended about 45 inches aft of the bevel drive gear. The outer diameter of the LPT shaft just aft of the bevel drive gear had circumferential rub marks. The bevel drive gear's teeth were intact. There was a piece of the LPT shaft that was in the piece of engine consisting of the diffuser to TRF that was sticking out in front of the diffuser case. There was a triangular-shaped notch on the fractured forward end of the LPT shaft sticking out the front of the diffuser. (Photo No. 17) The fractured ends of the 61-inch long piece and the piece in the diffuser case did not match.

Photo No. 16: The No. 1 engine's stub shaft and LPT shaft.

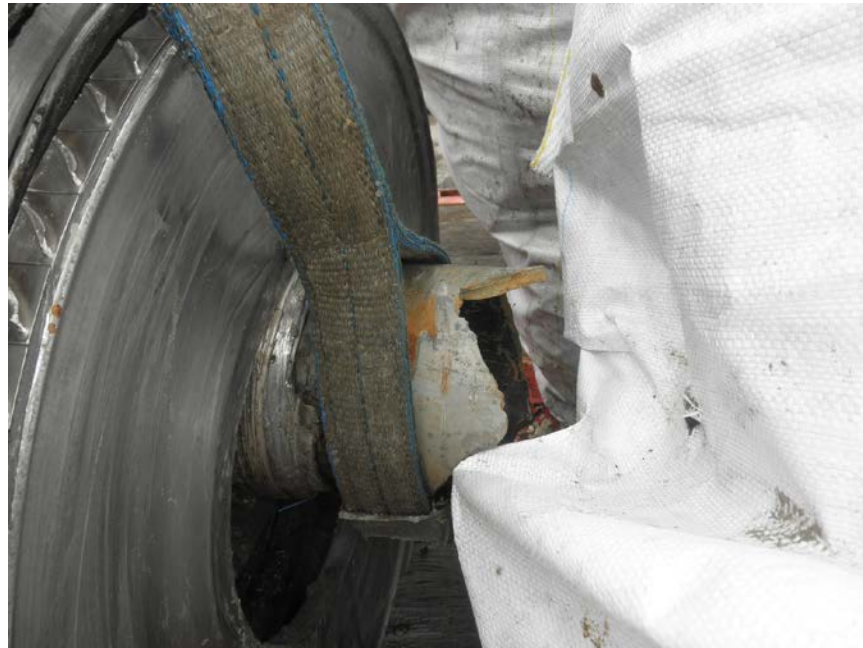
Photo No. 17: The broken aft end of the No. 1 engine's LPT shaft.

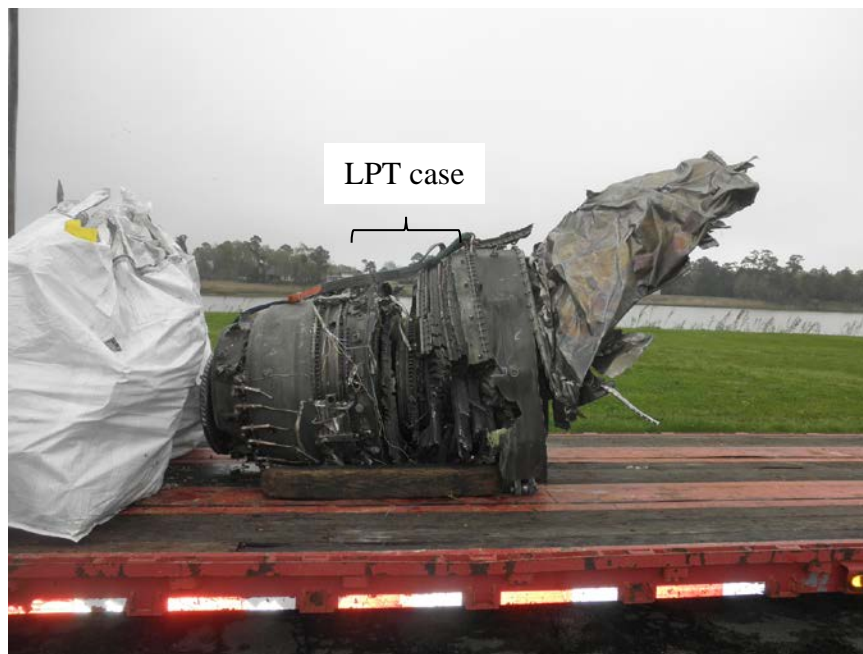
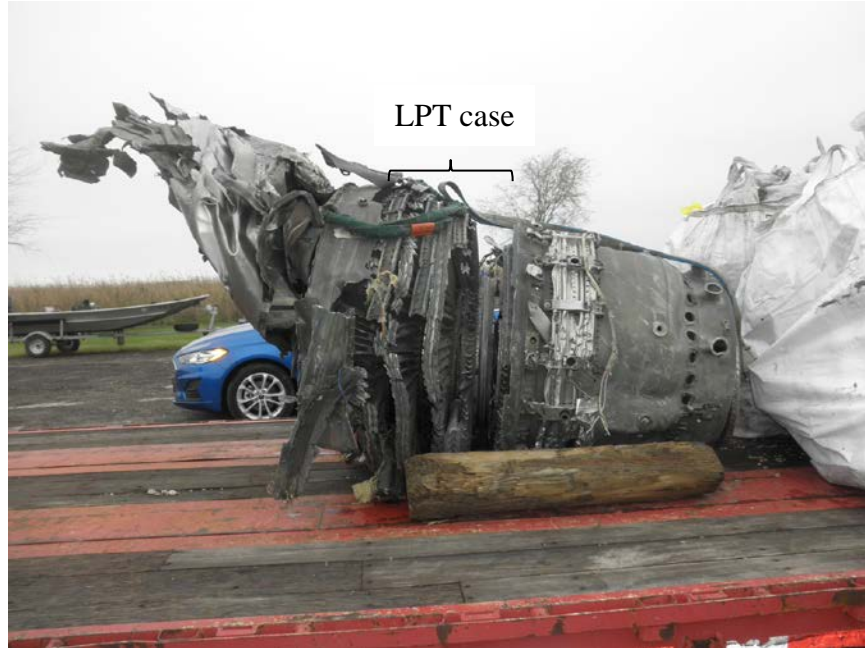
The LPT case and turbine rear frame were clocked about 180° from the diffuser case. The LPT case forward flange and about 5.5-inches of the forward part of the case and the LPT case rear flange and about 2.5-inches of the rear part of the case remained attached to the HPT case and TRF, respectively. The center portion of the LPT case was split open exposing the LPT

nozzles and blades. (Photos Nos. 18 and 19) The fractured ends of the LPT case did not match. There was one LPT stage 3 and two LPT stage 4 outer air seal segments that remained in the LPT case. The inside of the LPT case and the outer air seal honeycomb did not have any circumferential marks. The LPT stage 1 nozzles were in place, although most of the nozzles had damage to the trailing edges. All of the LPT stage 2 nozzles are missing. Most of the LPT stage 3, 4, and 5 nozzles were in place, although all had damage to the airfoils and many are bent rearward. All of the LPT rotor stage 1, 2, 3, 4, and 5 blades were present. All of the LPT blades had varying degrees of damage to the airfoils from being fractured transversely across the airfoil adjacent to the blade root platform to full length airfoils that were bent at the tips. There was an approximately 90° arc of the LPT stage 3, 4, and 5 blades that were bent opposite the direction of rotation. (Photo No. 20) There was an approximately 45° arc where the blades were bent and twisted rearward. The LPT nozzle and blade airfoils did not have any metal spray material or visual signs of thermal distress. The LPT ACC hardware was missing, although there was a circumferential pattern of small black marks on the LPT case consistent with the LPT ACC hardware having been in place.

Photo No. 18: The left side of No.1 engine showing the LPT case between the diffuser case and turbine rear frame on a truck bed.

Photo No. 19: The right side of No.1 engine showing the LPT case between the diffuser case and turbine rear frame on a truck bed.

The exhaust nozzle was in place on the rear of the TRF. The exhaust nozzle was crushed downward and forward against the back of the TRF. The exhaust center body remained attached to the TRF inner hub and was crushed with the exhaust nozzle. (Refer to Photo No. 18)

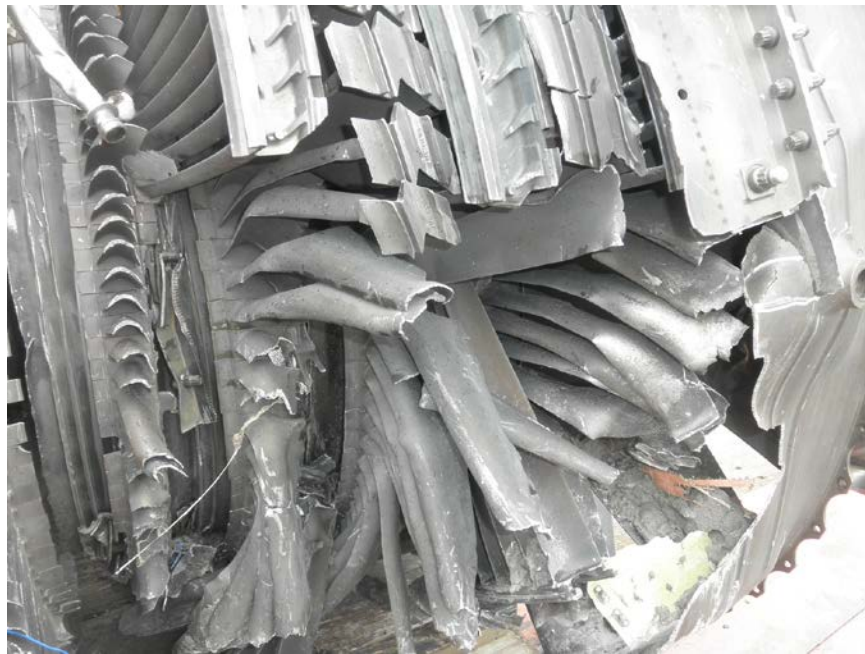
Photo No. 20: Close up view of the No. 1 engine's LPT blades that are bent and broken.

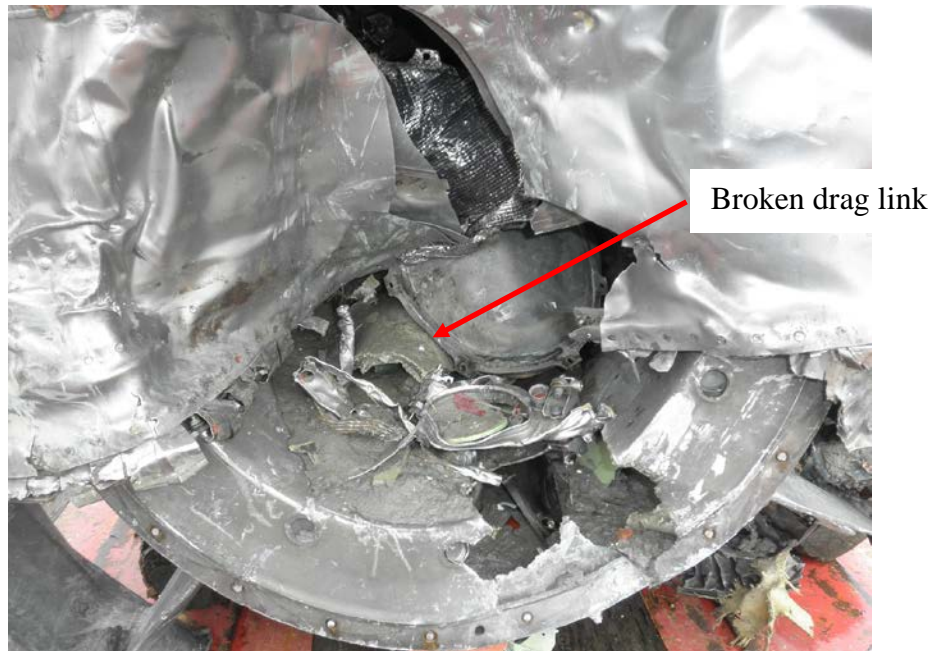
The TRF inner hub rear face had a part of the drag link embedded in it at about 12 o'clock. (Photo No. 21)

Photo No. 21: The rear of the No. 1 engine's TRF inner hub with embedded pieces of the broken drag link.

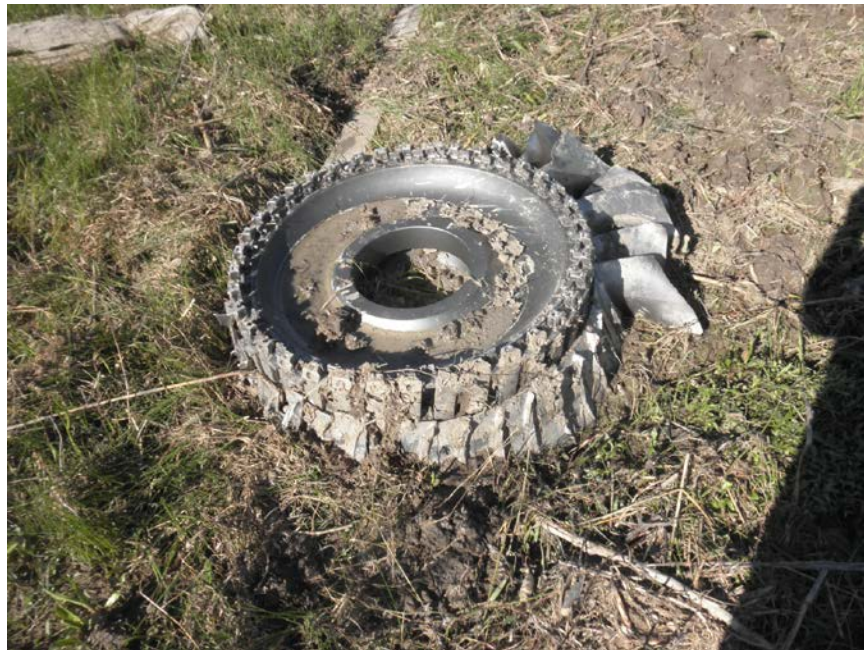
The fan disk was intact. (Photo No. 22) The fan disk was found on a marshy island with the front side facing up. The forward end of the stub shaft remained attached to the fan disk. The stub shaft was fractured at various lengths from the front flange that ranged from adjacent to the flange to about 3.5-inches aft of the flange.

Photo No. 22: The No. 2 engine's fan disk laying face up on marshy ground at the crash site.

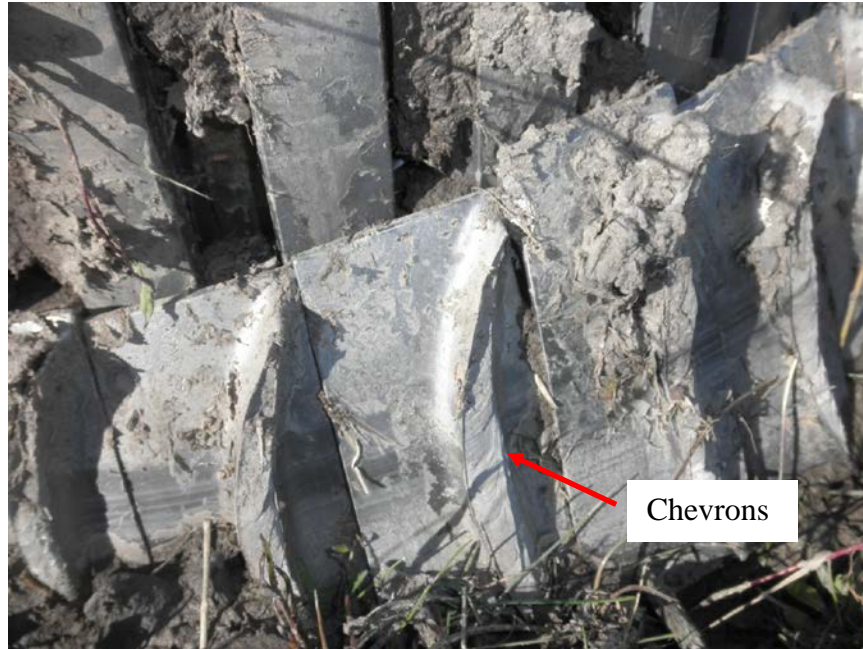
11-inches above the blade root platform. All of the other remaining fan blades were fractured transversely across the airfoil adjacent to the blade root platform. The fracture surfaces on all of the fan blades had chevrons that pointed towards the leading edge and shear lips. (Photo No. 23)

Photo No. 23: Close up of the No. 2 engine's fan blade fracture surfaces showing the chevrons pointing forward.

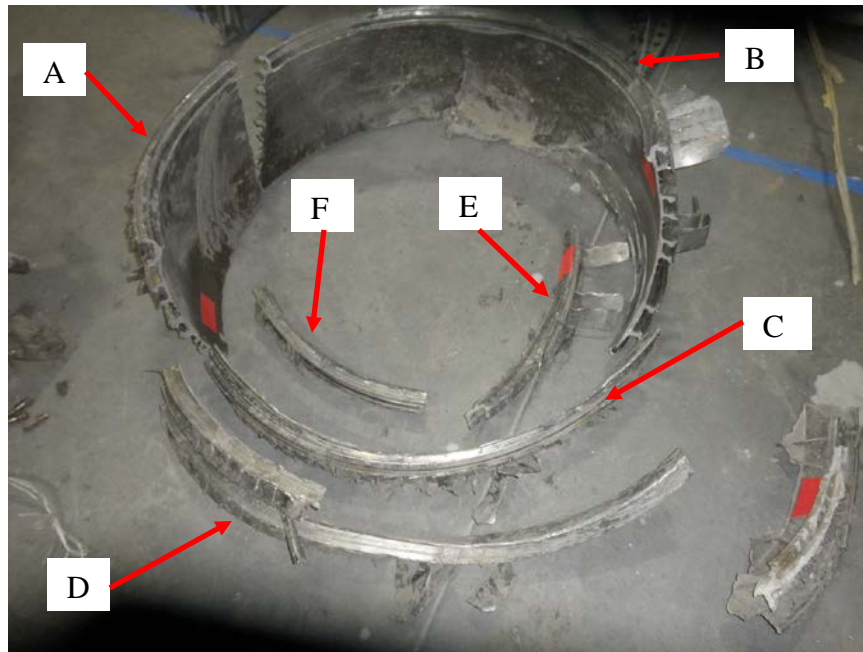
The booster spool, PN 1856M77P01 SN VOL86364, that corresponded to the No. 2 engine, was broken up with six identifiable pieces recovered. (Photo No. 24) The pieces were arbitrarily identified A through F and are listed in Table 2.

Photo No. 24: The pieces of the No. 2 engine's booster spool.

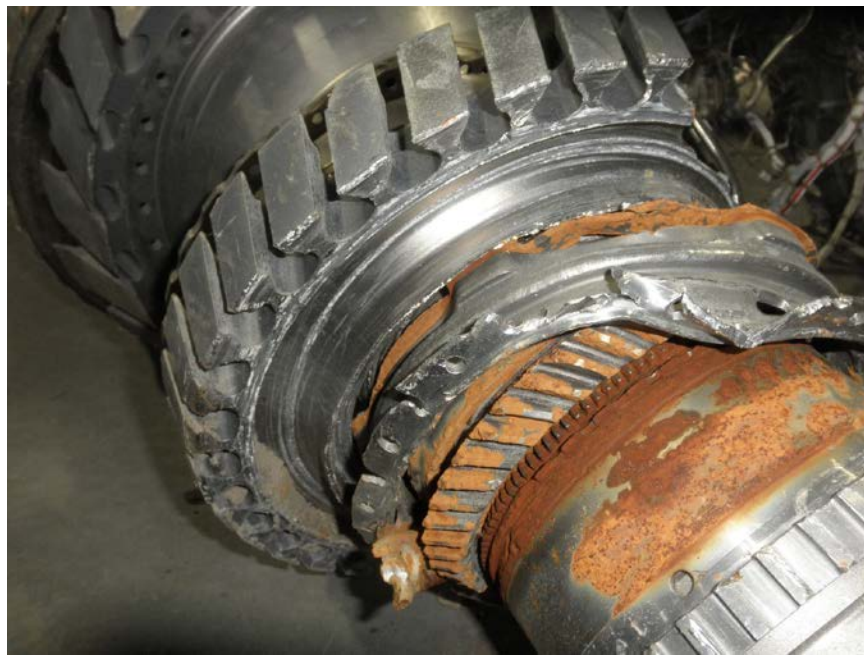
The HPC stage 1 disk was PN 1644M21P04 SN DC338937-F that corresponded to the No. 2 engine. The HPC stage 1 disk was in place around the LPT shaft, but was separated from the HPC stage 2 disk. The HPC stage 1 disk bore was intact, but the disk was missing an approximately 170° arc of blade posts and the adjacent web. (Photo No. 25) The disk was separated from the integral spacer arm adjacent to the rear face of the disk. The integral spacer arm remained intact and was in place between the HPC stage 2 disk and the bearing journal. The integral spacer arm was separated from the HPC stage 2 disk. All of the bolt holes in the integral spacer arm were intact and did not appear to be elongated. There were no HPC stage 1 blades in the disk's blade slots.

Photo No. 25: Close up of the No. 2 engine's HPC stage 1 disk.

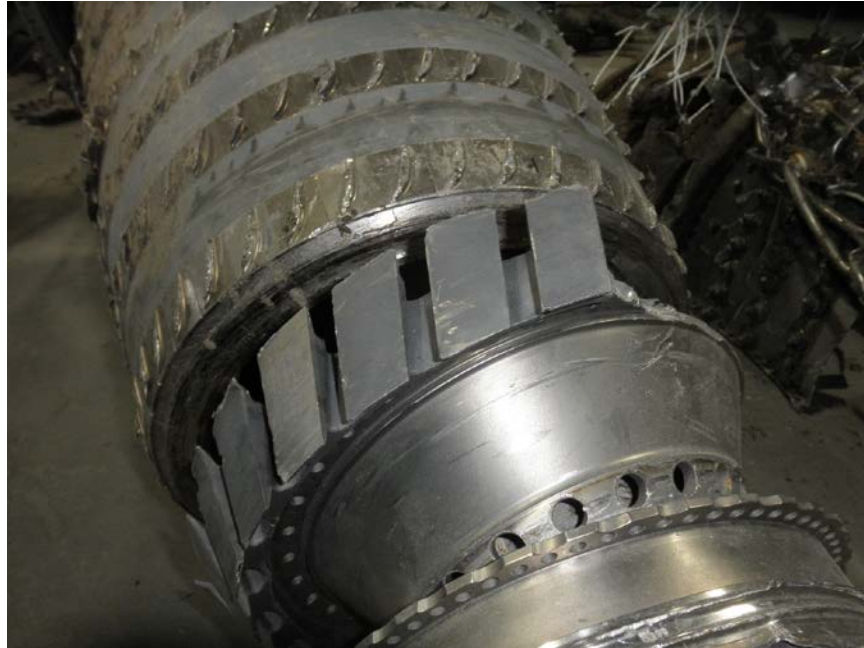
The HPC stage 2 disk's hub and bore were intact, but the disk was missing an approximately 180° arc of blade posts. The HPC stage 2 disk was in place around the LPT shaft, but was separated from the HPC stage 1 disk and HPC stage 3 to 9 spool. (Photo No. 26) There were no blades in the blade slots. There was about a 60° arc of the HPC stage 2 disk rim that was bent forward.

Photo No. 26: Close up of the No. 2 engine's HPC stage 2 disk.

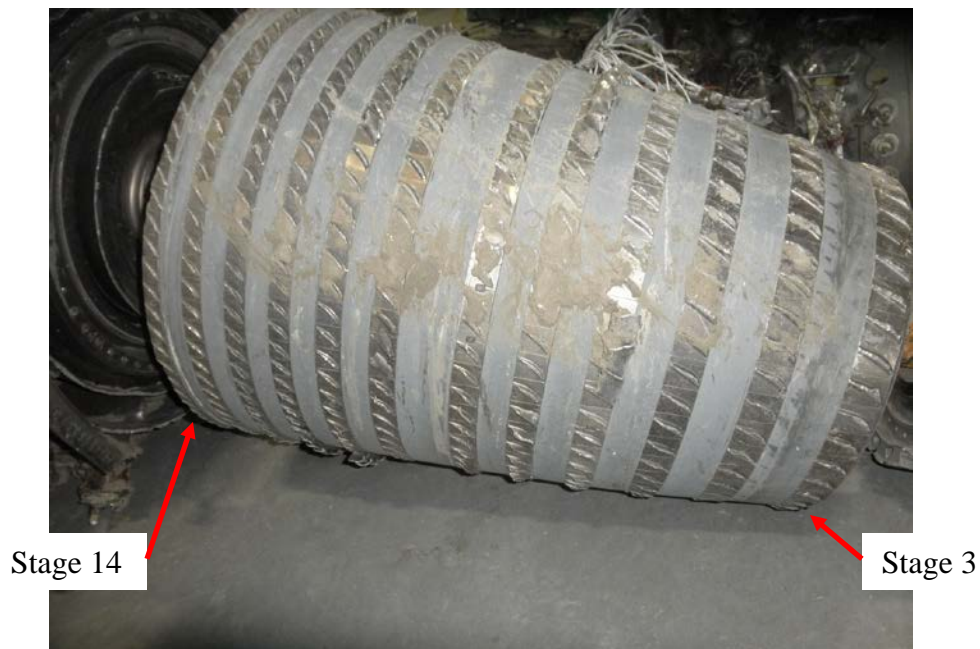
The remainder of the HPC from the from the stage 3 to 9 spool to the stage 14 disk was intact although the drive cone on the stage 14 disk was broken away directly aft of the disk. (Photo No. 27) All of the HPC blades between stage 3 and 14 were in place in their respective slots. There were random blades in stages 6, 7, 9, 10, and 11 that still had part of the airfoil all of which were bent over opposite the direction of rotation. All of the other HPC stage 3 to 14 blades were fractured transversely across the airfoil directly adjacent to the blade platforms.

Photo No. 27: The No. 2 engine's HPC between stages 3 and 14.

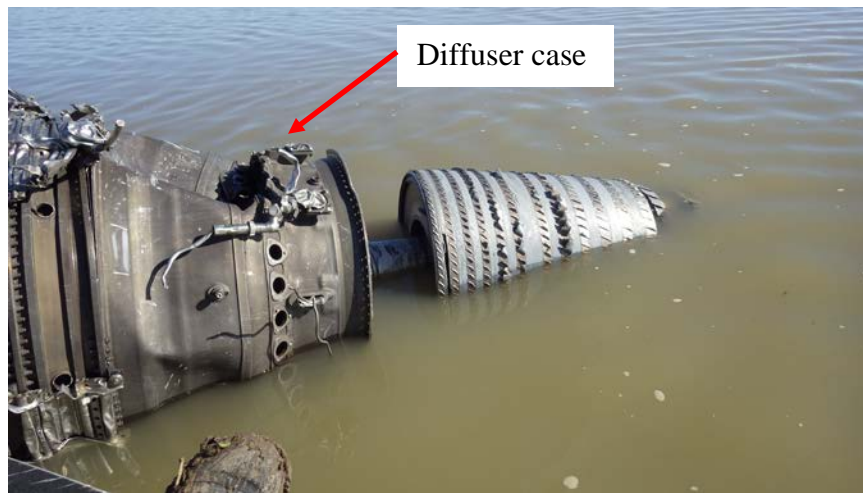
The diffuser case was in place on the front of the HPT case. (Photo No. 28) The diffuser case's forward flange from about 12 to 6 o'clock was missing. The remainder of the flange was in place and all of the bolt holes were in place, but the flange was bent rearward in several locations. The diffuser case was crushed inward between 6 and 8 o'clock and cracked circumferentially along the fuel nozzle bosses. The diffuser case was buckled in several places around the center of the case just aft of the pressure bosses and igniter plug bosses. The diffuser case did not have any indications of thermal distress. Both of the igniter plugs were missing. All of the fuel nozzles were missing except for seven between about 12 and 2 o'clock and one each at about 5 and 9 o'clock. All nine fuel nozzles that remained in the diffuser case were fully in the diffuser case. The dome of the combustor did not have any metal spray material.

Photo No. 28: The No. 2 engine's diffuser case when it was still in the water at the crash site.  
(GE)

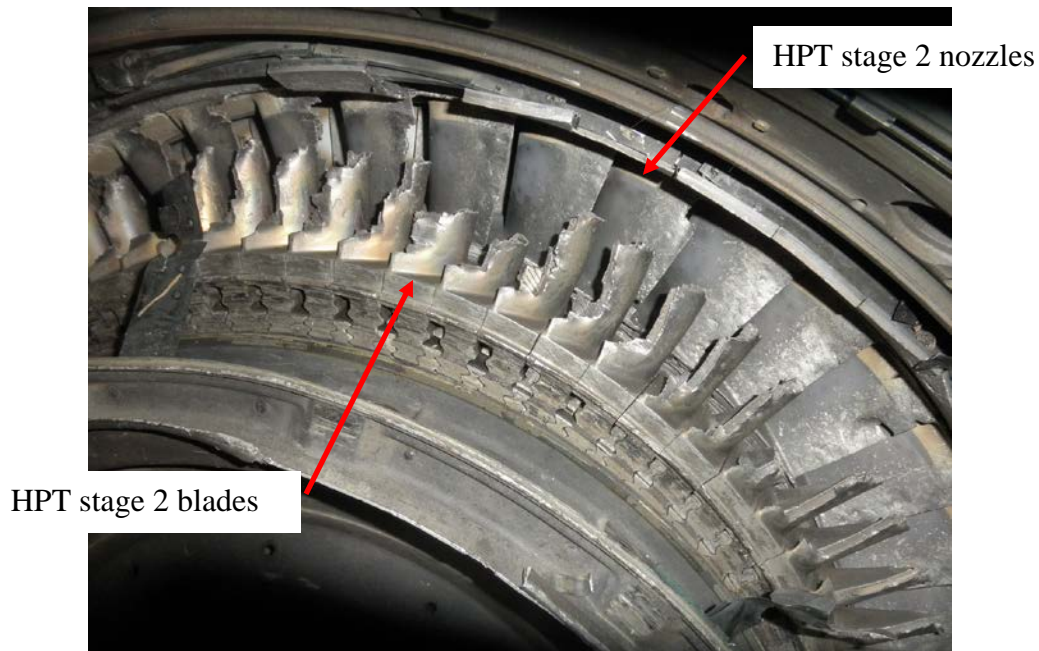
The HPT stage 2 disk was intact and all of the HPT stage 2 blades were in place in the disk. The HPT stage 2 blades varied in length from about 0.75-inches to about 2.5-inches above the blade root platform. The HPT stage 2 blades were rubbed on the trailing edge about an inch into the airfoil and the rubbed edges were bent forward. (Photo No. 29)

Photo No. 29: Close up of No. 2 engine's HPT stage 2 blades and nozzles.

The HPT stage 2 nozzles were all in place. The HPT stage 2 nozzles had impact damage with nicks, dents, and pieces missing from the trailing edges. (Refer to Photo No. 29)

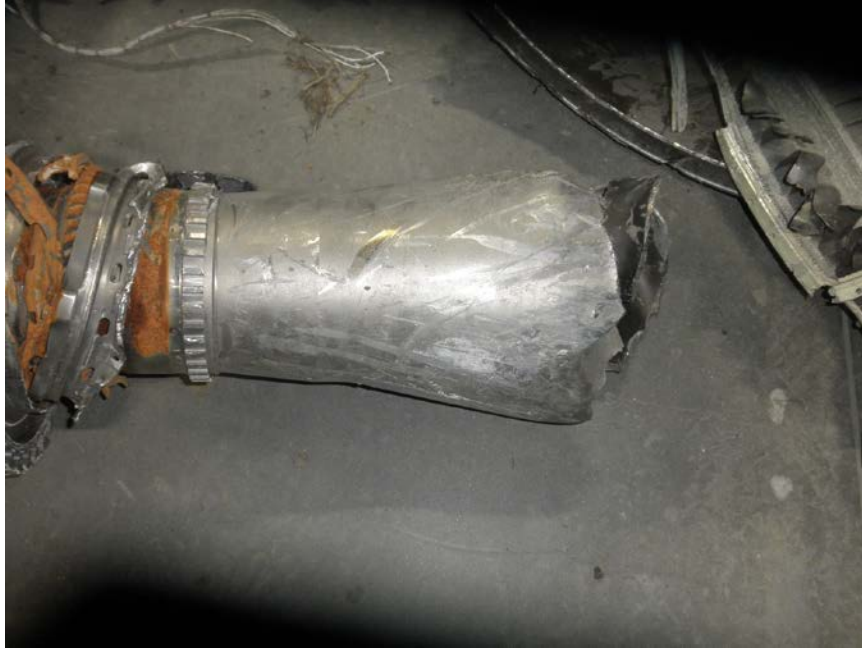
The forward end of the LPT shaft was visible between the HPC stage 2 disk and the front of the HPC stage 3 to 9 spool. (Photo No. 30) The aft end of the LPT shaft was visible between the rear of the HPT rotor and front of the LPT rotor. When the LPT rotor was turned, the stub shaft would turn concurrently and independently of the HPC and HPT.

Photo No. 30: The No. 2 engine's stub shaft.

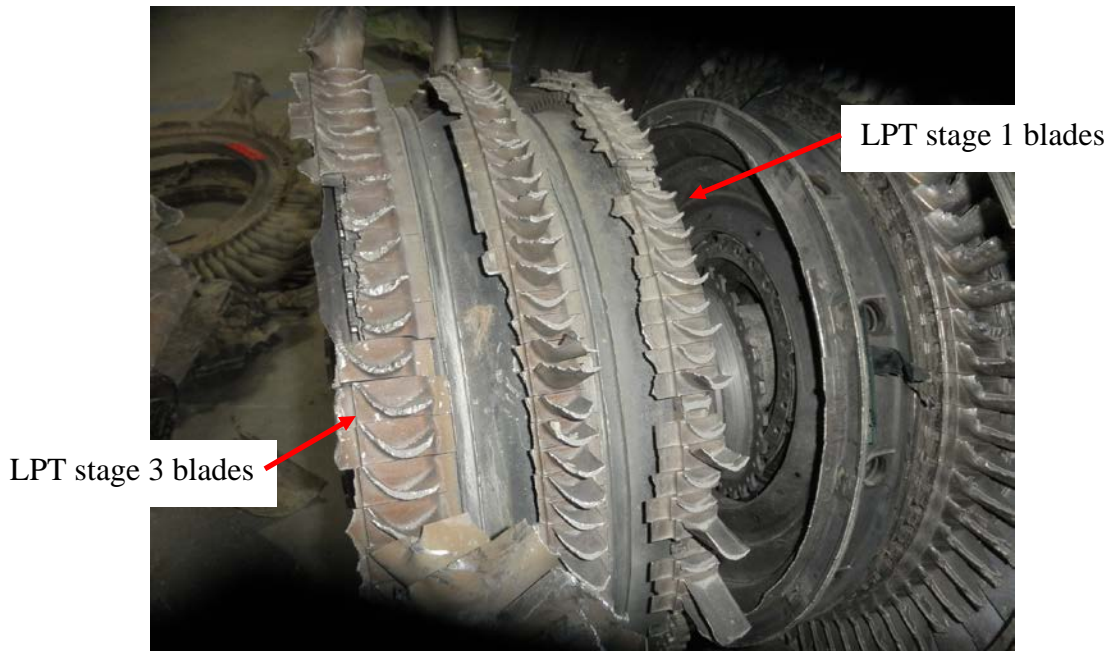
The LPT stage 1, 2, and 3 disks were in place, intact, and attached to each other as well as to the LPT shaft. (Photo No. 31) There were 42 of 118 LPT stage 1 blades that were missing from the blade slots. Of the remaining 76 blades, a few were broken below the platform and the others were fractured across the airfoil up to about 2-inches above the blade root platform. Of the 124 LPT stage 2 blades, there was sector of 14 blades that were fractured transversely across the airfoil adjacent to the blade root platform and the remaining 110 blades varied in length from about 0.5-inches to about 3.5-inches above the blade root platform. Of the 88 LPT stage 3 blades, there were 55 that were fractured transversely across the airfoil adjacent to the platform. There was one LPT stage 3 blade that was completely missing. And the remaining 32 blades varied in length from about 1- to 9-inches above the blade root platform and there was only 1 blade that still had the tip shroud.

Photo No. 31: Close up of No.2 engine's LPT stage 1 through 3 broken blades.
