NATIONAL TRANSPORTATION SAFETY BOARD  
OFFICE OF AVIATION SAFETY  
WASHINGTON, D.C. 20594

## **POWERPLANTS GROUP CHAIRMAN'S FACTUAL REPORT**

NTSB ID No.: DCA19MA086

Location: Anahuac, Texas  
Date: February 23, 2019  
Time: 1239 central standard time  
Aircraft: Boeing 767-375BCF, N1271A, Atlas Air flight 3591

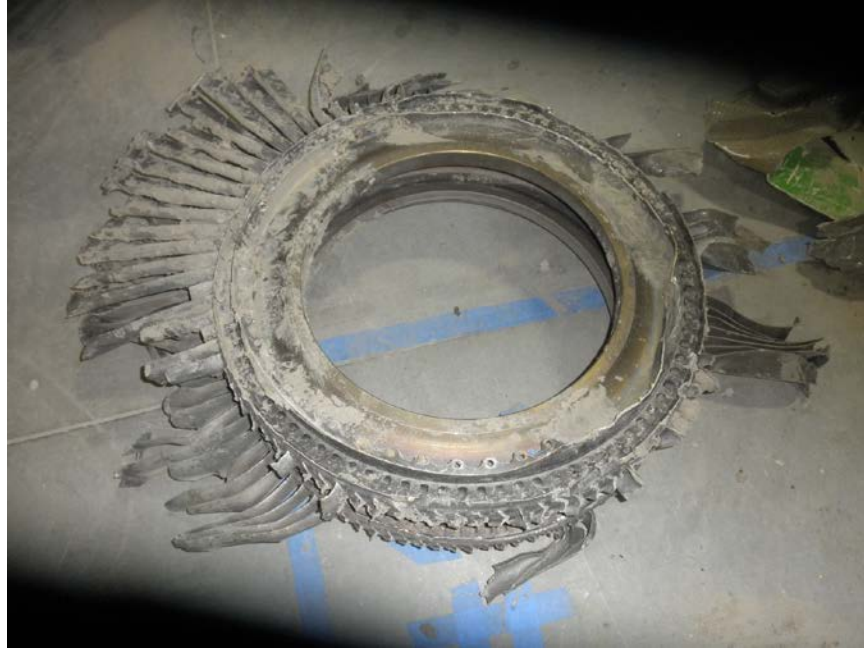
The LPT stage 4 and 5 disks were attached to each other, but the two disks were separated from the remainder of the LPT rotor. The LPT stage 4 and 5 disks are intact. (Photo No. 32) The stage 4 disk forward flange had about 140° of the bolt circle remaining. The bolt holes were intact and did not appear to be elongated. The remainder of the flange was missing along the middle of the forward spacer arm. All of the LPT stage 4 blades were in the blade slots in the disk. There was a continuous sector of 25 LPT stage 4 blades that had at least part of an airfoil from about 0.75-inches above the blade root platform to full length. Most of the airfoils were bent opposite the direction of rotation although the longer full length airfoils were bent and twisted randomly at the tip. There were five LPT stage 4 blades that had the tip shrouds still in place. The remaining LPT stage 4 blades were fractured transversely across the airfoil adjacent to the blade root platform. All 98 of the LPT stage 5 blades were in the slots. There were 67 LPT stage 5 blades that still had a portion of the airfoil ranging in length from about 0.75-inches above the blade root platform to full length. There were 16 blades that still had the tip shroud in place. The blades that had parts of the airfoils remaining were clustered in an arc of 7 blades, then 5 blades with no airfoil, then an arc of 57 blades, then 14 blades with no airfoil, and then a cluster of 3 blades with airfoils. Almost all of the blades were bent opposite the direction of rotation. The tips on the longer blades were bent and twisted in random directions. The LPT stage 4 and 5 blade airfoils did not have any metal spray material on the airfoils or visual signs of thermal distress.

Photo No. 32: The No. 2 engine's LPT stage 4 and 5.

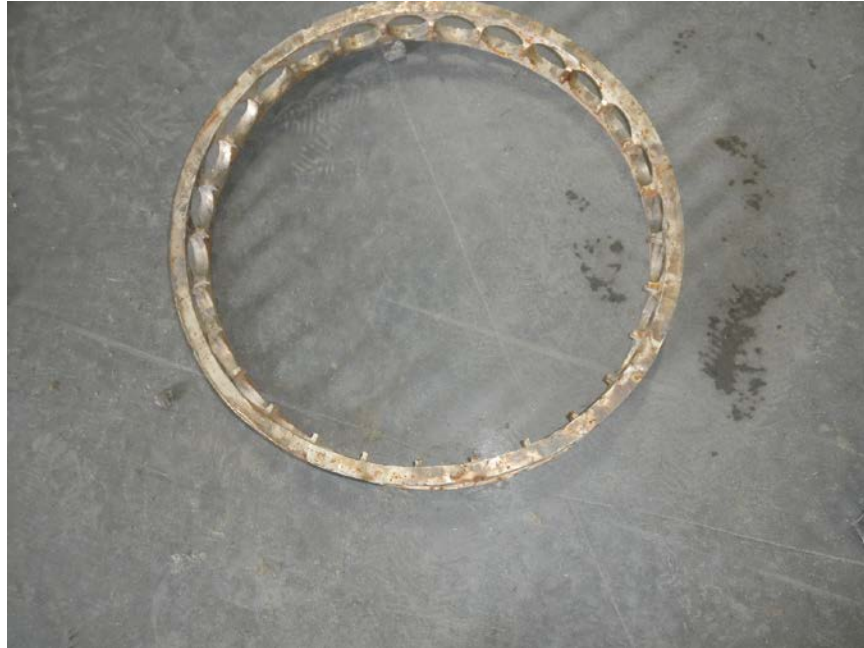
The No. 1B bearing cage, SN MDA231DU, that corresponded to the No. 2 engine, was intact, but was bent slightly. The cage pockets did not have any rotational distress. The silver plate was still in place on the cage. All of the bearing balls were missing. (Photo No. 33)

Photo No. 33: Close of the No. 2 engine's No. 1 bearing cage.

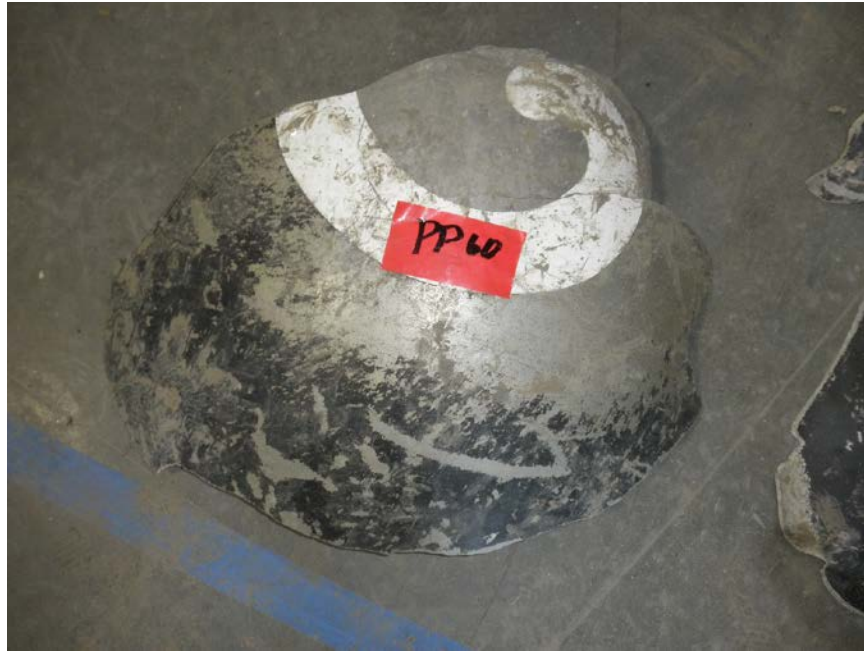
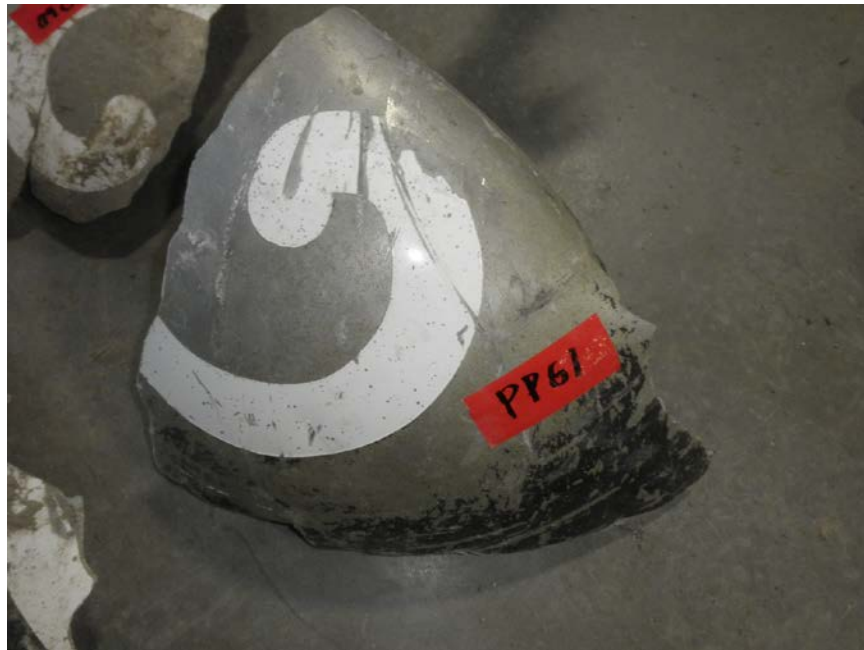
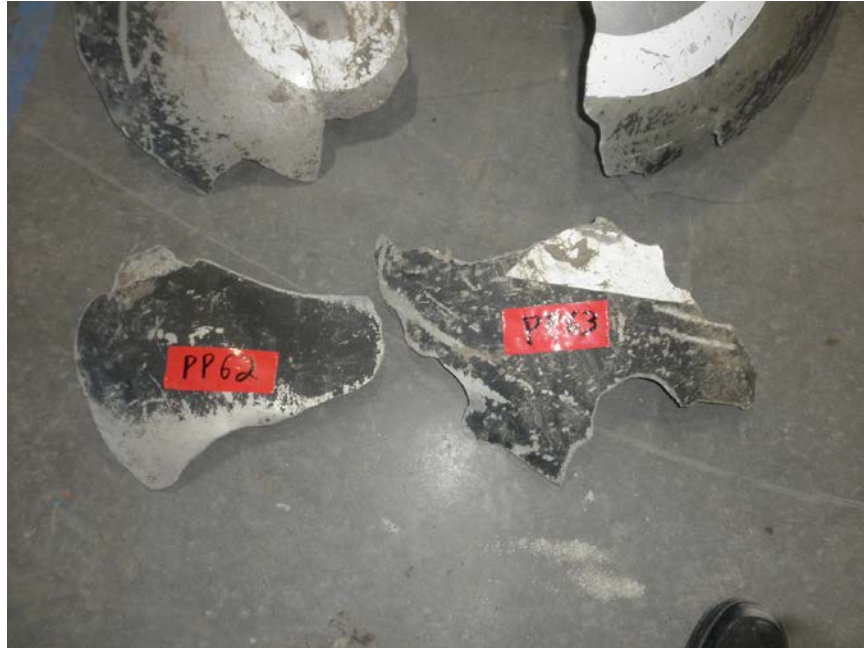
There were four broken pieces of spinner recovered including two domes. (Photos Nos 34, 35, and 36)

Photo No. 34: Broken piece of spinner cap.

Photo No. 35: Broken piece of spinner cap.

Photo No. 36: Two broken pieces of spinner cap.

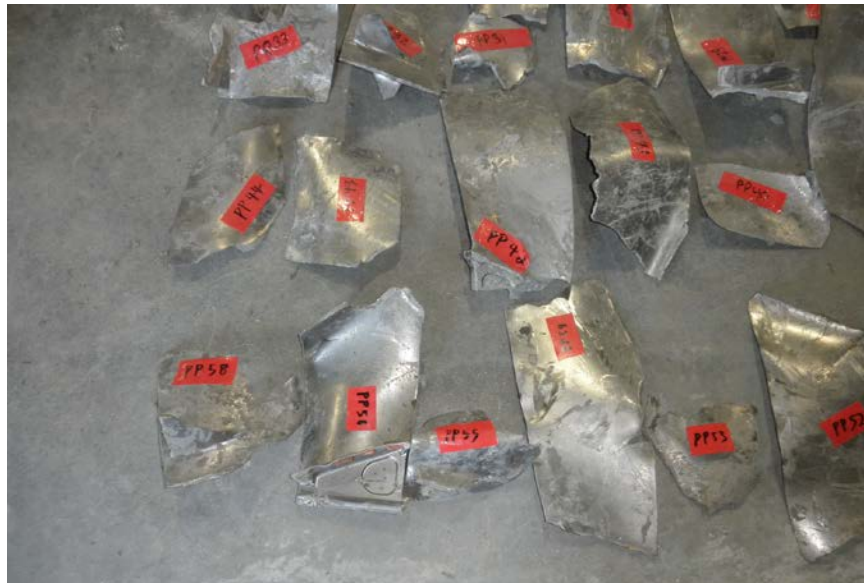
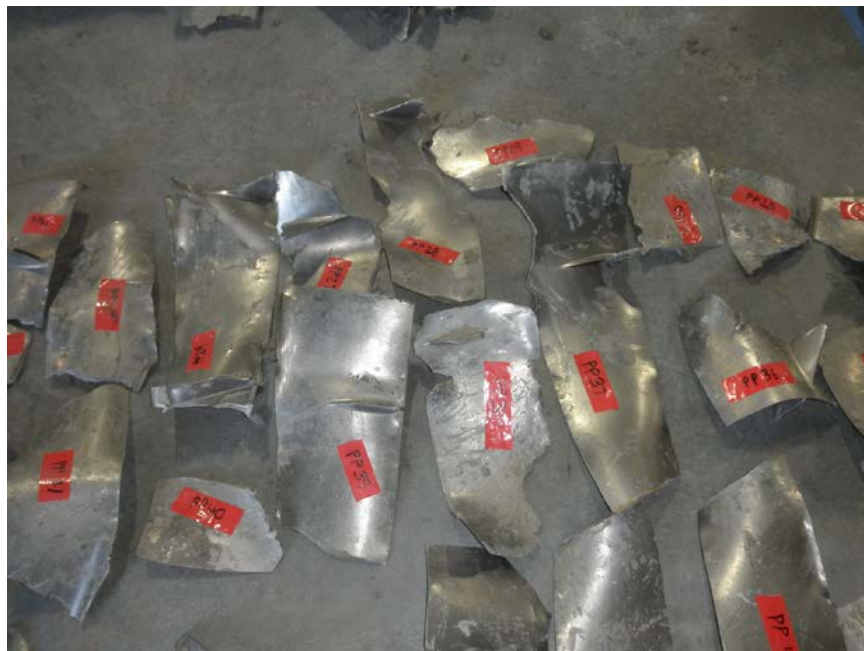
There were 35 pieces of fan blades ranging in size from about 7-inches long to about 28-inches long that were fractured at various locations from in the shank just under the root platform to outboard of the midspan shrouds. There was one fan blade that still had the dove tail root attached. Most of the airfoils were bent opposite the direction of rotation. Many of the airfoils had pieces of the leading and trailing edges missing. (Photos Nos. 37 and 38) The pieces of fan blade that had the mid span shrouds did not have any indications of shingling.<sup>5</sup>

Photo No. 37: Broken pieces of fan blade.

Photo No. 38: Broken pieces of fan blade.

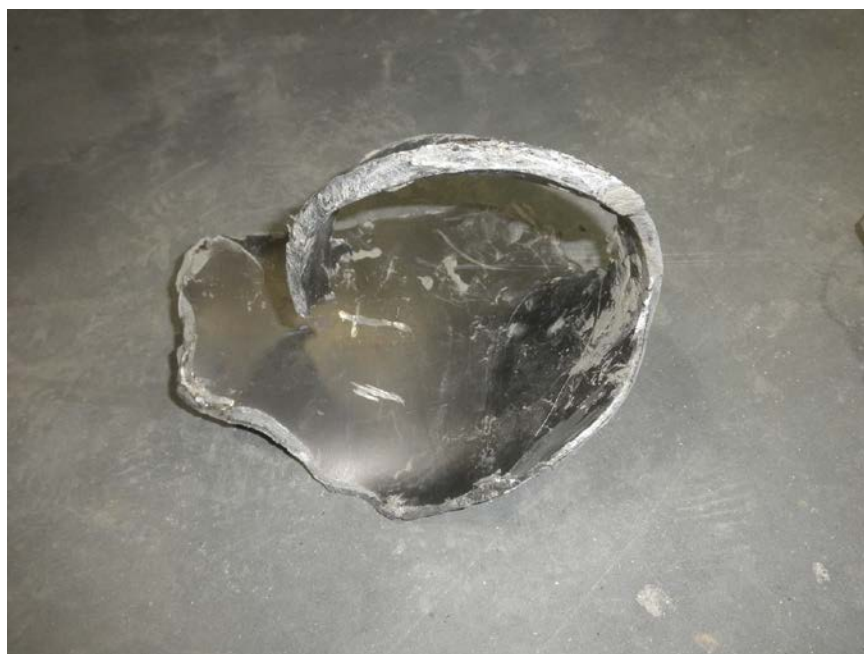
There was an approximately 21-inch by 7.5-inch piece of stub shaft that was twisted back onto itself. (Photo No. 39)

Photo No. 39: Close up view of a piece of stub shaft that is twisted back onto itself.

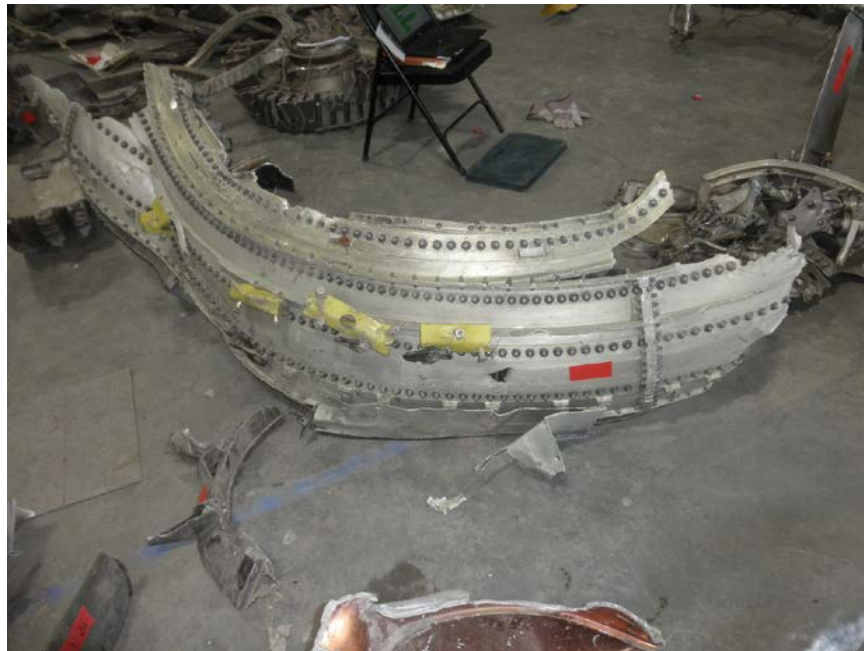
There were several pieces of spool case recovered. Some of the booster case pieces still had the splitter attached. There was a piece of booster case that was about 108-inches long circumferential and included all four stages of booster from the splitter to the rear flange as well as the left and right side horizontal split lines. (Photo No. 40) The airfoils that remained in place were mostly full length, but some were bent in the direction of rotation, some were bent in the direction opposition of rotation and some were straight. There was an approximately 15-inch long circumferential by 8-inch wide axial piece of booster case that included a left side horizontal split line and six booster inlet guide vanes and four partial stage 1 booster vanes. There was an approximately 17-inch long circumferential by 10-inch wide axial piece of booster case that included two stages of booster. The forward row of booster vanes consisted of 8 vanes that were all broken across the airfoil adjacent to the outer foot and the aft row consisted of 11 vanes that were full length, but were bent in various directions.

Photo No. 40: Large piece of spool case.

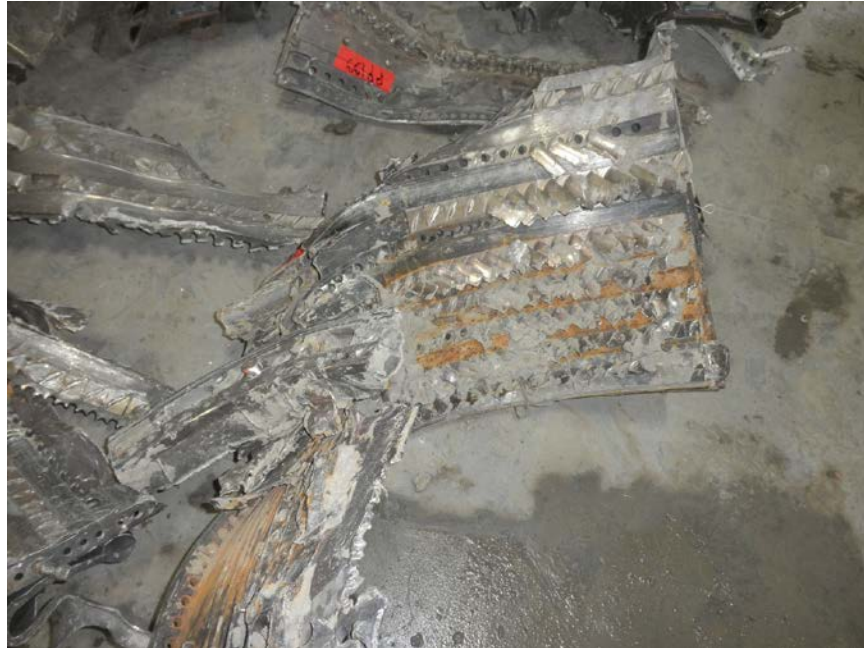
There were many pieces of the HPC case recovered that could not be attributed to a particular engine. The pieces were all broken up and twisted. Some of the pieces were twisted almost to the point of being inside out. The forward parts of the compressor case still had some VSVs in place, although they were bent and twisted in various directions as well as having nicks and dents on the leading and trailing edges. In the rear portion of the compressor cases, the fixed vanes were either broken adjacent to the case wall or the airfoils were bent in the direction of rotation. (Photo No. 41)

Photo No. 41: View of several broken pieces of HPC case.

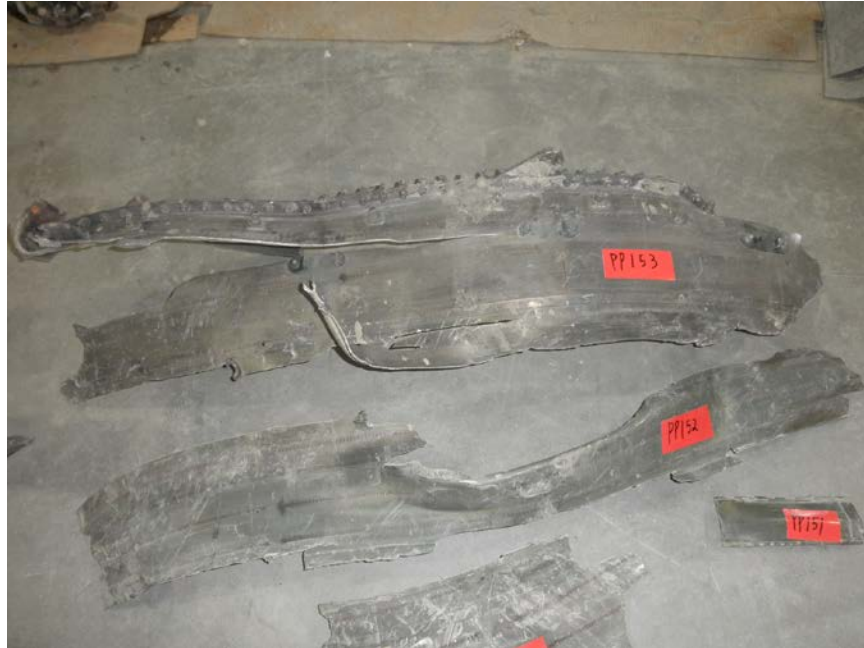
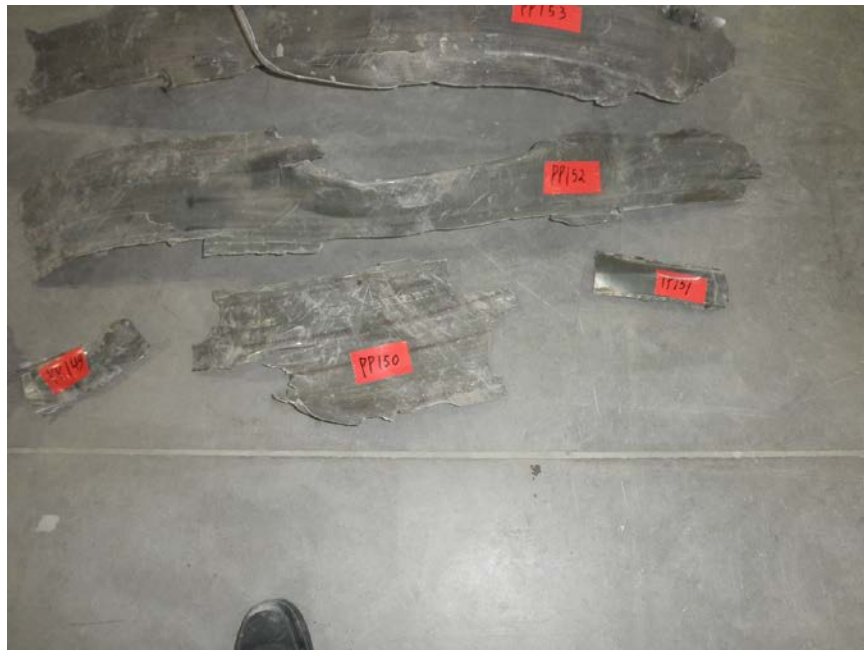
There were eight pieces of LPT case recovered that could not be attributed to a particular engine. (Photos Nos. 42 and 43) Of the eight pieces, five were essentially one or two stages wide and varied in length from about 8- to 51-inches long. There was a piece of LPT case that was approximately 21-inches long circumferential by 9-inches wide axial and spanned about three stages of LPT. There was a piece that was about 32-inches long circumferential by 21-inches long axial and spanned about four stages of LPT between about the stage 2 to stage 5. This piece included the rear flange of the LPT case. This piece was split circumferentially in the middle from the counterclockwise side. There was a piece that was about 52-inches long circumferential by 11-inches wide axial and spanned about two stages of LPT. This piece also included the rear flange and was split circumferentially in the middle from the counterclockwise side.

Photo No. 42: Broken pieces of LPT case.

Photo No. 43: Broken pieces of LPT case.

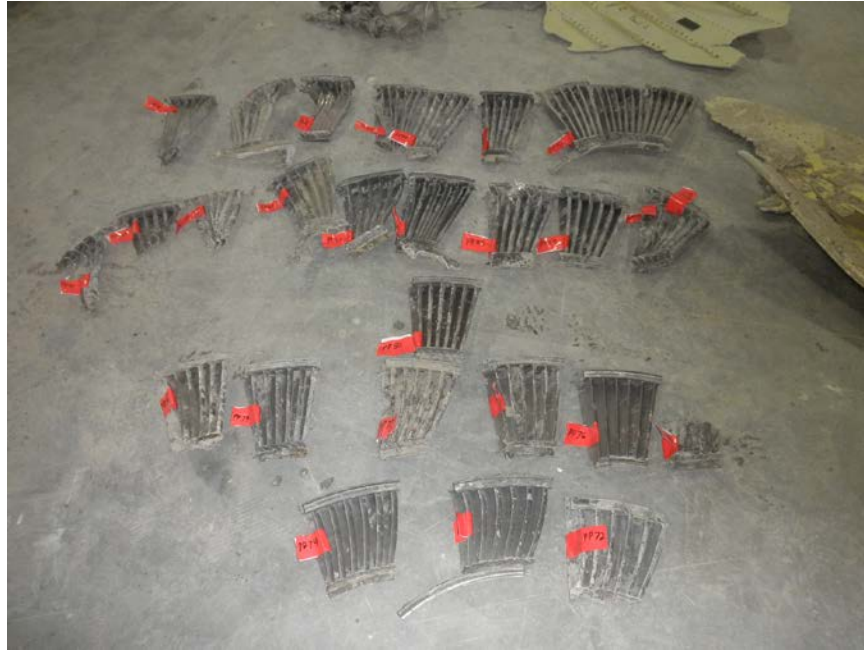
edge and/or were bent up. None of the LPT stator vane airfoils had any metal spray material on the leading edges or the convex surfaces or visual signs of thermal distress.

Photo No. 44: LPT vane segments.
