National Transportation Safety Board

Investigator-in-Charge's Accident Summary

NTSB Accident #PLD18FR002
Natural Gas-Fueled Explosion of Residence
February 23, 2018, Dallas, Texas

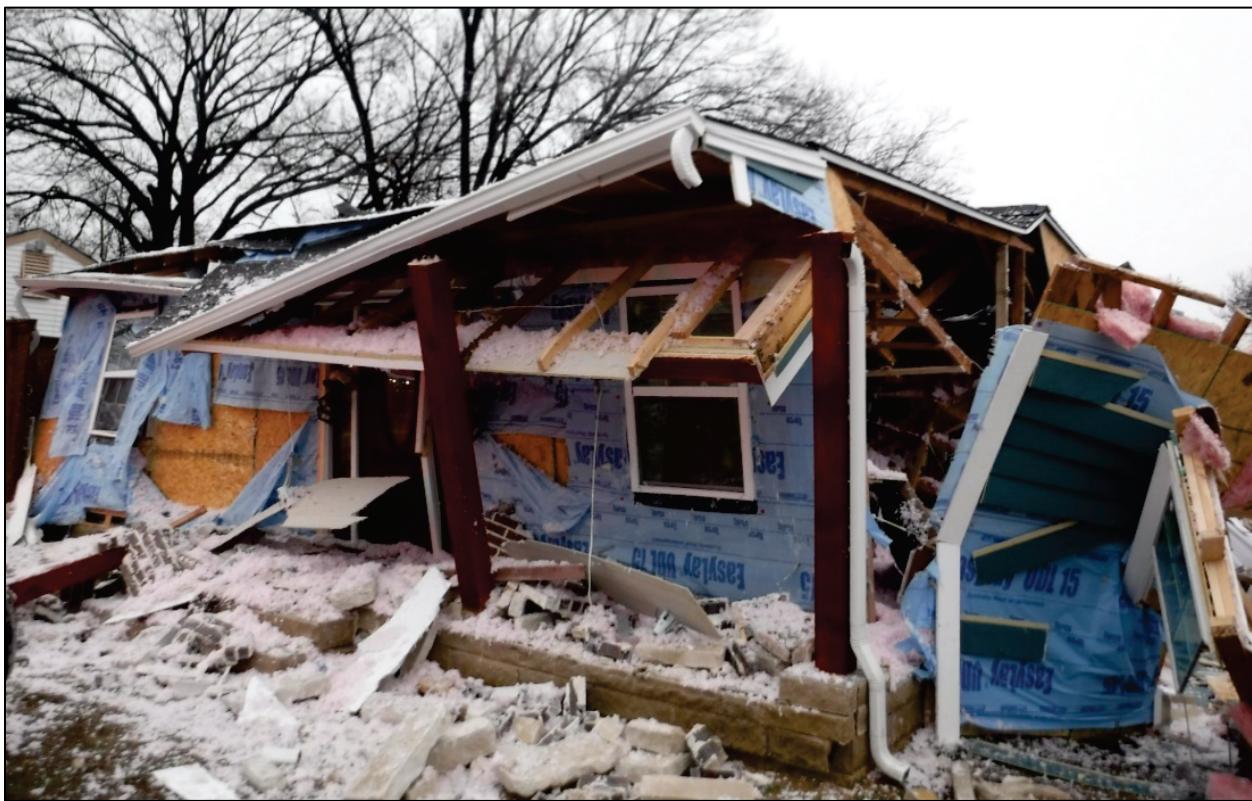
Figure 1. Front of 3534 Espanola Drive after the Explosion. Photo by DFR on February 23, 2018.
