National Transportation Safety Board
Washington, D.C. 20594

Group Chairman's Factual Report of the Investigation

Operations and Integrity Management Report

Natural Gas Pipeline Release

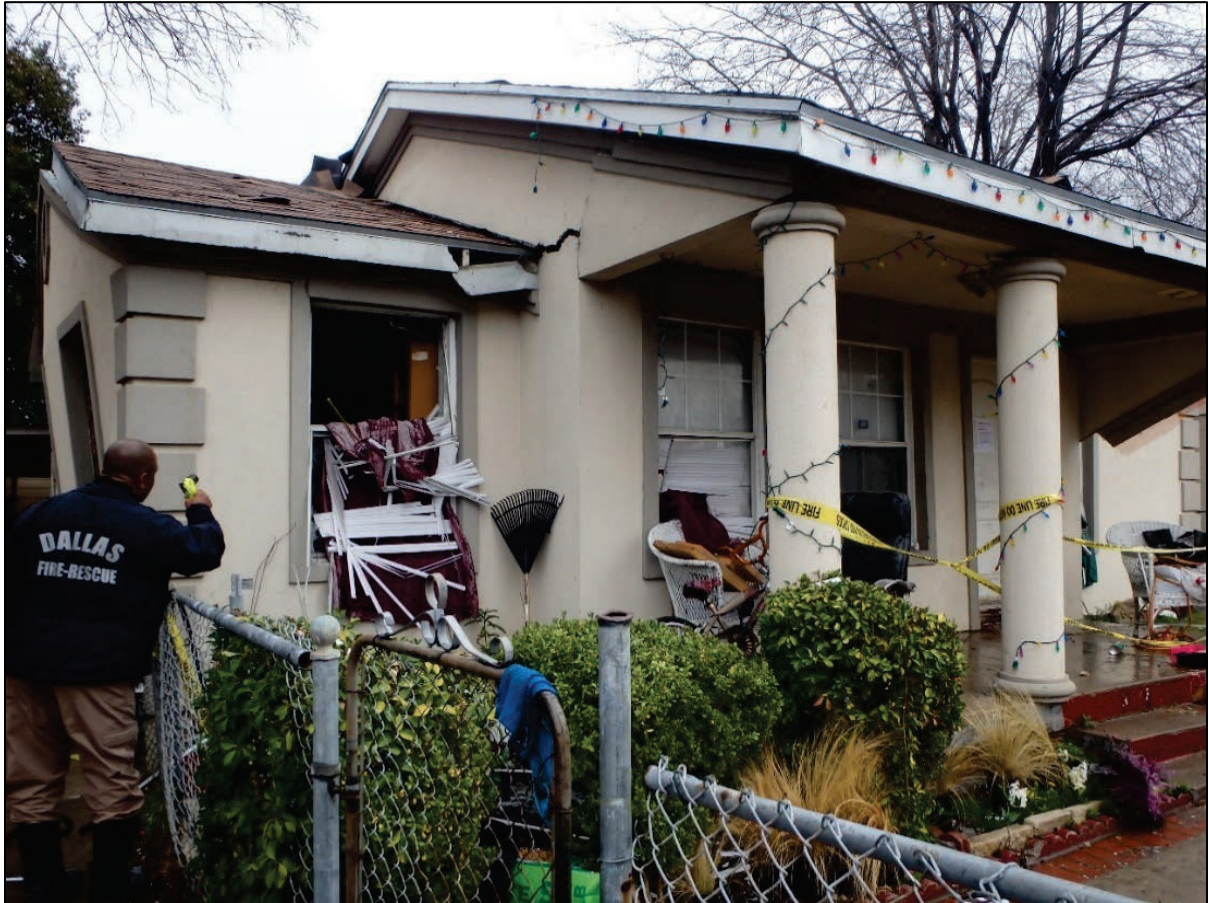
Figure 13. Photo of 3527 Durango Drive Post-Incident by DFR.

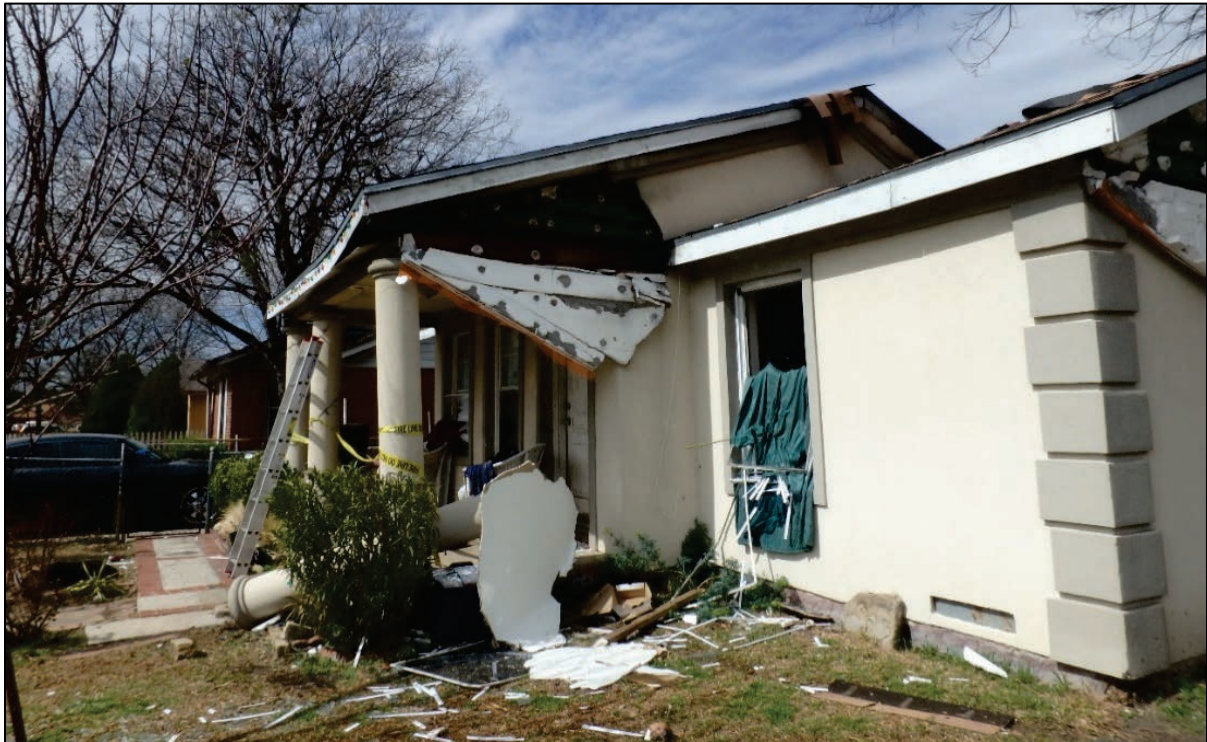
Figure 14. Photo of 3527 Durango Drive Post-Incident by NTSB.

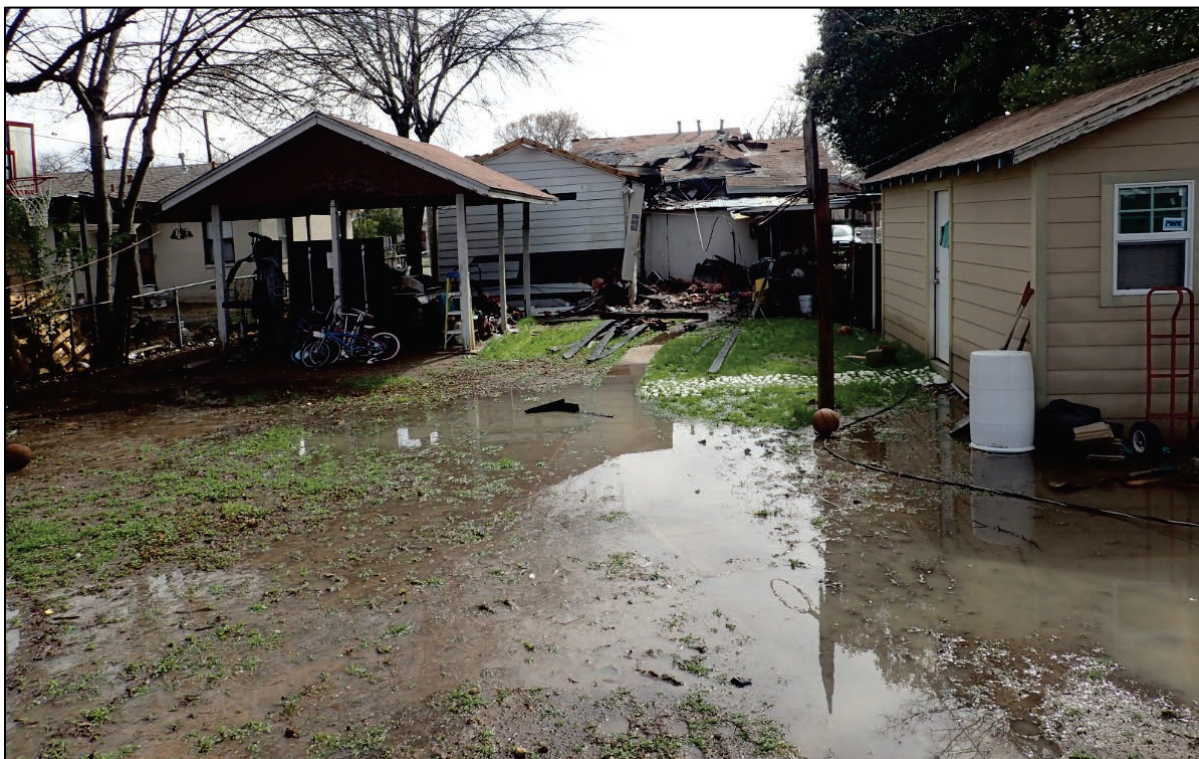
Figure 15. Photo of 3527 Durango Drive Taken by Atmos Energy on 2/24/2018. Image is taken from rear facing the back of the house. Standing water is shown in backyard.

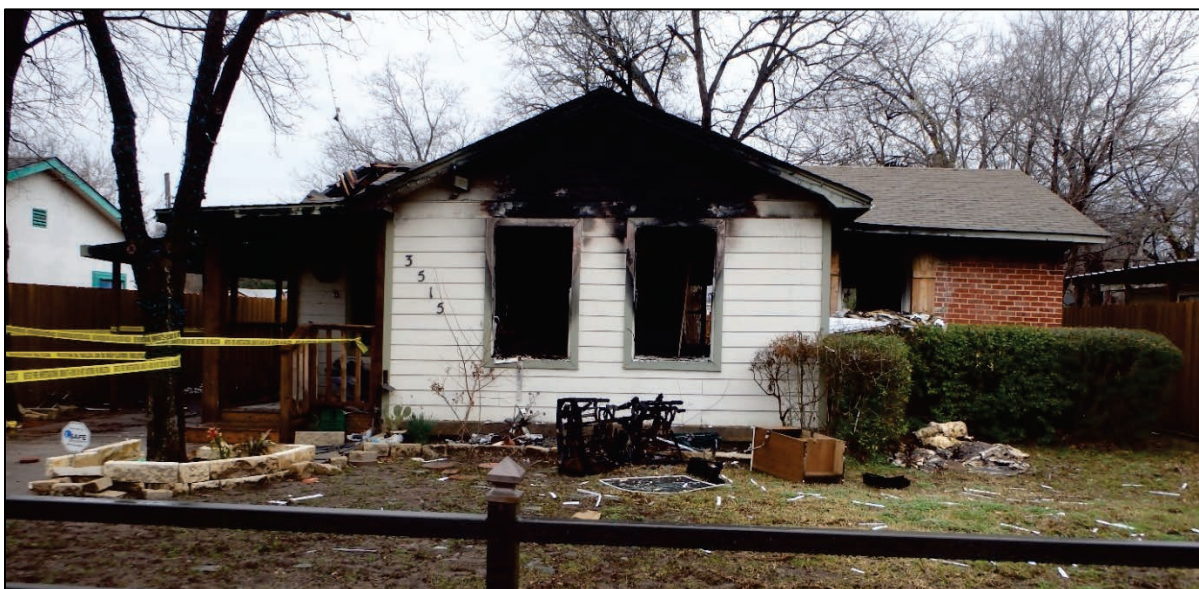
Figure 16. Front of 3515 Durango Drive. Photo by DFR.

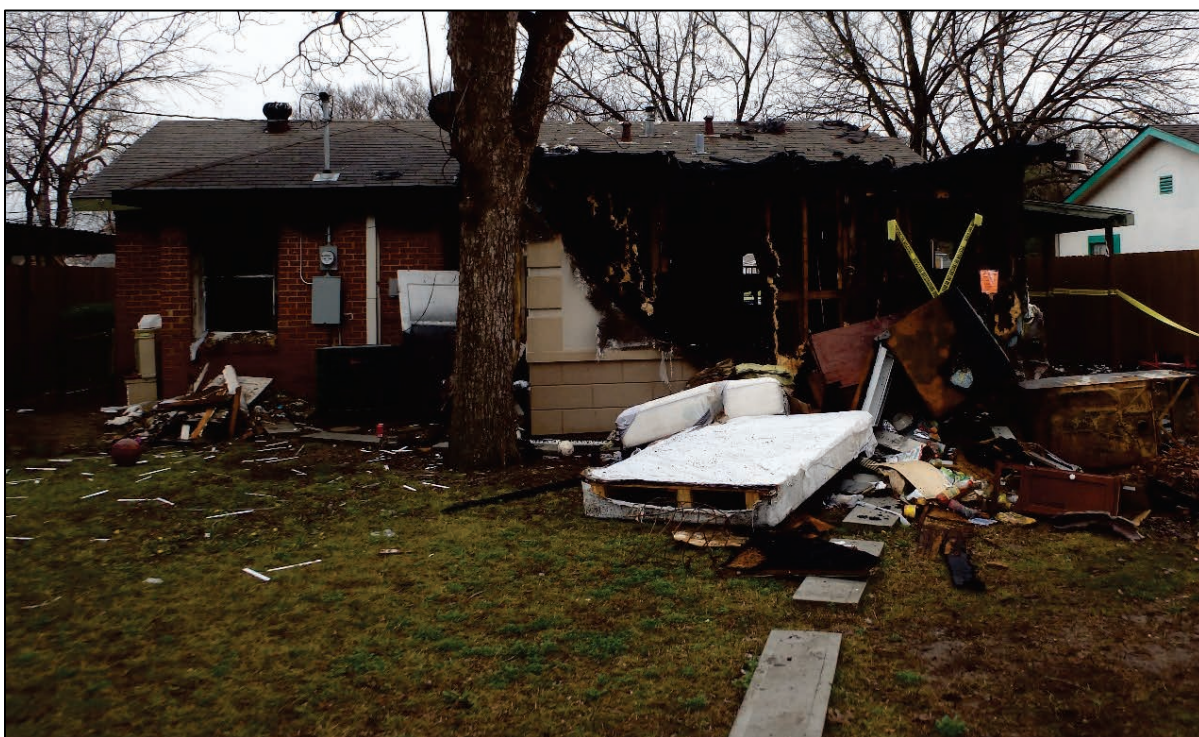
Figure 17. Back of 3515 Durango Drive. Photo by DFR.

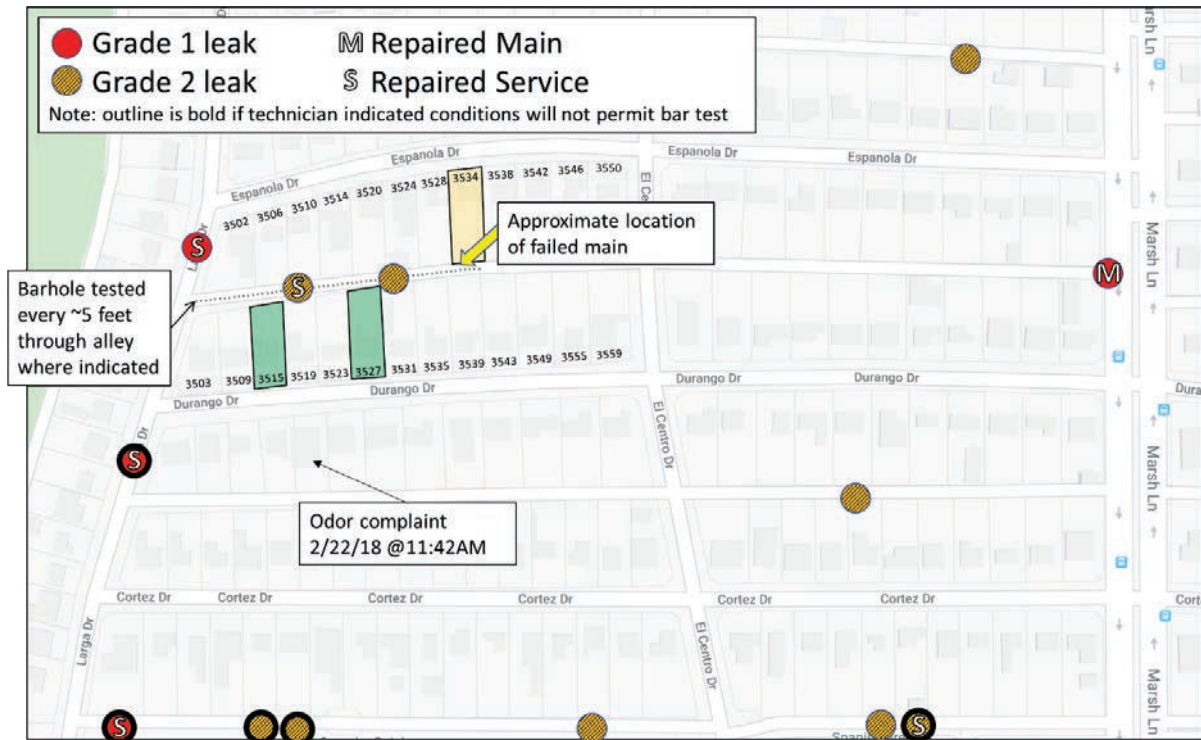
Figure 18. Leaks Identified by Atmos Energy Staff Following Event 2, Prior to the Accident on February 23, 2018. Repairs made prior to the accident are indicated by an "M" or "S" for repairs on the main and service lines, respectively.⁴²

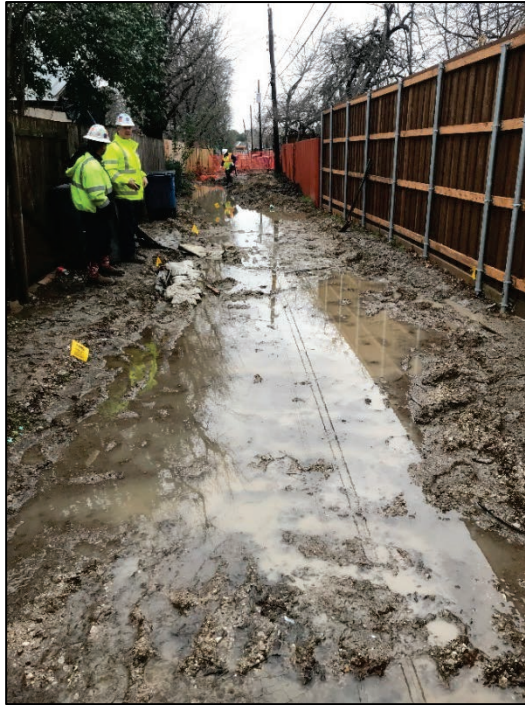
Figure 20. Alley Behind 3534 Espanola Drive Prior to Excavation. Wet muddy soil and puddles of standing water are shown. Photograph by Atmos Energy, 3/01/18.

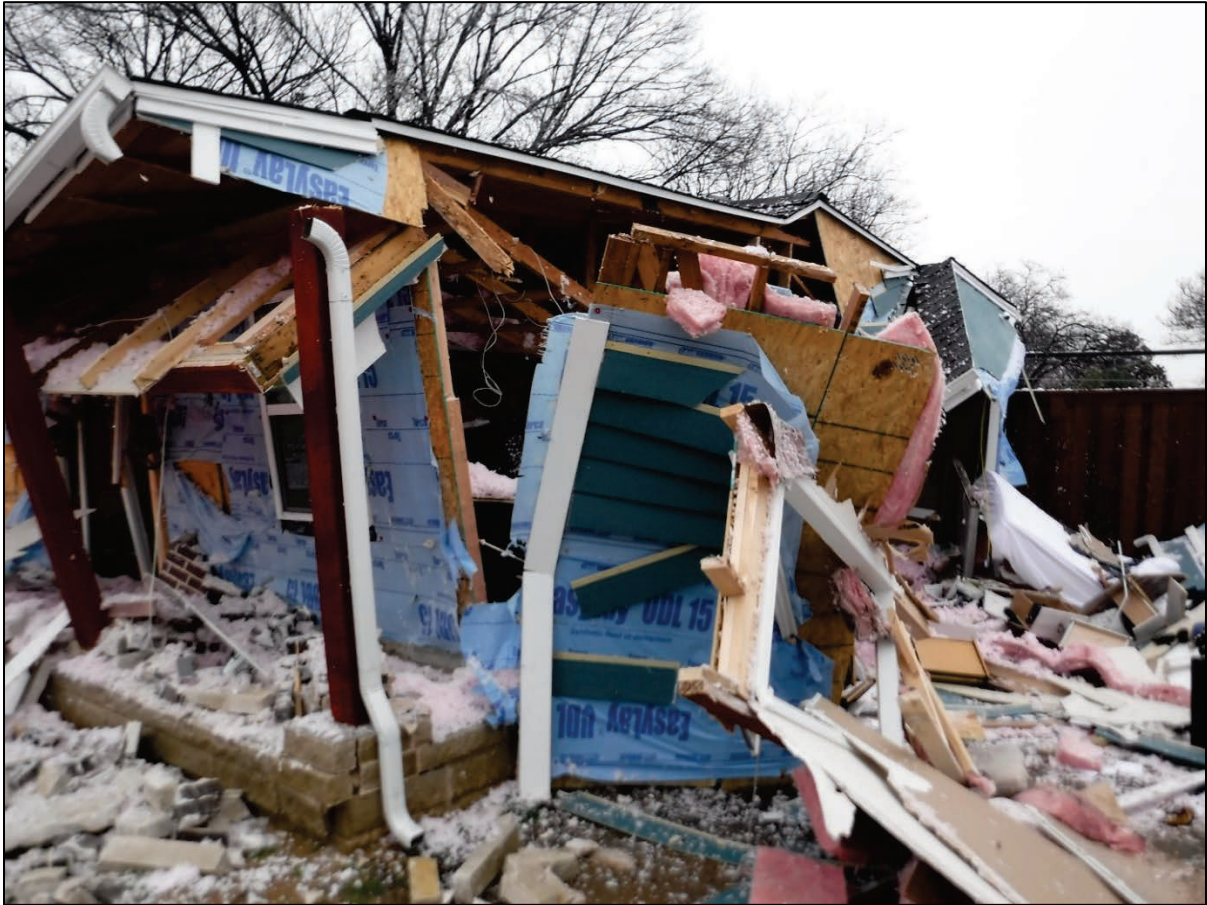
Figure 21. Northwest corner of 3534 Espanola Drive, Photo Taken Post-Accident on 2/23/18 by DFR

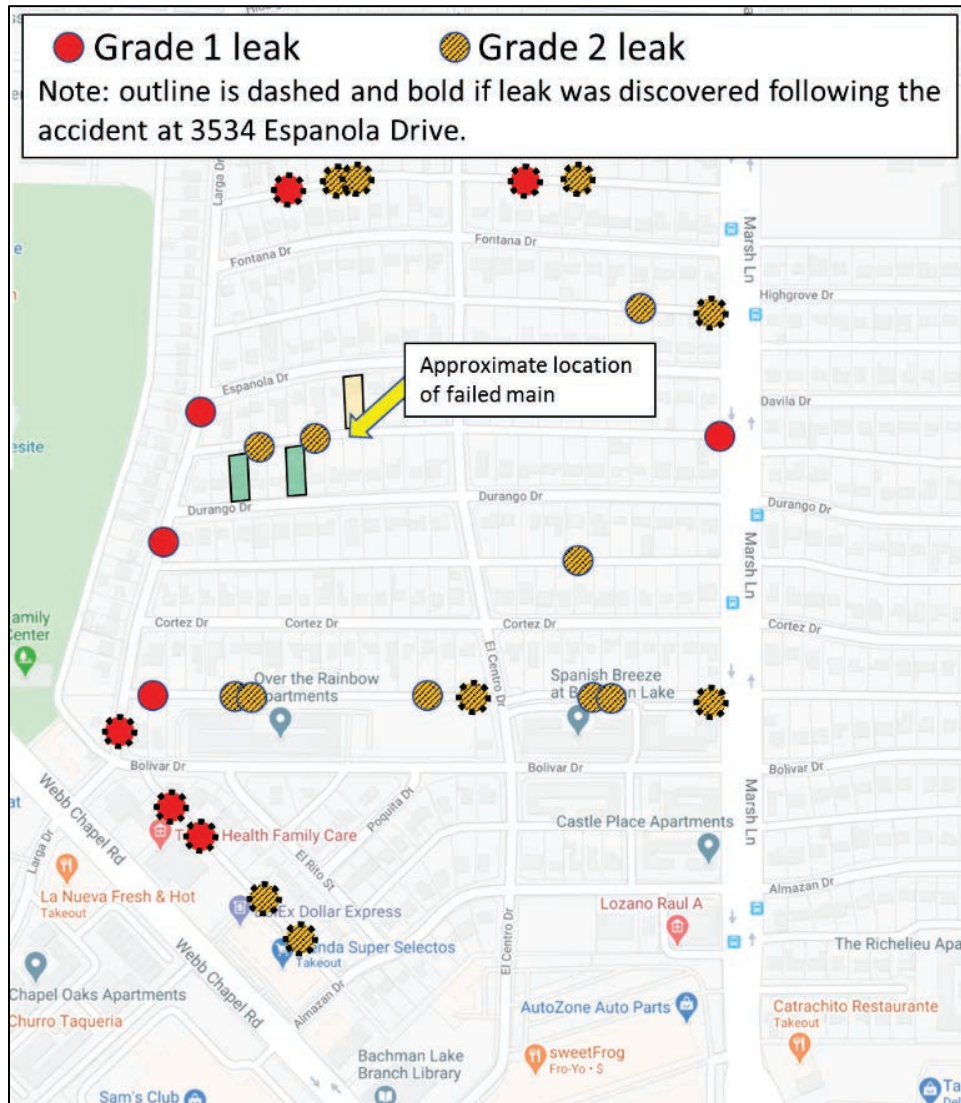
Figure 22. Grade 1 and Grade 2 Leaks Discovered Between February 22 and March 18, 2018

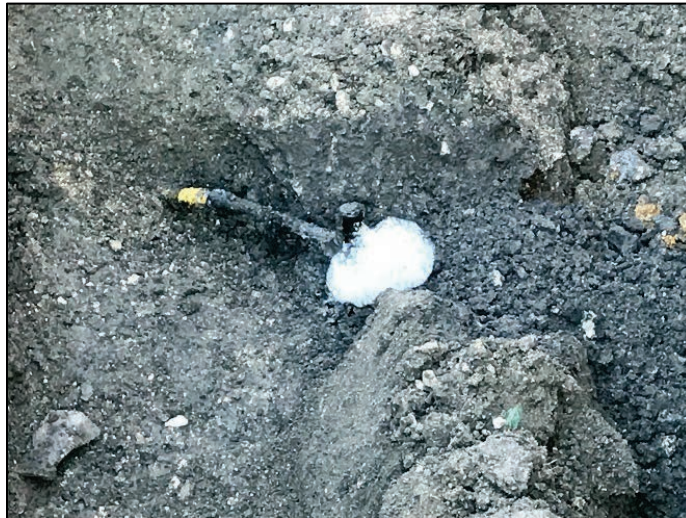
Figure 25. Photograph of Leak on Threads of 3524 Espanola Drive Service Tee and Service Tee Cap (Photograph by Atmos Energy, 2/28/19)

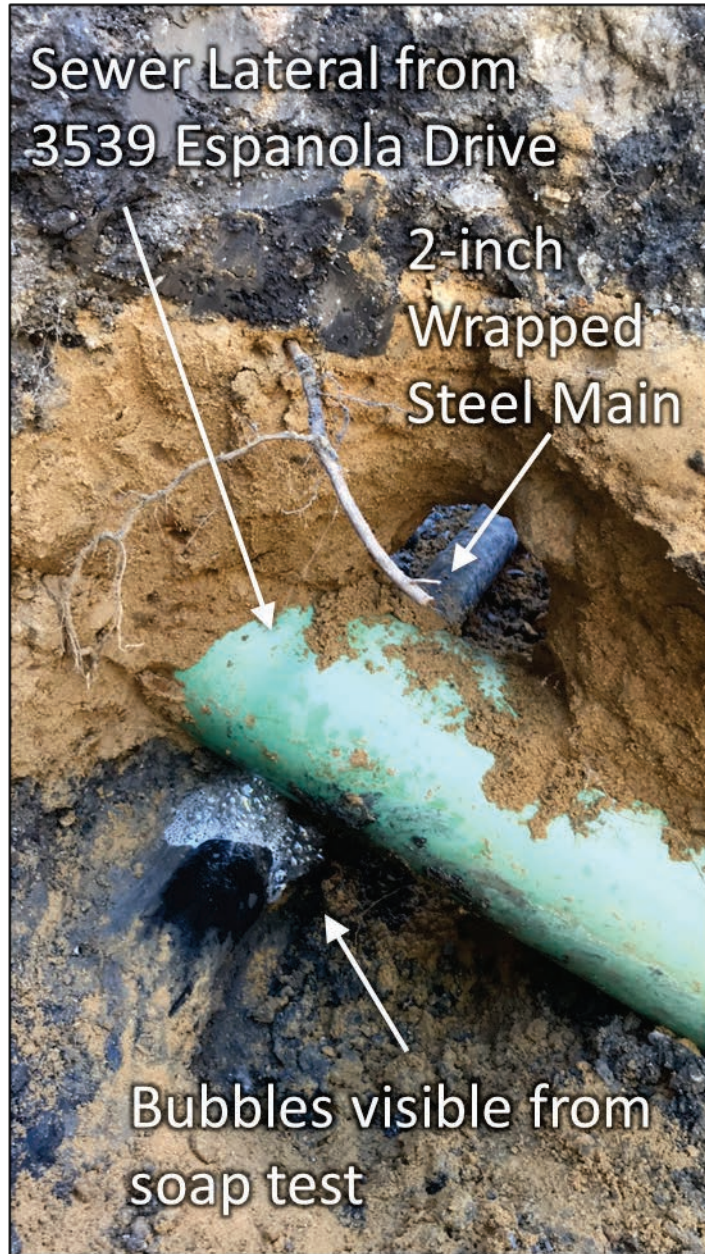
The 2" main directly beneath the sewer lateral was exposed. The circumferential crack that had been identified on the previous day was observed towards the top of the pipe. The extent of coating damage appeared across about 25-inches of pipe, mostly concentrated on the top of the pipe in the area directly beneath and to both sides of the sewer lateral. From the east property line of 3539 Durango Drive, the path of the gas main took a downward dip to the west, just west of the sewer lateral to 3539 Durango Drive; there appeared to be slight over-bend in the pipe.

Figure 29. Soap Bubbles from 2-inch gas main at 3539 Durango Drive sewer lateral crossing (Photograph by Atmos Energy, 3/6/18)

The damage main near the lateral to 3539 Durango Drive was removed as evidence. The remaining section was cap welded on west end and a preliminary pressure test at 25 psig for 30 minutes resulted in a pressure drop of 5 psig. A small leak was identified on the service tap to 3539 Durango Drive (Figure 31). The 3539 Durango Drive sewer lateral connection to sewer main was exposed; the sewer main had a depth of cover of approximately 75-inches (Figure 32). A plastic soft drink bottle (Coke) removed from the excavation above the sewer lateral to 3539 Durango Drive indicated a "1995 sweepstakes date."

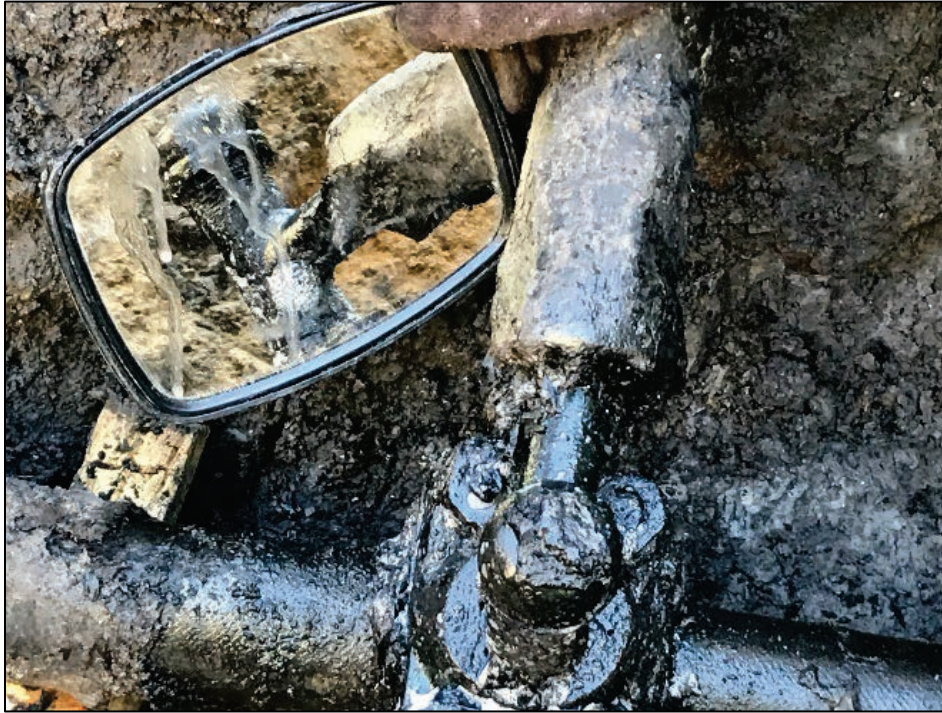
Figure 30. Photograph of Leak on 3539 Durango Drive Service Tap (Photograph by Atmos Energy, 3/7/18)

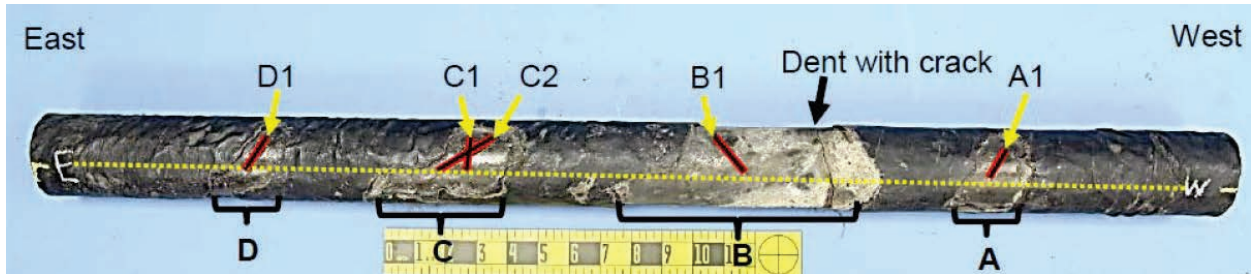
Figure 34 -- Top surface of the main showing location of five major gouges, "A1", "B1", "C1", "C2", and "D1", indicated by black and red outlines (black and red outlines are not to scale). Top of main line is indicated by a yellow dashed line.

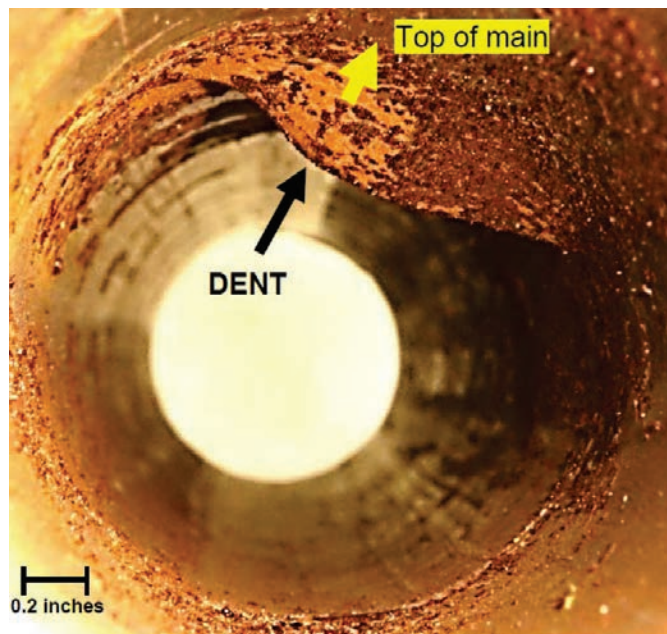
Figure 35 – View of the inner surface of the main looking east showing a dent that intersected the circumferential crack. Arrow also points to the approximate top of the main.

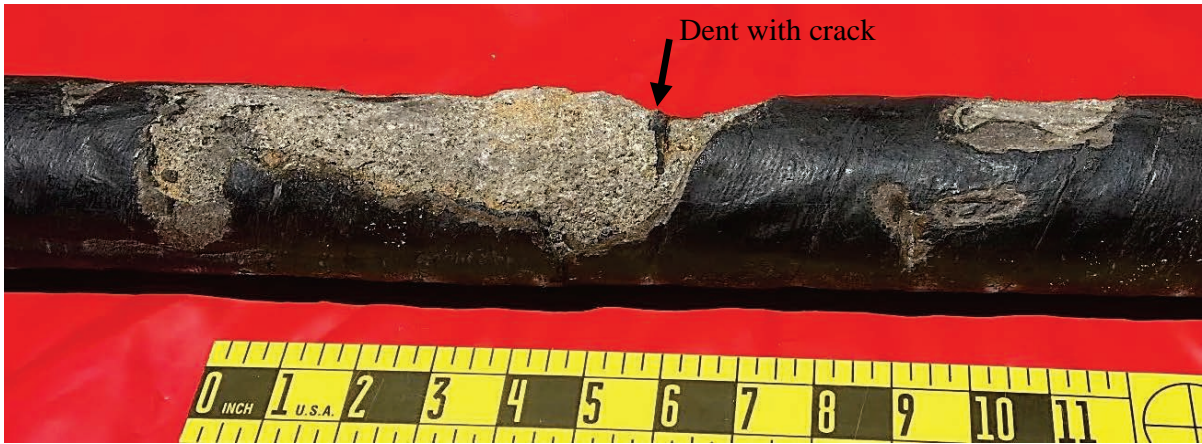
Figure 36 -- Side view of the as-received main showing the dent with a crack
