FACTUAL REPORT OF INVESTIGATION ATTACHMENT

Sunnyvale Inspection Photographs

West Hollywood, CA

HWY18FH014

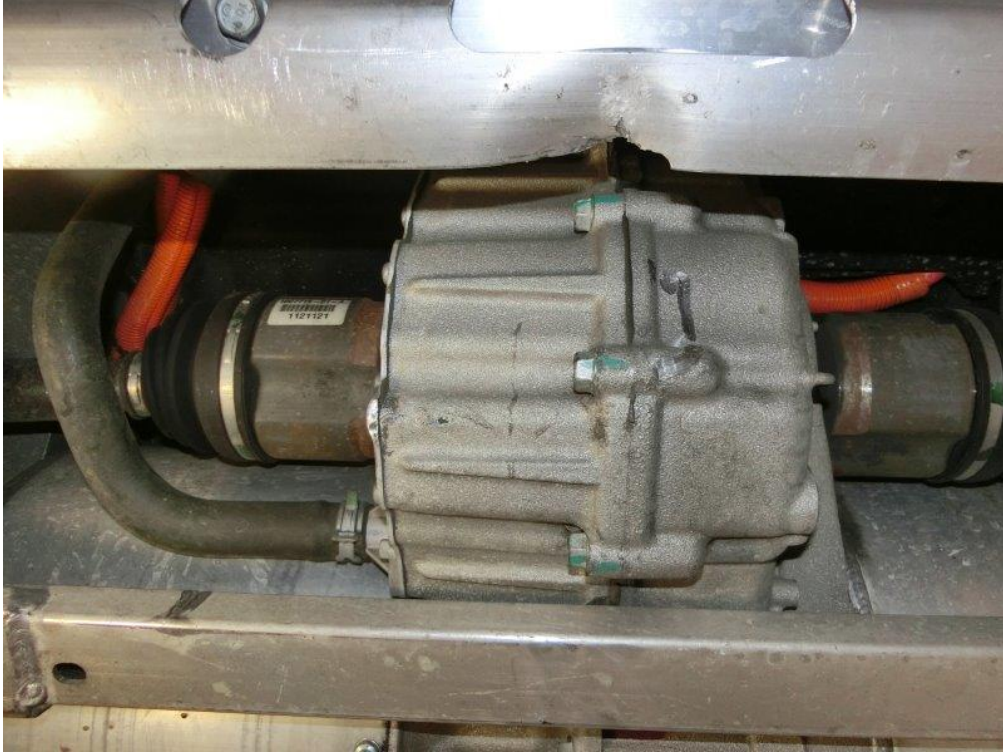
Sunnyvale Inspection Photo 1: view showing Tesla motor

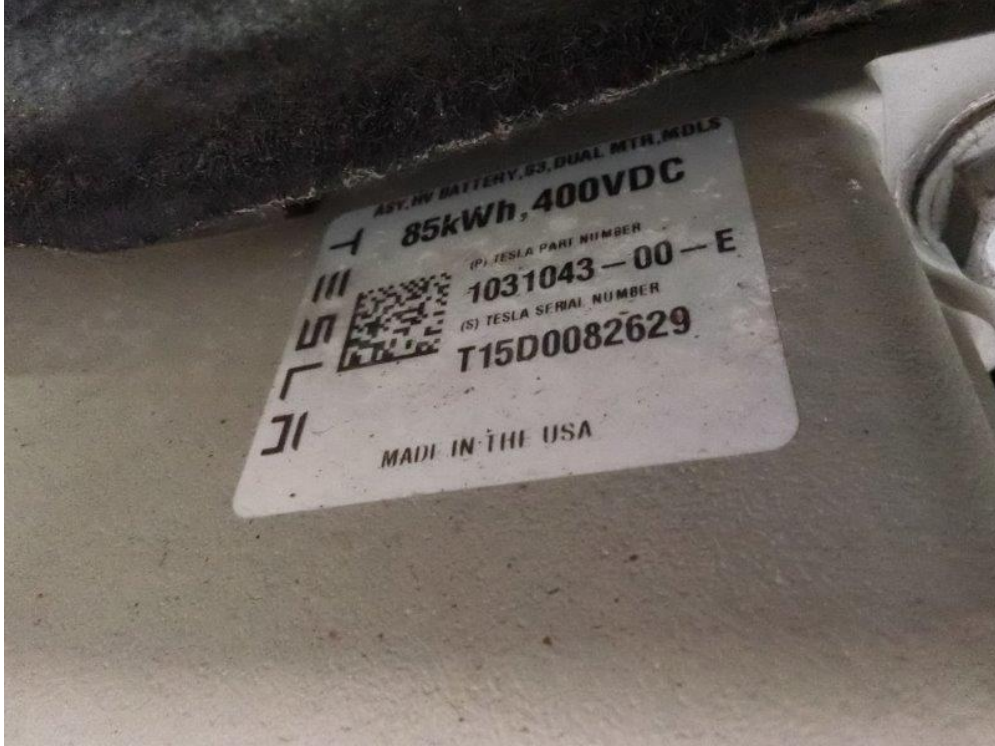
Sunnyvale Inspection Photo 2: view showing the battery pack label

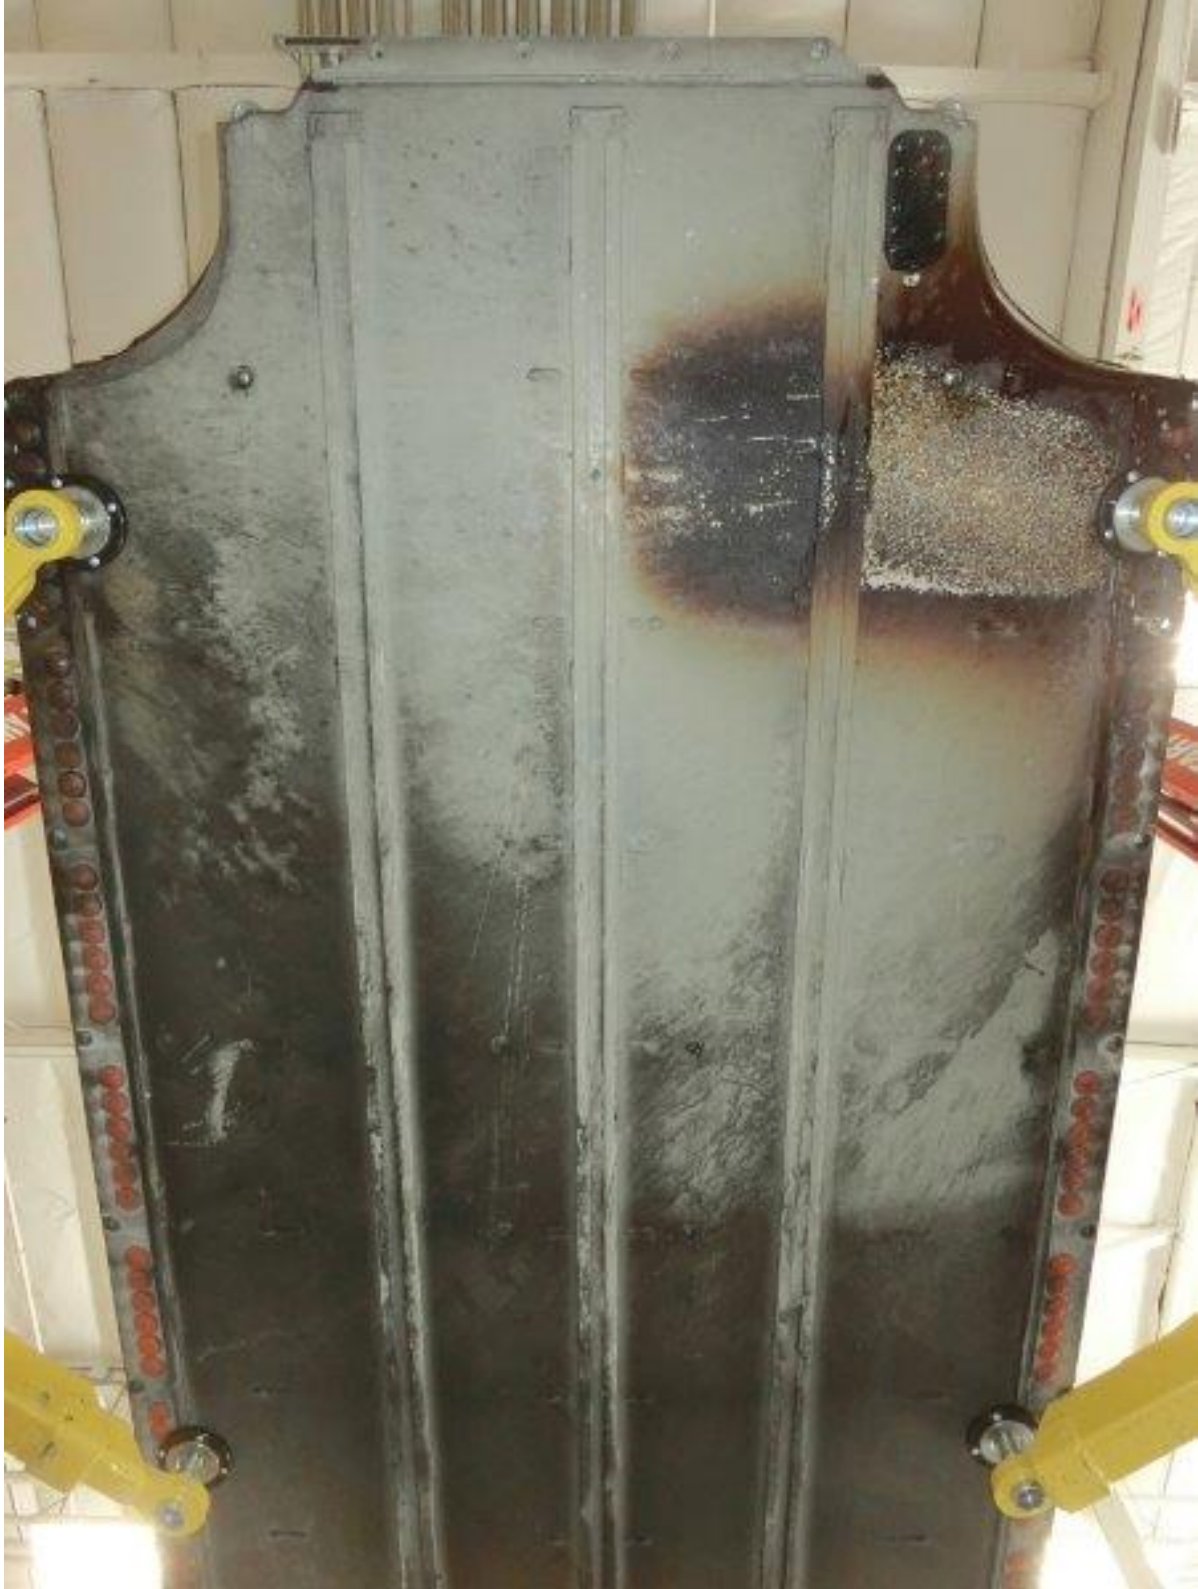
Sunnyvale Inspection Photo 3: view showing underside of Tesla battery pack

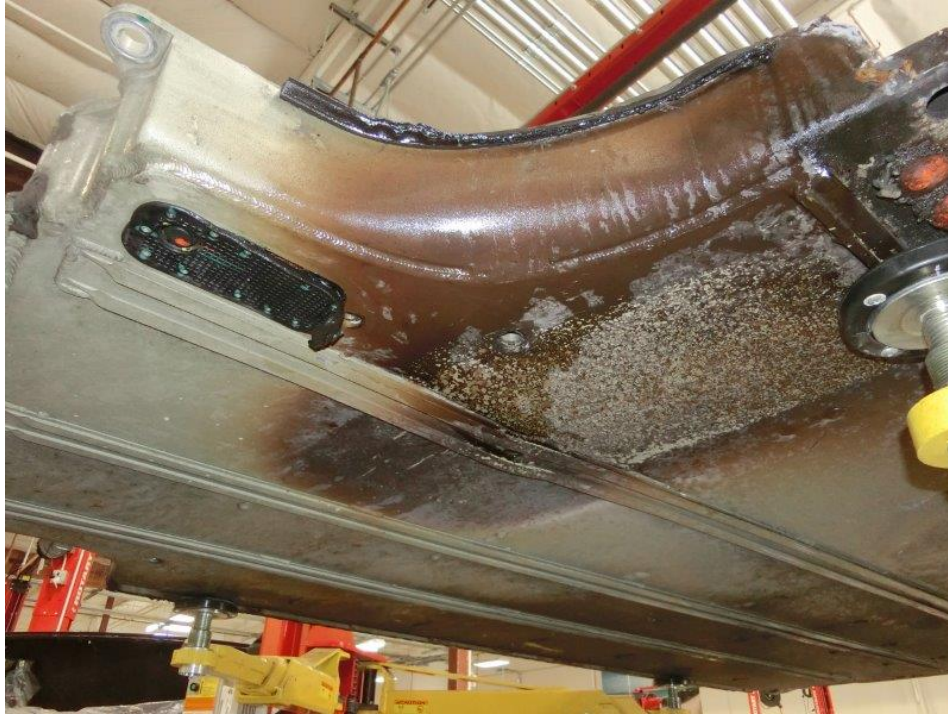
Sunnyvale Inspection Photo 4: view showing underside left front corner of battery pack

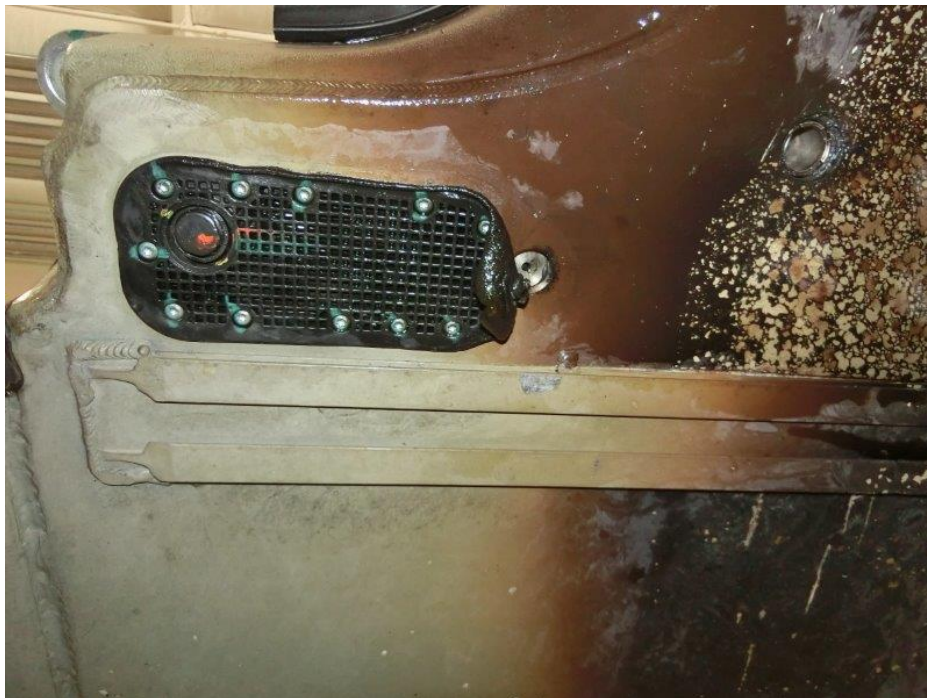
Sunnyvale Photo 5: view showing detail of the underside of the battery pack

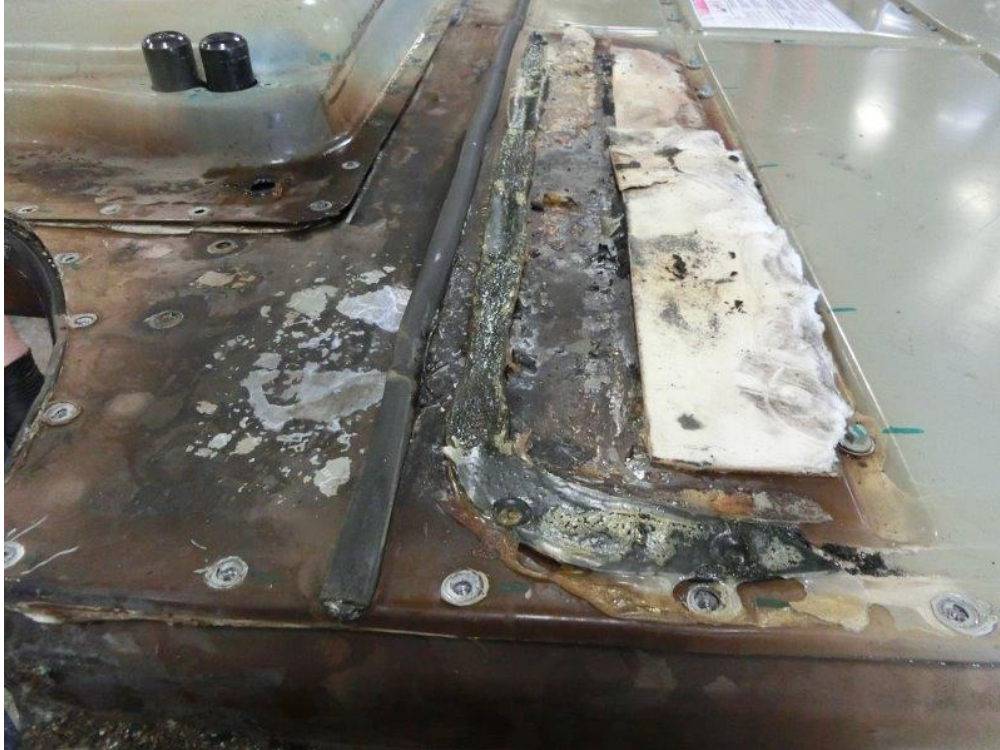
Sunnyvale Inspection Photo 6: view showing the upper left front of the battery pack at beginning stage of cover removal

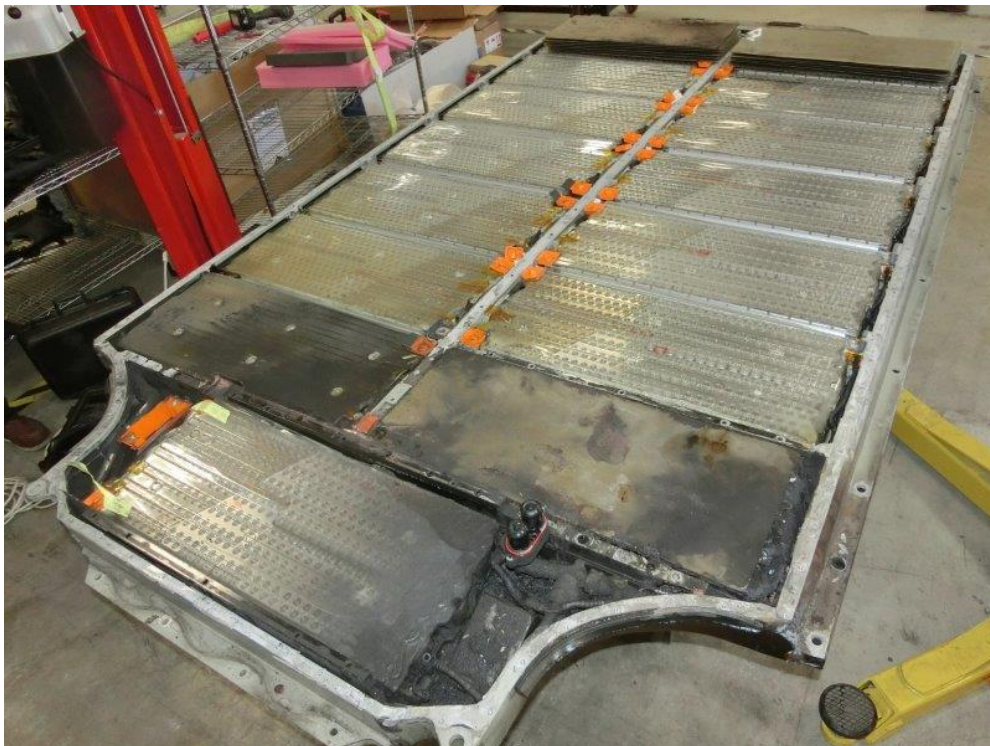
Sunnyvale Inspection Photo 7: view showing the upper side of battery pack with covers removed

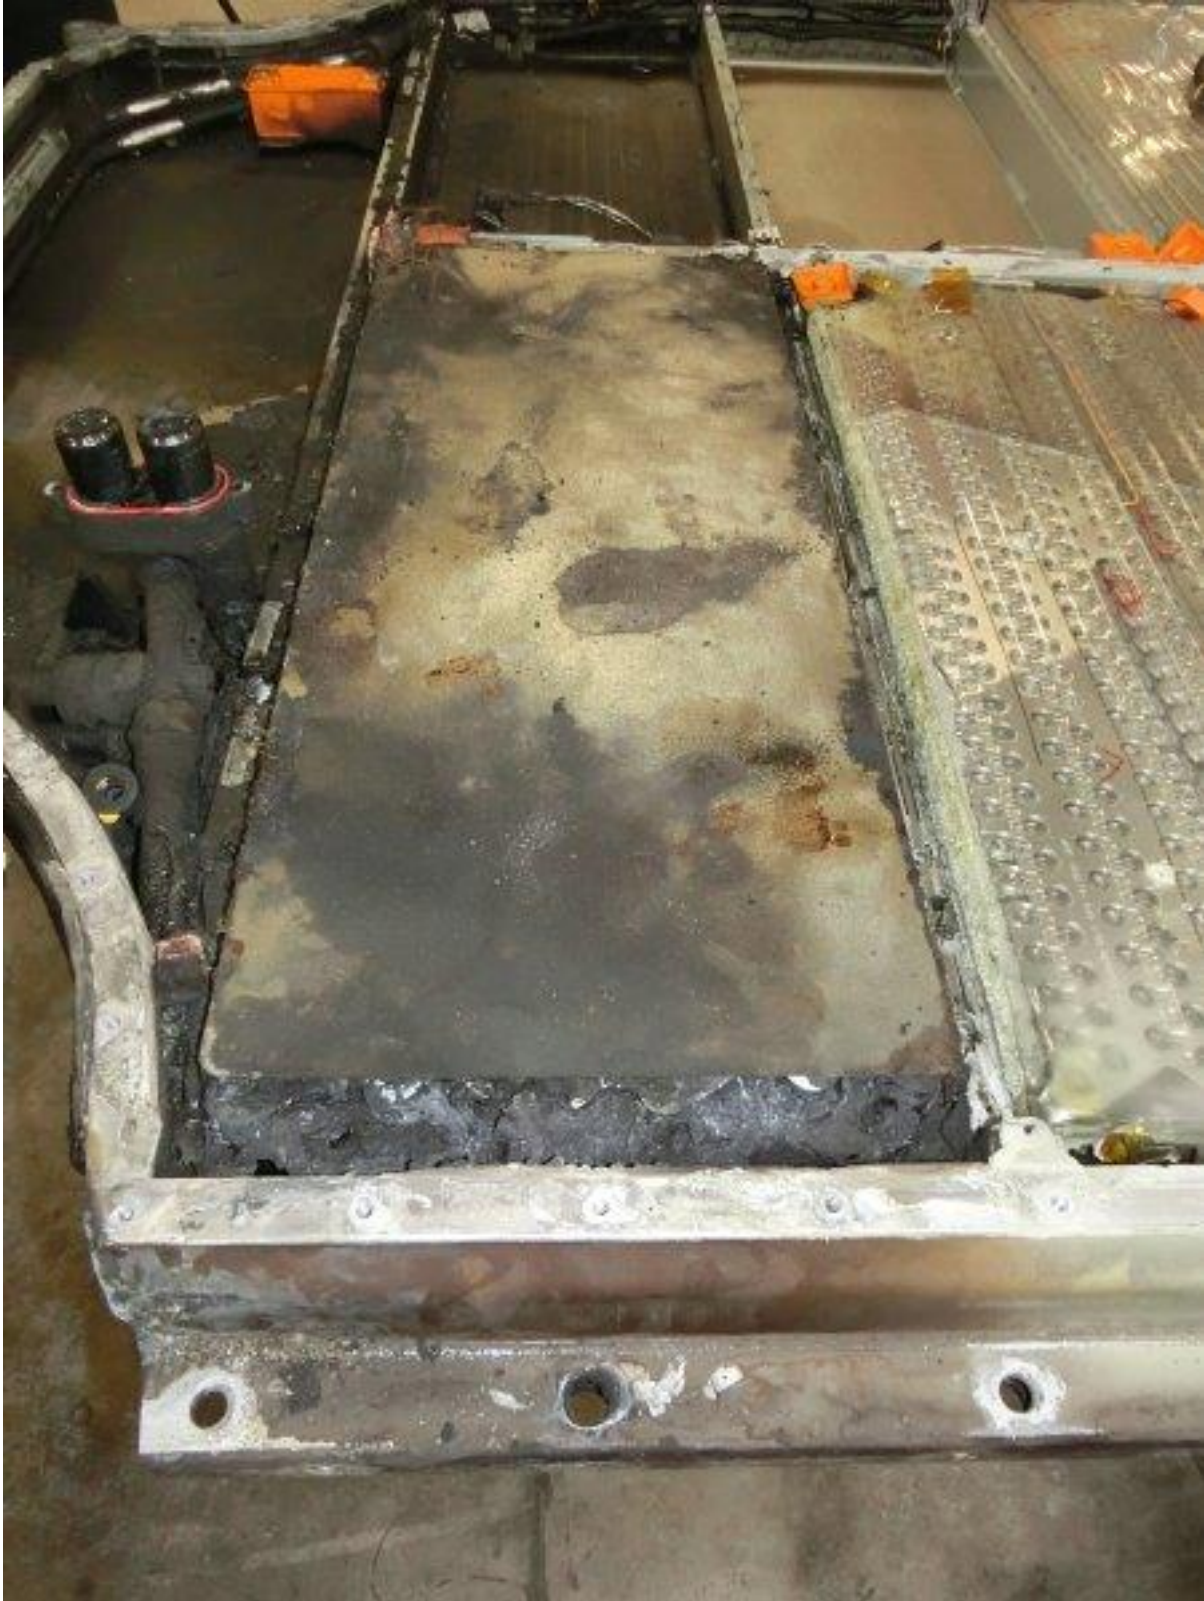
Sunnyvale Inspection Photo 8: view showing the front of the battery pack with some modules and components removed

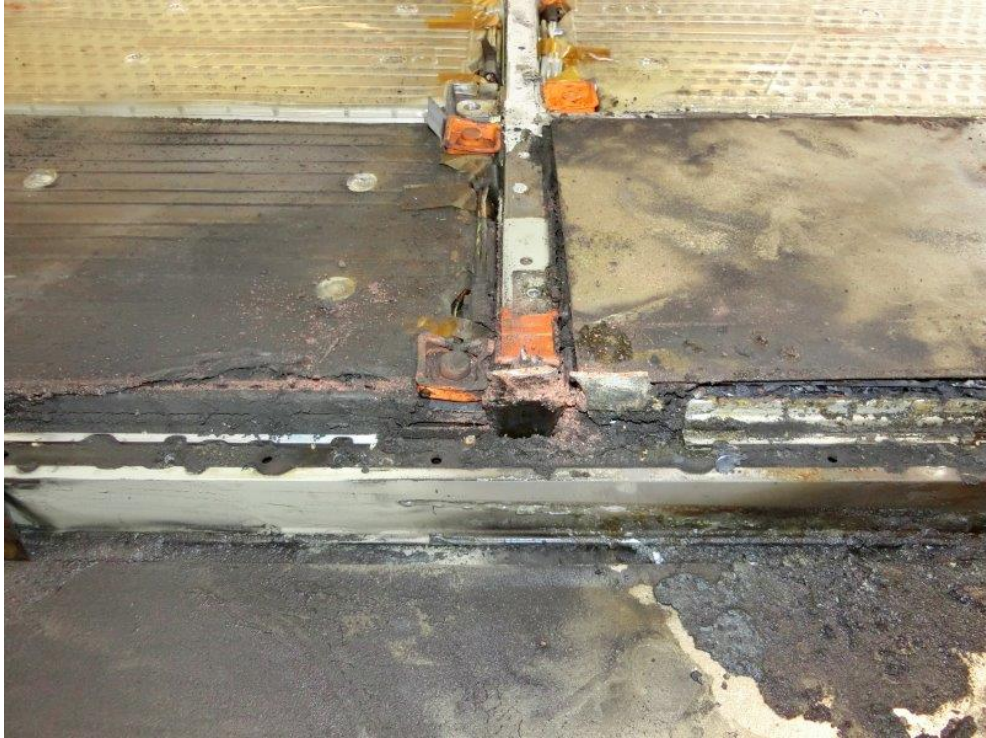
Sunnyvale Inspection Photo 9: view showing a detailed view of the front center of the battery pack with front modules removed

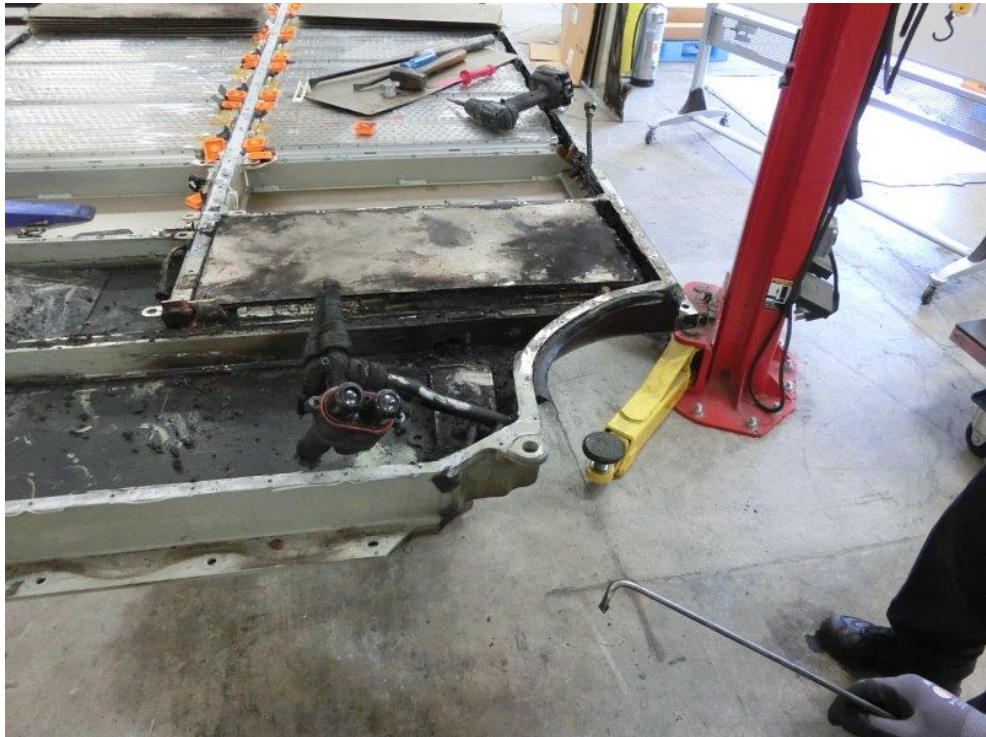
Sunnyvale Inspection Photo 10: view showing the left front of the battery pack with some components removed

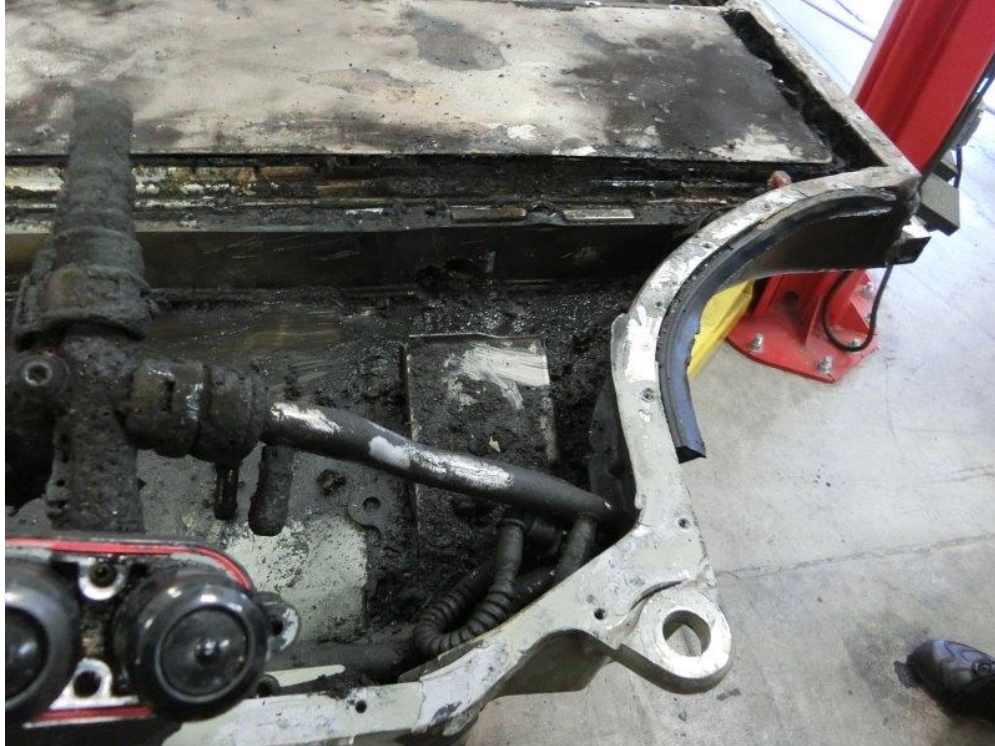
Sunnyvale Inspection Photo 11: detail view of the left front of the battery pack

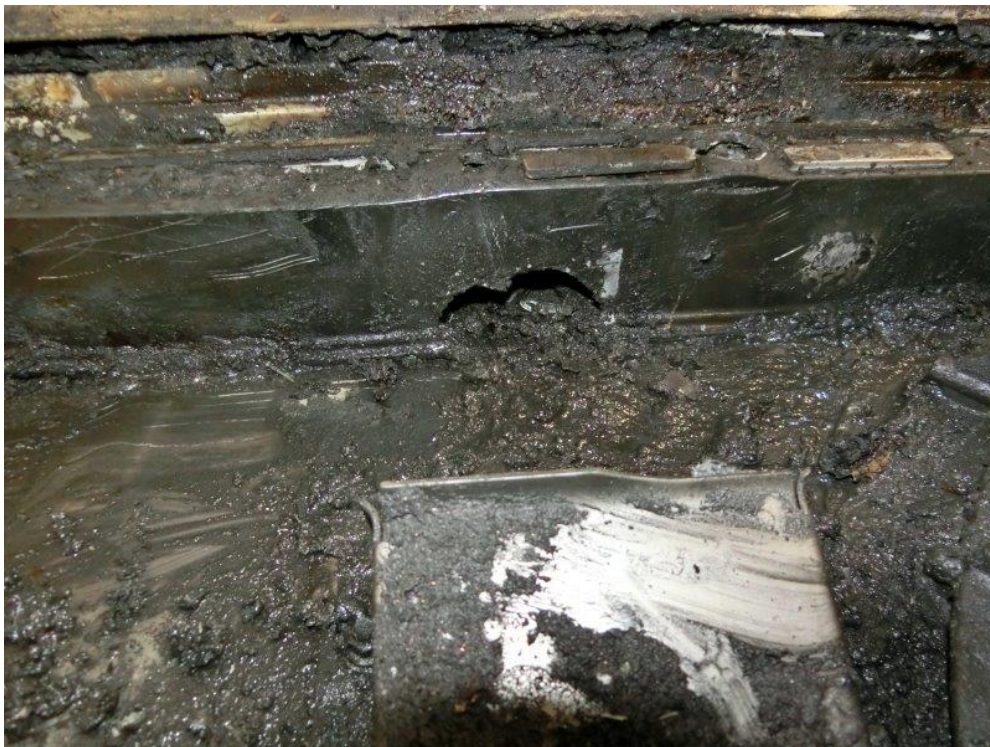
Sunnyvale Inspection Photo 12: detail view of damage to the left front battery case

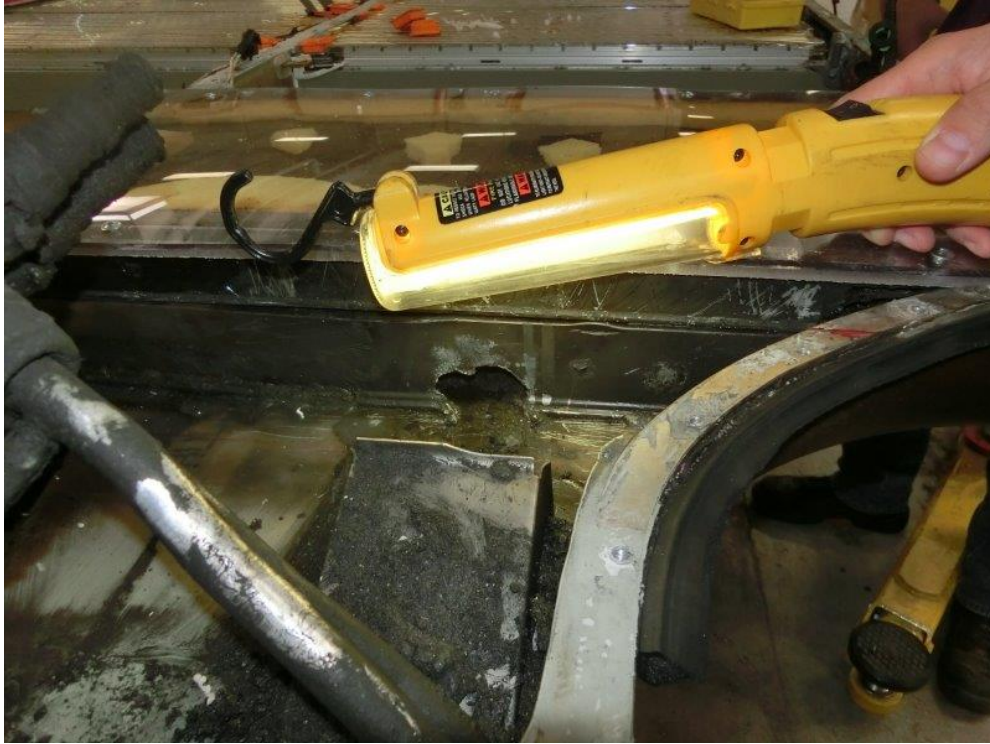
Sunnyvale Inspection Photo 13: detail view of damage to the left front battery case

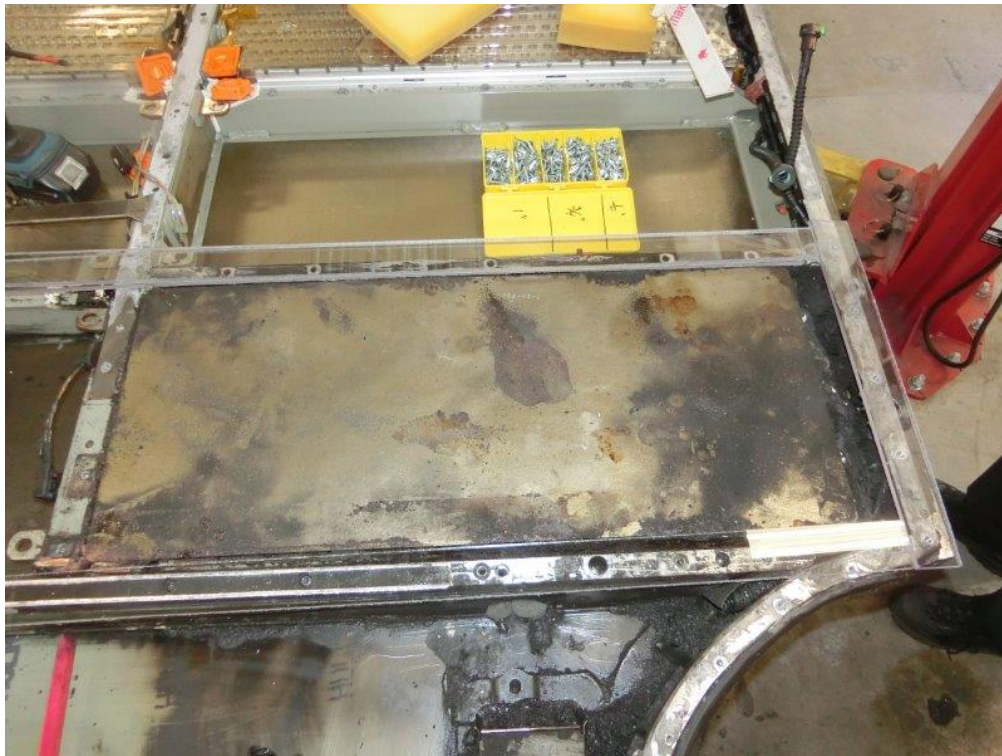
Sunnyvale Inspection Photo 14: view of left front battery case

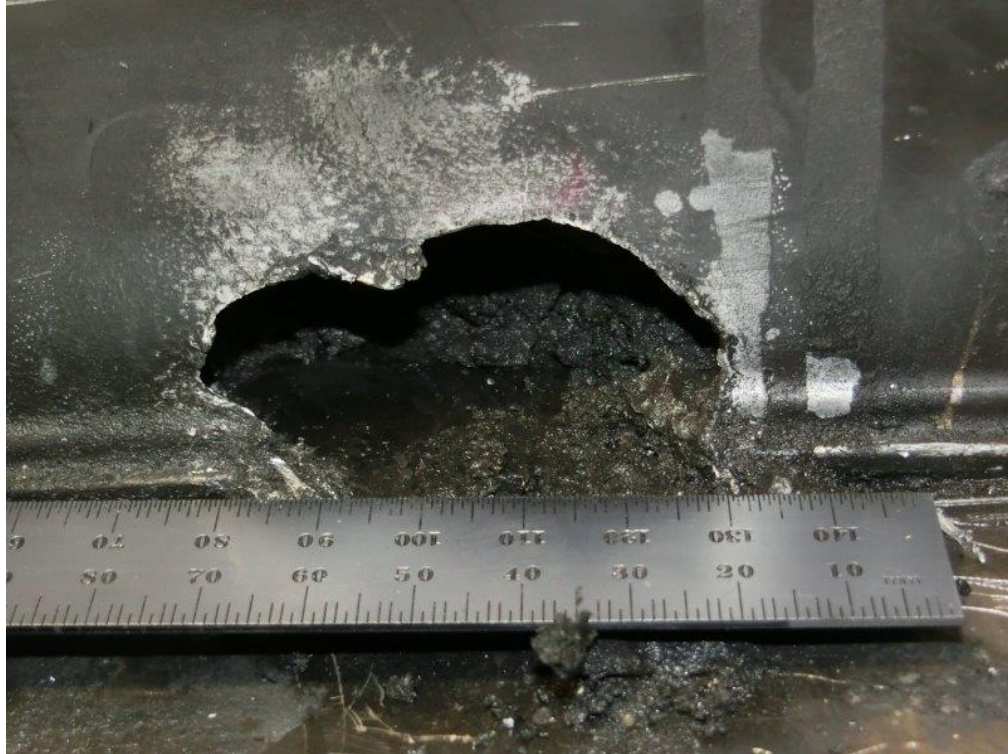
Sunnyvale Inspection Photo 15: detail view of the damage to battery case

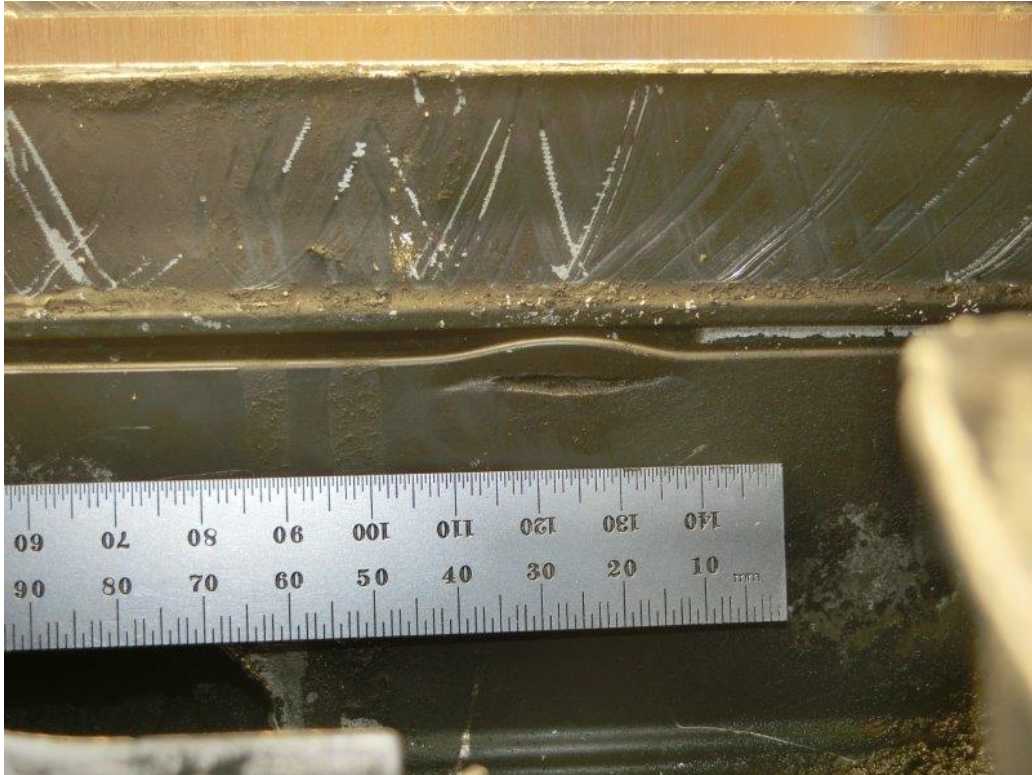
Sunnyvale Inspection Photo 16: detail view of damage to battery case
