POWERPLANT GROUP CHAIRMAN'S FACTUAL REPORT

ENG22LA002

IAE Metallurgical Report Titled "Metallurgical Investigation of (certain parts) from PW1100G Engine 771708", dated December 16, 2021

Subject: Metallurgical Investigation of (certain parts) from PW1100G Engine 771708

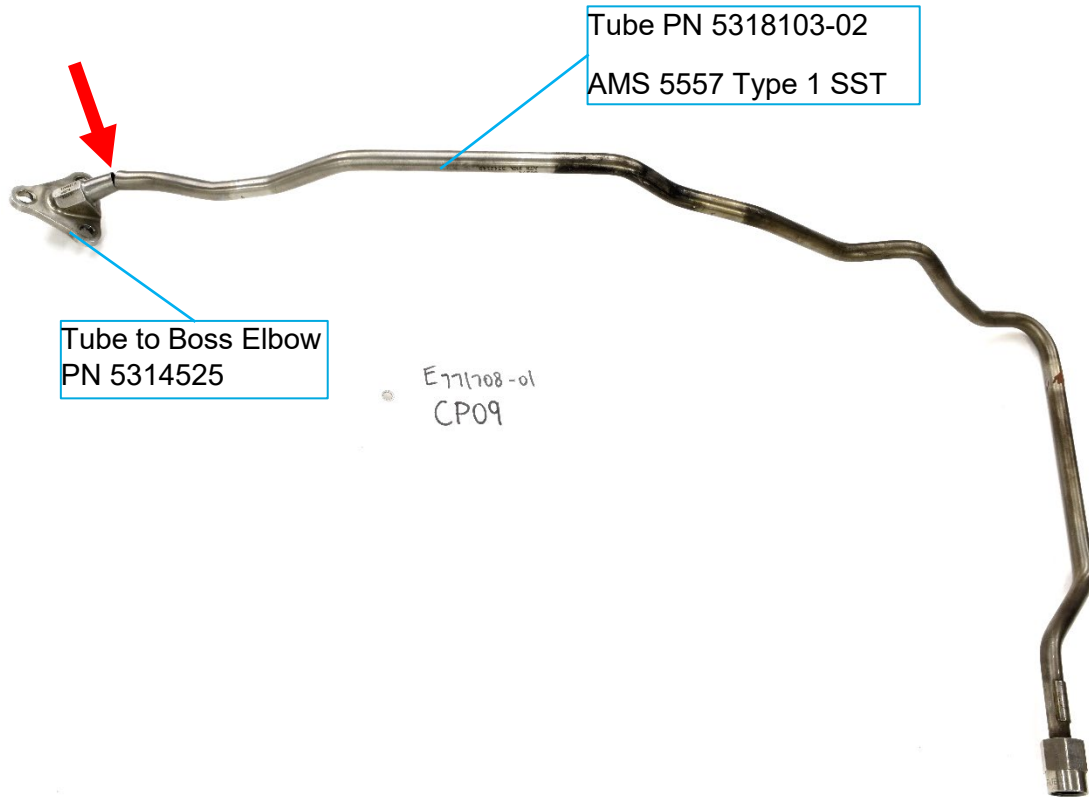
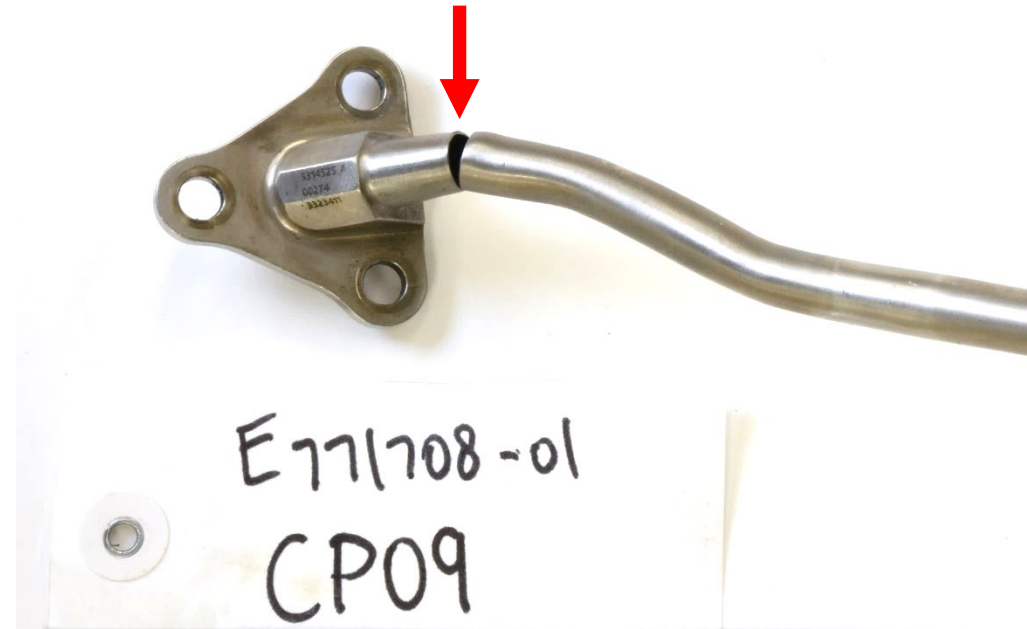
FIGURE 3: CRACKED CP09 TUBE

The CP09 tube cracked due to fatigue, which initiated at multiple origins along the outer diameter of the tube. It seems likely that the fatigue was driven by TMS motion. Tube wall thickness at the fracture location was 21.4% below nominal thickness.

The crack in the CP09 tube was in a straight region of tube near the PN 5314525 Tube to Boss Elbow. The crack was fractured open to allow examination of the crack surface. An additional cut was made between the crack surface and the Tube to Boss Elbow to facilitate examination. The sample was then ultrasonically cleaned in a mild alkali solution of Blue Gold Industrial Cleaner¹ for ten minutes and rinsed with isopropyl alcohol. Optical microscopic review of the cleaned surface revealed a region of fatigue progressing through wall from the external surface. The fatigue region and origin location are shown in **Figure 8**. The wall thickness at the origin region was 21.4% below nominal thickness.

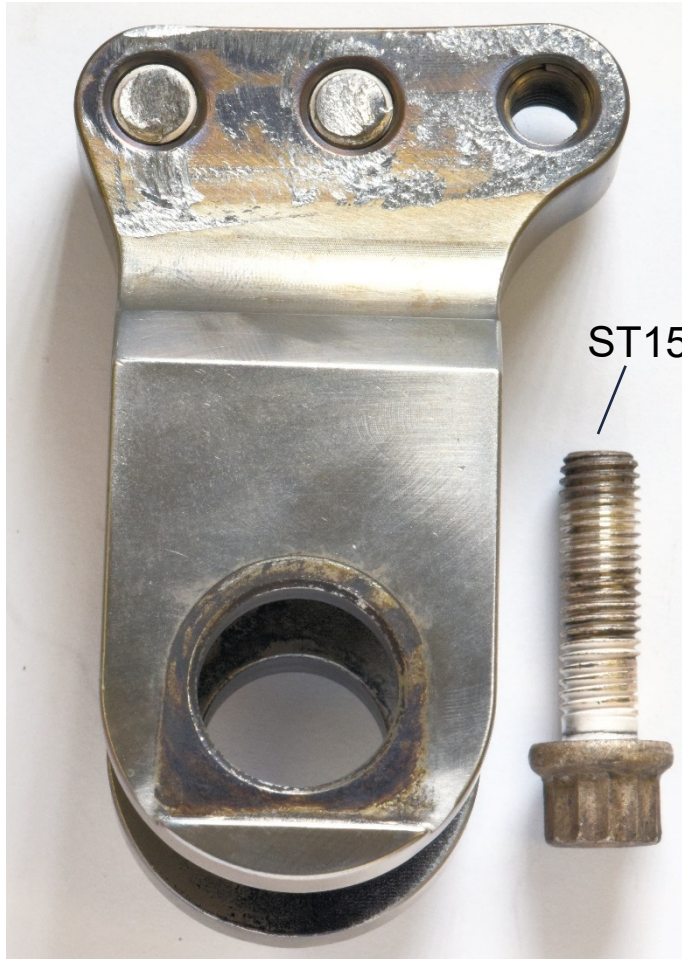
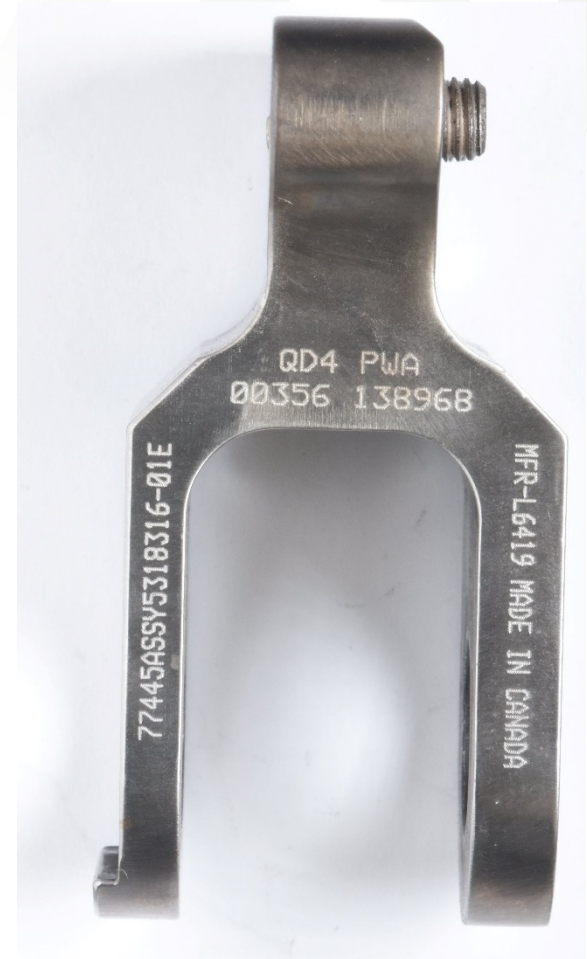
FIGURE 6: PN 5318316-01 TMS LOWER AFT CASE MOUNT

Two bolts that retain the TMS Lower Aft Case Mount fractured due to shear overstress. Secondary damage to the mount and the bolt fracture surfaces indicates that bolt fracture resulted in TMS motion.

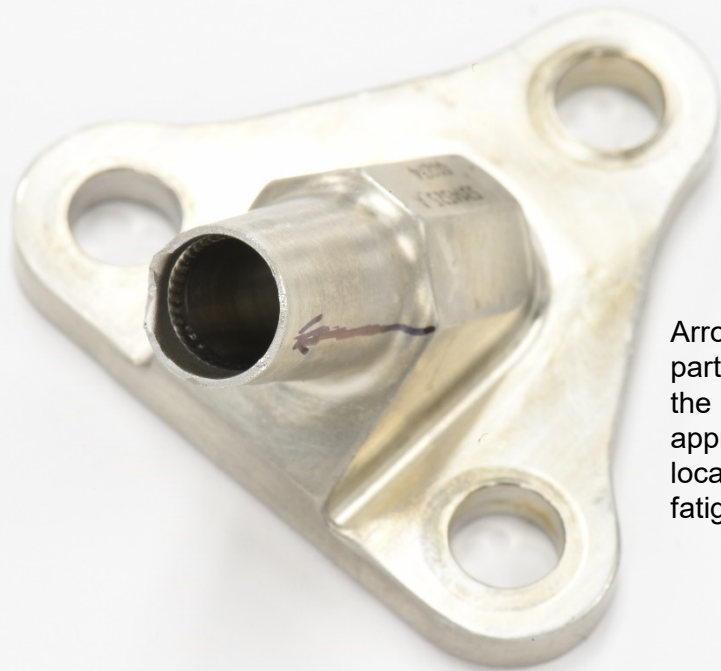
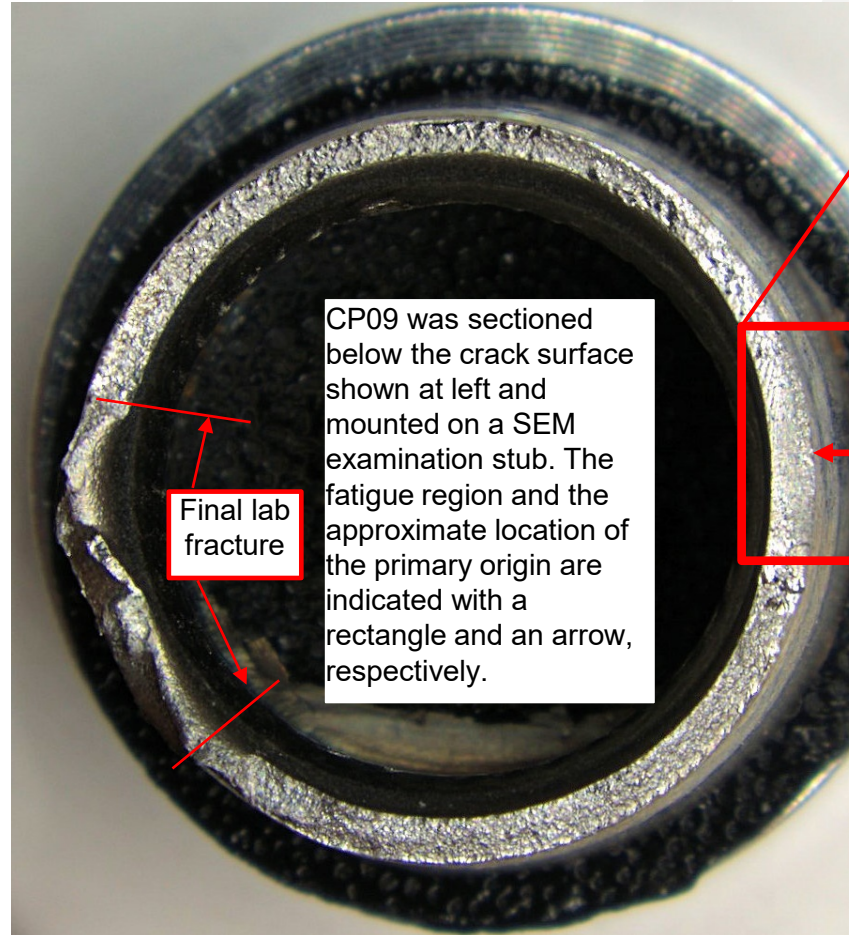
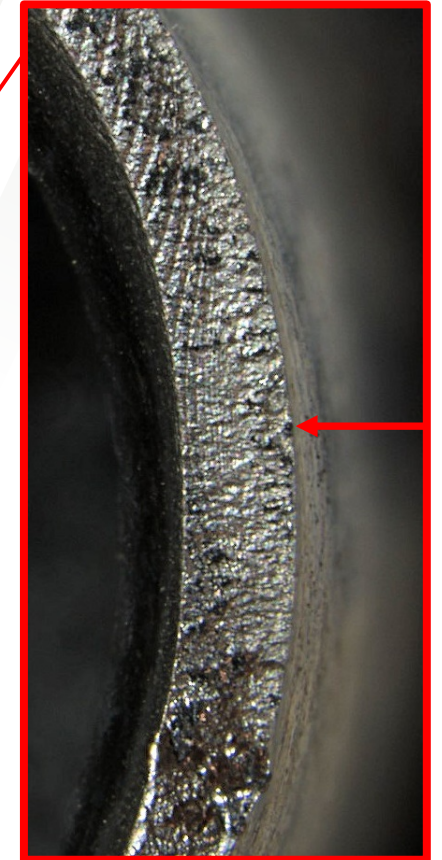
FIGURE 8: CRACK IN CP09 TUBE WAS FRACTURED OPEN

Arrow drawn on part indicates the approximate location of the fatigue origin

CP09 was sectioned below the crack surface shown at left and mounted on a SEM examination stub. The fatigue region and the approximate location of the primary origin are indicated with a rectangle and an arrow, respectively.

Through-wall fatigue region. Overstress cracking elsewhere.

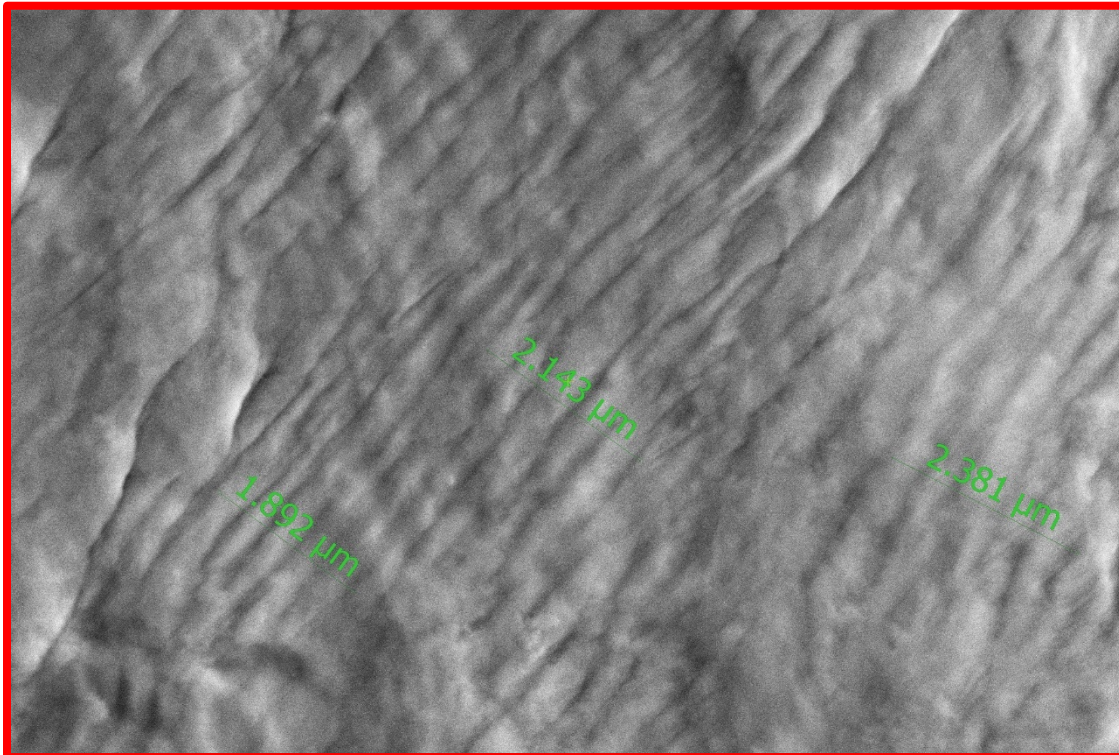
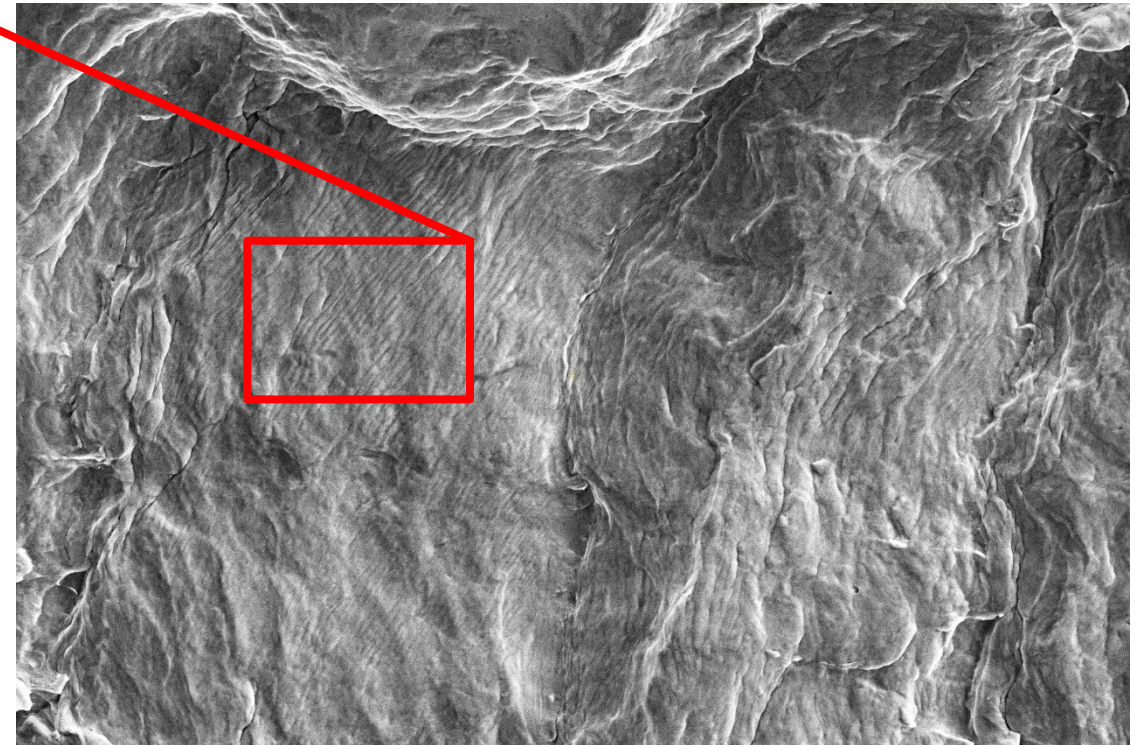
FIGURE 12: SEM EXAMINATION OF CP09 CRACK SURFACE LOCATION 9

Spacing of striations in this field of view was approximately $1.68\text{E-}5$ in. / cycle.

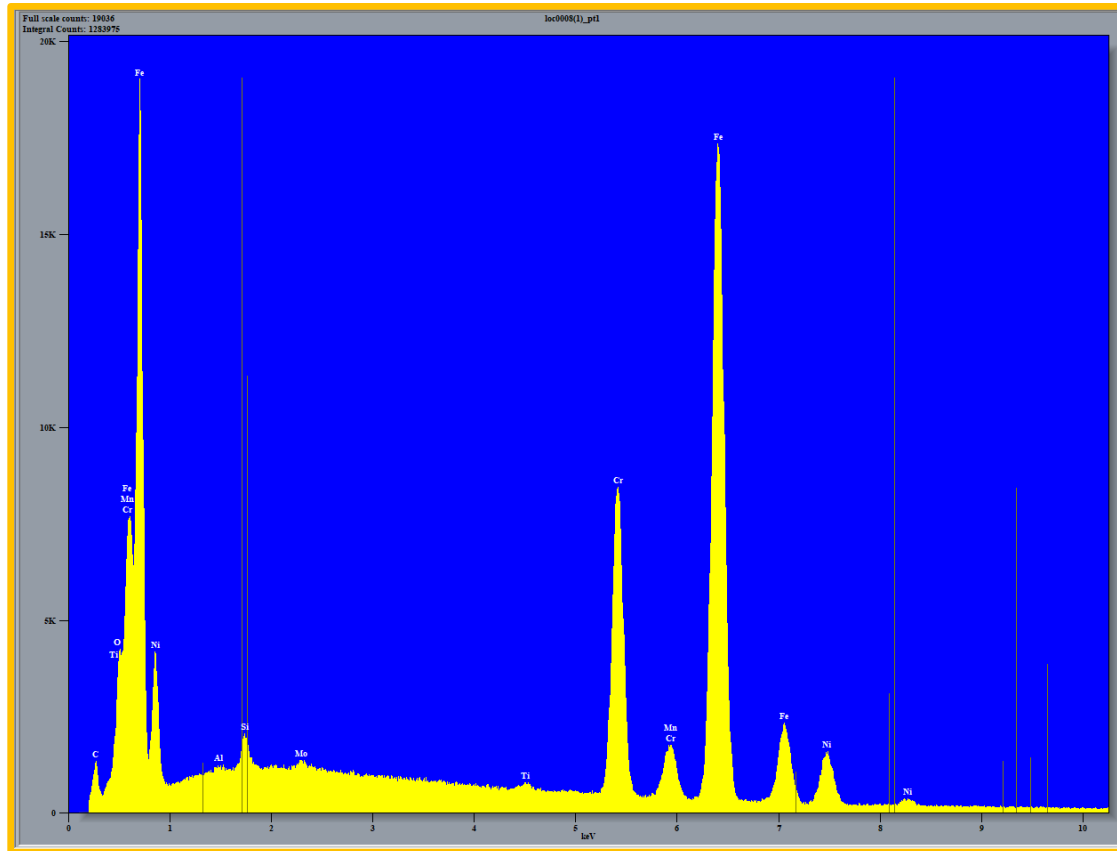
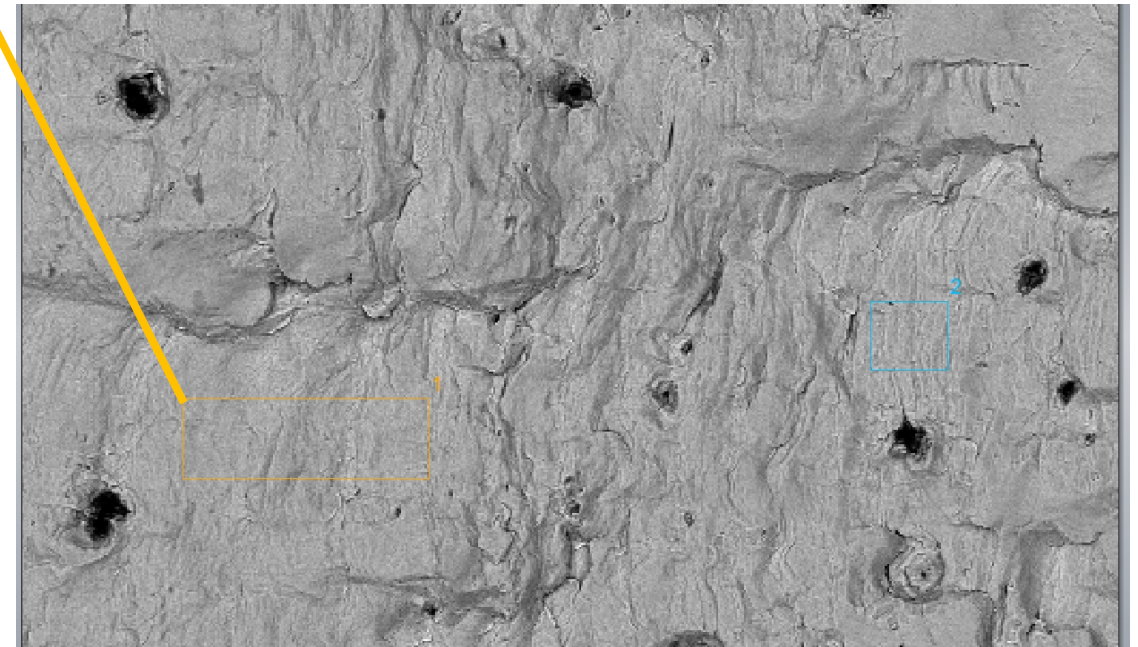
FIGURE 13: SEM EXAMINATION OF CP09 CRACK SURFACE EDS EVALUATION NEAR LOCATION 9

EDS Spectra of sub-region 1 (sub-region 2 was very similar). Composition was similar to the composition specified for tube, AMS 5557 321 SS.

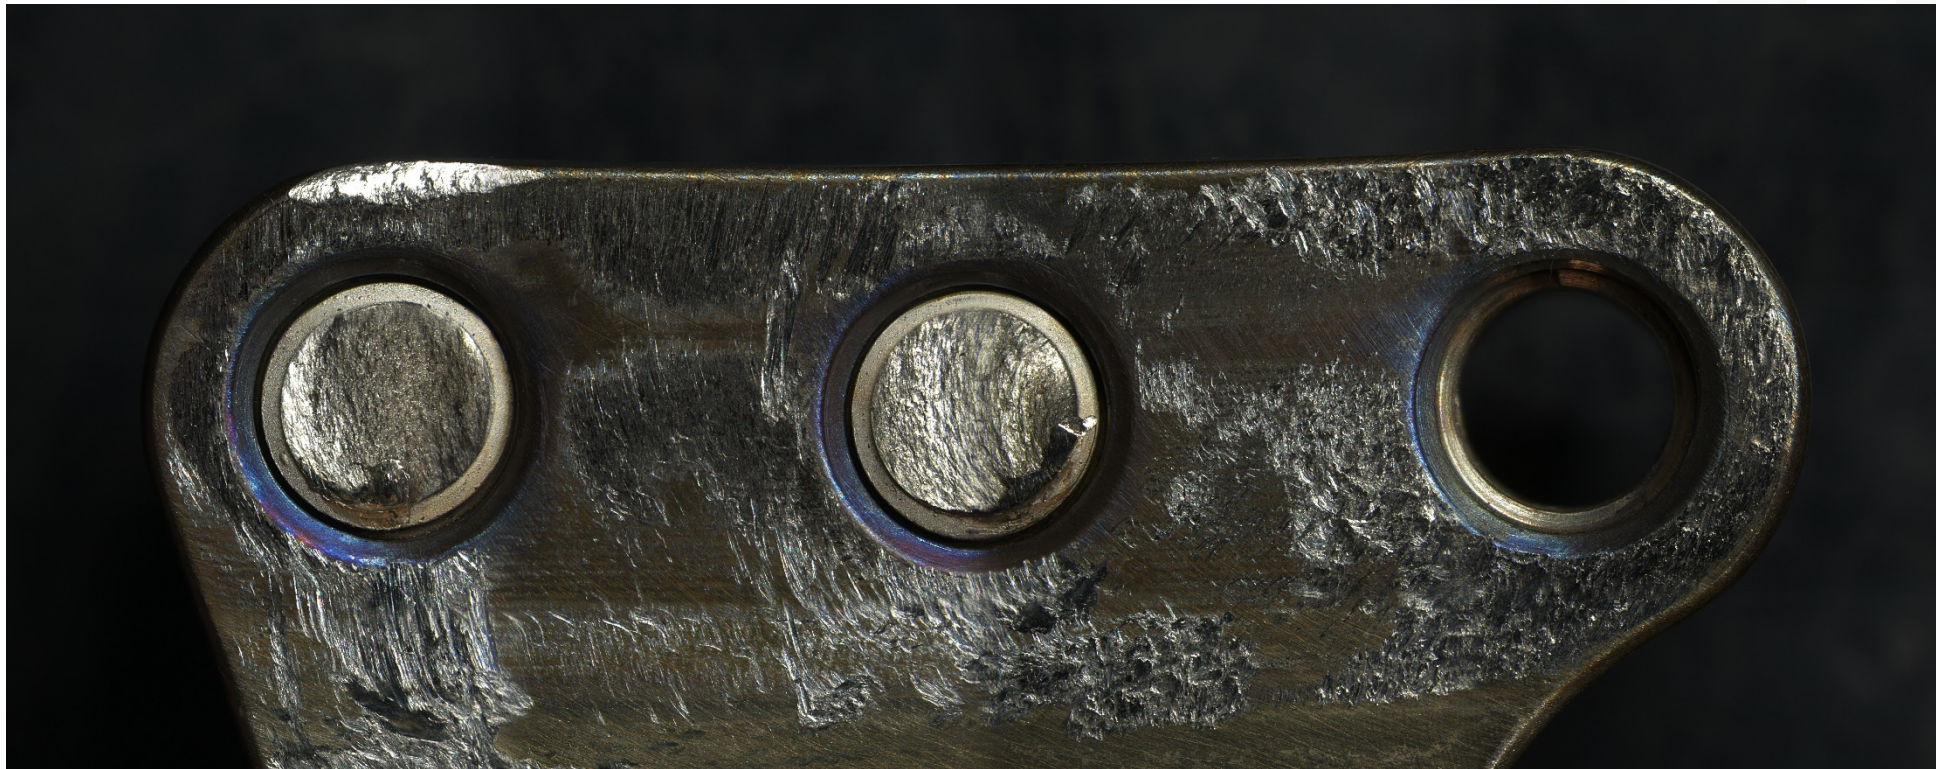
FIGURE 15: PN 5318316-01 TMS LOWER AFT CASE MOUNT – CLOSE-UP VIEW OF FRACTURED BOLTS AND SECONDARY DAMAGE

The fractured ST1503-12 bolts in the PN 5318316-01 TMS Lower Aft Case Mount were examined. Optical review revealed that the fracture surfaces and surrounding area of the case mount exhibited large area fractions of secondary damage (**Figure 15**). Both bolts were examined using a SEM. All regions of both fracture surfaces that were not smeared with secondary damage exhibited dimpled fracture features, indicative of an over-stress fracture mode (**Figures 16 and 17**). Microscopic inspection of the intact bolt associated with this assembly found cracks in several thread roots. The bolt appeared to be straight; there was no evidence of bending. The cracking was documented from three different rotational orientations of the bolt, as shown in **Figures 18 – 20**. A crack was fractured open, and the resulting exposed surfaces are shown in **Figure 21**. Optical microscopic review of the crack surface revealed features typical of shear overstress. SEM examination found dimples similar to those documented for the fractured bolts over much of the surface (**Figures 22 and 23**). However, a short, shallow band of striated fatigue progression was observed along the outer diameter as shown in **Figure 24 and Figure 25**.

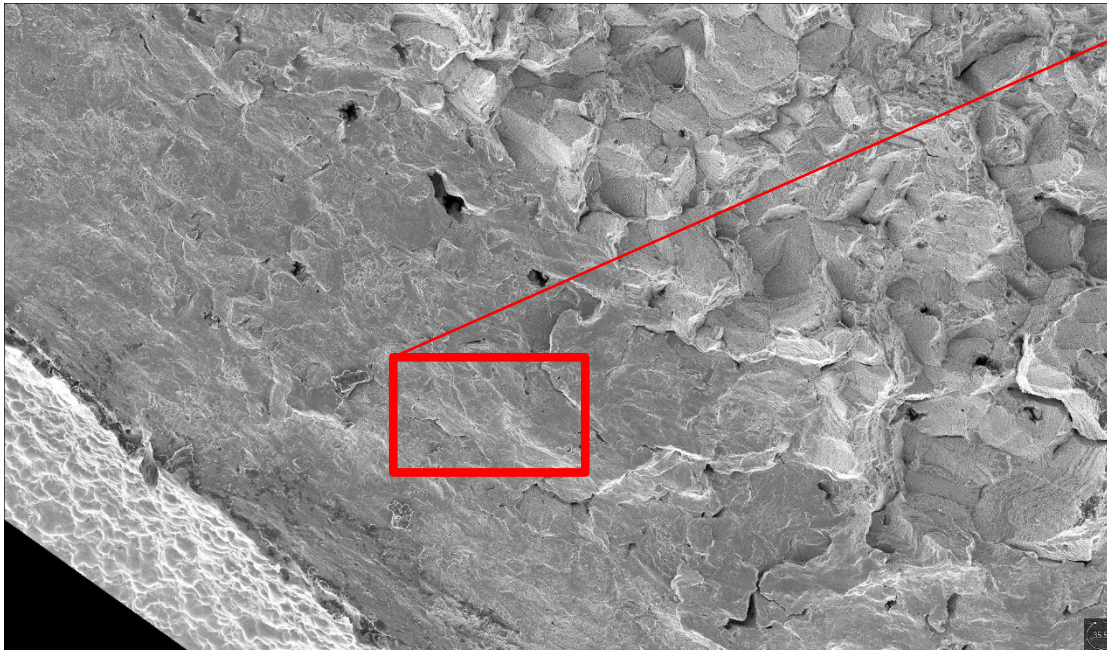
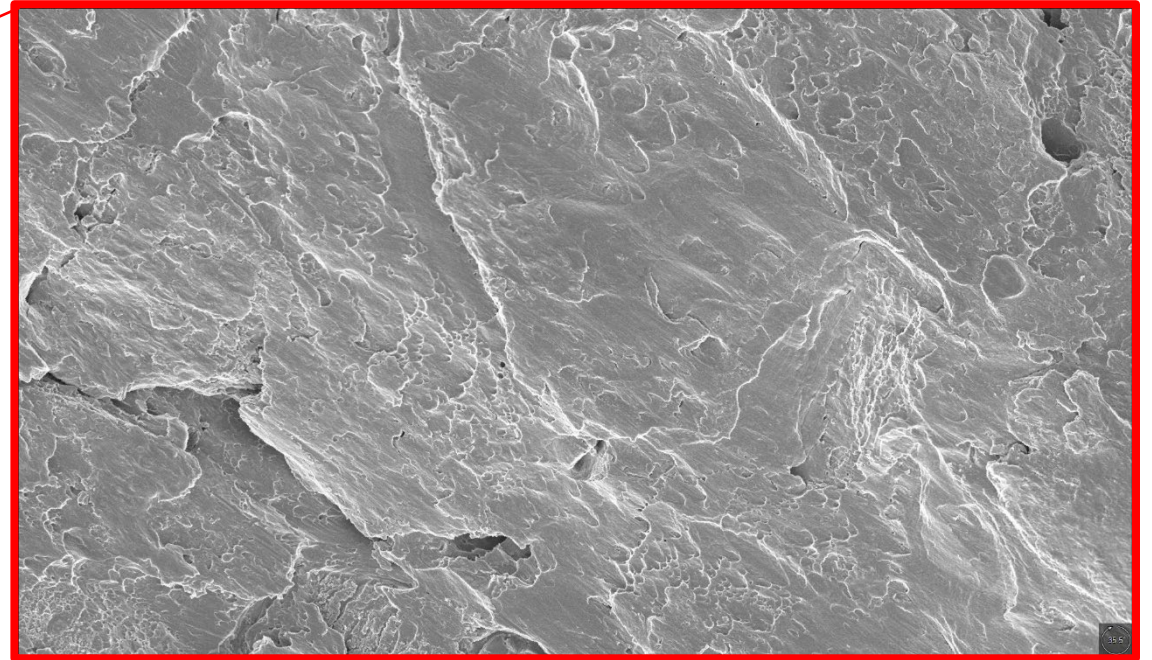
FIGURE 22: PN 5318316-01 TMS LOWER AFT CASE MOUNT; SEM VIEWS OF OPENED CRACK SURFACE

This region exhibits secondary damage of overstress (dimpled) features.

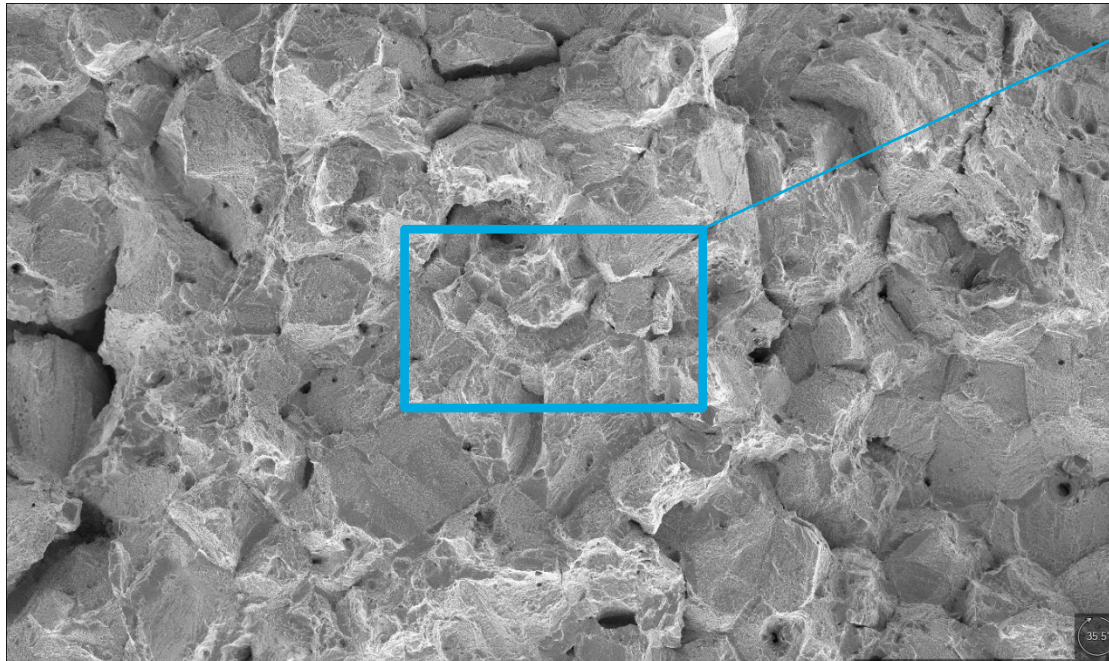
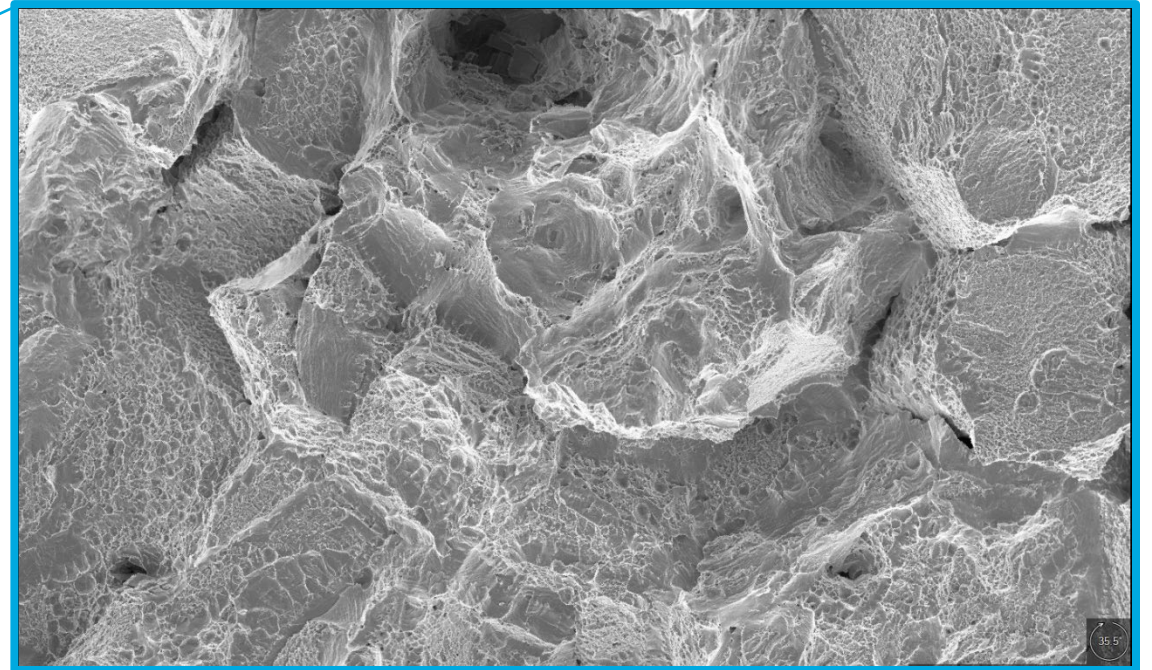
FIGURE 23: PN 5318316-01 TMS LOWER AFT CASE MOUNT; SEMP VIEWS OF OPENED CRACK SURFACE

This region exhibits secondary damage of overstress (dimpled) features.

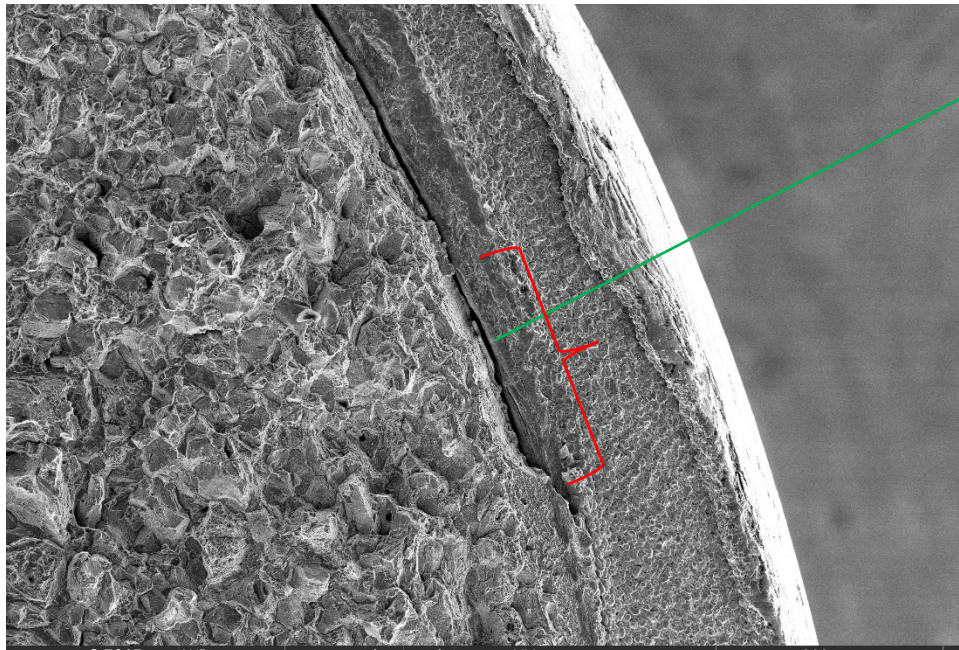
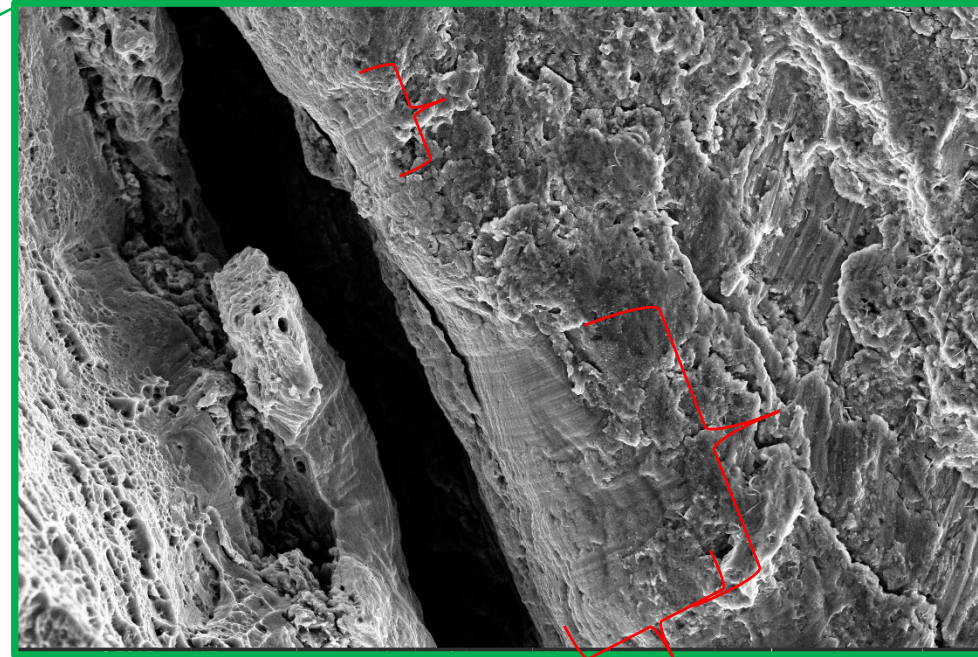
FIGURE 24: PN 5318316-01 TMS LOWER AFT CASE MOUNT; SEM VIEWS OF OPENED CRACK SURFACE

A shallow band of fatigue was observed in the region indicated with a brace.

Braces indicate fatigue; close-up images follow

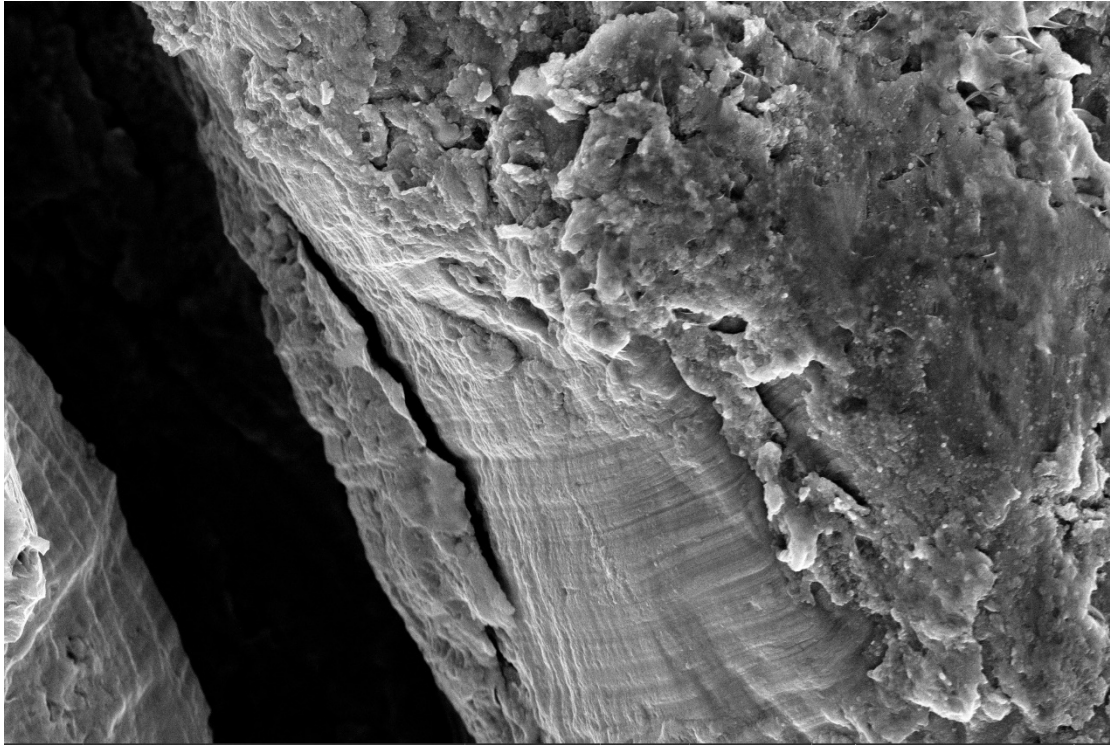
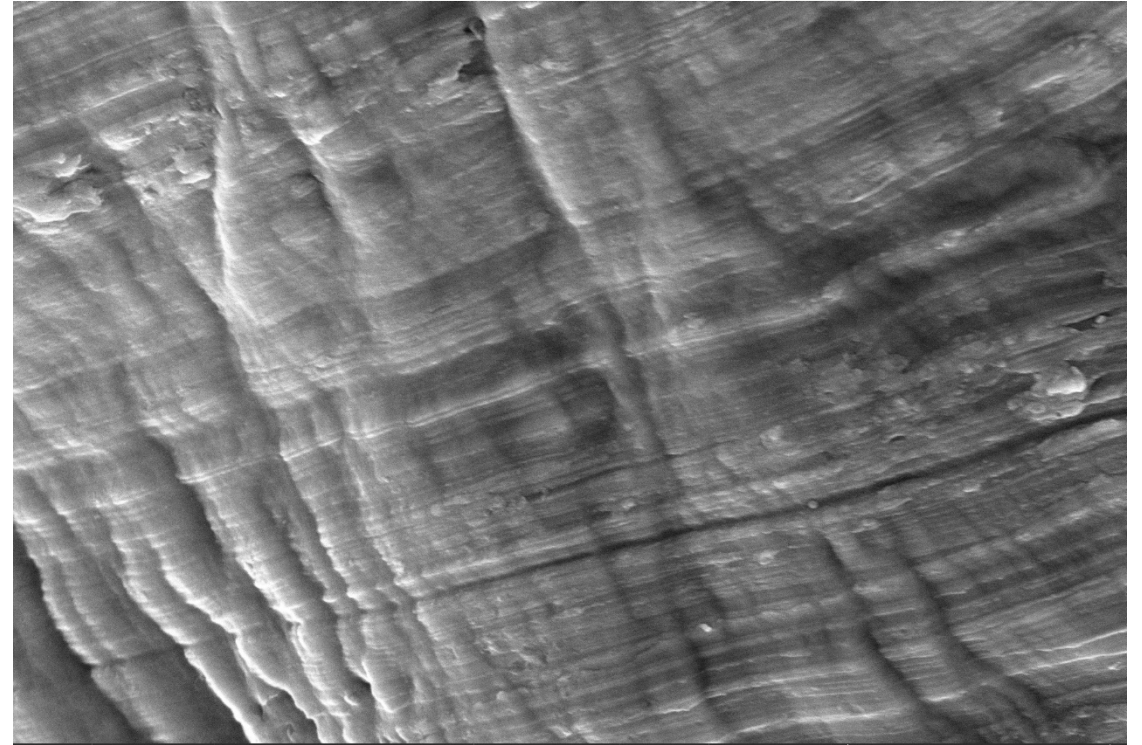
FIGURE 25: PN 5318316-01 TMS LOWER AFT CASE MOUNT; SEM VIEWS OF OPENED CRACK SURFACE

Striated fatigue origin region

Striated fatigue near the end of fatigue progression.

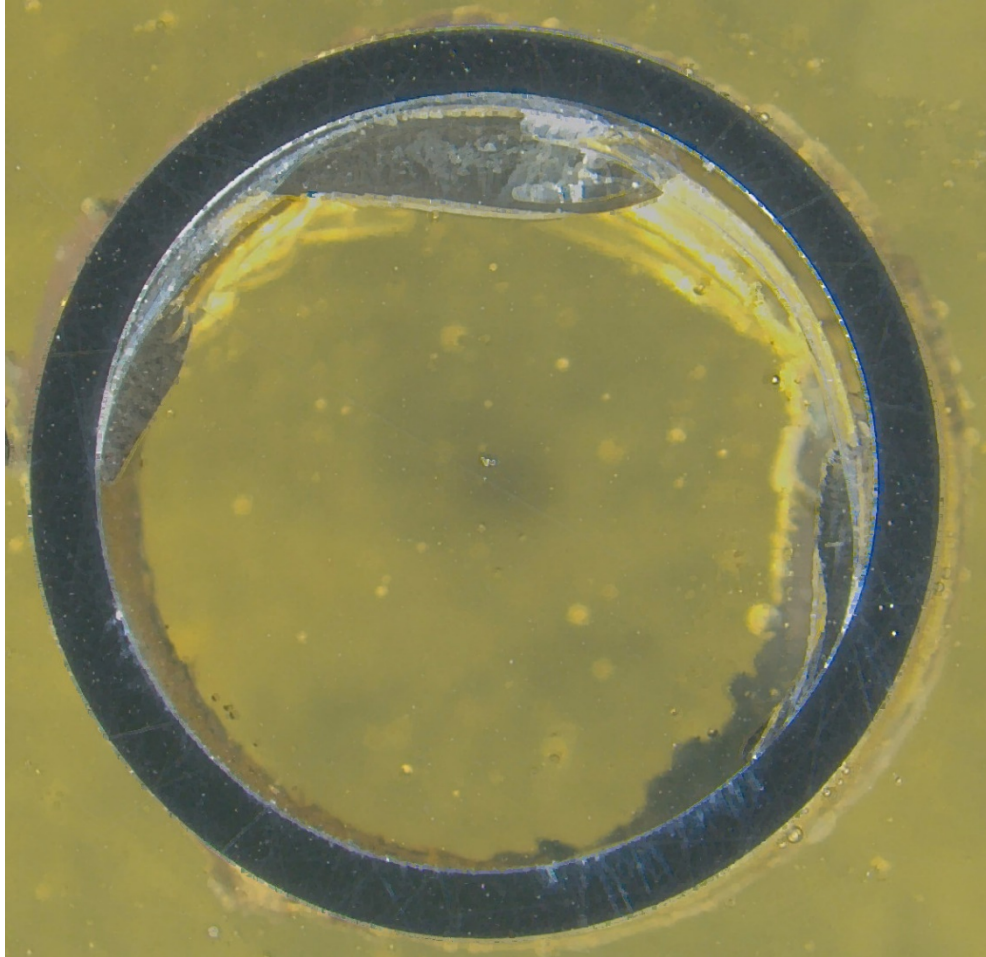
FIGURE 26: METALLOGRAPHIC SECTION THROUGH STRAIGHT REGION OF CP09 TUBE

Wall thickness was measured at 8 locations around the circumference and was within 0.001 inch of nominal thickness.

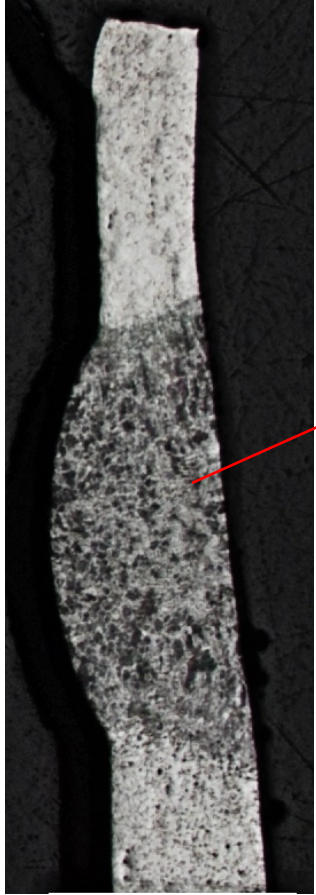
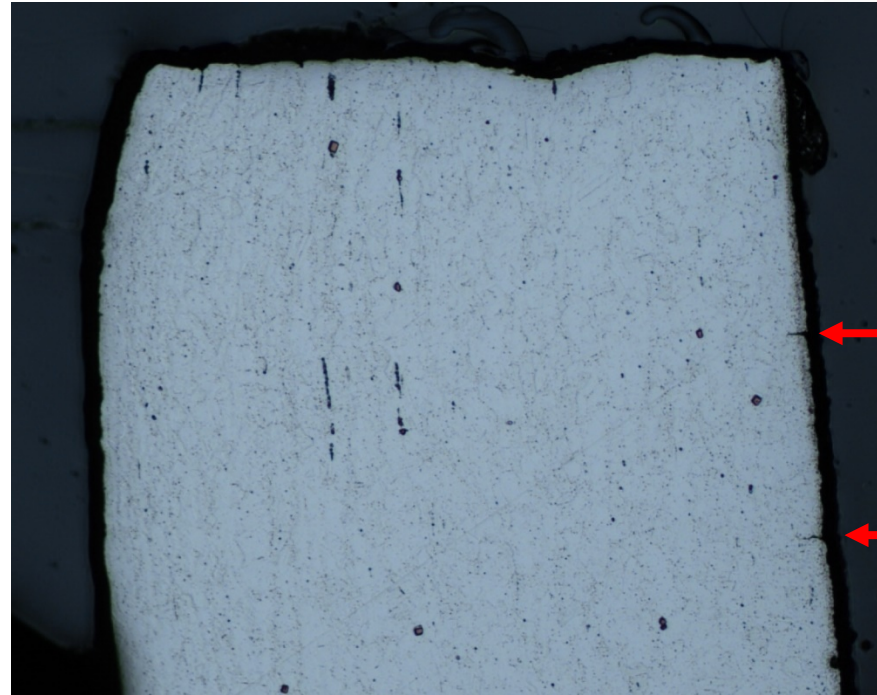
FIGURE 28: ETCHED METALLOGRAPHIC SECTIONS FROM CP09 TUBE

Two parallel secondary cracks were apparent at the indicated locations. Grain size was 9.

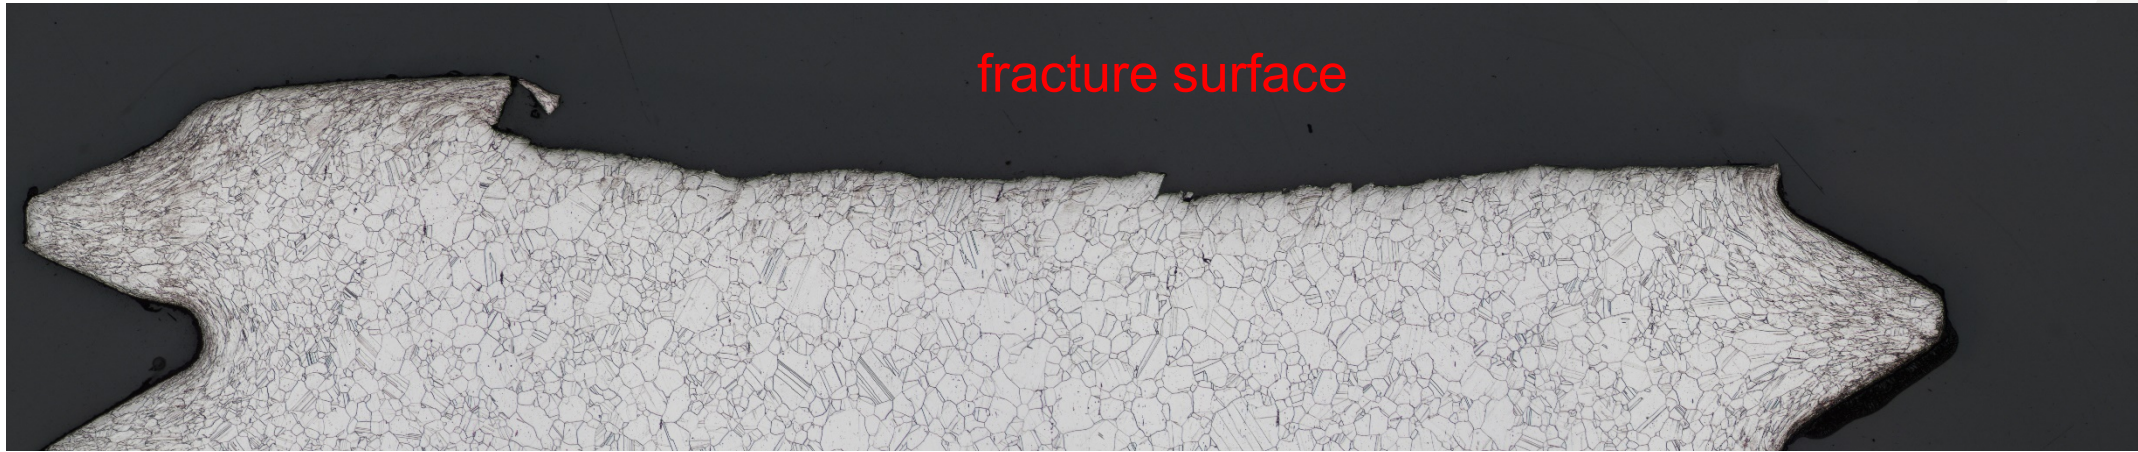
FIGURE 29: ETCHED METALLOGRAPHIC SECTION THROUGH A ST1503-12 BOLT FRACTURE SURFACE

Metallographic review of a ST1503-12 bolt revealed that grain size of the bolt was 6, which conformed to the AMS 5708 requirement of 3 or finer (**Figure 29**). Hardness of the bolt was measured at 5 locations and ranged from 37.3 to 39.2 HRC, which conformed to the AMS 5708 requirement of 32-42 HRC. The fracture surface was predominantly intergranular

Grain size of the bolt was 6, which conformed to the AMS 5708 requirement of 3 or finer. Fracture surface was predominantly intergranular.
