Chip Damage Evaluation for WPR19FA154

S.R. Cain, IEEC, Binghamton University

Prepared for the National Transportation Safety
Board

December 12, 2019

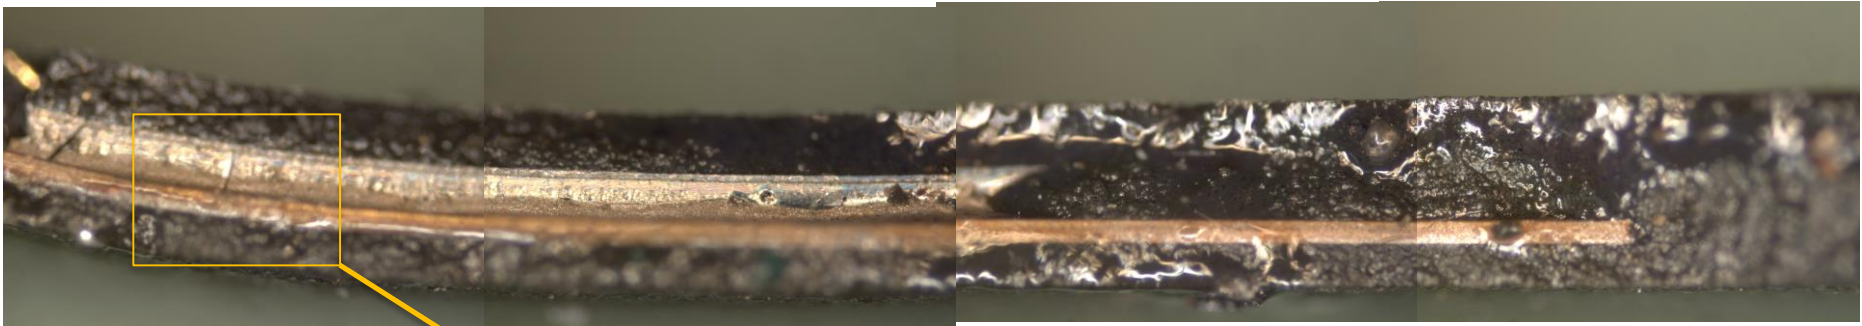
Stitched Images taken at 50x: note the bend in the package

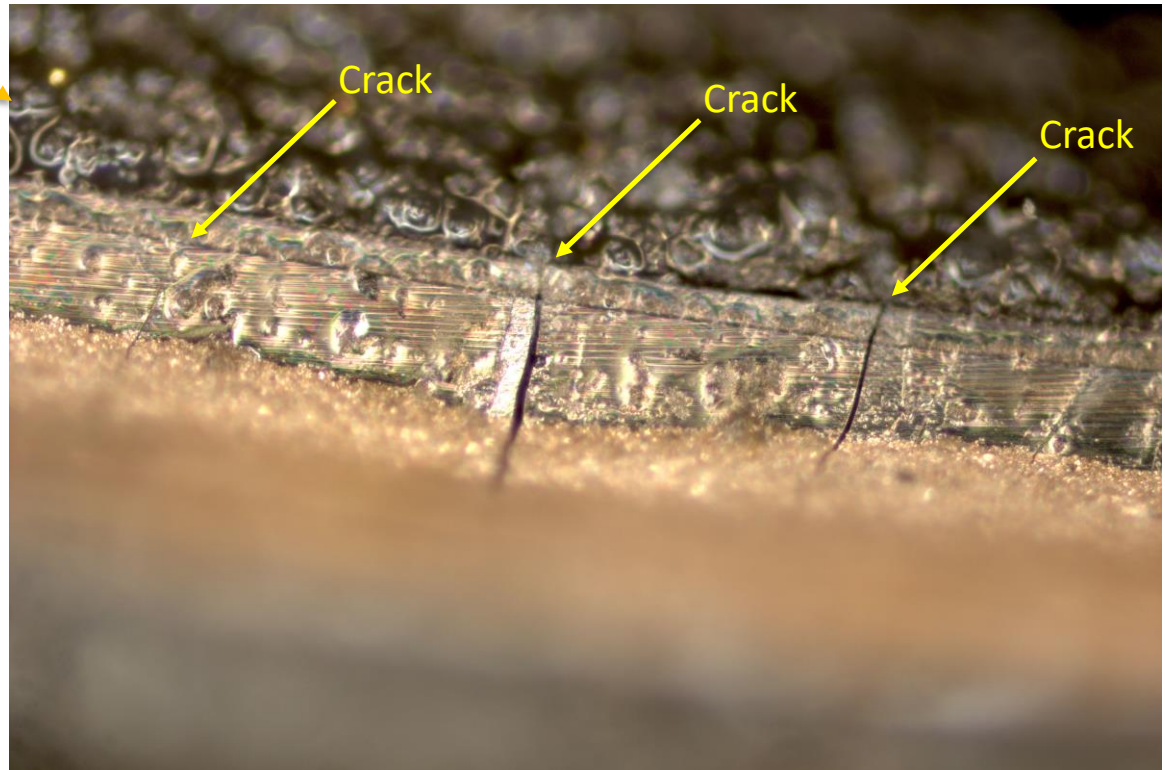
Image of the end segment at higher magnification (100x)

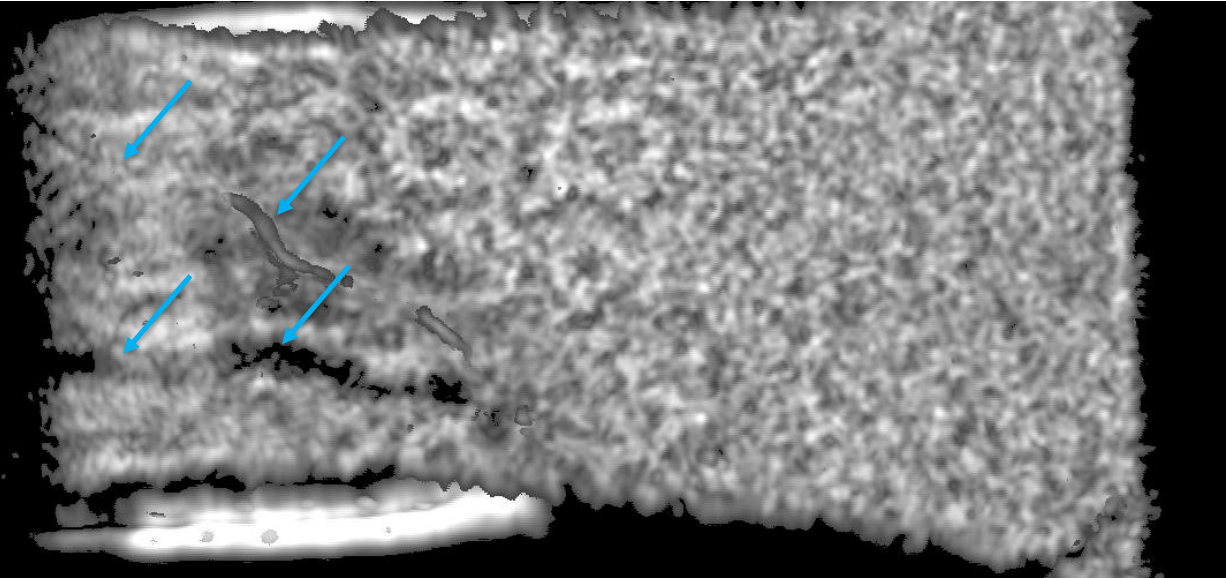
Surface

The bend deflected the sonic pulse away from the transducer: this region could not be imaged

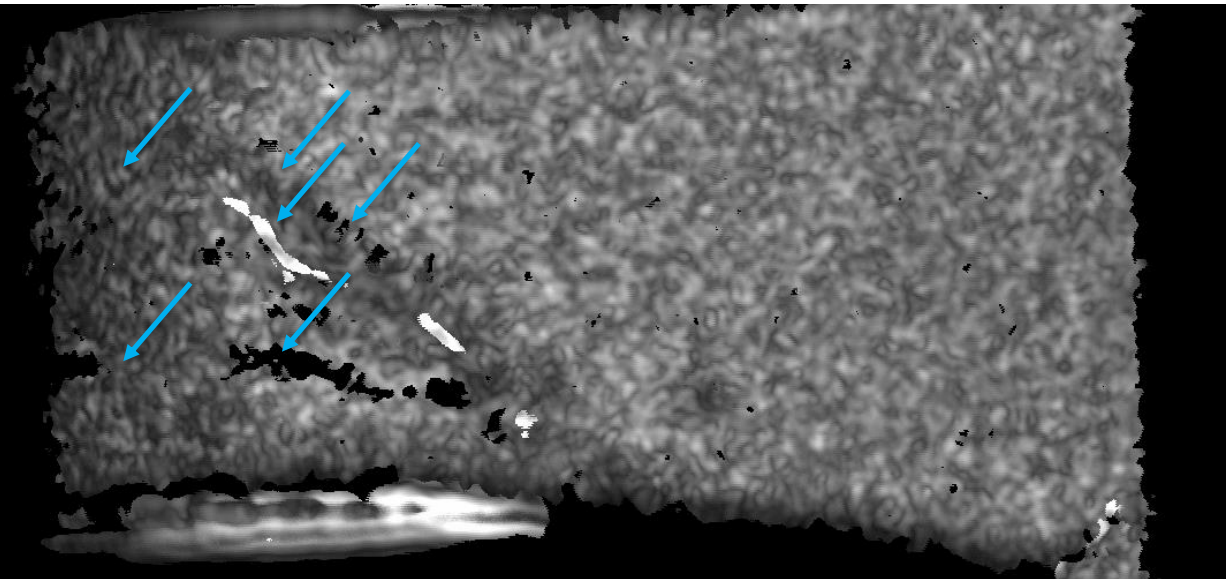
Overmold

The bend deflected the sonic pulse away from the transducer: this region could not be imaged

Blue arrows indicate regions of suspect cracks

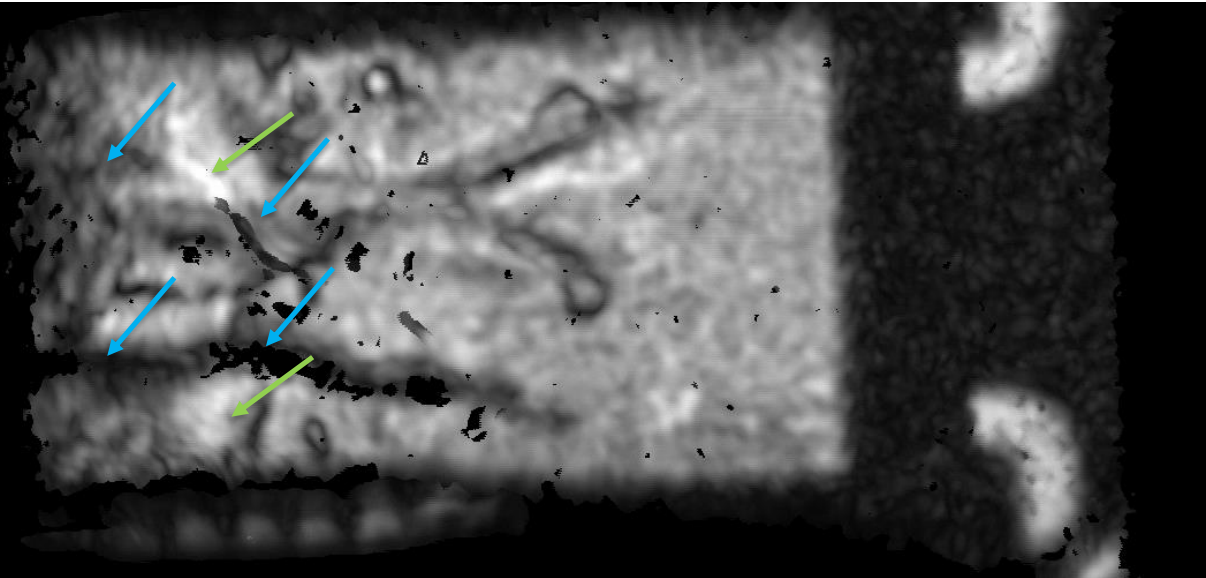
Chip

Disposition: the chip appears to be cracked, successful data recovery is highly unlikely

The bend deflected the sonic pulse away from the transducer: this region could not be imaged

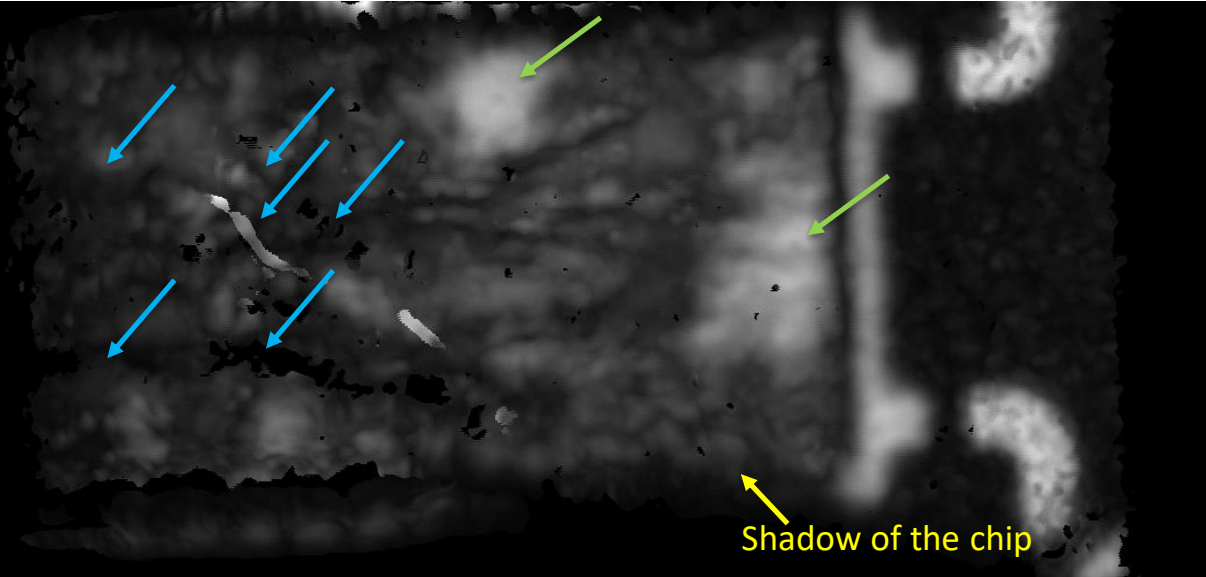
Lead Frame

The bend deflected the sonic pulse away from the transducer: this region could not be imaged
