Non-destructive testing of a ANC20LA004 Garmin memory package

- ANC20LA004 Garmin memory package, Samsung KLM8G2FEJA-A001 was received for non-destructive evaluation.
- The package was first imaged with a stereo optical microscope.

Repair Report for ANC20LA004

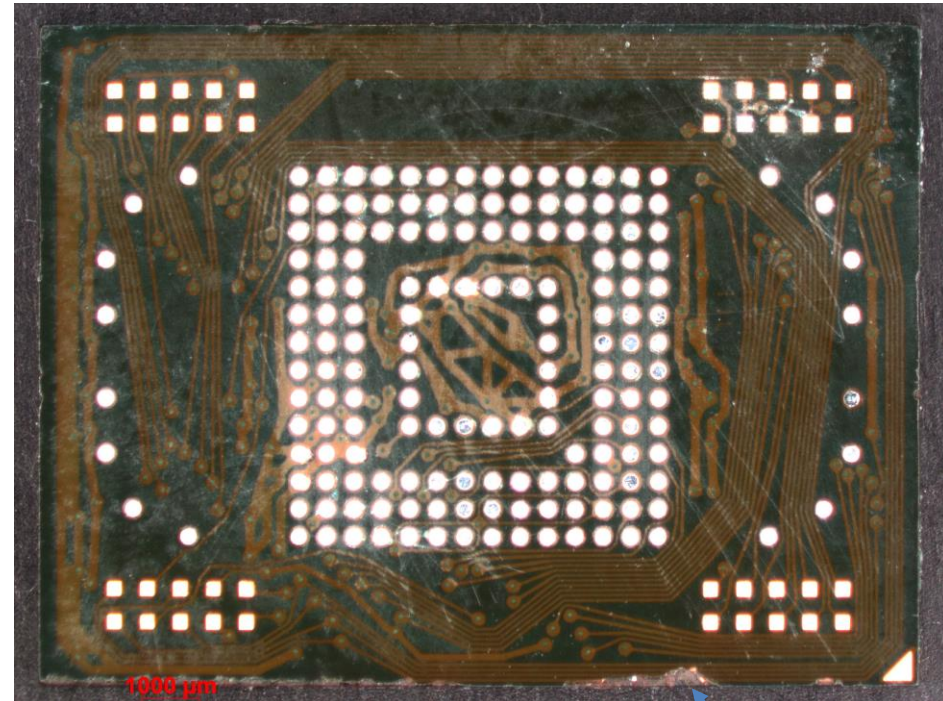
Backside of the memory package showing the chip carrier.

- Lower edge has some external damage.

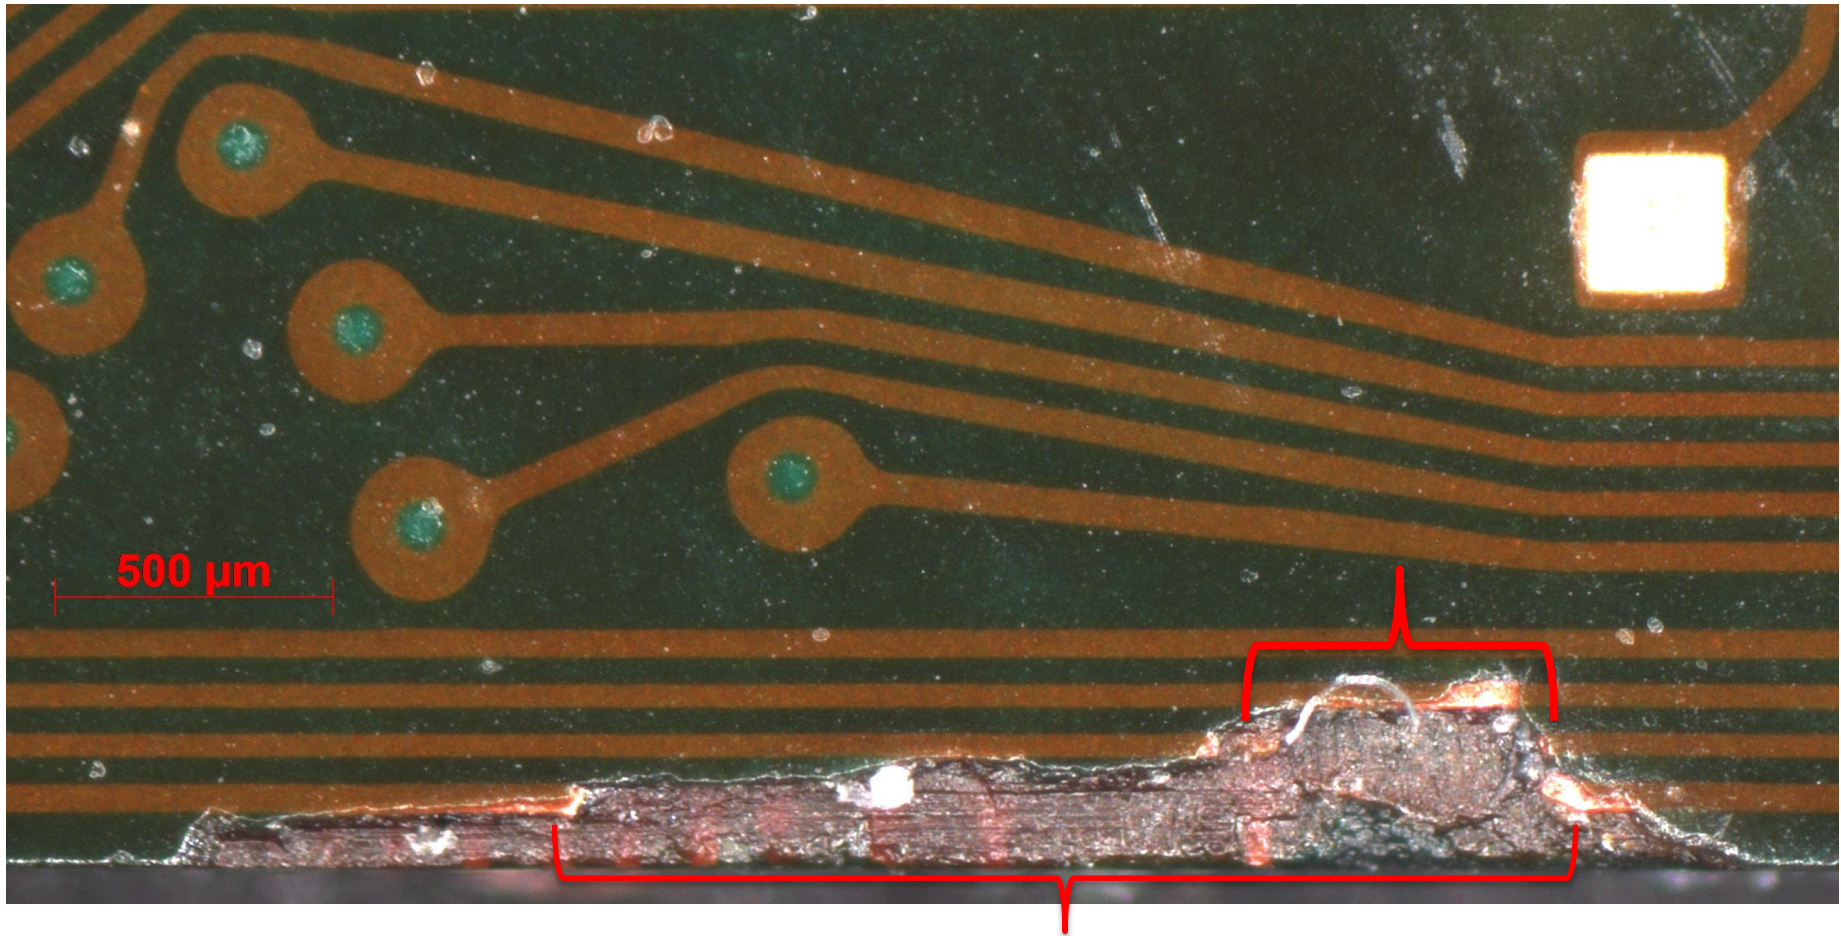
Optical image of the damaged area

Discontinuities in two Cu lines

The chip carrier has external damage at the bottom edge.

- Surface solder mask is peeled off.
- Some parts of two Cu lines are missing, making them open lines.

- No die cracks were found in any die.
 - There may be possible delaminations in the die attach and chip carrier.
- The only damage that is found, is the discontinuities of two Cu lines in the chip carrier. Since the damage is external, it can easily be fixed by metal deposition to make the two lines continuous.

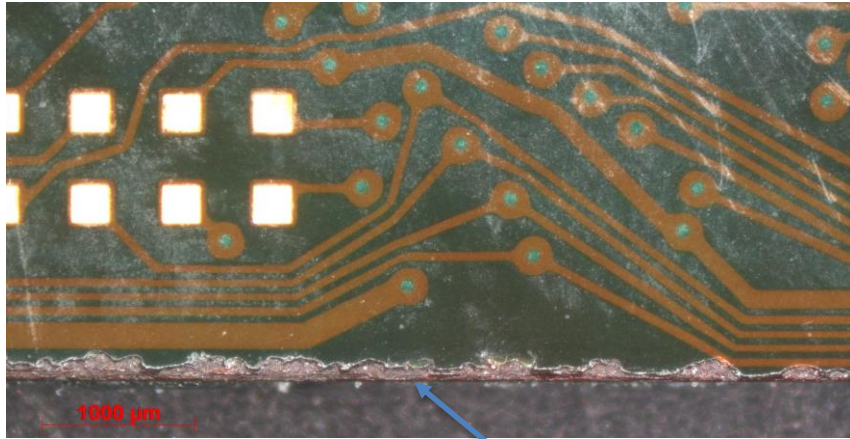
Backside of the package has external damage at the bottom edge.

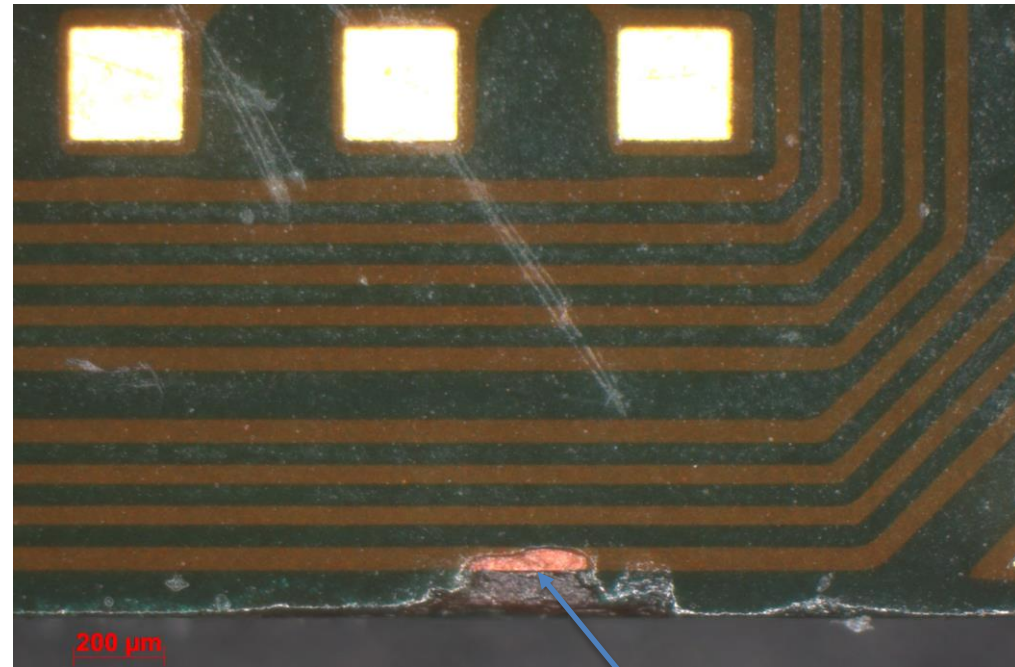
- Surface solder mask is peeled off exposing a Cu line. 5

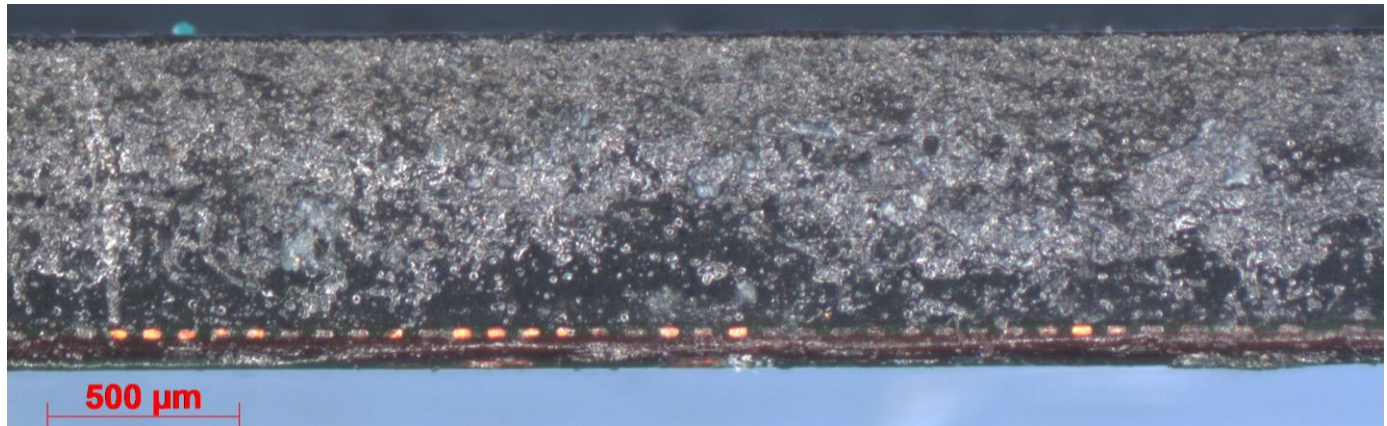
Damage to the chip carrier

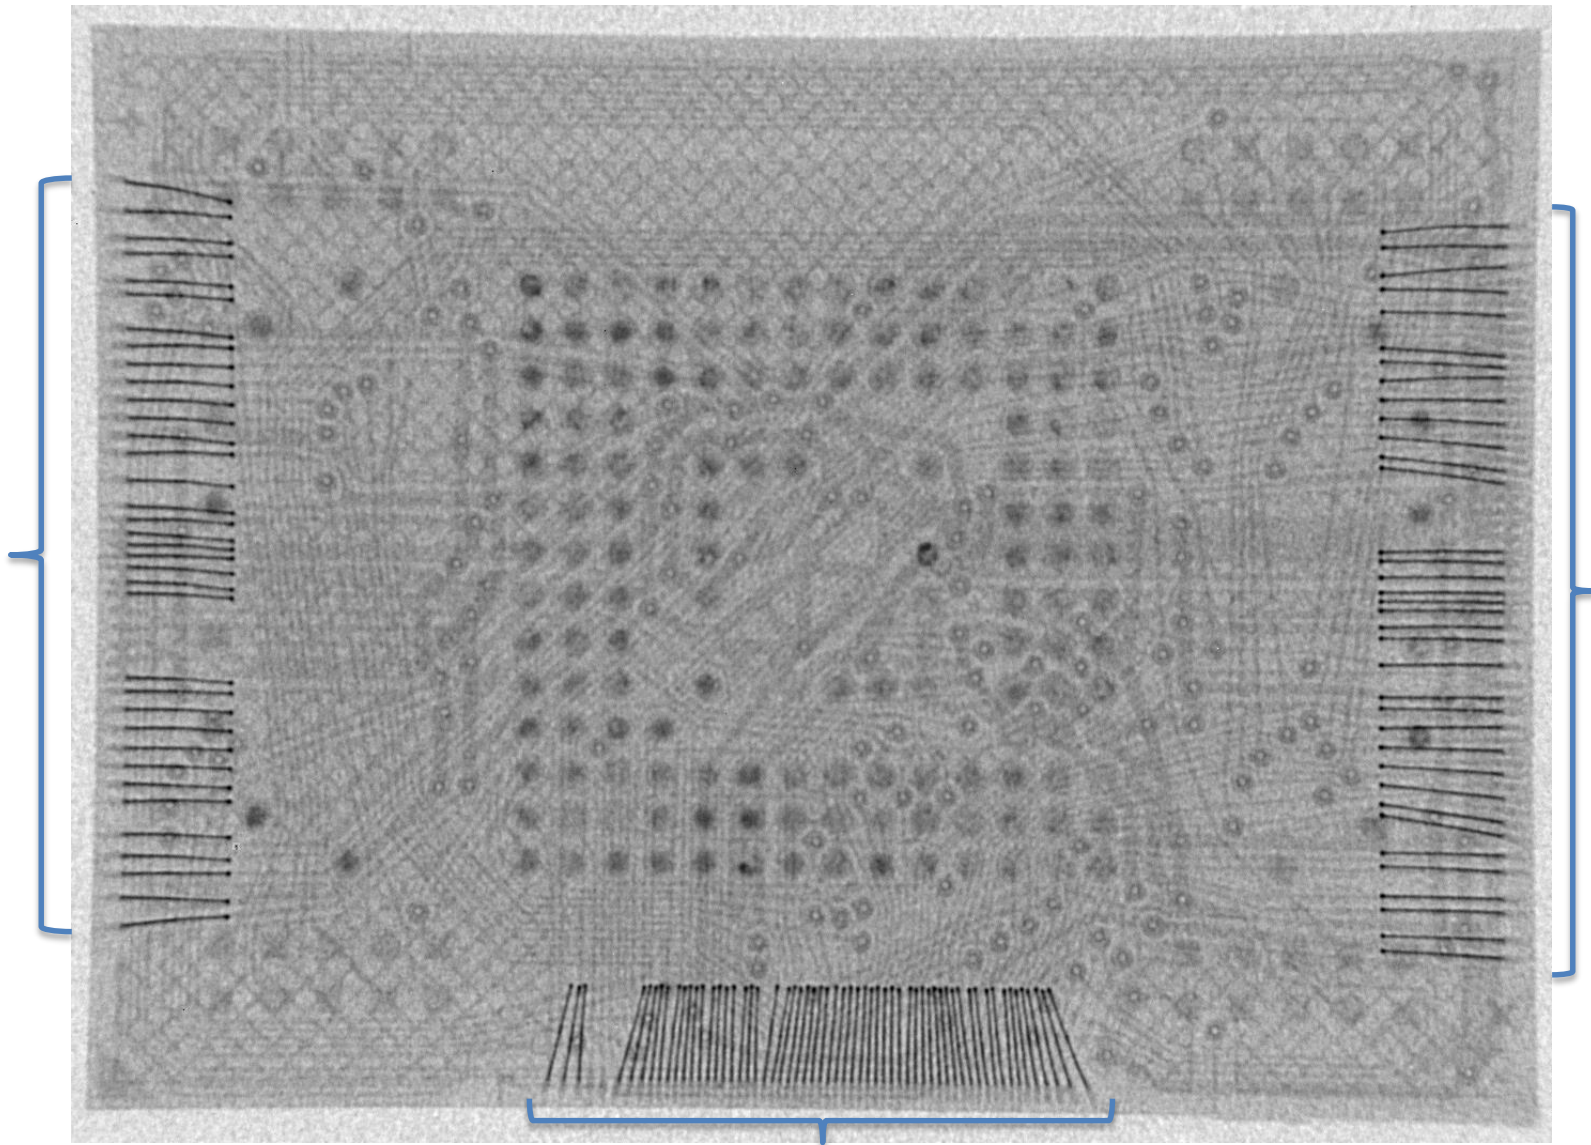
X-ray image of the package

Possibly contains multiple wire bonded dies

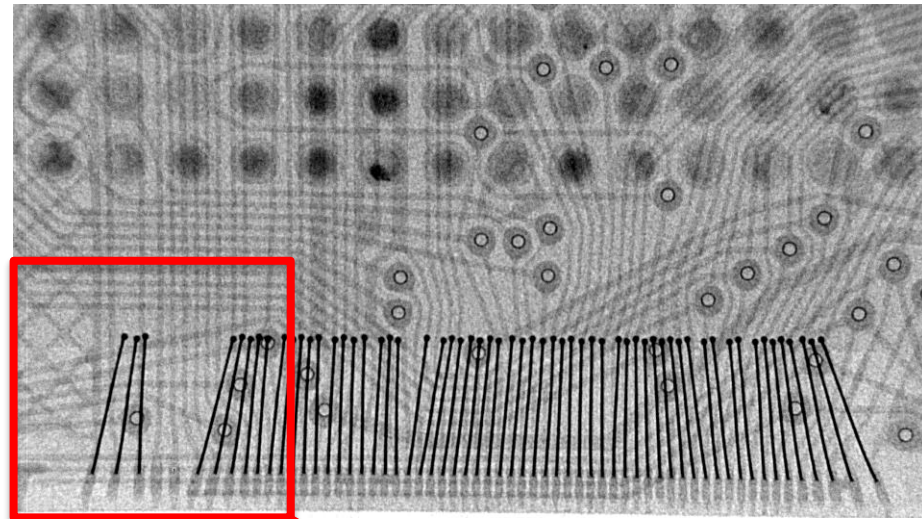
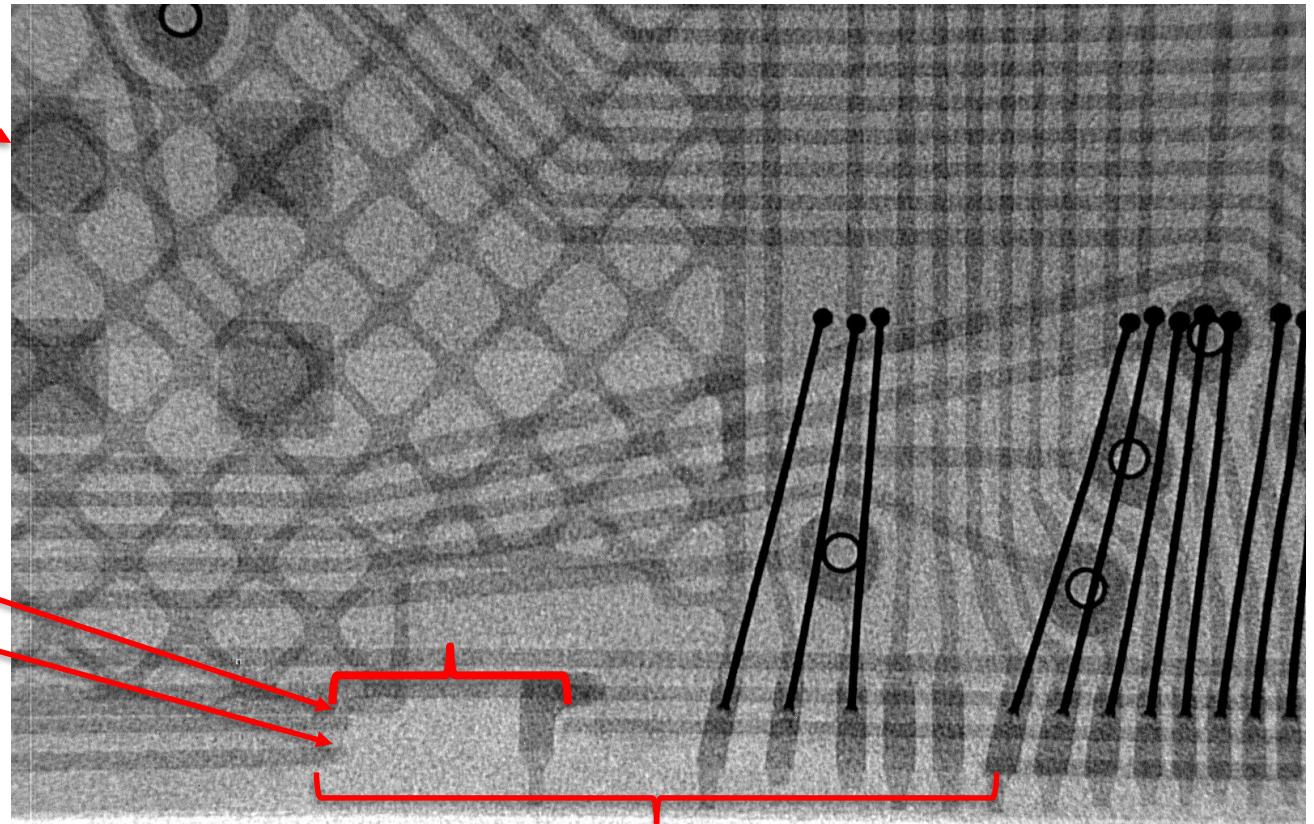
X-ray images of the package showing discontinuities in two Cu lines

Discontinuities in two
Cu lines

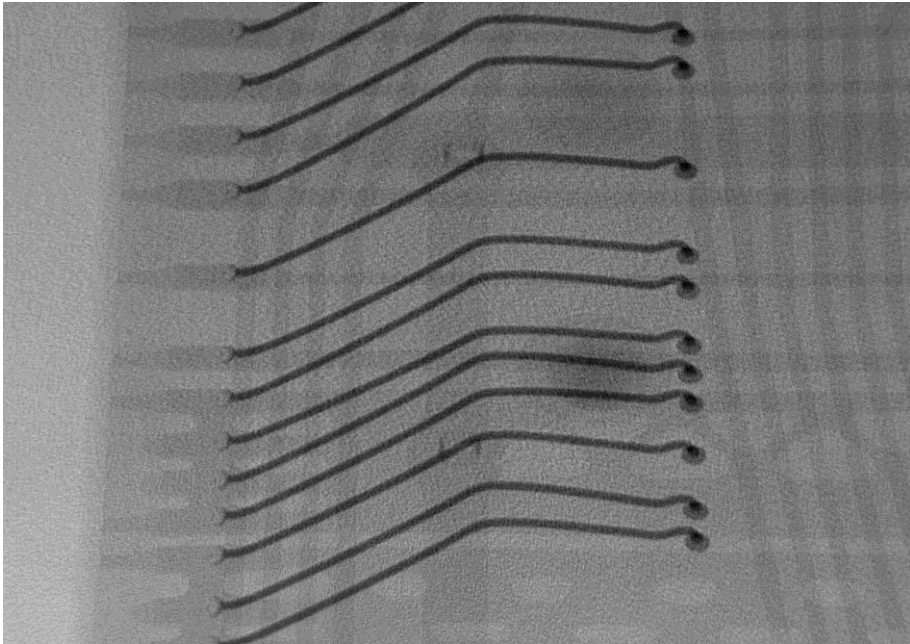
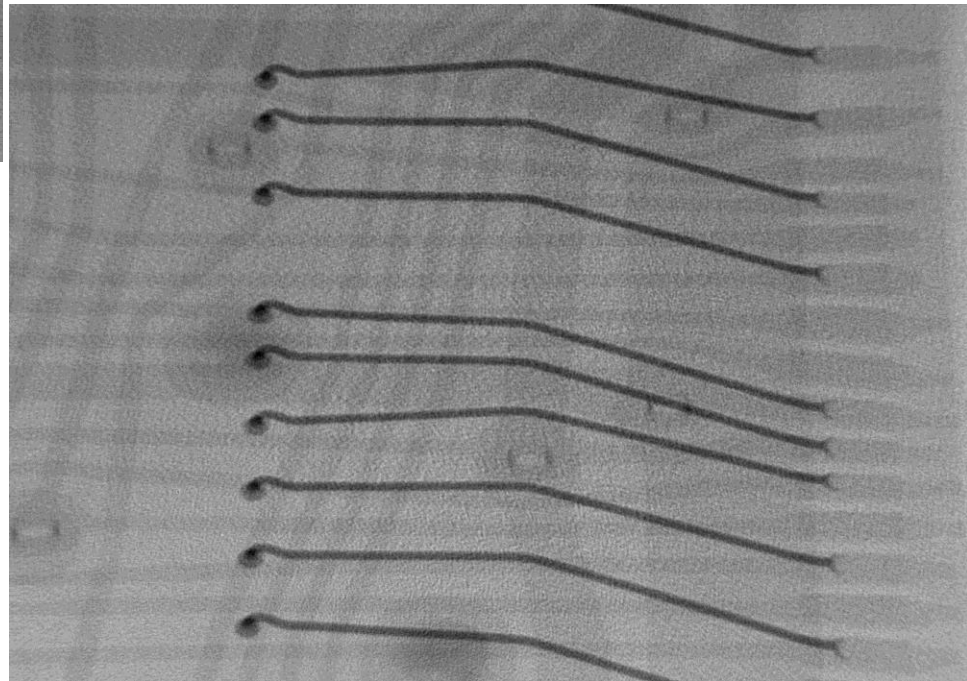
Wire bond images at oblique angles and high magnification.

No anomalies found in any wirebonds

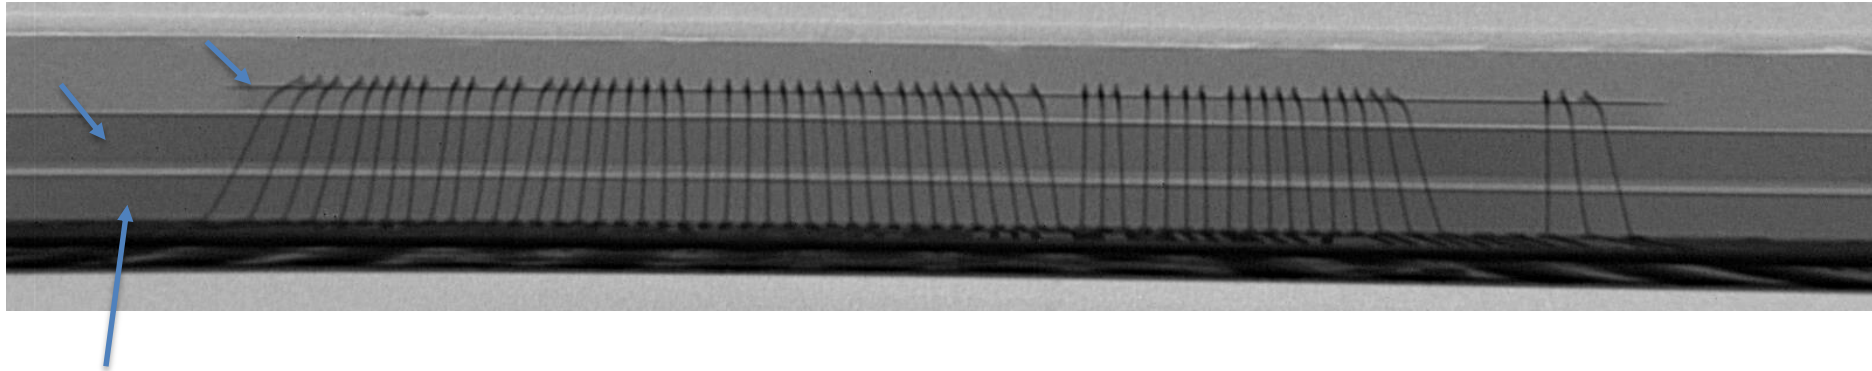
The package has 3 stacked dies. Each die has wire bonds on one edge

Arrows pointing to three stacked dies

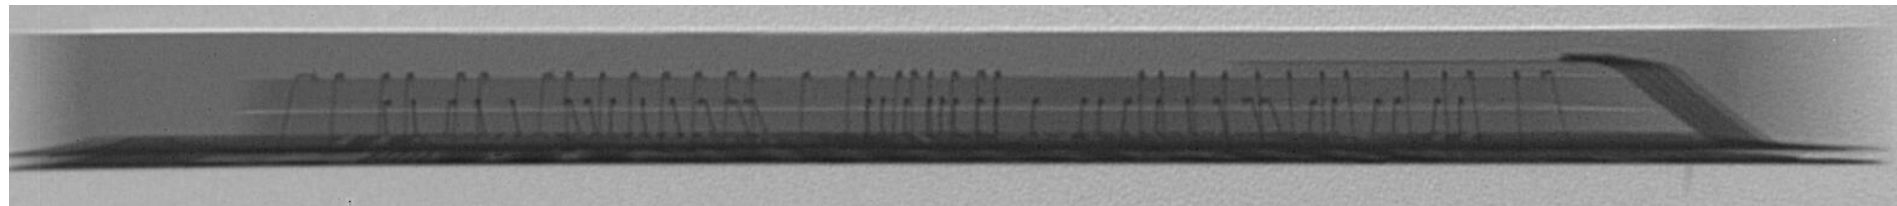
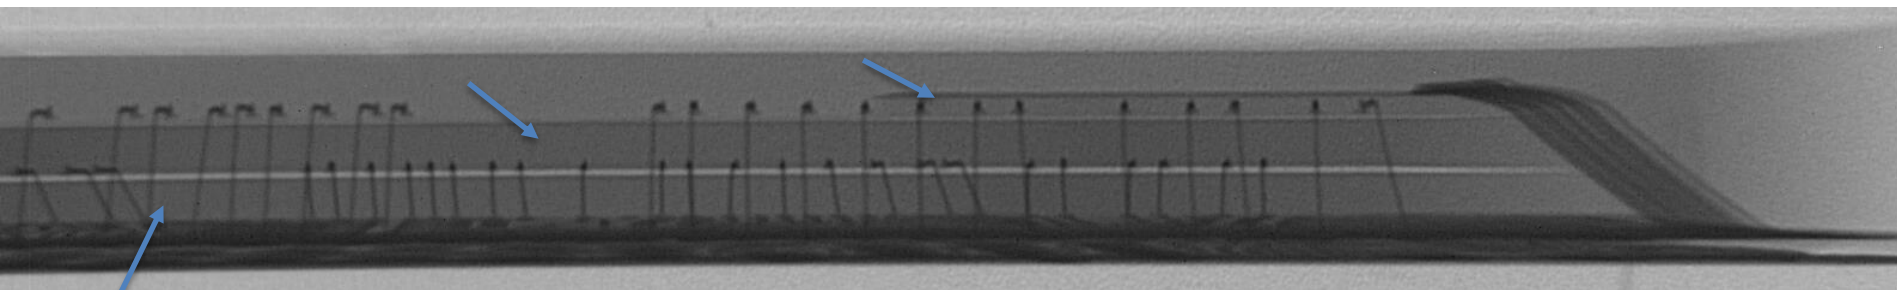
The package has 3 stacked dies. Each die has wire bonds on one edge

Arrows pointing to three stacked dies

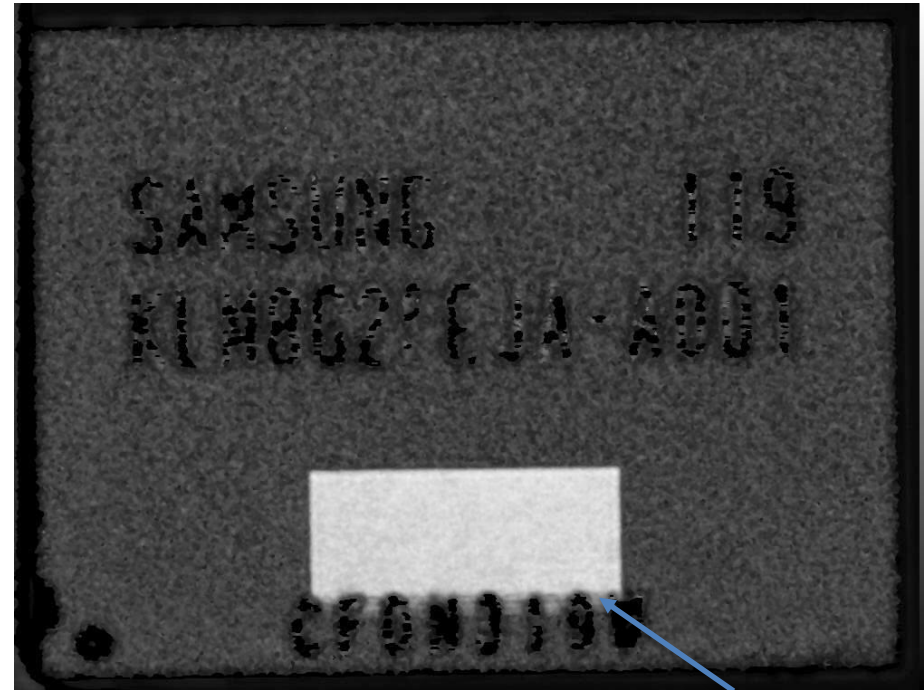
Small die (#1) with wirebonds on the bottom edge

Topmost, small die in the package. No die cracks found.

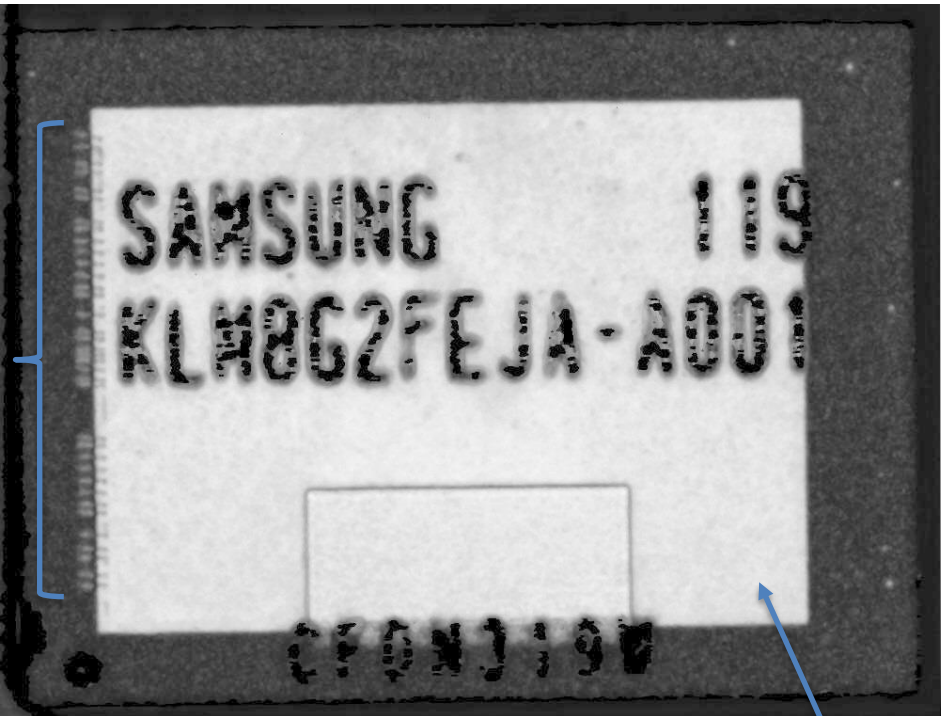
Die #2

- No die cracks detected.
- Wire bonds on left edge

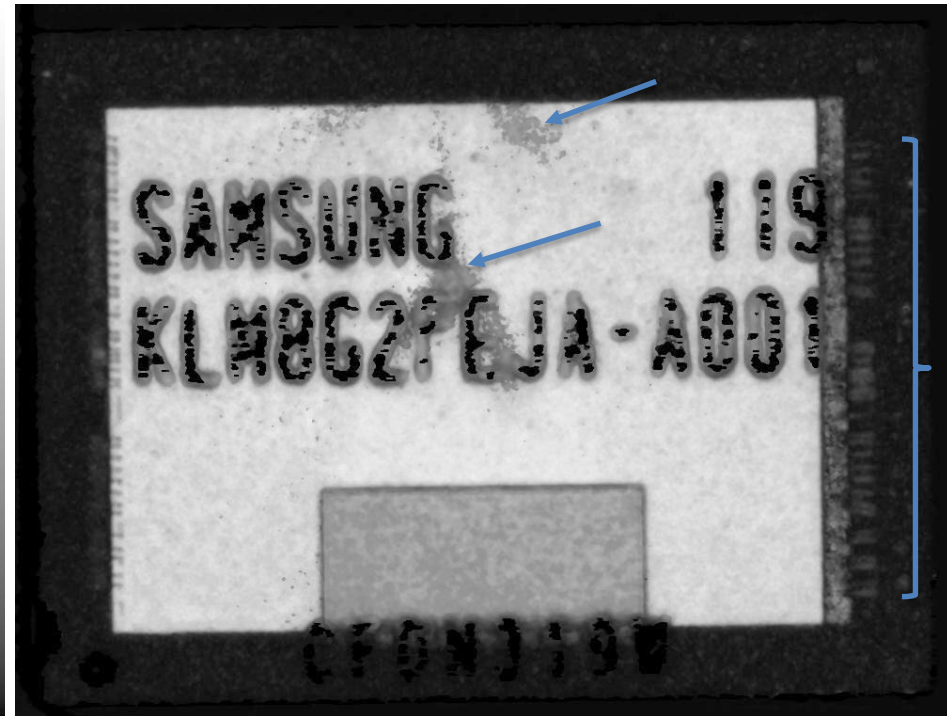
Backside of die#2

- Arrows indicating possible die attach delaminations
- Wirebonds of die#3 can be seen on the right edge

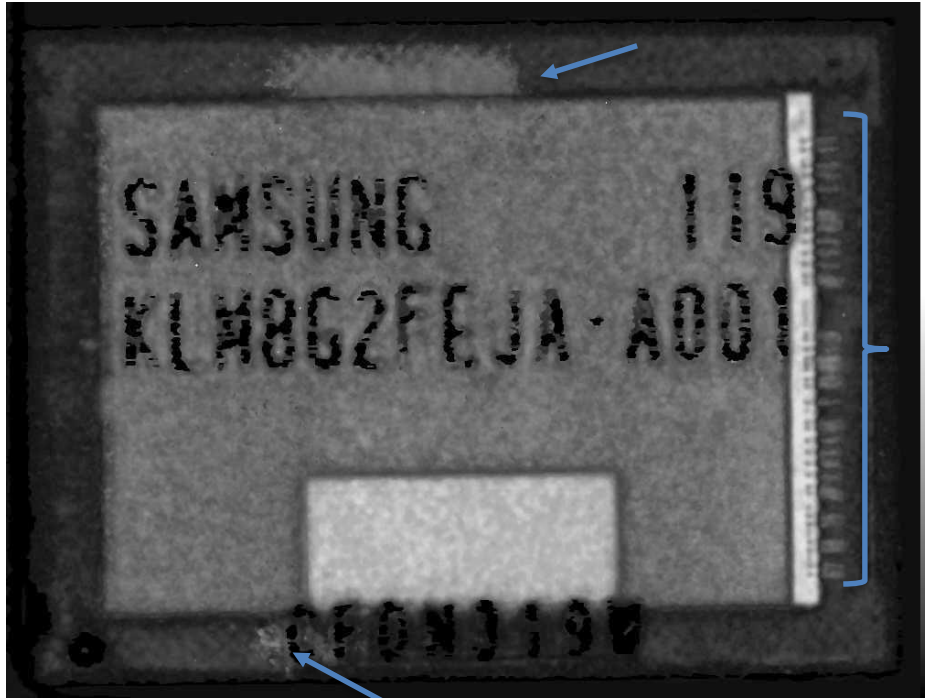
Image of die # 3

- wirbonds on the right edge.
- No die cracks found
- Arrows pointing to brighter areas: may be possible delaminations.

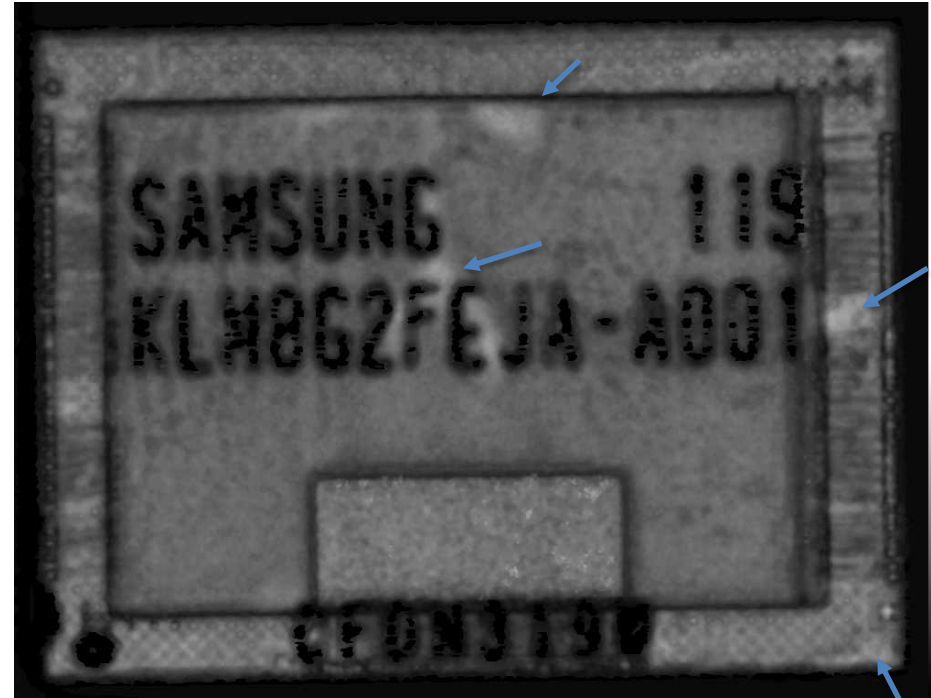
Image of the chip carrier.

- Arrows are pointing to brighter areas that may be possible delaminations

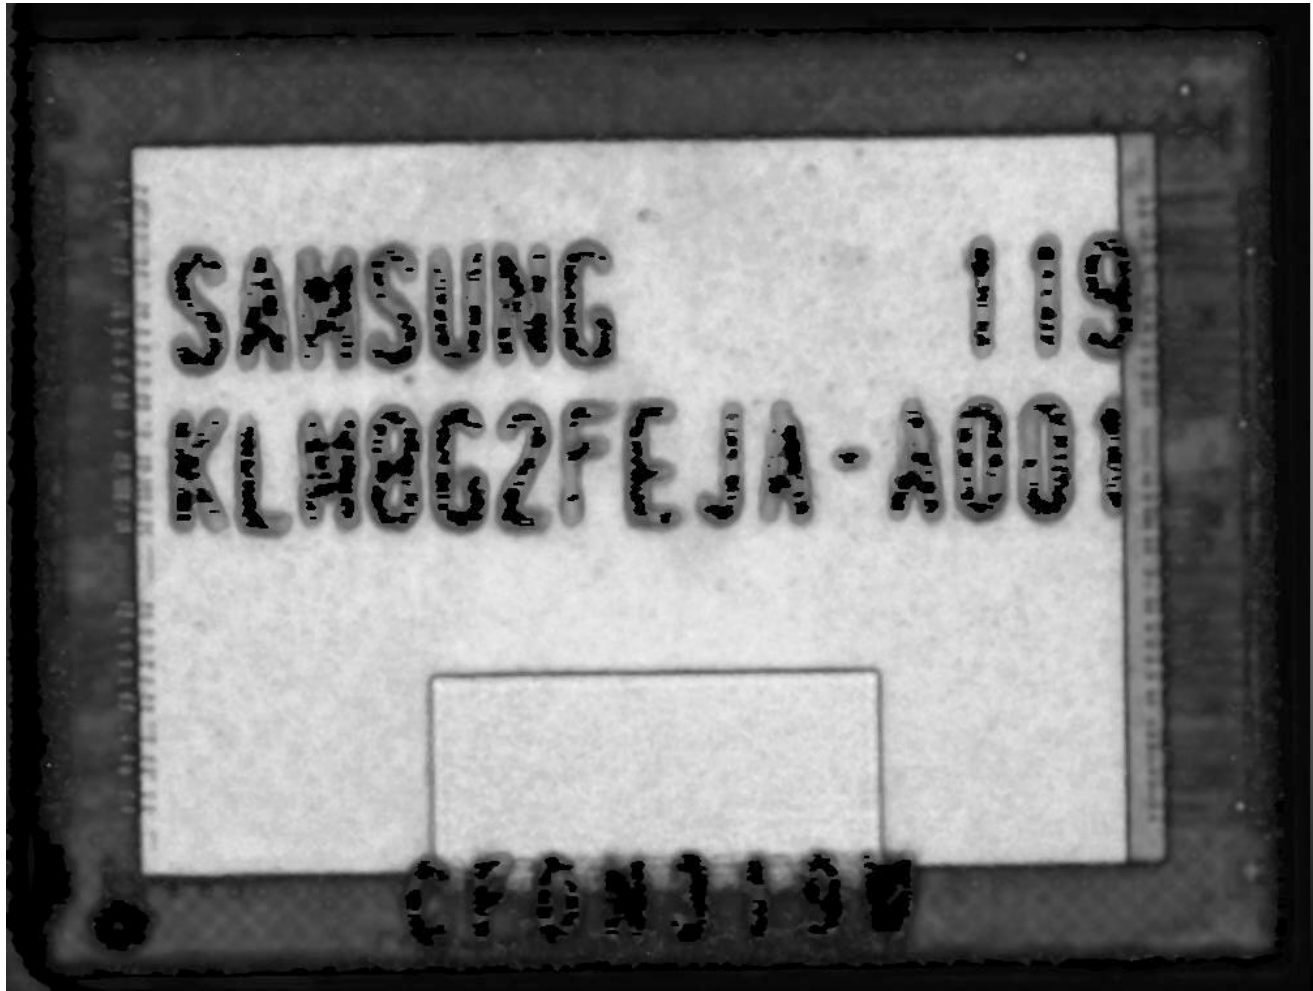
Composite image

No die cracks detected in any die.

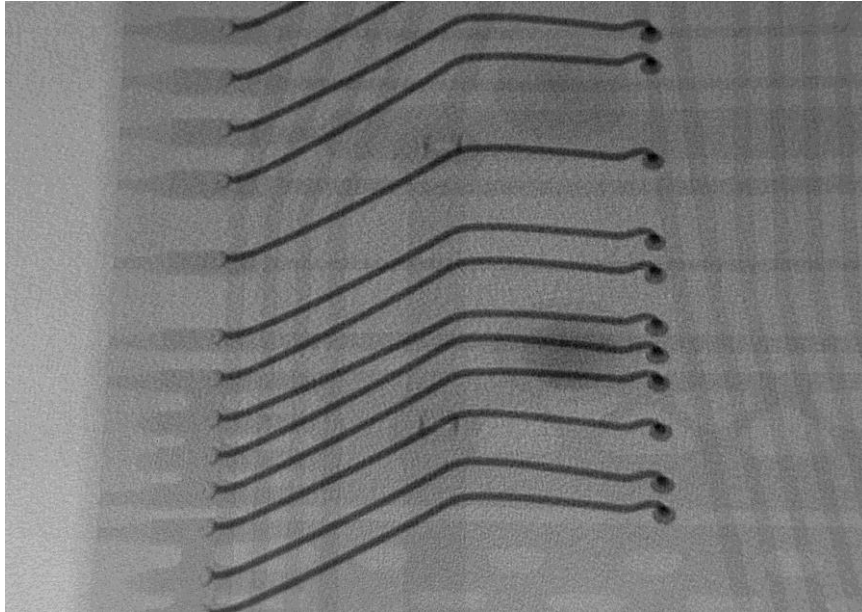
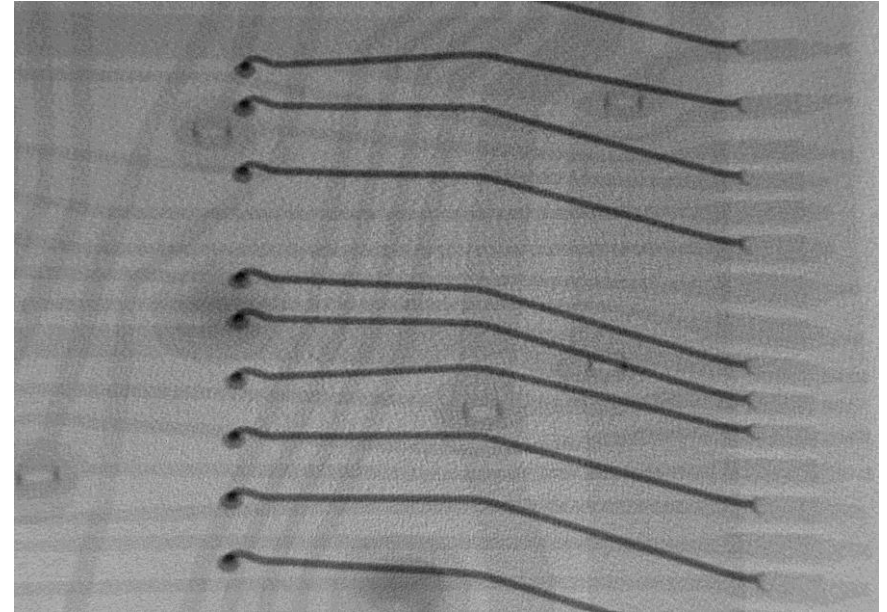
No evidence of broken or lifted wires; the “kinks” are from low-height loop processing, not deformation of the package

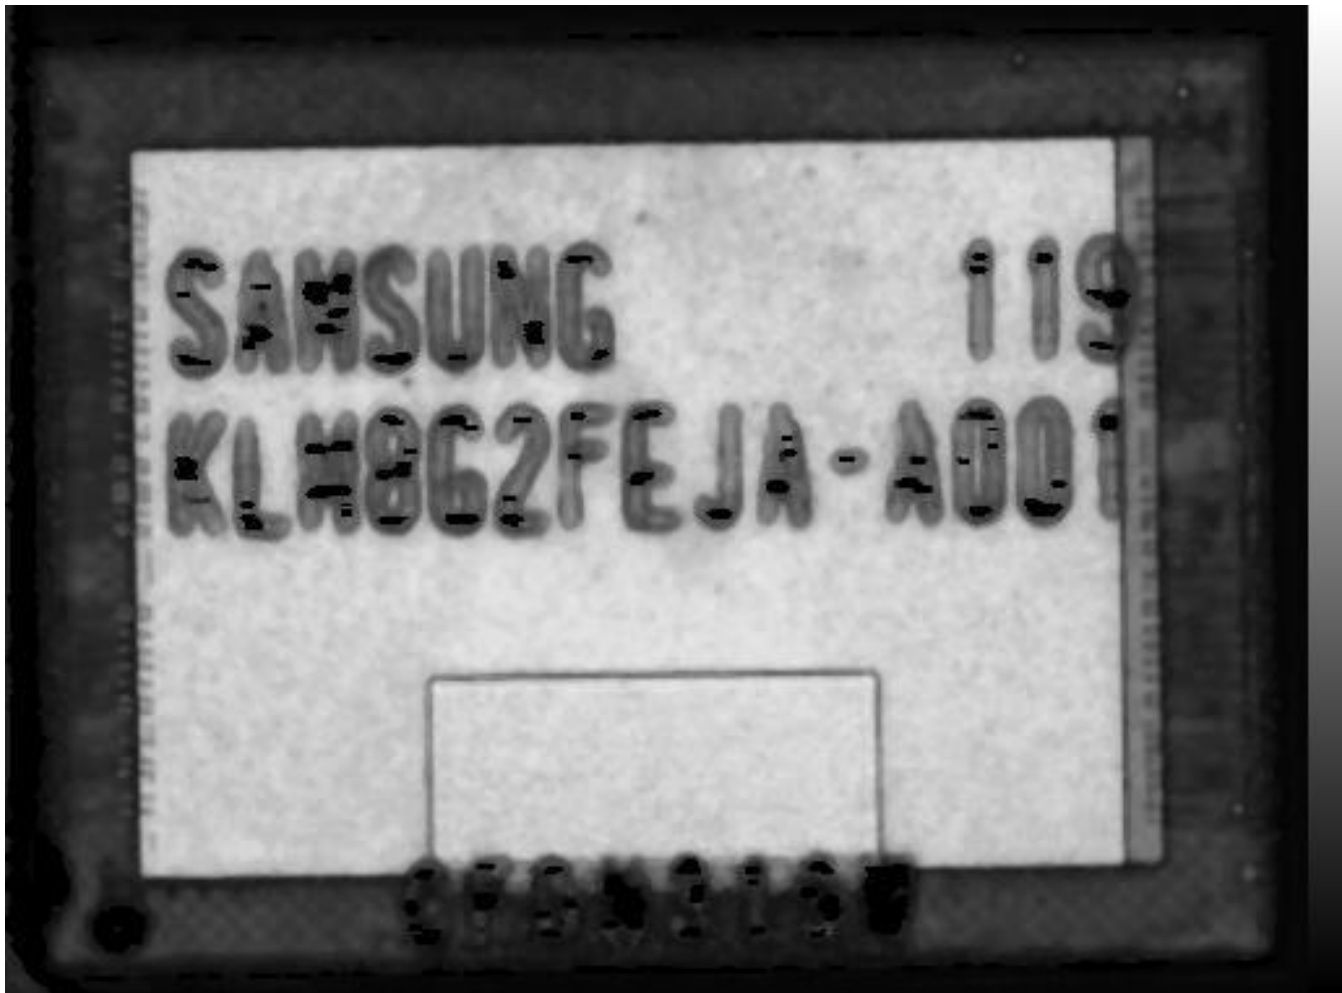
Composite C-SAM Image

No evidence of cracking in any of the chip layers
Minor delaminations, but not catastrophic

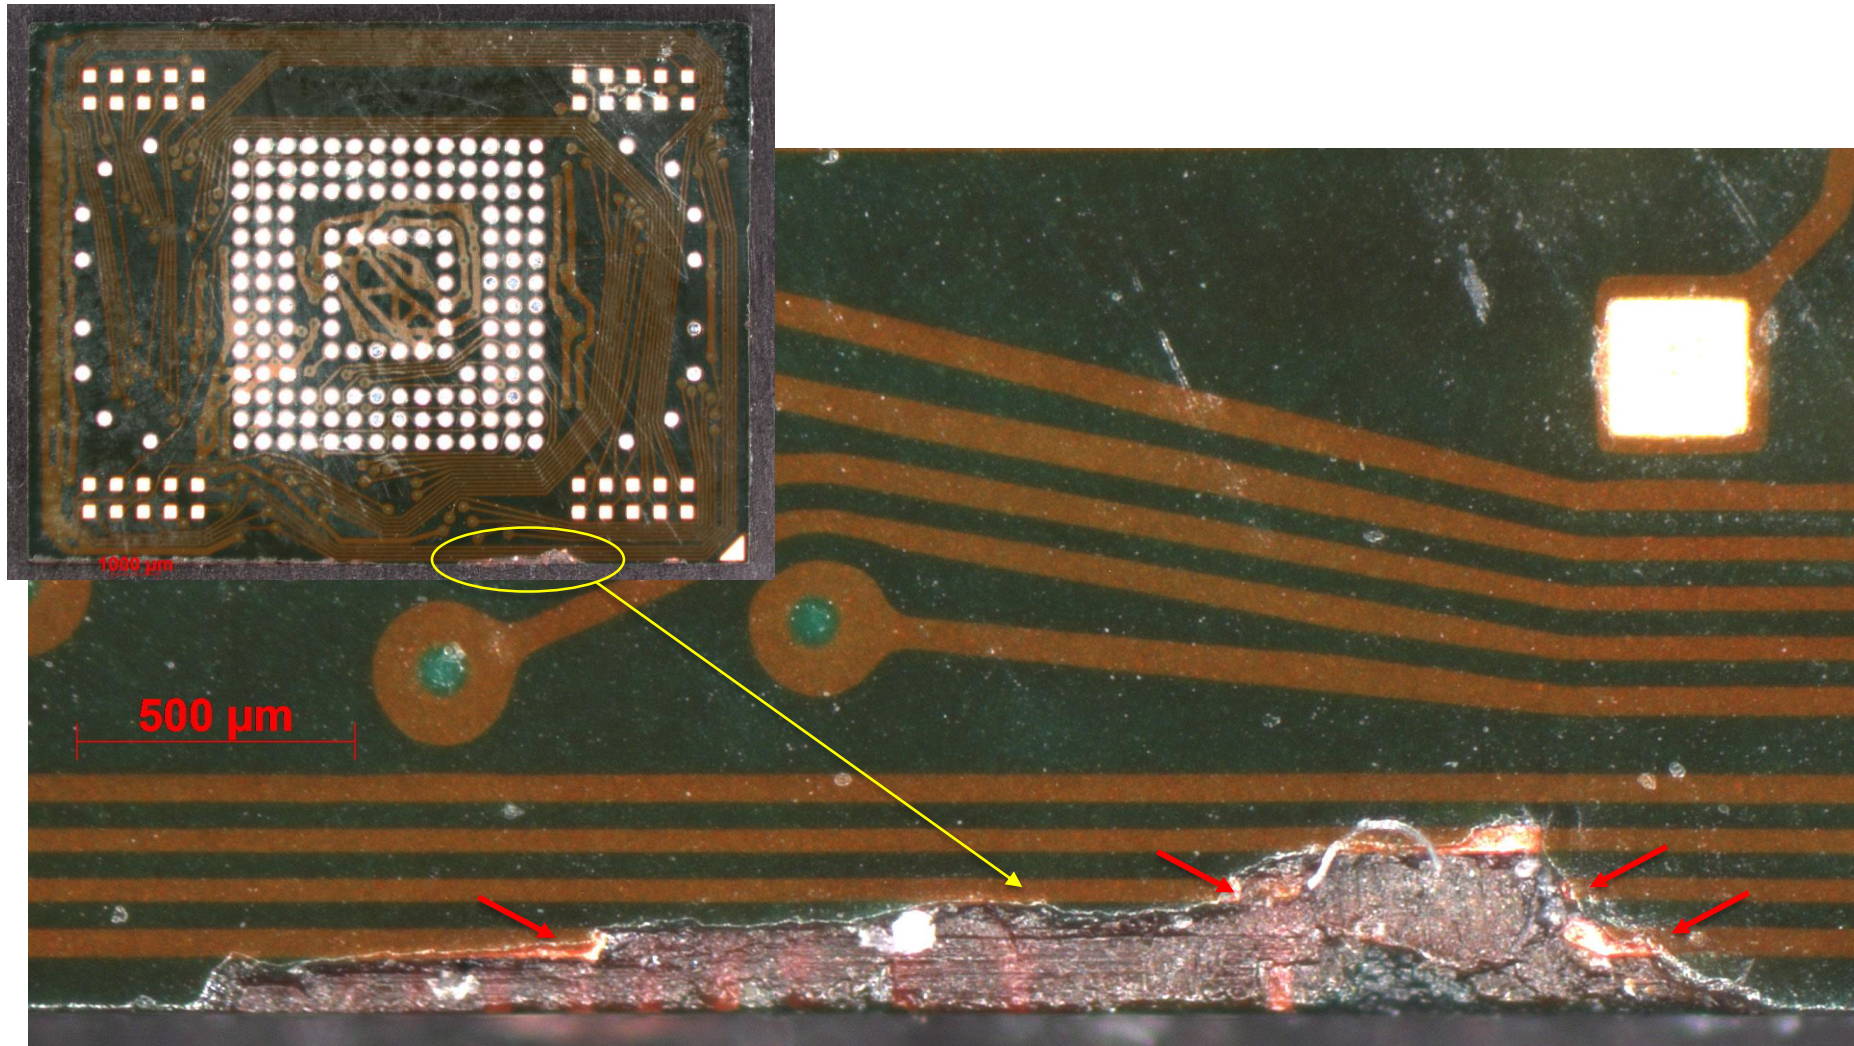
Optical Image of the Damage to the Chip Carrier

Red arrows indicate circuit lines that were broken
No other areas showed this level of damage

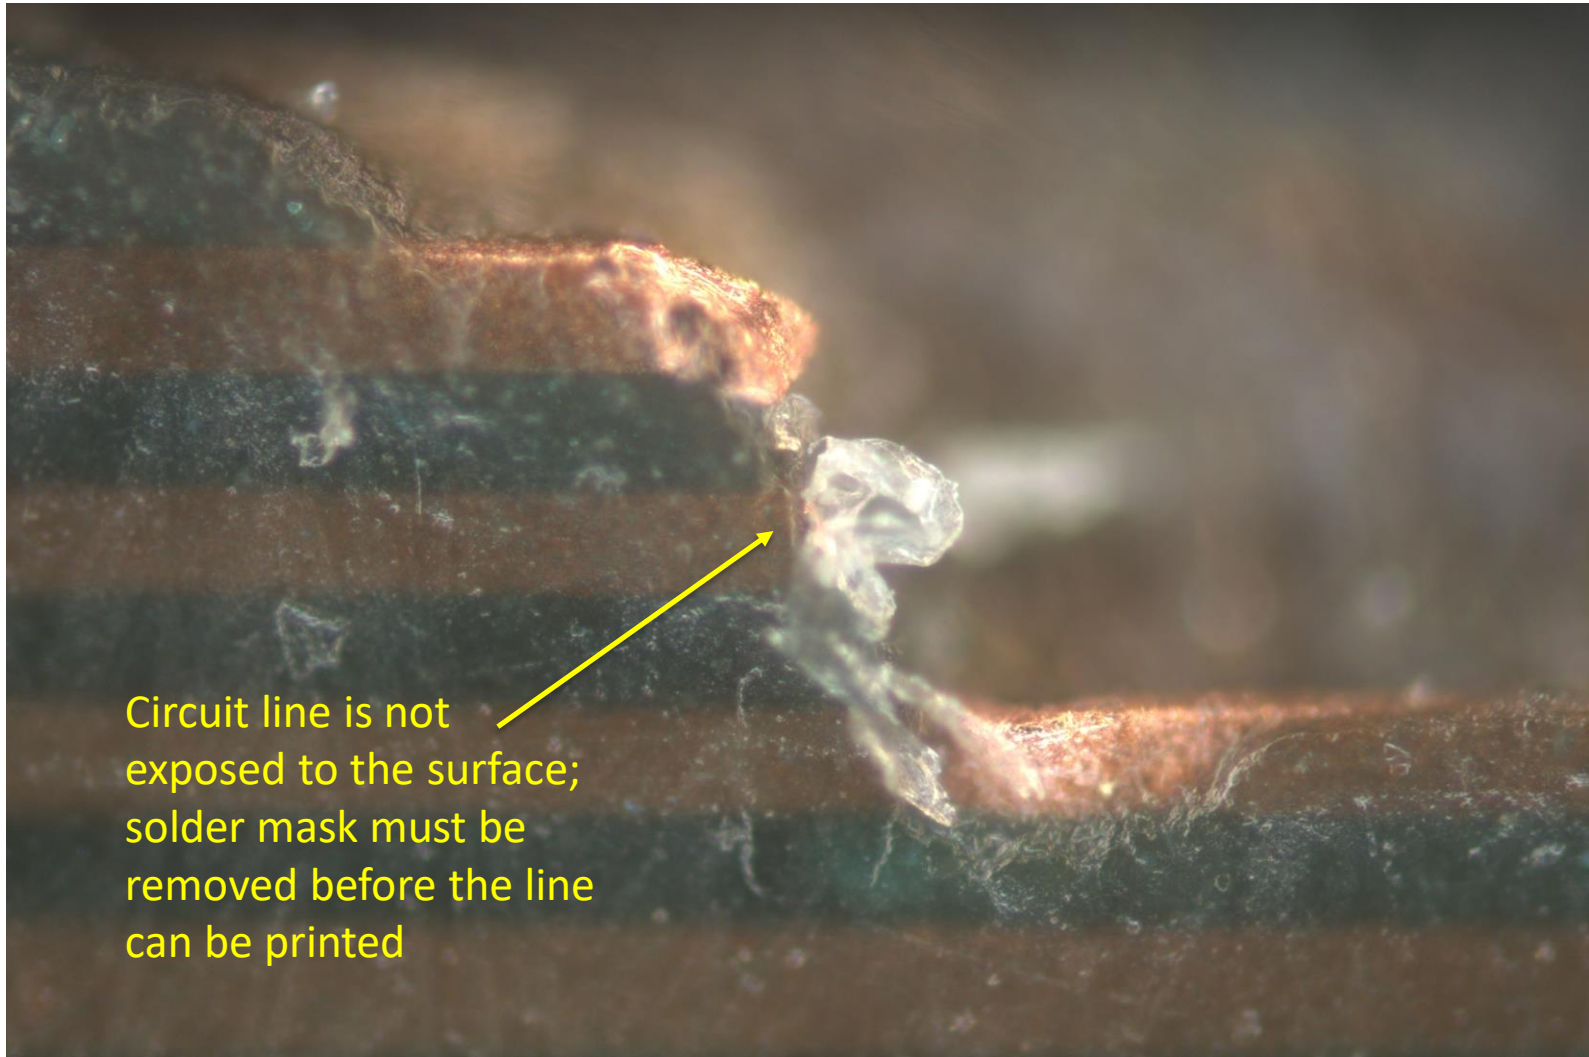
Circuit line is not exposed to the surface; solder mask must be removed before the line can be printed

- **Equipment**
 - Scalpel
 - Wild 420 Zoom Stereoscope
- **Procedure**
 - Solder mask was gently scraped from the damage circuit lines
 - Area was viewed through the stereoscope while scraping was being done
 - To avoid damaging subsurface circuits, only enough solder mask was removed to expose the copper traces
