Subject: Boeing Component Examination Report - Red Air MD-82 HI1064 Landing  
Gear Collapse and Runway Excursion Miami, Florida - 21 June, 2022

## FRACTURE ANALYSIS REPORT

Engineering Report No: MS 80040

A/P Customer:	RedAir	A/P Model:	MD-82
Registry No:	HI1064	Line Position No:	1805
Flight Hours:	68,229	Number of Landings:	35,873

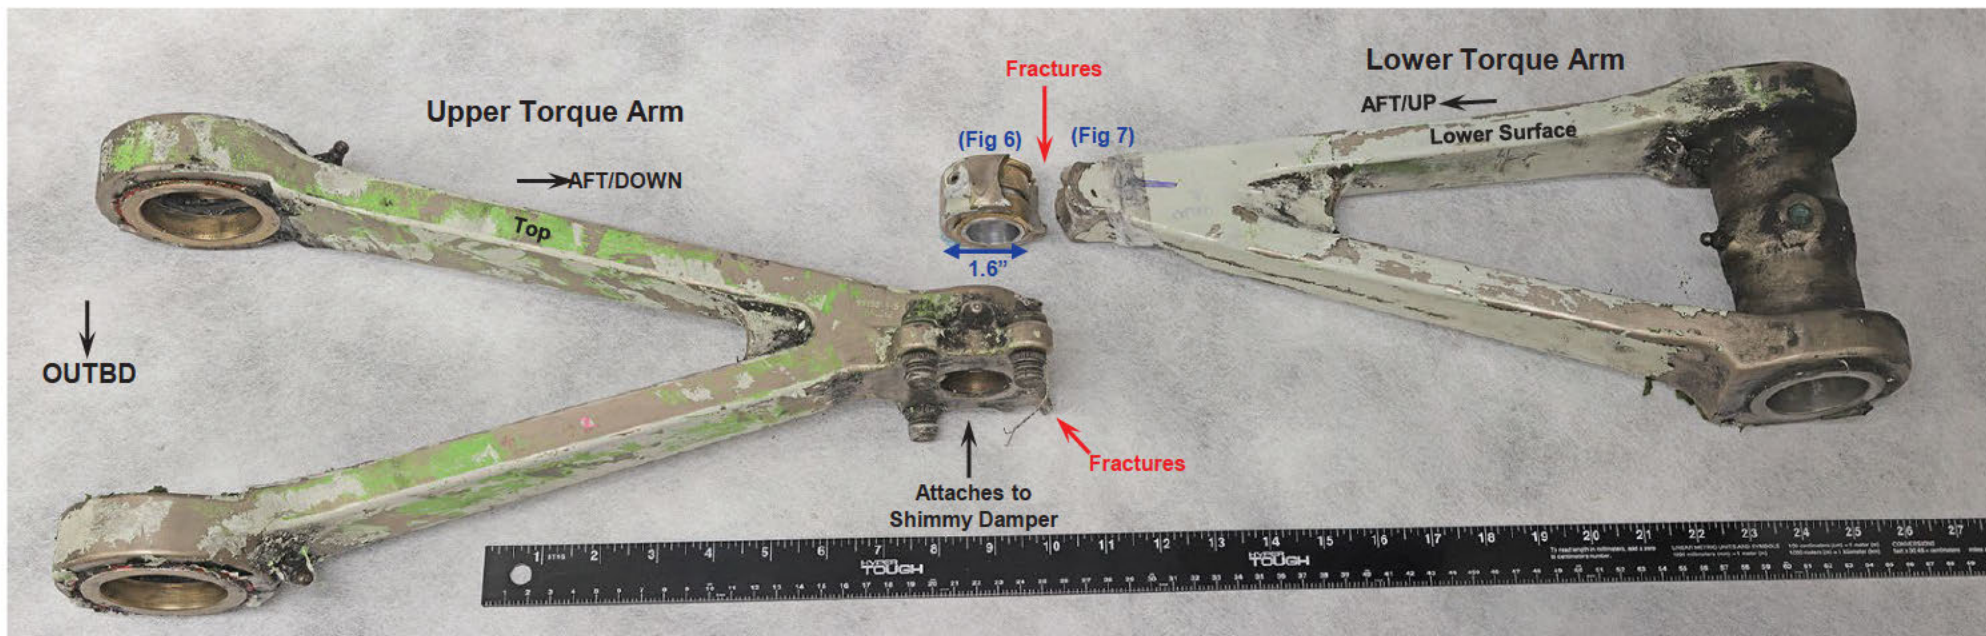
The upper torque arm exhibited transverse fractures through one of the shimmy damper attachment lugs (Figures 5 and 8 to 10). The fractures intersected almost diametrically opposite sides of the attachment lug hole. A large portion of one of the fractures was obscured. Undamaged regions were smooth in

Figure 5. Overall of upper and lower Torque Arms [paint partially stripped from upper Arm in lab].

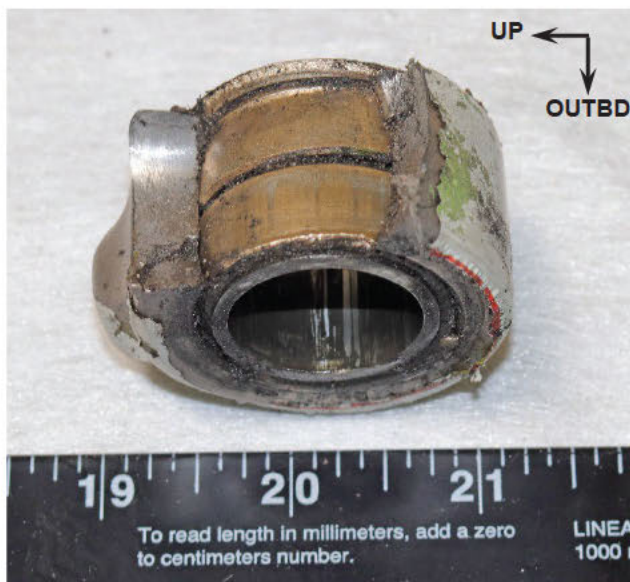
The lower torque arm was still attached to the axle, and the upper torque arm was still attached to the cylinder in the as-received condition (Figure 3). The lower torque arm exhibited two complete, transverse fractures which intersected the upper lug hole, approximately 1.6 inches from the end of the part (Figures 5 to 7). Both of the fracture halves closest to the upper end were relatively smooth and smeared in an inboard/outboard direction (Figure 6). The fracture surfaces occurred along an oval/elliptical path, indicating that the fracture may have occurred due to a combination of compression and bending/shearing. The mating fracture halves were heavily damaged due to post-fracture smearing (Figure 7). The fractured lug end appeared to be bent slightly in an inboard direction.

Figure 6. Close-up of fracture surfaces of Lower Torque Arm

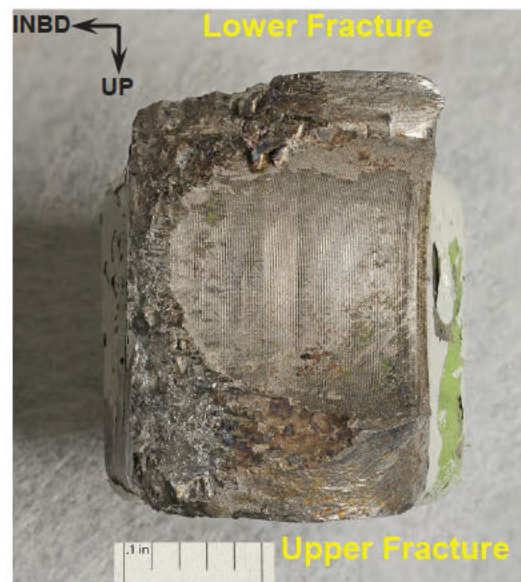
Figure 7. Close-up of mating fracture surfaces of Lower Torque Arm

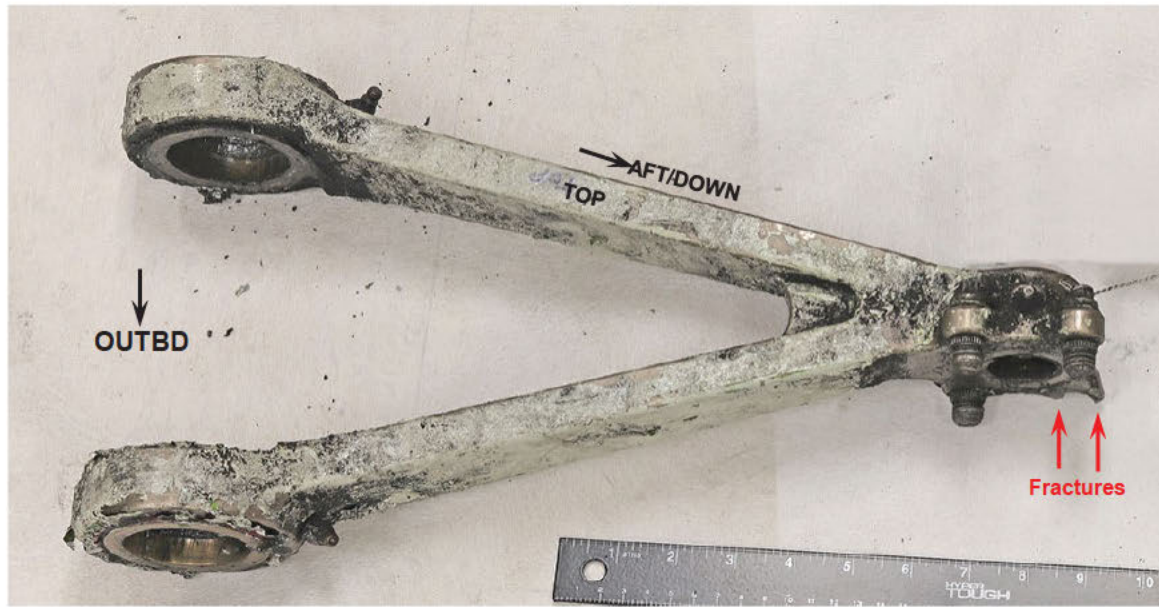
Figure 8. Overall of upper Torque Arm

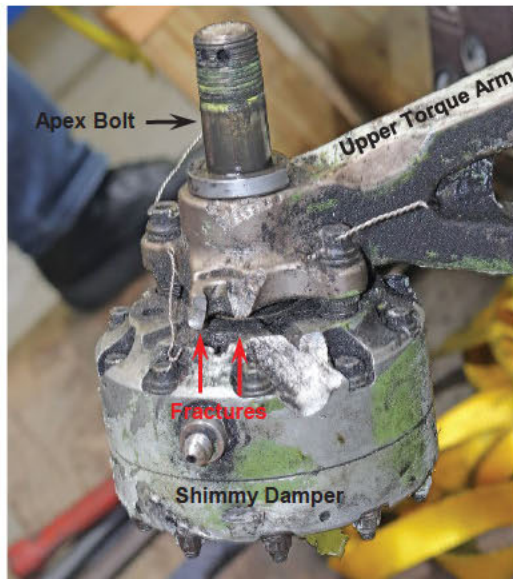
The associated apex bolt was difficult to remove from the assembly (Figure 9). Once removed, it was observed that the bolt was slightly bent.

Figure 9. Close-up of fracture surfaces on Upper Torque Arm with the Shimmy Damper and Apex Bolt attached

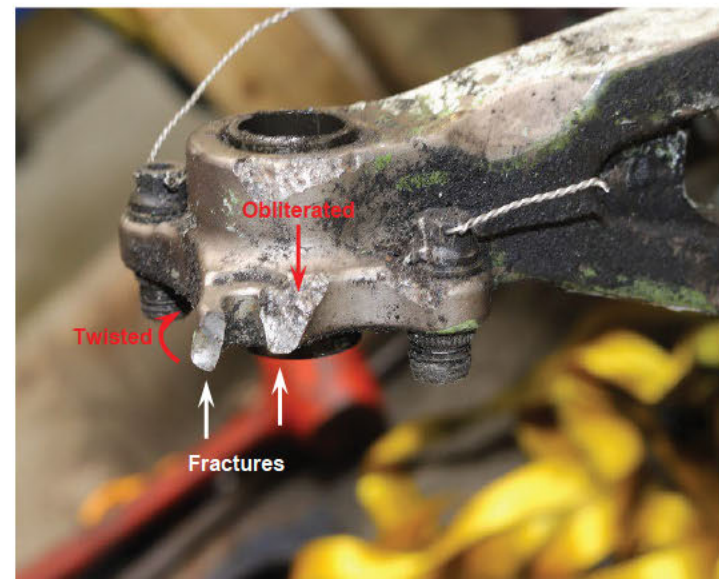
texture and smeared, typical of shear. The fractured area at the outer end of the lug was twisted in an inboard direction (Figure 10).

Figure 10. Close-up of mating fracture surfaces on the Upper Torque Arm

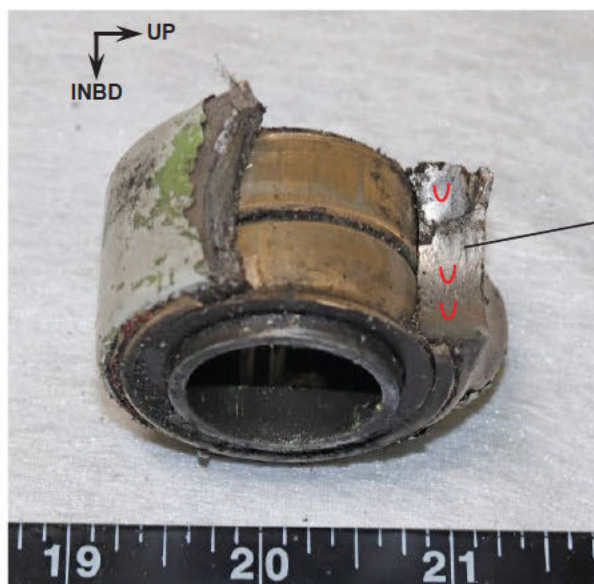
SEM analysis of the fracture surfaces in the lower torque arm revealed evidence of ductile separation (Figures 11 to 23). The upper and lower fracture surfaces of the lower torque arm exhibited a mixture of shallow elongated dimples, typical of shear, and somewhat more equiaxed dimples, typical of bending. Shear dimples were open toward the outboard side, suggesting that the fracture propagated in an inboard direction relative to the remainder of the part during fracture. SEM analysis revealed that the mating fracture halves were obliterated by post-fracture mechanical damage.

Figure 11. Close-up of fracture surfaces  
Red ellipses indicate direction of open-ended dimple formations.  
[Lower Torque Arm]

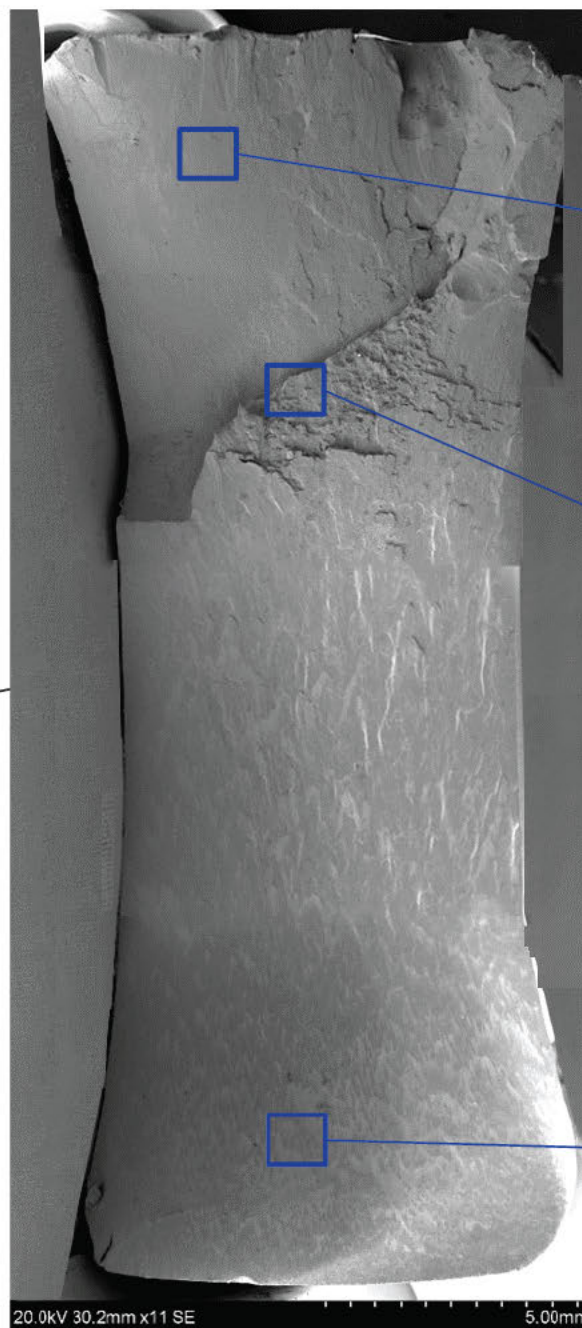
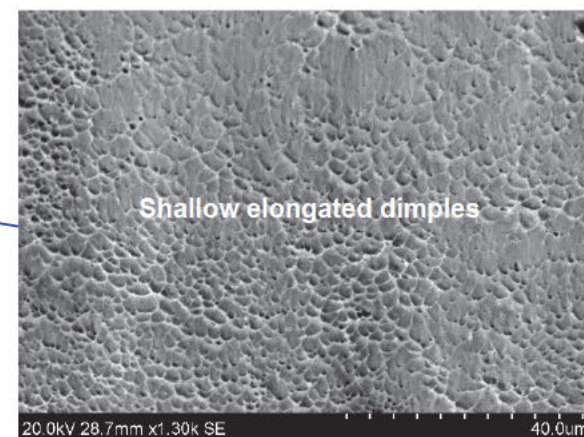
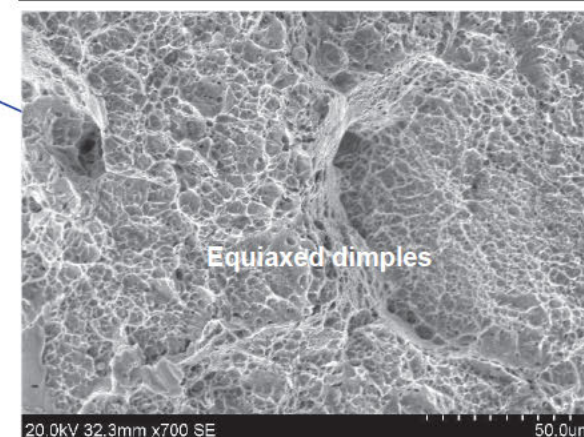
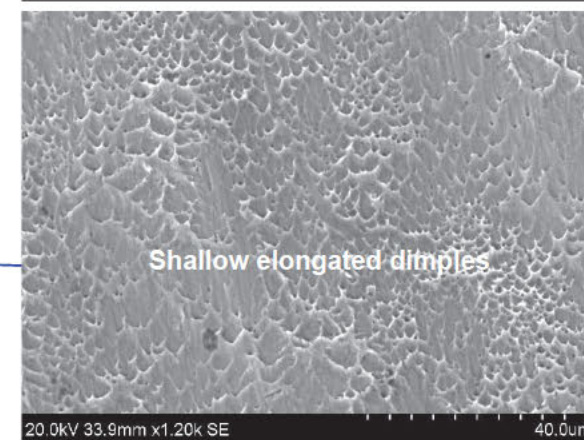
Figures 12 to 15. SEM close-ups from upper fracture segment

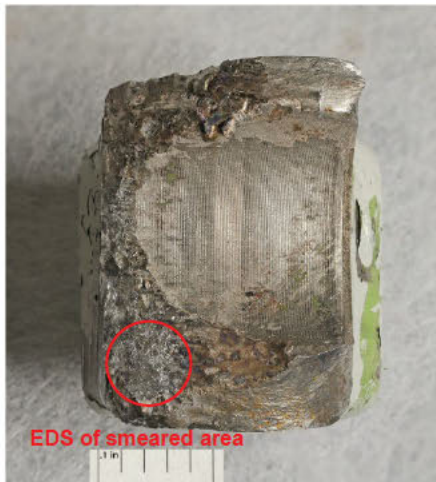
EDS analysis of the smeared fracture of the lower torque arm half revealed the presence of aluminum, nickel, and iron oxide (Figures 24 to 27). Aluminum may have resulted from impact with the shimmy damper housing; nickel was most likely smeared from the nickel-plated lug hole; and iron oxide was due to post-fracture oxidation [rust].

Figure 24. Close-up of mating fracture surface [Lower Torque Arm]

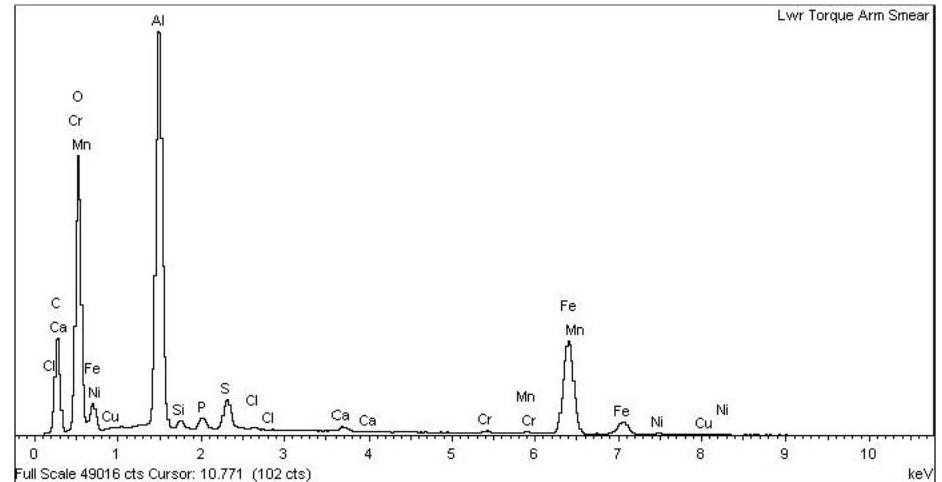
Figure 25. EDS spectrum from smeared metal on fracture surface

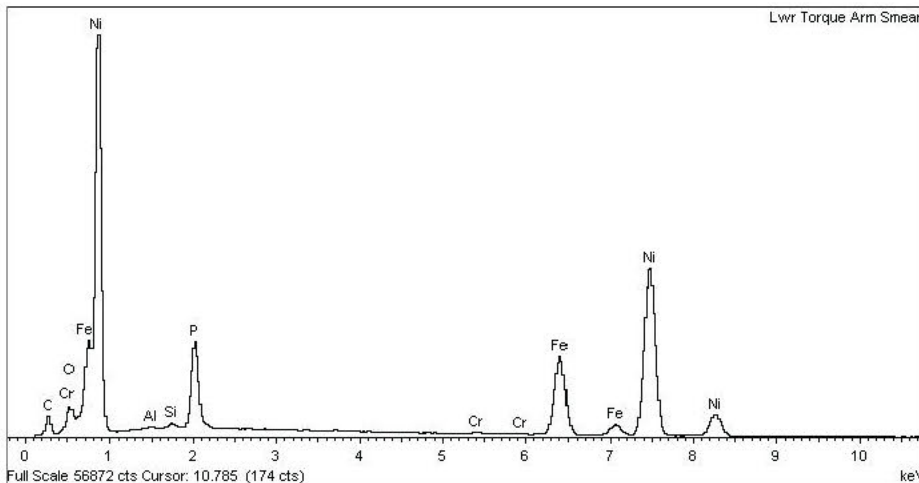
Figure 26. EDS spectrum from smeared metal on fracture surface

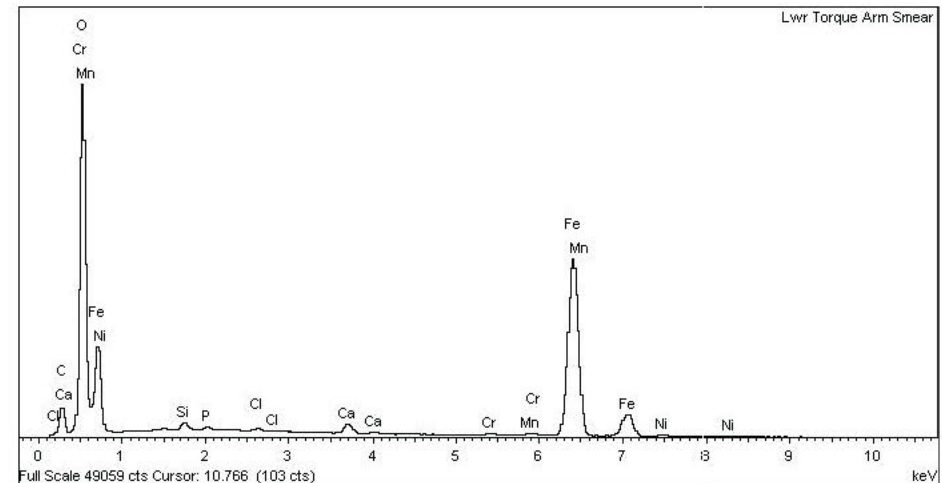
Figure 27. EDS spectrum from rust on fracture surface

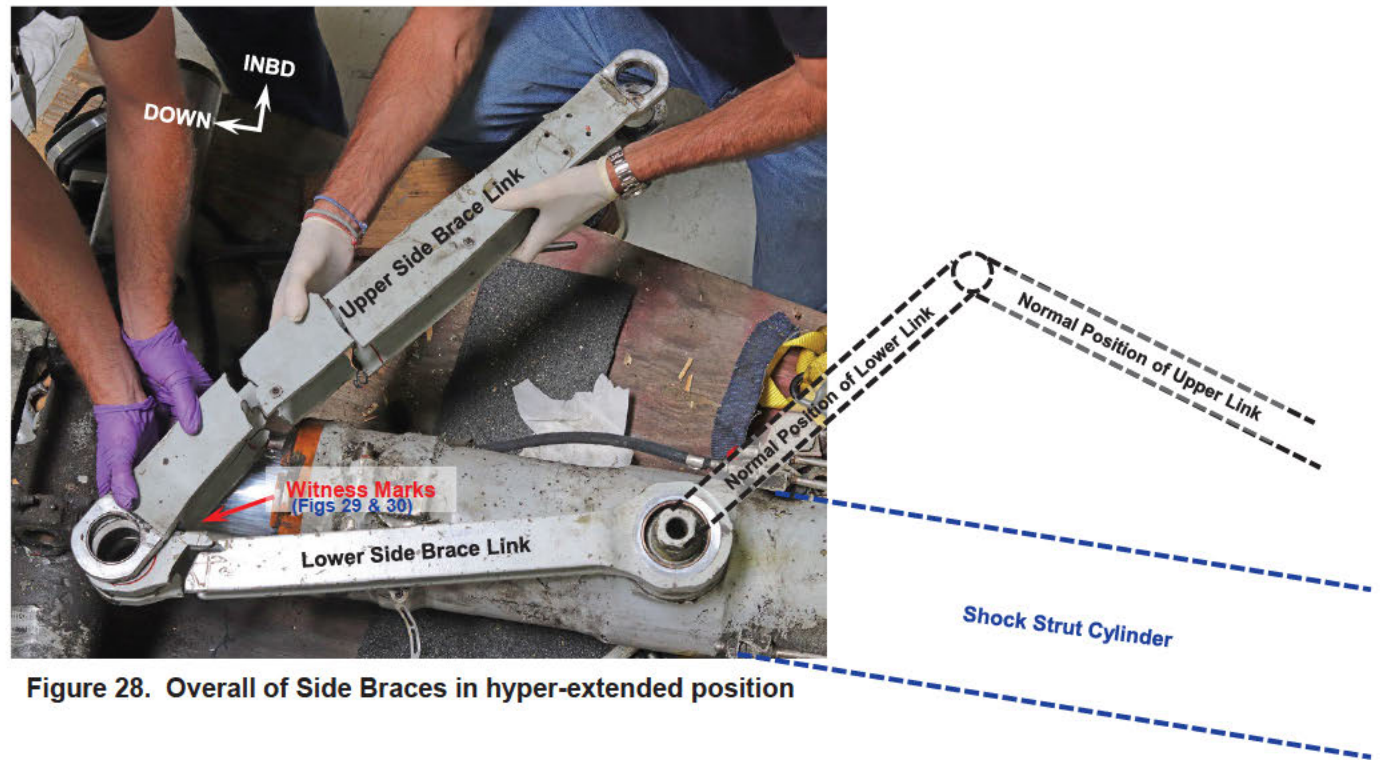
The lower side brace link was still attached to the shock strut cylinder in the as-received condition (Figure 3). The upper side brace link had been separated from the assembly. Once reassembled, witness marks on the cylinder and links indicated that the side brace assembly had become hyper-extended and crossed over the cylinder (transitioned from inboard to outboard side of cylinder) during the incident (Figures 28 to 31).

Figure 28. Overall of Side Braces in hyper-extended position

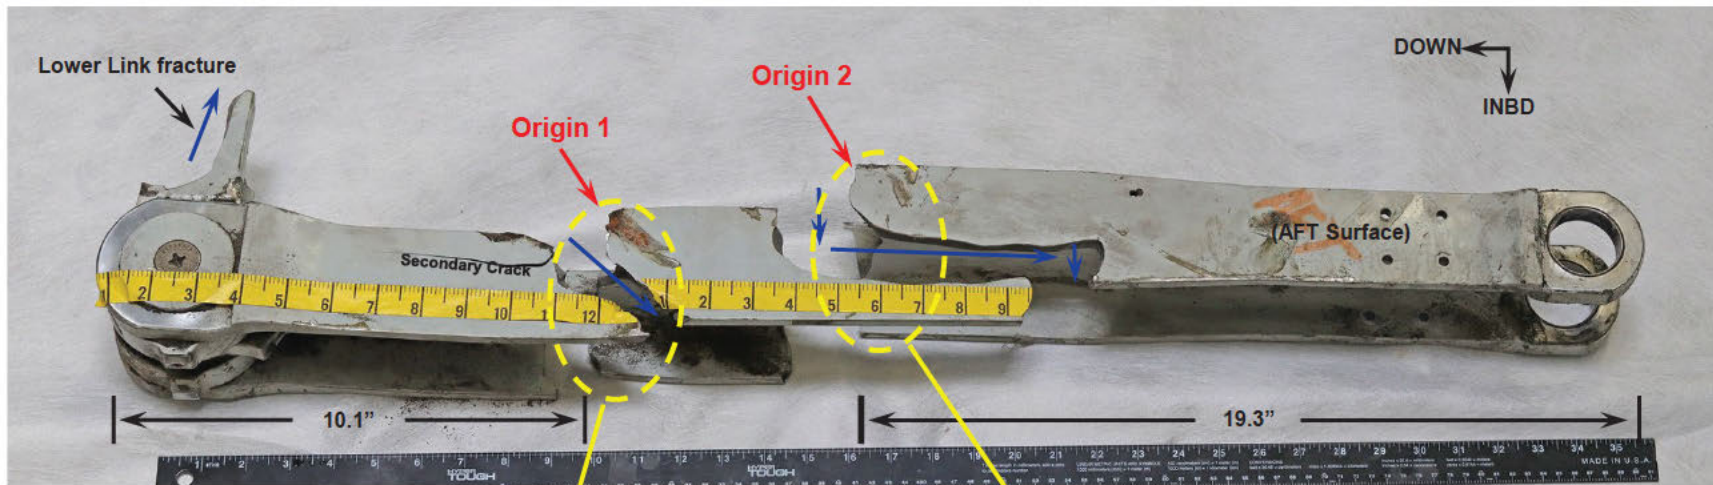
The upper side brace link exhibited two complete, transverse fractures which were located approximately 10 inches and 15 inches from the lower end (Figures 32 and 33). Both fractures initiated from areas of mechanical damage along the aft, outboard flange. The fractures were arbitrarily identified as #1 and #2 in the lab for discussion purposes. The origin area of fracture #1 was heavily smeared (Figure 34). The flange was heavily damaged and deformed inward in this area. The origin area of fracture #2 exhibited an elliptical shape, and the fracture surface exhibited a dull texture, typical of ductile separation (Figure

Figure 33. Overall of upper Side Brace Link [Blue arrows indicate directions of crack propagation]

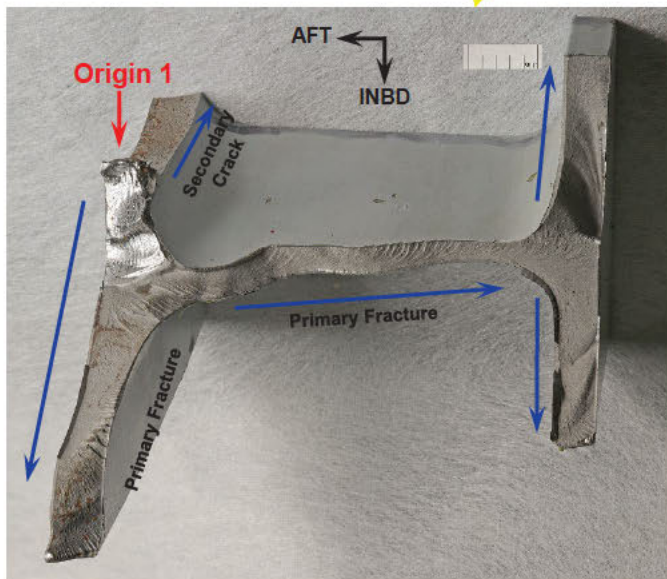
Figure 34. Close-up of Fracture 1 [Blue arrows indicate directions of crack propagation]

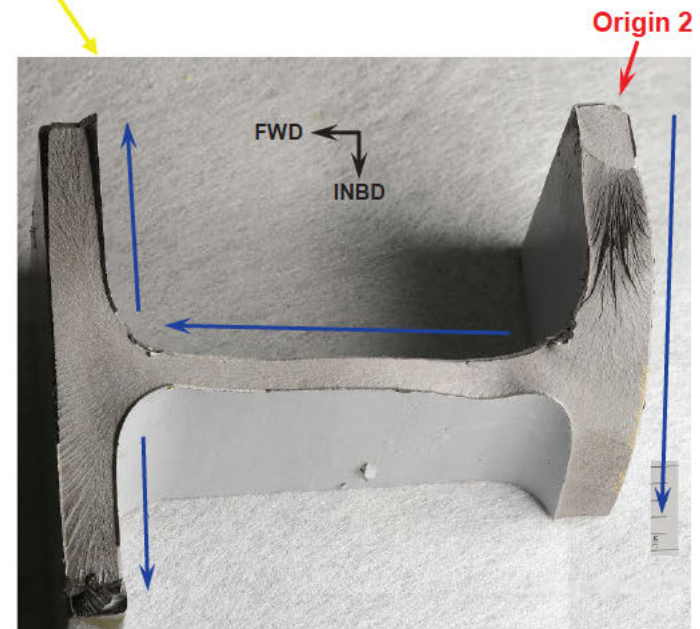
Figure 35. Close-up of Fracture 2 [Blue arrows indicate directions of crack propagation]

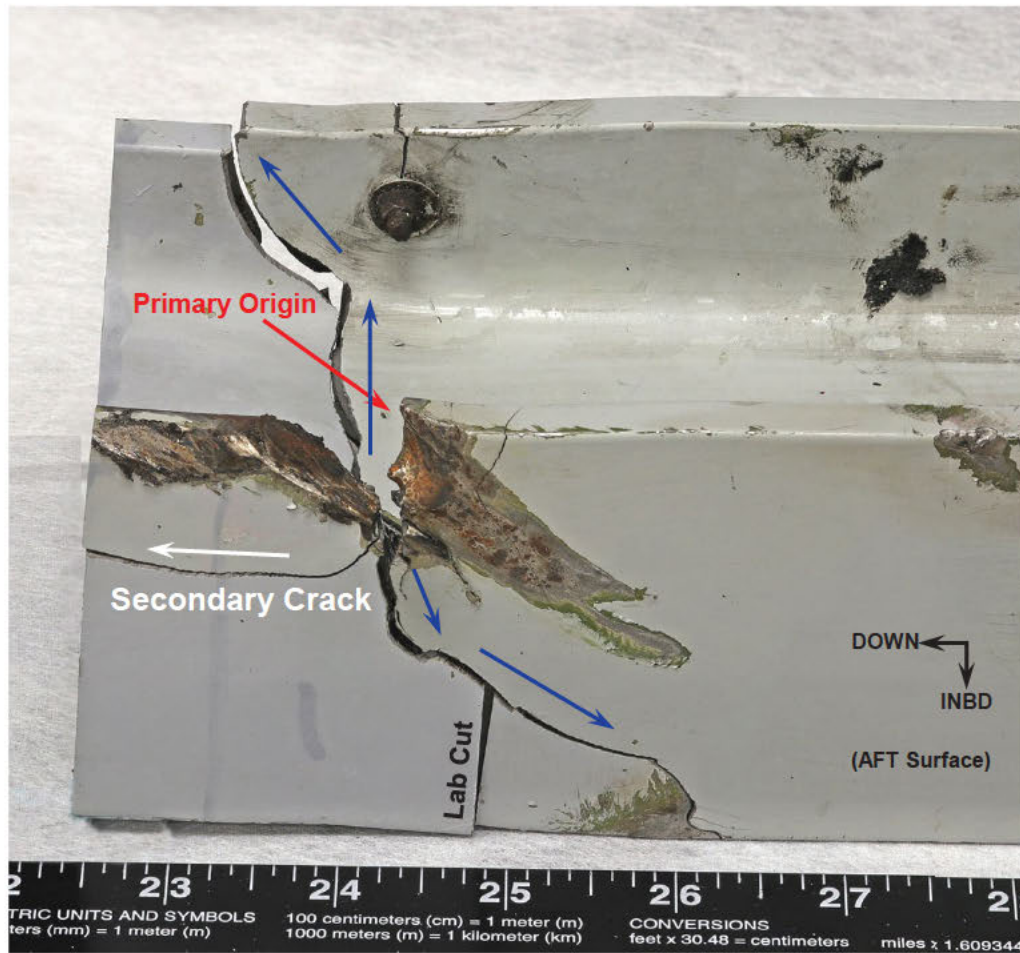
35). During sectioning in the lab, a secondary crack which intersected fracture #1 was exposed (Figures 33 and 36). The initial portion of this crack, which originated from fracture #1, exhibited a somewhat grainy texture, typical of brittle fracture, to a crack depth of 0.09 inch (Figure 37). This initial portion did not appear oxidized.

Figure 36. Close-up of Fracture 1 and adjacent secondary crack in Upper Side Brace Link  
 [Blue arrows indicate directions of primary crack propagation]  
 [White arrow indicates direction of secondary crack propagation]

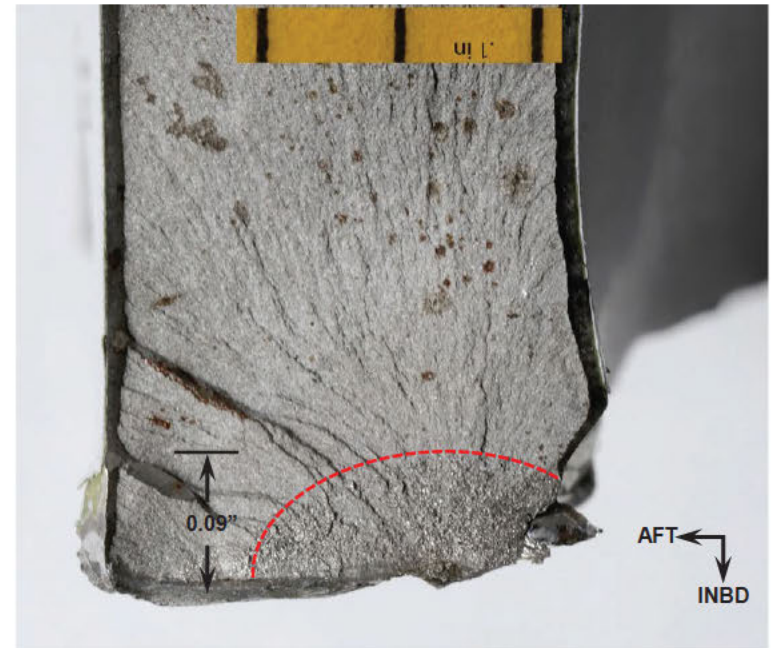
Figure 37. Close-up of secondary origin area.

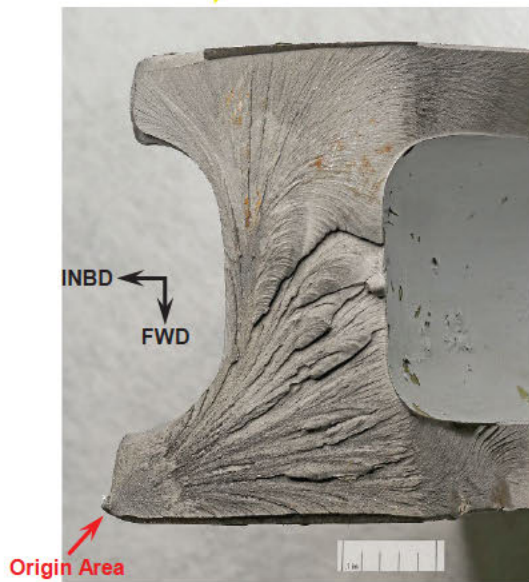
The lower side brace link exhibited a complete, transverse fracture approximately 4.1 inches from the upper end (Figure 38). The fracture initiated at the forward, inboard flange (Figure 39). The origin area appeared elliptically-shaped and rusted to a crack depth of 0.05 inch (Figure 40). The remainder of the fracture surface appeared less oxidized and exhibited a dull texture, typical of ductile separation. Witness/damage marks along both sides of the fracture indicated that the pieces were still together during hyper-extension of the side brace links (Figure 38).

Figure 39. Close-up of fracture surface

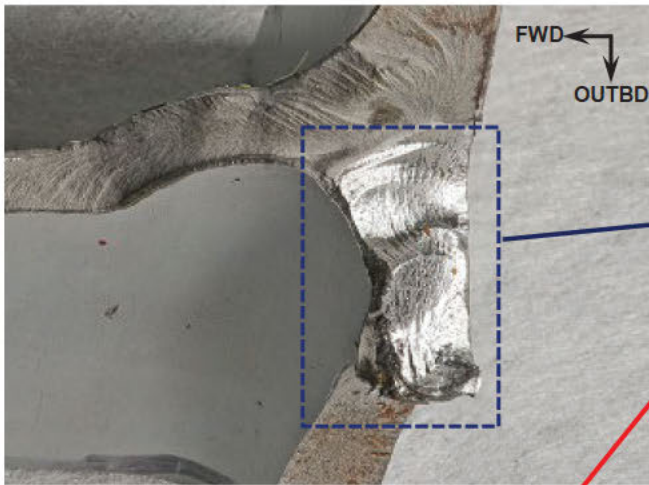
A majority of the origin area of fracture #1 in the upper side brace link was smeared from post fracture damage. All undamaged, observable regions exhibited evidence of ductile separation (Figures 41 to 46).

Figure 41. Close-up of origin area [Upper Side Brace Fracture 1]

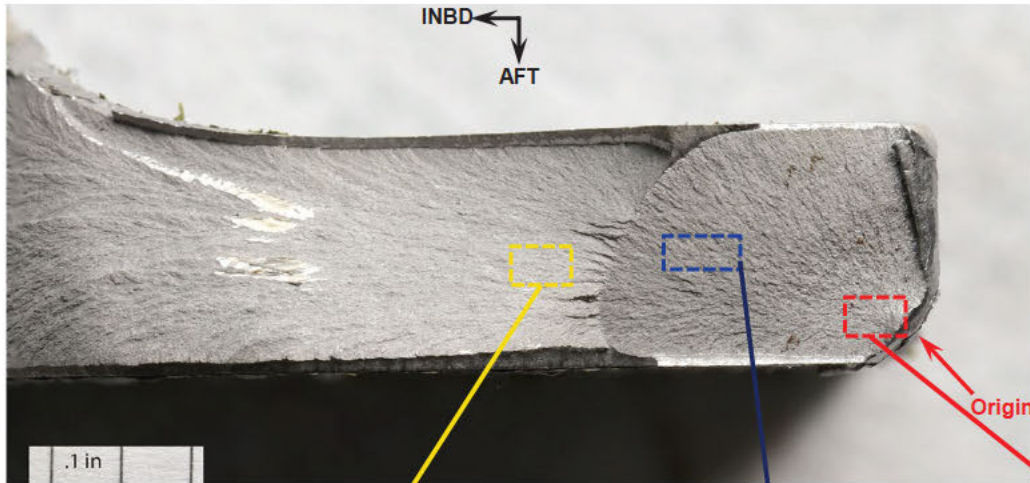
SEM analysis of fracture #2 revealed evidence of ductile separation (Figures 53 to 57).

Figure 53. Close-up of origin area [Upper Side Brace Fracture 2]

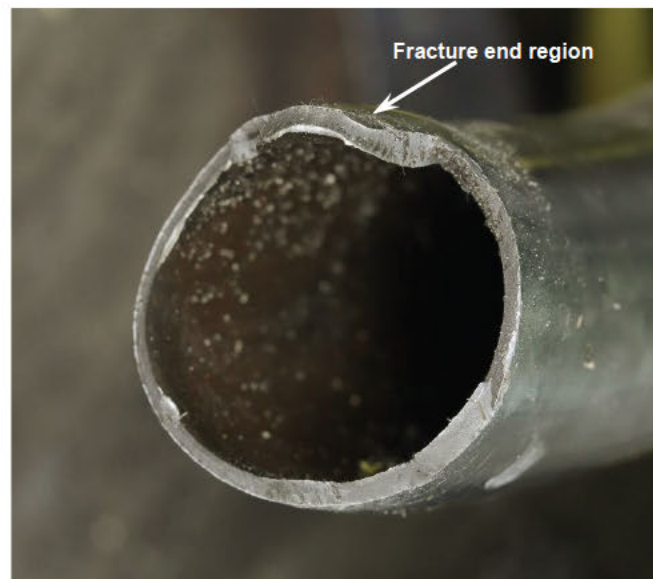
The retract cylinder rod was still attached to the cylinder in the as-received condition (Figure 3). The rod exhibited a complete, circumferential fracture approximately 16 inches from the attached end (Figure 64). The rod was bent in an outboard direction. The fracture surface occurred along oblique planes and the fracture end portion, along the concave side, was locally buckled, typical of ductile separation due to bending (Figure 65).

Figure 65. Close-up of fracture surface [Retract Rod]

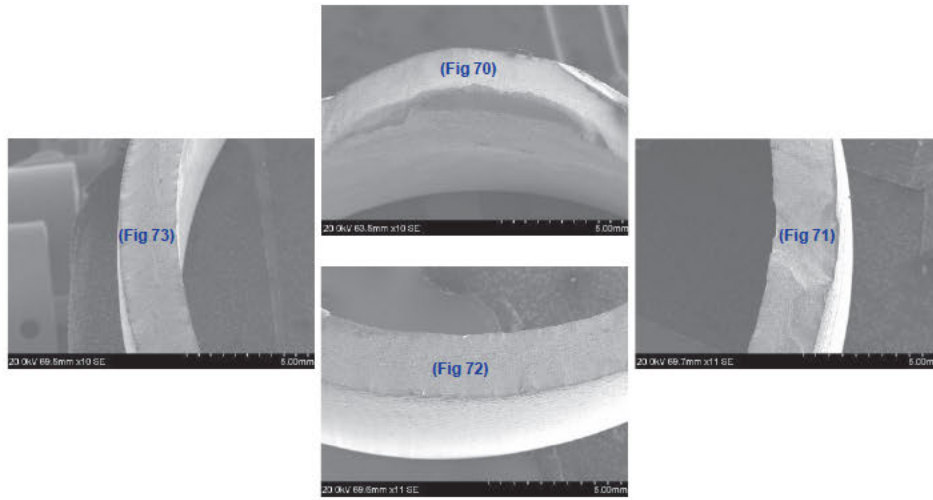
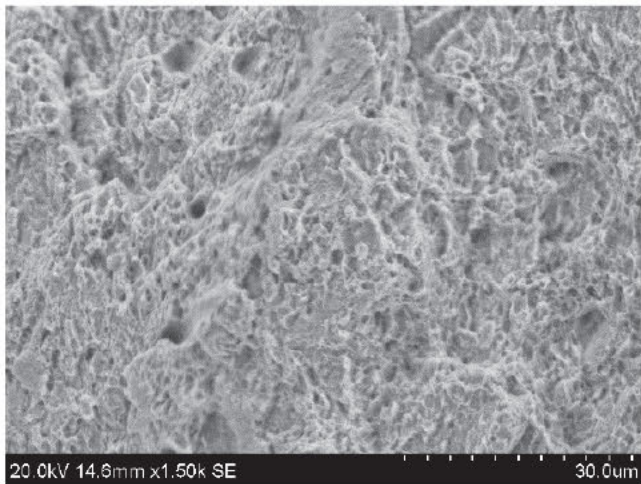
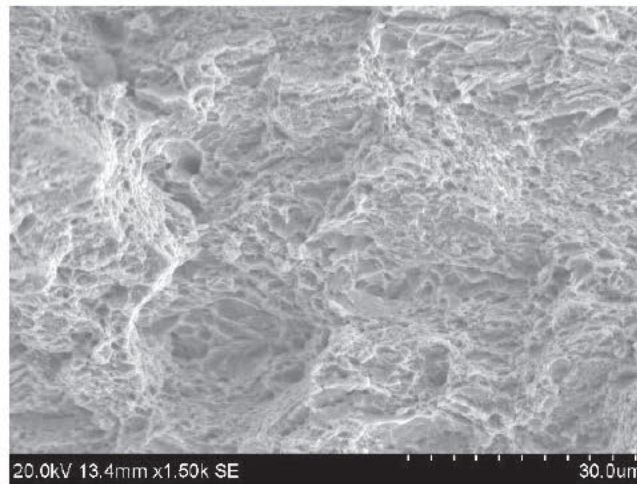
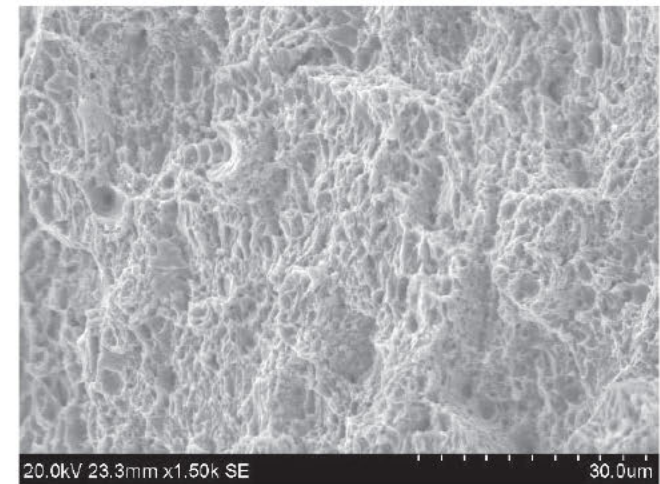
SEM analysis of the fracture surface revealed evidence of ductile separation (Figures 66 to 73).

Figures 66 to 69. SEM close-ups of fracture surface [Retract Rod]

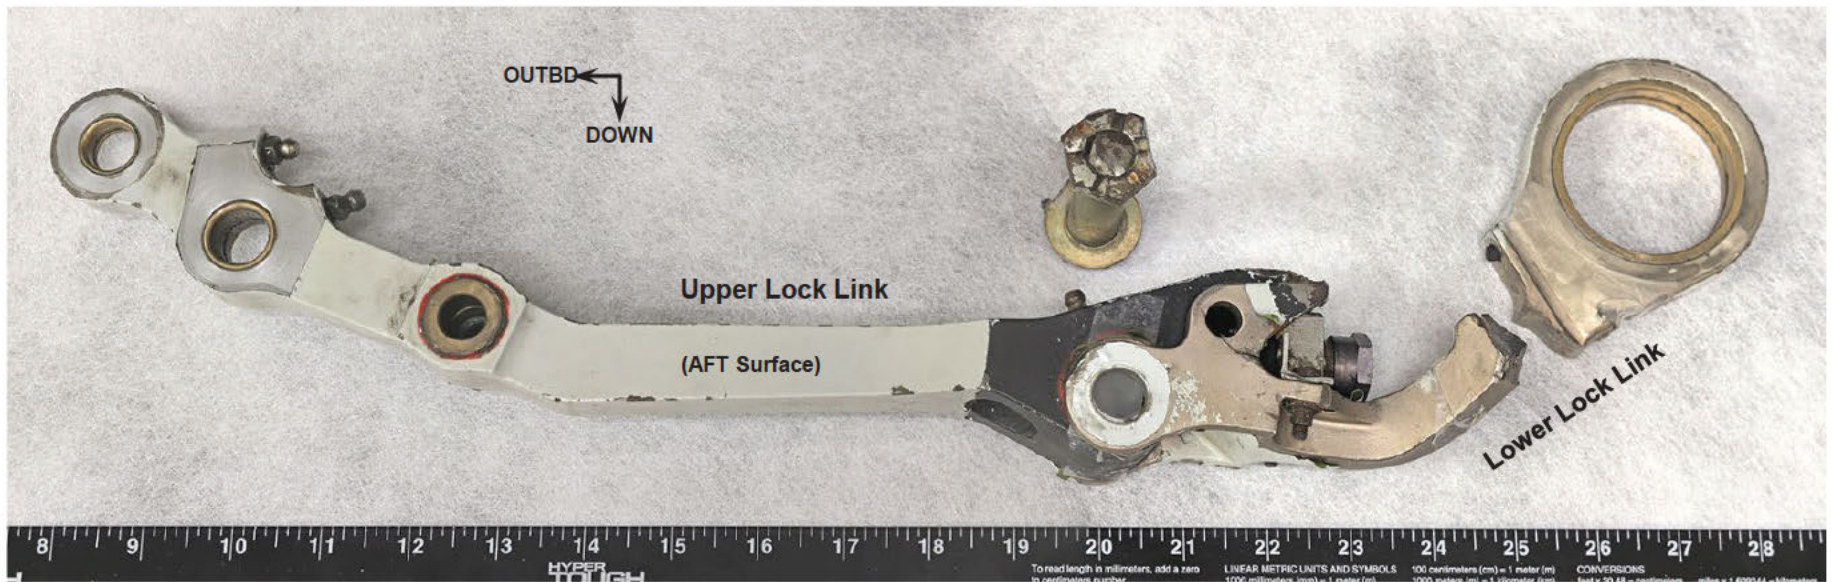
The lower lock link exhibited complete transverse fractures through the arm approximately four inches from the inboard end (Figures 74 to 78). The upper end of the lower link was still attached to the upper link (Figures 74 and 75), and the lower end (the lug portion of lower lock link) was still attached to the side braces in the as-received condition (Figure 76). The lower lock link was bent in an upward and aft direction (Figures 77 and 78). The upper link was bent in a forward direction (Figure 77). One fracture intersected a hole in the arm (Figures 79 and 80). This fracture consisted of two segments which intersected diametrically opposite sides of the hole. The fracture surfaces were smeared in a forward/aft direction (Figure 80). The other fracture appeared to have occurred outside the hole (Figure 81). This fracture appeared smeared in a longitudinal (up/down) direction.

Figures 77 and 78. Close-ups of Lock Links after removal

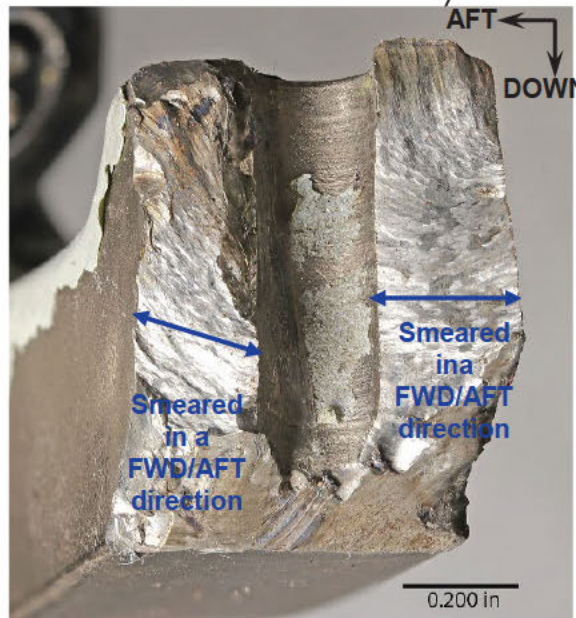
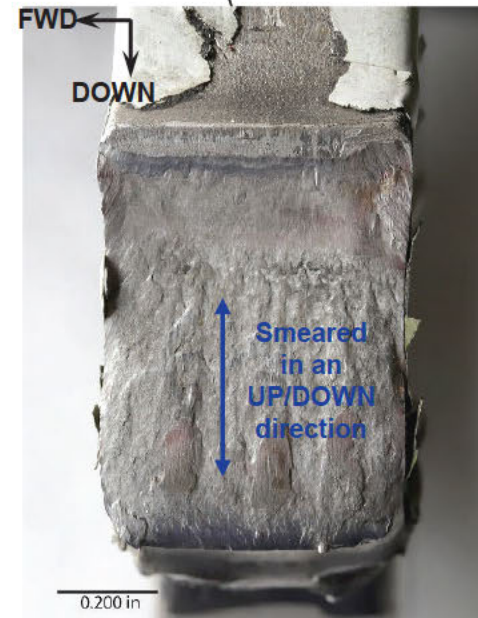
Figures 80 and 81. Close-ups of fracture surfaces [Lower Lock Link]

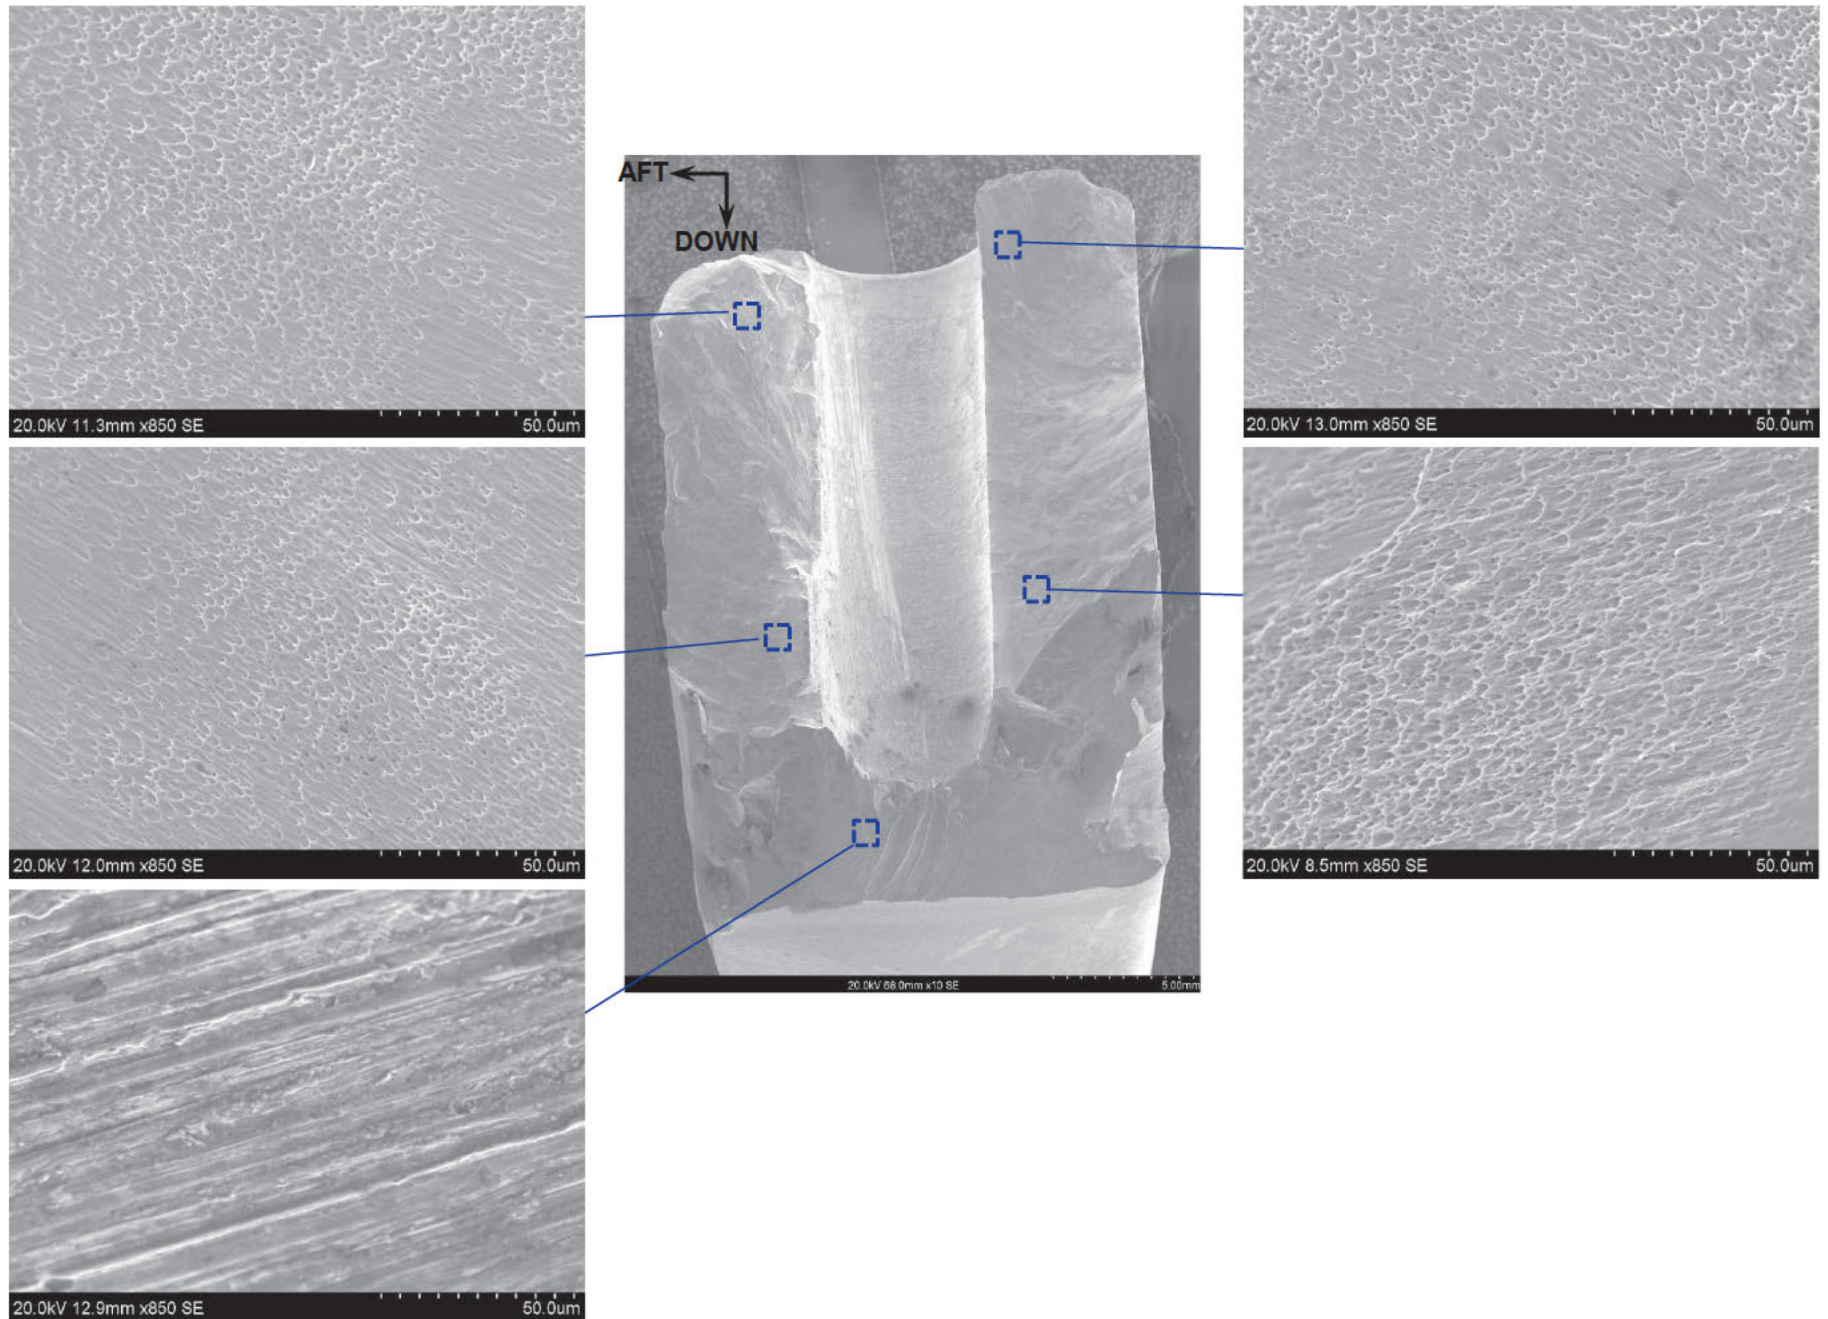
SEM analysis of each fracture surface revealed evidence of ductile separation. A majority of dimple formations were shallow and stretched, typical of ductile separation due to shear loads (Figures 82 to 91).

Figures 82 to 87. SEM close-ups from fracture surfaces [Lock Link]

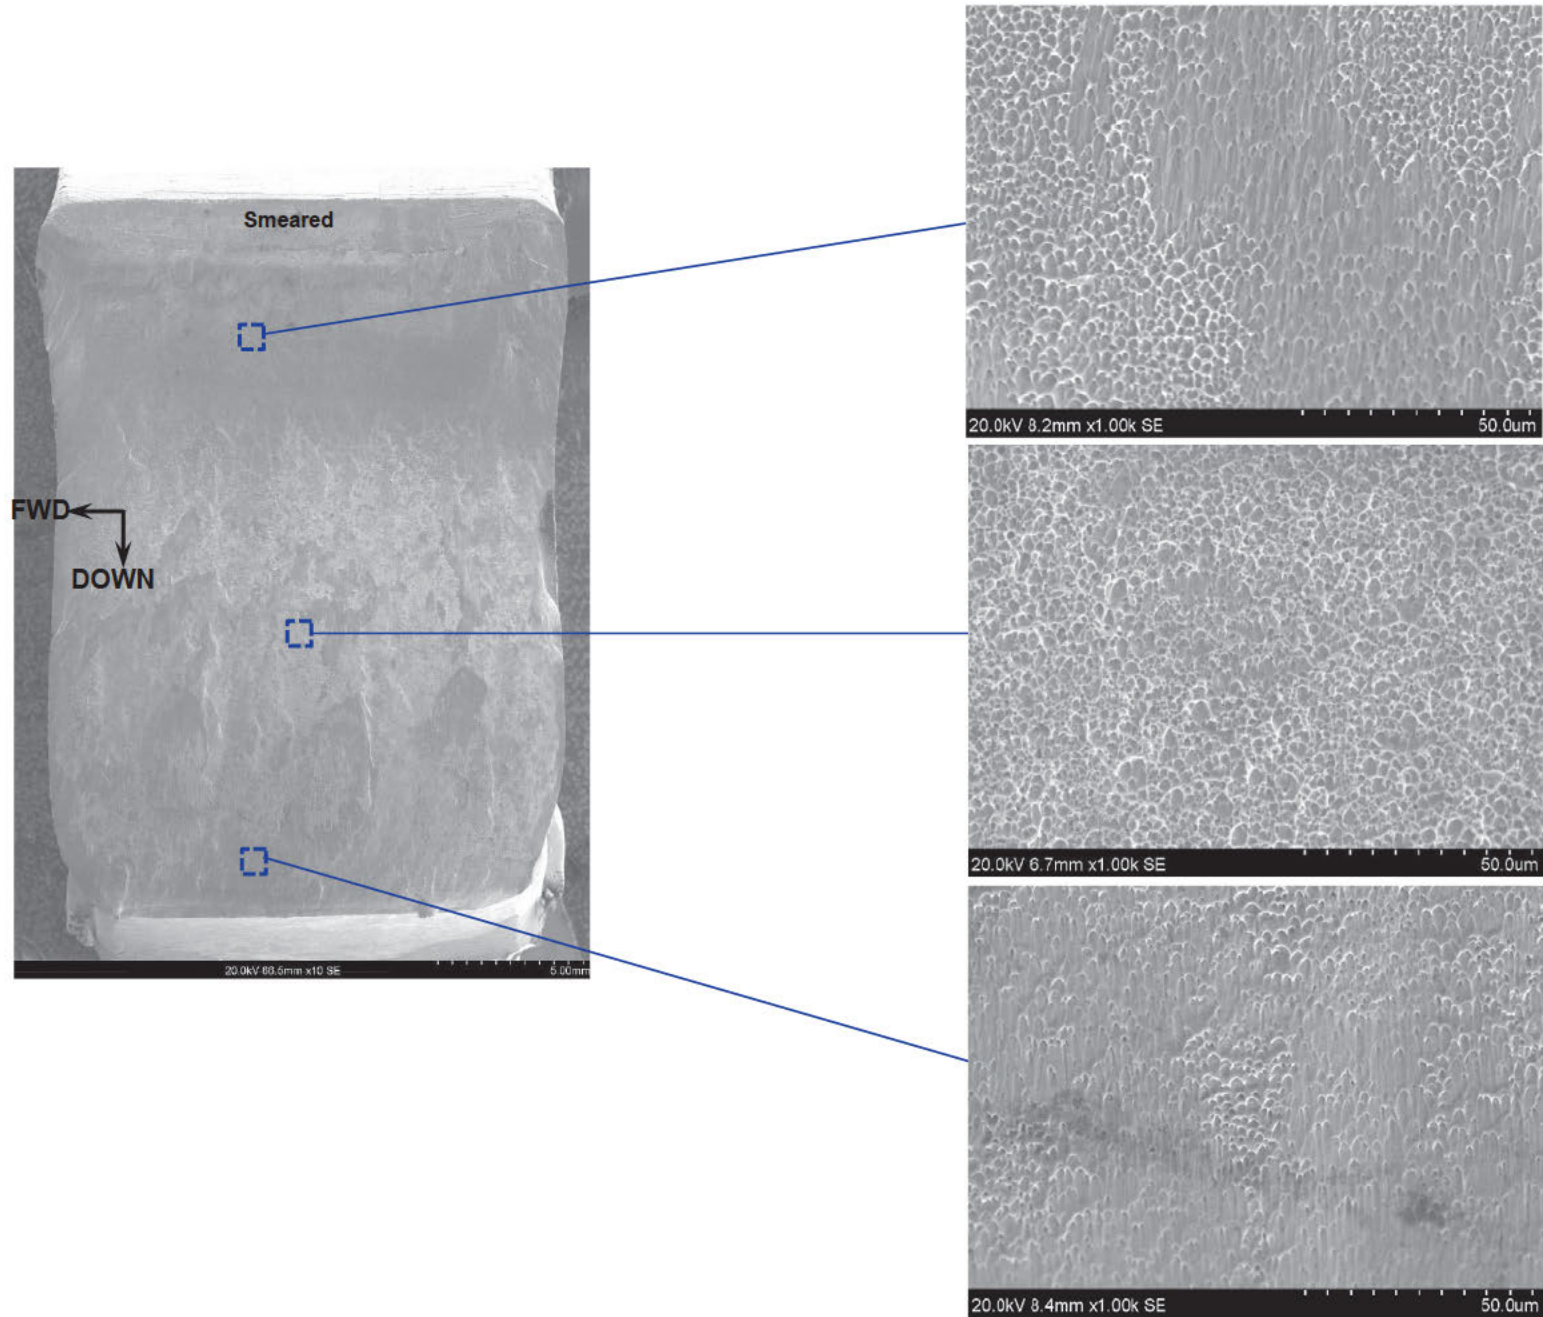
Figures 88 to 91. SEM close-ups from second fracture [Lock Link]
