Subject: Boeing Component Examination Report - Red Air MD-82 HI1064 Landing  
Gear Collapse and Runway Excursion Miami, Florida - 21 June, 2022

## FRACTURE ANALYSIS REPORT

Engineering Report No: MS 80040

A/P Customer:	RedAir	A/P Model:	MD-82
Registry No:	HI1064	Line Position No:	1805
Flight Hours:	68,229	Number of Landings:	35,873

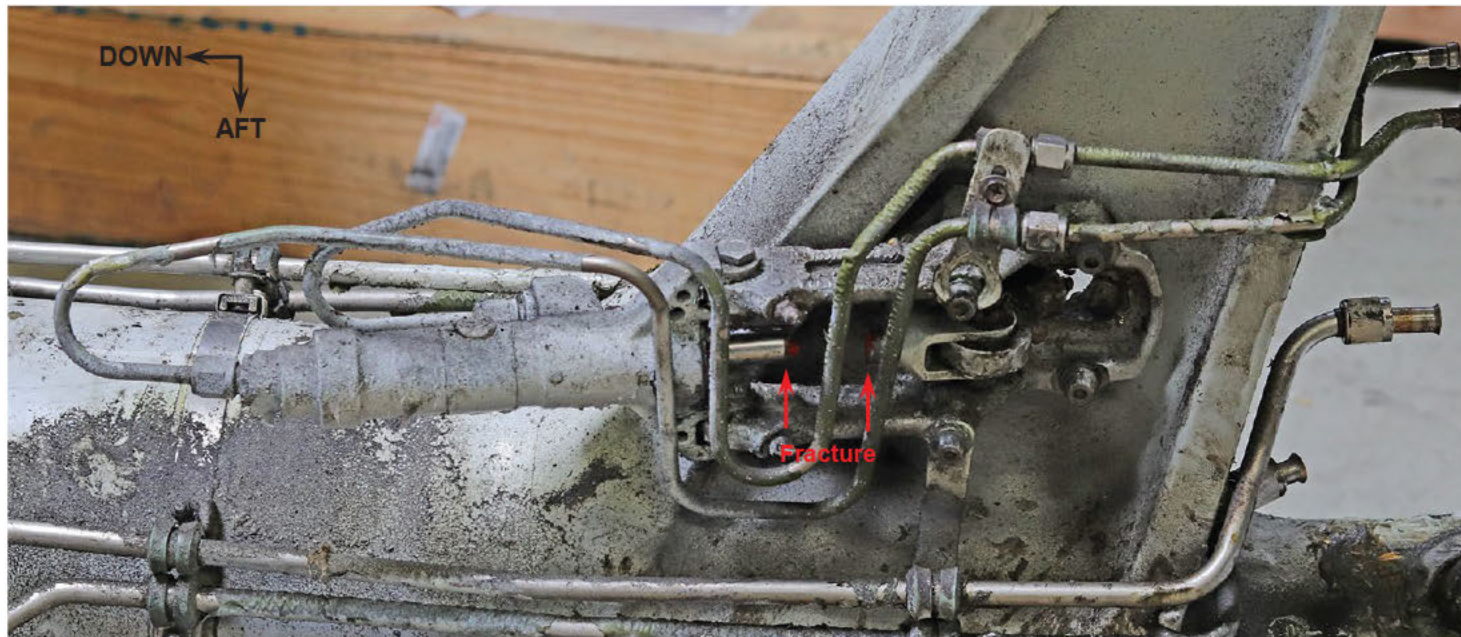
The bungee piston rod exhibited a complete fracture approximately two inches from the end of the clevis lug (Figures 92 to 94). The fracture surface occurred along an oblique plane, typical of ductile separation (Figures 95 and 96). The rod appeared to be bent slightly in an aft direction in the area of fracture.

Figure 92. Close-up of fractured Bungee Piston [looking Inbd]

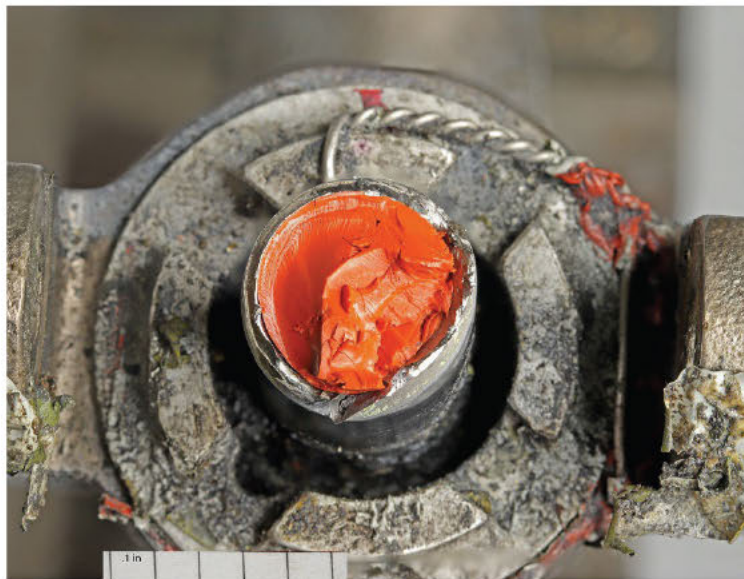
Figure 95. Close-up of fracture surface at cylinder end

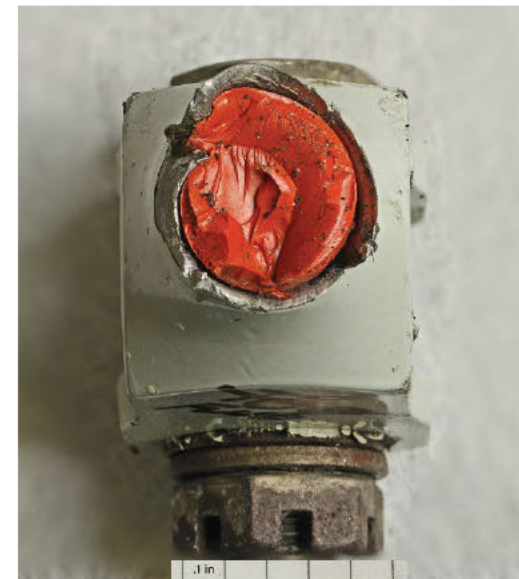
Figure 96. Close-up of fracture surface at clevis lug end

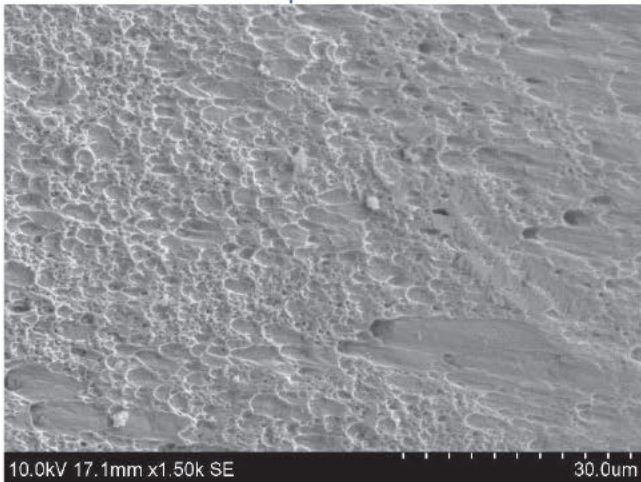
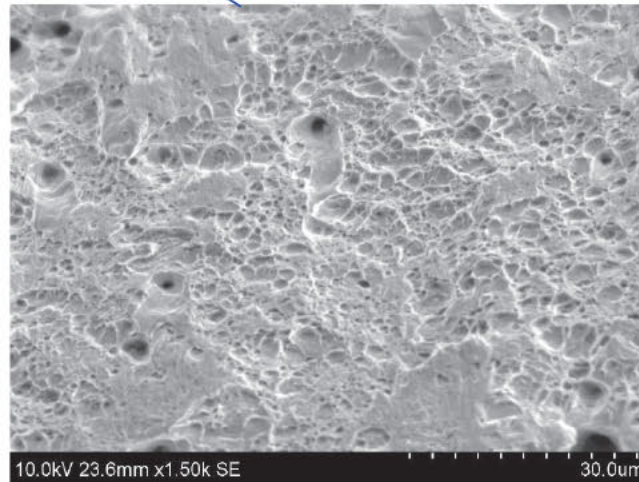
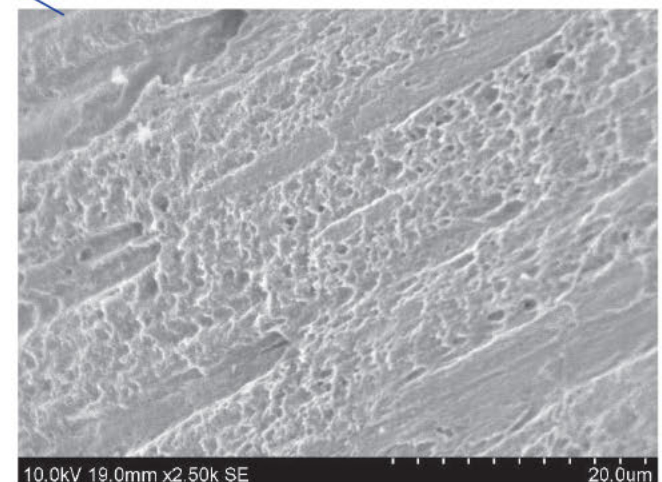
SEM analysis of the fracture surface revealed evidence of ductile separation (Figures 97 to 101).

Figures 99 to 101. SEM close-ups of fracture surface [Bungee Piston]

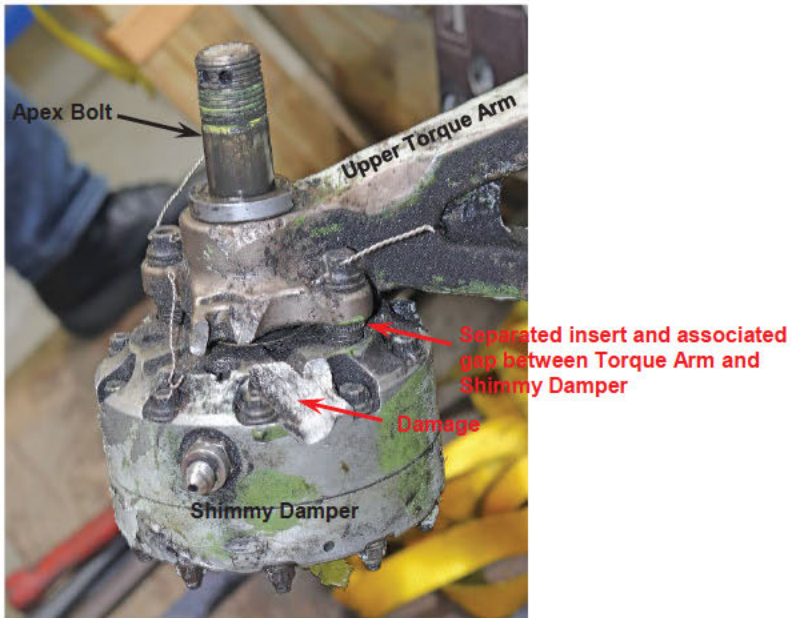
The shimmy damper housing exhibited evidence of impact damage, and a number of the threaded inserts had partially pulled out of the housing (Figure 102). Some of the insert threads contained remnants of the mating shimmy damper housing threads which had been sheared away. The ends of the holes were elongated in a mostly circumferential direction (Figure 103). The hole surfaces exhibited circumferential scrape/shear marks (Figure 104).

Figure 102. Close-up of Shimmy Damper

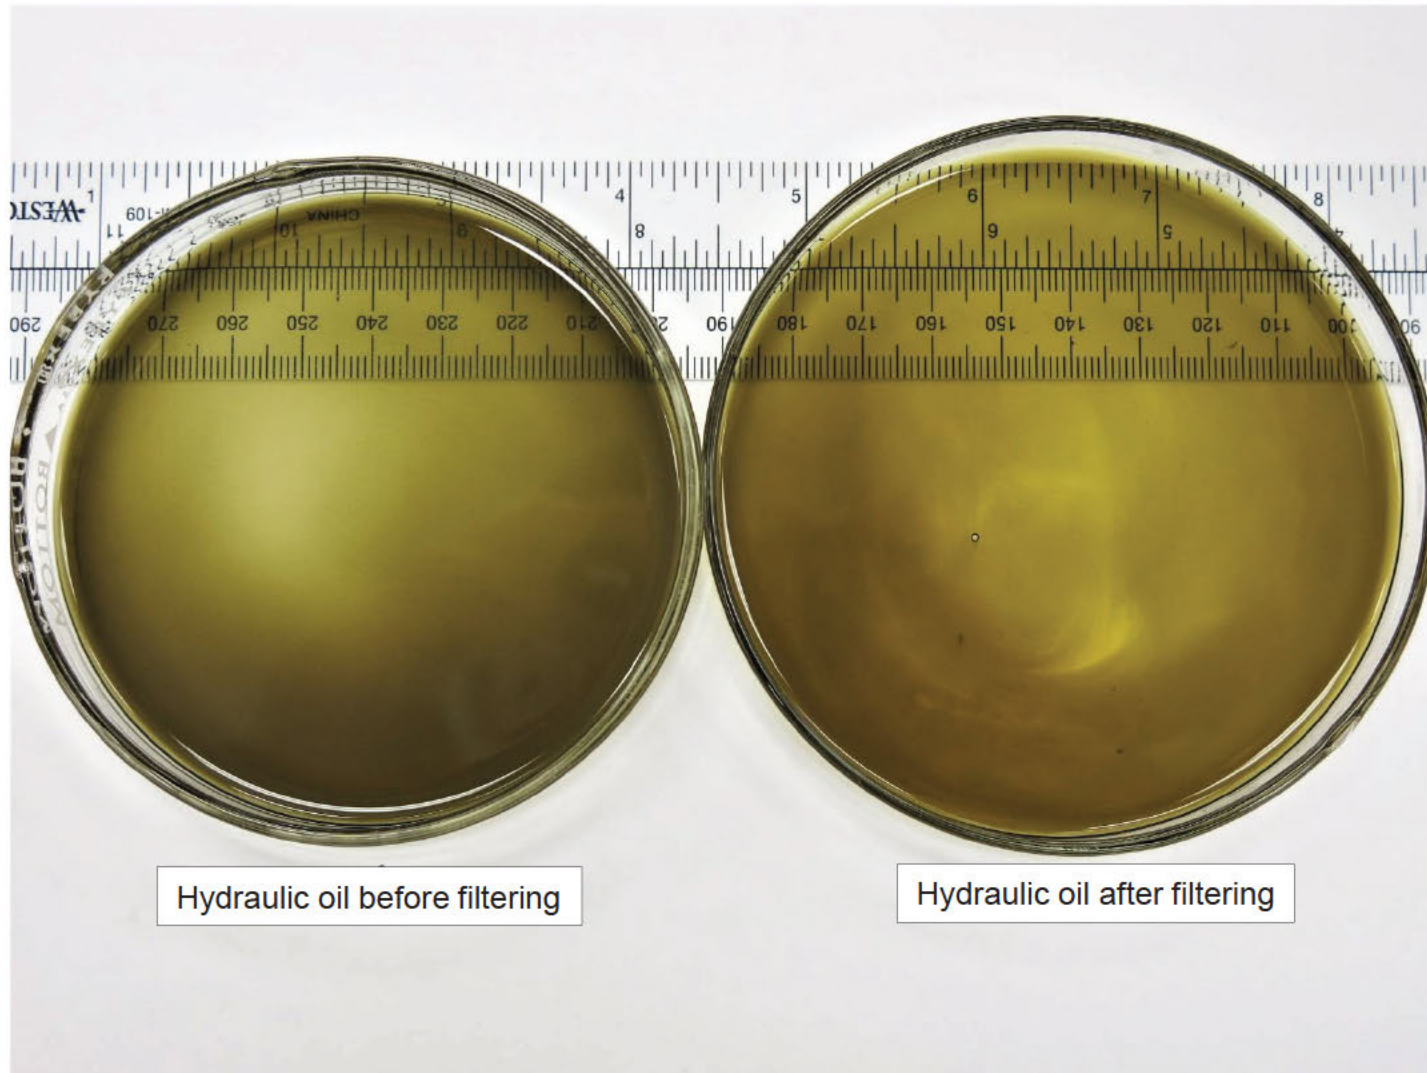
Figure 2. Hydraulic oil, as-received in a Petri dish on left; hydraulic oil after filtering through 0.45 micron pore size filter on right. Particulates still appear to be present in filtered oil.

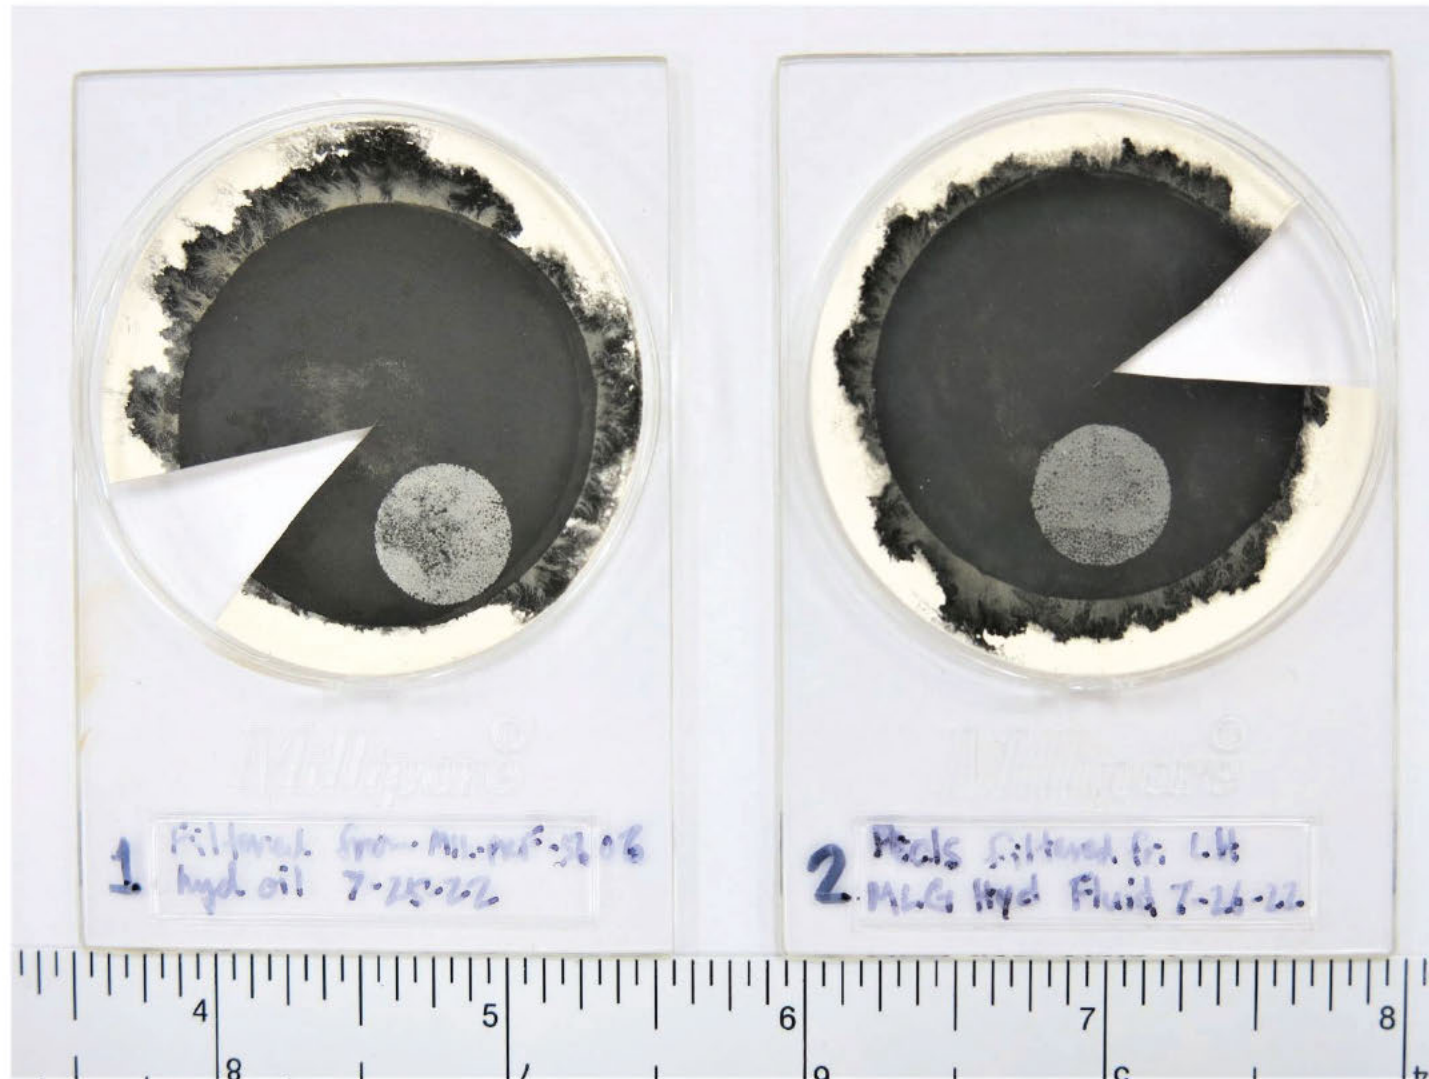
The filtered black silt appeared to consist of a mixture of oil, an acrylate and the wear additive from the hydraulic oil, but the source of Teflon particles (probably from wear) was unknown. It was suspected that the black particles that passed through the 0.45 micron pore size filter were carbon soot, which may also have been a component of the solids that were retained by the filter. Carbon was not identifiable by FTIR analysis. The carbon particles may have been picked up if it flowed over contaminated external surfaces during collection.

Figure 3. Particles filtered from oil. Filter 1 with particles left after decanting oil after filter plugged. Filter 2 with particles filtered from entire volume of oil added to filter. Both were hexane flushed.

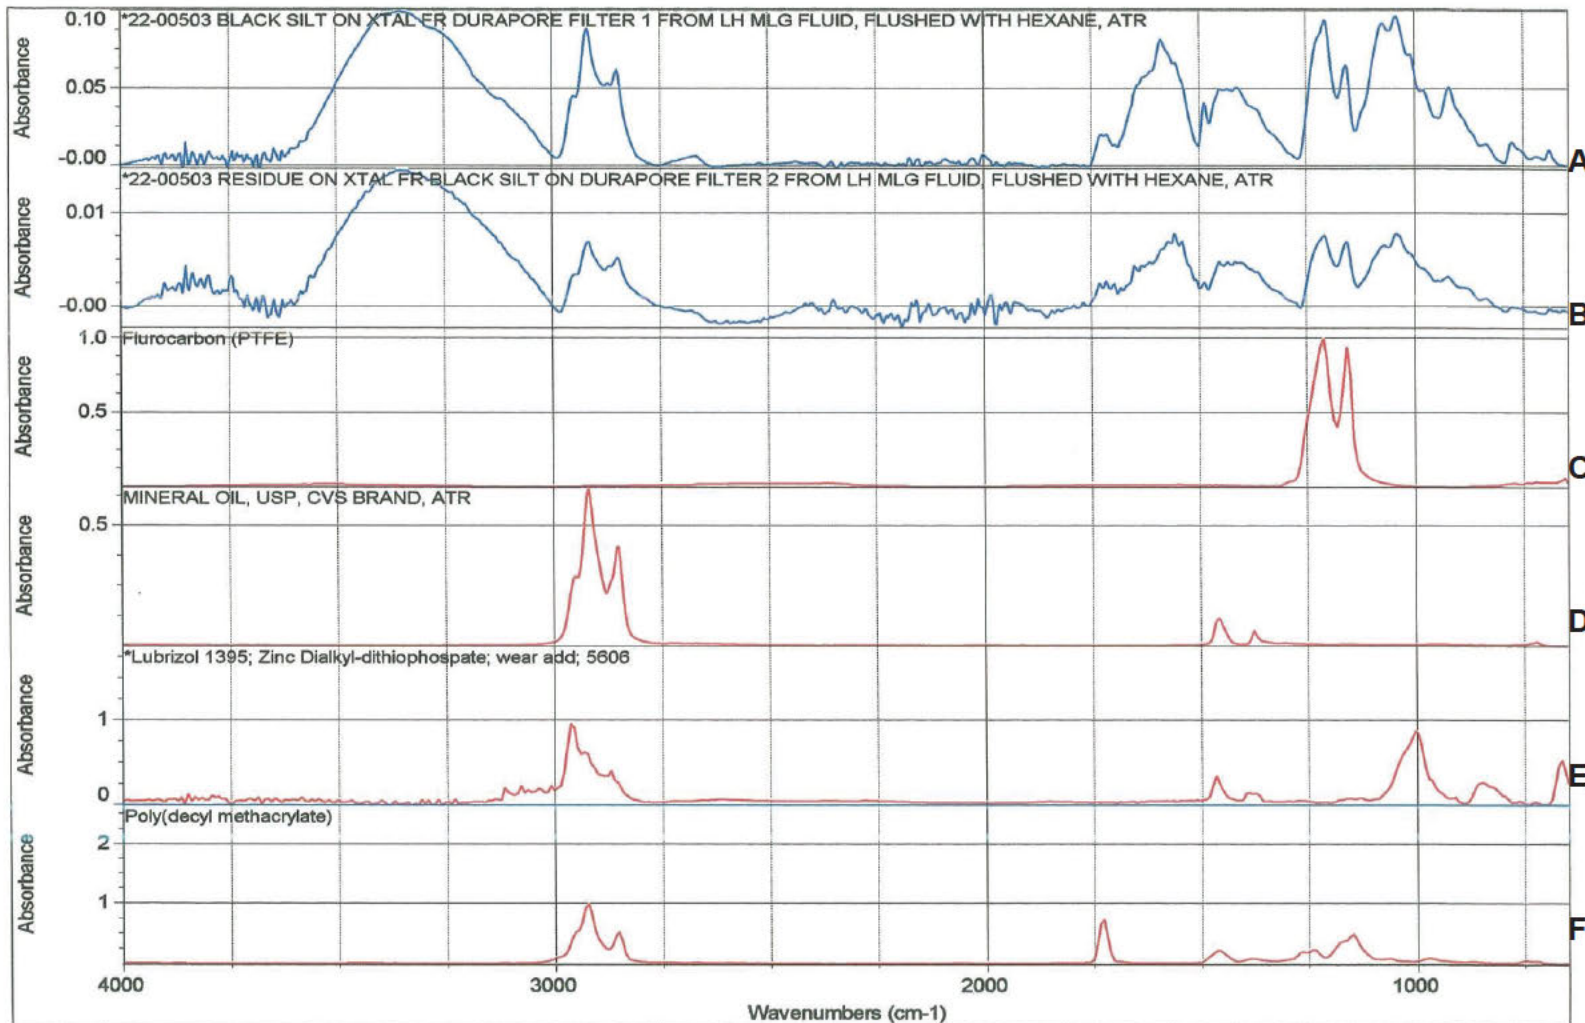
The FTIR spectra of the black filtered silt on both filters were similar (Fig. 5). A mixture of Teflon particles, possibly an acrylic material, zinc dialkyldithiophosphate wear additive and residual hydrocarbon oil residue may be present.

Figure 5. FTIR spectra of filtered black silt in blue (A-B), reference spectra in red (C-F).
