**NATIONAL TRANSPORTATION SAFETY BOARD**

**Attachment 1 - Simulator Evaluation**

**OPERATIONAL FACTORS/HUMAN PERFORMANCE**

**DCA18LA163**

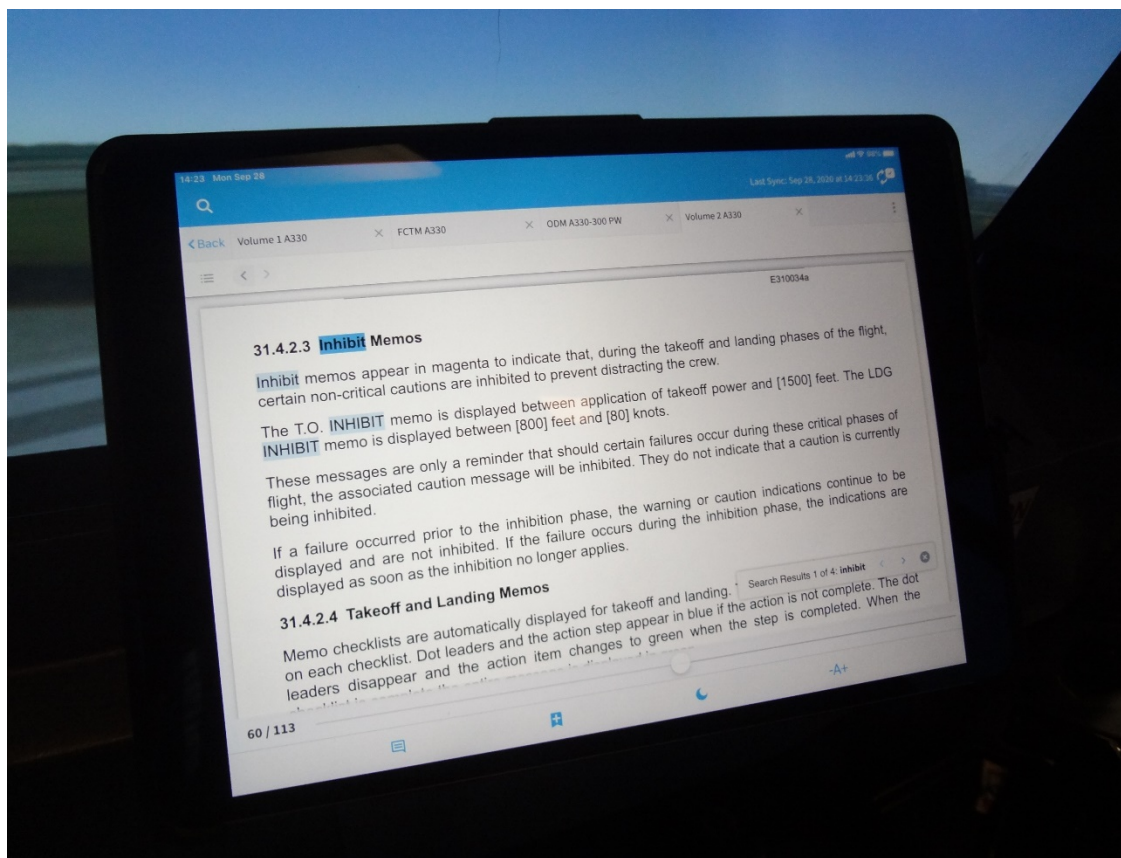
Notes
	Aircraft indications noted Aircraft/Pilot Notes: T/O Inhibit message. (Ref Photo 1 below) Inhibit non-essential messages and inhibited until 1,500 feet for takeoff. Landing also has an inhibit switch and that is in effect from 800 feet and below

Photo 1: DAL Inhibit Message Guidance

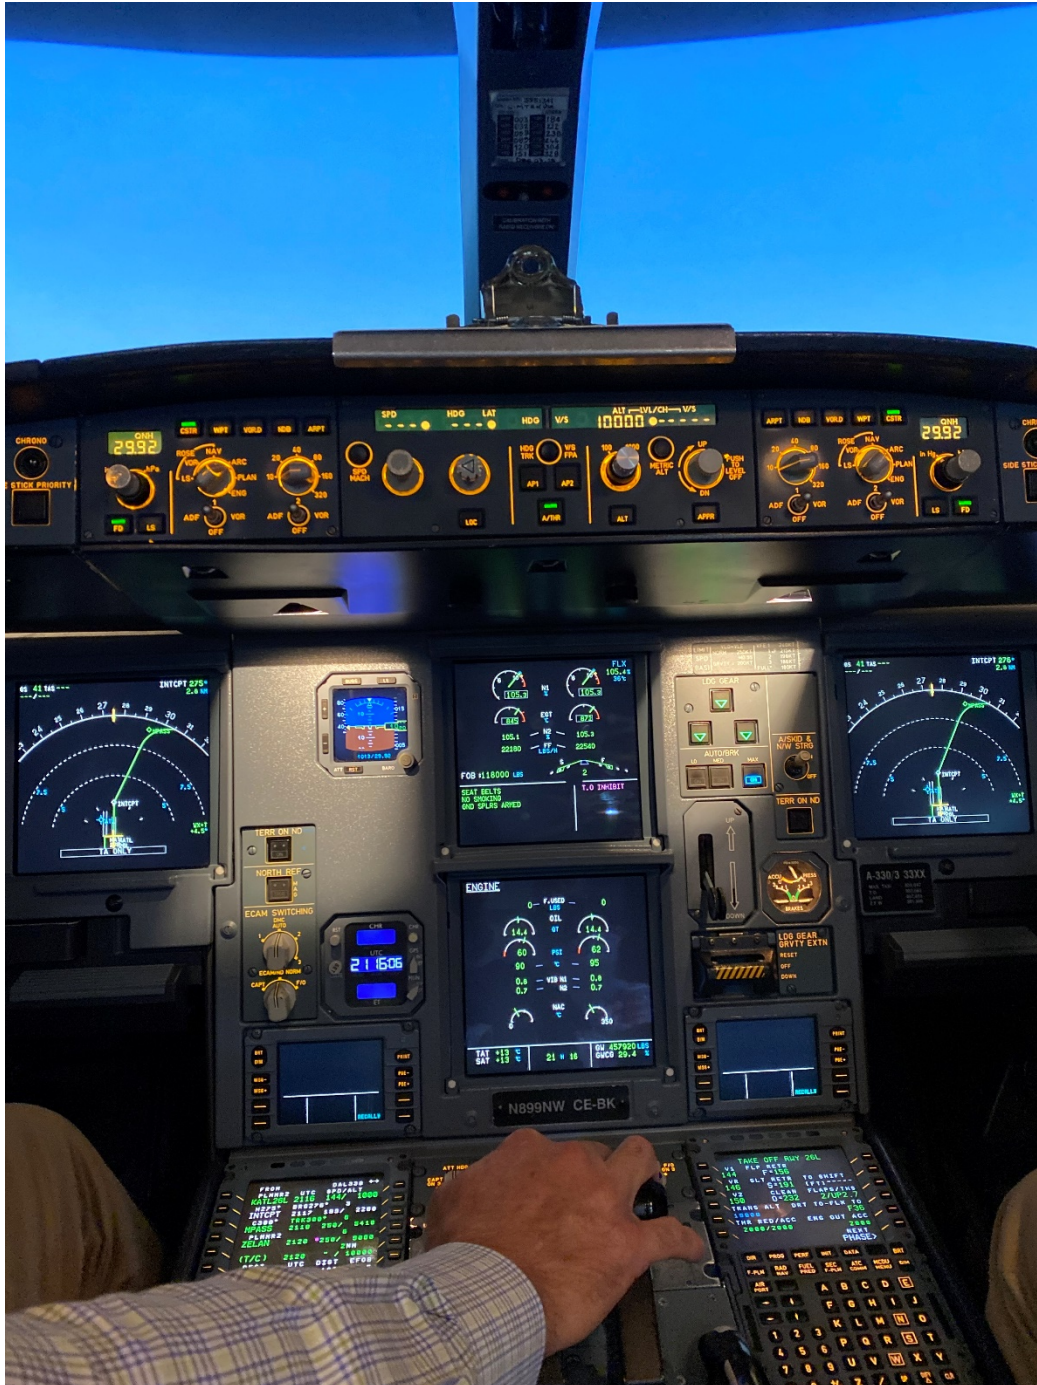
<b><i>Notes</i></b>
		Normal RTO event. Fire Light on overhead panel illuminated approximately 2 seconds prior to ECAM message indication and fire audible alert <sup>3</sup> . It was determined to be a simulator limitation. Possibility of the Fire Warning Computer simulation delay. The firelight did illuminate at 135 knots on the overhead panel and the audible V1 was heard followed almost immediately by the fire bell.

*Photo 2: T/O Inhibit Message  
(Note: ENG 2 FIRE P/B on Upper Center Panel Illuminated)*

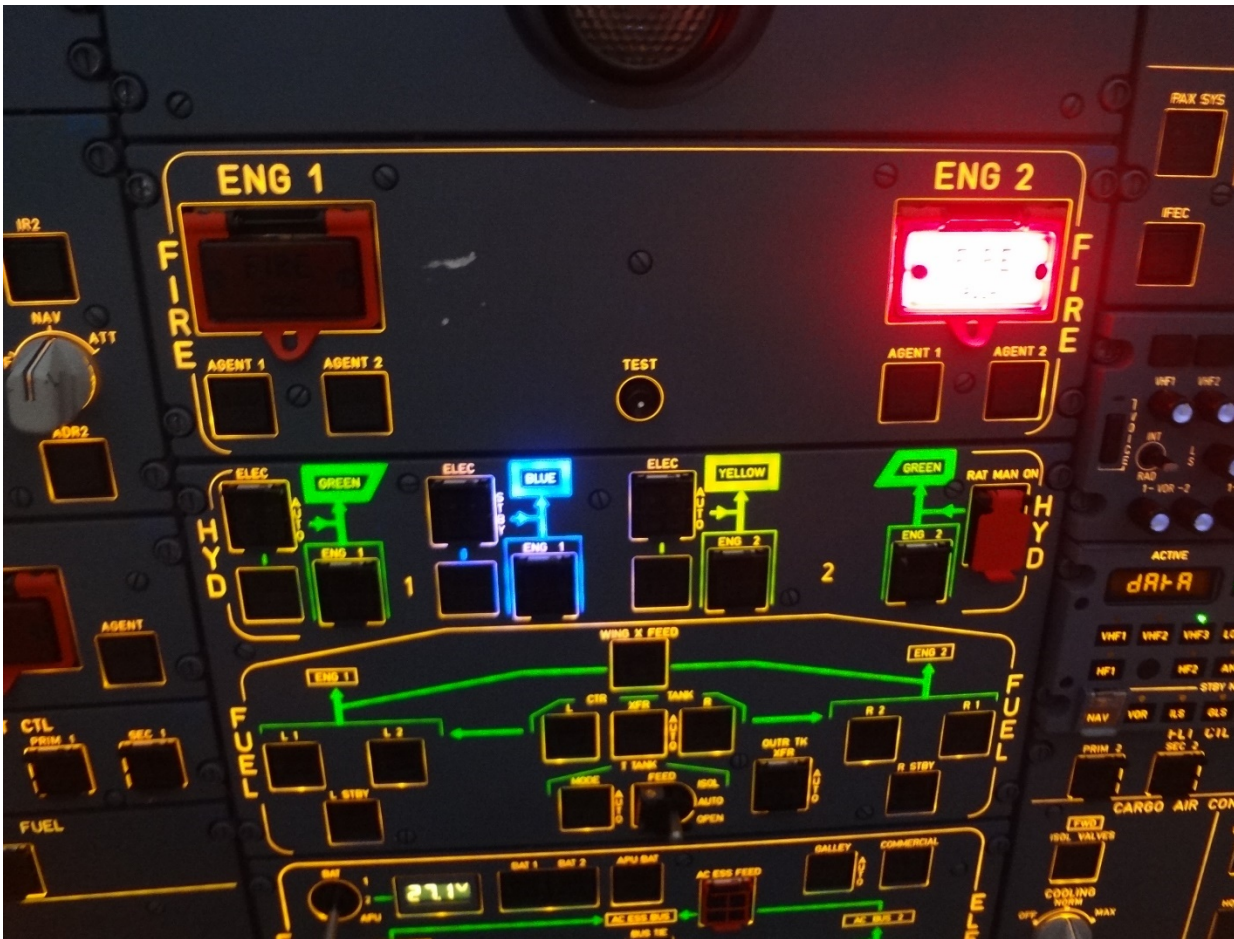
*Photo 3: ENG 2 FIRE P/B Located on Upper Center Panel*

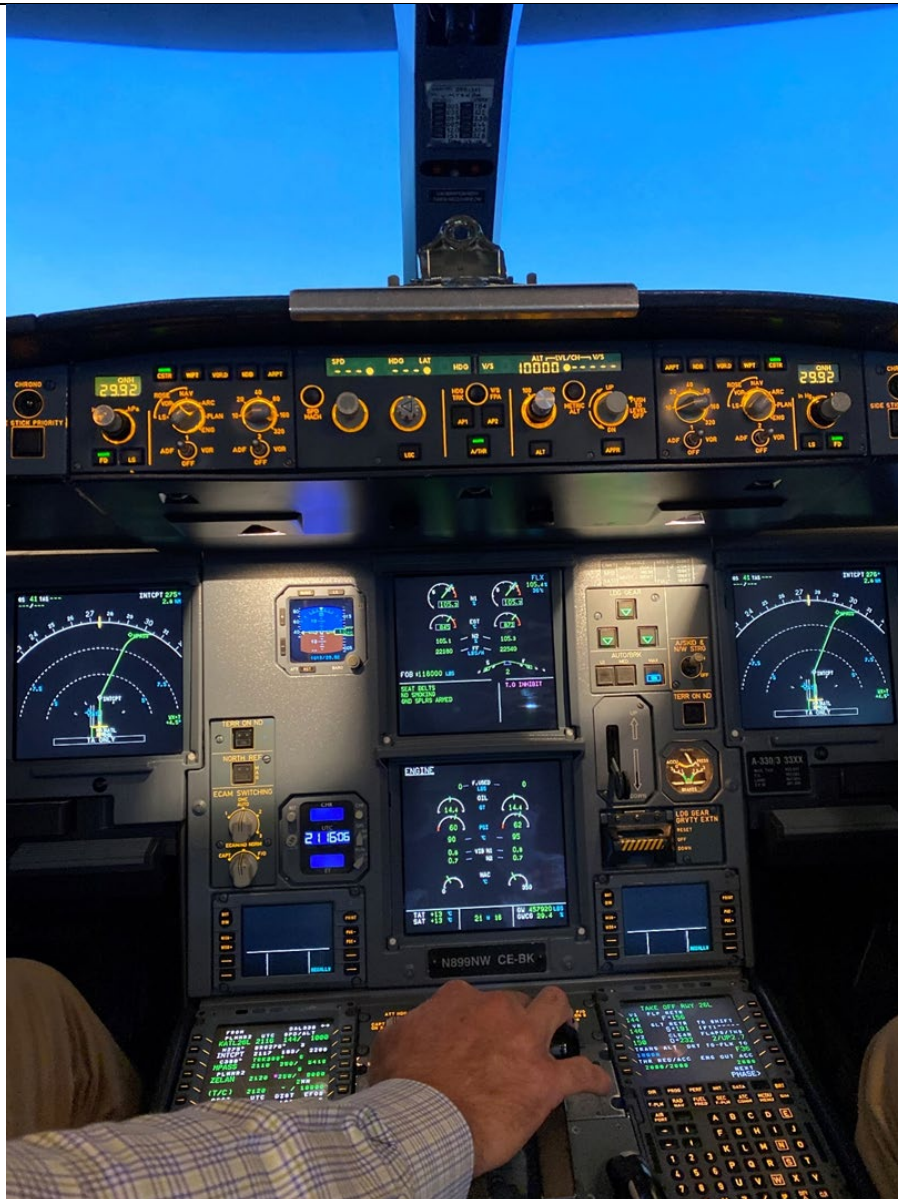
<i>Notes</i>
	<p>Engine fire was initiated at 150 knots and the indication was about 160 knots. The engine fire light on the overhead panel and on center console illuminated; however, no audible bell or Engine Fire Warning message illuminated on the ECAM until about 15 seconds after liftoff during the inhibit phase<sup>4</sup>. After that time expired the engine fire warning message illuminated and the audible fire bell was observed. During climbout crew ran the following checklist:</p> <p>ENG 2 FIRE<sup>5</sup>  ENG 2 SHUT DOWN  AIR ABNORM BLEED CONFIG (reappeared after the discharge of agent 2 on ENG 2)  ELEC amber message appeared with master lever was shutoff.  The following messages were indicated on the ECAM following the ENG 2 FIRE pushbutton being pressed:  HYD  *HYD (an * item denotes association with an item on the current open or primary checklist)  F/CTL</p> <p>Additionally the simulator operator simulated a Dual Loop fault by simulating opening of the Eng 2 Loop A and Eng 2 Loop B fire loop circuit breaker which resulted in the Elect C/B Tripped message, which is a normal message generated by the Fire Warning Computer. However, in the simulator this message was a result of the simulator operator simulating pulling the two-circuit breaker to simulate the fault; that method was only used due to the limitation of the simulator. Additionally, ENG 2 FIRE DET FAULT caution message illuminated, and the LAND ASAP red message changed to an amber message<sup>6</sup>, which were messages the crew should have received. Of note: The Nacelle Temp Advisory message remained after the fire indication stopped. The run ceased with the beginning of the fire checklist.</p> <p>The crew received vectors from simulated ATC while they accomplished the checklist items associated with the various messages.</p> <p>Additionally, it was noted that when only Loop B was failed the fire light on the overhead panel and the fire light at the Master</p>

*Photo 4: T/O Inhibit Message  
(ENG 2 FIRE P/B Illuminated on Upper Center Panel)*

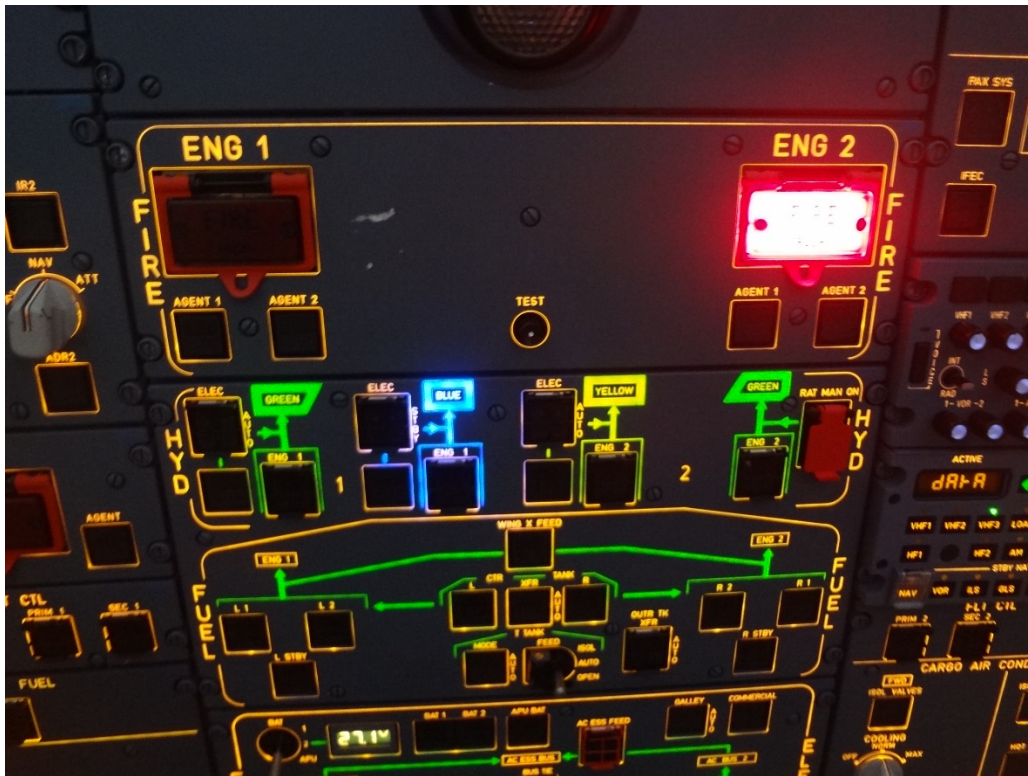
*Photo 5: ENG 2 FIRE P/B Located on Upper Center Panel*

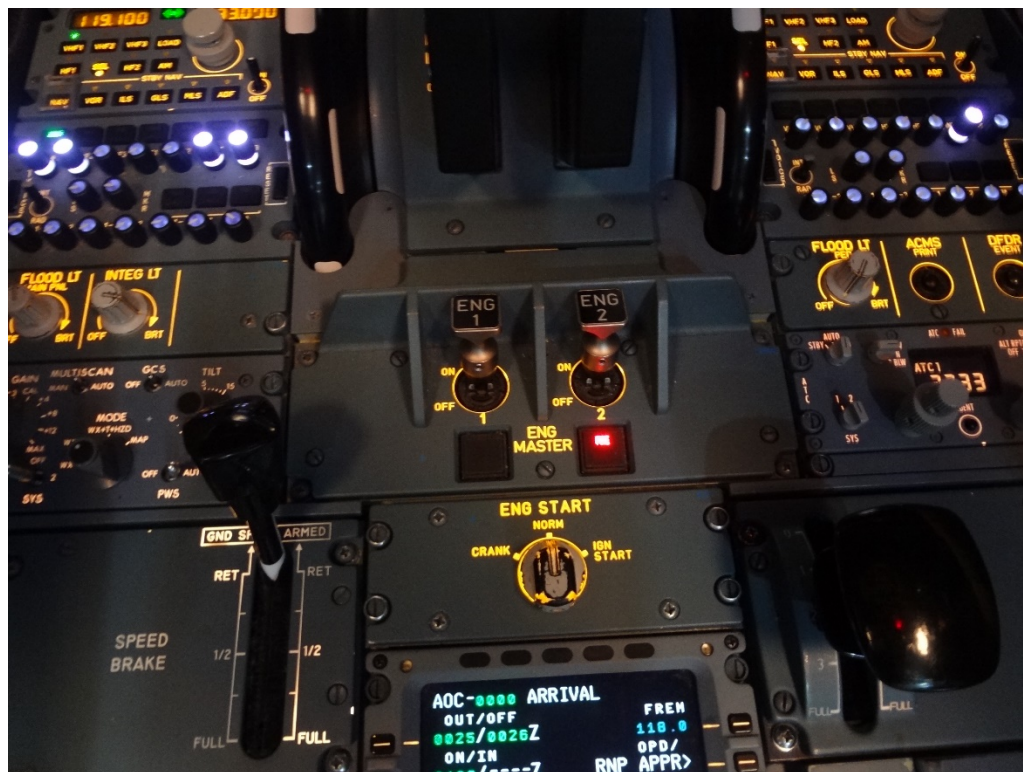
Lever illuminated; however, when Loop A failed and Loop B was operational only the overhead Engine Fire light illuminated. Airbus will research if that is normal in the airplane or if a simulator limitation. Additional question for Pratt and Whitney would be where in the loop the fire is detected. Additionally, powerplants may have asked that question in reference to the fire indication within the timeline.

*Photo 6: Engine 2 Master FIRE Light Illuminated*

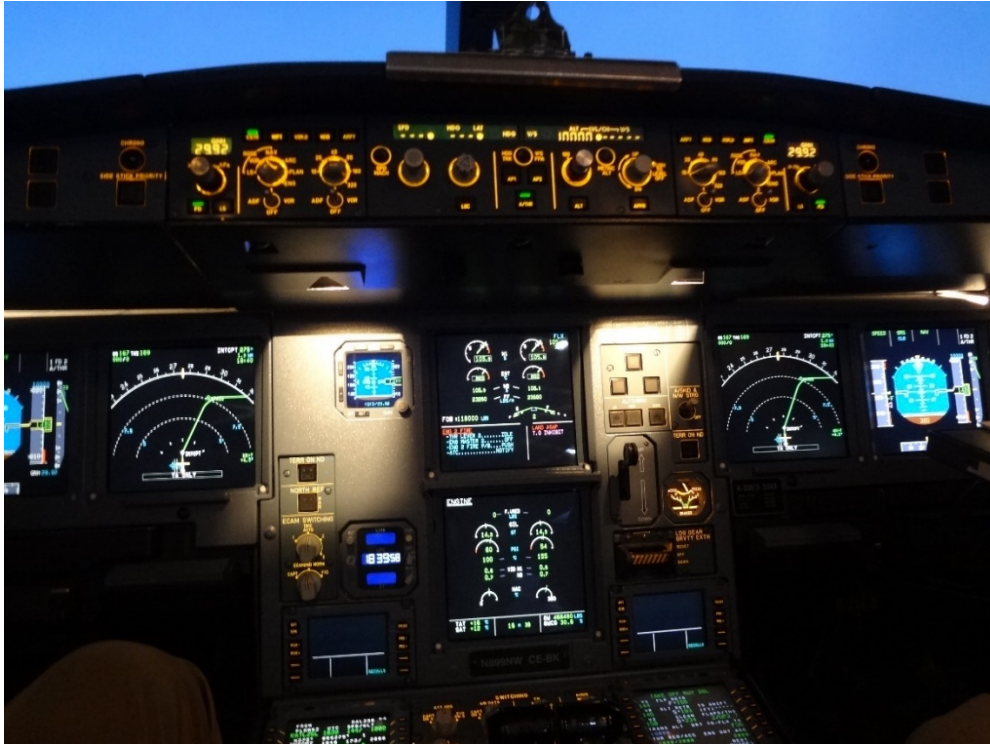
Photo 7: Liftoff + 15 seconds ENG 2 FIRE message<sup>7</sup>

<sup>7</sup> T/O Inhibit is still illuminated however, Liftoff + 15 seconds will illuminate specific messages, ENG FIRE was one of those messages.

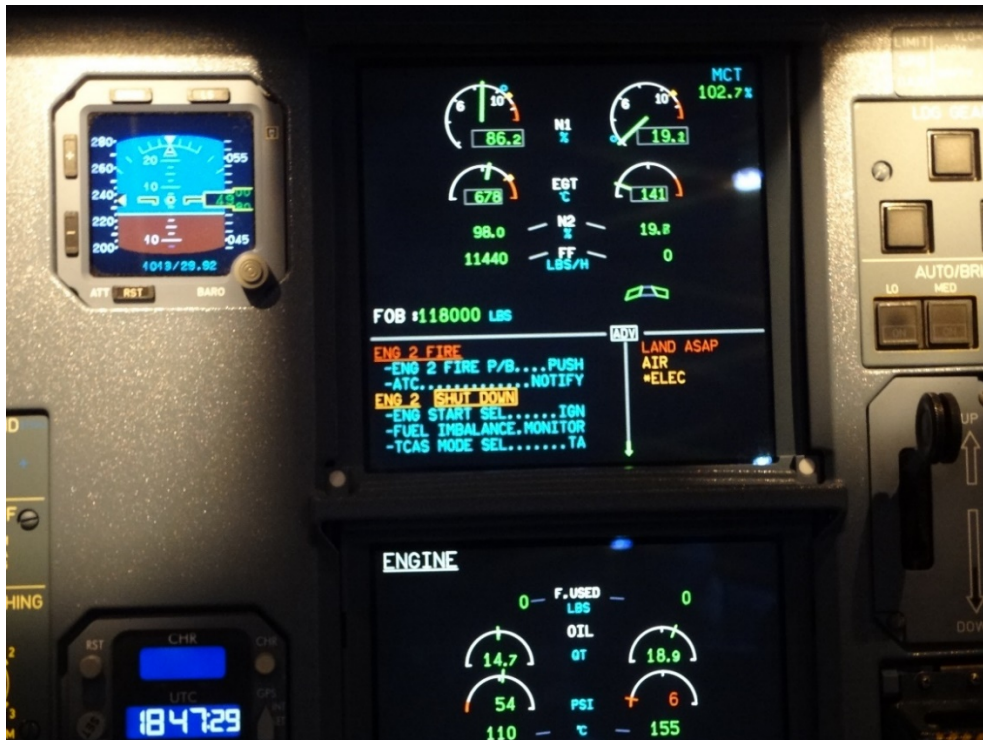
Photo 8: ENG 2 FIRE message and Additional Prioritized messages

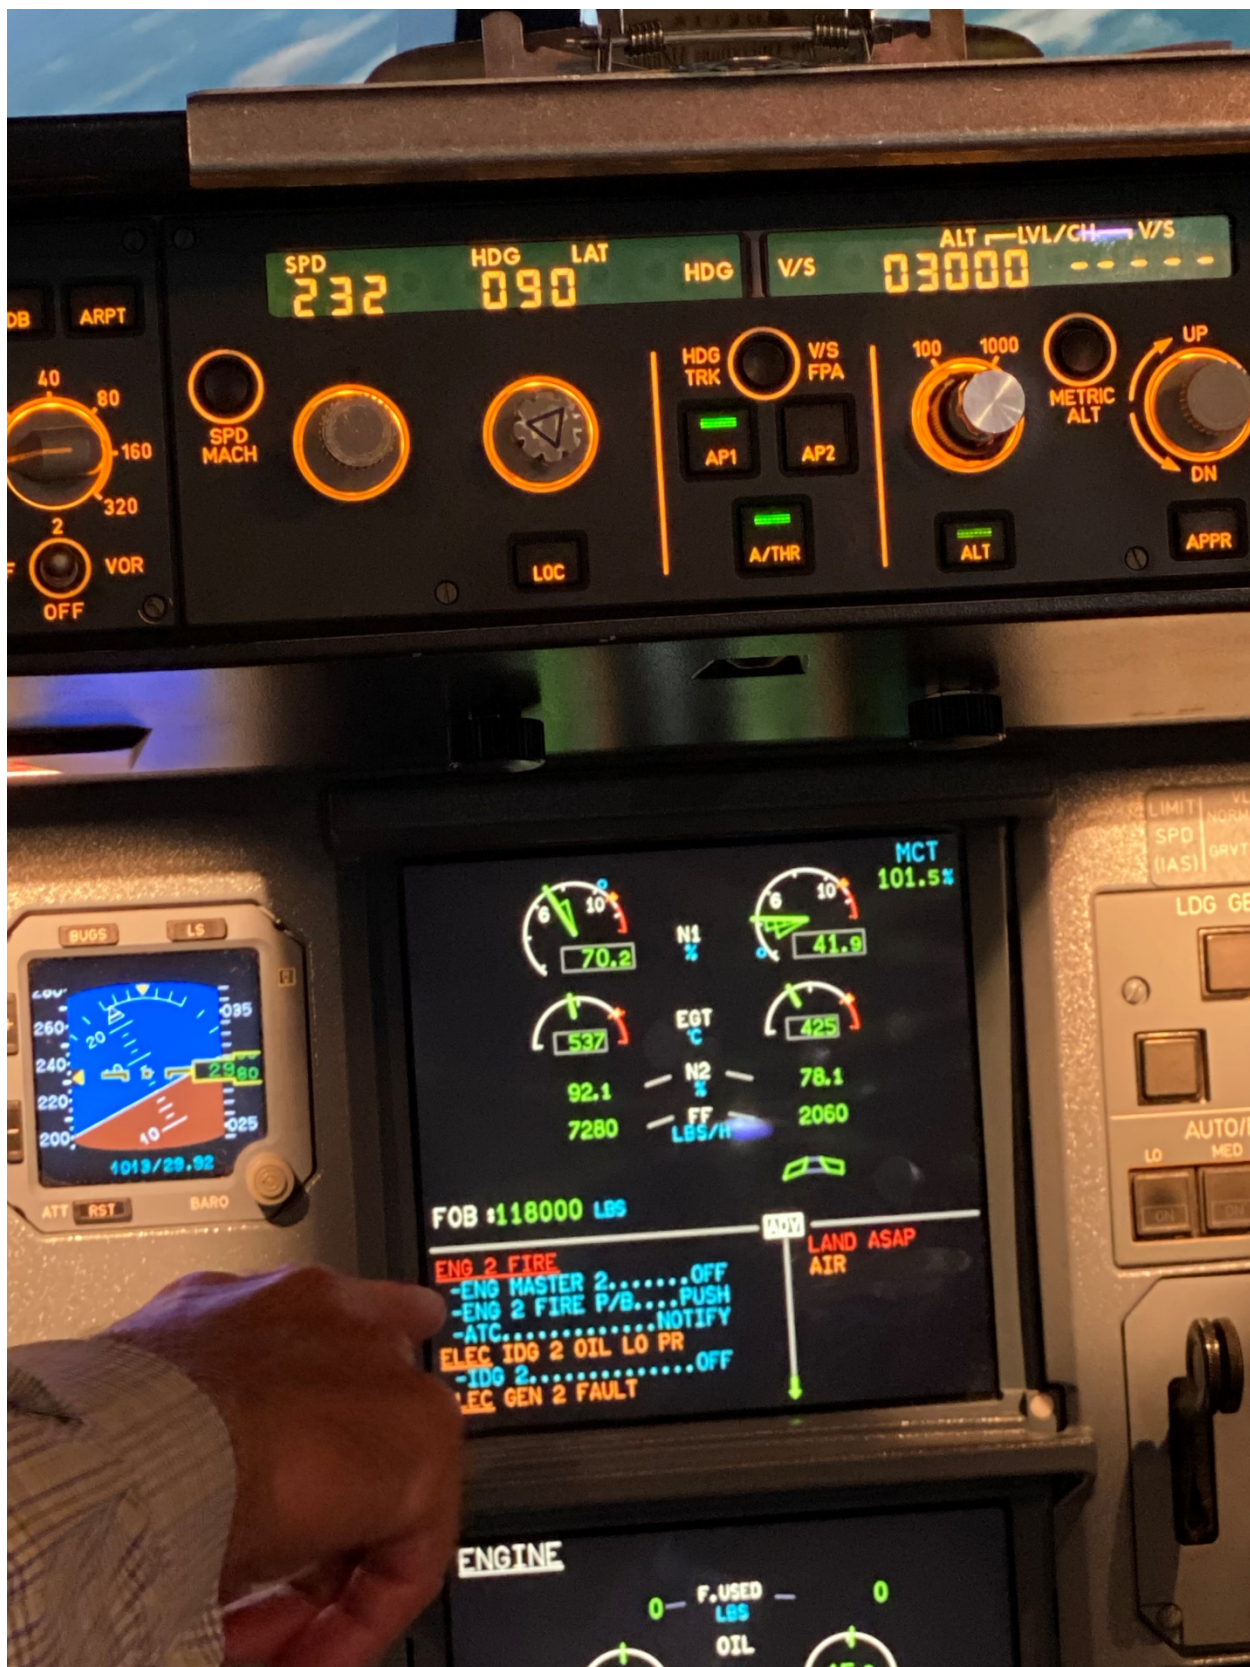
Photo 9: ENG 2 FIRE checklist items displayed on the ECAM

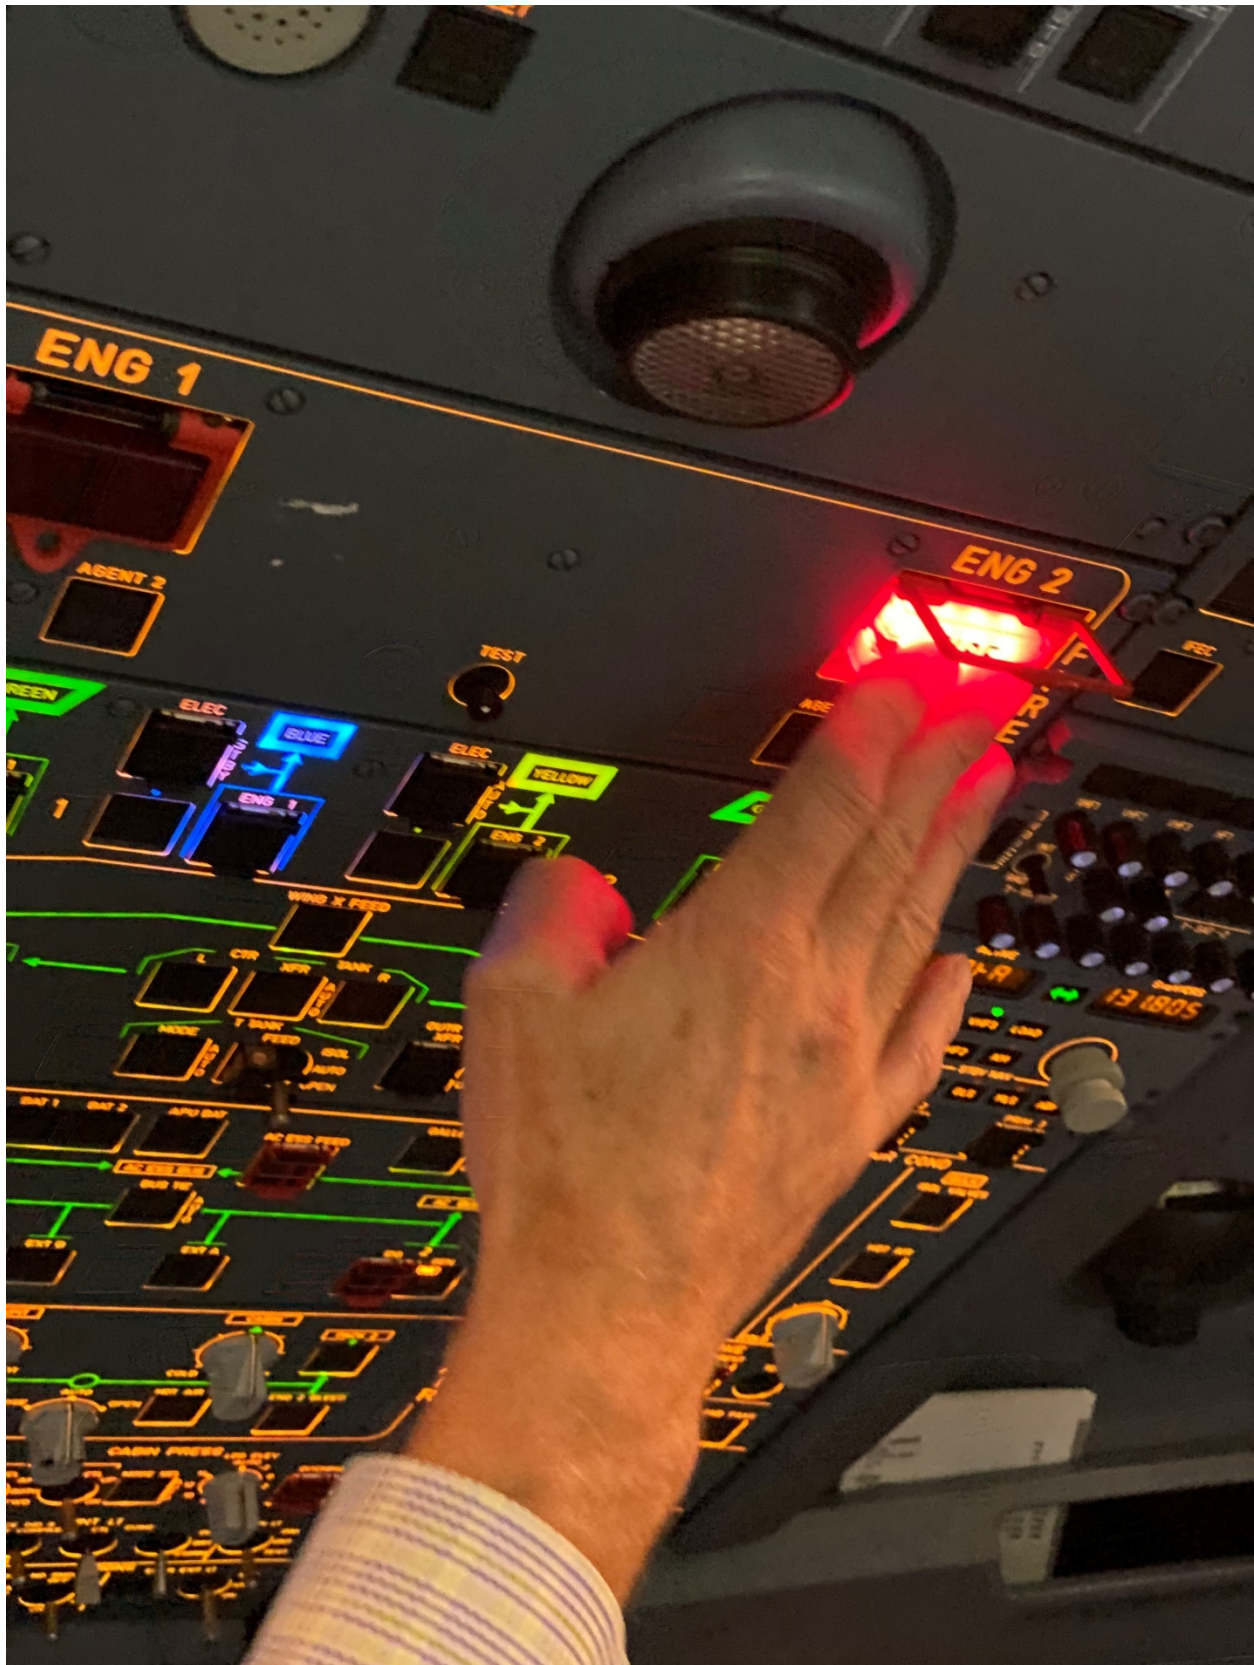
*Photo 10: ENG 2 FIRE P/B on Upper Center Panel*

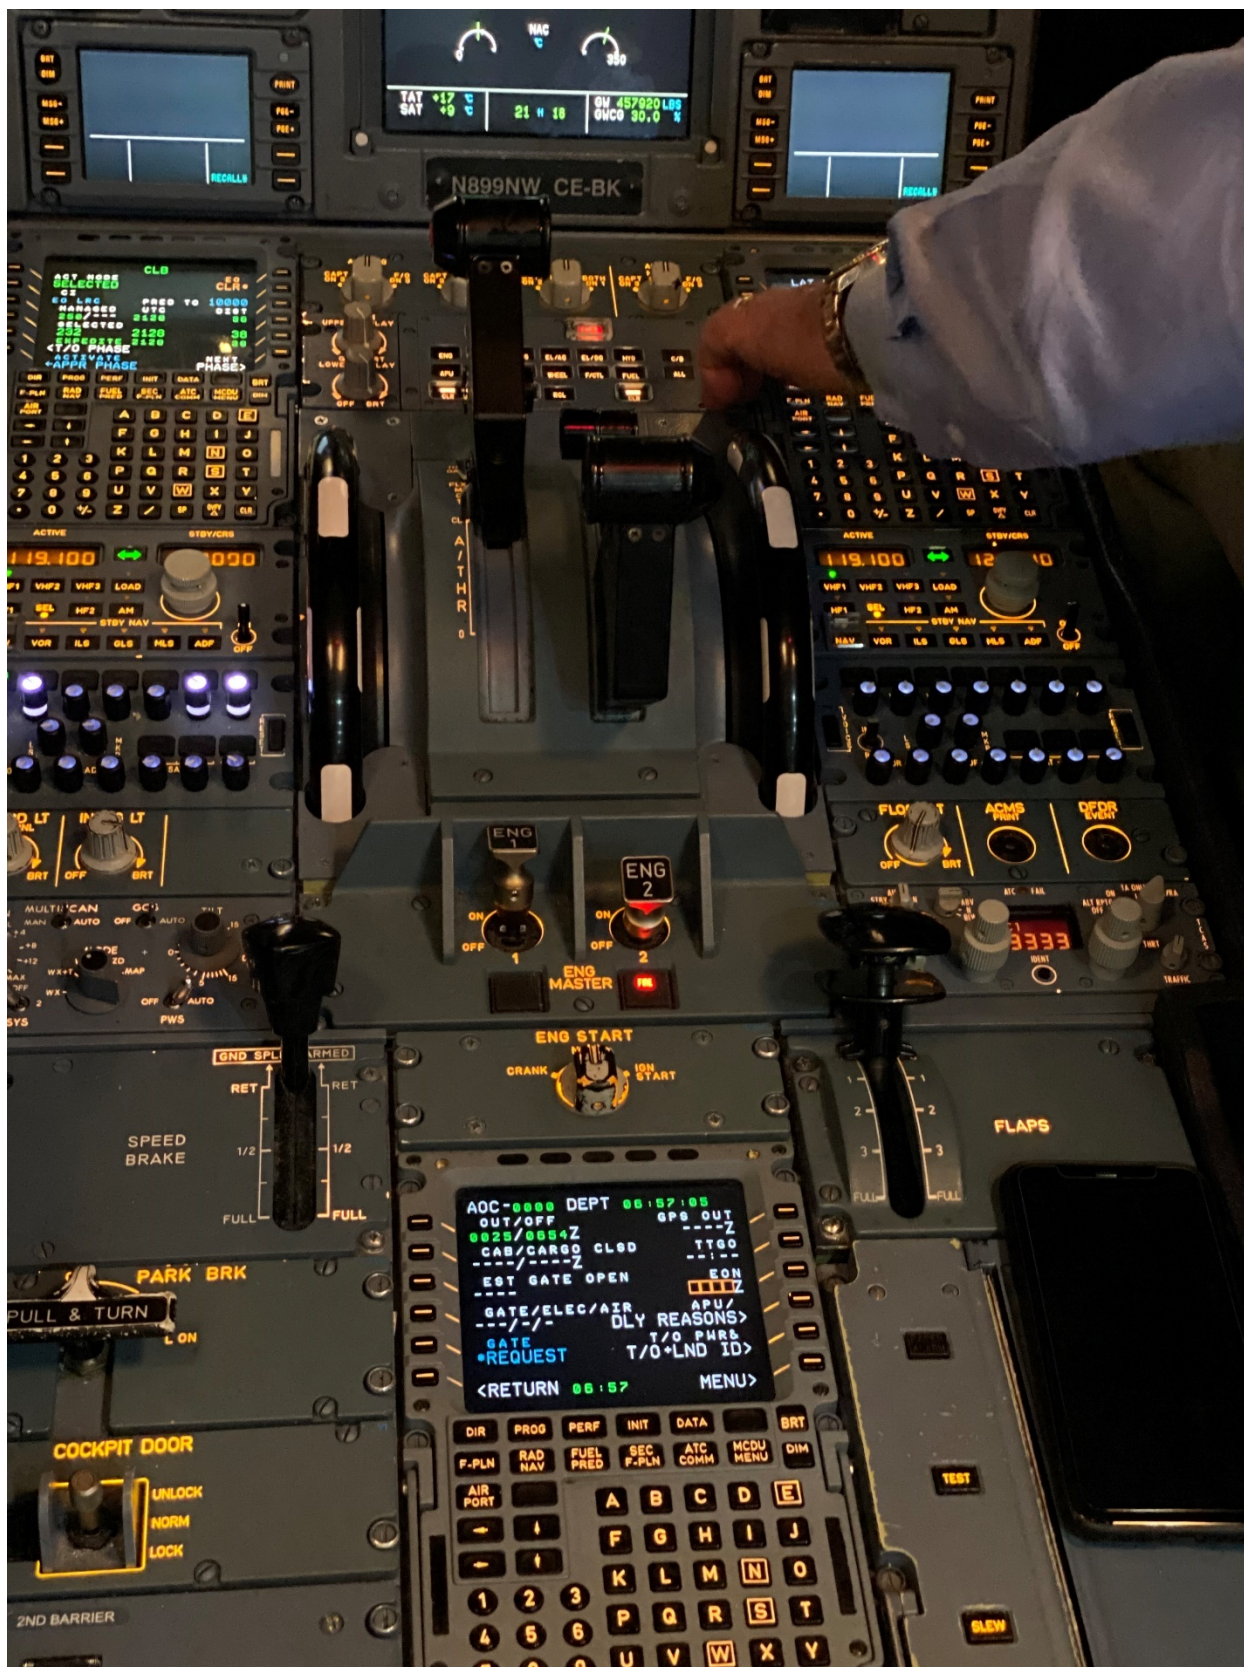
Photo 11: ENG 2 Master FIRE Light Illuminated on Center Pedestal Aft of the Thrust Levers.

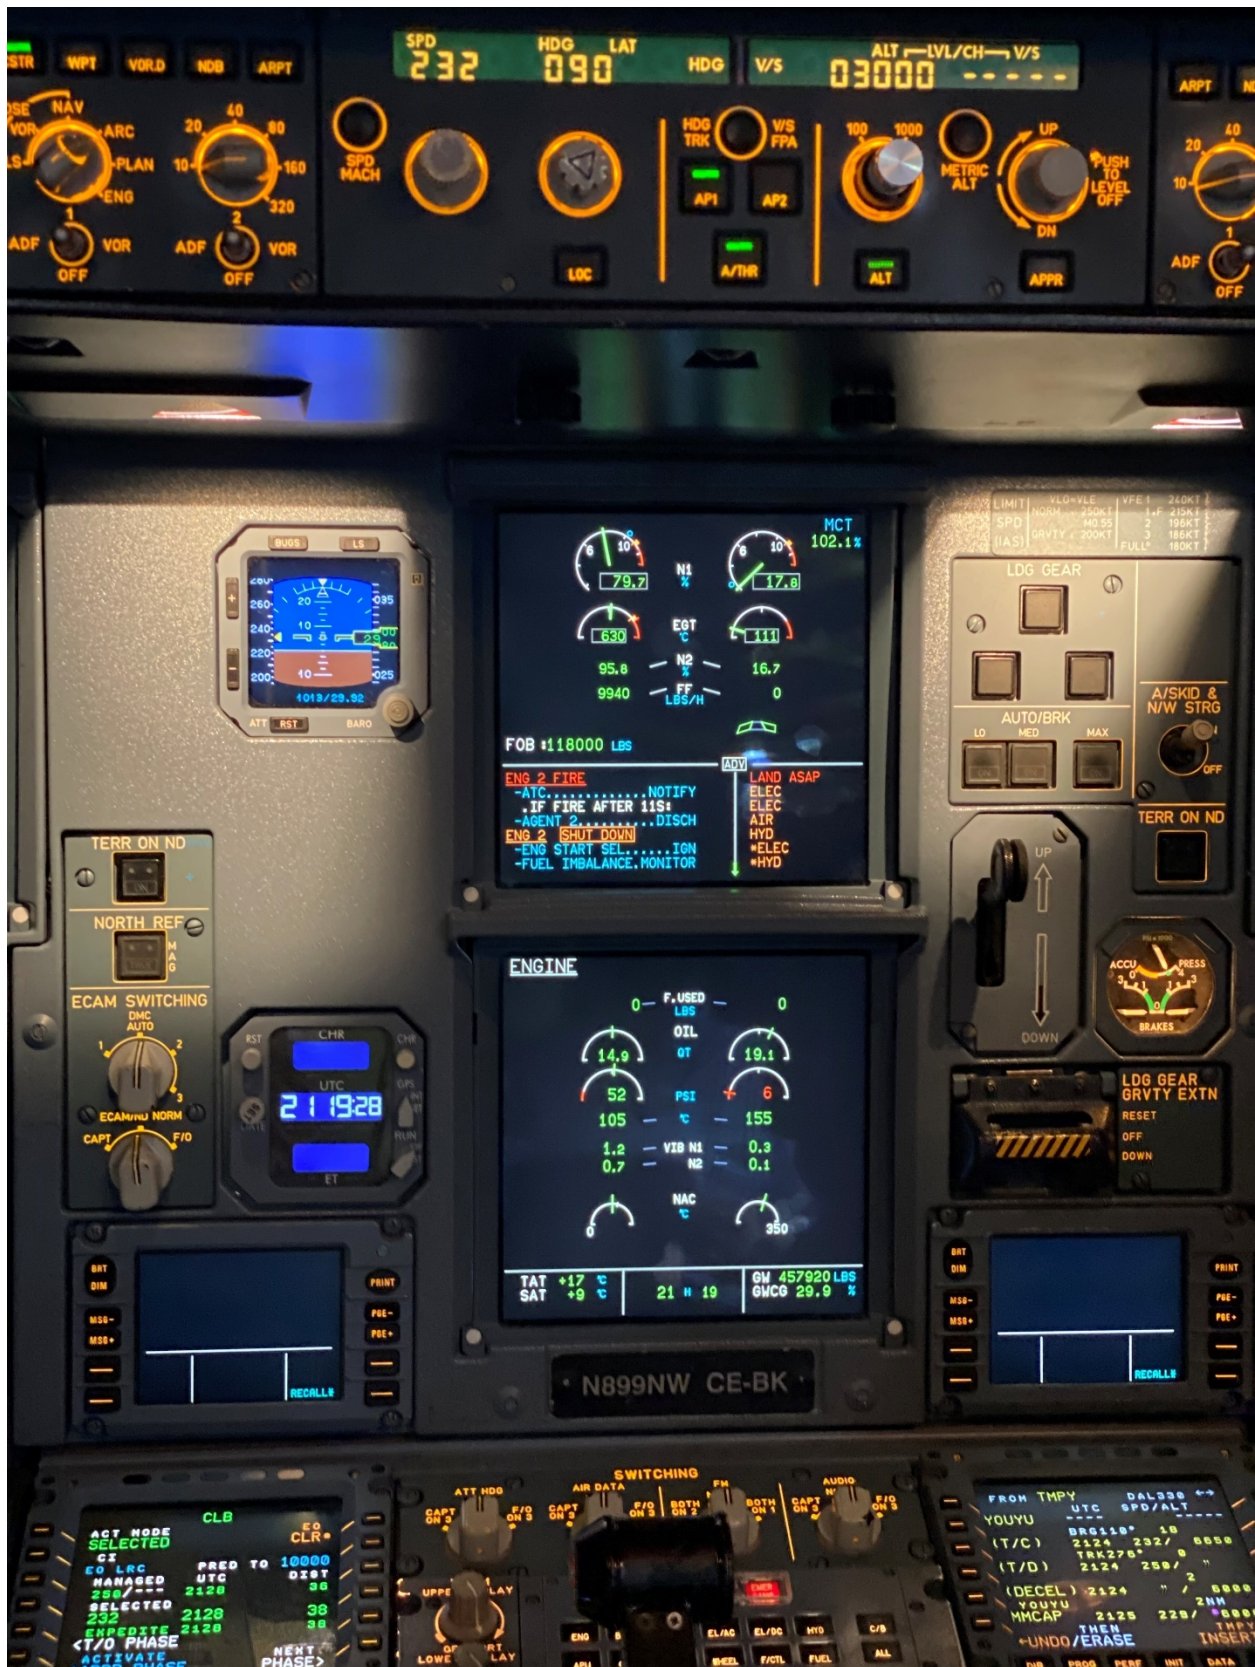
Photo 12: ENG 2 FIRE Message and Associated Messages on ECAM

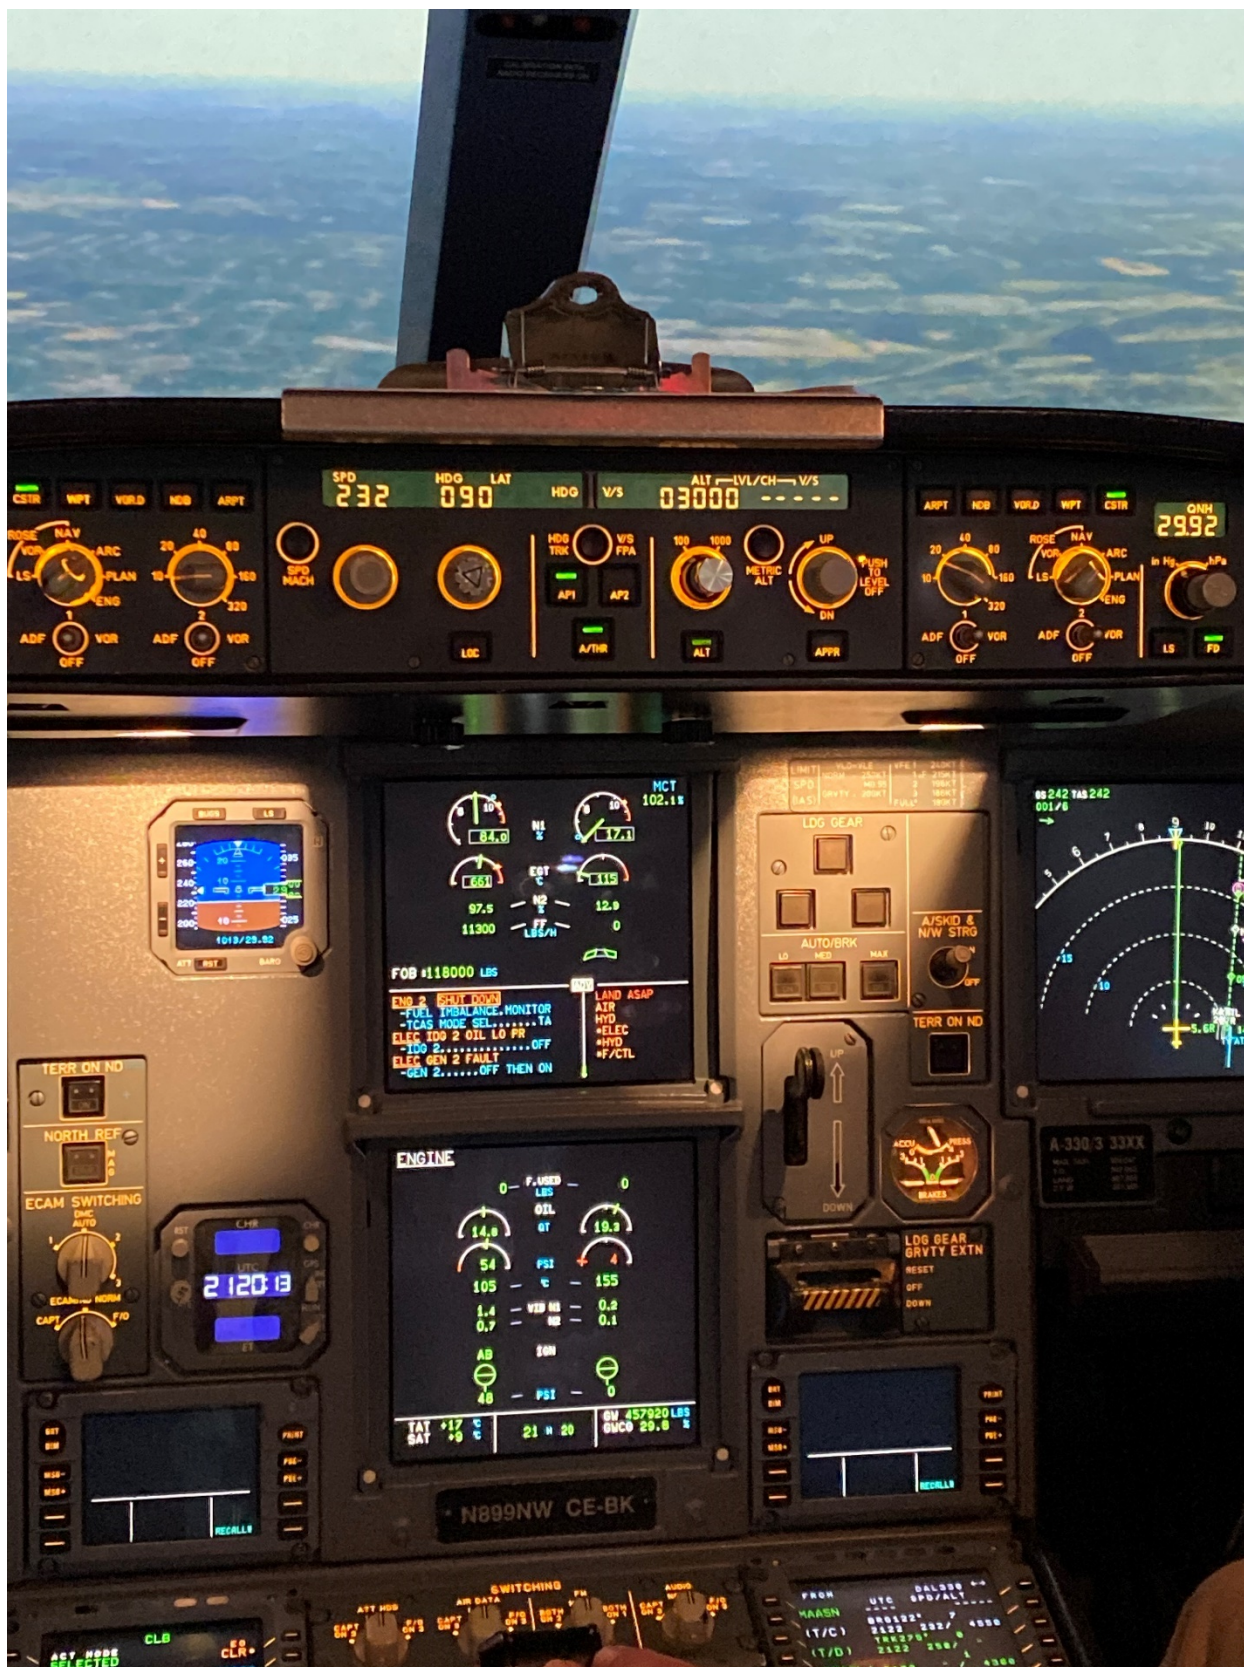
Photo 13: ENG 2 SHUT DOWN Checklist on ECAM.

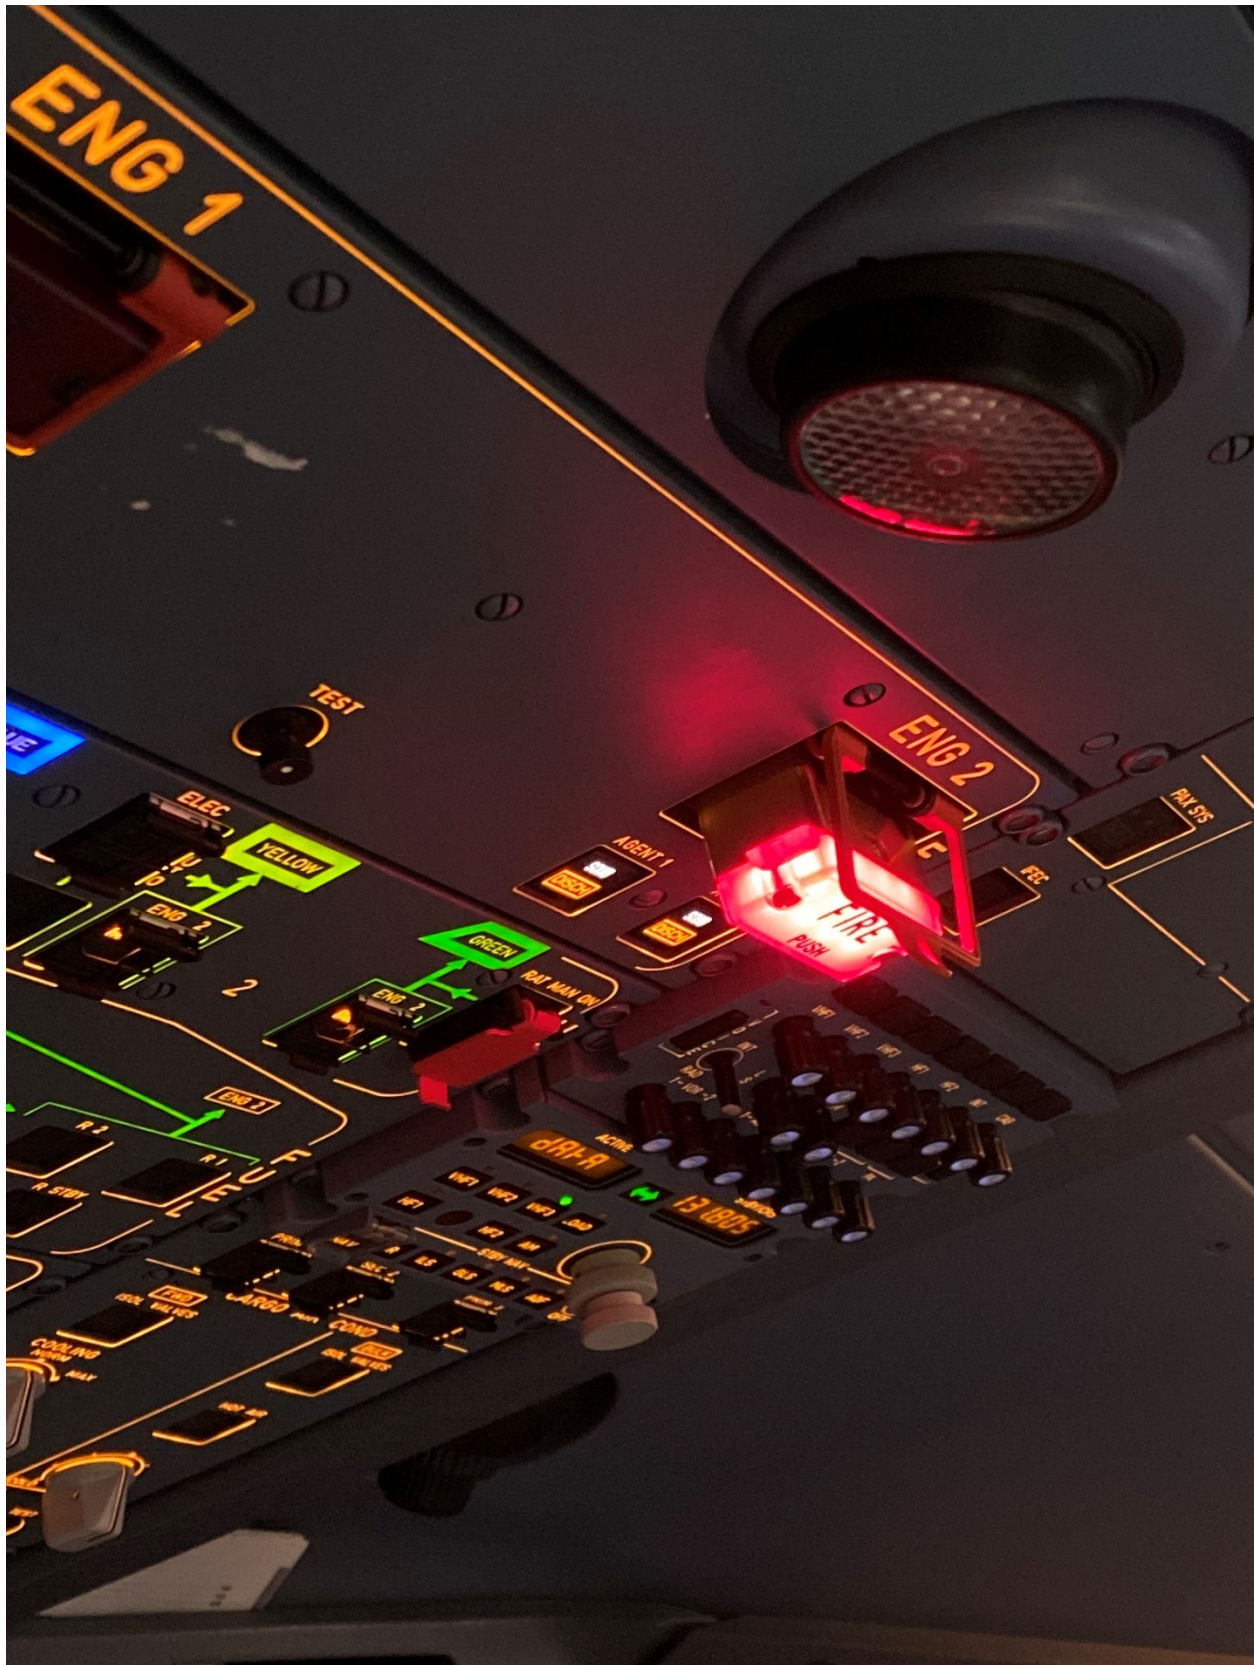
*Photo 14: ENG 2 FIRE P/B Pressed and Agents 1 and 2 Discharged*
