**NATIONAL TRANSPORTATION SAFETY BOARD**

**Attachment 1 - Simulator Evaluation**

**OPERATIONAL FACTORS/HUMAN PERFORMANCE**

**DCA18LA163**

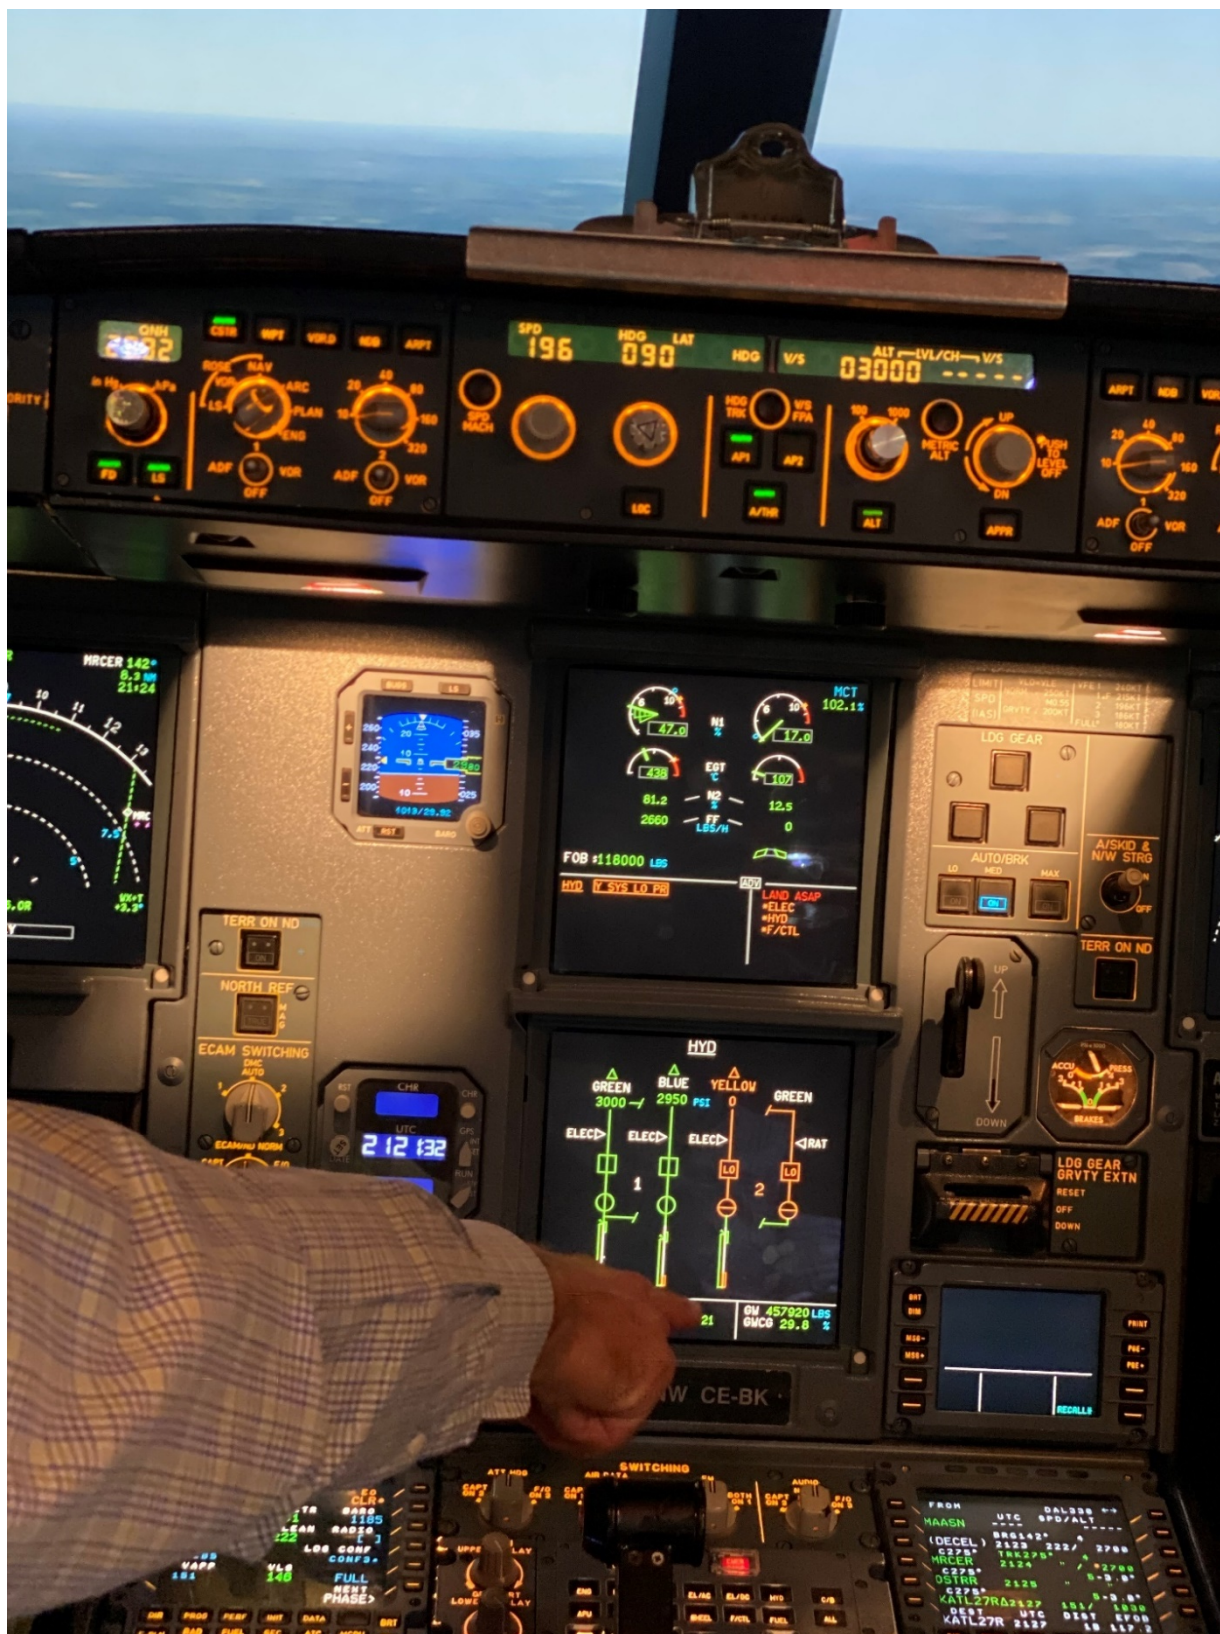
*Photo 15: HYD Y SYS LO PR Message on ECAM and Hydraulic System Page Displayed on Lower Screen*

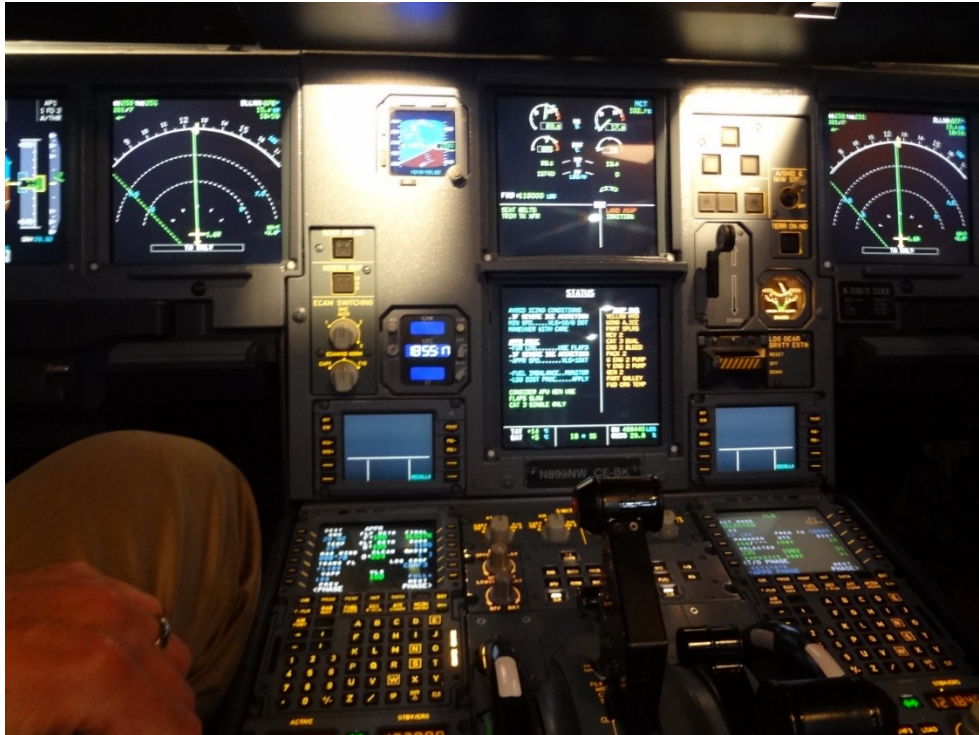
*Photo 16: Status Messages on ECAM*

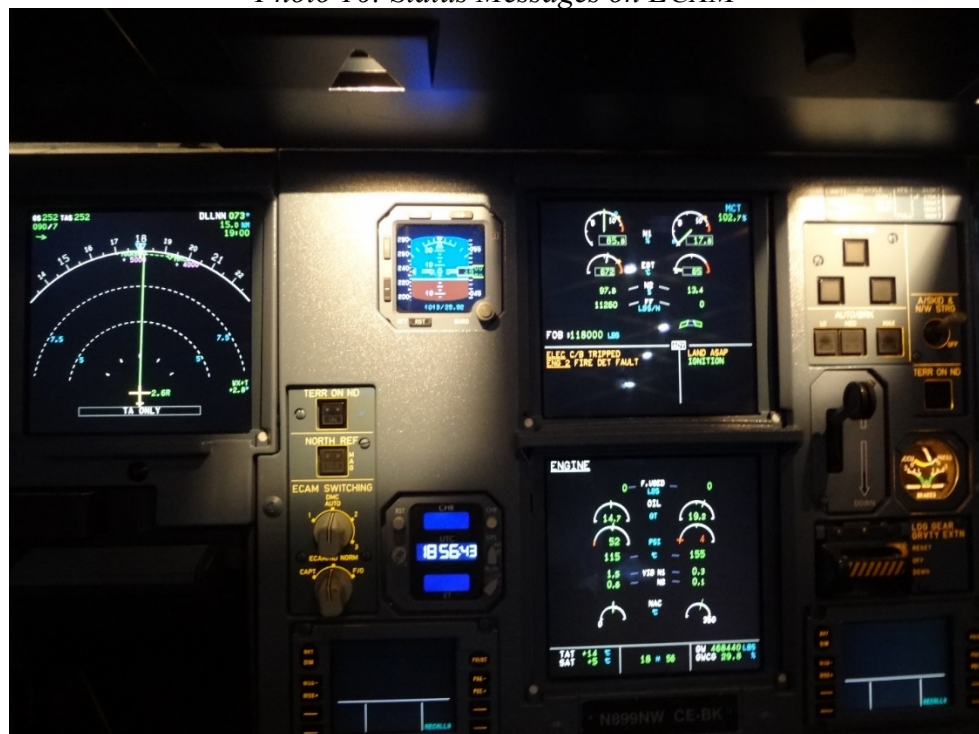
*Photo 17: ENG 2 FIRE DET FAULT Message<sup>11</sup>*

<sup>11</sup> C/B TRIPPED message was due to the simulator operator simulating opening up the circuit breaker as was the way of simulating both fire loop A and B fault messages.

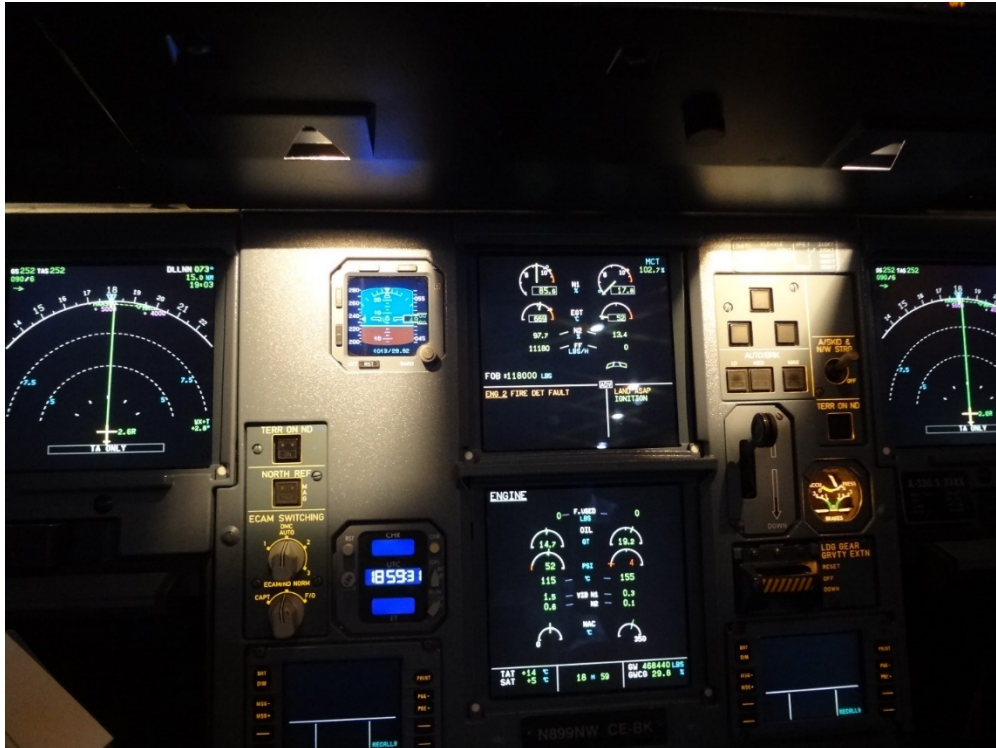
*Photo 18: Normal Indication of FIRE DET FAULT Message Without Opening Circuit Breaker*

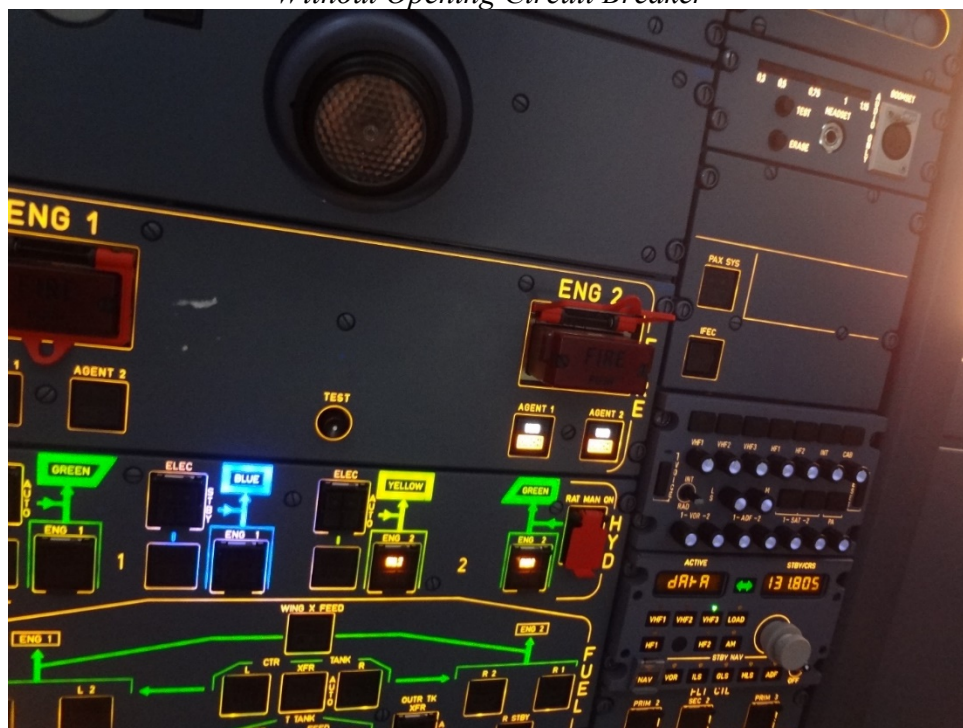
*Photo 19: ENG 2 FIRE P/B Not Illuminated Following the FIRE DET FAULT Message.*

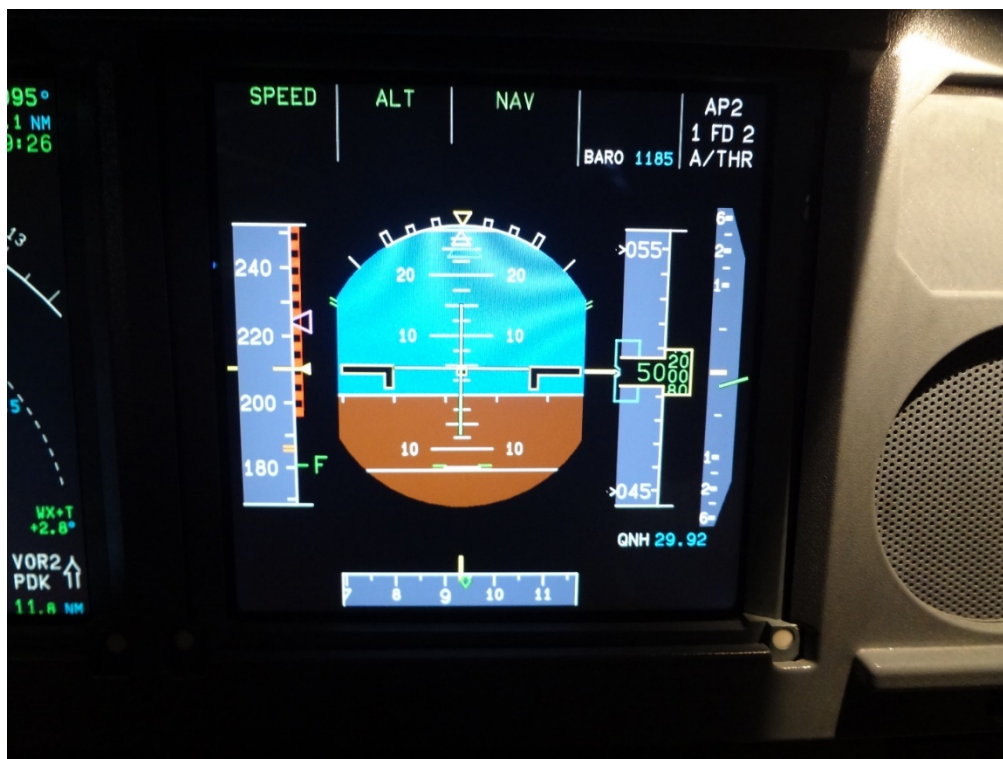
*Photo 20: Overspeed Indication when Thrust Levers Not Reduced*
