DCA21FA174

POWERPLANTS

Specialist's Factual Report - Attachment 1
Serial Number Identifications

October 5, 2022

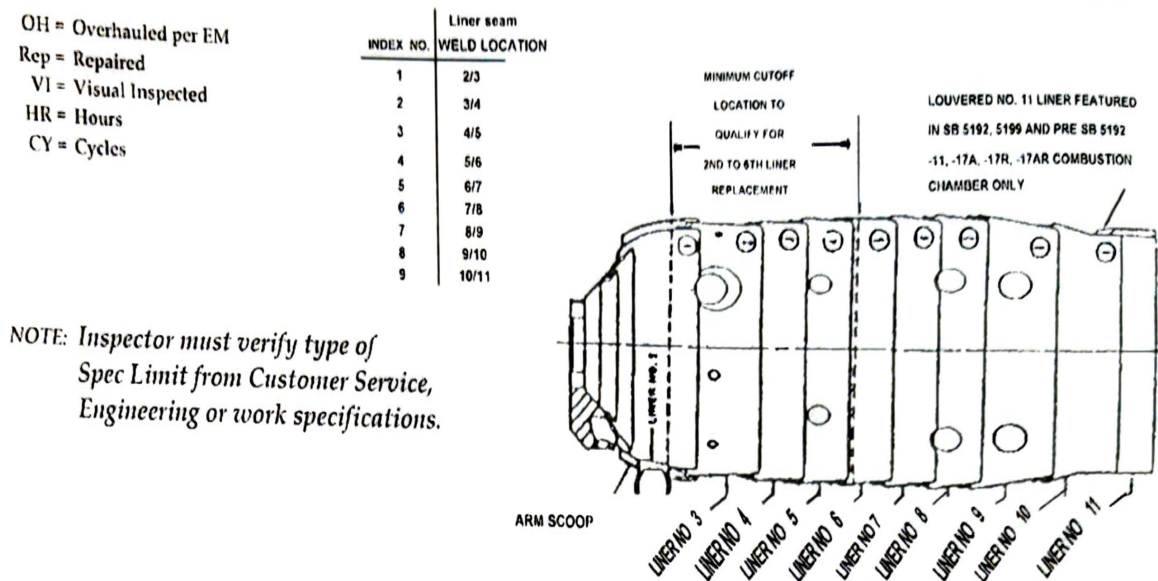
The engines were identified by matching serialized internal components to engine repair shop build records. A combustion chamber, serial number (SN) VS0510, was matched to the build records for engine serial number (ESN) 674548. See Figure 1.

Figure 1 Repair station engine combustion chamber installation sheet showing S/N VS0510 was installed during the engine's final shop visit in September 2019. From APECS Engine Center Engine Mini Pack for ESN 674548, under Work Order #193000

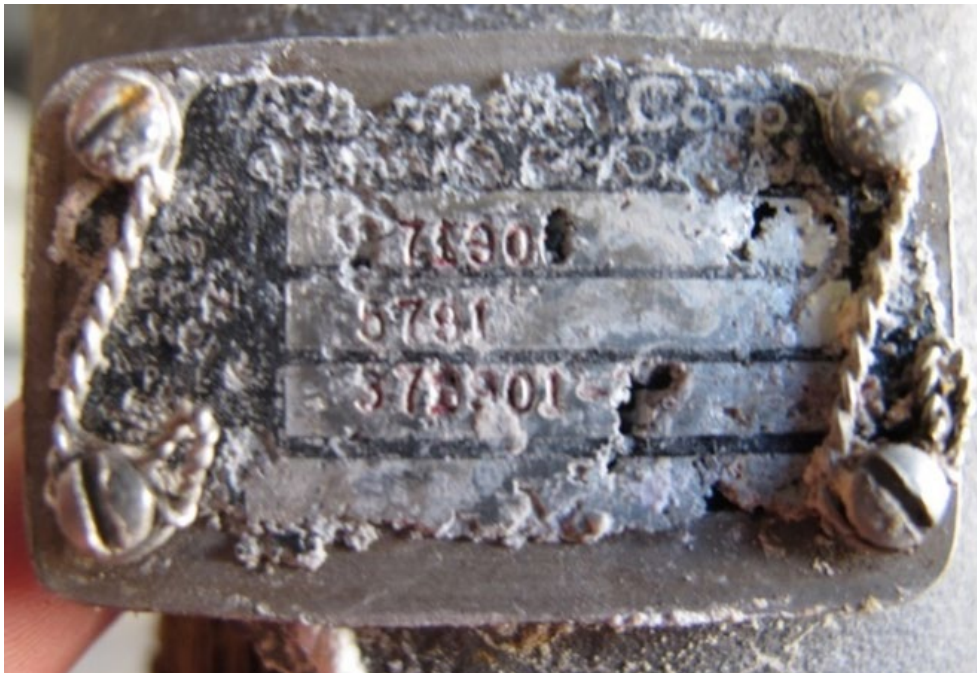
The uncoupled fuel pump dataplate was partially disintegrated but displayed the integers "7190" in the part number (PN) location and a full serial number, "5791". See Figure 2.

Figure 2 Data plate attached to a recovered fuel pump

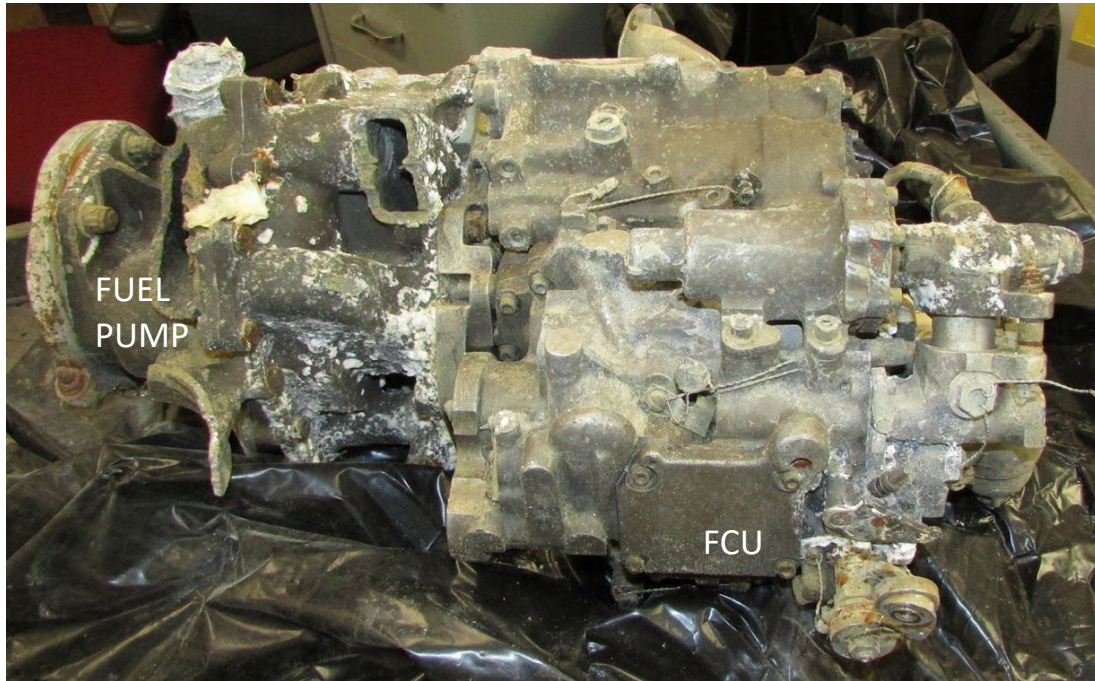
The assembled fuel pump/fuel control was identified as belonging to the No. 1 engine by the process of elimination.

Figure 4 No. 1 engine fuel pump/FCU assembly
