Federal Railroad Administration
Tank Car Damage Assessment Form

Reporting Marks	PPRX 171143		Car Location City/State	Custer, WA	
Date inspected	12/28/2020	Railroad	BNSF	DOT Specification	DOT 117 R 100 W
Last Contained	PETROLEUM CRUDE OIL		Was product released?	NO	
(Jacket thickness)	Jacket <u>1/8</u> _____	Non-jacketed	Does car contain product	Yes	
Car builder	TRIN	Stub Sill Design	TRN 024	Built Date	1/31/2013
Capacity (GAL)	31760		LD Limit (LB)	200200

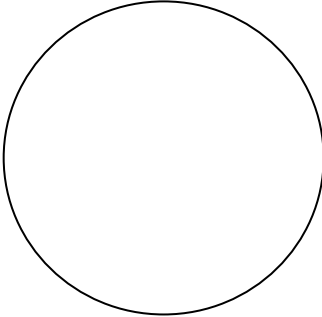
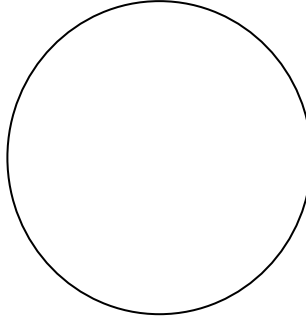
No damage car was upright and just trucks derailed

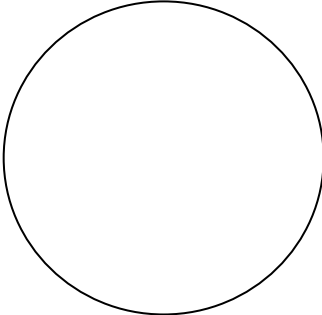
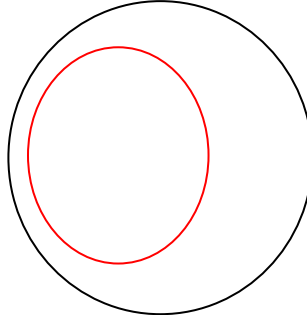
1.	Affected?	Head	Location?	"A" end	Dimensions:	Length	85" high	Width	80"	Depth	Est 6"
-	Defect type?	Dent	Shape?	Oblong	Possible Cause?	Coupler strike					
2.	Affected?		Location?		Dimensions:	Length		Width		Depth	
-	Defect type?		Shape?		Possible Cause?						
3.	Affected?		Location?		Dimensions:	Length		Width		Depth	
-	Defect type?		Shape?		Possible Cause?						
4.	Affected?		Location?		Dimensions:	Length		Width		Depth	
-	Defect type?		Shape?		Possible Cause?						
5.	Affected?		Location?		Dimensions:	Length		Width		Depth	
-	Defect type?		Shape?		Possible Cause?						
6.	Affected?		Location?		Dimensions:	Length		Width		Depth	
-	Defect type?		Shape?		Possible Cause?						
7.	Affected?		Location?		Dimensions:	Length		Width		Depth	
-	Defect type?		Shape?		Possible Cause?						
8.	Affected?		Location?		Dimensions:	Length		Width		Depth	
-	Defect type?		Shape?		Possible Cause?

2. Was this tank car exposed to fire? (Indicate one) **Yes** No
3. How long was the car exposed to fire? Unknown
4. What percentage/locations of the tank were exposed to fire? **"A" end, 15%** Indicate location in figures on page 1.
5. What material burned to create the fire that the car was exposed to? **Petroleum crude**
6. To what degree did the car roll? Initially **90 degrees** and stopped at **Upside down**
7. Distance traveled from track center? B-end? **8 feet west** A-end? **16 feet** Center?
8. Brief description of details of surfaces tank was exposed to in transit to present location? E.g. mud, track, rocks, etc...

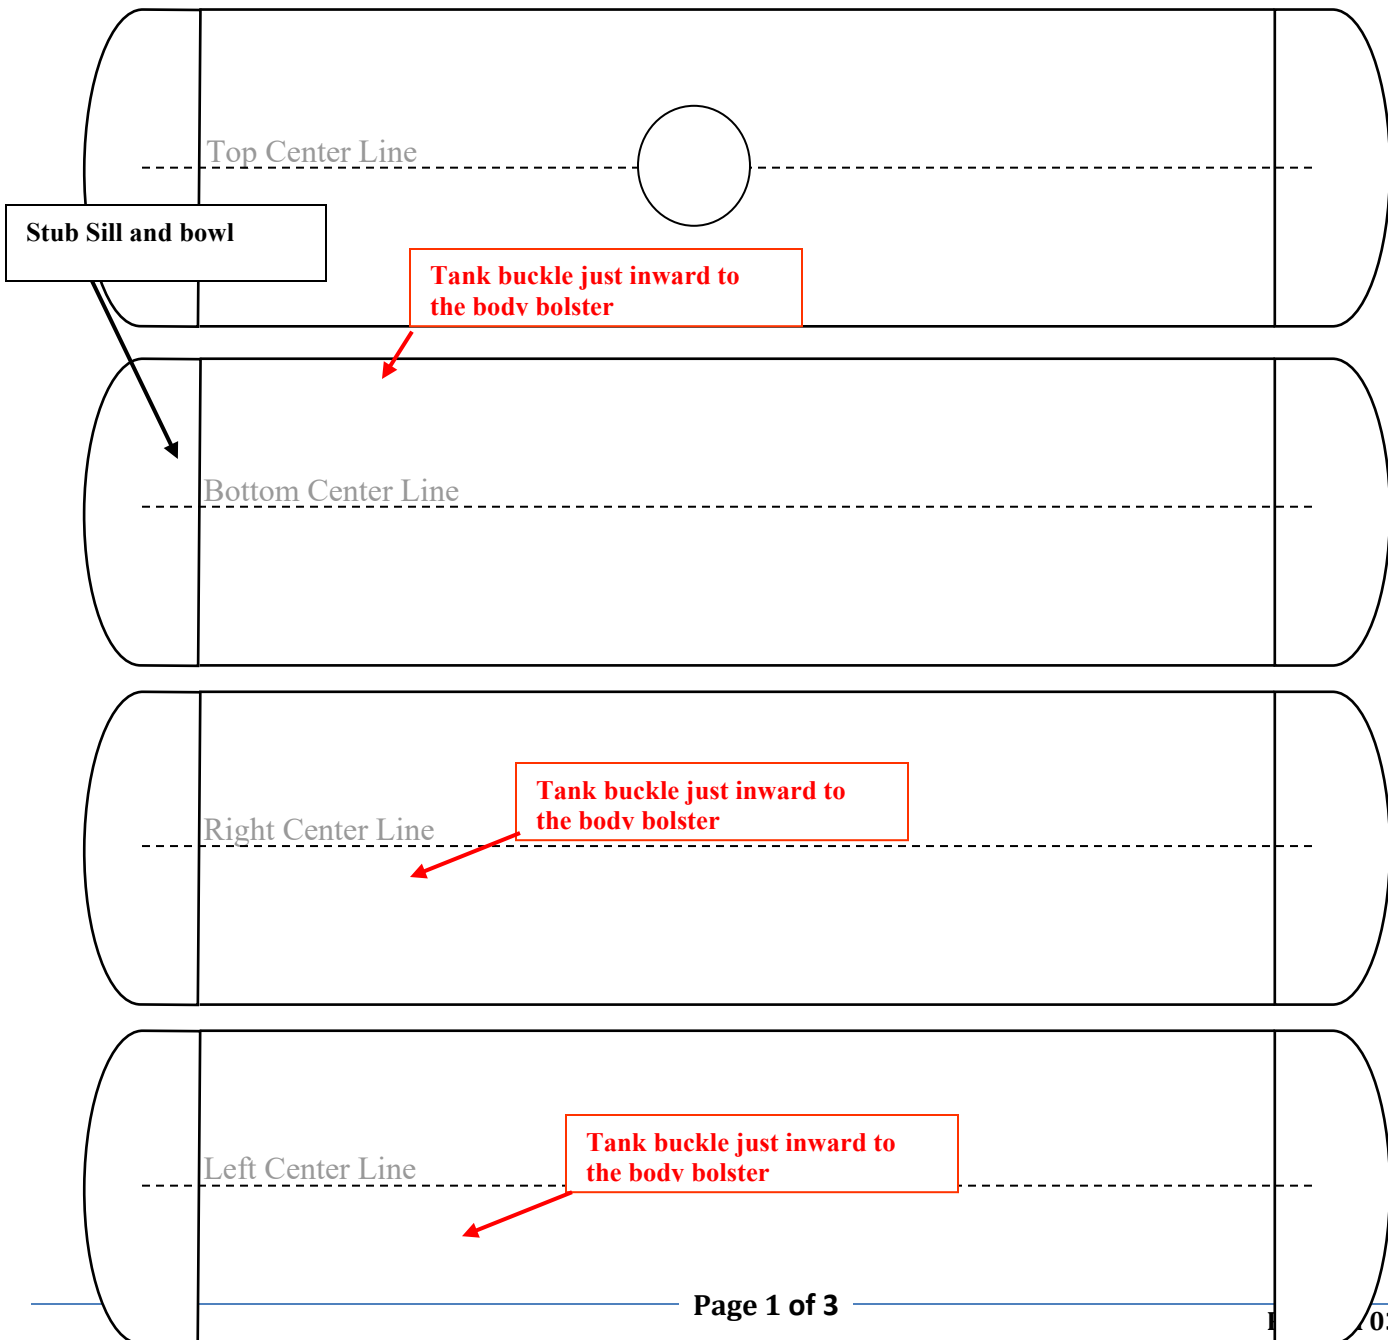
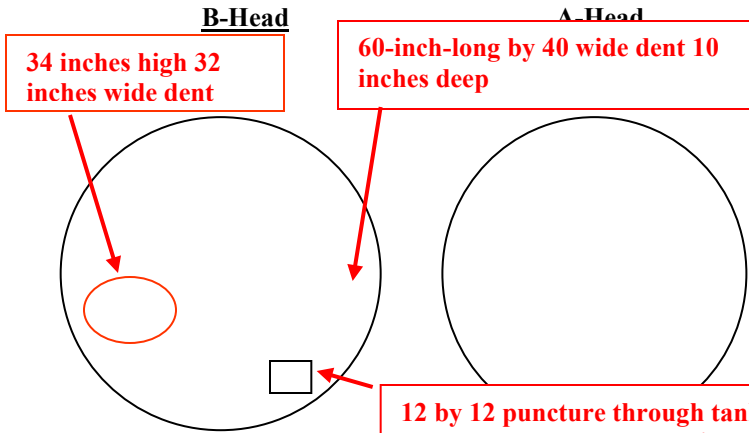
1.	Affected?	"B" end	Location?	bottom right	Dimensions:	Length	12	Width	12	Depth	
-	Defect type?	Punch hole	Shape?	12x12	Possible Cause?	Coupler strike					
2	Affected?	"B" end	Location?	Bottom center to right	Dimensions:	Length	40	Width	60	Depth	10 inches

-	Defect type?	Dent	Shape?	Crescent moon	Possible Cause?	Coupler strike					
3	Affected?	"B" end	Location?	Left side	Dimensions:	Length	34	Width	32	Depth	2 inches

-	Defect type?	Dent	Shape?	Oblong	Possible Cause?	Unknown					
4	Affected?		Location?		Dimensions:	Length		Width		Depth	
-	Defect type?		Shape?		Possible Cause?						
5	Affected?		Location?		Dimensions:	Length		Width		Depth

- Was this tank car exposed to fire? (Indicate one) **Yes** No
- How long was the car exposed to fire? Approx 2 hours
- What percentage/locations of the tank were exposed to fire? 30 % Indicate location in figures on page 1.
- What material burned to create the fire that the car was exposed to? Petroleum crude oil

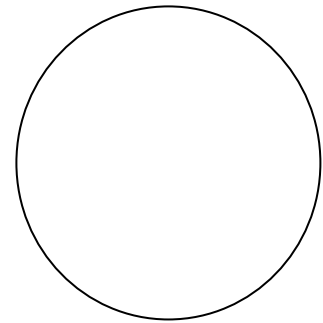
2. Description of damage? Valve, Coils etc... BOV Document station stencil if other than qual. Decal _____

a	Type of damaged valve?	Sheared off	Manufacturer?	4" EXTERNAL FULL PORT BOV (EXISTING AND ALTERNATE) JAMESBURY 9RET - --- AAR E172109	Cause?	Roll and or slide
-	Gasket Type?		O-ring type?		Serial Number	
b	Type of damaged valve?		Manufacturer?		Cause?	
-	Gasket Type?		O-ring type?		Serial Number	
c	Type of damaged valve?		Manufacturer?		Cause?	
-	Gasket Type?		O-ring type?		Serial Number	
d	Type of damaged valve?		Manufacturer?		Cause?	
-	Gasket Type?		O-ring type?		Serial Number	
e	Type of damaged valve?		Manufacturer?		Cause?	
	Gasket Type?		O-ring type?		Serial Number

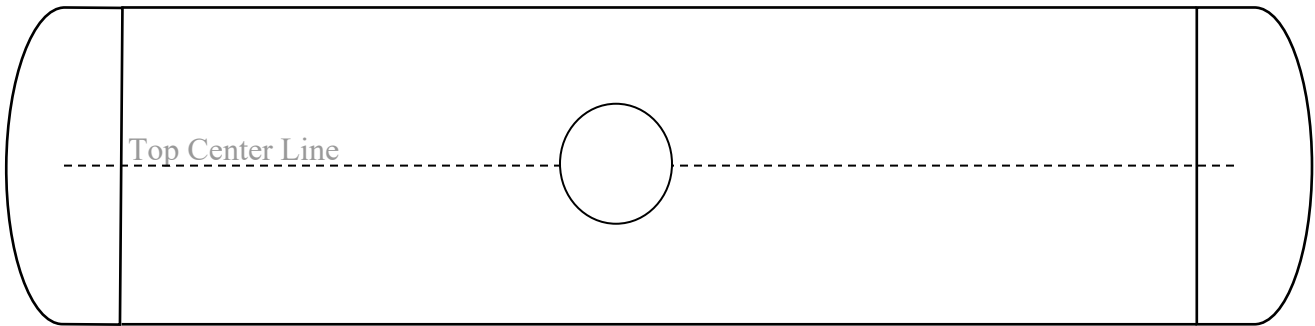
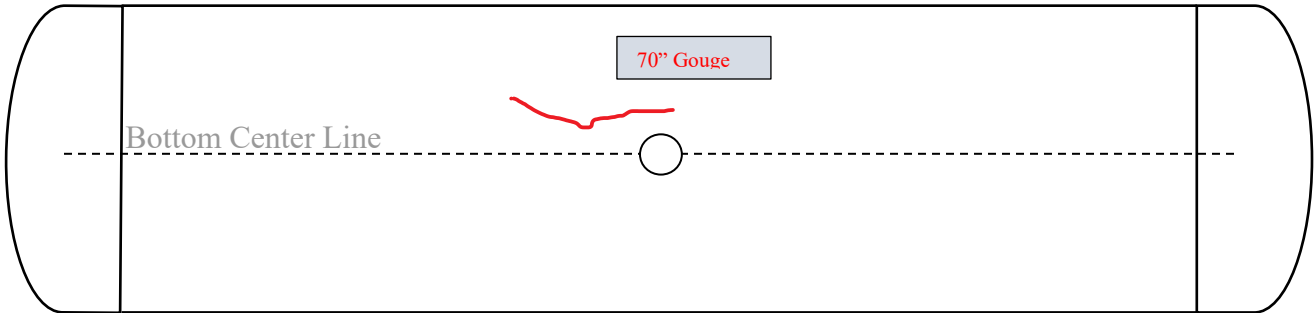
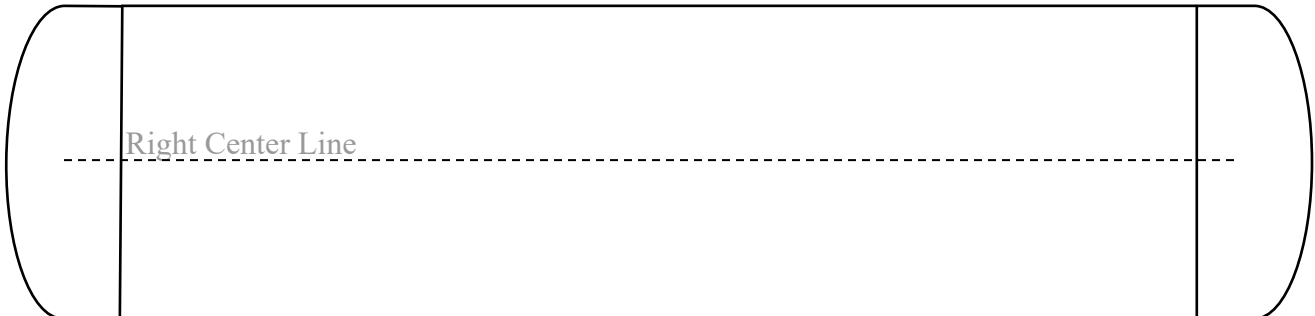
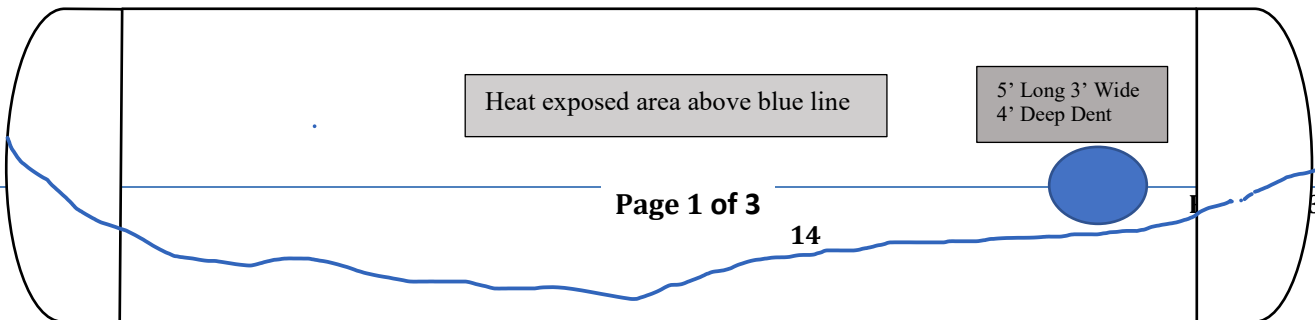
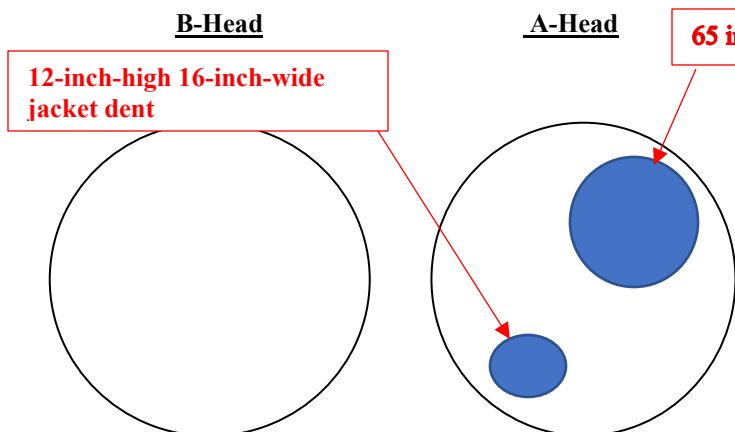
1.	Affected?	Jacket possible tank	Location?	Bottom "B" end	Dimensions:	Length	5' long	Width	3' wide	Depth	4"
-	Defect type?	Dent	Shape?	Oblong	Possible Cause?	Unknown					
2	Affected?	Jacket	Location?	Just right of BOV	Dimensions:	Length	70"	Width	3"	Depth	Just jacket
-	Defect type?	Gouge	Shape?	Jagged	Possible Cause?	Unknown					
3	Affected?	Head Jacket	Location?	"A" end upper right	Dimensions:	Length	65 inches	Width	65 inches	Depth	10 inches deep
-	Defect type?	Dent	Shape?	Round	Possible Cause?	Coupler					
4	Affected?	Head Jacket	Location?	"A" end lower left	Dimensions:	Length	12 inch	Width	16 inches wide	Depth

-	Defect type?	Dent	Shape?	Oblong	Possible Cause?	Unknown					
5	Affected?		Location?		Dimensions:	Length		Width		Depth	
-	Defect type?		Shape?		Possible Cause?						
6	Affected?		Location?		Dimensions:	Length		Width		Depth	
-	Defect type?		Shape?		Possible Cause?						
7	Affected?		Location?		Dimensions:	Length		Width		Depth	
-	Defect type?		Shape?		Possible Cause?						
8	Affected?		Location?		Dimensions:	Length		Width		Depth	
-	Defect type?		Shape?		Possible Cause?

- Was this tank car exposed to fire? (Indicate one) **Yes** No
- How long was the car exposed to fire? Approx 2 hours N/A
- What percentage/locations of the tank were exposed to fire? Leftside 40% Indicate location in figures on page 1.
- What material burned to create the fire that the car was exposed to? Petroleum Crude
- To what degree did the car roll? Initially Upright degrees and stopped at _____
- Distance traveled from track center? B-end? 5" West A-end? 12" East Center? _____
- Brief description of details of surfaces tank was exposed to in transit to present location? E.g. mud, track, rocks, etc...

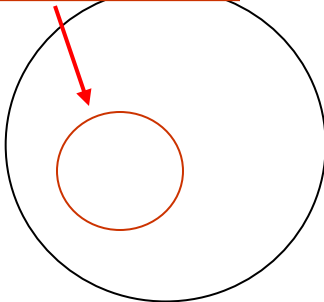
51 high 48 wide, 3.5 inches deep

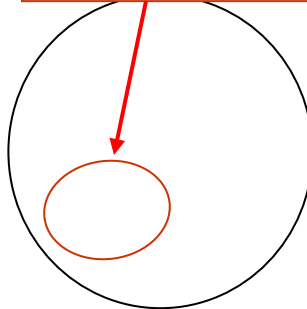
29 high 39 wide, 4 inches deep

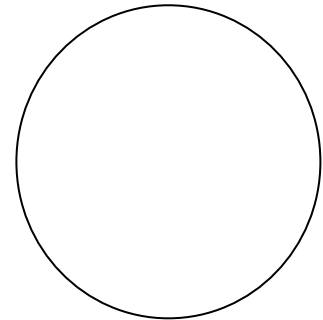
2. Description of damage? **BOV Nozzle Shear** stencil if other than qual. Decal _____

a	Type of damaged valve?	BOV Nozzle	Manufacturer?	4" EXTERNAL FULL PORT BOV (EXISTING AND ALTERNATE) JAMESBURY 9RET - --- AAR E172109	Cause?	Sheared off
-	Gasket Type?		O-ring type?		Serial Number	
b	Type of damaged valve?		Manufacturer?		Cause?	
-	Gasket Type?		O-ring type?		Serial Number	
c	Type of damaged valve?		Manufacturer?		Cause?	
-	Gasket Type?		O-ring type?		Serial Number	
d	Type of damaged valve?		Manufacturer?		Cause?	
-	Gasket Type?		O-ring type?		Serial Number	
e	Type of damaged valve?		Manufacturer?		Cause?	
	Gasket Type?		O-ring type?		Serial Number

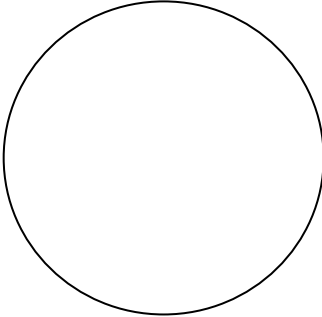
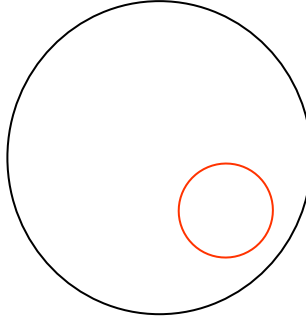
1.	Affected?	"A" end	Location?	Head	Dimensions:	Length	2 FT	Width	2 FT	Depth	4 Inches deep
-	Defect type?	Dent	Shape?	Round	Possible Cause?	Possible coupler strike					
2	Affected?		Location?		Dimensions:	Length		Width		Depth	
-	Defect type?		Shape?		Possible Cause?						
3	Affected?		Location?		Dimensions:	Length		Width		Depth	
-	Defect type?		Shape?		Possible Cause?						
4	Affected?		Location?		Dimensions:	Length		Width		Depth	
-	Defect type?		Shape?		Possible Cause?						
5	Affected?		Location?		Dimensions:	Length		Width		Depth	
-	Defect type?		Shape?		Possible Cause?						
6	Affected?		Location?		Dimensions:	Length		Width		Depth	
-	Defect type?		Shape?		Possible Cause?						
7	Affected?		Location?		Dimensions:	Length		Width		Depth	
-	Defect type?		Shape?		Possible Cause?						
8	Affected?		Location?		Dimensions:	Length		Width		Depth	
-	Defect type?		Shape?		Possible Cause?

2. Was this tank car exposed to fire? (Indicate one) **Yes** No
3. How long was the car exposed to fire? **Unknown, light exposure leftside**
4. What percentage/locations of the tank were exposed to fire? **33** % Indicate location in figures on page 1.
5. What material burned to create the fire that the car was exposed to? **Petroleum Cude Oil**
6. To what degree did the car roll? Initially **5** degrees and stopped at **5**
7. Distance traveled from track center? B-end? **12 foot west** A-end? **5 foot east** Center? **From original track**
8. Brief description of details of surfaces tank was exposed to in transit to present location? E.g. mud, track, rocks, etc...
