Federal Railroad Administration Localized Corrosion or Material Degradation Form

Reporting Marks	UTLX 954193	DOT Specification	112J340W
Date when damage first observed:	04/27/24	Location where damaged first observed (City/State):	Manuelito, NM
NDT Method: MT__ PT__ UT__ UTT X VT X	Procedure(s)/Revision(s) Used: N/A	Original thickness of coupon/test area	.608
Equipment used: GE POCKETMIKE 35900	Equip. cal. date (if applicable): <small>BEFORE USE</small> _____	Cal block ID and Cal. due date (if applicable):	FLAWTECH 26705
Cable type/length (if applicable):	N/A	Scan techniques/plans (if applicable):	POINT
Search Unit(s) (if applicable): PULSE-ECHO/DUAL ELEM	Angle /MHz: N/A 5 MHz	Size: .475	Serial # 5191
Couplant/Penetrant/Particles manufacturer/type (if applicable):	GE REF 0102790	Exam date/time: 5/24/24	Special equip. (if applicable): N/A
Coupon Location - Ring #, B or A Head:	Ring #1	Clock Position Top = 12, Bottom = 6, facing the B head:	1 O'clock
Surface conditions, Surface Temp. and side(s) examined from:	Surface: clean and free of moisture ID__ OD X Surface Temp: N/A	Indication(s) (Type/Size/Location):	Thermal tear/8 inches long/Ring 1/1 o'clock

Client	ENSCO, Inc.	Inspection N

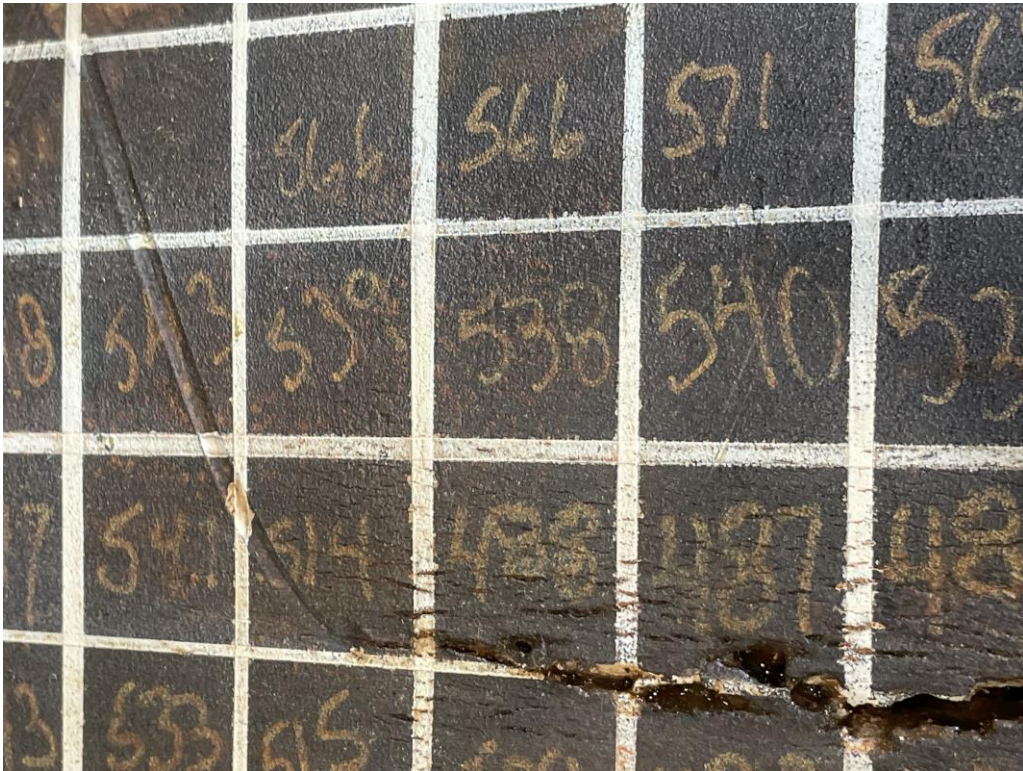
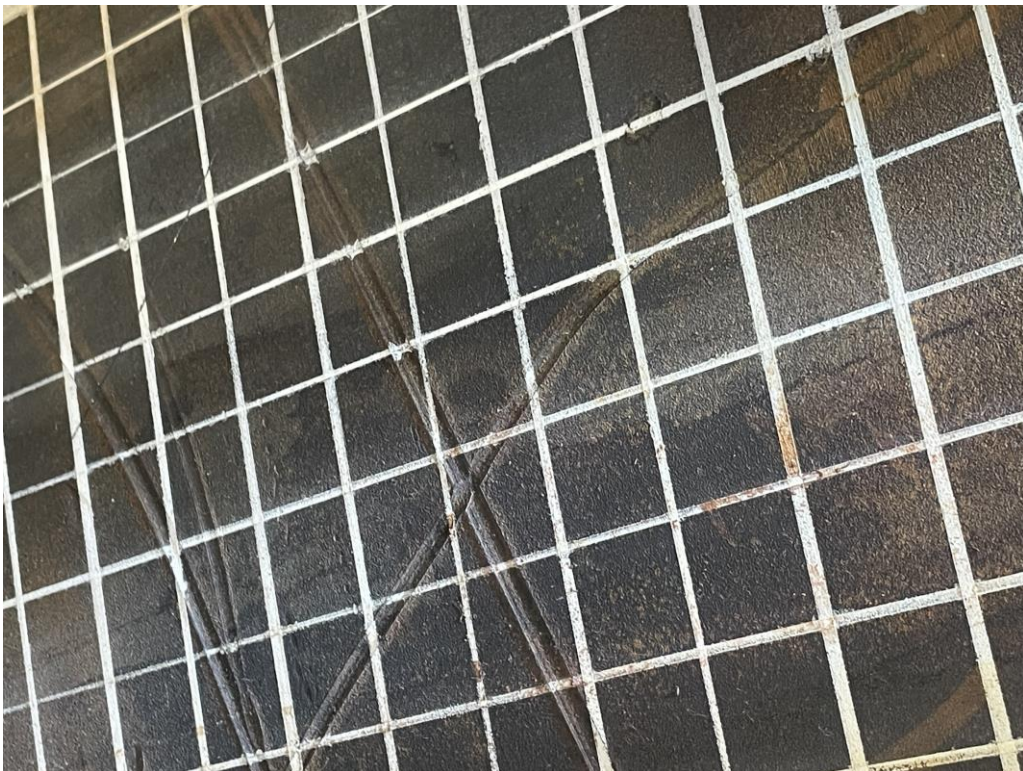
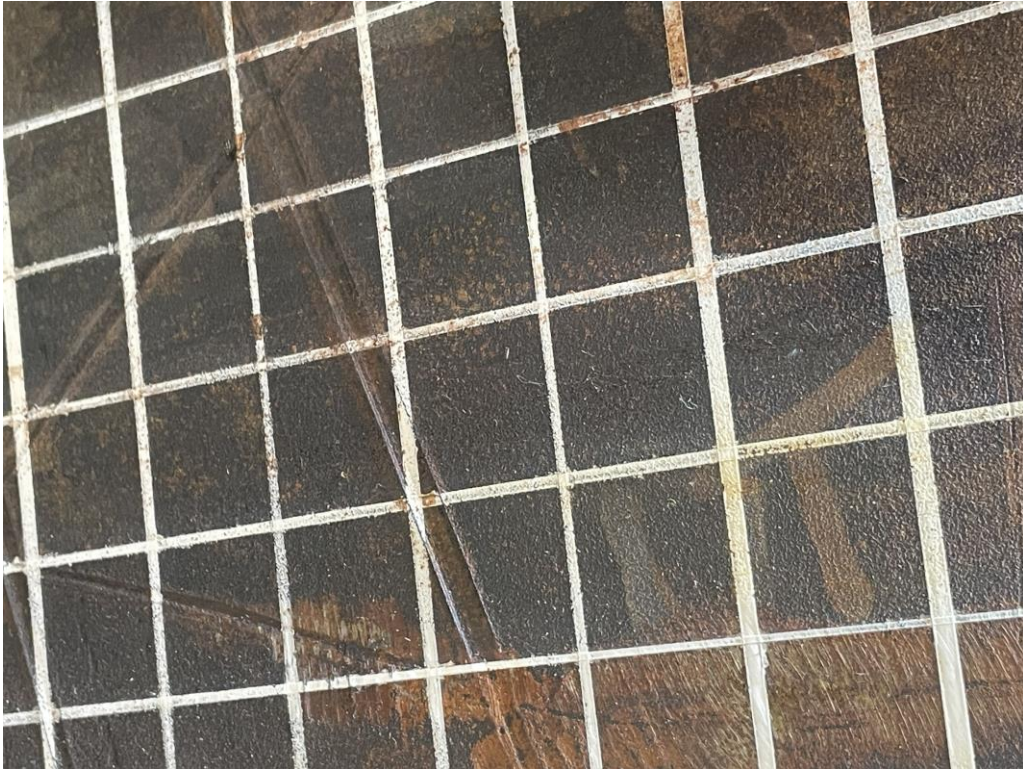
Mechanical Grooves on OD Surface

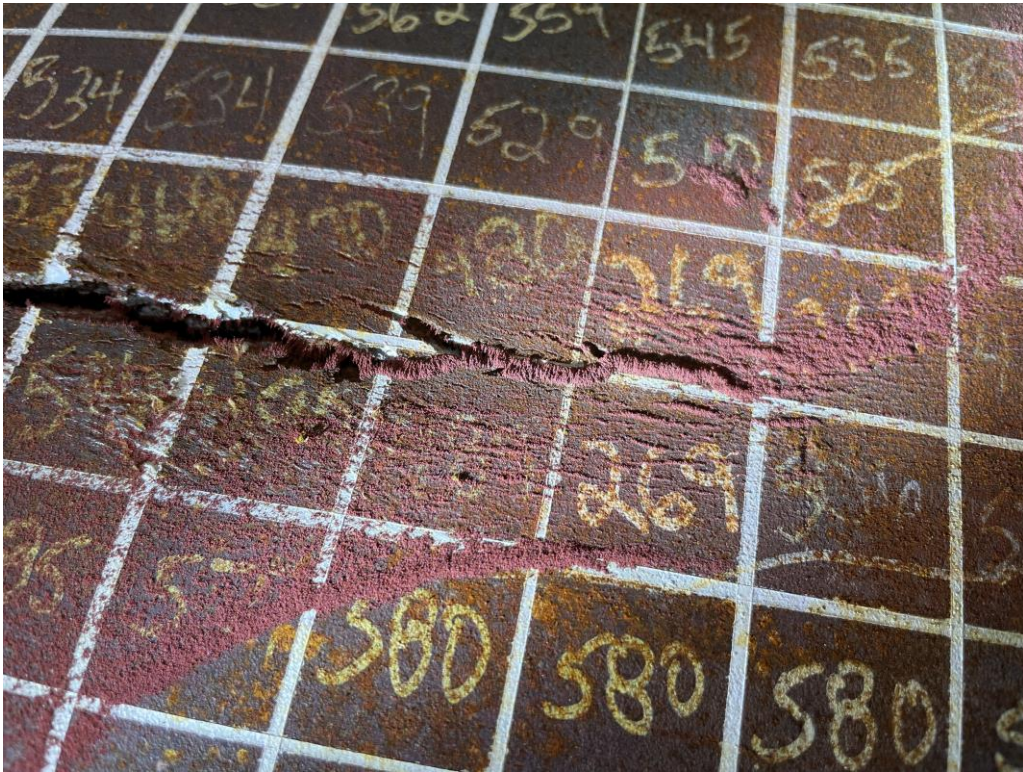
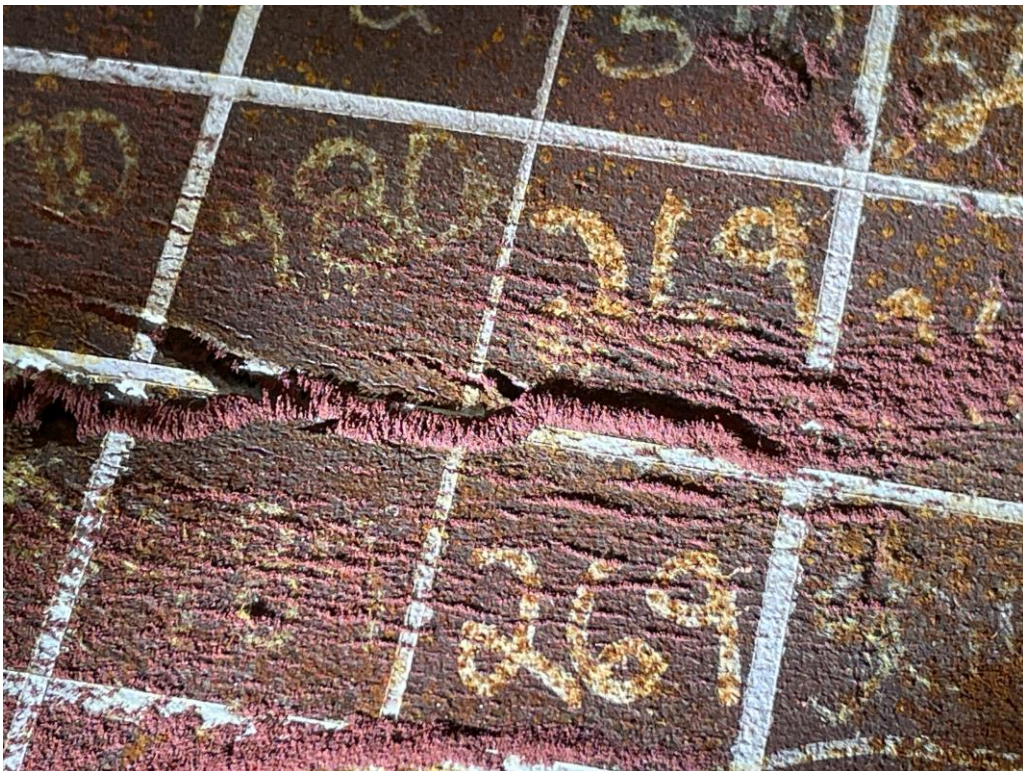
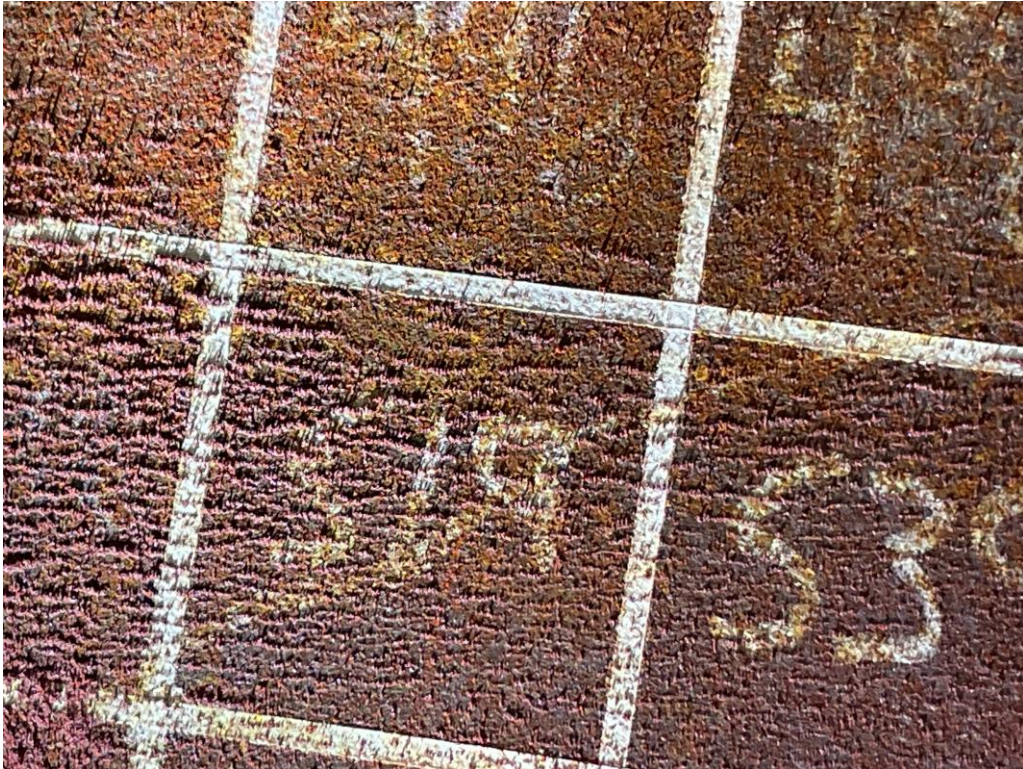
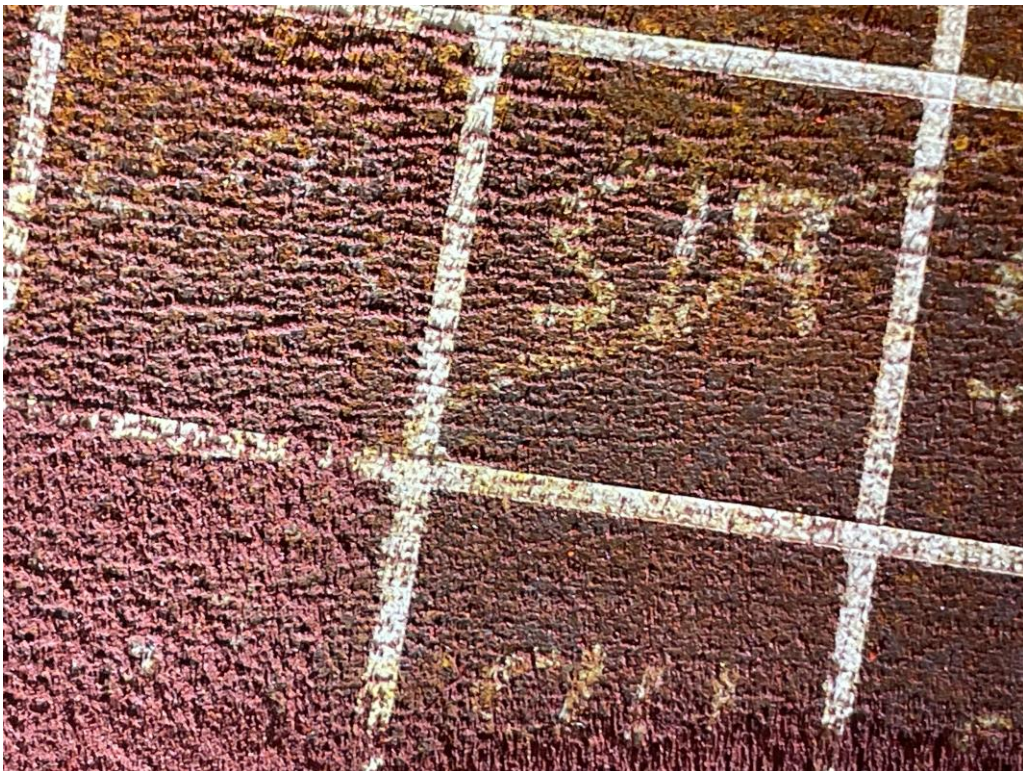
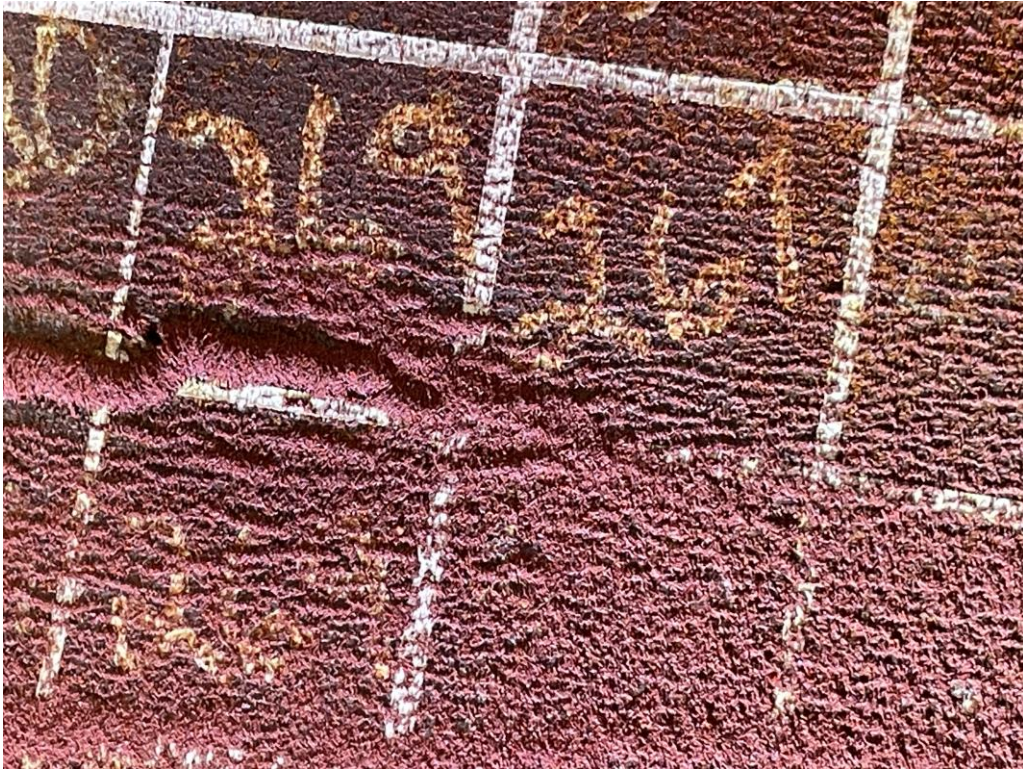
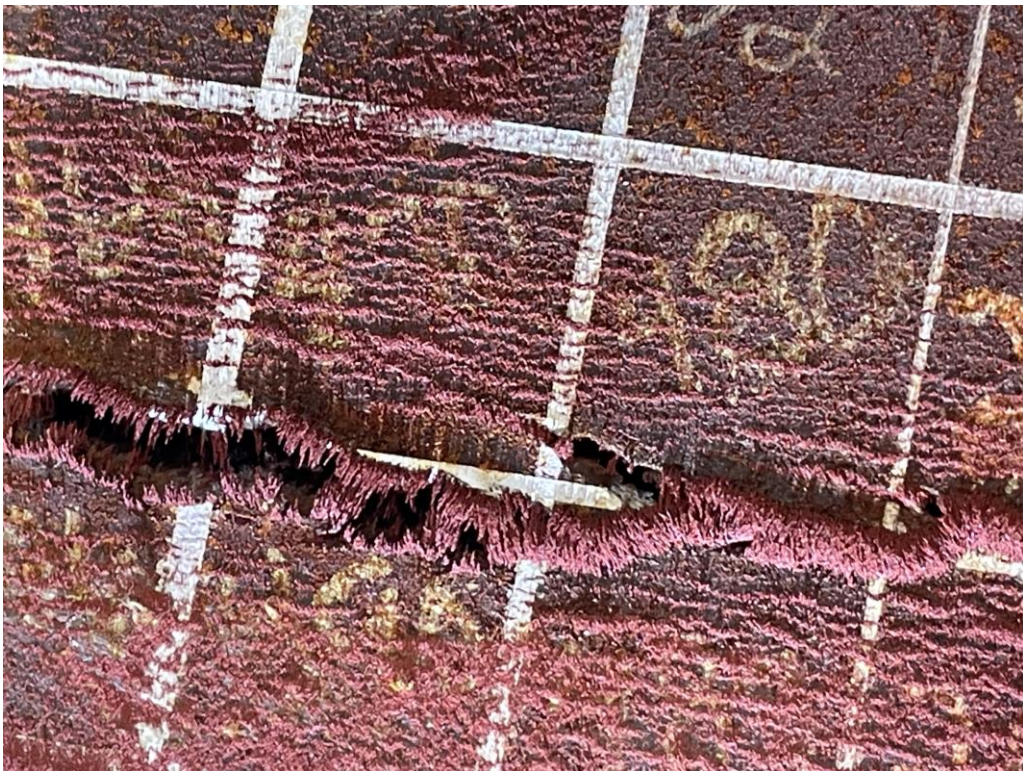
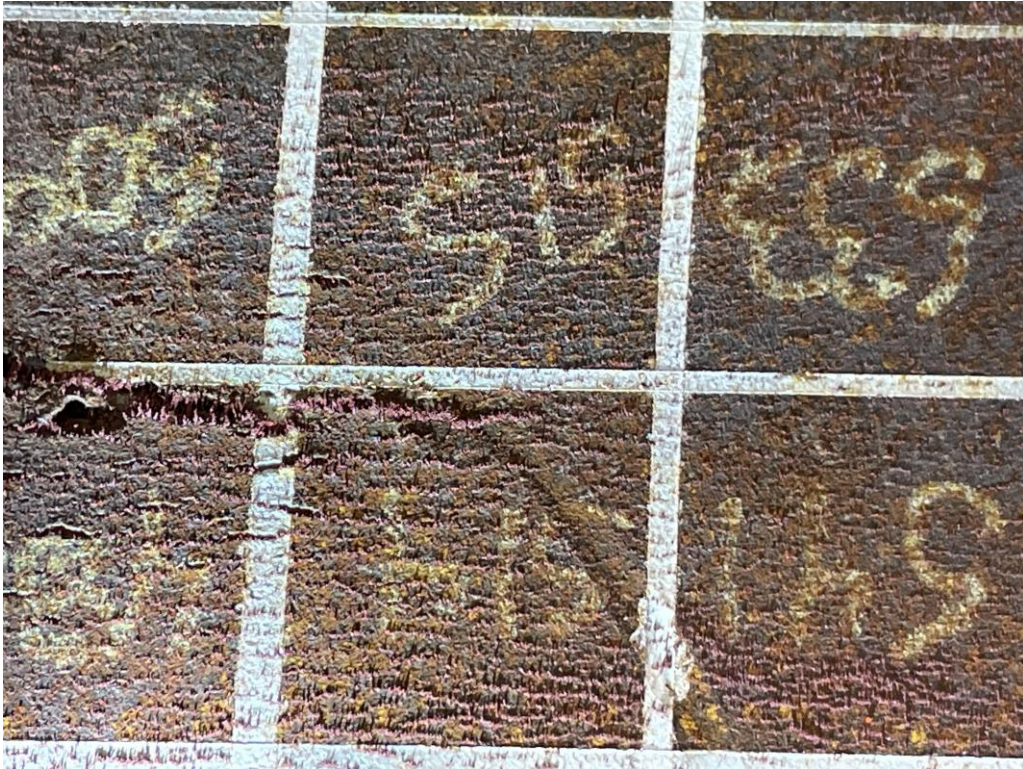
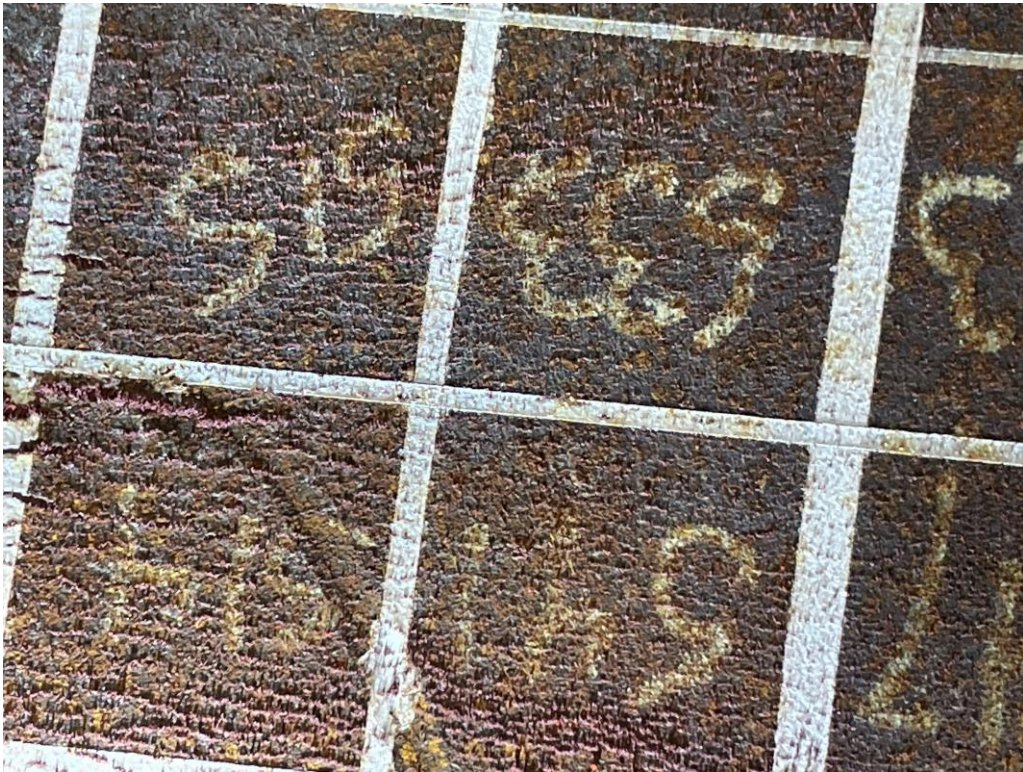
OD surface with MT

1) Surface cracking detected on outside surface surrounding and parallel with rupture and extending toward end of panel.					
2) Inside surface inspection impeded by embedded carbon. Indications only detected near rupture where cracks have wide opening.					
<input type="checkbox"/> MT acceptable <input checked="" type="checkbox"/> MT not acceptable		Page 1 of 1	Technician (Signature/Date)

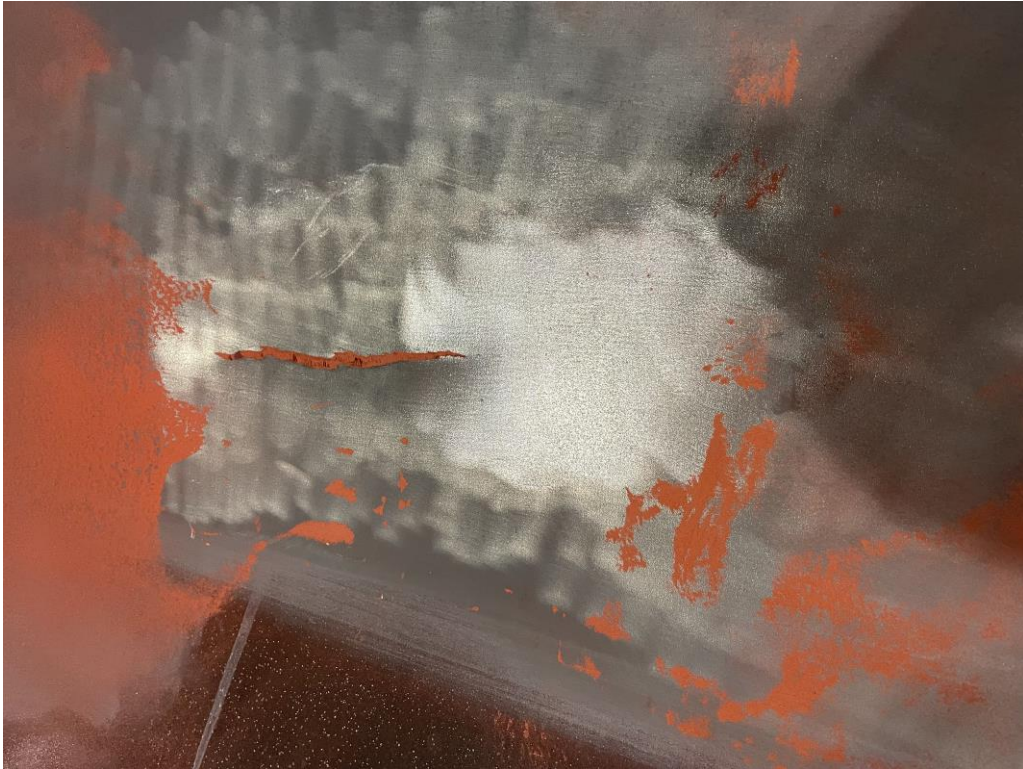
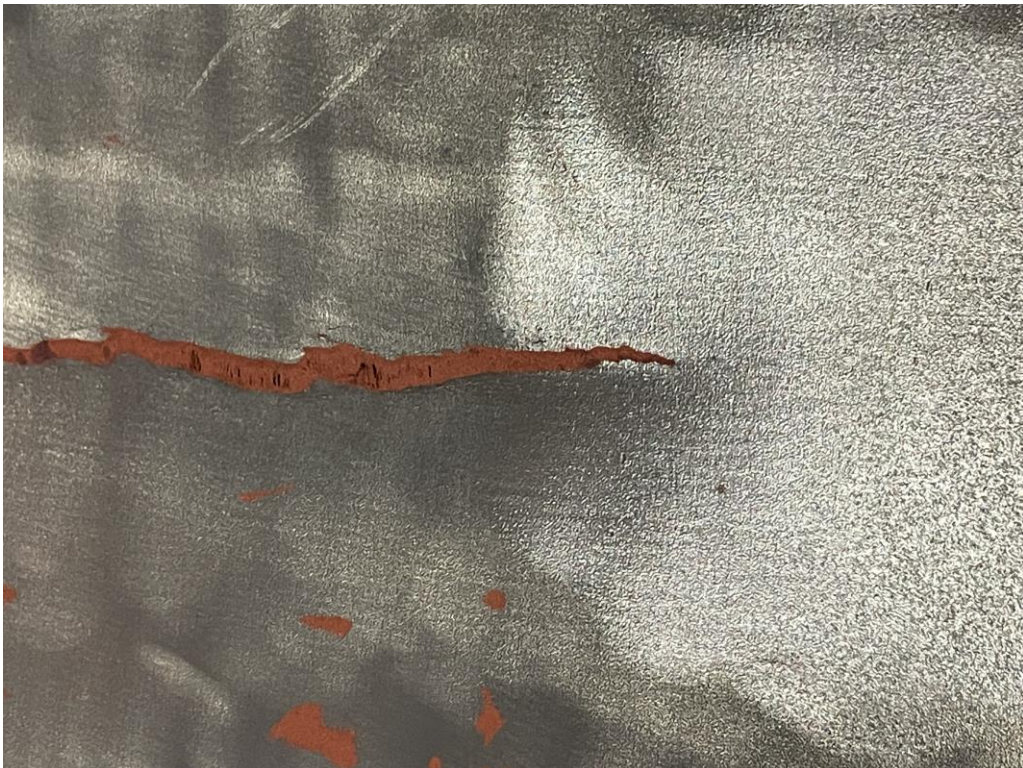
ID Surface with MT

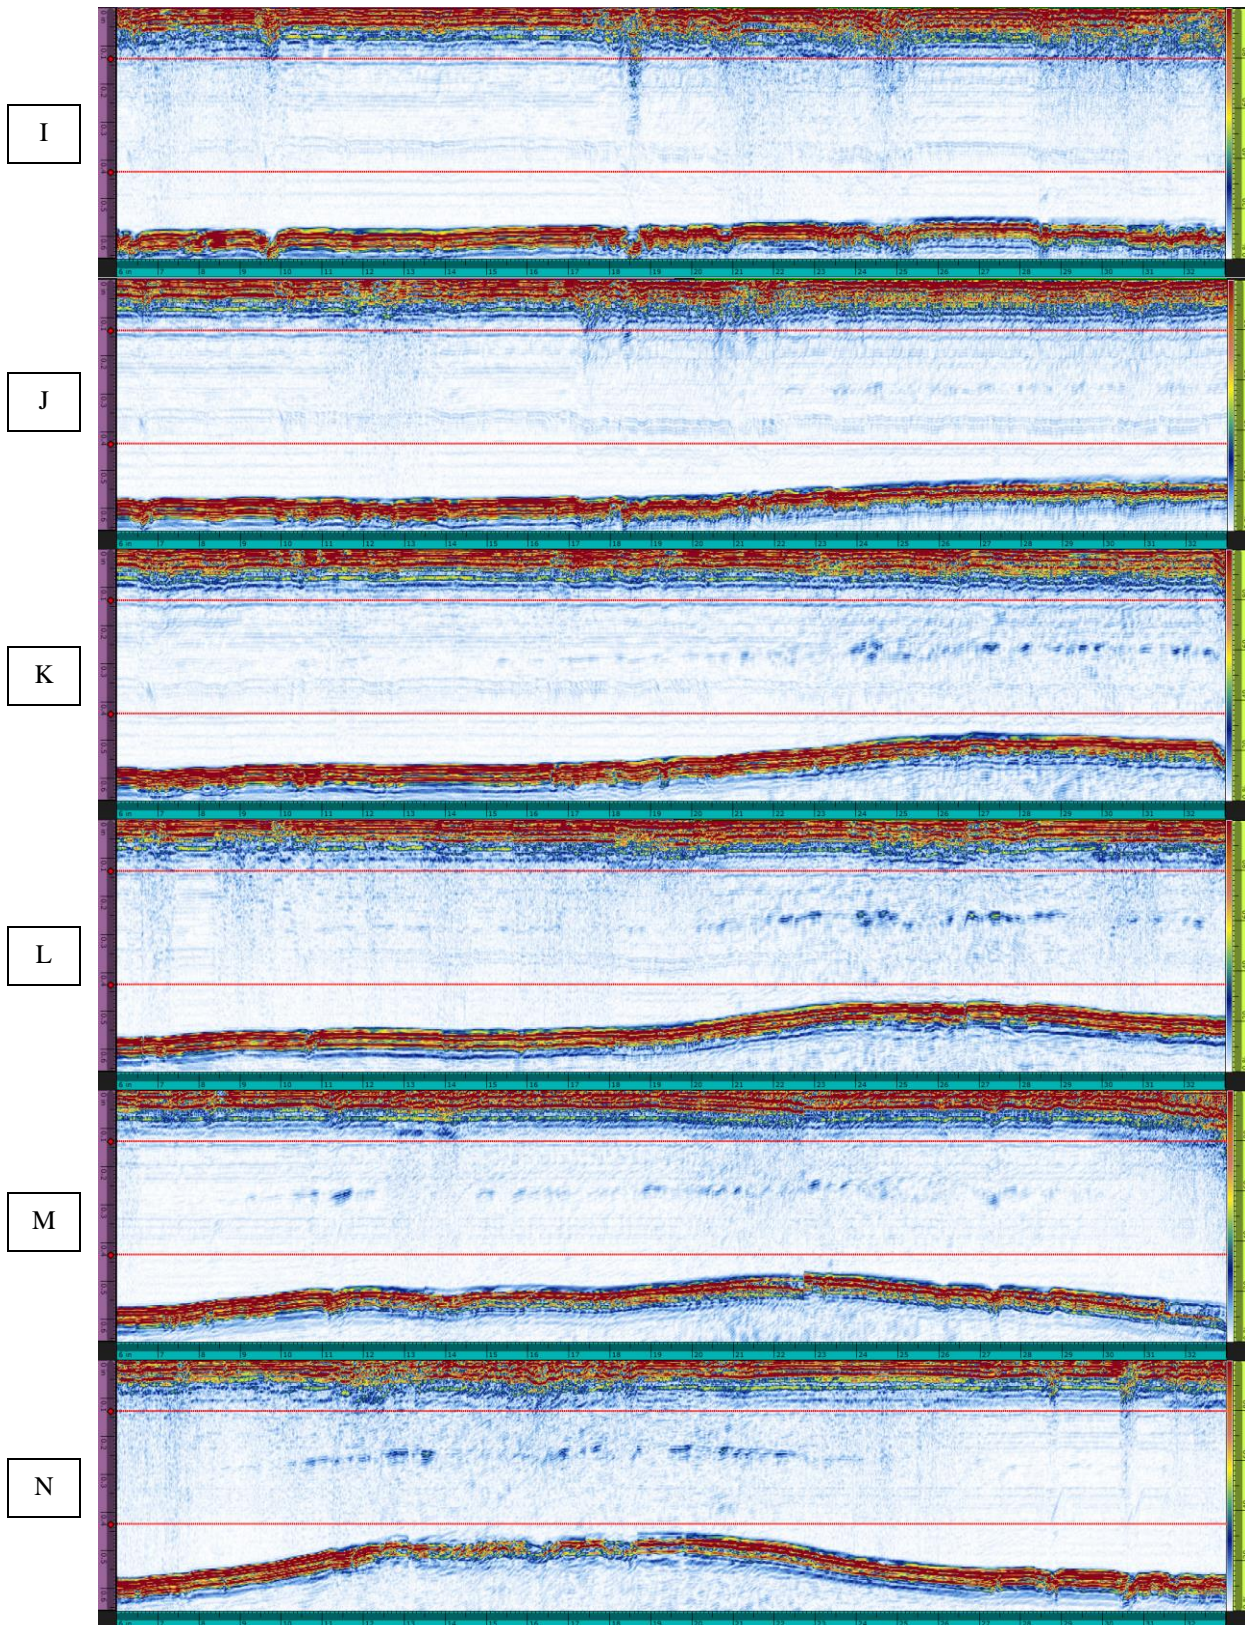
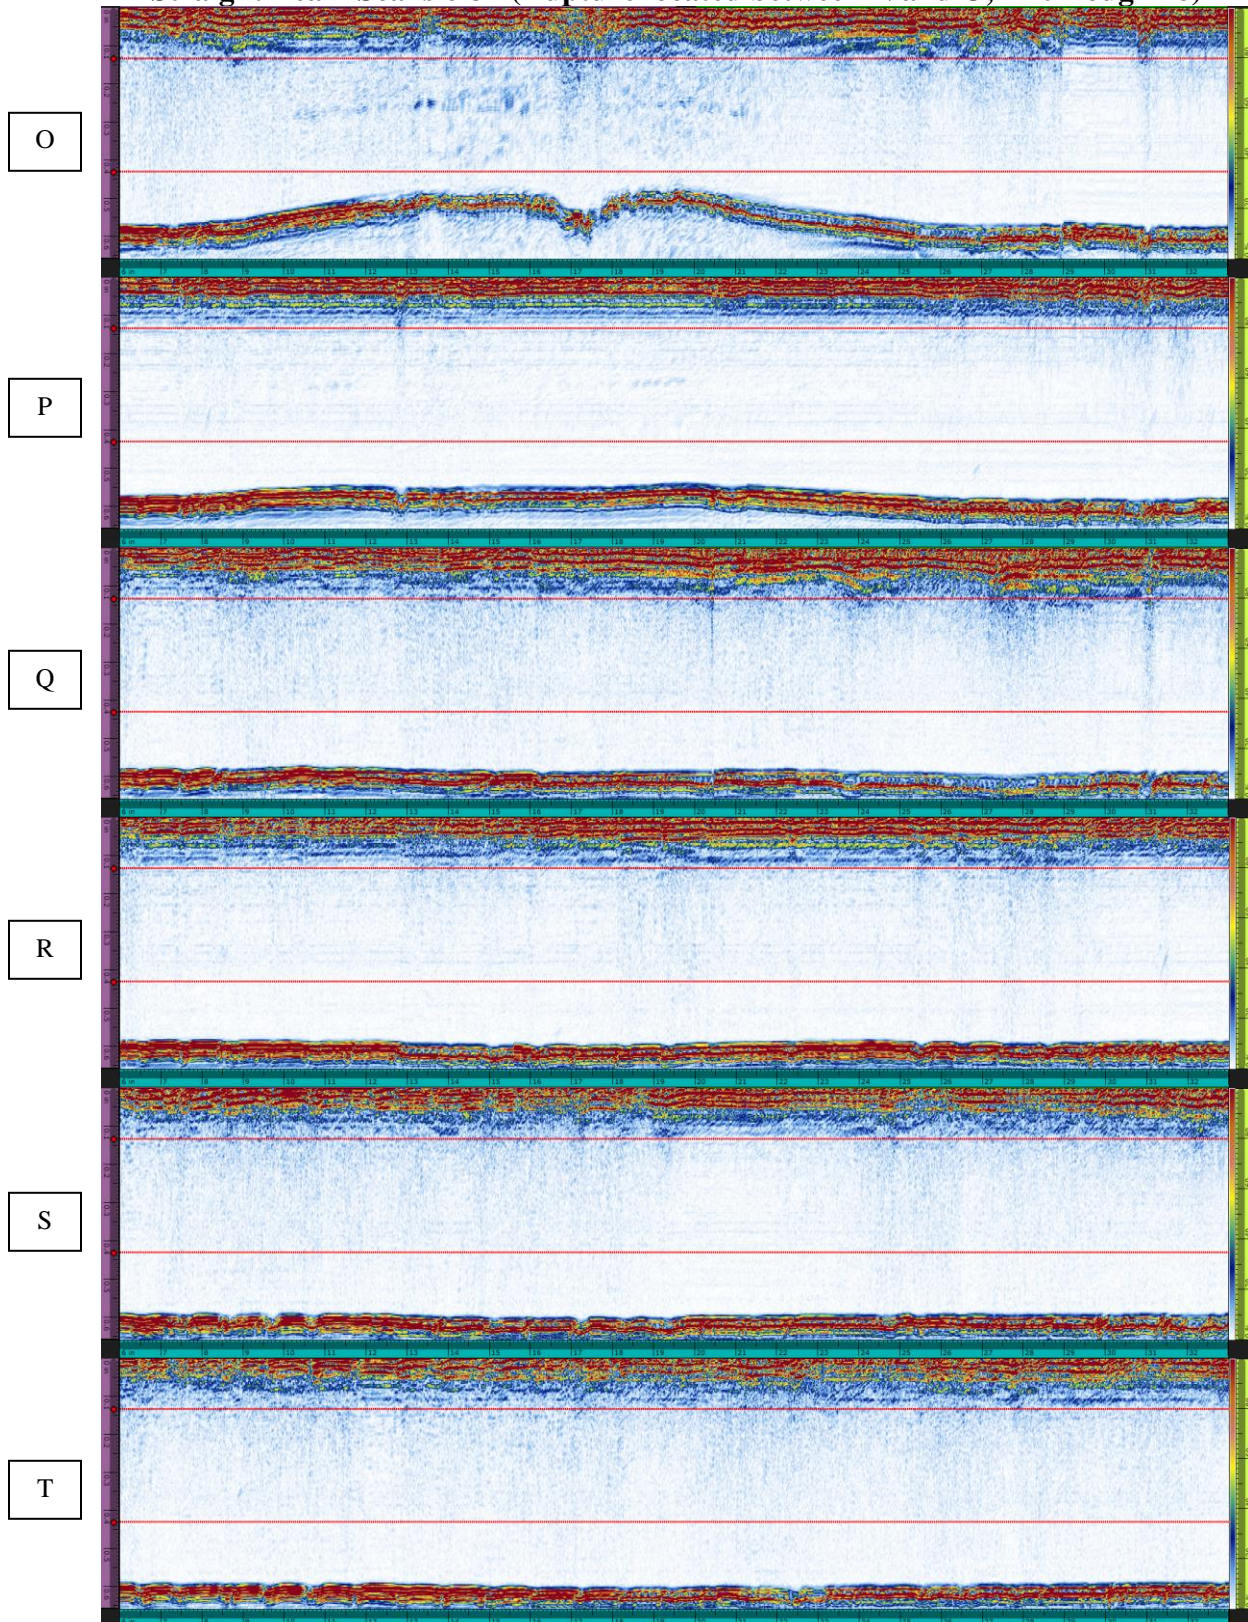
Straight Beam Scans 6-32 (Rupture located between N and O, 14 through 18)

Data File Name	TTC TK Sample 1 0 I6-32.nde
Inspection Date	07/10/2024 10:31
Report Date	07/13/2024 13:14
Procedure / Code	SOP-PAUT-03 R0 / ASTM E2700
Remark	Variations in wall thickness (thinning) and suspected centerline segregation coincide with location of damage and surface cracking.

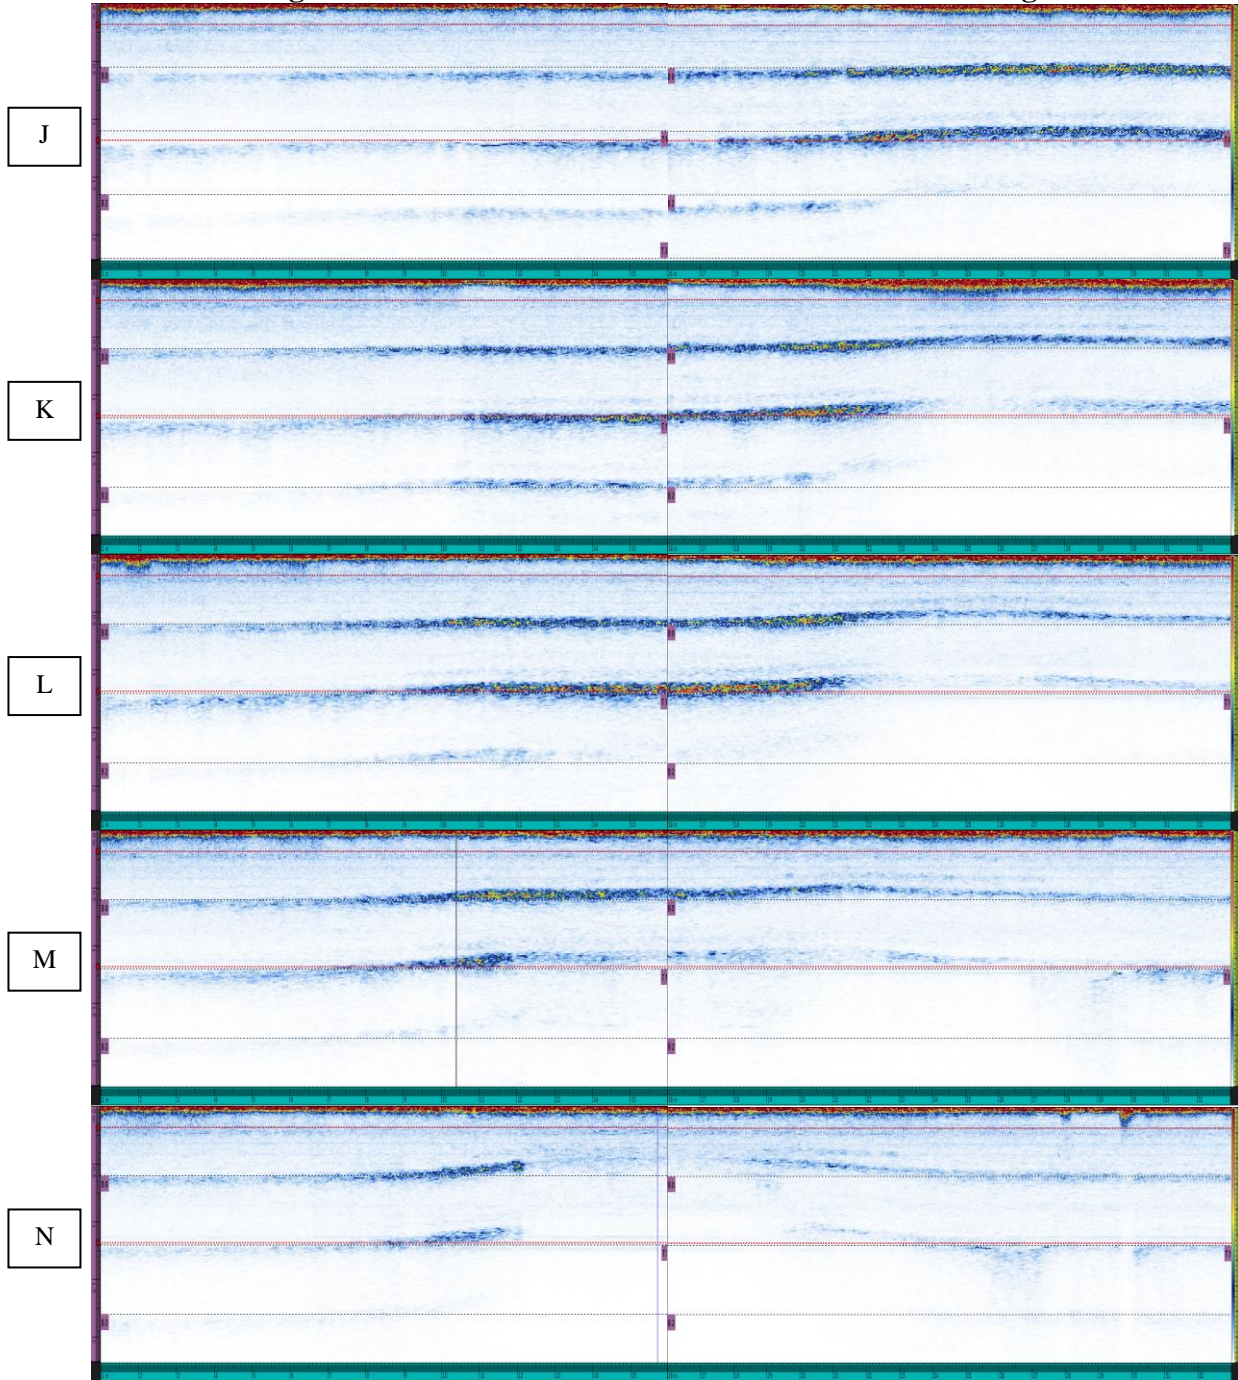
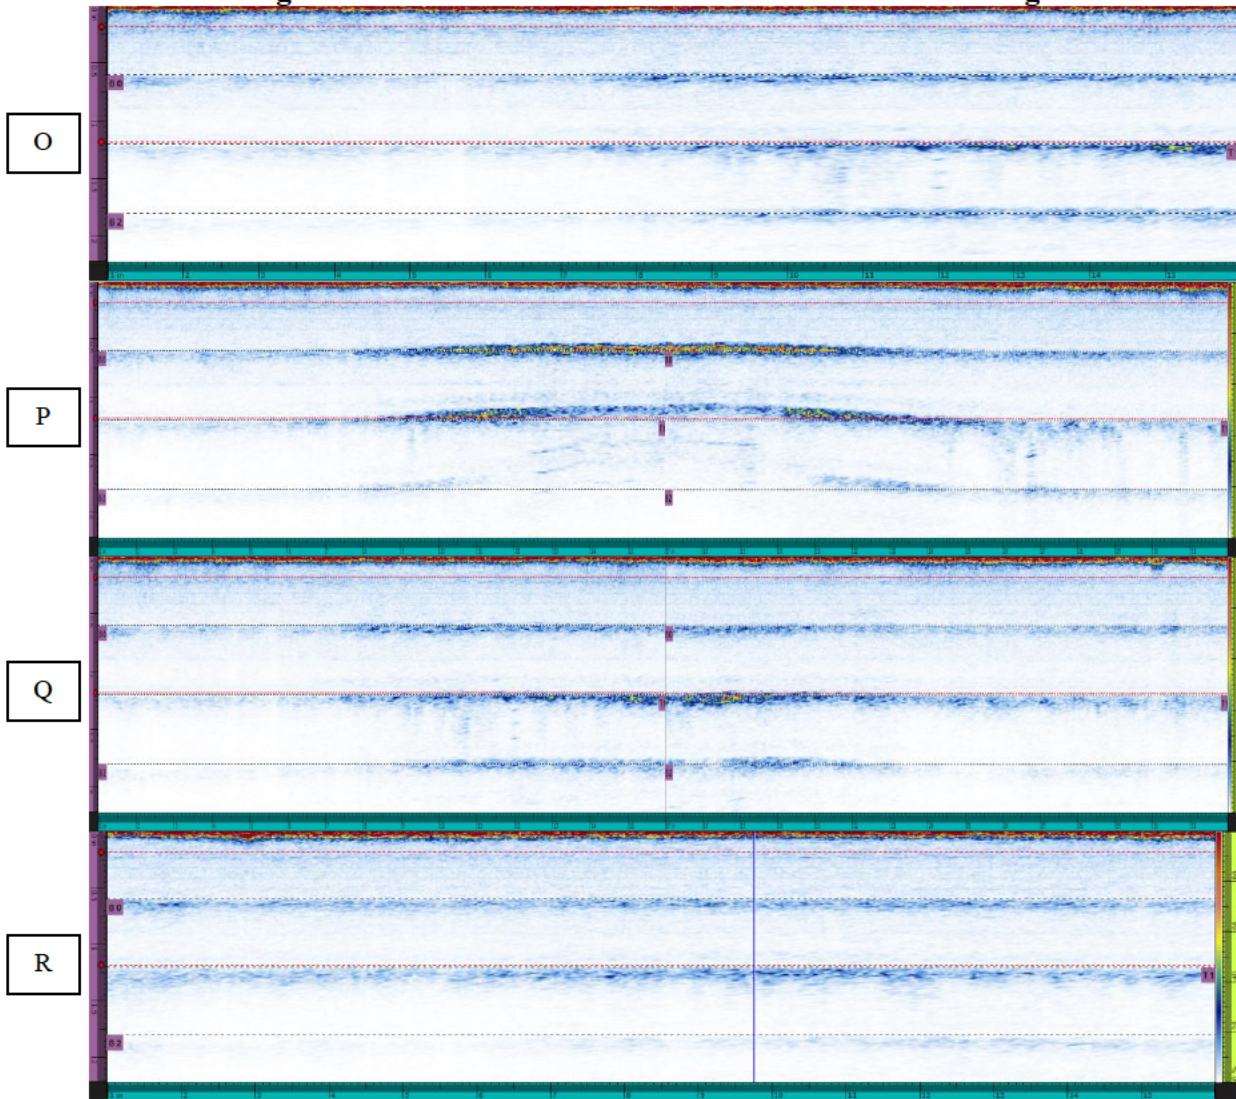
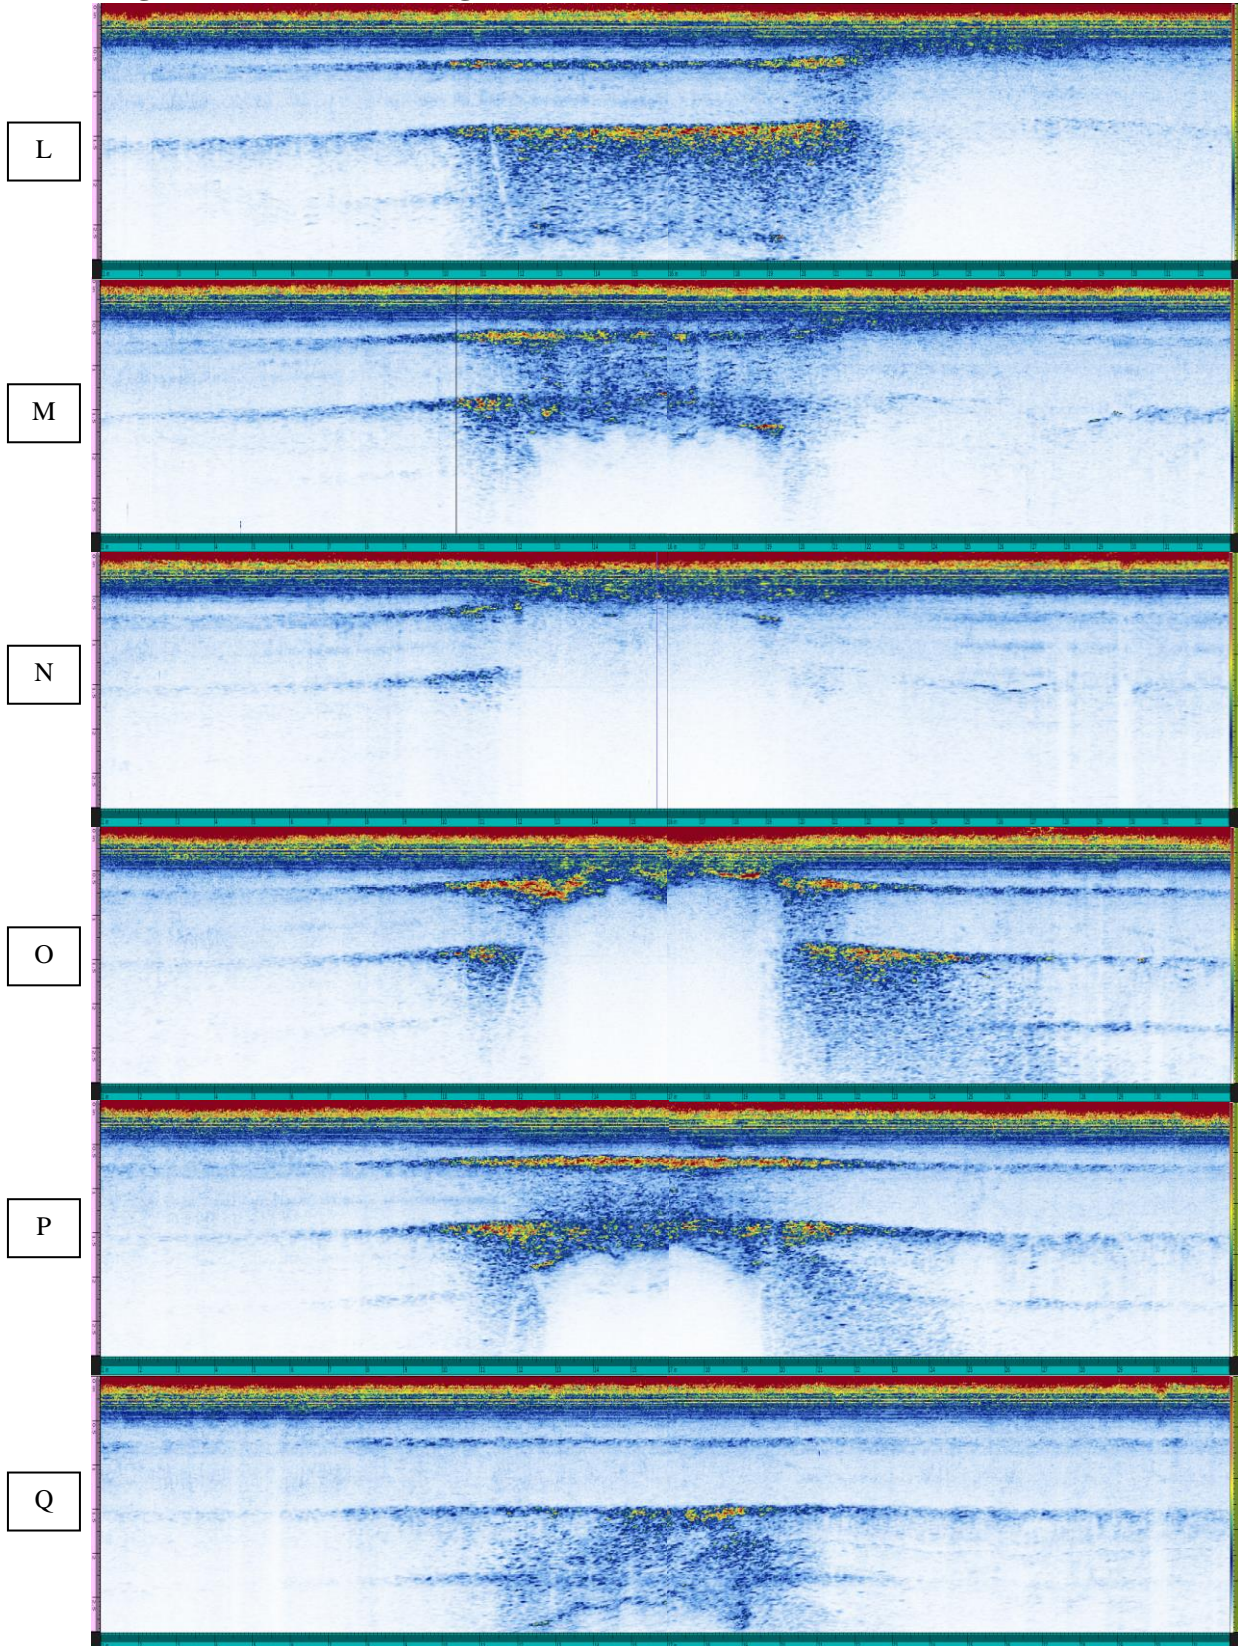
Angle Beam Sectorial B-Scans – PAUT Skew 90 at 40 Degrees

Data File Name	TTC TK Sample1 H16-H32 90.nde
Inspection Date	07/09/2024 15:54
Report Date	07/13/2024 13:20
Procedure / Code	SOP-PAUT-03 R0 / ASTM E2700
Remark	Surface cracking detected on the OD and ID consistent with that detected with the PT method.

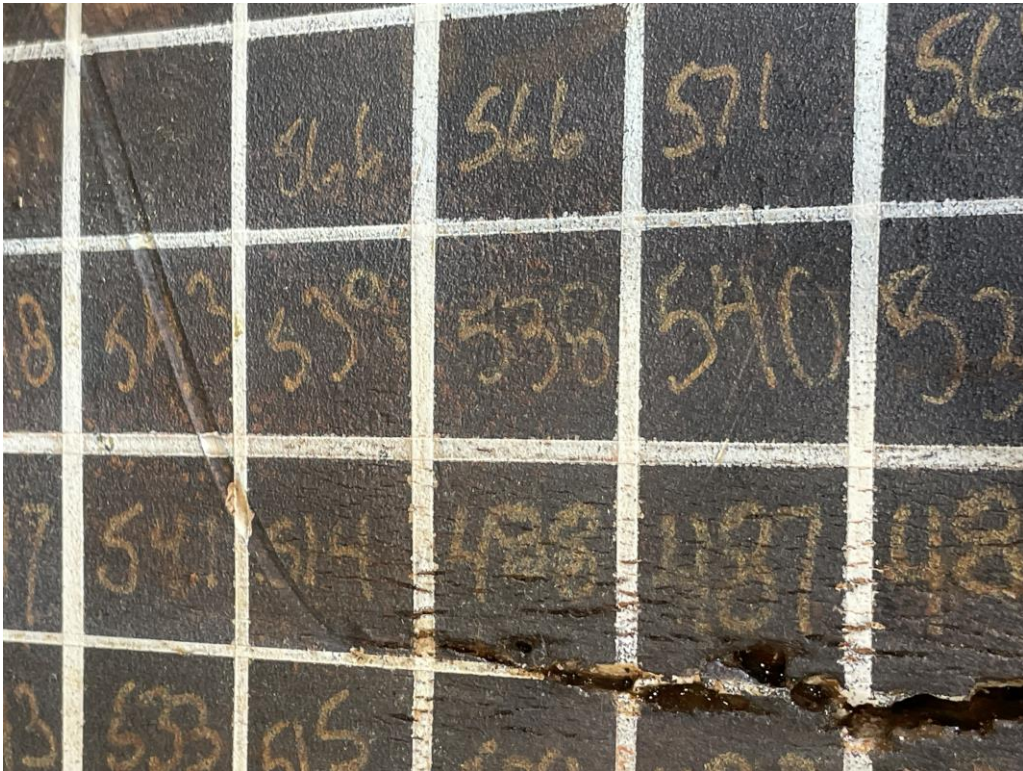
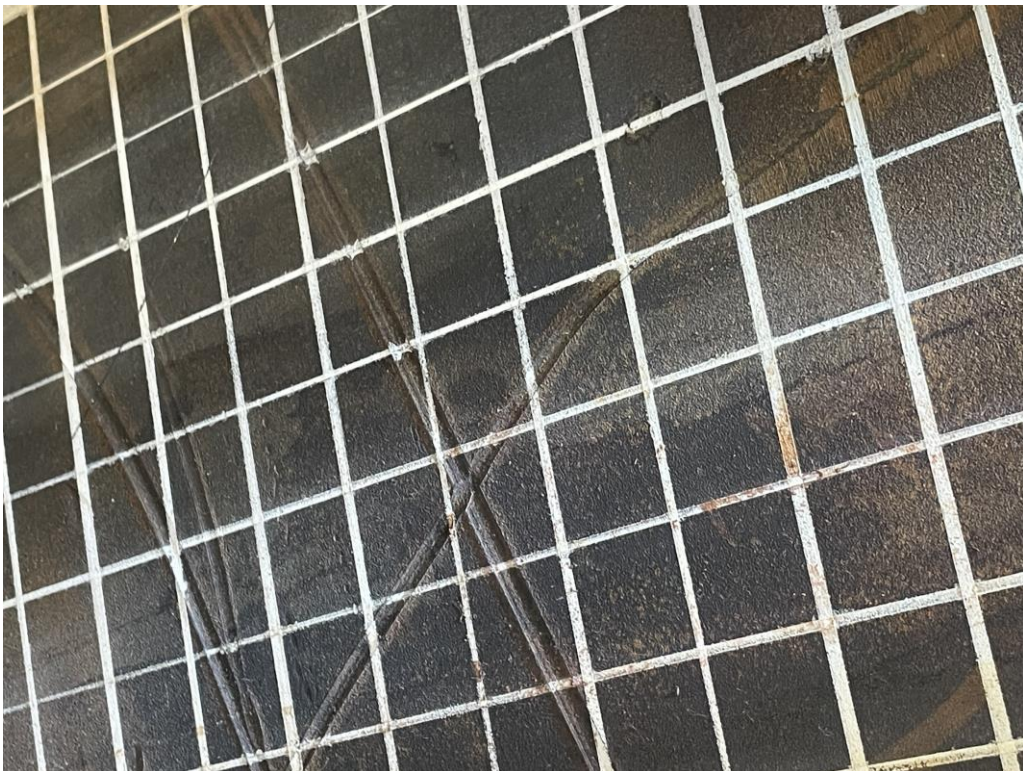
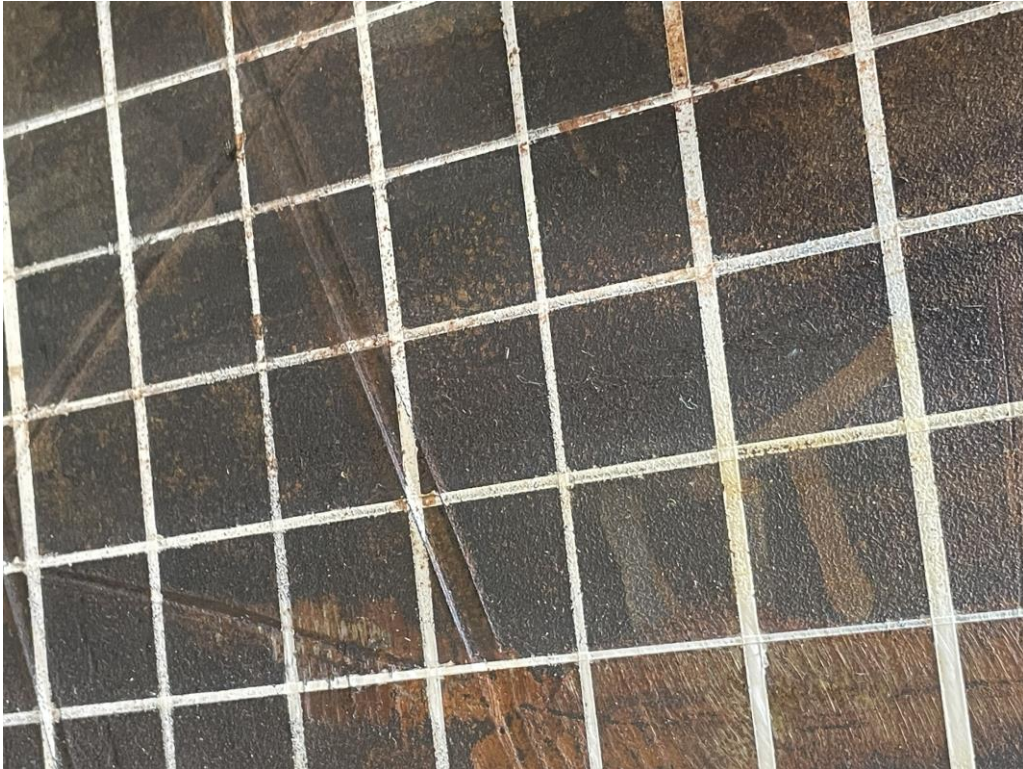
Mechanical Grooves on OD Surface
