Federal Railroad Administration Localized Corrosion or Material Degradation Form

Reporting Marks	UTLX 954193	DOT Specification	112J340W
Date when damage first observed:	04/27/24	Location where damaged first observed (City/State):	Manuelito, NM
NDT Method: MT__ PT__ UT__ UTT X VT X	Procedure(s)/Revision(s) Used: N/A	Original thickness of coupon/test area	.608
Equipment used: GE POCKETMIKE 35900	Equip. cal. date (if applicable): <small>BEFORE USE</small> _____	Cal block ID and Cal. due date (if applicable):	FLAWTECH 26705
Cable type/length (if applicable):	N/A	Scan techniques/plans (if applicable):	POINT
Search Unit(s) (if applicable): PULSE-ECHO/DUAL ELEM	Angle /MHz: N/A 5 MHz	Size: .475	Serial # 5191
Couplant/Penetrant/Particles manufacturer/type (if applicable):	GE REF 0102790	Exam date/time: 5/24/24	Special equip. (if applicable): N/A
Coupon Location - Ring #, B or A Head:	Ring #1	Clock Position Top = 12, Bottom = 6, facing the B head:	1 O'clock
Surface conditions, Surface Temp. and side(s) examined from:	Surface: clean and free of moisture ID__ OD X Surface Temp: N/A	Indication(s) (Type/Size/Location):	Thermal tear/8 inches long/Ring 1/1 o'clock

Client	ENSCO, Inc.	Inspection N

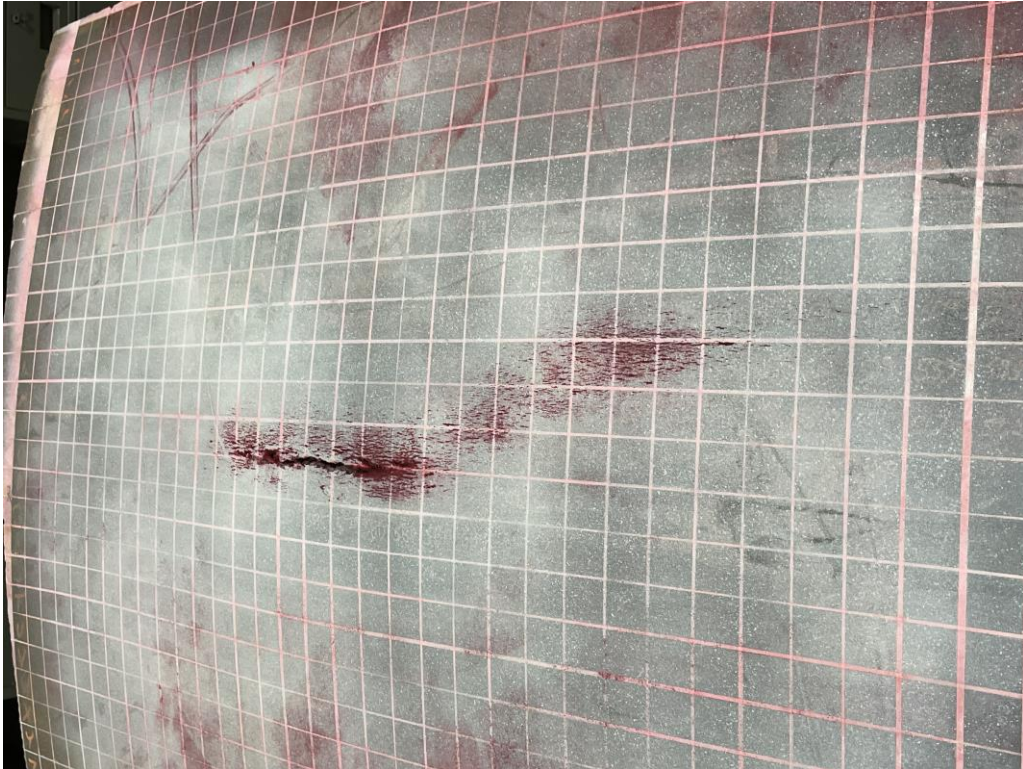
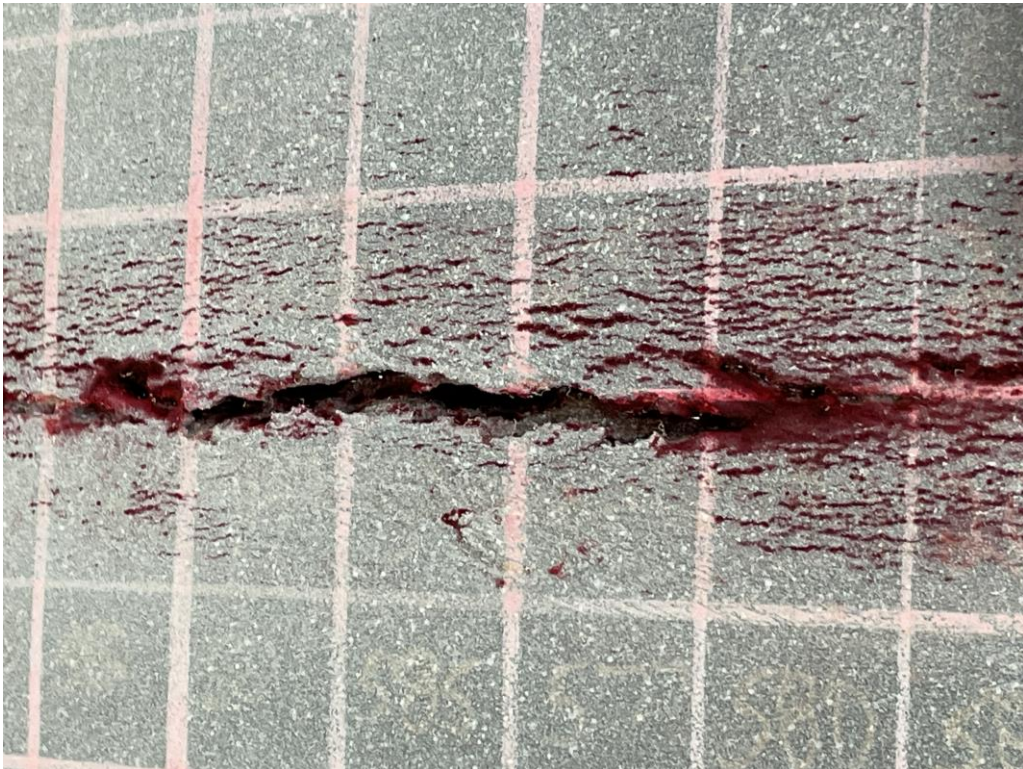
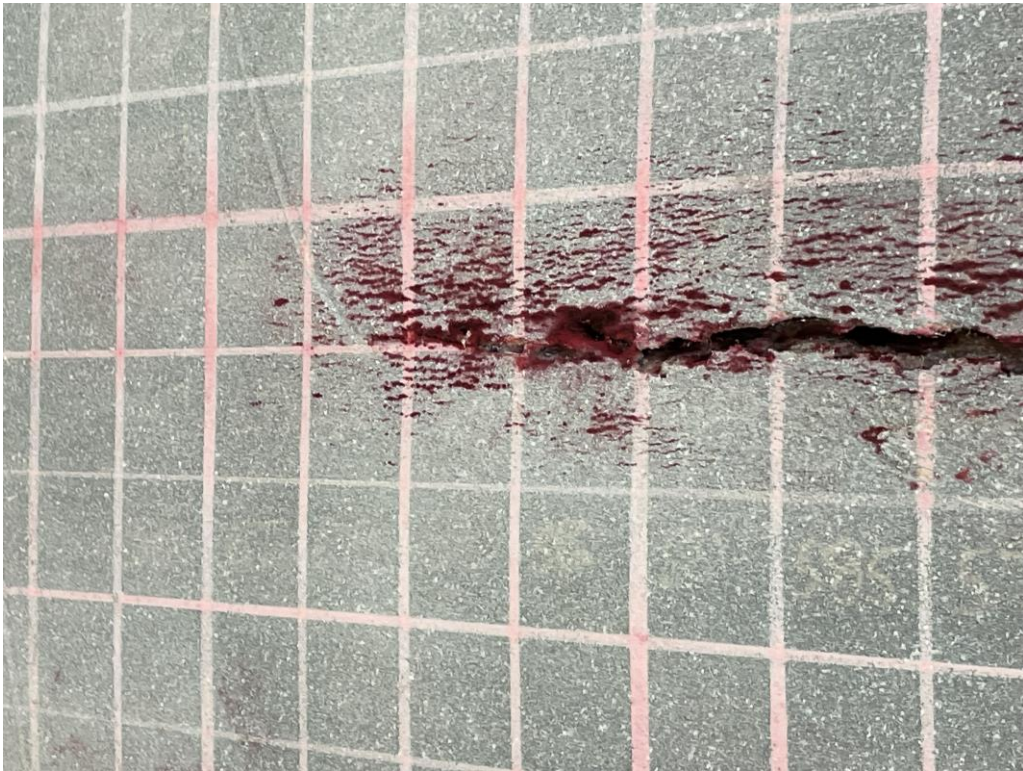
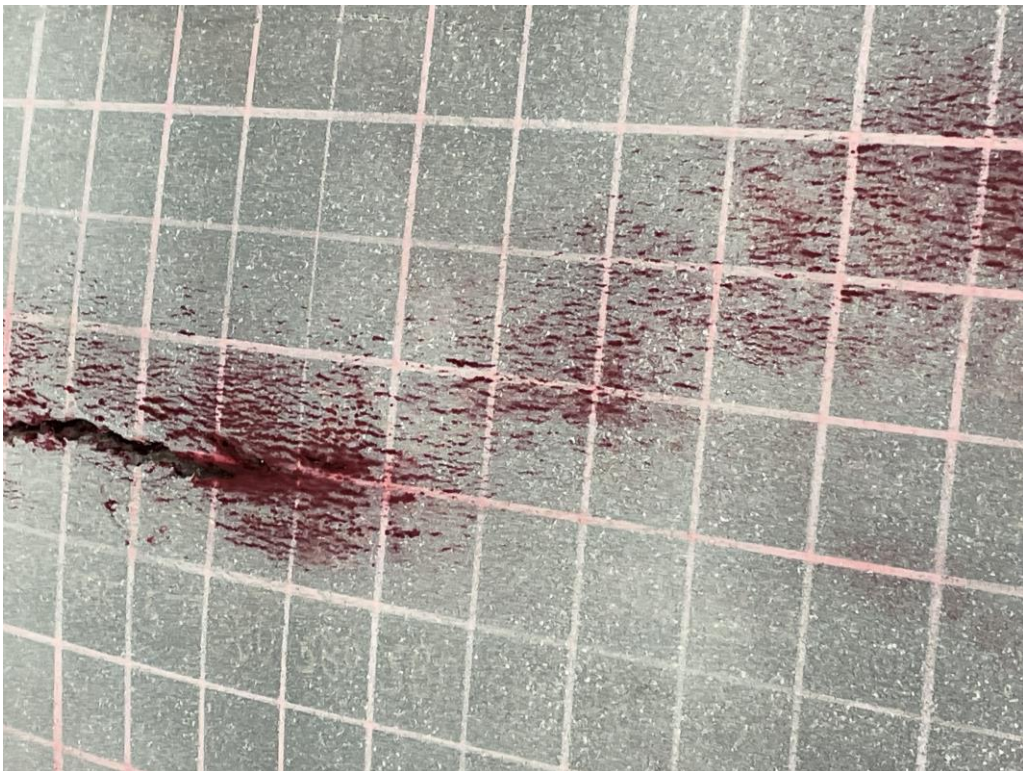
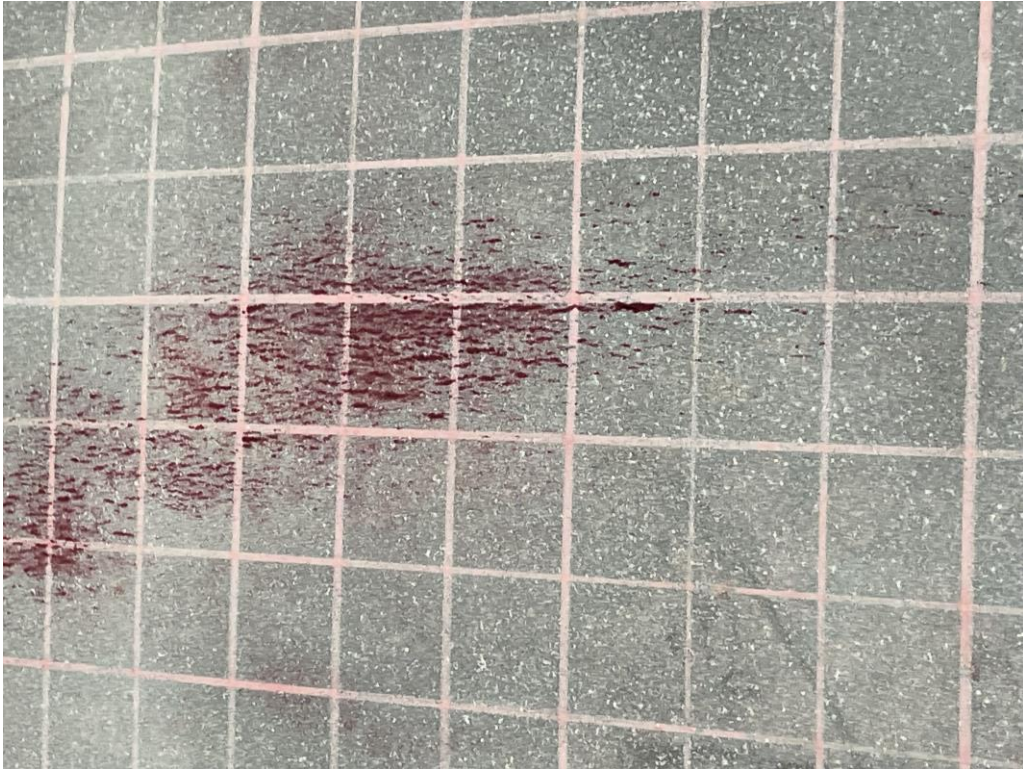
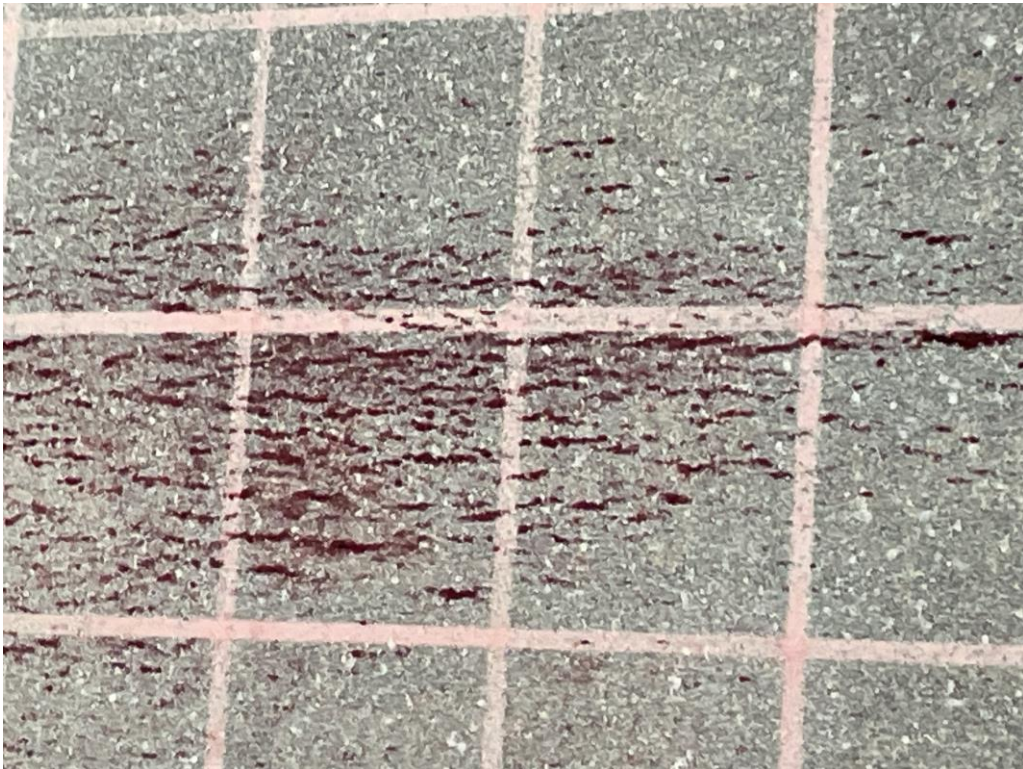
OD surface with PT

1) No relevant MT indications detected other than those detectable with the unaided eye.				
2) Inside surface inspection impeded by embedded carbon. Indications only detected near rupture where cracks have wide opening.				
<input type="checkbox"/> PT acceptable <input checked="" type="checkbox"/> PT not acceptable		Page 1 of 1	Technician (Signature/Date)

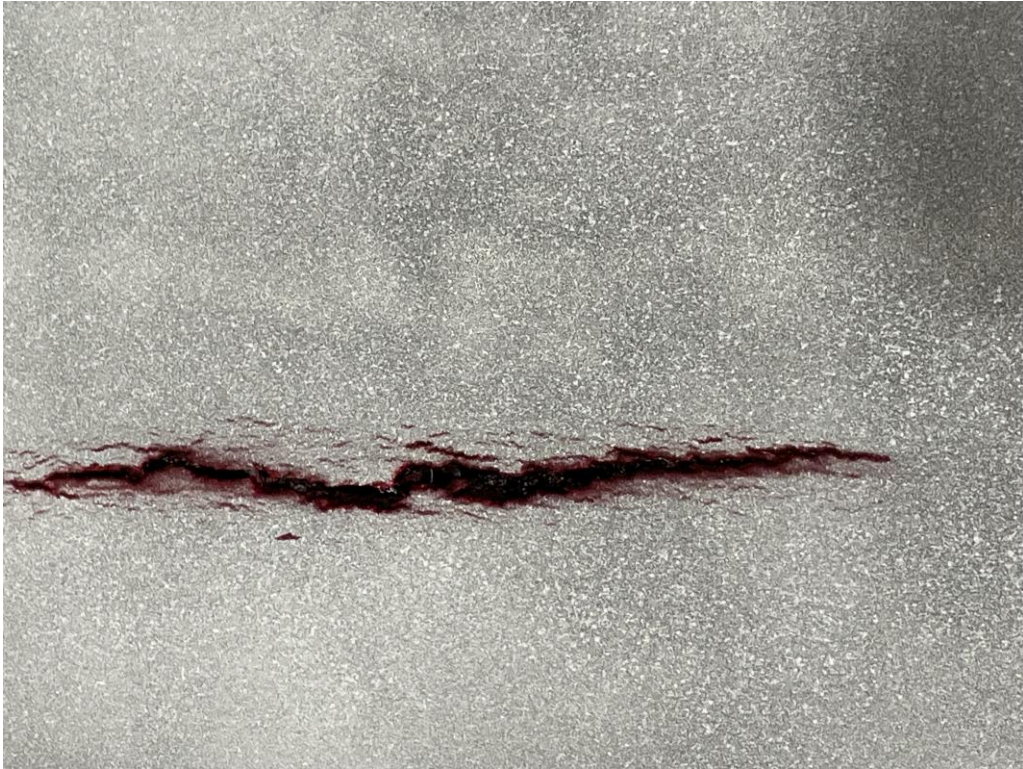
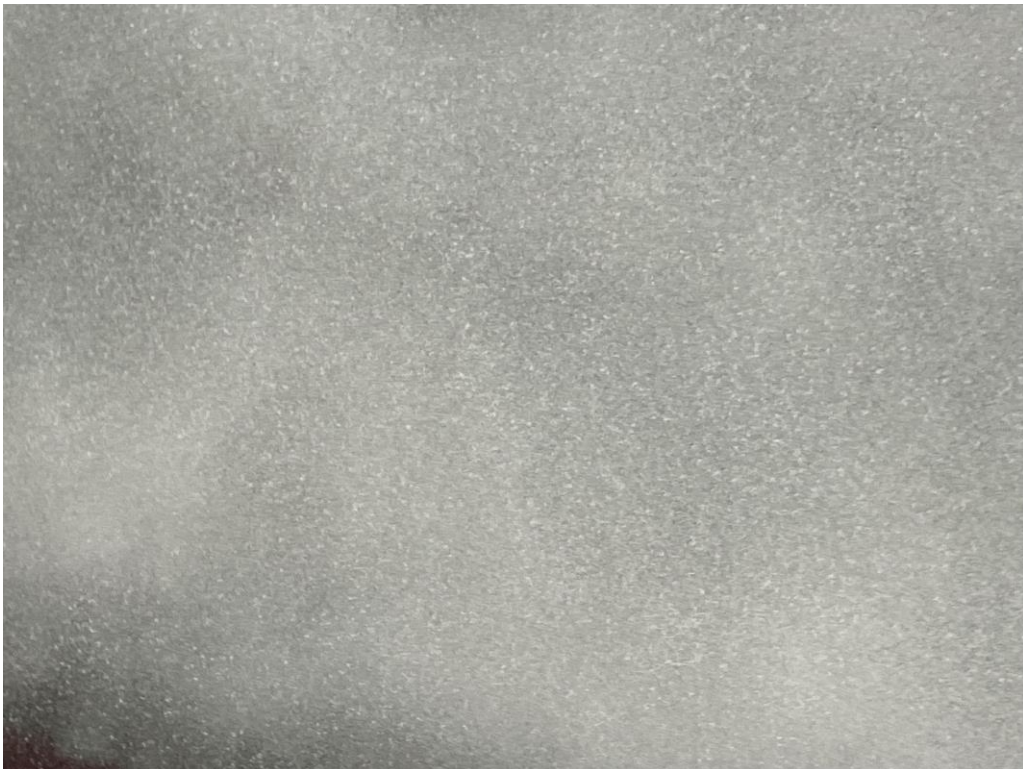
ID surface with PT
