## Federal Railroad Administration Localized Corrosion or Material Degradation Form

Reporting Marks	NATX 400688	DOT Specification	112J340W
Date when damage first observed:	04/27/24	Location where damaged first observed (City/State):	Gallup, NM
NDT Method: MT___ PT___ UT___ UTT X VT X	Procedure(s)/Revision(s) Used: N/A	Original thickness of test coupon	.608
Equipment used: GE POCKETMIKE 35900	Equip. cal. date (if applicable): BEFORE USE _____	Cal block ID and Cal. due date (if applicable):	FLAWTECH 26705 _____
Cable type/length (if applicable):	N/A	Scan techniques/plans (if applicable):	POINT
Search Unit(s) (if applicable):	Angle /MHz:  N/A 5MHz	Size:  .475	Serial #  5191
Couplant/Penetrant/Particles manufacturer/type (if applicable):	GE REF 0102790	Exam date/time: 05/24/24	Special equip. (if applicable): N/A
Coupon Location - Ring #, B or A Head:	B-HEAD	Clock Position Top = 12, Bottom = 6, facing the B head:	N/A
Surface conditions, Surface Temp. and side(s) examined from:	Surface CLEAN ID___OD X Surface Temp: N/A	Indication(s) (Type/Size/Location):	Thermal tear 18" long Undercut in two places @ jacket standoff welds 1" each

Client	ENSCO, Inc.	Inspection No.	PAUT 24-0710-02	Contac

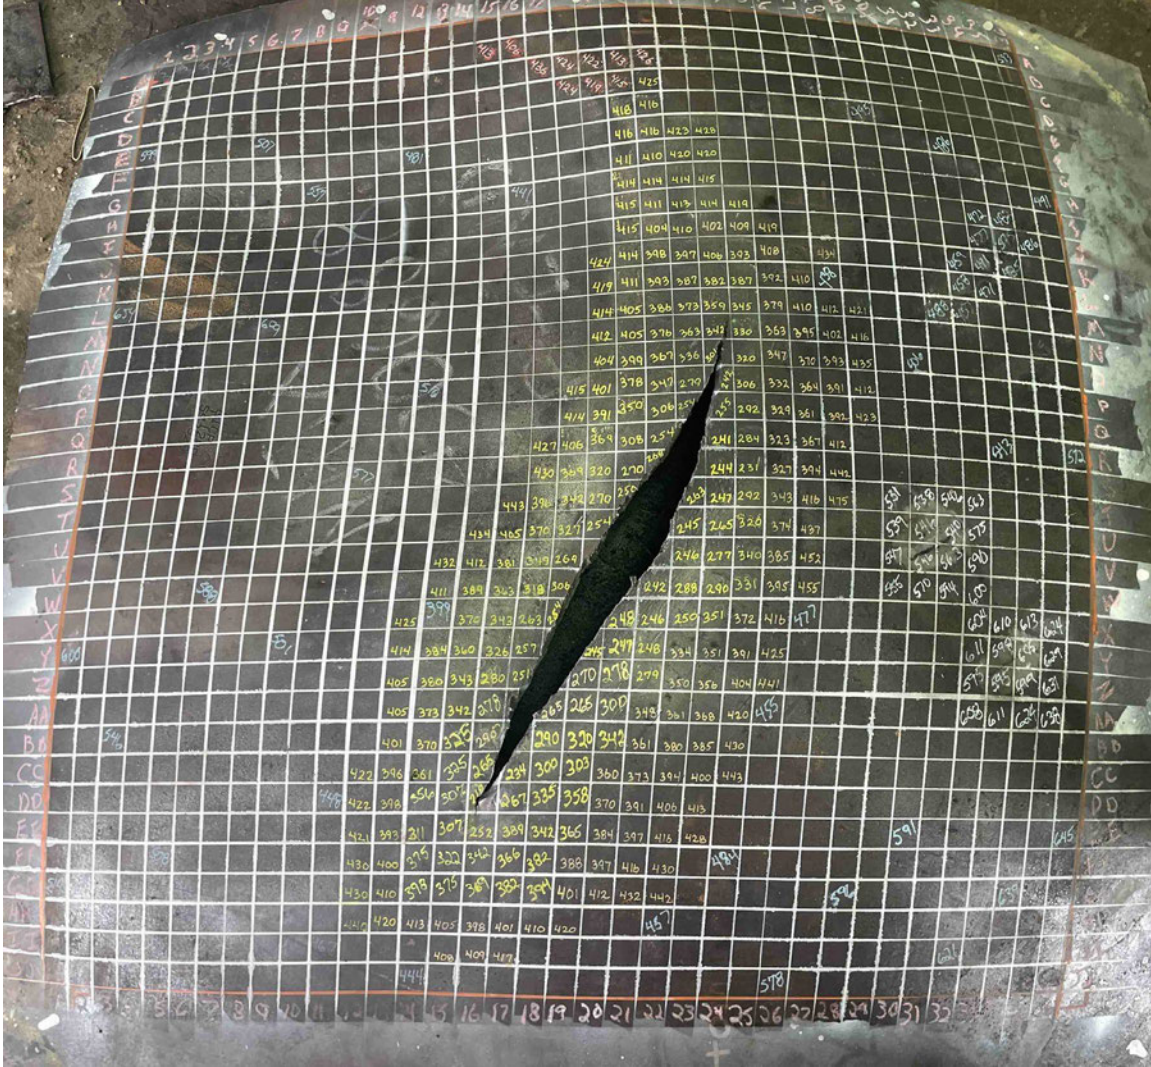
COMMENTS: Defect is consistent with a thermal tear approximately 18" long and 3" wide at some points. Head shield was still in place when first observed but was severely melted from commodity (LPG) having been ignited and leaking. Material thinning was also observed throughout the large coupon several inches from the breach.

There were also two additional defects created at the time of manufacturing from undercut created by the welds attaching the jacket standoff to the tank located in the T30-U31 area and Y34 to Z33.

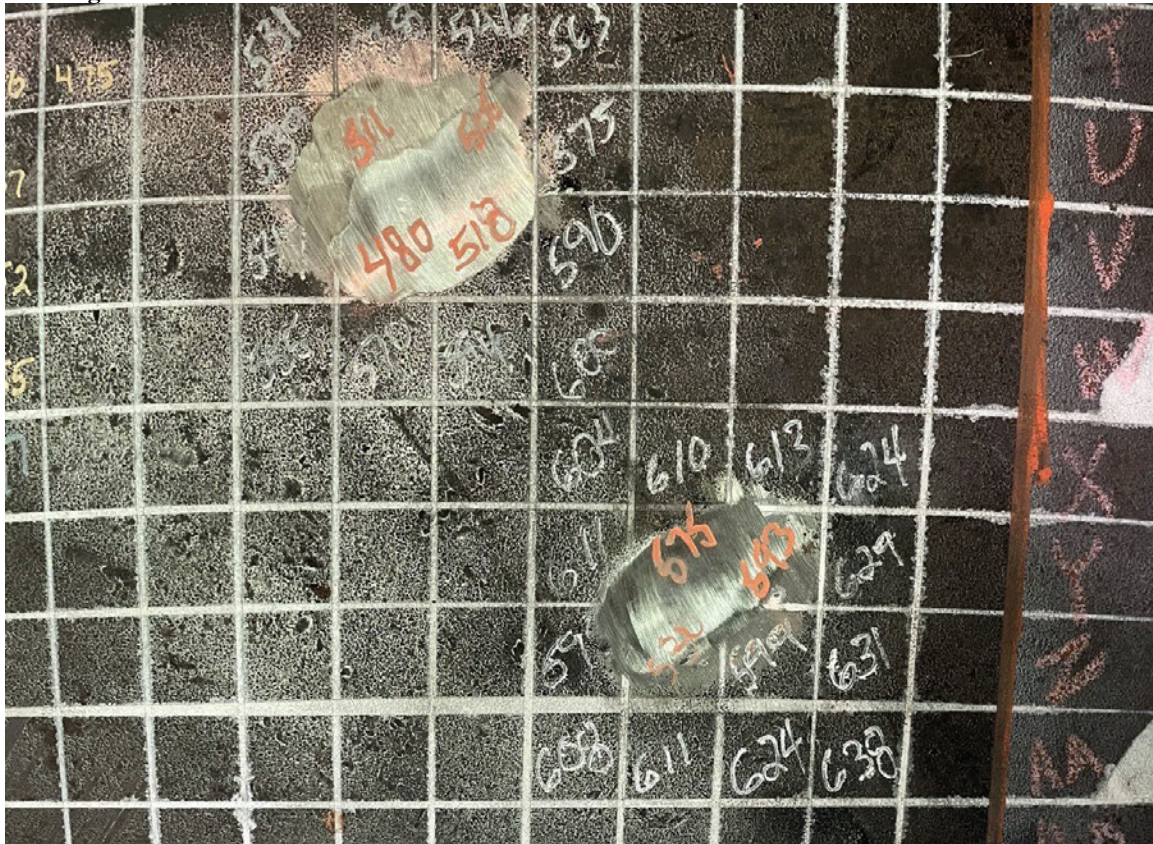
Reading after removal of Undercut.

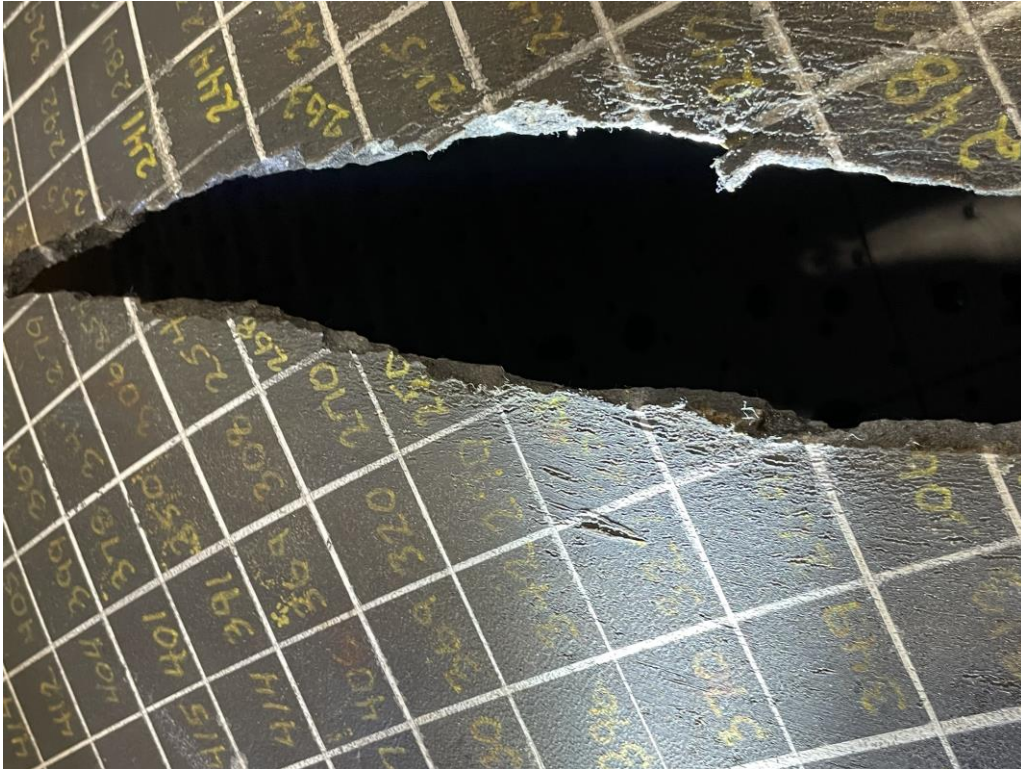
OD surface prior to MT

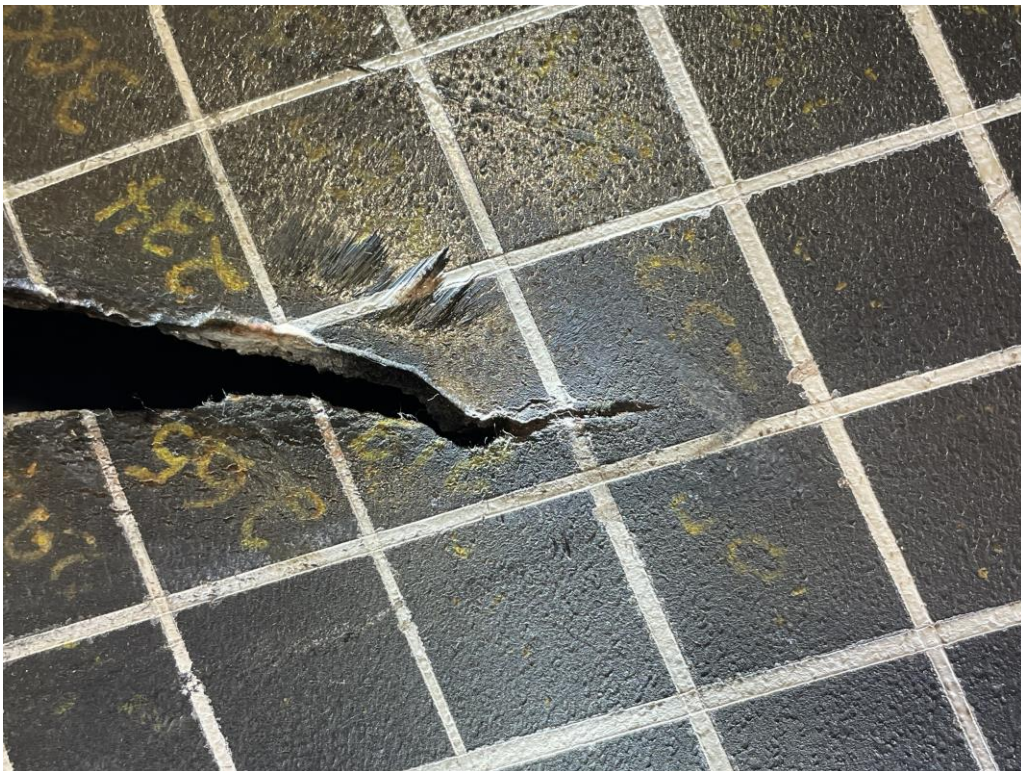
OD surface prior to MT

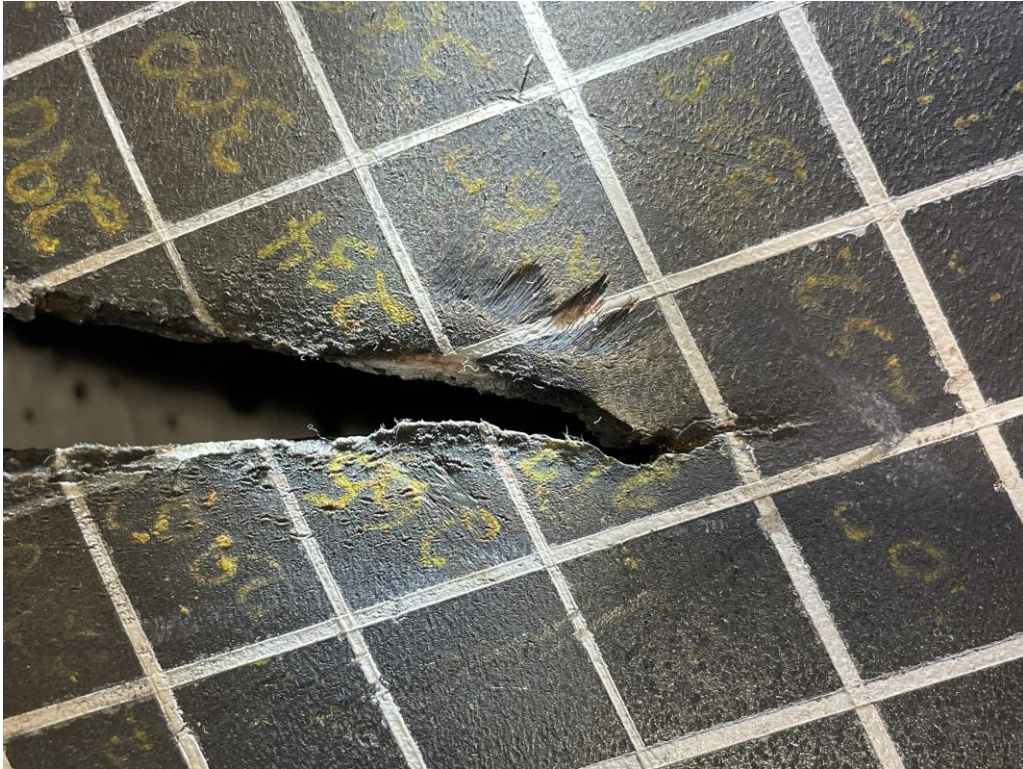
OD surface prior to MT

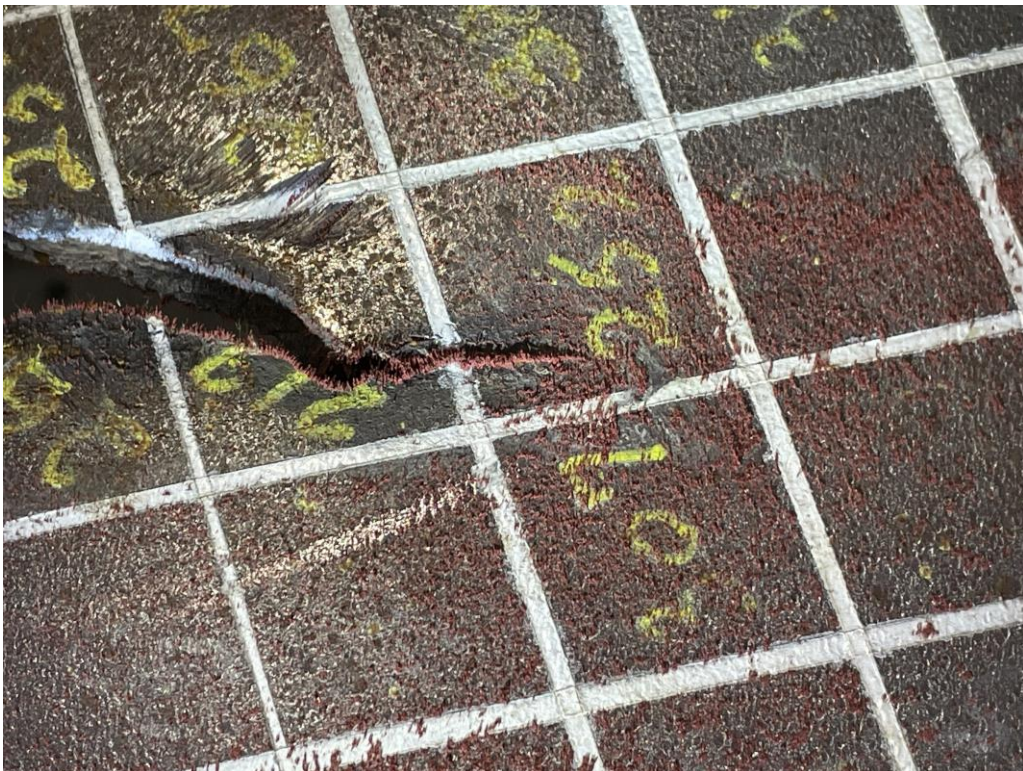
OD Surface with MT

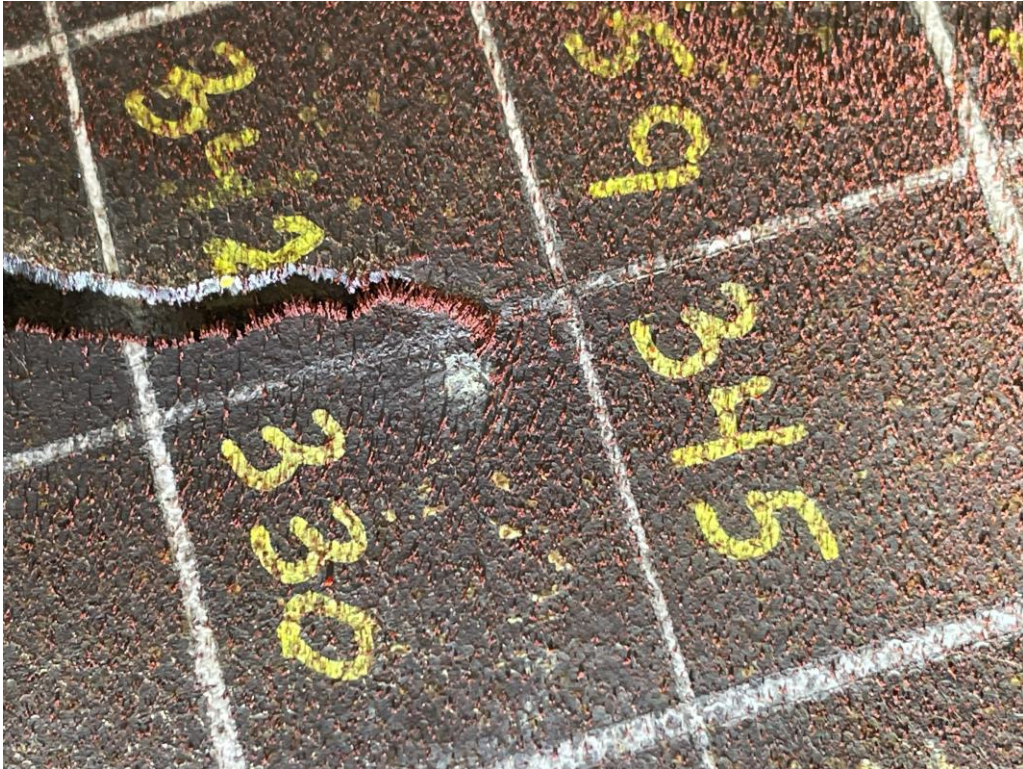
OD Surface with MT

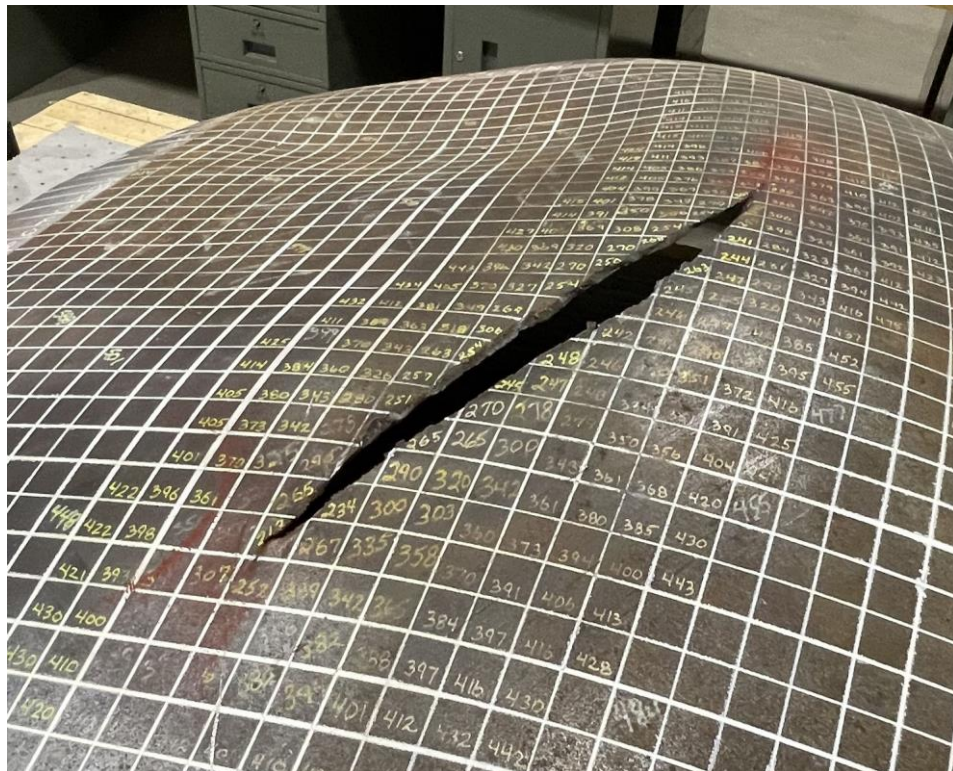
OD Surface with MT

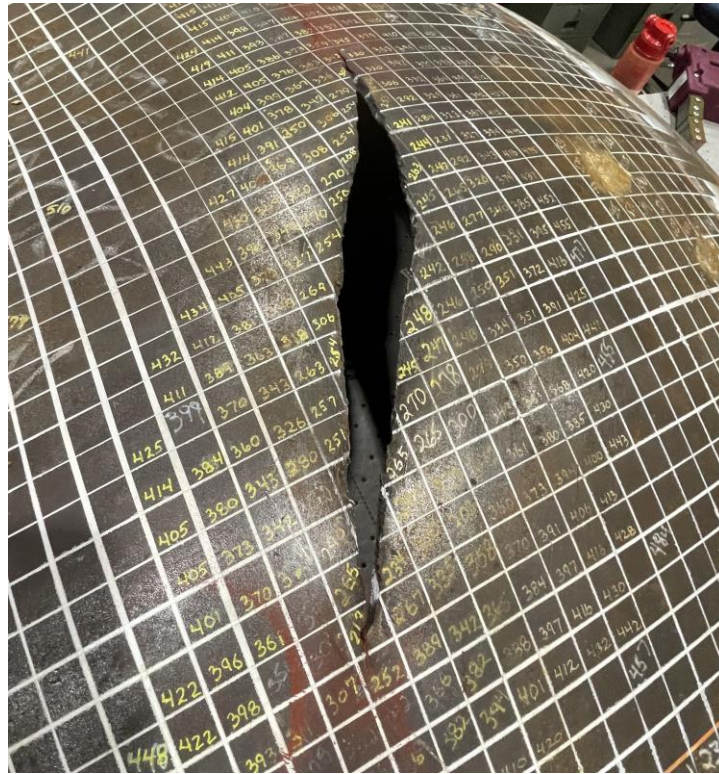
OD Surface with MT

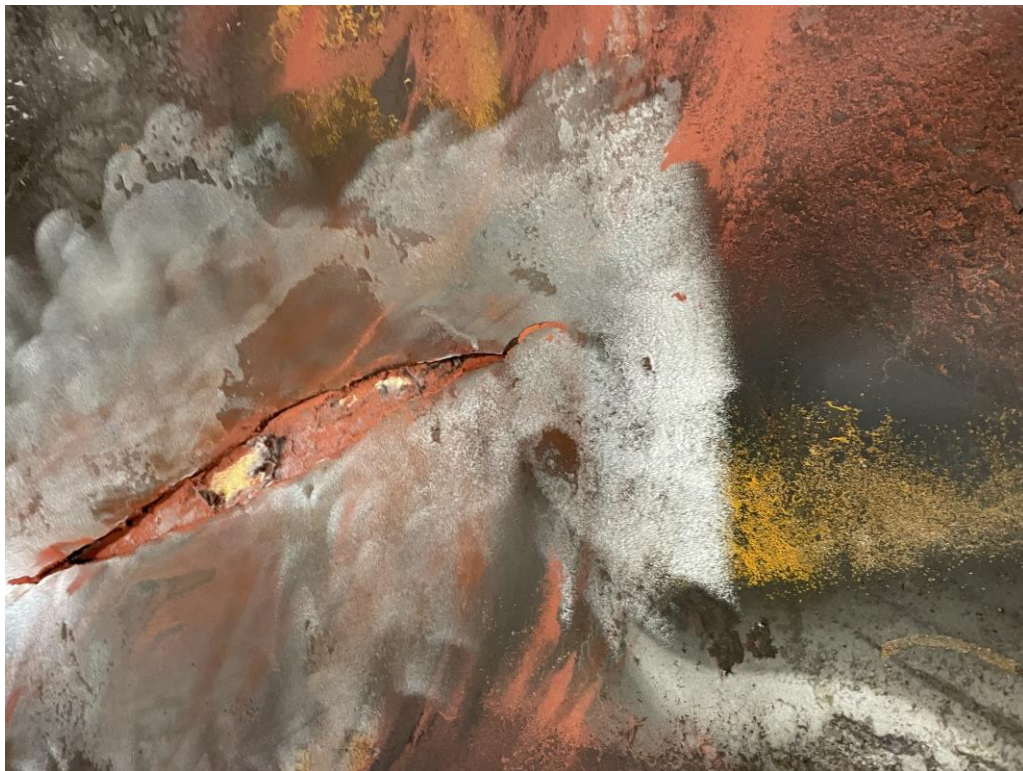
ID Surface with MT

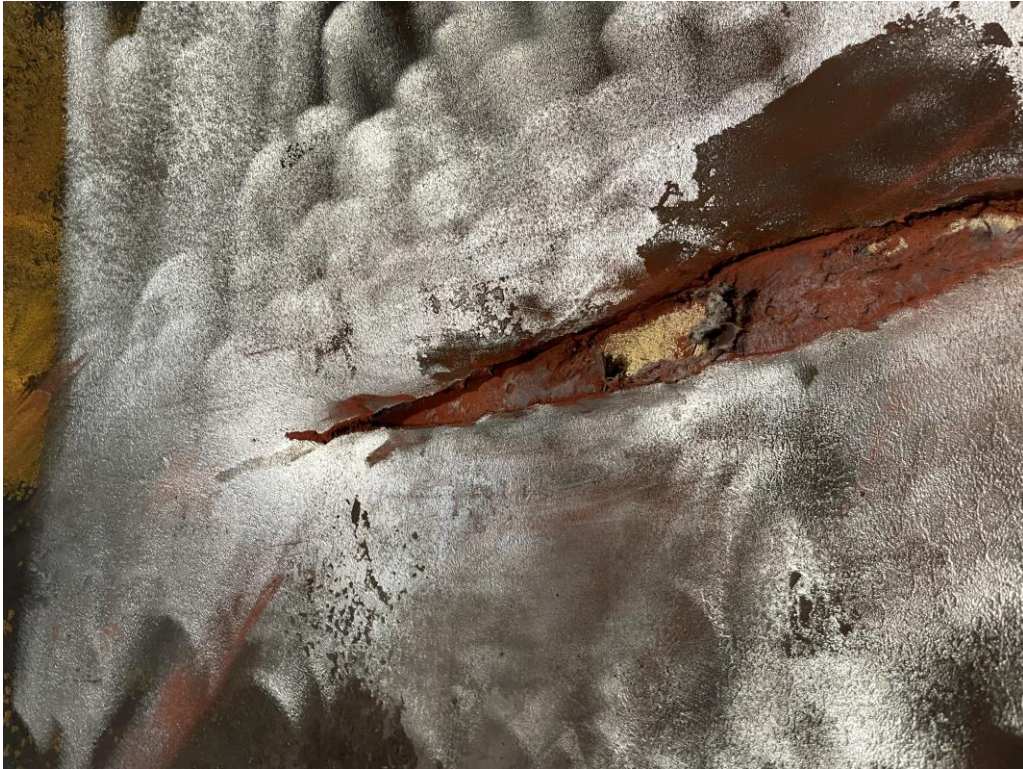
ID Surface with MT

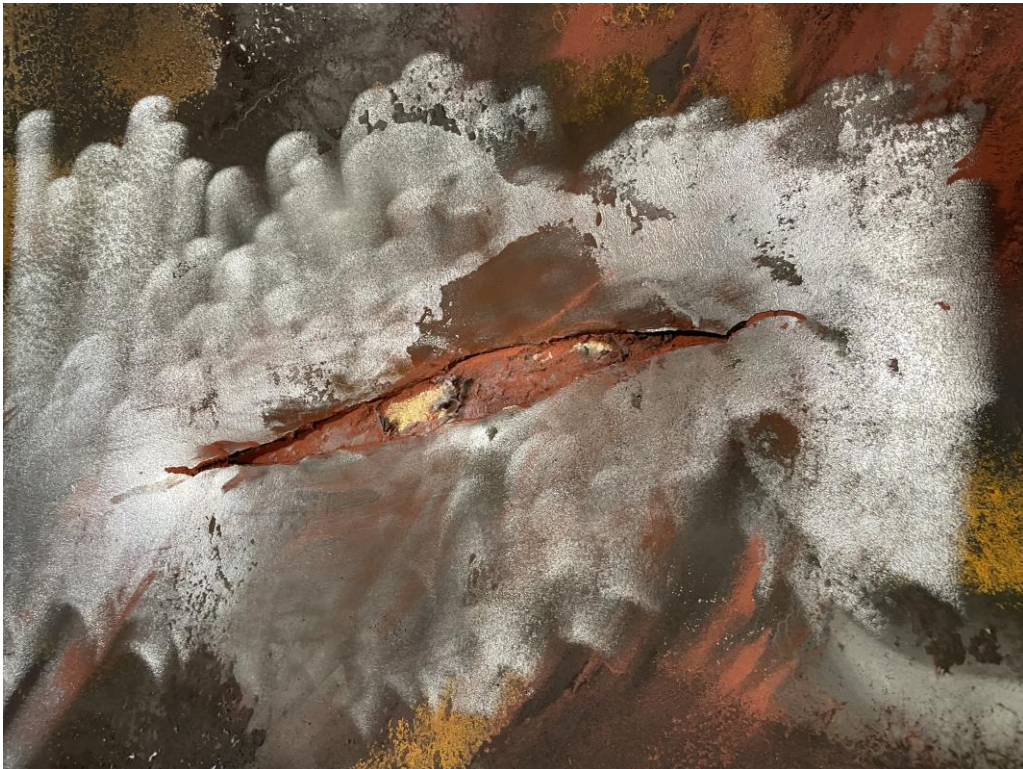
ID Surface with MT

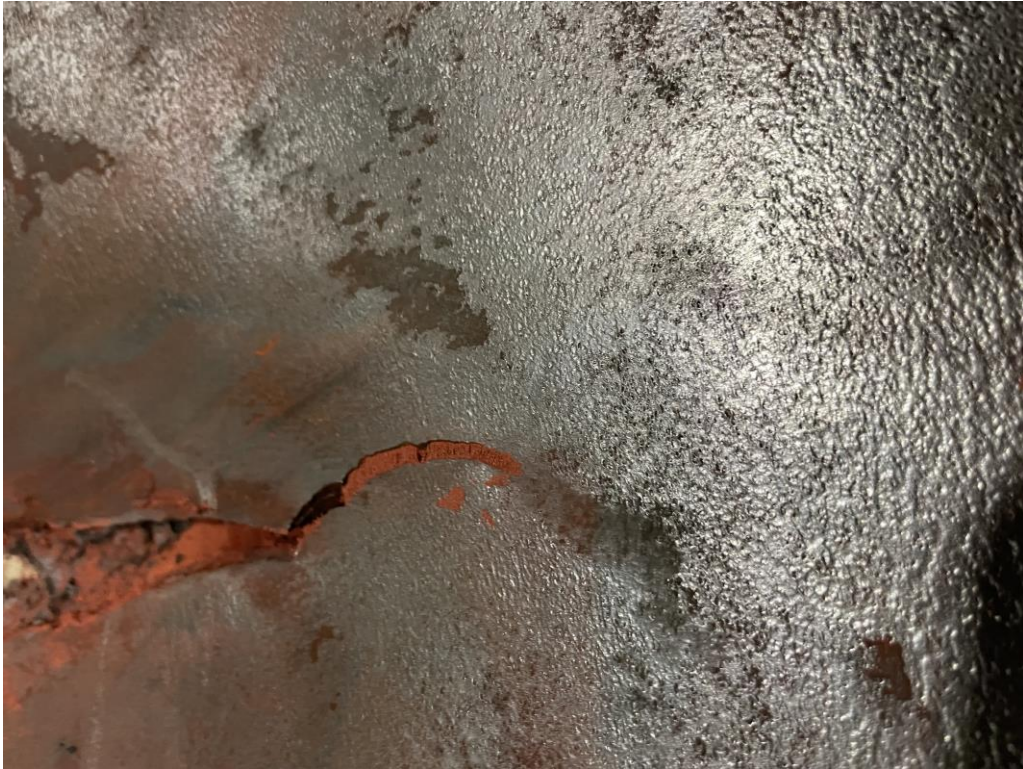
ID Surface with MT

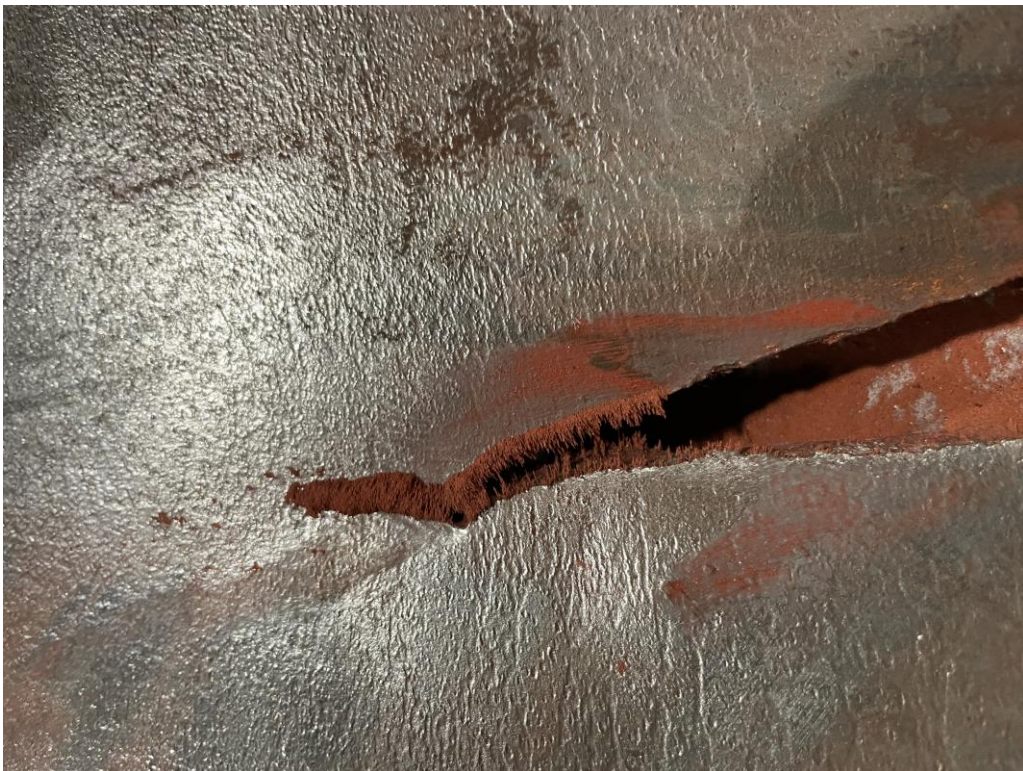
ID Surface with MT

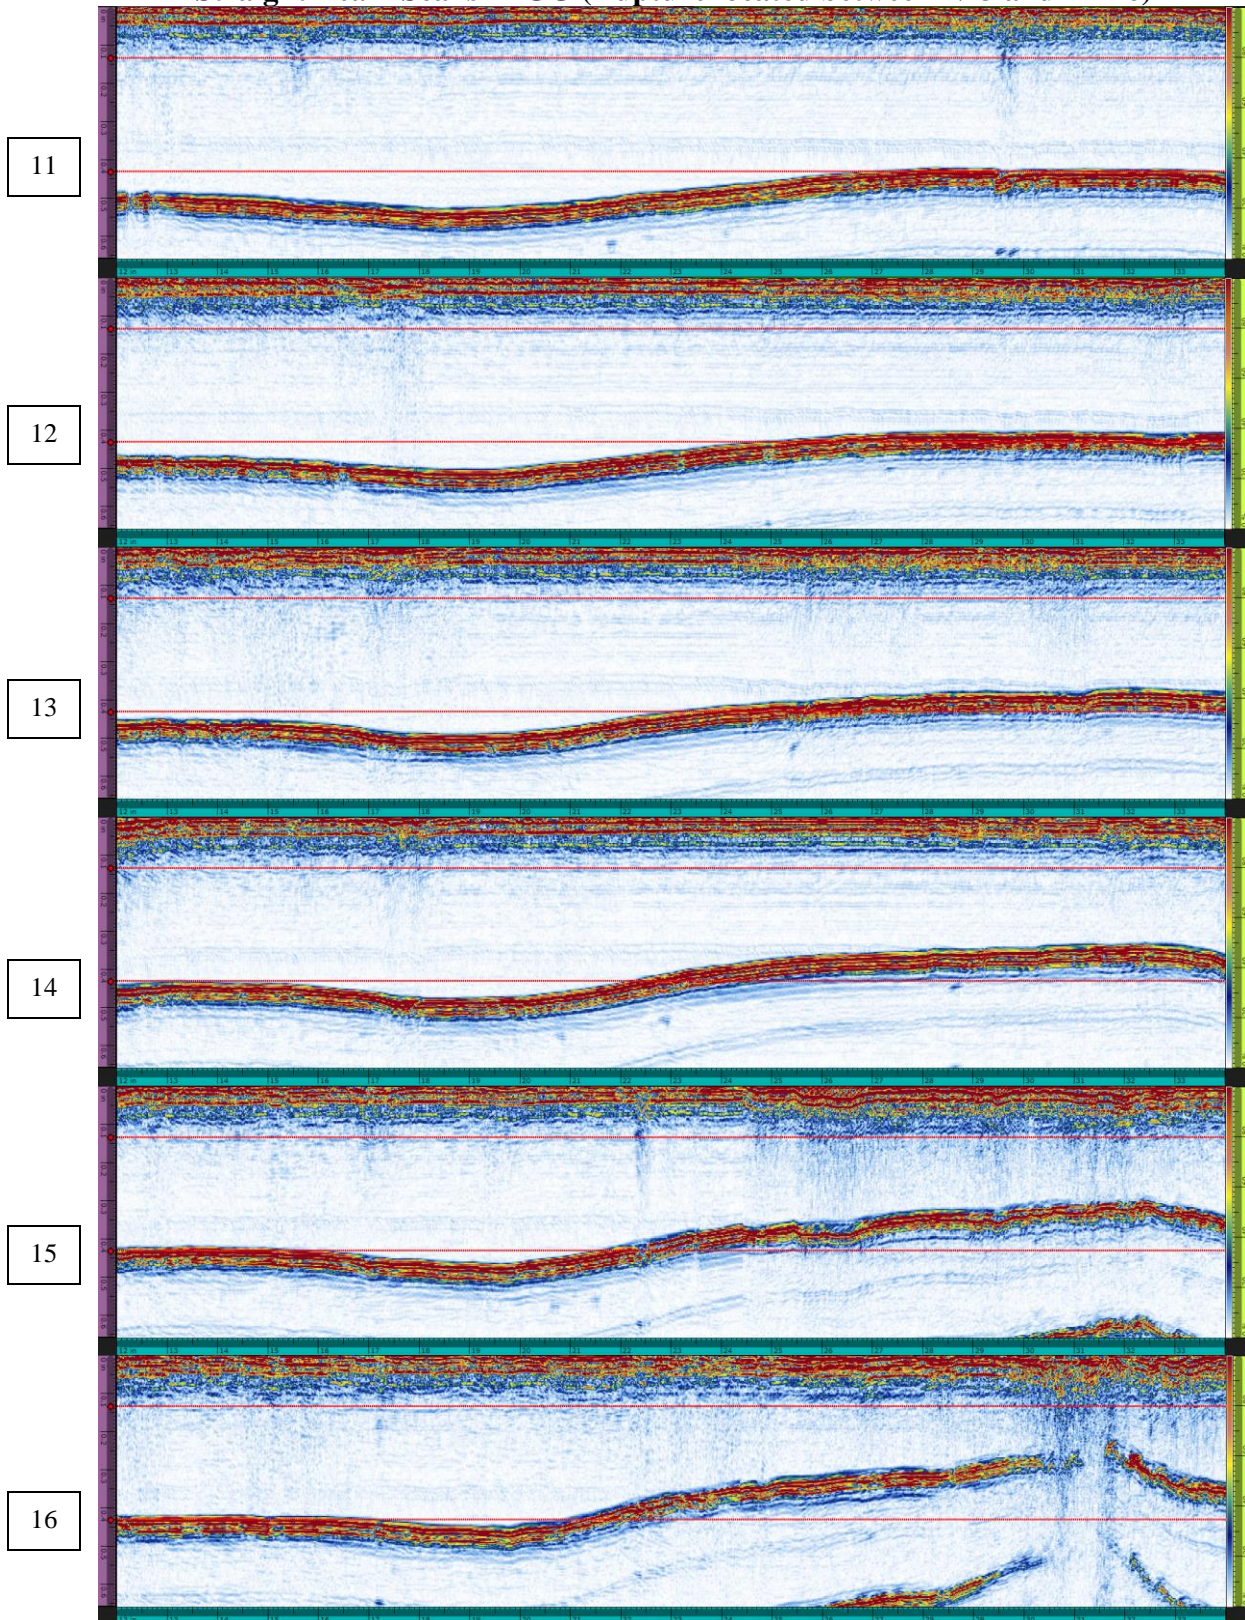
**Straight Beam Scans K-GG (Rupture located between N23 and DD16)**

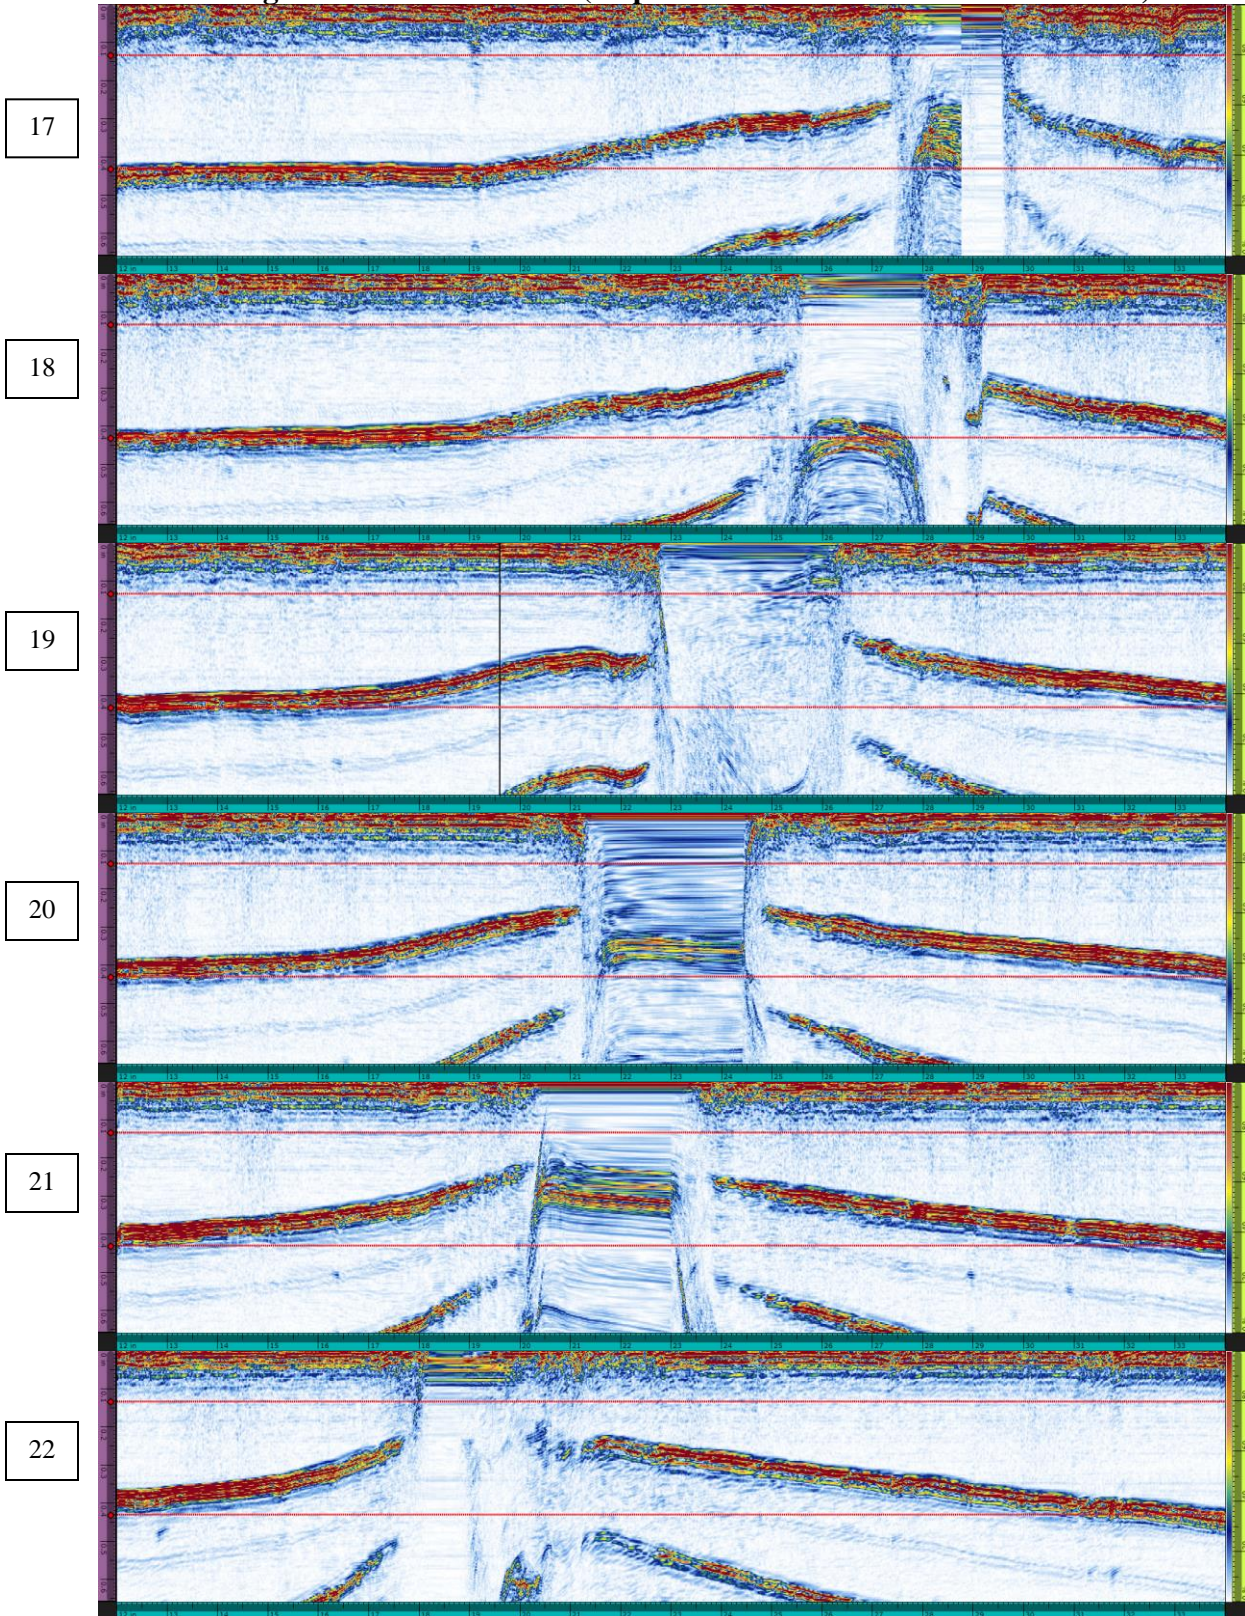
**Straight Beam Scans K-GG (Rupture located between N23 and DD16)**

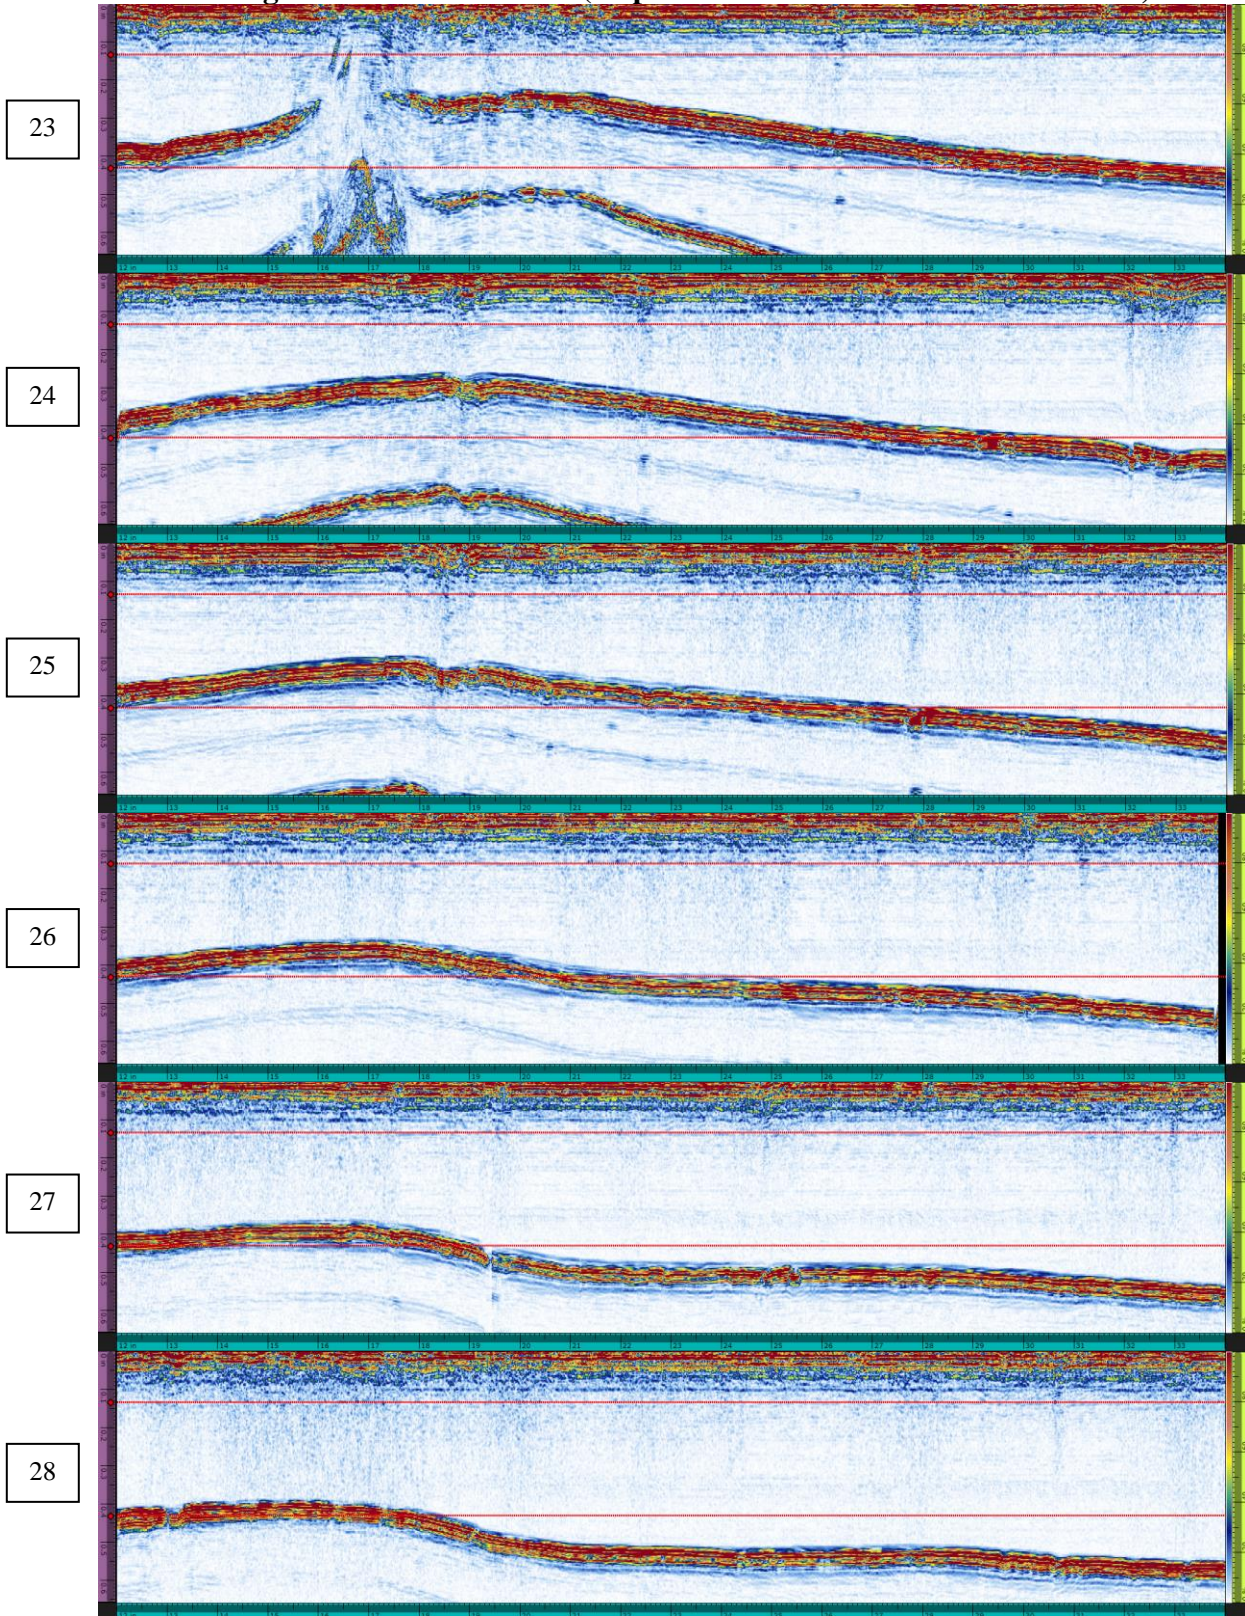
**Straight Beam Scans K-GG (Rupture located between N23 and DD16)**

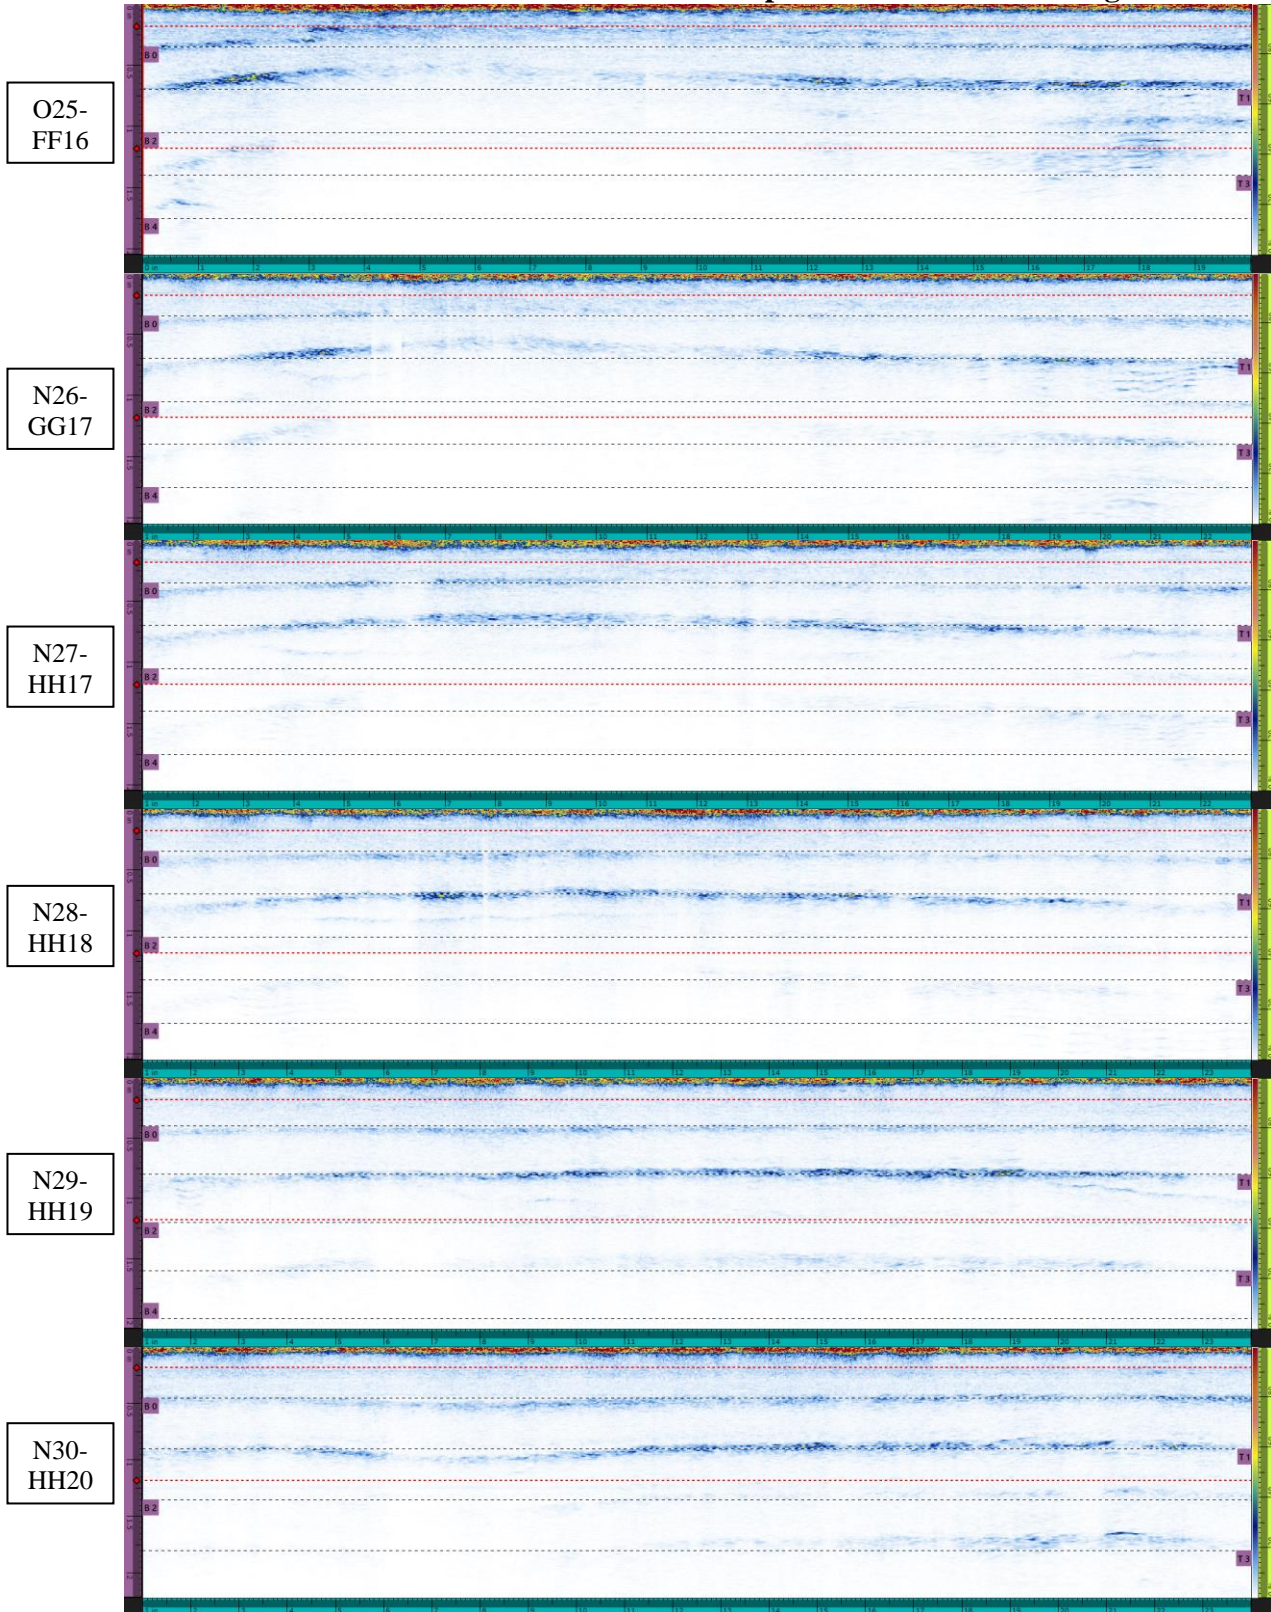
PAUT Sectorial B-Scans Parallel to Rupture – Skew 90 at 45 Degrees

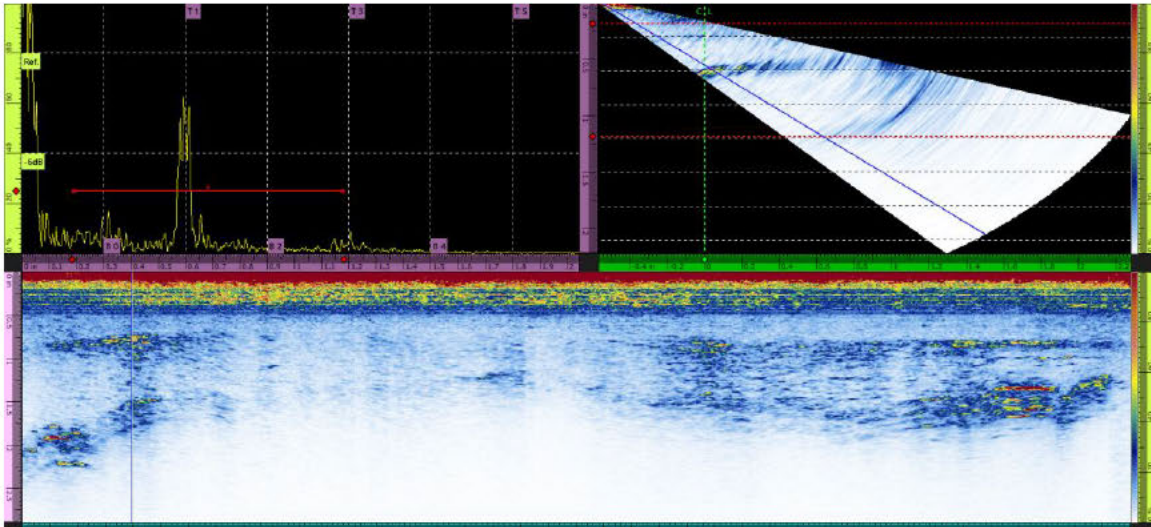
O25-  
FF16

PAUT Angle Beam Merged B-Scans –Skew 90 O25-FF16, N26-GG17, N27-HH17

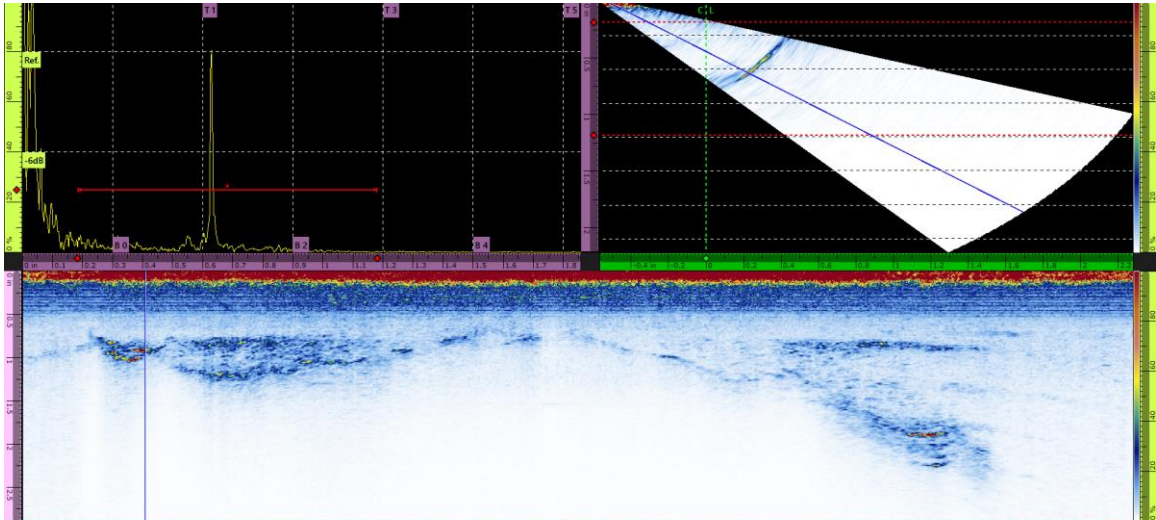
L24-  
FF13

PAUT Angle Beam Merged B-Scans –Skew 270 L24-FF13, L23-FF12, K23-FF11

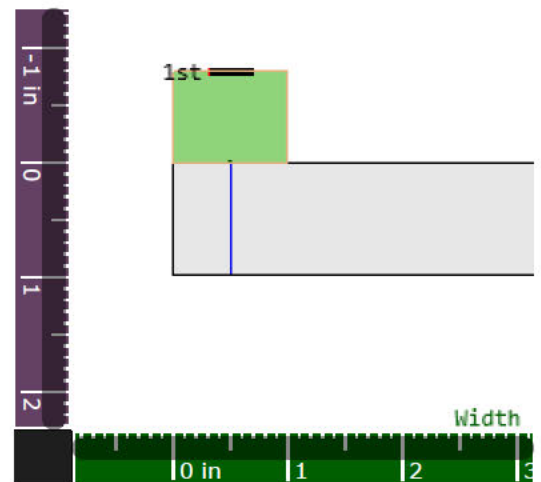
Data File Name	TTC TK Sample 2 0 K11-GG11.nde
Inspection Date	07/10/2024 11:44
Report Date	07/17/2024 17:10
Procedure / Code	SOP-PAUT-03 R0 / ASTM E2700
Remark	Variations in wall thickness (thinning) coincide with location of rupture.

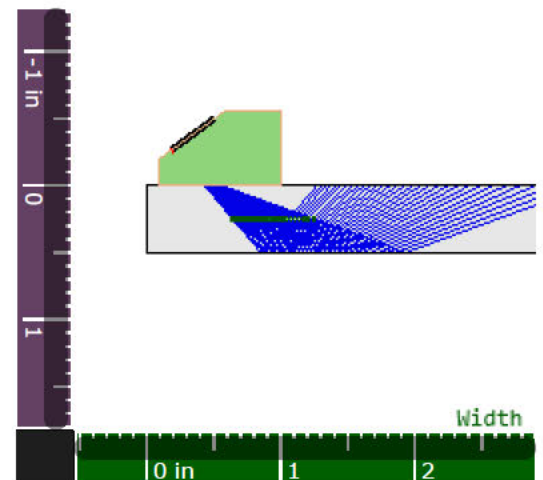
Data File Name	TTC TK Sample2 AA19-JJ19 90.nde
Inspection Date	07/09/2024 16:18
Report Date	07/17/2024 17:14
Procedure / Code	SOP-PAUT-03 R0 / ASTM E2700
Remark	No significant surface or interior indications detected other than that from rupture.

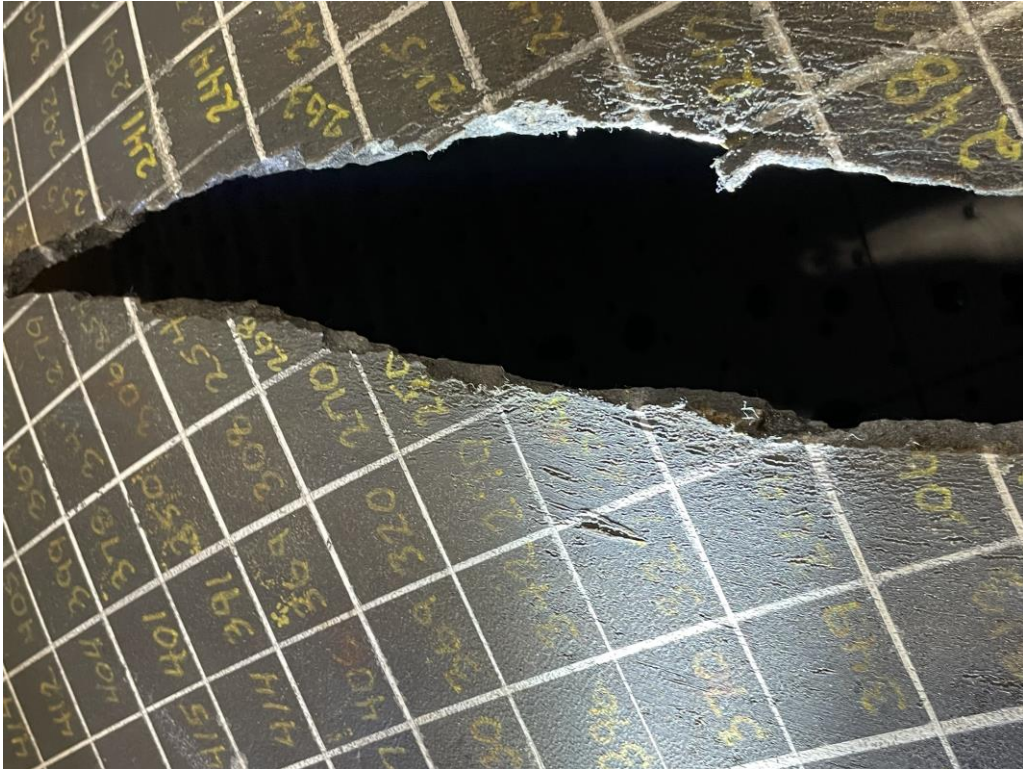
OD surface prior to PT
