## Federal Railroad Administration Localized Corrosion or Material Degradation Form

Reporting Marks	NATX 400688	DOT Specification	112J340W
Date when damage first observed:	04/27/24	Location where damaged first observed (City/State):	Gallup, NM
NDT Method: MT___ PT___ UT___ UTT X VT X	Procedure(s)/Revision(s) Used: N/A	Original thickness of test coupon	.608
Equipment used: GE POCKETMIKE 35900	Equip. cal. date (if applicable): BEFORE USE _____	Cal block ID and Cal. due date (if applicable):	FLAWTECH 26705 _____
Cable type/length (if applicable):	N/A	Scan techniques/plans (if applicable):	POINT
Search Unit(s) (if applicable):	Angle /MHz:  N/A 5MHz	Size:  .475	Serial #  5191
Couplant/Penetrant/Particles manufacturer/type (if applicable):	GE REF 0102790	Exam date/time: 05/24/24	Special equip. (if applicable): N/A
Coupon Location - Ring #, B or A Head:	B-HEAD	Clock Position Top = 12, Bottom = 6, facing the B head:	N/A
Surface conditions, Surface Temp. and side(s) examined from:	Surface CLEAN ID___OD X Surface Temp: N/A	Indication(s) (Type/Size/Location):	Thermal tear 18" long Undercut in two places @ jacket standoff welds 1" each

Client	ENSCO, Inc.	Inspection No.	PAUT 24-0710-02	Contac

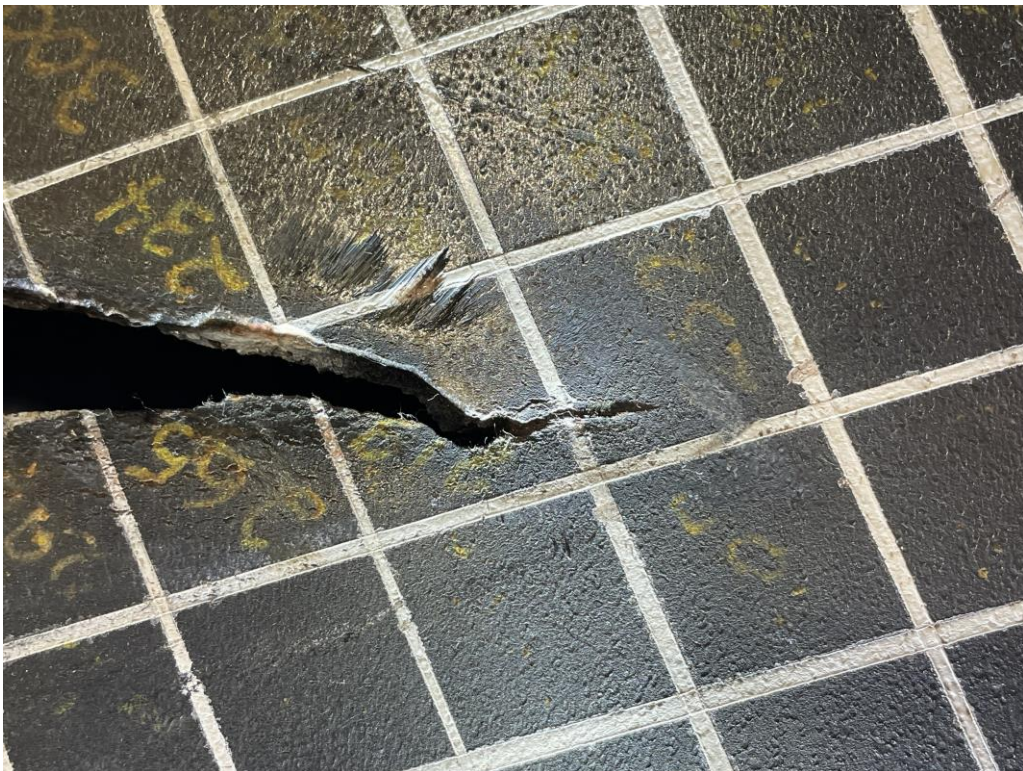
OD surface prior to PT

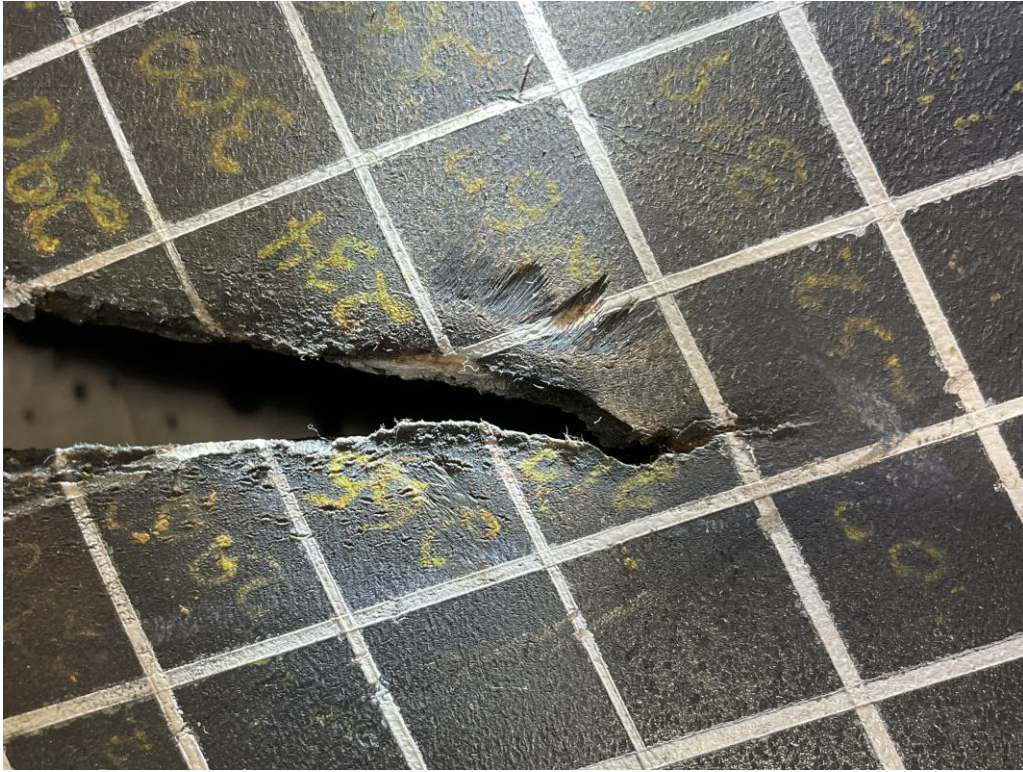
OD surface prior to PT

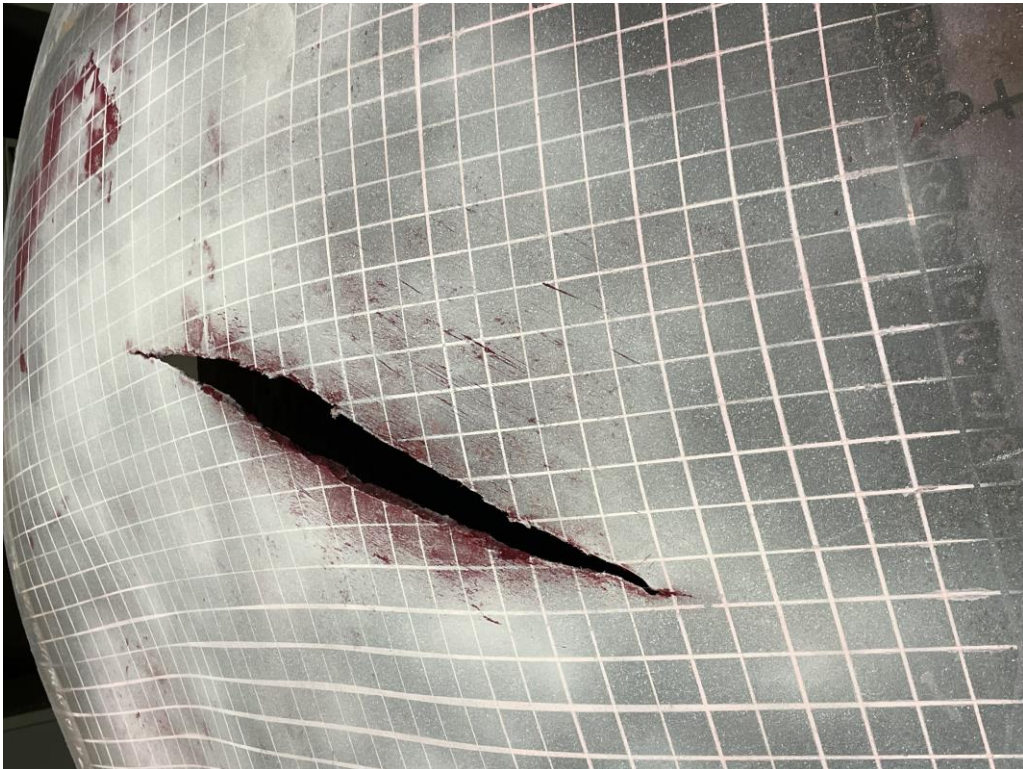
OD Surface with PT

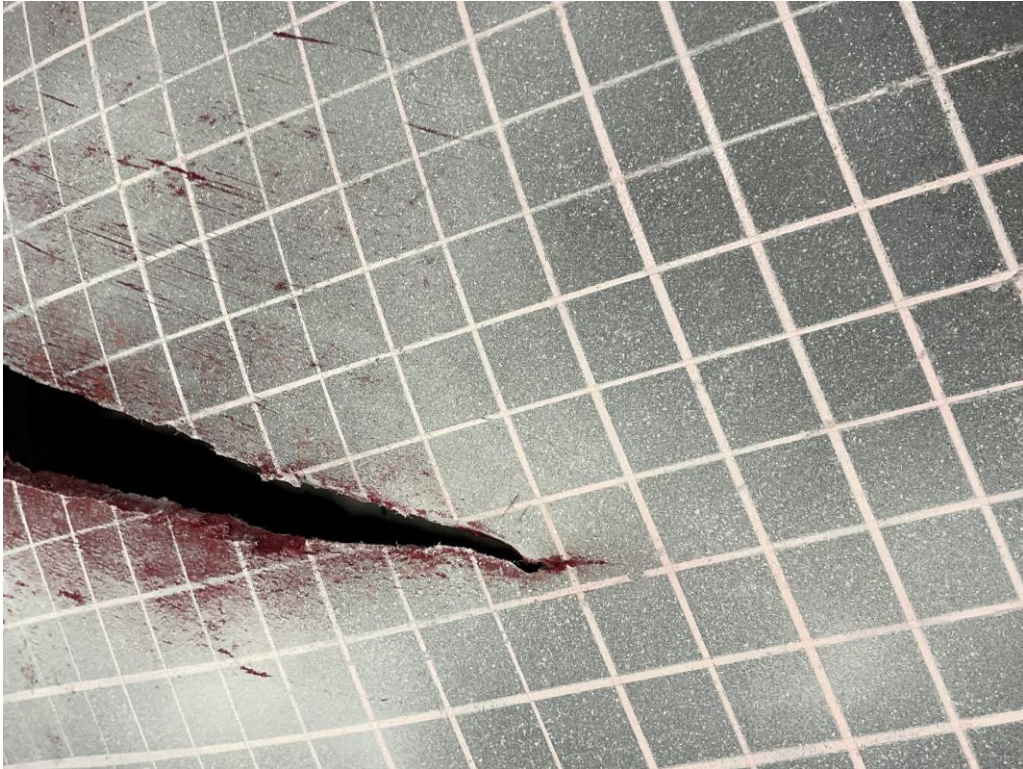
OD surface with PT

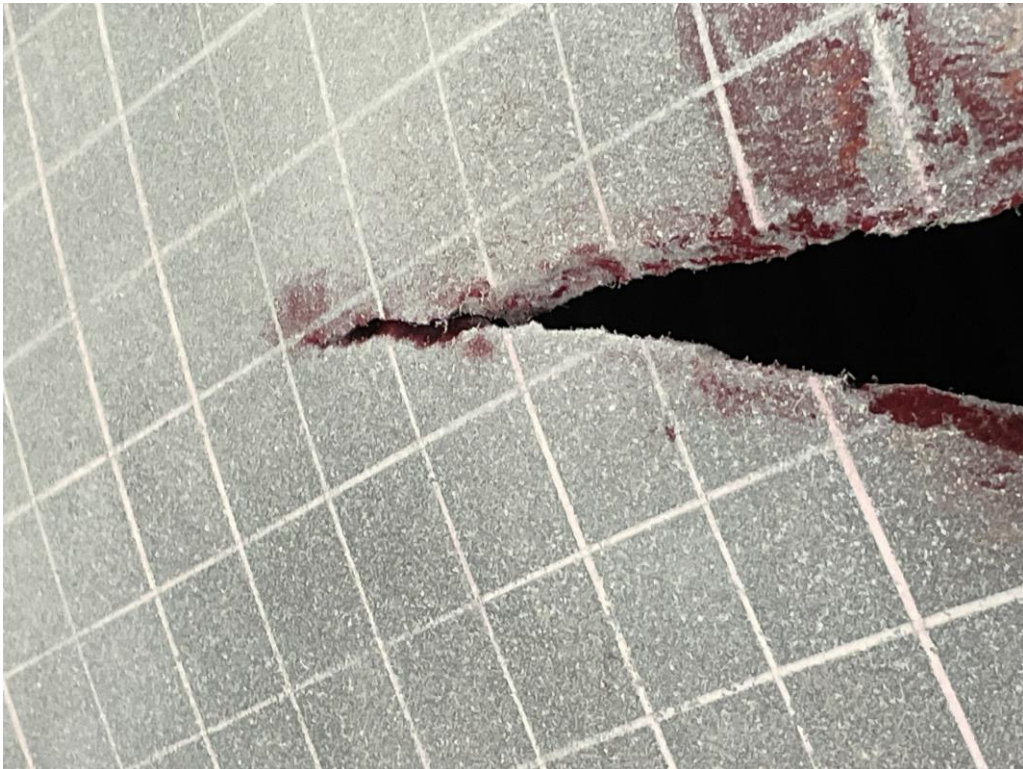
OD Surface with PT

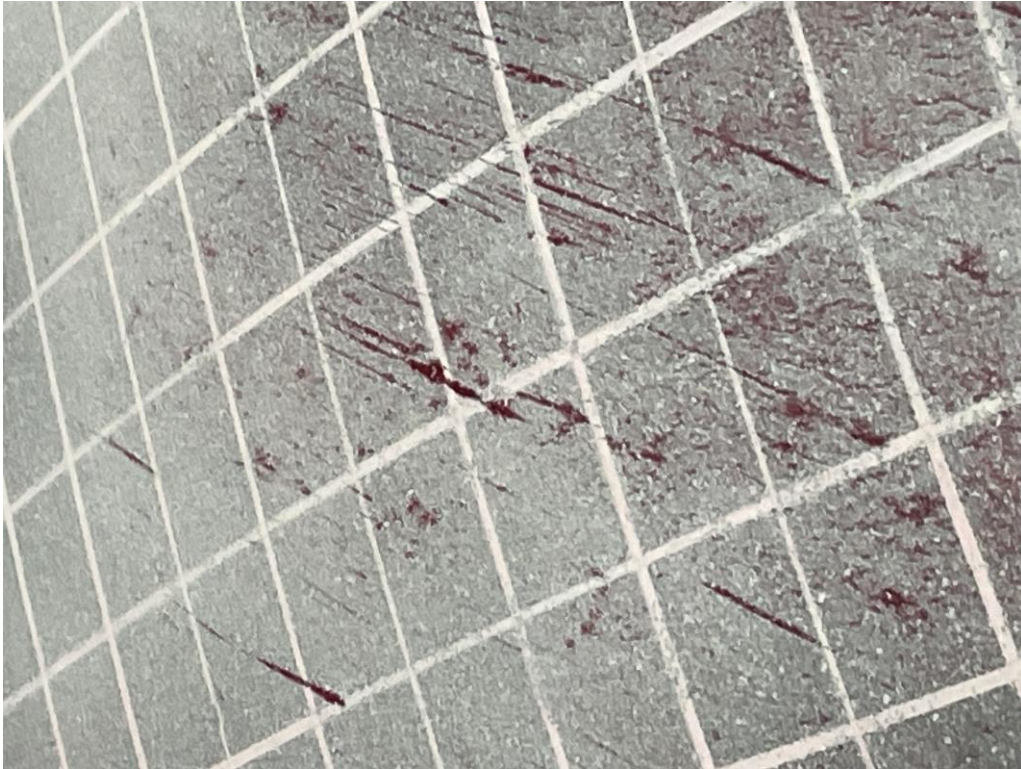
OD surface with PT – Mechanical Scratches

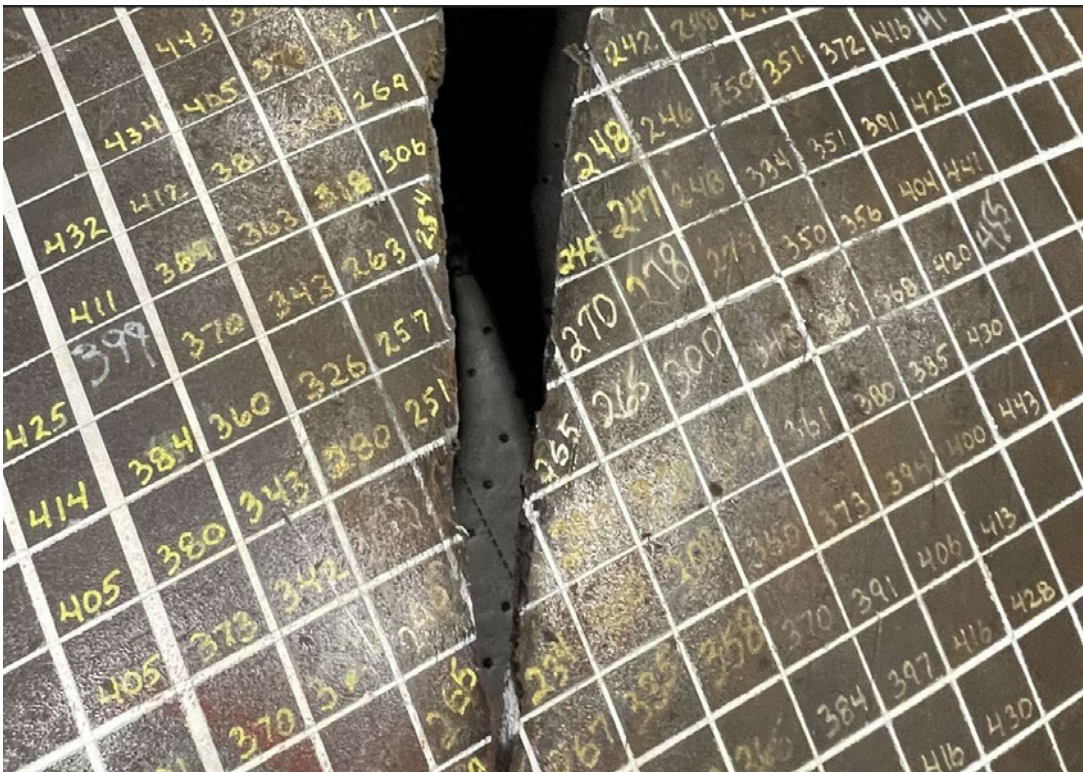
OD Surface Prior to PT – Mechanical Scratched Visible
