Federal Railroad Administration  
Tank Car Damage Assessment Form

Reporting Marks	GATX 3501		Car Location City/State	HYNOMAN, PA.	
Date inspected	8/5/17	Railroad	CSX	DOT Specification	DOT-111A100W-1
Last Contained	ASPHALT 3257		Was product released?	NO	
(Jacket thickness)	Jacket YES	Non-jacketed	Does car contain product	YES	
Car builder	TRINITY	Stub Sill Design	Built Date	03/1991	
Capacity (GAL)	23629		LD Limit (LB)

# Car Damage Report

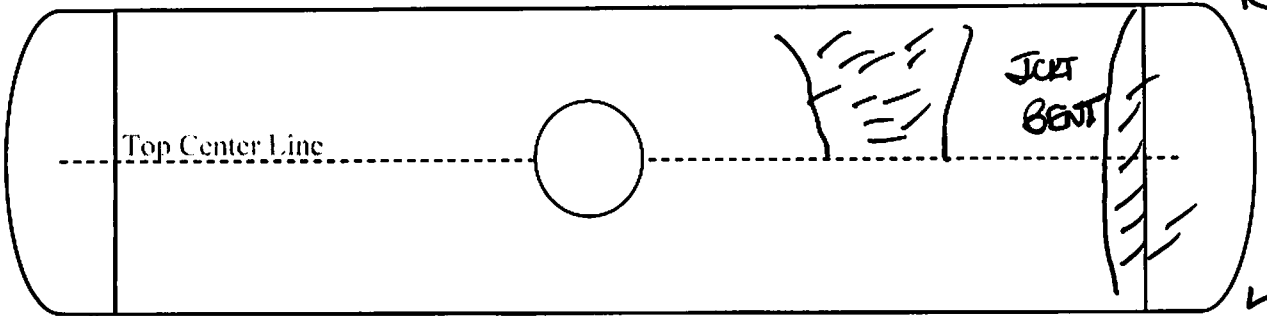
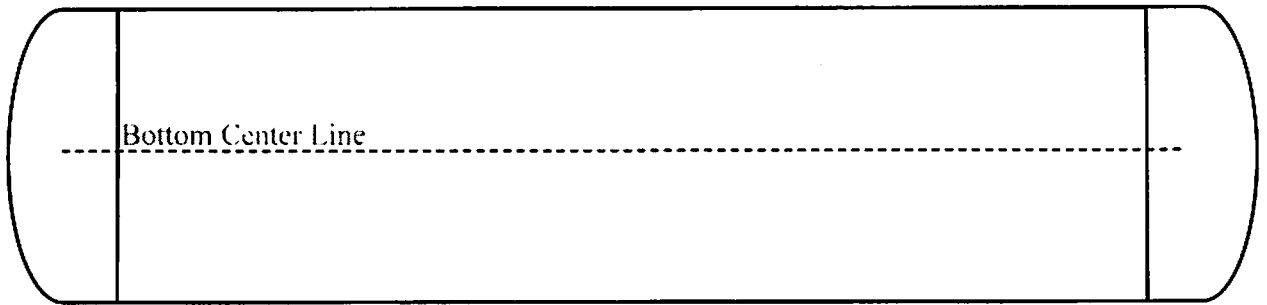
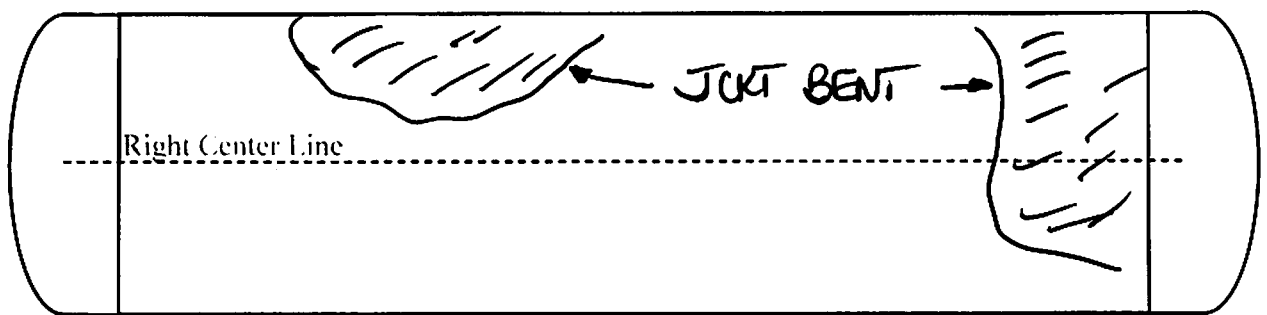
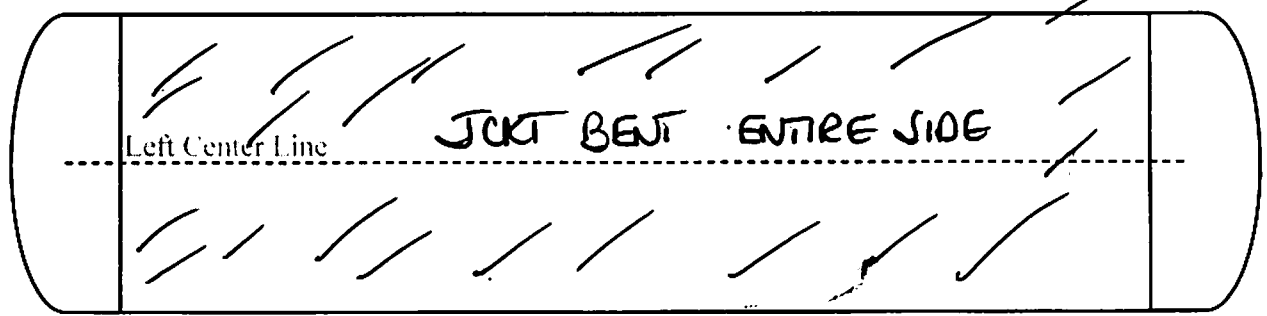
NOTE:  
 BON MIDLAND  
 ASH IN PLACE  
 OUTLET CAP &  
 NOZZLE  
 SHEARED OFF

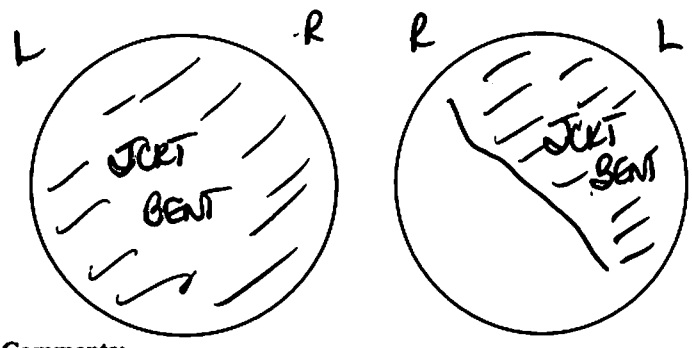
NOTE: GAZ BURIED.  
 BOLTS BURIED

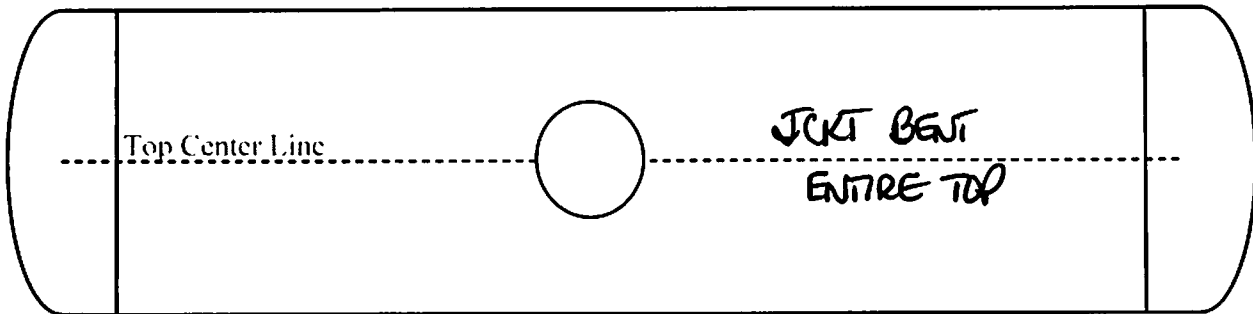
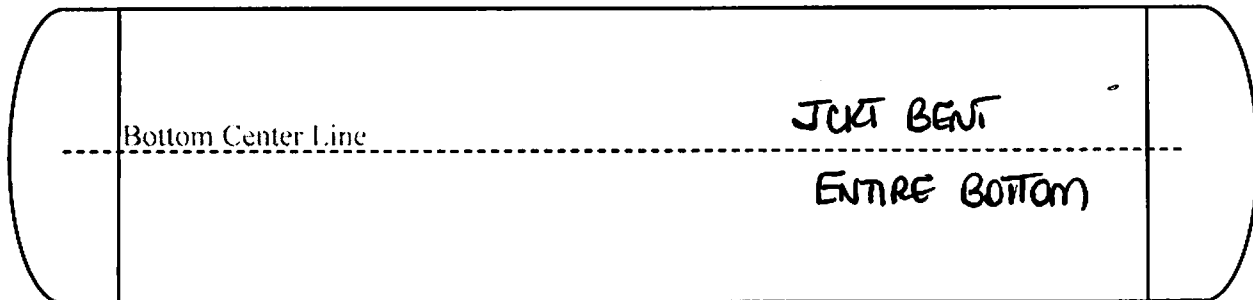
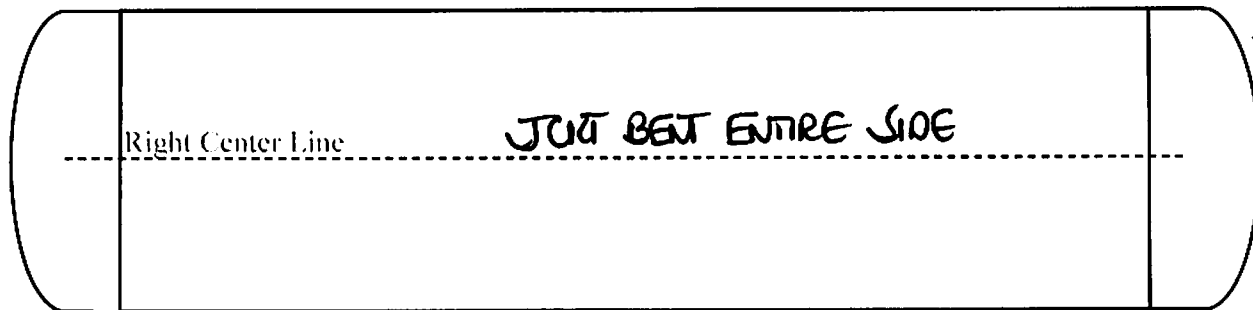
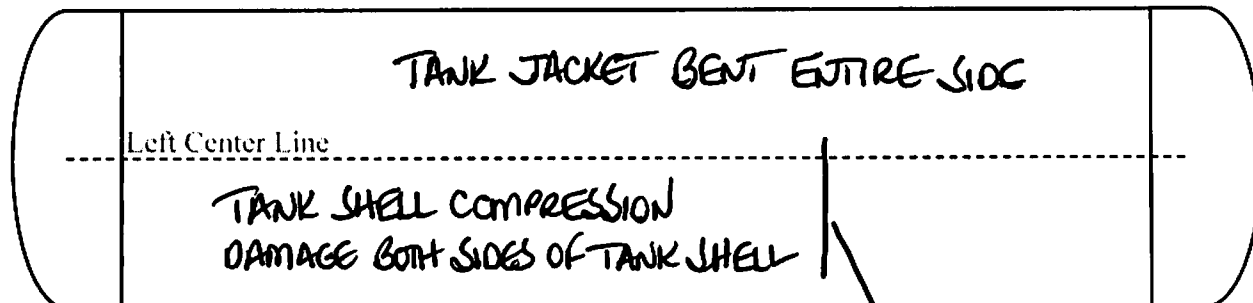
NOTE: ALL 4 BOON BOLSTERS BENT  
BOUN IN PLACE

6'0"  
TEAR IN JCKT

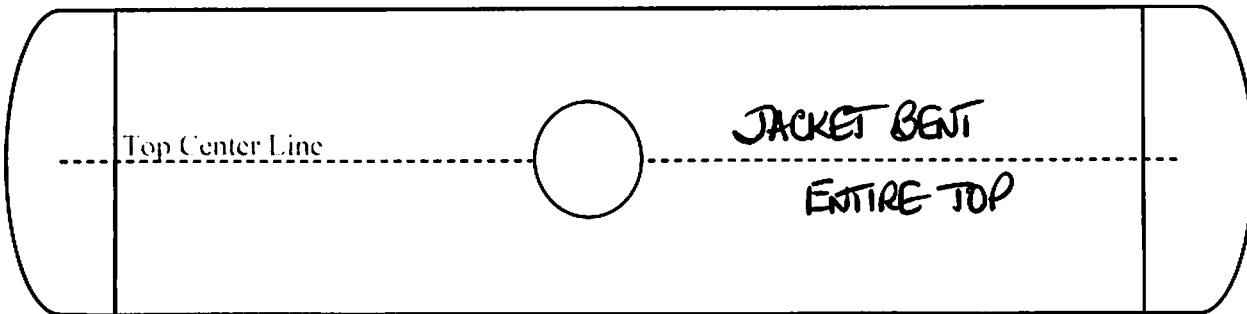
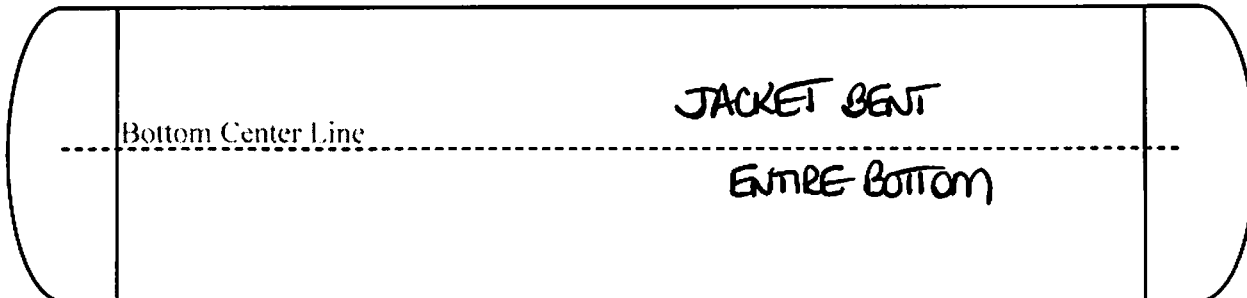
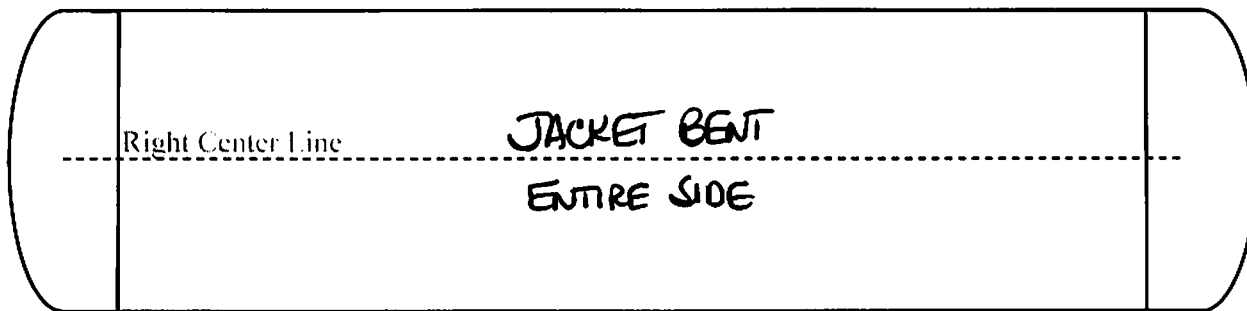
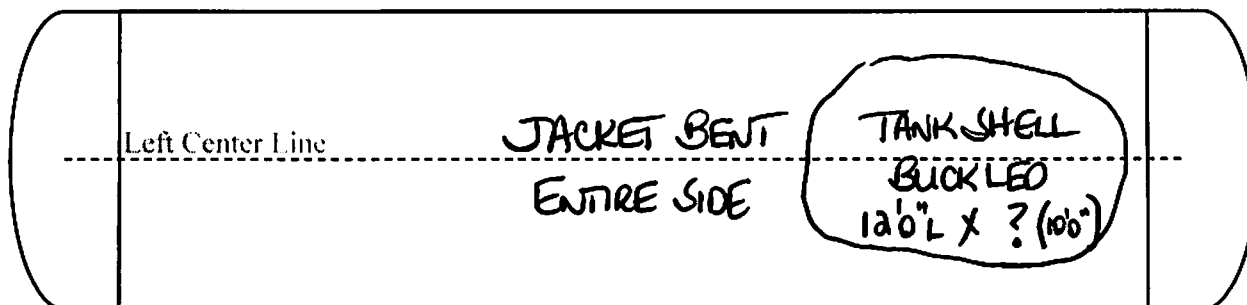
NOTE: ALL 4 BODY BOLSTERS BENT

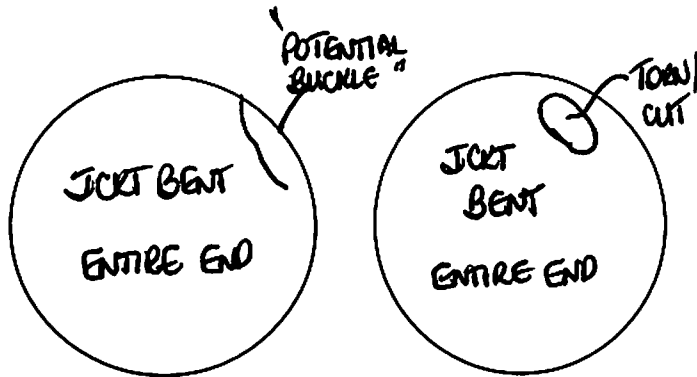
SUX 299124

A END DRAFT SILL TWISTED & BROKEN  
 B END INTACT - BURIED IN SOIL

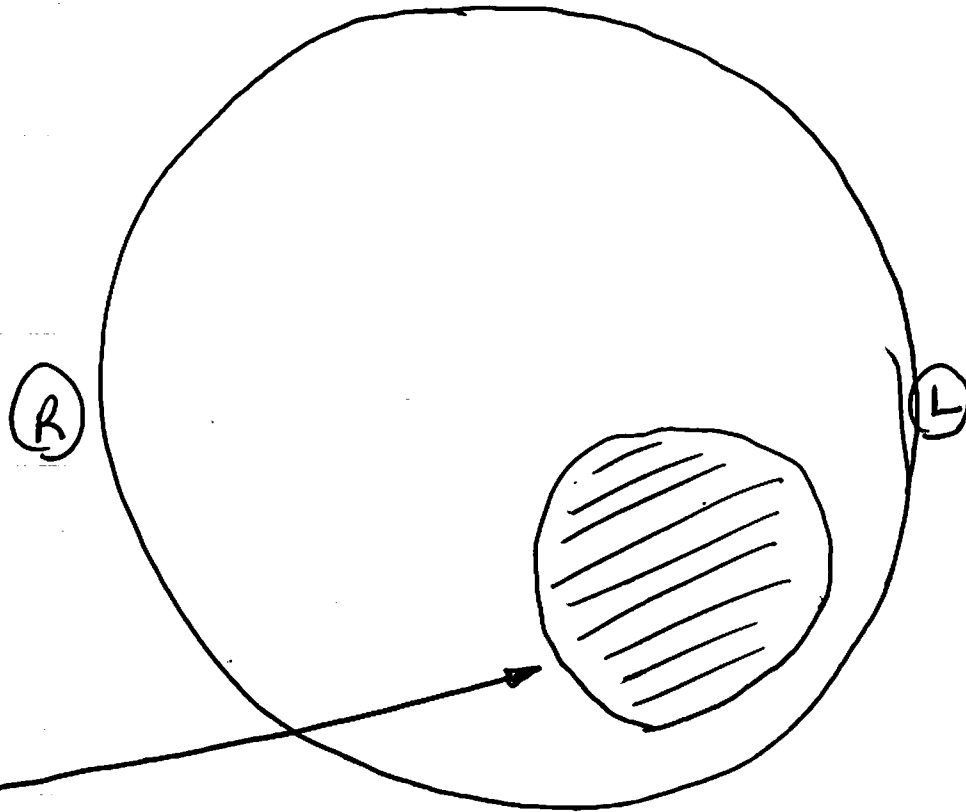
SHQX 5290

6" DEEP }  
48" DIA }

A HEAD SHIELD

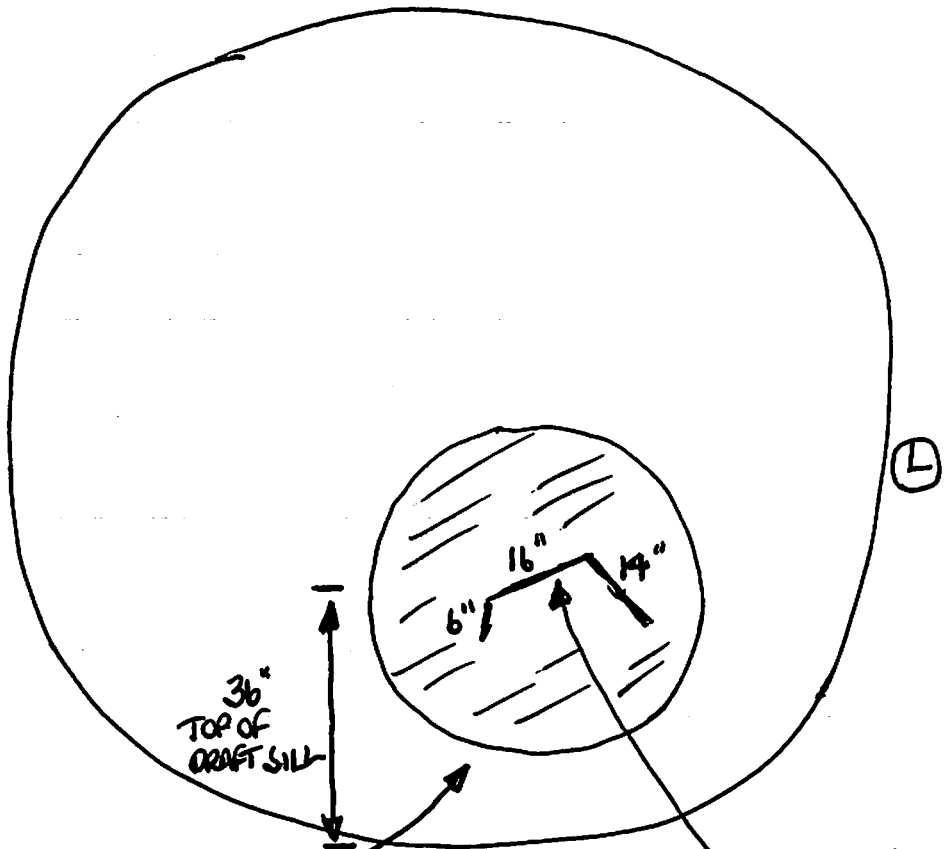
SHOX 5771

A HEAD SHIELD

8" DEEP  
36" DIA. }

CUT IN SHIELD

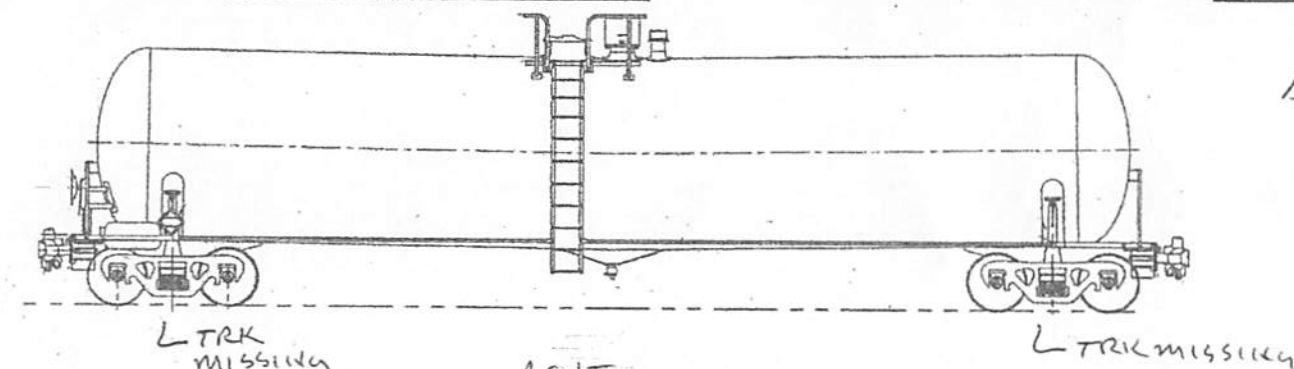
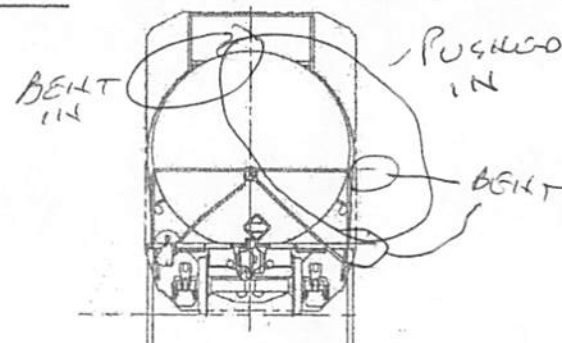
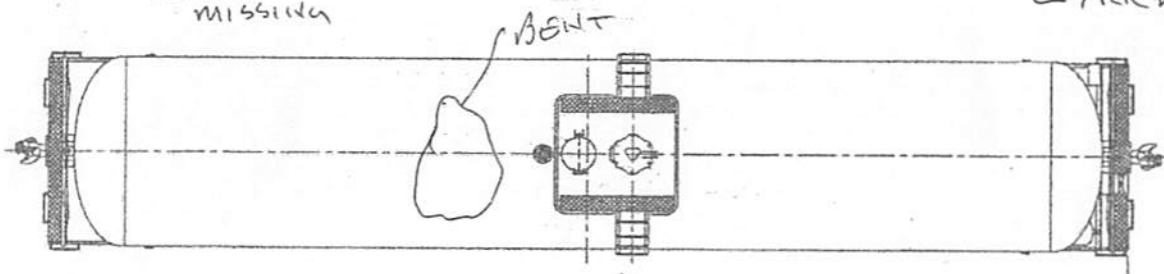
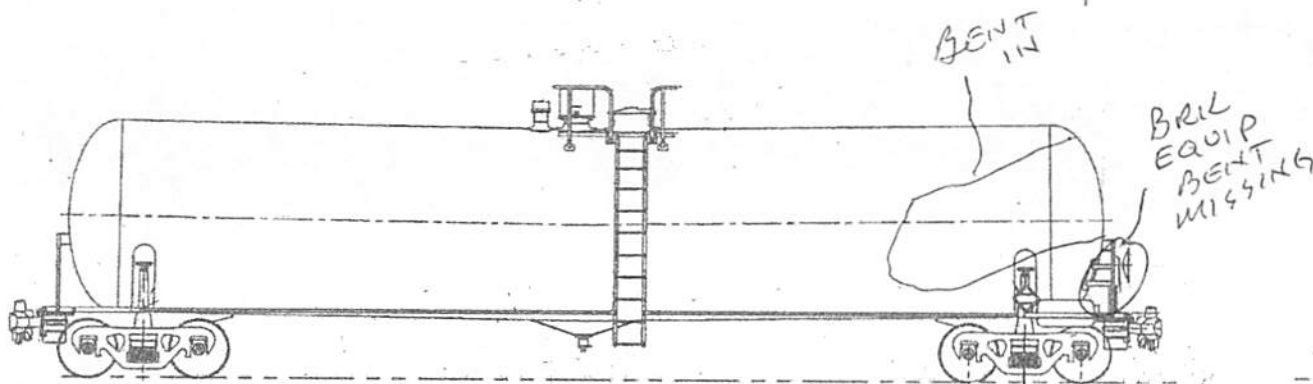
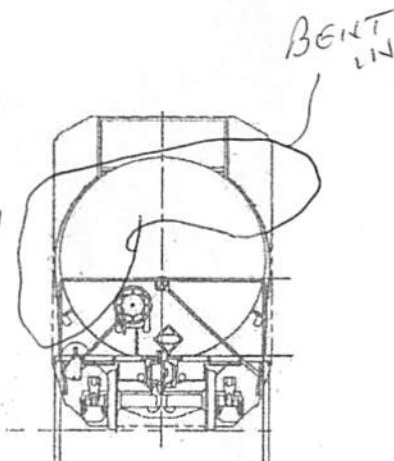
Car Number GATX 3501

Top fittings IN TACT  
Bottom Outlet IN MUD HATCHOLE & COIL PIPES OK  
Punctures NO  
Draft sill A-Burred B-Burred

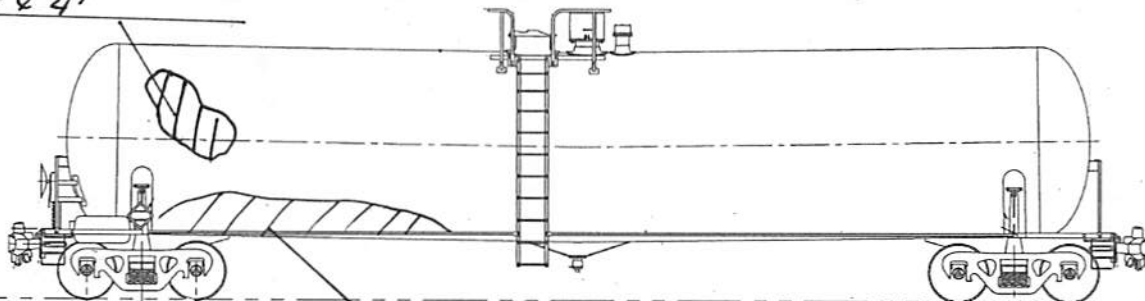
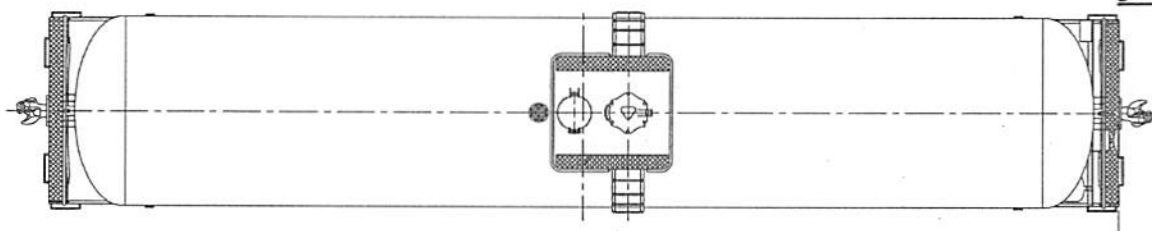
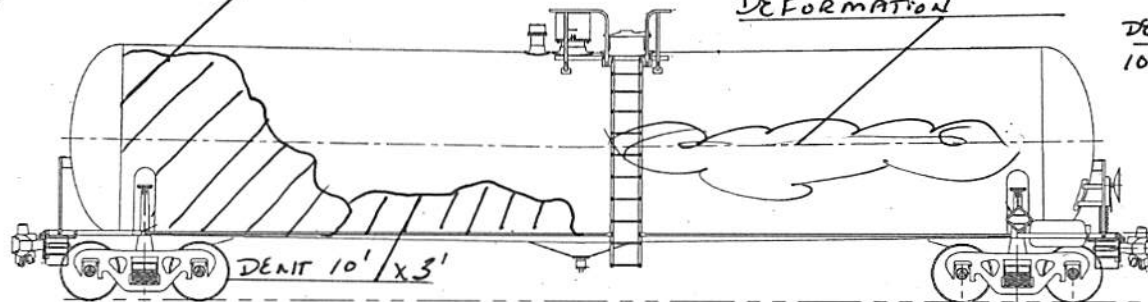
Car Number SHLX 383

DENT 4' x 4'

DENT 11'

DENT 6' x 6'

DENT 7' x 5'

DENT 5' x 3'

DENT / DEFORMATION 100" x 120"

DEFORMATION

DEFORMATION  
10' x 4'

DENT 10' x 3'

DENT 4' x 3'

Top fittings INTACT  
Bottom Outlet \_\_\_\_\_  
Punctures \_\_\_\_\_  
Draft sill A - BROKEN B - BENT

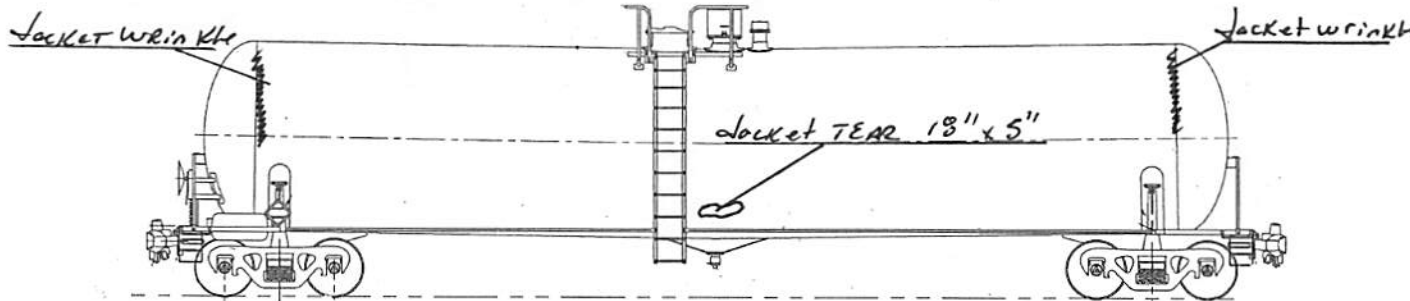
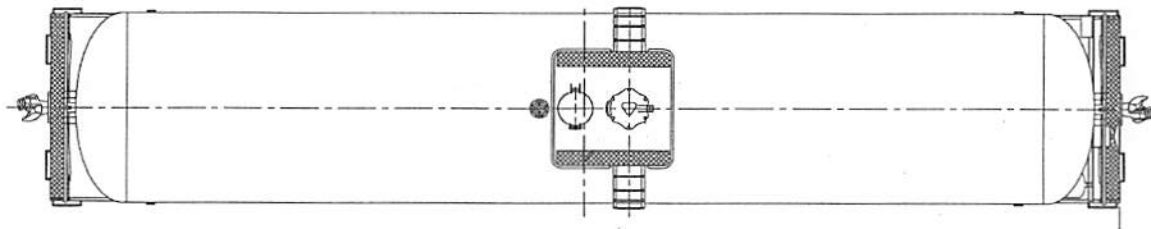
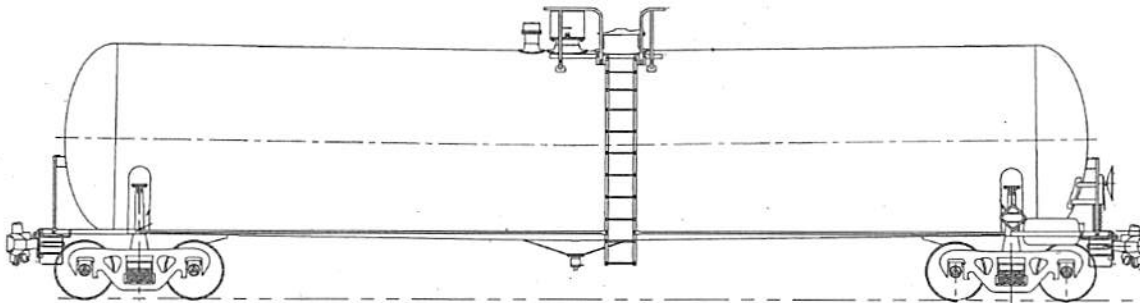
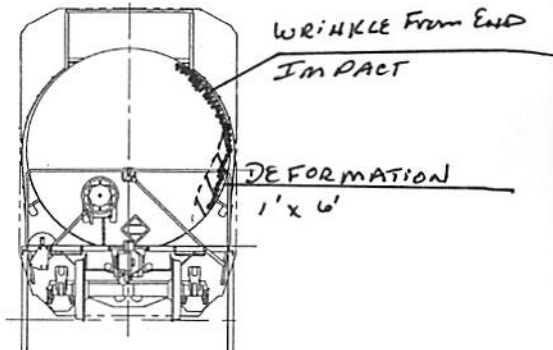
Car Number SHOX 5771

WRINKLE FROM END IMPACT

DEFORMATION 1' x 6'

Top fittings INTACT  
Bottom Outlet NA  
Punctures Right Side Jacket ONLY  
Draft sill B-TWISTED A-Buried

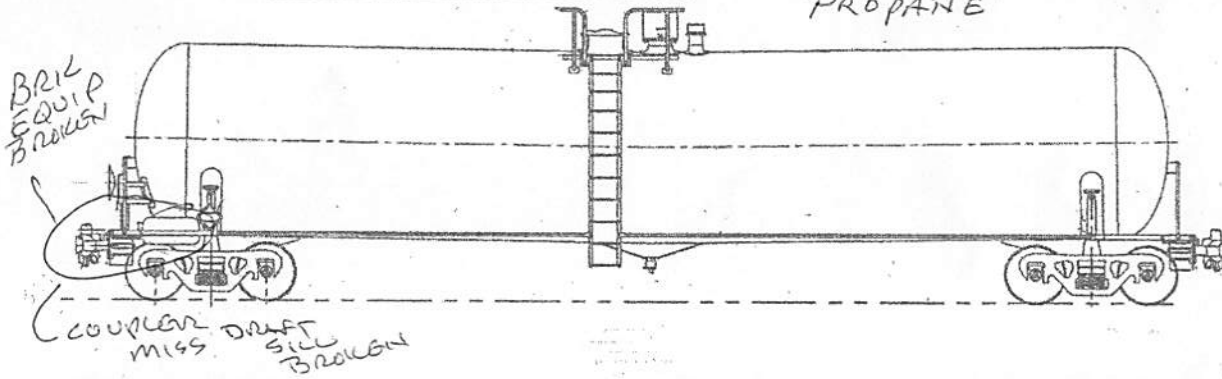
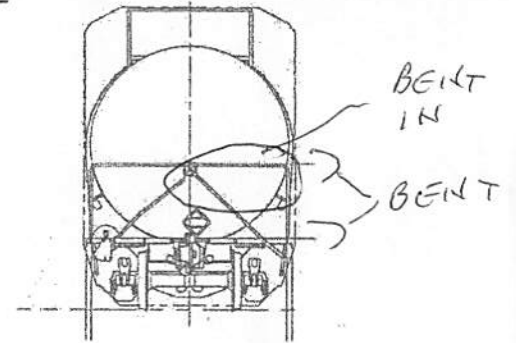
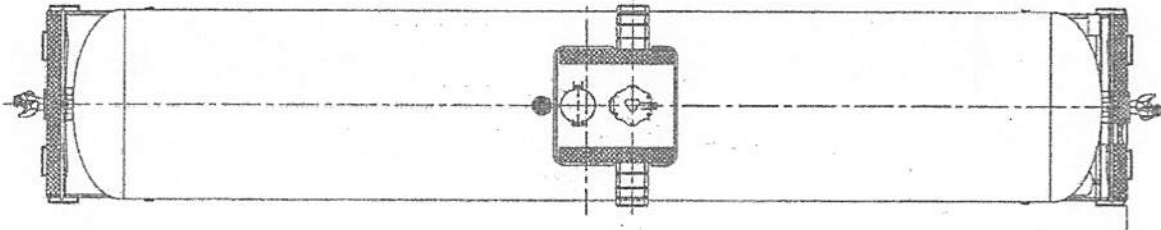
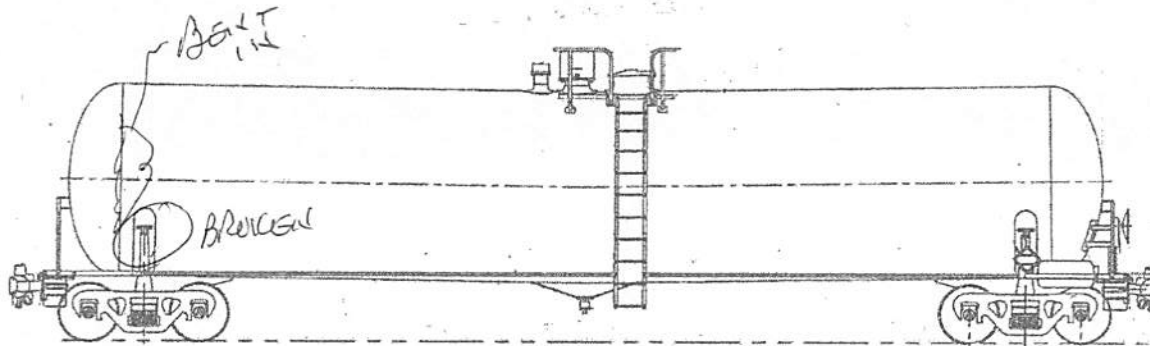
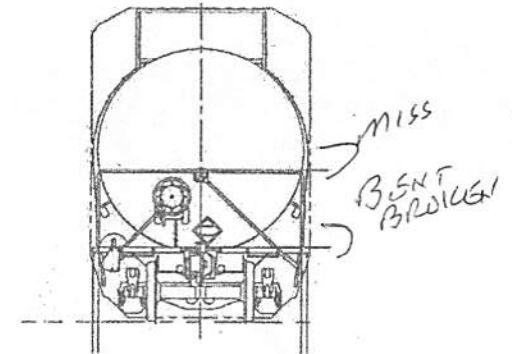
Car Number SHQX 5290

Punctures JACKET ONLY

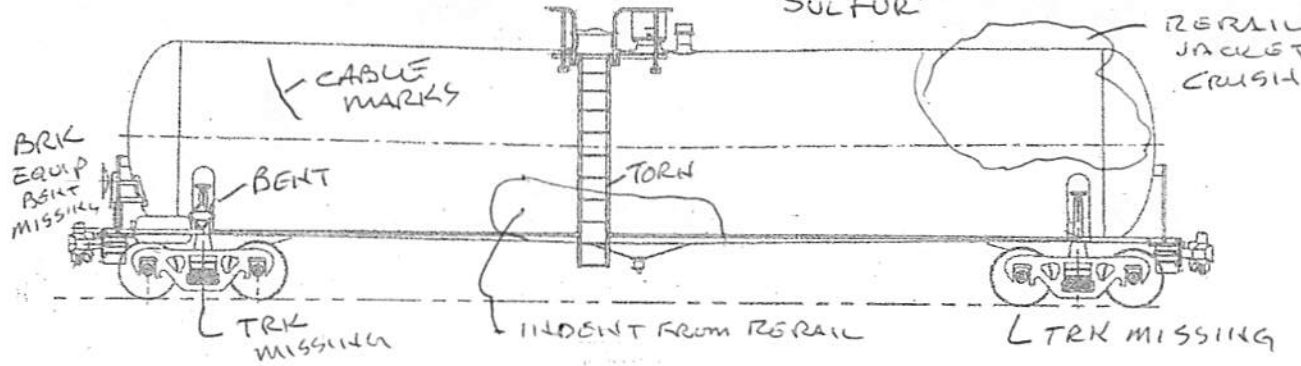
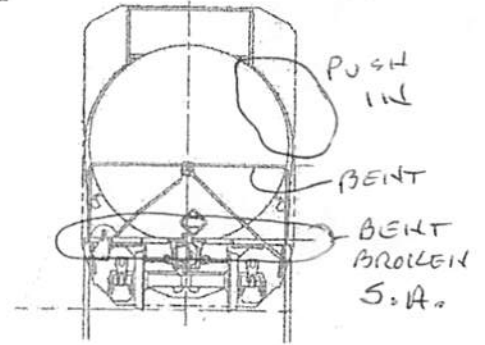
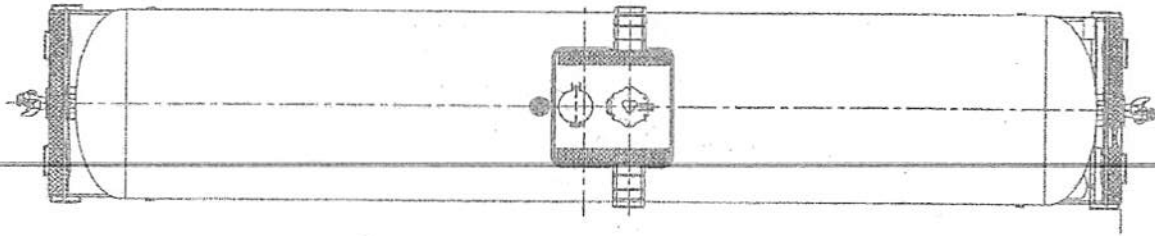
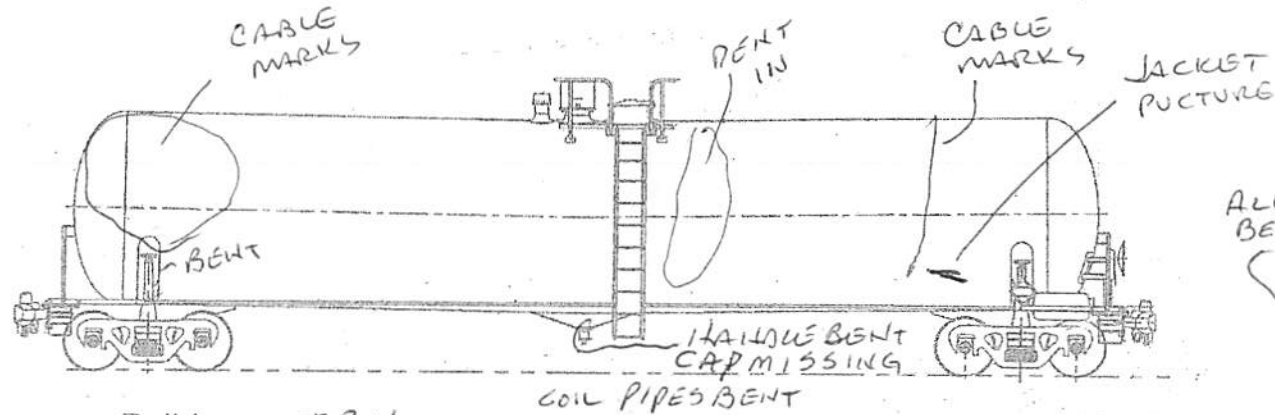
Car Number TILX 135361

Top fittings OK BONNET REMOVED FOR MOVEMENT

Bottom Outlet CLOSED ASSY OK HANGING BENT

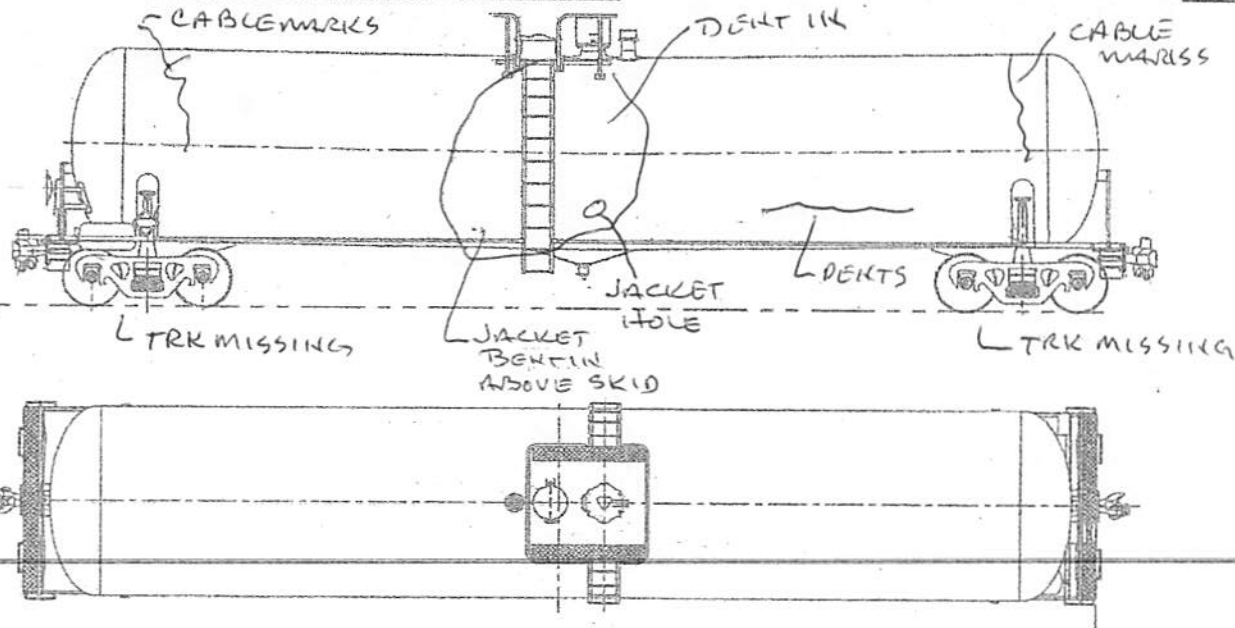
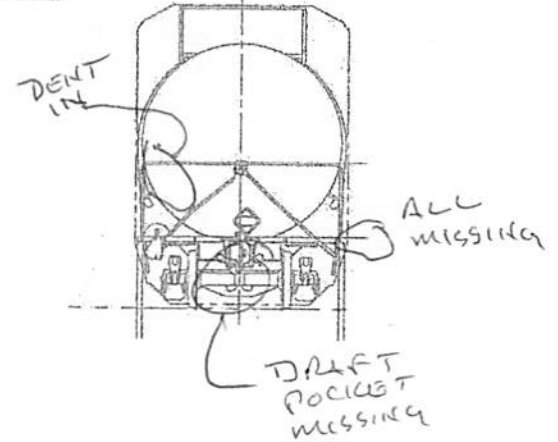
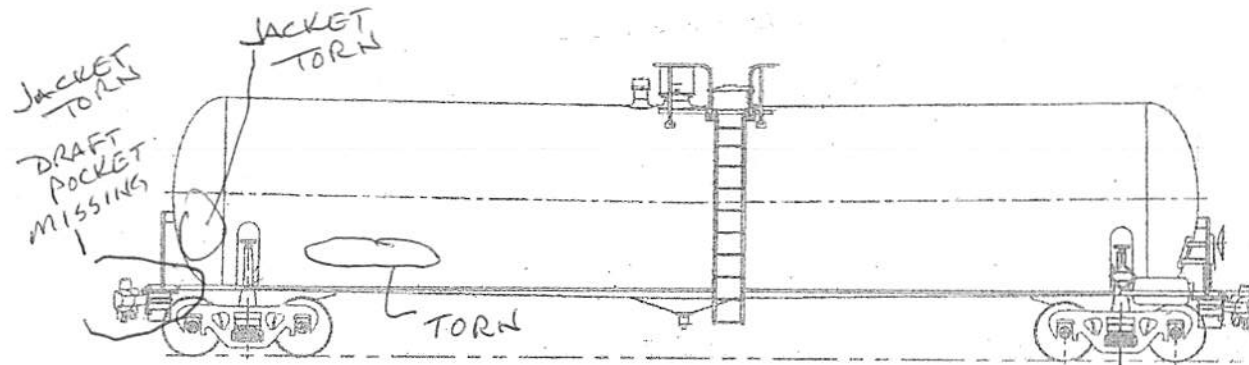
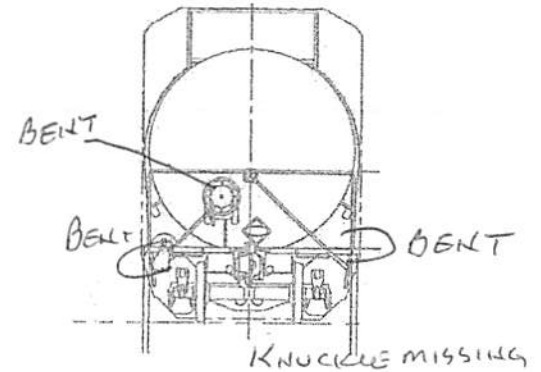
Car Number TILX 291055

Top fittings OK  
Bottom Outlet A ADAPTOR MISSING VALVE CLOSED  
Punctures JACKET ONLY HANDLE BENT  
Draft sill B - BENT & TORN A - TORN & SEPERATED

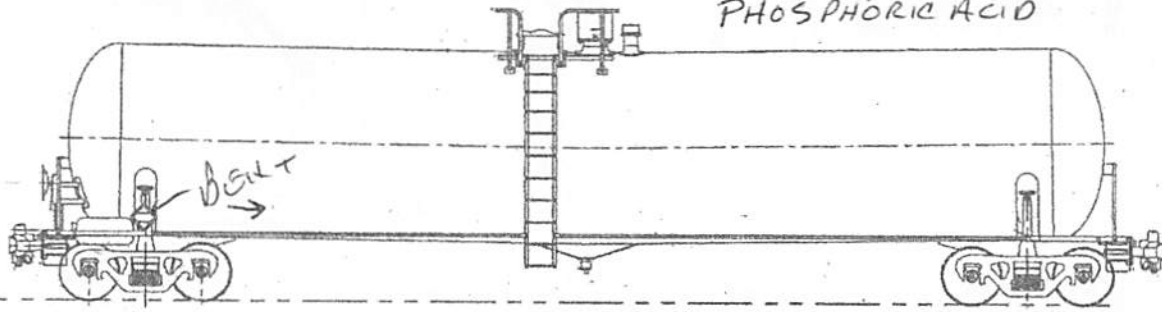
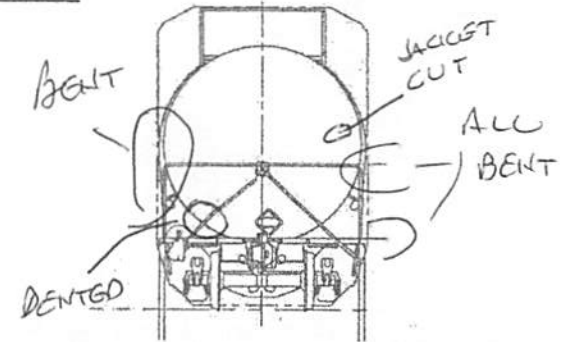
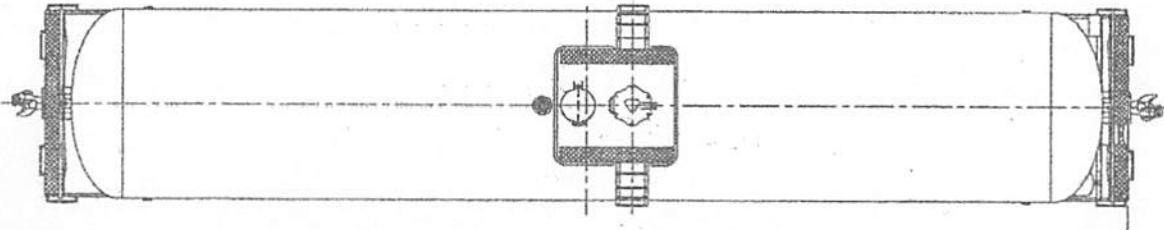
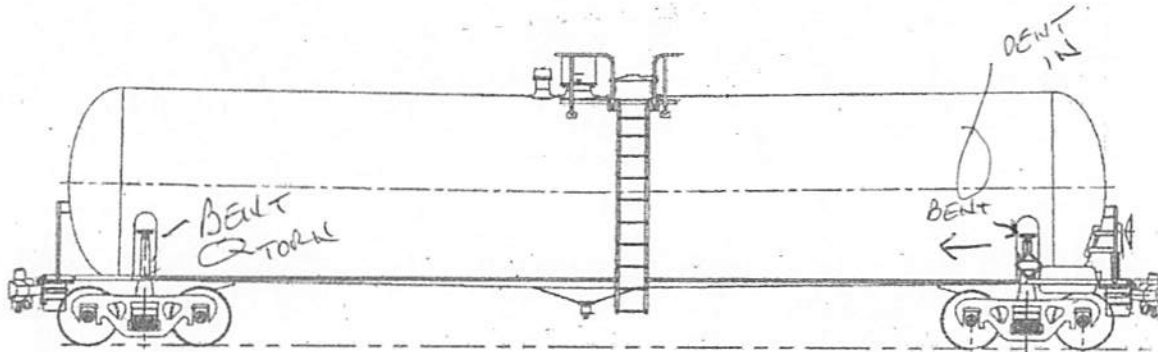
Car Number WACX 151157

Bottom Outlet IN MUD?

Punctures JACKET ONLY

Draft sill SLIGHT BENDING.
